Building 45

Chapter 11

Lisa Yeomans

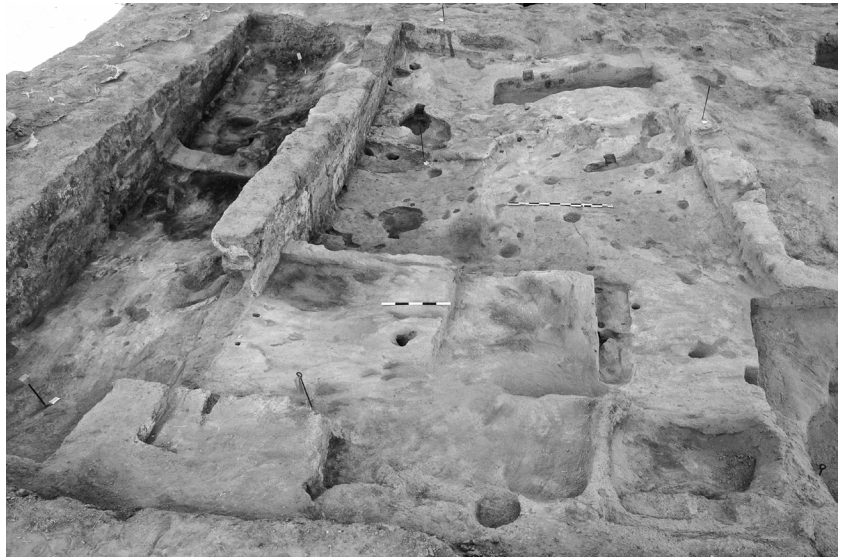
Figure 11.2. Overhead photograph of B.45 (Photograph by Jason Quinlan).

The archaeological deposits under the topsoil in the area of B.45 survived as a gradient sloping down west to east leaving the building better preserved on the western side compared to the eastern side. Where the mudbrick walls offered some degree of protection, the survival of the archaeological evidence was better and this was particularly notable by the western wall of Sp.228. The eastern platform F.1408, on the other hand, barely remained, and parts of an underlying midden were visible in patches where the platform had been completely eroded away. A post-Neolithic grave cut and a large late pit also truncated the north and southeast parts of B.45. Few artifacts were found in the pit but the small amount of pot, which was probably residual, dated to substantially later than the building ruling out the possibility that the pit was associated with the use or abandonment of B.45 (Fig. 11.2).

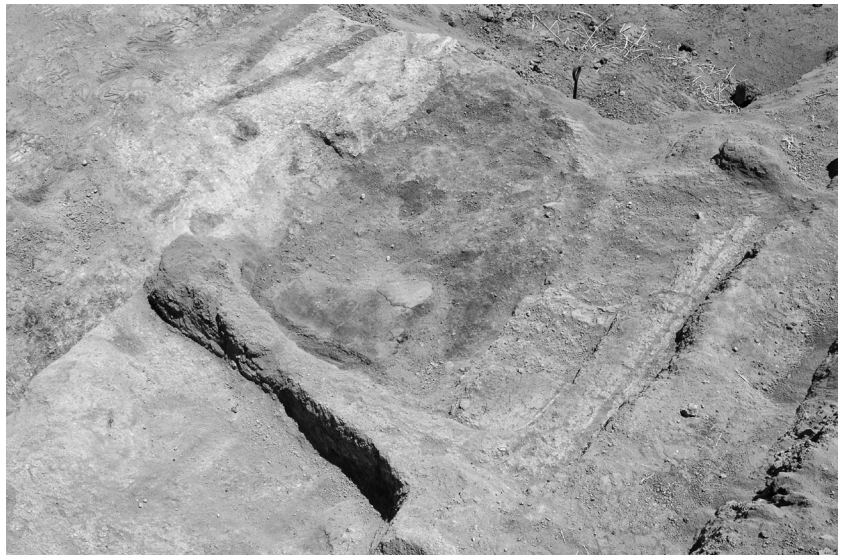
Figure 11.4. Oven F.1415 (Photograph by Elizabeth Tien Ha).

The oven F.1415 (Fig. 11.4) was planned in the original layout of the building. Two thin mudbrick projections extending from the southern external wall were constructed at the same time that the wall was built. The western of these extended 1.02m into Sp.228 and the eastern one had been truncated through erosion and by a large late pit. Despite this, the main part of the oven survived and these two projections demarcated the area of the oven. Multiple oven bases were constructed and used within this superstructure and three eroded burnt bases were excavated. These layers were built directly on top of one another: (10039), sealed by base (10038) and then (10037). Although badly affected by erosion, these bases seem to indicate a square oven base with rounded corners. The shape of the oven also suggests that the third of the oven base rebuilds was larger, extending further southwards. The floors around the oven associated with these oven bases have been lost to erosion and truncation. A micromorphology sample was taken though the floor surfaces around the oven where they had been truncated by the late pit. *“This indicated that in the early phases of the building the floors in front of the oven area were made from thick gray-brown or slightly orange-brown sandy silt loam, with anthropogenic debris. The surfaces of the floors were abraded and irregular, suggesting considerable use of this area, although they were generally kept clean, with only occasional layers of burnt fuel, with charred woody fragments, ash, and gramineae phytoliths. Only one plaster in this sequence was made from whitish sandy silty clay, with charred flecks in contrast to the northern platforms. In the later phases of the building, following a major episode of leveling, the plasters in front of the oven area were more consistently made from gray silt-loam to sandy silt loam plasters, with charred plant and other anthropogenic inclusions. These surfaces were kept very clean, and probably covered in mats, with smoother surfaces and accumulations of thin dust, <0.05mm thick. As in the earlier sequence, only one plaster was made from white sandy silty clay, c.5mm thick, at the end of the use of this area”* (Volume 9 Chapter 7 pp). This floor sequence around the oven was not excavated as work within B.45 was limited to one season and, because of erosion, the latest excavated floor layer did not survive around the oven.

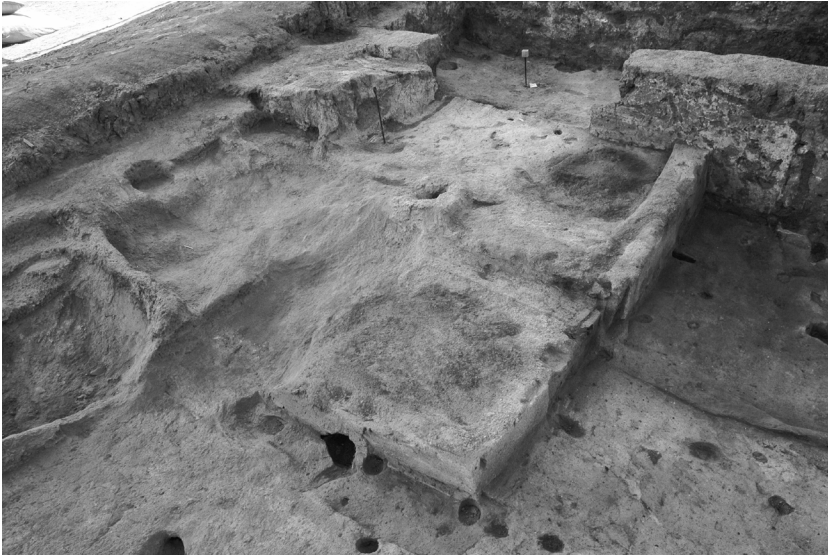
Figure 11.5. Platform F.1410 adjacent to access-hole between Sp.228 and Sp.238 with platform F.1411 later added (Photograph by Jason Quinlan).

One of the earliest visible features installed in the building is the southwest platform F.1410 and the use of this feature continued through the occupancy of the building with various episodes of replastering. Although the platform was used for a long time it was evidently not present when the building was first constructed since layers of wall plaster were visible behind the platform lining the internal wall F.1413. The final dimensions of the platform were 1.95m north to south and 1.62m east to west after the multiple plaster additions. Where the platform had suffered from erosion in the southeast corner, the method of construction was suggested by the presence of a course of mudbricks aligned north-south along the platform's eastern edge. Presumably the platform was fabricated by extending two lines of mudbricks at right angles from walls F.1414 and F.1413 and infilling the resultant space with looser material. The northern margin of the platform was distinct, forming a higher, more compact rim measuring 0.18m in width. This appears to have been added on to extend to the platform northwards (Fig. 11.5). There is also some

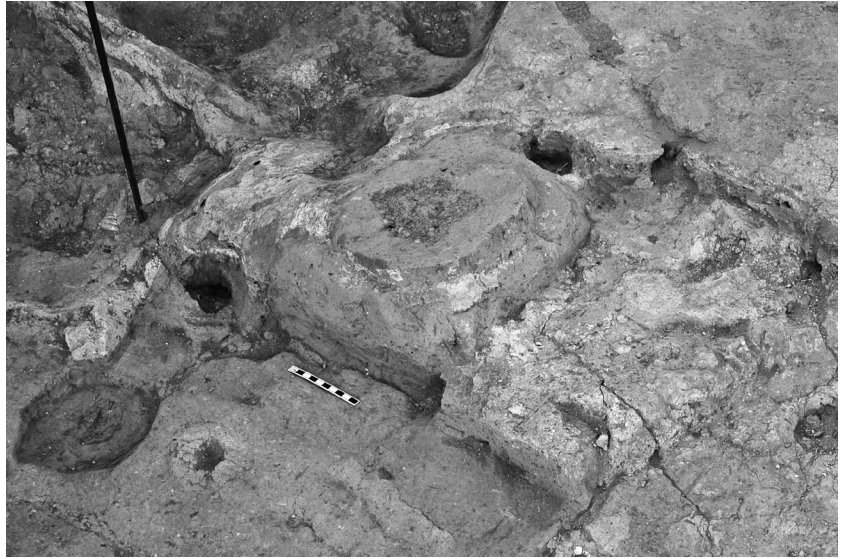
Figure 11.6. Orange sandy clay packing (10100) around core of pillar F.1417 (Photograph by Jason Quinlan).

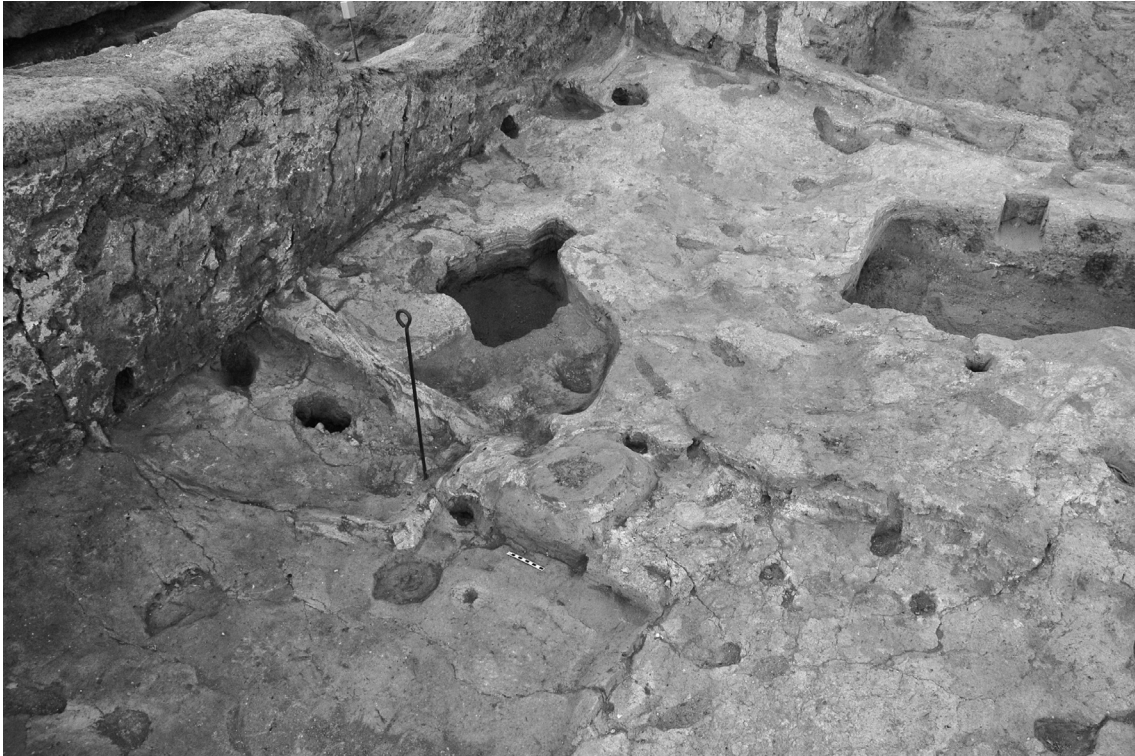
Figure 11.8. Difference between the clean and dirty areas of floor in Sp.228 (Photograph by Jason Quinlan).

The central area of Sp.228 was frequently modified towards the end of the occupation of B.45 after the platforms and basic features had been constructed. A number of units representing plaster repairs, occupational material and thin make-up layers covering the central area of Sp.228 were excavated. There was a clear division between the eastern and western sides of the area, defining different activity zones. This boundary was reinforced by a lip (F.1428) in the plaster floors running north to south demarcating the western side from the eastern side (Fig. 11.8). The layers (10118), (10105), (10092), (10077) and (10070) next to the internal wall appear to have been used for dirty activities whilst

the floors (10096), (10083), (10082), (10079), (10062) and (10056) east of this line were generally cleaner. Only two of the deposits associated with the dirty floors (10070) and (10105) produced obsidian from the dry sieve, a mere two broken and used pressure-flaked blade fragments, one of East Göllü Dağ obsidian (10070.A1), the other of Nenezi Dağ (10105.A1). The heavy residue samples from these units (10092), (10105) and (10118) added little extra material, with only a couple of broken blades from the 4mm fraction. Perhaps unsurprisingly, the clean floors in the eastern part of Sp.228 (10096), (10083), (10082), (10079), (10062) and (10056) produced no chipped stone whatsoever (Volume 9, Chapter 17). The clean floors sealed the plaster remolding of pillar F.1417.

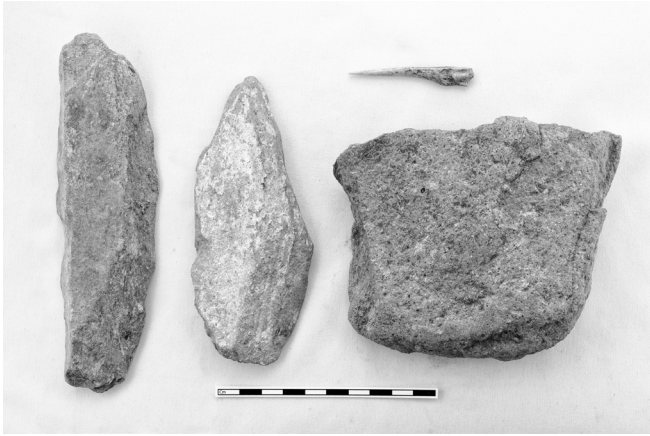
Figure 11.9. Group of artifacts placed into the base of small pit (10055) (Photograph by Jason Quinlan).

A small pit (10055) cutting one of the dirty surfaces (10070) "contained two stone grinders and a worked bone point (Fig. 11.9). The position of these artifacts on the base of the cut suggests they may have been placed deliberately" (US 10054, DE, 18.07.04). The worked bone point is a quartered distal sheep/goat metapodial that had been scraped and smoothed and later resharpened. The tip is significantly rounded and the tool is highly polished, all suggesting that it had been in use for a substantial period of time. Although the pit cut a floor relatively early in the excavated floor sequence, stratigraphically the fill of this pit was directly under the infill and it is therefore possible that it relates to an abandonment activity in the building.

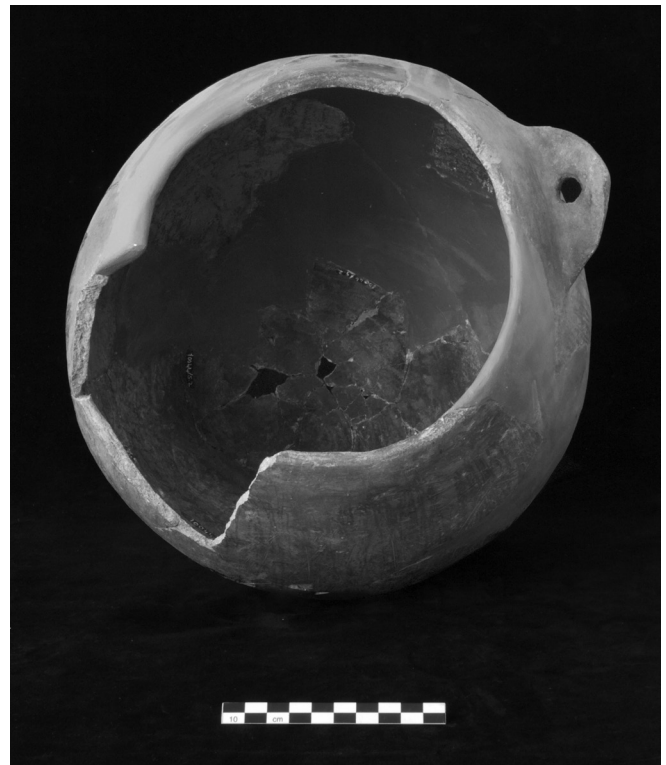
Figure 11.11. Pot (10044) after conservation (Photograph by Jason Quinlan).

Pit (10045) F.1418 measured 0.28m by 0.3m by 0.31m in depth and been dug to house a complete pot (Fig. 11.10). The facts that the pot had been manufactured with a handle and had a soot-like deposit coating its external surface, suggest

that it had not been specifically made for its final placement in the pit (Fig. 11.11). The pot was deliberately broken, as it was placed in a pit too small to house it whole and the sherds were overlapping and displaced when excavated. The fill of the pot contained an intensively reduced projectile (Fig. 11.12) made of Nenezi Dağ obsidian (10043.x1), although the piece is barely recognizable as such (only by the remnant retouch along one margin and its vaguely ovate outline), having had a number of linear blanks removed from both ends and both faces. “*This piece is of some significance as it provides us with both another example of projectiles being heavily reduced, for symbolic reasons in our opinion, and their inclusion in ritual/magical deposits that appear to mark specific events within the life of a building*” (Volume 9 Chapter 21, PAGE). The heavy residue sample from the pot also produced a small quantity of obsidian, much of which is likely to be background material from general fill, although there is a 25mm long blade fragment of East Göllü Dağ obsidian with use-wear. The animal bone in the fill is highly fragmented and a high proportion of the bone had been heated to high temperatures. The fill, however, also contained unburnt fragments of human skull (see Fig. 11.12) and vertebrae, and it is probable that these were deliberately placed. The botanical remains from the fill are low density and probably, like the animal bone, unrelated to the specific use of the pot. This was an interesting feature whereby human bone was placed in a pot set into a cut truncating the mixed occupation/surface in the central floor area. Both the human bone (because of the small size of the broken fragments) and the obsidian projectile appear to have been kept and moved/used for a long period of time before being finally placed in the pot set into the floor.

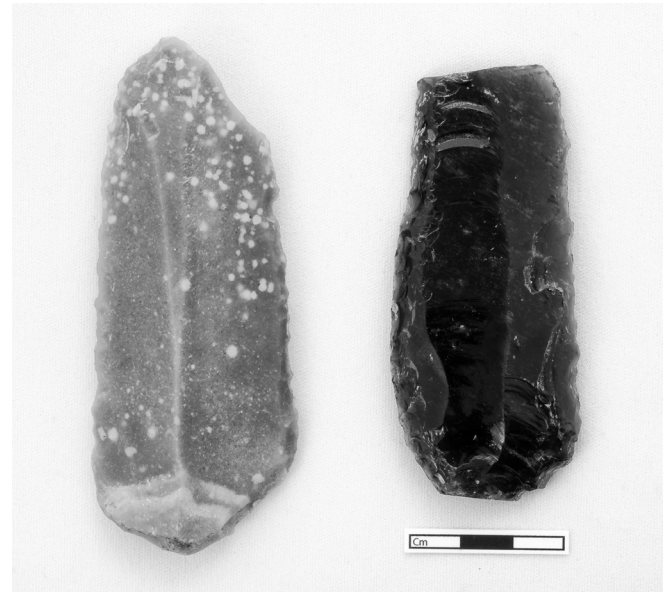
Figure 11.13. *Chipped stone tools 10042.x1 and 10042.x2 intentionally placed in the thick makeup layer (10042) (Photograph by Jason Quinlan).*

a couple of “exceptional finds (Fig. 11.13) and were probably added to the make-up intentionally before the plaster surface of the floor was constructed” (US 10042, LY, 13.07.04). The first is a 0.1m long, near complete end-scraper 10042.x1 made on a prismatic blade of light brown chert. There is no associated evidence for the manufacture of such high quality percussion technology blades at Çatalhöyük **implying that it was imported ready-made**. It is also worn on the dorsal ridges and has an overall surface sheen suggesting that the implement had a long life in circulation prior to its inclusion in this deposit. The second piece is a large (84mm by 3.2mm) retouched blade 10042.x2 of East Göllü Dağ obsidian, a product of a non-local percussive technology with heavy use-wear from cutting something of medium to hard resistance such as wood, bone or horn (Volume 9 Chapter 21).

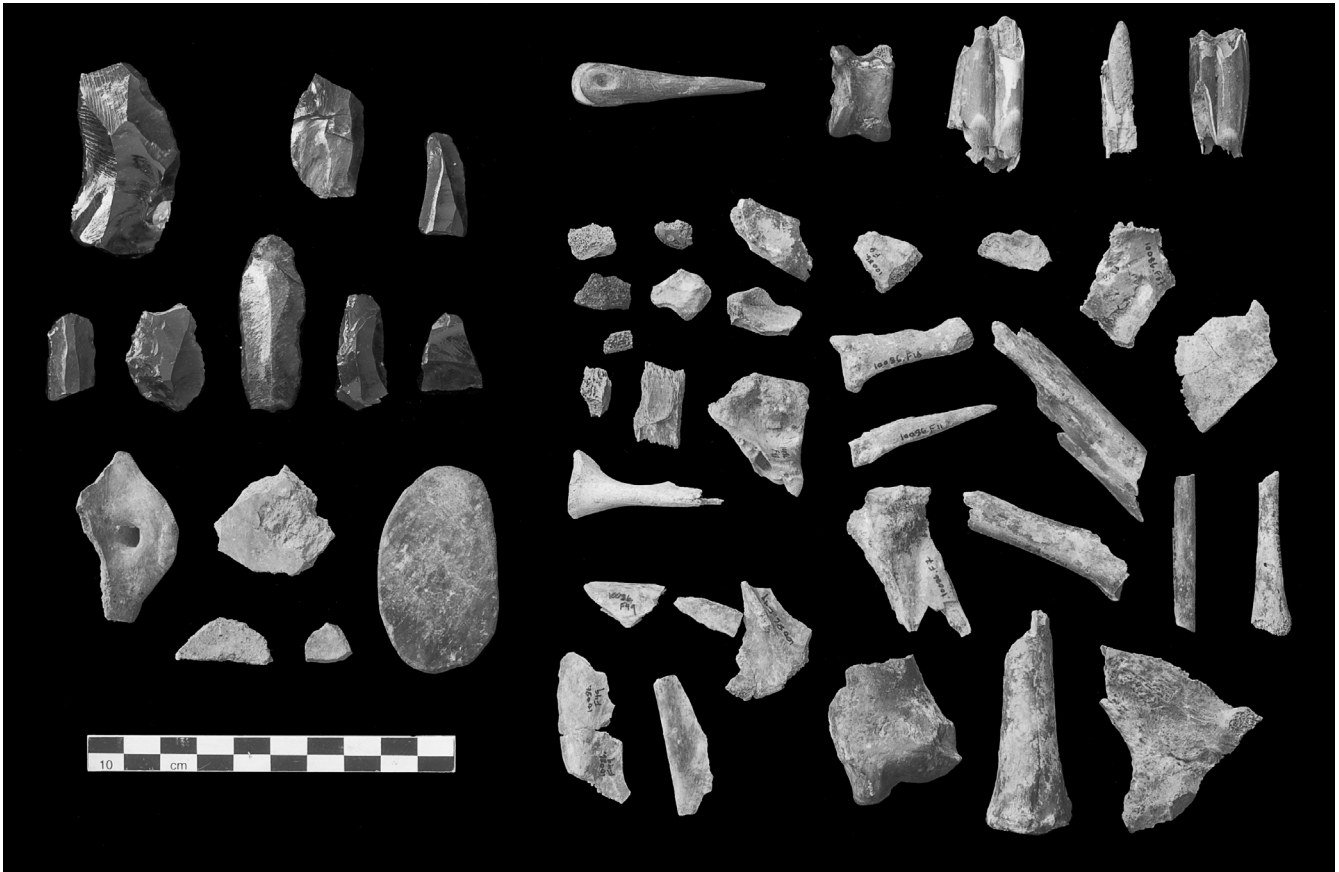
Figure 11.14. Group of worked bone and obsidian from (10086) (Photograph by Jason Quinlan).

The burnt make-up ((10086)/(10101)) below the floor surface was excavated producing a large fragment of worked serpentine, possibly a pounder 10086.x1 as well as sheep astragalus 10086.F12 flattened on the dorsal side with the medial projection ground-off. A sheep/goat metatarsal 10086.F42 formed into a point was also recovered from this context and this bone tool was decorated with four transverse incisions opposite three transverse incisions and a diagonal incision on the inner face of the bone where the bone had been split in two between the condyles. Twelve pieces of obsidian were recovered, mostly blades and all but two of which appeared to have been used (Fig. 11.14). Of note are two percussion-knapped and retouched blades of East Göllü Dağ obsidian 10086.A1 and 10086.A6. There was also a correspondingly productive heavy residue sample, with nine pieces from the 4mm fraction, including two pressure-flaked blades of East Göllü Dağ obsidian and a retouched flake of Nenezi Dağ obsidian. There is also the mid section of a 30mm wide burnt and retouched prismatic blade of a brownish fine-grained chert. The piece is conceivably a sickle fragment, but the sheen from long-term use and burning makes it impossible to tell and the implement is a non-local import (Volume 9 Chapter 21). The packing was stratigraphically above the mudbrick (10122) and mortar (10127) used to construct the partition step F.1423 suggesting that it was used to raise the northern section of the room before the

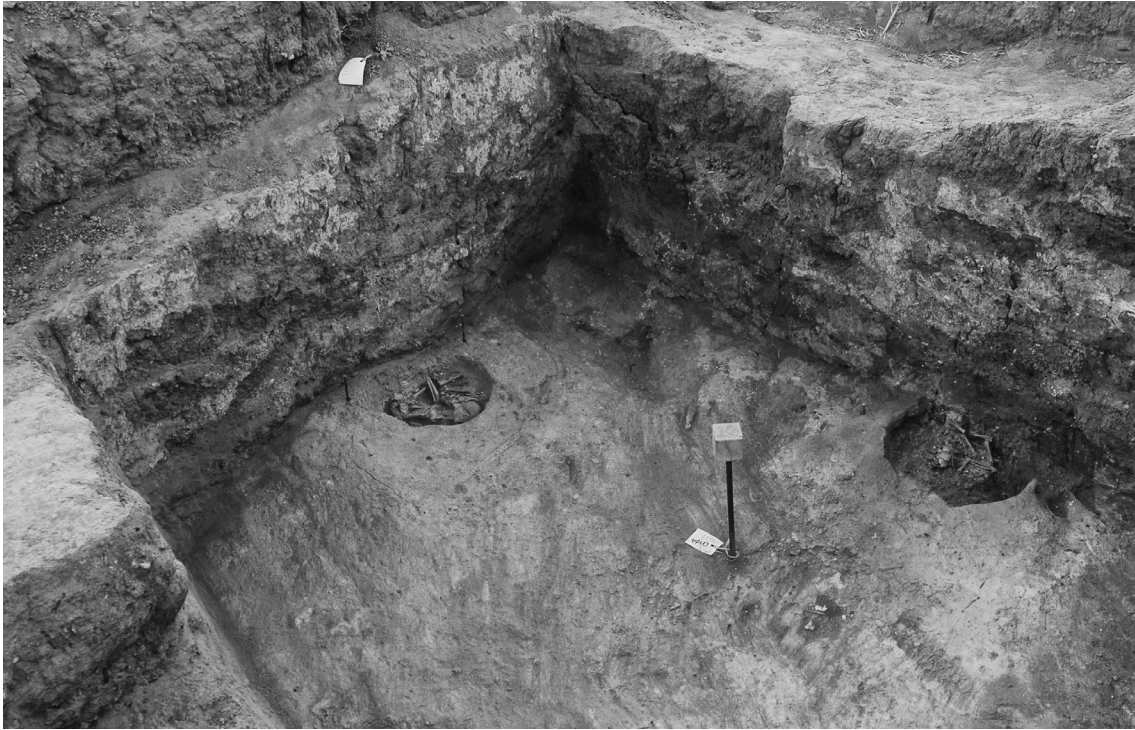
Figure 11.15. Neonate burials F.1430 (10109) [right] and F.1431 (10112) [left] in the southern end of Sp.238 (Photograph by Jason Quinlan).

by for the interment F.1430 of another neonatal baby (10109) next to the western wall opposite the access-hole. The two neonatal burials were both within the southern part of the room (Fig. 11.15). The baby (10109) had also been placed in a tightly crouched position but on its left side. Neither of the two babies had been buried with any grave goods and no visible traces of phytoliths were present to indicate that they had been interred inside baskets. Further potential burial cuts were visible at the end of the excavation season hinting at the possibility of additional neonatal babies or infants under the earlier, unexcavated floor surfaces in the southern portion of Sp.238.

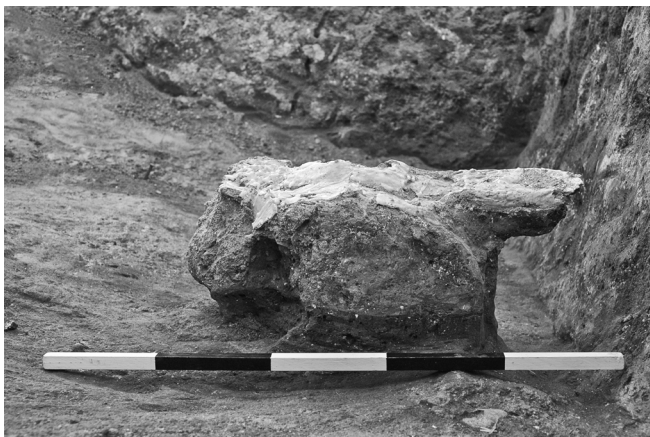
Figure 11.19. Bucrania placed next to wall in Sp.238 (Photograph by Valeriano Saucedo III).

Towards the end of the use of the building a fire occurred in the side room. The fire started in Sp.238 damaging the northern part of the room, spread up the walls and set fire to the structural timbers around the access-hole. In Sp.228 the effects of the fire were minimal. There were a couple of groups of finds left from the final occupation or added to the building when it was abandoned (Fig.11.18). The first of these was spatially above the neonatal burial against the western wall of Sp.238. Above the floor was a dismantled cattle bucranium (10057) that had been discarded or, more probably, purposefully left (Fig. 11.19). The cattle bucranium had been set in greenish-gray clay that formed a flat surface on the posterior side of the skull and roughly followed the contours of the skull around the frontal bone to a flat anterior side. The bone itself comprises only the back of the skull and much of the structure of the installation was made from clay. Traces of plaster were visible on the left horn core but this did not

extend to cover the clay around the head of the piece. “The feature was not, however, found in its original location since a small area of infill separated the clay block (10059) from the wall and the skull was facing the wrong direction pointing down the room rather than projecting from the wall. Also there would not have been enough space between the frontal bone and the wall for a complete horn core to be present. It seems that this bucranium was removed from elsewhere and placed in Sp.238 before the room was filled. The horn cores were removed before this happened” (Diary, LY, 26.07.04). Analysis of the faunal remains shows that there are no traces of horn sheath removal and that the bucranium is that of a mature female aurochs (Russell *et al.* 2004). At the same time that the bucrania had been put in the space, the skull of a wild boar was placed immediately to its north (Fig. 11.20), perhaps reflecting a special event associated with the dismantlement of the bucranium and its placement in Sp.238. The boar skull is comprised of a posterior cranium in articulation with the modified mandible. The skull is in poor condition and only the back of the cranium was found with the rostrum removed prior to the placement of the skull. The mandible is more complete, but its anterior cheek teeth have been deliberately removed. A concentration of phytoliths were found in the area at the back of the mandible and analysis of these shows that the back of the mouth had been packed with wheat and, to a lesser extent, barley husks rather than stems (Twiss

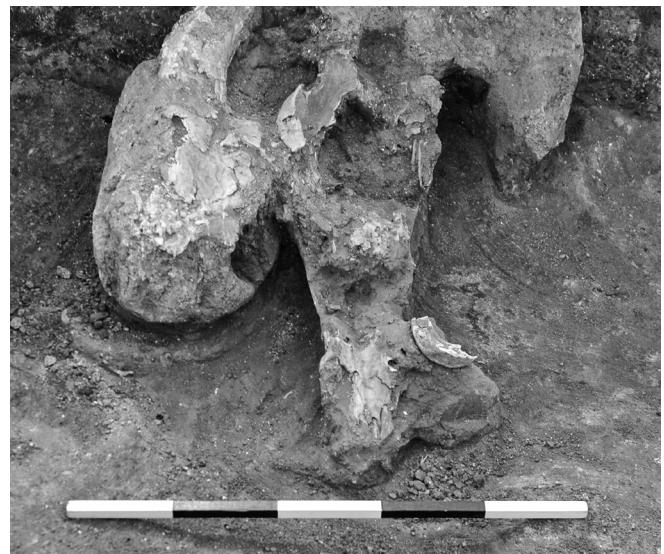
Figure 11.20. Dismantled aurochs bucrania and boar skull and modified mandible placed next to the wall of Sp.238 opposite the access-hole (Photograph by Jason Quinlan).

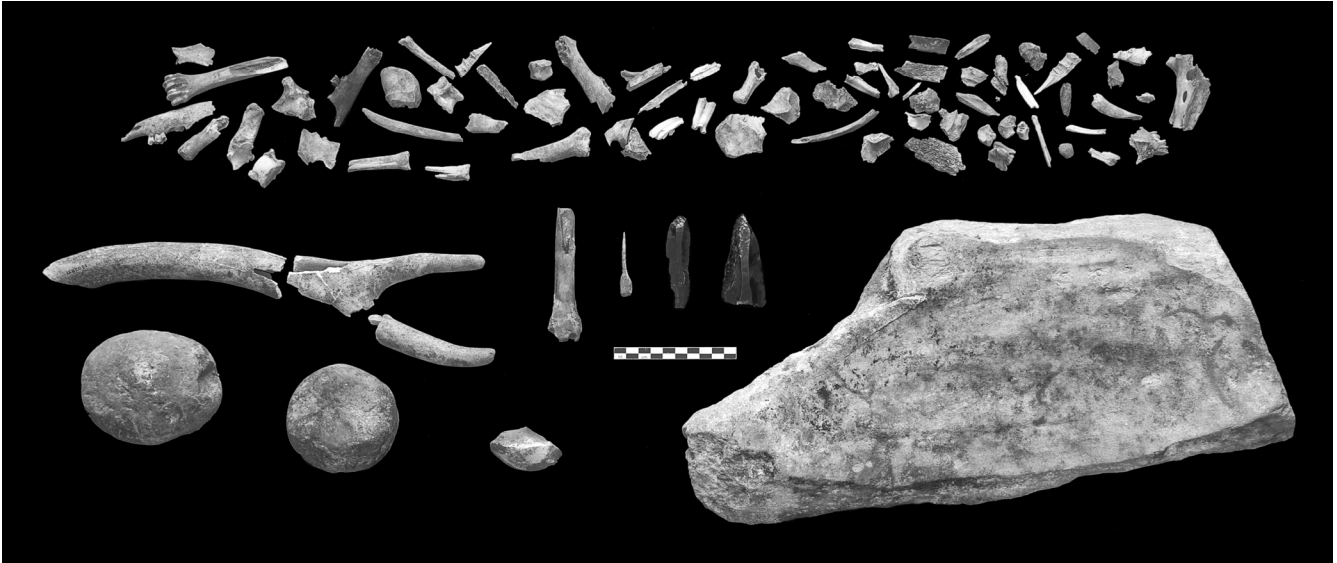
Figure 11.21. Finds left on the floor at the abandonment of B.45 (Photograph by Jason Quinlan).

In Sp.228, on platform F.1410 were a number of finds presumably left as the building went out of use. Southeast of the hearth, a grinding stone 10028.x10 was found *in situ* and its presence limited the erosion of the floor directly underneath. Finds found on the platform and floor surfaces were given the unit number of the building fill (10028) and these were

probably left at the abandonment of the building (Fig. 11.21). These include a 77mm long, near complete pressure-flaked blade backed (blunted) on one side, with heavy use-wear from cutting on the opposing margin, plus a large (79mm) broken and used spearhead and/or retouched blade. Both pieces 10028.x8 and 10028.x9 were shown by pXRF to be made of East Göllü Dağ obsidian. Technologically and typologically, the latter piece differs from the B.45 assemblage as it is the result of using a technique dedicated to making large thick blades by percussion and almost certainly represents an import. Perhaps significantly, one other large retouched blade 10042.x2 from this manufacturing tradition was found buried in a special deposit in the packing layer laid down for the construction of a new floor in Sp.228 (see above). A third piece of obsidian 10028.x4 from the group is another point, albeit of very different form to the previous example, being stemmed, complete and measuring 76mm in length (Volume 9 Chapter 21). Additionally, there is a ground stone 10028.x12 and a chisel 10028.x6 made from a sheep/goat tibia with a chipped tip that may have ended the use of the tool. A large 0.4m segment of red deer antler 10028.x1 was also found in the fill immediately above the floor of the building. This is the crown portion of the antler with the two uppermost tines but there is no sign of working. It could, however, be waste from antler working. Also recovered was a split distal metapodial 10028.x5 of a sheep/goat that has a rounded and battered tip and a shaft polished from use, probably on an organic substance. Many of the finds were found close to platform F.1410 possibly indicating a concentration of activity in this area before the abandonment of the building.

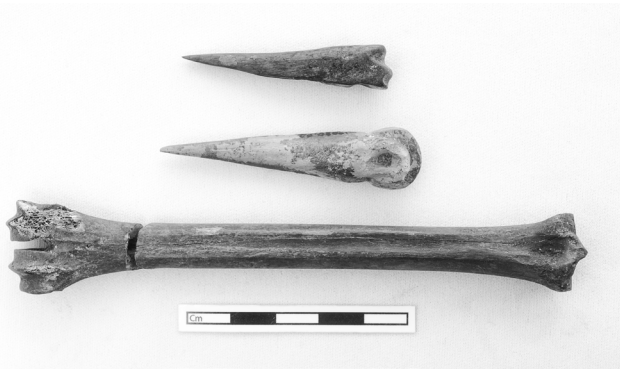
Figure 11.22. Group of worked bone and possible bone-working material (Photograph by Jason Quinlan).

Two bone points and a complete metatarsal (10080) could be the remains of a bone-working group found on the northern end of Sp.238 (Fig. 11.22). The bones are charred black

from the fire in Sp.238, rather than from a deliberate action to modify the bones. One of the points, 10080.F1, is made from a split and squared distal metapodial of a sheep/goat. The possibility that the bones form a bone-working group is indicated by the fact that the tip had been re-sharpened just before the fire carbonized the bones where they were left. The other bone point, 10080.F2, is a split distal metatarsal of a sheep/goat that is significantly worn, with the tip polished and flattened by use apparently as a leather-working tool (Video 11.1 on CD). All of the tools are well worn, with the exception of the articular end of 10080.F2, which indicates that this part of the tool was probably held in a handle of some kind, protecting it from wear. Above the finds left on the surfaces, the upper infill contained only occasional inclusions and is typical of the clean infill of buildings.
