Qatar Islamic Archaeology and Heritage Project

End of Season Report : 2013-2014

Citation for published version (APA):
Rosendahl, S. (Ed.), Cockin, G., Estrup, E., Hawksworth, C., & Nymann, H. (Ed.) (2015). *Qatar Islamic Archaeology and Heritage Project: End of Season Report : 2013-2014*. Copenhagen: University of Copenhagen and Qatar Museums.

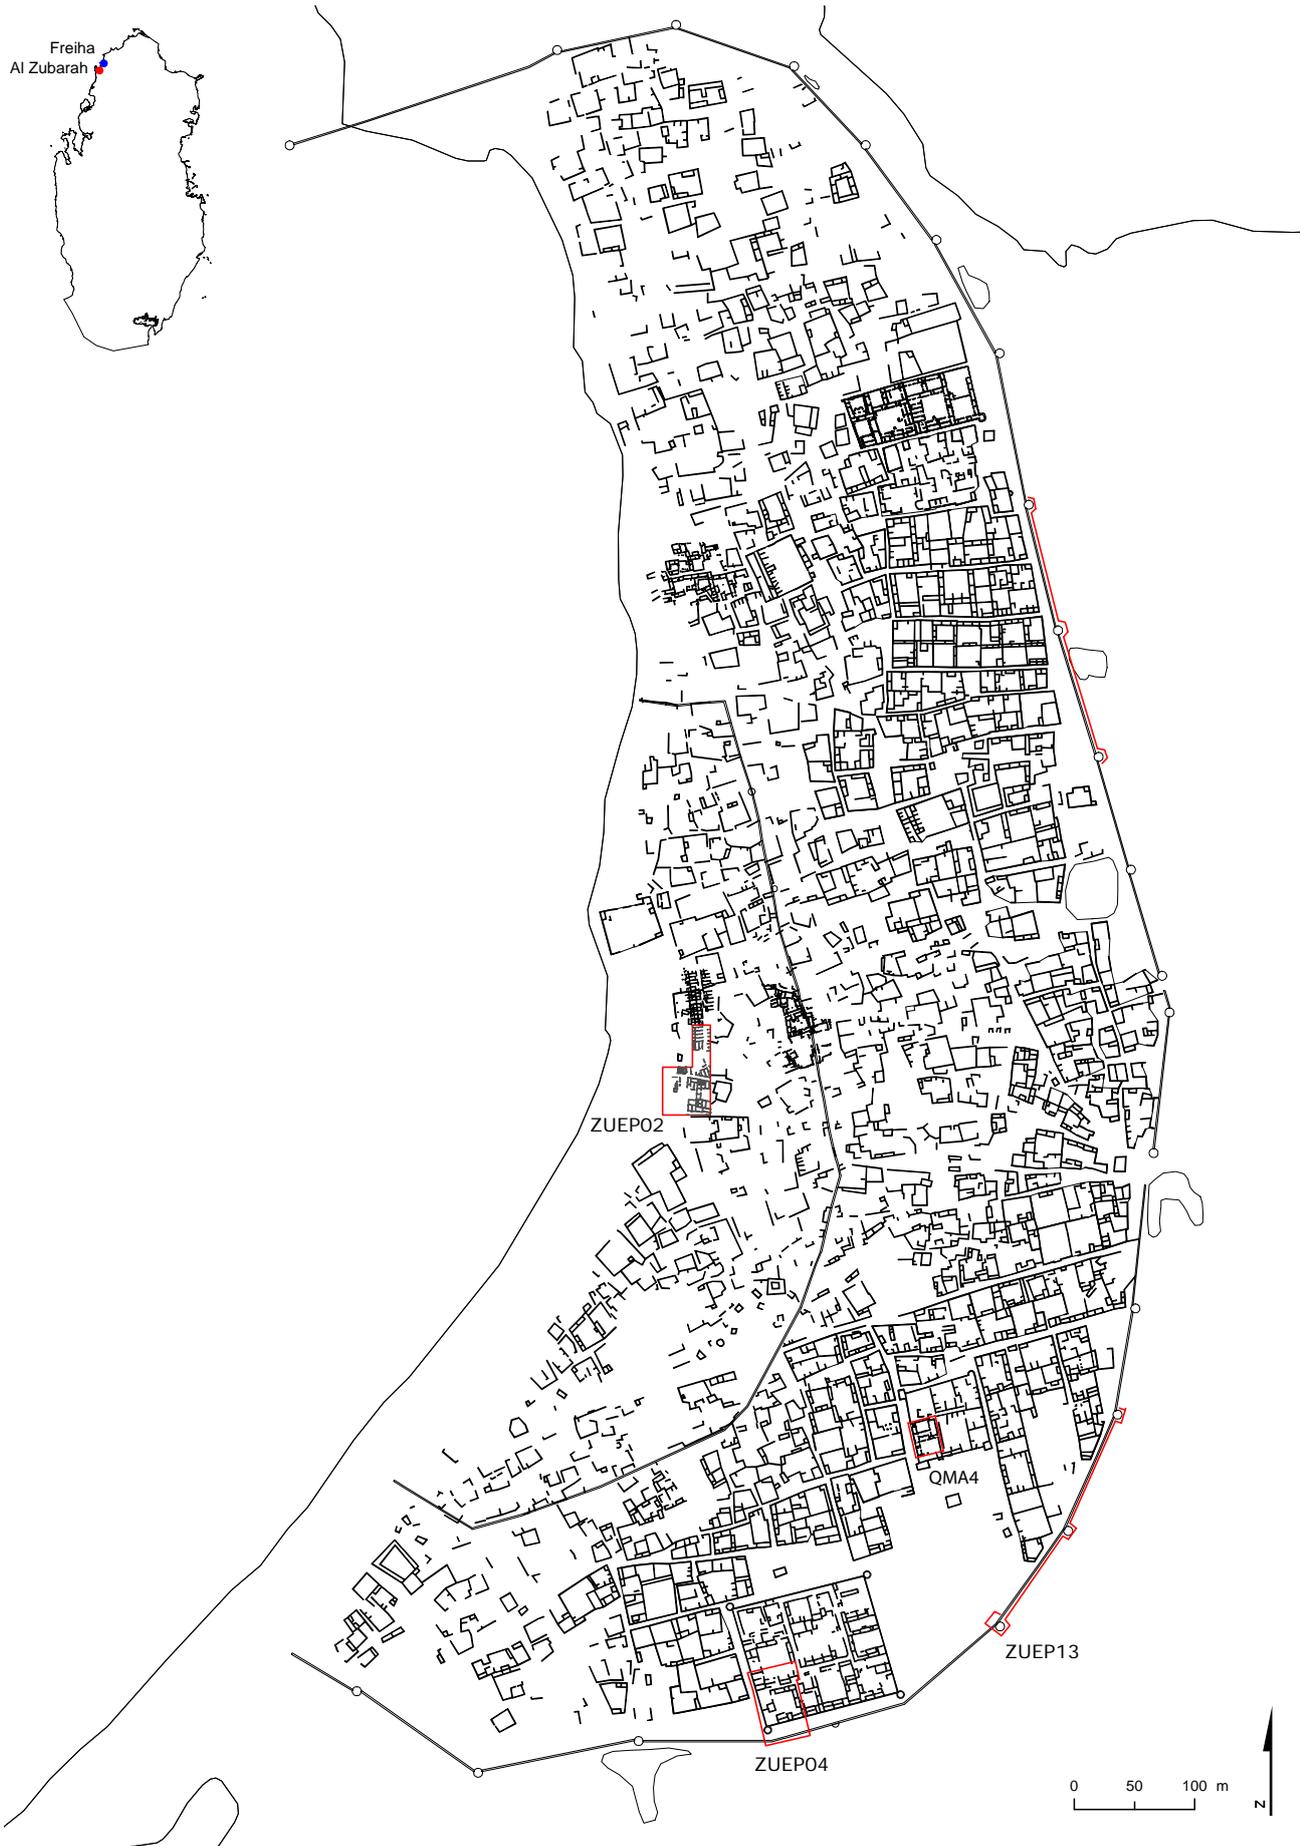
Figure 1.1: Plan of excavation and conservation areas in Al Zubarah in 2013/2014.

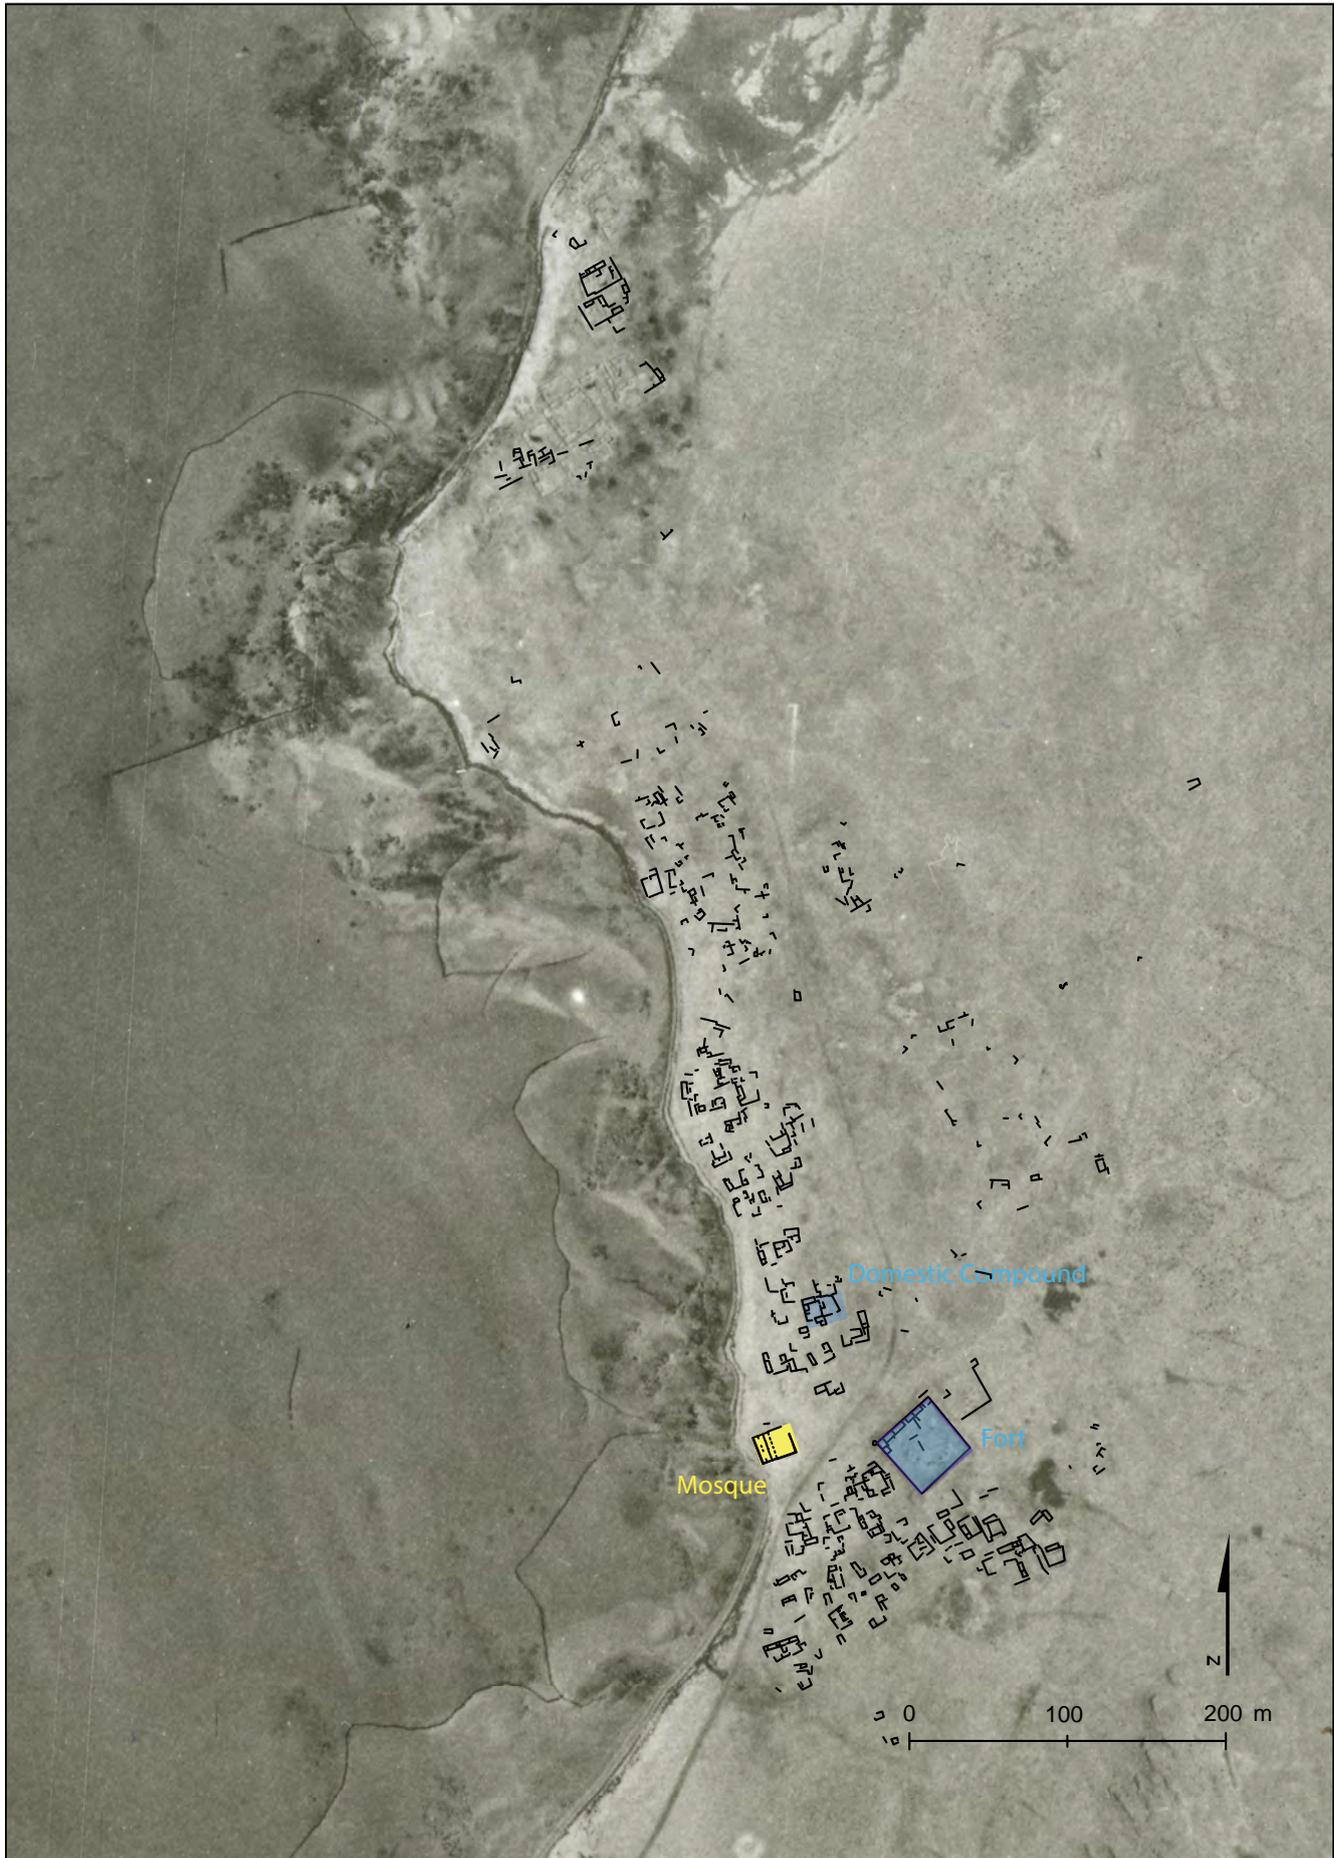
Figure 1.2: Plan of excavation and conservation areas in Freiha in 2013/2014.

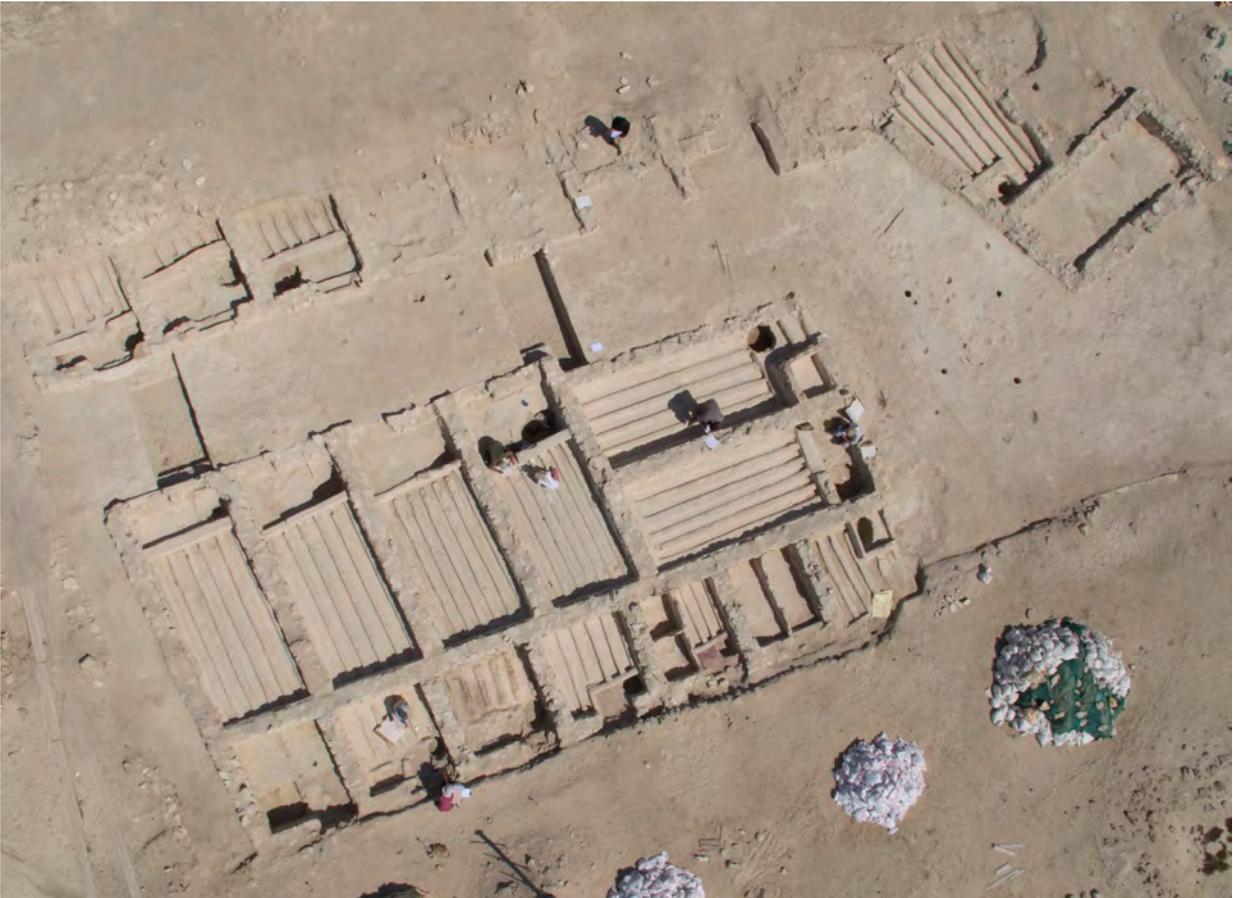
Figure 2.1: End of Season kite photograph of the Northern Extension. (QF-0125)

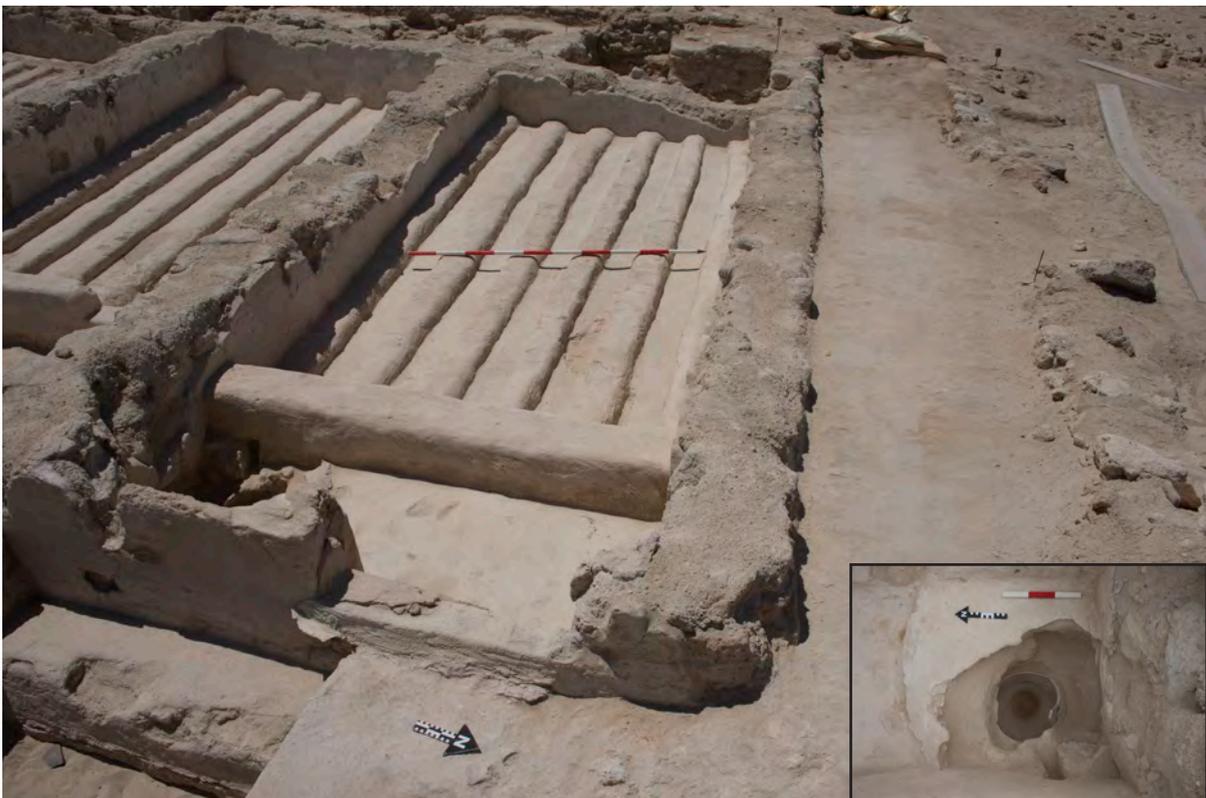
Figure 2.3: Date press Space 71, looking west. (KF-0541) The inset shows a detailed view of the date syrup catchment vessel *in situ*. (KF-0426)

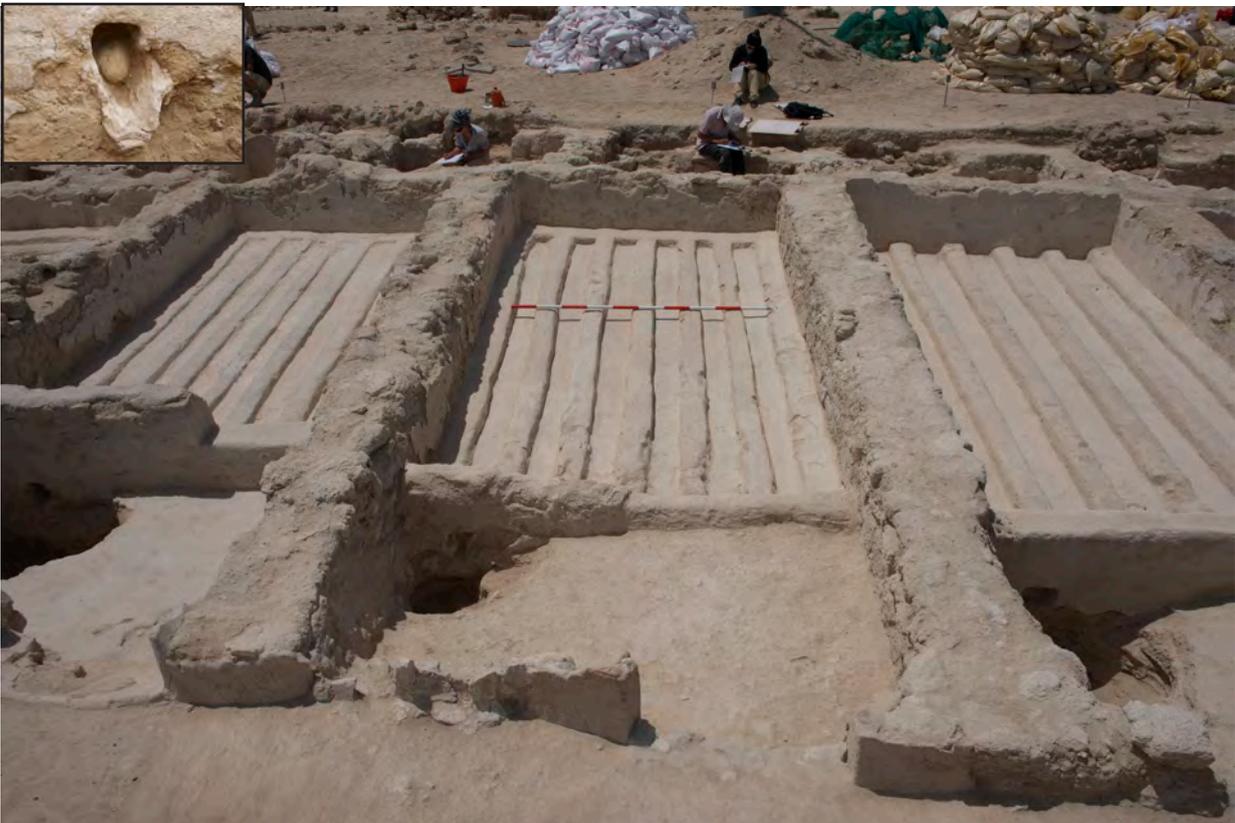
Figure 2.4: Overview of date press Spaces 76, 75 and 74 (left to right), looking west. (KF-0766) Inset shows the stopper *in situ* within the channel. (BE-0573)

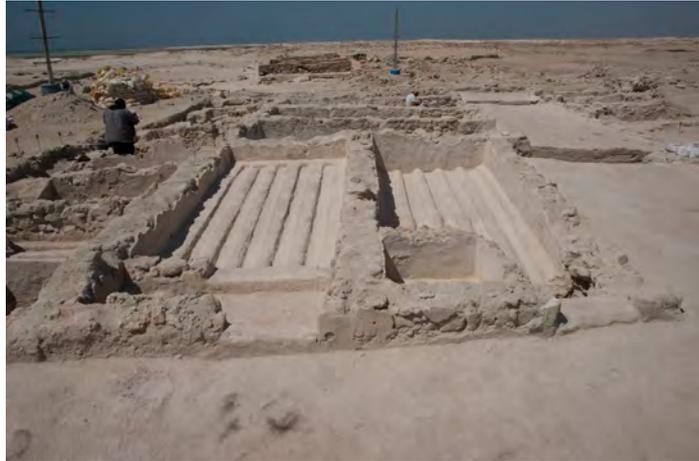
Figure 2.5: View, looking north, of Spaces 77 and 78. (KF-0552)

These final two rooms form the SE corner of the western *souq* block (Figure 2.5). Both were aligned perpendicular to the four northern spaces. The long rectangular rooms are, based on wall articulations, later in date than the other four. The spaces measured 7.00m (N-S) x 2.30m (E-W) and were both accessed from the south from the E-W aligned street (Space 603).

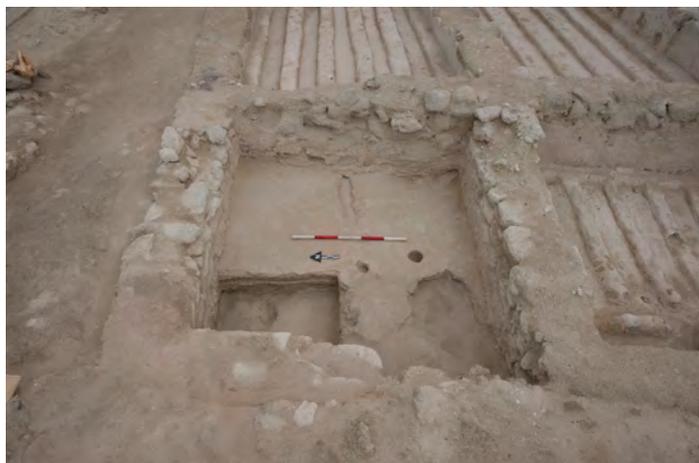
Figure 2.6: View of Space 99 looking east. Sondage 3 can be seen in the NW corner. (KF-0461)

This simple room had no wall plaster, and was likely mud-rendered, with a simple compressed earth floor (based on analysis of the primary collapse) and an entrance in the western wall allowing access to an exterior space currently below the limit of excavation (Figure 2.6). Based on structural evidence seen in the Main Area, the exterior space is likely a further street running parallel to Space 602, with another range of buildings (possibly more date presses) to the west.

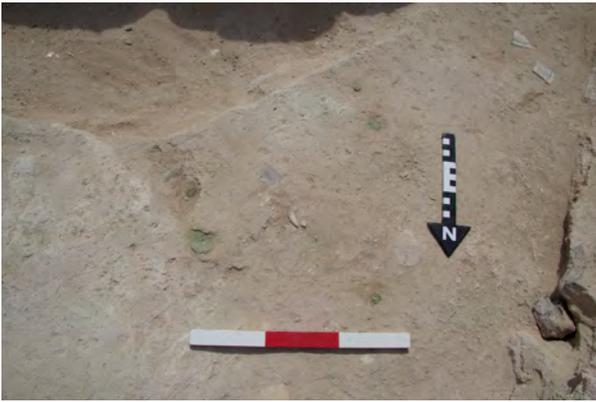
Figure 2.8: Detail of coin *in situ* in Space 99. (PF-0601)

Removal of the occupation deposit, rich in fish remains, revealed two cut features: a small pit and a single post hole. Below this lay a compact sand surface that contained five coins (Figure 2.7) and at least two small weights, bringing the total to 11 coins from this one small space. This could give an indication as to the function of the space, maybe as an administrative room for commerce linked to the trade in dates. This sandy occupation deposit sealed a coarse plaster floor which had been laid by hand, the finger marks clearly evident in the surface (Figure 2.8).

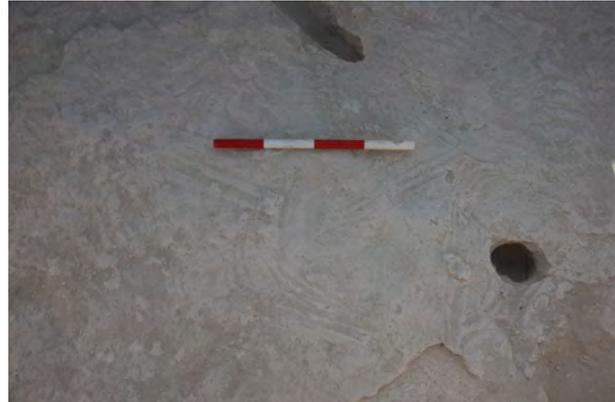
Figure 2.7: Detail of finger smears on plaster surface. (KF-0395)

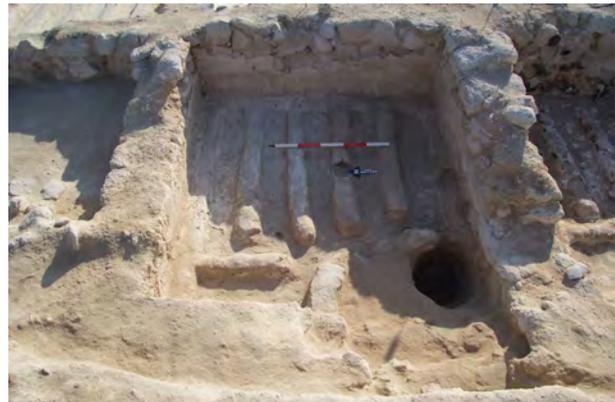
Figure 2.9: View looking west of Space 97 with its curved catchment pit kerb wall. (PF-0384)

Located to the south of Space 99 and of similar dimensions, this small square room, in its latest incarnation, housed a well-formed date press with a particularly nice curved kerb wall separating the press superstructure from the catchment pit (Figure 2.9). Above the finely plastered date press were the remains of an articulated cat skeleton – something seen in several buildings across the excavation area at the end of the Phase 5 occupation and clearly representing a prolonged period of abandonment prior to structural collapse or demolition.

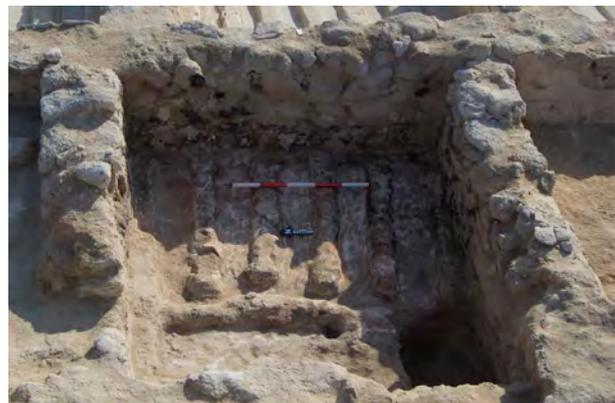
Figure 2.10: Overview, looking east, of the burnt date press Space 96. (PF-0281)

This small, square date press (2.34m x 2.20m) is located to the south of Space 97. It varies from the other surrounding rooms primarily due to having been subject to extensive fire damage (Figure 2.10); its infill was also rather unusual as the burnt date press structure was covered with a layer of sand and bitumen. The initial construction techniques of the date press appear, when compared with others nearby, somewhat primitive, as even before the fire the walls were only mud-rendered, although it is possible that the fire may have powdered the plaster. All of the bitumen was sealed below the primary collapse which also contained very little plaster, and this could indicate usage of the room after the fire as a bitumen processing space, or indeed that the fire was a result of the bitumen processing and the deposits covering the date press surface protected it from the worst of the heat.

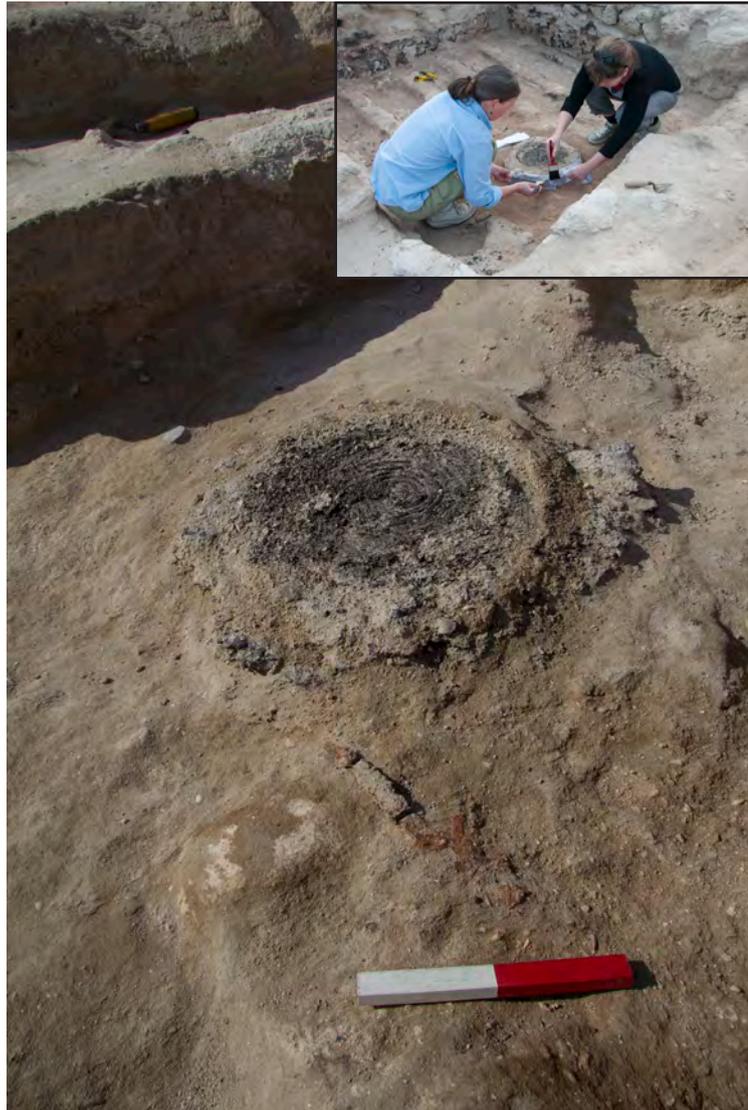
Figure 2.11: Burnt basket base and iron knife found within the infill of the burnt date press room Space 96. (PF0239). The inset shows the conservation team lifting the basket base. (KF-0095)

The primary collapse included a mix of beach stone, sand and mud mass. The latter appears, like in most rooms, to be derived from roof collapse/removal and here also from the walls. This material sealed an interesting deposit of bitumen covering the entire space and formed of lumps and chunks mixed with heat-affected sand; this contained some cultural waste including fish bone, four coins, a glazed bowl with a flower motif at the base (dating it to the early 19th century), an iron knife with infused organic material (most likely a sheaf or handle), and a spectacularly well-preserved basket base which was block-lifted and is

currently being conserved (Figure 2.11). The origin of the bitumen and its relationship with the burning event remain unclear. The layer sealed a thin ash deposit located at the western end of the date press, which is likely all that remains of the fuel or accelerant of the fire.

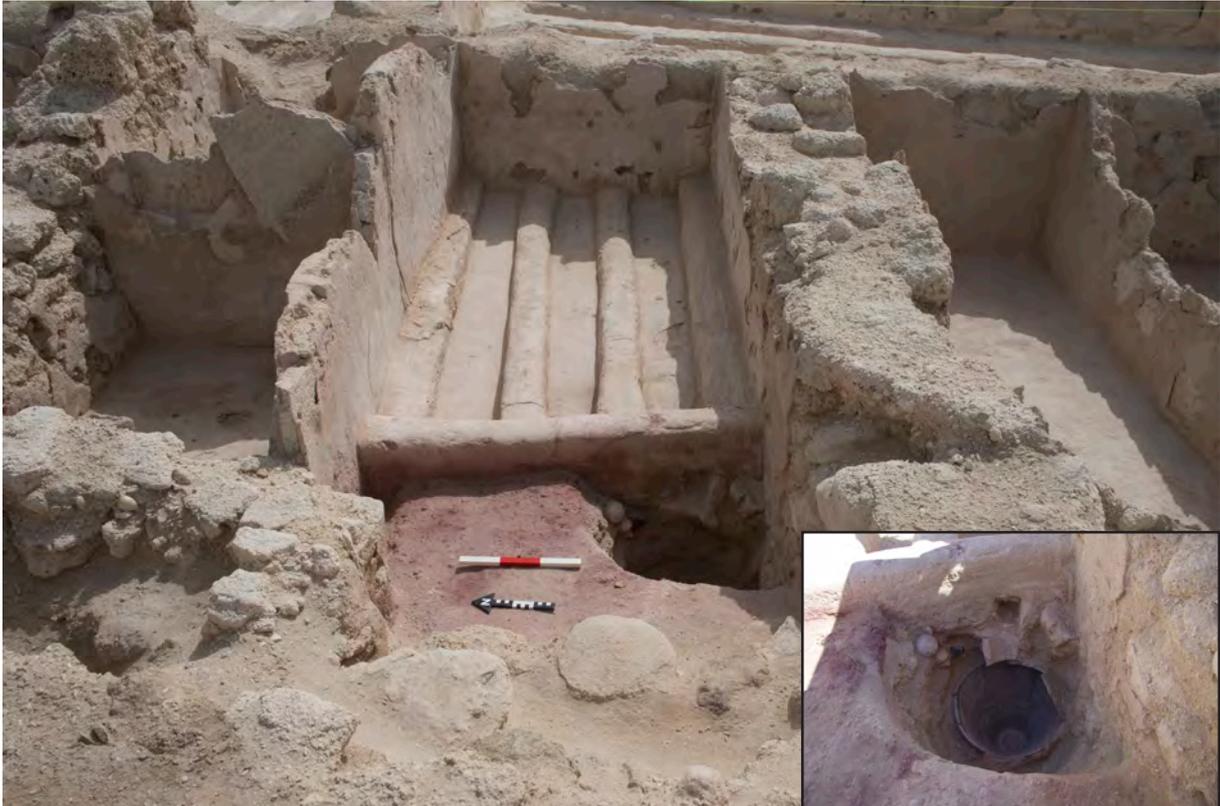
Figure 2.13: Post-excitation view, looking east, of date press Space 92 , clearly showing the crushed haematite in the catchment room. (KF-606). The inset shows the *in situ* catchment pot and stone stoppers. (PF-0508)

Space 92, located to the south of Spaces 93 and 94, is a small plastered rectangular room (2.50m x 1.20m) which turned out to be a very small date press. This was an exact miniature of its large counterparts in the rest of the Northern Extension, even down to a small catchment room at its western end (Figure 2.13). The surface of the *madbasa* was strewn with ceramics and stained with a red powder as well as some fragments of the pigment itself, and mixed with the ceramics were another intact faience button, a single coin, some iron brackets or buckles, and a small spherical copper alloy earring or bell (Figure 2.14). A disturbed area against the northern wall of the space (possibly an animal burrow) contained a fine stone bead and a faience button, but these can likely be attributed to the usage phase of the room. The ceramic fragments of the catchment vessel were removed, including the fill of the *in situ* base and the partial body.

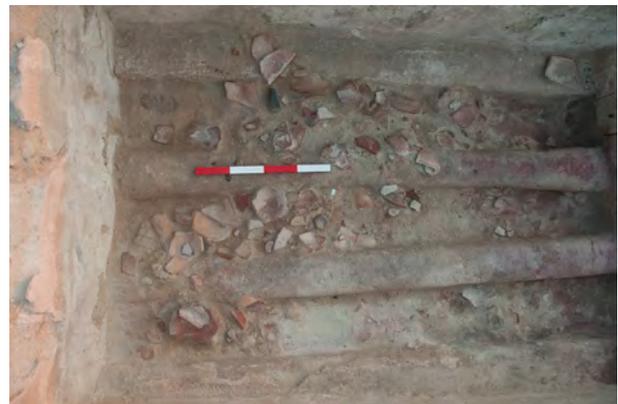
Figure 2.14: Detail view, looking south, of the ceramic spread on the date press surface in Space 92. (KF-0039)

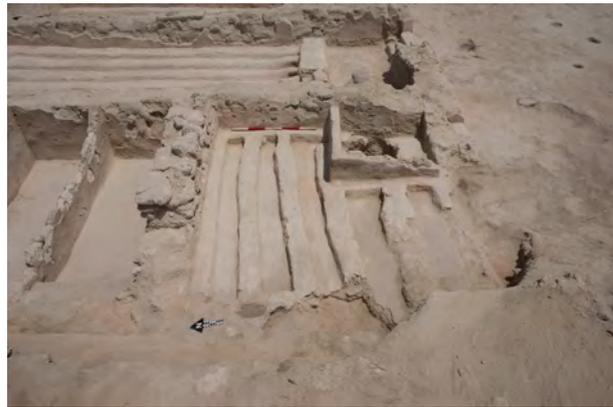
Figure 2.15: View, looking east, of date press and catchment Spaces 600 and 601. (KF-0770)

In the main room of the *madbasa* (Space 601), the channels of the press were well constructed, and the light grey gypsum plaster was crisp and clean (Figure 2.15). The southern wall had been completely robbed of stone in antiquity, leaving only a small portion of the threshold intact (located in the catchment room). The room was similar in form and dimension as the other spaces in this row. However, the entrance was located in the southern wall, and on closer inspection of the robbed western wall, it was clear that the room was once larger, with the wall being constructed over the date press structure which would have extended further to the west below the current limit of excavation.

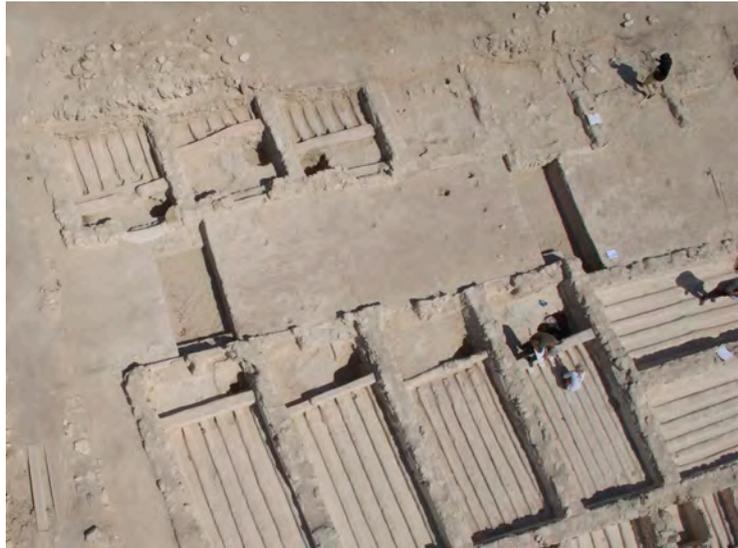
Figure 2.16: Kite aerial photograph showing the eastern *souq* block in the top of the image, as well as the location of the street sondages. (QF-0119)

Only the first three of these rooms have been excavated down to the abandonment surfaces: Spaces 80, 81 and 85, all of which were functioning as date presses. The three rooms have not been fully exposed due to their location on the eastern limit of excavation (Figure 2.16). They mirror their counterparts across the street (Space 602) in width and, based on photos from the 1980s excavations of QMA1, likely in length. All were accessed from the street to the west. The size of the catchment rooms varied, and the catchment vessel had been

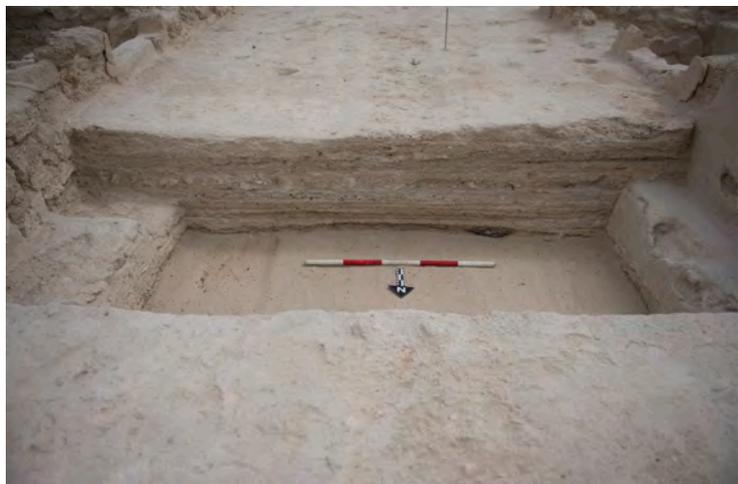
Figure 2.17: North-facing section of the *souq* street Space 602, Sondage 1, showing the depth of deposits in this compressed archaeological sequence. (KF-0646)

the depositional sequence of successive road surfaces, repairs and drainage cuts within the street's soft deposits (Figure 2.17). The sondages provided a sample of the activities and a view of the Phase 6 deposition below.

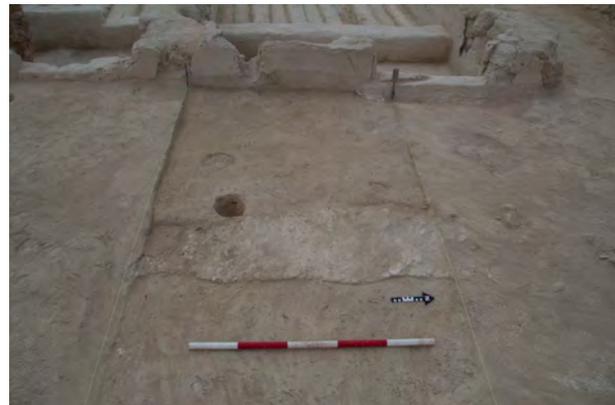
Figure 2.18: Crushed limestone in the central drainage channel located in the *souq* street Space 602. (PF-0528)

Below the upper street surface (Sondage 1), a shallow drainage channel filled with crushed limestone had been cut into an earlier surface (Figure 2.18), designed as a soak-away to stop water pooling after heavy rain or flooding; a broken carved bone pin was found within this fill. This system of water management was also visible lower in the stratigraphic sequence, with a second channel cutting an earlier street surface. Several more of these highly compacted street surfaces were removed.

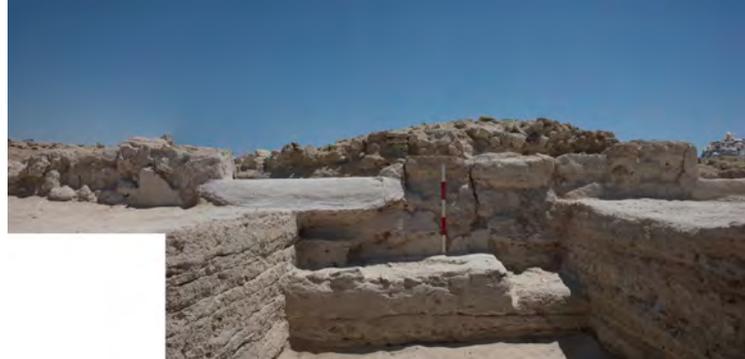
Figure 2.19: Looking east within Sondage 1 (Space 602) – clearly visible are the changes made to the entrance and threshold of Space 81 in relation to surfaces within the *souq* street. (KF-0475)

At least six major resurfacing events, often associated with makeup layers and drainage cuts in the middle of the street, could be identified in Sondage 1. These surfaces have been accurately linked in with several adjustments made to the entrances to rooms on either side of the street (Figure 2.19). This is also reflected in Sondage 2, with slight variations based on small localised repairs.

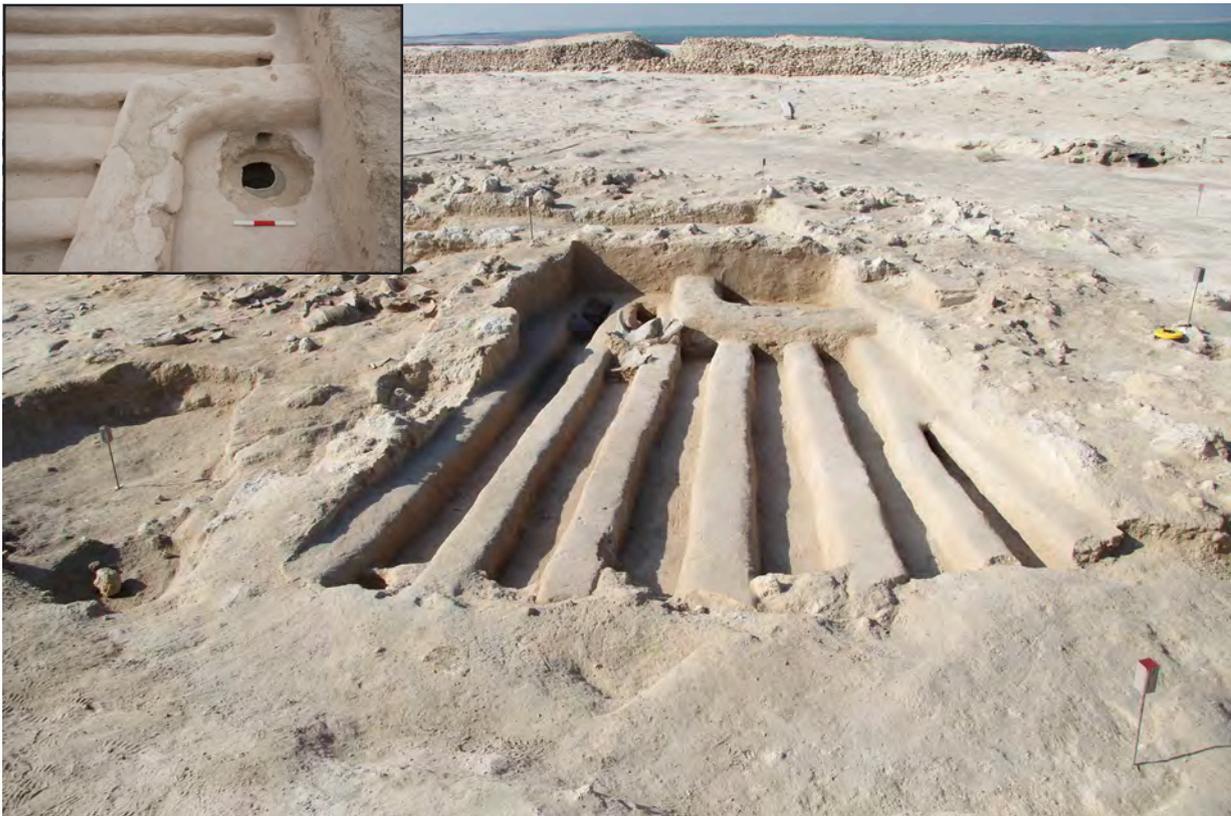
Figure 2.21: Looking west across the fan-shaped date press Space 88 and ceramic spread. (PE-0032). Inset is the *in situ* catchment vessel. (KF-0436)

Located to the east of Space 87 lies a large, sub-rectangular room 5.00m NE-SW x 2.10m – 3.50m wide (wider in the east). This space is architecturally spectacular, due mainly to the form of the room dictating the unique fan shape of the date press. This unique room also had a small space in the NW corner formed by a low kerb wall, the location for the catchment pot for the *dibs* which was present *in situ*. Above the plastered surface of the press was a large, broken ceramic storage vessel, which may well have been used in conjunction with the press (Figure 2.21).

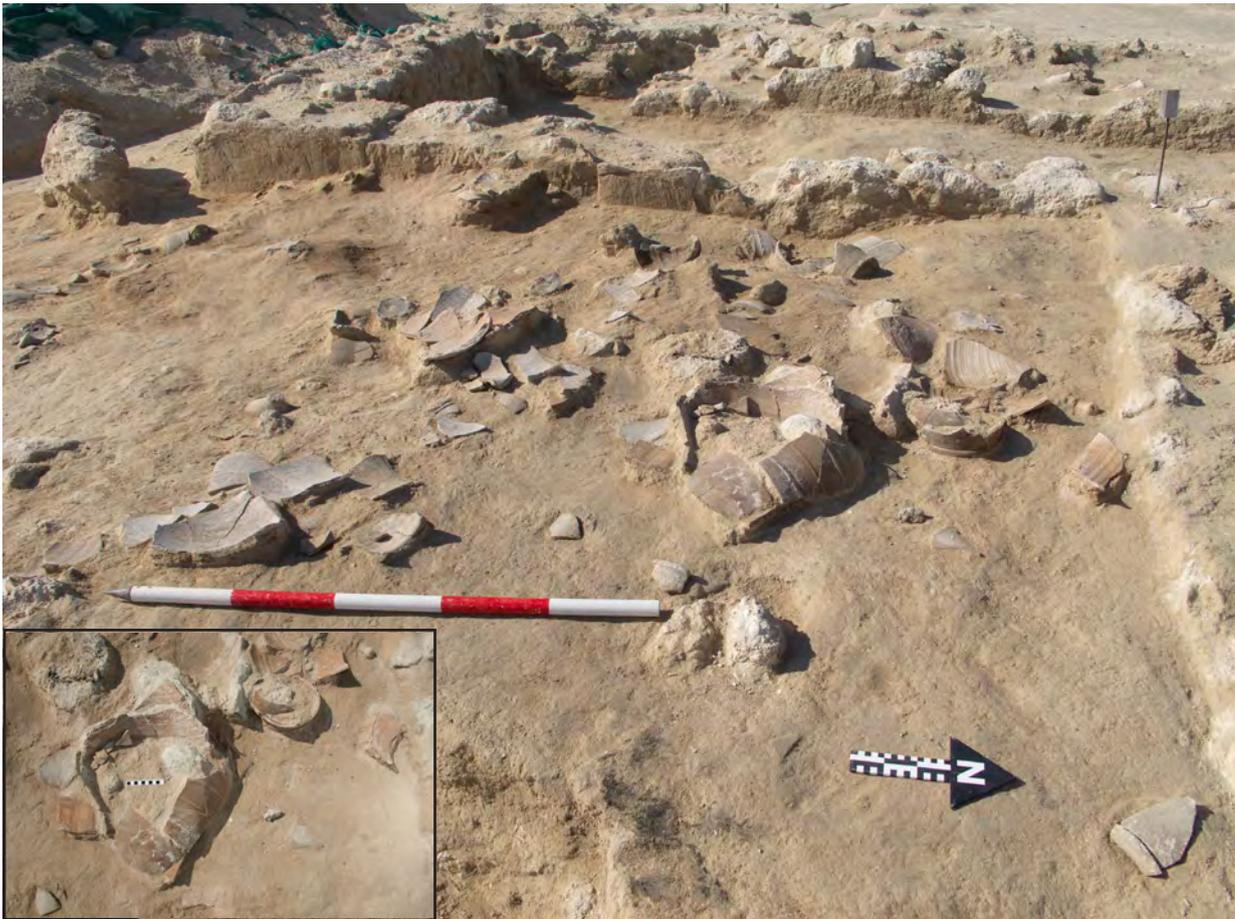
Figure 2.22: Looking west at the courtyard compound Space 16 showing the extensive spread of ceramics on the abandonment surface. (BE-0618) Inset shows a detail of ceramics. (KE-0252)

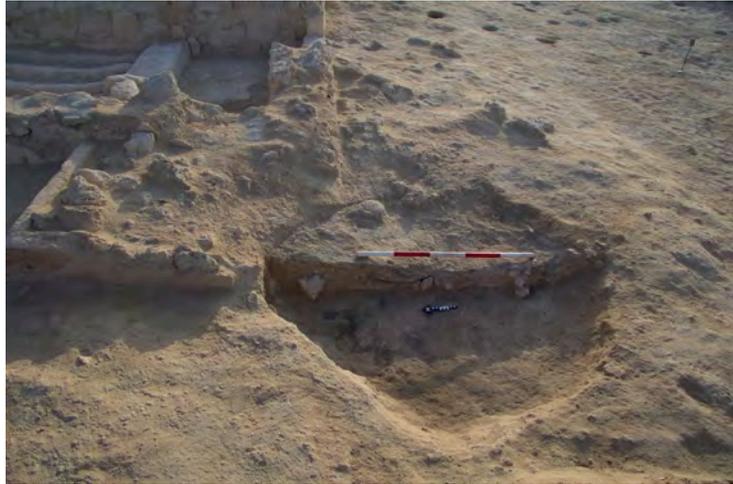
Figure 2.23: Half-sectioned Phase 4 pit cutting the southern wall of Space 601. (PF-0468)

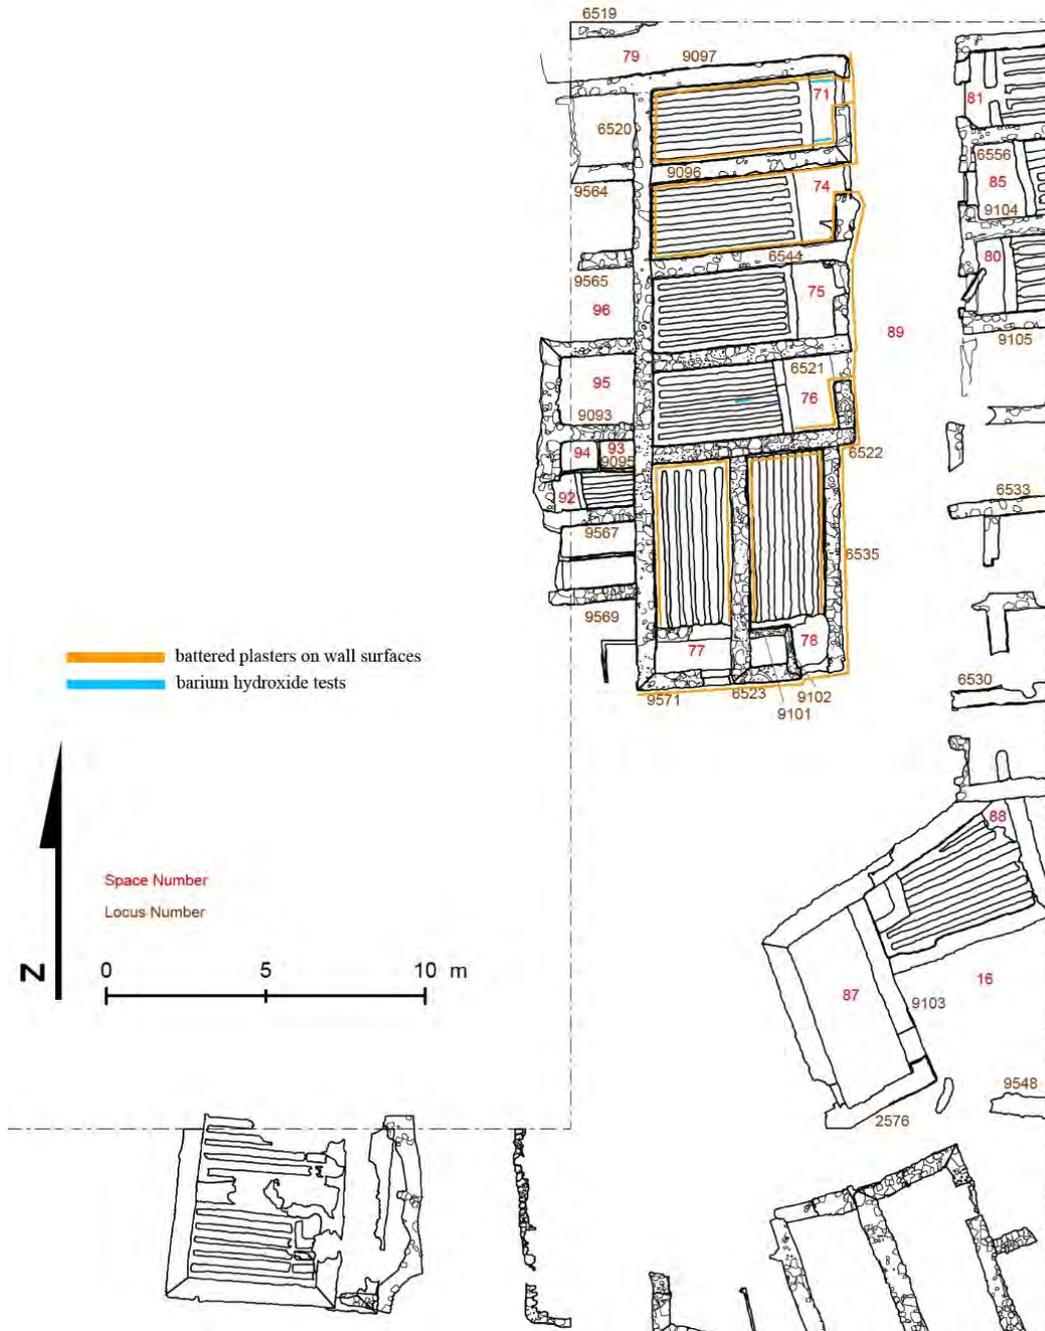
Figure 2.24: Areas of work for the conservation team.

Conservation activities in ZUEP02 focused on two aspects in spring 2014 (Figure 2.24):

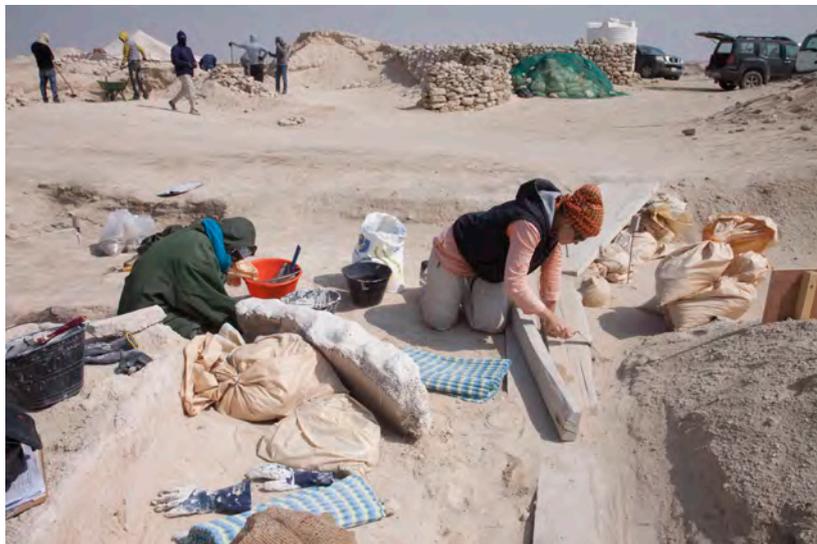
Figure 2.25: Restorers preparing an arch fragment for recovery in Space 16. (DF-0106)

On several occasions during the ongoing excavations, members of the conservation team were called in to assess and document findings of plasters, walls and other architectural fragments. Several significant fragments were collected from Spaces 16, 80, 89 and 96 (Figure 2.25).

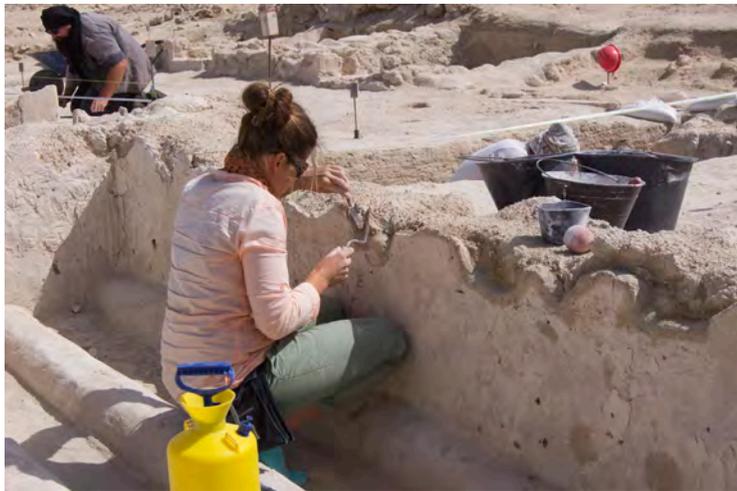
Figure 2.26: Battering of the rims of the plaster in Space 78 with mix 3.8. (YF-0204)

After visual assessment, battering of the plasters in some of the date press rooms was carried out (Figure 2.26). The usual gypsum plaster mix 3.8 (3:1:8 mix of local gypsum Sadaf : NHL5 St. Astier : fine desert sand and 0,1% tylose) was slightly modified and no tylose has been added. The rims of the plasters were cleaned, the softened and brittle parts removed, and rims watered and reattached with restoration plaster to the walls. Some of the voids in plasters on the date presses were repaired as well.

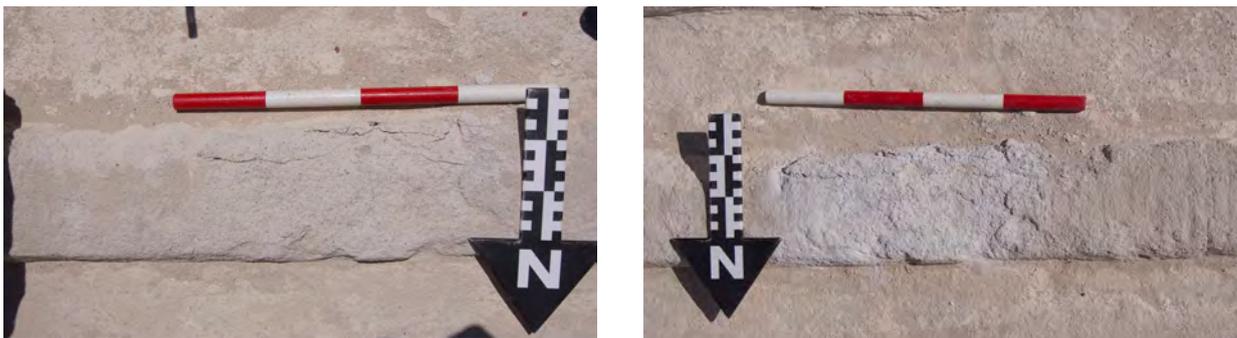
Figure 2.27: Barium hydroxide treatment test in Space 76. Left: before treatment (YF-0212). Right: Surface saturated with barium hydroxide (YF-0216).

Plasters in some rooms show different thickness and differ strongly in their state of preservation. The plasters in Spaces 75 and 76 resemble slurry more than plaster, and are in the poorest condition that does not allow any treatment. These are likely going to be lost in the near future.

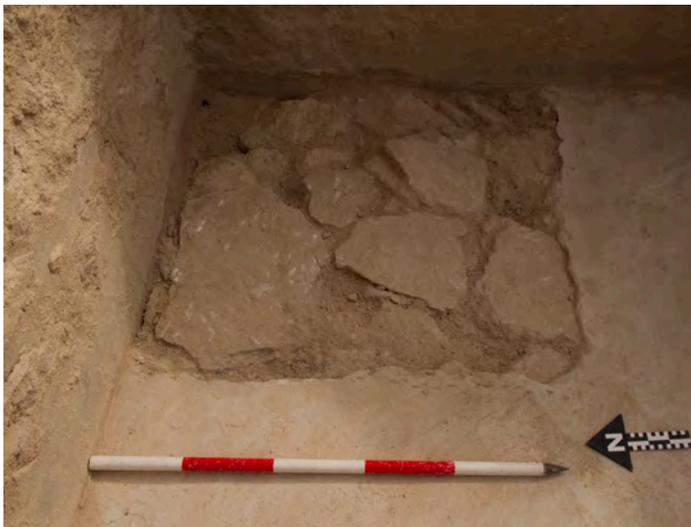
Figure 3.3: Flagstone foundation for plaster floor revealed in sondage in Space 3031. (HF-0777)

The plaster work surface was then deliberately covered with a layer of moderately silty sand. This elevated the floor level and, more importantly, provided a level foundation for the subsequent overlying flag stone floor foundation and plaster skim. The flagstone floor foundation was formed by large tabular slabs. These stones were laid closely together to form a platform for the subsequent plaster (Figure 3.3). This method of making a beach stone foundation for the floor can be seen extensively in rooms throughout PS8 and PS7, particularly where the overlying plaster skim had been badly damaged and eroded away.

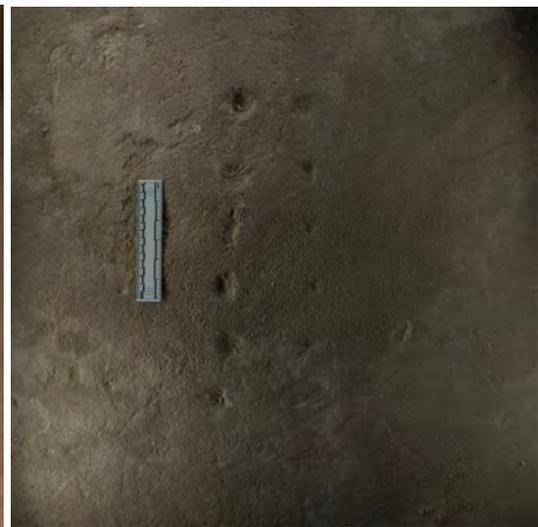
Figure 3.4: Game indentations found gouged into plaster floor. (KF-0457)

The very thin plaster skim overlying the flagstone foundation was the final part of the process of floor construction. Interestingly, this floor had two parallel lines of six small circular indentations gouged onto its surface. These were slightly reminiscent of similar features etched into stone outcrops at Bala'a (QNHHER 3615), approximately 1km to the northeast of Al Zubarah fort, and were interpreted as signs of a game or other social activity (Figure 3.4).
