Qatar Islamic Archaeology and Heritage Project

End of Season Report : 2013-2014

Citation for published version (APA):
Rosendahl, S. (Ed.), Cockin, G., Estrup, E., Hawksworth, C., & Nymann, H. (Ed.) (2015). *Qatar Islamic Archaeology and Heritage Project: End of Season Report : 2013-2014*. Copenhagen: University of Copenhagen and Qatar Museums.

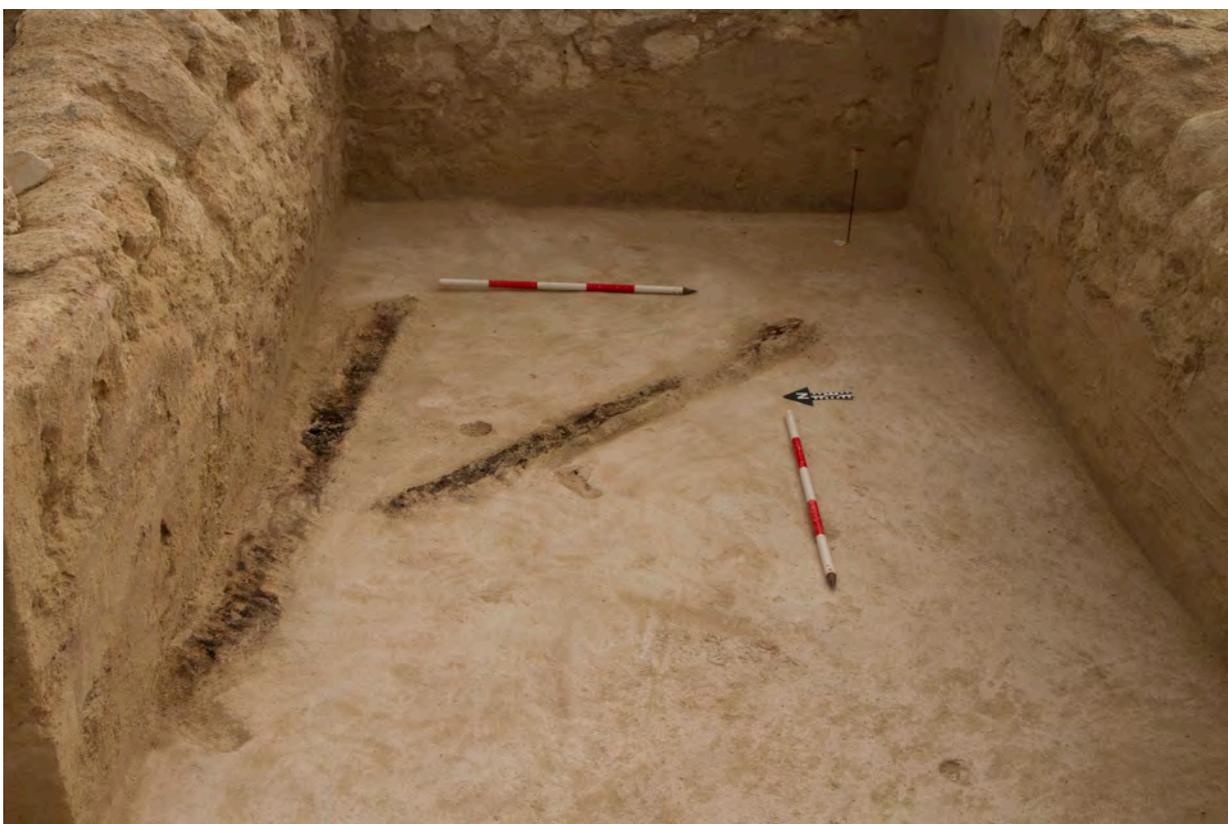
Figure 3.5: Collapsed ceiling beams at the eastern end of Space 3031. (HF-0771)

No occupation deposits were found in this room. Instead, large plastered architectural elements were discovered. In addition to the collapsed arch fragment left *in situ*, a large plastered door post element was found lying near to the doorway to Space 3035 in 2013. Underlying rubble collapse layers were then investigated, but these too were not fully excavated since the western ends were left *in situ* to support the arch remnants. Two large chunks of fallen plaster and masonry were found sandwiched between these two layers. They lay at the base of the southern wall and were presumed to be part of the higher wall surfaces that had fallen down fairly early in the buildings collapse. Most interestingly, the remains of collapsed ceiling beams were discovered lying directly above the plaster floor (Figure 3.5). These consisted of dark brown to black, organic, degraded wood and were superb evidence of the roof that once covered the space.

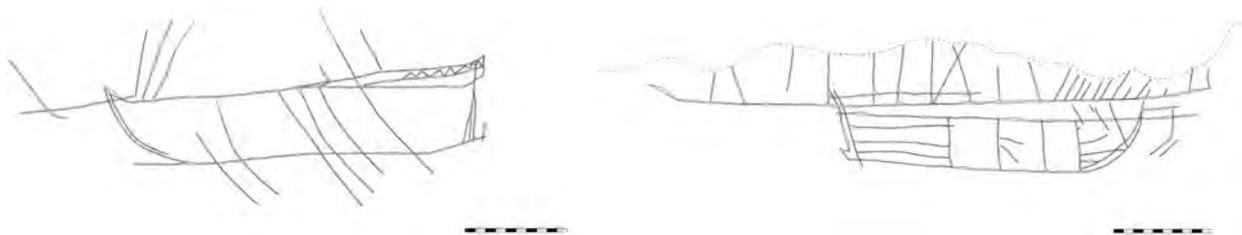
Figure 3.6: Dhows 12 and 14 in Space 3033 (drawing by Ann Andersson).

Time constraints did not allow the full excavation of these spaces, and they will be finished in a future season. However, even though Space 3033 still contained rubble collapse, more drawings were revealed etched crudely onto the plaster wall surfaces. Work in 2013 had already revealed several of these (see Collie 2013), but two more were found inscribed on the southern wall of Space 3033 (Figure 3.6) Directly east, an excellent etching of what resembled a large ship was inscribed into the wall plaster. These etchings had been inscribed on the plaster before the collapse of the building, but it is uncertain whether they were drawn during occupation or while the building fell into decline.

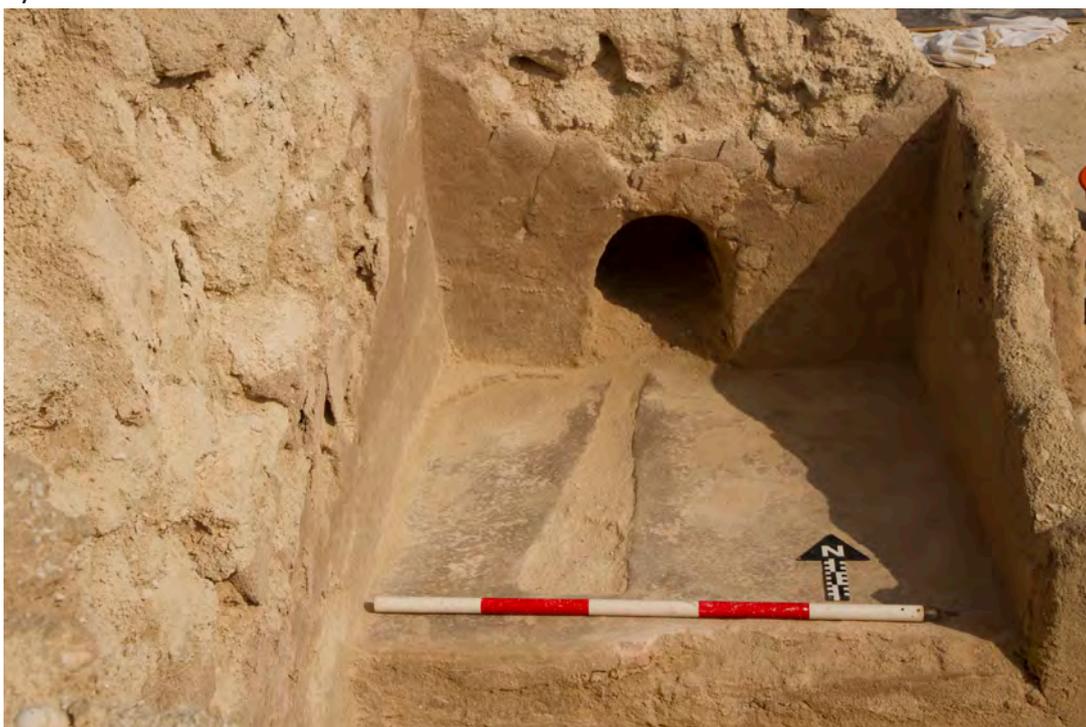
Figure 3.7: *Hammam* in Space 3035. (HF-1094)

The total excavation of Space 3035 revealed the extant remains of a *hammam* in the north-western corner. It was comprised of an elevated platform with a thin plastered stone wall in the east and the south. Entrance to the *hammam* came from the south. The platform base had a very shallow channel which sloped and tapered down from a wider end to a narrower lower end, which then ran into a cavity built into the northern wall (Figure 3.7). The *hammam* drained into a soakaway pit either in the southern side of courtyard Space 3039 or indeed into a pit directly under the wall.

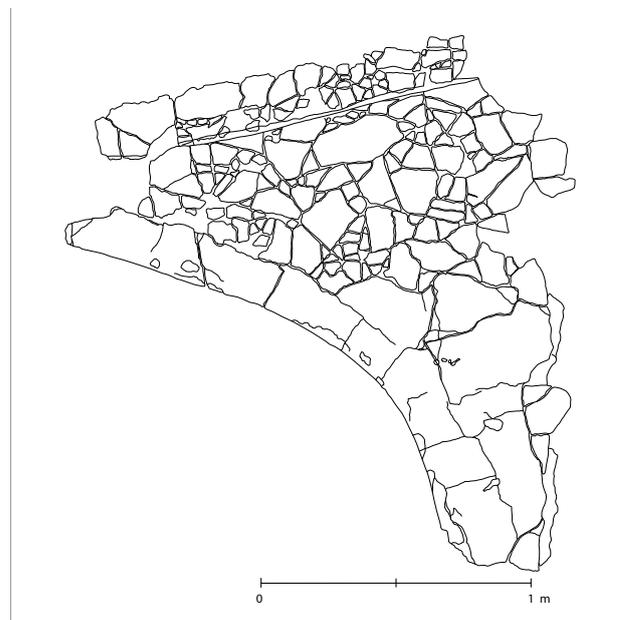
Figure 3.8: Drawing of rescued arch remnants at the entrance to Space 3036 (Drawing: Bernadeta Schäfer)

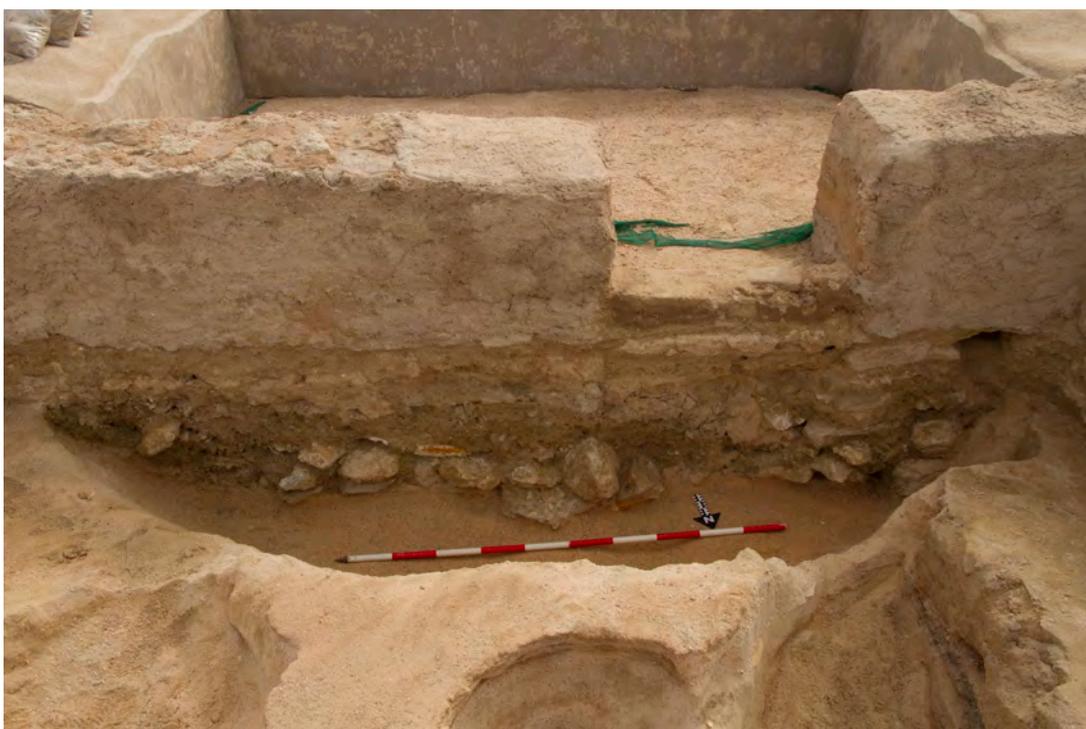
Figure 3.9: Pit underlying the southern wall of Space 3020. (HF-0096)

Space 3020, like the main courtyard Space 3012, yielded archaeological features pre-dating the construction of the compound. A total of 13 pits cut through the natural geology, along with one deposit that extended under the wall shared with Space 3009 to the south. The most interesting of these was a large elongated pit which extended beneath walls to Space 3007 (Figure 3.9). This predated the construction of the building, thereby placing it stratigraphically in the main Al

Zubarah timeline of Phase 6. The pit was extremely large, measuring 4.5m long and contained two curious fills. The top fill was an organic, dark brown-green, sandy silt containing only a small number of finds. Beneath lay a similar deposit, but this time packed with abundantly large angular stone. This stone was unusual since it was not the typical beach stone found so commonly in the walls of PS8; rather, it resembled rock seen more commonly to the east of Al Zubarah at Murair. It was believed that this pit was related to a water basin in Space 3007 since its fill deposits appeared green and organic. The large unusual stone was considered as support for the overlying structures but also a means to aid filtration and subsequent water drainage.

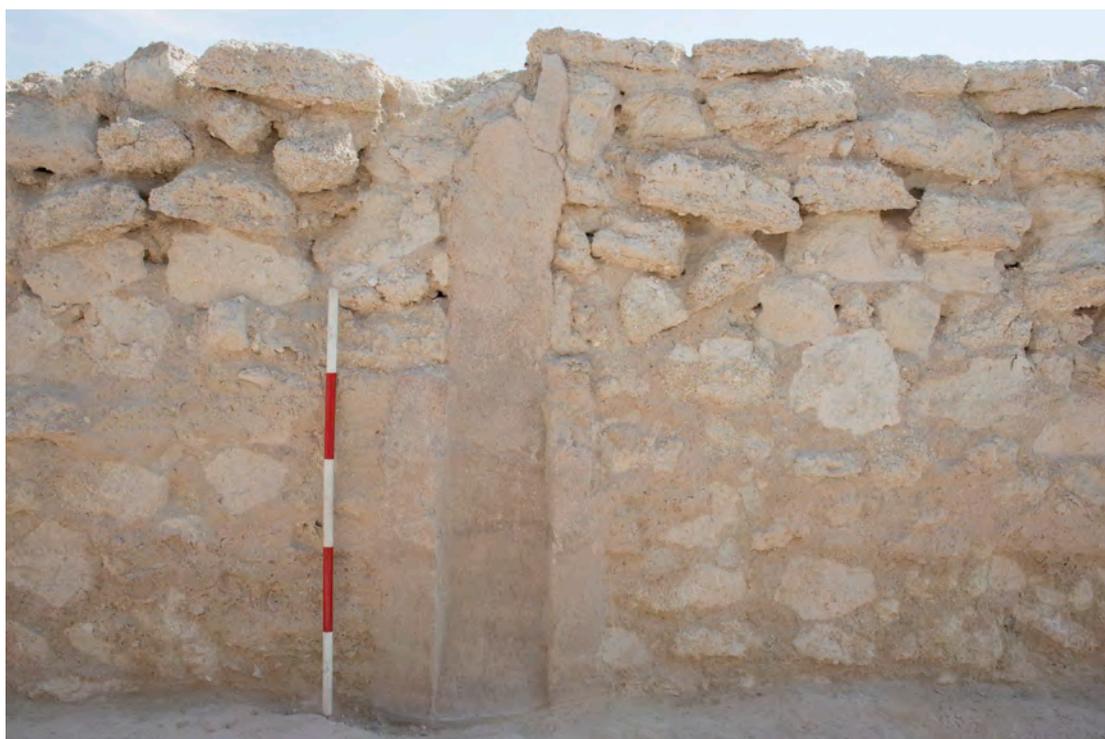
Figure 3.11: Gutter feature on the southern corridor wall in Space 3026. (KF-0372)

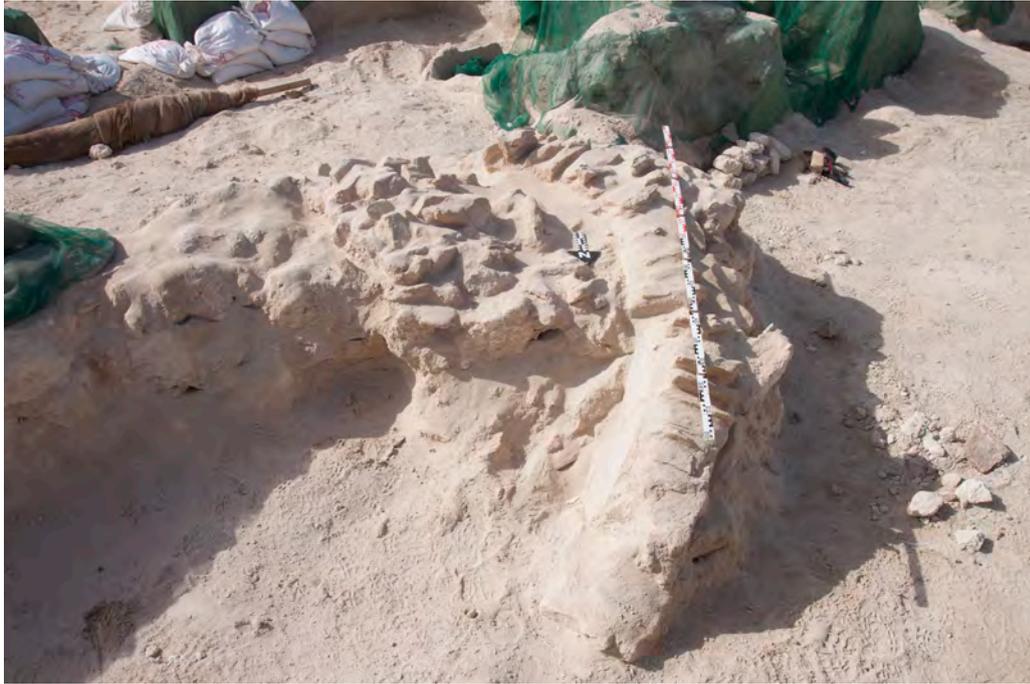
Figure 3.12: Remains of arch 4860 prior to excavation. (CE-0321)

The first arch thus recovered in autumn 2013 was located in Space 3035, which collapsed into the existing doorway and the courtyard Space 3039 (Figure 3.12). It was clear from the beginning that not all parts of the arch were present. Three large fragments could be recovered, including a nearly complete sequence on the right side from the impost to just before the arch rise (Fragments 1 and 2) and about a third of the left side showing the impost and the start of the intrados (Fragment 3).

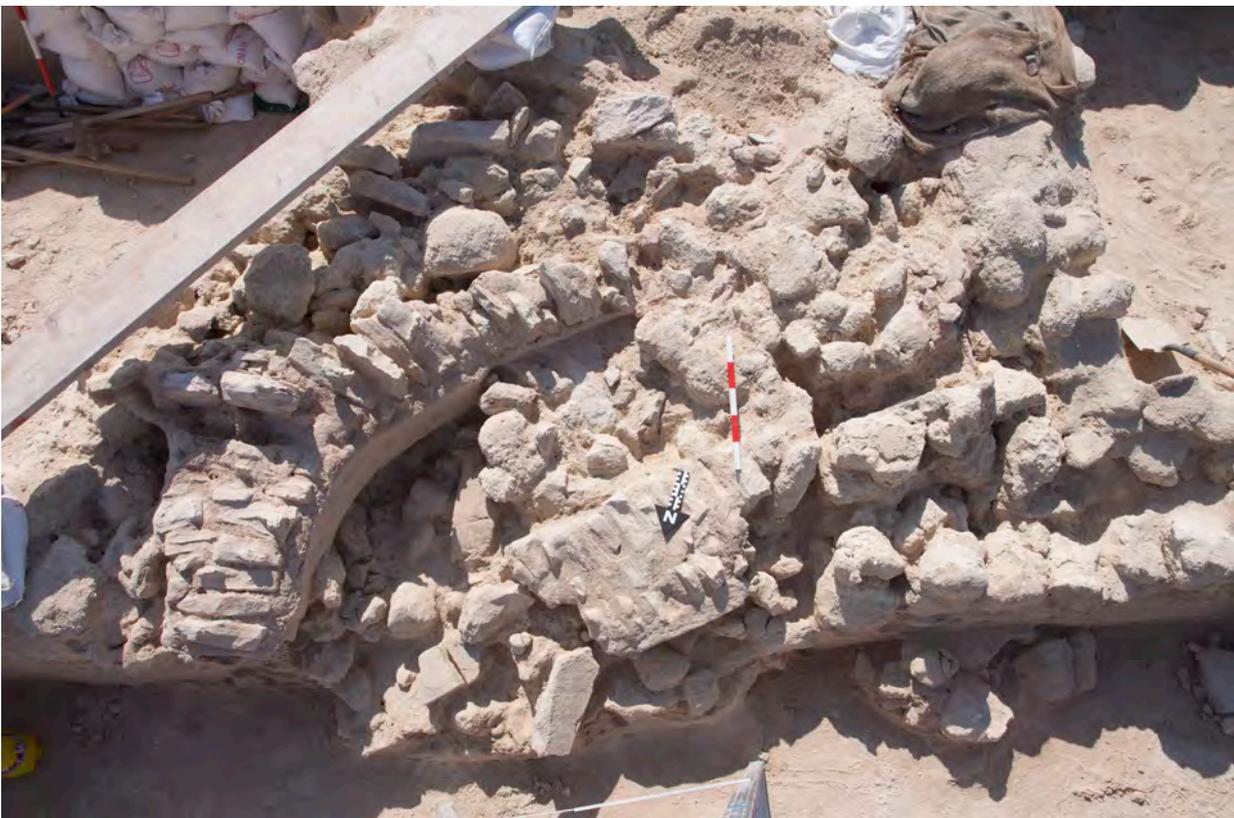
Figure 3.15: Working area of arch 4859 after superficial cleaning. The largest arch fragment is visible on the left. Any exterior plaster had deteriorated in the past. (DF-0178)

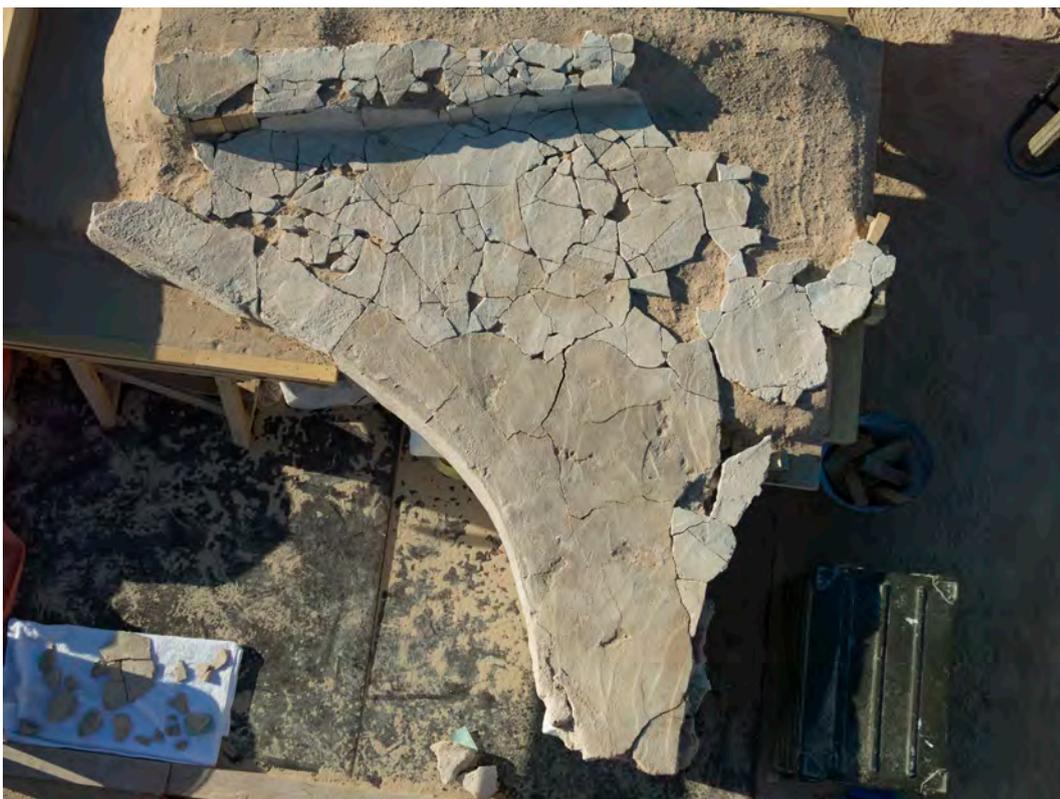
Figure 3.16: Front of arch 4859 showing the cornice. Compare drawing Figure 3.8. (WF-0395)

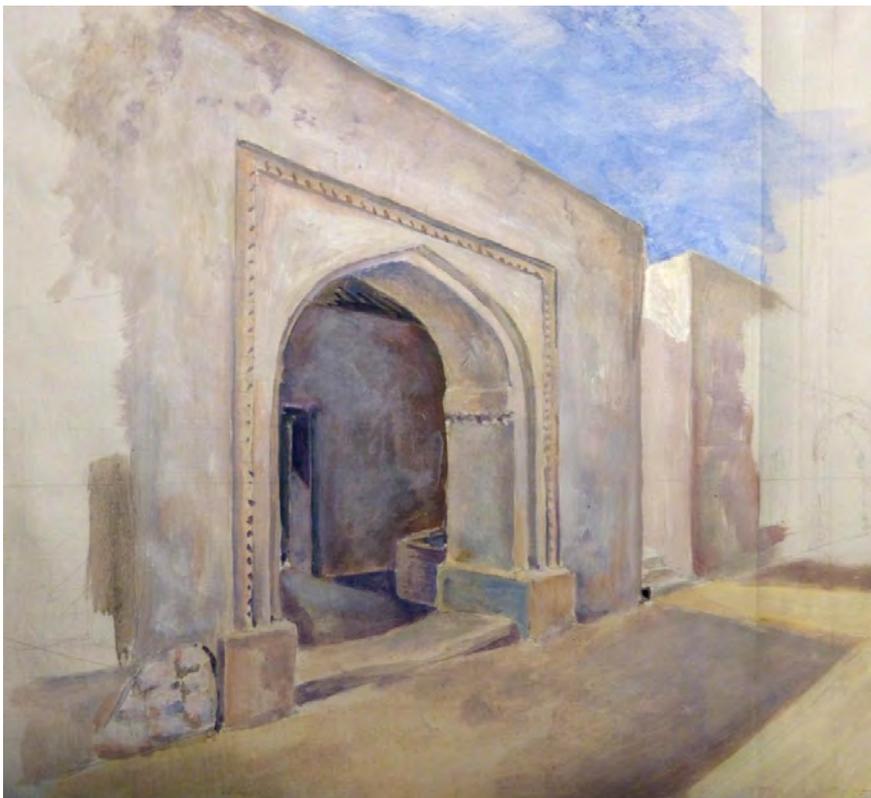
Figure 3.17: Graphical reconstruction suggestion.

The vast body of information thus collected raises questions regarding its presentation. Following suitable conservation efforts, it is technically possible to reconstruct the architectural feature with the historical material, or at least guided by it, to allow any visitor the experience of full immersion (Figure 3.17). This must form a discussion point in any presentation proposals for the entire compound.

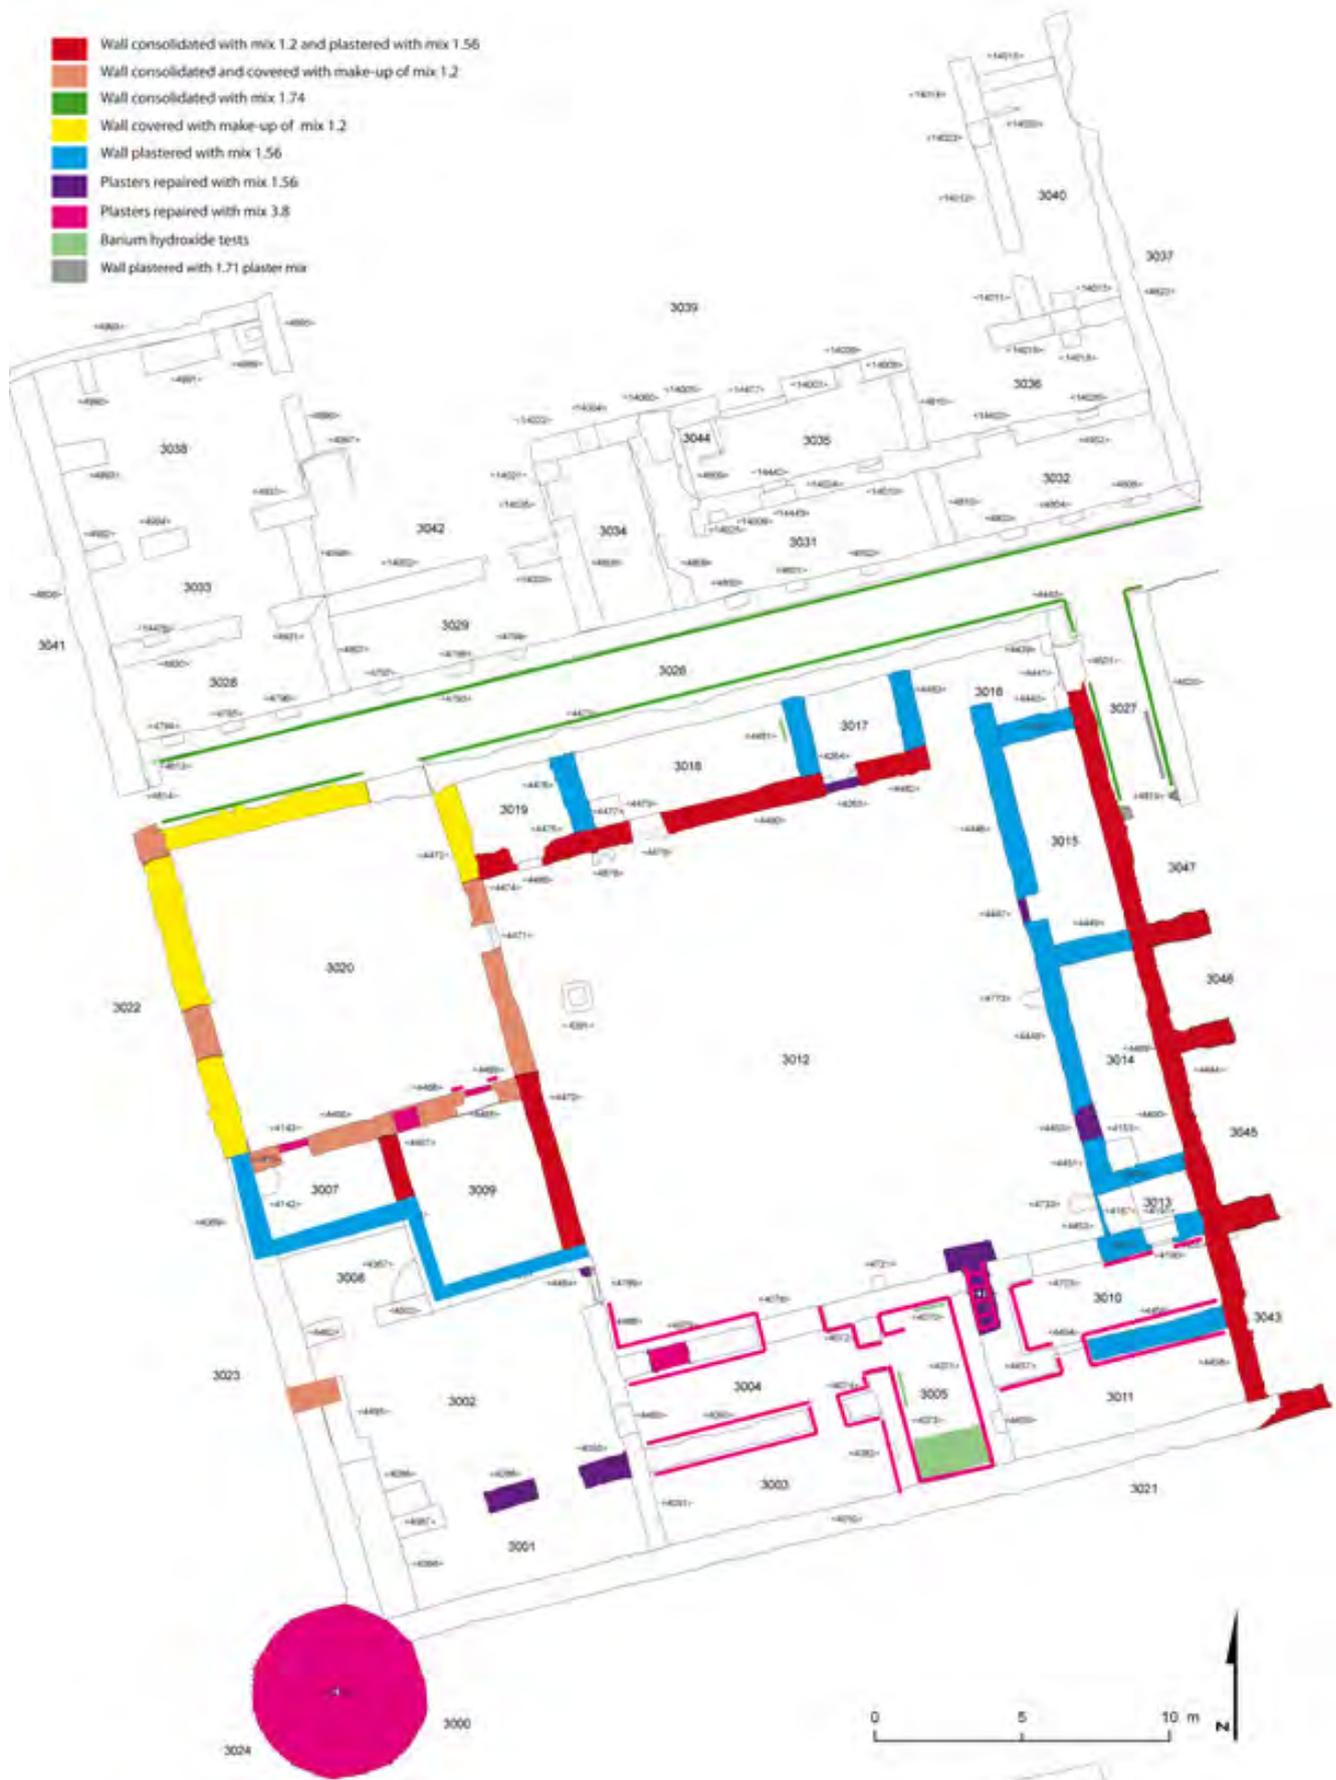
Figure 3.19: Conservation work in ZUEP04 in autumn 2013 and spring 2014.

Conservation work in ZUEP04 consisted of the monitoring and documentation of the condition of previously consolidated structures, the consolidation of further walls, the application of make-up and fine plaster layers, and repairs to damage in the historic plaster (Figure 3.19).

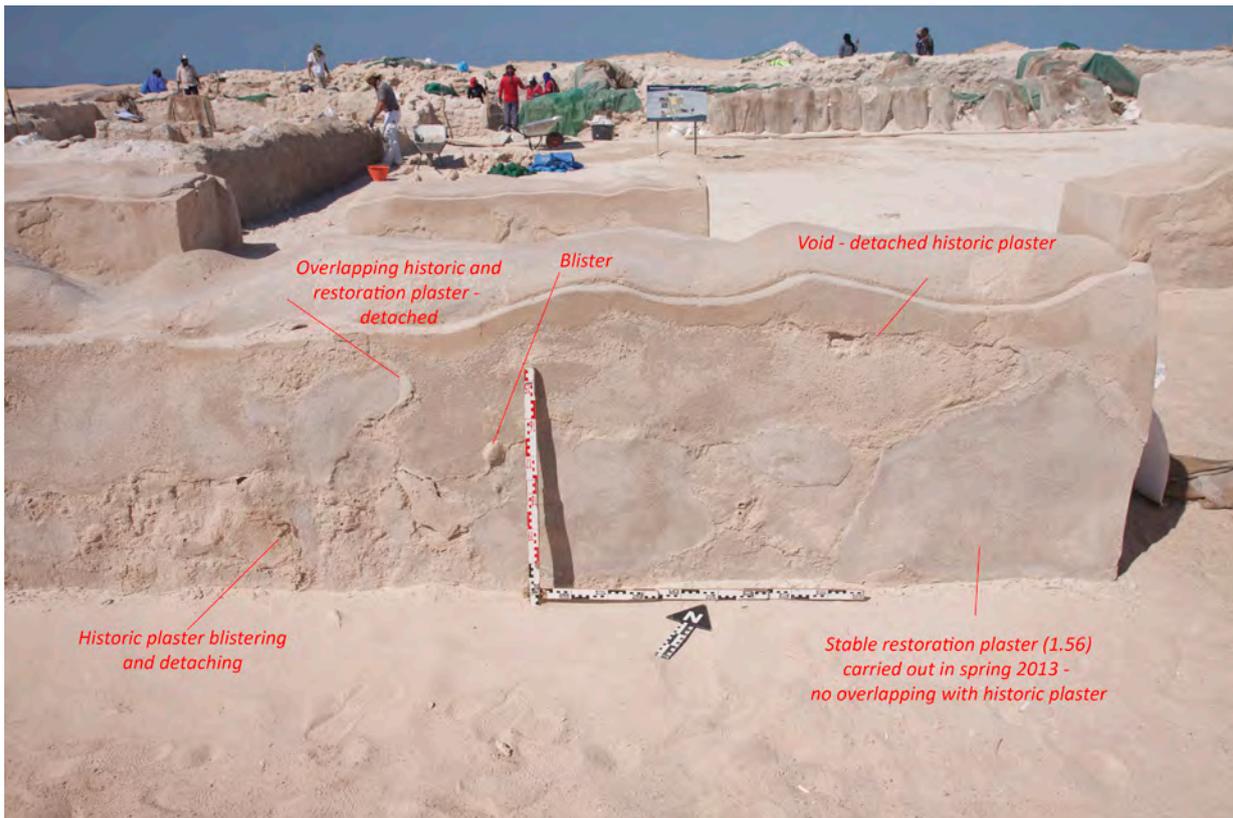
Figure 3.20: Wall 4090 in Space 3003, showing damage patterns on the plaster surface. (DE-0560)

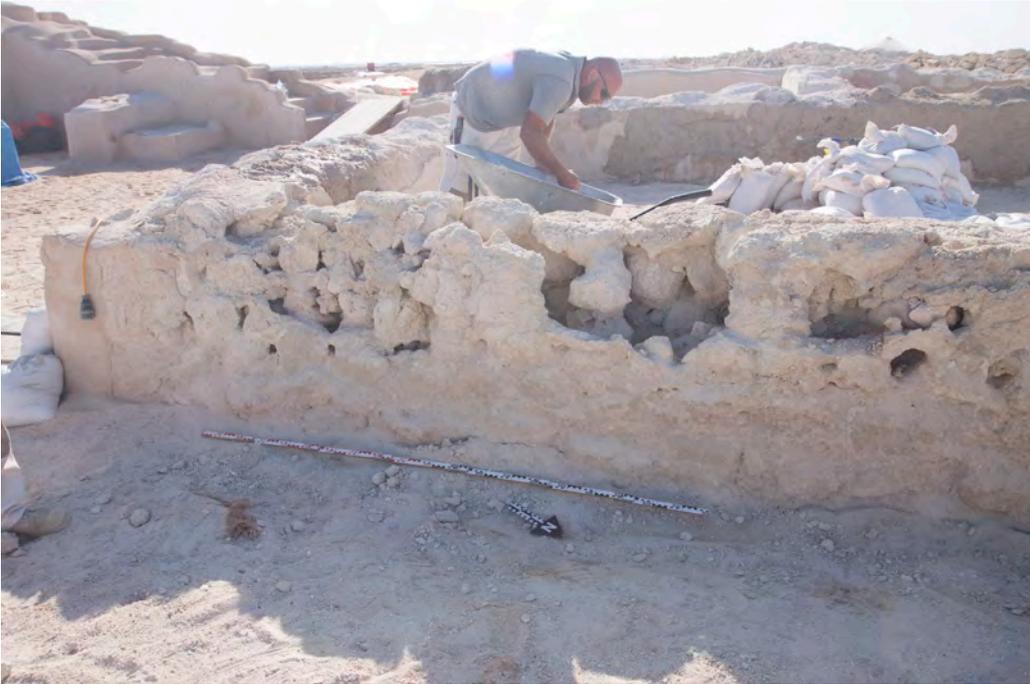
Figure 3.21: Spacious voids in the wall structure in Space 3012 after cleaning. (DE-0466)

The masonry of the western courtyard Space 3012 wall in PS8 was in particularly bad condition (Figure 3.21). Spacious voids appeared when vacuuming the masonry, which had to be complemented with dolomite stones.

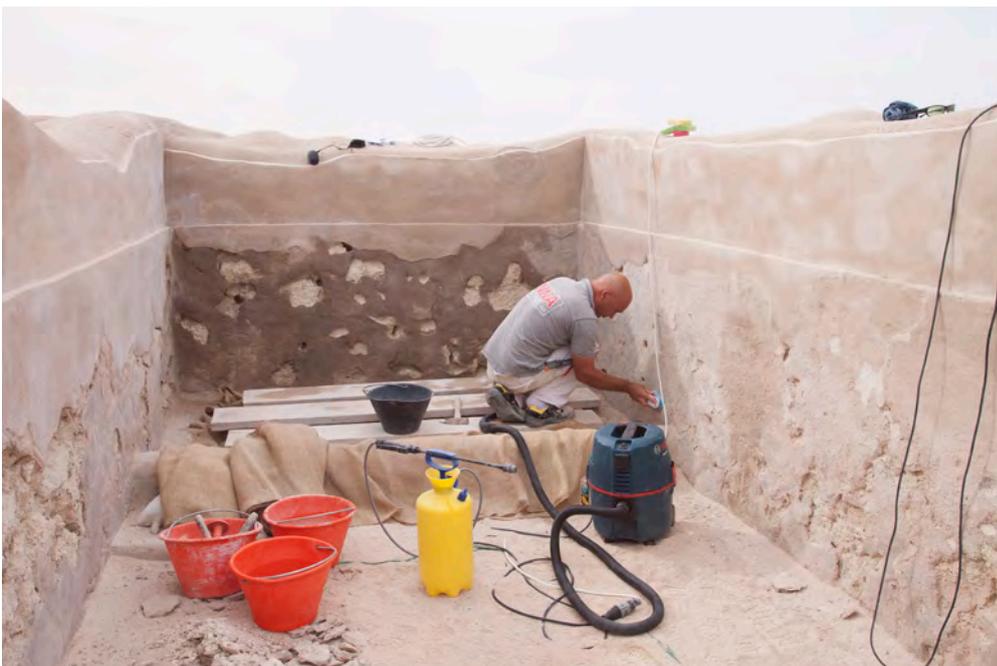
Figure 3.22: Preparation of walls in Space 3005 for void repair. Detached plaster were removed. (DF-0378)

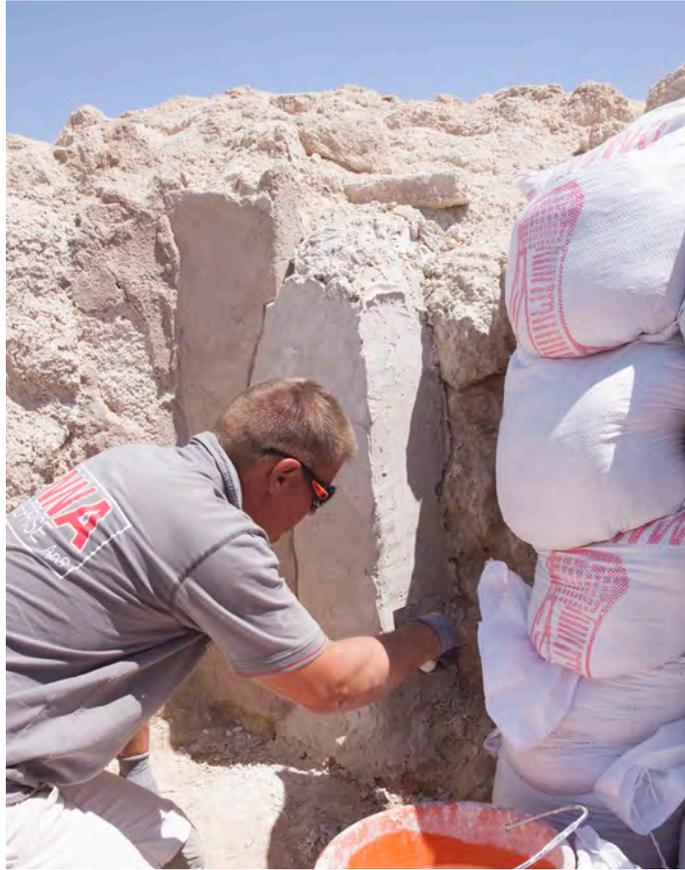
Figure 3.23: Reconstructing the plaster surface on the door jamb, scratching the surface with a knife. (DF-1085)

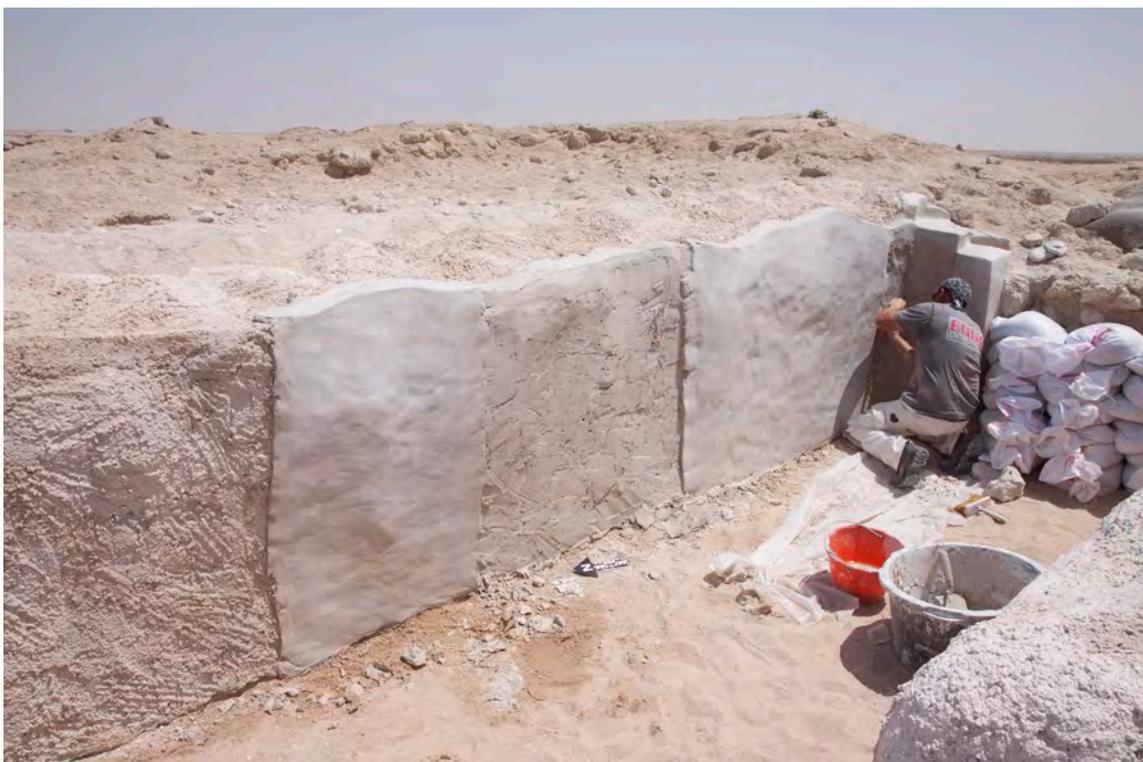
Figure 3.24: Gypsum plaster test fields in Space 3027. (DF-1131)

After the application of mortar mix 1.74, tests for application of fine plaster finish were carried out on the eastern wall of Space 3027 (PS1). The test area was divided in three fields: on the southern field, the plaster was applied in two layers; on the middle field, only the first layer

was applied; and on the northern field, the entire plaster was applied as a single layer (Figure 3.24). The application in two layers following each other in a short time span proved to be most practicable, as the surface did not crack as much as on the single-layer field. Craftsmen had to be encouraged to follow the irregularities of the wall surface as there was a strong tendency to level the surface with plaster.

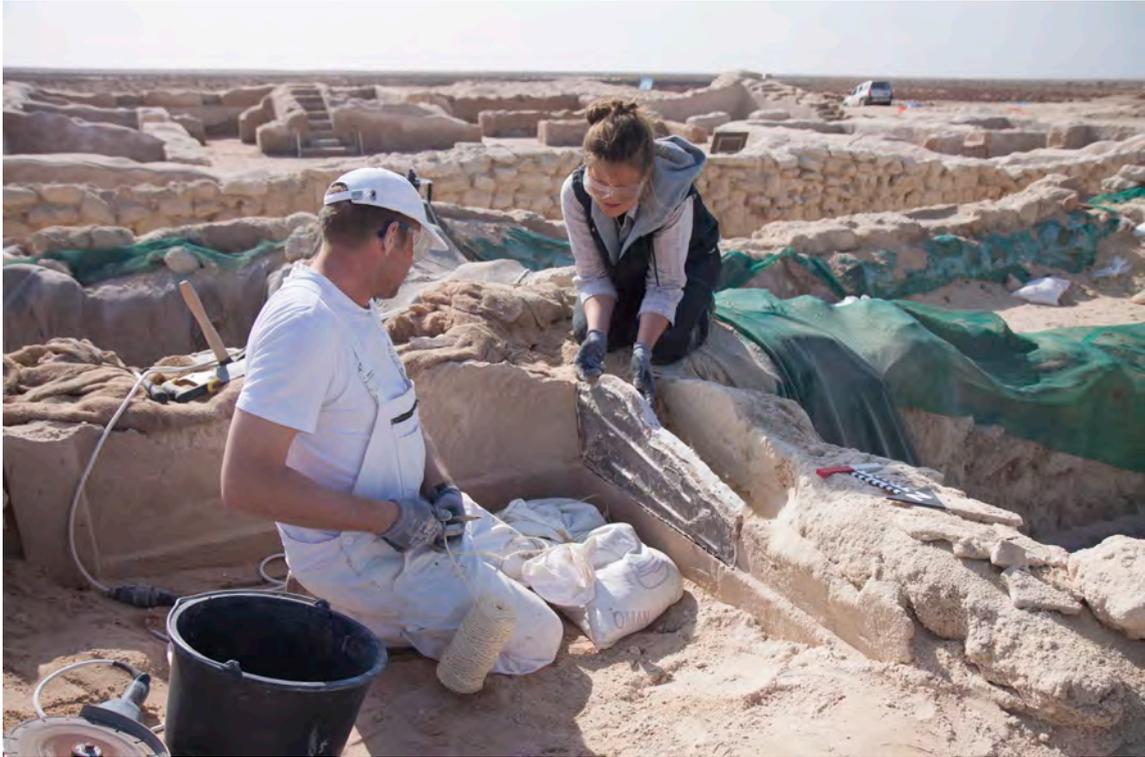
Figure 3.25: Restorers recovering plaster with *dhow* etchings. (DE-1596)

The considerable number of *dhow* etchings and historic graffiti in PS7 was addressed in autumn 2013. Most of the etchings have been removed from the walls, as they would not have survived long-term exposure *in situ*. All were documented by photographs, drawings and 3D photogrammetry, and moulds were created (Figure 3.25). After removal, the etchings were conserved and stored at Zubarah Research Station.

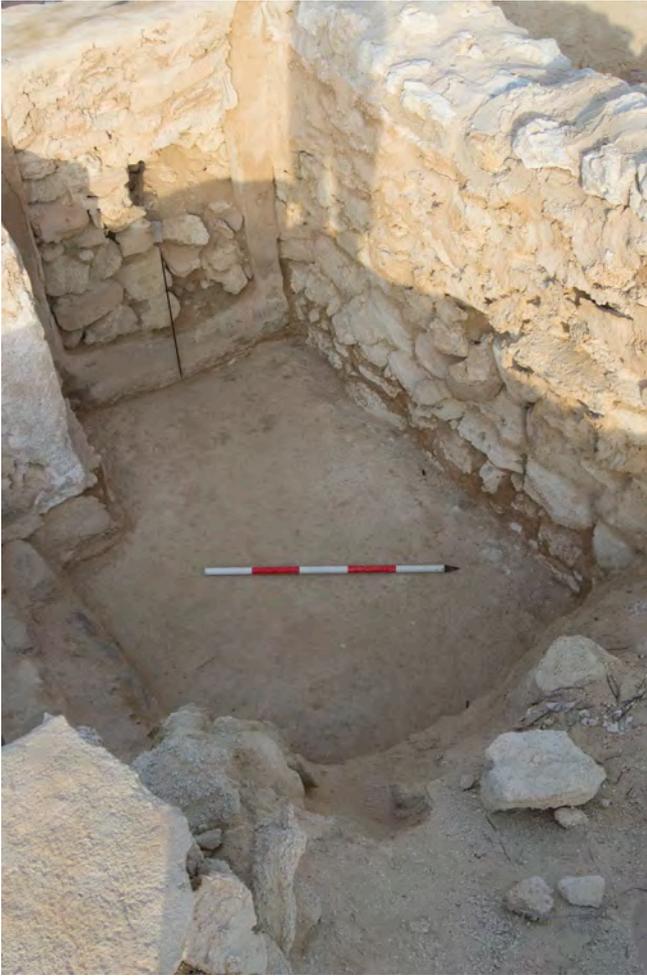
Figure 4.2: Space 10008 showing gypsum plaster floor, door frame and blocking. (YF-0040)

but instead to gather as much significant information within a short time-frame. The earliest deposit reached was a hard gypsum plaster floor covering the majority of the area. This surface was unexcavated but seems likely to have been contemporary with the earliest construction in the area and was laid during the same major building phase associated with the earliest architecture in QMA4 (Figure 4.2). Above this lay a mud-based surface which became considerably thicker as it approached the northern and southern walls, where it blended into the joint mortar and patchy plaster used on these faces. It also contained a number of lenses of degraded imprinted straw or reed, seemingly trampled into the deposit. This may have been the result of either the installation or perhaps collapse and repair of the ceiling (Figure 4.3). Potentially woven reed material was used across the roof, with some falling to the ground and gradually becoming part of the accumulated surface. Another gypsum-based plaster floor then overlaid this deposit acting as both a newly-laid surface and a make-up layer for the installation of the door-frame. This marks the first

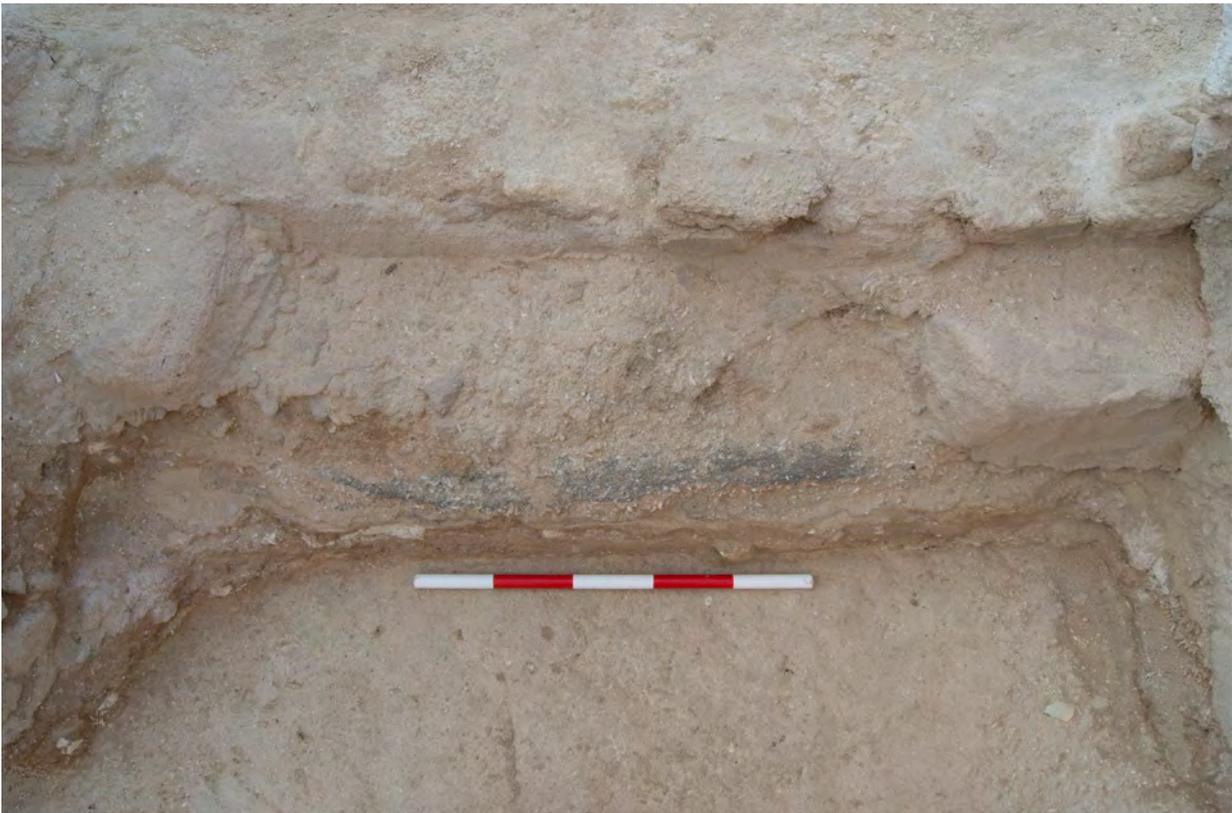
Figure 4.4: Entrance-way into Space 10008 with added door sockets. (YF-0043)

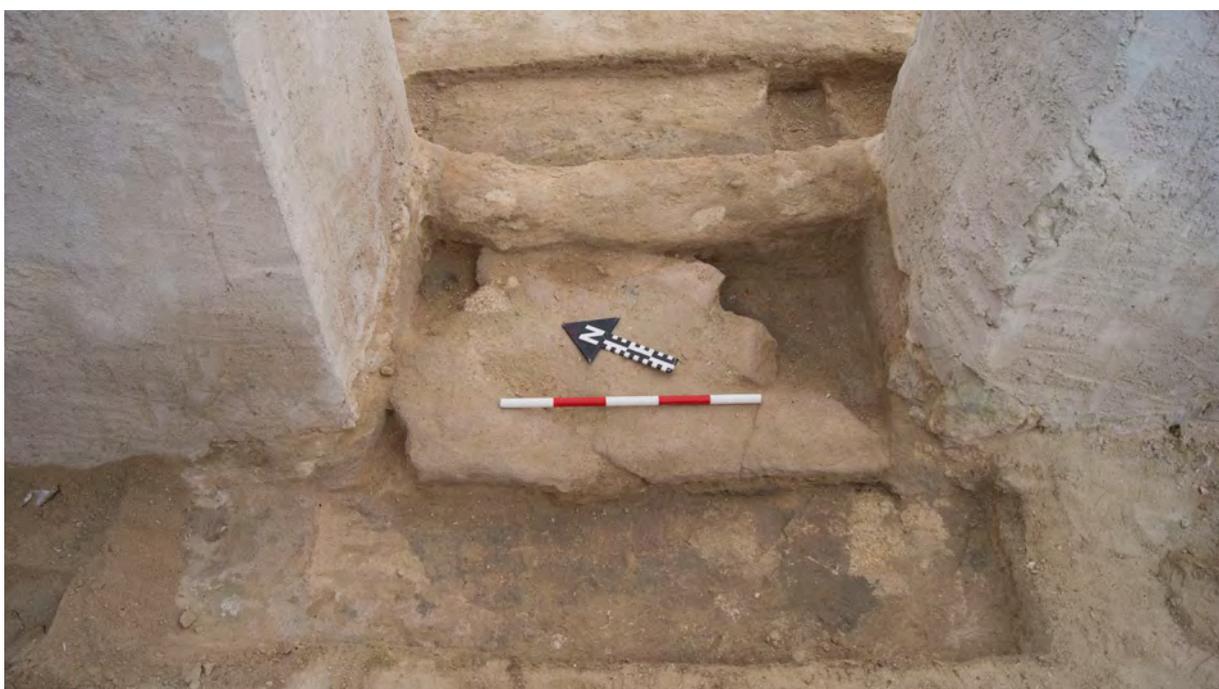
Figure 4.5: Doorway between Spaces 10010 and 10011. (XF-0685)

The sondages also helped to define more clearly the nature of the thresholds to Space 10011 (Figure 4.5) and Space 10013.

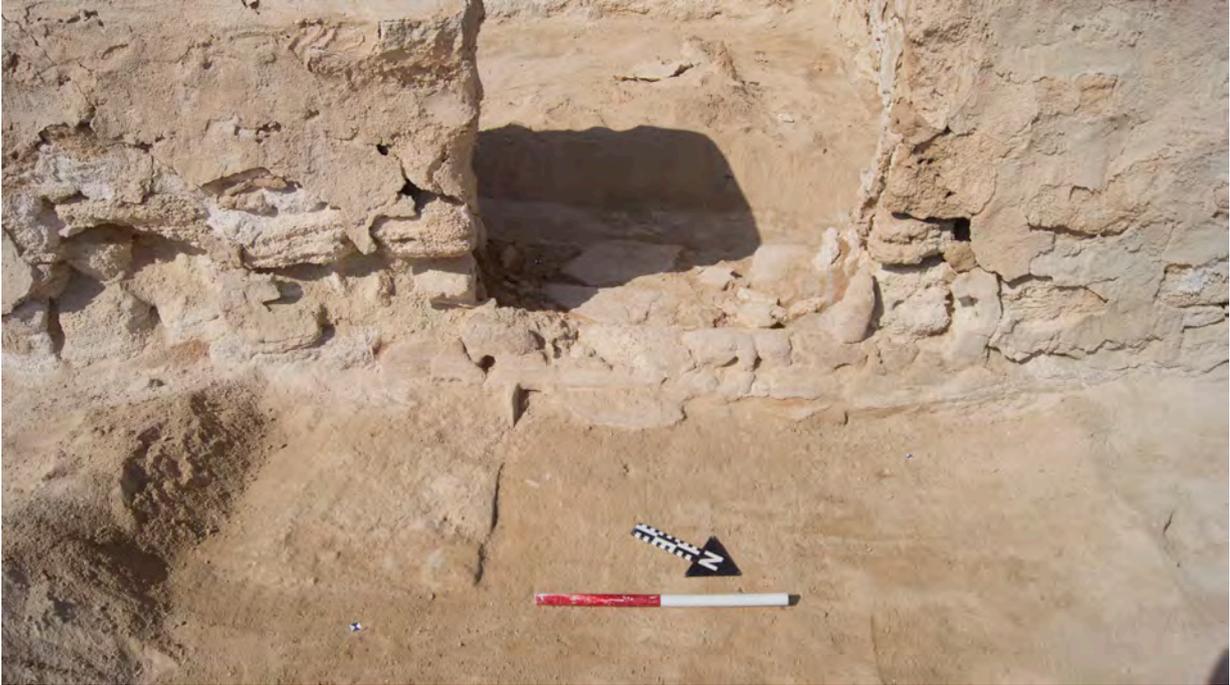
Figure 4.6: Badly preserved threshold between Spaces 10001 and 10003. (XF-0661)

This sondage investigated the doorway between Spaces 10001 and 10003. A possible platform could be identified here as in the other courtyard spaces. The doorway's threshold was only partly preserved (Figure 4.6).

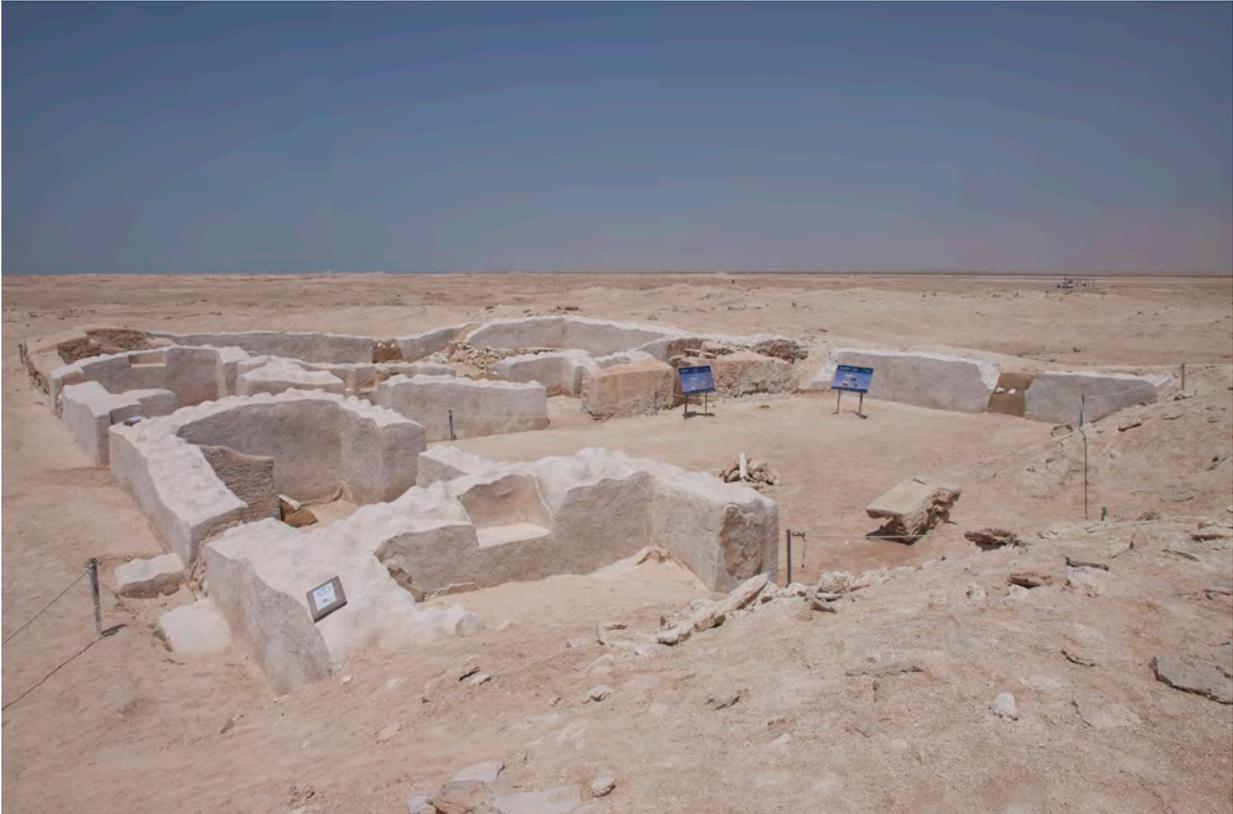
Figure 4.8: Overview of QMA4 at the end of the season. (DF-1135)

The conservation team was engaged in QMA4 throughout the season, initially documenting the state of preservation through photographs, descriptive records and drawings. This was followed by the consolidation of the masonry and application of a make-up layer, and the repair and reattachment of historic plasters (Figures 4.7 and 4.8).

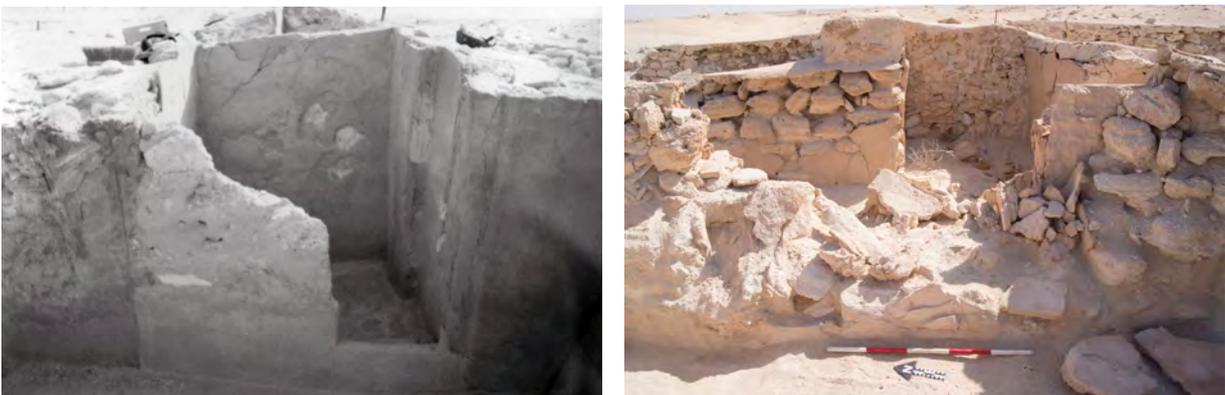
Figure 4.9: State of conservation of a hamam in Space 10006 after excavation in the 1980s (left) and at the beginning of the autumn 2013 season (right). (QM & YE-1230)

The historic gypsum/anhydrite plasters were of very good quality, but the lack of maintenance after abandonment of the compound led to significant collapse. The modern cement cappings and plasters did not offer suitable protection to the fragile beachrock that were used to construct the historic walls. Plasters were only applied to the joins instead of the entire wall surface; strong winds, heavy winter rains and chemical processes between the cement mortars and historic building materials led to serious decomposition of the beachrock (Figure 4.9).

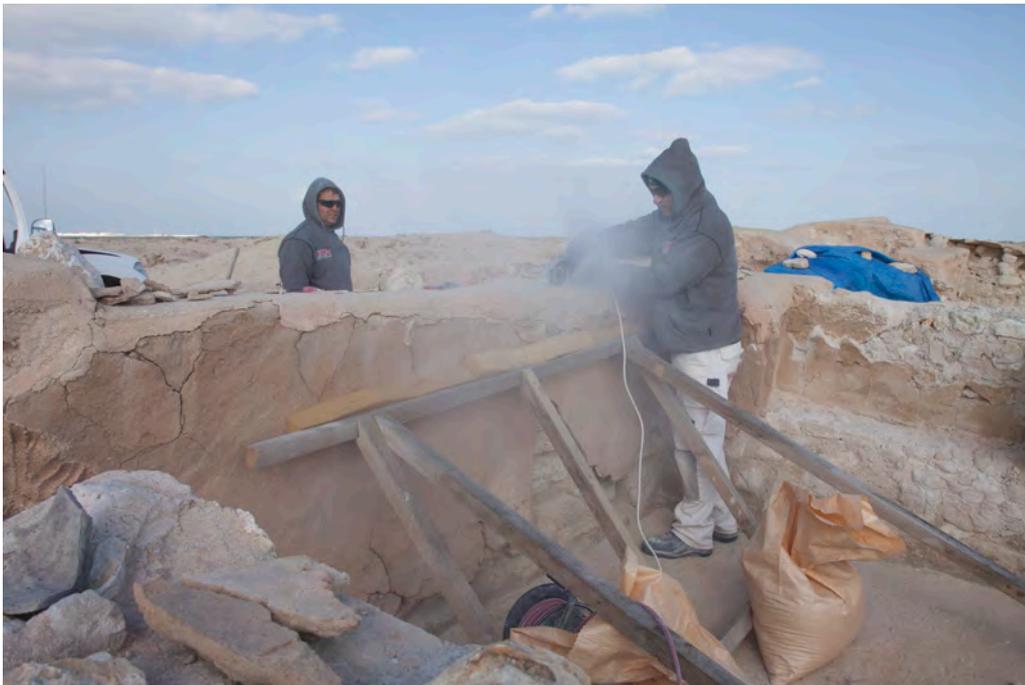
Figure 4.10: Removal of the cement capping on a wall in Space 10006. (DF-0075)
