Qatar Islamic Archaeology and Heritage Project

End of Season Report : 2013-2014

Citation for published version (APA):
Rosendahl, S. (Ed.), Cockin, G., Estrup, E., Hawksworth, C., & Nymann, H. (Ed.) (2015). *Qatar Islamic Archaeology and Heritage Project: End of Season Report : 2013-2014*. Copenhagen: University of Copenhagen and Qatar Museums.

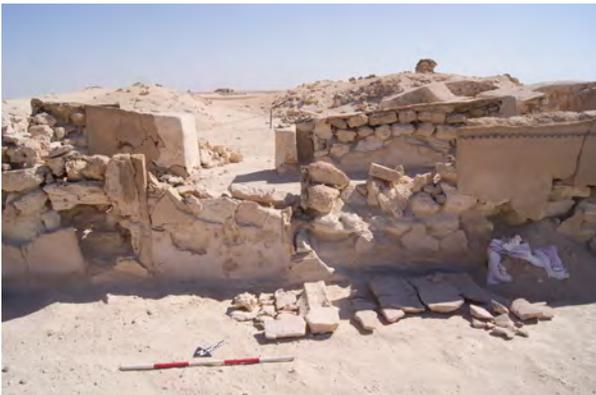
Figure 4.11: Before conservation, with detached plaster fragments in front. (YE-1293)

The most spectacular plaster feature survived in Space 10005 in the form of a dragon tooth decoration. Restorers and masons together reconstructed the particularly badly preserved wall where possible, and filled any remaining voids with a liquid plaster mix using small pipes and syringes. The historic plaster could then be reattached (Figures 4.11 to 4.14).

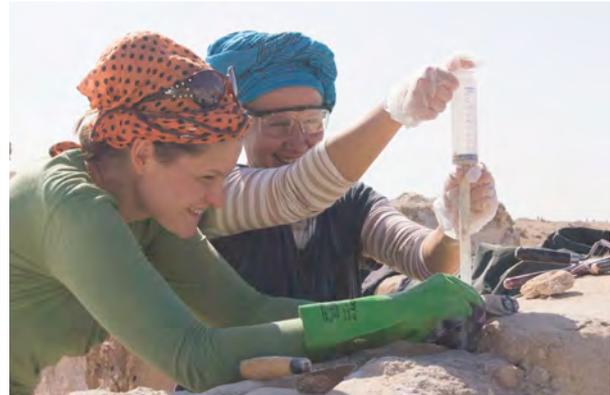
Figure 4.12: Restorers filling voids in the wall with liquid mix. (XF-0213)

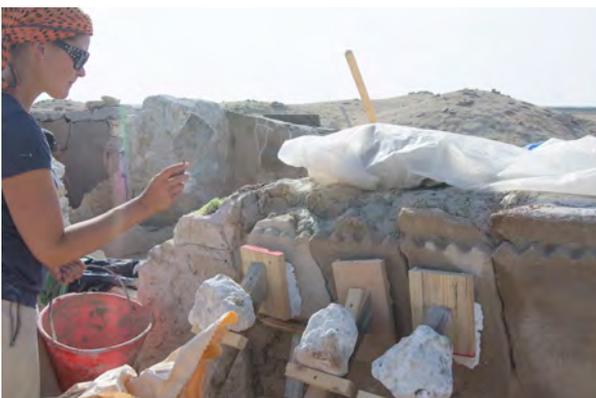
Figure 4.13: Reattaching the detached fragments of historic plaster. (YF-0091)

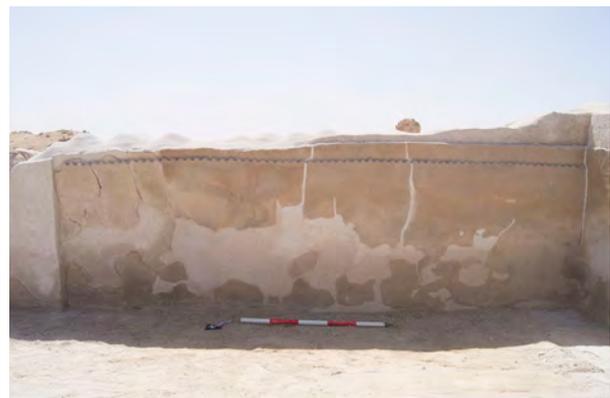
Figure 4.14: After conservation, with plaster reattached and voids filled. (XF-0710)

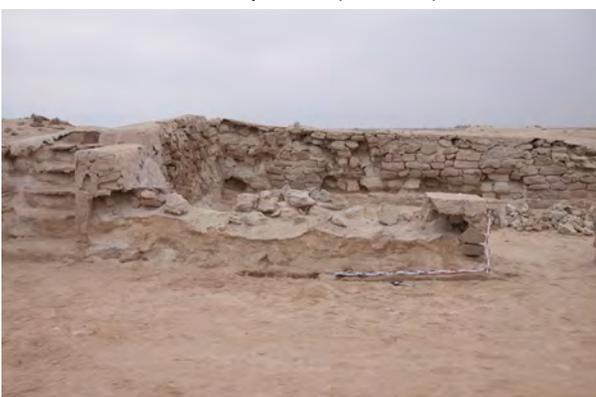
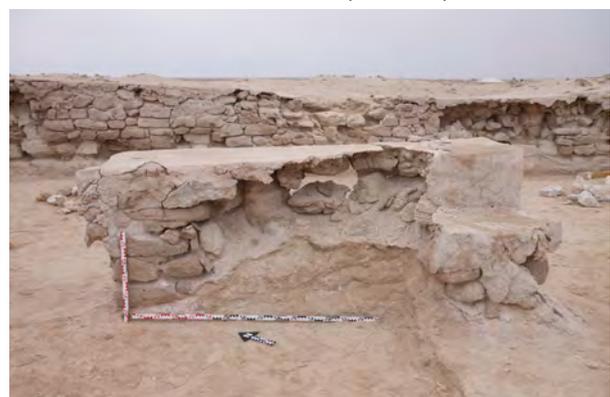
Figure 4.15: Two walls on the eastern side of Space 10001 remaining untouched to serve as reference objects for the conservation and need for maintenance. (DF-0022 & DF-0023)

Two of the walls previously conserved in the 1980s campaign have been left without any renewed consolidation efforts in order to demonstrate to visitors the need for maintenance and repeated measures (Figure 4.15). Other as yet unconserved features have been protectively backfilled for future work.

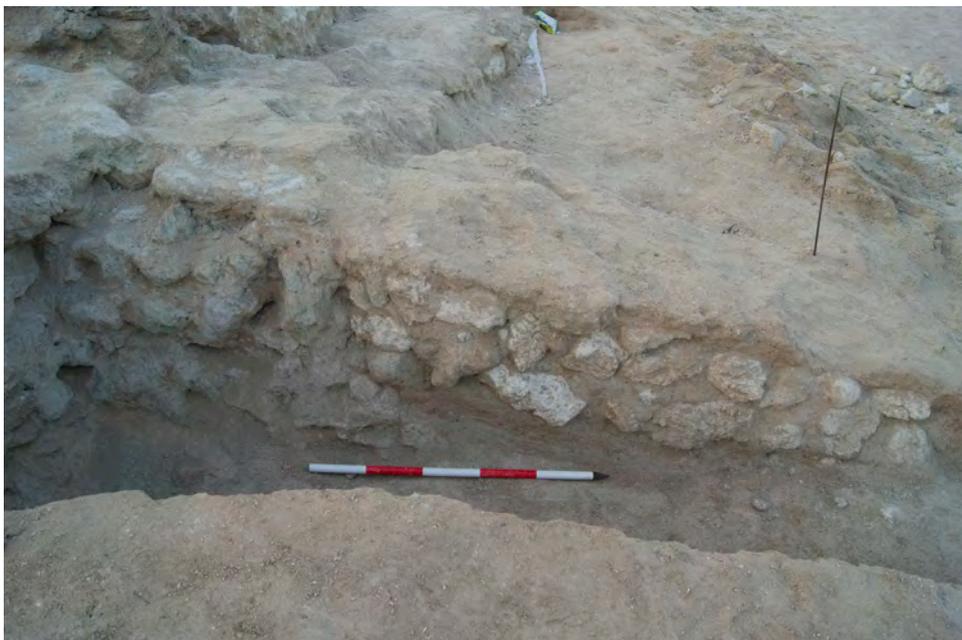
Figure 5.2: Cleaned section of 1980s excavation slot showing collapse and deposits. (YF-0229)

An area measuring 3.2m by 3.8m on the western side of Tower 17 (Figure 5.1) began with the removal of a layer of wind-blown sand covering the entire area. This uncovered a backfilled slot from the 1980s dug through the surviving deposits banked against the *banquette* wall. This slot was emptied out to reveal the sequence in section (Figure 5.2). The *banquette* wall here was of slightly different form, with the main constituent being soft clay-based masonry roughly coursed and bonded by a gypsum-based mortar. The soft nature of this feature has led to a higher level of degradation than seen in other parts of ZUEP13. Likely to be contemporary with the construction of the *banquette* was the blocking off of the main tower entrance. This infill into the entranceway consisted mostly of irregularly-shaped mud or clay-based stones bonded with a mud-based mortar and would have levelled the entrance into the tower to the same height as the *banquette*. The earliest deposit here was laid against the *banquette* and was likely a washed layer of bond material that had gradually weathered from the upper sides. Sat on top of this was a thick ramped layer of silty sand packed with large clay-based stones. This deposit was tightly packed and deliberately laid seemingly to provide support to the inside of the tower. Its ramp-like shape also suggests the possibility that it may have been added to facilitate the use of a small cannon from the top of the tower. The area was then covered across the whole extent by a thick layer of wall and tower collapse which was mixed with wind-blown sand and backfill from the 1980s excavation.

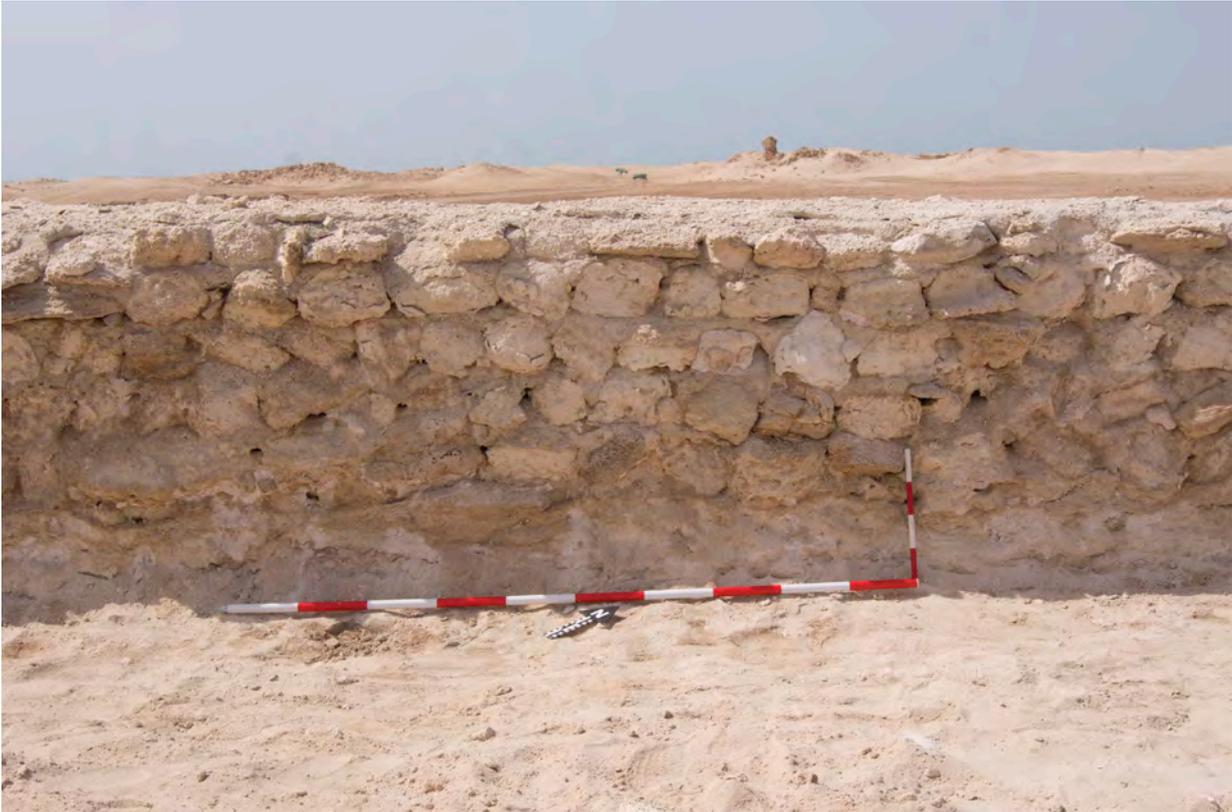
Figure 5.4: Condition of the outer shell of the Outer Town Wall before conservation. The brittle beachstone is extremely eroded. Hard cement mortar can be seen in horizontal layers. (YE-0229)

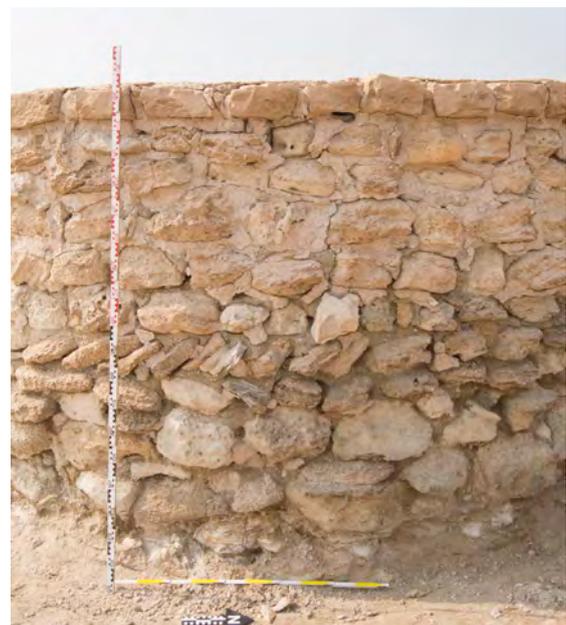
Figure 5.5: Original lower courses, upper courses consolidated in the 1980s, capped with aeolianite slabs. (XF-0165)

The tower was reconstructed to great extent in the 1980s. Cement mortar was used for joints, capping and the construction of the steps and platform. Several varieties of beachstone were

used as building stones. The cement mortar was applied to the joints only thinly, and the capping formed as flat surface. Two different mortars were used: white cement for the joints and steps, grey cement for the capping. In autumn 2013 the stones were strongly eroded, and there was often no connection between the joint mortar and the stones. Two walls were in such poor condition that they collapsed at the tower entrance during excavation in spring 2013.

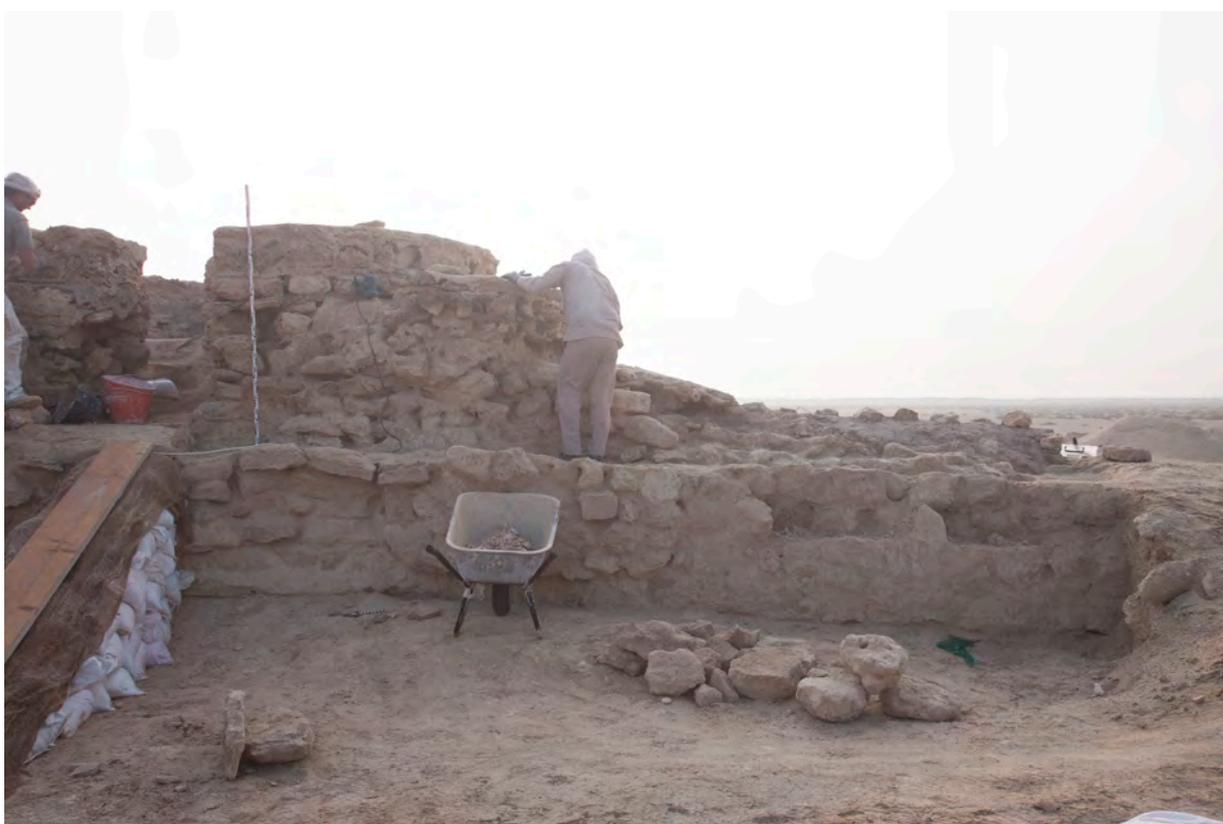
Figure 5.6: Walkway in front of T18 before consolidation. A blocking is seen behind the wheelbarrow. (DE-1339)

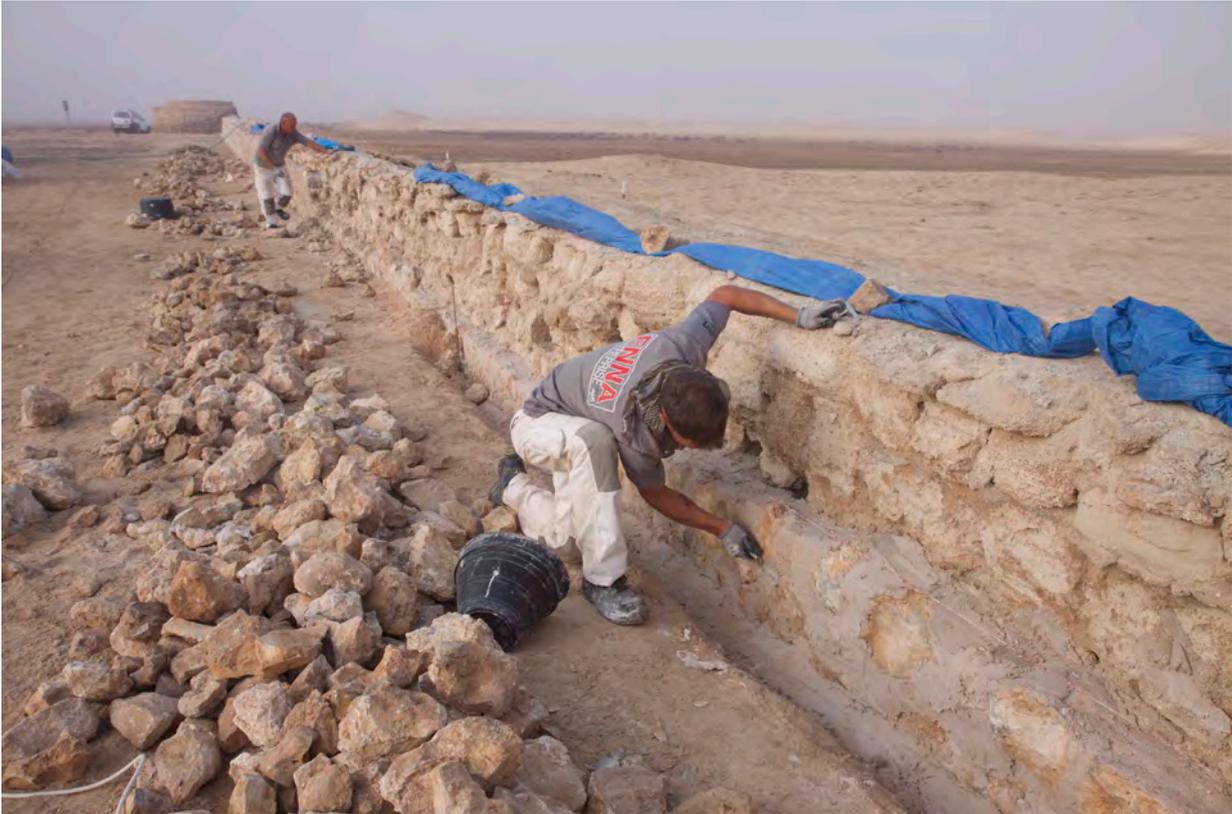
Figure 5.7: The new shell of the Outer Town Wall being constructed in front of the 1980s shell. (DE-0640)

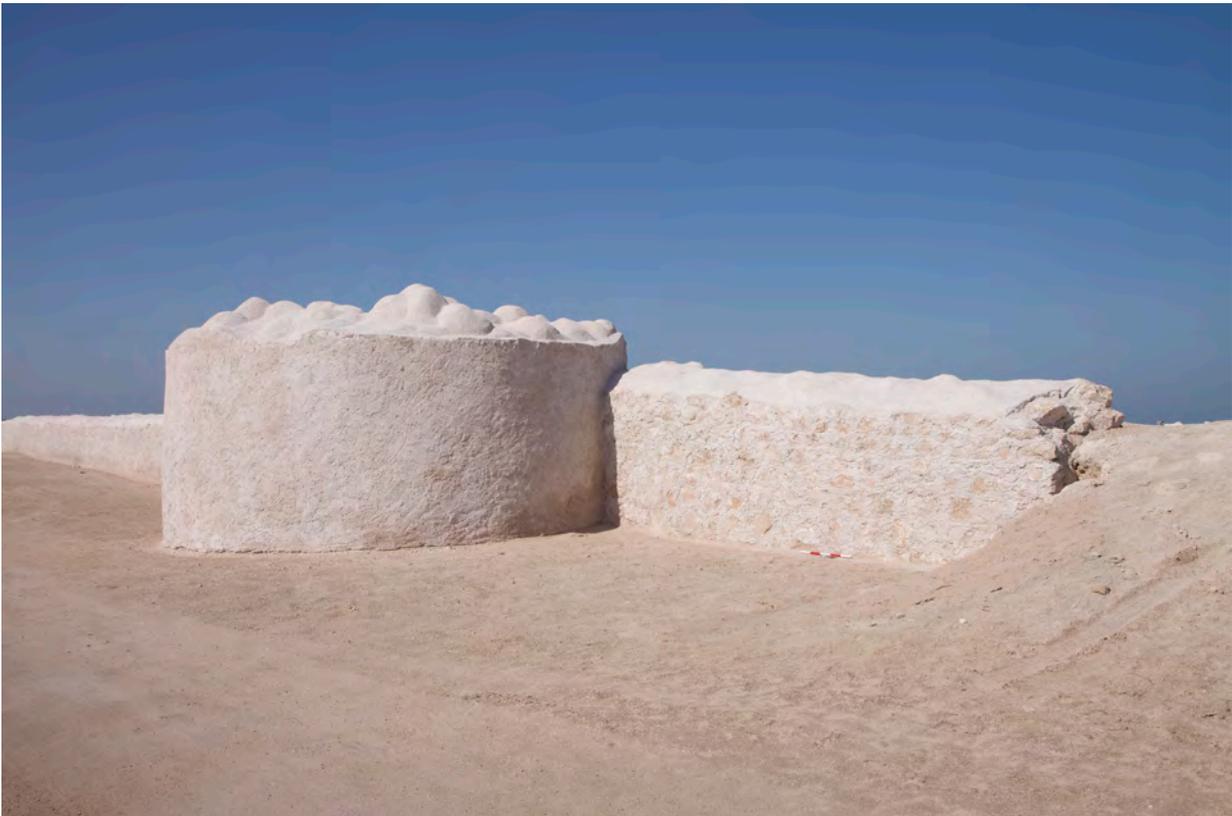
Figure 5.8: T16 after finished consolidation. The rough capping allows better drainage (DF-1076)

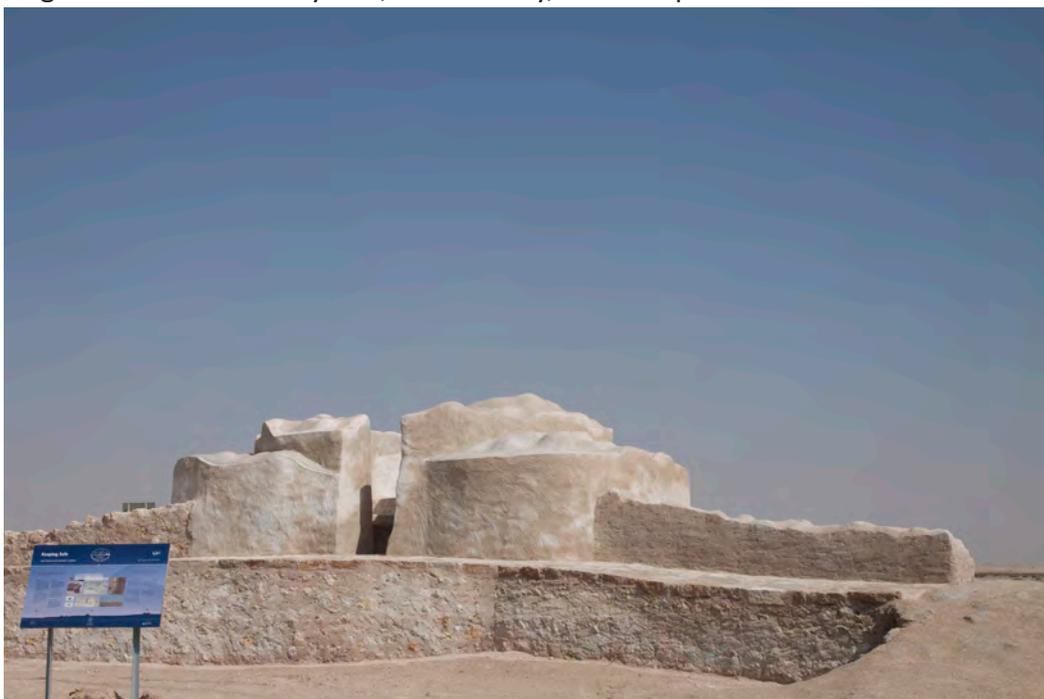
Figure 5.9: T18 after conservation.

The gypsum plastering of T18 has to be carefully monitored and will deliver a solid base for a decision on the use of gypsum plasters for future plastering of exposed walls in Al Zubarah.

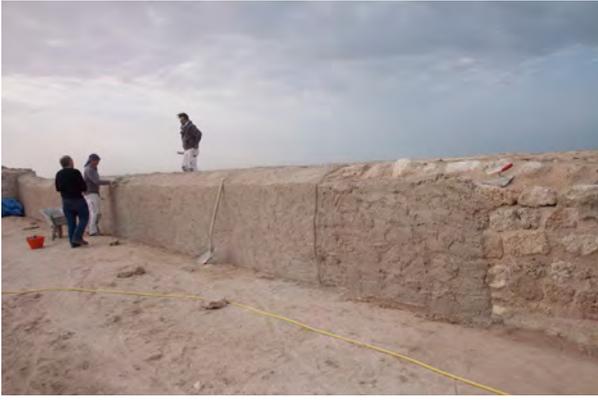
Figure 5.10: Application of the make-up in two layers. (DE-1634)

The plastering of the southern sections of the town wall (ZUEP11) took place in two steps, applying first a make-up layer and then a fine finish, both using NHL-based mix 1.56 (1:3 mix of NHL5 St. Astier and quartz sand). After the application of the two phases of the make-up layer, the wall was protected by a strong plastic film for about four weeks to ensure proper curing (Figure 5.10). The fine finish layer was added by hand-tooling, providing a smooth finish to improve drainage of rain water (Figure 5.11).

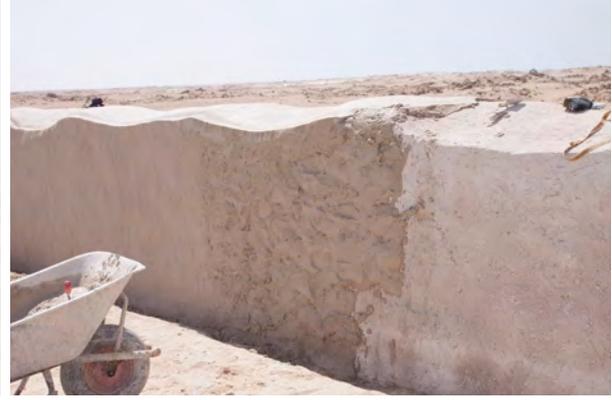
Figure 5.11: Application of the finish plaster layer on the town wall. (DF-0307)

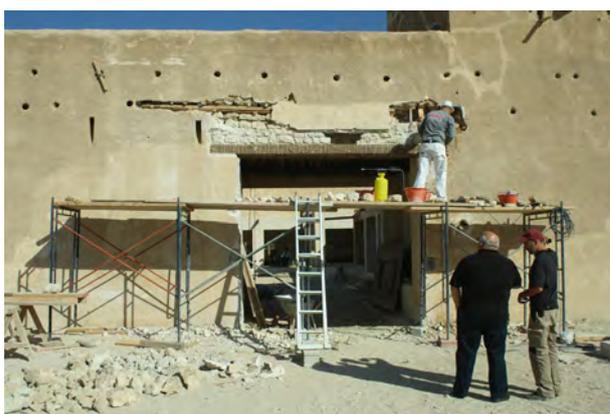
Aim of the repositioning of the main gate was to re-establish the original state seen in historic images. The process turned out to be substantially more difficult and time-consuming than initially expected. A substantial challenge was created by the discovery of a re-used dhow mast with a length of approximately 5.75m inside

the façade masonry above the gateway. It was heavily infested by termites, causing substantial loss of substance and attachment to the masonry. A removal and replacement of the mast was inevitable, which for structural reasons could not happen in one piece. The dhow mast was conserved and is now on display in the artefact exhibition (Figures 6.3 and 6.4).

Figure 6.3: Exposed dhow mast above the main gate in October 2013. (ZUUE-0363)

Immediately after removal, the masonry was repaired and cavities closed. Despite all precautions, some cracks in the masonry above the main gate appeared. The cracks remained to be a hair line, but their course was clearly identifiable as a result of settling after the removal of the mast.

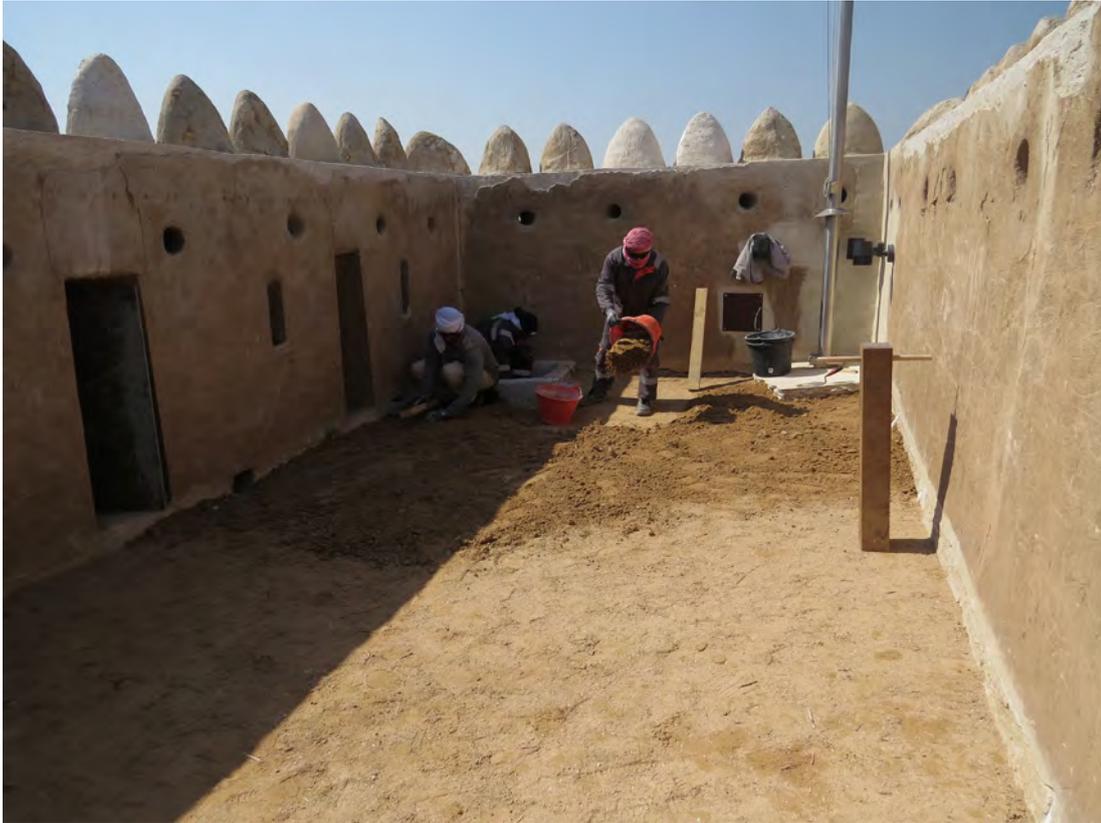
Figure 6.5: Earthen roof on the rectangular tower renewed with traditional techniques. (ZUTF-0568)

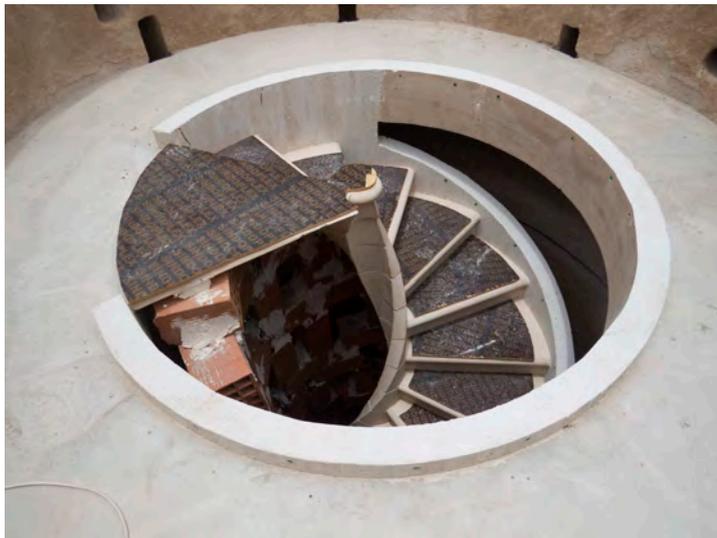
ruins of Al Zubarah town. The work started with the documentation and removal of the existing floor in F1-04, followed by the removal of parts of the infill for a foundation to carry the load of the staircase and the laying of that foundation. The upper floor was then replaced by the new viewing platform. In early April 2014, the pre-cast steps of artificial stone were inserted, and finally in May, the torsion beam of reinforced concrete could be poured (Figure 6.6).

Figure 6.6: Staircase in the north-western tower under construction. (ZUTF-2048)

In autumn, both the lower and the upper floor will receive a screed, the torsion beam will be rendered and a metal railing needs to be inserted to finalise the work.

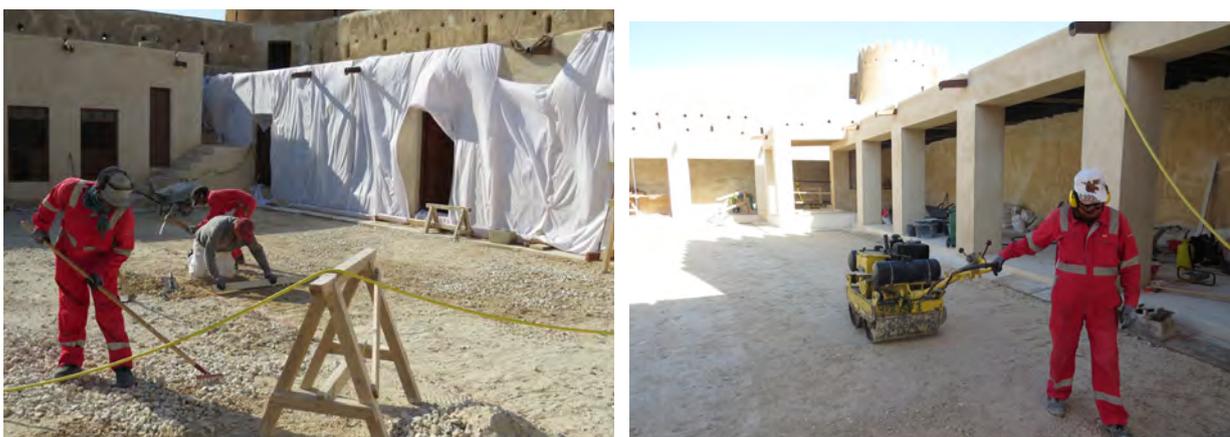
Figure 6.7: Applying the two layers of the new courtyard surface. (ZUTE-0327 and ZUTE-0356)

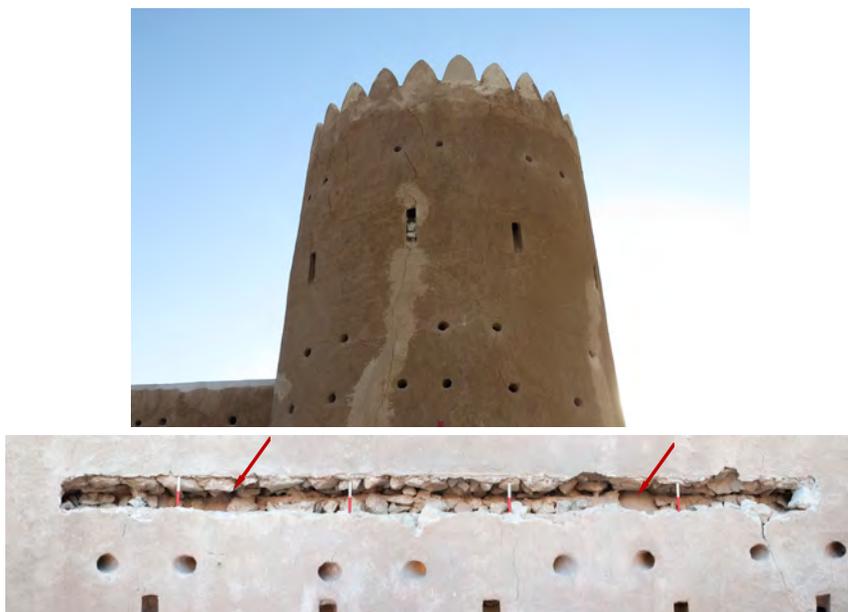
The tower today is, at 9.28m above ground, the highest of all four. The older crenellation is located approximately 0.60m underneath the present one (Figure 6.8). The fact that the older crenellation is fully plastered and can be traced almost all along the tower indicates that the tower was planned and built with a lower total height than today. Yet both the upper viewing platform in the tower and also the highest row of loopholes are not consistent with the lower height of the tower. This leads to the assumption that the height of the tower was not considered to be sufficient at an early state. A historic image from 1958 indicates that the tower has already been raised at that time.

Figure 6.8: View of the south-western tower (top) and a rectified image of the opened interior wall with battlements partially revealed. (ZUTF-2120 and KE-0122)

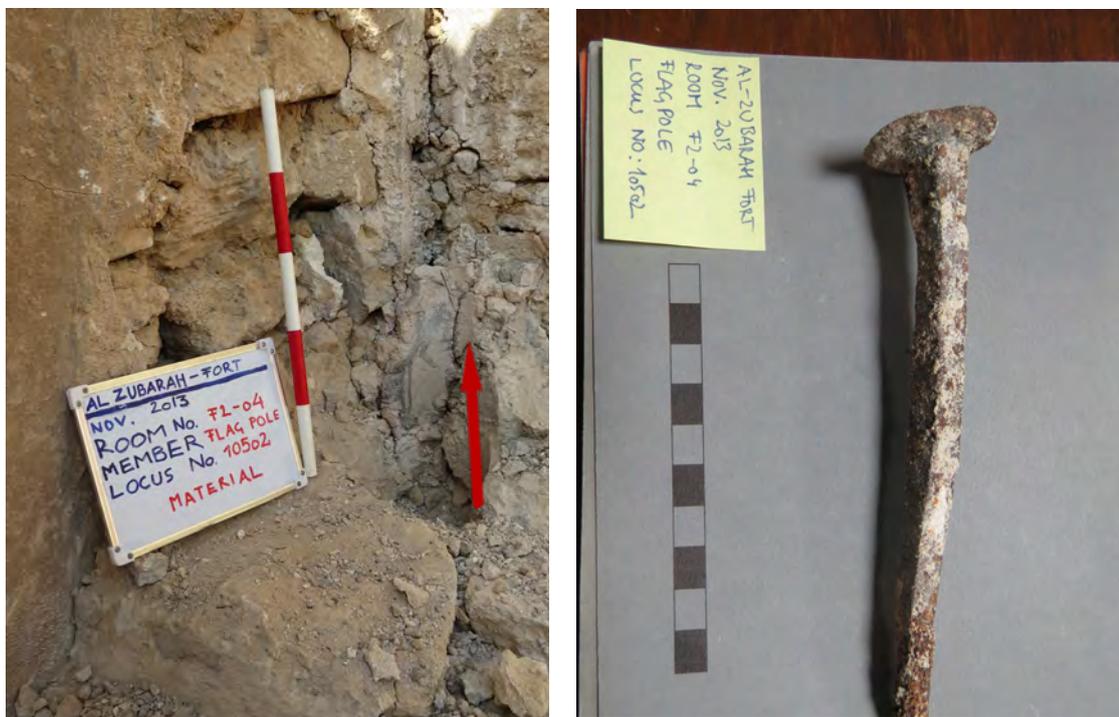
Figure 6.9: Left (ZUTE-0061): Masonry block for the flag pole during its demolition. The cement-based plaster shows a circular void with the impression of the texture of a wooden trunk (arrow). Right (ZUTE-0084): Hand-forged nail found in the masonry of the flag pole base. Similar nails were found in the dhow mast.

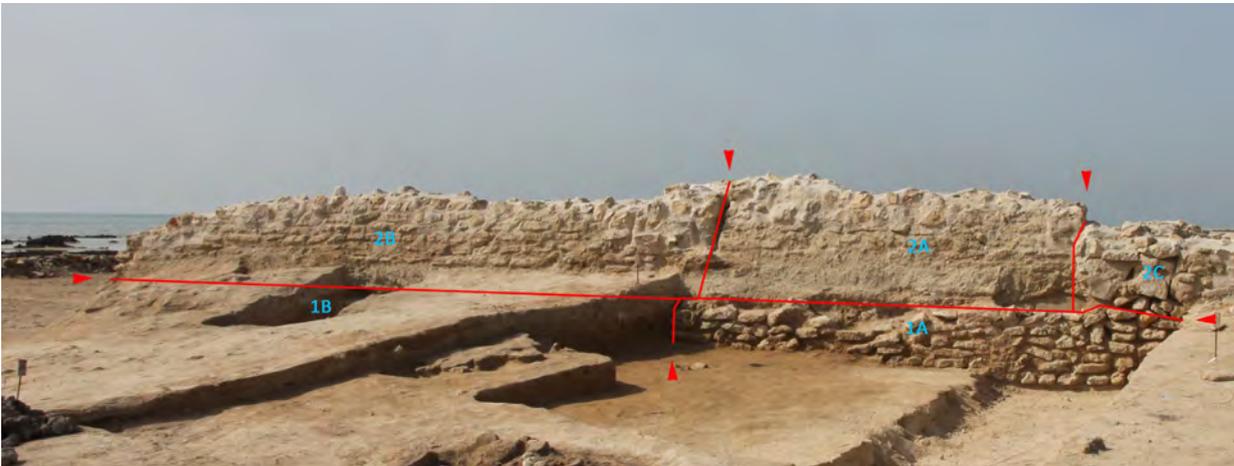
Two major building phases, divided into several sub-phases, can be distinguished in the mosque (Figures 7.2 and 7.3).

Figure 7.2: View towards the north on to the western part of the southern facade of the mosque, showing construction joints in red. Visible are the early and late phase (1B/2B) of the prayer hall (left), the early and late phase (1A/2A) of the portico (centre), and the early and late phase (1A/2C) of the courtyard. (CF-0233)

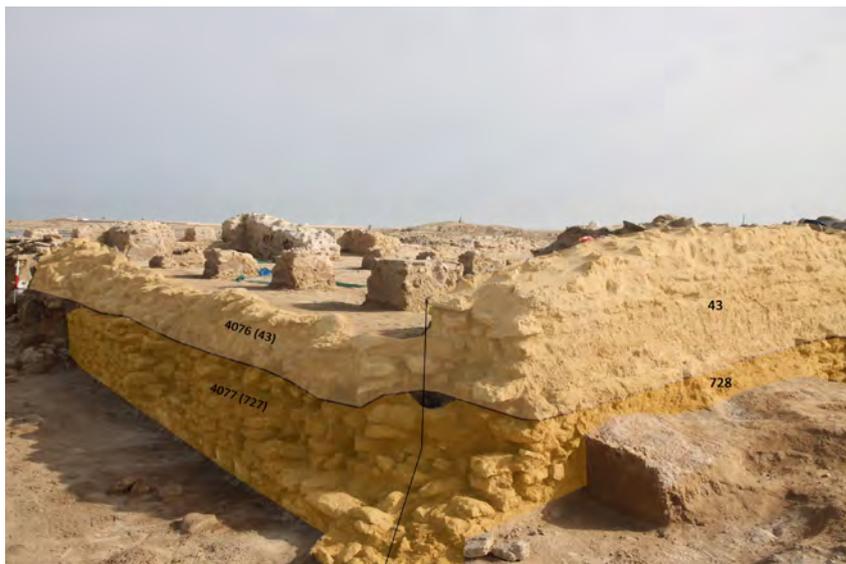
Figure 7.3: Southwest corner of the mosque, highlighting the two major building phases. (CF-0479)

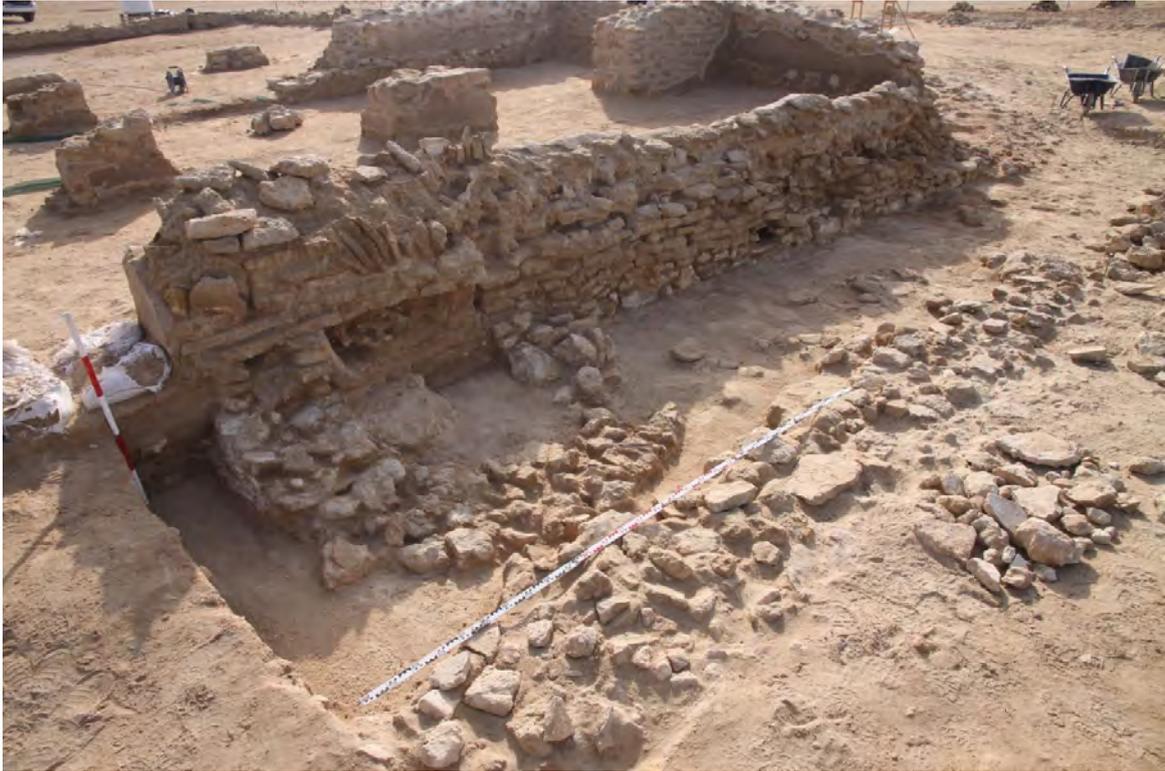
A newly discovered *mihrab*, found in the course of the excavations along the western exterior of the mosque, also belongs to this early phase. The *mihrab* forms a half-oval and is only bonded to the wall masonry on its north end (Figure 7.4). This suggests that the western wall of the prayer hall was built in two phases. It also shows the presence of two different plasters with a height difference of c. 0.3m, which had resulted in the need for backfilling the interior of the building by that difference and necessitating a secondary plaster on the remaining upstanding masonry as part of renovation work.

Figure 7.4: Southern part of the western wall showing the early phase wall and *mihrab*.

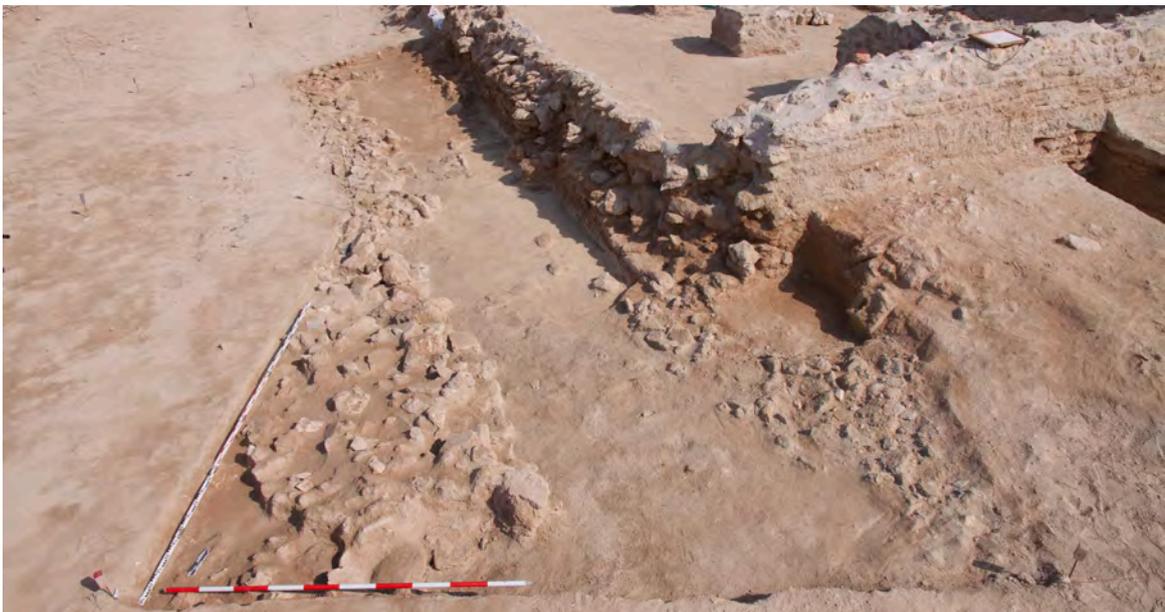
In this later phase, the mosque was first built back to an even level. The material removed for this purpose was likely used in a wall-like accumulation of large stones which, at a distance of 2m from the west wall, could be exposed for 11.3m (Figure 7.5). Preserved on its eastern face were the remains of the exterior shell of an old wall. The stones are of different sizes, but the remnants of mortar still stuck to the rocks suggest that they came from the masonry of the mosque and were removed to here in the course of the renovations. Further stones from the older building were used in the new mosque, as is indicated by the variety of stone sizes found in this younger phase compared to the regularity of material in the older phase.

Figure 7.5: View to the northeast showing the corner of the mosque and the stone accumulation towards the sea. (CF-0356)

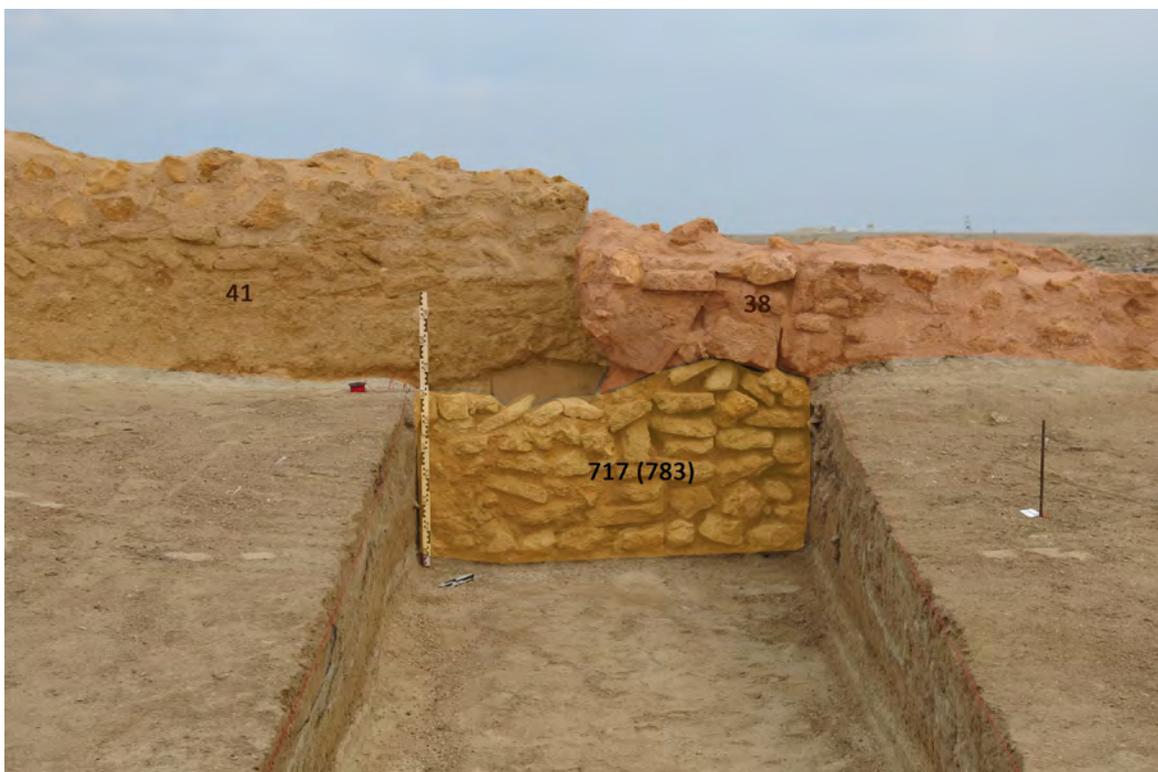
In the upper parts of the south wall and the southern parts of the west wall, three sub-phases could be distinguished (2A, 2B, 2C). The south wall shows two vertical construction joints between the prayer hall (2B), the portico (2A), and the courtyard. In addition, the alignment of the later walls differs from the earlier ones, and the younger walls were offset to the interior in both the prayer hall and the portico by one stone course. This is displayed clearly in the creation of an apparent landing between the wall of the courtyard (2C) and the south wall of the portico (Figure 7.6).

Figure 7.6: View to the north of the intersection between the lower wall of the portico and courtyard (1A, bottom), the upper portico wall (2A, upper left) and the upper courtyard wall (2C, upper right). (WF-0719)

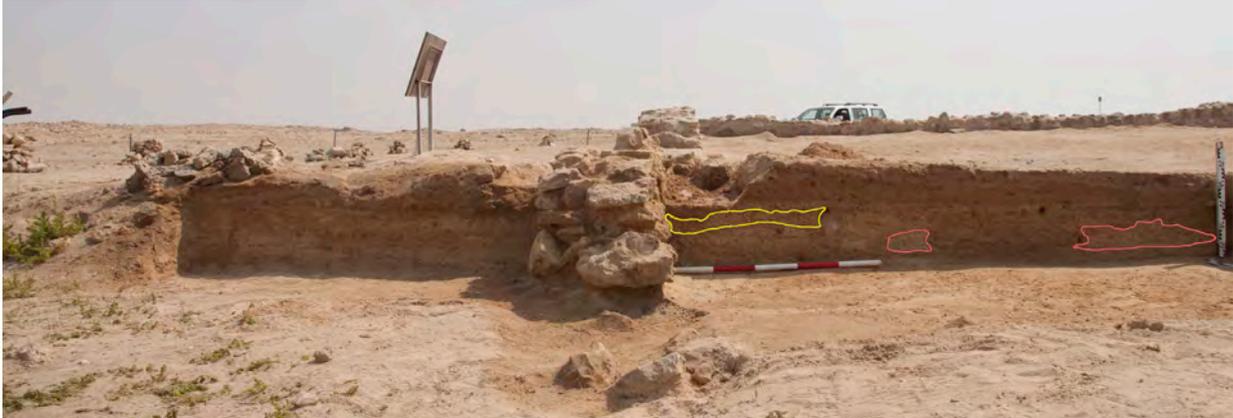
The raising of the floor level (see above in the description of the *mihrab*), can also be seen in the section of the robbed-out northeast corner of the building in the form of two subsequent shell surfaces (Figure 7.7). It was likely at this point that the old courtyard wall was offset to the east.

Figure 7.7: North-facing profile of the robbed-out corner of the minaret, highlighting shell surfaces. (CF-0328)

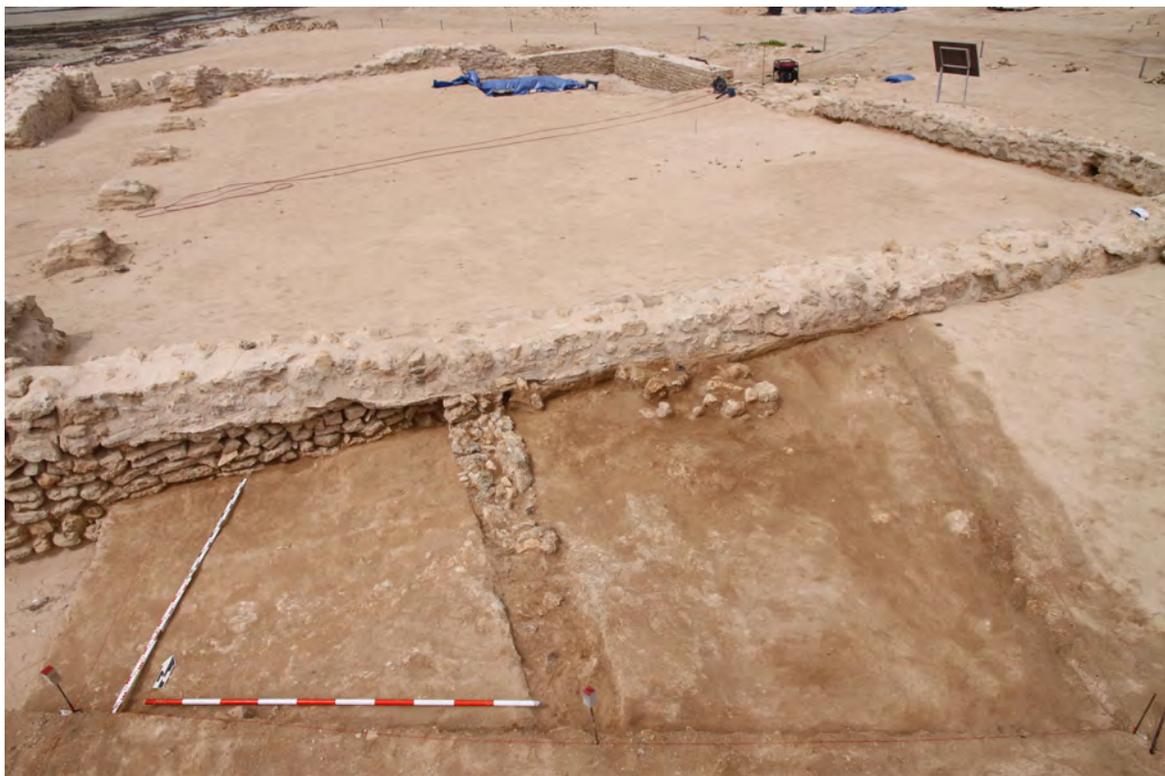
Figure 7.8: Remnants of an annex of a possible wash room to the southeast of the building.

Excavations immediately south of the courtyard are not yet finished. However, first investigations exposed a dolomite wall which ran perpendicular to the southern courtyard wall but was not bonded to it (Figure 7.8). It is likely that this forms part of an external wash room that was abandoned and backfilled in the later building phase; at this time, a well appeared inside the courtyard in its south-eastern corner.

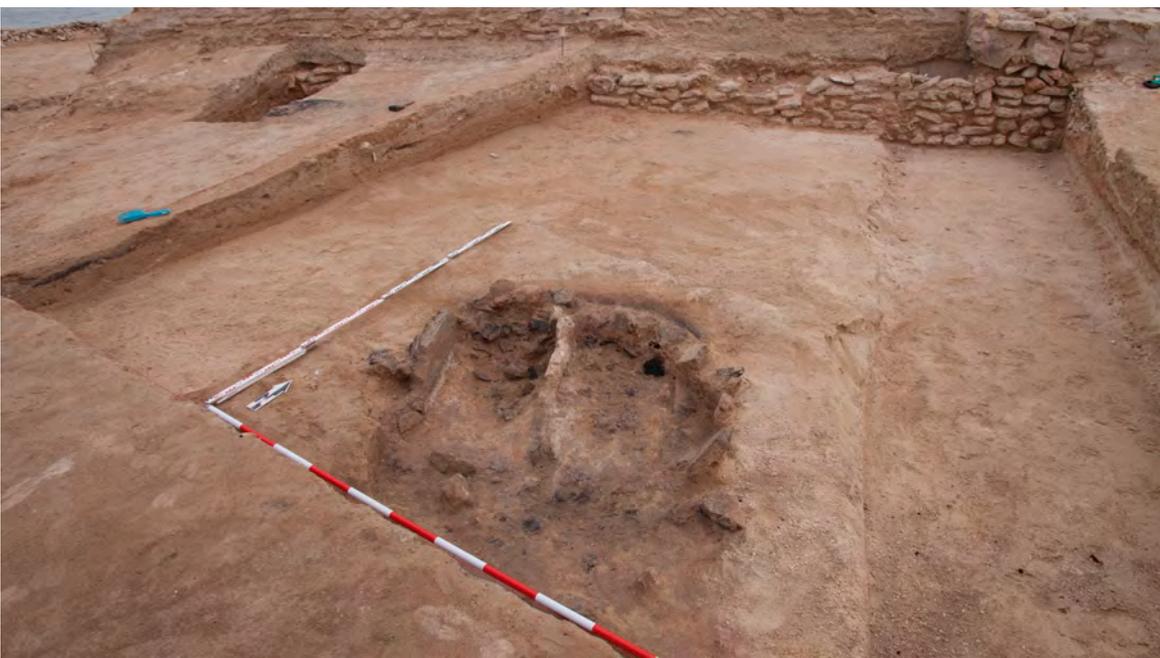
Figure 7.10: Double-chambered oven after excavation of the collapse. (CF-0276)

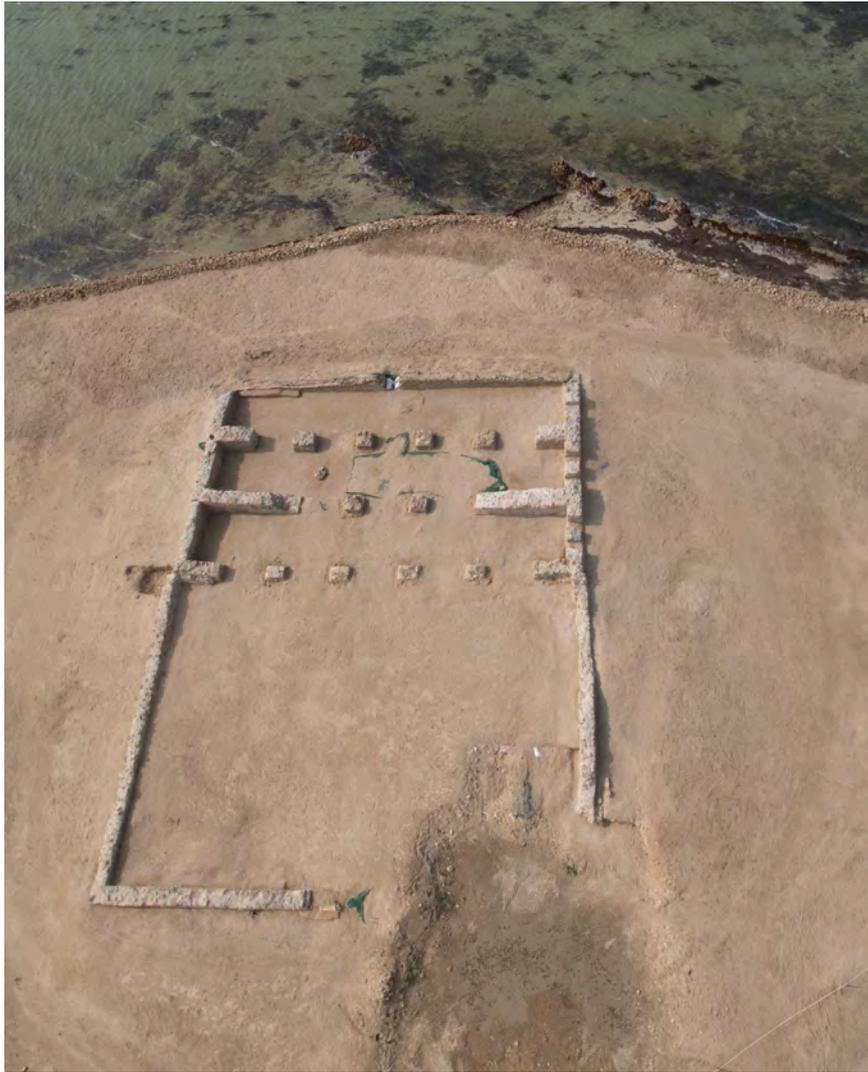
The mosque's west wall lies perilously close to the current high-tide line of the sea. Accordingly, one of the aims of this season was to enlarge the beach area to provide greater protection. A large dry-stone wall was built 10m west of the mosque, consisting of stacked stones up to 1.3m high and c. 1.5m wide at the base. The area between the wall and the mosque was backfilled with sand (Figure 7.12). Material for both was recovered from rubble of the previous excavations.

Figure 7.12: The mosque after the beach enlargement. (QE-0063)

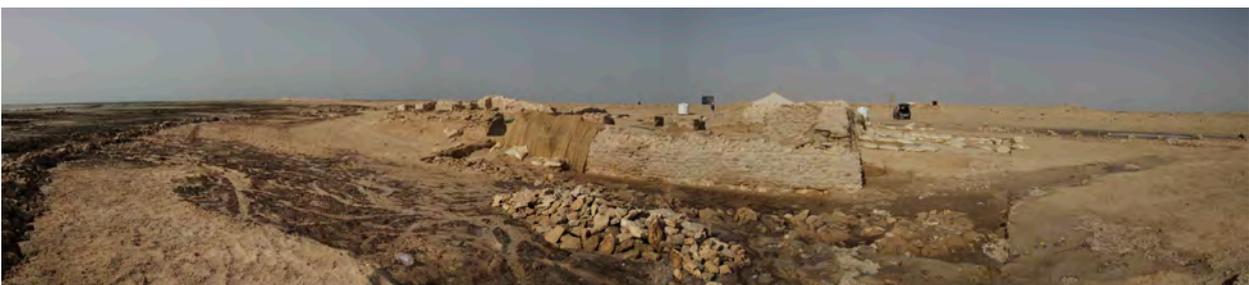
While the wall provides adequate protection from normal high-tide conditions, particularly strong winds are still able to push water through the backfill (Figure 7.13).

Figure 7.13: Breach of the new beach wall after particular strong wind in spring 2014. (BF-0334-0342)

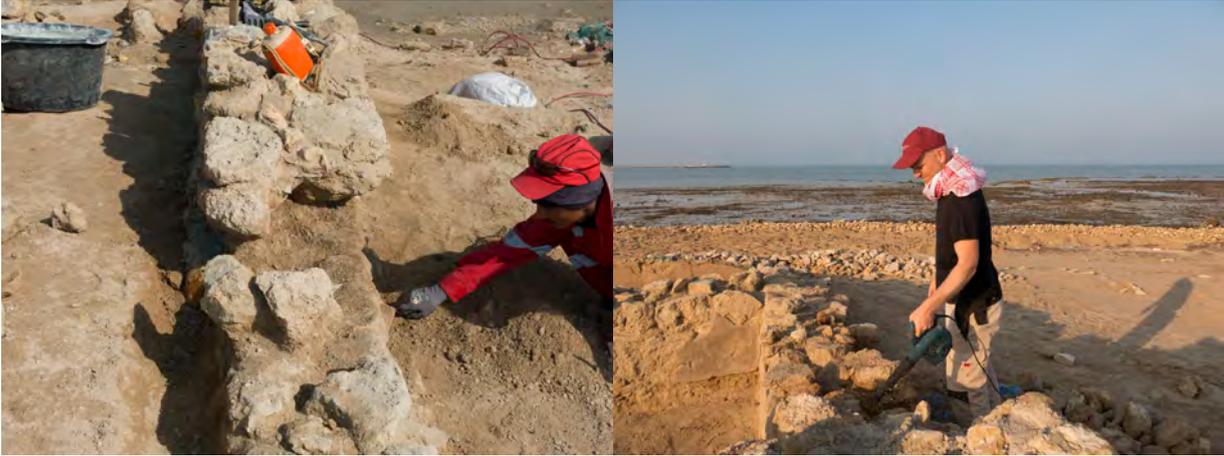
Figure 7.14: Dust, dirt and loose stones and mortar were removed with trowel and hand brush; eroded joints were scraped and cleaned with a blower before being repointed. (WE-0013 & WE-0040)

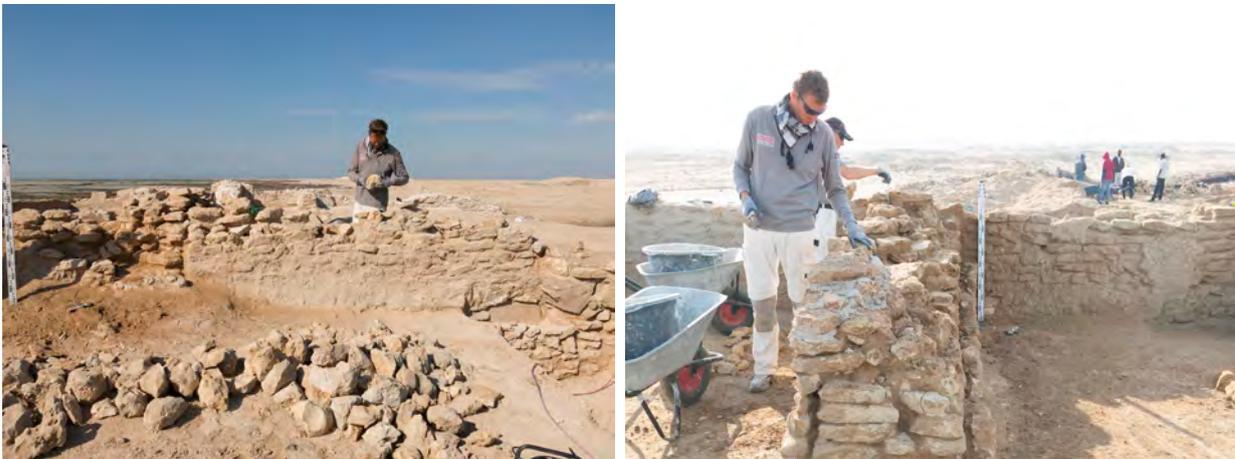
Figure 7.15: Voids in the structure and the capping were closed with dolomite stones and lime mortar. (WE-0100 & WE-0116)
