Qatar Islamic Archaeology and Heritage Project

End of Season Report : 2013-2014

Citation for published version (APA):
Rosendahl, S. (Ed.), Cockin, G., Estrup, E., Hawksworth, C., & Nymann, H. (Ed.) (2015). *Qatar Islamic Archaeology and Heritage Project: End of Season Report : 2013-2014*. Copenhagen: University of Copenhagen and Qatar Museums.

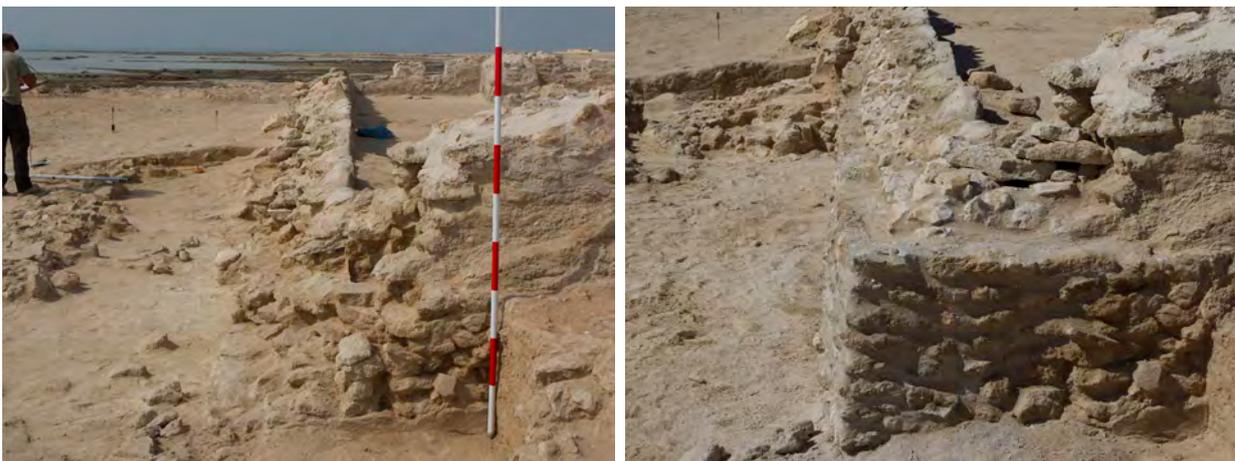
Figure 7.16: Southwestern corner of the mosque before conservation (left), and after rebuilding (right). (BF-1005 & BF-1075)

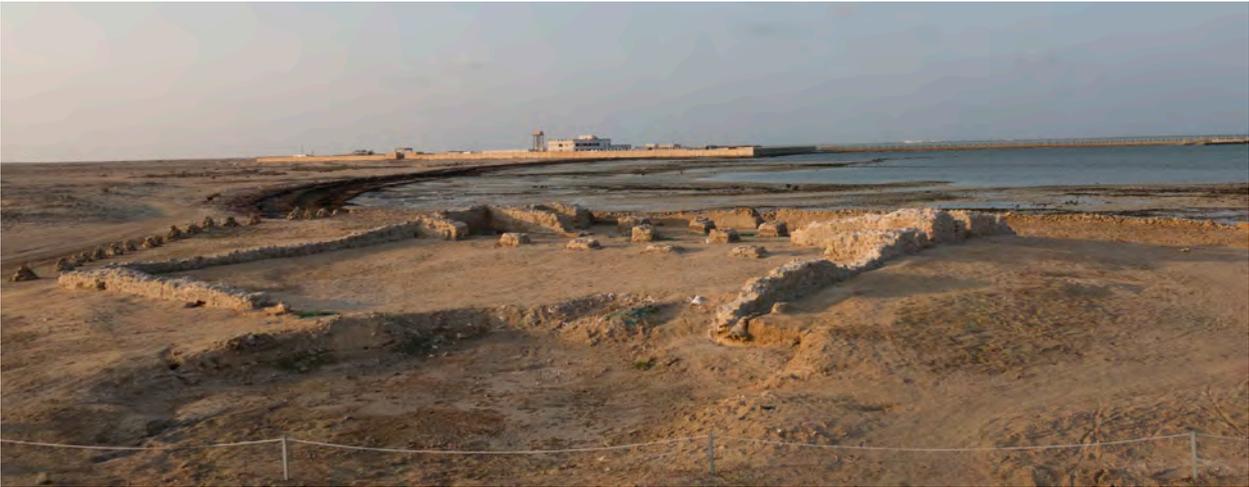
Figure 7.17: View of the mosque before restoration work, showing the robbed-out northeast corner in autumn 2013. (WE-0139)

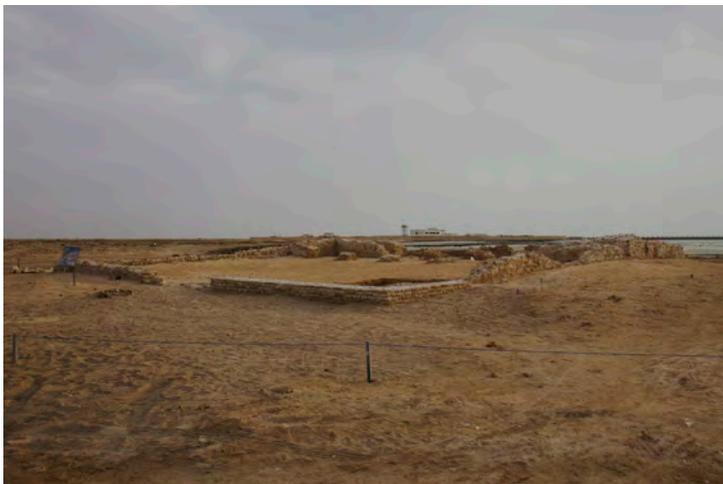
Figure 7.18: View of the mosque after restoration work, showing the new corner as well as levelling of the exterior. (BF-1120)

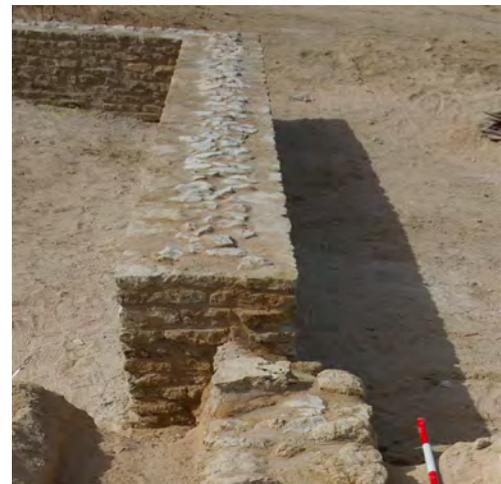
Figure 7.19: Detail of the double-shell masonry of the reconstructed wall. (BF-1051)

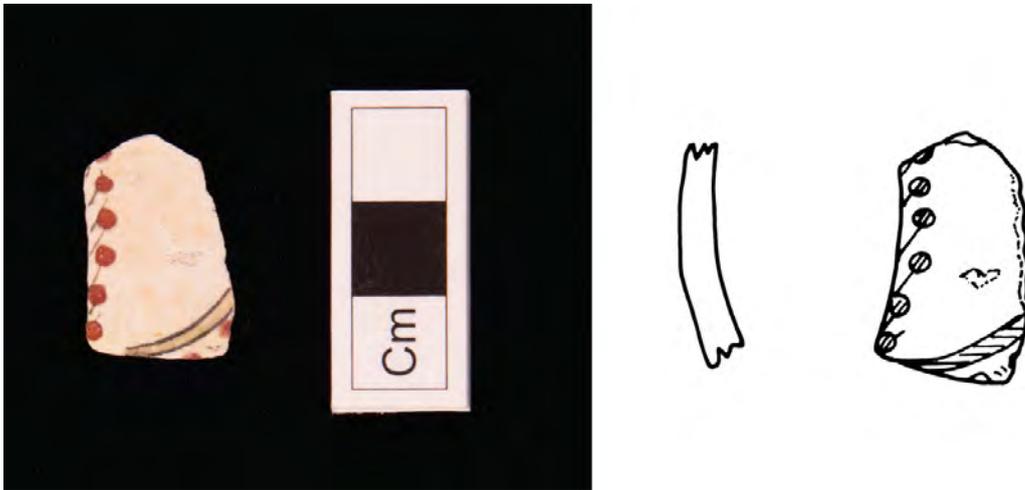
Figure 8.16: Photograph and line drawing of Stone Pasted Ware.
Small Bowl (pot cat 19)

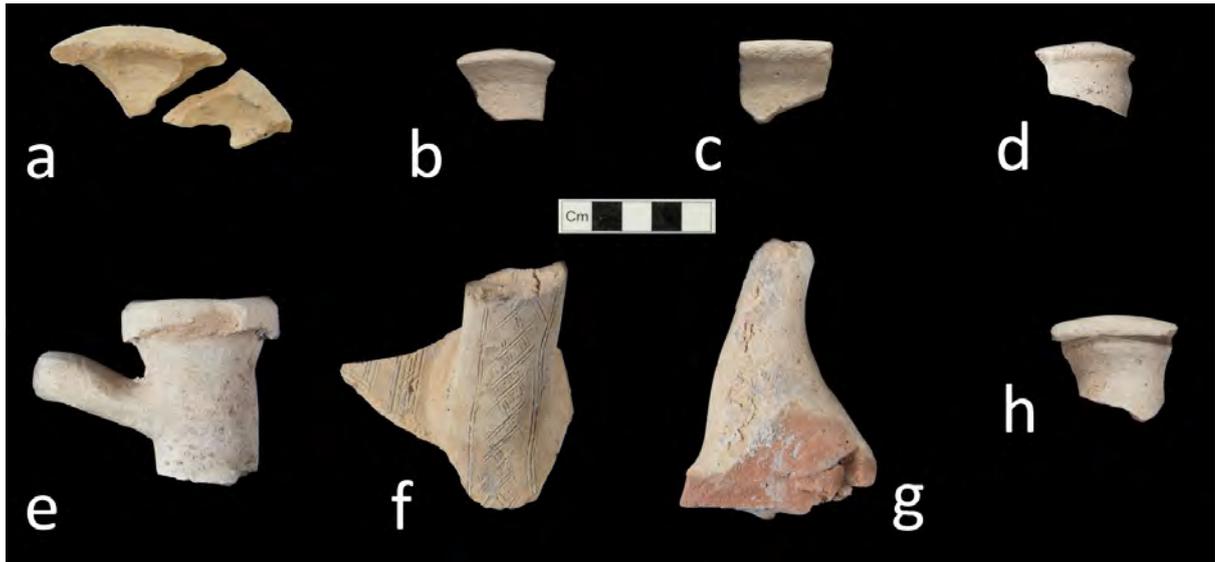
Figure 8.32: Creamy and Orange Sandy Ware Jugs.

- a. Jug (pot cat 412) b. Jug (pot cat 175) c. Jug (pot cat 176) d. Jug (pot cat 312)
 e. Jug (pot cat 379) f. Jug Handle (pot cat 356) g. Jug Spout (pot cat 322) h. Jug/Bottle (pot cat 279)

three handles), rounded or collared rim, and with a ring base (Figures 8.32, 8.35 and 8.36)

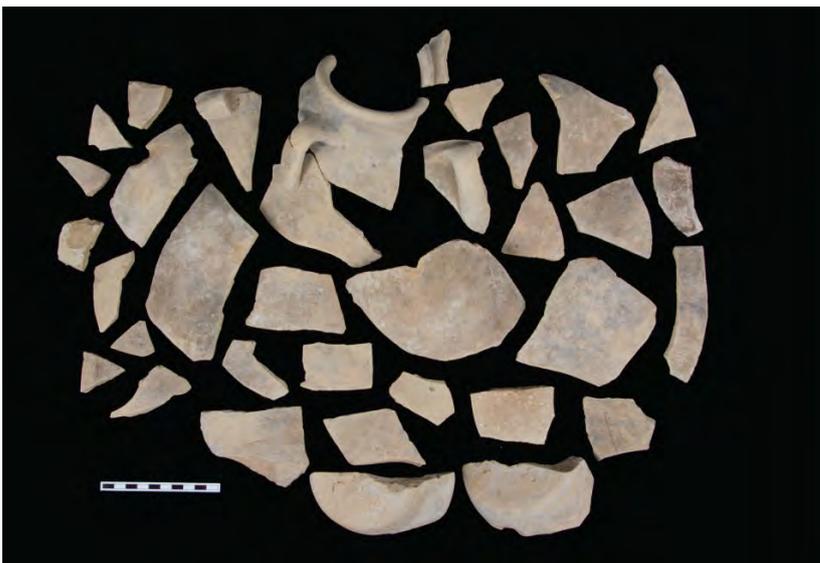
Figure 8.35: Creamy Sandy Ware Jar fragments and reconstructed (pot cat 82).

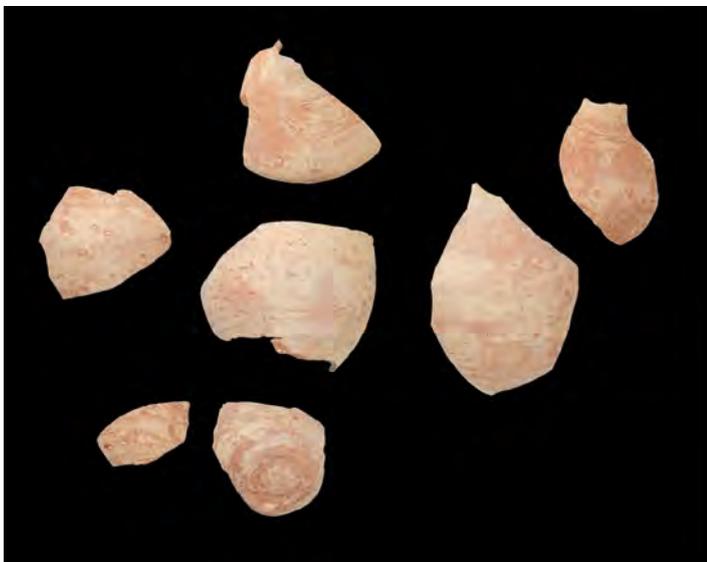
Figure 8.36: Orange Sandy Ware Jar fragments and reconstructed (pot cat 81).

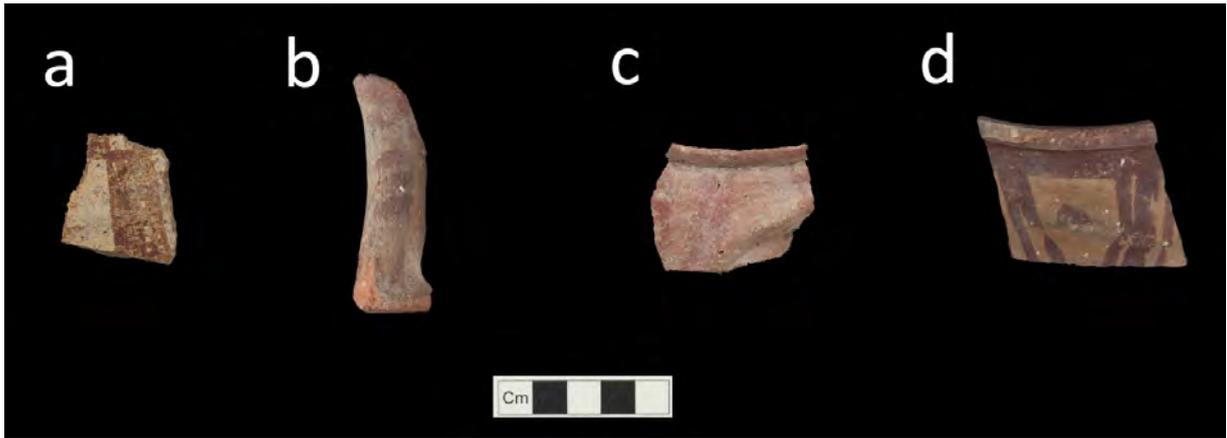
- Julfar 1: Orange ware with white wash and decoration painted in red. Forms found in this type are jugs and table jars (Figure 8.42).
- Julfar 2: Reduced black ware with painted dark red or purple decoration. Forms are mainly cooking pots with rounded body and externally bevelled rim (parallel to Kennet form CP 4.1, CP4.3, CP4.4, CP5.1) (Figure 8.43).

Figure 8.42: Julfar 1 Ware.
 a. Jug (pot cat 461) b. Jug Handle (pot cat 329) c. Bowl/Jar (pot cat 421) d. Bowl Jar (pot cat 437)

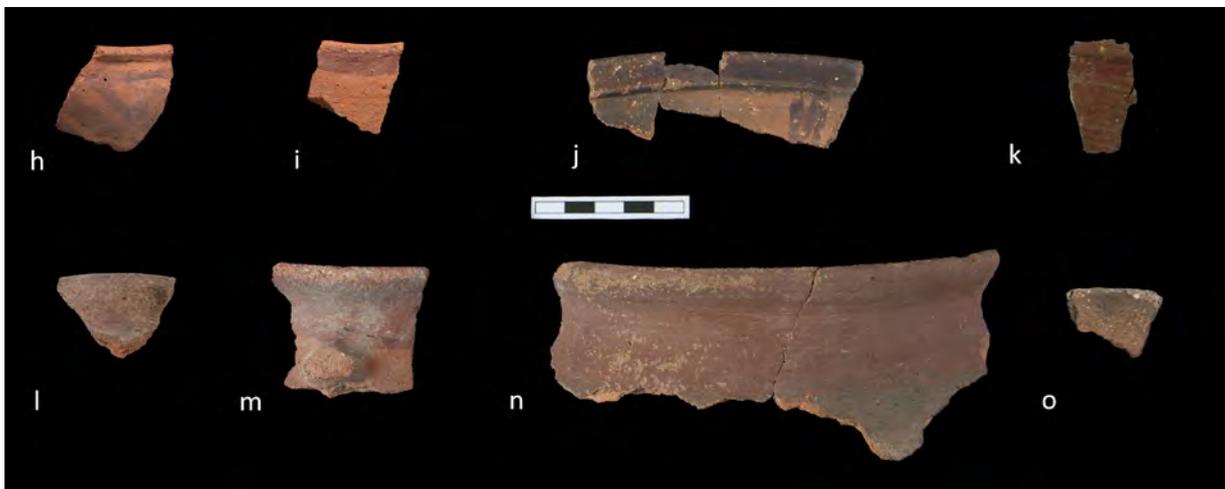
- Julfar 3: Red-painted decoration but no white wash (sometimes self-slip in pale orange colour) (Figures 8.44 and 8.45).

Figure 8.45: Julfar 3 Ware.

- h. Cooking Pot (pot cat 271) i. Jar (pot cat 328) j. Bowl (pot cat 372) k. Lid (incense burner) (pot cat 425)
- l. Jar (pot cat 433) m. Jar (pot cat 390) n. Jar (pot cat 352) o. Jar (pot cat 157)

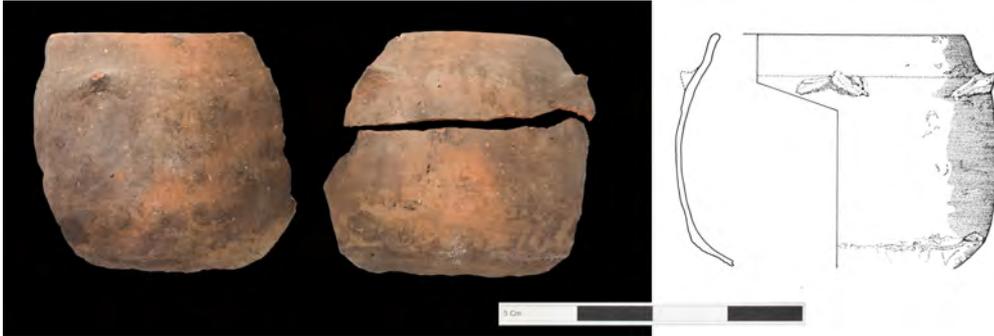
- Julfar 5: The ware is not decorated and has no self-slip (Figures 8.47 and 8.48). Vessels with side lugs, closed form and 'S' shape profile of the neck could be compared with Kennet's CP5.1.

Figure 8.47: Julfar 5 Ware. r. Cooking Pot (pot cat 428).

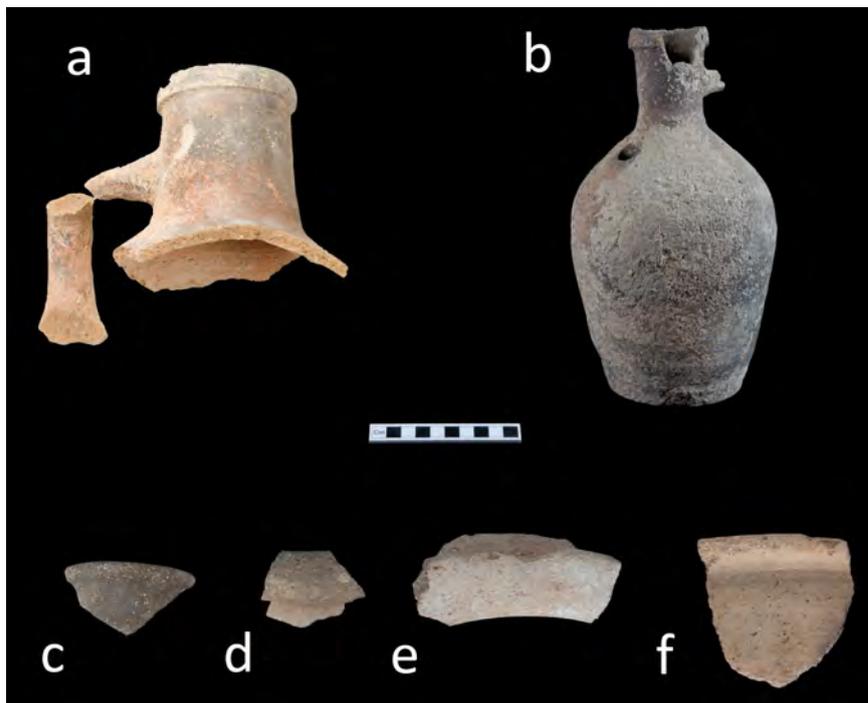
The ware is coarse and gritty, hard and dark grey in colour (Figures 8.51 and 8.52).

Figure 8.51: Buff Coarse Ware.

a. Jug (pot cat 440) b. Jug (pot cat 155) c. Jug (pot cat 255)
d. Jar (pot cat 268) e. Jar (pot cat 317) f. Jar (pot cat 451)

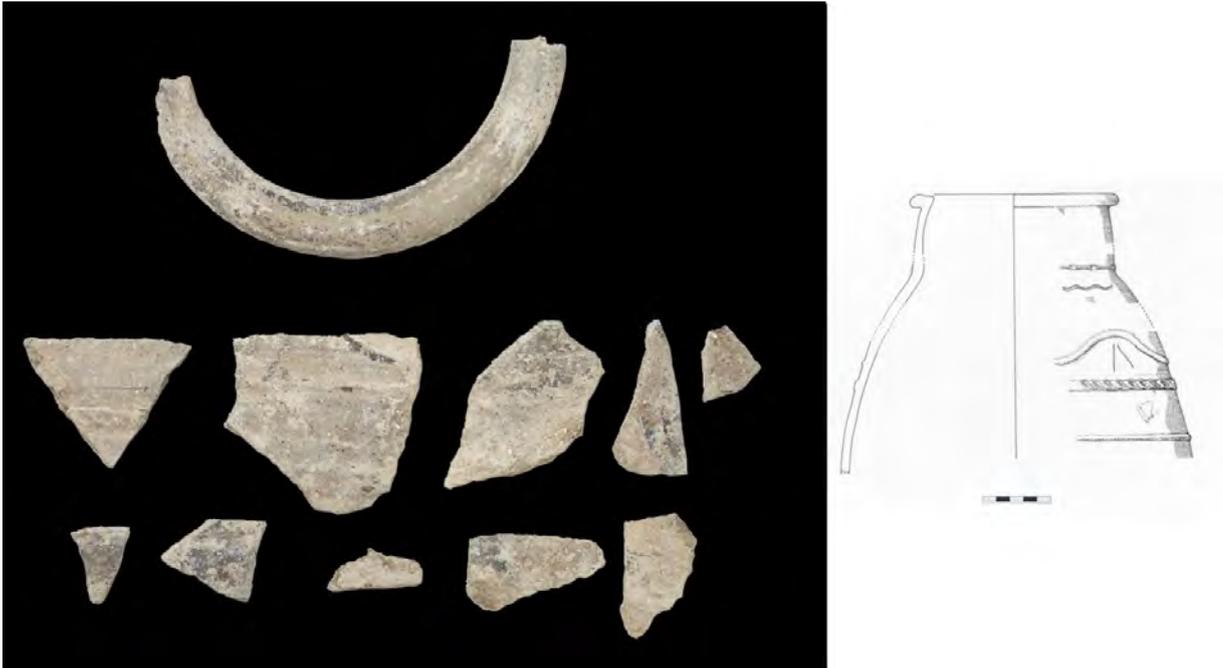
Figure 8.52: Buff Coarse Ware. Jar (pot cat 83)

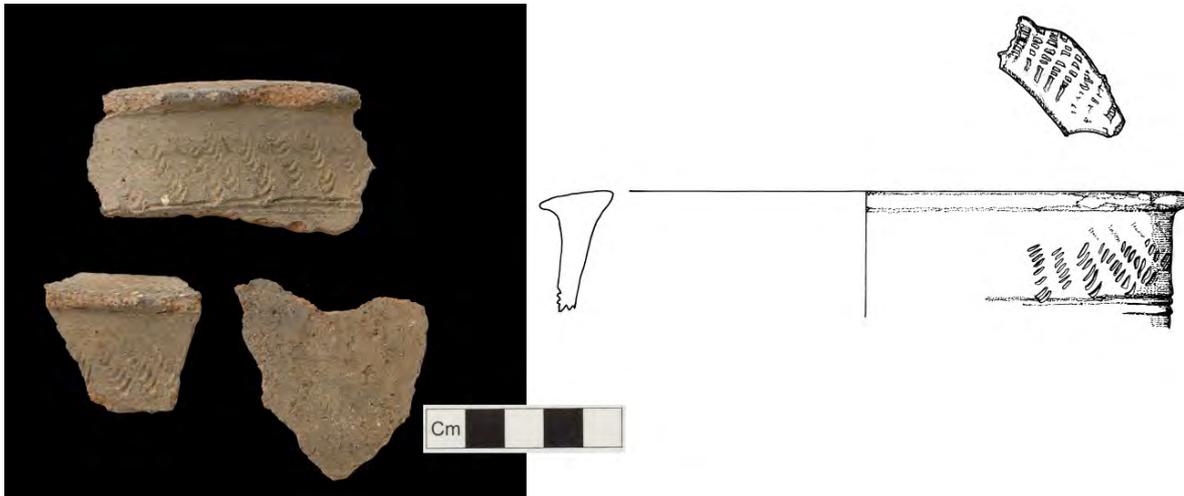
The body type of this ware is coarse brown to orange, hard and sandy. Decoration consists of incised lines and marks with brown-grey external slip with metallic hue. Only three sherds were recorded under this category (Figure 8.54).

Figure 8.54: Coarse Brown Sandy Ware. Jar (pot cat 40)

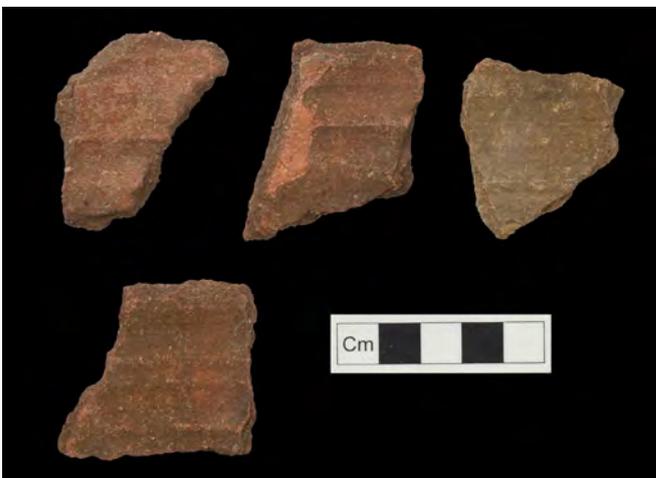
The ware is dark orange, well-fired and hard (Figure 8.55). The sherds are most likely a part of a wheel-thrown jar and they are only residual. No parallels are known.

Figure 8.55: Orange Hard Ware. Jar (pot cat 16)

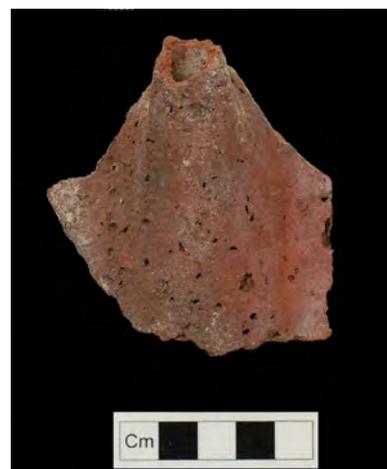
The ware is very hard, very coarse, red-brown, and often the external surface has a creamy hue. The forms recorded at Freiha are jug and jar with flared neck and plain rim (Figure 8.56).

Figure 8.56: Oxidised Coarse Ware. Jug.

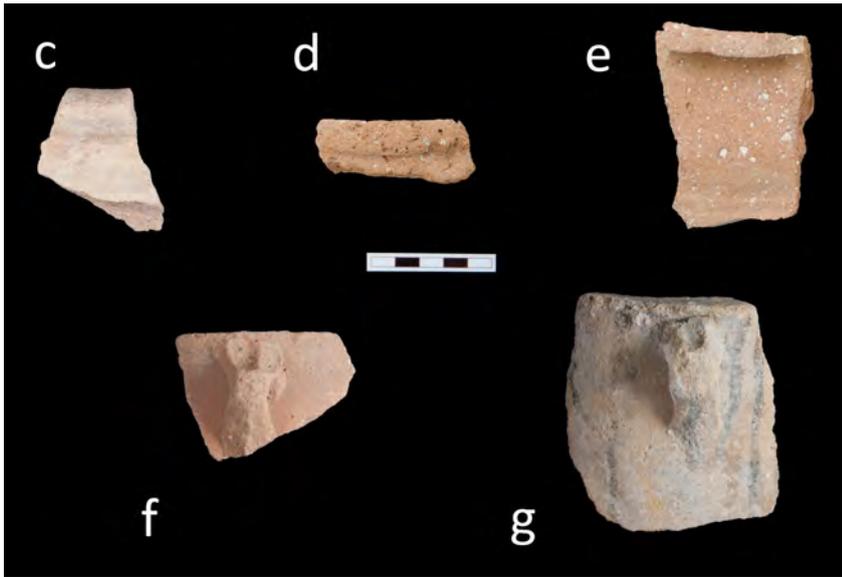
This ware describes large storage jars with in-turned rim, small loop handles, basins and large bowls with thickened externally or in-turned rims; and flat lids (note that example p and r show a wavy impressed-line decoration) (Figures 8.57 to 8.60).

Figure 8.58: Oxidised Coarse Sandy Ware Jars.
 c. Jar (pot cat 19) d. Jar (pot cat 438) e. Jar (pot cat 439)
 f. Jar (pot cat 79) g. Jar (pot cat 289)

A very similar lid was found in Qala'at Bahrain outside the Northern Semicircular Tower of the Islamic fortress in the upper layers of the excavation. It is described as red-brown gritty ware, and the lid is described as 'disc-shaped (...) with a center handle' (Frifelt 2001: 99). The lid from Freiha has two perforations and is decorated with incised/impressed wavy lines. Frifelt states that these lids 'fit the larger container with broad flat rim', possibly like these from Freiha (see Figure 8.58 e,f,g).

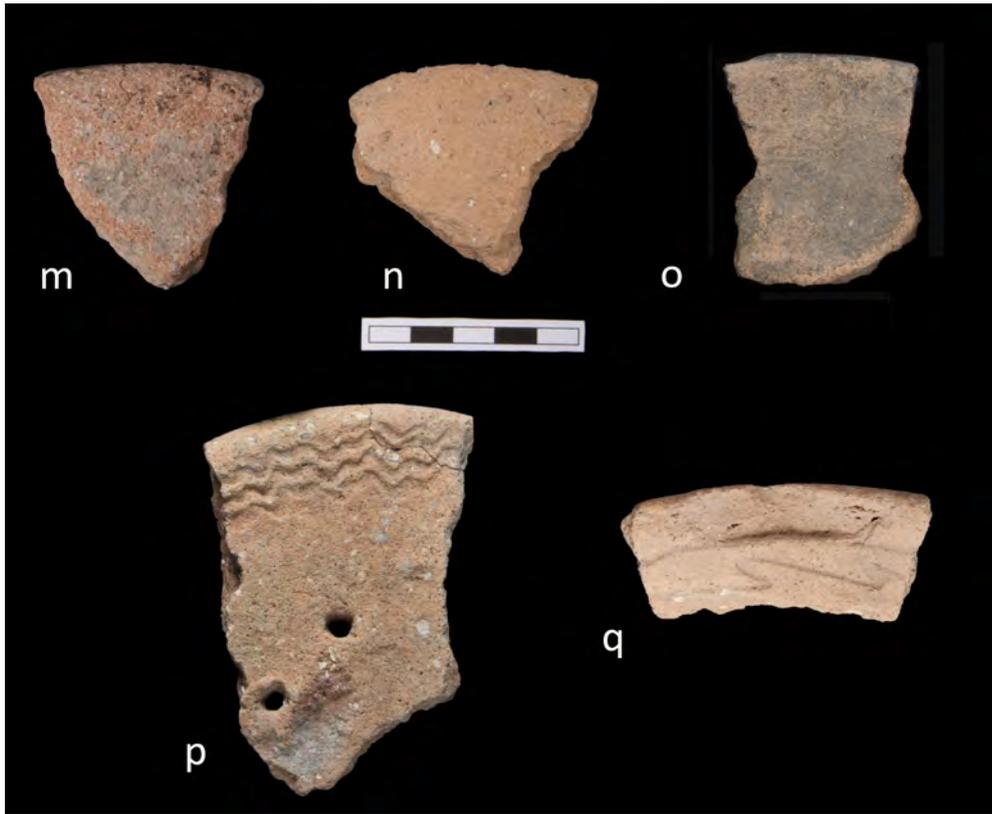
Figure 8.60: Oxidised Coarse Sandy Ware Lids.
 m. Lid (pot cat 96) n. Lid (pot cat 444) o. Lid (pot cat 376) p. Lid (pot cat 374) q. Lid (pot cat 66)

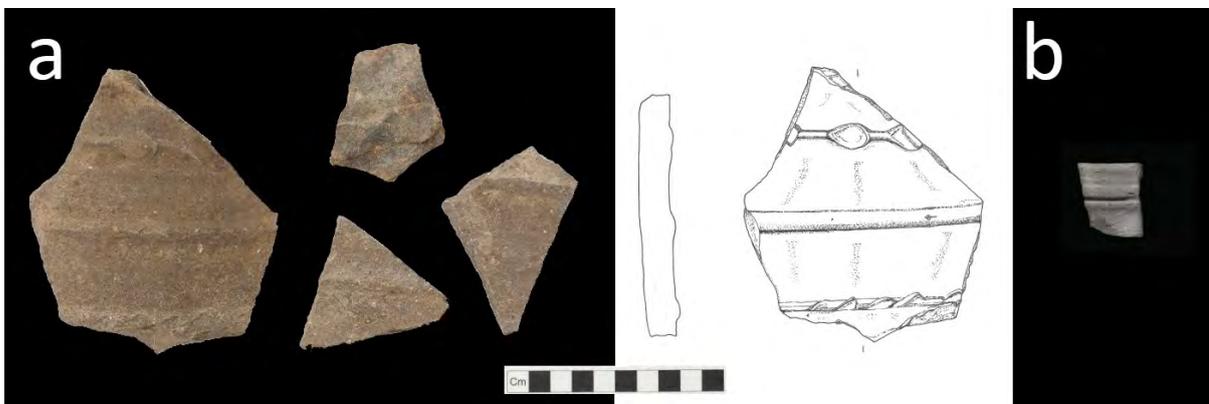
The origin of this ware could be Iran or Bahrain. The body is very coarse, very hard with large, ill-sorted black quartz inclusions, and a grey or dark grey fabric. The decoration is a black or dark grey slip (on the exterior surface of a vessel); combing and cordon decoration is also often present. Reduced Coarse Ware heavy duty jars are well represented in the Freiha assemblage. These wheel-made vessels could be compared with Reduced Coarse Ware found in Al Zubarah.

Forms recorded at Freiha are jar, heavy duty jar and basin (Figure 8.62).

Figure 8.62: Reduced Coarse Ware.
 a. Jar (pot cat 476). b. Basin (pot cat 301)

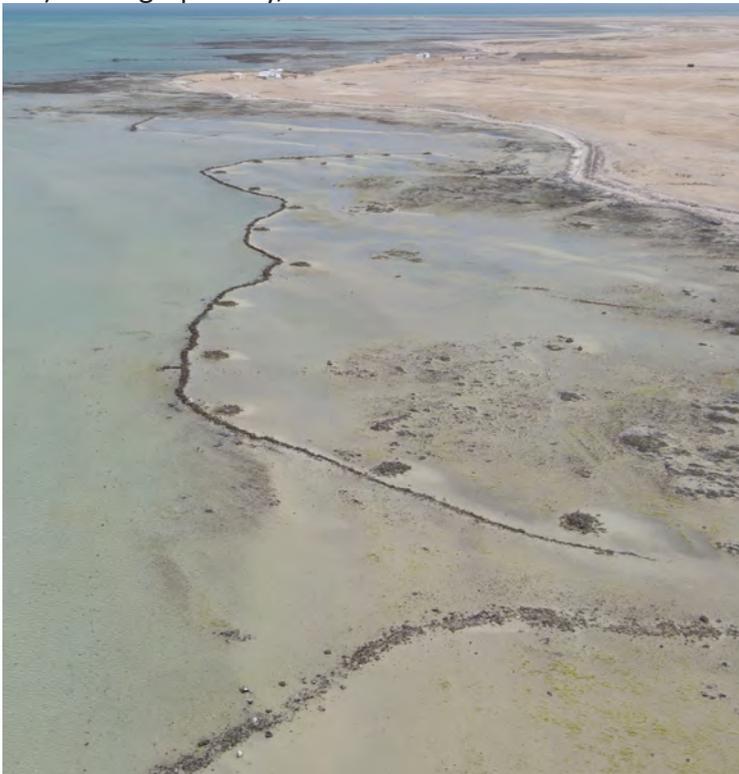
Freiha is surrounded by numerous stone-built intertidal fish traps, known locally as *hadrah* (Figure 9.3). Stratigraphically, these structures cannot be tied into the occupation sequence at Freiha,

Figure 9.3: Stone built intertidal fish trap (*hadrah*) off the coast from the settlement of Freiha.

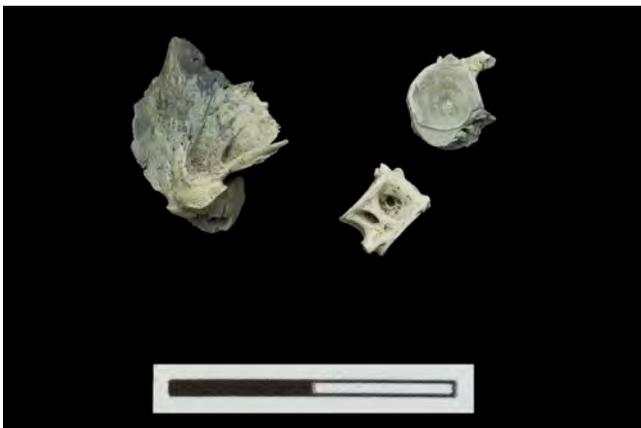
The fills of tannurs and fire pits contain a mixture of bone that accidentally fell into these installations whilst the fish were being cooked, and ended up burnt due to their proximity to hot embers. Bones displaying burning (Figures 9.11 and 9.12) are clearly from the use phase of the tannurs and fire pits, with unburnt bones present as secondary material. Overall, there is not much burnt bone in such features as they only occur when parts of the cooking fish were accidentally dropped into the embers. Combining the occurrence of burnt bones from all phases and spaces can provide the range of species cooked in the tannurs and fire pits (Table

Figure 9.11: Burnt catfish (*Arius* spp.) from the fill of a tannur in Phase 4.3.

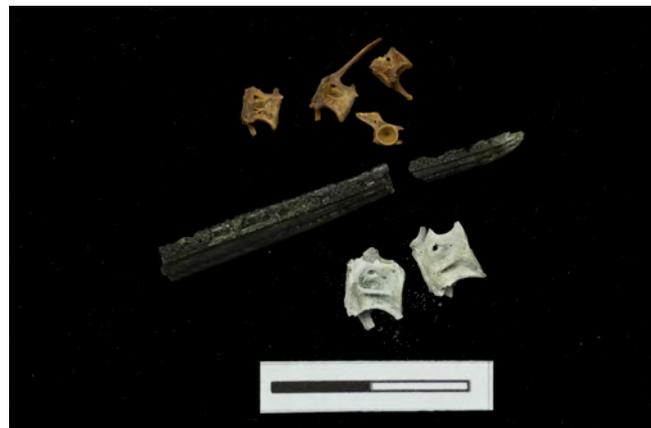
Figure 9.12: Emperor fish, threadfin bream and needlefish bones at different burning stages recovered from the fill of a tannur from Phase 6.

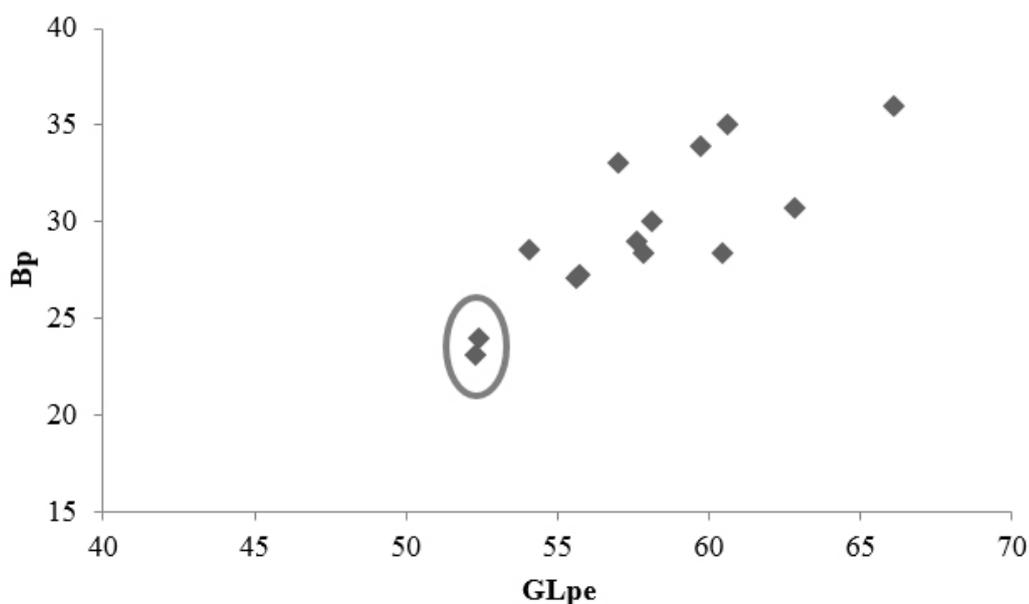
Figure 10.1: Size variation of 1st phalanges from cattle – circled are the two Freiha specimens, the remainder are from Jarash (Early Islamic) and Tell-el-Fukhar (multiple periods) in Jordan as well as the Barbar temples (Dilmun), Bahrain. (Driesch, 1979)

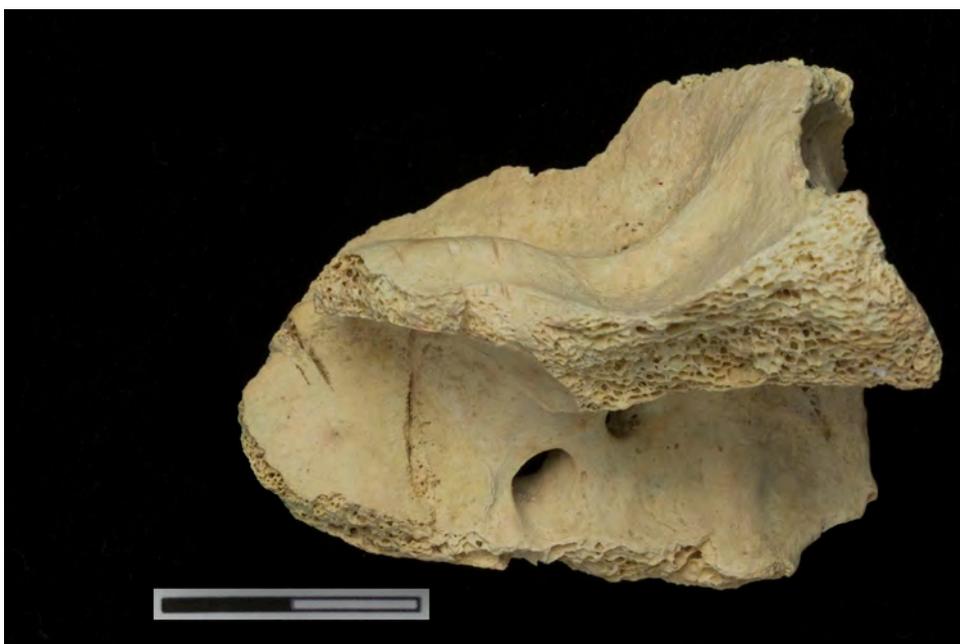
A number of other cut marks were identified in the Freiha assemblage: two on long-bones from pheasants and/or partridges and two on sea mammal ribs. The latter are most likely dugong, and thus testify to the consumption of this animal. The remaining cut marks were found on sheep, goat and dromedary bones. When more of the Freiha assemblage has been registered, this group of data promises to become the basis for a full analysis of butchering and carcass handling, and as such may give insight into cooking techniques and eating habits at the site. For the moment it is worth noting that the majority of cut marks on the sheep and goat remains can be attributed to the dismembering process and the division of the carcass into more manageable pieces of meat. One such mark is Cv1, which consist of transverse cuts across the ventral and cranial surface of atlas, the first of the cervical vertebrates (Figure 10.2).

Figure 10.2: Atlas from a sheep or goat (*Capra/Ovis* sp.) with clear cut-marks, associated with the separation of the head and the neck.

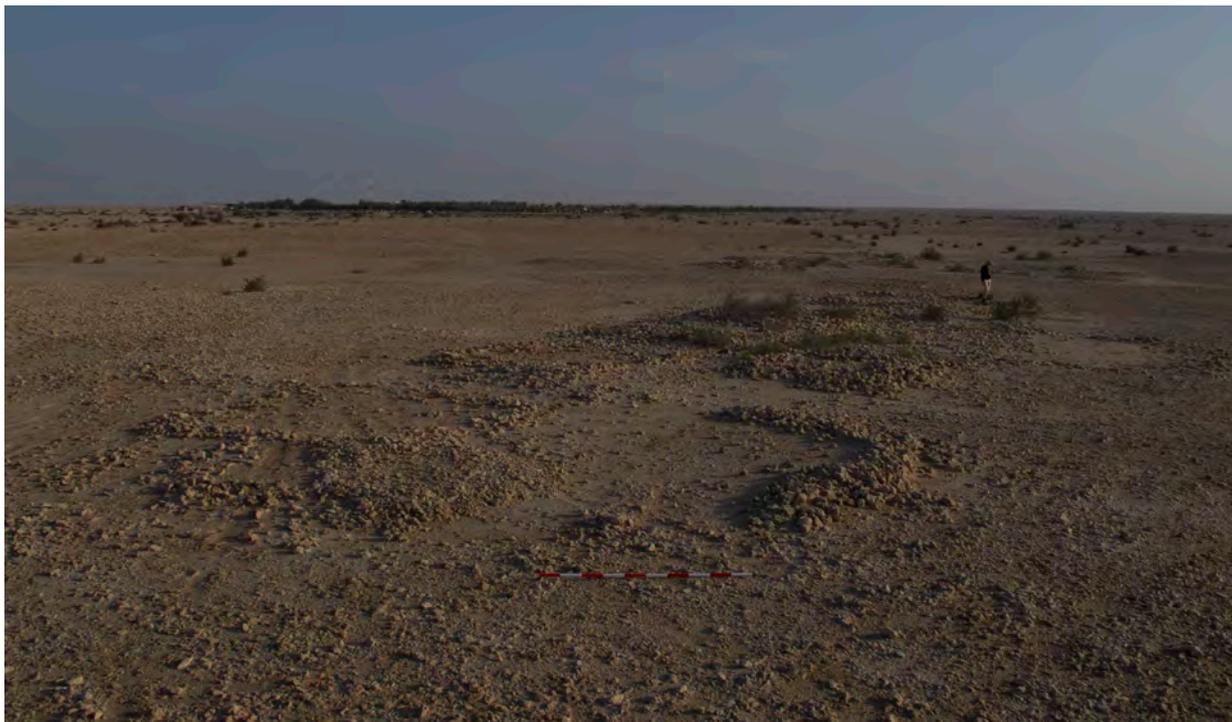
This is the southern-most site and the smallest of the four settlements. It is divided into two groups of structures with connected ancillary structures and walls with outlying structures (Figure 13.5).

Figure 13.5: Overview of QNHER 3226 showing remains of structures and walls. (JD-0078)

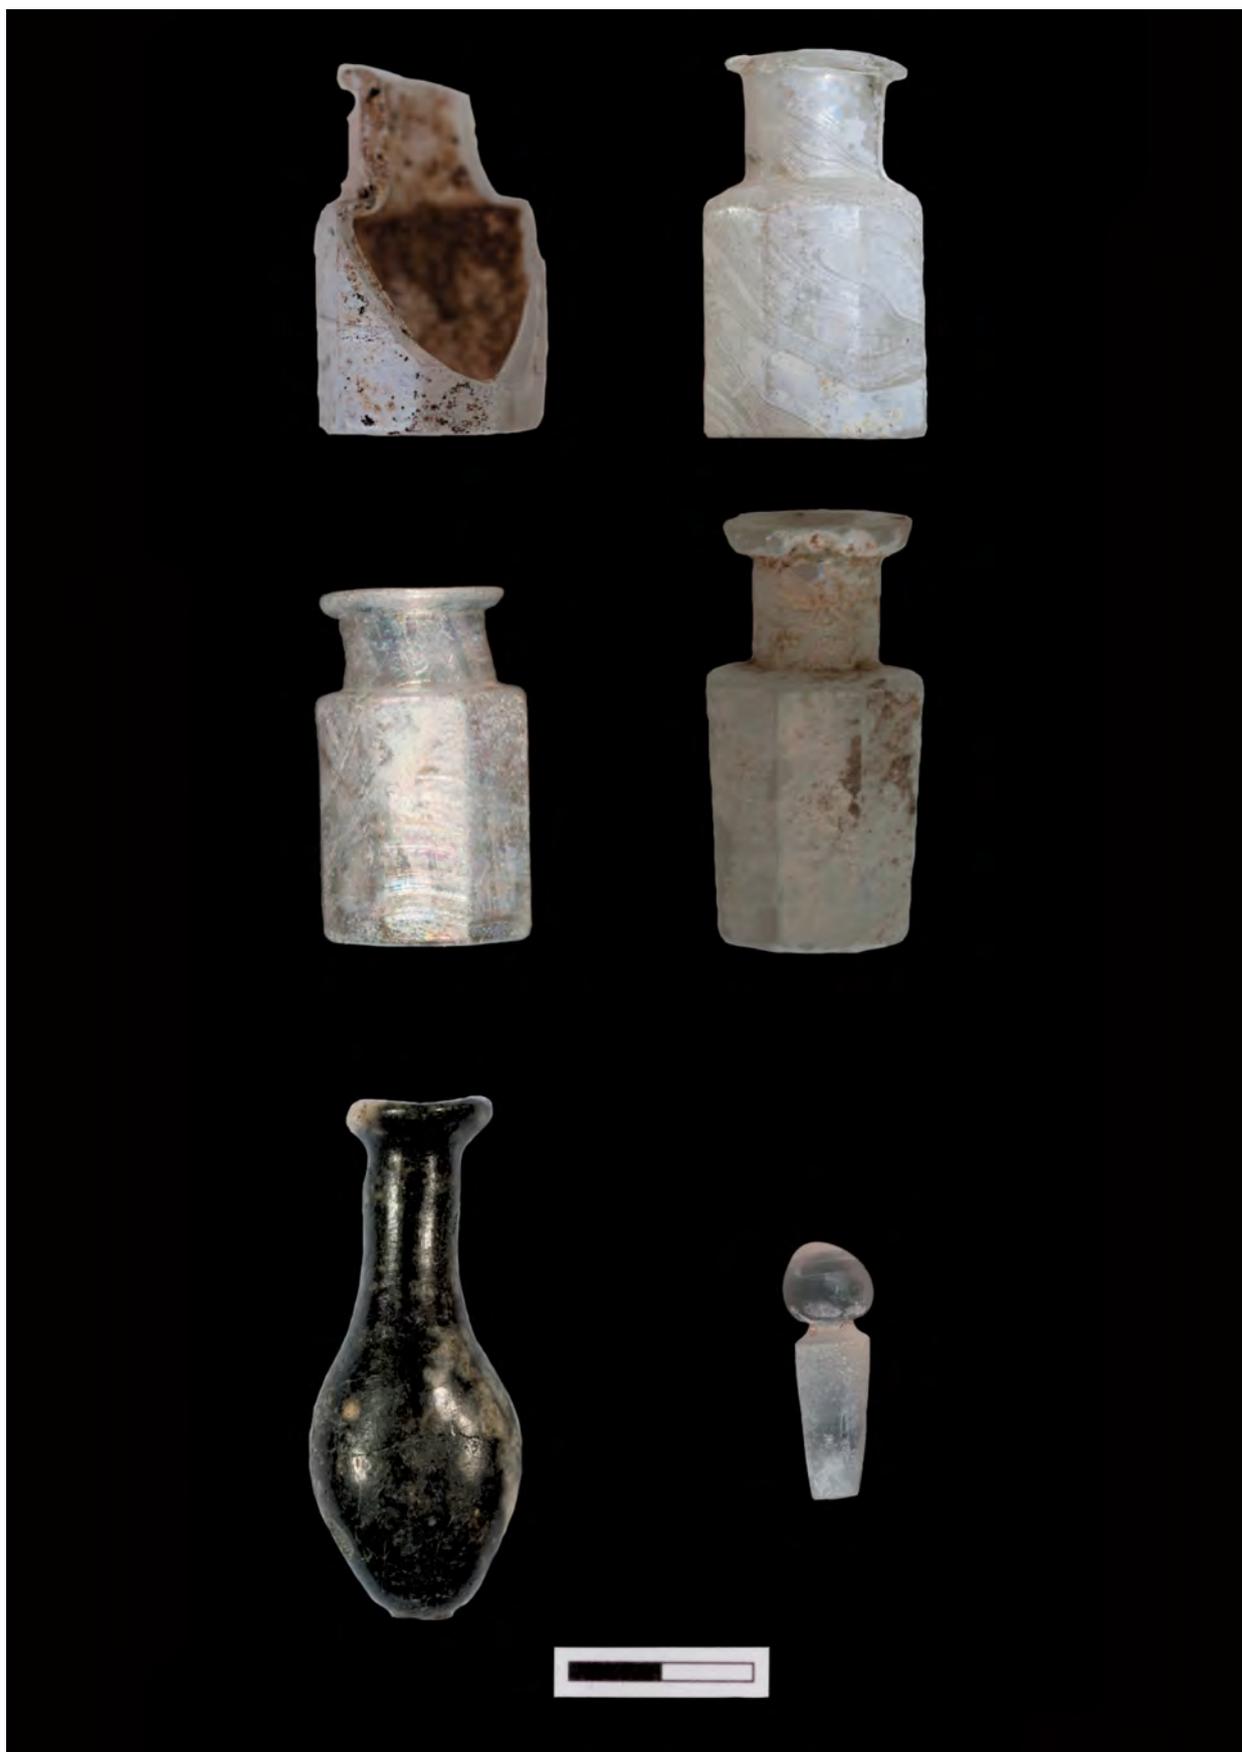
A small glass bottle with an octagonal body and a circular neck was found in ZUEP02 in spring 2014. The rim is flattened and out-turned with a rounded tip. The base of the small vessel is flat. The bottle is made from a clear glass and has a white mother-of-pearl-like coating on the interior, which may be a patina resulting from deterioration of the glass (Figure 14.2).

Figure 14.2: Top row: Glass bottle (catalogue # 2027) before and after conservation
Middle row: Two bottles from ZUEP02, catalogue # 1011 (left) and catalogue # 422 (right).
Bottom row: Black glass bottle from ZUEP04, catalogue # 351 (left), and a glass stopper, catalogue # 1231 (right)

they are all of a similar shape and design. At ZUEP04, a different type of miniature bottle made from a dark coloured glass and with an oval body was found on the floor of a room in Precinct Section 8. It has a rounded base and a long narrow neck with a flared rim. Its form indicates that it was especially suited as a liquid container, perhaps for holding perfume.

The bottle is interpreted as a decorative vessel for the storage of small quantities of medicine, ointments or perfume. It was found within the abandonment or collapse layers above the street through the date press area in ZUEP02, and may thus date from the intermediate occupation phase of the site.

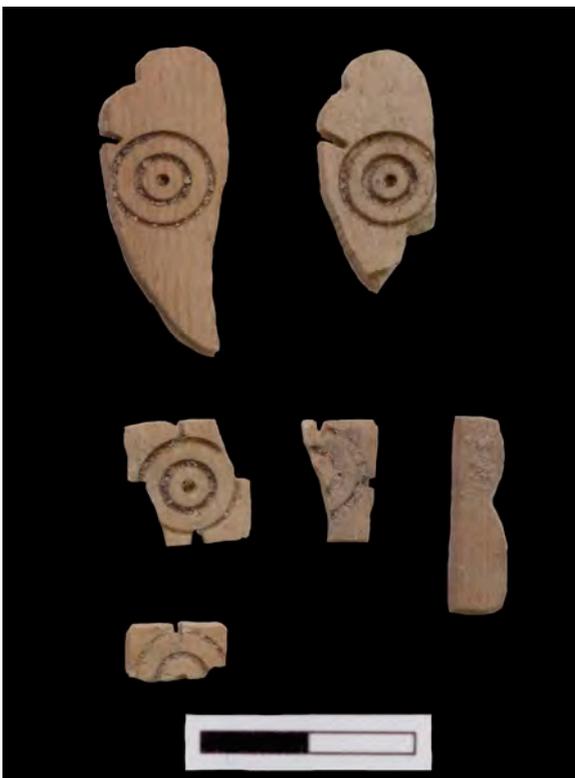
Within the backfill of Space 3040 in Precinct Section 7, a room with a *hammam* in the corner, eight fragments of a bone object with an incised dot-in-circle motif were recovered (Figure 14.3). They likely formed parts of a decorative inlay or other ornamental object.

The incisions consist of a central dot surrounded by two concentric circles. This motif is produced by a specific carving tool called a *zahrāh* (Ziolkowski and Al-Sharqi 2006).

Figure 14.3: Six of the bone inlay fragments (catalogue # 2001) (OF-0547)

Bone inlays were used in the decoration of furniture such as chairs, tables, storage boxes, game boards etc. In the Gulf region, the dot-in-circle motif has been used as an element in decorative designs for millennia, for example in Bronze Age seals and soft stone vessels.

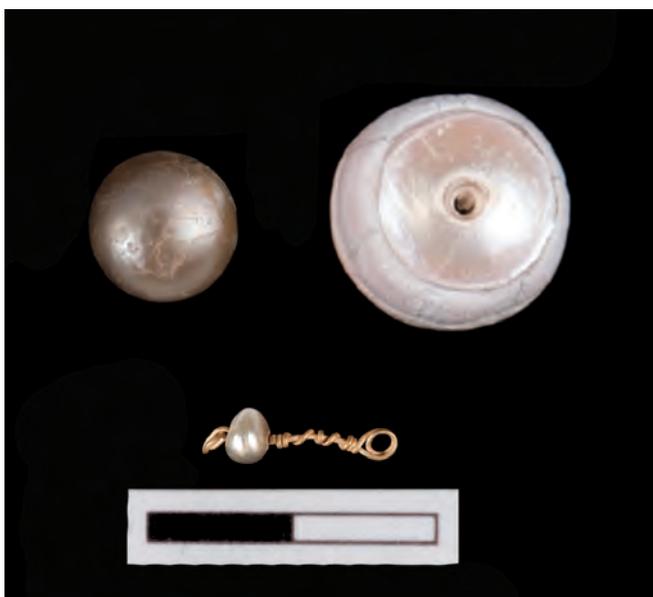
The four pearls at Freiha illustrate different degrees of working. The pearl found in the sondage is a natural pearl without signs of working (Figure 14.5). Its surface is smooth, showing that it is well-formed, and nacreous and iridescent with a greyish and golden shine. It has a diameter of 5.1mm and weighs only 0.19 grams.

A third pearl has been perforated and worked into a bead. The pearl has been drilled from two points, at angles to each other but with no indication of the drill holes meeting. This pearl has a diameter of nearly 8mm, and appears somewhat irregular with banding and minor flaws resulting from natural discontinuous growth.

The last pearl recovered from the heavy fraction came from the backfill of a fire pit in an early-phase temporary shelter area. It has not only been perforated and worked into a bead, but additionally had a gold wire attached to it, demonstrating its likely use as a part of a jewellery item, perhaps an earring or other ornamentation. The length of the gold wire is 9.21mm, and the entire item weighs less than 1 gram.

Figure 14.5: Top row: Natural pearl (catalogue # 667), left, and perforated pearl (catalogue # 240), right. Bottom row: Pearl on a gold wire (catalogue # 467).

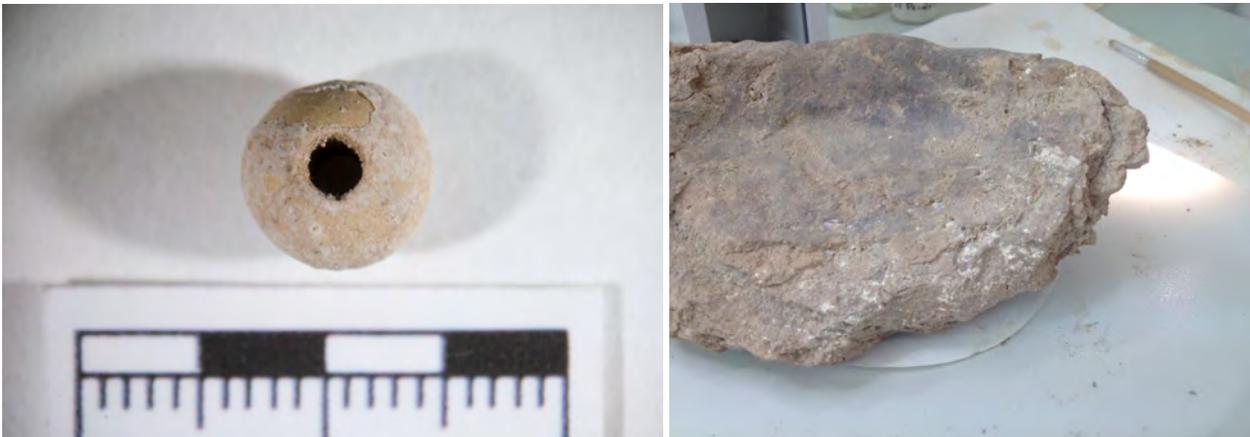
Figure 15.1: An example of visual efflorescence of salt on the exterior of a ceramic bead and a low fired ceramic fragment. (OF-3731 & UG)

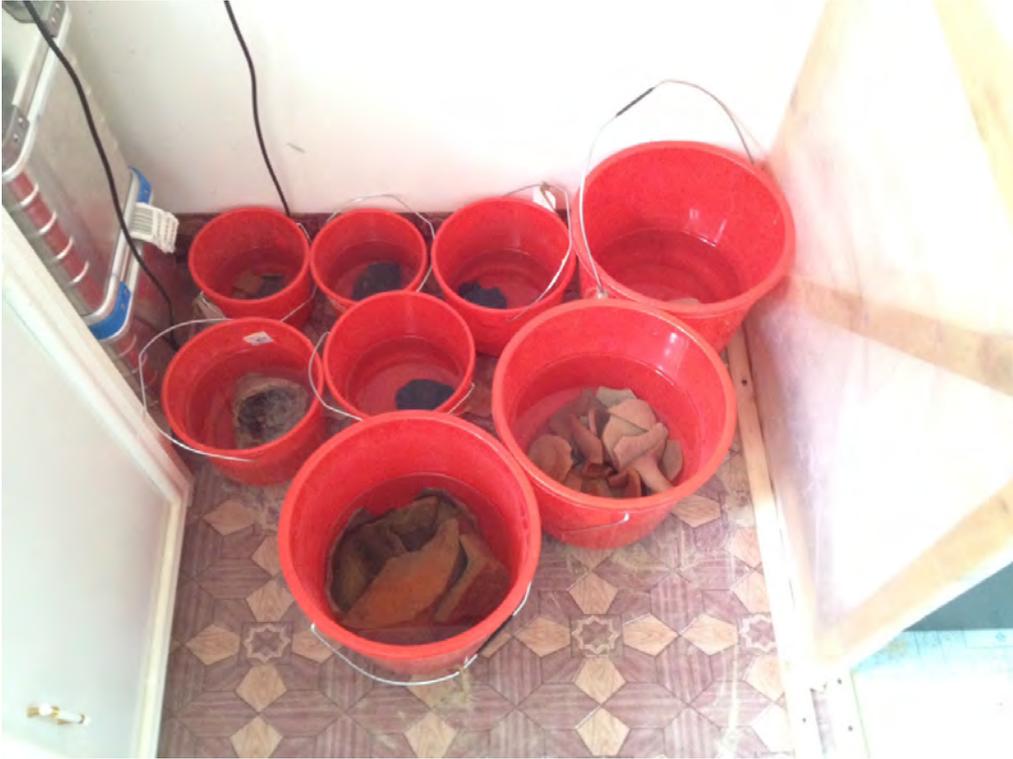
The standard desalination method consists of placing the object in a static bath of tap water, usually in a plastic bucket (Figure 15.2). The water is changed daily except for weekends; a line is drawn on the bucket to obtain the same volume of water at each change. This is continued until the salinity of the solution has stabilised. The time taken to remove the soluble salts can vary from a few weeks to several months.

Figure 15.2: Desalination in progress. Ceramics are immersed in a static bath of tap water. (UG)

The extraction of salts in each bath is monitored by conductivity, microSiemens per cm ($\mu\text{S}/\text{cm}$) being the standard unit of measurement using a conductivity meter (Hanna Waterproof Tester EC/TDS). Studies on the desalination end-point suggest that a conductivity somewhere between 100-150 μS is a safe level to end the desalination (Montana et al. 2013:7, Stephen et al. 2000:271, Unruh 2001:81). Finally, the object is removed from the water and air-dried (Figure 15.3).

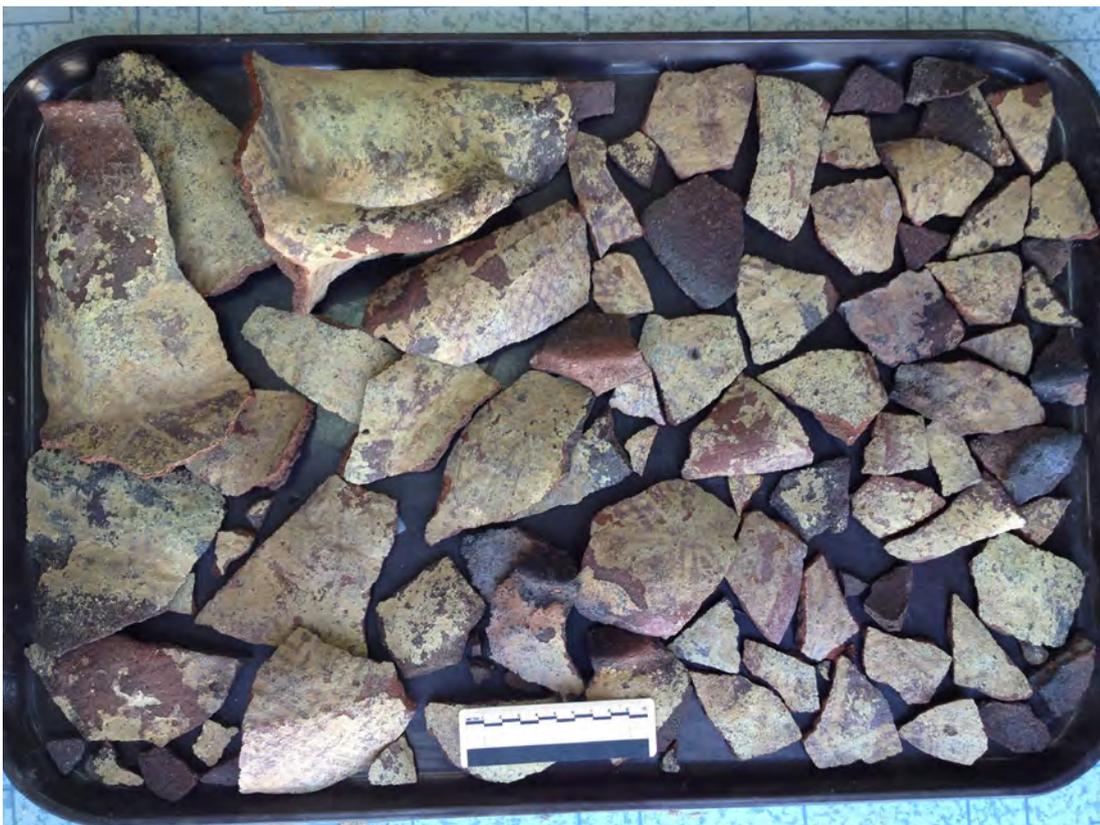
Figure 15.3: Ceramics drying after desalination. (OF-3373)

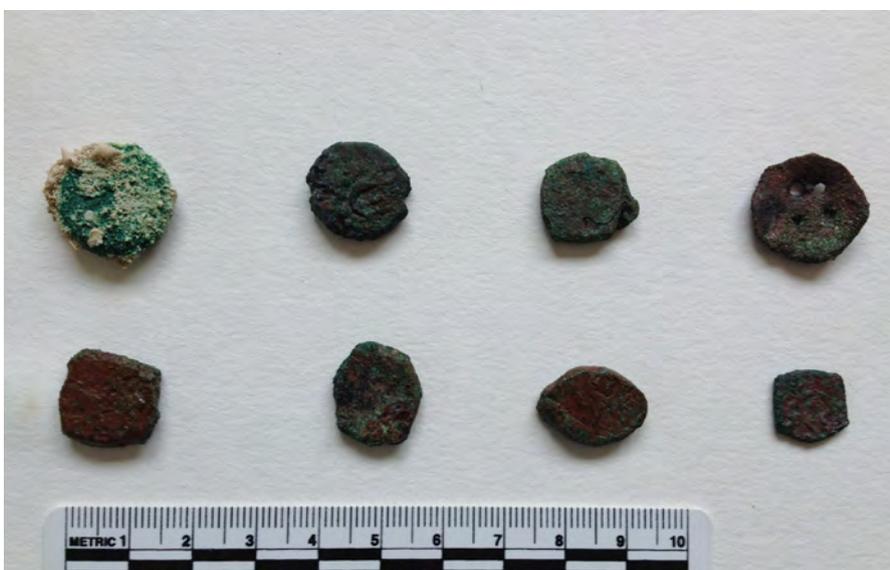
Figure 15.4: A collection of copper alloy coins, showing one untreated and seven treated by mechanical cleaning, chemical inhibition and consolidation. (OF-3311)

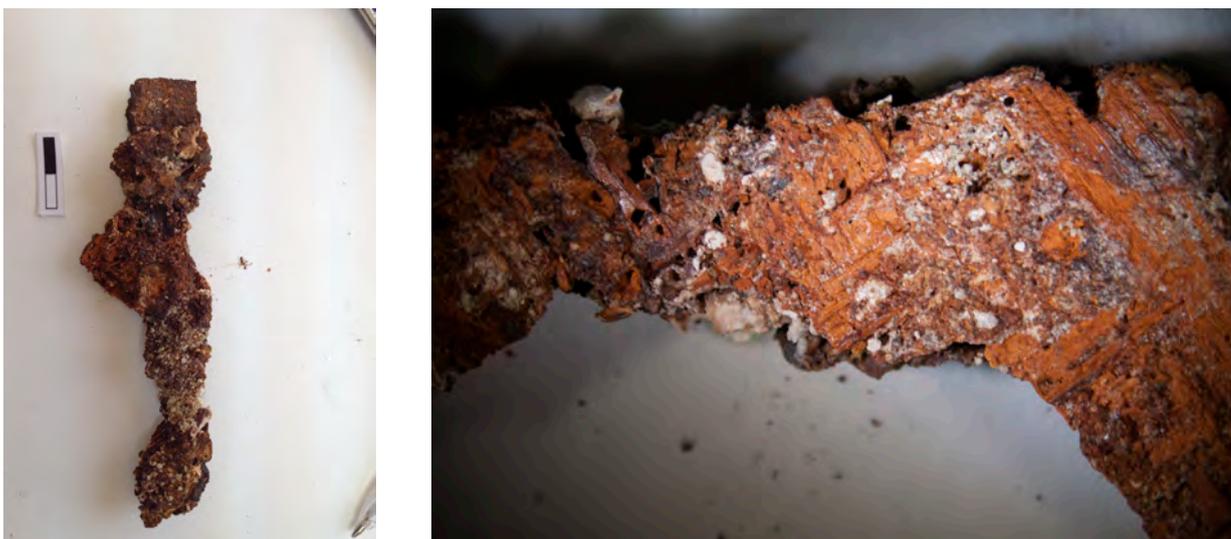
Figure 15.5: An untreated iron knife with a thick corrosion layer. Attached to the surface are residues of organic material. (UG & OF-3914)
