Qatar Islamic Archaeology and Heritage Project

End of Season Report : 2013-2014

Citation for published version (APA):
Rosendahl, S. (Ed.), Cockin, G., Estrup, E., Hawksworth, C., & Nymann, H. (Ed.) (2015). *Qatar Islamic Archaeology and Heritage Project: End of Season Report : 2013-2014*. Copenhagen: University of Copenhagen and Qatar Museums.

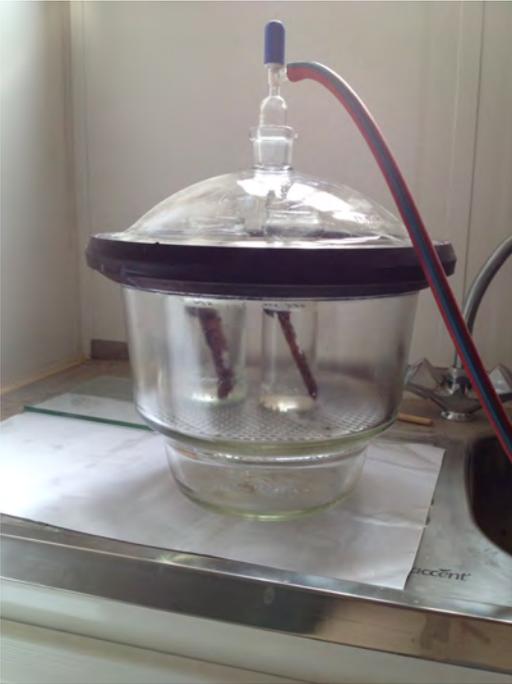
Figure 15.6: Two iron knives consolidated in a solution of 7 % Paraloid B72 and ethanol/acetone 3.2 under vacuum. (UG)

In principle, the desiccation method is used in Al Zubarah before and after treatment. First, the corrosion layer is removed mechanically by light sandblasting using micro-crystalline glass beads and with a miniature drill, followed by consolidation in a solution of 7% Paraloid B72 in ethanol/acetone 3:2 under vacuum for 8-12 hours (Figure 15.6). This helps to stabilise the iron; at the same time, the consolidation acts as a coating on the surface that prevents incoming moisture to dissolve the chlorides.

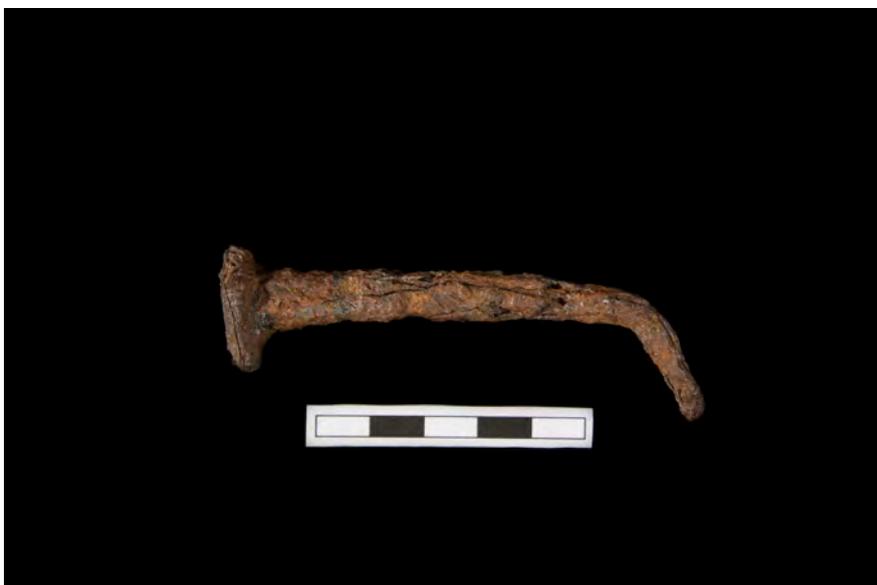
Figure 15.7: Iron nail after conservation by desalination experiment. (OF-4889)

After desalination, the nail was chemically stabilised with 3% BTA for 24 hours under vacuum as an extra experiment to study if BTA can act as an inhibitor on archaeological iron. This was followed by consolidation in a solution of 7% Paraloid B72 in ethanol/acetone 3:2 for three hours under vacuum to physically stabilise the nail (Figure 15.7).

The experiment concluded without any clear results. However, the results indicate that the desalination process did wash out some chlorides, especially during the first couple of weeks. How much chloride was extracted was not possible to detect.
