Utilizing Vegetation Indices as a Proxy to Characterize the Stability of a Railway Embankment in a Permafrost Region

Priscilla Addison ^{1,*}, Pasi Lautala ² and Thomas Oommen ¹

This study focused on the Hudson Bay Railway (HBR), a 510-mile track constructed within the permafrost region of northern Manitoba, Canada. The HBR, owned by OmniTRAX Inc. at the time of this study, serves as a critical linkage for passengers and freight from The Pas (milepost 0) to Churchill (milepost 510), connecting locations in North America to international destinations through the Port of Churchill. All three permafrost types occur along the HBR route. From The Pas to Churchill, there is a gradual northward transition from no permafrost zone, to sporadic discontinuous, to extensive discontinuous, and finally to continuous permafrost (Figure 1).

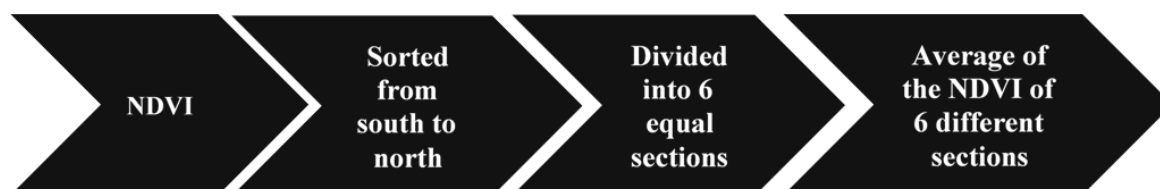
Figure 2. Process for determining relation between NDVI and track geometry exceptions.

Results from the ERT surveys at the 10 sites were compared against the track exception data to identify trends between these datasets. The objective was to infer subsurface conditions delineated by the ERT from the surficial data of the track exceptions. After establishing this relationship, the NDVI from the remote sensing analyses was compared against their corresponding average number of track exceptions recorded. This analysis was modelled after Roghani et al.’s approach [31] by dividing the study section into 22-mile sections, resulting in six subsections from milepost 341 (southern end) to milepost 473 (northern end). The process is summarized in Figure 2. The corresponding track exceptions per mile of track were calculated by combining the recorded yearly average exceptions per section and dividing them by the segment length (22-miles).

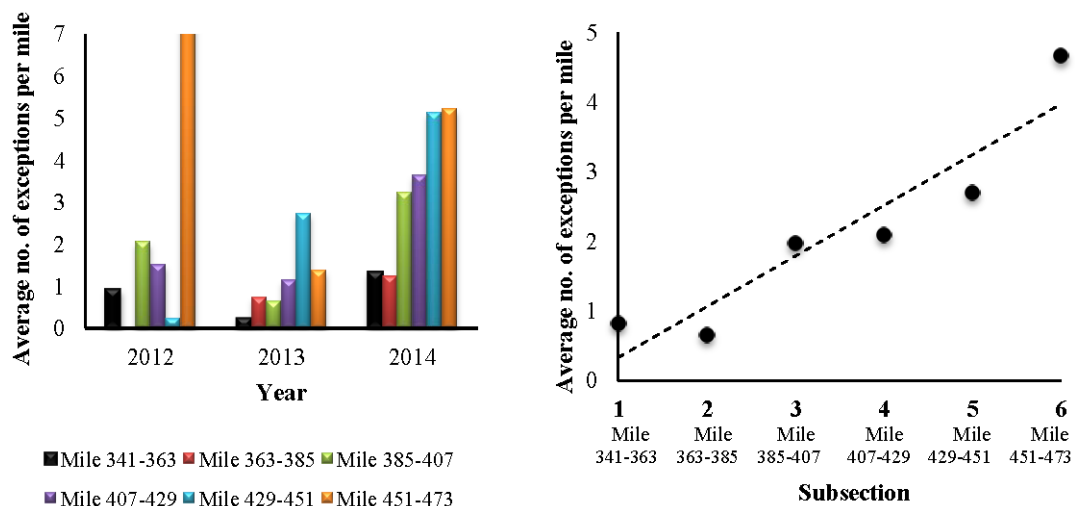
Figure 3. A plot of track exceptions recorded for the six subsections in 2012–2014 (left); and a plot of the average track exception recorded for the investigative period for each subsection (right).

A plot of the six subsections against their recorded average geometry exceptions indicated a general increasing trend in exceptions from subsection 1 to 6 (Figure 3) which confirms worsening track conditions from south to north.

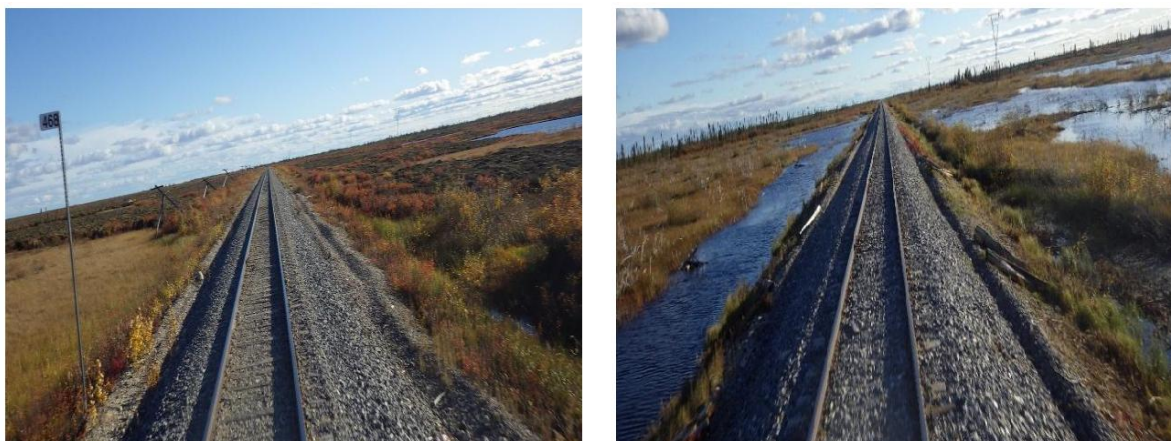
Figure 6. Photos of milepost 468 (left) and milepost 448 (right) showing no tree cover and ponded water close to embankment shoulders.

Photo images were taken in 10-second intervals while traversing the entire study area by a hi-rail truck. A comparison between the photos and research findings revealed that the northernmost sections with the lowest NDVIs (Subsections 5 and 6) are generally devoid of tree cover. This is intuitive; however, a more noteworthy finding was that these sections had substantial amounts of ponded surface water close to the embankment shoulders. Figure 6 shows two such typical images for milepost 468 (Subsection 5) and milepost 448 (Subsection 6). Conversely, the southernmost sections, which recorded the highest NDVIs, had denser vegetation with no surface water close to the embankment shoulders (Figure 7). From these photos, it was realized that the low NDVIs obtained for this particular study site translate not only to low vegetation densities but also to high percentage of ponded surface water.

These photos also reinforced the perceived relationship between the NDVI and track exceptions, as past literature have shown collected waterbodies in the form of ponds and lakes have deleterious effects on underlying permafrost. Ponded water absorbs the sun's heat and transfers it to the permafrost table [33], which explains why the northernmost sections recorded higher frequencies of track exceptions, indicative of permafrost degradation.

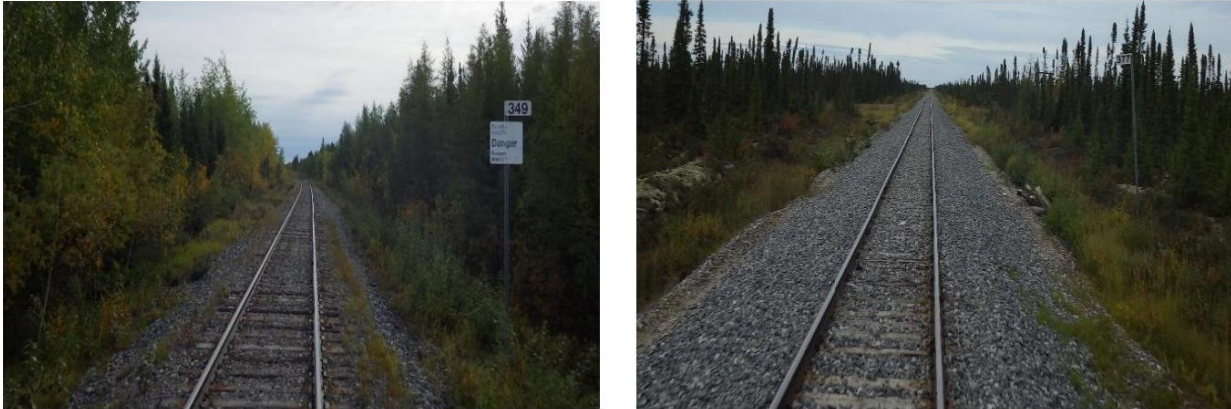
Figure 7. Photos of milepost 349 (left) and milepost 377 (right) showing population of trees and no surface water ponded close to the embankment shoulders.
