3D Tunnel Inspection with Photogrammetric and Hybrid Systems

3D tunnel inspection with photogrammetric and hybrid systems

Dibit measuring technique

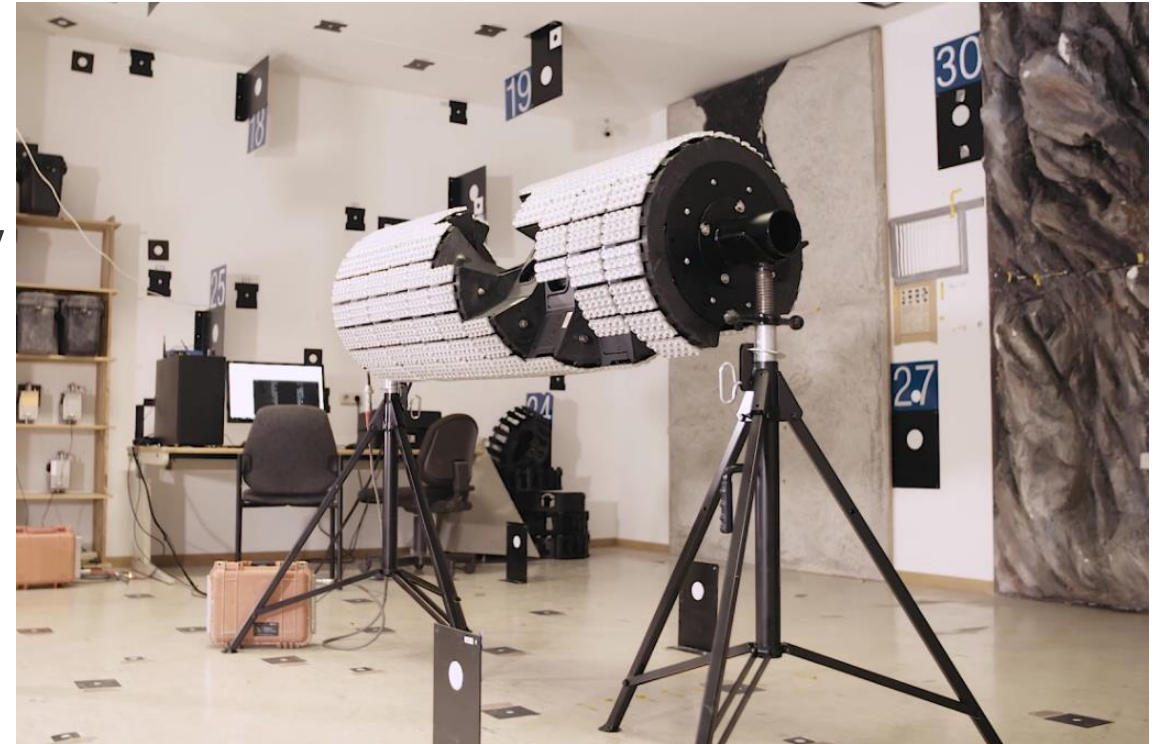
Dibit Highspeed Scanning System

- Highspeed industrial cameras
 - Cameras: > 30 fps (frames per second) exposure time
- Special design of high-performance LED technology
- 360° scanning area
- Technical data:
 - Measurement speed: up to 50 miles/h
 - Resolution: 1 x 1 mm (1/25 inch)
- Modular construction (camera, laser-scanner, additional sensors (thermal, multispectral..))

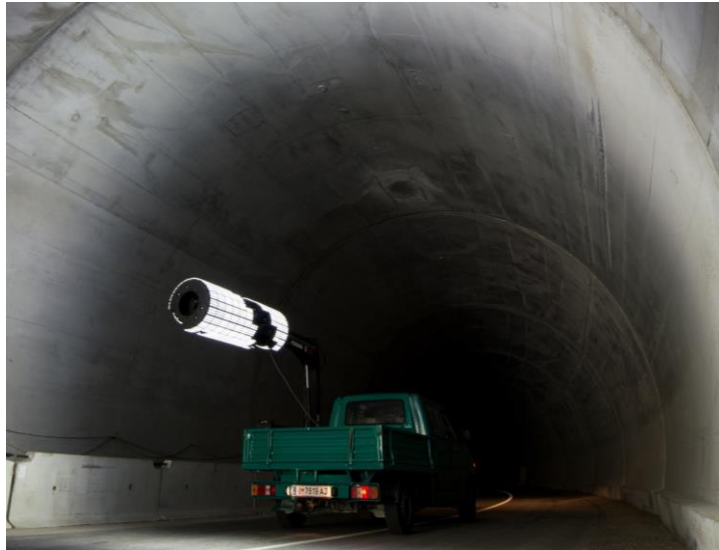
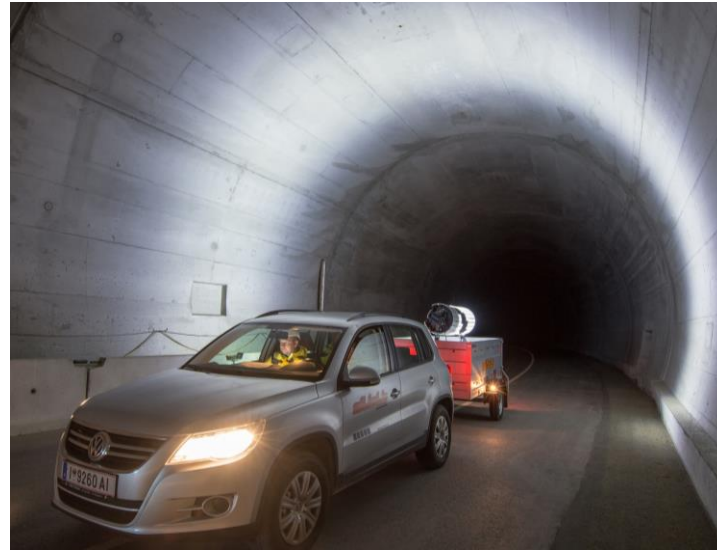
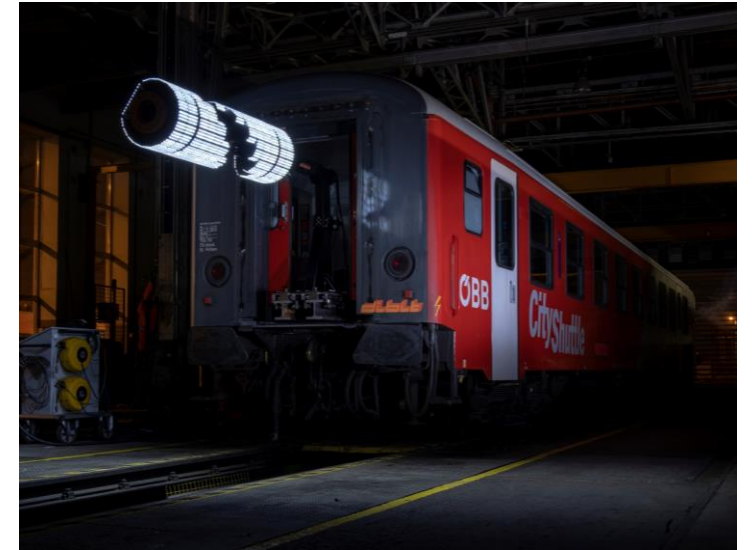
Dibit Highspeed Scanning System

- Measurement system can be mounted on various vehicles

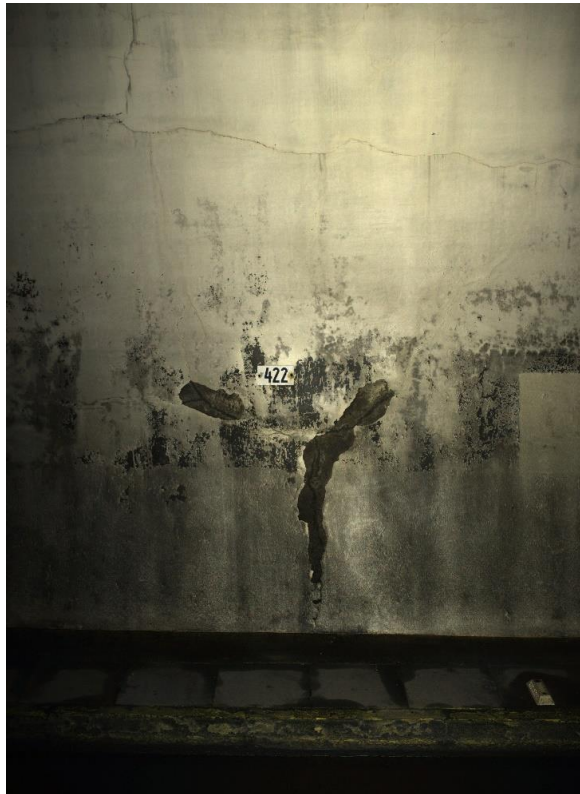
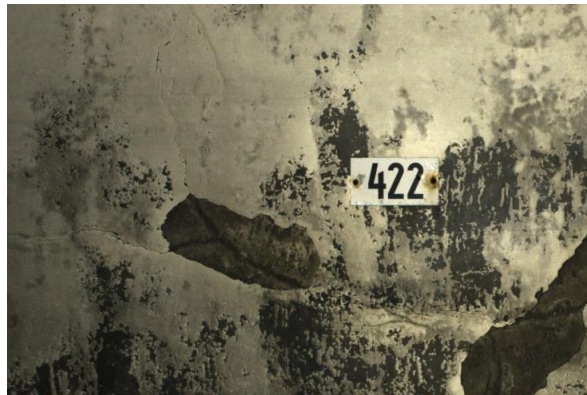
Dibit Highspeed Scanning System

- Up to 30 frames per second for each camera (300 fps in total)

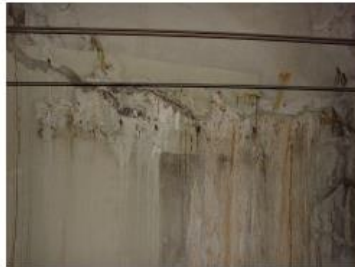
Inspection Photo 2001

Crack in Crown

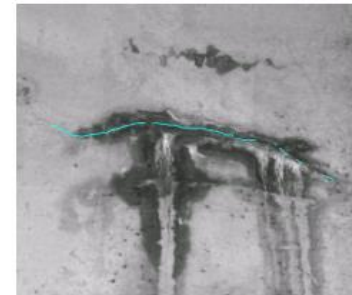
Scanner Inspection 2001

Deficiency Name **RF_B/GL1_2001-0004**

SyncID T0cen2BbTAapwfAPNCTgvA==
Position 3D 85800,8200; 6547,0960; 101,2970
Station/BL/R 1115,4918; 3,4942; -0,0285
Length 1,5970
Surface Area 0,0000
SSR - Length 0,0000
SSR - Width 0,0000
SSR - Surface Area 0,2380
SSR - Circumference 3,3380
SSR - Rotation 0,0000
Width 0,4000
Depth 0,0000
Degree of Leakage Damp
Sediment Heavy
Identified 0
Inspector Kuno, Dipl.-Ing. Norbert
Inspection Date 20001001
Comments Crack on Wall
