Calendar Year 2013 Report to the Rio Grande Compact Commission

U. S. Department of the Interior
Bureau of Reclamation
Albuquerque Area Office
Albuquerque, New Mexico

March 2014

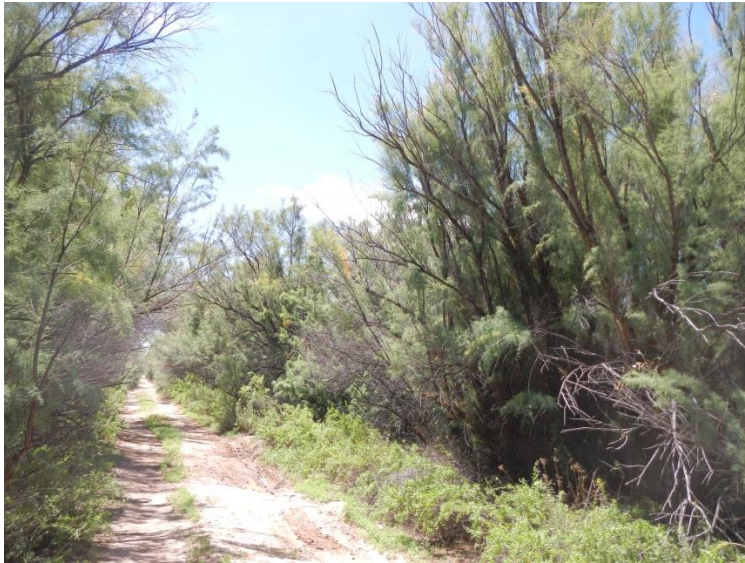
Photo 1: San Francisco Wasteway before maintenance (July 2013)

- **San Francisco Wasteway Vegetation Removal:** The purpose of the proposed work on the San Francisco Riverside Drain Wasteway is to 1) improve wasteway flow conveyance and water salvage capabilities, 2) improve maintenance access, and 3) reduce potential safety risks to the general public and maintenance crews. Maintenance consisted primarily of

removing large vegetation.

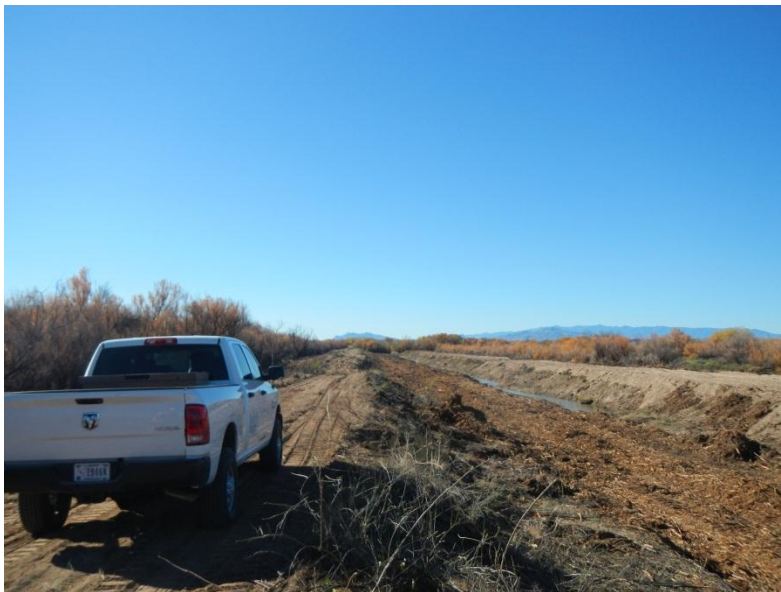
Photo 2: San Francisco Wasteway with maintenance mostly complete (November 2013)

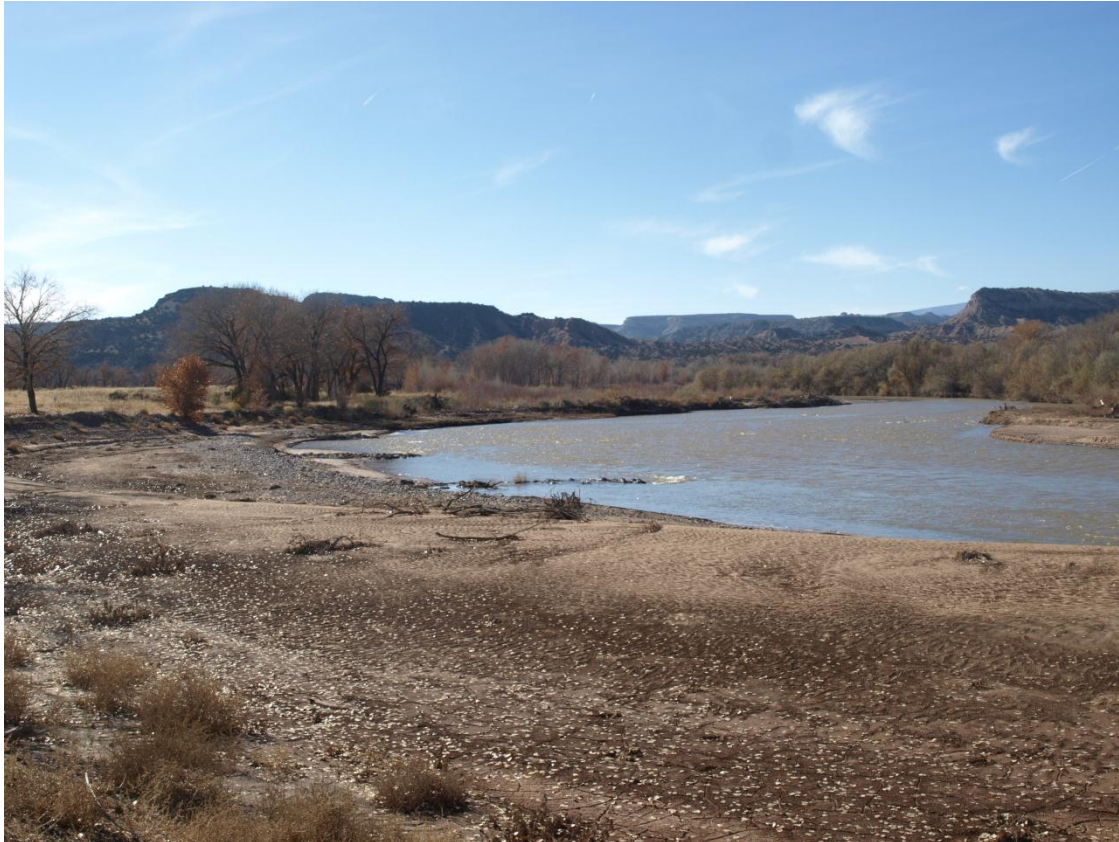
Photo 3: Constructed bendway weirs at San Ildefonso Priority Site (November 2013, AuBuchon)

This priority site is located at RM 259. In spring 2007, a river maintenance project was constructed by Reclamation's Socorro Field Division to provide protection for the San Ildefonso fishing pond. During the spring runoff of 2009, the channel eroded through a line of dense vegetation planted as part of the project. This erosion resulted in the loss of up to 75 feet of bankline upstream of the previous project area. This bank erosion exposed and threatened to flank three of the buried rock vanes. Reclamation worked with the Pueblo de San Ildefonso to construct a temporary solution prior to the 2010 spring runoff. The project consisted of a buried trench riprap revetment and a riprap windrow. This 2010 temporary protection work allowed for the development and permitting of a longer term solution.

The selection of a preferred alternative for the longer term solution was made in April 2012. The project was divided into two phases. The first phase involved construction of seven bendway weirs; the second phase involves installing a west bank floodplain side channel to complement bendway work from the first phase. Detailed designs, construction drawings, project description, and environmental compliance for the first phase were completed in 2012, with construction of the bendway weirs (Photo 3) beginning in January 2013 and ending in March 2013. Detailed designs, construction drawings, project description, and environmental compliance for the second phase were completed in 2013, with construction beginning in January 2014.

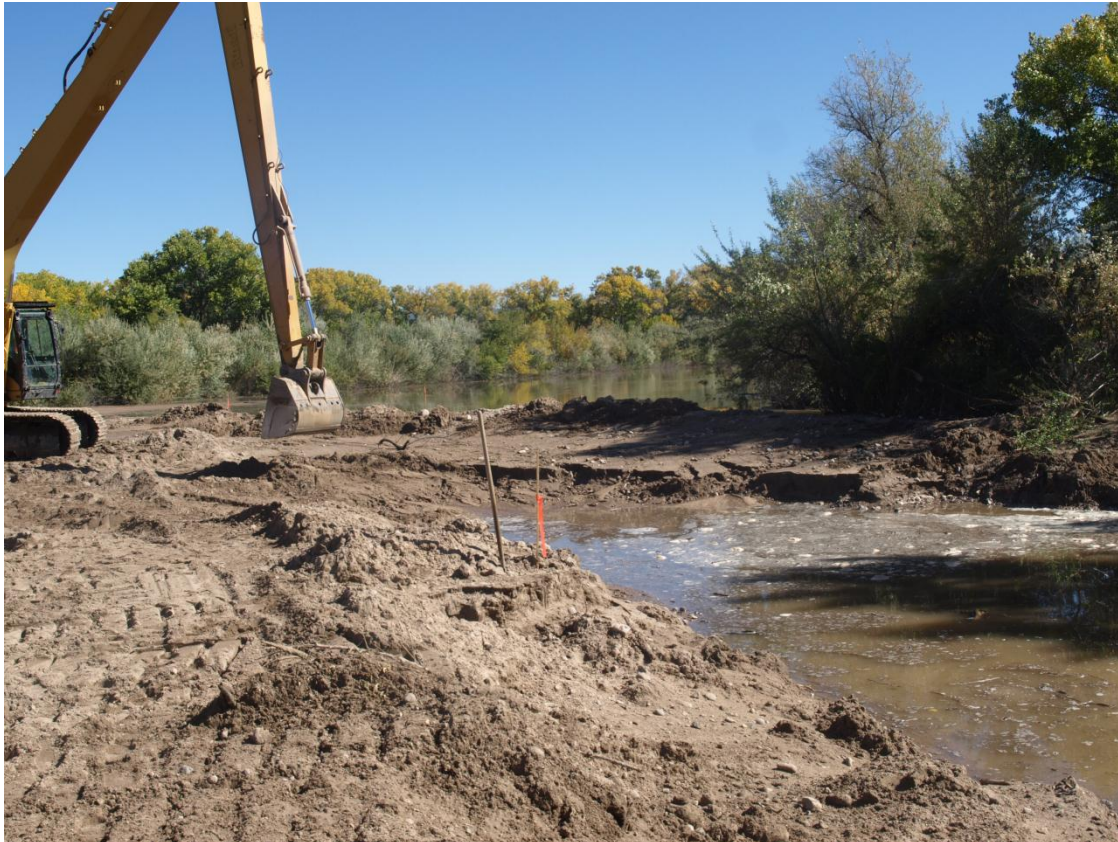
Photo 4: Construction of pilot channel at Peralta Arroyo (October 2013, AuBuchon)

On October 8, 2013, work began on the first phase, excavation of a pilot channel through the sediment at the Peralta Arroyo confluence. The pilot channel was opened on October 9, 2013

(Photo 4). The second phase is augmentation of natural flow paths to take advantage of overbanking on the existing eastern terrace, in an effort to develop side channels through the terrace. Topographic data collection and soil sampling were completed in November 2013 for design of the side channels. A project description was completed in December 2013. The design report, construction drawings, and environmental compliance are expected to be finished before the anticipated construction of the side channels in March 2014.

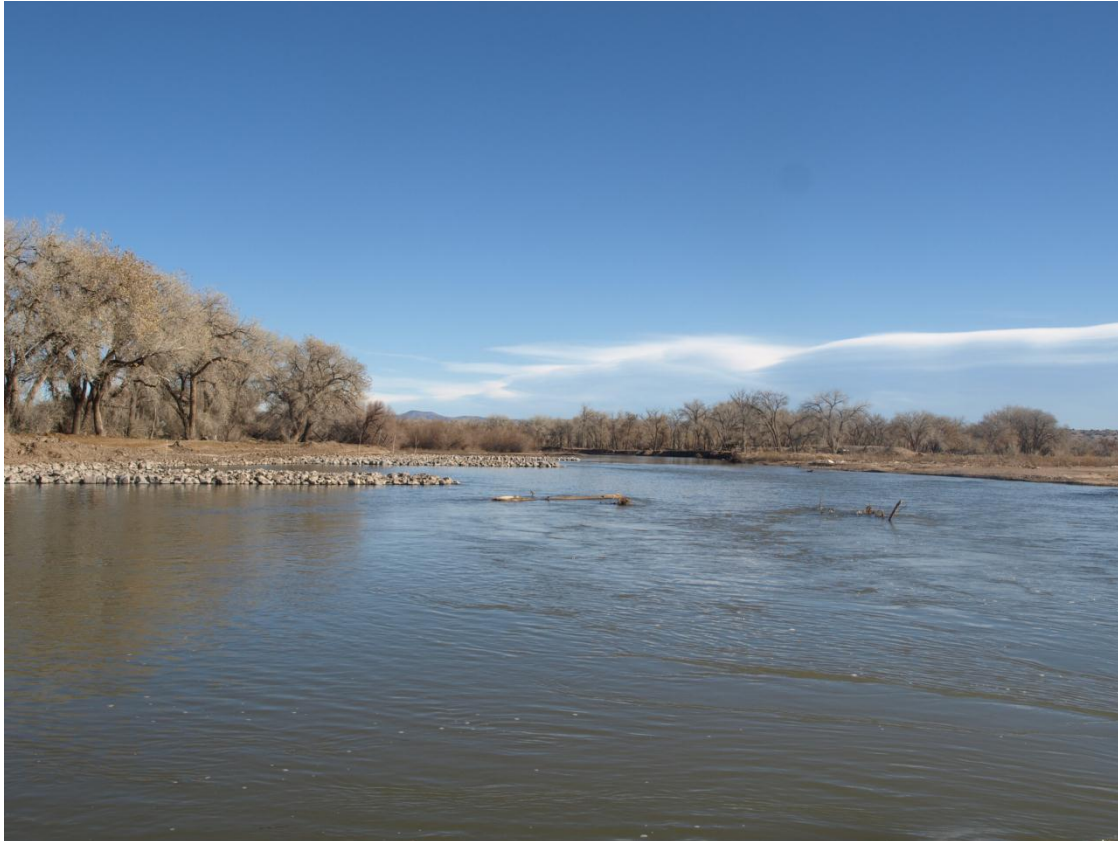
Photo 5: Constructed bendway weirs and longitudinal stone toe with bioengineering at Santo Domingo RM 224.6 (January 2014, S. Benoit)

The three project sites were divided into two phases, RM 225.1 as Phase 1, and RM 224.6 and RM 223.9 as Phase 2. Detailed designs, construction drawings, a project description, and environmental compliance for RM 225.1 were completed in September 2012. Construction began for this site in October 2012 and was completed in January 2013. The project description for RM 224.6 and RM 223.9 was completed in the spring of 2012 and detailed designs,

construction drawings, and environmental compliance were completed in 2013. Construction for RM 224.6 started in October 2013 and is expected to be completed in January 2014. A picture of the construction at this site is shown in Photo 5. Construction for RM 223.9 is planned for February 2014.

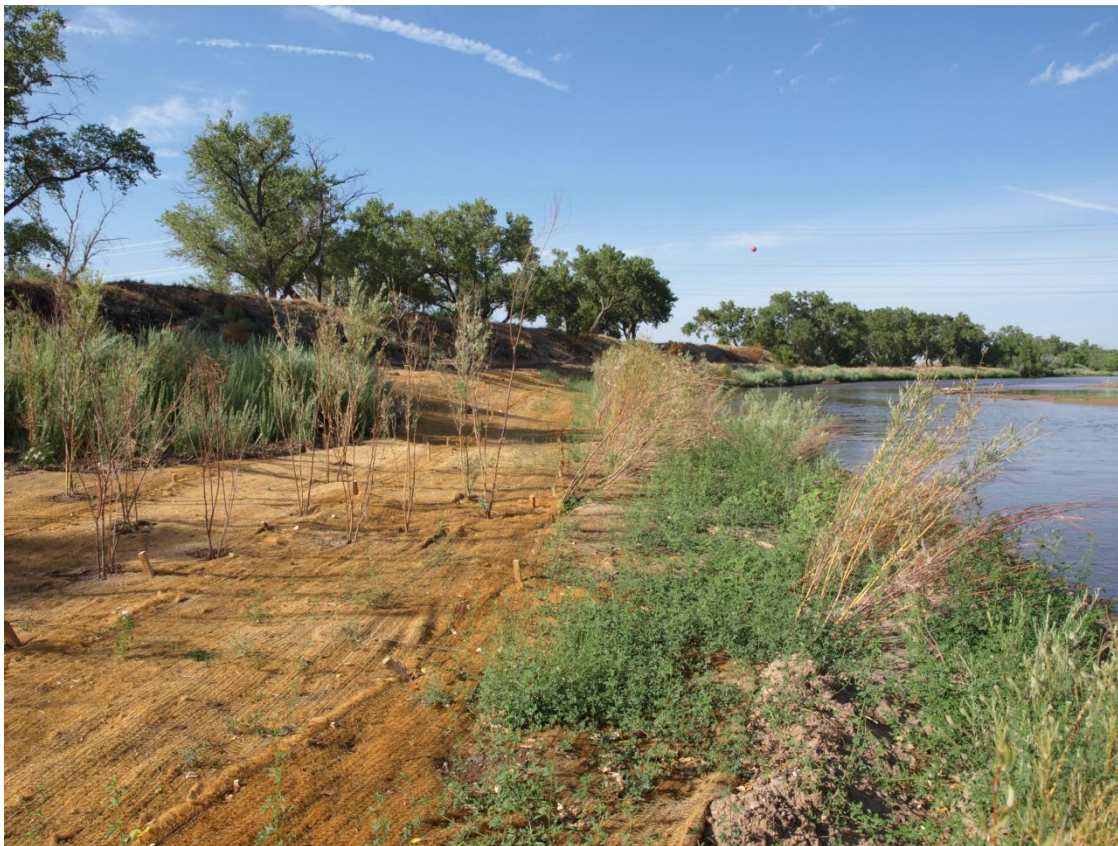
Photo 6: Native vegetation planted at the Pueblo of Santa Ana (July 2013, AuBuchon)

Reclamation's river maintenance work associated with a large scale project at the Pueblo of Santa Ana is complete. The work at this site extended from RM 208.4 to 207.2, with major features including river realignment and construction of a gradient restoration facility (GRF) completed in 2002 by Reclamation's Socorro Field Division. Adaptive management projects at this site have been implemented four times since the original project construction (2005, 2008, 2009, and 2012). The adaptive management projects included lowering the elevation of backwater areas in 2005, adding flanking protection in 2008, placing bendway weirs in 2009, and constructing a longitudinal fill stone toe with tie backs in 2012. Re-vegetation with native vegetation (Photo 6) was accomplished at all of these sites through a P.L. 93-638 contract with the Pueblo of Santa Ana, which concluded this large scale project.

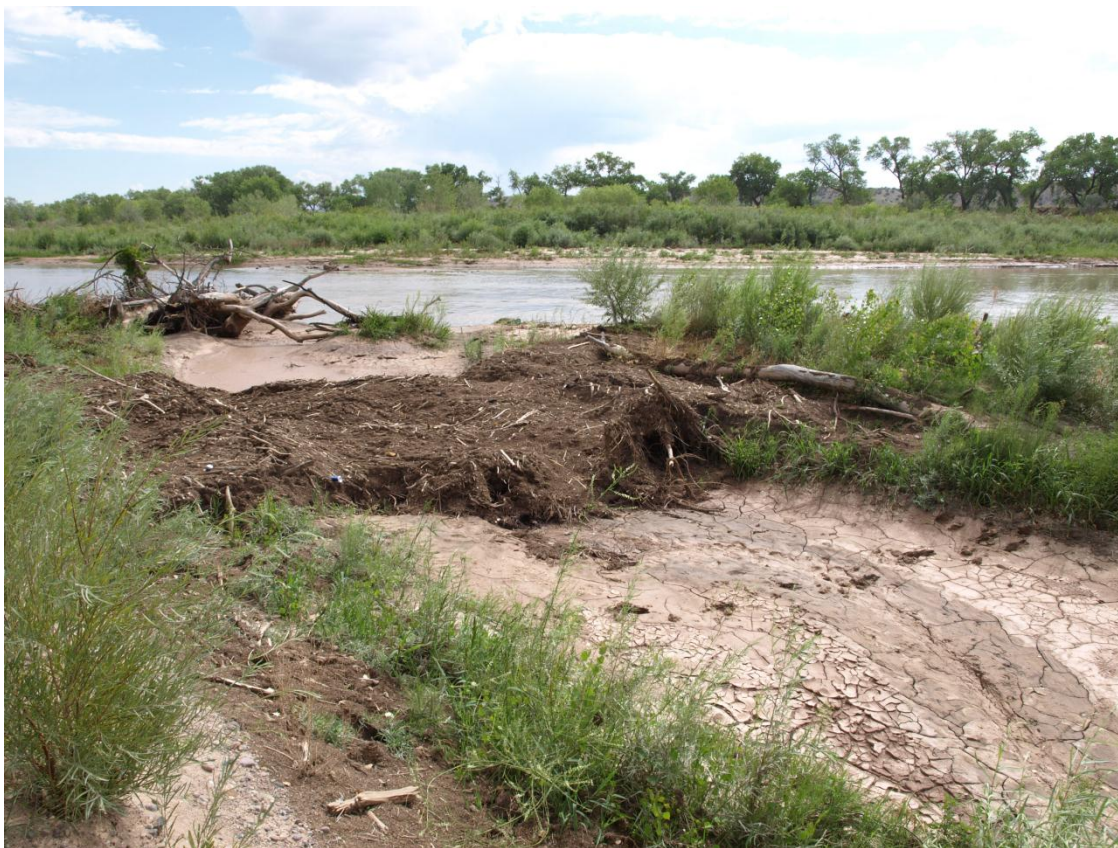
Photo 7: Sediment plug at RM 207.1

Monsoonal rains during the summer of 2013 moved a large amount of organic material (sticks, manure, juniper leaves and berries, etc.) and cobble into a naturally formed, pre-existing side channel at RM 207.1, near the Santa Ana RM 205.8 project, creating a plug (Photo 7). Silvery minnows are known to utilize this side channel during spring runoff and other high flow events. The Pueblo of Santa Ana requested that Reclamation remove the plug while construction is occurring at RM 205.8, since it is close to the project site and they wish to keep it available as minnow habitat. The side channel is currently dry and is expected to remain dry during the plug removal. Environmental compliance for Santa Ana RM 205.8 was revised in December 2013 to cover the removal of this plug. Plug removal is expected to happen in concurrence with the construction of the bendway weirs at RM 205.8.

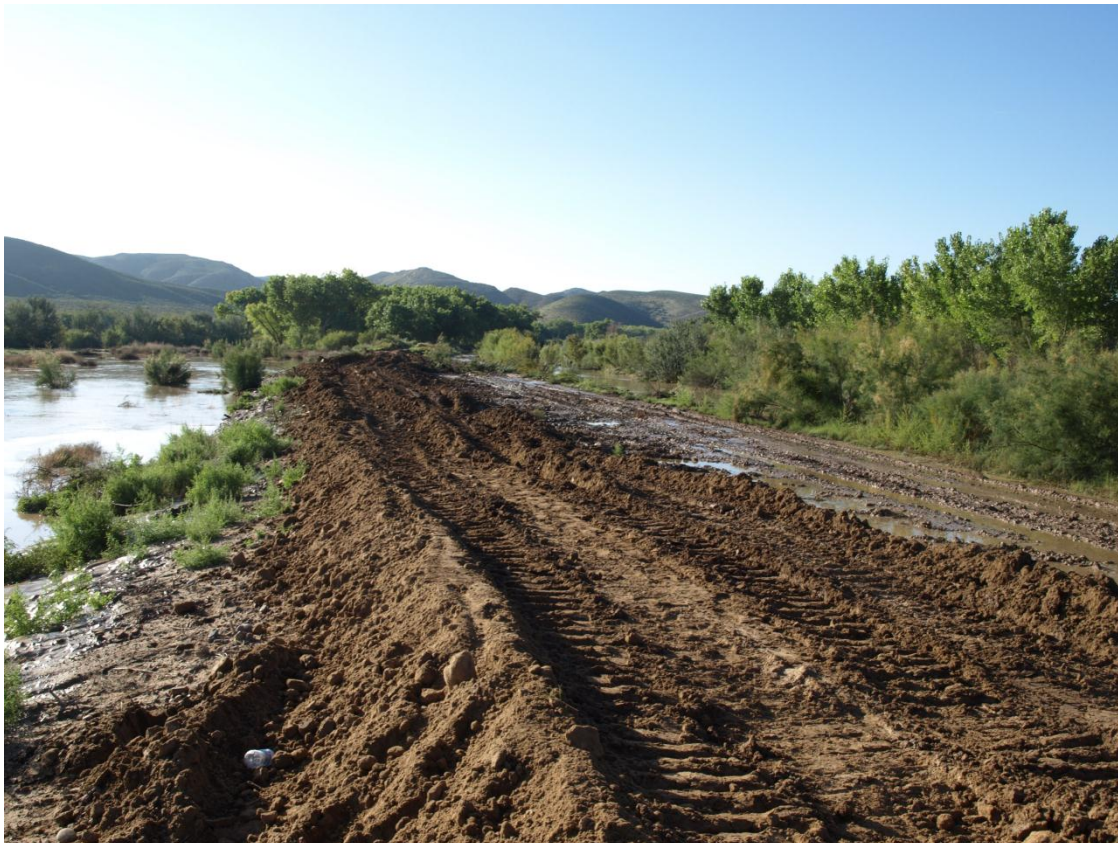
Photo 8: Temporary fix of spoil levee between Drain Unit 7 Extension and the Rio Grande (September 2013, AuBuchon)

High flows from monsoonal rains in 2013 caused overbanking which overtopped and saturated the spoil levee in between the Rio Grande and Drain Unit 7 Extension. This led to failure of the spoil levee at one location and near failure at another. Emergency repairs to both areas took place in September 2013. Earthen material from higher areas of the spoil levee was used to fill areas of the spoil levee damaged by overbanking. Large vegetation, mostly Russian olives and saltcedars, was also removed to help stabilize the breach area. This area will need a more permanent fix to restore the grade on the spoil levee. Construction drawings for permanent repair of approximately 1,000 feet of spoil levee were completed in November 2013.

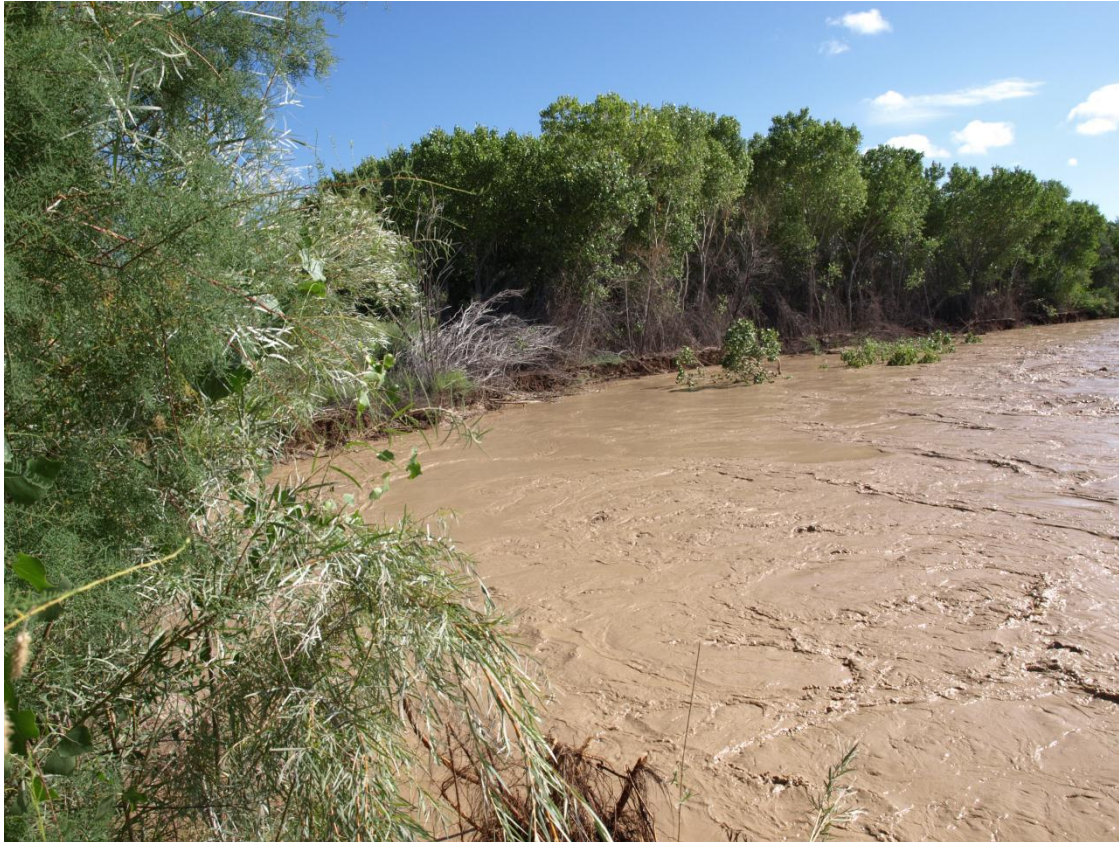
Photo 9: Bend at Drain Unit 7 Priority Site actively mobilized

A site visit on September 17, 2013, detected a meander bend that was moving extensively just upstream of the site (Photo 9). Currently the apex is located at the land side edge of the placed riprap windrow. A phase 3 for this project to extend this riprap windrow another 383 feet to tie into an existing groin field that protects the spoil levee of the Drain Unit 7 Extension is necessary. This length is heavily vegetated and would need to be cleared. The rock for phase 3 has already been stockpiled near this site. It is anticipated that sustained high flows from runoff or monsoon events will mobilize the bank if phase 3 is not implemented. This would threaten the spoil levee embankment that protects the Drain Unit 7 Extension irrigation structure. Environmental compliance is needed before placement of rock for phase 3 occurs.

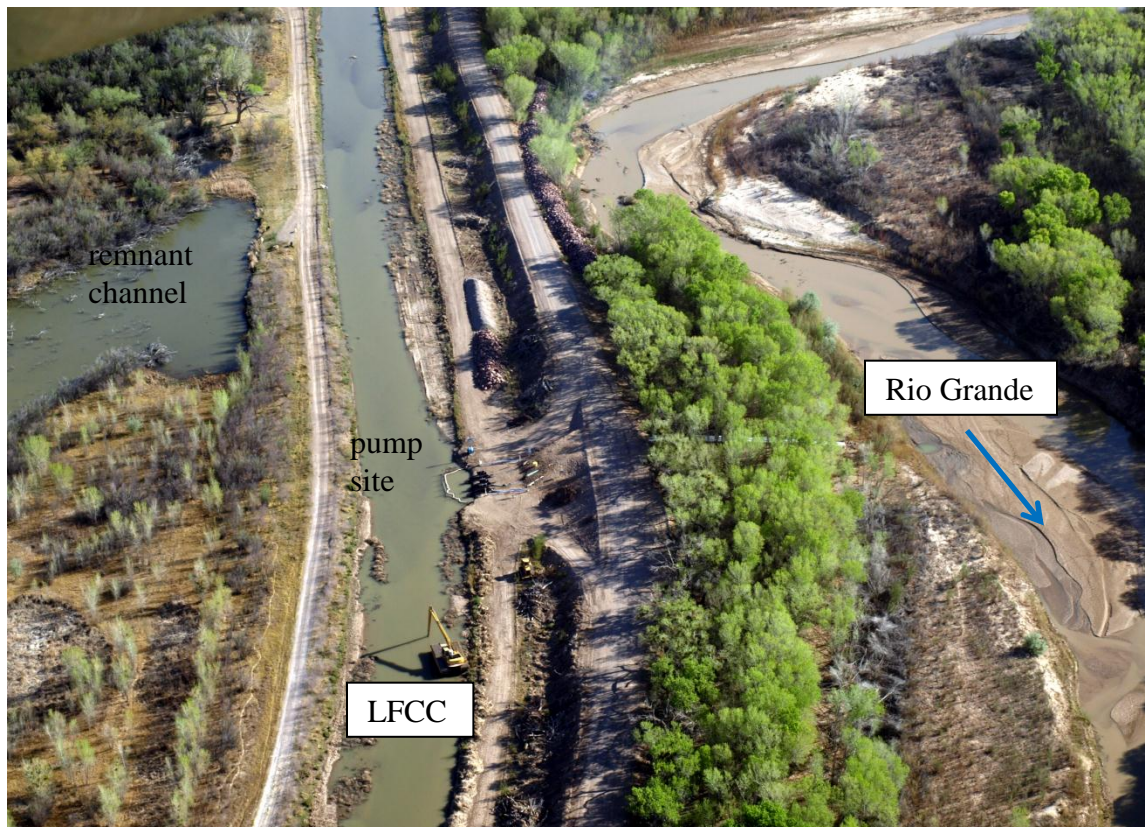
Photo 10: Fort Craig Bend, looking north at the Bend, pump site, and LFCC (April 2013, Holste)

planform has developed. This has caused the formation of multiple bends including Fort Craig Bend near RM 64 (Photo 10) and the S-curve bend at RM 60. The outside of these bends are near the western edge of the confined floodplain and adjacent to the spoil levee and the Low Flow Conveyance Channel (LFCC). Continued bank erosion and lateral migration at these locations threatens to breach the spoil levee and cause damage to the LFCC, access road, and Fort Craig pump site. Downstream water delivery and habitat for endangered species are also likely to be negatively impacted by a breach. A multi-disciplinary project team is currently being established to develop and evaluate alternatives to reduce maintenance frequency, increase water salvage, and enhance wildlife habitat. The multi-disciplinary project team decided to combine Fort Craig Bend and RM 60 into one comprehensive project because the two sites are close to each other.

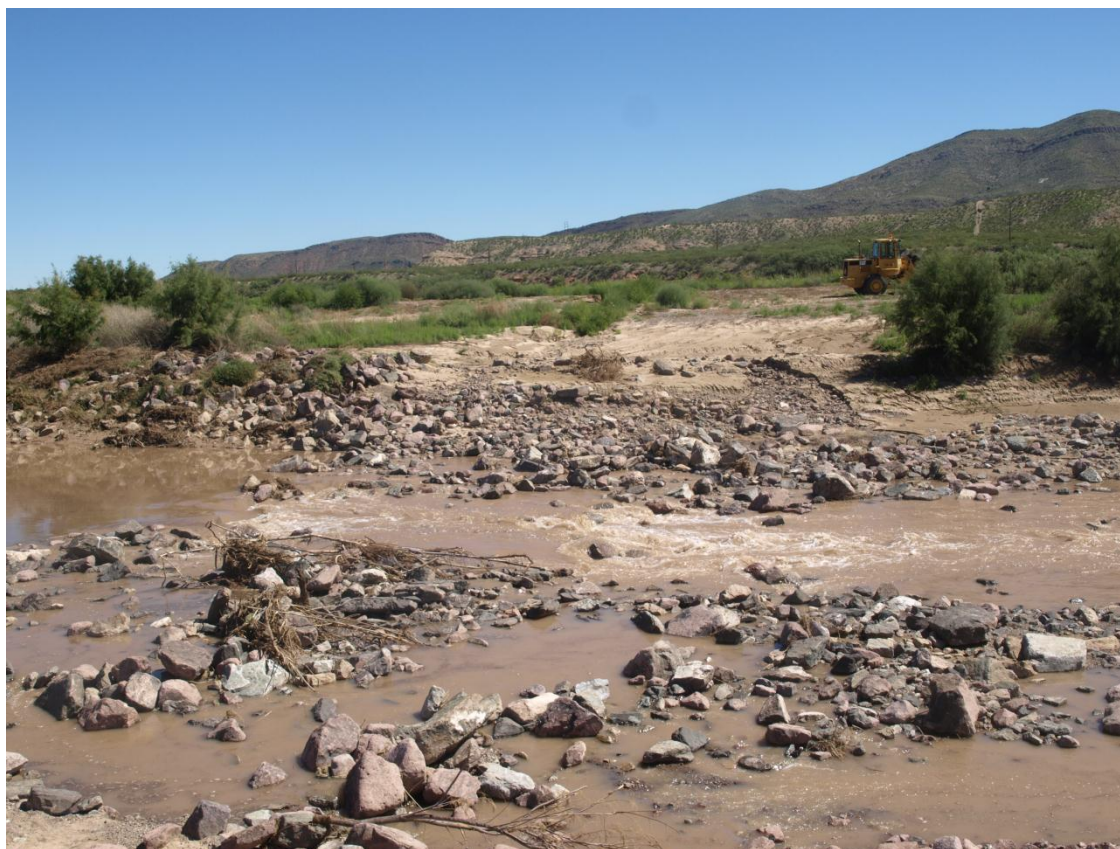
Photo 11: Temporary dike taken out by monsoons in 2013 (September 2013, AuBuchon)

Heavy monsoonal rains in 2013 brought significant amounts of sediment to the Rio Grande at confluences of arroyos with the Rio Grande, such as Mescal Arroyo, Cuchillo Negro Creek, Feykus Plug, Arroyo Hondo, and local unnamed arroyos. Significant arroyo flows occurred at Cuchillo Negro Creek and Arroyo Hondo. Monsoonal rains in 2013 also took out the Temporary Dike (Photo 11). Channel maintenance work such as removal of sediment at arroyo confluences, excavation of pools in confluences of arroyos to provide habitat, and rebuilding the Temporary Dike should happen before the beginning of Elephant Butte water operations in the spring of 2014.
