# Environmental Effects of Gully Erosion in Nigeria Case Study of Nanka Community, Orumba North, L.G.A of Anambra State

Iiyasu M. Anzaku<sup>1</sup> Buba Y. Alfred<sup>3</sup> Timnan Nden<sup>3</sup> Sunny Emeson<sup>3</sup> Oyekeshi Nkiru<sup>2</sup>

3.Nigerian Building & Road Research Institute, 10 NBRRI Road/ I.T. Igbani Street, Jabi District, Abuja, FCT, Nigeria

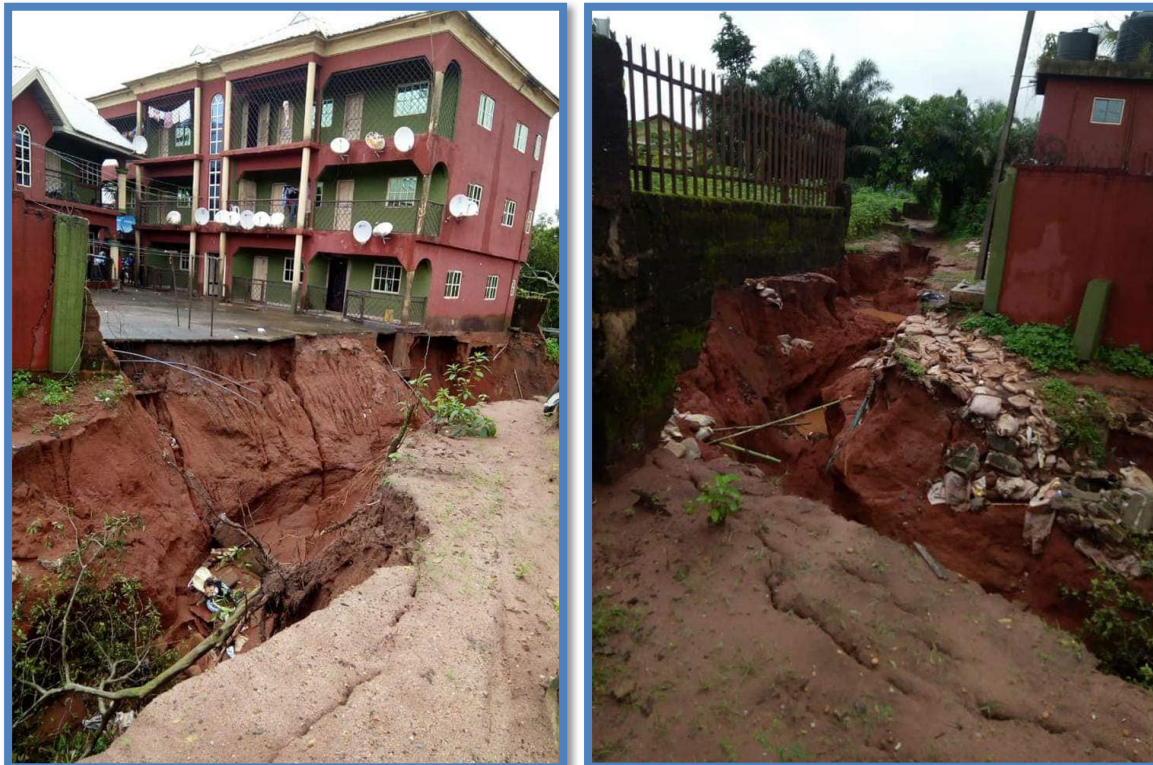
**Plate 0.1: Gully Erosion Affecting the Environment in Niger Delta, Nigeria**

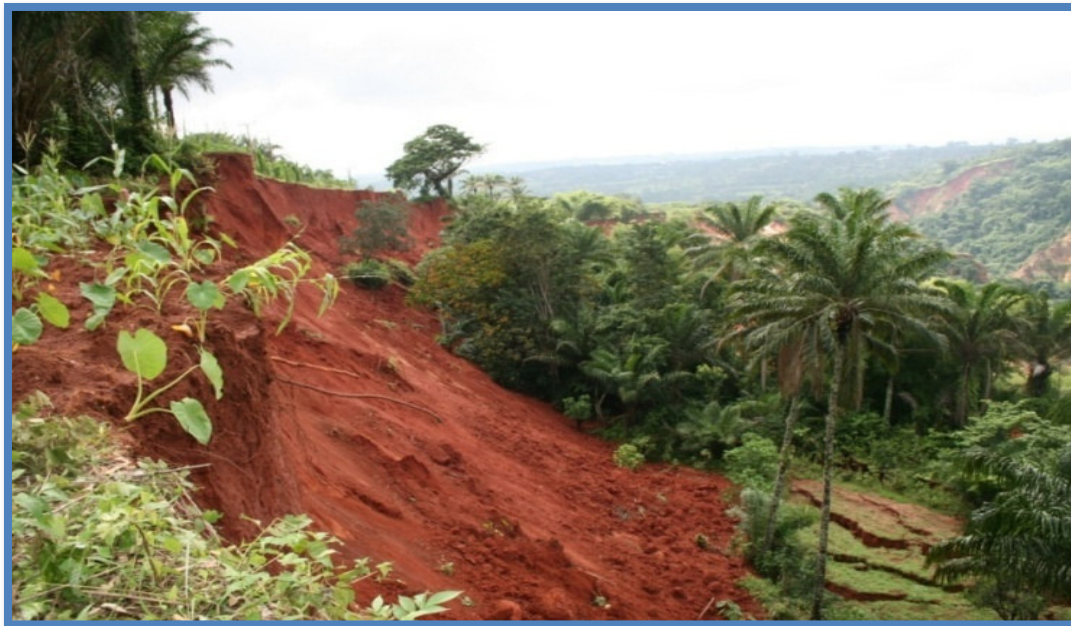
**Plate 3.1:** Debris slump at Isiakpuenu, Nanka

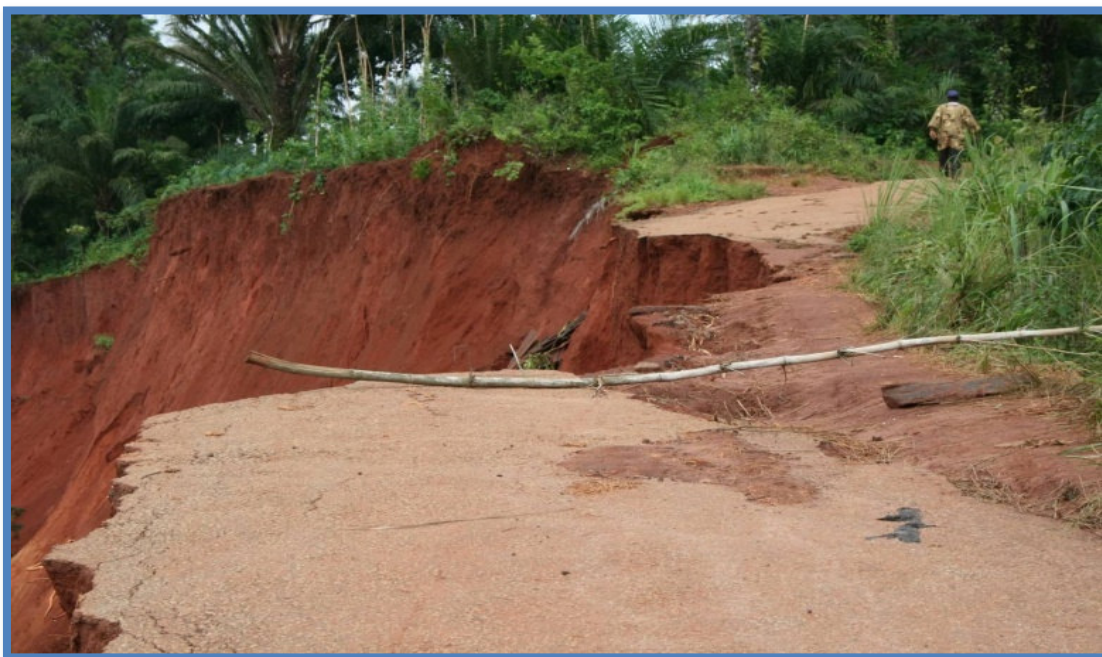
**Plate 3.2:** Road cut at Isiakpuenu, Nanka

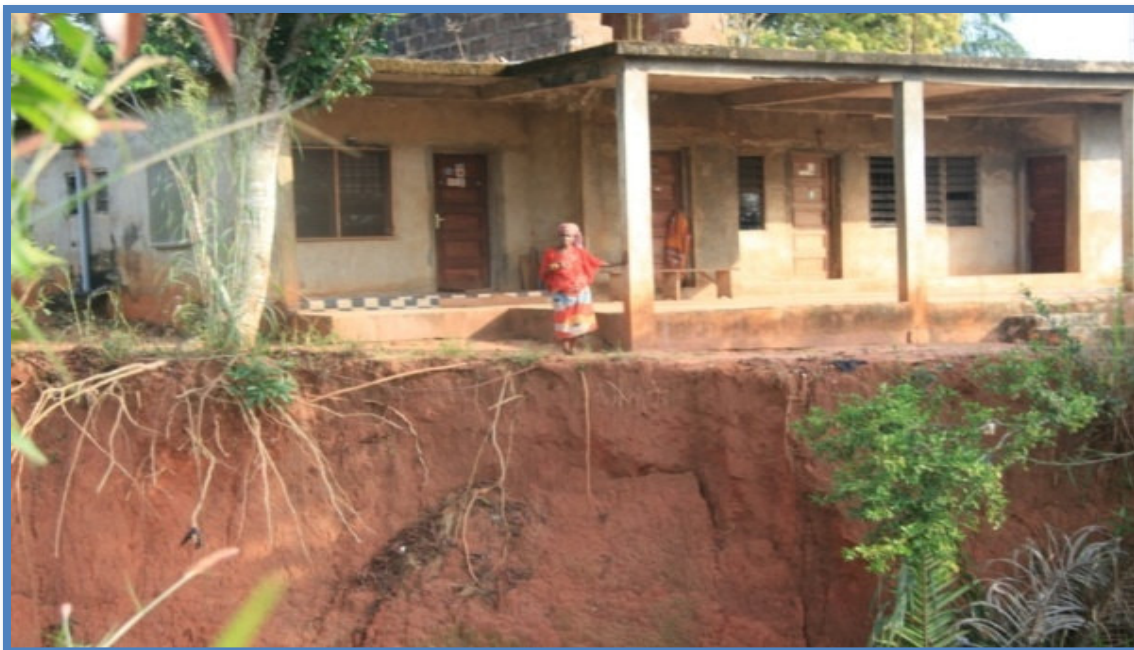
**Plate 3.3:** Residential Buildings under threat by gully at Amako, Nanka

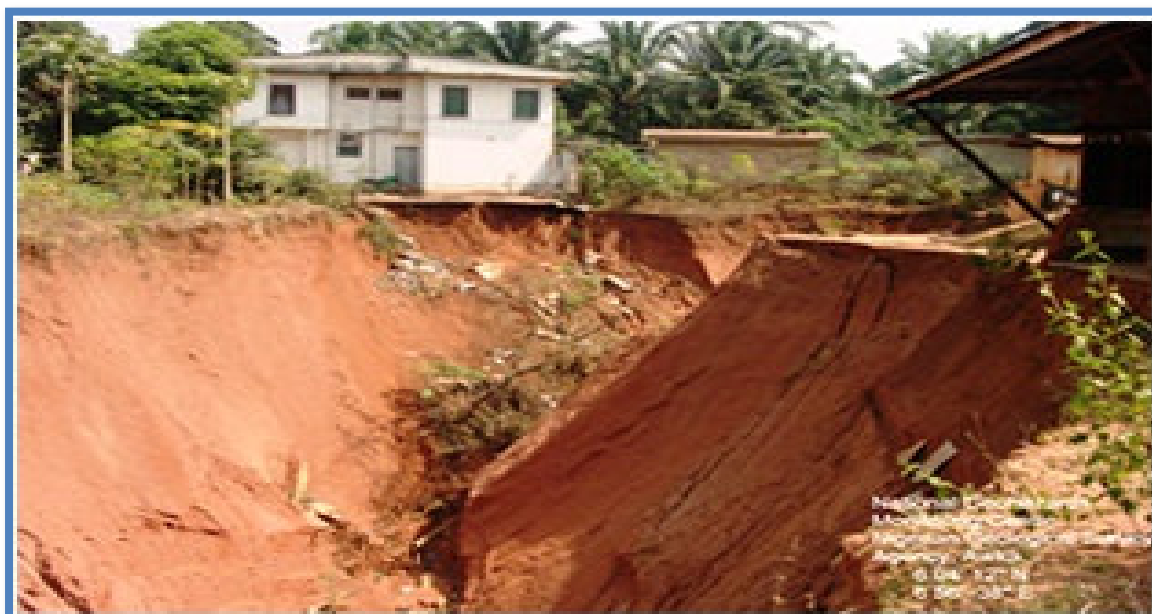
**Plate 3.4:** Residential Buildings under threat by gully at Amako, Nanka
