JOINT TRANSPORTATION RESEARCH PROGRAM

Link Slab Details and Materials

Haikal, G., Ramirez, J. A., Jahanshahi, M. R., Villamizar, S., & Abdelaleim, O. (2019). *Link slab details and materials* (Joint Transportation Research Program Publication No. FHWA/IN/JTRP-2019/10). West Lafayette, IN: Purdue University. <https://doi.org/10.5703/1288284316920>

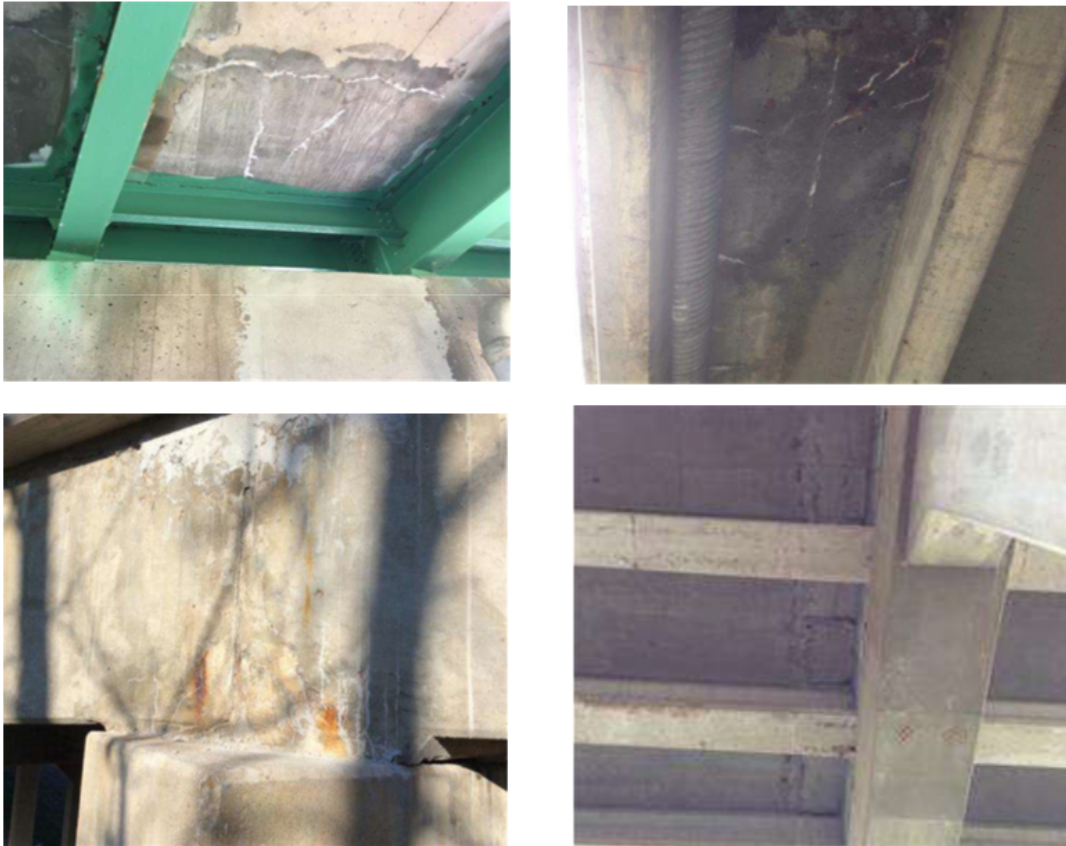
Figure 2.18: Cracking in Indiana link slab bridges as reported in inspection reports

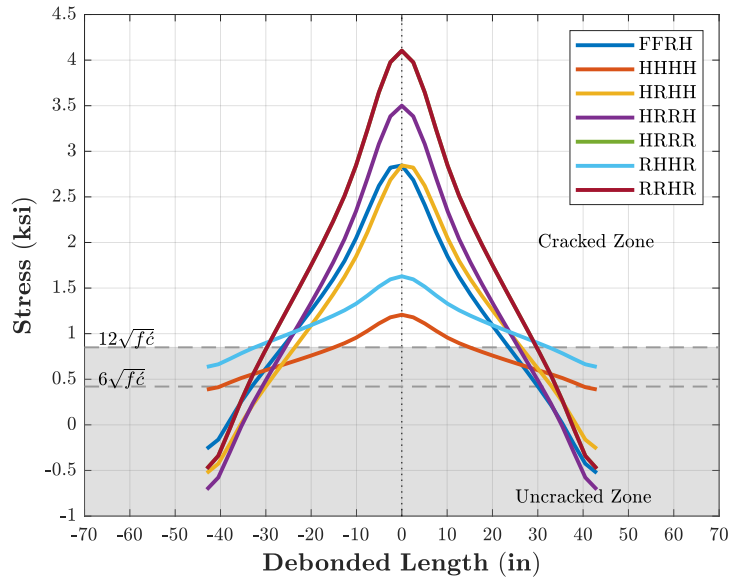
Seven different combinations of girder support restraints are considered in this study: FFRH, HHHH, HRHH, HRRH, HRRR, RHHR, and RRHR. These support arrangements are selected because some of them represent the practice in Indiana and others are previously identified from the literature. Figs. 4.5 and 4.6 show the longitudinal normal stresses measured at the top of the link slab when the bridge structure is subjected to live load and uniform temperature load, respectively. Notice that both figures show the stresses for only the link slab region. For all support cases shown in these figures, the length of the full-depth link slab is kept constant as 43 in at each side from the axis of symmetry over the gap. This length is equal to 5% debonding. It can be seen from the figures that the behavior of link slabs is affected by the bridge boundary conditions. Fig. 4.5 shows that higher longitudinal normal stresses on the link slab under live load are produced for those support arrangements with roller support below of the link slabs (i.e., support cases RRHR, HRRH, FFRH, and HRHH). Fig. 4.6 shows that, as the structure is more restrained at the outer supports, higher longitudinal normal stresses are observed due to uniform thermal load (i.e., support cases HRRH, FFRH, HRHH, and HHHH). Tables 4.3 and 4.4 show the comparison between the two bridge cases considered in this study when the beam model is subjected to live and thermal loads, respectively. The results presented in Table 4.3 show that using a link slab with a debonded length of 5% at each span decreases the stresses due to live load around 38% for all support cases when comparing the results from those of a continuous and fully bonded deck (0% debonding). For the uniform temperature load case, the results of Table 4.4 show that the effect of 5% debonding was negligible for all support cases except one. For HHHH, no thermal release was available and the thermal gradient resulted in an increase of 26% compared with the continuous and fully bonded deck. Notice from the information presented that changing position of H support does not produce any difference on the link slab response for both live and thermal loads (i.e., stresses for support cases RRHR and HRRR are the same). Due to symmetry in the model, stresses in the link slabs remained the same when having fixed (i.e., FFRH) or pinned supports (i.e., HRHH) at the ends under the loadings cases considered.

Figure 4.5: Effect of boundary conditions under live load

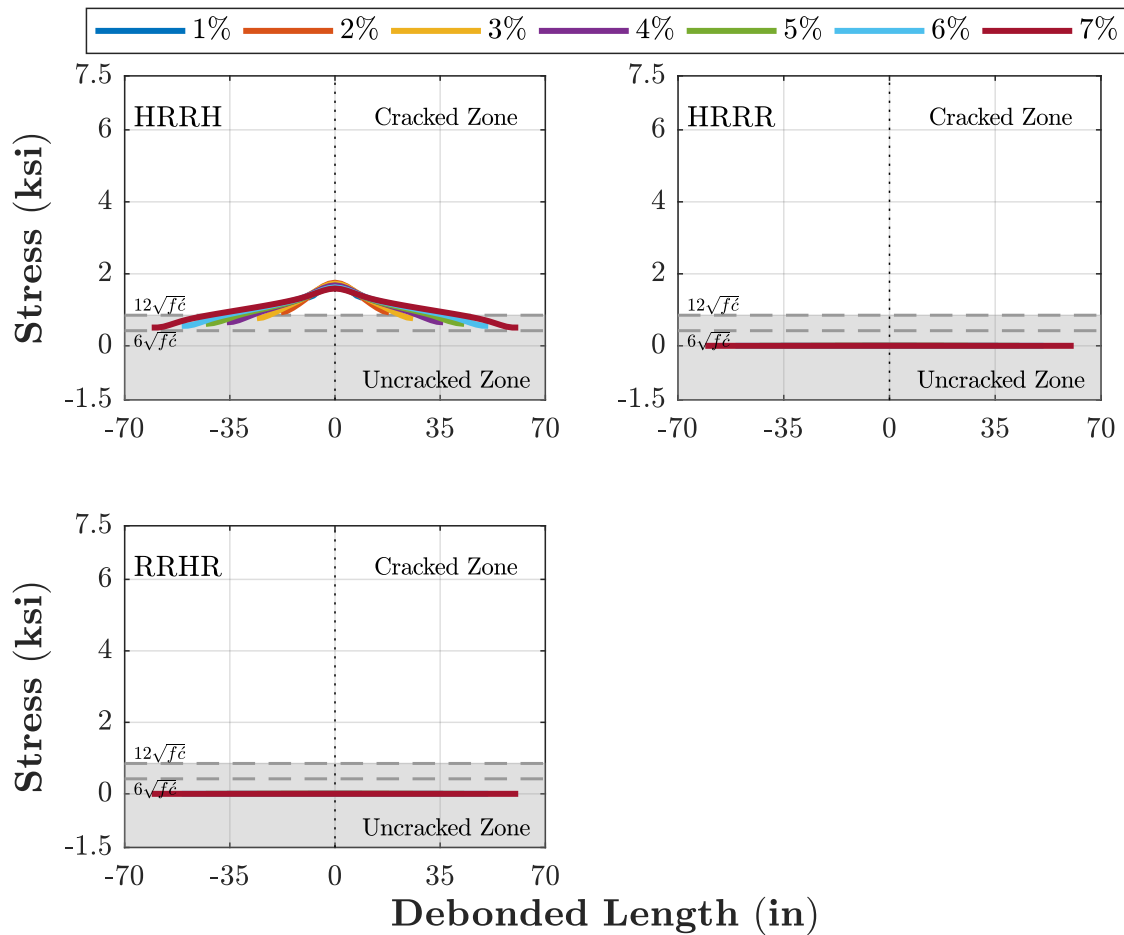
bridge is subjected to live load. Figs. 4.9 and 4.10 illustrate the effect of varying the debonded length when the bridge is subjected to uniform temperature load. Notice that in all figures the results are presented for only the link slab region and for each support arrangement. The longitudinal normal stresses are measured at the top of the link slab. It can be seen from the results that increasing the debonded length, when the bridge is subjected to live load, results in reduced longitudinal normal stresses for all the boundary conditions considered. Bridges that allow thermal expansion experience no stresses in the link slab. For all boundary conditions considered, stresses due to live load are approximately three times greater than those observed due to temperature loads.

Figure 4.10: Effect of debonding under uniform temperature load for support conditions: HRRH; HRRR; and RRHR
