AALTO UNIVERSITY
School of Engineering
Department of Mechanical Engineering

Influence of hot dip galvanizing on fatigue behavior of welded steel joints

Master's thesis submitted in partial fulfillment of the requirements for the degree of Master of Science in Technology.

Espoo, 25th November 2019

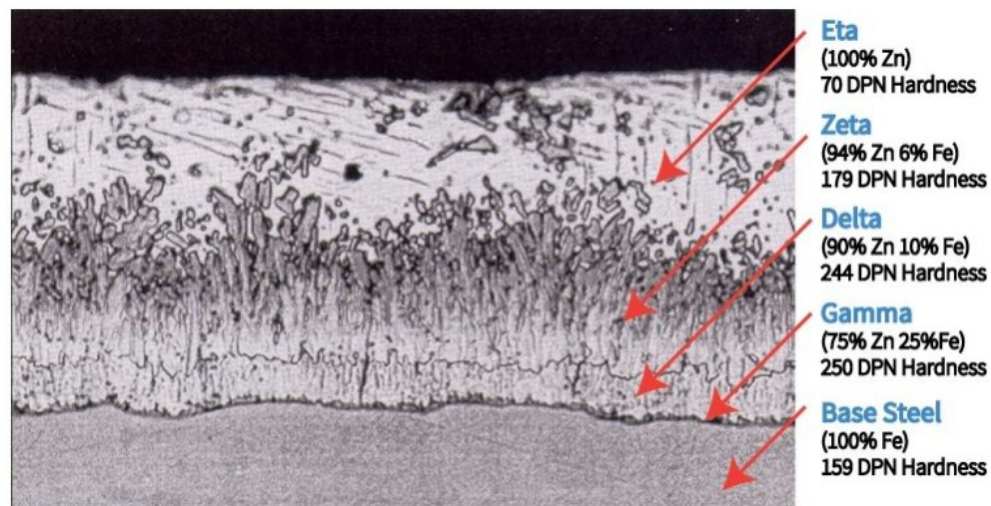
Figure 1 shows a cross-section of the galvanized steel coating, showing a typical microstructure comprised of three inner alloy layers of iron and zinc intermetallic phases and a layer of pure metallic zinc, the layers becoming successively richer in iron with depth [27].

- The thin Gamma (Γ) layer composed of an alloy that is 75% zinc and 25% iron
- The Delta (δ) layer composed of an alloy that is 90% zinc and 10% iron
- The Zeta (ζ) layer composed of an alloy that is 94% zinc and 6% iron
- The outer Eta (η) layer that is composed of pure zinc

Fig. 1. Photomicrograph of galvanized coating layers [27].

In addition to the chemistry of each layer, the figure identifies the hardness of each layer expressed as a Diamond Pyramid Number (DPN). The DPN is a progressive measure of hardness; the higher number shows the greater hardness. Typically, the

Gamma, Delta and Zeta layers are harder than the underlying steel. The hardness of the inner layers provides very good protection against coating damage by abrasion. The Eta Layer is quite ductile and provides the coating with some impact resistance [27].

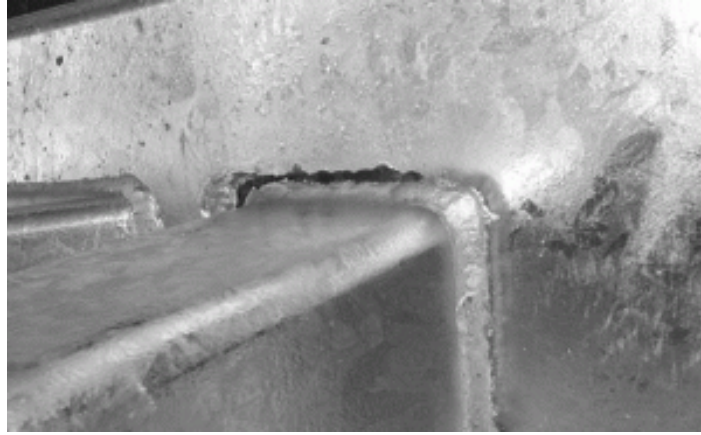
The cracks found in galvanized welded steels can be attributed to stresses introduced during the welding of two different thicknesses of steel. The stresses from the welding are from the weld metal itself, as it is typically harder than the base metal, and from the heat applied during welding. The welding process can reduce the ductility of material and increase the hardness of steel in the HAZ and making it more susceptible to brittle fracture. Another factor that could potentially play a role in cracking is hydrogen embrittlement. Steels with bigger hardness are more susceptible to hydrogen embrittlement [26].

Fig. 3. Crack in heat affected zone in galvanized coating [26].

The weld metal and HAZs can obtain hardness values much higher than other areas of the steel. The area with higher hardness is susceptible to hydrogen embrittlement and is highly susceptible to cracking, especially when put under load. Figure 3 shows crack in heat affected zone. The fact that welding stresses are partially relieved in the galvanizing kettle, and the combination of different section thicknesses thermally expanding and contracting at different rates, combined to cause the cracking in welded area. As it is shown in Fig. 3, all of the cracking originated in the weld area, particularly in the HAZs where the hardness values could potentially be high. Also in these areas is the combination of two different thickness steels, which will expand and contract at different rates, adding even more stress to an already highly-stressed area [26].

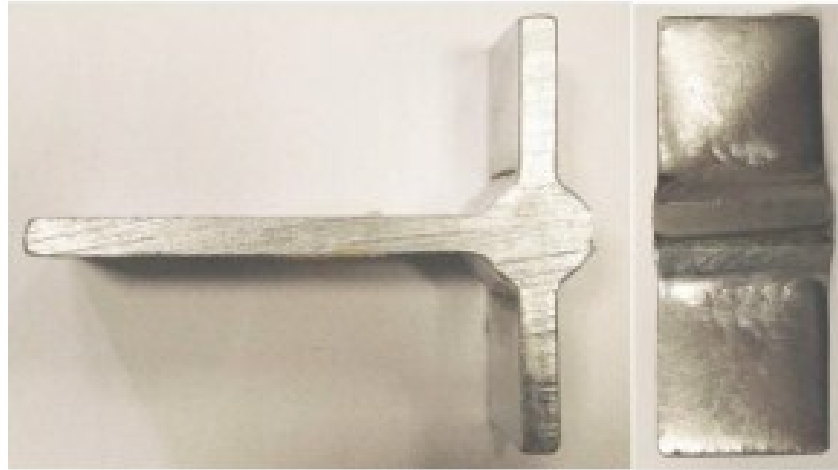
The specimens' ends were machined to lower the secondary bending stresses before clamping on the machine. The load level was selected and applied on the specimens as well as the stress range calculated based on the load, parent material geometry and the stress ratio, the range of loads is between 77 and 187 MPa. Tests were run until total failure or reaching two million cycles. One broken sample after fatigue test is shown in Fig. 12.

Fig. 12. Typical broken specimens under fatigue test [39].

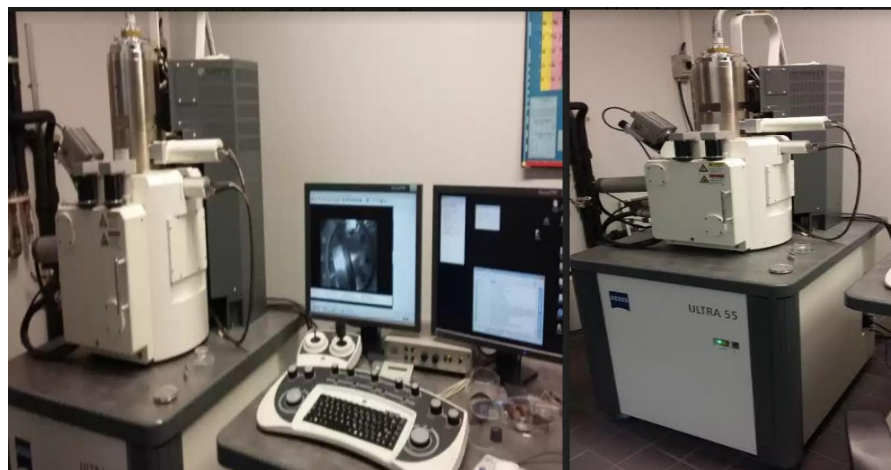
SEM test equipment is shown in Fig. 14.

Fig. 14. SEM test equipment.

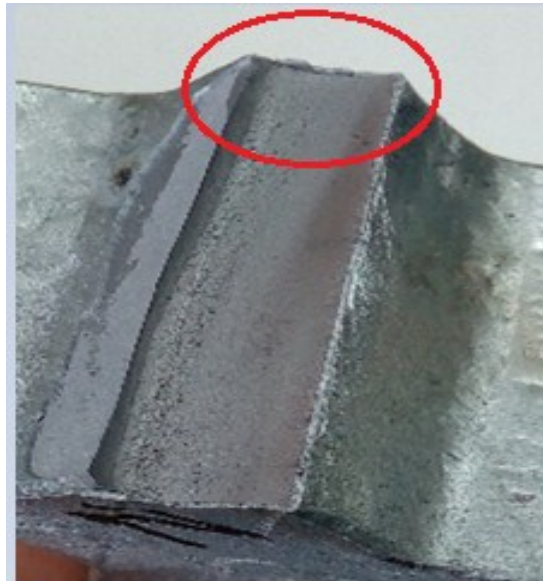
The fracture surface of the specimen No. 5 that failed from weld toe during fatigue test has been checked to find crack initiation area. Figure 18 shows crack propagation and the coating condition after fracture. Initial crack marked on the picture and shows propagation from backside top weld toe.

Fig. 18. Specimen No. 5, macro observation of fracture surface after cyclic loading.

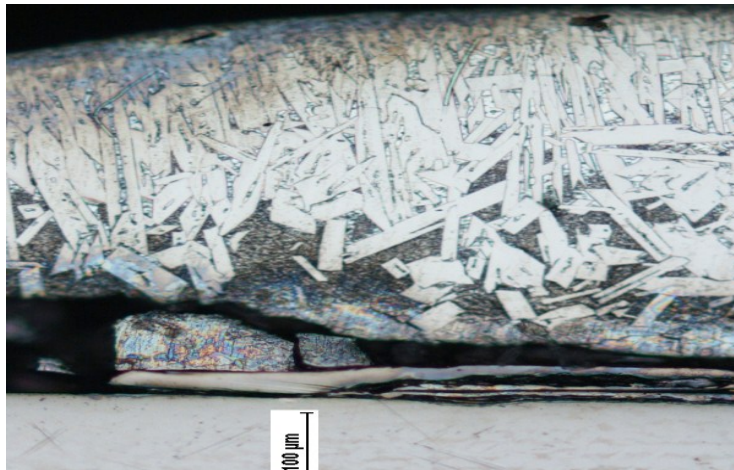
In this thesis debonding and delamination have been observed. Macro graphic figures show weak interconnection between Zn and steel substrate that probably depends on HDG bath condition (temperature and composition) and the quality of cleaning the surface before HDG. Moreover, there is some segregation between coating and steel substrate in some locations after fatigue test. As we can observe in Fig. 19, debonding has been created between HDG and base metal after cyclic loading in some locations. By this segregation, debonding can happen and it means that many holes have been appeared between coating and base material. These holes are the location of stress concentration and can be the crack initiation site.

Fig. 19. Debonding between the base material and coating.

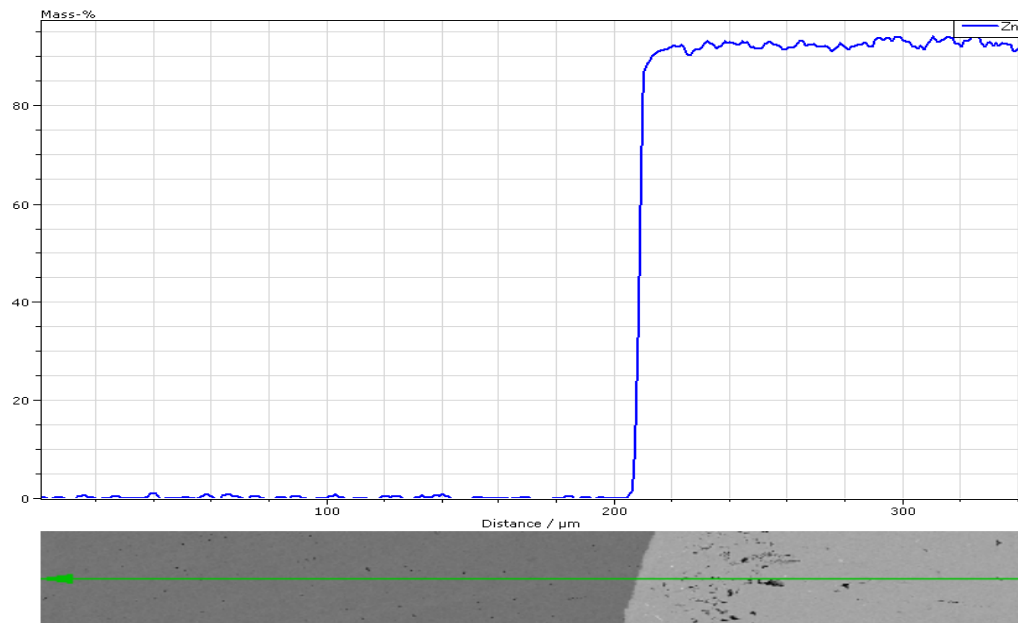
In Fig. 30, SEM micrograph shows that there is not any zinc diffusion in the base material.

Fig. 30. No diffusion of Zinc in the steel Substrate SEM test
