ADVANCED MASTERS IN STRUCTURAL ANALYSIS  
OF MONUMENTS AND HISTORICAL CONSTRUCTIONS

# Master's Thesis

**Study of the seismic vulnerability  
of Catalonian Romanesque churches:  
Church of the cathedral of La Seu  
d'Urgell and church of the Monastery  
of Vilabertran**

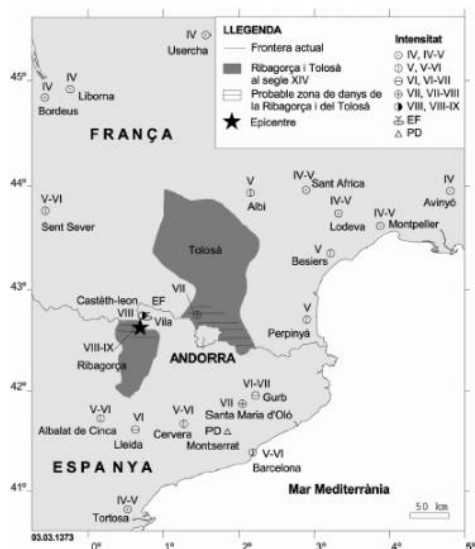
The 3<sup>rd</sup> of March 1373, an earthquake of intensity VIII-IX occurred in the north of Ribagorça, a Pyrenean city. According to the numerous documentation found in cities close to the epicentre, this earthquake caused a lot of damage in the region. The intensity corresponding to the damages has been identified and is illustrated in the intensity map of the Figure 3.4. According to this figure, the intensity recorded in La Seu d'Urgell for this earthquake is VI-VII while in Vilabertran it is V-VI. [30]

Figure 3.4. Intensity map of the earthquake of 1373 [30]

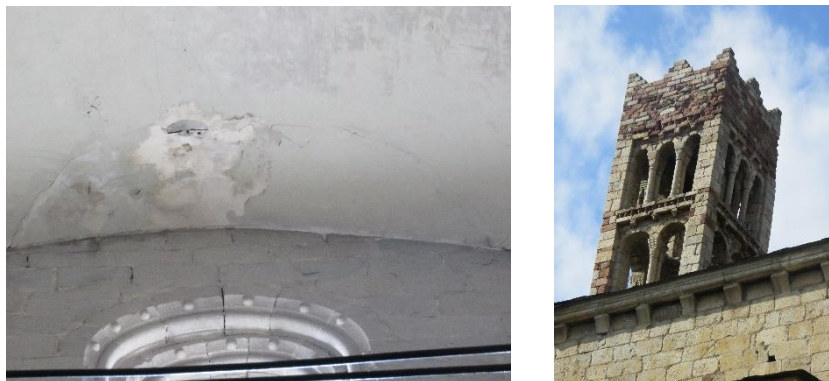
The most significant damage concerns the tower leaning in the front façade. Indeed, this bell tower is leaning both in the façade and in the central vault. The resistance of the façade and the vault is significantly different and the vault cannot resist to the weight of the tower, inducing the presence of crack in the vault around the location of the tower as shown in Figure 3.15 and Figure 3.13. Because of this phenomenon, a deformation of the top of the tower can also be observed as illustrated in the Figure 3.15.

Figure 3.15. Damages due to the presence of the bell tower

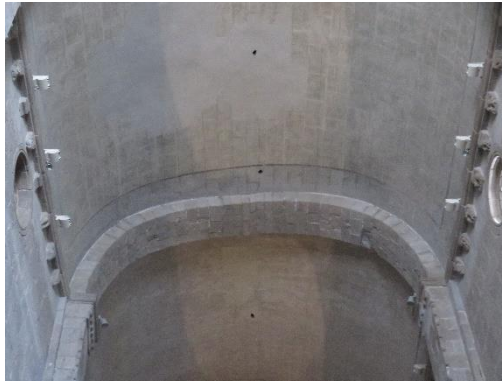
The second phenomenon that can be observed in La Seu d'Urgell is the transversal deformation of the nave. This is the deformation of the central nave and the lateral walls due to the self-weight of the vault or some extra loads from the roof. In this case, during the inspection an important deformation of the vault and in particular of the arches that help supporting the vault has been noticed. Figure 3.16 illustrates this deformation. This deformation was accompanied by the presence of a crack along the whole central vault as shown in Figure 3.13.

Figure 3.16. Transversal deformation of the central vault of the nave

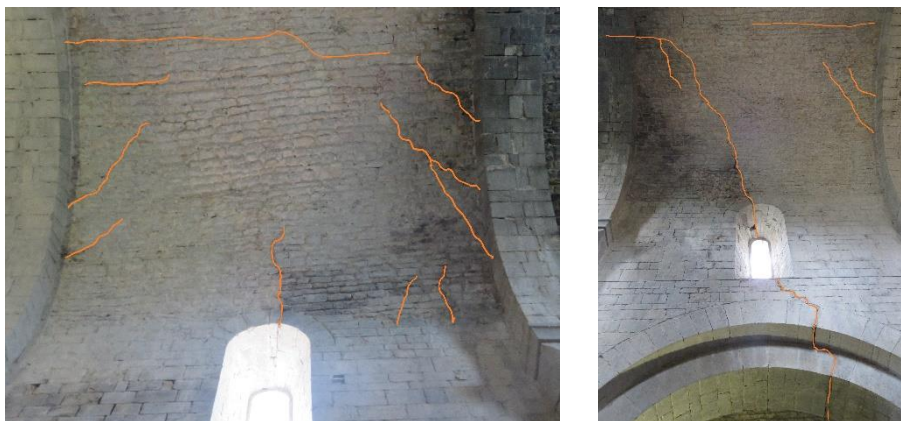
The most important damage concerns the vaults of the church. As shown in Figure 3.21 and Figure 3.22, the central vault contains significant cracks. These cracks are mostly localized in the two first bays, where the first bay is the closest to the main façade. Some of them are already repointed, but their number shows the importance of the damages. It is also possible to notice a large crack starting from the main façade and going to the side wall in a diagonal. This crack is probably due to the presence of the tower in this corner. All of these cracks might be explained by the strong earthquake that occurred in 1428 and created similar damage to the churches of the region - the damages from this earthquake in the church of Vilabertran have not been documented on the contrary to other churches. However, these cracks could be also caused by soil settlement due to the weight of the tower in only one corner of the structure. In both cases, the presence of the tower might have influenced the development of the damages.

Figure 3.22. Cracks in the central vault of the nave

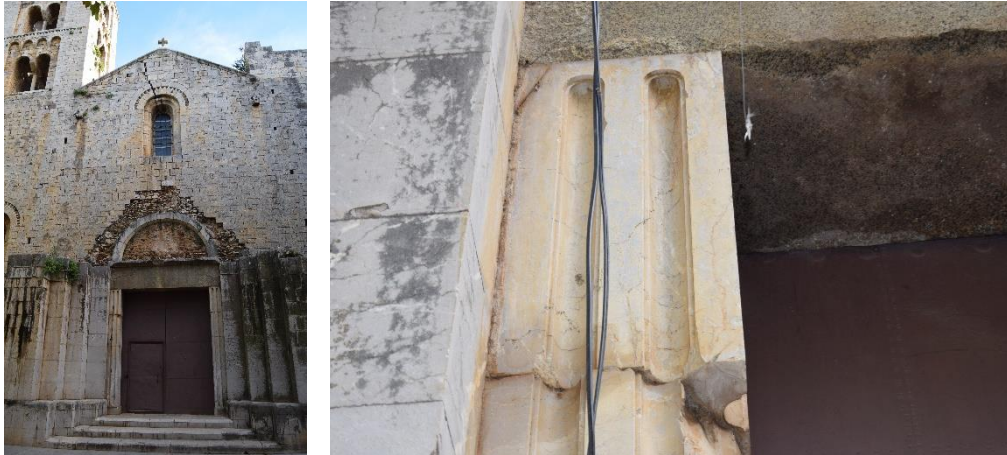
A second important damage can be observed in the main façade of the church as illustrated in Figure 3.23. A large crack of around 5 cm wide is visible in the top of the window and can be due to shear mechanism. Other diagonal cracks are present between the window and the door and a part of the first leaf of the masonry felt from the top of the door along the diagonal crack. Another observable damage is the displacement of the two stones under the lintel which seems recent. Moreover, the stones under these two ones are damaged in the corner. All the damages could have been induced by a shear mechanism that would have developed during the earthquake of 1428.

Figure 3.23. Damages in the main façade of Vilabertran

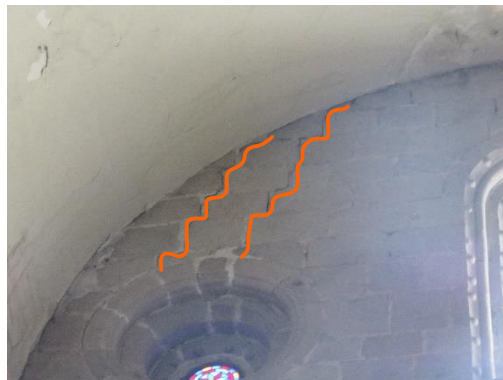
3 – *Shear mechanism in the façade:* For this mechanism, it was noticed that there are no anti-seismic measures. Regarding the vulnerability indicators, the main façade is composed of a large door and a lot of small windows. Considering the number, the size and the disposition of the openings, it was assumed that the effectiveness of the vulnerability indicator was low, which induced a vulnerability grade of 1. Inside of the church, some cracks were observed near the openings as illustrated in Figure 4.1. As these damages were located in different parts of the façade, a damage grade of 2 was assigned to this mechanism.

Figure 4.1. Shear cracks in the main façade of La Seu d'Ugell

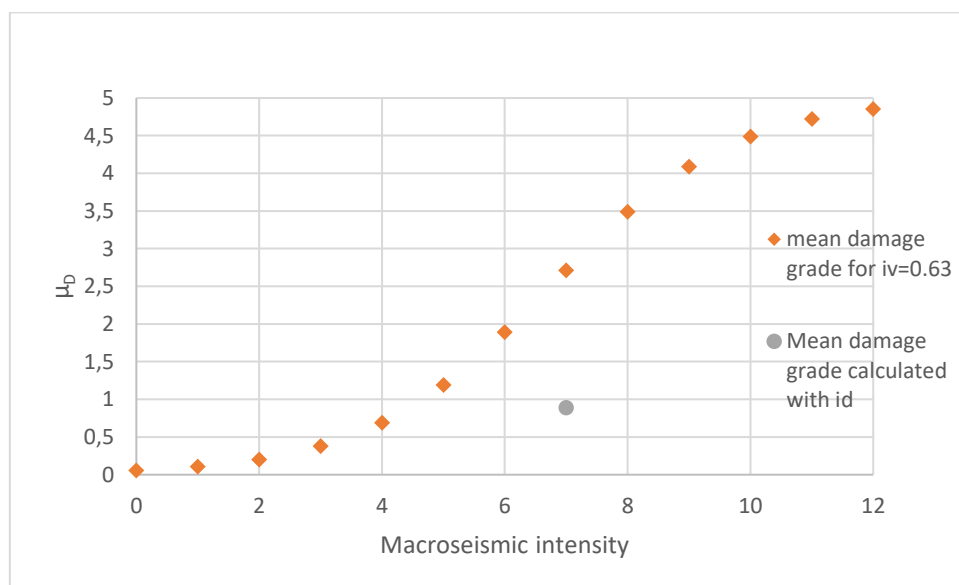
Another method to obtain the mean damage grade is to use the damage index. By multiplying the damage index by 5, it is possible to obtain the mean damage grade corresponding to the maximal macroseismic intensity that occurred in La Seu d'Urgell. The seismic analysis of Catalonia of section 3.3 indicates that this maximal macroseismic intensity is VII. The value of the mean damage grade calculated with the damage index is 0.89. As illustrated in the Figure 4.3, this value is less than half of the value calculated with the previous method. This result reinforces the idea that the damage index is too low. Another explanation of this difference might be in the calibration of the expression of the mean damage grade, which were done for the Italian stock of churches.

Figure 4.3. Vulnerability curve of La Seu d'Urgell

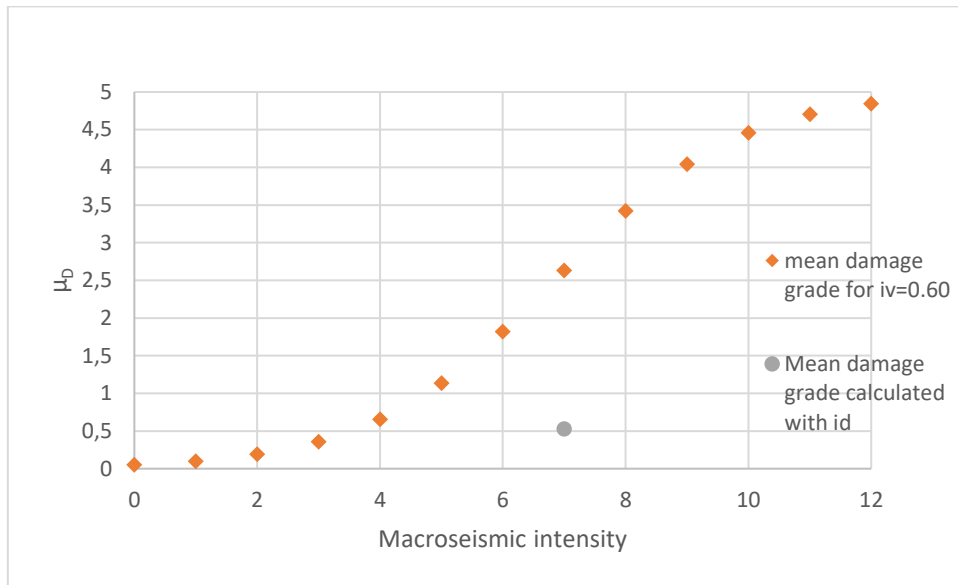
Figure 4.6. Vulnerability curve of Vilabertran

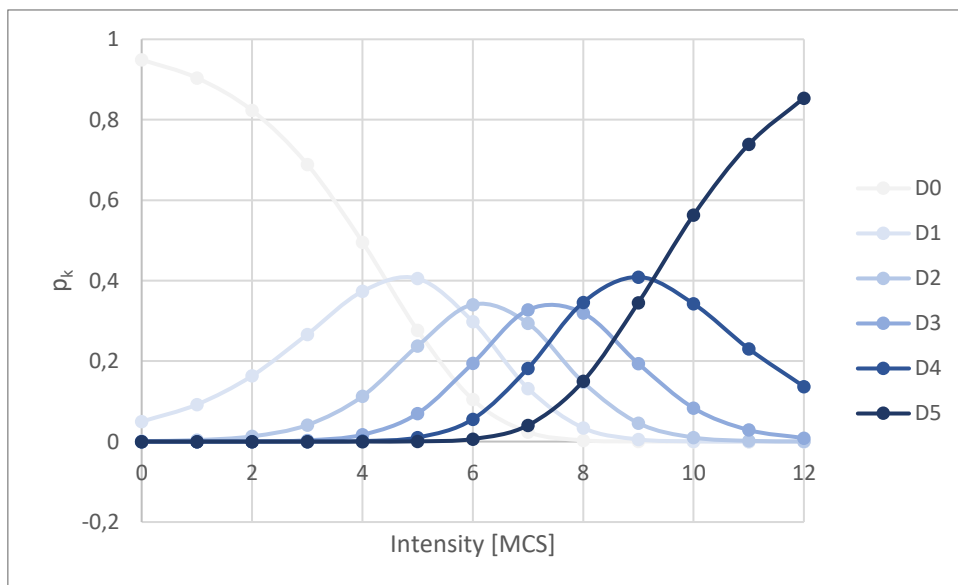
Figure 4.7. Fragility curves of Vilabertran: probability of reaching a damage level

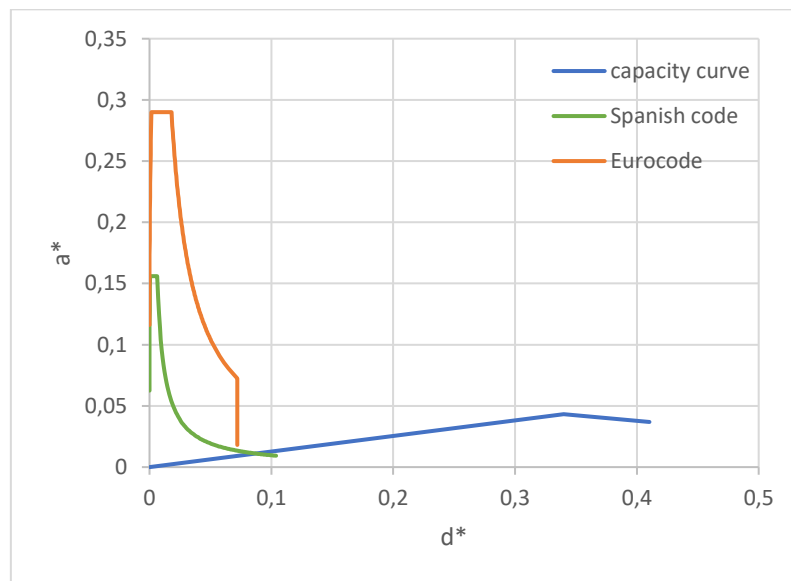
Figure 4.12. Capacity and demand curves of the case SU1

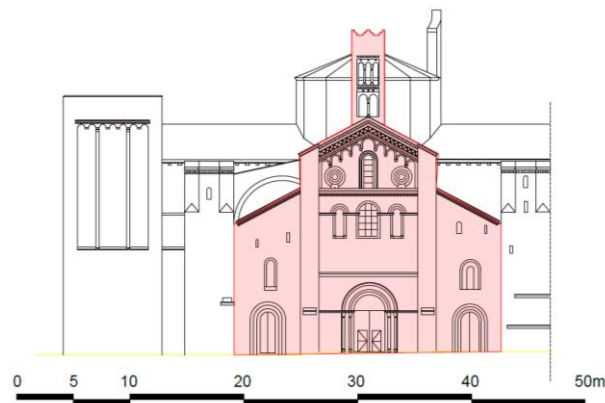
Figure 4.13. Overturning of the main façade of La Seu d'Urgell (SU1)

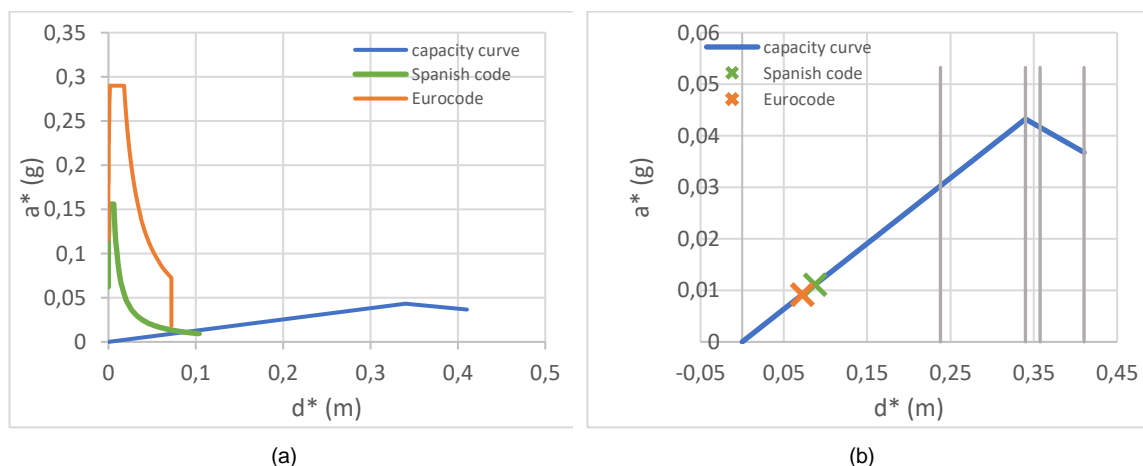
Figure 4.18. Capacity curve and spectra (a) and Position of the performance point (b) (SU1)

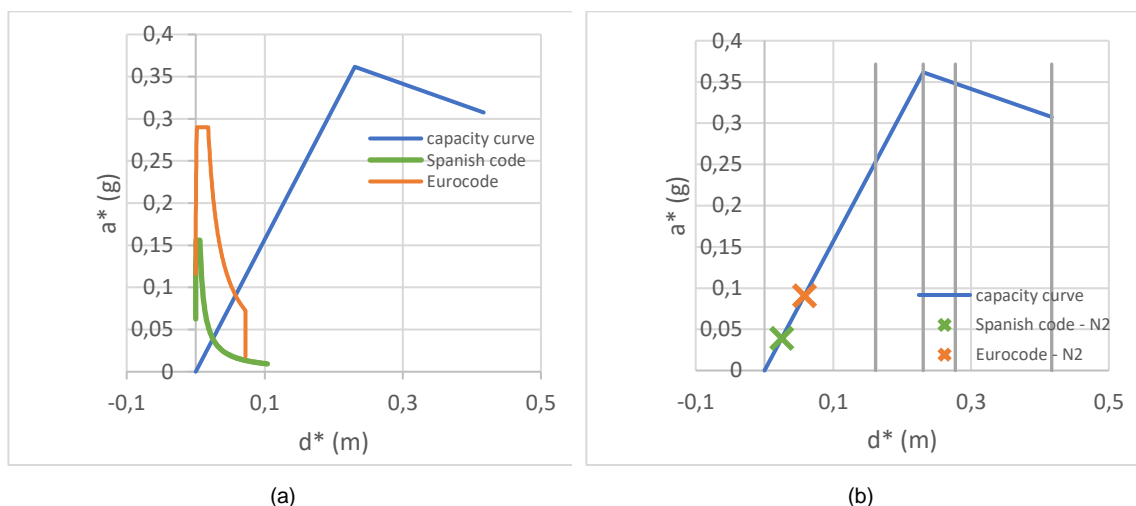
Figure 4.22. Capacity curve and spectra (a) and Position of the performance point (b) (SU4)

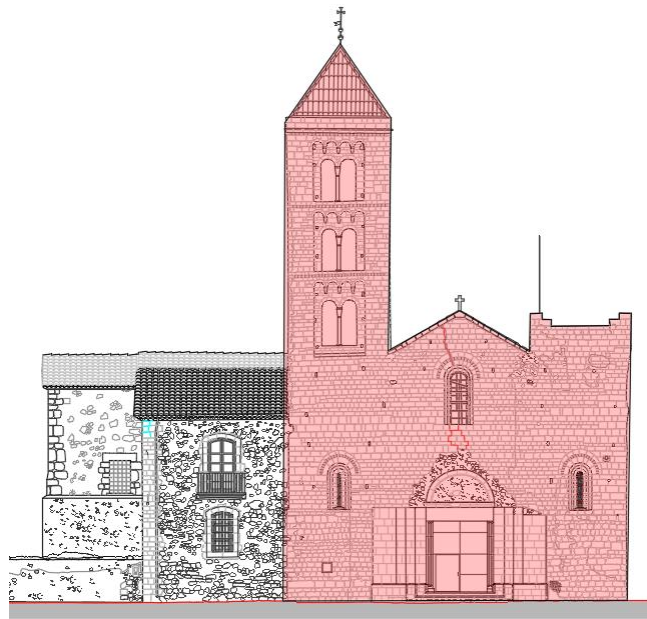
Figure 4.25. Overturning of the main façade of Vilabertran (V2)

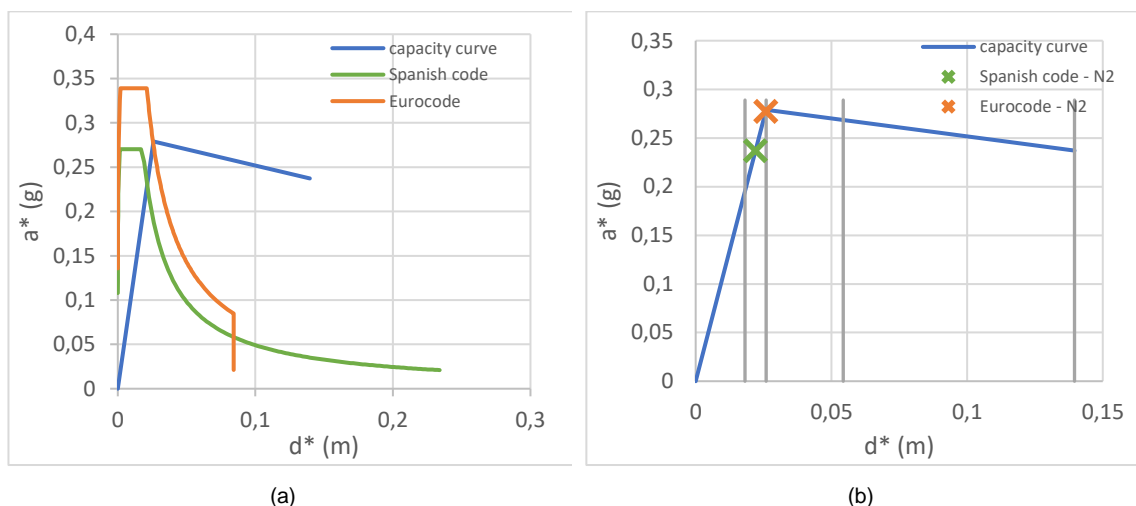
Figure 4.32. Capacity curve and spectra (a) and Position of the performance point (b) (V4)

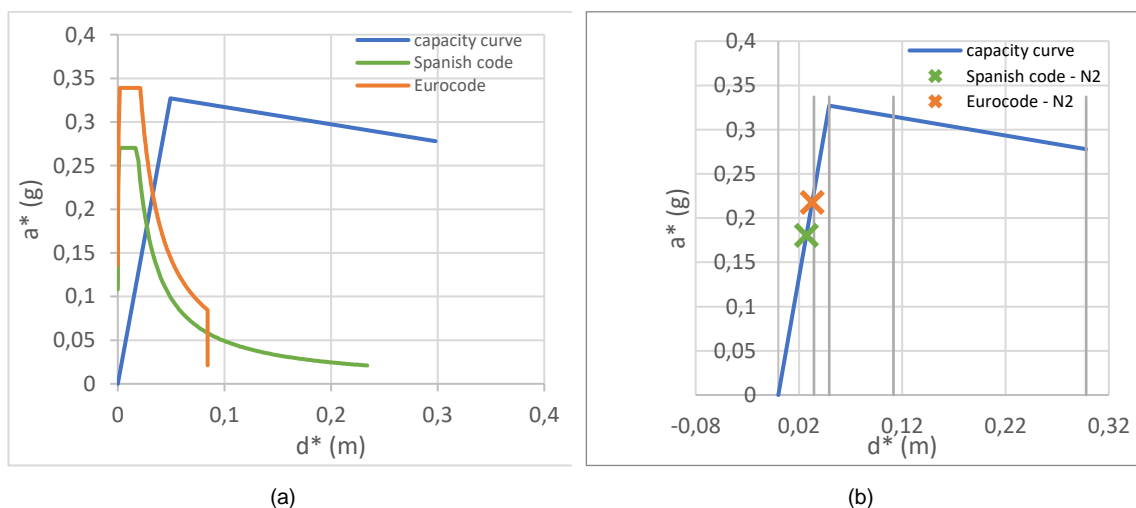
Figure 4.33. Capacity curve and spectra (a) and Position of the performance point (b) (V5)

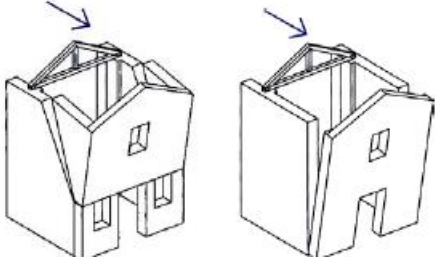
<p style="writing-mode: vertical-rl; transform: rotate(180deg);"><b>2 - Damage at the top of the façade</b></p>	<p>Overturning of the gable, with horizontal or V-shaped cracking. Disaggregation of masonry or shifting of tie beams. Rotation of the trusses</p> <p><i>Aseismic measures:</i></p> <ul style="list-style-type: none"> <li>• Presence of local connections to roof elements</li> <li>• Presence of roof braces</li> <li>• Presence of lightweight tie-beams</li> </ul> <p><i>Vulnerability indicators:</i></p> <ul style="list-style-type: none"> <li>• Presence of large openings (rose window)</li> <li>• Presence of large and heavy towering gable</li> <li>• Rigid tie-beams in R-C, heavy roof covering in R-C</li> </ul>

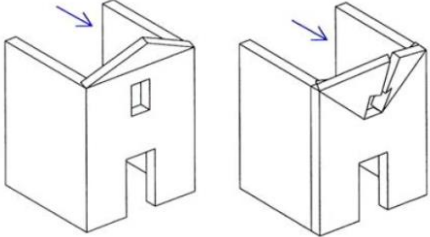
<p style="writing-mode: vertical-rl; transform: rotate(180deg);"><b>3 – Shear mechanism in the façade</b></p>	<p>Diagonal cracking (shear). Vertical or arched cracking (rotation). Other cracking or bulging</p> <p><i>Aseismic measures:</i></p> <ul style="list-style-type: none"> <li>• Presence of tie rods at the rear of the façade</li> <li>• Lateral contrast supplied by leaning building</li> </ul> <p><i>Vulnerability indicators:</i></p> <ul style="list-style-type: none"> <li>• Presence of large or numerous openings</li> <li>• Thin vertical elements</li> </ul>

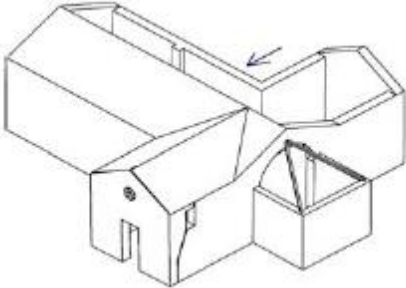
<p><b>11 – Shear mechanism in the transept walls</b></p>	<p>Diagonal cracking (single or crossed). Cracking next to wall discontinuities</p> <p><i>Aseismic measures:</i></p> <ul style="list-style-type: none"> <li>• Good quality masonry (without different construction phase)</li> <li>• Presence of good architraves over the openings</li> <li>• Presence of lightweight tie-beams</li> </ul> <p><i>Vulnerability indicators:</i></p> <ul style="list-style-type: none"> <li>• Presence of large openings or wide zone with limited masonry thickness</li> <li>• Presence of stiff tie-beam, heavy roof covering</li> </ul>

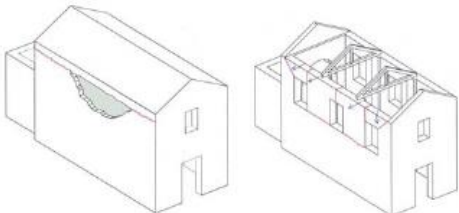
<p><b>20 – Roof mechanism: transept</b></p>	<p>Cracking near the head of wooden beams, sliding of the beams. Detachment between tie-beams and masonry. Significant displacement of the covering carpet</p> <p><i>Aseismic measures:</i></p> <ul style="list-style-type: none"> <li>• Presence of light weight tie-beams</li> <li>• Presence of good wall to beam connections</li> <li>• Presence of roof braces</li> <li>• Presence of good connections between roof elements</li> </ul> <p><i>Vulnerability indicators:</i></p> <ul style="list-style-type: none"> <li>• Presence of static thrusts in the roof</li> <li>• Presence of rigid tie-beam, heavy roof</li> </ul>

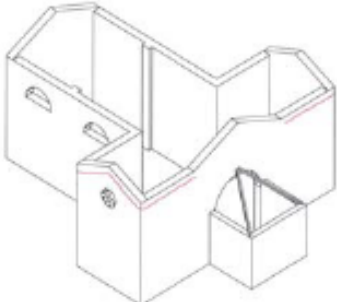
<p><b>21 – Roof mechanism: apse and presbytery</b></p>	<p>Cracking near the head of wooden beams, sliding of the beams. Detachment between tie-beams and masonry. Significant displacement of the covering carpet</p> <p><i>Aseismic measures:</i></p> <ul style="list-style-type: none"> <li>• Presence of light weight tie-beams</li> <li>• Presence of good wall to beam connections</li> <li>• Presence of roof braces</li> <li>• Presence of good connections between roof elements</li> </ul> <p><i>Vulnerability indicators:</i></p> <ul style="list-style-type: none"> <li>• Presence of static thrusts in the roof</li> <li>• Presence of rigid tie-beam, heavy roof</li> </ul>

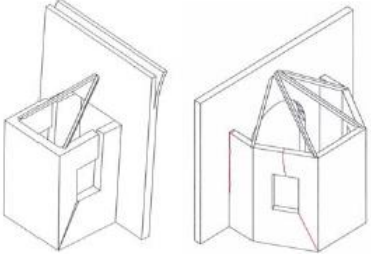
<p><b>23 – Shear mechanism in the chapel walls</b></p>	<p>Diagonal cracking (single or crossed). Cracking next to masonry discontinuity</p> <p><i>Aseismic measures:</i></p> <ul style="list-style-type: none"> <li>• Good quality masonry (without different construction phase)</li> <li>• Presence of good architraves over the openings</li> <li>• Presence of lightweight tie-beams</li> </ul> <p><i>Vulnerability indicators:</i></p> <ul style="list-style-type: none"> <li>• Presence of large openings or wide zone with limited masonry thickness</li> <li>• Presence of stiff tie-beam, heavy roof covering</li> </ul>

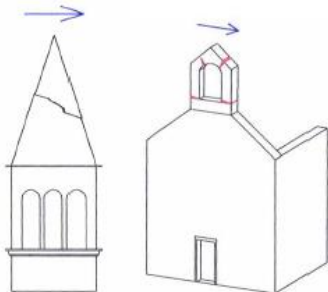
<p><b>27 – Bell tower</b></p>	<p>Cracking next to the connection between the bell tower and the church. Shear cracking or sliding. Vertical or curved cracking (bulging of one or more corner)</p> <p><i>Aseismic measures:</i></p> <ul style="list-style-type: none"> <li>• Good quality uniform masonry</li> <li>• Presence of tie-rods at different height</li> <li>• Presence of an adequate joint between the church walls</li> <li>• Presence of good wall to wall connections in the church</li> </ul> <p><i>Vulnerability indicators:</i></p> <ul style="list-style-type: none"> <li>• Presence of large openings at different heights</li> <li>• Asymmetrical support on the church walls at its base</li> <li>• Irregular support elements at ground level of towers</li> </ul>

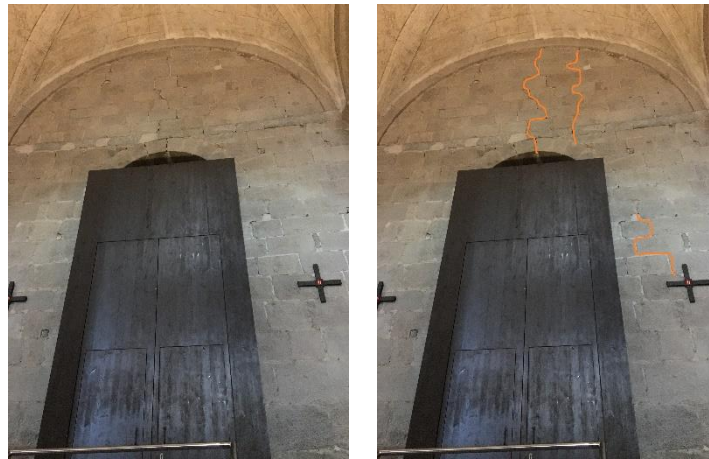
Cracks in the side walls

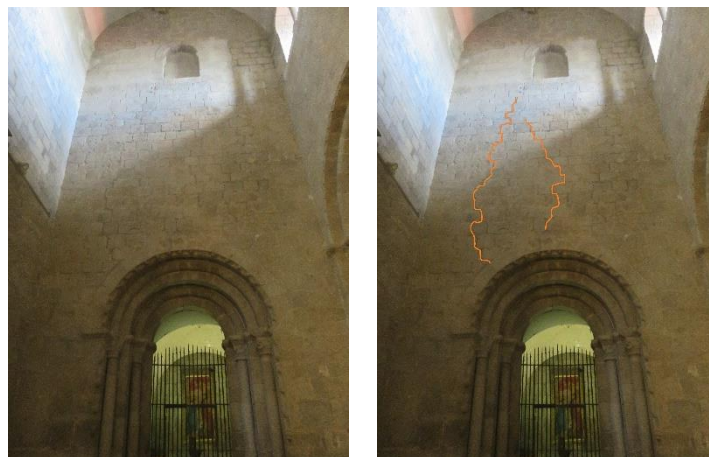
Cracks in the transept

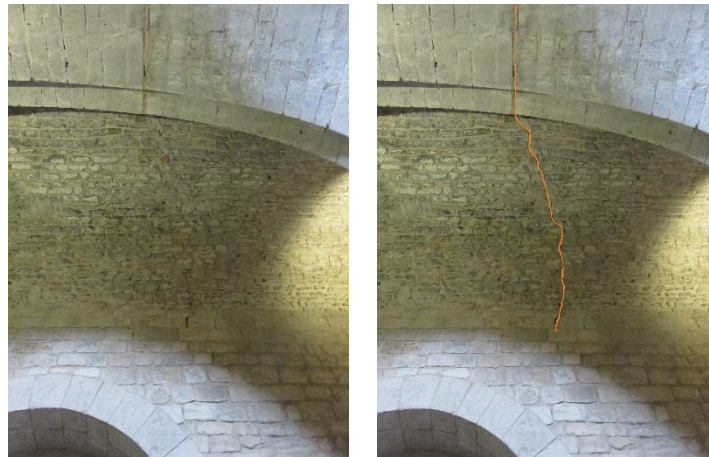
Cracks in the side wall

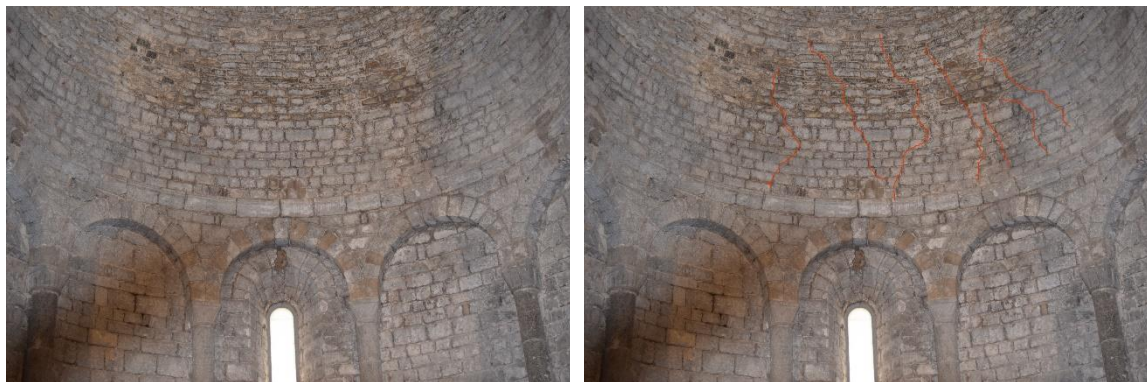
Cracks in the apse
