HEALTH MONITORING OF PRECAST BRIDGE DECK PANELS  
REINFORCED WITH GLASS FIBER REINFORCED  
POLYMER BARS

A thesis submitted to the faculty of  
The University of Utah  
in partial fulfillment of the requirements for the degree of

Department of Civil and Environmental Engineering

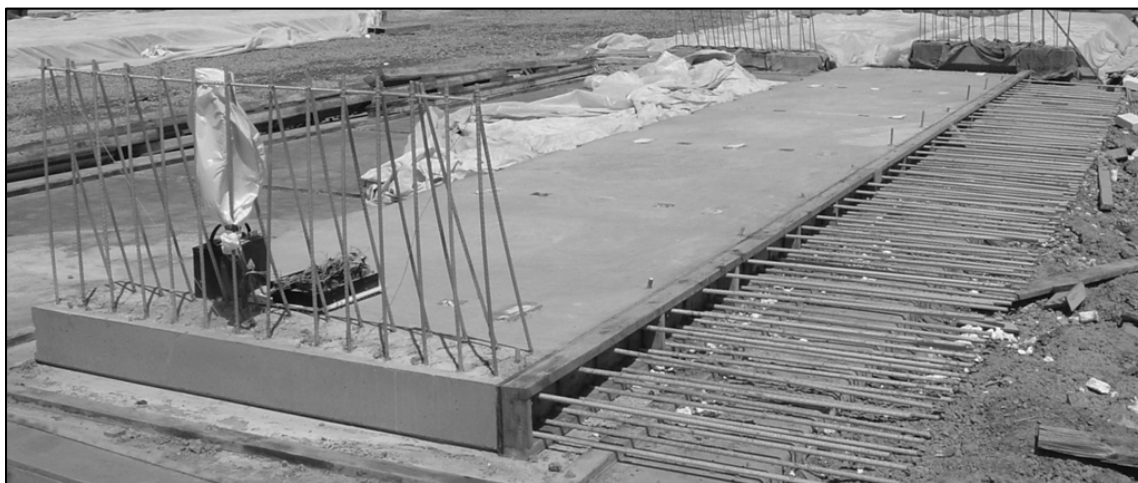
Figure 5. Panel EP3 sitting in the precast yard with approach slab rebar on the right

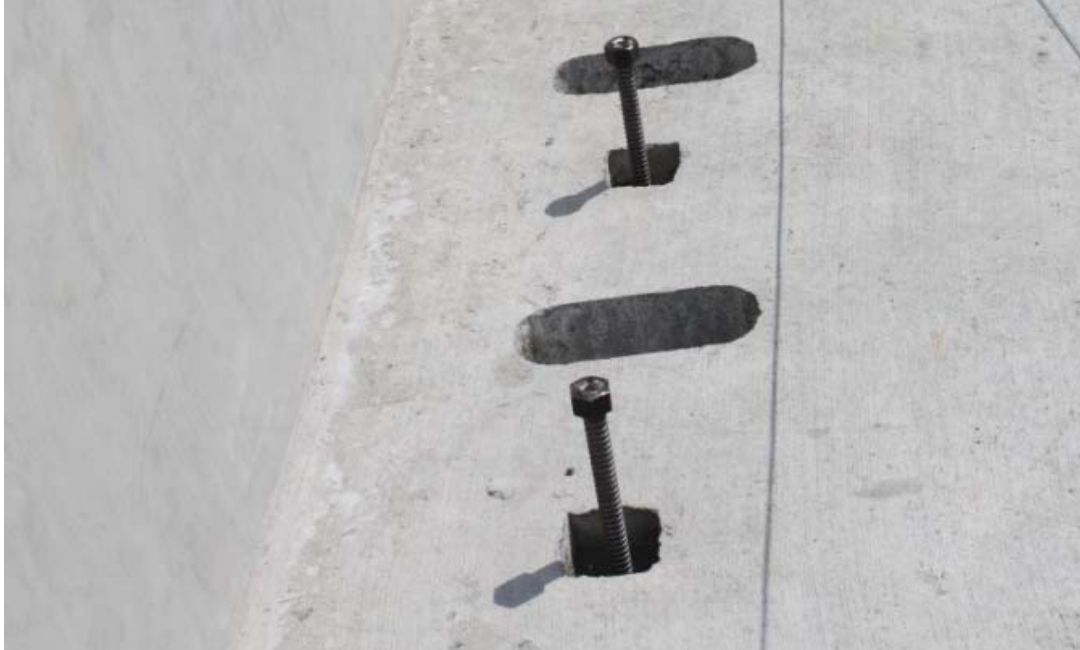
Figure 6. Leveling bolts and shear stud blockouts.

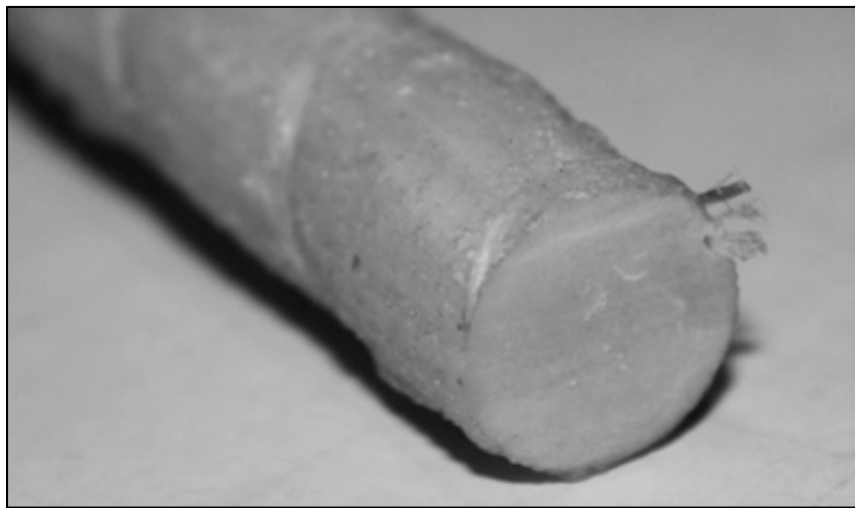
Figure 7. Close-up of GFRP bar

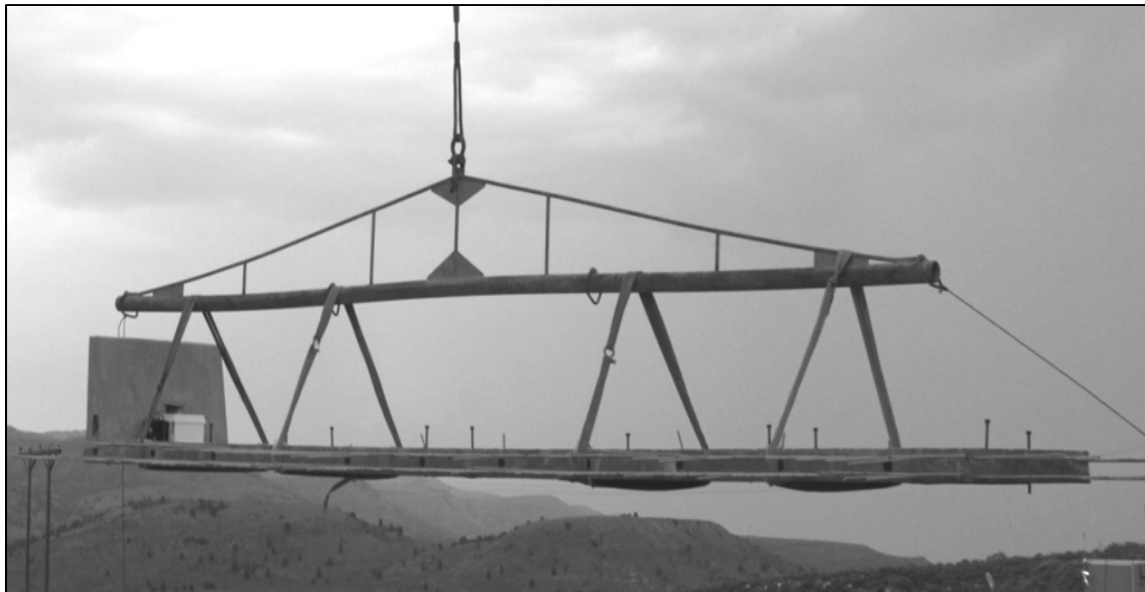
Figure 9. Panel P2-05 being lifted using straps at the bridge site

The twenty-four deck panels were fabricated in Pleasant Grove Utah, individually transported 64 miles to the bridge site, and lifted into place. Each of the panels were lifted a total of three times before ending up in their service position. The first lift removed the deck panel from its formwork. This lift took place before the parapet had been cast. Once the parapets had been cast, a second lift placed the panel on the bed of a tractor trailer. The final lift placed the panel atop the girders.

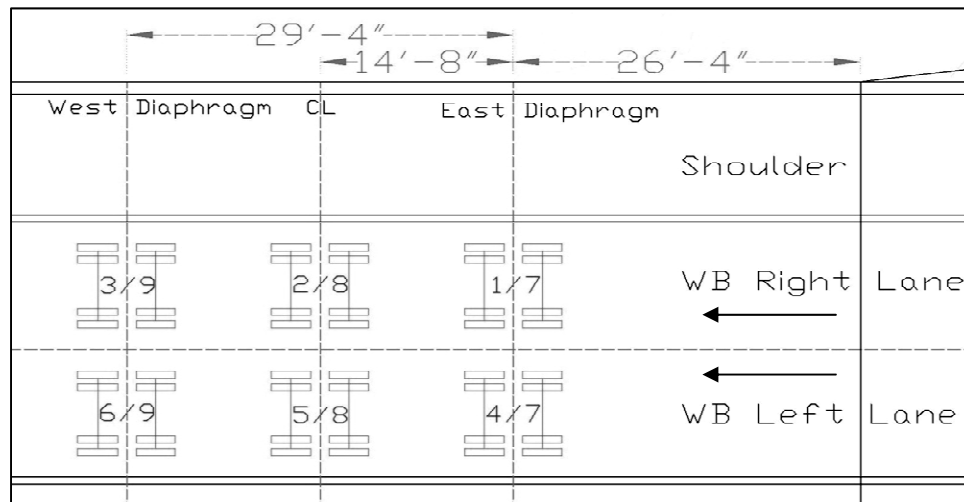
Figure 12. Locations of trucks during truck load test

Test #	Type of test	Lane tested	Truck used	Rear axle position
1	Static	Right	A	East Diaphragm
2	Static	Right	A	Midspan
3	Static	Right	A	West Diaphragm
4	Static	Left	B	East Diaphragm
5	Static	Left	B	Midspan
6	Static	Left	B	West Diaphragm
7	Static	Both	A&B	East Diaphragm
8	Static	Both	A&B	Midspan
9	Static	Both	A&B	West Diaphragm

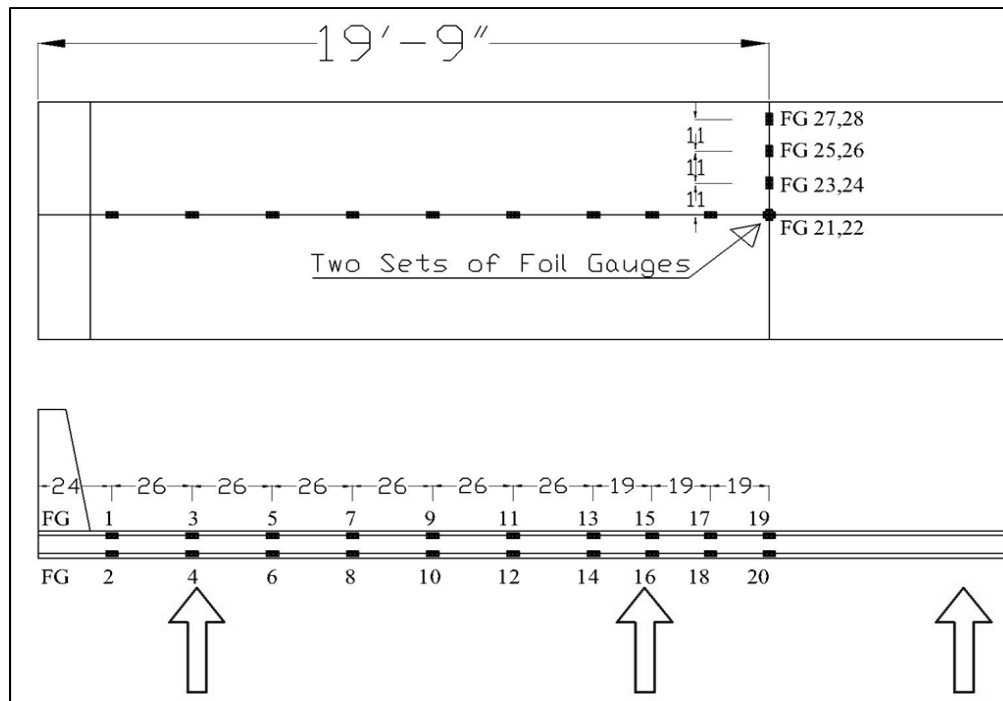
Figure 14. Foil gauge locations for both panels

Each panel was instrumented with twenty-eight foil strain gauges, to be used during the lifting and transportation of the panels. These gauges were attached directly to both the top and bottom GFRP mats and recorded the strains in the bars. Of the twenty-eight foil gauges, twenty were placed in the transverse direction of the bridge

(longitudinal direction of the panel) to record strains in the long direction of the panel during lifting. The remaining eight gauges were placed in the longitudinal direction to record strains in the short direction. Figure 14 provides a more detailed look at the locations of the foil gauges. Gauge locations were chosen due to their proximity to the lifting points and point of maximum theoretical moment. Foil gauges were chosen due to their high sampling rate potential, relatively low cost, and overall simplicity. Their drawbacks include their difficulty in attachment to GFRP bars, as well as their short life span.

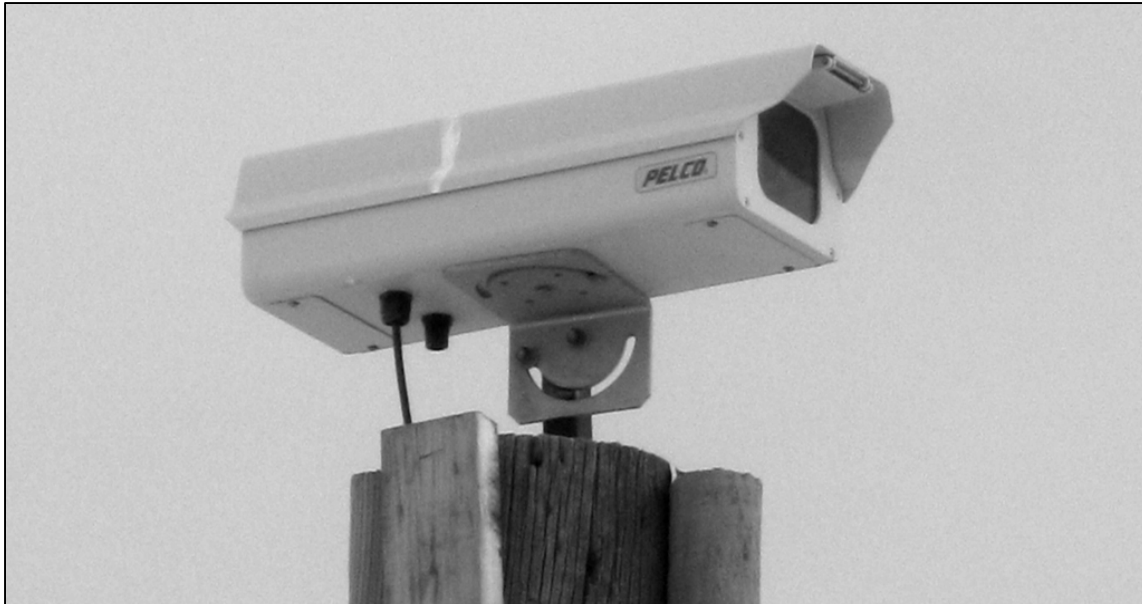
Figure 20. Still camera used for visual record of largest accelerations

A still camera was mounted atop a 15 ft. tall post stationed approximately 30 ft. north of the west abutment, as seen in Figure 20 and Figure 21. The camera was aimed toward the bridge with the lens setting on wide, as seen in Figure 22. The purpose of the camera was to obtain a visual record of what caused the largest accelerations. The camera is triggered whenever accelerometer #5 meets a specific threshold, typically around 0.025g.

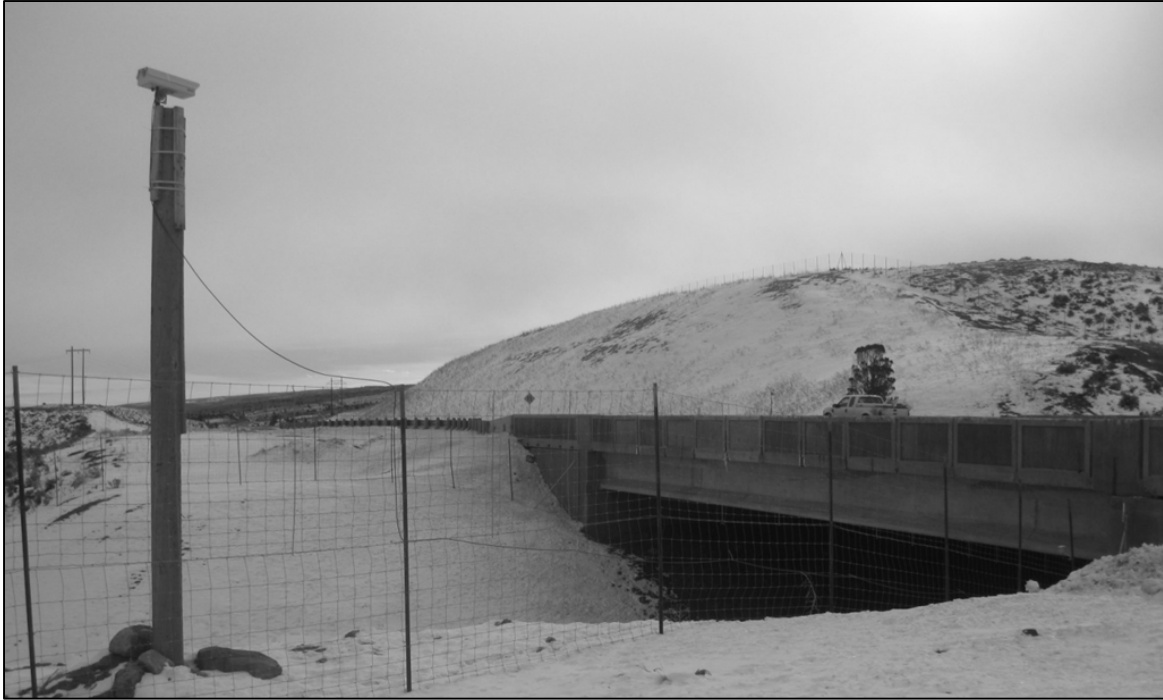
Figure 22. Location of camera with respect to bridge

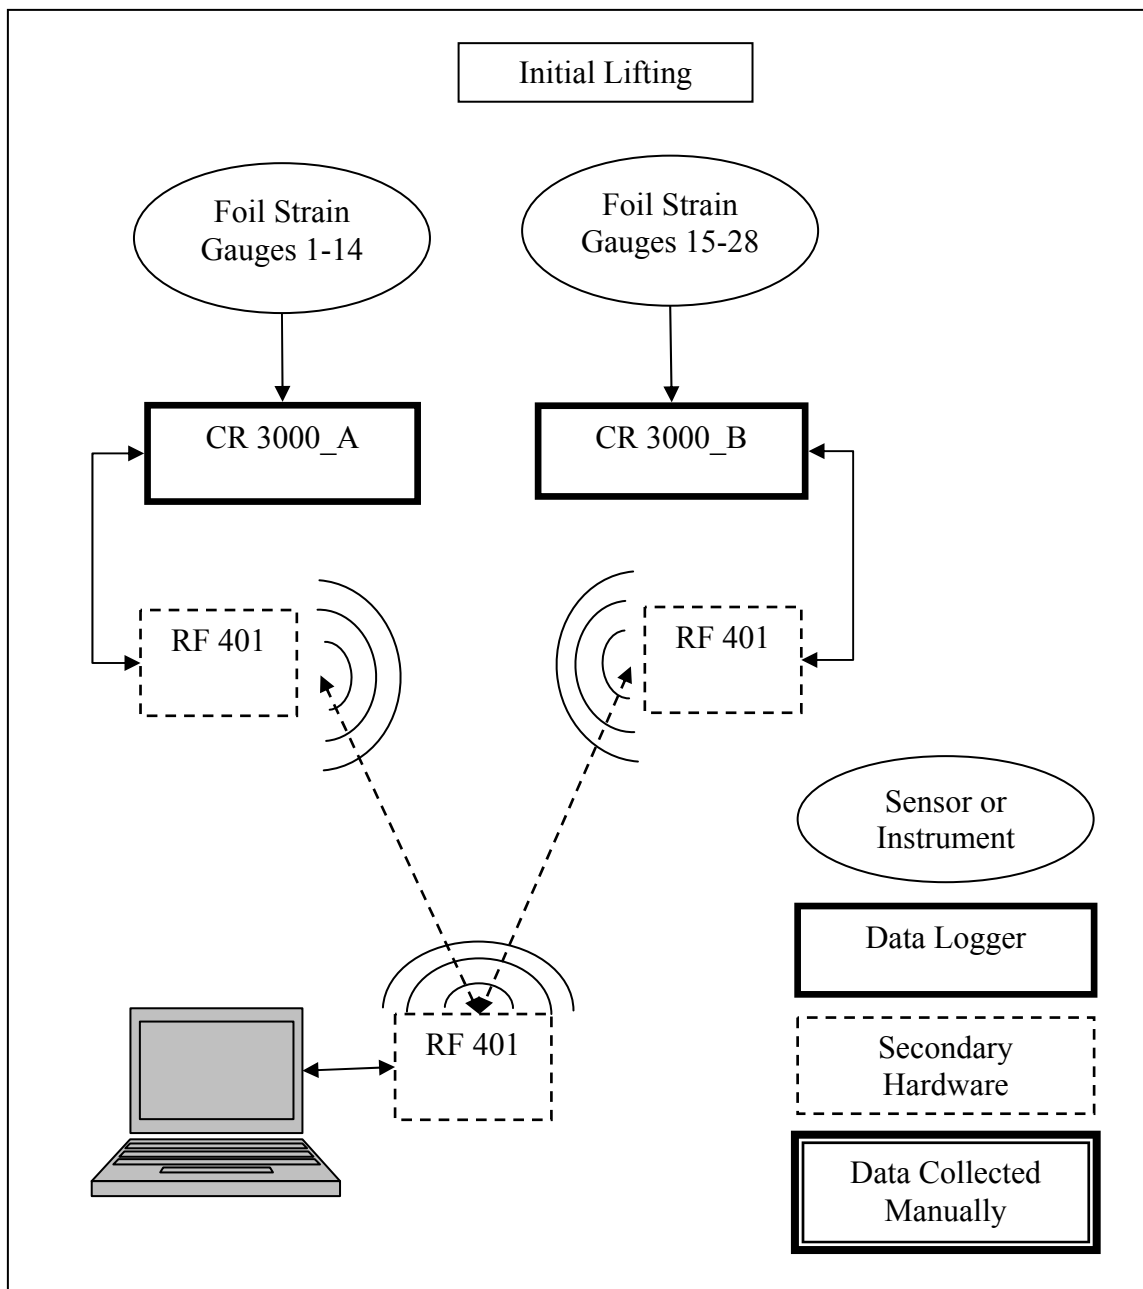
Figure 23. Equipment setup for initial lifting

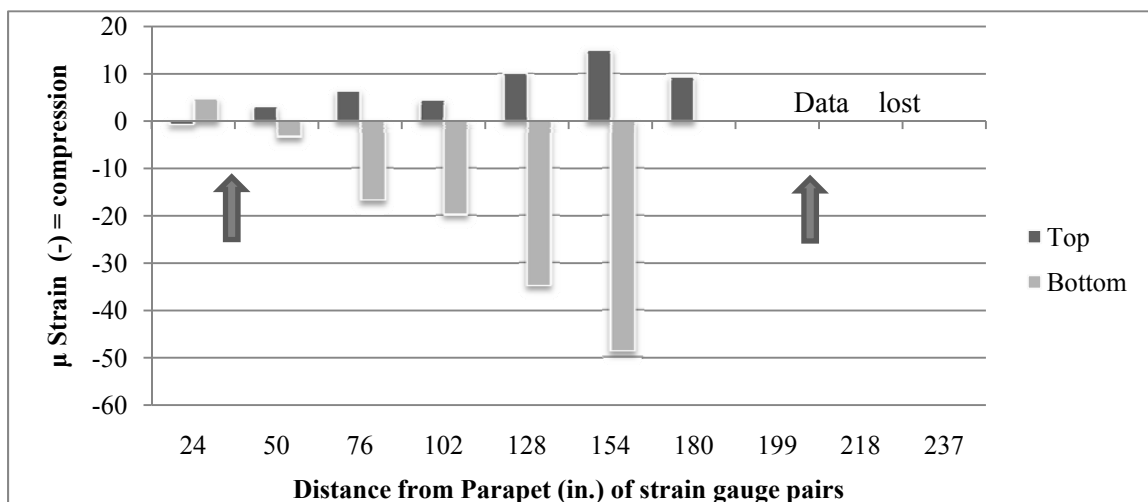
Figure 28. Strain profile for panel EP3 during its second lift

maximum strain profile during the second lift for half of panel P2-05 is shown in Figure 28. From the graph, we can see that the maximum strain in the bottom matt is  $-45 \mu\text{strain}$  while the maximum strain in the top matt is approximately  $30 \mu\text{strain}$ . The maximum strain of  $-45 \mu\text{strain}$  corresponds to 0.3% of the ultimate GFRP strain. The lifting points are located at 46 in. and 202 in. from the parapet, and are represented by arrows. Overall the strains observed during the second lift were insignificant.

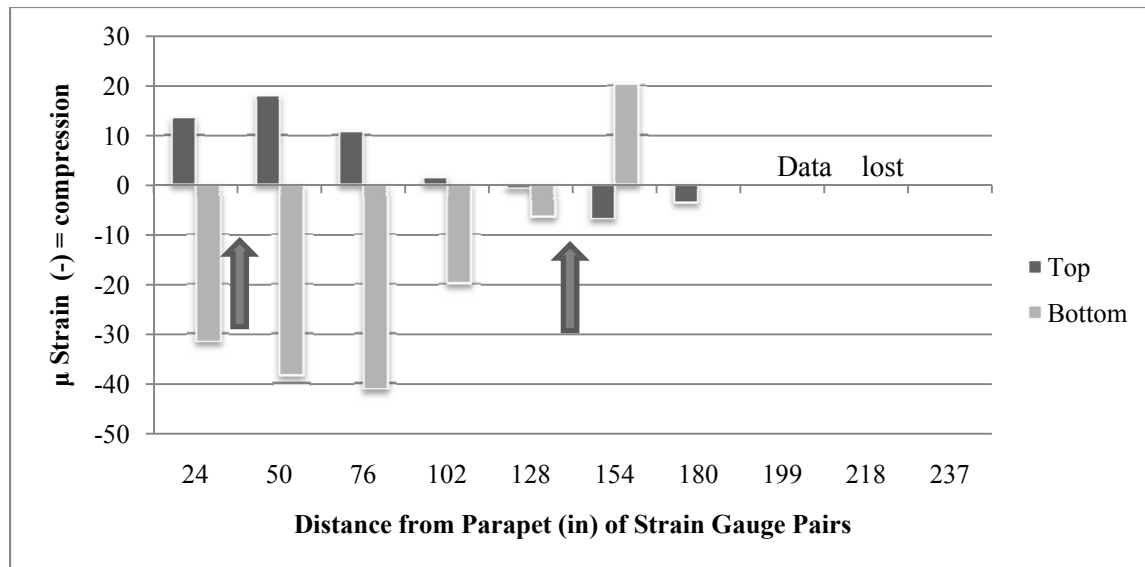
Figure 30. Strain profile for EP3 during its third lift

The maximum strain profile during the third lift is shown in Figure 30. The third lift occurred directly after the transportation of the panel, resulting in added difficulty in acquiring base line data. From the graph, we can see that the maximum strain in the bottom matt is  $-45 \mu\text{strain}$  while the maximum strain in the top matt is  $-35 \mu\text{strain}$ . The maximum strain of  $-45 \mu\text{strain}$  corresponds to 0.3% of the ultimate GFRP strain. The strains for all three lifts were in the same range, and never exceeded  $125 \mu\text{strain}$ , or 0.8 % of the ultimate GFRP bar strain.

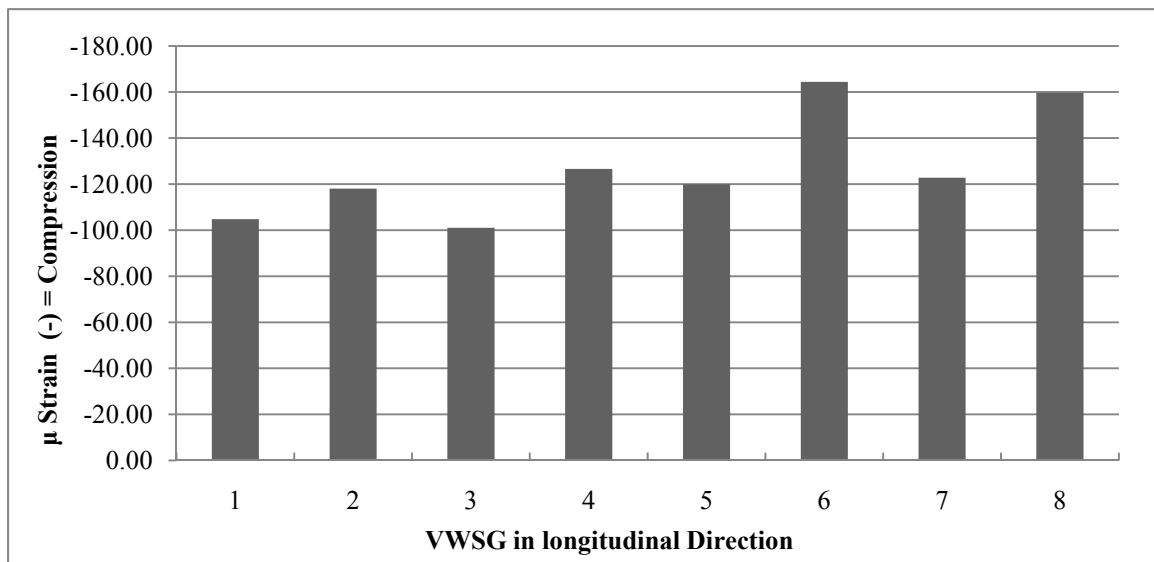
Figure 31. Posttensioning strains in bridge deck

The average concrete strain from all 8 gauges is approximately 130  $\mu$ strains in compression. However, the average concrete strain for panel EP3 is 112  $\mu$ strains, almost 30  $\mu$ strains lower than those found in panel P2-05 where the average strain was 141  $\mu$ strains. Approximately the same difference in strain was found when comparing the averages of the top gauges to those of the bottom gauges. This difference is most likely due to the camber of the bridge.

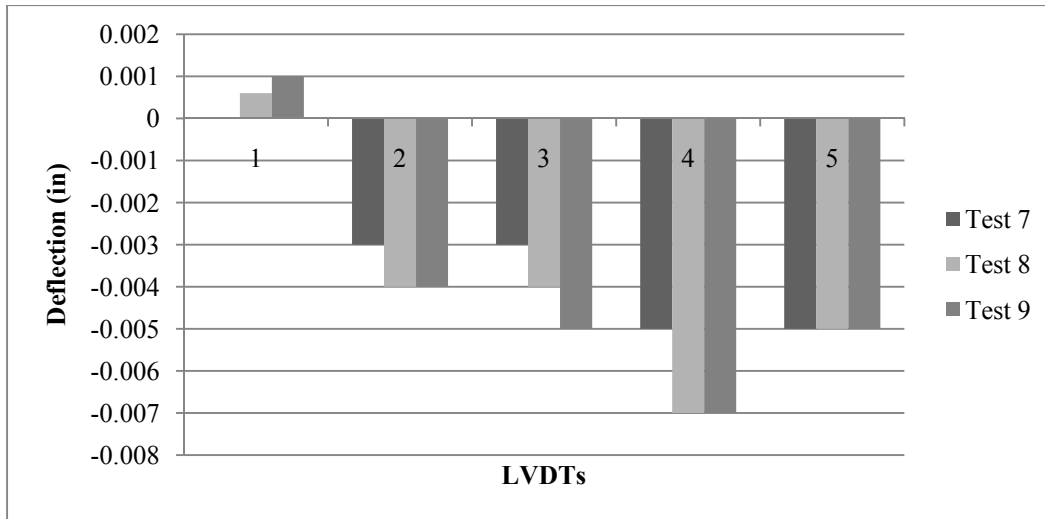
Figure 34. Panel deflections relative to the girders above the west diaphragm

As expected, the maximum panel deflections occurred during truck load test #9 when both trucks were parked above the west diaphragm. The maximum deflection was 0.007 in. relative to the girders, as seen in Figure 34. This was well below the AASHTO limit of  $L/800$ , or in this case  $83''/800=0.104''$ .

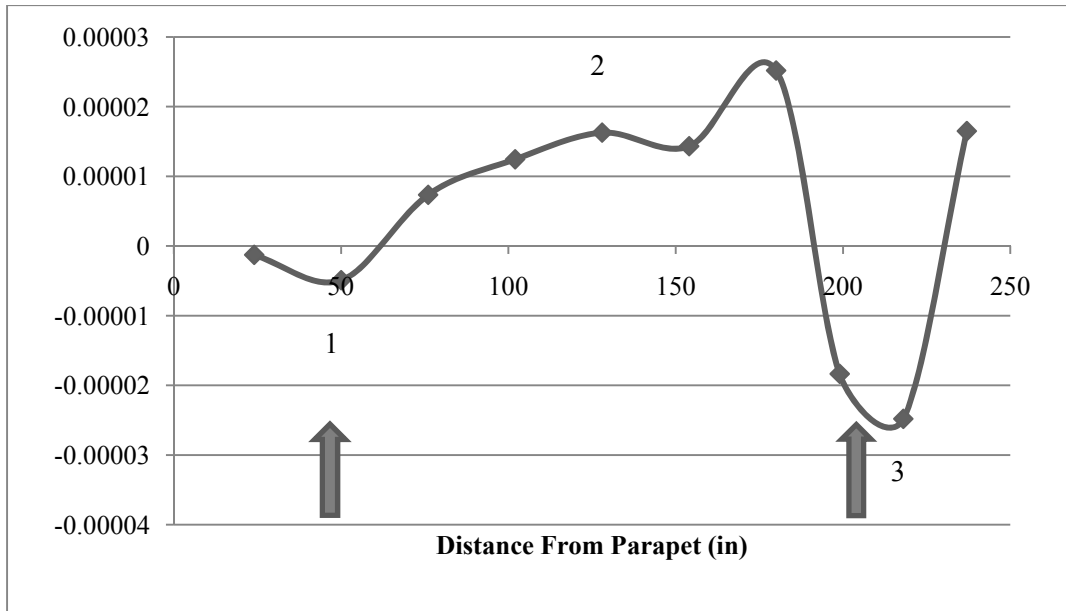
Figure 41. Curvature diagram from experimental results; arrows represent lifting points

From the recorded strains during lifting, the curvature of the panel was determined using Eq. (3), where “ $\epsilon$ ” is the strain recorded and “ $d$ ” is the distance between the top and bottom reinforcing mats. The measured curvature diagram from the first lift of P2-05 is shown in Figure 41, along with two arrows representing the closest lifting points. The theoretical curvature will be compared to the measured curvature at three points, under each lifting point, and at midspan between the two lifting points.

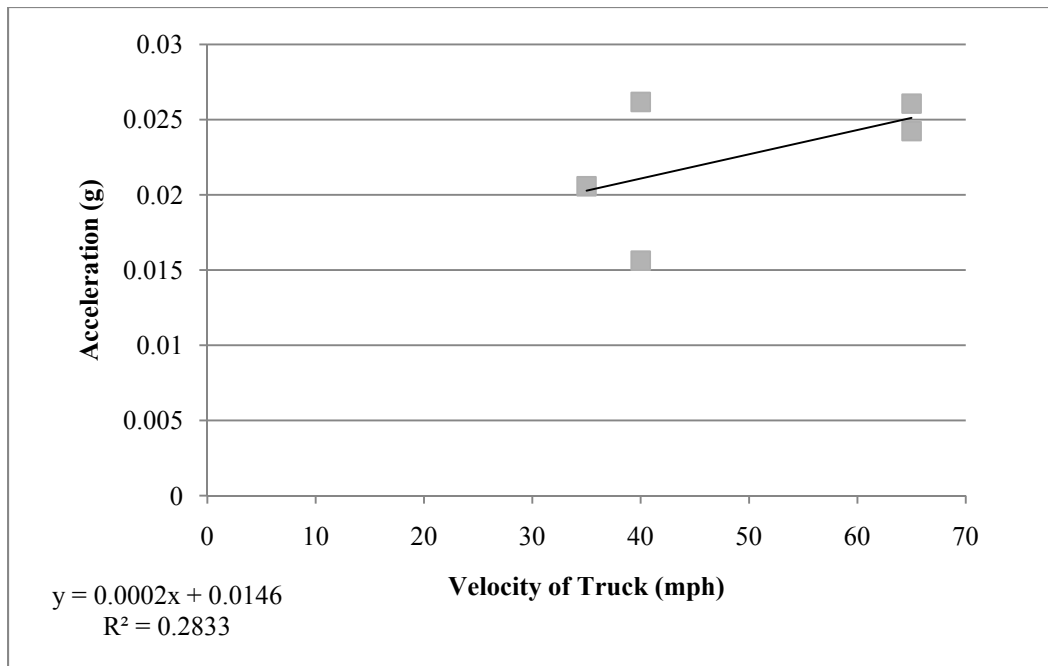
Figure 42. Correlation between maximum acceleration observed during dynamic test and velocity at which test was performed

It was expected that the tests involving faster moving trucks would also correlate to higher accelerations; this turned out not to be the case. As seen in Figure 42, the maximum accelerations of faster moving trucks were no higher than those at lower speeds. The trend line drawn in the graph does represents a positive correlation. However, the R-squared value is only 0.283, meaning that there is little correlation between velocity and maximum accelerations at midspan. Given the nature of the accelerometer data, it is difficult to hypothesize on potential trends, and more data are needed before a firm conclusion can be drawn.
