BEHAVIOR OF CORRODED REINFORCED CONCRETE COLUMNS WITH
CARBON FIBER REINFORCED POLYMER JACKETS AND COLUMNS
WITH INTERNAL GLASS FIBER REINFORCED POLYMER SPIRALS

A thesis submitted to the faculty of
The University of Utah
in partial fulfillment of the requirements for the degree of

Department of Civil and Environmental Engineering

August 2011

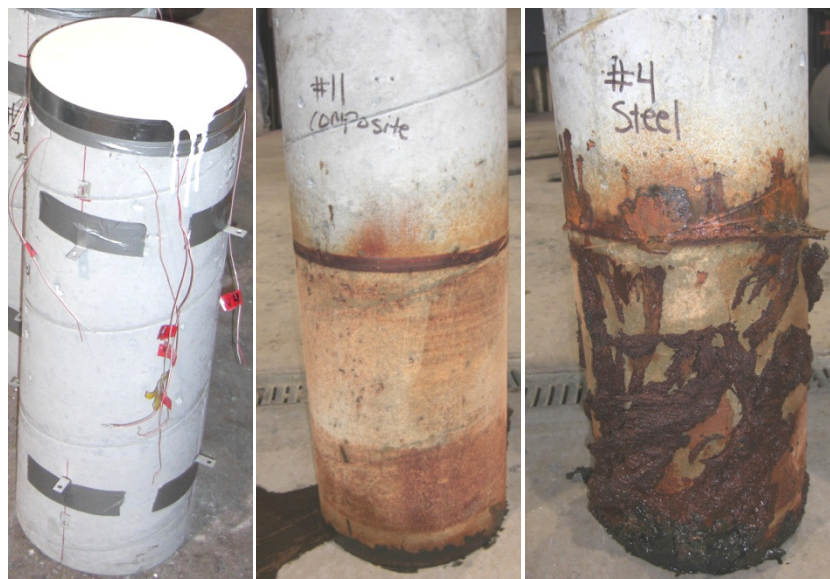
Figure 2.6: Condition comparison: (a) Typical control specimen (b) Typical hybrid corrosion specimen (c) Typical steel corrosion specimens

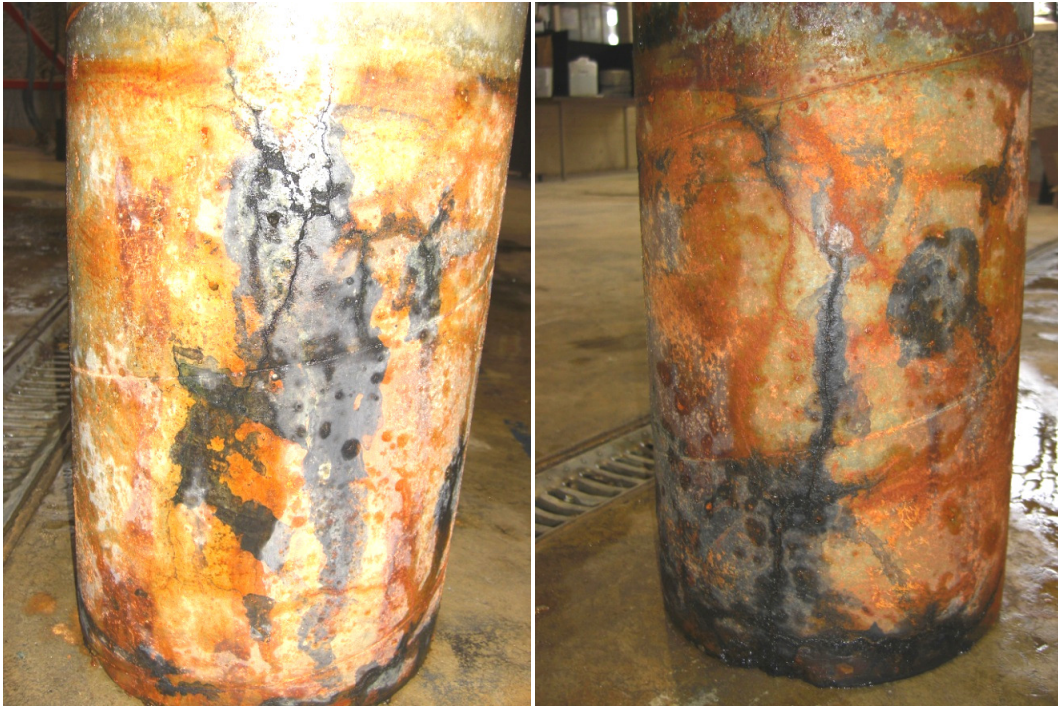
Figure 2.7: Trial corrosion specimen comparison (a) #7SCOREX after 5 weeks of corrosion (b) #8SCOREX after 10 weeks of corrosion

The two specimens were observed visually on a weekly basis and pictures were taken. One of the two preliminary corrosion specimens, #7SCOREX, was removed from the corrosion environment on Oct. 23, 2009 (after 5 weeks) and is shown in Figure 2.7(a). Column #8SCOREX was removed on Nov. 27, 2009 (after 10 weeks) and is shown in Figure 2.7(b). Cracks were measured and documented as shown in Table 2.2. It is important to note that these cracks developed while the specimen was cycled in the corrosive environment at room temperature and that no freeze thaw cycles were applied.

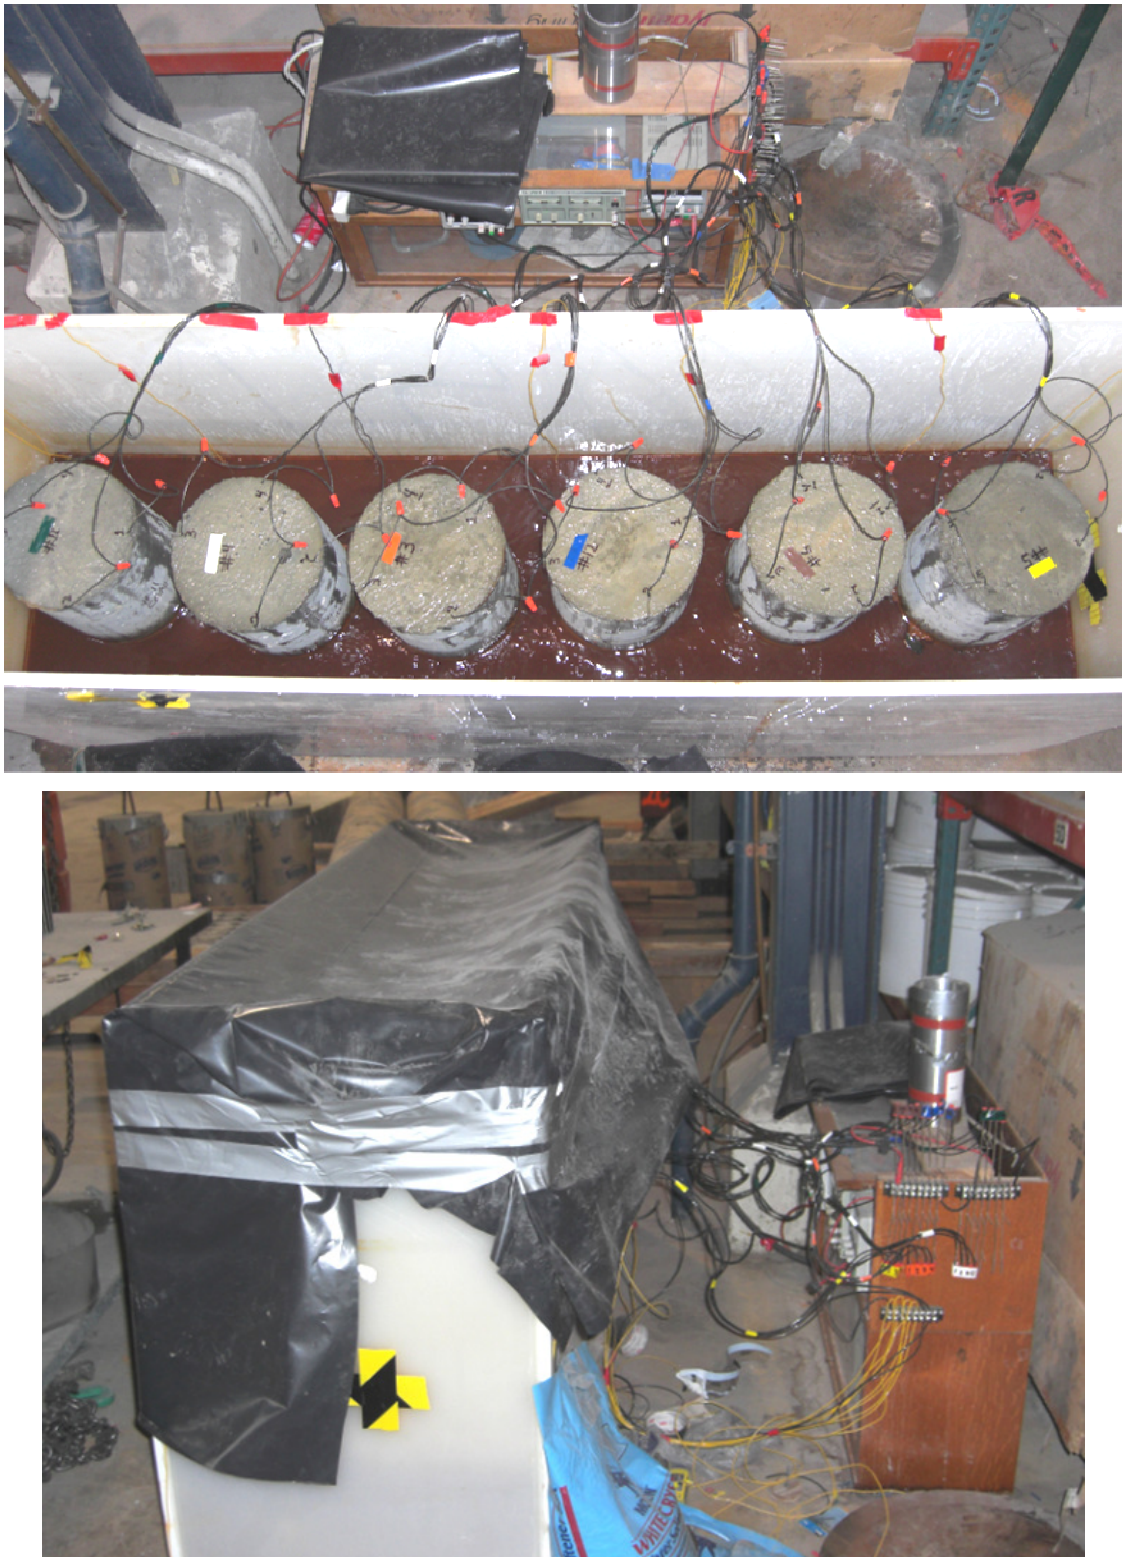
Figure 2.8: Corrosion system for medium-scale RC columns

Corrosion of the remaining six medium-scale columns was initiated in March of 2010. Four of the six columns had all-steel reinforcing bars and spirals and two had steel vertical bars with glass fiber reinforced polymer (GFRP) spirals. The columns were placed in the corrosion tank with 5% salt water solution by weight, and were allowed to soak in the solution for 1 week before the power supply was connected on March 24, 2010 (see Figure 2.8). Three DC power supplies were required to implement corrosion of the six medium-scale columns. Each power supply was connected to two columns and supplied a constant 5.0V potential across each vertical rebar. The 5.0V potential was checked with a voltmeter after initial set up and every time readings were taken to ensure it stayed constant at 5.0V throughout the corrosion process.

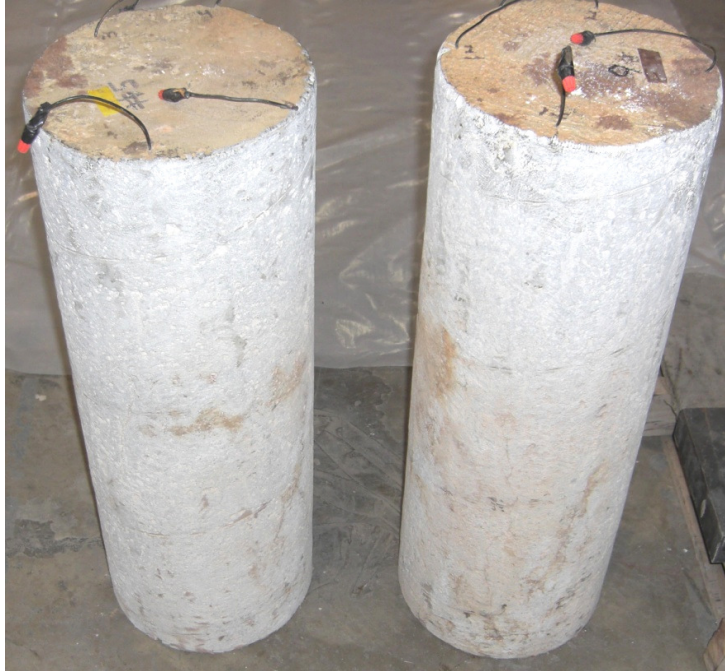
Figure 2.9: Roughened surface of Columns #5SCORW and #6SCORW

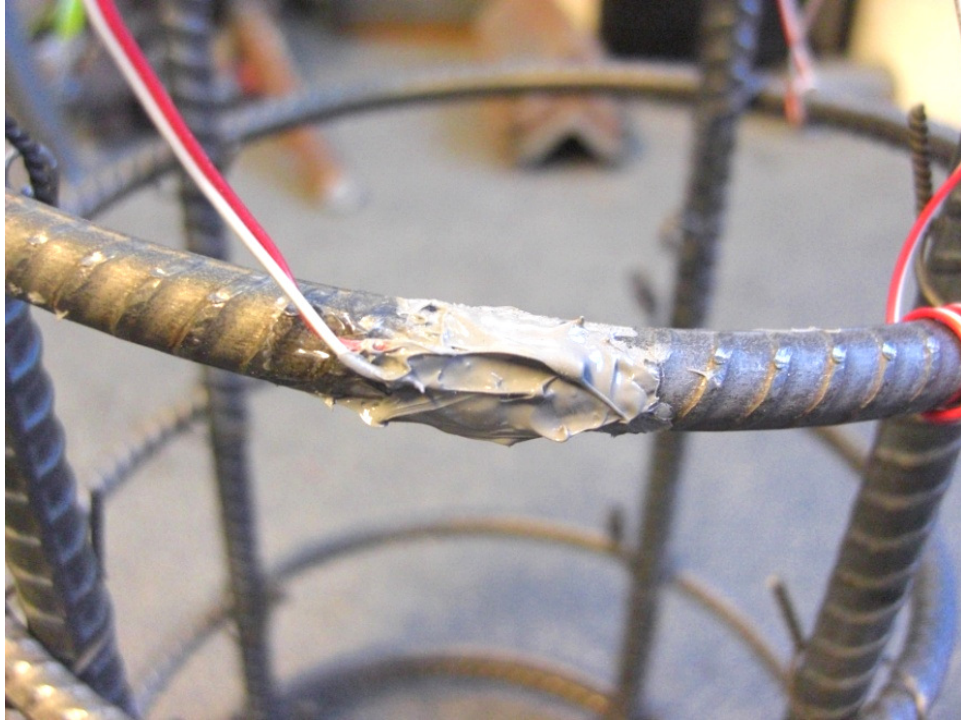
Figure 2.13: Internal strain gauge protective coating

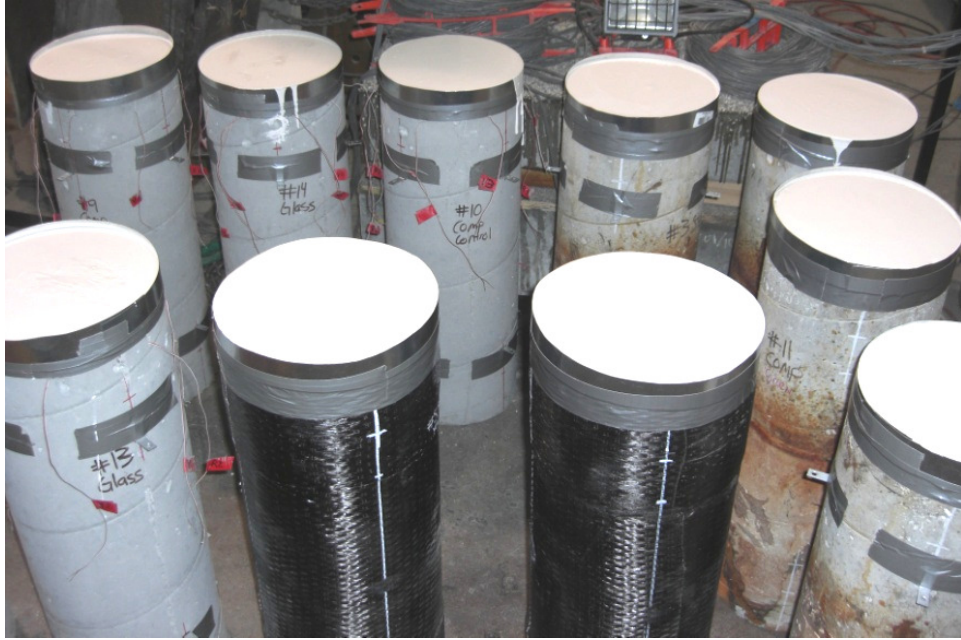
Figure 2.15: Hydrostone caps

Hydrostone, a high strength plaster, was used to cap the columns to provide a level and smooth top surface. The plaster mix used a 32% water to Hydrostone ratio by weight. This was fluid enough to self level and leave a smooth surface, but also had a compressive strength at least 2,000 psi higher than the concrete. Figure 2.15 shows the columns after Hydrostone was applied.

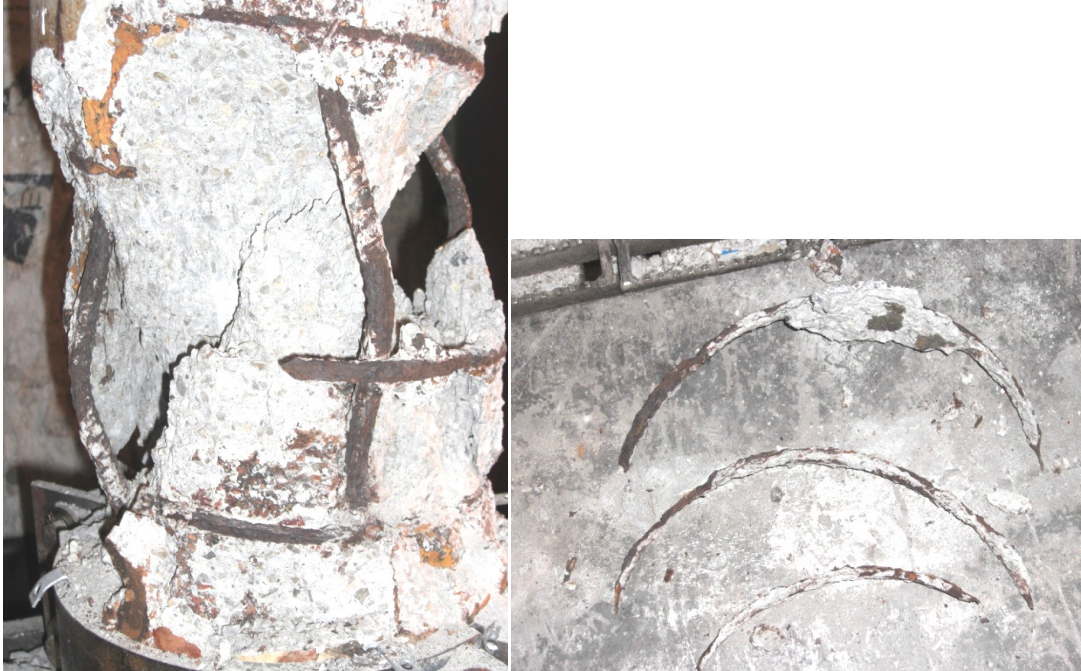
Figure 3.1: Effects of corrosion on steel spiral

Mass loss values were then converted to percent steel loss by dividing the mass loss by the original steel mass. The final values after 78 days of corrosion are summarized in Table 3.1. It is important to note that this is an indirect method of calculating steel mass loss because current not actual mass loss was being measured. In the all-steel reinforced concrete columns it was apparent that most of the corrosion occurred in the steel spiral, as observed in the large field specimens. This is to be expected because the hoops have the least amount of concrete cover. In all tests of the corroded columns, the hoop steel was corroded to the point that it provided little confining support and resulted in sudden brittle failures as shown in Figure 3.1. The vertical bars were also affected by the corrosion, but not as significantly as the steel spirals. In some cases the vertical steel had only minor corrosion as shown in Figure 3.1.

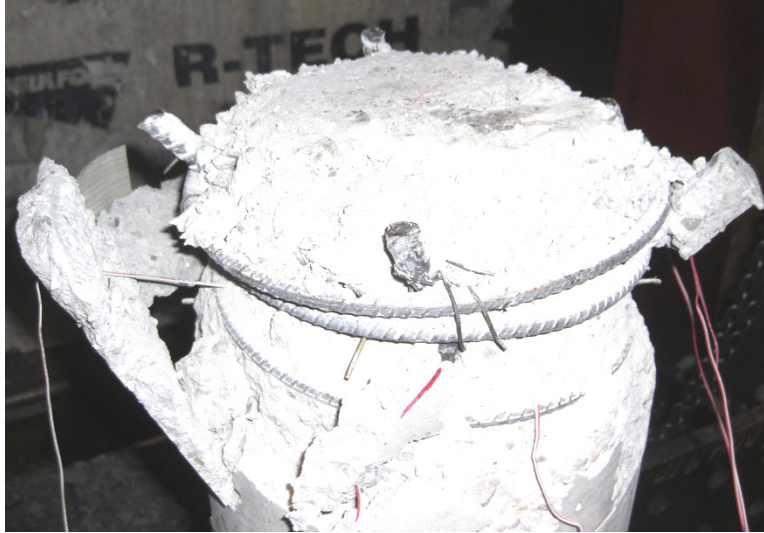
Figure 3.5: #1SCTL premature end crushing

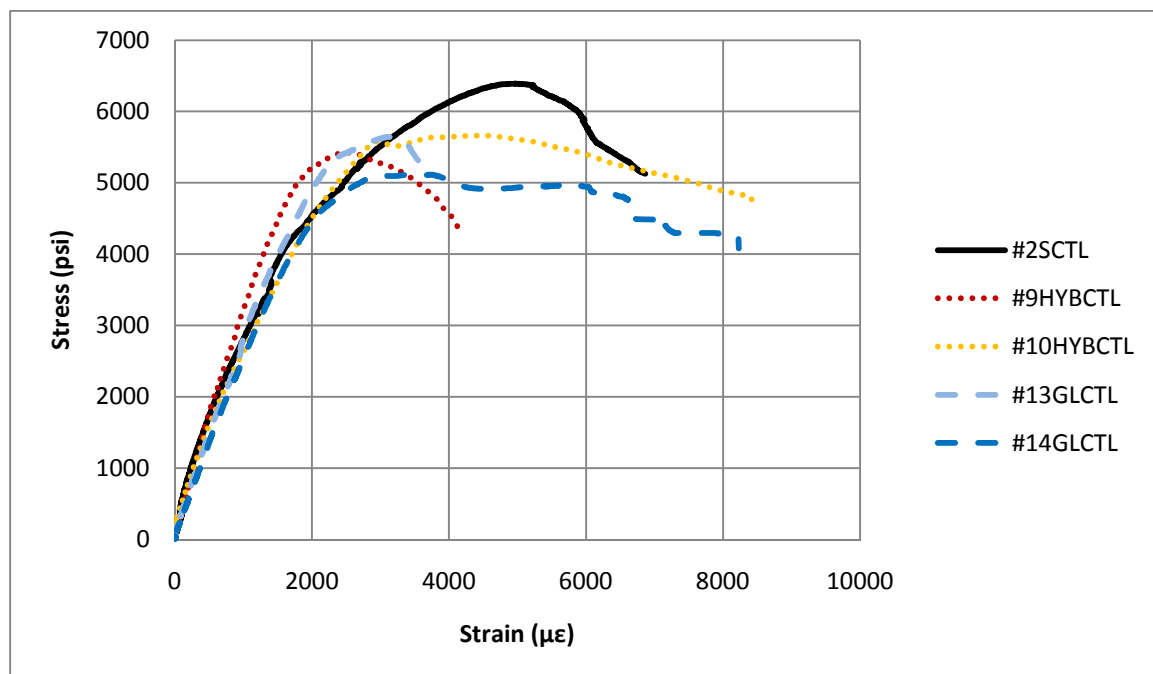
Figure 3.22: Stress-strain curves of all control specimens

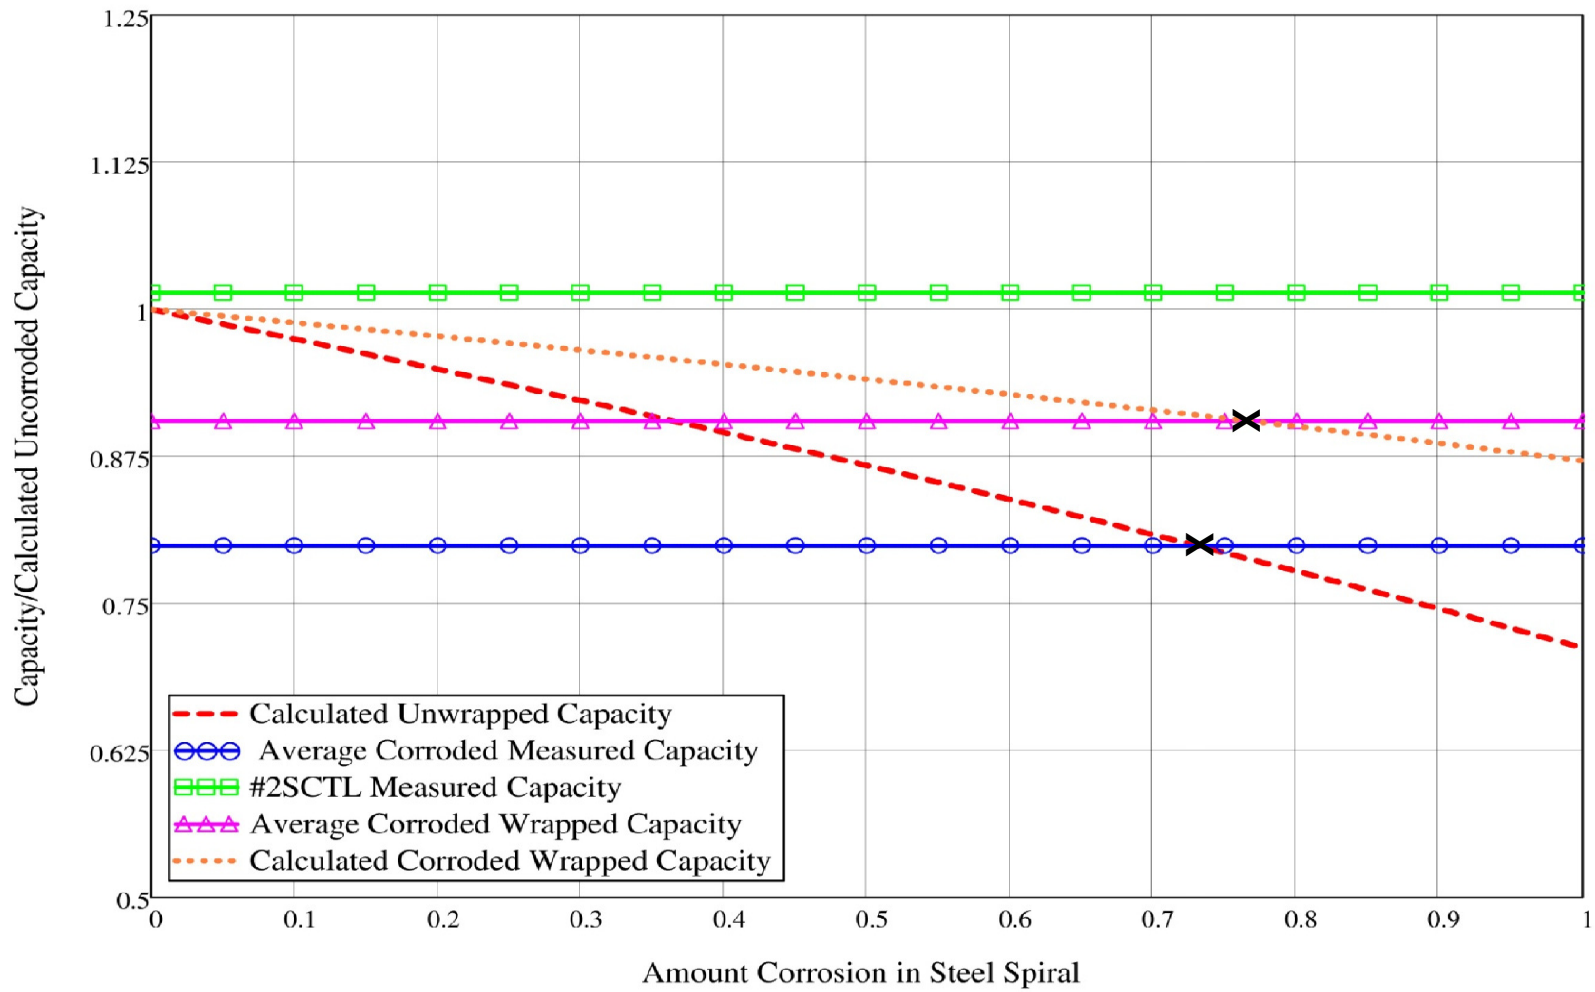
Figure 3.24: Axial capacity versus corrosions

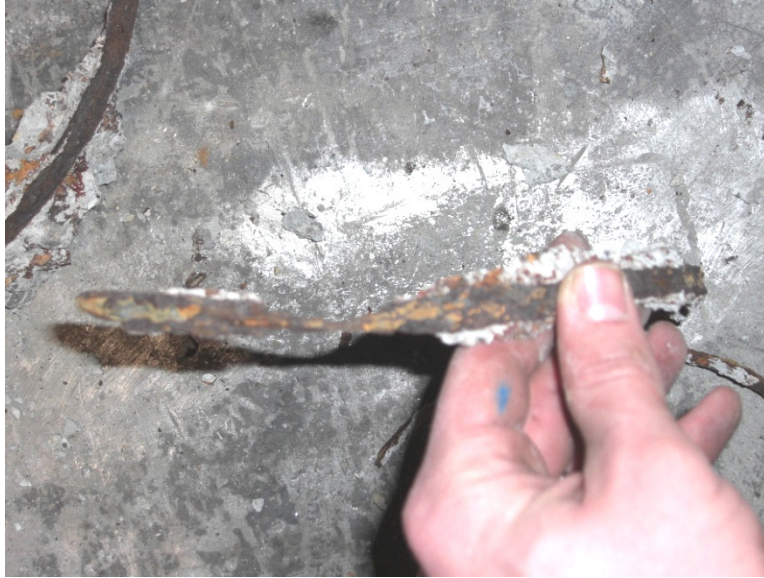
Figure 3.25: Section of spiral with more than 75% steel loss

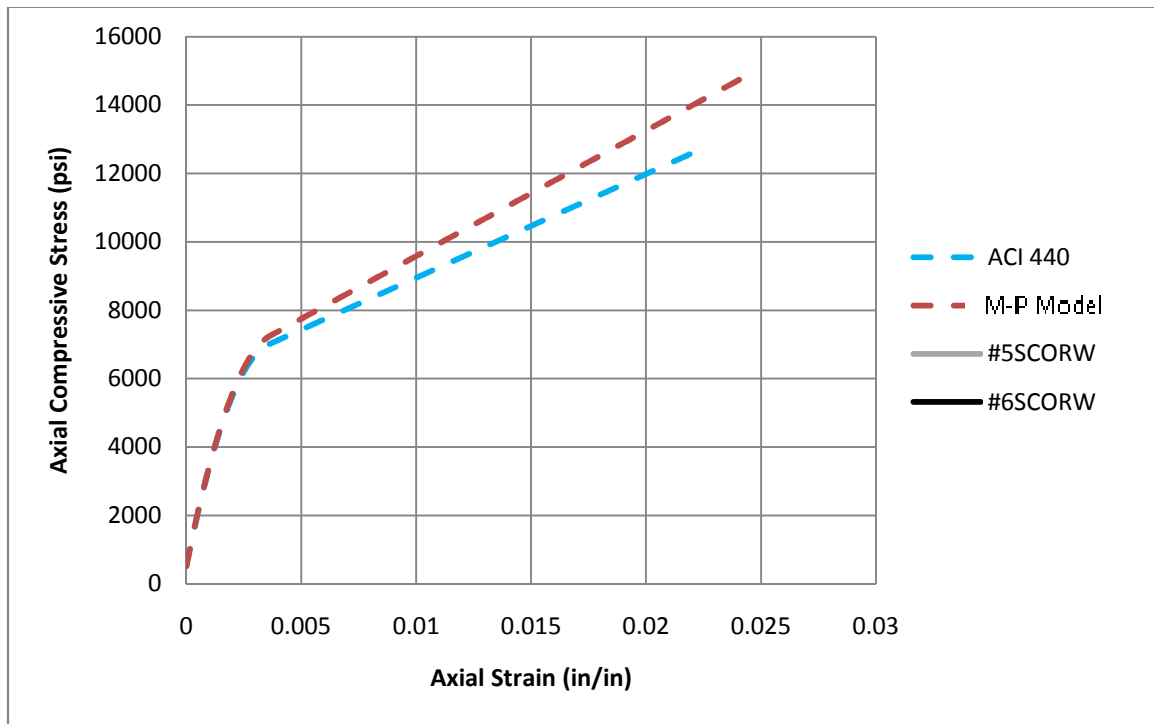
Figure 3.26: Stress-strain models assuming 75% spiral steel loss

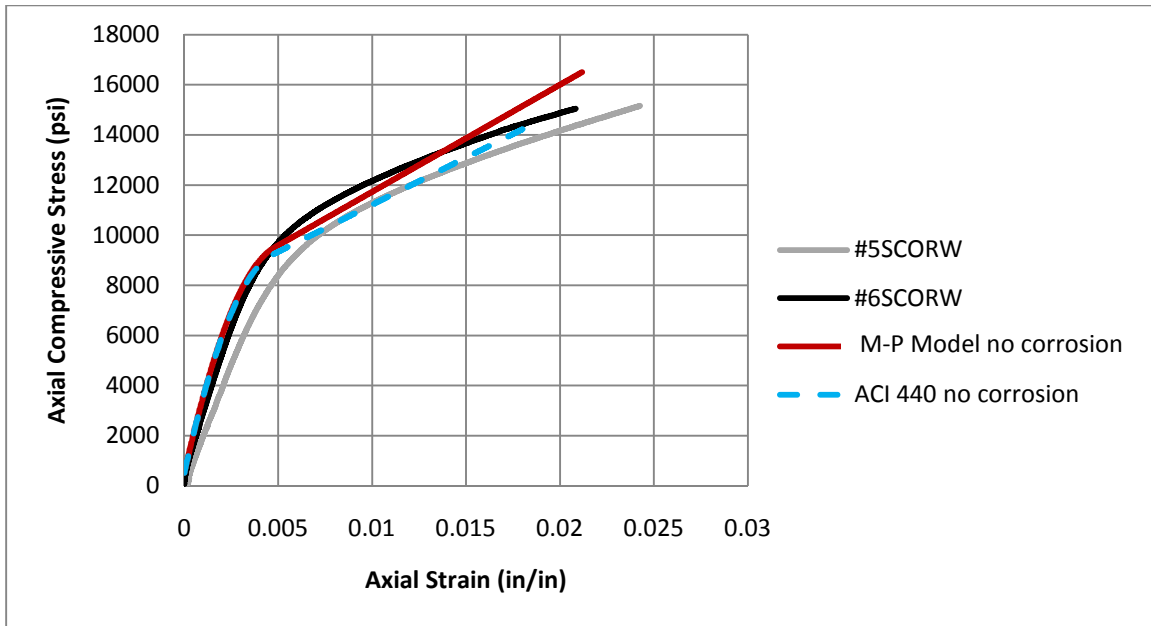
Figure 3.27: Stress-strain models assuming no spiral steel loss

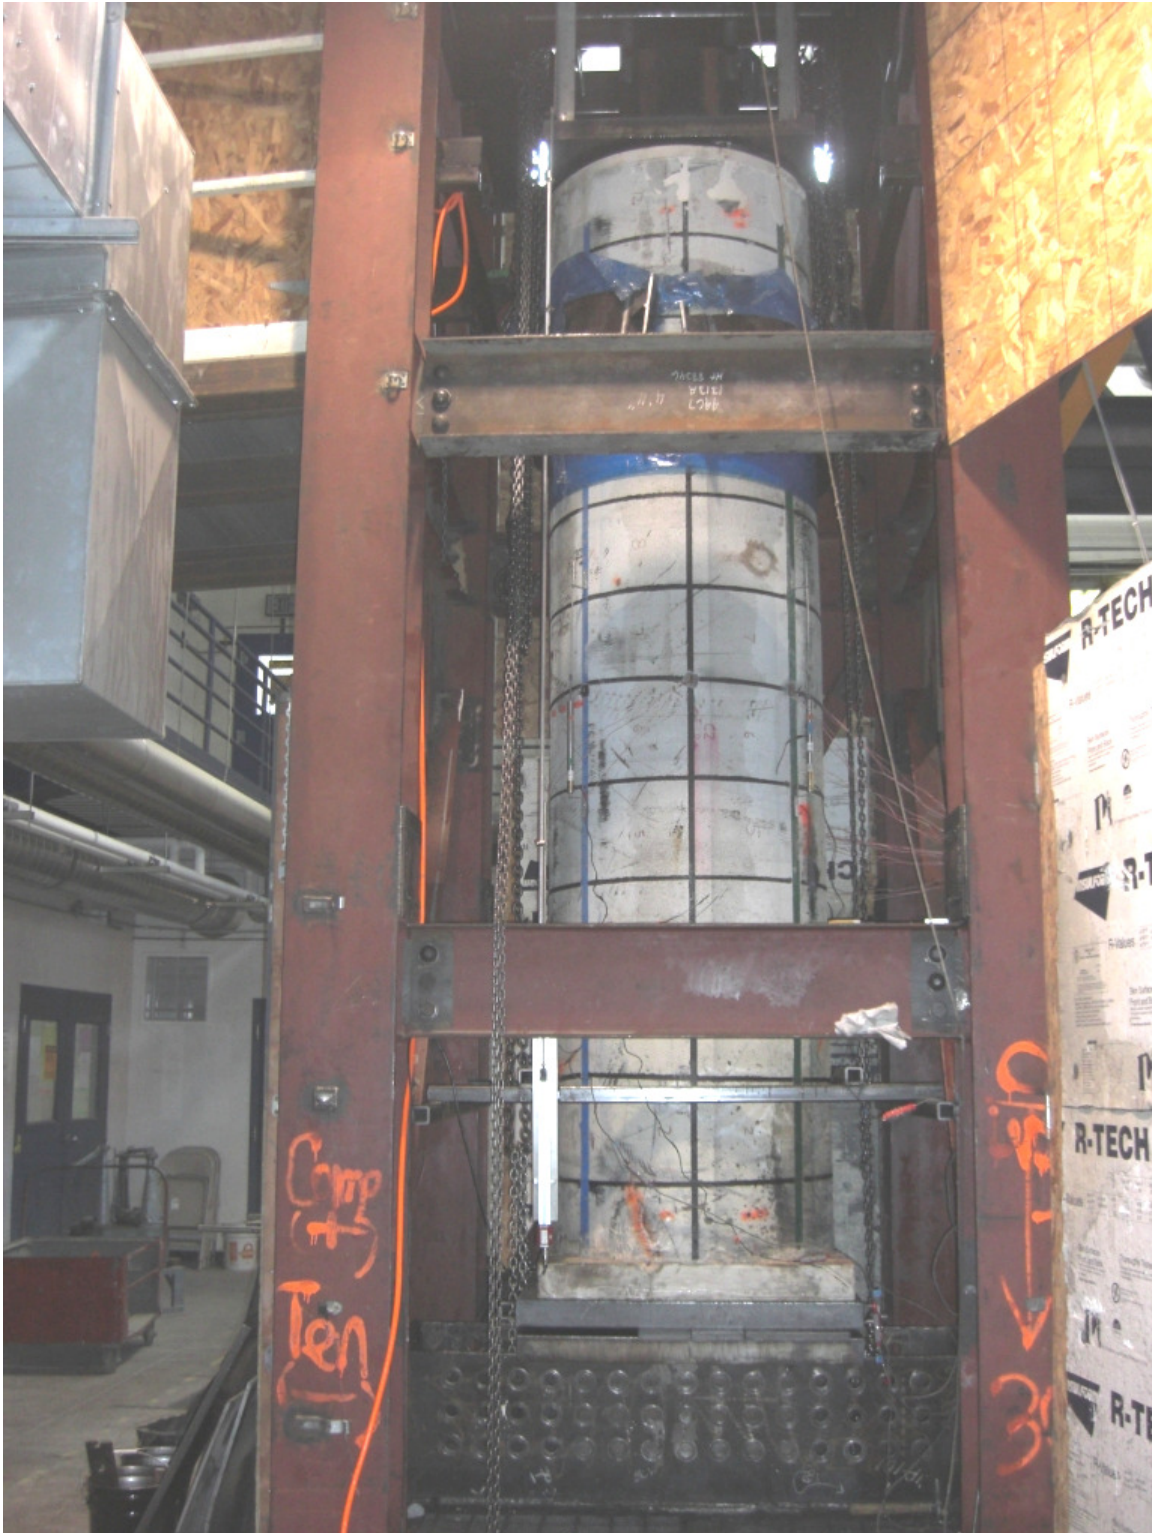
Figure 4.1: Column in load frame

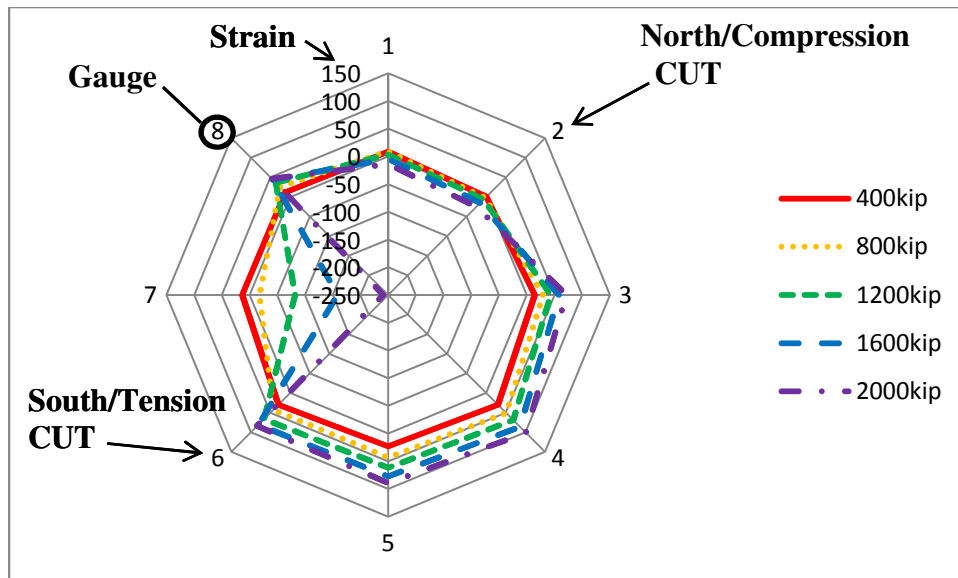
Figure 4.6: Radial micro-strain for column LG2 during CUT concentric test

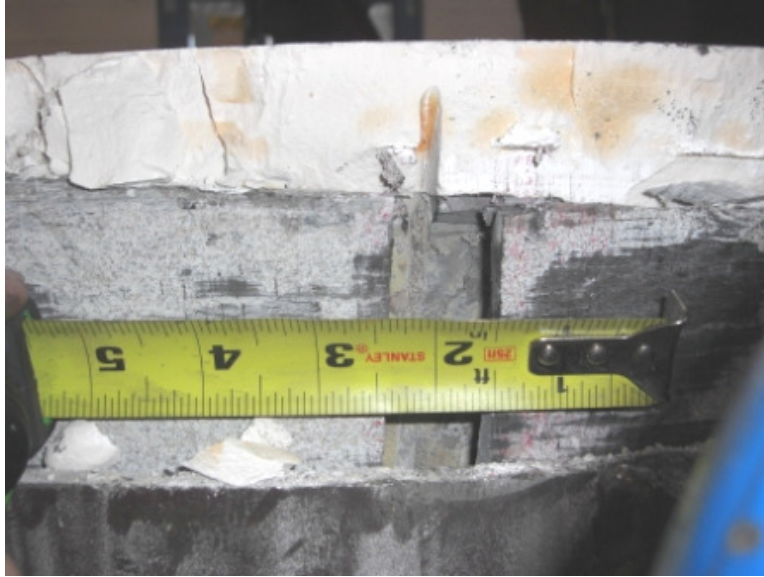
Figure 4.8: Delamination cracking at end of LG1 CUT eccentric 3 test

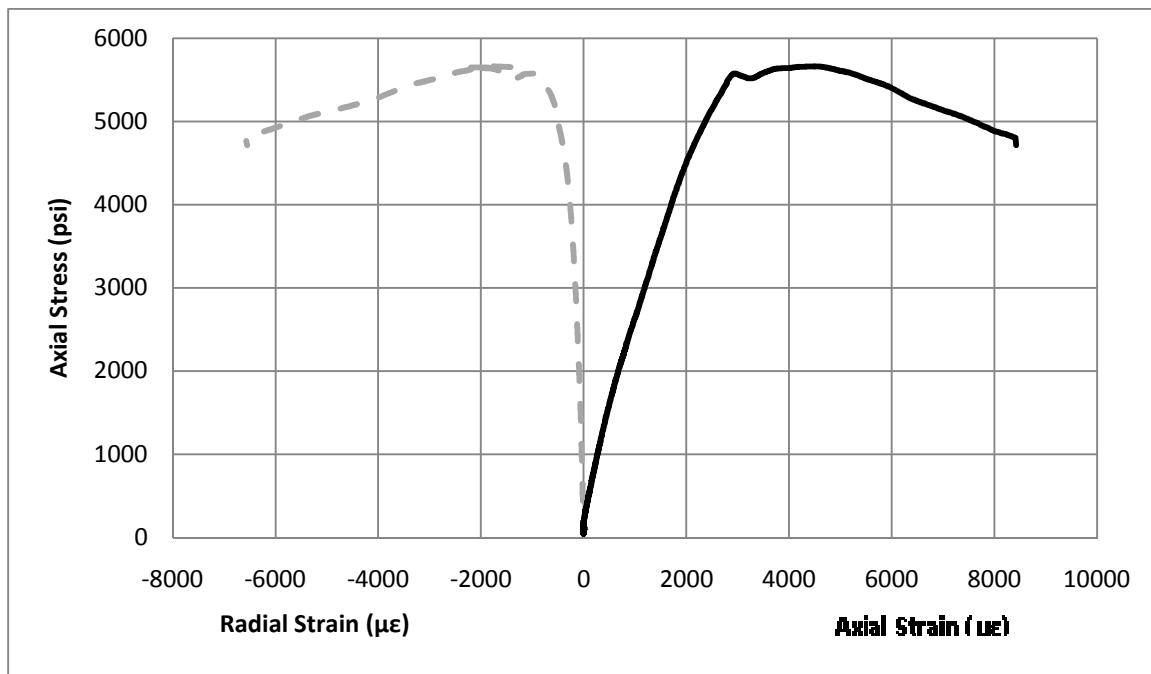
Figure A.3: #10HYBCTL axial stress versus radial and axial strain
