Image in cardiology

A Okreglicki

Cardiac Clinic, Groote Schuur Hospital, Cape Town, South Africa

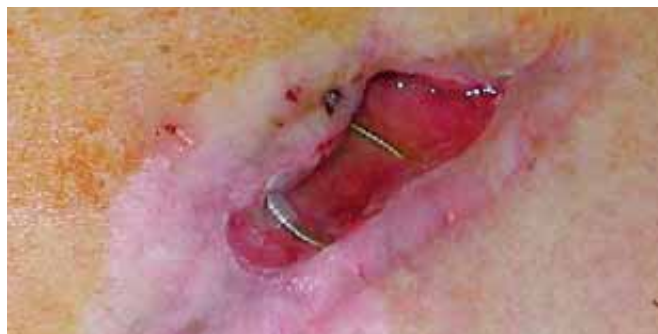
FIGURE 1: The pacemaker wound

A 67-year-old woman was referred with an "oozing" pacemaker wound for an opinion regarding whether the pacemaker pocket was infected. She had her original pacemaker implanted in 1984 and had had a number of pacemaker replacements, the most recent in 2005. She presented 6 months ago to her doctors with rigors, "soaking sweats" and loss of weight of 12kg and was treated for various presumed infections without resolution. A few months later, she noted a discharge from the pacemaker wound. Local wound treatment was given and despite attempts by a surgeon to bury the pacemaker deeper and close the wound, the problem recurred. On examination the pacemaker wound revealed a draining sinus which, after cleaning, showed exposed leads and infected granulation tissue (Figure 1).

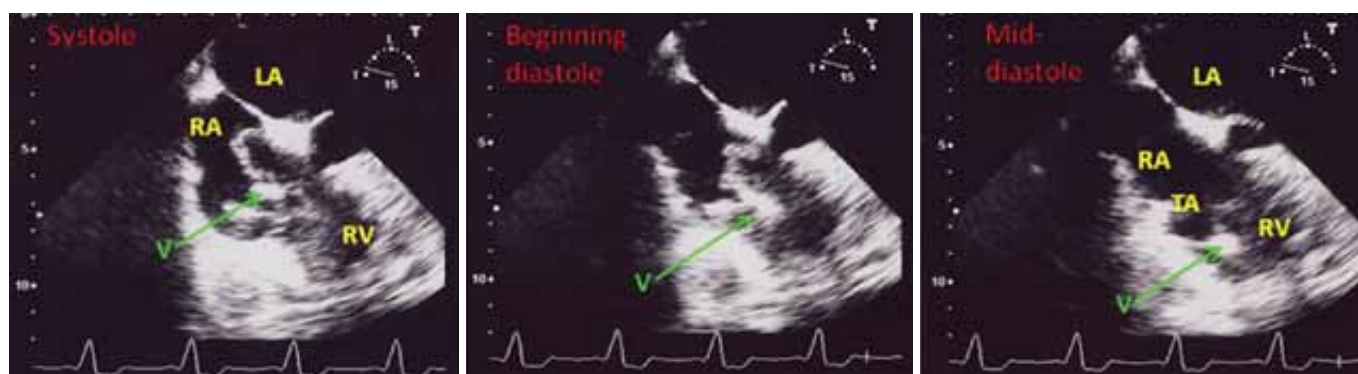
elongated pedunculated mobile vegetation 0.75 × 3cm attached to the pacing lead and prolapsing in and out of the tricuspid valve. Figure 2 shows the transesophageal images in various phases of the cardiac cycle with the vegetation.

FIGURE 2: The transesophageal echocardiogram in various phases of the cardiac cycle showing the large echobright mobile density, the vegetation (V), which was attached to the pacing lead, prolapsing in and out of the right ventricle (RV). (Abbreviations: RA=Right atrium, LA=Left atrium, TA=Tricuspid annulus)

This patient clearly had both local pacemaker wound sepsis and endocarditis. Blood cultures were positive for coagulase negative staphylococcus. Before planning lead extraction, echocardiography was done. Transthoracic echocardiography was reported as possibly showing some "thickening" of the right ventricular pacing lead. The transesophageal echocardiogram, however, showed a large
