Structural Health Monitoring of M1114 High Mobility Multipurpose Wheeled Vehicle Armor System

THESIS

AFIT/GEM/ENV/12-M19

AIR FORCE INSTITUTE OF TECHNOLOGY

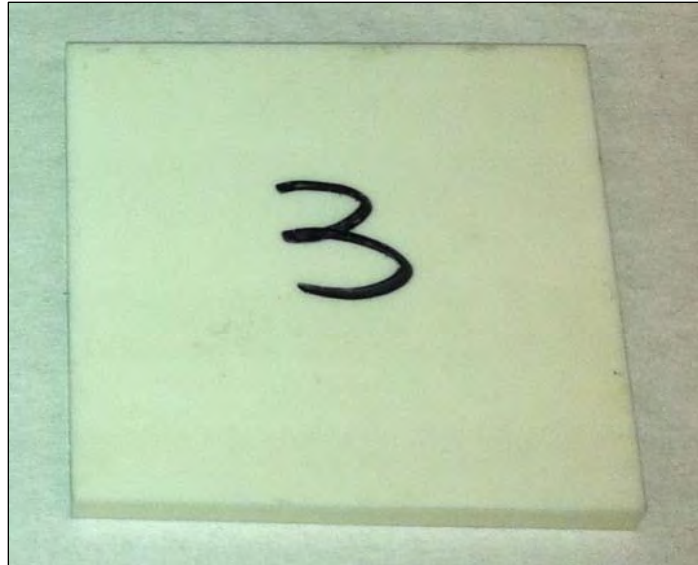
Figure 2.1. Ceramic Frontal Plate

Alumina (Al₂O₃), used in the form of ceramic tiles, is light, hard, and strong in compression. Figure 2.1 is an example of a alumina ceramic frontal plate. When a ceramic tile sustains a ballistic impact, the face of the tile experiences compressive forces, against which ceramics are extremely strong and typically will not fail. Erosion of

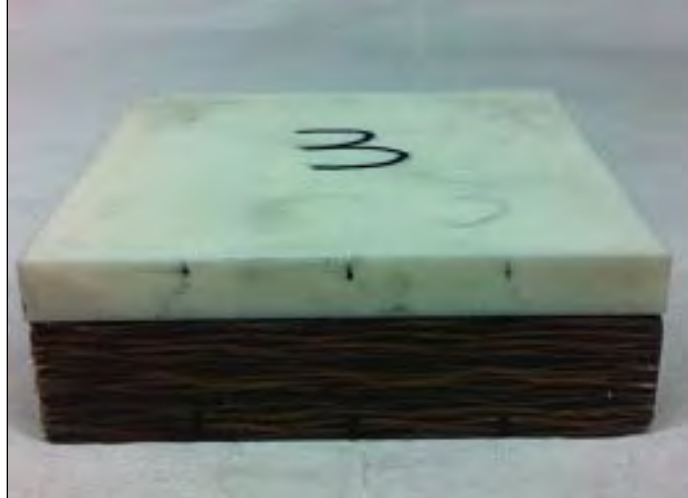
Figure 2.3. Two Layer Armor with Ceramic Frontal Plate and HJ1 Composite

The composite backing material (HJ1) serves a dual purpose; it carries the bulk of the load when the armor is used for structural applications in addition to ballistic protection. It also absorbs the kinetic energy of the armor-piercing projectile once its tip is blunted. The kinetic energy is absorbed through a combination of fiber strain and fracture, fiber pullout, and composite delamination. Figure 2.3. illustrates a coupling of the ceramic and composite as an armor system.

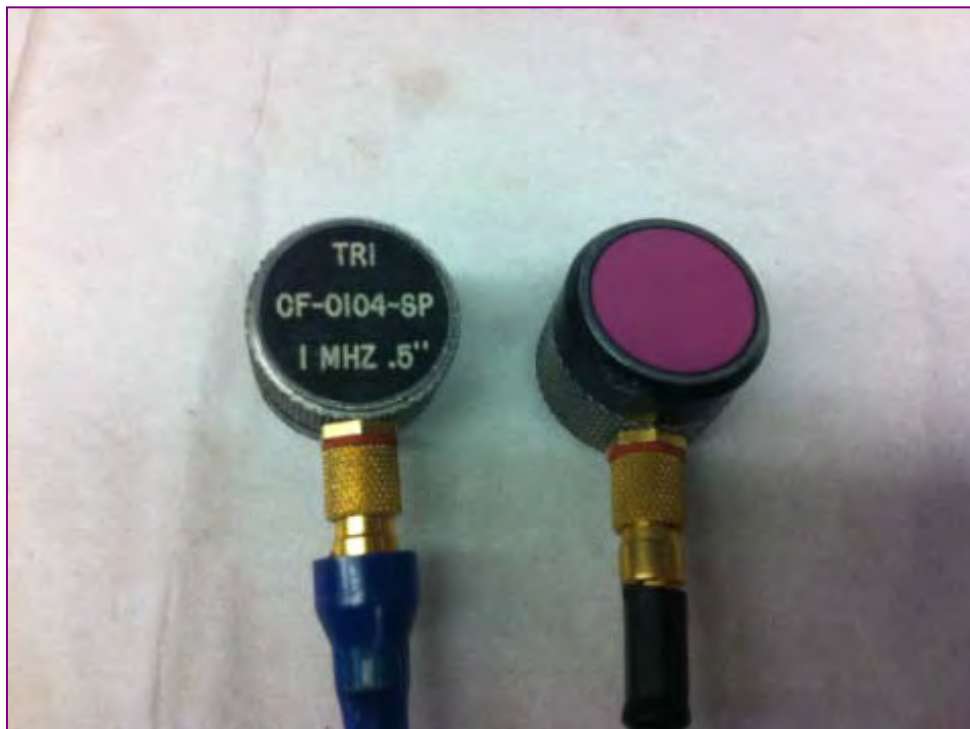
Figure 2.5. PZT Sensor used to Induce and Collect Wave Propagation

Lead zirconate titanate also referred to as PZT, these sensors are used to induce and receive ultrasonic Lamb waves, see Figure 2.5. PZT materials exhibit an effect whereby they expand or contract in the presence of an applied electrical field (Gautschi, 2002). The electrical source can be a waveform generator like the one on Figure 2.6. The propagated waves received by the PZT sensor will be outputted to the oscilloscope to collect data, see Figure 2.7.

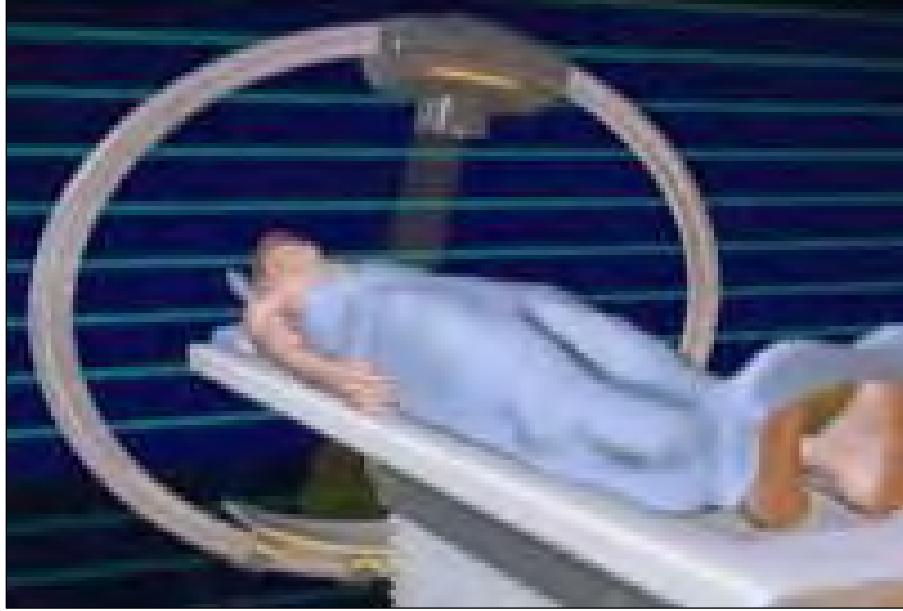
Computed tomographic reconstruction has been used in many industries. Since the 1970s, computed tomographic reconstruction has become a crucial tool in the medical industry. Tomographic reconstructions has been used for medical imaging of human internal organs and bone structures using conventional x-ray tomography, where the X-ray technician captures images of the body by moving an X-ray source and film in opposite directions during the exposure. Three-dimensional images are created by taking images around a single axis of rotation, see Figure 2.9.

Figure 2.9. X-Ray Images Taken Around a Single Axis Rotation to Create a Three-Dimensional Image (Donaldson, 2010)

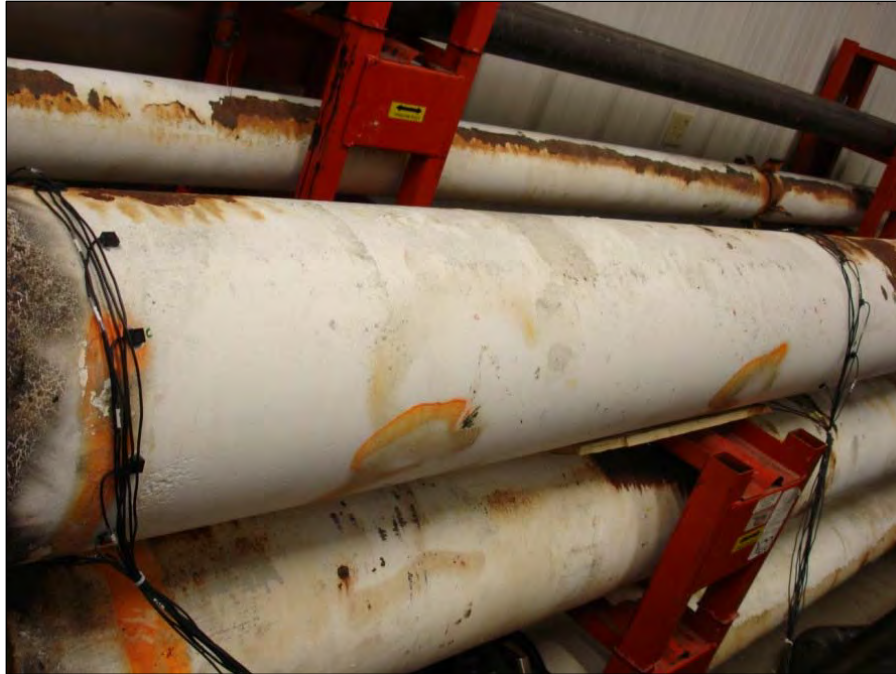
Figure 2.10. Photo Showing One Setup for Using CT Approach for Pipeline Health Monitoring (Royer, Velsor & Rose, 2009)

Specific uses of ultrasonic Lamb waves on tomographic reconstruction have been used to monitor the structural integrity of pipelines. On Figure 2.10, PZT sensors are placed to form two vertical arrays around the circumference of a 10” steel pipe (schedule 40) at two different axial positions 48” apart (Royer, Velsor & Rose, 2009). Ultrasonic waves are induced and acquired between the two boundaries using all possible combinations of pitch-catch patterns between inducing and receiving sensor. Preliminary data sets were collected as a baseline data set for an undamaged pipe. Material was removed to form damage and new data sets were collected from the PZT sensors. A tomographic image was reconstructed by comparing the undamaged and damaged data, see Figure 2.11.

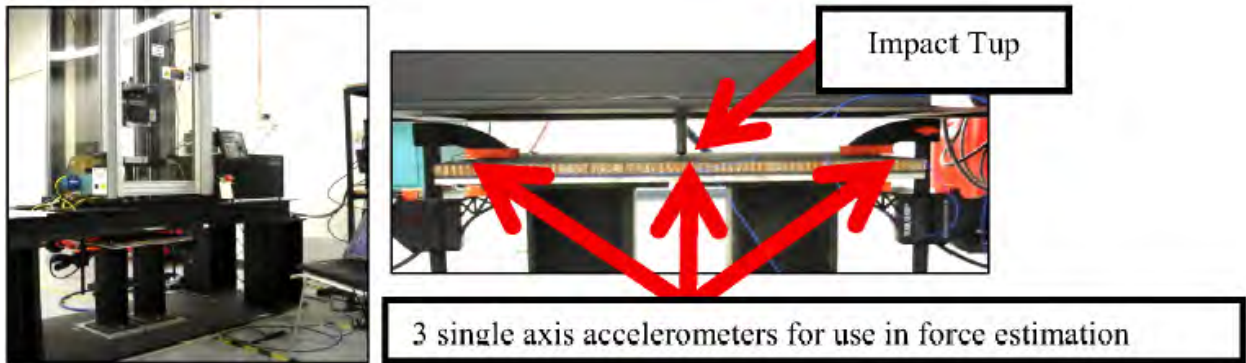
Figure 2.14. Passive Structural Health Monitoring on S-2 Composite Armor

In an experiment conducted by facility of University of Purdue in conjunction with the US Army Research Laboratory, vibration-based structural health monitoring was successfully conducted on one layer S-2 composite system, see Figure 2.14. The researchers were successfully able to passively identify the external force, identify the amount of damage, and quantify damage (Stities, 2007). Damaging impact energy (weighted hammer test) was applied to the test specimens and the passively measured frequency response of the armor was used to produce a dynamic model of the specimen

The researchers were able to correctly identify the location of the impact 93.4% of the time, while 100% identification was produced within a 1” of the actual impact location. Impact identification was done using a single tri-axial accelerometer to calculate the force impact. The major limiting factor of this research is that the impact was completed by dropping 4.5, 5.25, and 6.0 lb. weights on to the S-2 composite. This produced a small amount of damage compared to a .30 AP projectile. It is also limited to single layer sensing instead of two layers.

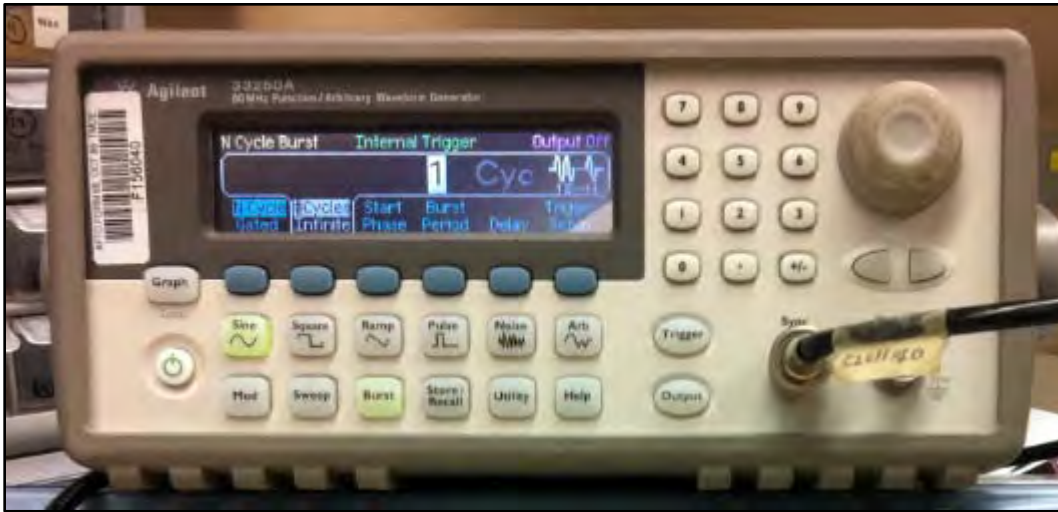
Figure 3.4. Agilent 80 MHz Function/Waveform Generator, Model 33250A

- Agilent 80 MHz Function/Waveform Generator, Figure 3.4
 - Model: 33250A
 - Calibrated 14 April 2010 Figure 3.5

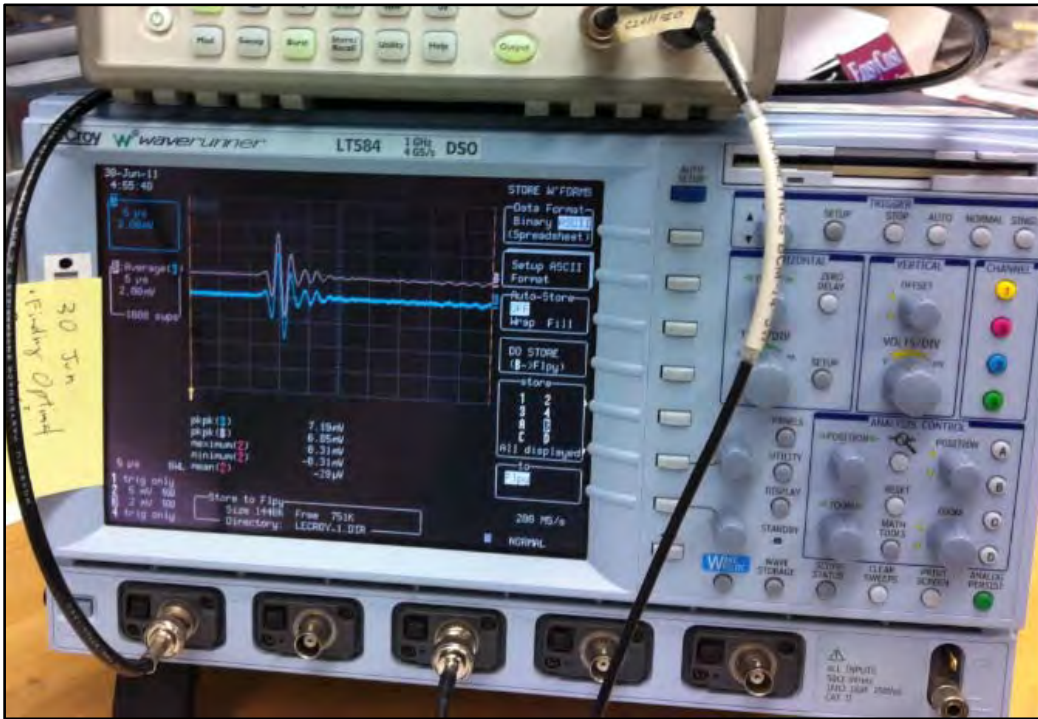
Figure 3.6. LeRoy Digital Oscilloscope, Model LT584

- LeCroy Digital Oscilloscope, Figure 3.6

- Model LT584
- Calibrated: 21 October 2010, Figure 3.7

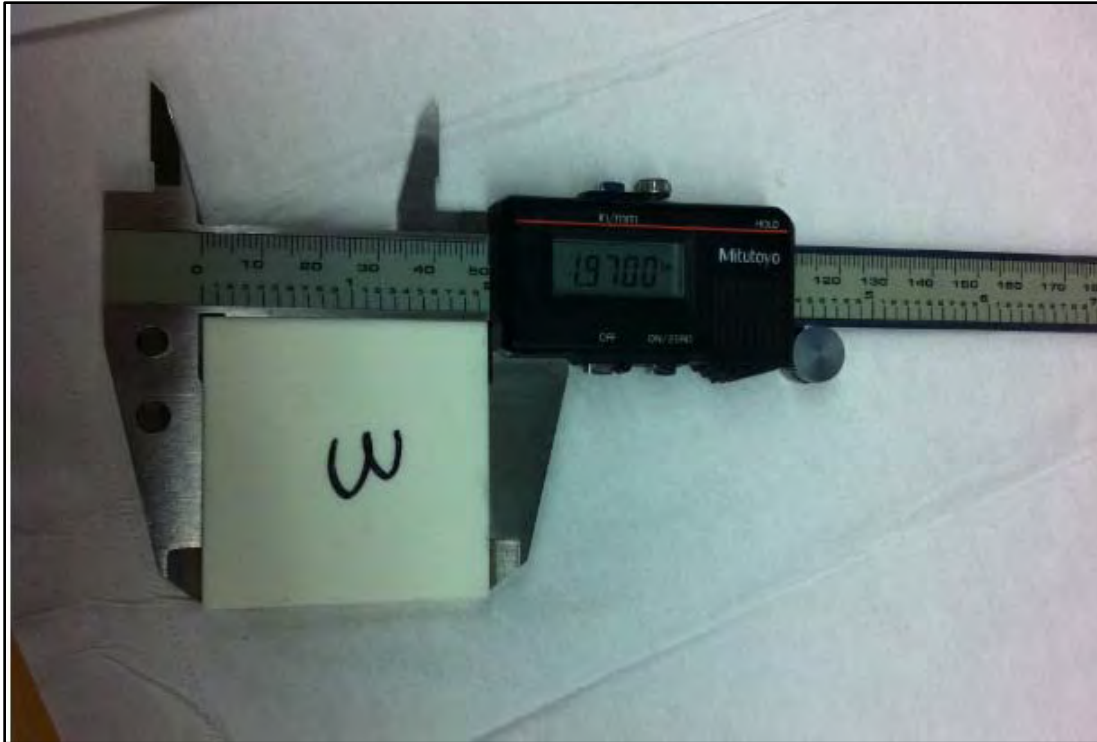
Figure 3.8. Mitutoyo Digital Caliper

- Mitutoyo Digital Caliper, Figure 3.8
 - Model: 500-352
 - Calibrated: 14 December 2010 Figure 3.9

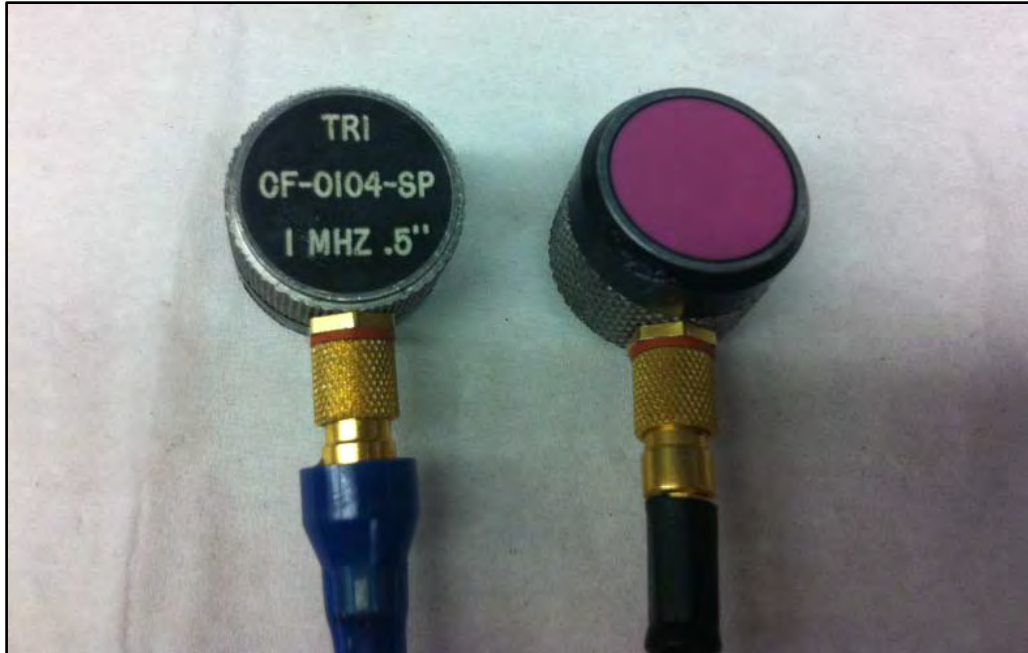
Figure 3.10. PZT Sensors

- Two Piezoelectric Longitudinal Wave Sensors, Figure 3.10
 - 1 MHz capacity, 0.5" diameter
 - Calibrated: 28 Jun 2011

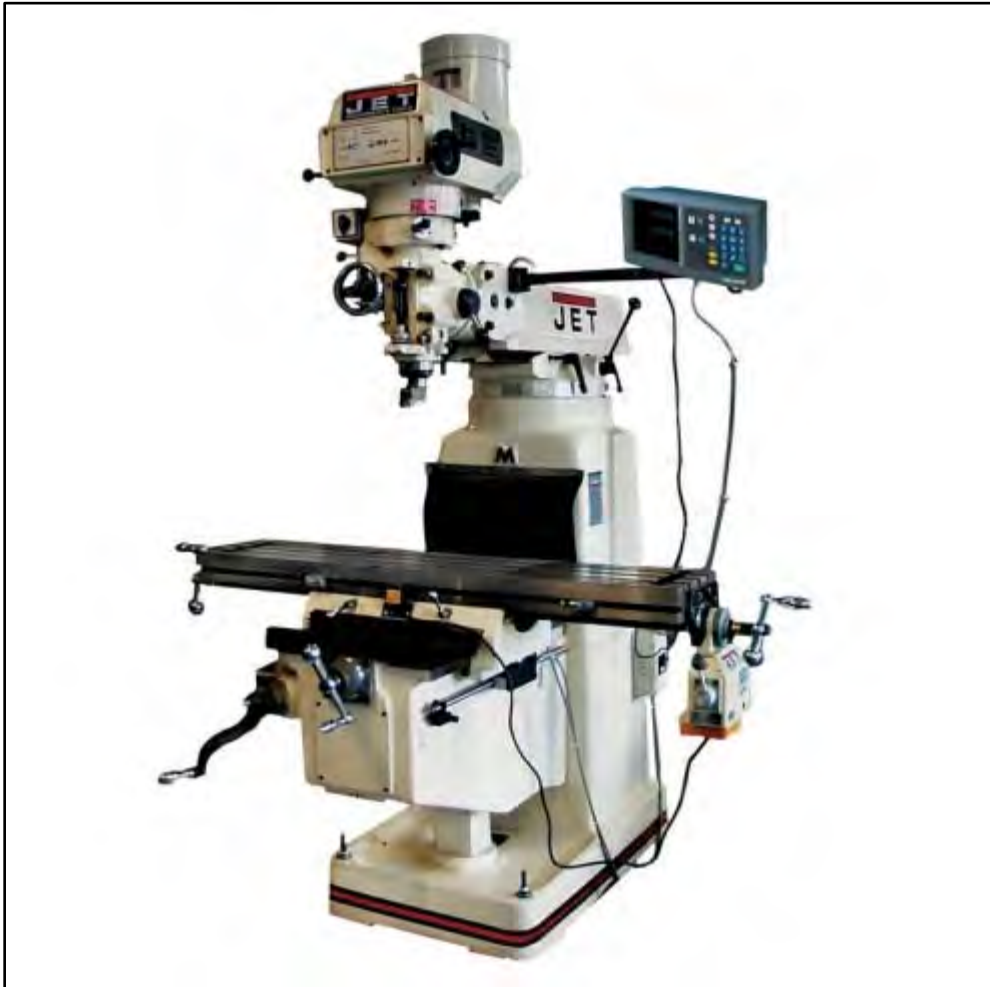
Figure 3.12. Jet JTM-1050 Mill

- Jet JTM-1050 Mill/Acu-Rite, Figure 3.12
 - Model: 6-200-010

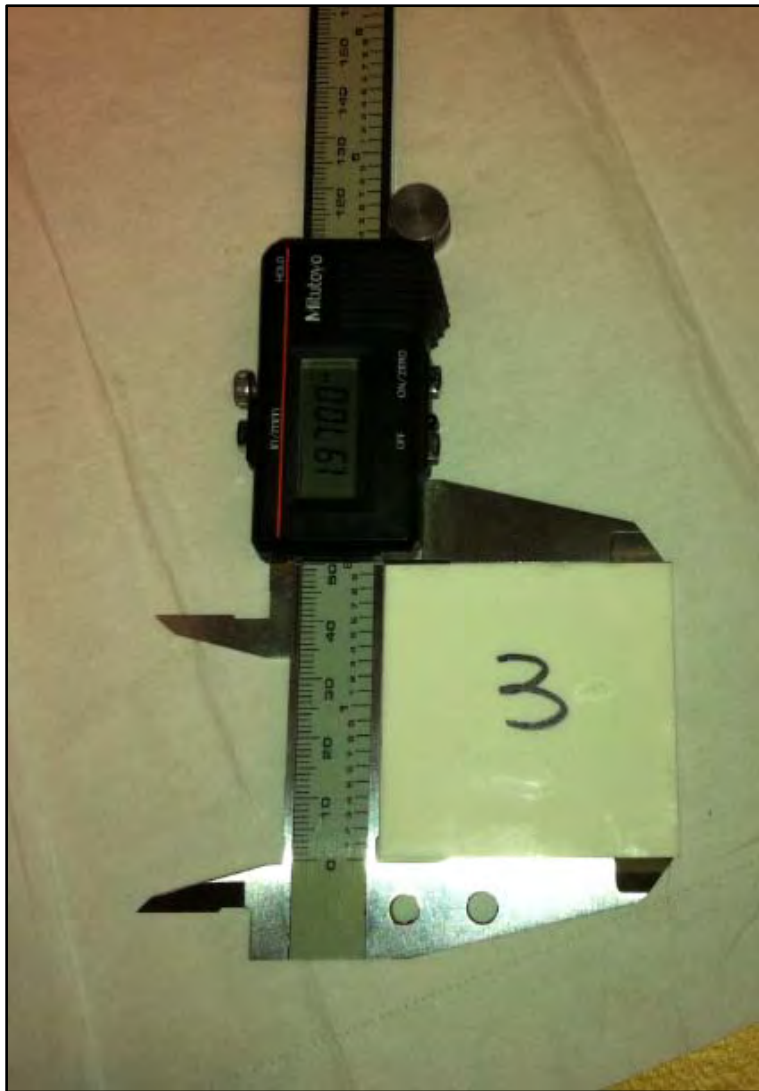
1) The first step was to measure the dimensions of the five ceramic coupons, see Figure 3.16.

Figure 3.16. Measuring the Dimensions of Ceramic Coupon #3

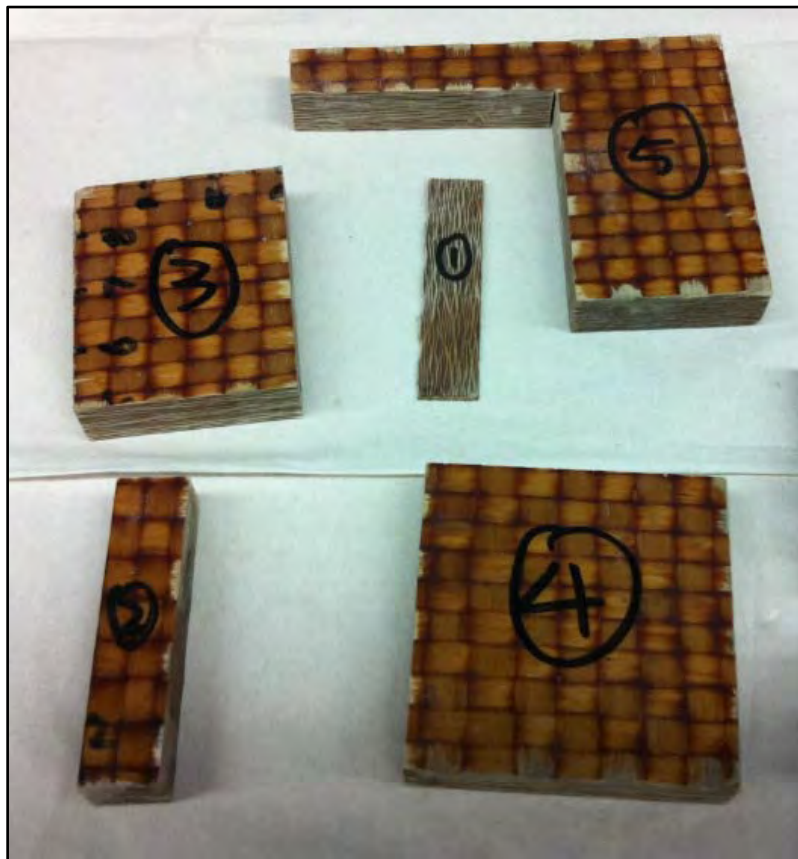
3) Cut other HJ1 coupons of varies sizes, see Figure 3.17.

Figure 3.17. Various Different Cuts HJ1 Coupons

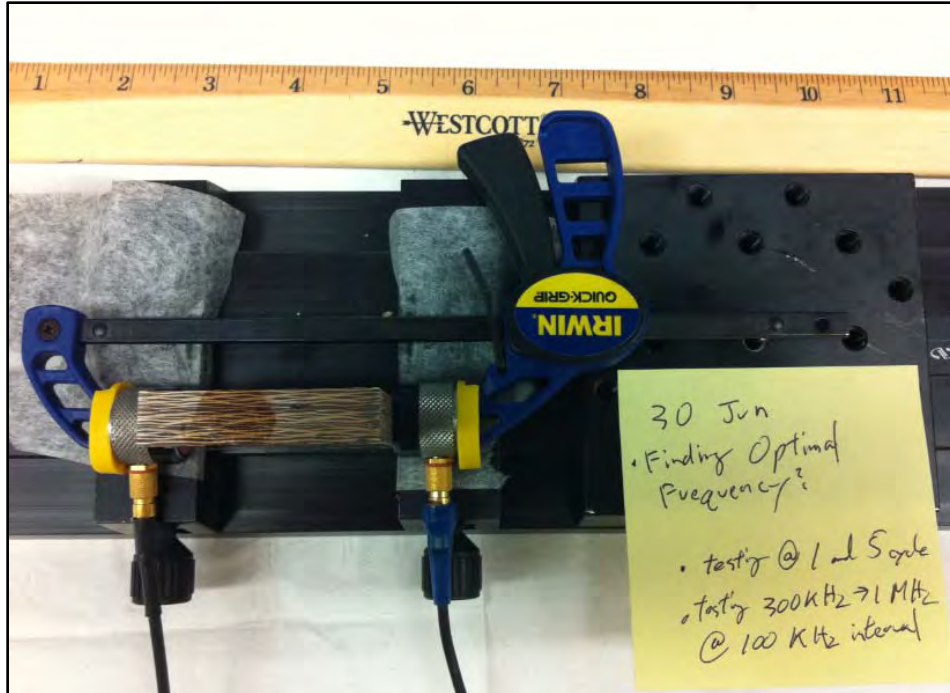
Figure 3.18. Top View of the Composite Coupon on the Mounting Platform with PZT Sensors Clamped on to the Coupon

- I. Place the composite on the secured mounting platform.
- II. Place a PZT sensor on each side of the composite with a small amount of coupling grease.
- III. Ensure that the PZT sensors are placed in a straight line to optimize capturing of the wave propagation data.
- IV. Use the Irwin Quick-Grip to secure the sensors in place.

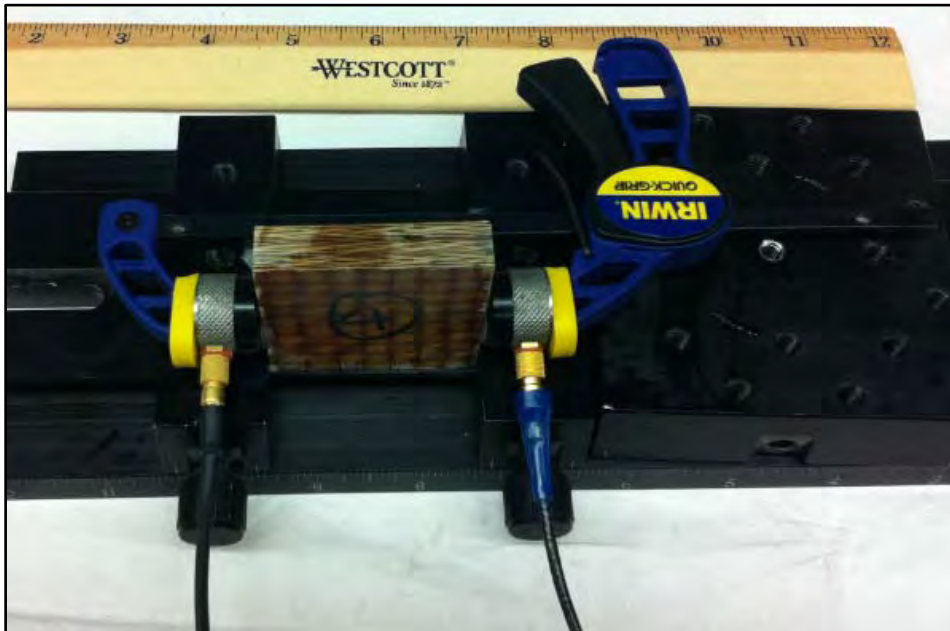
5) Conduct wave propagation experiments on composite samples 1 through 5 to determine optimal frequency settings for the rest of the experiment, see Figure 3.18 and Figure 3.19.

Figure 3.19 Another top View of the Composite Coupon on the Mounting Platform with PZT Sensors Clamped on to the Coupon

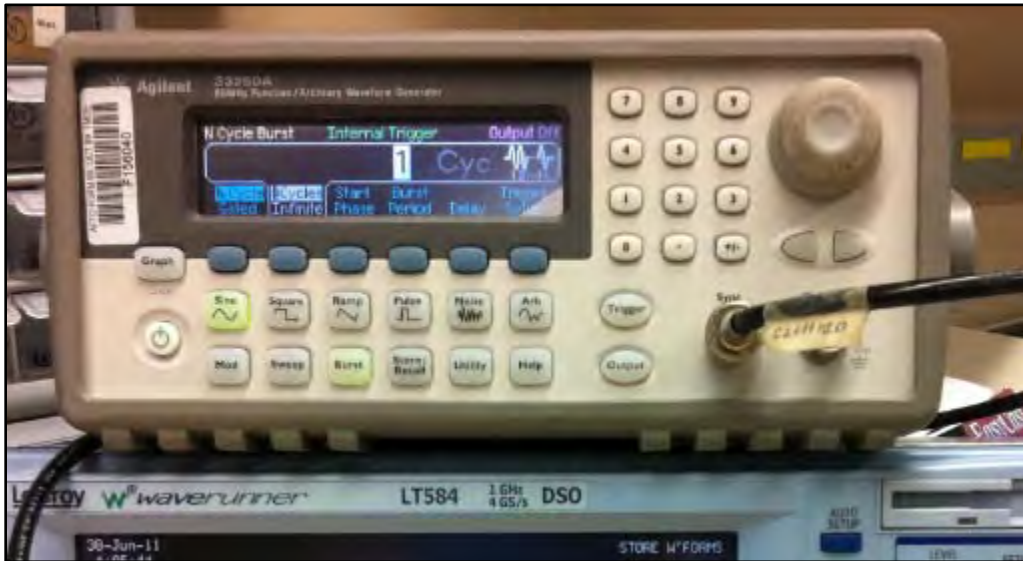
- V. Settings on the wave form generator see Figure 3.20.
- VI. 300-1000 KHz (100 KHz intervals).

- VII. Tone bursts of 1 and 5 cycles.
- VIII. Period (2 – 5 μ s, which ever that presented a clean output).

Figure 3.20. Waveform Generator Used to Create Input Wave Propagations

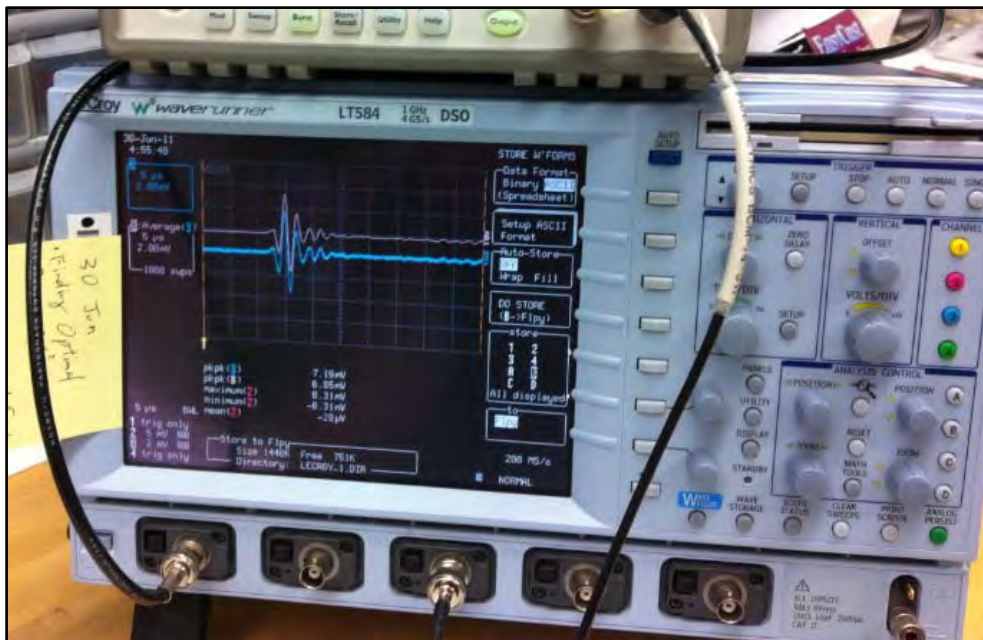
- IX. Record data on the oscilloscope, Figure 3.21.
- X. Record max pike-to-pike voltage (mV) on the floppy drive.

Figure 3.21. Oscilloscope Used to Capture Output Wave Propagations

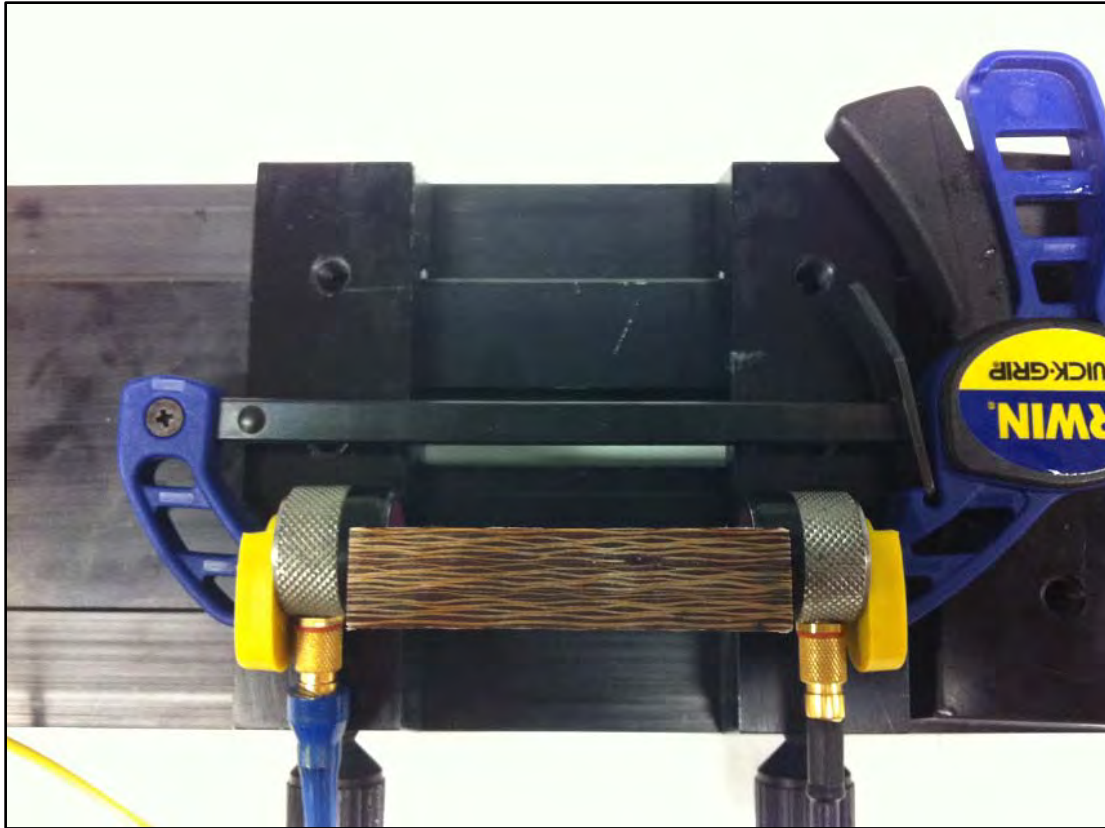
Figure 3.26. PZT Sensors Placed on the Composite in an Offset Orientation

9) Repeat step 7 without the composite, but with the sensors in the exact location as if the composite was still present. See Figure 3.26.

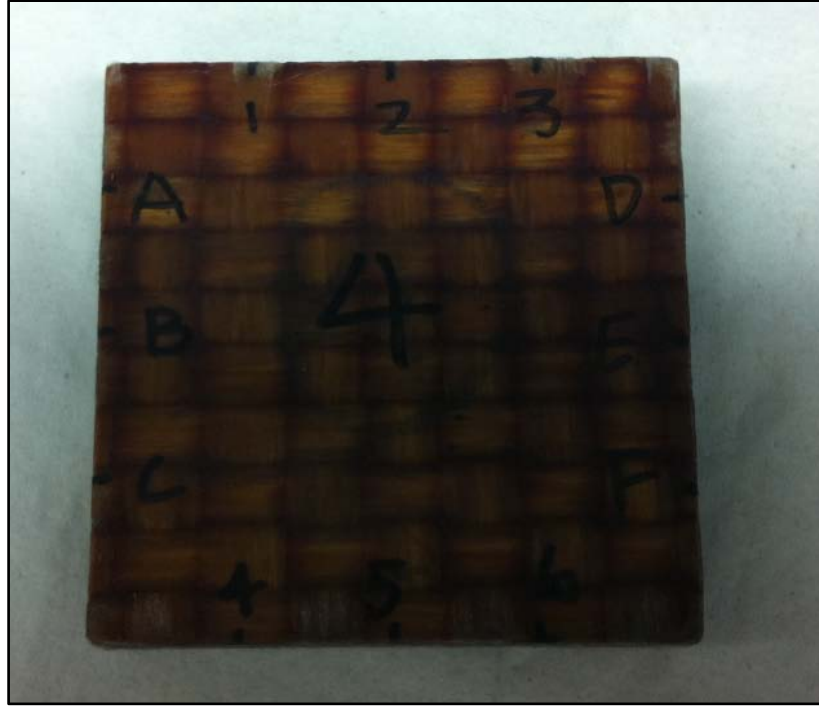
11) Divide each sides of the composite into four sectors, see Figure 3.27.

Figure 3.27. Composite #4 with the Divided Markings

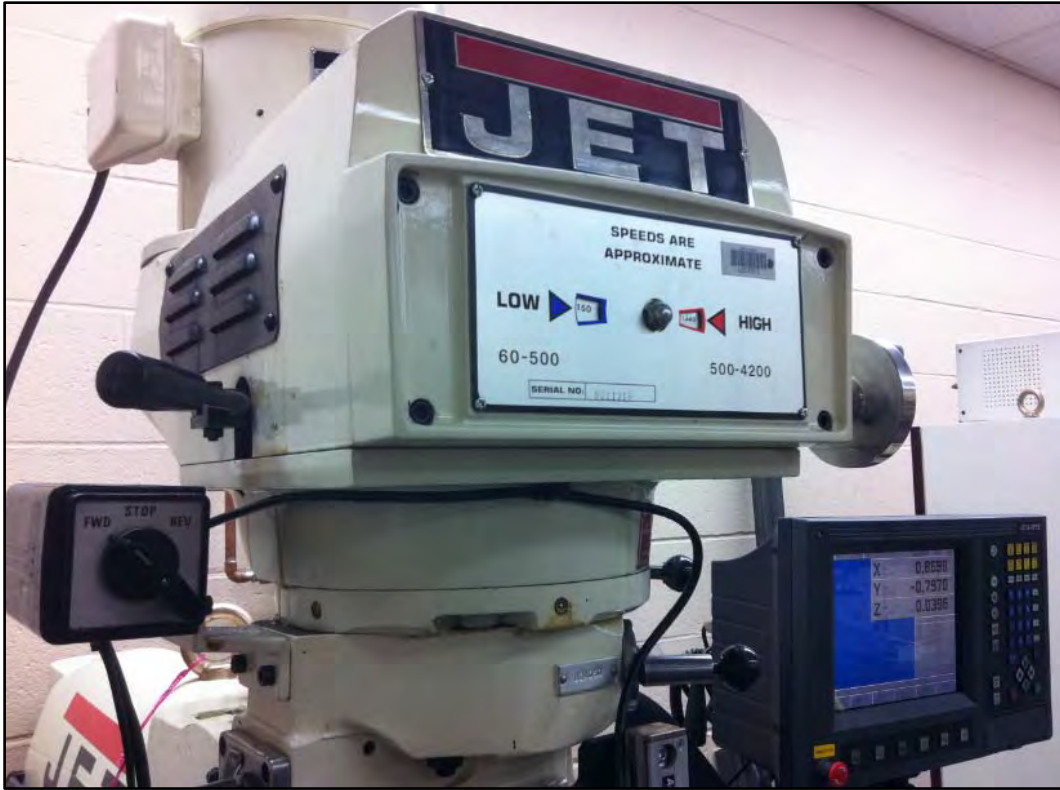
Figure 3.28. JET mill with Acu-Rite display

- 12) Repeat step 11 on the ceramic coupons.
- 13) With the Starlite diamond tipped drill bit and JET mill, drill 1.52 mm into the center of the ceramic, see Figure 3.28, 29, and 30.
 - I. The ceramic and the mounting structure was kept submerged in a container of water to dissipate the heat from the drilling, see Figure 3.31
 - II. Set the low speed to 150 and high to 1240, see Figure 3.32.

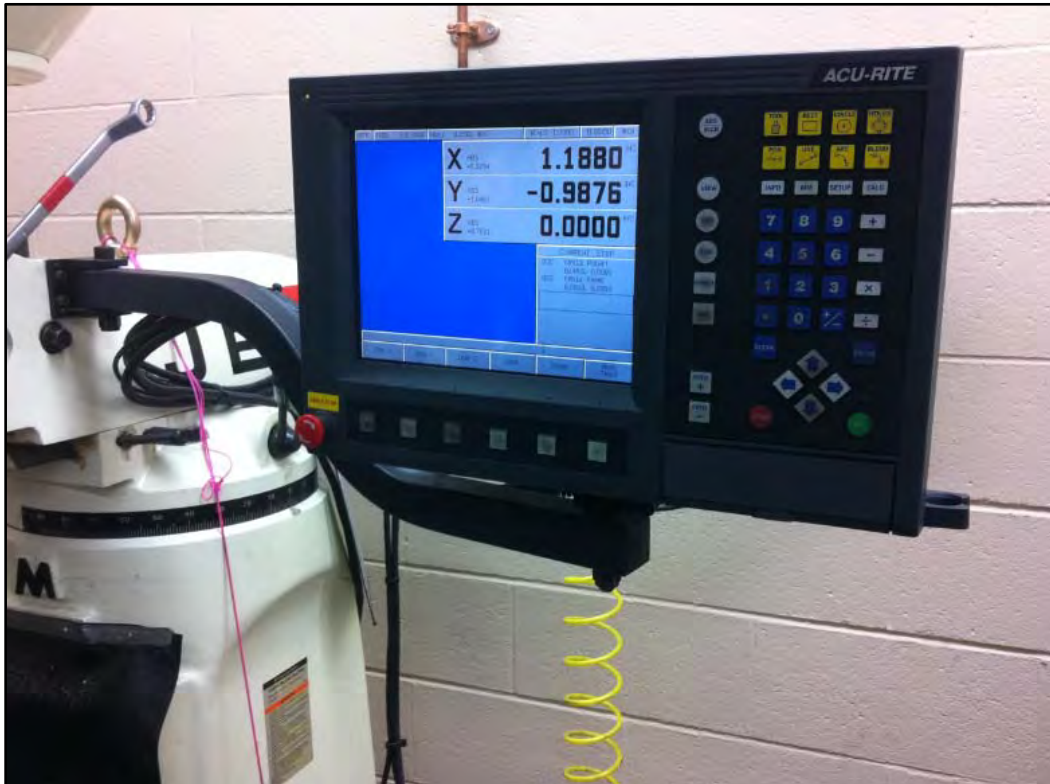
Figure 3.29. Acu-Rite Display Used to Control Location and Depth of the Drill Operation

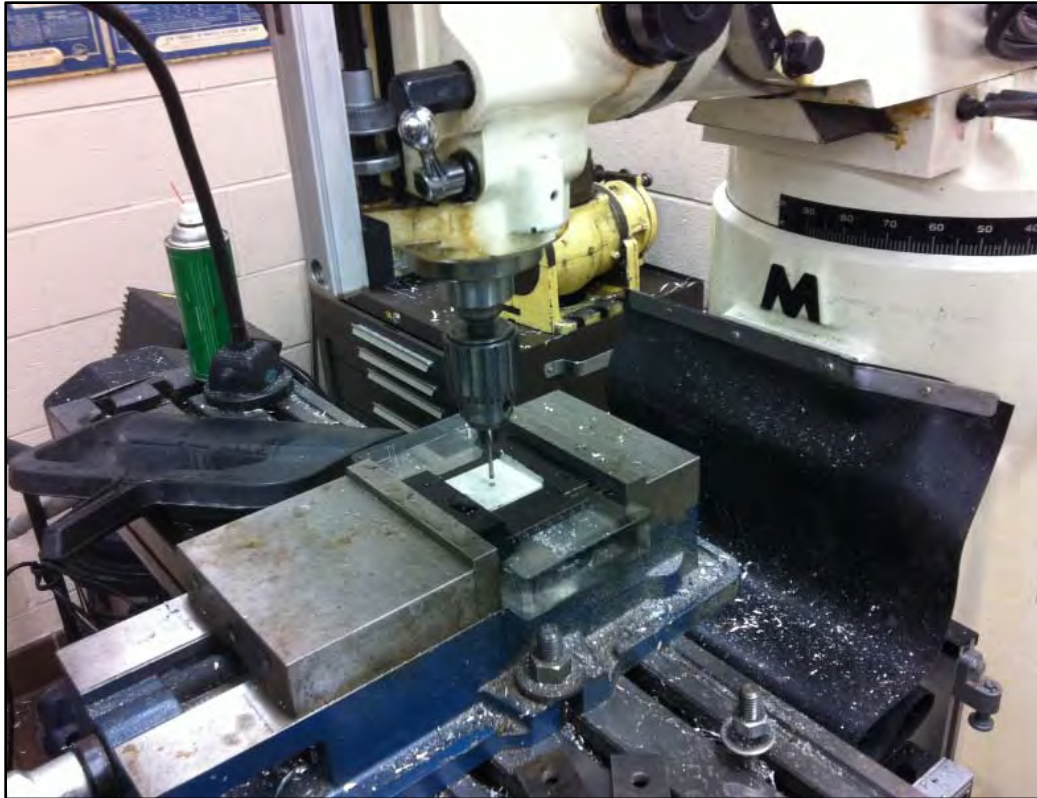
Figure 3.30. Ceramic Coupon Being Drilled

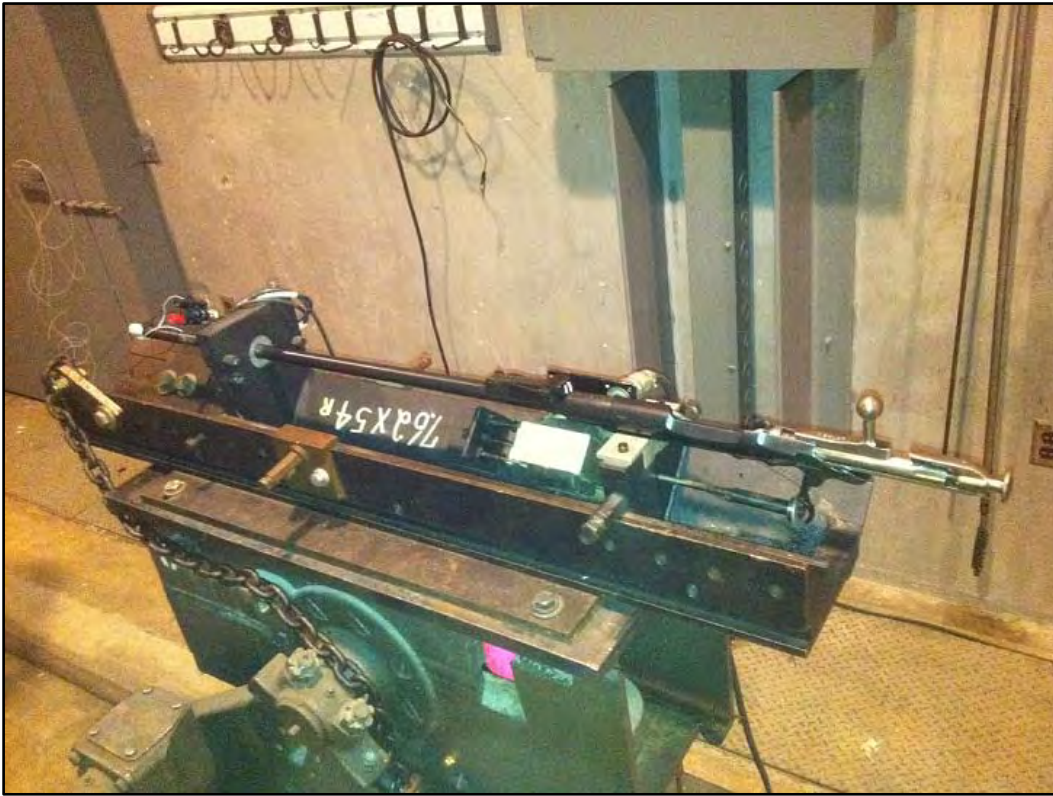
Figure 3.41. Remote Triggered Rifle

- Remote triggered rifle, Figure 3.41 and 42.

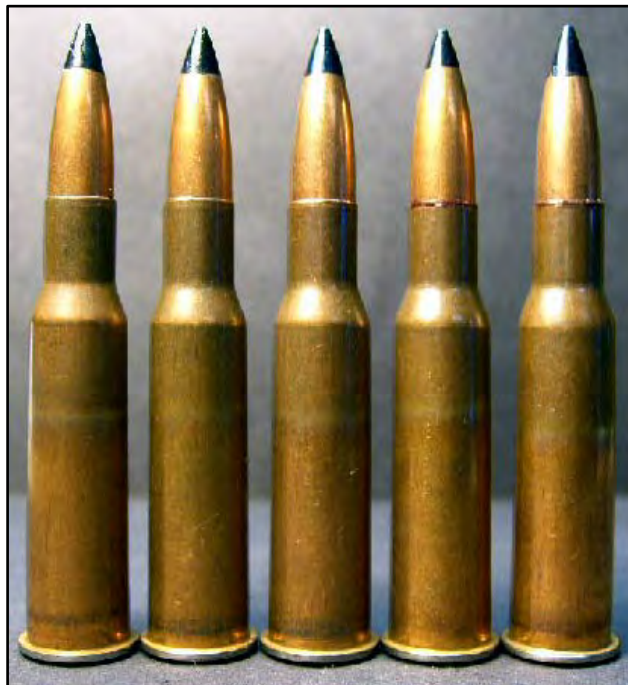
Figure 3.43. Projectiles

- Two 30 cal (7.62 x 54 mm) Armor Piercing Projectiles, Figure 3.43

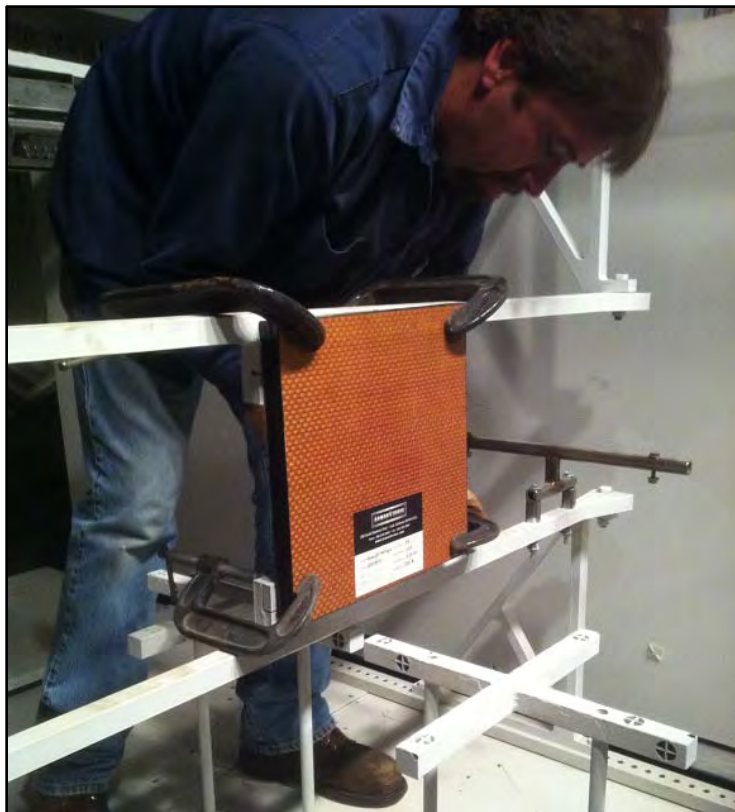
12) Place the two layer armor on to firing mount structure and use the four c-clamps to hold in place. See Figure 3.46 and 47.

Figure 3.46. 46th Test Group Personnel Clamping on the Armor System

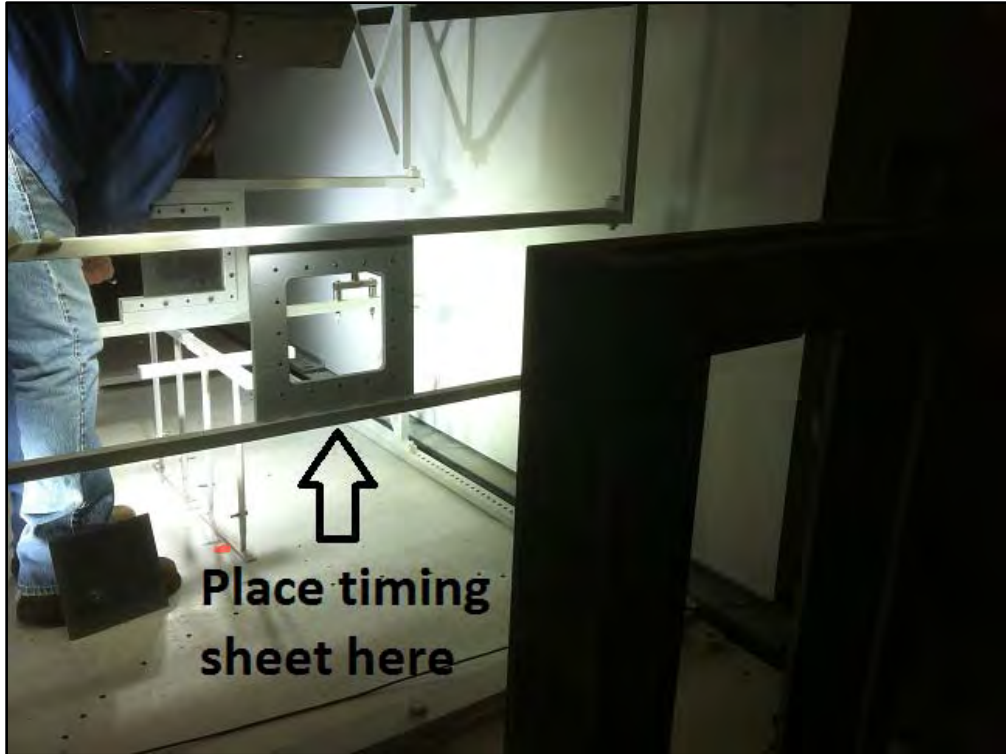
- 13) Make sure that the strike face of the armor is place in the correct direction
- 14) Place the timing sheet on the mount as shown on Figure 3.48.

Figure 3.48. Location of where the Timing Sheet is Placed

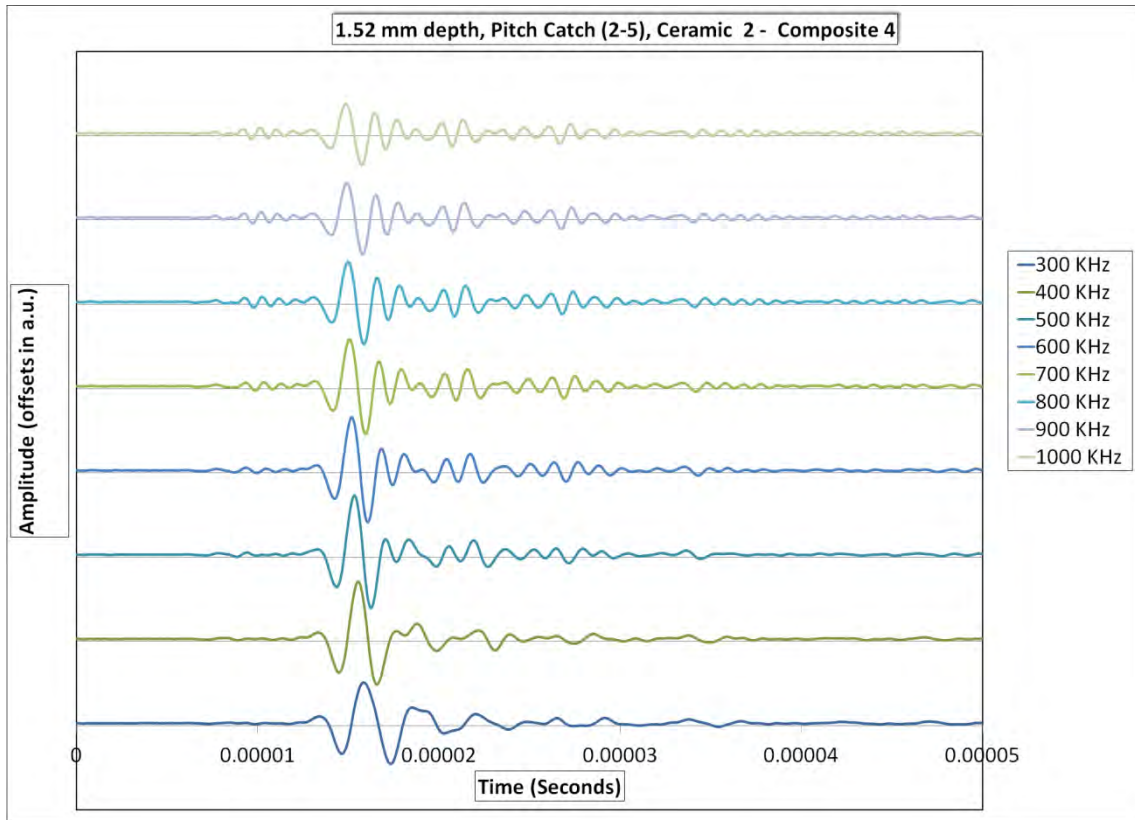
Figure 4.6. Wave Propagation with Damage at 1.52 mm Depth from 300 KHz to 1000 KHz

The wave propagations on Figure 4.6 are of those using 300-1000 KHz with the ceramic coupon and composite coupons clamped together, with a controlled circular hole (3.13 mm diameter) drilled 1.6 mm into the ceramic. The overall characteristic is consistent throughout the 300 to 1000 KHz range. This would indicate that input frequency changes will not affect the data capture and analysis of the structural change that has occurred.

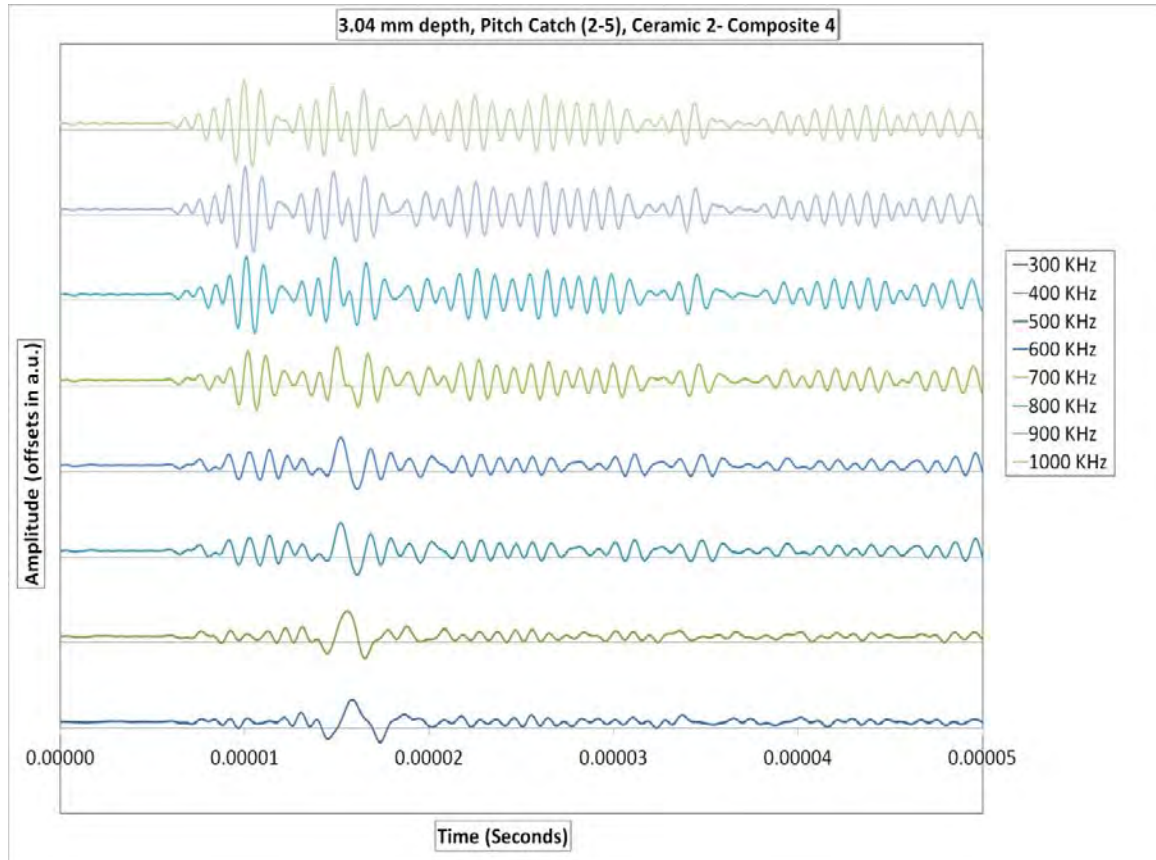
Figure 4.7. Wave Propagation with Damage at 3.04 mm Depth from 300 KHz to 1000 KHz

least within this procedure step, the overall characteristic is consistent throughout the 300 to 1000 KHz range.

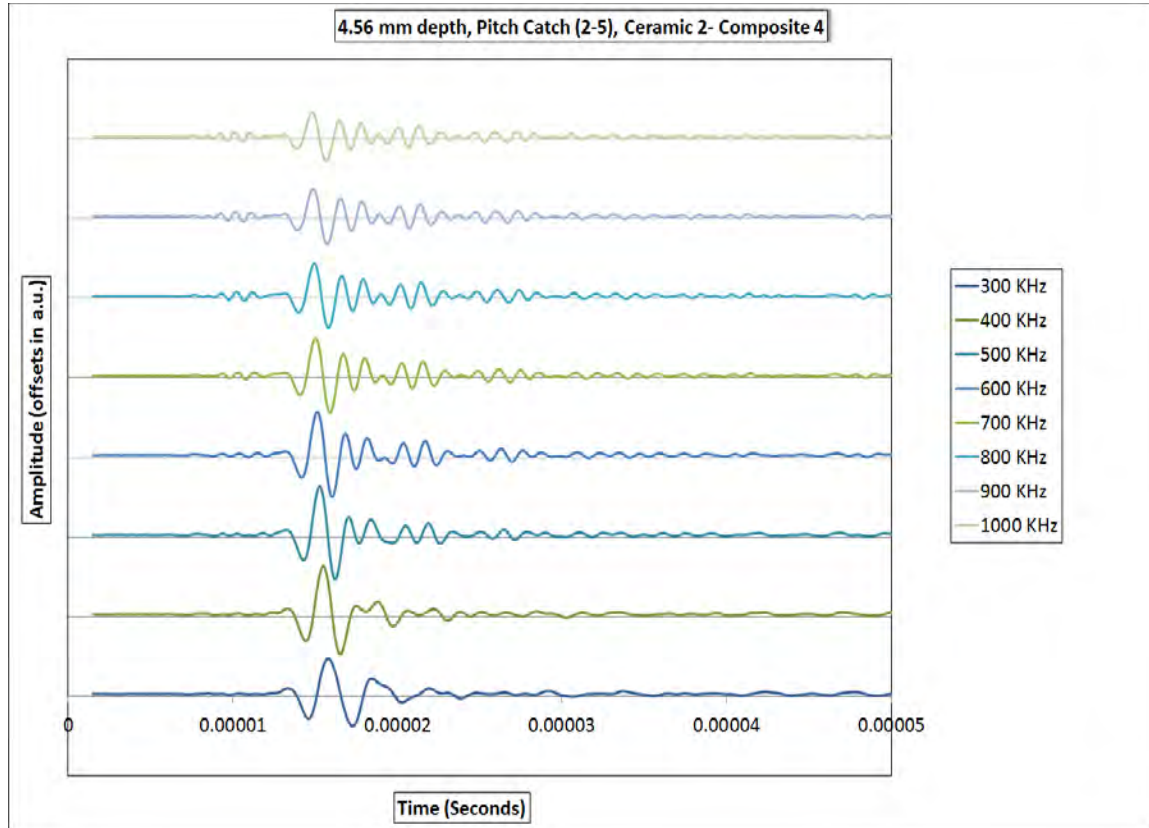
Figure 4.8. Wave propagation with damage at 4.56 mm depth from 300 KHz to 1000 KHz

of changes to wave propagation to investigate. This also confirms that it can be replicable.
