Structural Health Monitoring of M1114 High Mobility Multipurpose Wheeled Vehicle Armor System

THESIS

AFIT/GEM/ENV/12-M19

AIR FORCE INSTITUTE OF TECHNOLOGY

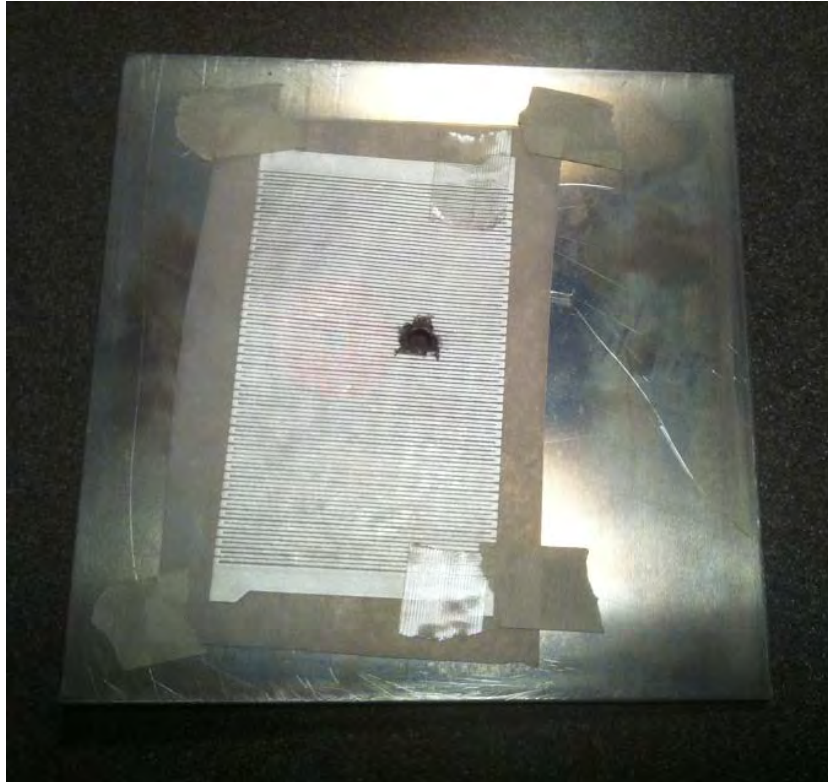
Figure 4.10. Successful Test Fire for Equipment Check

The equipment test fire on the sheet of aluminum was a success, see Figure 4.10. The test fire ensured that the slow motion cameras and the timing system were functioning properly. The target was struck dead center mass and at a zero degree angle of strike. The test did indicate that the maximum achievable velocity for the ballistic range was 834.8 meters/second instead of the goal of reaching 948 meters/second.

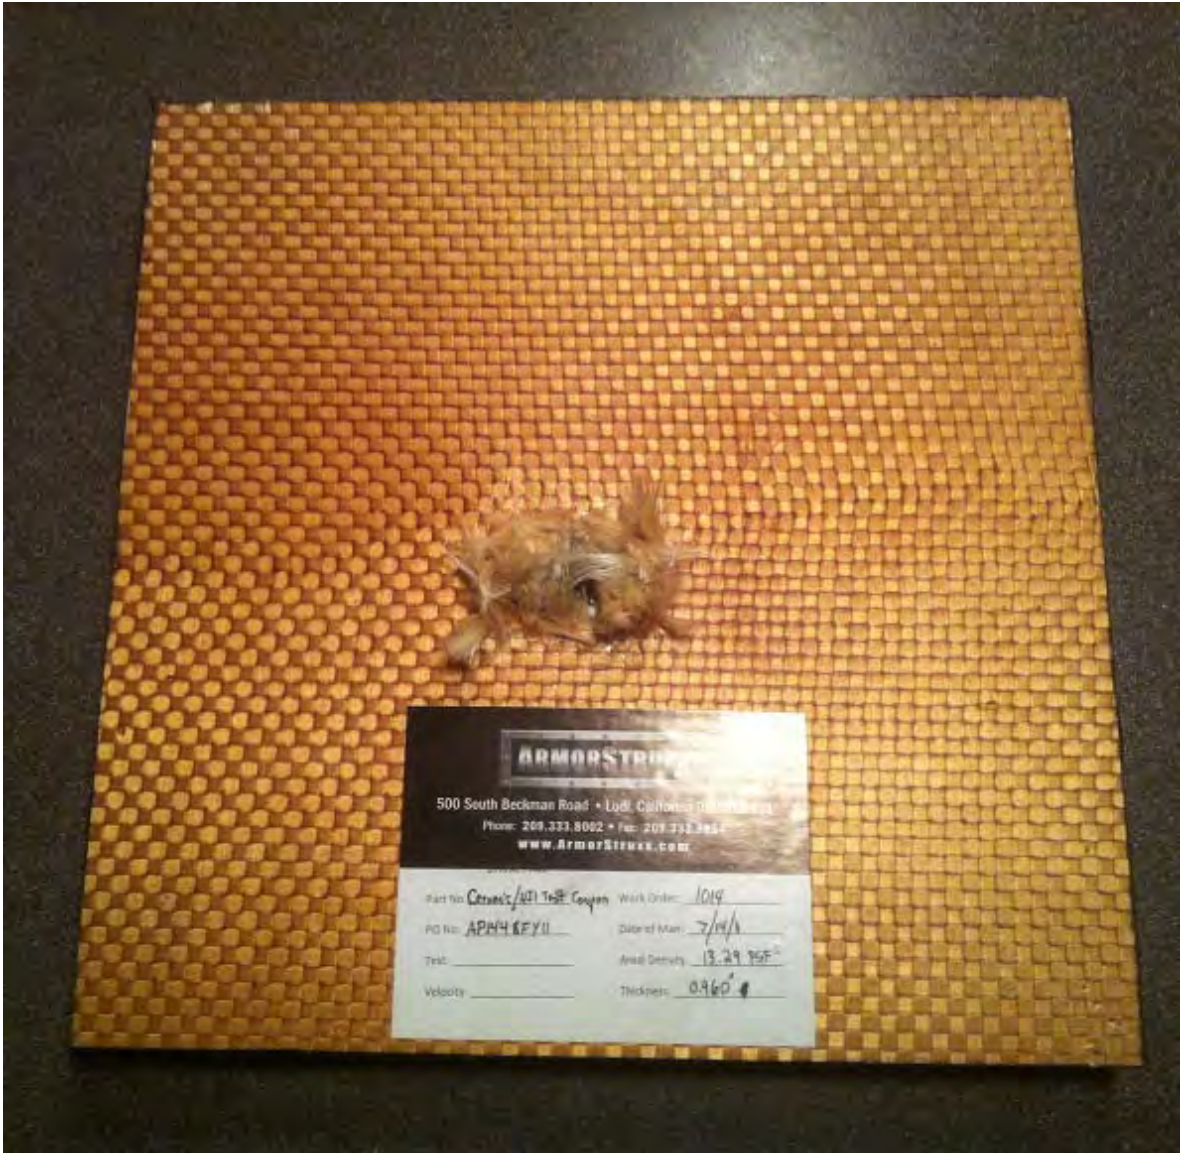
Figure 4.11. Successful Ballistic Test on the Two Layer Armor

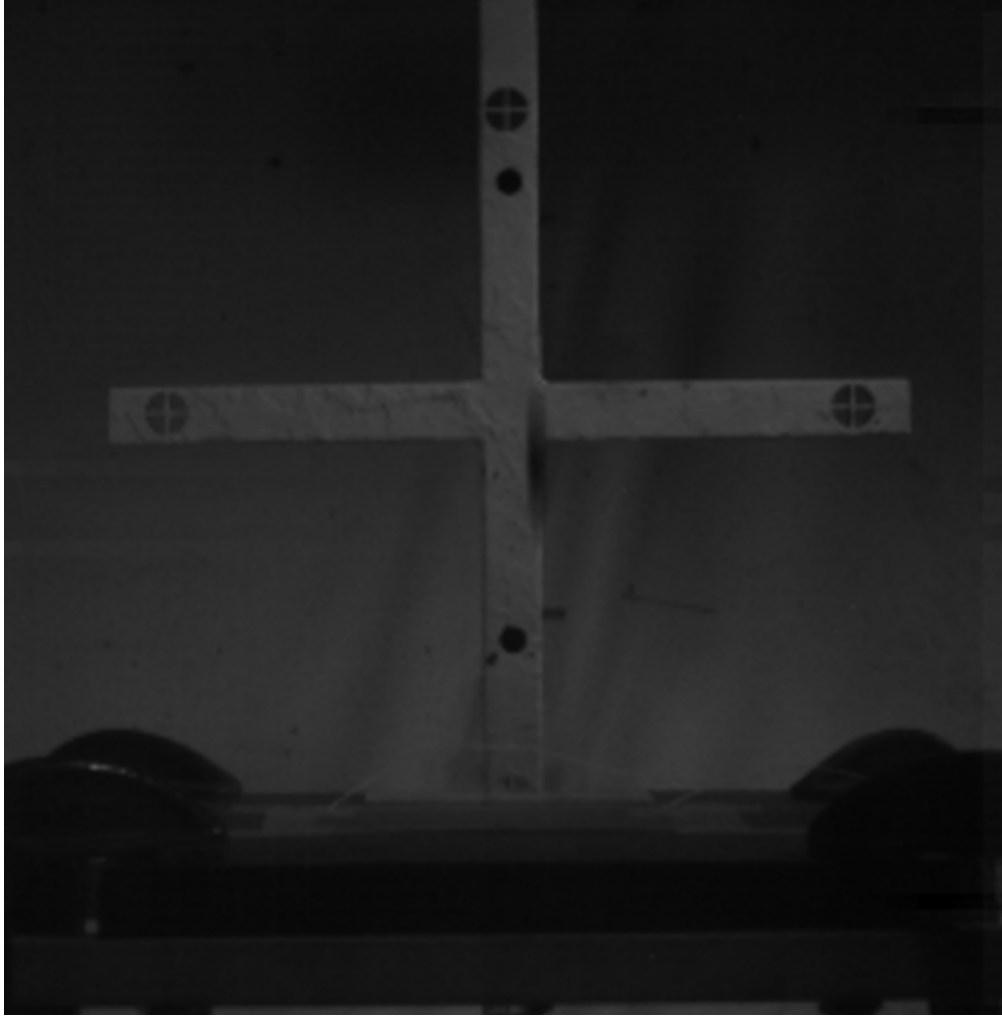
Figure 4.12. Top View of the Projectile Before Impact

The ballistic was successful just like the test fire. The two layer armor in Figure 4.11 was struck center mass with a zero degree angle of strike. The ceramic frontal plate functioned as it was designed to do so. The ceramic's high mechanical strength, hardness, and stiffness absorbed the majority of the kinetic energy from the armor piercing projectile. The ceramic's structural integrity breaks as it deforms the tungsten core of the projectile. The HJ1 composite absorbs and dissipates the remaining energy in the layered structure of the composite. There is a bulge on the back side of the armor system, but there was no penetration through the HJ1 composite. Figures 4.12 -15 provides a top view of the ballistic impact testing. Figures 4.16 -19 provides a top view of the ballistic impact testing.
