Tension-Compression Fatigue of Hi-Nicalon/SiC Ceramic Matrix Composite at 1200°C in Air and Steam

**TENSION-COMPRESSION FATIGUE OF Hi-NICALON/SiC CERAMIC MATRIX
COMPOSITE AT 1200 °C IN AIR AND IN STEAM**

THESIS

AIR FORCE INSTITUTE OF TECHNOLOGY

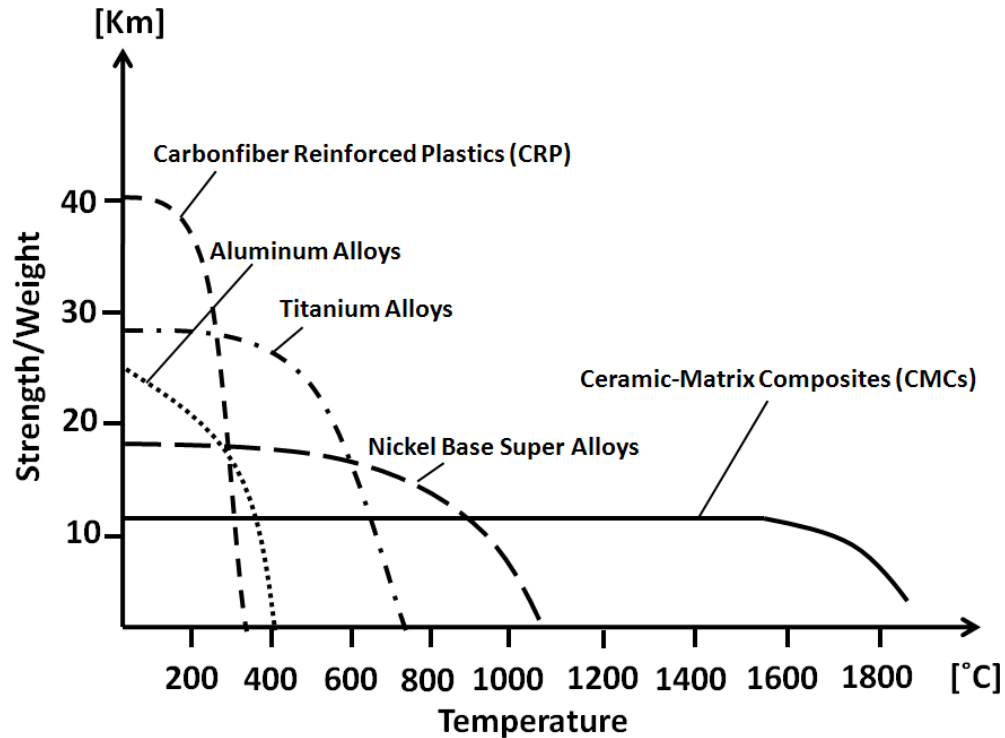
Figure 1: Strength to weight ratio vs. operating temperature for various materials [21].

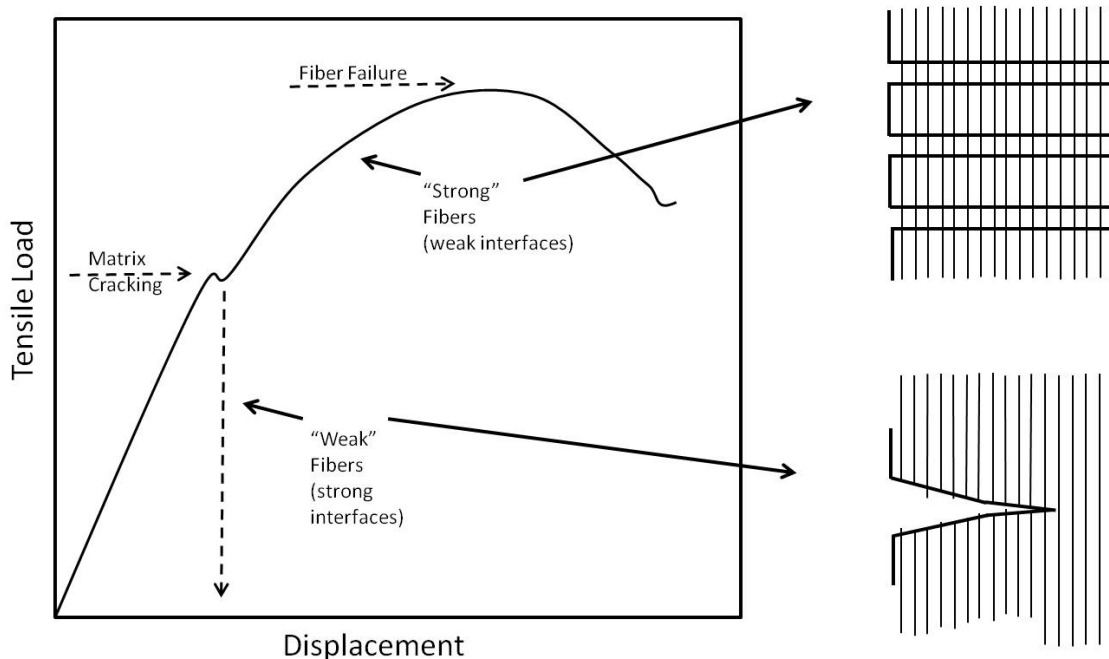
Figure 2: Tensile stress-strain curve for a “tough” ceramic matrix composite.

A typical stress-strain curve and associated failure mechanisms are given for a CMC in Figure 2. The difference in strong and weak matrix fiber interfaces is shown. Strong fiber matrix bonds lead to premature failure compared to a weaker fiber matrix bond. In ceramic fiber composites the failure strain of the reinforcing fiber ($\epsilon \sim 1-1.5\%$) is much greater than that of the matrix (0.1-0.2%). Therefore, under an applied tensile stress the matrix will always fail first [13]. The unreinforced ceramic matrix exhibits catastrophic brittle failure at low strain. The CMC exhibits linear stress-strain until the matrix starts to crack. This initial matrix micro-cracking is treated by the ACK theory of matrix strain enhancement [2]. ACK theory is derived from an energy criterion where the fiber strength is large enough to support the load with a matrix crack transversing the fibers.

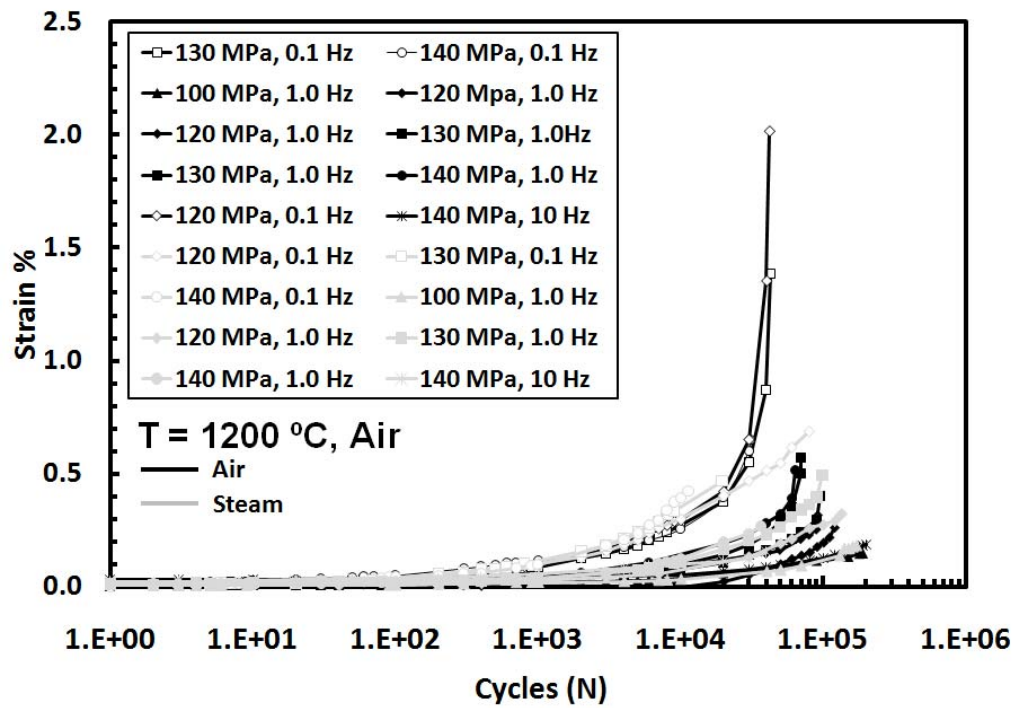
Figure 3: Accumulated strain vs. fatigue cycles for the Hi-Nicalon/PyC/HyprSiC ceramic composite at 1200°C in laboratory air and steam [7].

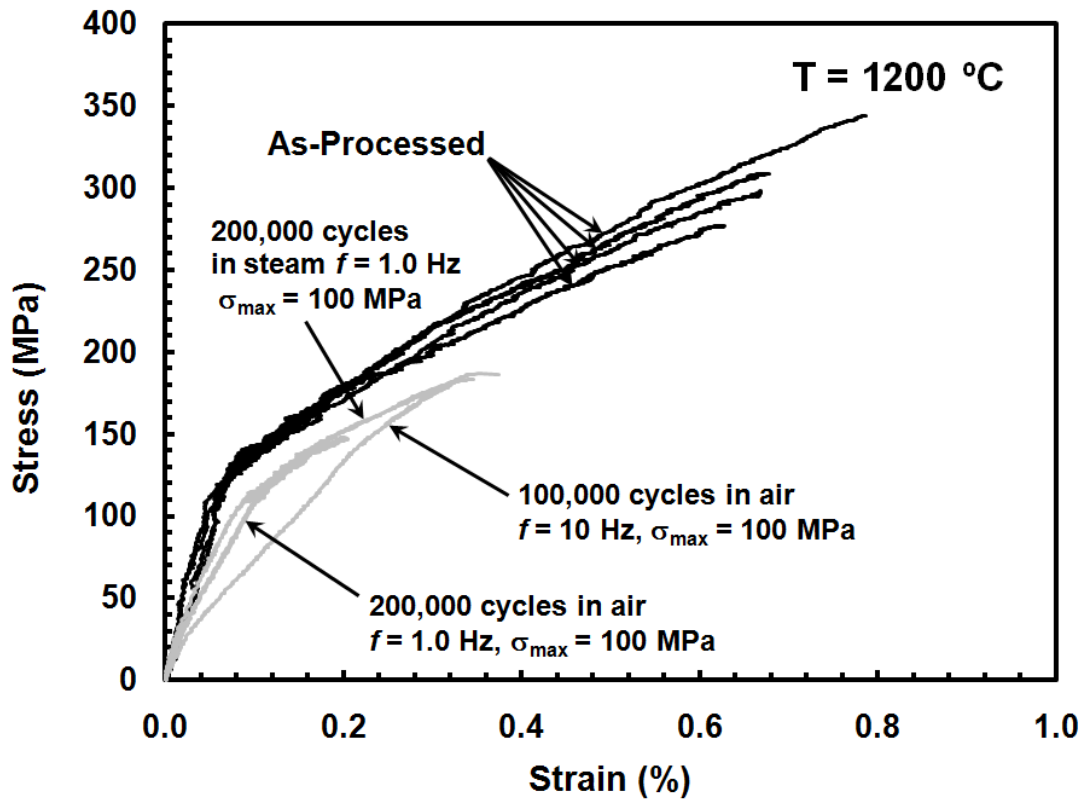
Figure 4: Tensile stress-strain curves obtained for the Hi-Nicalon/ PyC/HyprSiC specimens subjected to prior fatigue at 1200°C. Tensile stress-strain curves for the as-processed specimens are shown for comparison [7].

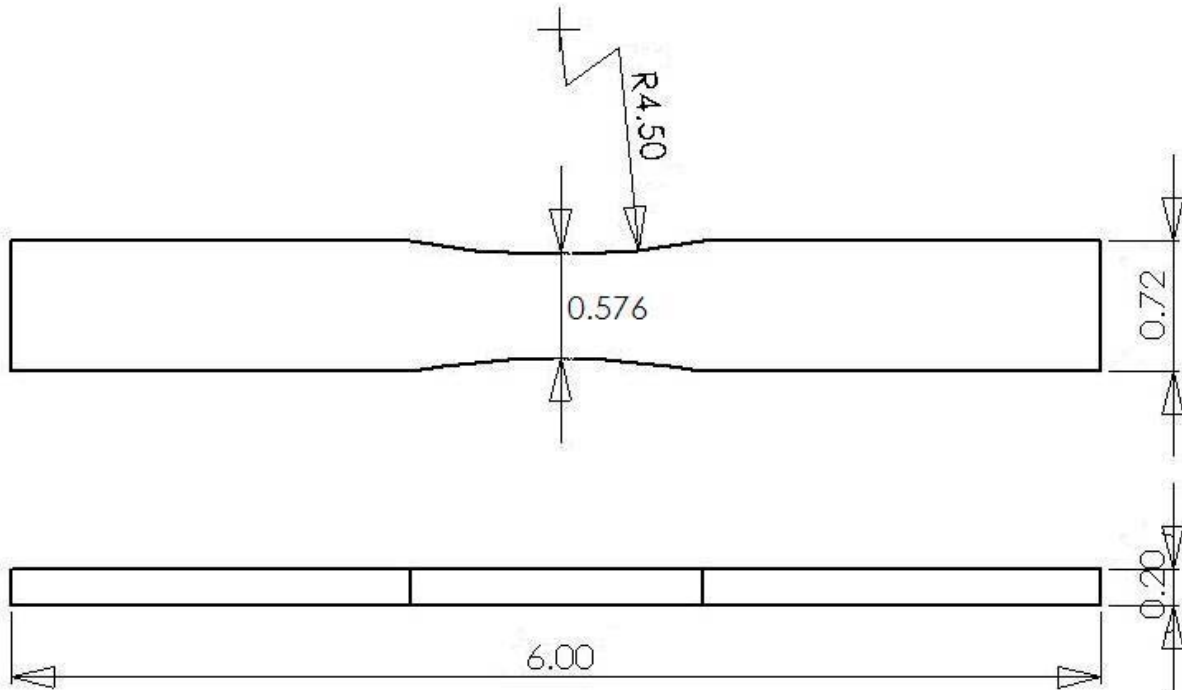
Figure 5: Test Specimen Specifications, all dimensions in inches.

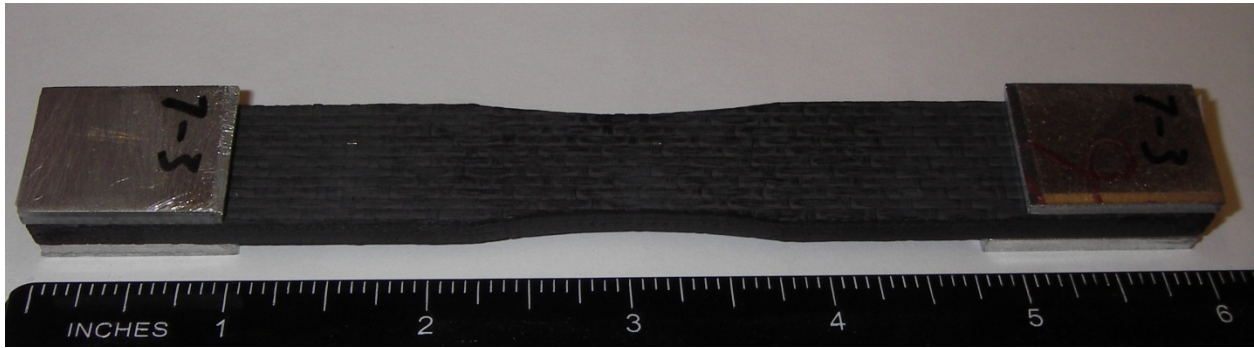
Figure 6: Final Test Specimen shown with aluminum tabs attached.

Before testing each specimen was fitted with aluminum tabs to protect the specimen from the MTS machine grips. The 6061-T6 aluminum tabs are ductile enough to form a sufficient mechanical bond between the specimen and the grips, while also able to transfer the high loading conditions without failing. Care was taken to keep the tab-specimen surface free of adhesive. This was accomplished with bonding a piece of paper to the end of the specimen, and bonding the aluminum tabs to the paper. This held the tabs in place prior to gripping in the MTS machine and provided a suitable tab-specimen interface. The presence of adhesive in the gripping surface was found to cause slippage of the specimen in the grips under the loads experienced in this effort. The final specimen before testing can be seen in Figure 6. Detail of aluminum tabs is given in Figure 7.

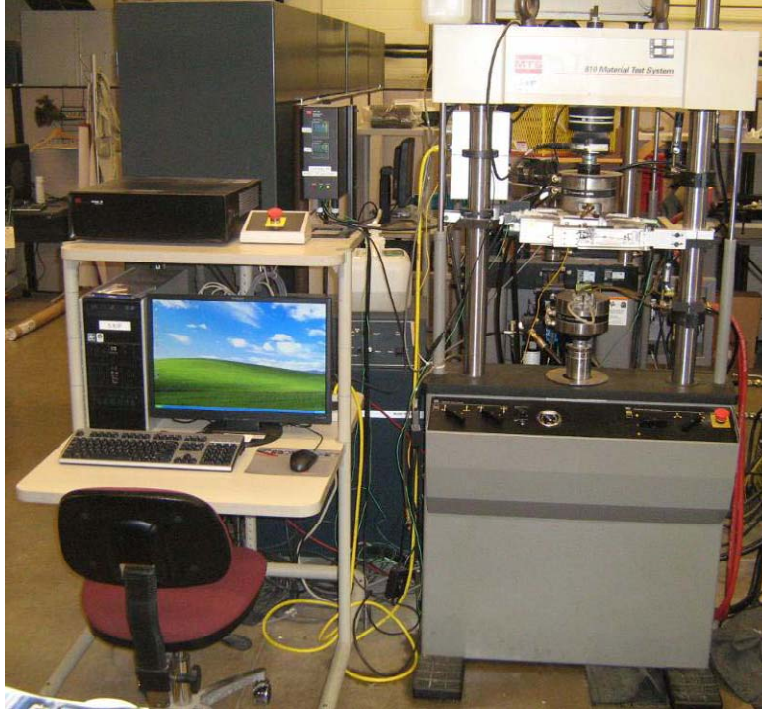
Figure 8: MTS 5 Kip Machine

Mechanical testing was performed with a MTS 810 Material Test System 5,000 lb capacity servo-hydraulic machine MTS Station run by a Flextest 40 digital controller and Manager/Multipurpose Testware software, as pictured in Figure 8. An MTS Model 632.53 E-14 uniaxial low contact force, high temperature extensometer was employed for strain measurement. The gauge section of the extensometer was 12.7mm. Water cooled wedges with Surfalloy grip treatments were used to grip the specimens. Cooling water was supplied to the wedges at 15°C by a Neslab Coolflow Refrigerated Recirculator, Model HX-7. A purpose built compact two-zone resistance-heater furnace using an MTS 409 temperature controller was used for elevated temperature testing. For tests that required steam an Amteco Chromalox 2110 Steam Generator supplied with distilled water was used.

Specimens were loaded into a small ceramic cylinder called a susceptor before being placed in the MTS grips.

The wedge grip pressure was raised to 20MPa to prevent slippage without crushing the test specimen.

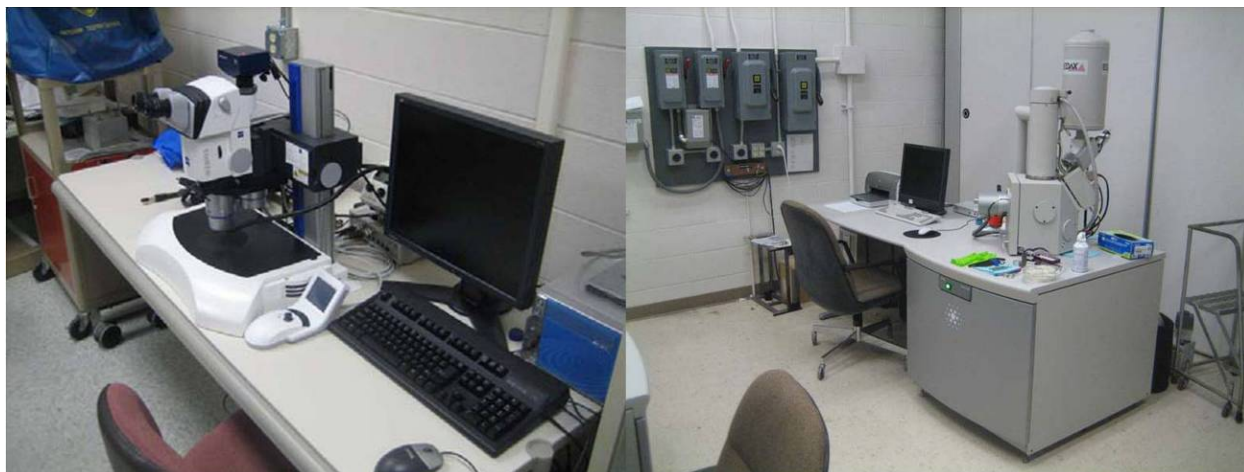
Figure 9: Zeiss Stemi SV II optical microscope (left) and Quanta 200 scanning electron microscope (right).

The fracture surfaces of test specimens were evaluated with a Zeiss Stemi SV II optical microscope equipped with a Zeiss AxioCam HRc digital camera and the Quanta 200 scanning electron microscope (SEM).

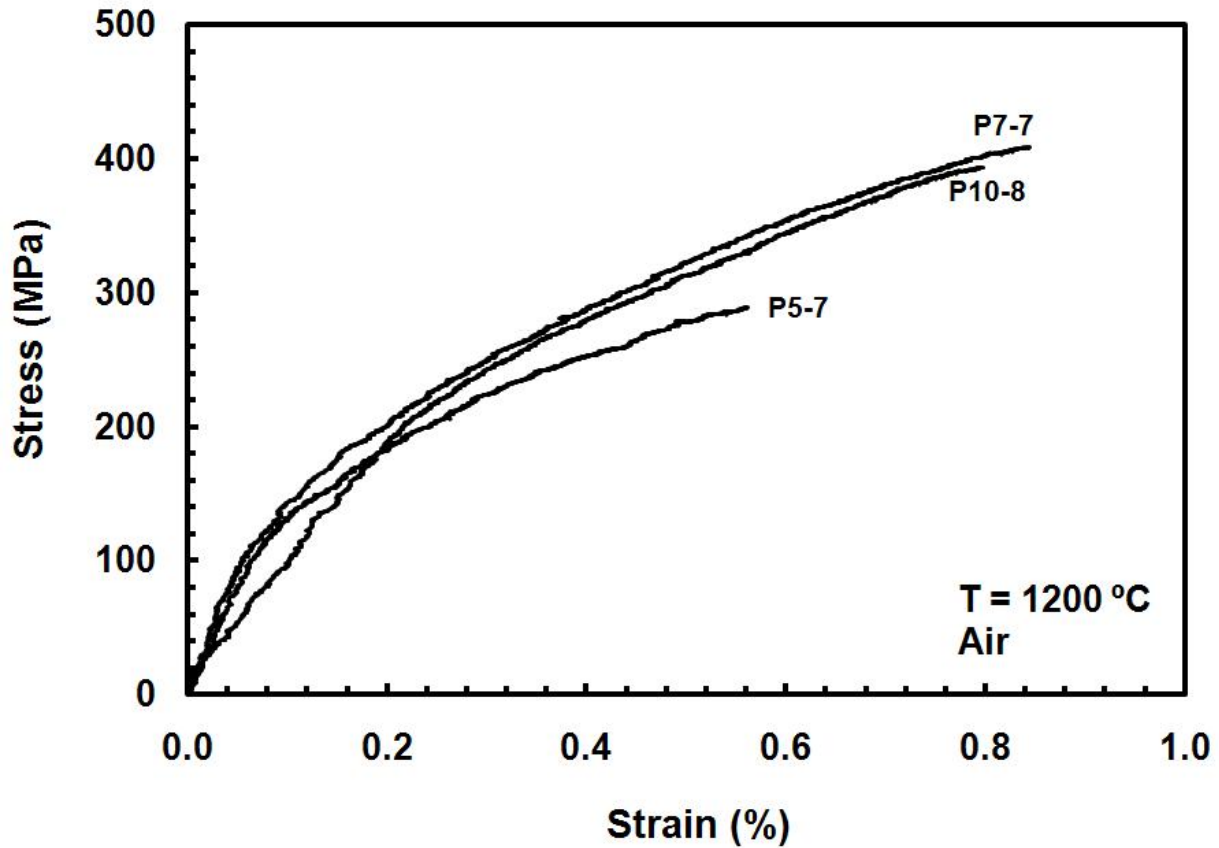
Figure 10: Tensile stress-strain curves for Hi-Nicalon/PyC/HyprSiC Ceramic composite at 1200°C in air.

To determine the initial tensile properties at 1200°C, one specimen from each panel was tested in monotonic tension to failure. The measured results and corresponding properties for each specimen are given in Table 10. The tensile stress strain curves are given in Figure 10. An average ultimate tensile strength (UTS) of 365.03 MPa, the average elastic modulus was 144.08 GPa, and the average failure strain was 0.72%. The point at which the stress strain curve transitions from linear to non linear behavior is the proportional limit. The average proportional limit was 123.33 MPa, or approximately 34% of the average UTS. This value is similar to Delapasse[7] Table 12. However unlike the previous work a distinct “knee” in the stress strain curve is not seen. This would indicate that the fibers are carrying a significant portion of the load before extensive matrix micro cracking occurs. This comparison is shown in Figure 11 with the tensile stress strain curves for this effort plotted with those of Delapasse[7].

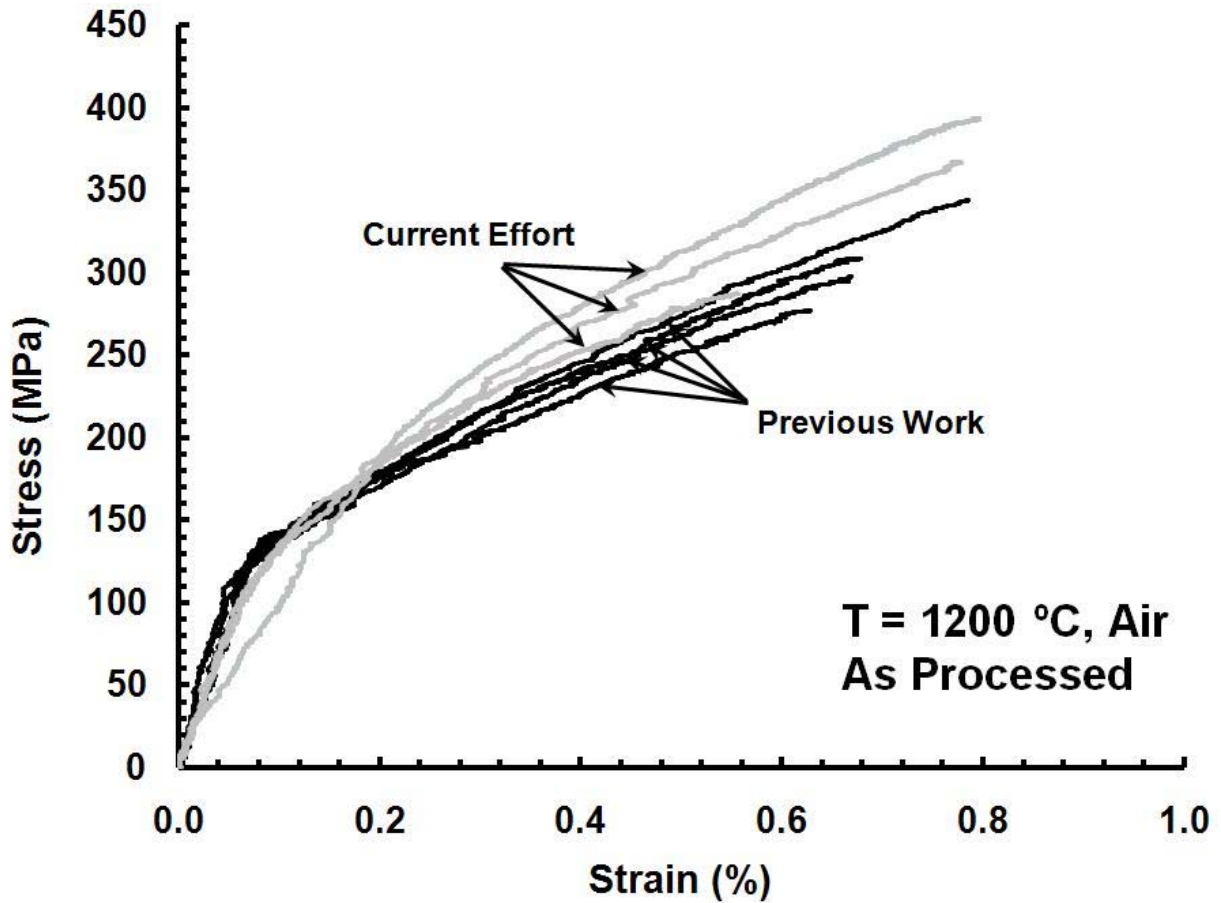
Figure 11: Tensile stress-strain curves for Hi-Nicalon/PyC/HyprSiC Ceramic composite at 1200°C in air compared to work by Delapasse[7].

The specimens tested in this effort averaged about a cross sectional area of about $7.5 \times 10^{-5} \text{ m}^2$, about twice the area of specimens tested in tension-tension [7]. For composites that are manufactured with the chemical vapor infiltration process the increasing of thickness tends to lead to more voids within the specimen and a less dense matrix. More voids between fiber tows and a less dense matrix would lead to poor performance in tension for the CMC. However this is not the case for specimens tested in this work. Figure 11 shows the comparison of the stress strain properties of the smaller specimens and larger hourglass specimens. No loss of strength is

observed for the larger hourglass specimens, conversely they perform better in tensile loading. This can be due to better control of the fiber perform weaving and CVI process.

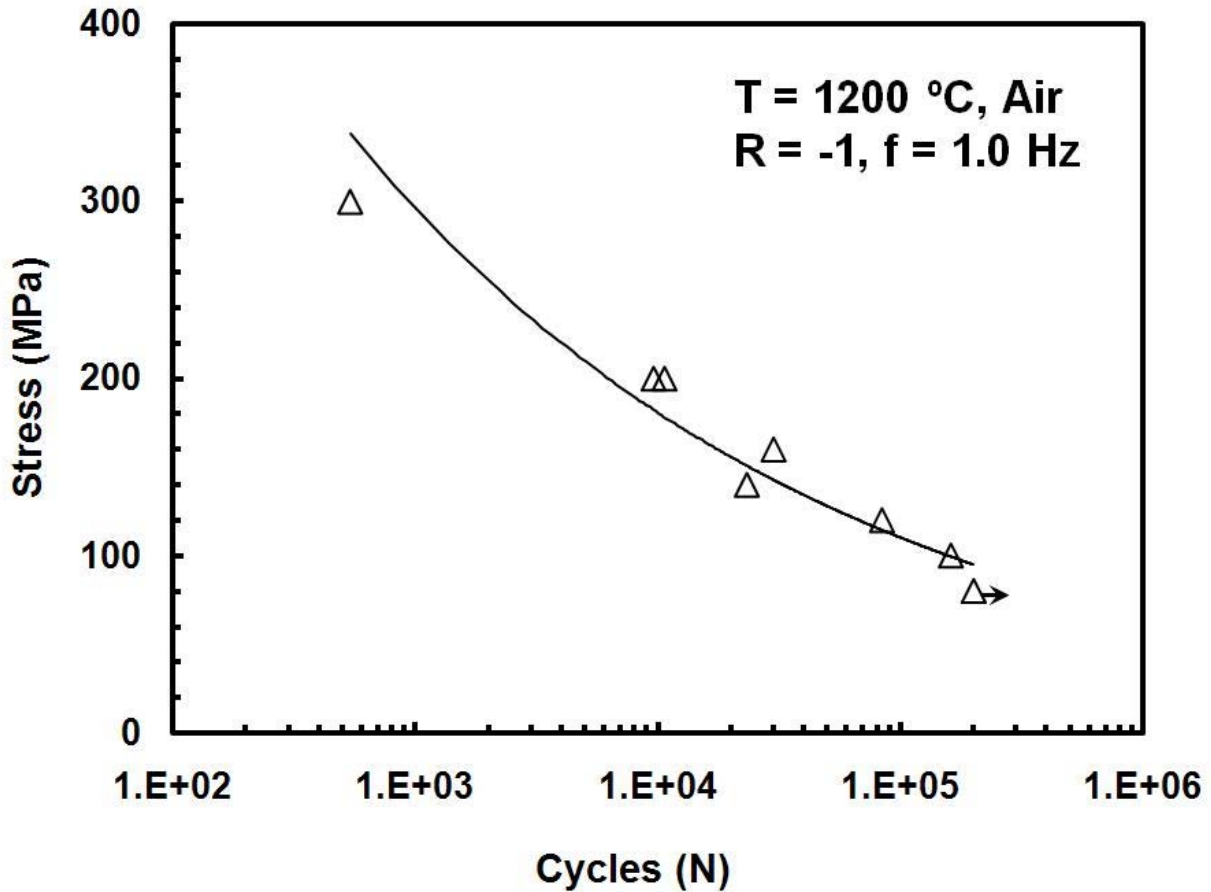
Figure 12: Fatigue S-N diagram for the Hi-Nicalon/PyC/HyprSiC composite at 1200°C in laboratory air.

80 to 300 MPa. The run-out condition of 200,000 cycles was achieved at a stress of 80 MPa. Table 11 summarizes the results of fatigue testing in air. A stress vs. cycles to failure plot is given in Figure 12.

The data in Table 11 shows that as the stress is increased the fatigue performance decreases. This expected decrease in cycles to failure is also shown in Figure 12. The stress level of 80 MPa at which run-out was achieved is below the proportional limit of the material found from tensile testing. Fatigue run-out is depicted in Figure 12 with an arrow on the data point.

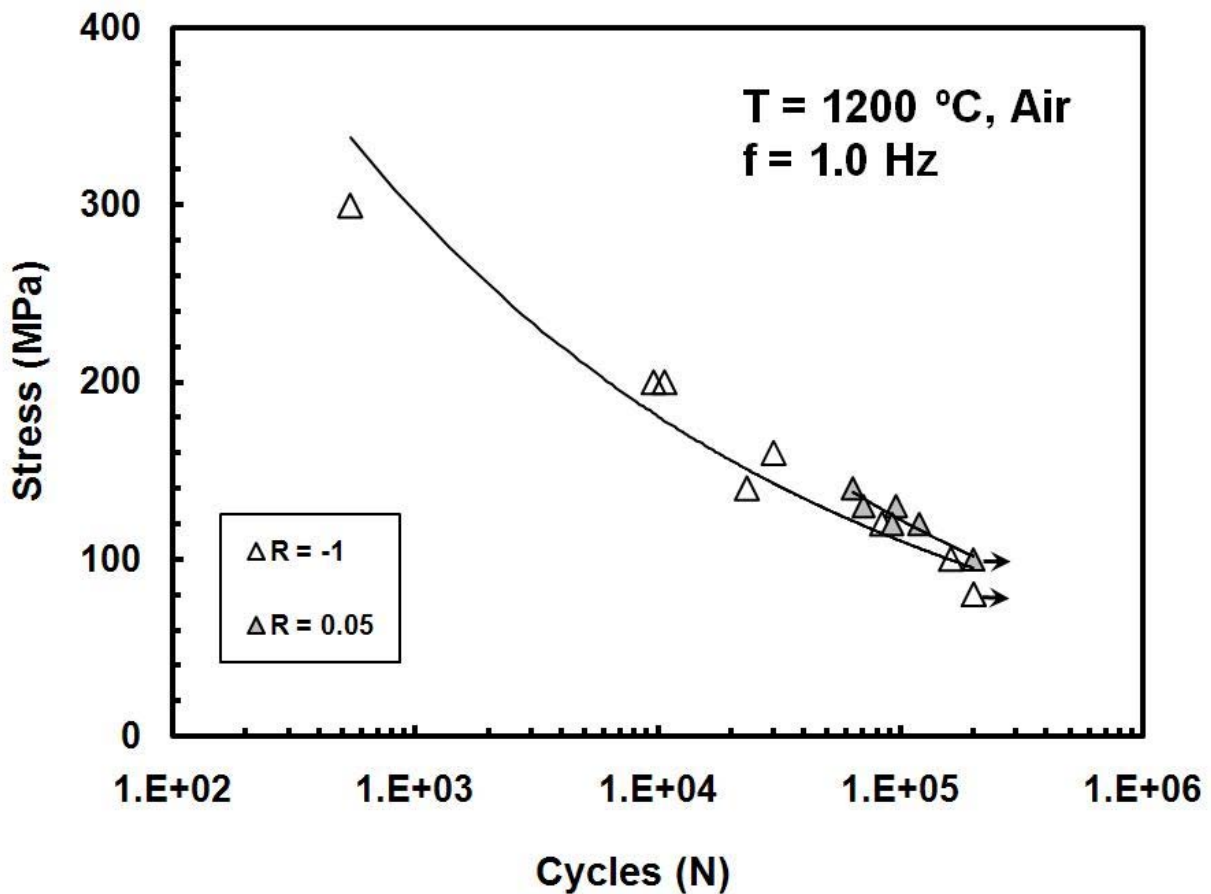
Figure 13: Fatigue S-N diagram for the Hi-Nicalon/PyC/HyprSiC CMC at 1200°C in laboratory air. Data for R ratio = 0.05 from Delapasse [7].

stress of 100 MPa to 63.3% for a max stress of 140 MPa. When the maximum stress exceeded the approximate proportional limit of 120 MPa the reduction in cycles to failure doubled to 63.3%. Past the proportional limit where matrix cracking occurs the presence of a compressive load in the fatigue cycle significantly reduces life.

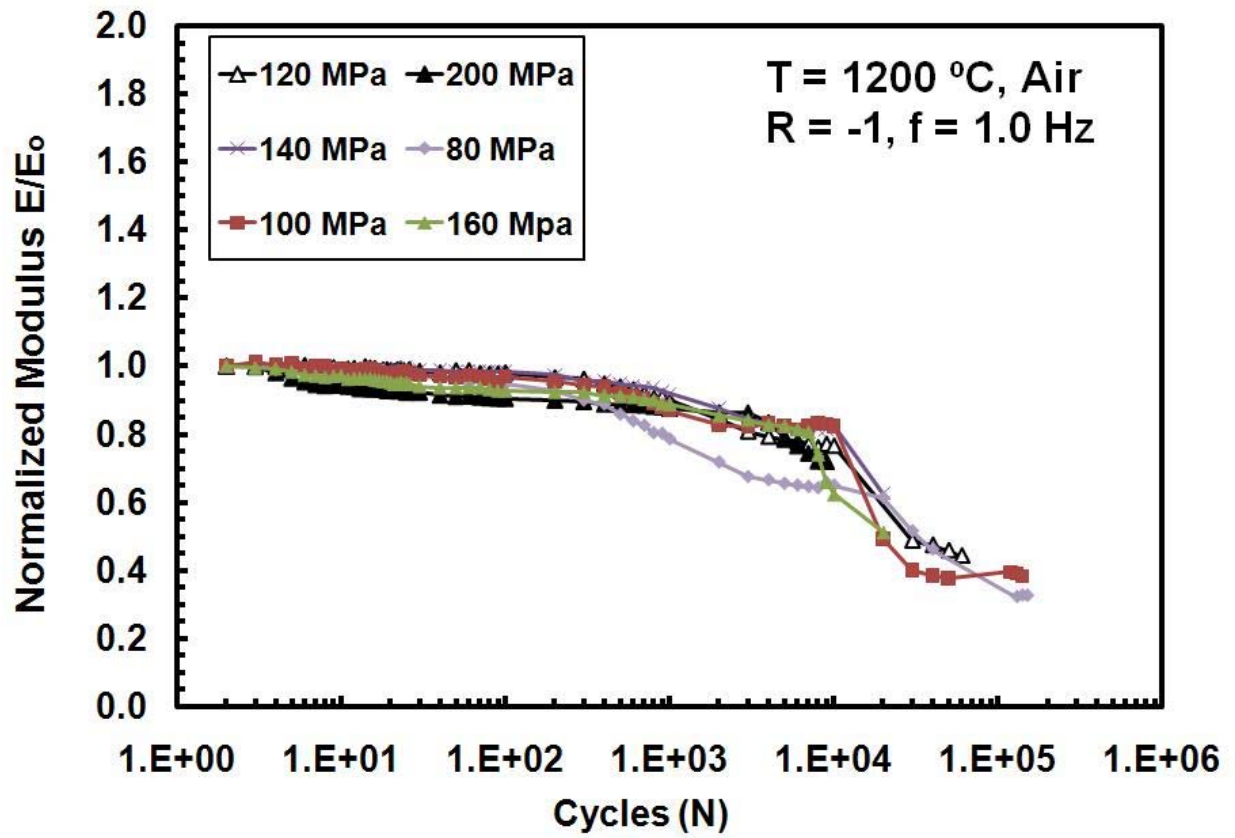
Figure 14: Normalized tensile modulus vs. fatigue cycles for the Hi-Nicalon/PyC/HyperSiC ceramic composite at 1200°C in laboratory air.

During cyclic fatigue the extent of damage development in the composite can be investigated by observing the reduction in stiffness over time. The tensile and compressive stiffness of the composite or, hysteresis modulus for a cycle is determined from the corresponding maximum and minimum stress-strain points. The tensile modulus evolution with fatigue cycles is shown in Figure 14. In Figure 14 the modulus is normalized for each cycle to the second cycle to show a relative change and plotted vs. fatigue cycle number. All specimens tested in Air showed a decrease in the normalized modulus with increasing cycle numbers. This indicates that damage such as matrix cracks are forming in the specimen. As these cracks grow the modulus of the composite decreases due to progressively less matrix contribution to stiffness. Comparing to work done by [7] the modulus loss in fully reversed fatigue did not exhibit a high dependence on stress levels.

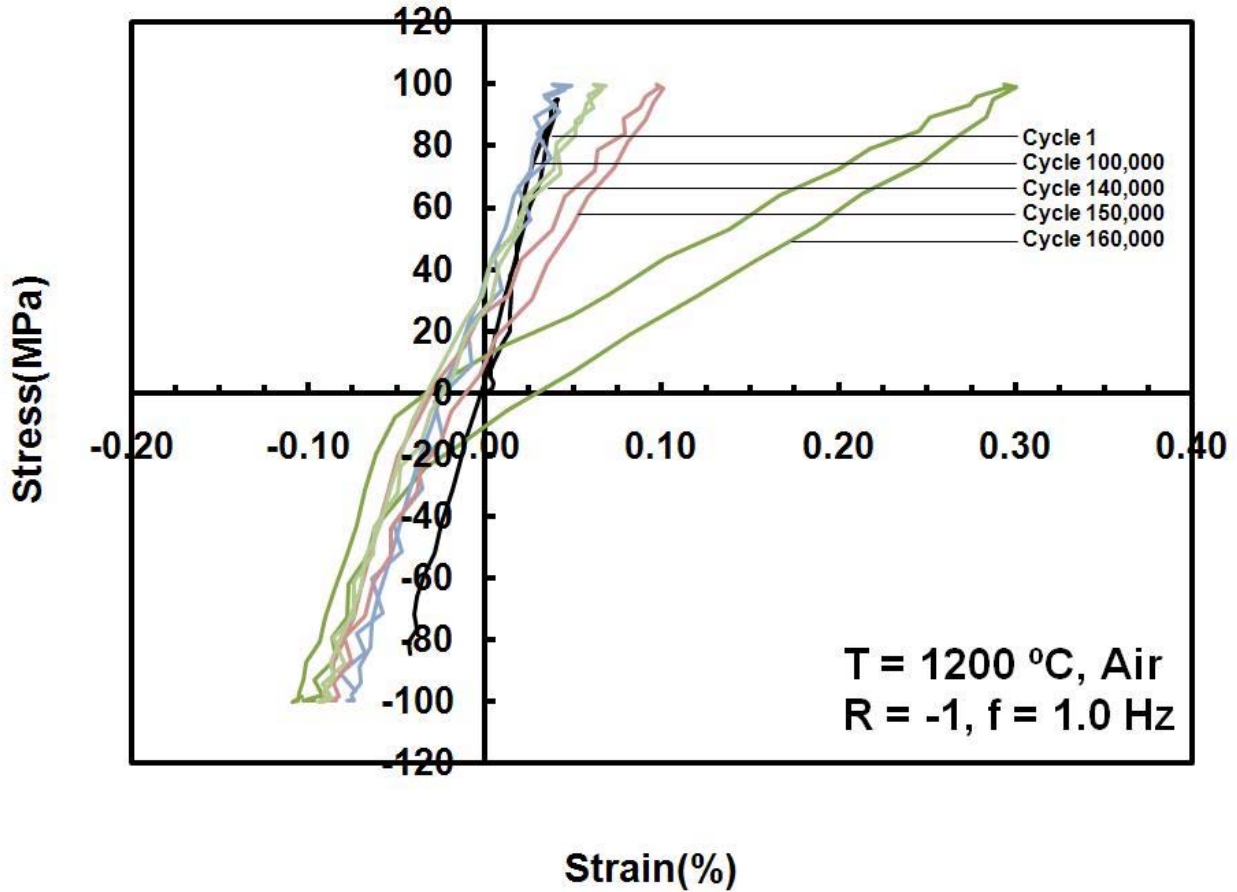
Figure 15: Evolution of stress-strain hysteresis response of Hi-Nicalon/PyC/HyperSiC with fatigue cycles in laboratory air at 1200°C.

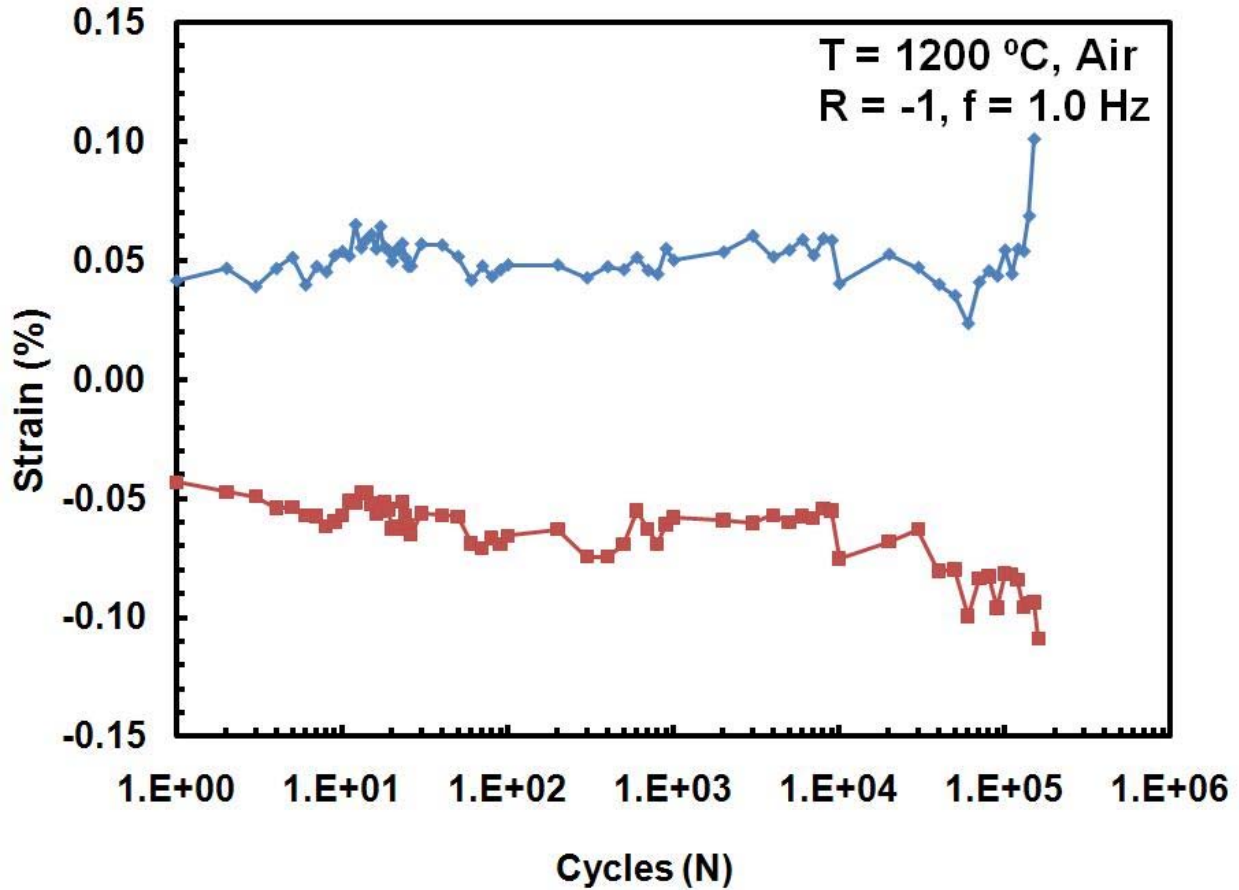
Figure 16: Maximum and minimum strains vs. fatigue cycles for the Hi-Nicalon/PyC/HyperSiC ceramic composite at 1200°C in laboratory air and $\sigma_{\max} = 100$ MPa.

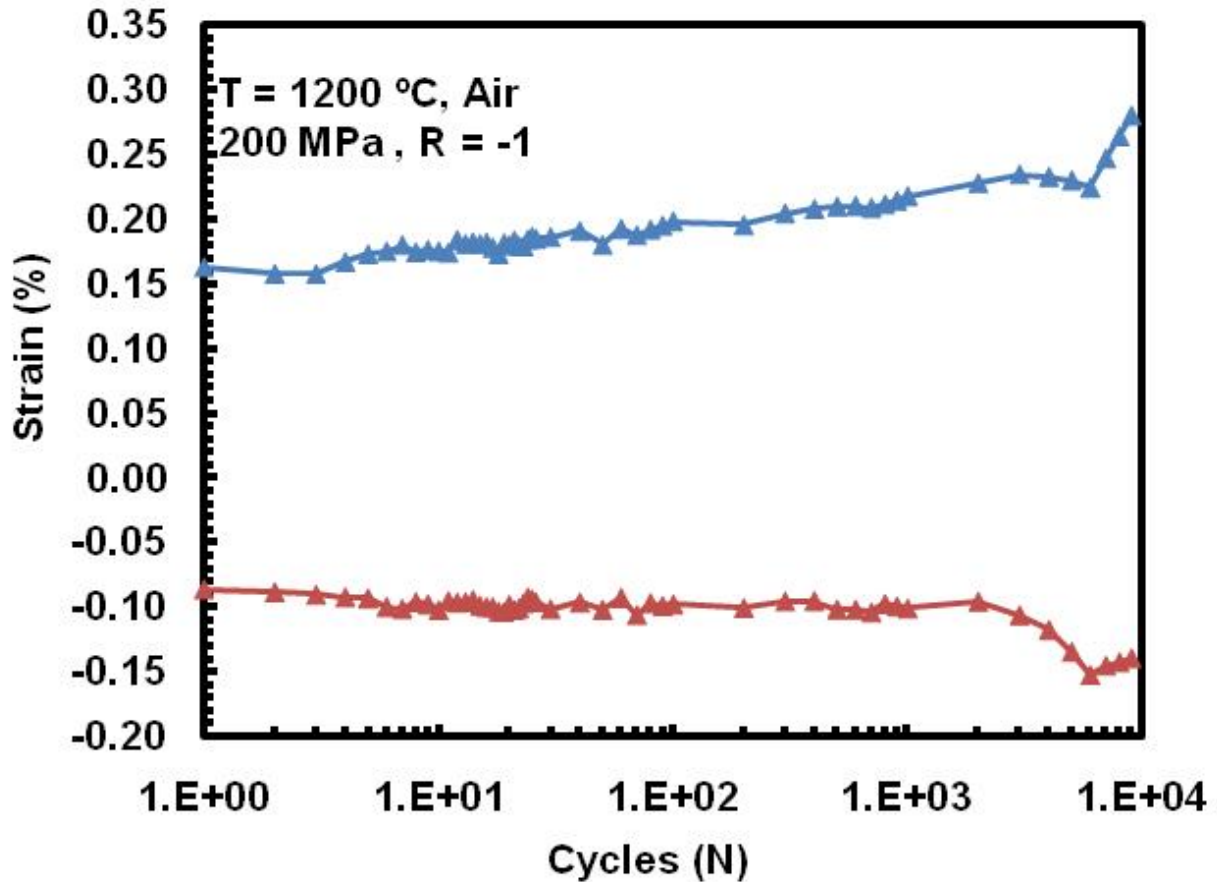
Figure 17: Maximum and minimum strains vs. fatigue cycles for the Hi-Nicalon/PyC/HyperSiC ceramic composite at 1200°C in laboratory air and $\sigma_{\max} = 200$ MPa

gradually increases about 0.15% while the minimum strain remains fairly constant at about -0.10%.

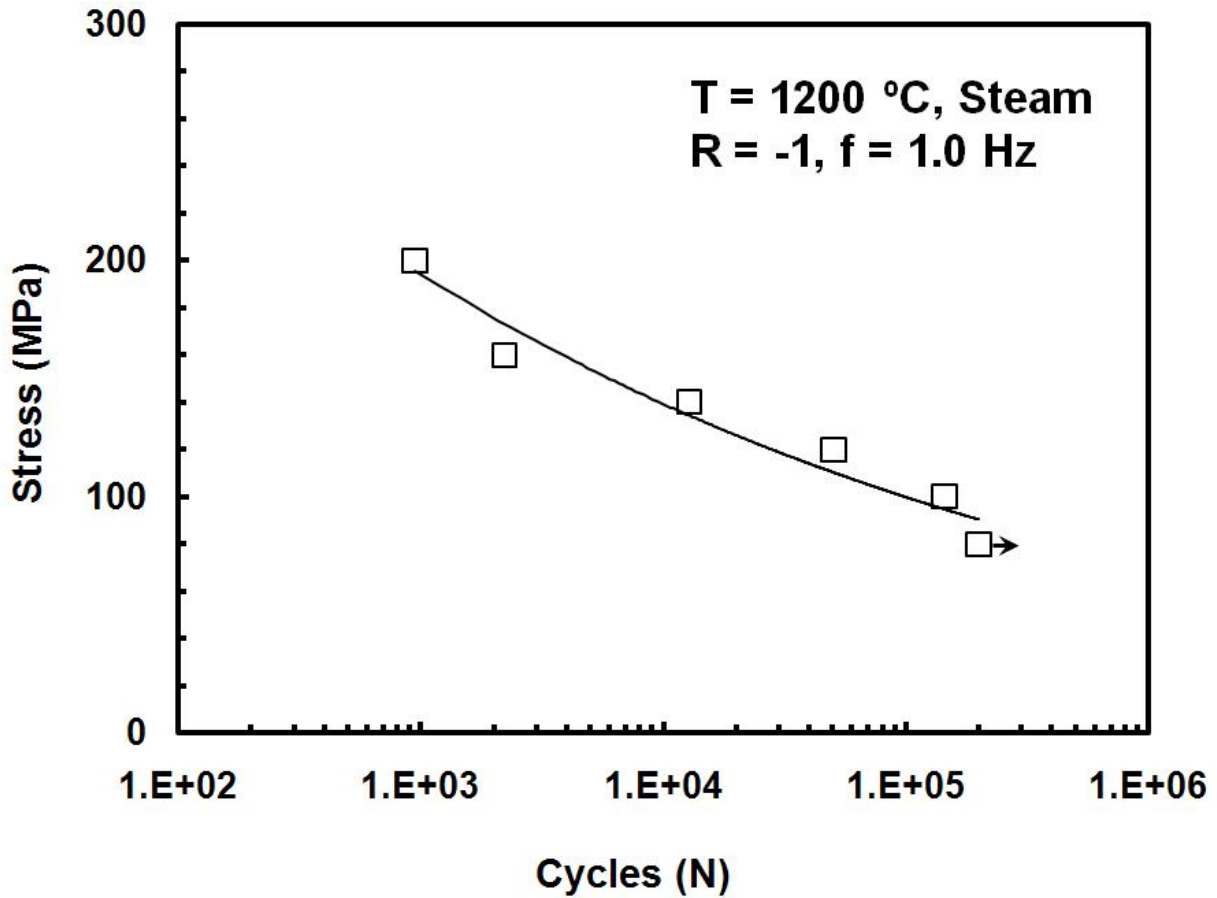
Figure 18: Fatigue S-N diagram for the Hi-Nicalon/PyC/HyprSiC CMC, R ratio of -1 composite at 1200°C in steam.

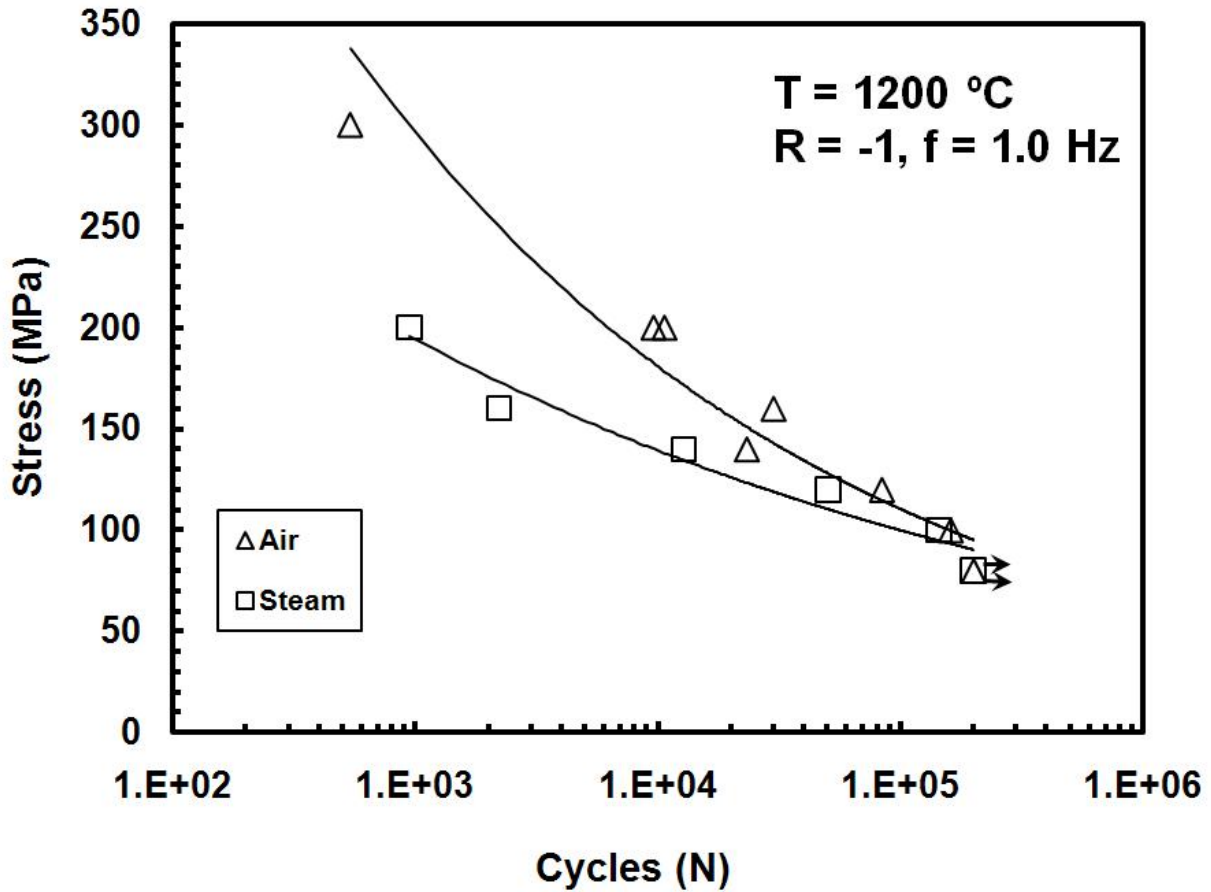
Figure 19: Fatigue S-N diagram for the Hi-Nicalon/PyC/HyprSiC composite at 1200°C in laboratory air and steam.

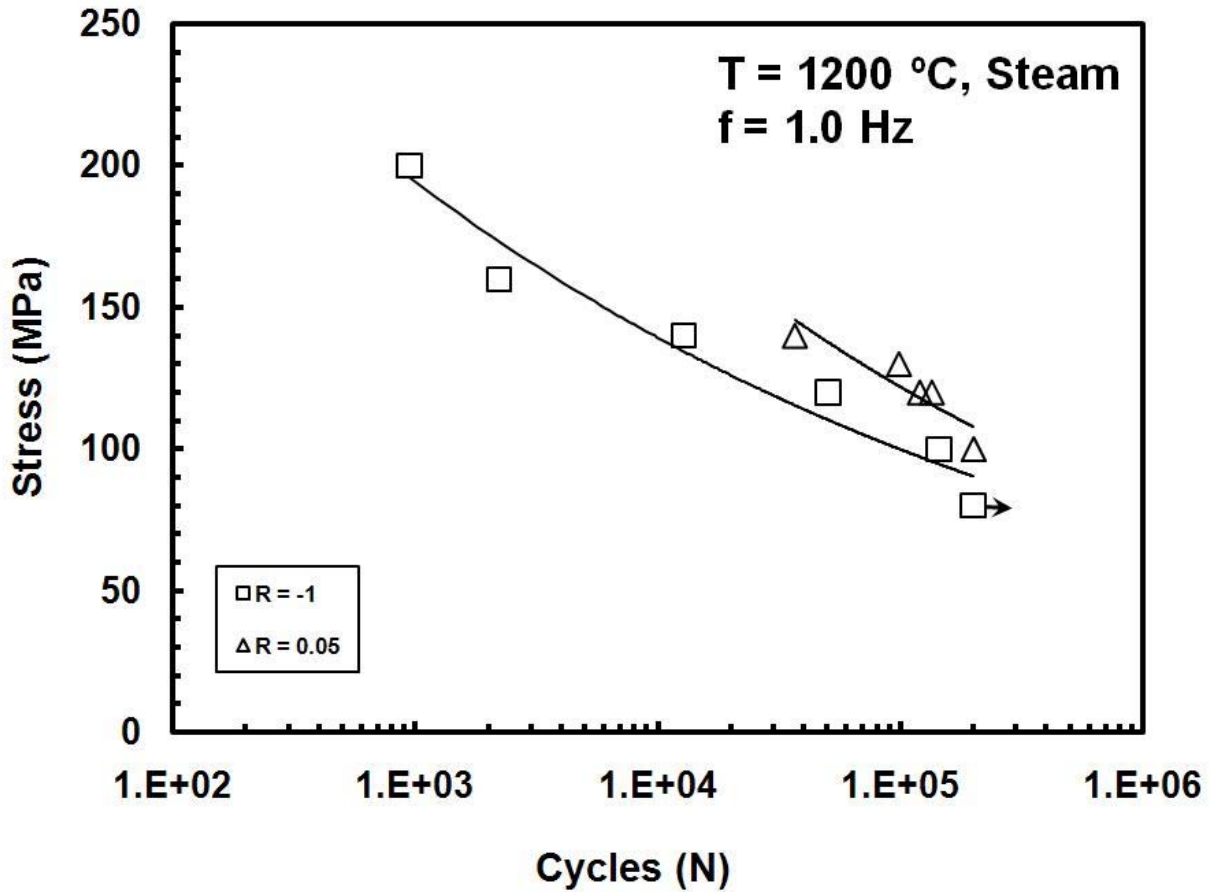
Figure 20: Fatigue S-N diagram for Hi-Nicalon/PyC/HyprSiC composite at 1200°C in steam. Data for R ratio = 0.05 from Delapasse [7].

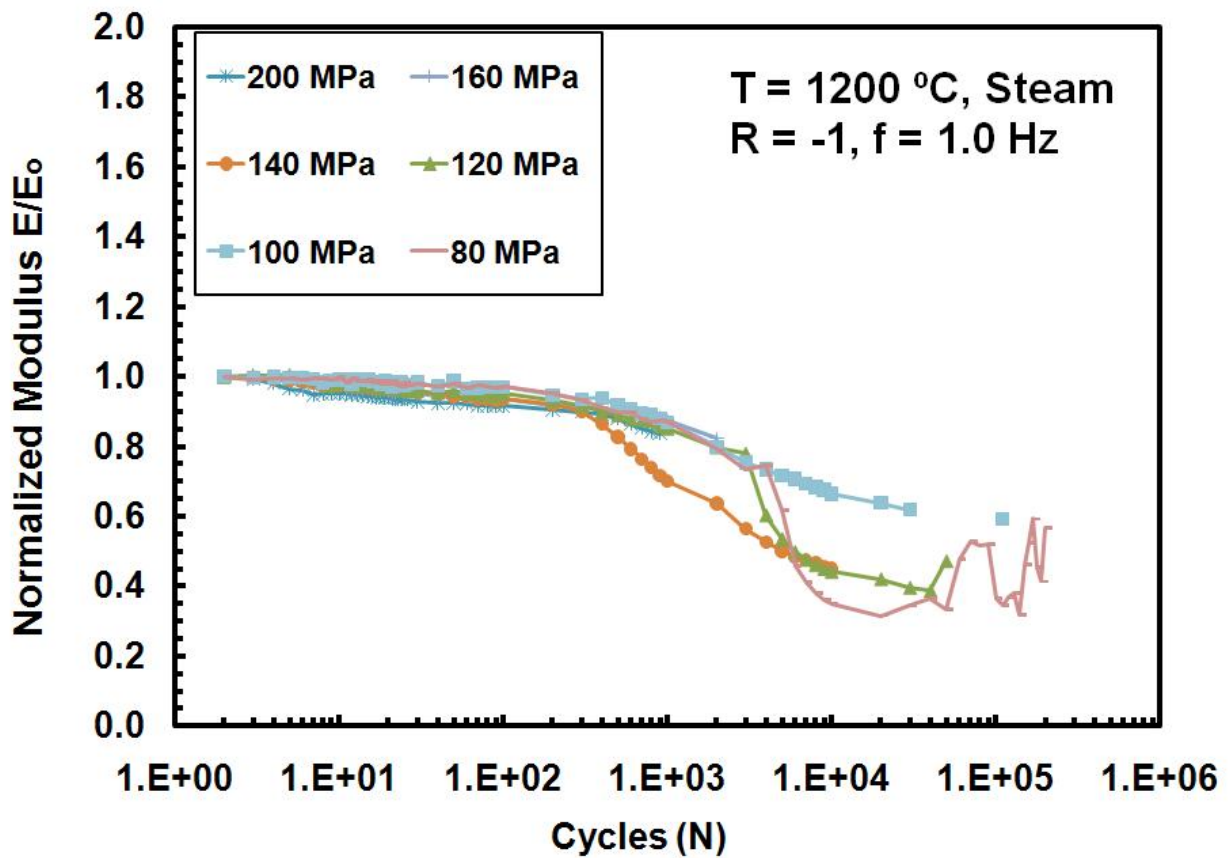
Figure 21: Normalized tensile modulus vs. fatigue cycles for the Hi-Nicalon/PyC/HyperSiC ceramic composite at 1200°C in steam.

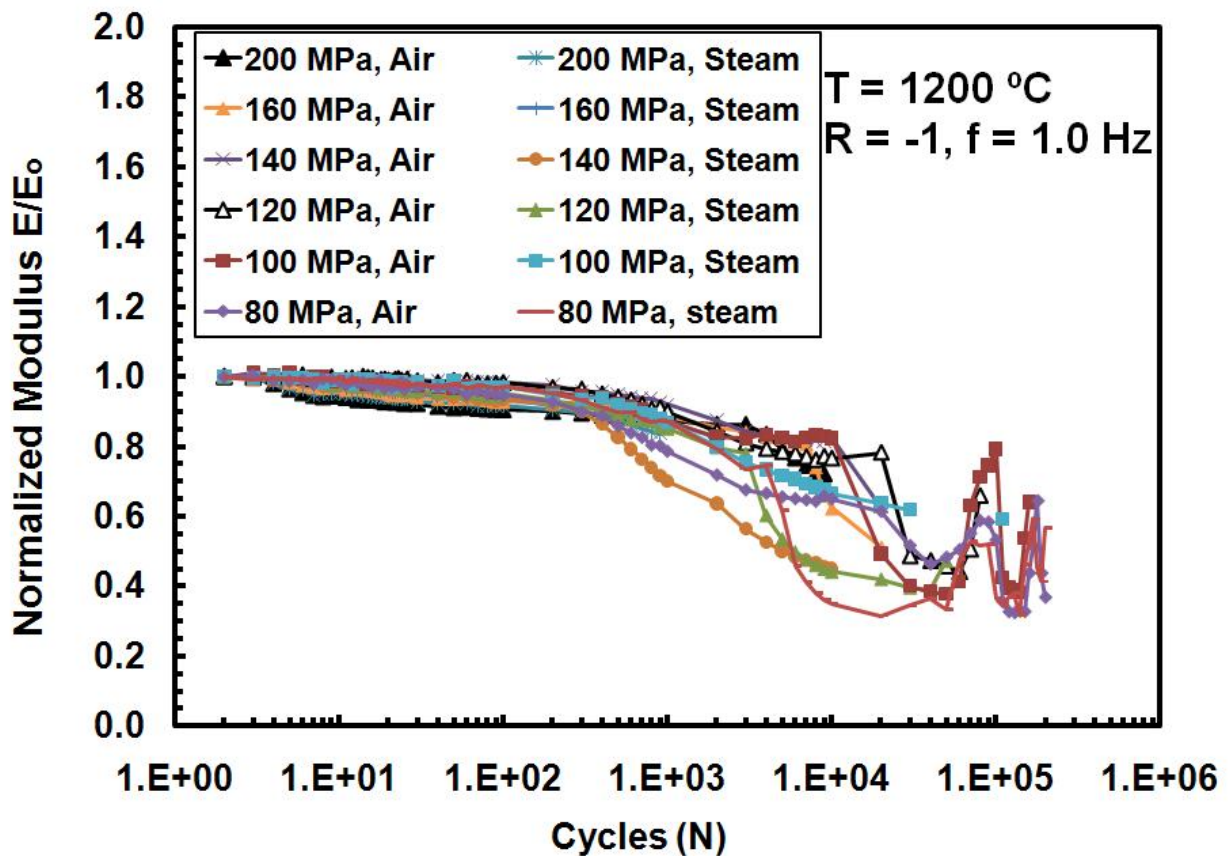
Figure 22: Normalized tensile modulus vs. fatigue cycles for the Hi-Nicalon/PyC/HyperSiC ceramic composite at 1200°C in laboratory air and steam.
