Tension-Compression Fatigue of Hi-Nicalon/SiC Ceramic Matrix Composite at 1200°C in Air and Steam

**TENSION-COMPRESSION FATIGUE OF Hi-NICALON/SiC CERAMIC MATRIX
COMPOSITE AT 1200 °C IN AIR AND IN STEAM**

THESIS

AIR FORCE INSTITUTE OF TECHNOLOGY

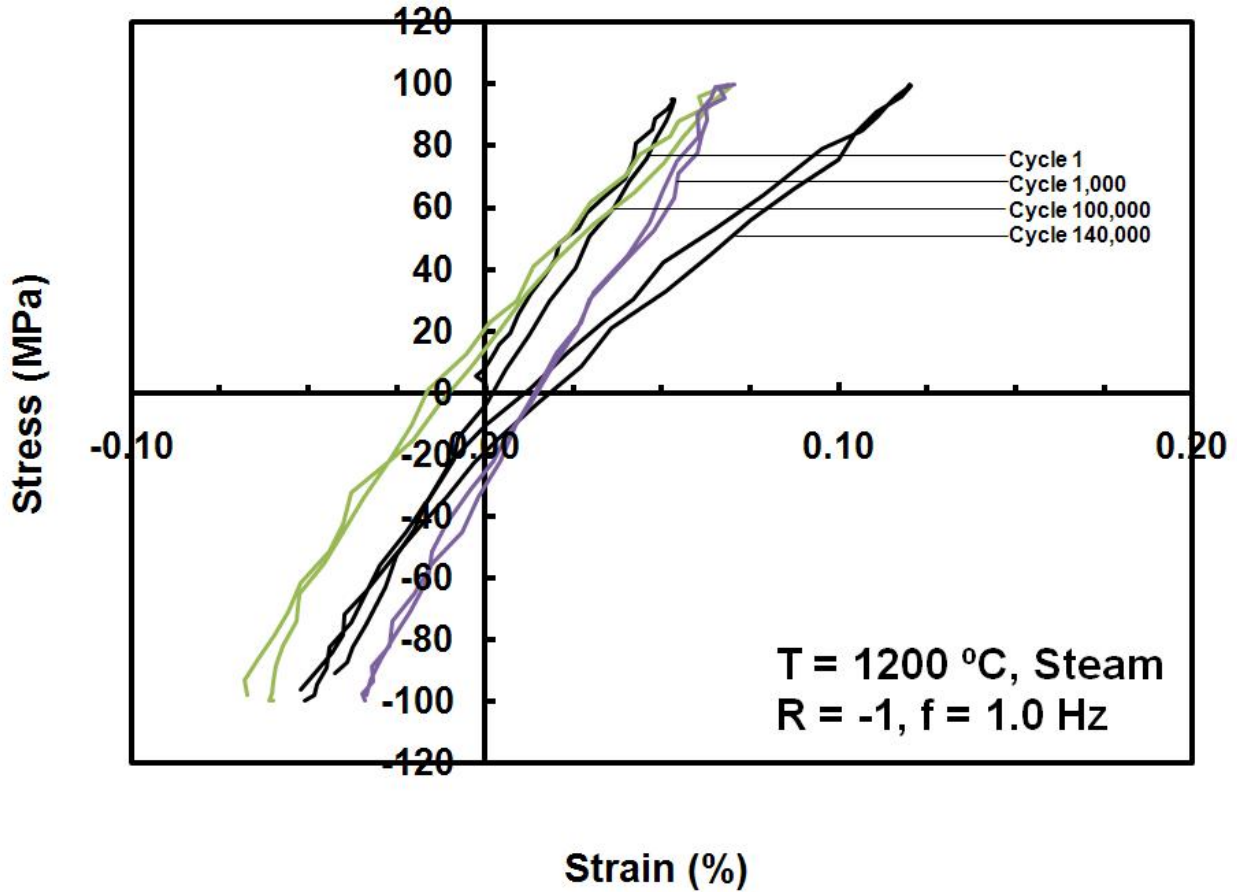
Figure 23: Evolution of stress-strain hysteresis response of Hi-Nicalon/PyC/HyperSiC with fatigue cycles in steam at 1200°C.

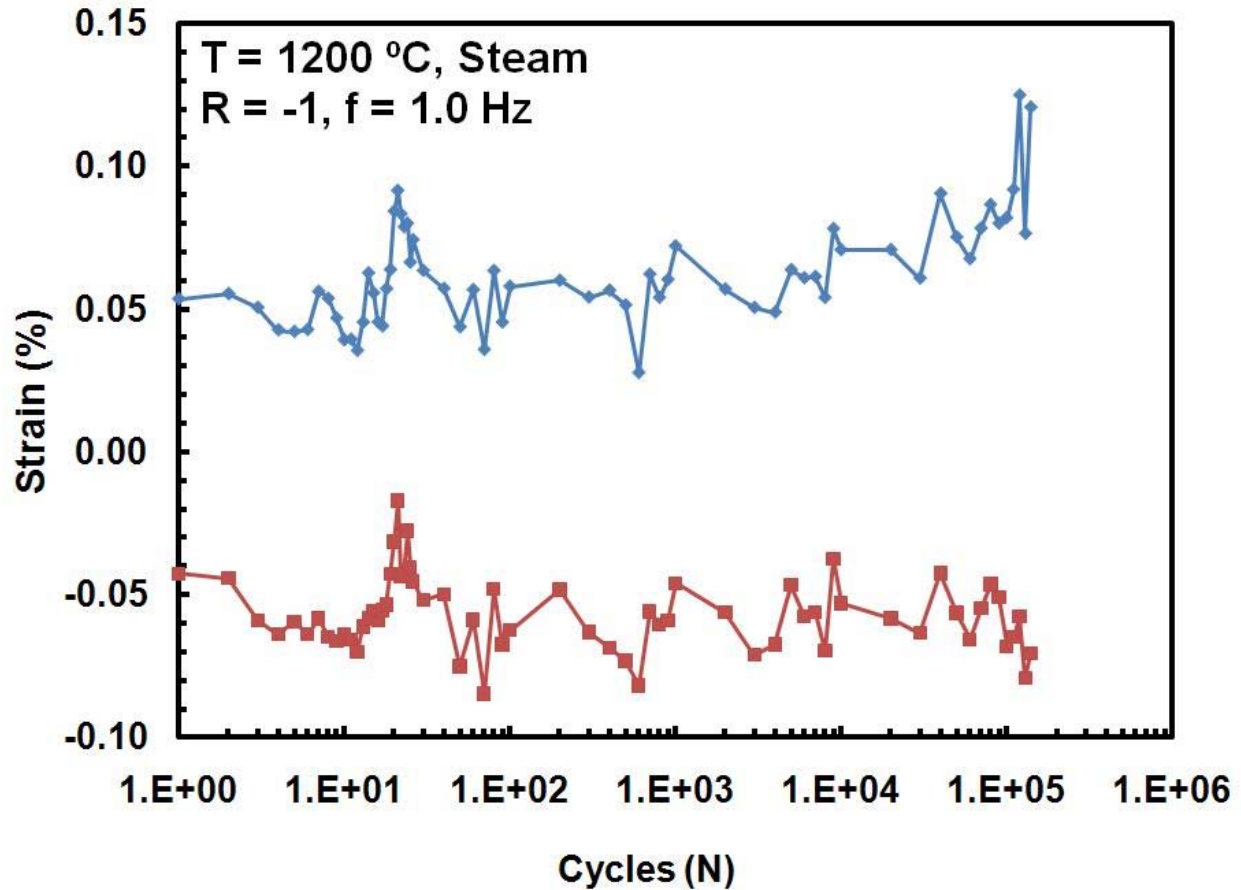
Figure 24: Maximum and minimum strains vs. fatigue cycles for the Hi-Nicalon/PyC/HyperSiC ceramic composite at 1200°C in steam and $\sigma_{\max} = 100$ MPa.

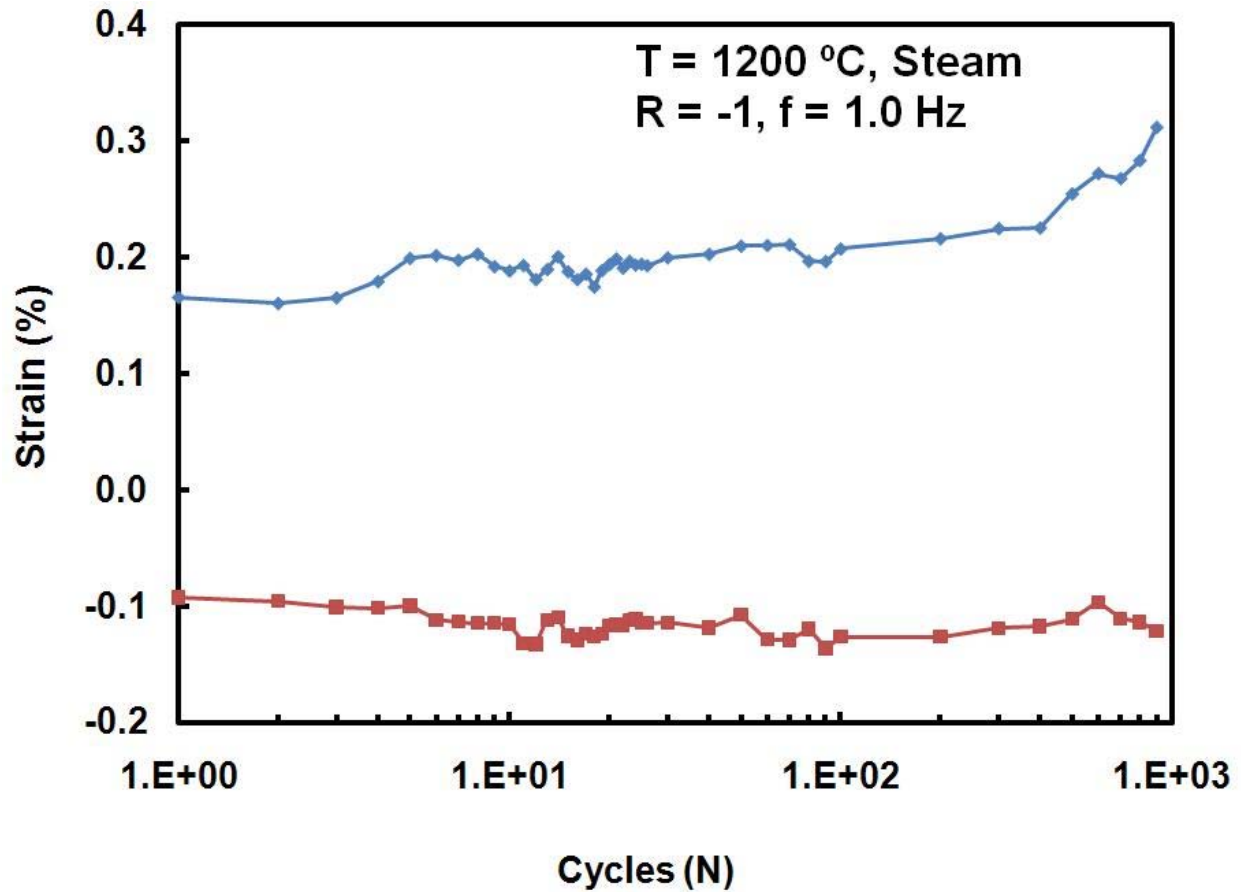
Figure 25: Maximum and minimum strains vs. fatigue cycles for the Hi-Nicalon/PyC/HyperSiC ceramic composite at 1200°C in steam and $\sigma_{\max} = 200$ MPa.

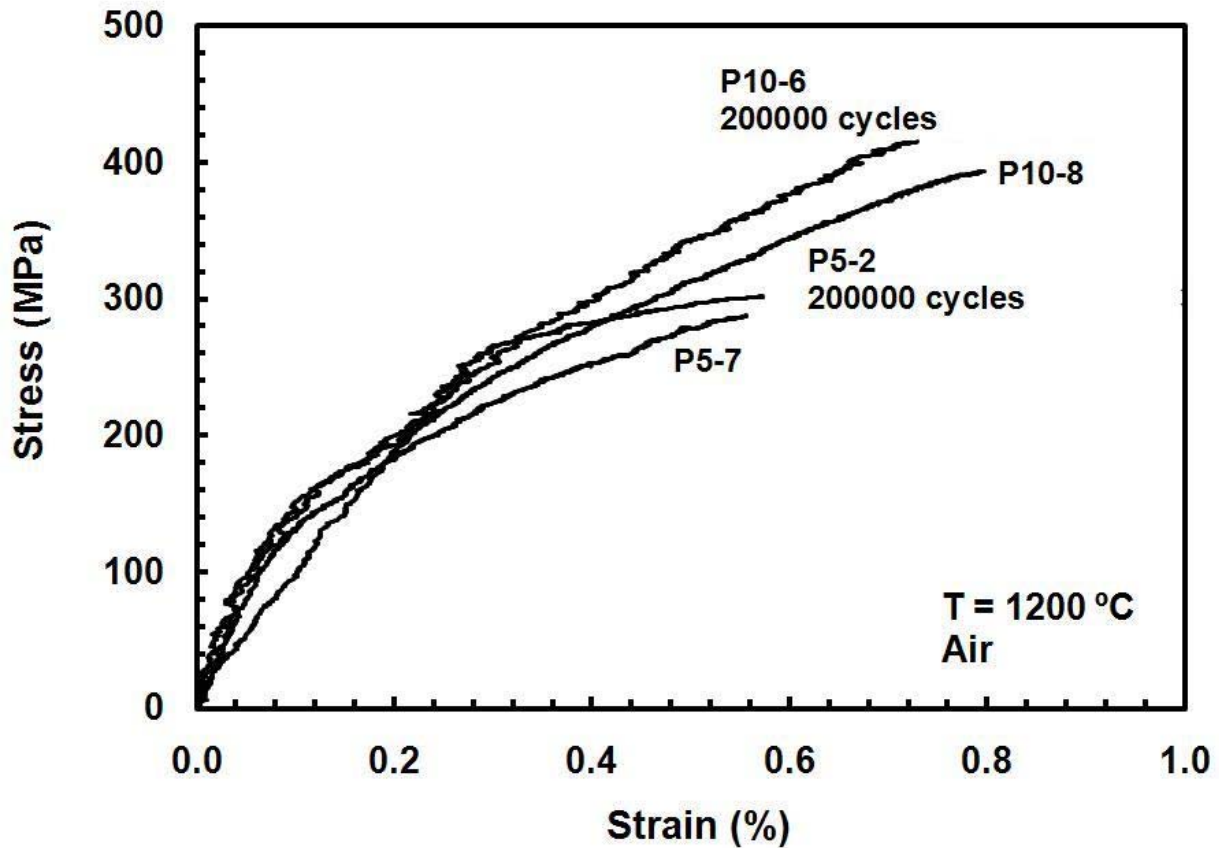
Figure 26: Tensile stress-strain curves for Hi-Nicalon/PyC/HyprSiC Ceramic subjected to prior fatigue at 1200°C. Tensile stress-strain curves for the as-processed specimens are shown for comparison.

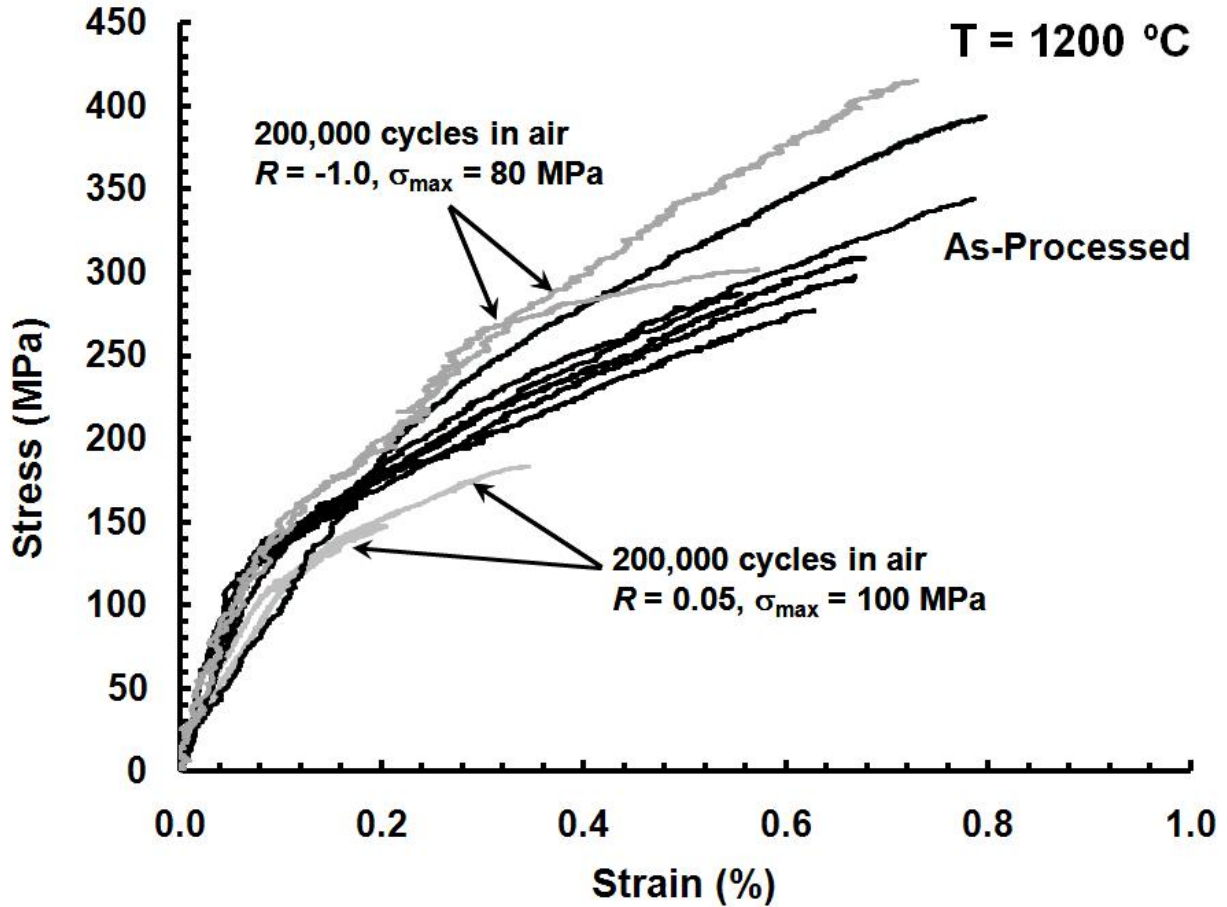
Figure 27: Tensile stress-strain curves for Hi-Nicalon/PyC/HyprSiC Ceramic subjected to prior fatigue at 1200°C at $R = -1.0$ and 0.05 [delapasse]. Tensile stress-strain curves for the as-processed specimens are shown for comparison.

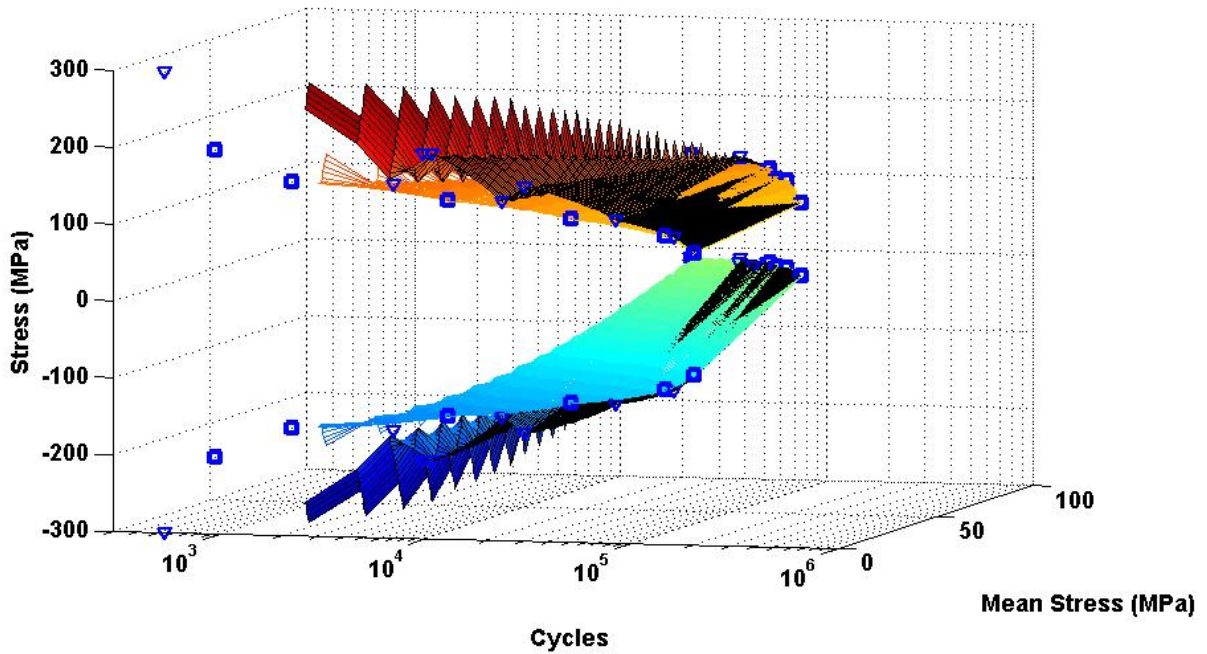
Figure 29: Fatigue failure envelope for Hi-Nicalon/PyC/HyprSiC tested at 1200°C in laboratory air and steam.

Figure 29 displays fatigue stress amplitude, mean stress, and cycles to failure data for Hi-Nicalon/PyC/HyprSiC at 1200°C in air and steam as a three-dimensional fatigue failure

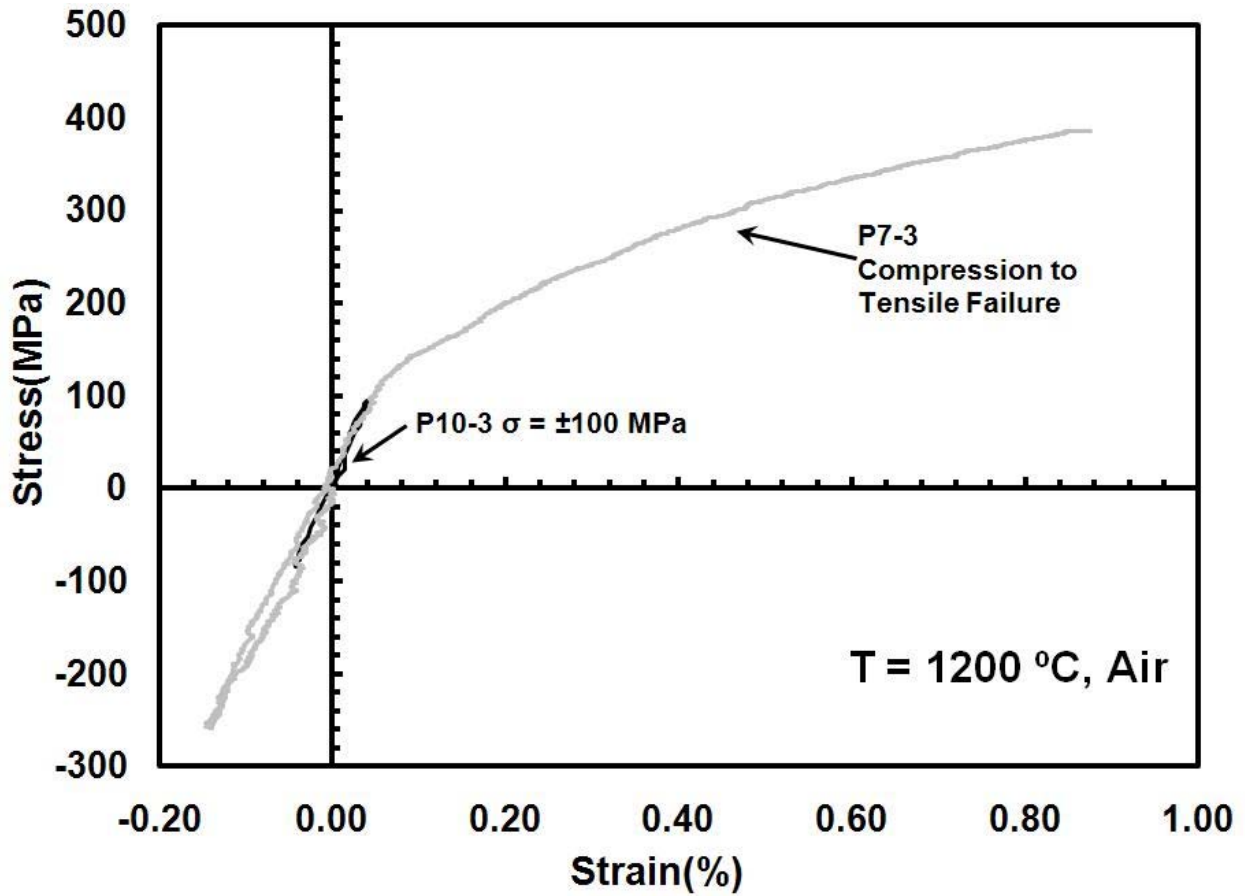
Figure 30: Stress-strain curve for as processed material loaded in compression-tension to failure compared to hysteresis curve of P10-3.

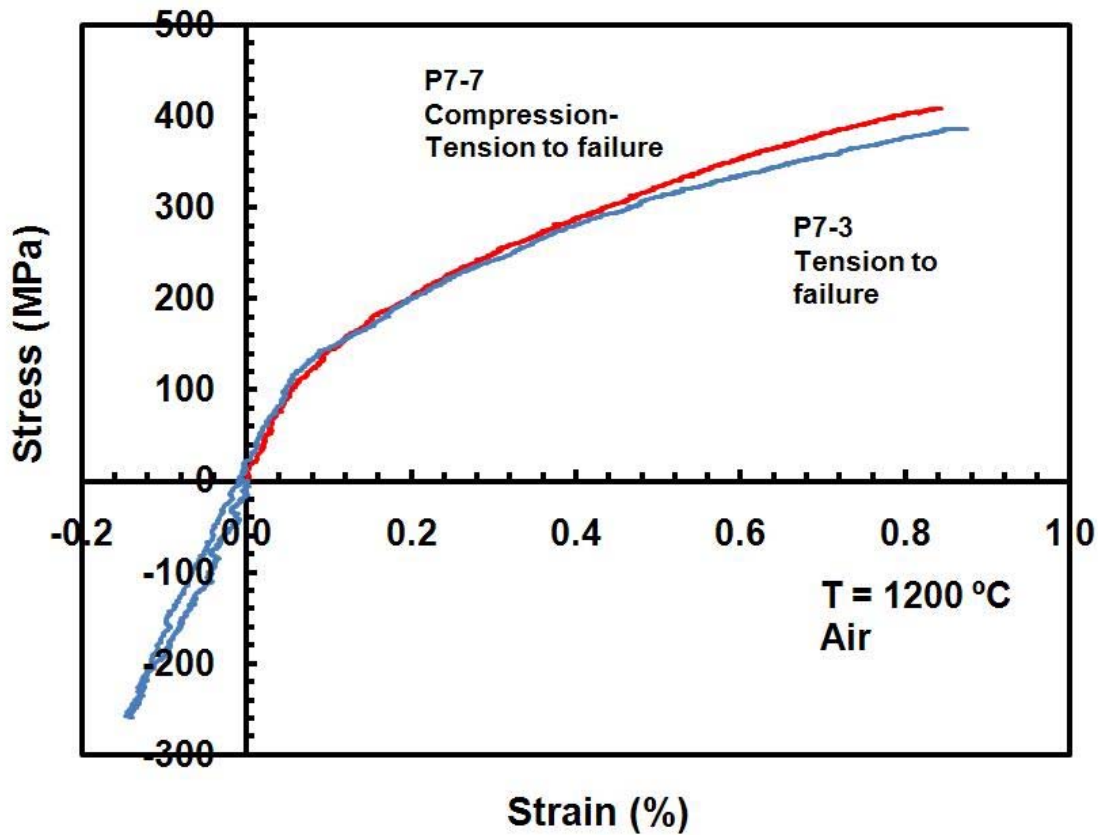
Figure 31: Stress-strain curve for as processed material tested in compression-tension to failure compared to tension to failure.

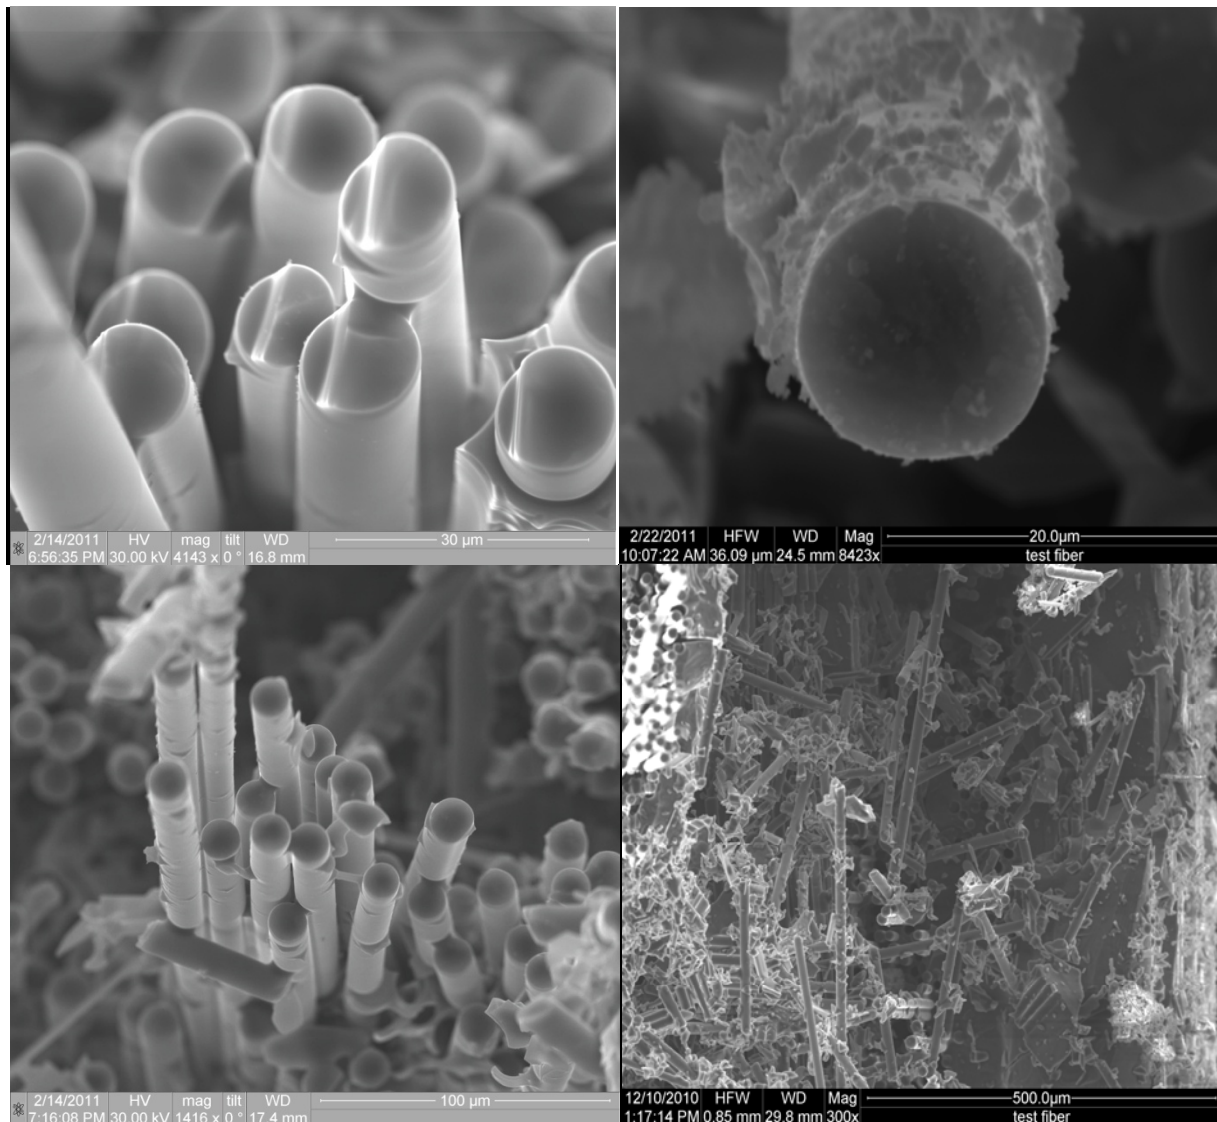
Figure 32: SEM micrograph of non oxidized fracture surface for 0.05mm/s tension to failure test at 1200°C in air on specimen P7-7.

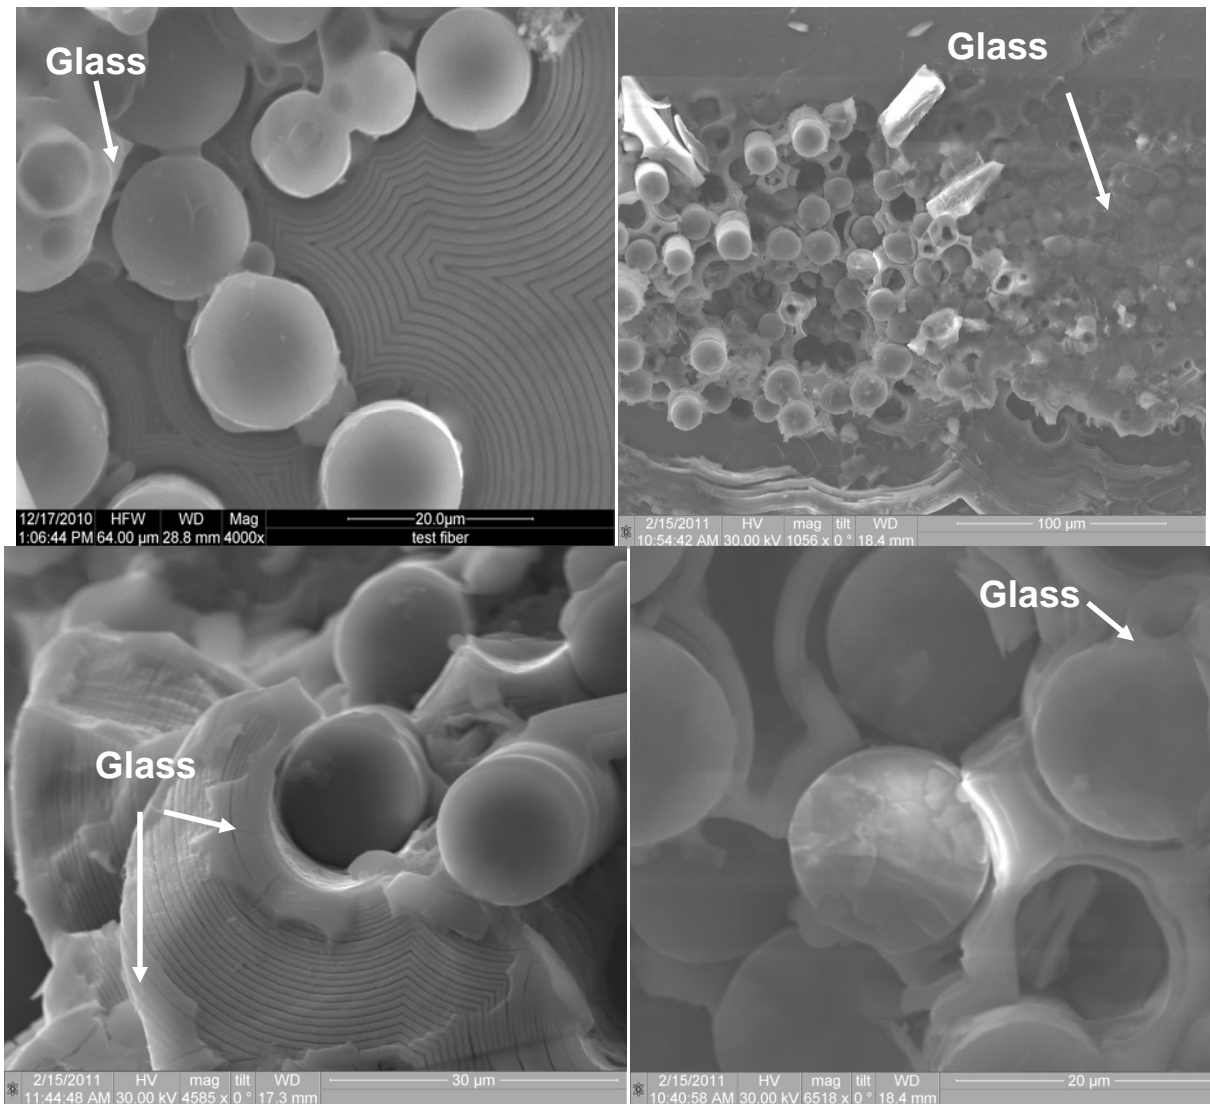
Figure 33: SEM micrograph of oxidized fracture surface for P5-2 tested in fatigue at 1200°C in steam. $\sigma = 80$ MPa, $N_f = 200000$.

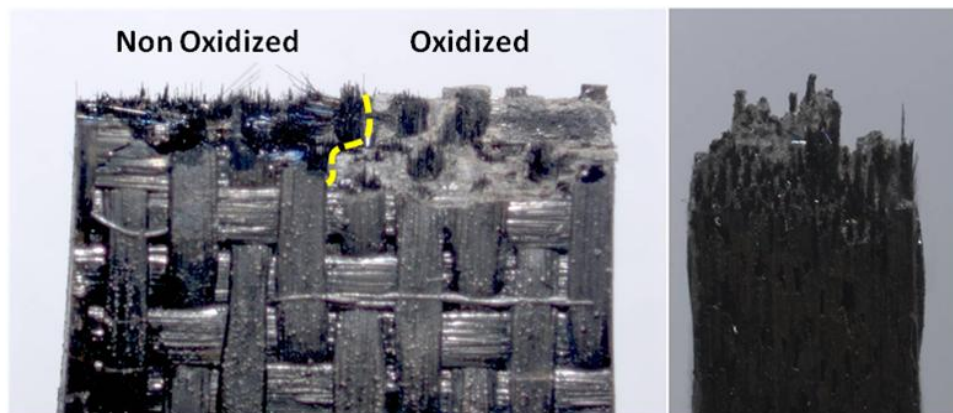
Figure 34: Optical micrograph of specimen P10-7 fracture surface.

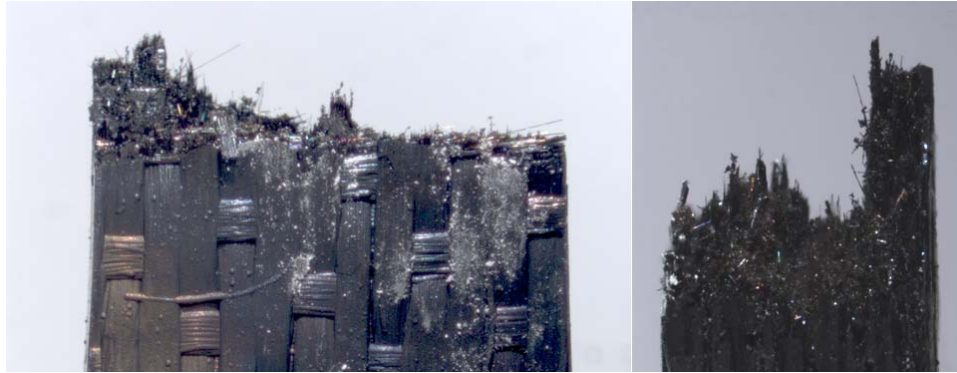
Figure 35: Optical micrographs of specimen P5-7 tested in tension at 1200°C in air. UTS = 296.3 MPa.

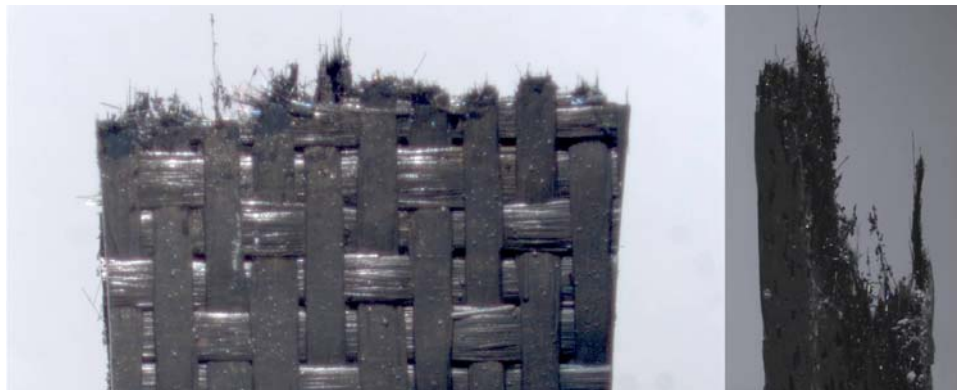
Figure 37: Optical micrographs of specimen P10-8 tested in tension at 1200°C in air. UTS = 391.9 MPa.

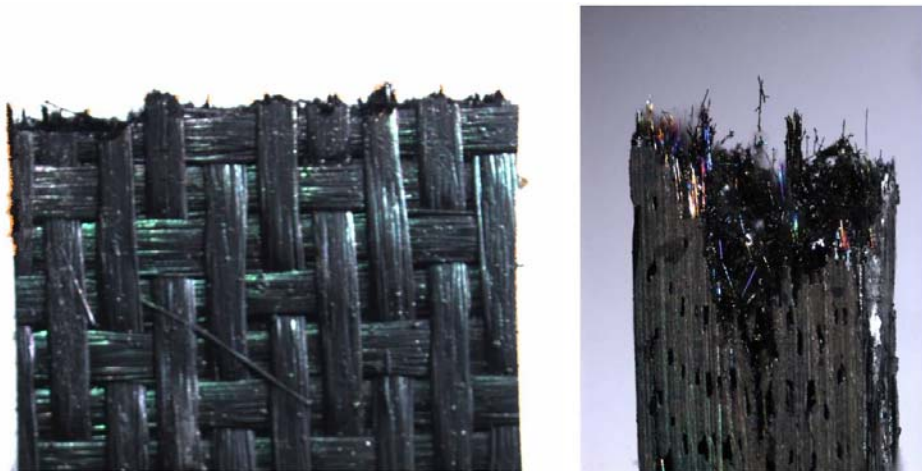
Figure 38: Optical micrograph of specimen P10-6 tested in fatigue at 1200°C in air. $\sigma = 80$ MPa, $N_f = 200000$.

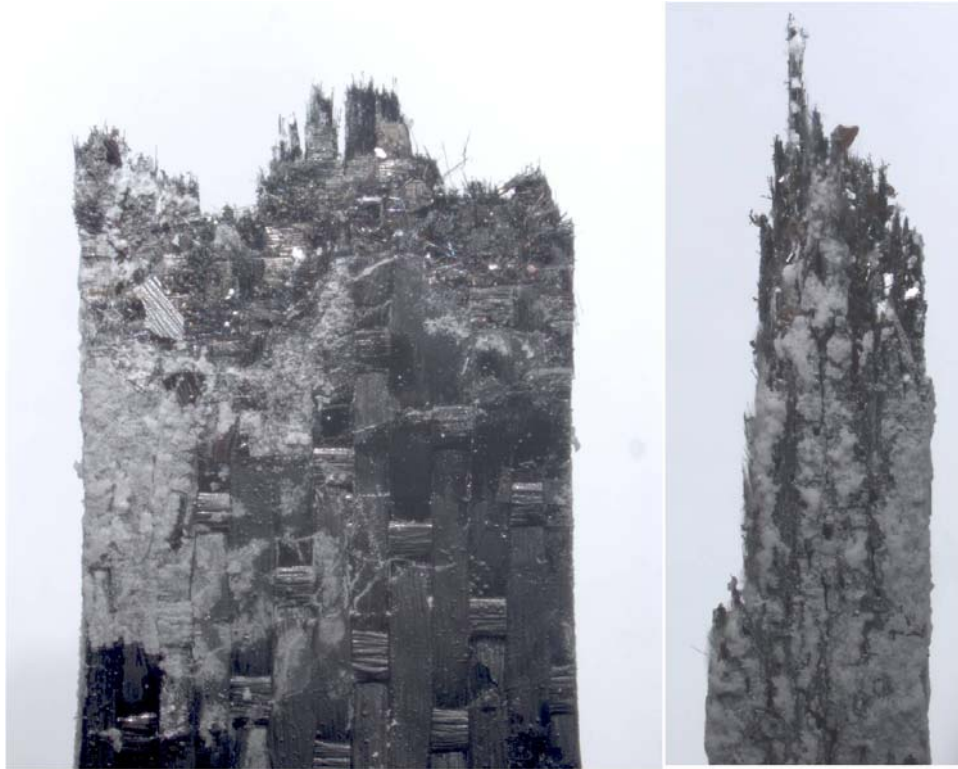
Figure 39: Optical micrograph of specimen P5-2 tested in fatigue at 1200°C in steam. $\sigma = 80$ MPa, $N_f = 200000$.

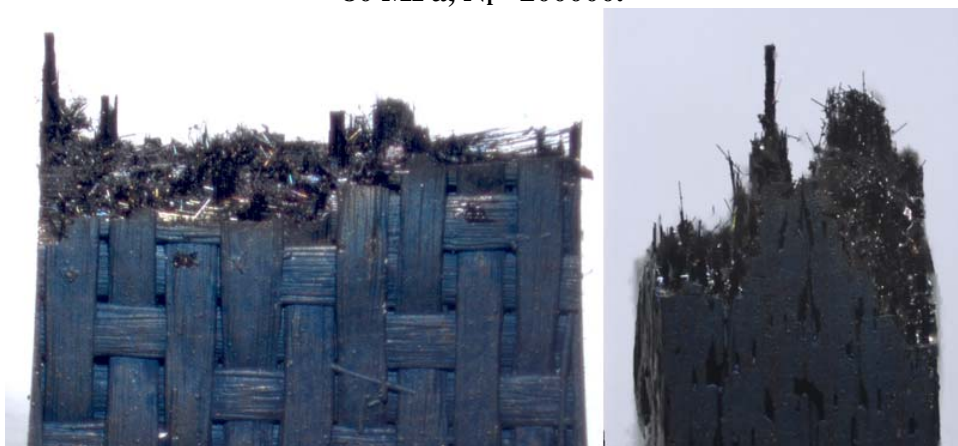
Figure 40: Optical micrograph of specimen P7-8 tested in fatigue at 1200°C in air. $\sigma = 200$ MPa, $N_f = 10656$.

Specimens tested in tension-compression fatigue were examined with the optical microscope and SEM. Optical micrographs of the fracture surfaces for specimens tested with a maximum stress of 80 MPa in air and steam are presented in Figure 38 and Figure 39. The optical micrographs of fracture surfaces for specimens tested in fatigue with a maximum stress of 200 MPa in air and steam are given in Figure 40 and Figure 41 respectively.

Specimens tested in a steam environment formed glass (SiO_2) deposits on the fracture surface. Longer exposure to the oxidizing environment typically corresponded to higher amounts of glass. Specimen P5-2 having reached run-out at 2×10^5 cycles has significant SiO_2 formations on the specimen surface, as well as on the fracture surface as evident in Figure 39. Specimen P7-4 given in Figure 41 does not display glass formations characteristic of fatigue testing in steam at 1200°C due to the relatively short ($N_f = 948$ cycles) exposure time. Specimens tested at maximum stress levels of 80MPa and 200MPa in air and steam environments demonstrated fiber pull-out as well as tensile failure modes.

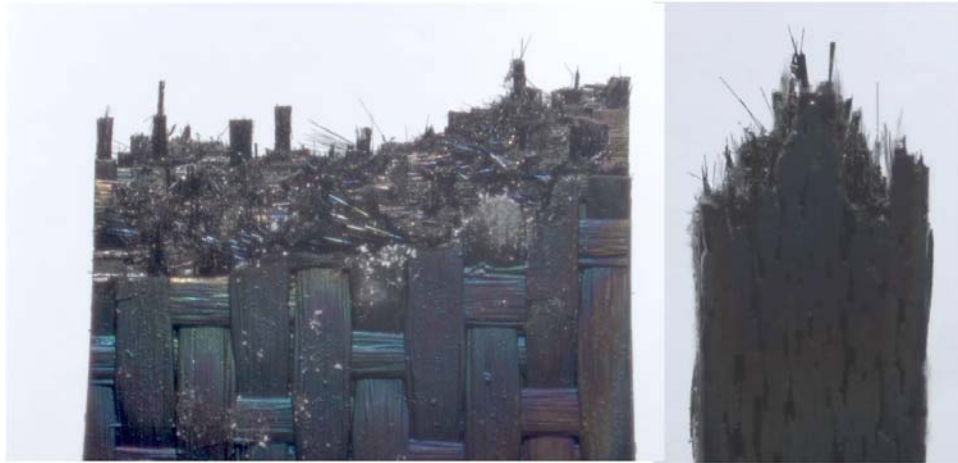
Figure 41: Optical micrograph of specimen P7-4 tested in fatigue at 1200°C in steam. $\sigma = 200$ MPa, $N_f = 948$.

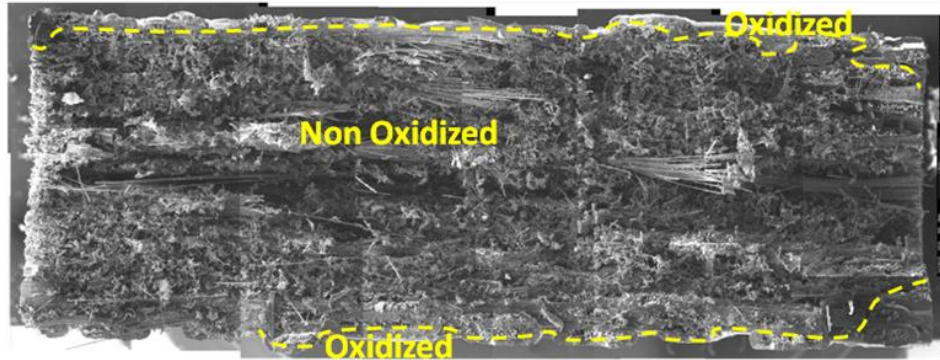
Figure 42: SEM micrograph specimen P10-6 fracture surface tested in fatigue at 1200°C in air. $\sigma = 80$ MPa, $N_f = 200000$.

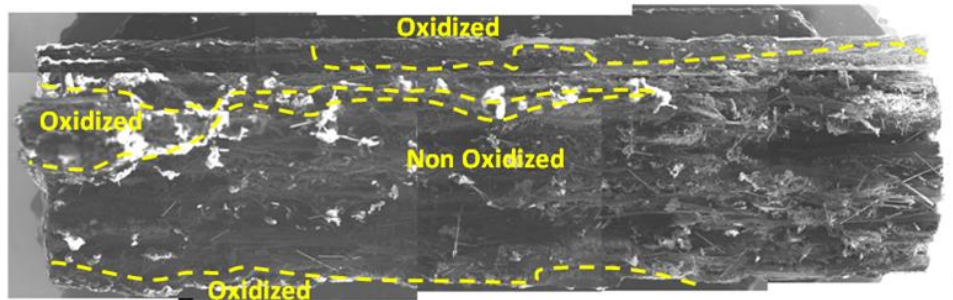
Figure 43: SEM micrograph specimen P5-2 fracture surface tested in fatigue at 1200°C in steam. $\sigma = 80$ MPa, $N_f = 200000$.

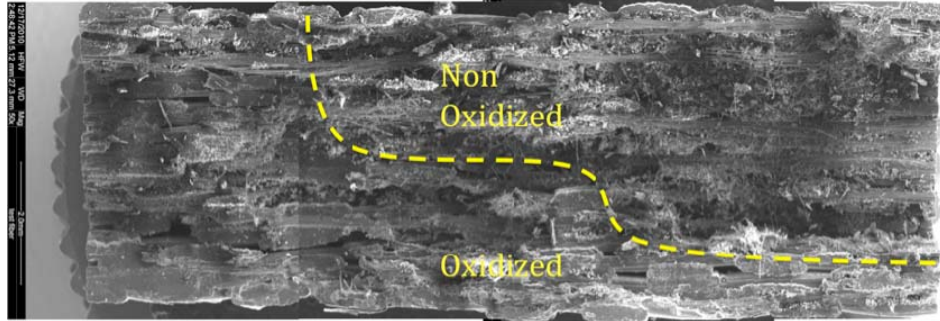
Figure 44: SEM micrograph specimen P10-3 fracture surface tested in fatigue at 1200°C in air. $\sigma = 100$ MPa, $N_f = 161110$.

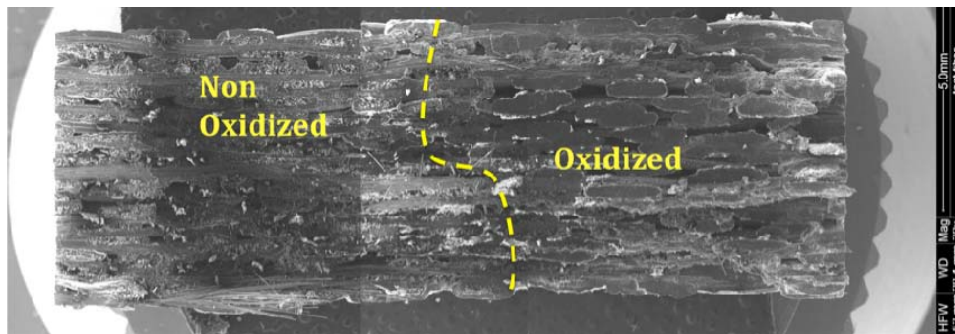
Figure 45: SEM micrograph of specimen P10-7 fracture surface, tested in fatigue at 1200°C in steam. $\sigma = 100$ MPa, $N_f = 144519$.

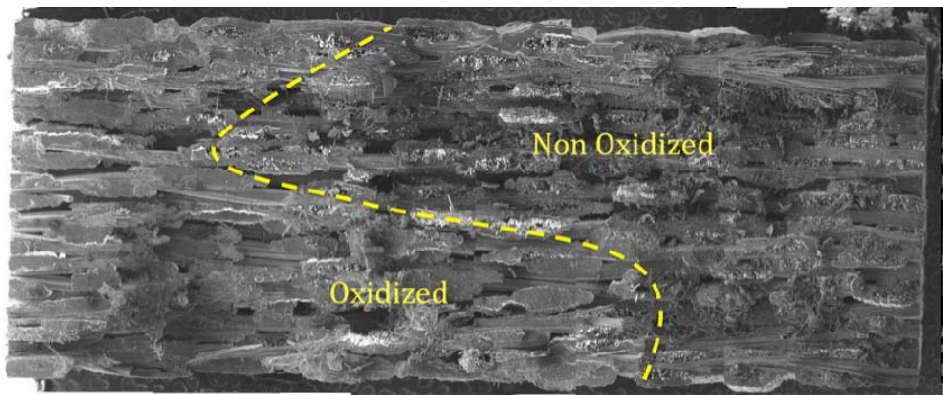
Figure 46: SEM micrograph of specimen P10-5 fracture surface, tested in fatigue at 1200°C in air. $\sigma = 120$ MPa, $N_f = 83799$.

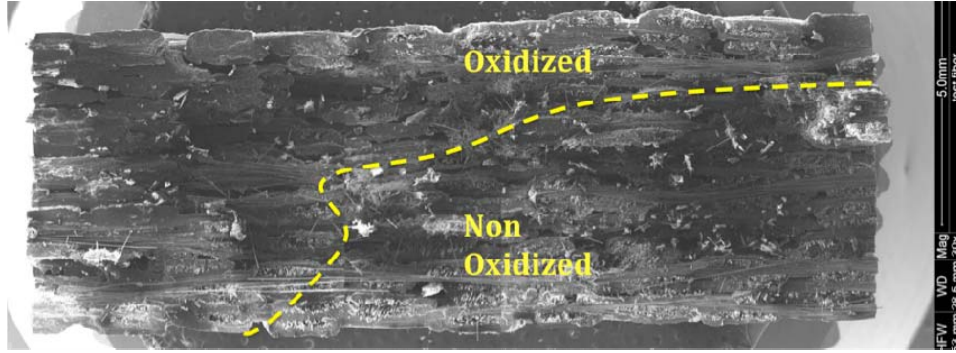
Figure 47: SEM micrograph of specimen P10-1 fracture surface, tested in fatigue at 1200°C in steam. $\sigma = 120$ MPa, $N_f = 50499$.

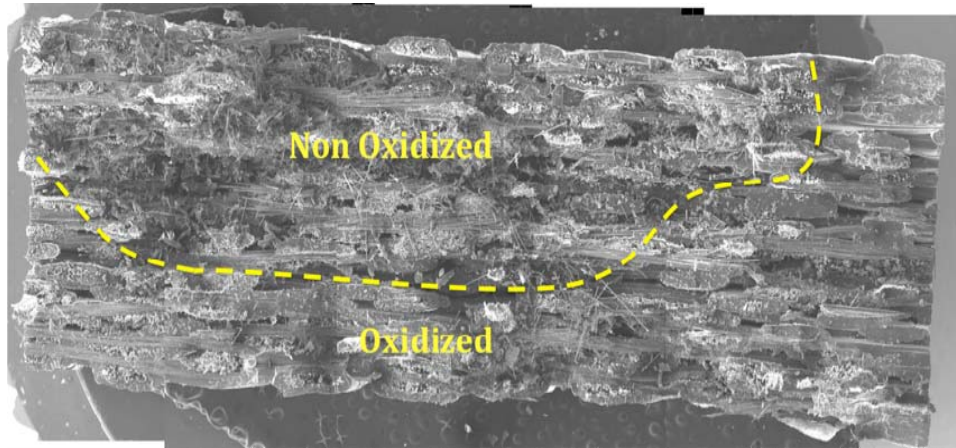
Figure 48: SEM micrograph of specimen P10-2 fracture surface, tested in fatigue at 1200°C in air. $\sigma = 140$ MPa, $N_f = 23277$.

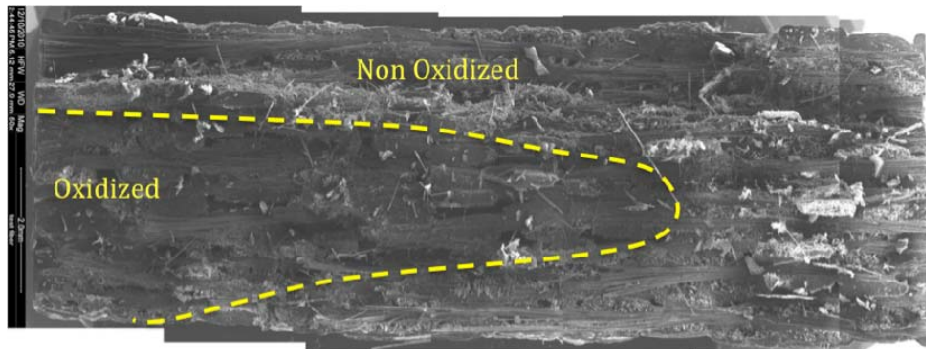
Figure 49: SEM micrograph of specimen P5-4 fracture surface, tested in fatigue at 1200°C in steam. $\sigma = 140$ MPa, $N_f = 12784$.

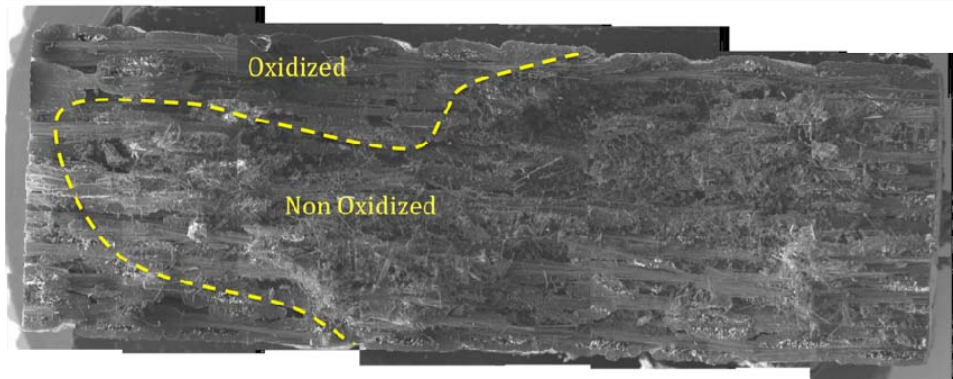
Figure 50: SEM micrograph of specimen P7-1 fracture surface, tested in fatigue at 1200°C in air. $\sigma = 160$ MPa, $N_f = 6914$.

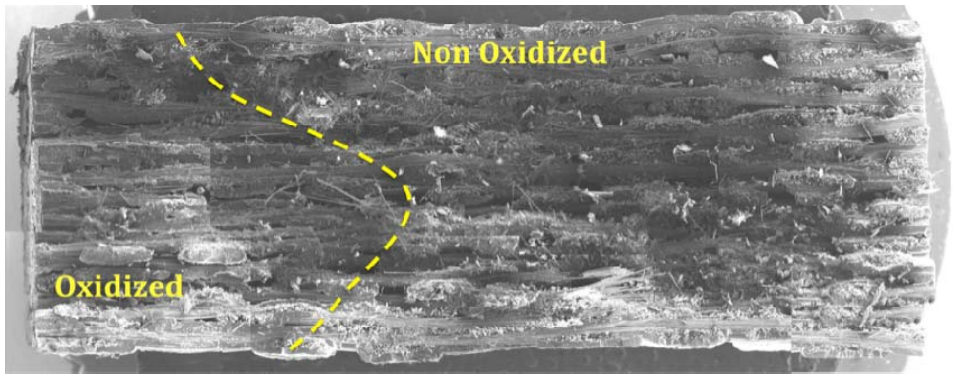
Figure 51: SEM micrograph of specimen P7-2 fracture surface, tested in fatigue at 1200°C in steam. $\sigma = 160$ MPa, $N_f = 2214$.

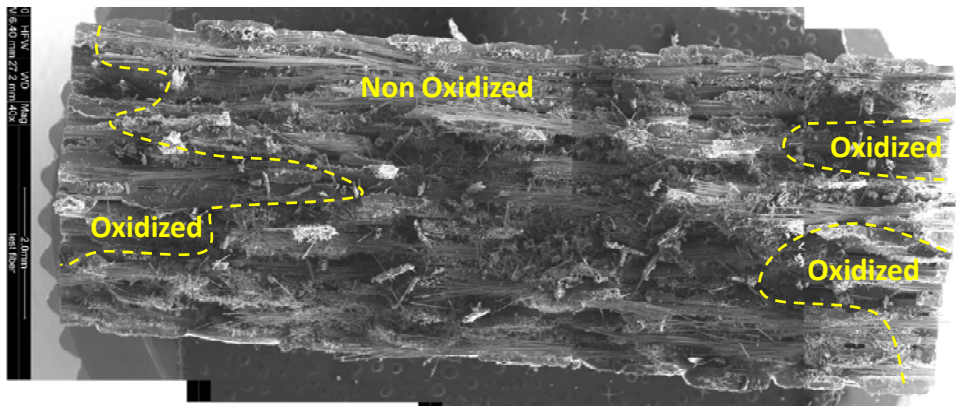
Figure 52: SEM micrograph of specimen P7-4 fracture surface, tested in fatigue at 1200°C in steam. $\sigma = 200$ MPa, $N_f = 948$.

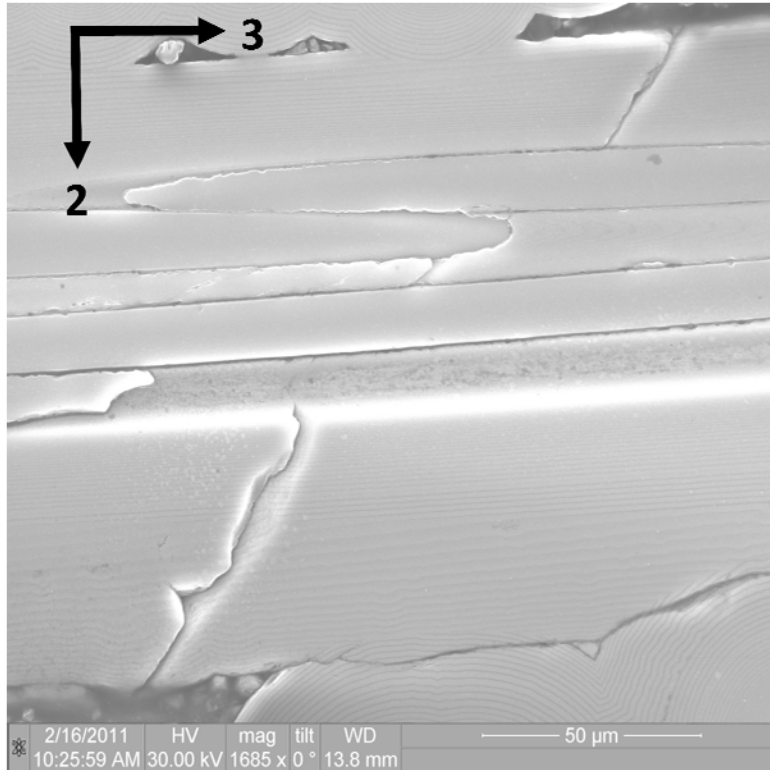
Figure 53: Longitudinal crack in 1-2 and 1-3 planes of specimen P10-6.

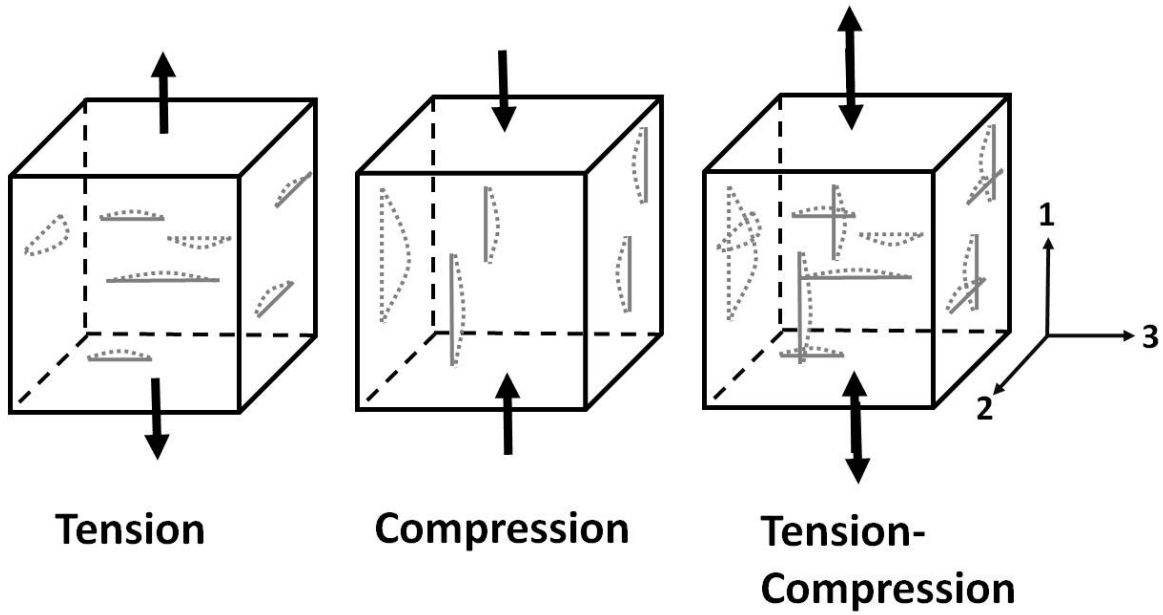
Figure 54: Material element crack development for tension, compression, and tension-compression loading for mode 1.

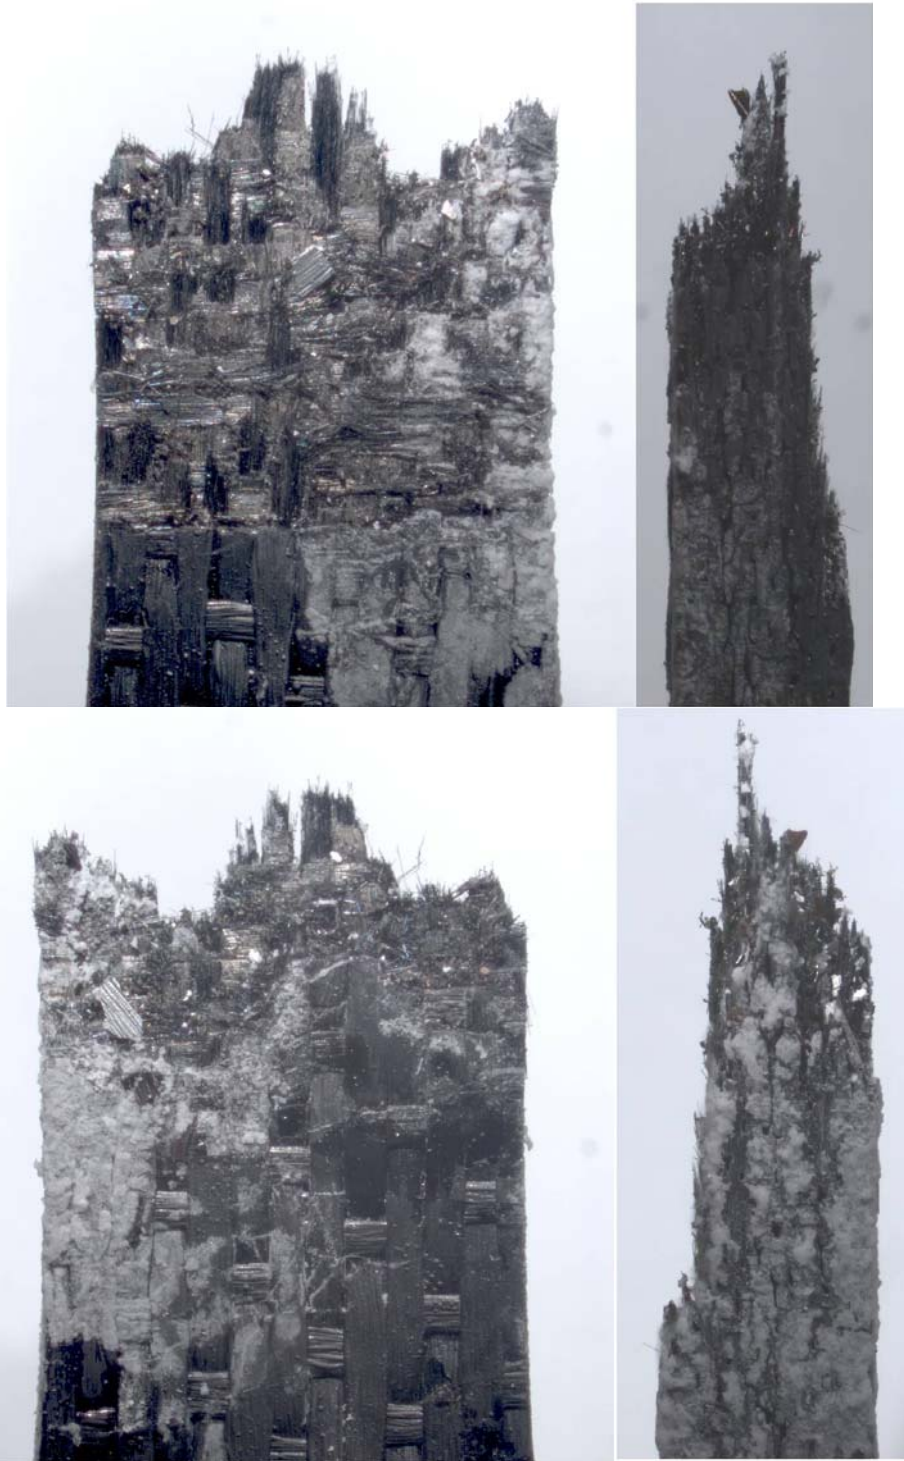
Figure 55: Optical micrographs of specimen P5-2 tested in fatigue at 1200°C in steam . $\sigma = 80$ MPa, $N_f = 200000$.
