Tension-Compression Fatigue of Hi-Nicalon/SiC Ceramic Matrix Composite at 1200°C in Air and Steam

**TENSION-COMPRESSION FATIGUE OF Hi-NICALON/SiC CERAMIC MATRIX
COMPOSITE AT 1200 °C IN AIR AND IN STEAM**

THESIS

AIR FORCE INSTITUTE OF TECHNOLOGY

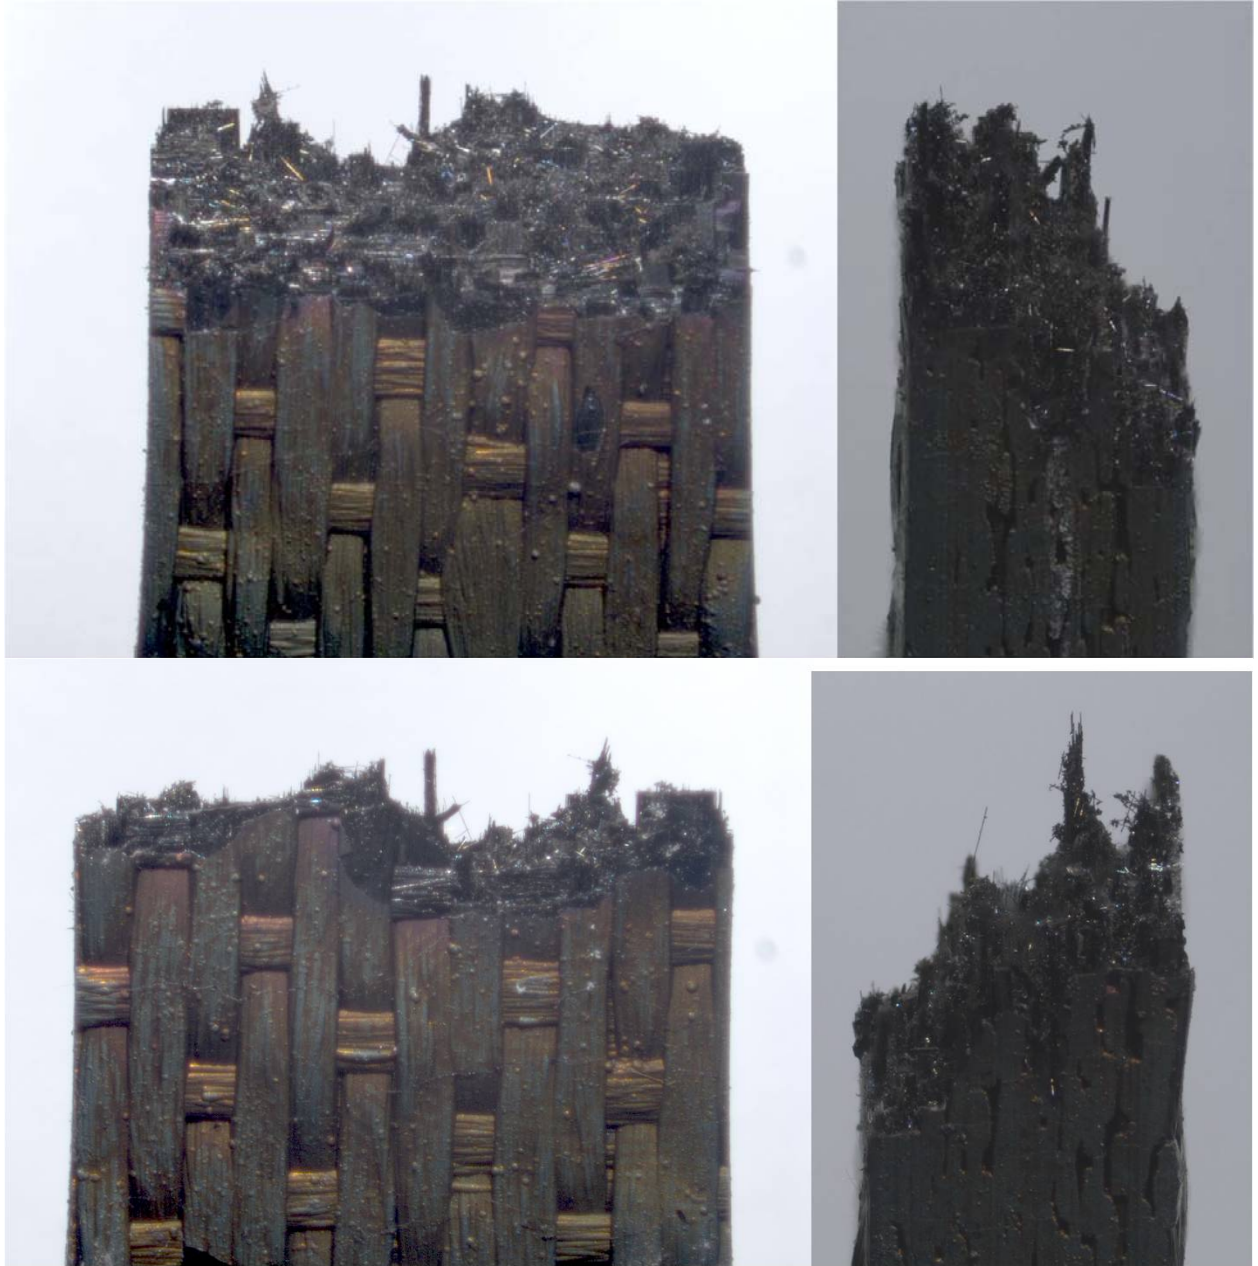
Figure 56: Optical micrographs of specimen P5-3 tested in fatigue at 1200°C in air. $\sigma = 160$ MPa, $N_f = 29988$.

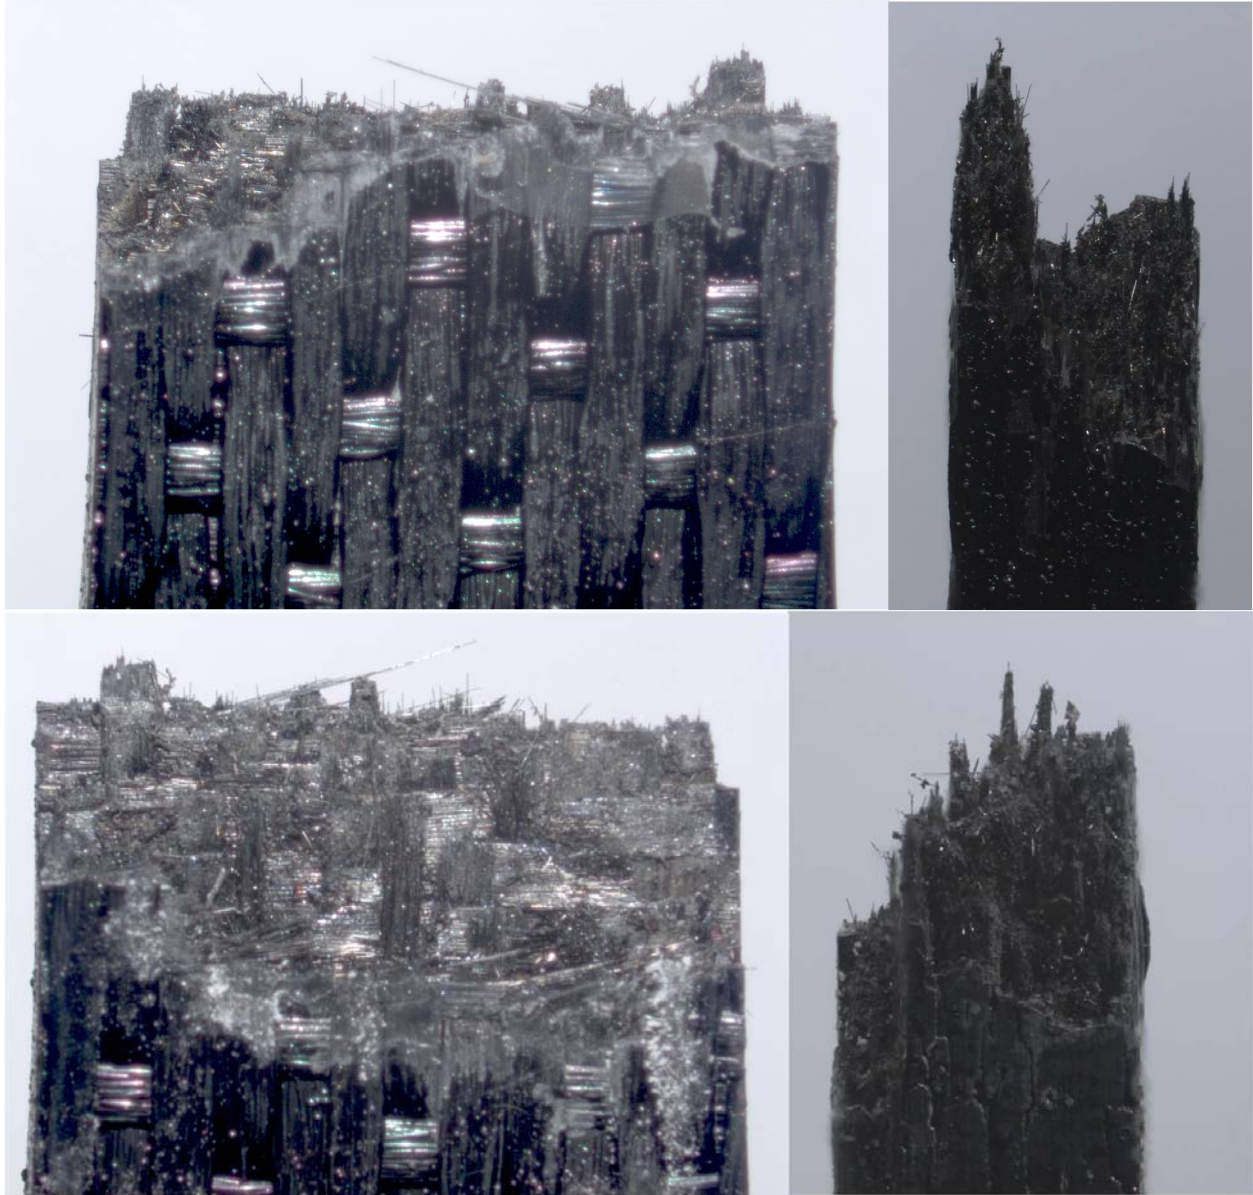
Figure 57: Optical micrographs of specimen P5-4 tested in fatigue at 1200°C in steam. $\sigma = 140$ MPa, $N_f = 12784$.

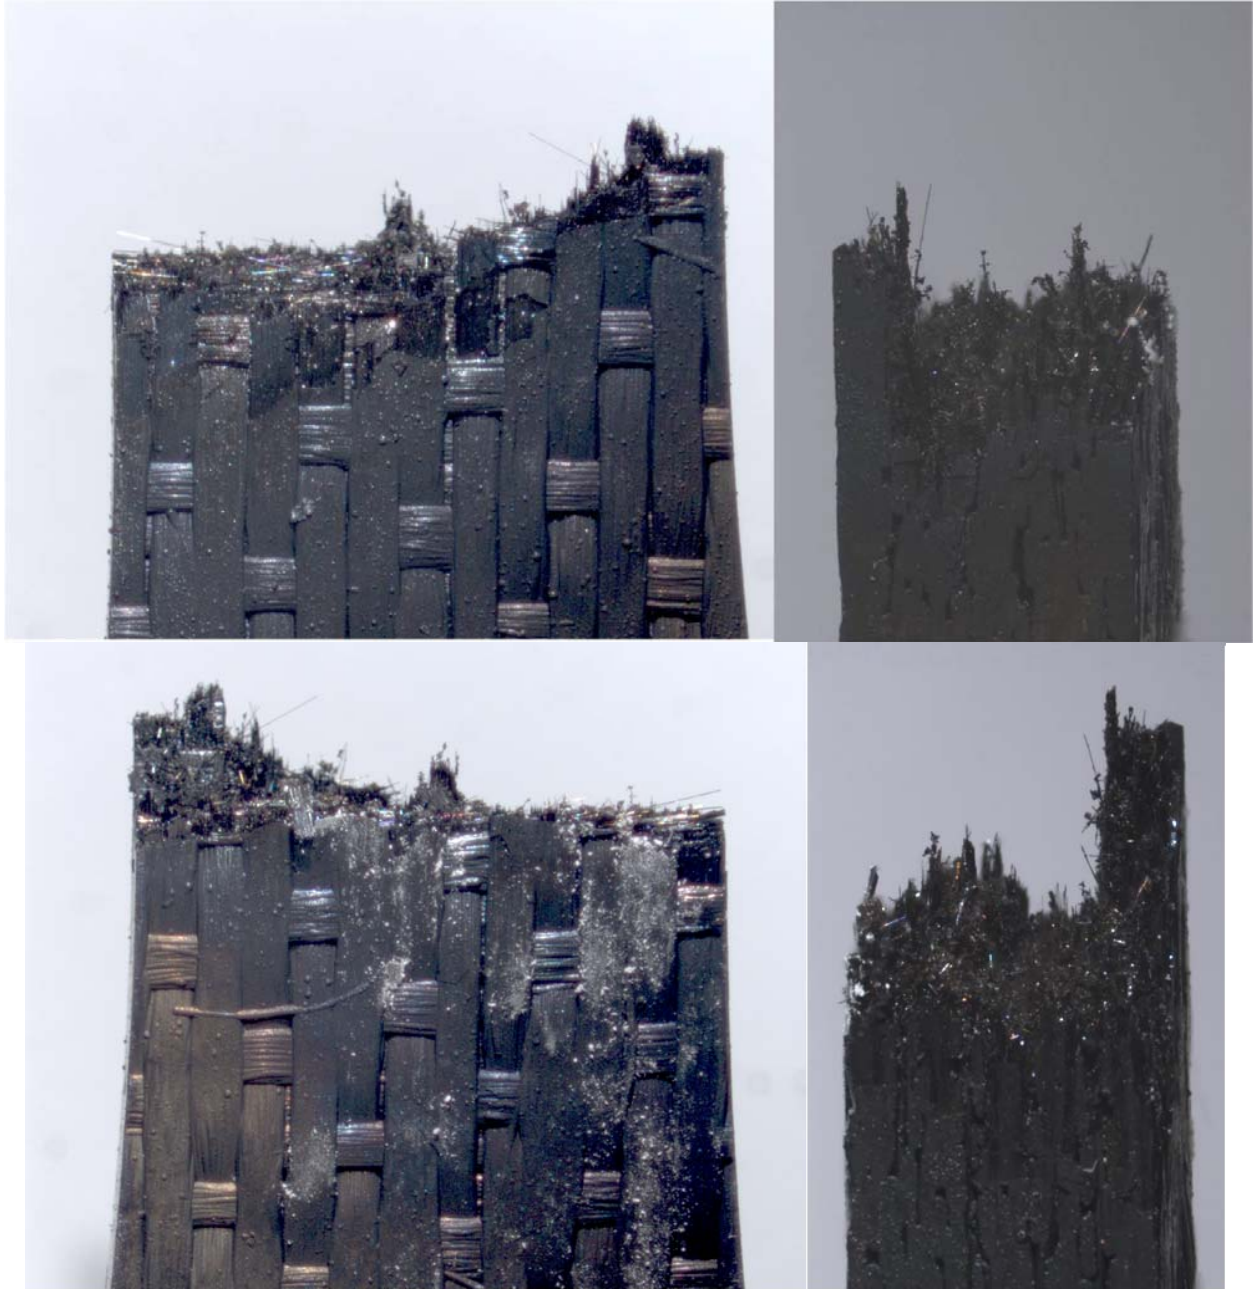
Figure 58: Optical micrographs of specimen P5-7 tested in tension at 1200°C in air. UTS = 296.3 MPa.

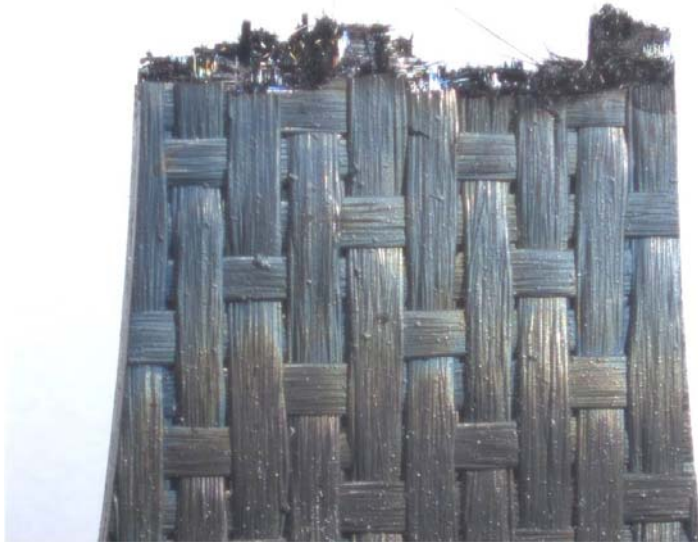
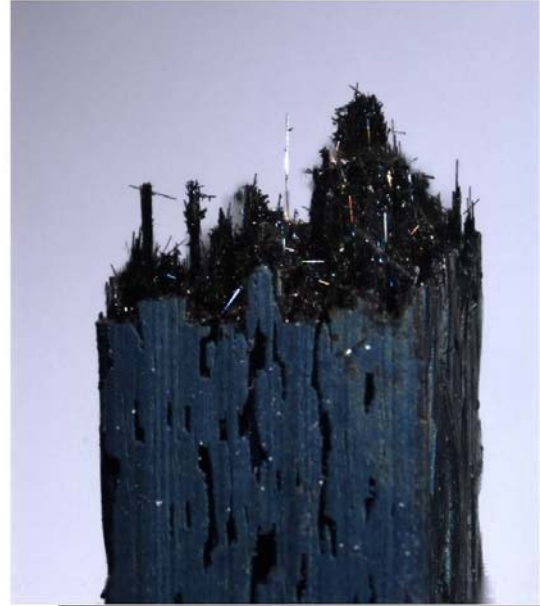
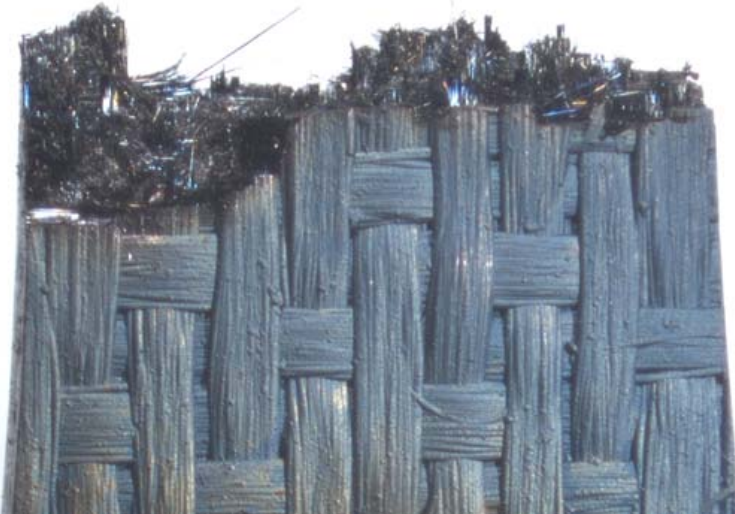
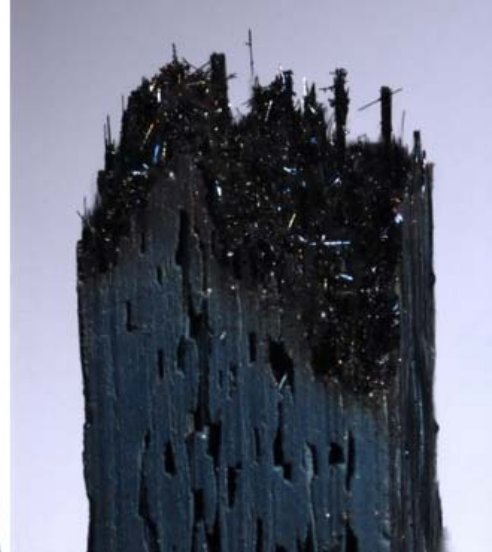
Figure 59: Optical micrographs of specimen P7-1 tested in fatigue at 1200°C in air. $\sigma = 160$ MPa, $N_f = 6914$.

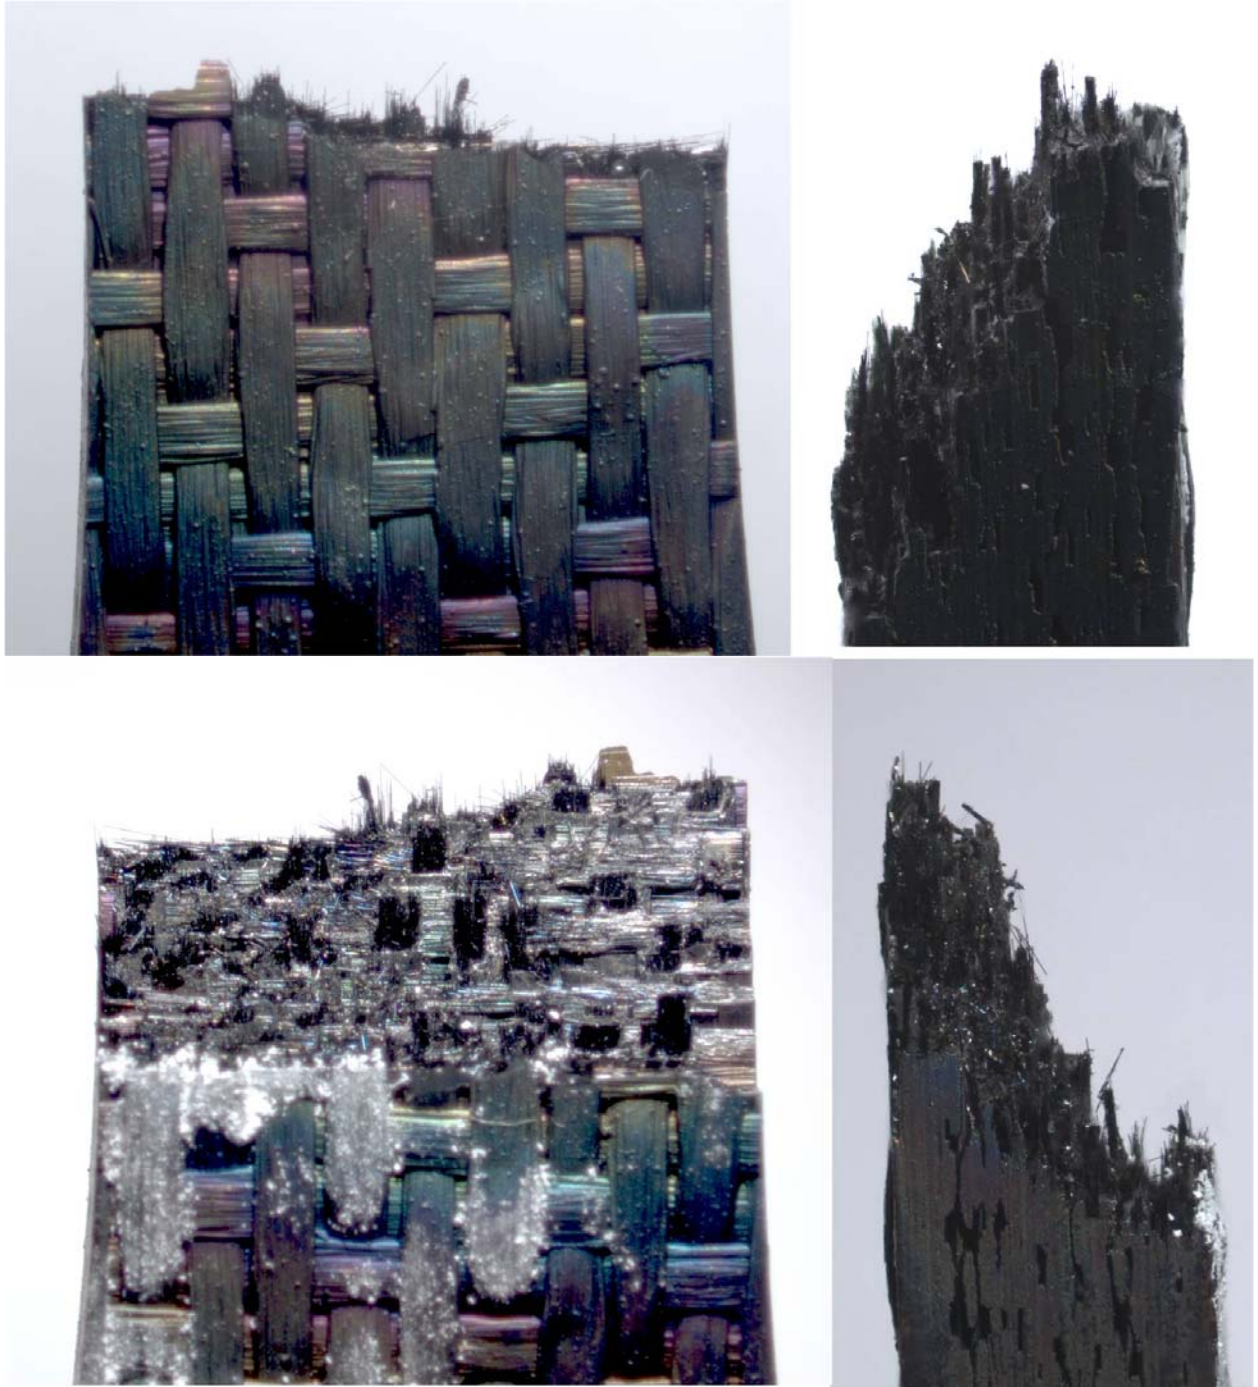
Figure 60: Optical micrographs of specimen P7-2 tested in fatigue at 1200°C in steam. $\sigma = 160$ MPa, $N_f = 2214$.

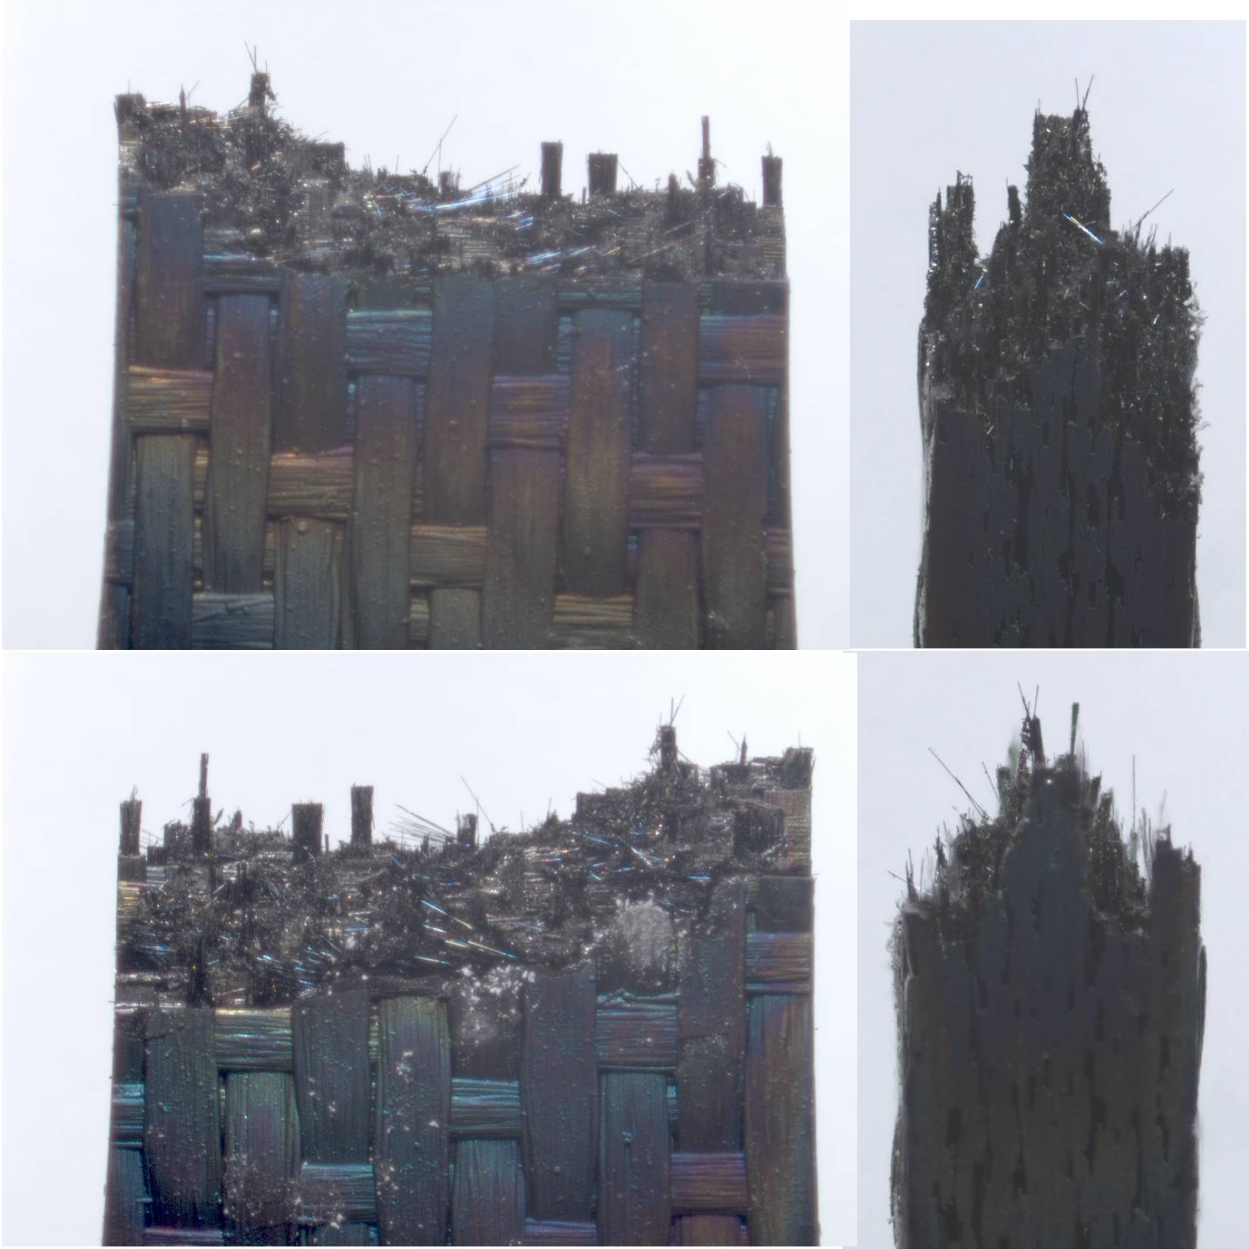
Figure 61: Optical micrographs of specimen P7-4 tested in fatigue at 1200°C in steam. $\sigma = 200$ MPa, $N_f = 948$.

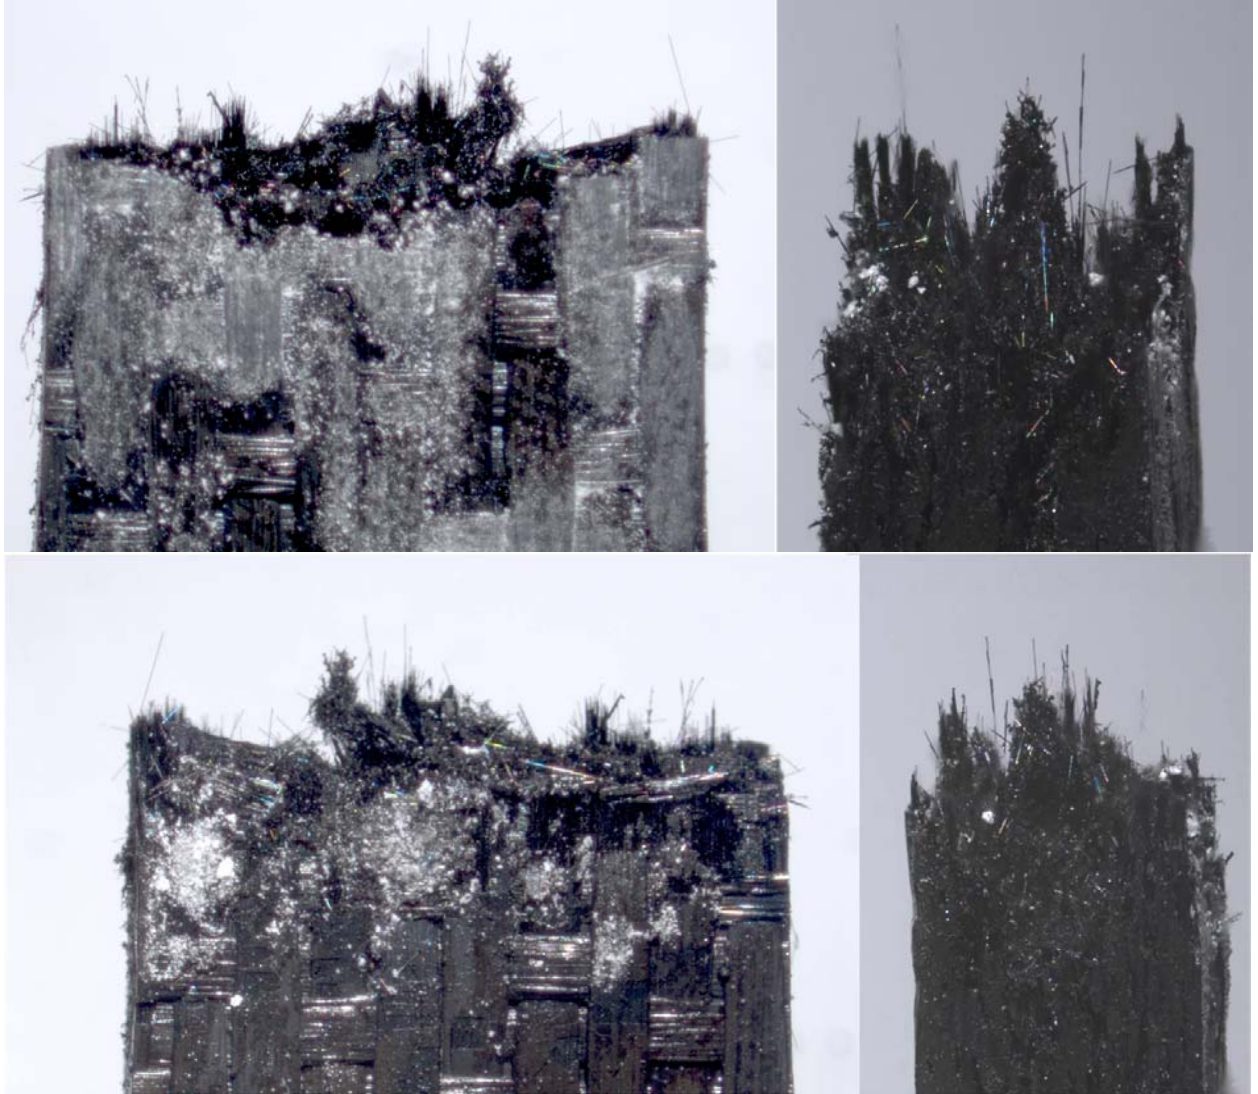
Figure 62: Optical micrographs of specimen P7-7 tested in tension at 1200°C in air. UTS = 406.9 MPa.

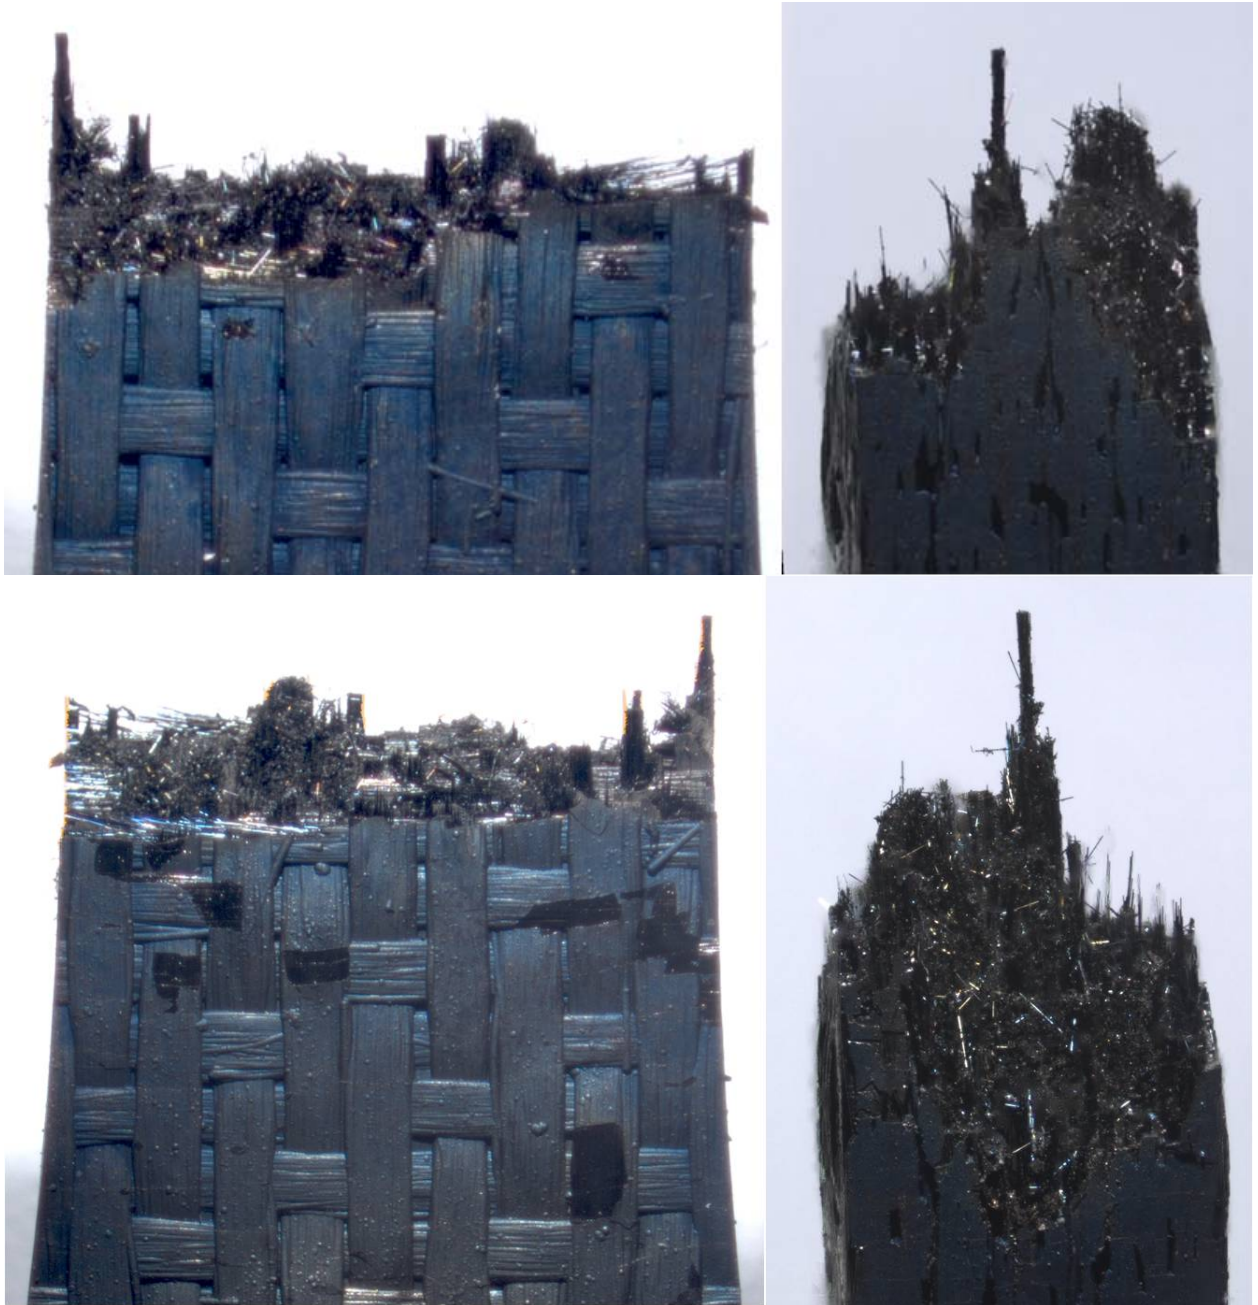
Figure 63: Optical micrographs of specimen P7-8 tested in fatigue at 1200°C in air. $\sigma = 200$ MPa, $N_f = 10656$.

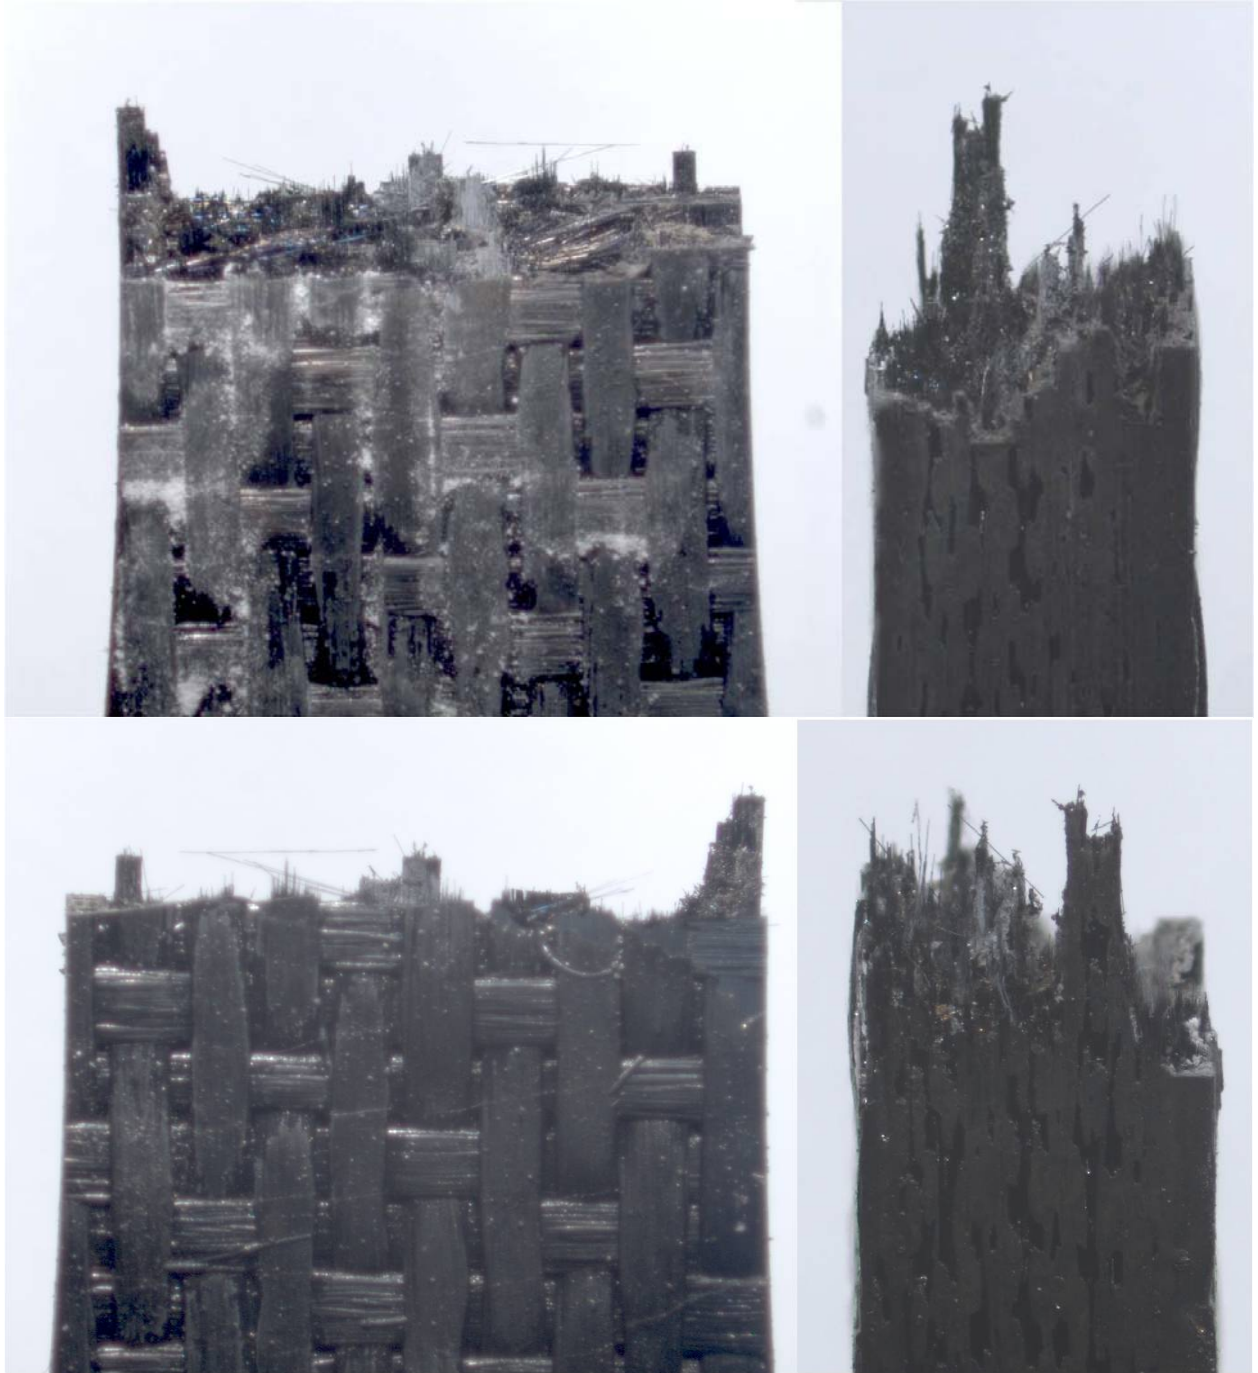
Figure 64: Optical micrographs of specimen P10-1 tested in fatigue at 1200°C in steam. $\sigma = 120$ MPa, $N_f = 50499$.

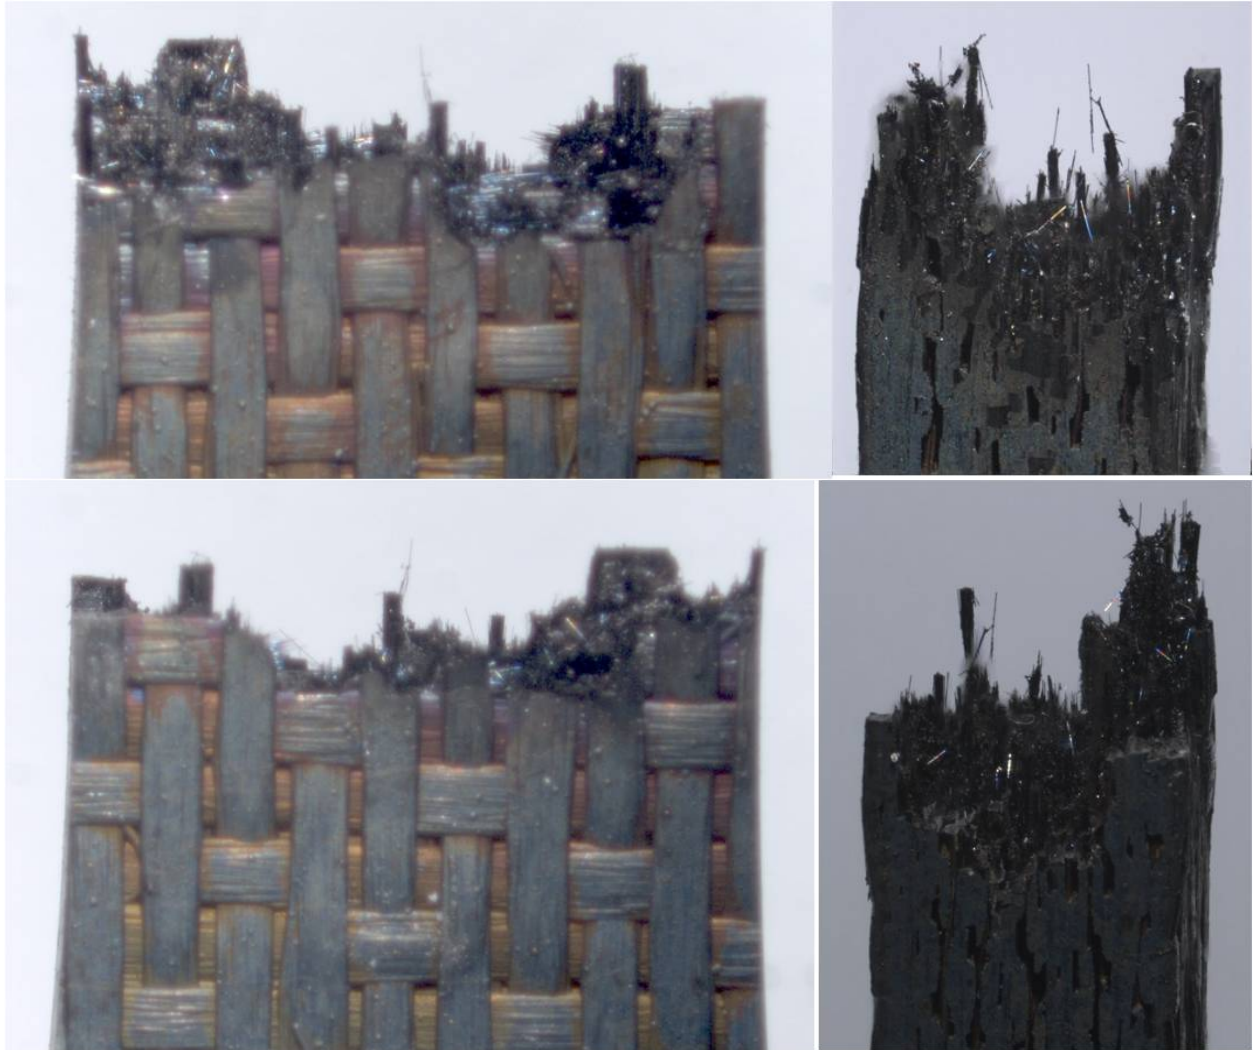
Figure 65: Optical micrographs of specimen P10-2 tested in fatigue at 1200°C in air. $\sigma = 140$ MPa, $N_f = 23277$.

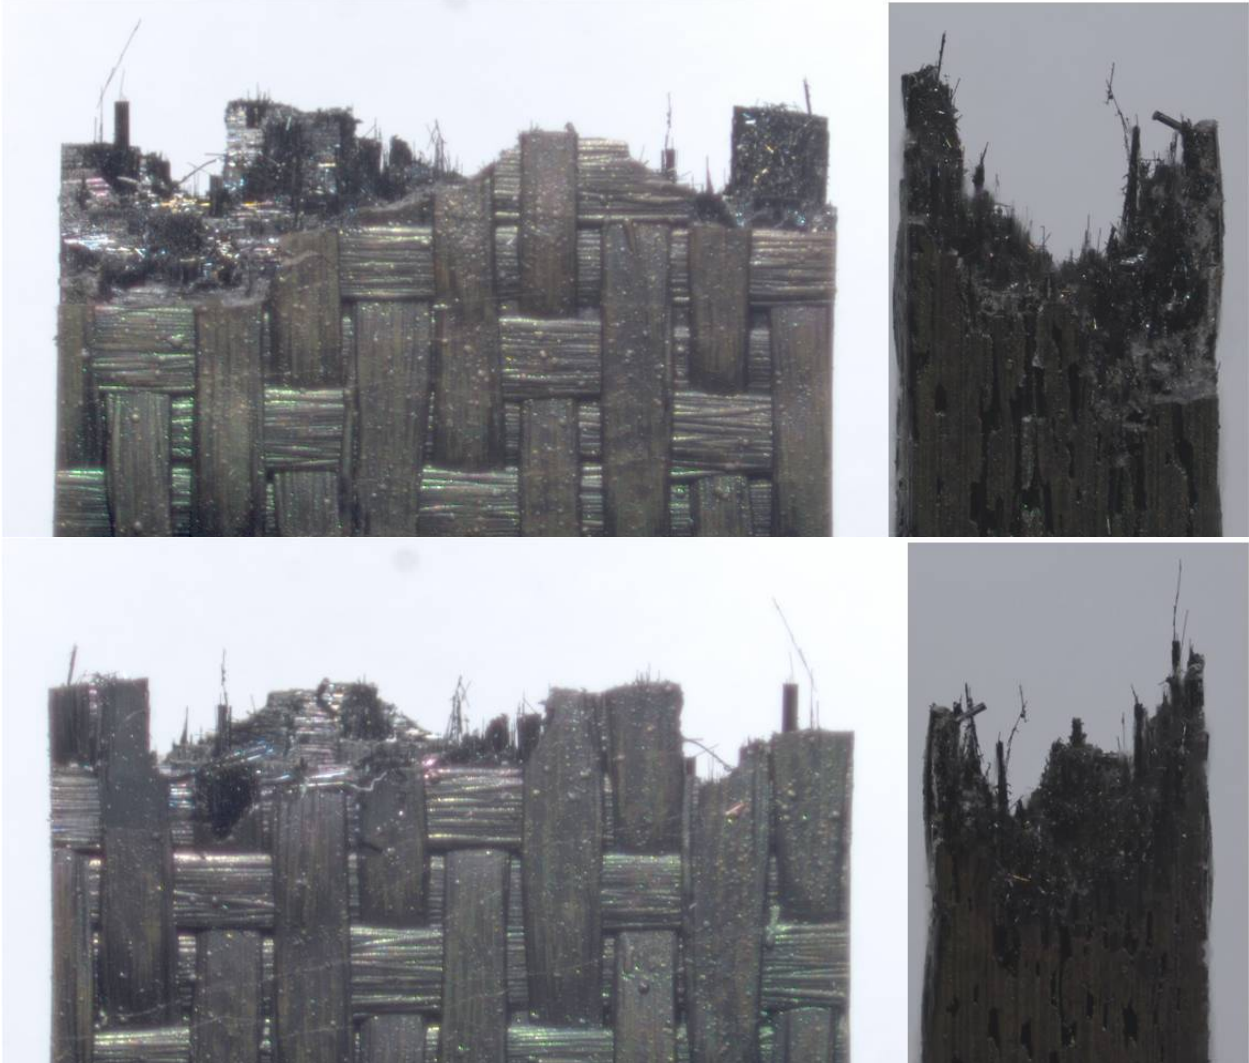
Figure 66: Optical micrographs of specimen P10-3 tested in fatigue at 1200°C in air. $\sigma = 100$ MPa, $N_f = 161110$.

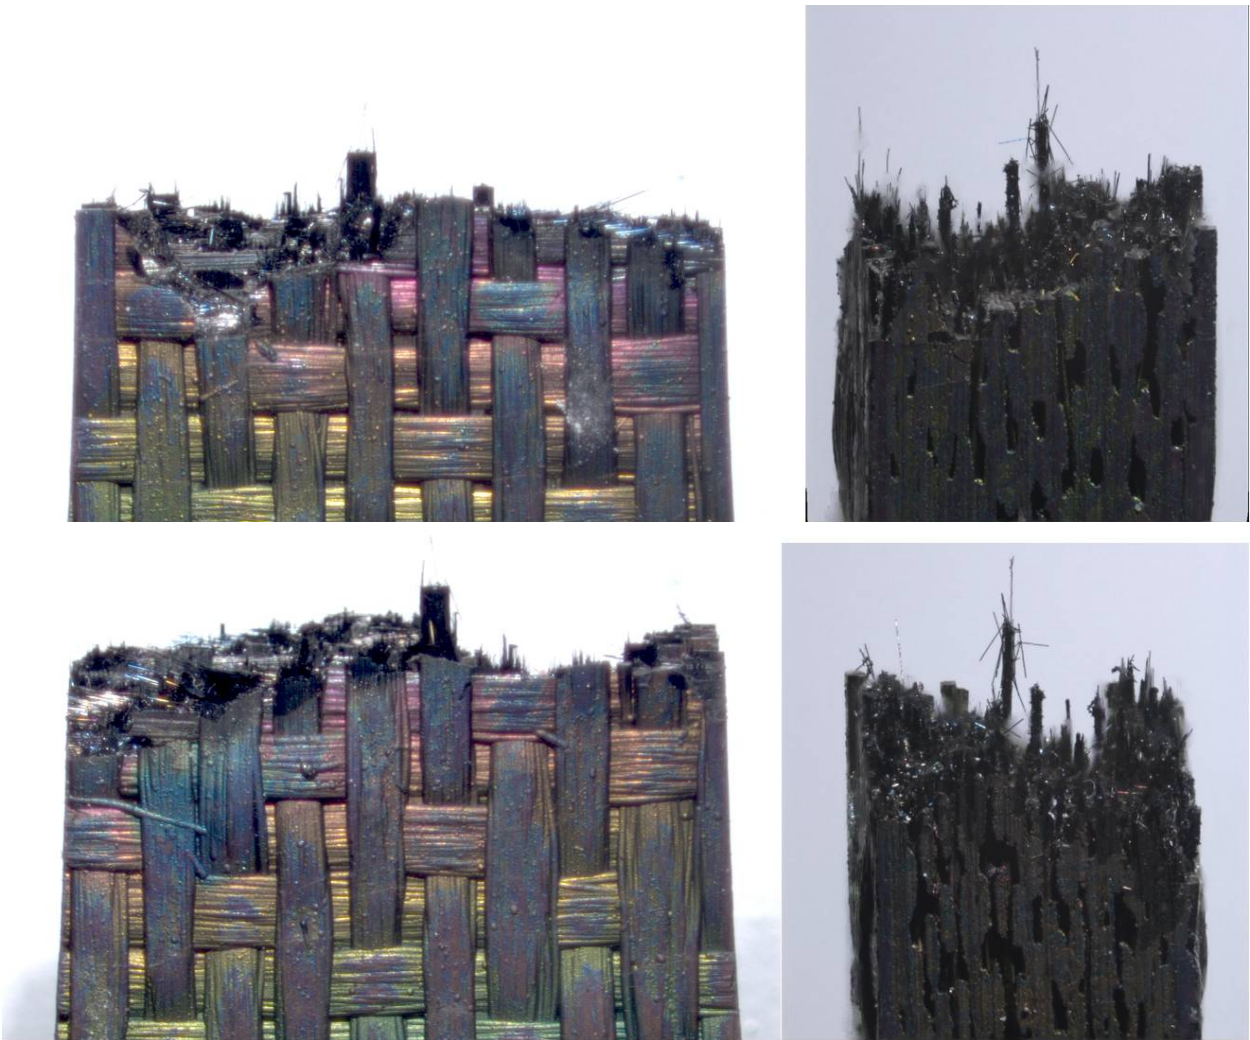
Figure 67: Optical micrographs of specimen P10-5 tested in fatigue at 1200°C in air. $\sigma = 120$ MPa, $N_f = 83799$.

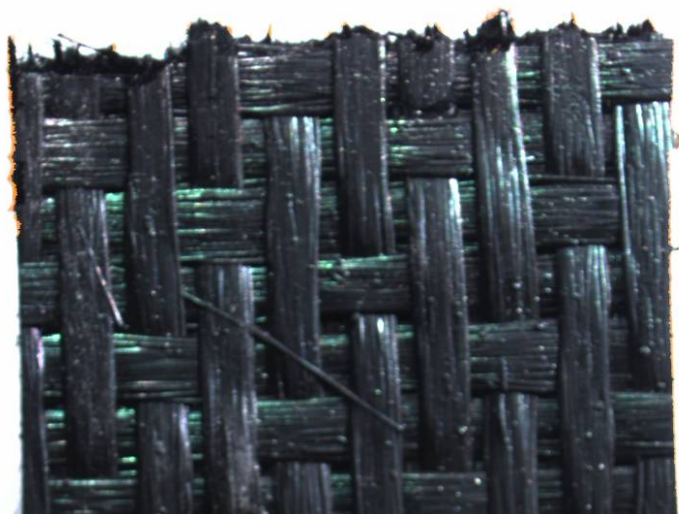
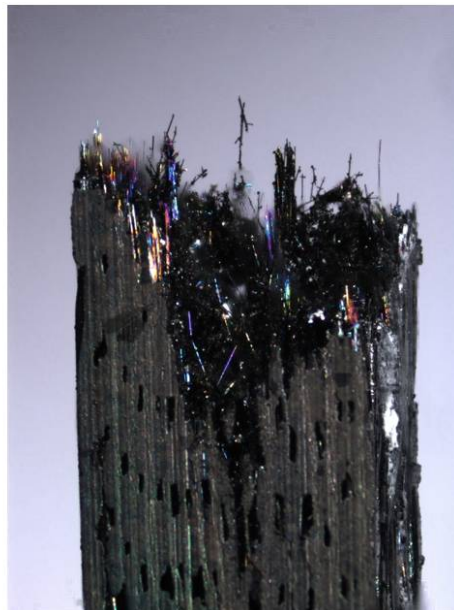
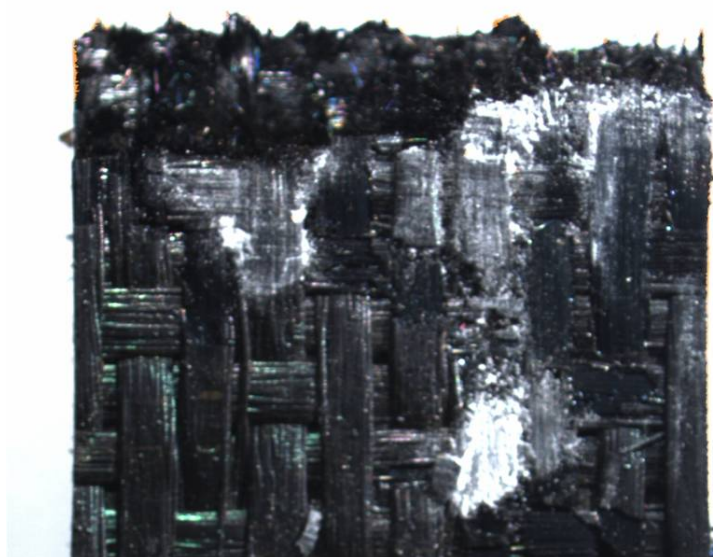
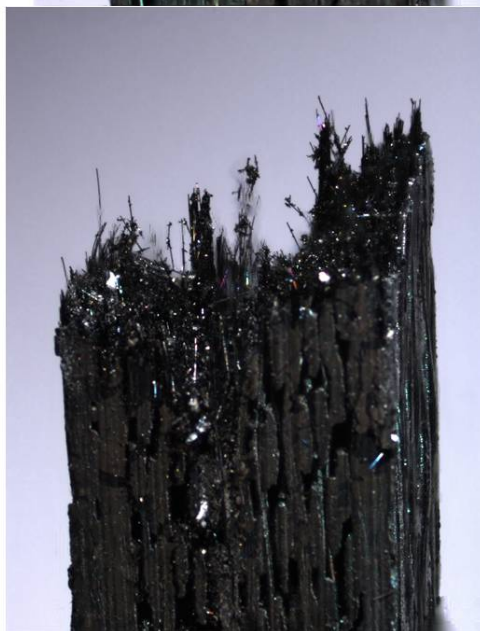
Figure 68: Optical micrographs of specimen P10-6 tested in fatigue at 1200°C in air. $\sigma = 80$ MPa, $N_f = 200000$.

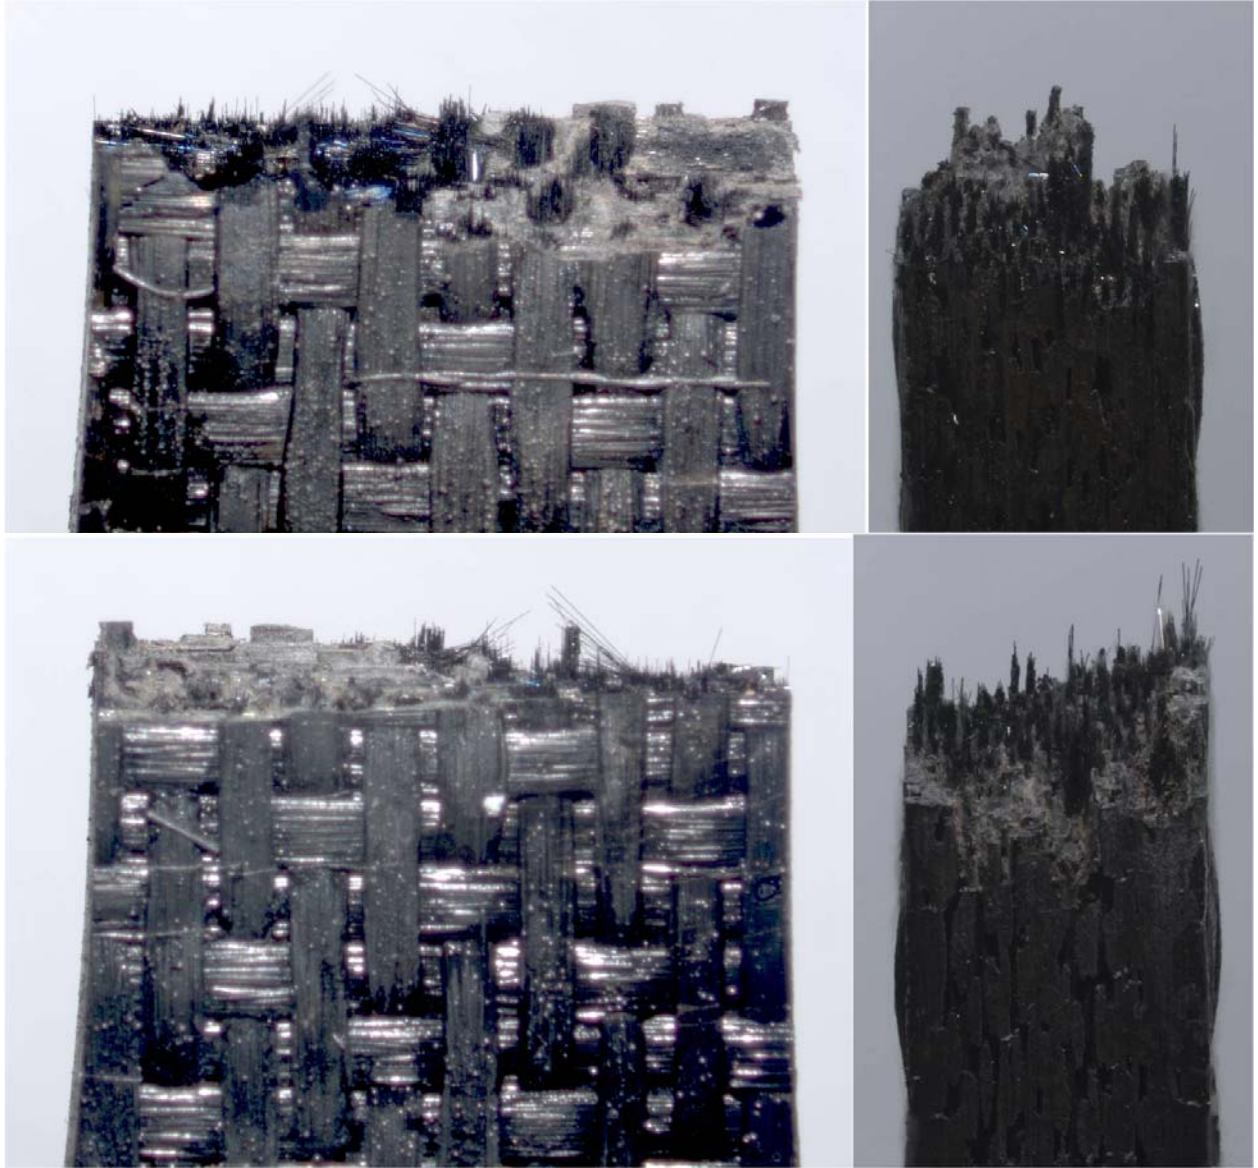
Figure 69: Optical micrographs of specimen P10-7 tested in fatigue at 1200°C in steam. $\sigma = 100$ MPa, $N_f = 144519$.

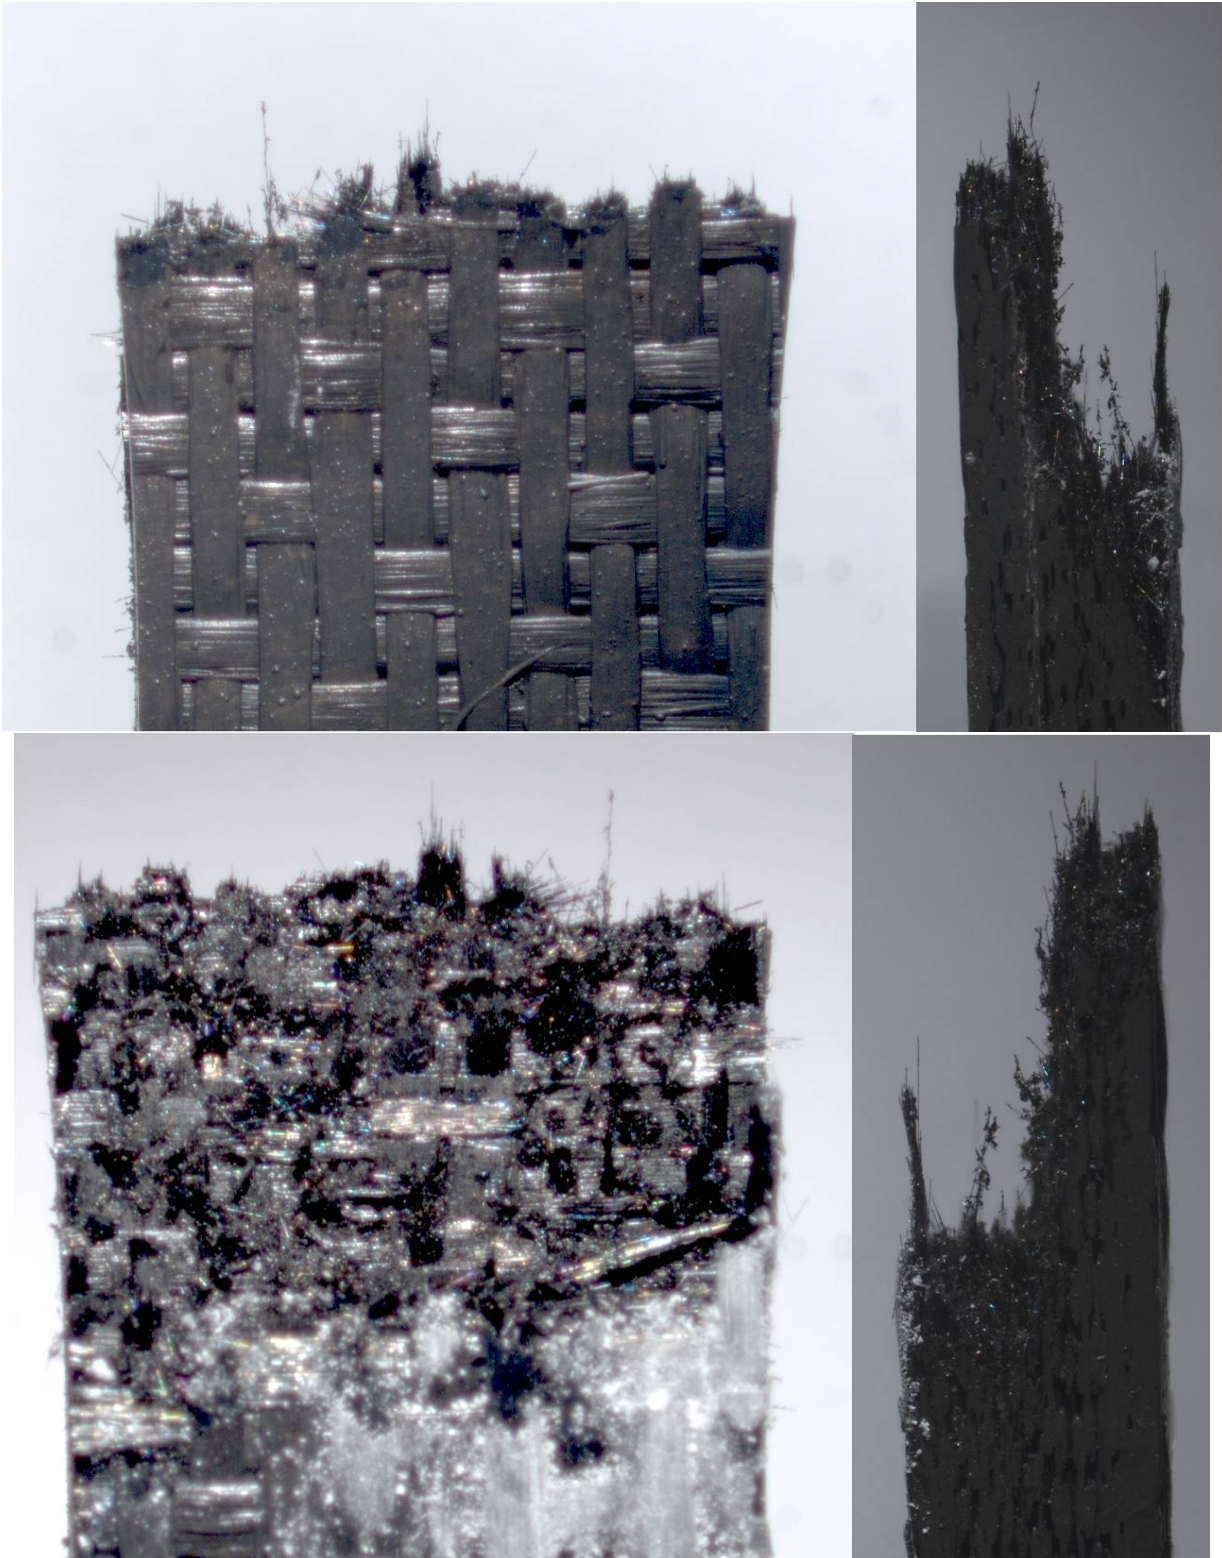
Figure 70: Optical micrographs of specimen P10-8 tested in tension at 1200°C in air. UTS = 391.9 MPa.
