Tension-Compression Fatigue of Hi-Nicalon/SiC Ceramic Matrix Composite at 1200°C in Air and Steam

**TENSION-COMPRESSION FATIGUE OF Hi-NICALON/SiC CERAMIC MATRIX
COMPOSITE AT 1200 °C IN AIR AND IN STEAM**

THESIS

AIR FORCE INSTITUTE OF TECHNOLOGY

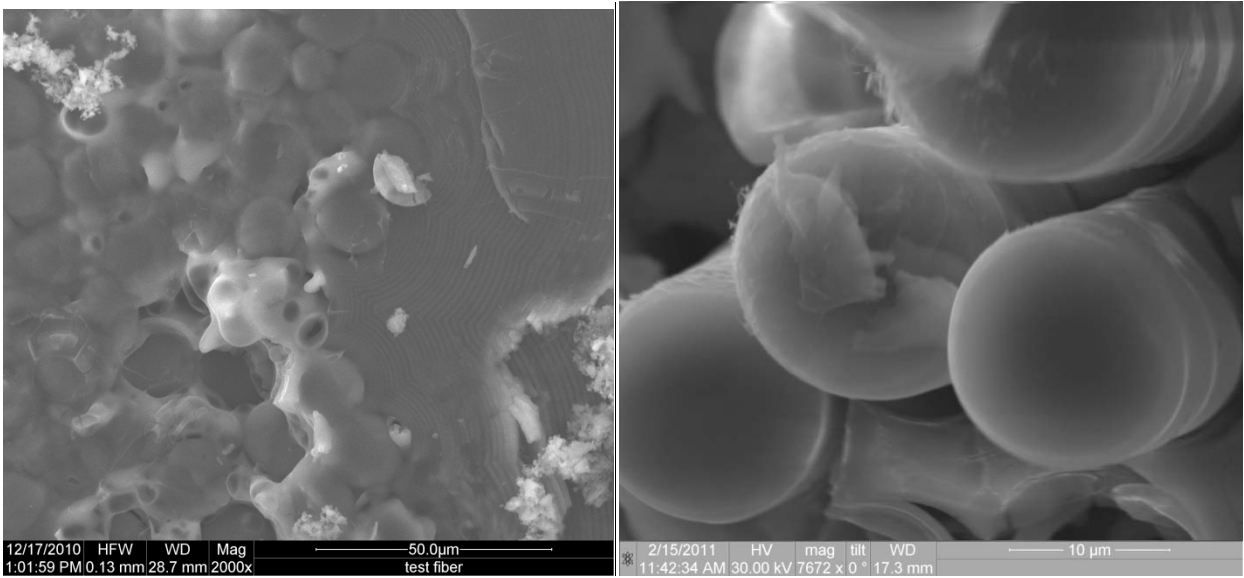
Figure 71: Scanning Electron Micrographs of specimen P5-2 tested in fatigue at 1200°C in steam. $\sigma = 80$ MPa, $N_f = 200000$.

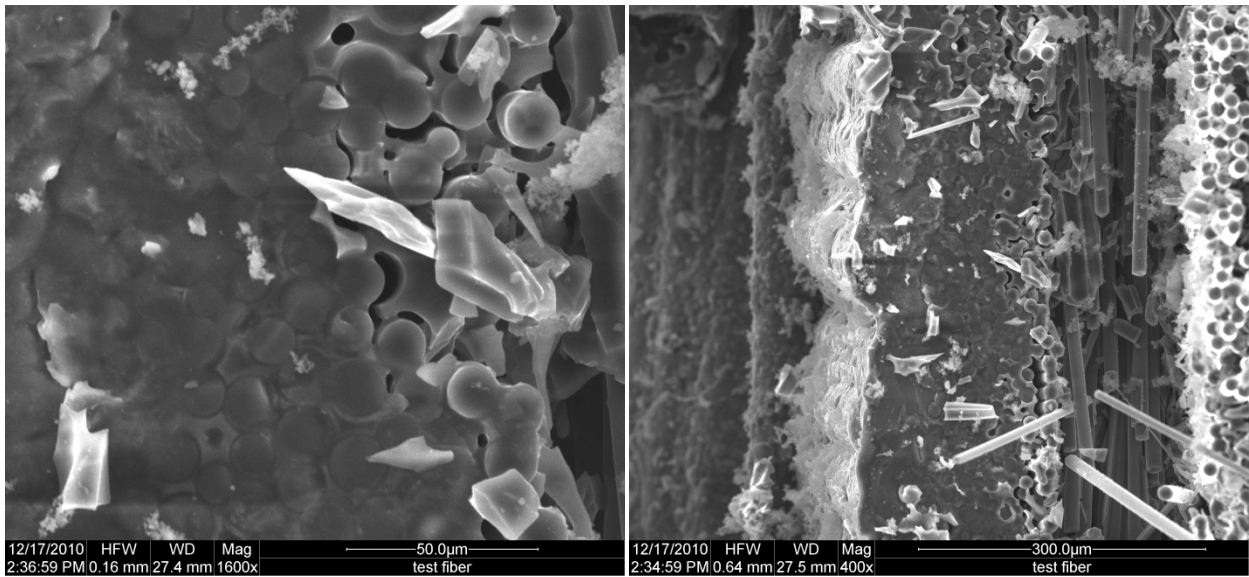
Figure 72: Scanning Electron Micrographs of specimen P5-3 tested in fatigue at 1200°C in air. $\sigma = 160$ MPa, $N_f = 29988$.

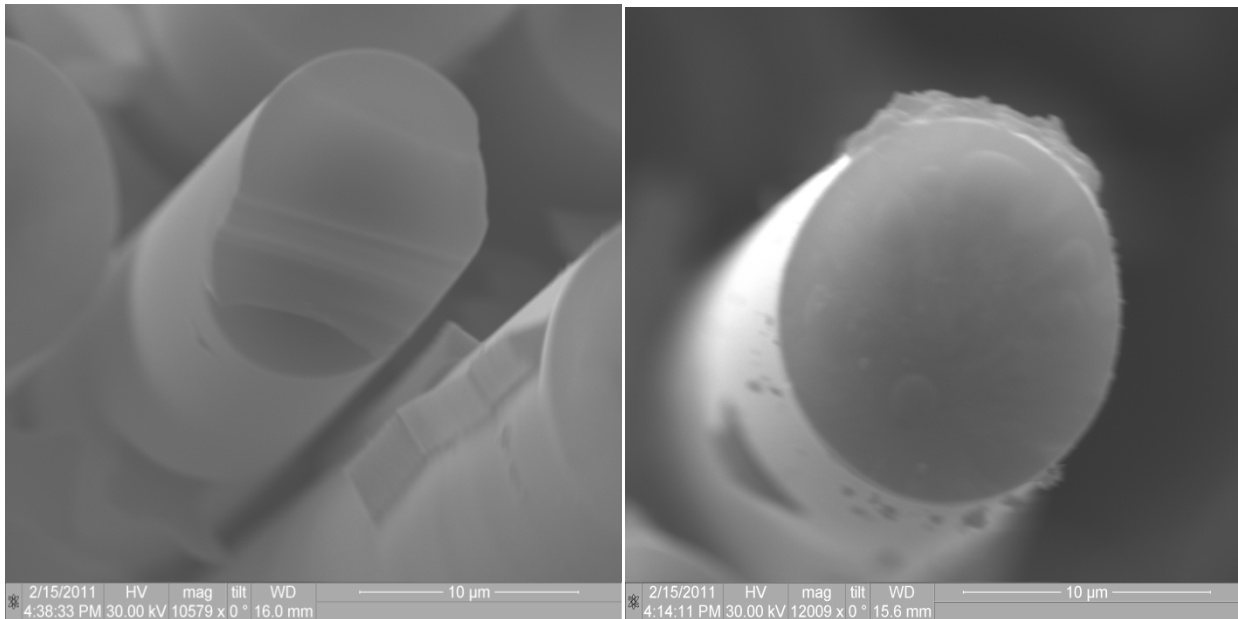
Figure 74: Scanning Electron Micrographs of specimen P5-5 tested in fatigue at 1200°C in steam. $\sigma = 200$ MPa, $N_f = 9612$.

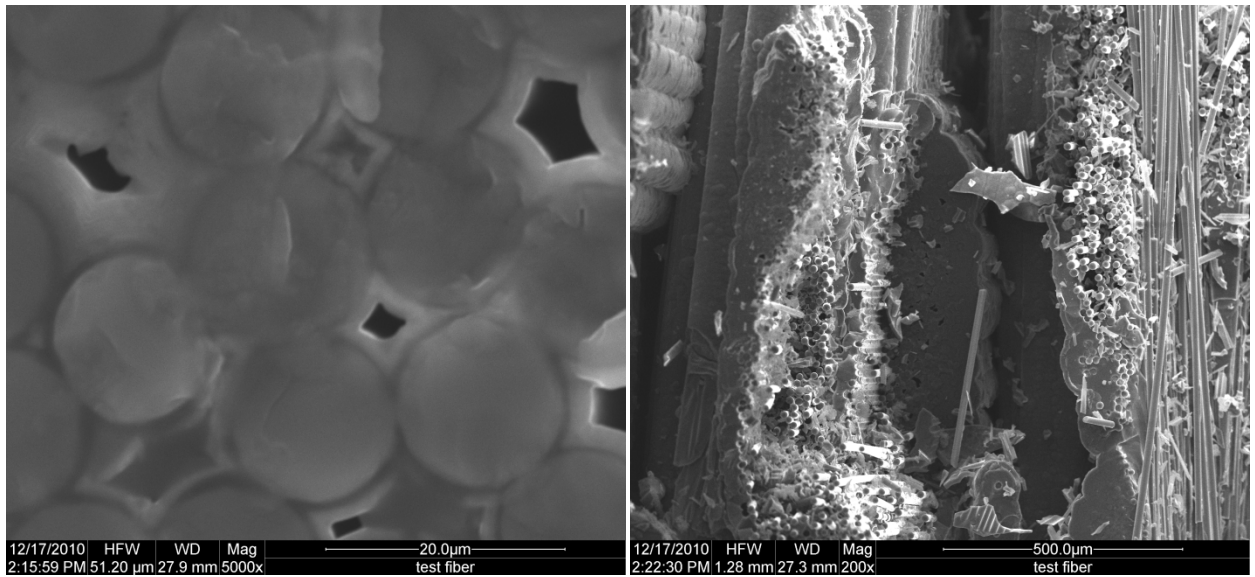
Figure 78: Scanning Electron Micrographs of specimen P7-4 tested in fatigue at 1200°C in steam. $\sigma = 200$ MPa, $N_f = 948$.

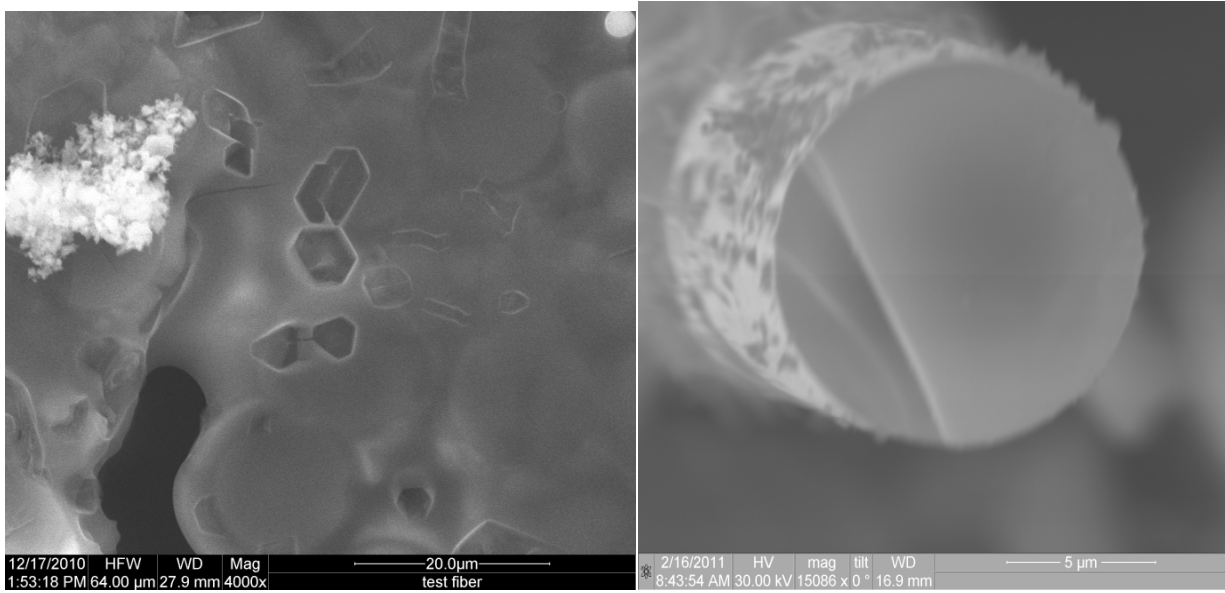
Figure 81: Scanning Electron Micrographs of specimen P10-1 tested in fatigue at 1200°C in steam. $\sigma = 120$ MPa, $N_f = 50499$.

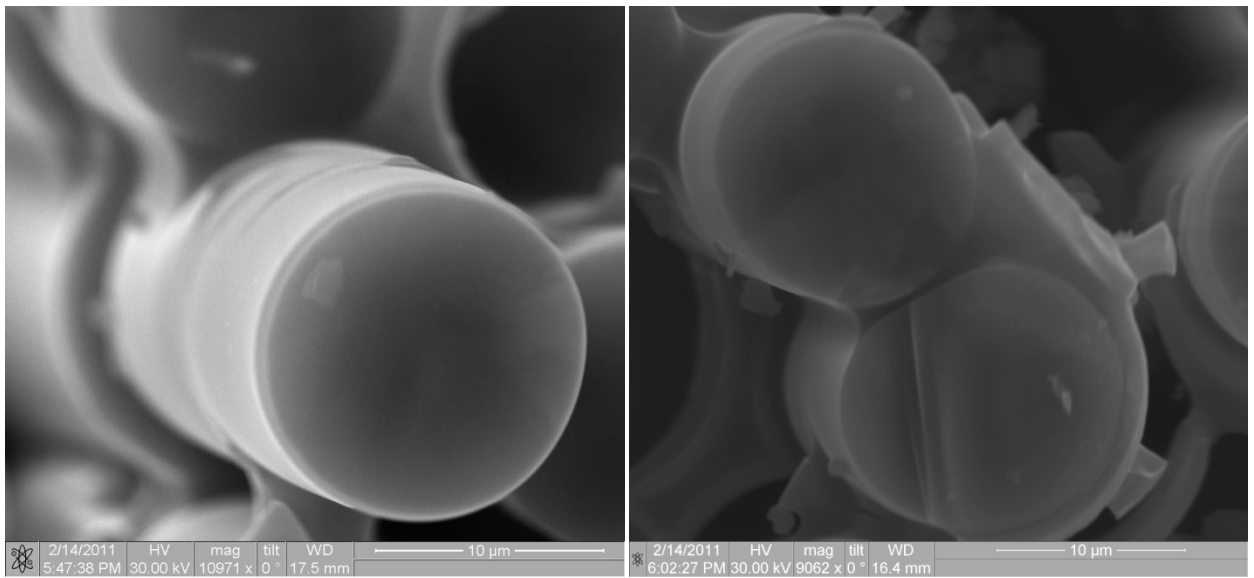
Figure 85: Scanning Electron Micrographs of specimen P10-6 tested in fatigue at 1200°C in air. $\sigma = 80$ MPa, $N_f = 200000$.
