**EFFECT OF PRIOR EXPOSURE AT ELEVATED TEMPERATURES ON  
TENSILE PROPERTIES AND STRESS-STRAIN BEHAVIOR OF THREE  
OXIDE/OXIDE CERAMIC MATRIX COMPOSITES**

THESIS

Christopher J. Hull, Captain, USAF

AFIT-ENY-MS-15-M-228

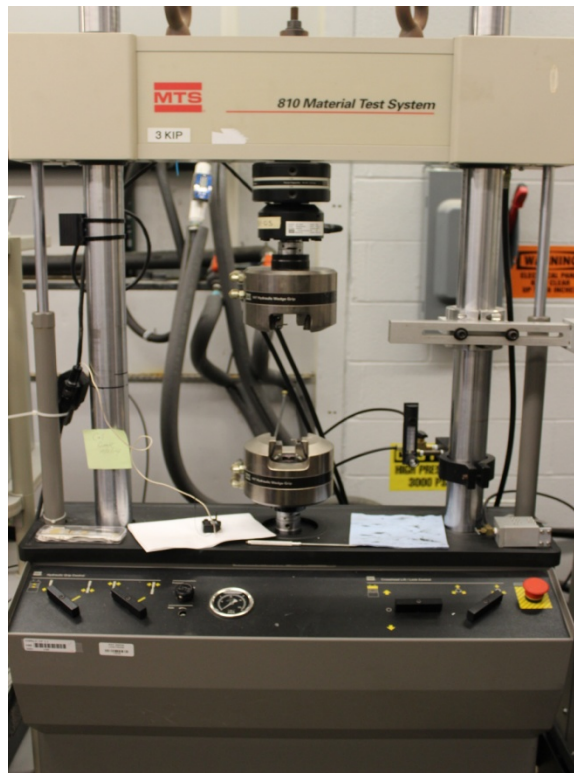
**Figure 4 – MTS 810 Material Test System utilized for uniaxial tensile testing**

Uniaxial mechanical testing was completed using a MTS 810 Material Test System of 13.3 kN (3 kip) capacity (Figure 4) equipped with hydraulic wedge grips. An MTS FlexTest™ 40 digital controller was used for input signal generation and data collection.

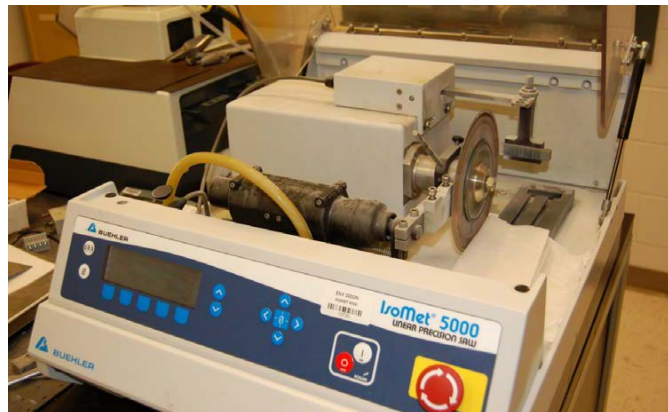
**Figure 8 – IsoMet 5000 linear precision saw**

For greater magnification than that available from the optical microscope, a FEI Quanta 450 SEM was used (Figure 7). To prepare the specimens for viewing with the SEM, a Buehler IsoMet 5000 Linear Precision Saw (Figure 8) was used to cut the specimen.
