Tension-Compression Fatigue of an Oxide/Oxide Ceramic Matrix Composite at Elevated Temperature in Air and Steam Environments

THESIS
MARCH 2015

Richard L. Lanser, Captain, USAF

AIR FORCE INSTITUTE OF TECHNOLOGY

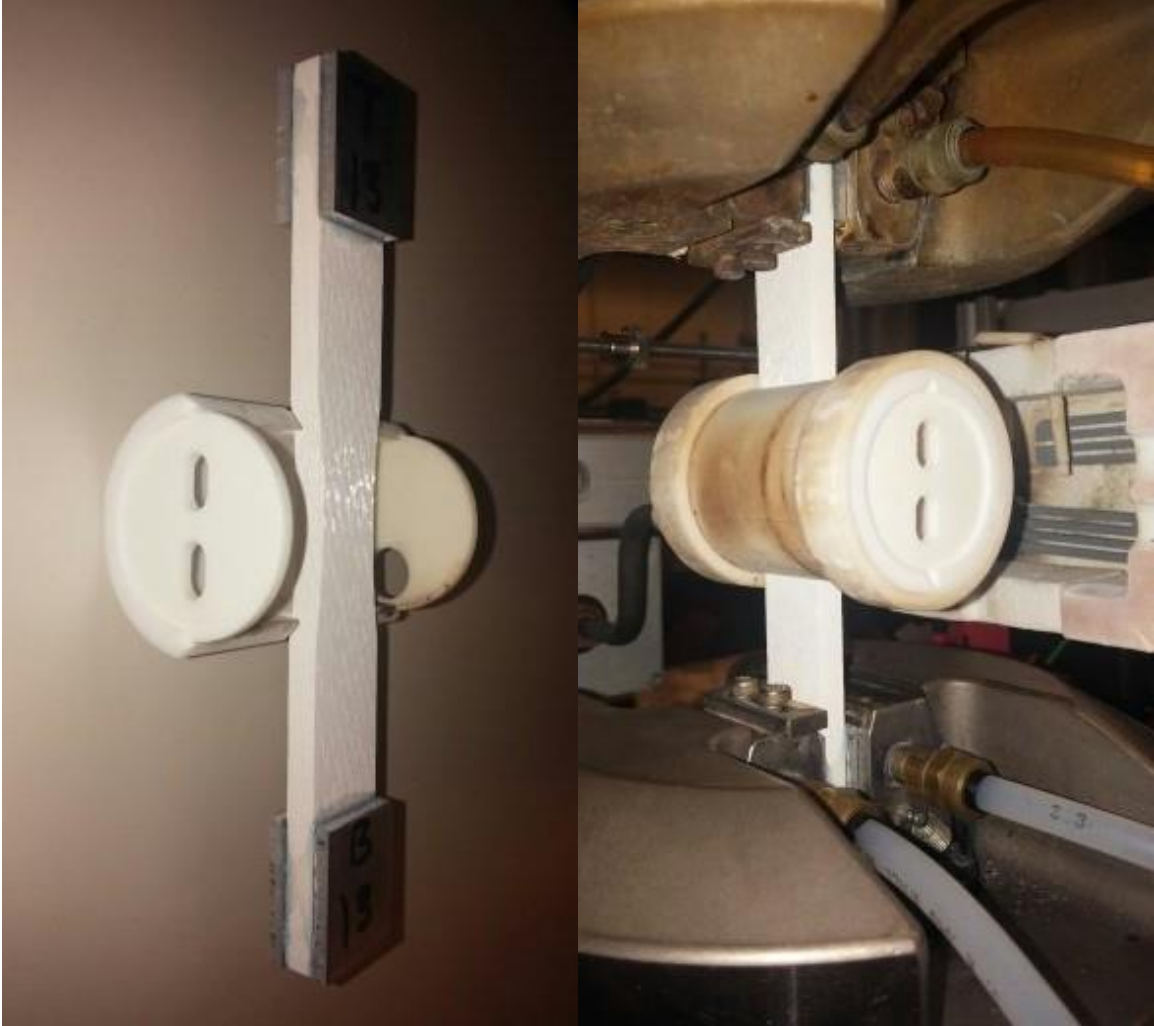
To achieve a more uniform and repeatable temperature distribution along the specimen gage section, a cylindrical alumina susceptor was used in all tests. The susceptor fits inside the furnace, specimen gage section is located inside the susceptor, with the ends of the specimen passing through slots in the susceptor (see Figure 11). For testing in steam, steam was supplied to the susceptor through a feeding tube in a continuous stream with a slightly positive pressure, expelling the dry air and creating a near 100% steam environment inside the susceptor. An AMTECO Chromalox model HRFS-STMGEN steam generator and deionized water were used to produce steam.

Figure 11: Alumina susceptor.

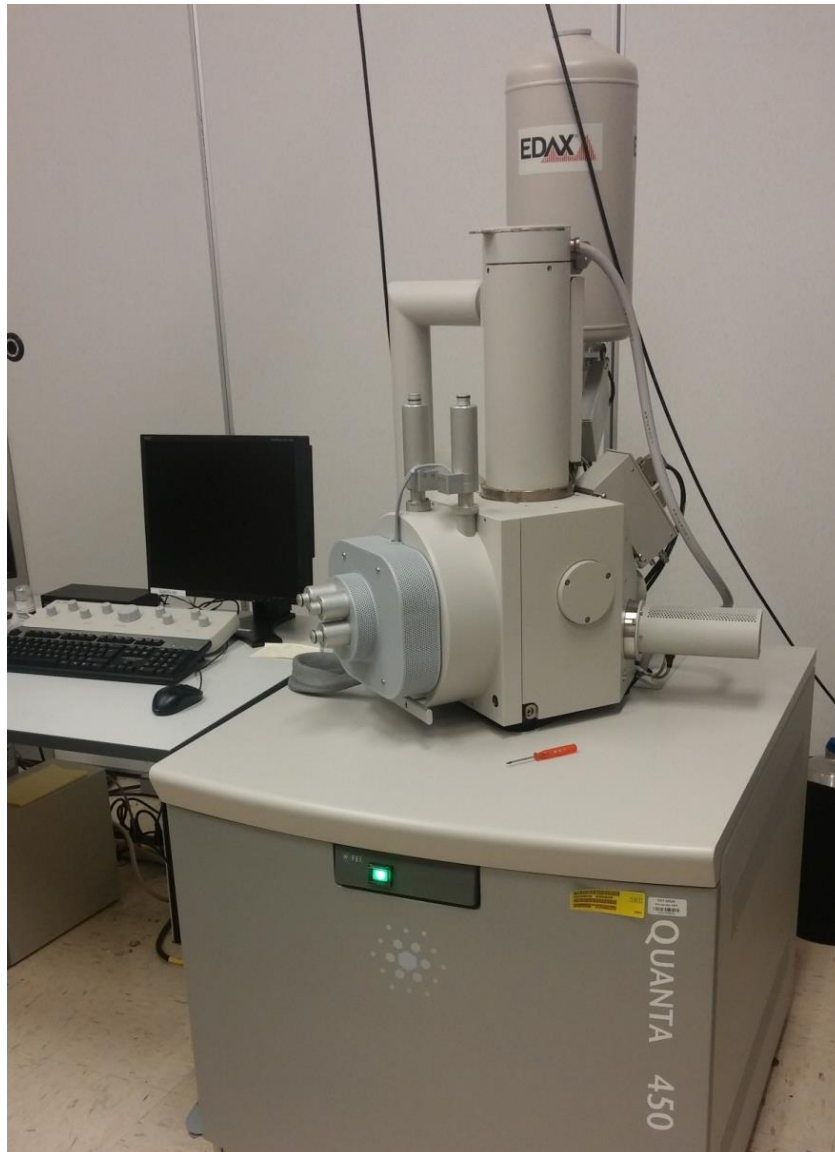
Figure 13: Quanta 450 scanning electron microscope (SEM).

Prior to testing all specimens were examined with an optical microscope in order to identify and document any defects. A Zeiss Discovery.V12 stereo optical microscope with a Zeiss PlanApo S 0.63x FWD 81-mm lense was used to image the specimens (Figure 12). Images were captured using a Zeiss AxioCam HRc digital camera. Image processing was carried out with AxioVision 4.8 software. Fracture surfaces of failed specimens were examined using a scanning electron microscope (FEI Quanta 450) as well as an optical microscope (Zeiss Discovery V12). The scanning electron microscope is shown in Figure 13.

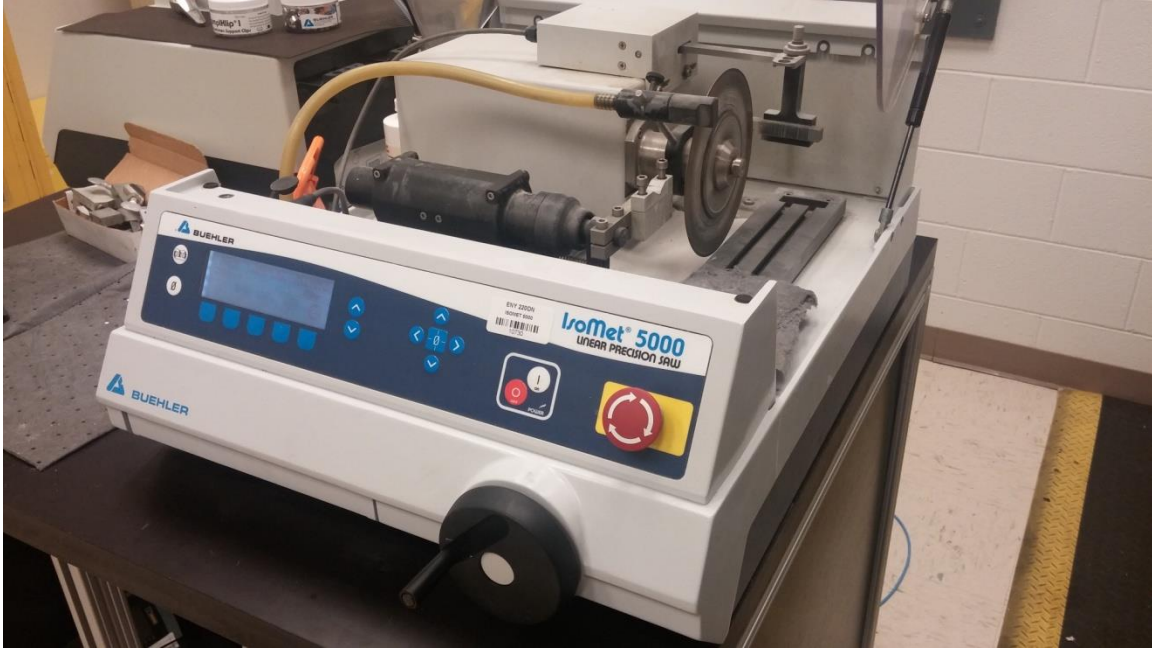
For examination with an SEM the fractured portions of the specimens were cut normal to the loading direction using a Buehler IsoMet 5000 linear precision saw with a diamond abrasive cutting wheel (Figure 14). The blade speed was set to 2500 rpm with a feed rate of 10 mm/min. No cutting fluid was used in order to prevent specimen contamination.

Figure 14: Buehler IsoMet 5000 linear precision saw.
