Creep of Sylramic-iBN Fiber Tows at Elevated Temperature in Air and in Silicic Acid-Saturated Steam

THESIS
JUNE 2015

Kevin B. Sprinkle, Captain, USAF

AIR FORCE INSTITUTE OF TECHNOLOGY

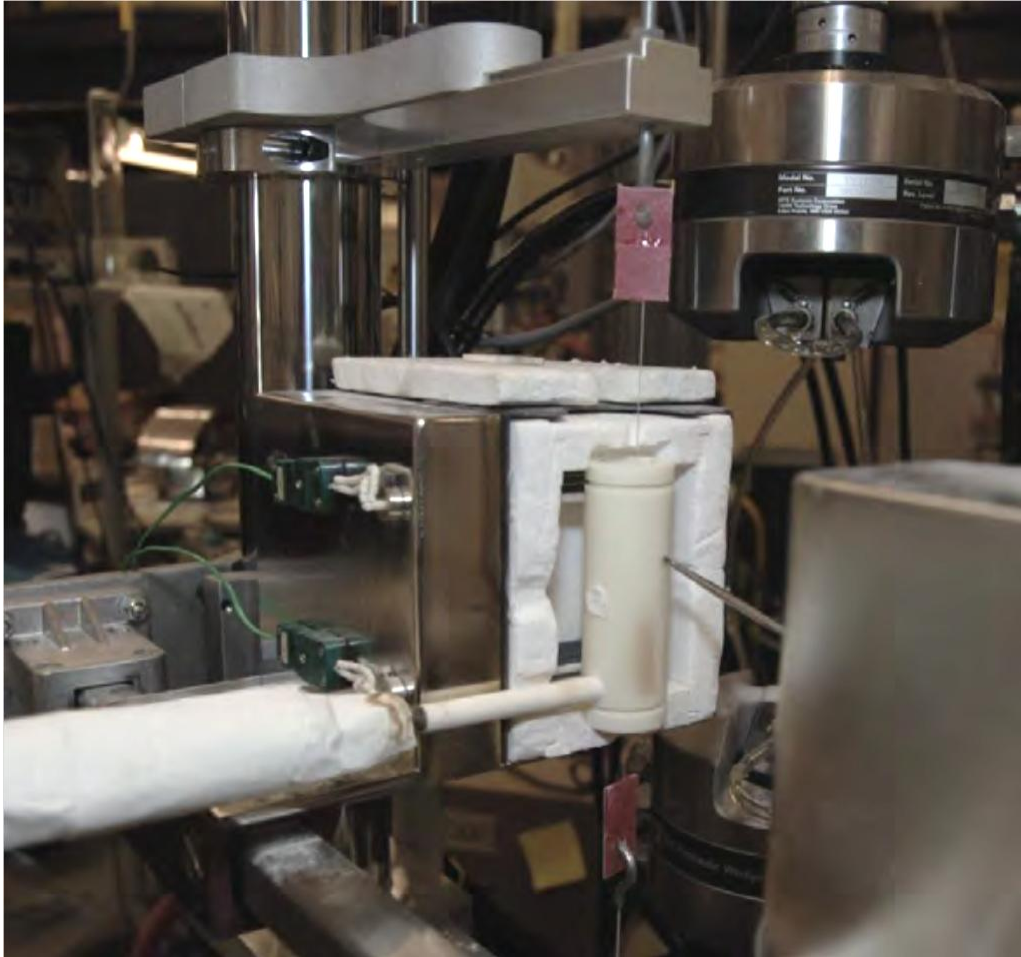
Figure 21: Alumina susceptor and feeding tube assembled in one half of the furnace, along with fiber tow specimen mounted and running through the alumina susceptor; reproduced from Armani [15]

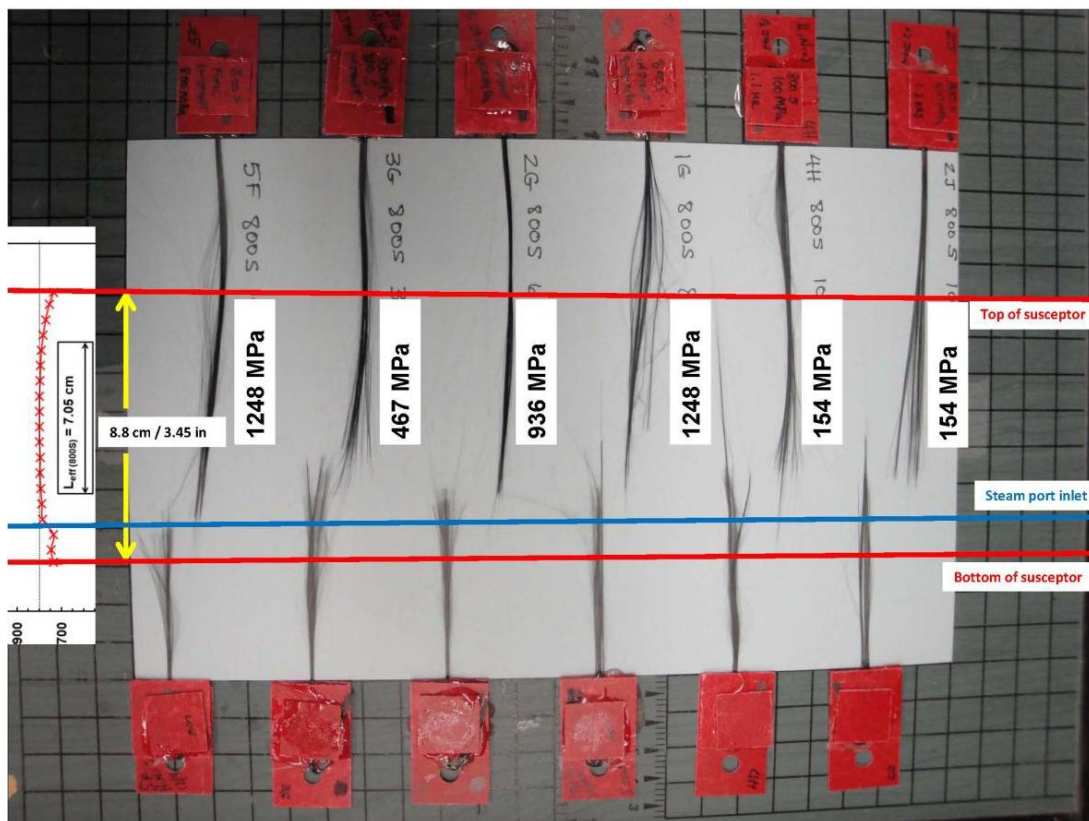
Figure 25: Effect of steam impinging on fiber tows upon entry into the test chamber; reproduced from Steffens [32]

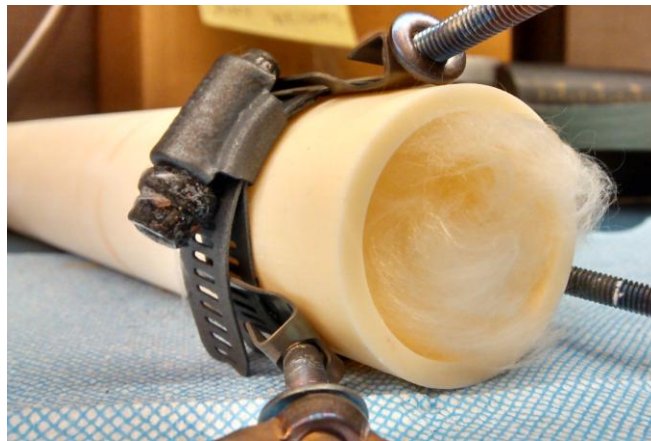
Figure 29: Silica wool placed inside the heating tube to achieve saturation of heated steam with silicic acid

The results of prior research reviewed in Section 4.1.3 suggest that in order to study creep of SiC fiber tows at elevated temperature in steam, we must ensure that steam entering the test chamber is at test temperature and saturated with silicic acid. To accomplish steam saturation, silica wool (Hereaus Quartz, LLC USA, Austin, TX) was placed inside the large-diameter alumina tube (see **Figure 29**) that passes through the heating chambers of the two modified CX1300 heating units (see **Figure 30**). The high surface area of the fibrous silica wool allows for a faster reaction with the steam as it passes through, assuring steam saturation with silicic acid. Placing the silica wool inside the heating units assures that steam is at the target test temperature as it undergoes saturation. As a result, steam is saturated with silicic acid at test temperature prior to entering the test chamber.

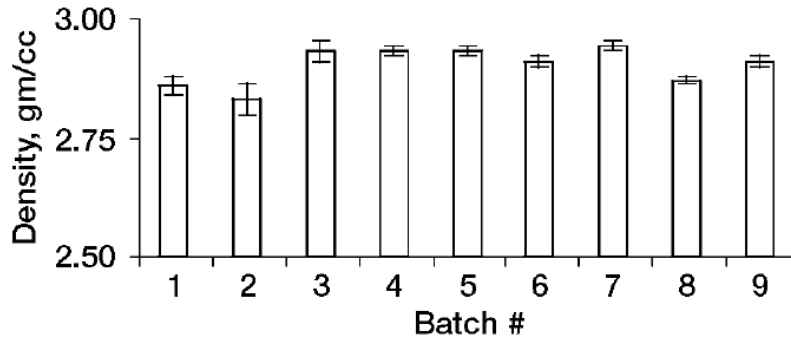
Figure 31: Batch to batch variation in Archimedes density for BN/SiC coated Sylramic fiber perform specimens; reproduced from Bhatt, et al [49], with kind permission from Springer Science and Business Media

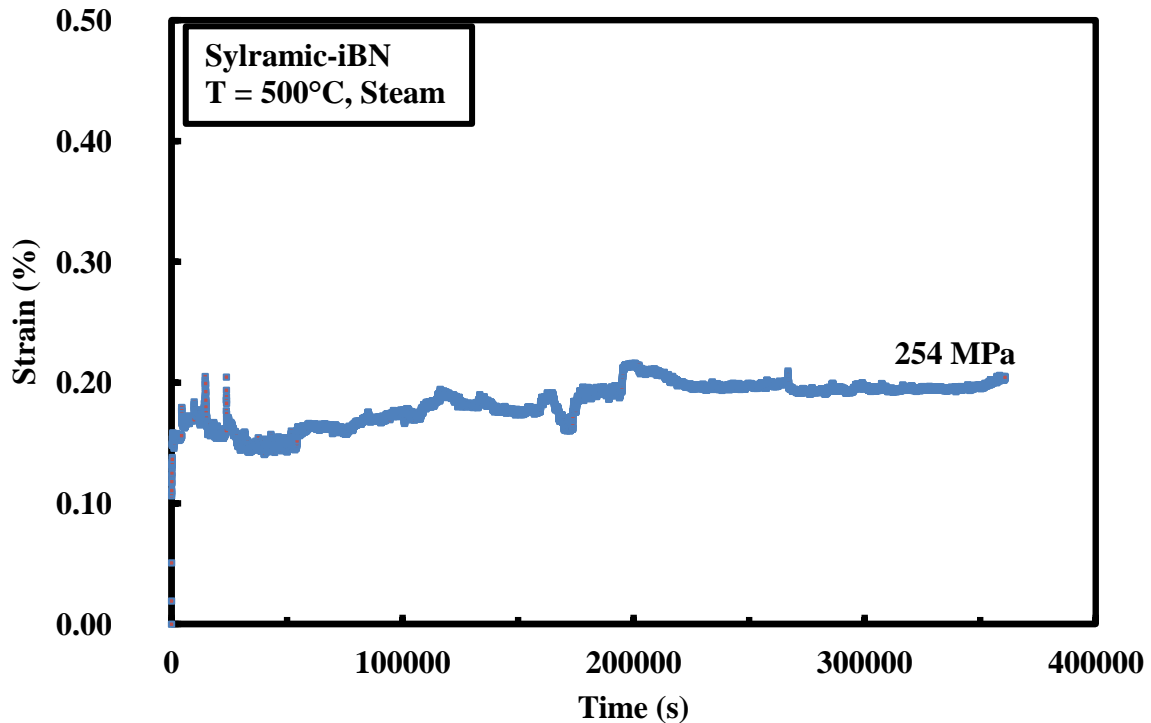
Figure 37: Creep strain vs. time curve obtained for Sylramic-iBN fiber tow at 500°C in silicic acid-saturated steam
