**QUANTIFYING AND MONITORING PERMAFROST EXTENT, CONDITION,  
AND DEGRADATION AT EIELSON AIR FORCE BASE**

THESIS

Theodore J. Labedz, Captain, USAF

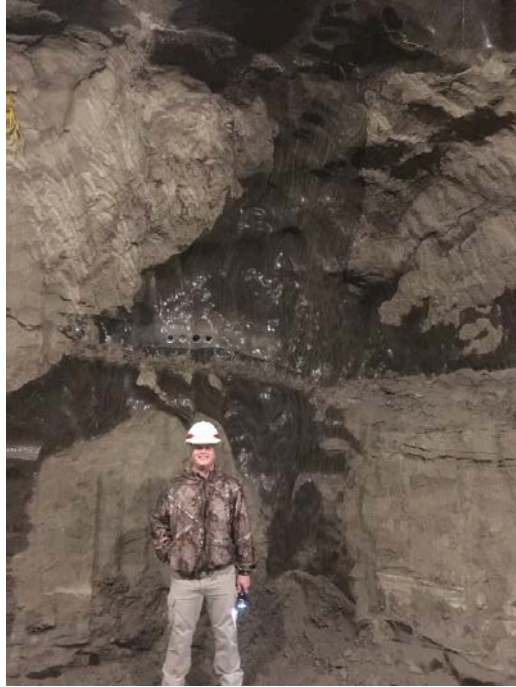
Figure 2.3: Ted Labeledz Pictured with Ice Wedge at CRREL Tunnel near Fox, AK

The second, and most dramatic, subterranean ice feature found in permafrost regions are called ice wedges. The best way to visualize the formation of these wedges is to imagine how freeze thaw cycles crack concrete. As water enters the voids, it freezes, expands, and creates additional voids that can be filled with additional water and ice. This same process happens on permafrost, but on a timescale of thousands of years. As these wedges migrate downward into the earth, they correspondingly increase in width [20, 35]. These formations can vary from millimeters to meters, as were witnessed during a site visit to the CRREL Permafrost Research tunnel in Figure 2.3. As these wedges form and grow they produce a polygonal shape to the overlaying landscape, which is indicative of the permafrost and ice wedges beneath. As the active layer of the permafrost warms and subsequently deepens, the top of the ice wedges melt and cause a depression in tundra when the melted ice drains [1]. This exacerbates the appearance of the polygonal or thermokarst terrain features [1]. The ice wedge behind Captain Labeledz in Figure 2.3 is estimated to be approximately 33,000 years old. While remarkable, these formations and ‘ice-rich’ permafrost are of increased concern for engineers because when they melt, the ice that was providing the bearing capacity in the soil column loses its crystalline

structure resulting in a loss of load bearing capacity, settling, and terrain destabilization [1, 3, 33].

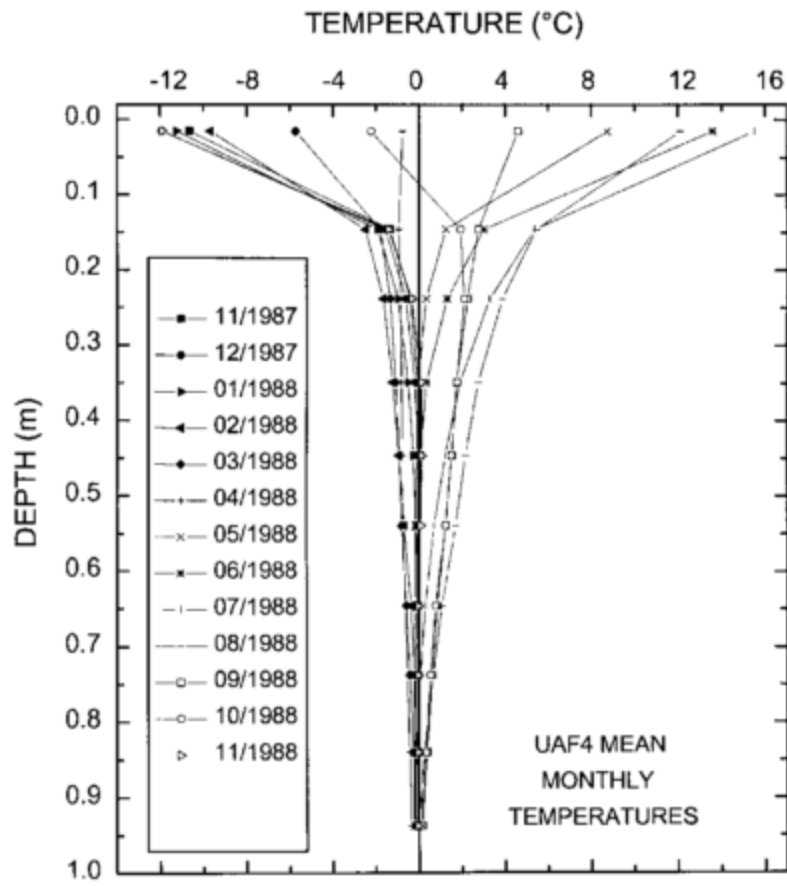
Figure 2.6: A Trumpet Curve for Active Layer Located at UAF's Site 4 Borehole [7].

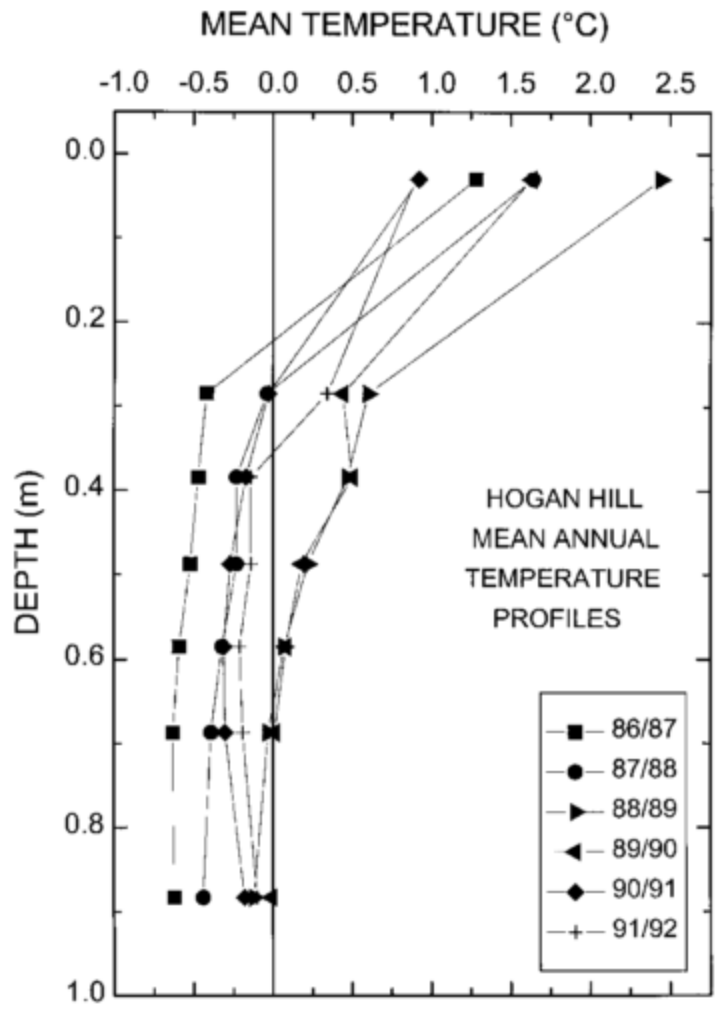
Figure 2.7: Example of Mean Temperature Migration at the Hogan Hill Research Site [7].

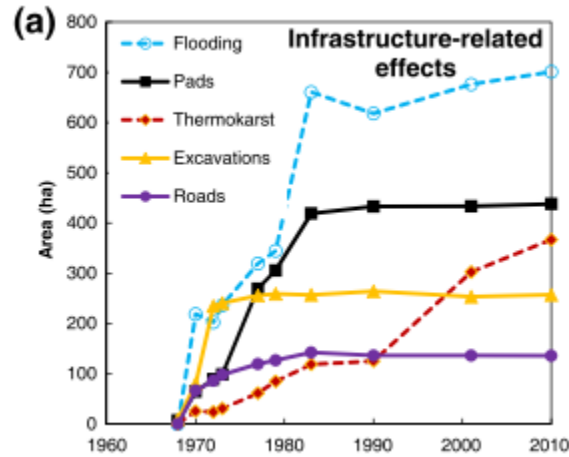
Figure 2.9: Infrastructure Development-Related Effects on Permafrost [42]

effect of changing hydrology and flooding in fact creates the greatest amount of damage to the permafrost at Prudhoe Bay [42].

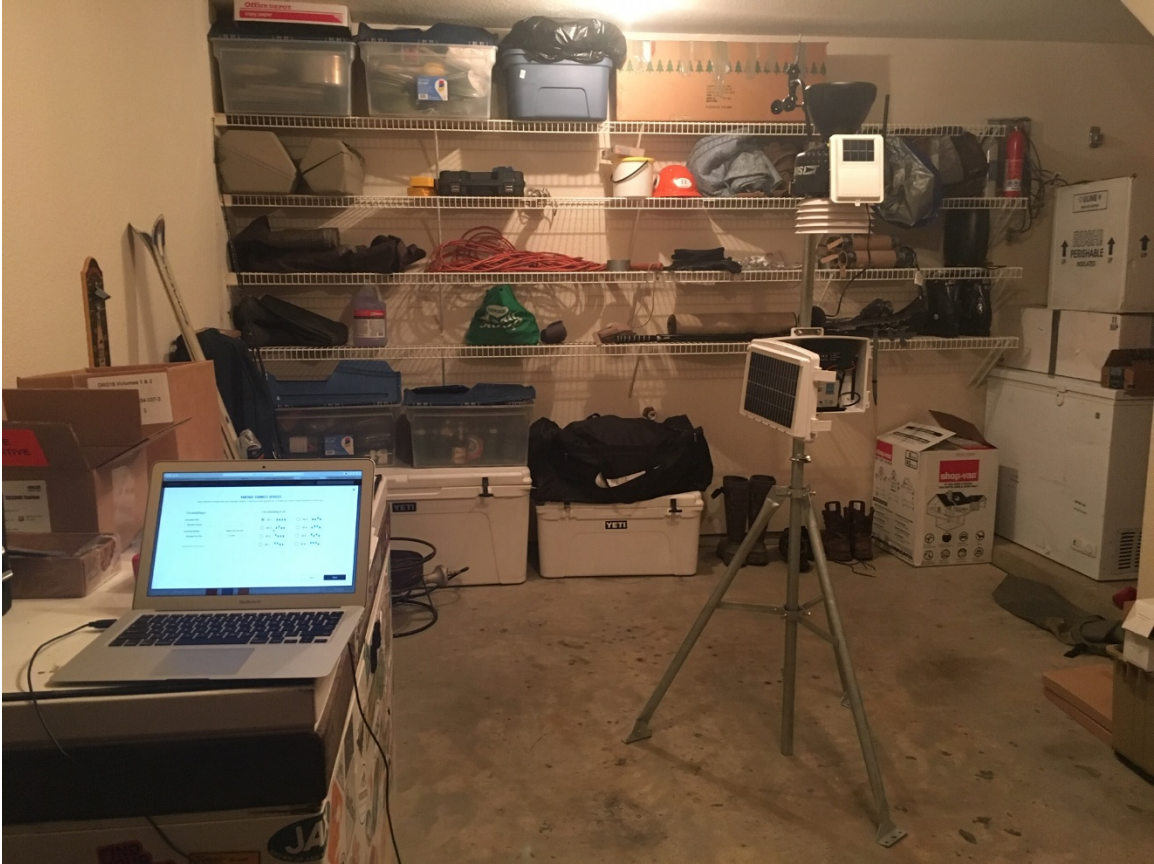
Figure 3.1: Weather Station Assembly, Calibration, and Testing

equipment vulnerable to trampling by wildlife and submersion by the winter snowpack. The purchase of a two-meter tripod was determined to be the ideal balance between protection height and proximity to the soil. Raising it up to this height would keep the sensors protected up off the ground, adequate access to the sunlight required for the solar panels, and not be unnecessarily far away from the permafrost. This height of tripod could also be readily acquired commercially from Davis as opposed to a custom fabrication.

One of the limitations of weather station as it exists today is that it does not have the capability to measure snowpack. As highlighted in Chapter 2, snowpack is an important consideration when studying permafrost behavior as it further insulates the permafrost from the climate above. Should this be deemed necessary to incorporate into future models, snowfall amounts are not nearly as variable as the temperatures in this region and this data could be pulled from base weather or from the town of North Pole. As it stands, this is a limitation of this sensor package.

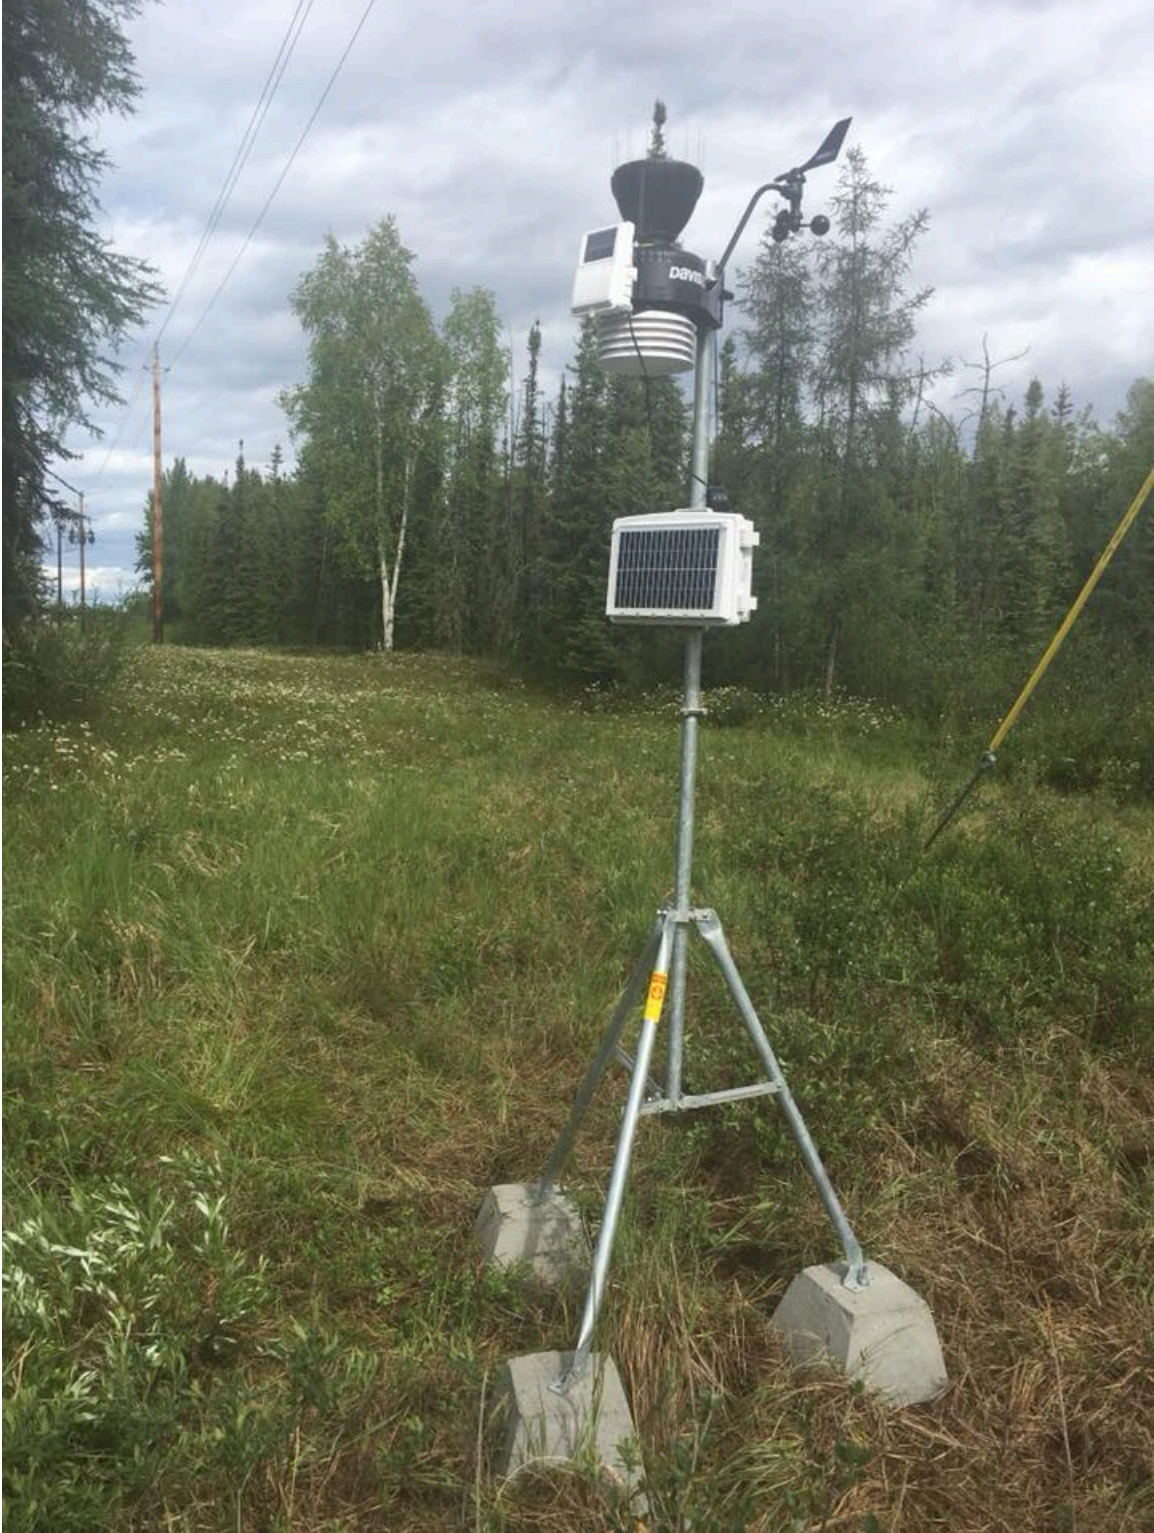
Figure 3.2: Weather Station Deployment and Orientation

In order to solve this problem, I drove to the Home Depot in Fairbanks, AK to see what readily available materials I could use to solve this problem. The solution I came up with was to use a combination of concrete blocks, all-thread, bolts, and washers. This system worked by placing the 36 inch all-thread through the hole at the center of the block and adhering it to the concrete block using a bolt and washer on both the top and the bottom of the block. This served two purposes. First, as the summer and winter freeze thaw cycles occurred in the active layer, this would prevent the concrete block from migrating from its installed position. Secondly, by having bolts on the top and the bottom I could adjust and loosen the three concrete bases in order to achieve a perfectly level base. This also allowed for approximately 30 inches of penetration by the all-thread into the ground, which affixed it more securely than the 6-inch alternatives. The completed assembly of one of the tripod bases is depicted in Figure 3.3. Upon achieving a level foundation, I bolted the tripod assembly on top of the base and ensured it was level, plumb, and properly oriented. The final assembly is shown in Figure 3.2.

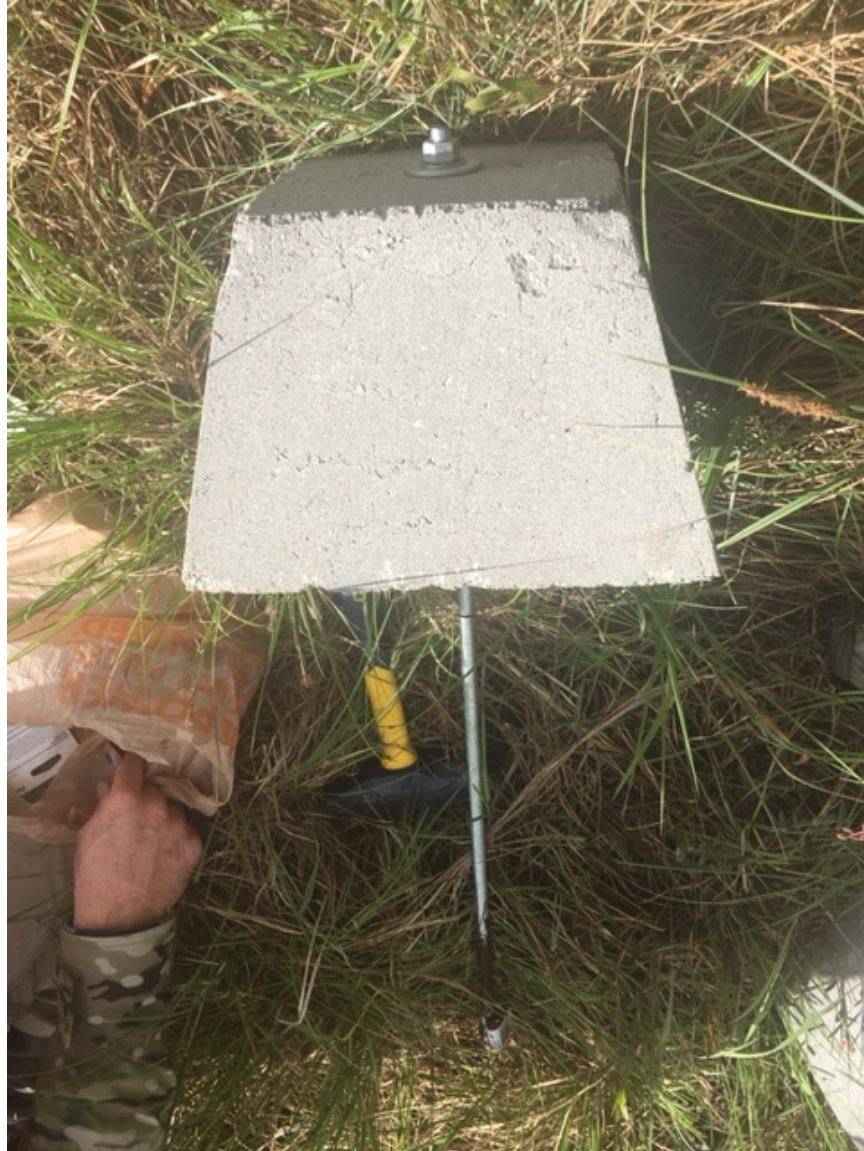
Figure 3.3: Completed Tripod Foundation

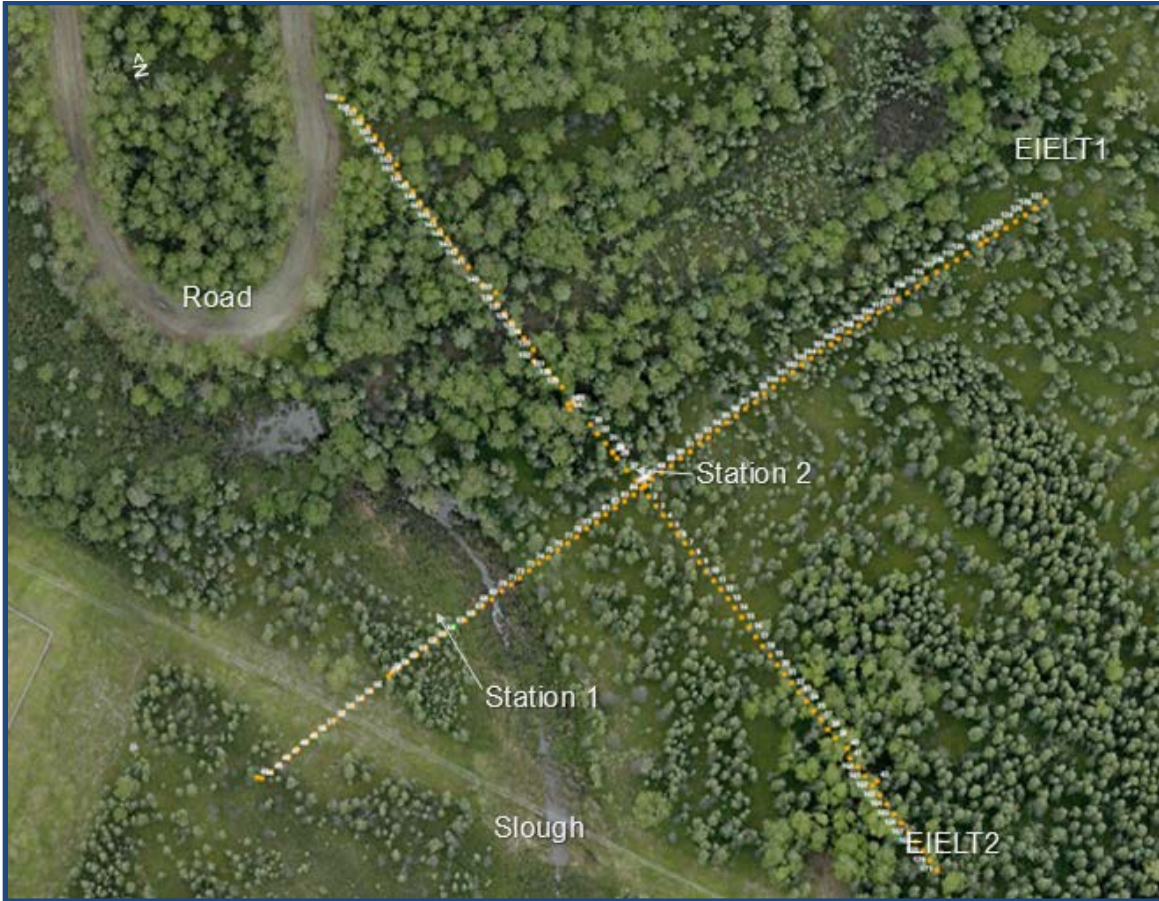
Figure 3.4: ERT and Frost Probe Survey Points [37]

Each of the orange points represents a location where one of the ERT probes was placed into the ground and each gray points symbolize the location where we conducted a frost probe. Figure 3 also depicts how Station 2 is in the center of the two transects and station one is closer to the slough as well as the construction being conducted to beddown the F-35s.

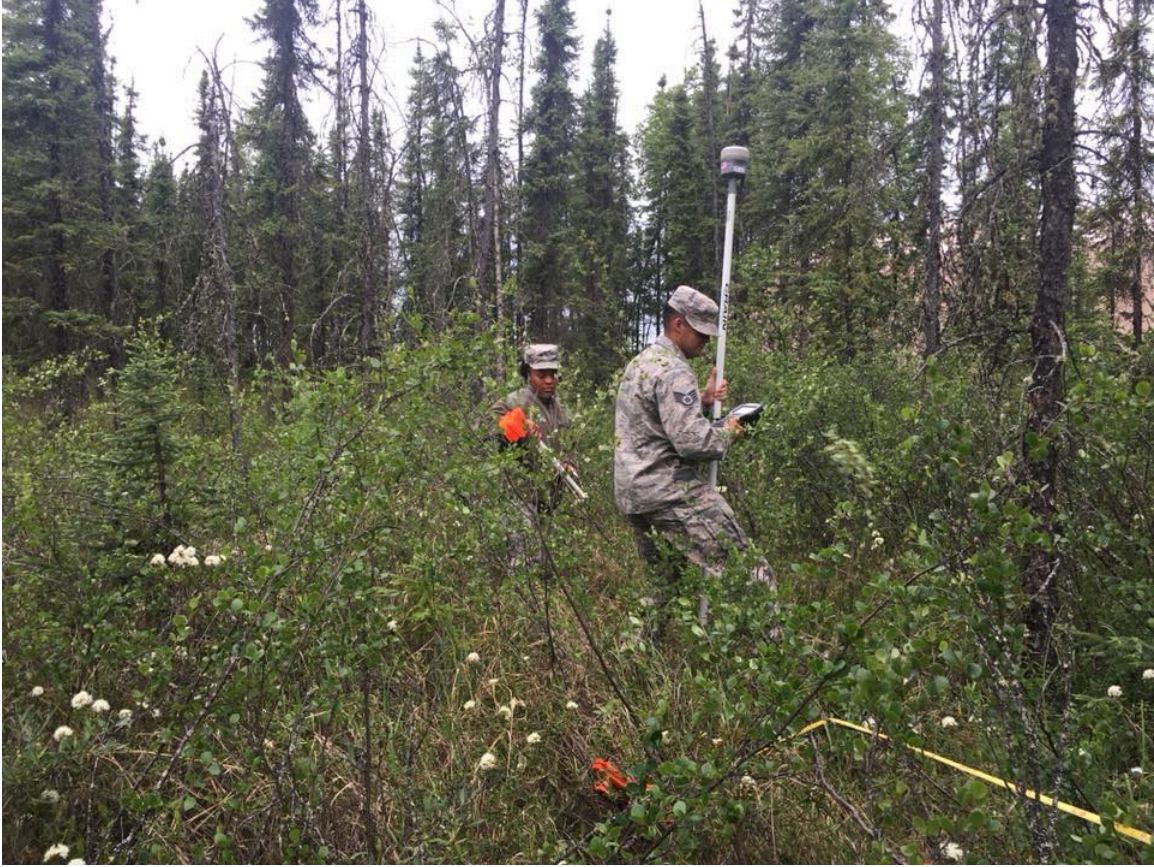
Figure 3.5: ERT and Frost Probe Point Survey

Additionally, the Engineer Assistants from the 354 Civil Engineer Squadron graciously offered to assist me in marking the points at the research site prior to conducting the ERT. It would have been difficult for me to generate this capability, as I did not have the ability or access to this specialized surveying equipment. Figure 3.5 shows the type of field conditions and equipment being used to generate the points used for the ERT surveys.

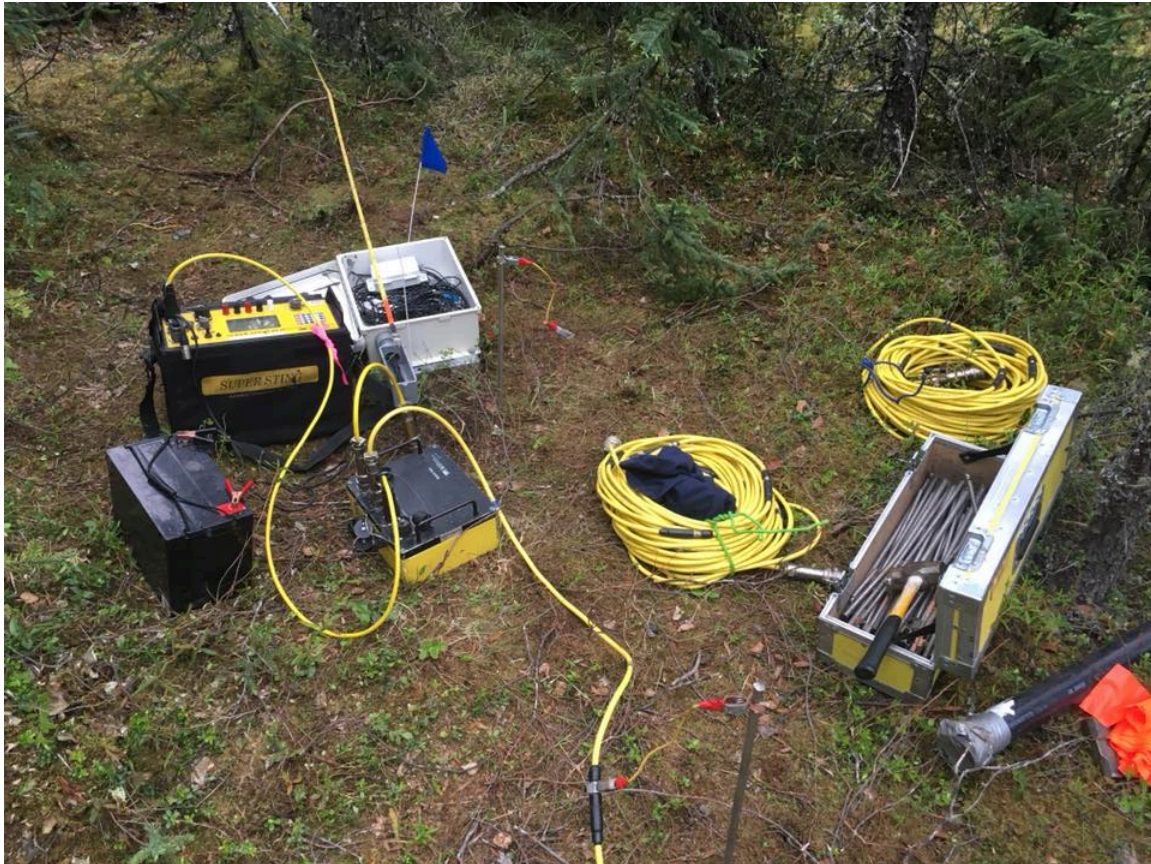
Figure 3.6: ERT Field Equipment

ERT scans are time and labor intensive and would take one whole day to complete each. The first day of ERT scans were 18 June 2018. I began the day by meeting staff from the Cold Regions Research and Engineering Lab (CRREL) on Fort Wainwright. After introductions, we loaded up their ERT equipment and convoyed out to Eielson AFB where we met up with the Engineer Assistants that were helping with the surveying portion of the study. After inspecting the transects and ensuring they had 2-meter intervals, we were ready to begin scans. However, the equipment required to conduct an ERT is quite heavy and cumbersome including: two deep-cycle batteries, the ERT console, 84 steel stakes with sledgehammers, eight 10-meter cables, 84 connection clips, and other miscellaneous tools. This equipment all had to be carried from our trucks

into the woods approximately 200 meters. A sampling of this equipment is pictured in Figure 3.6.

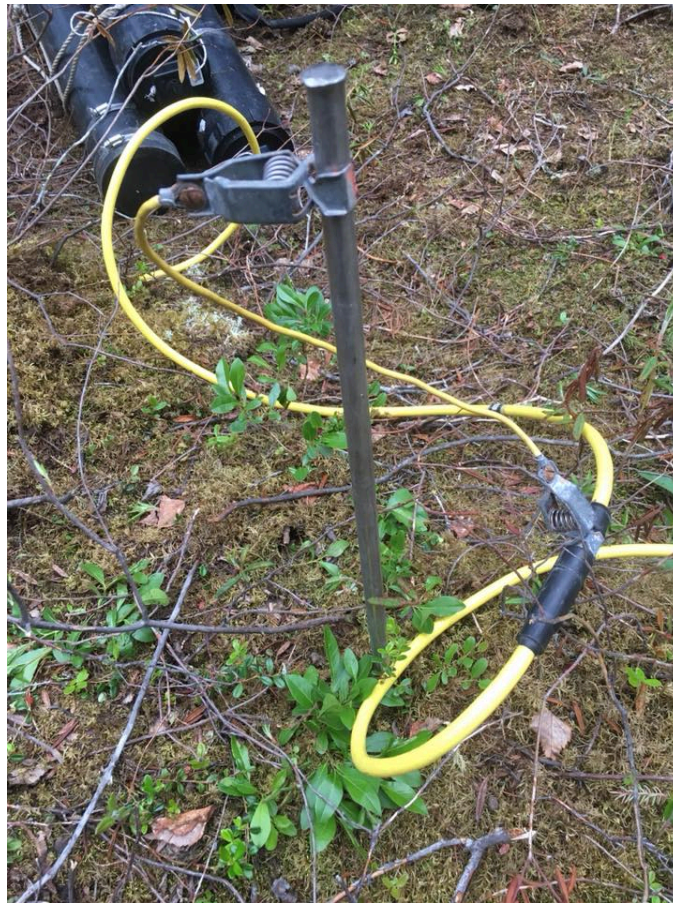
Figure 3.7: Standard ERT Probe Configuration

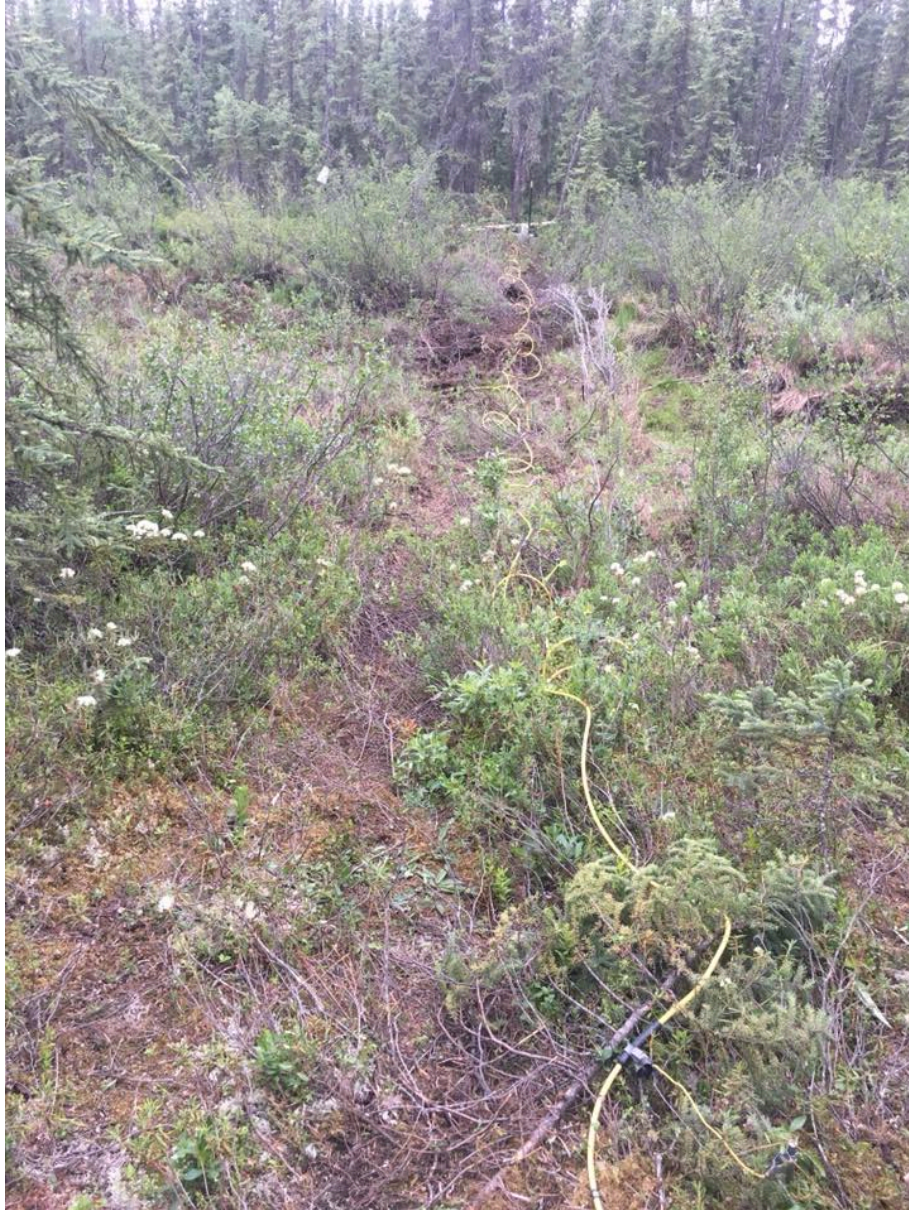
Figure 3.8: ERT Probes Along Transect One

Once we transported our gear into the field, we then pounded steel-stakes into the ground with sledgehammers and connected the electrical wires to the deep cycle batteries. The pounding of the stakes is conducted largely by feel. In order for the results to be accurate, the bottom of the stake needs to be in contact with the permafrost below. While hammering, there is a distinct feeling once the permafrost layer is reached as the stake penetrates much less into the ground with each blow as the frozen ground is far more impenetrable than thawed ground. Furthermore, we had two lengths of stakes available: short and long models. The short ones are nice for areas where the permafrost

is shallow and much less weight to haul into the field. There were several occasions when short stakes needed to be replaced with longer ones when they did not strike frozen soil. Once complete, we then checked the conductivity of the ground and had to pour water on the stations that were unresponsive to improve the conductivity. This was indicated on the ERT module and would specify which stakes had insufficient conductivity with the ground. The configuration of the individual probes is depicted in Figure 3.7. The first ERT scan took several hours. During that time, while the electrical current was running, I elected to bring out the equipment that I would need the following day in order to upgrade the data loggers.

Once all the individual probes were installed they needed to be connected to the transmission cable in a very specific order. Each location on each cable has an individual conductor assigned to it within the cable. That way, the ERT module is able to know what information it is picking up from which probe. In this manner, the ERT sends the electrical current to two different probes along their specific conductors within the cable. The electrical current travels to the oppositely charged stake. By measuring the voltage and current properties between these points, the resistance of the ground is calculated by using Ohm's Law. Figure 3.8 depicts how all the probes are connected to one another. The module runs its programs and bounces electrical currents between different probes for several hours and in doing so is able to map the resistivity of the soil at different depths and displacements from the module. This resistance will then be an indicator of how frozen the soil is underneath the ground as ice-rich permafrost soils are characteristically electrically resistive and thawed ground is far more electrically conductive. The results of these scans and the comparison between 2017 and 2018 will be in Chapter 4.

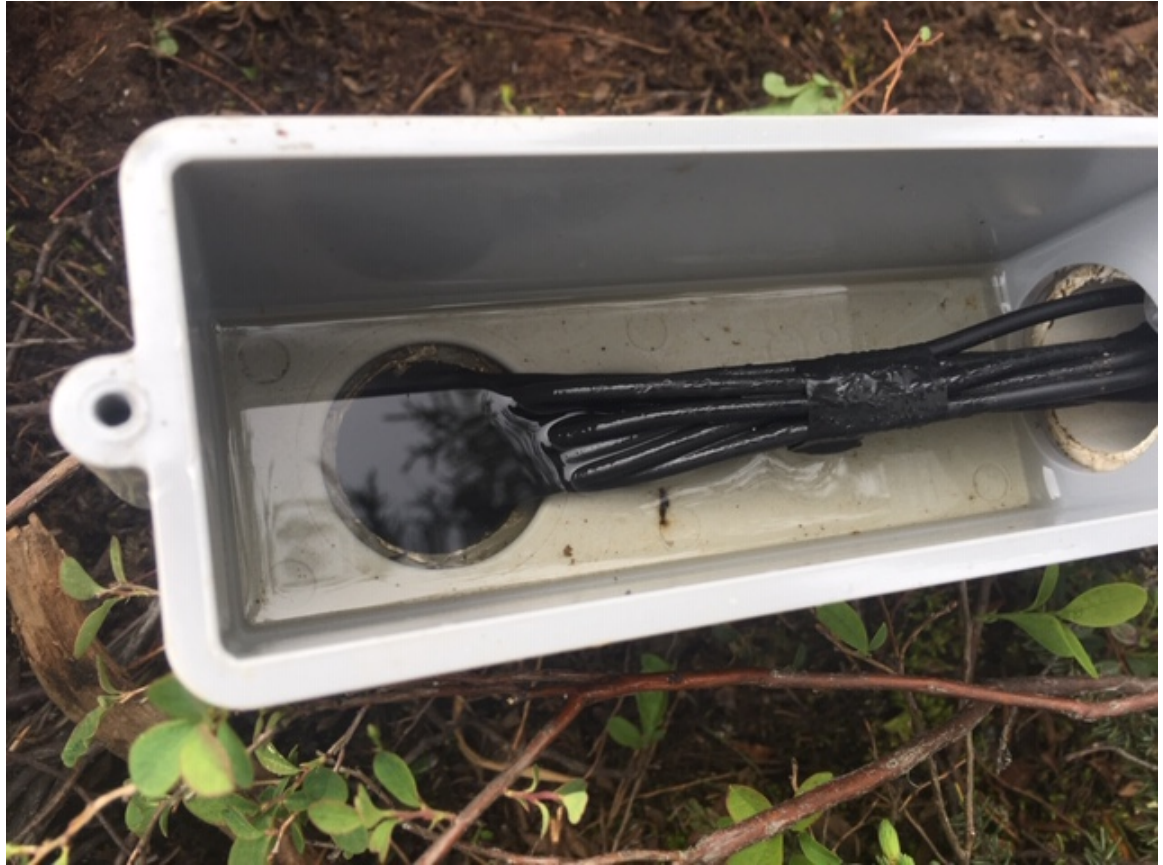
Figure 3.9: Borehole One Flooded

After the completion of the ERTs, it was time to upgrade the data loggers. Upon inspecting Station One, we quickly discovered that both the data logger housing and the borehole were both flooded as shown in Figure 3.9. Many of the components in the

housing were submerged as depicted in Figure 3.10. Even the data logger appears to have been submerged for an unknown period of time. These issues caused damage that would need to be addressed prior to making the planned upgrades to the data loggers.

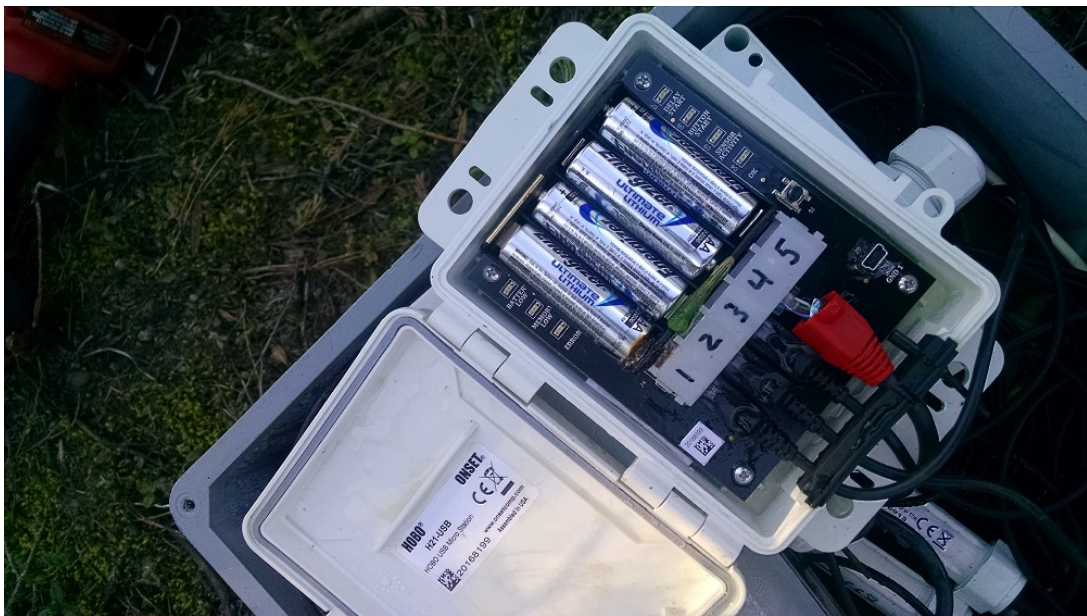
Figure 3.11: Data Logger Damage from Corrosion

Specifically, corrosion was occurring on the data logger battery leads as shown in Figure 3.11.

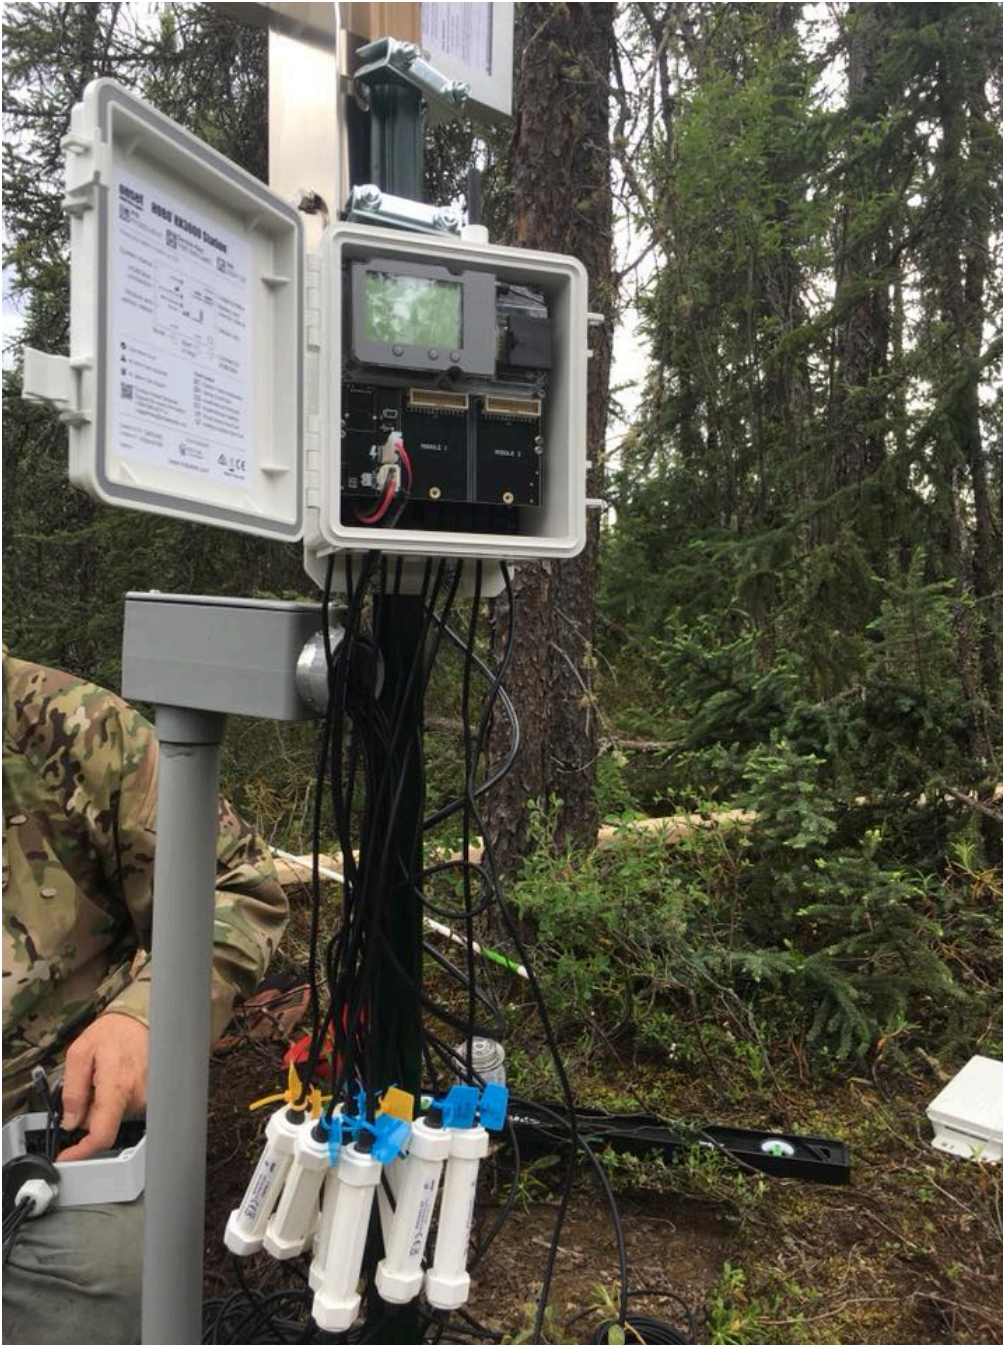
Figure 3.12: Troubleshooting and Rewiring the Data Loggers

3.12. I was careful to wire the thermistors and other sensors in the same order that they were on the previous data logger, which corresponded to their sequential depth in the borehole. I then sealed any of the unused ports with rubber plugs in order to ensure that no moisture would be able to penetrate the data logger as had occurred on the previous data loggers. Additionally, I oriented the data logger in the upright position, which minimized exposure to any of the leads. Lastly, I mounted the solar panel on the top of the post and oriented it southward using my handheld GPS. I then made the power connection from the solar panel to the data logger in order to provide continuous, remote power.

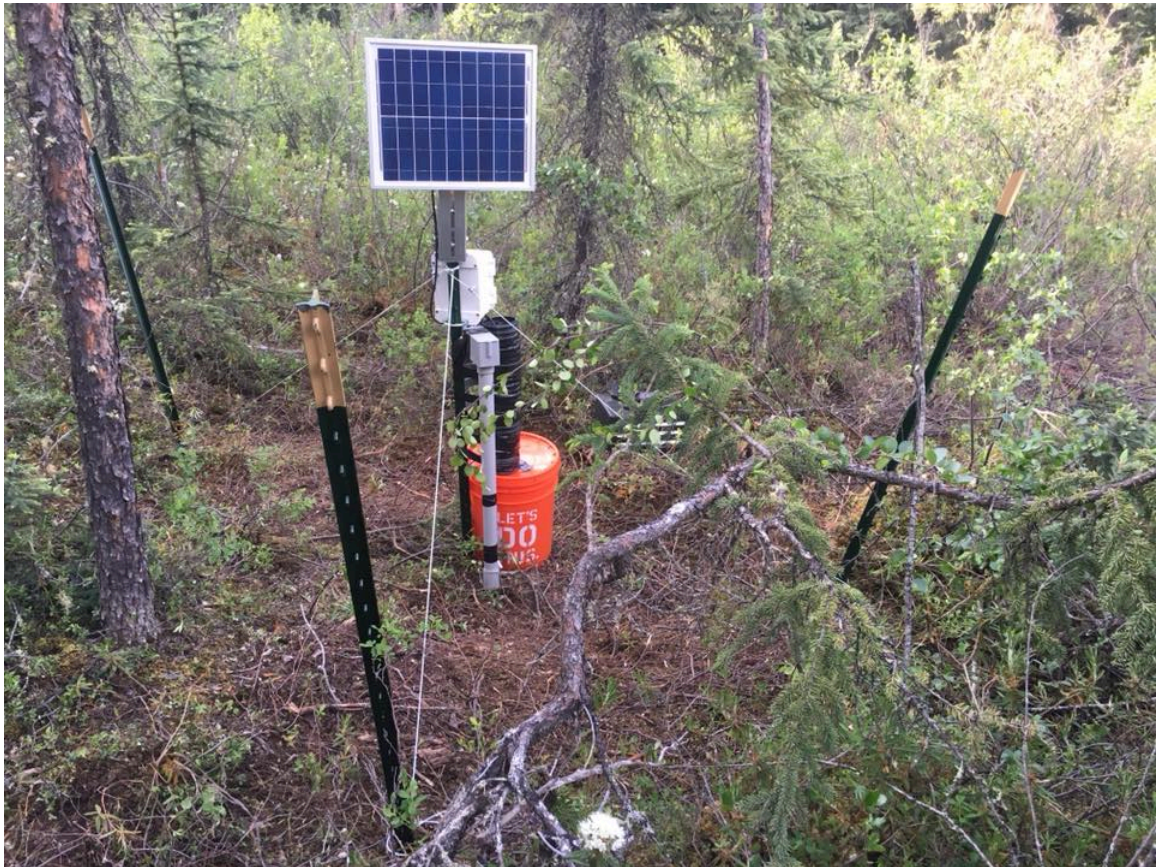
Figure 3.13: Station One Upgrades

After completing all the installations and upgrades there was still several cables and connectors that would be vulnerable to the elements. The most expedient decision I could find was to place them all inside of a plastic five-gallon bucket and seal them against any kind of intrusions from weather or vermin. In case water did penetrate it somehow, I did place some small weep holes in the bottom of the bucket so it could drain. Figure 3.13 shows the completion of Station One.

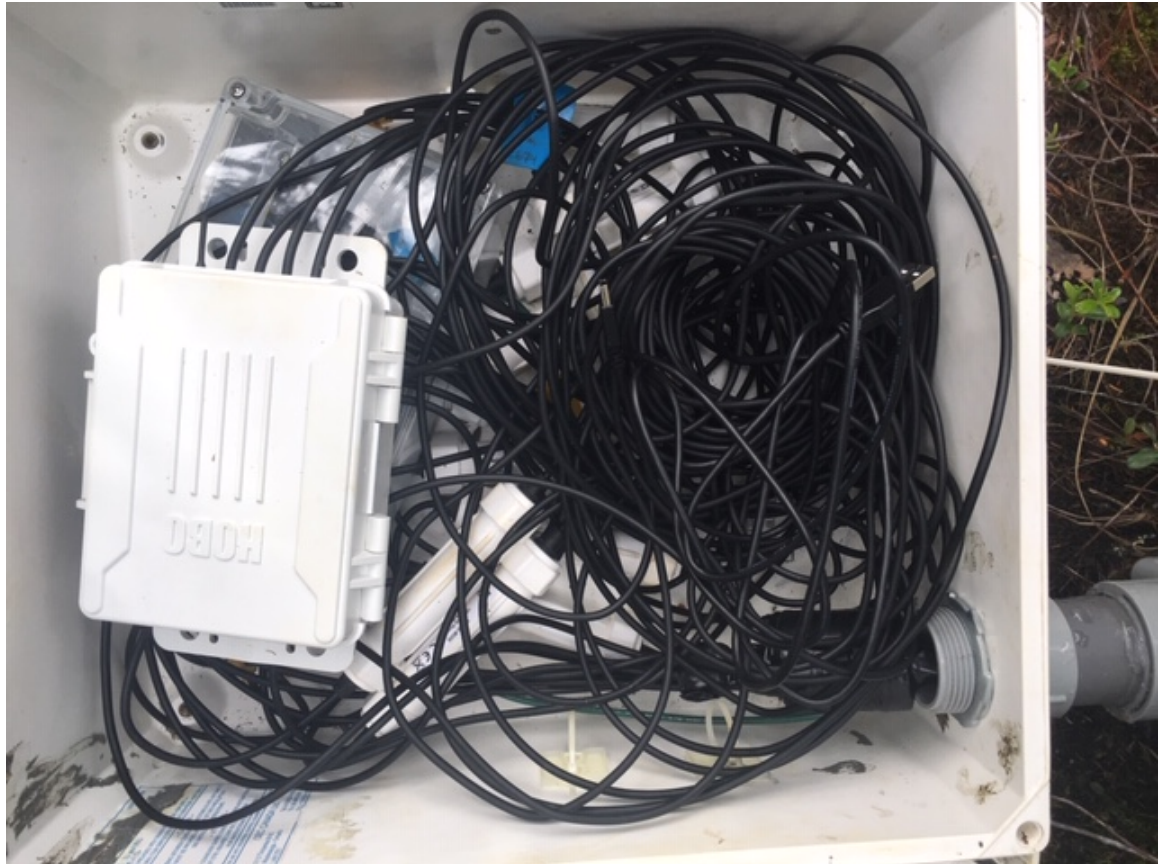
Figure 3.14: Station Two Instrument Housing

The instrumentation at Station Two was found to be in better condition than Station One. Figure 3.14 shows that the box was not compromised by any water. Prior to unplugging the instruments for the upgrade process, all of the data was downloaded and

inspected for lapses. Station Two had performed well and collected all the data since July 2017.

Despite the fact that Station Two had not been compromised, to be safe and for the sake of uniformity, I elected to standardize Station Two with Station One. I pounded in the main support T-post and the three additional support posts the exact same way as I had done on Station One. I then connected the support posts to the main post using the same style guy wires and guy wire fasteners. Once again, I disconnected all of the sensors, extended the borehole housing and ran the cables through the PVC in order to protect them from the elements, and reconnected them to the new data logger. I also waterproofed this RX 3000 and ensured that the sensors were once again in the same

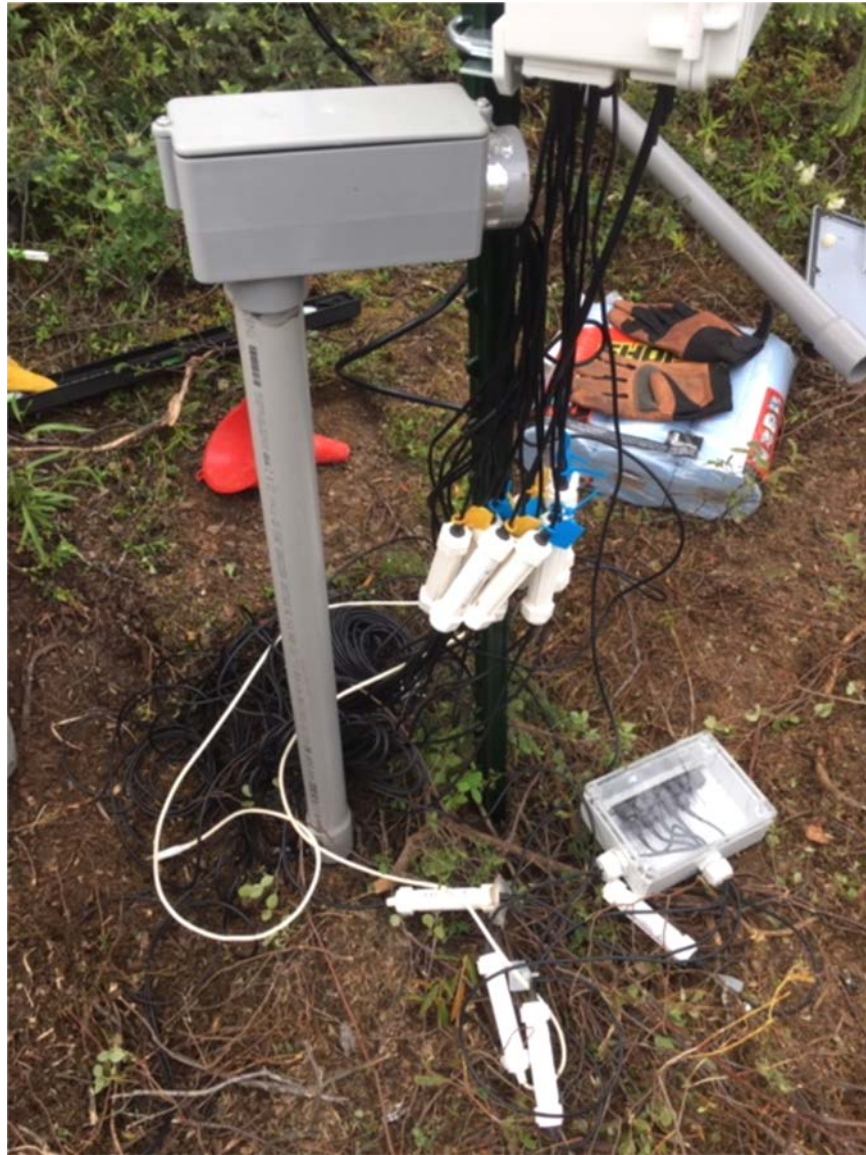
Figure 3.15: The Process of Upgrading Station Two

order that they had been installed on the other data logger to ensure continuity. The process of conducting these upgrades can be seen in Figure 3.15. After the installation of the data logger, I installed an additional solar panel at this location (oriented south) and connected it the battery bank in the RX 3000.

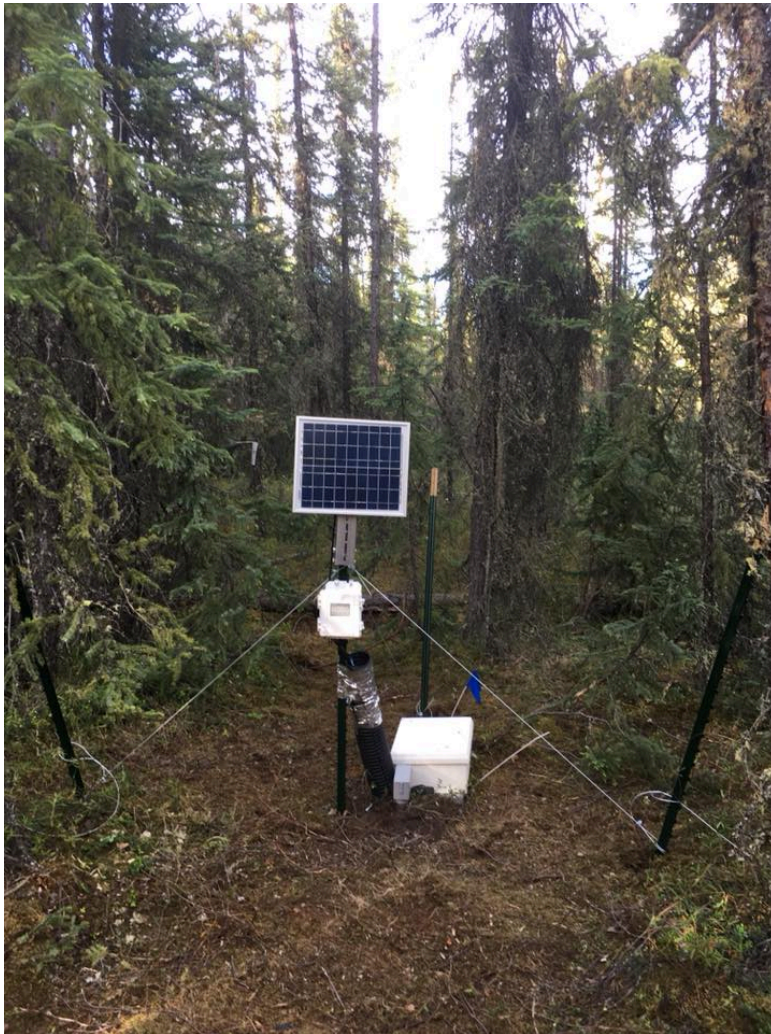
Figure 3.16: Station Two Upgrades

Since the box on Station Two was not compromised, we elected to recycle it and use it to hold the additional cables and connectors. Unlike Station One, where I needed to replace the box with a bucket to house these items, we were able to simply leave these items in place. This is the only deviation in the upgrades that occurred between Station One and Station Two. The completed upgrades to Station Two can be seen in Figure 3.16.

After completing the upgrades at both sites and removing the last of our gear from the field, it was time to test their operability. In order to ensure they were transmitting data we returned to the main part of base to see if we could view the data collected by the new data loggers. Unfortunately, they were not transmitting, so we had to return to the

site to see if we could troubleshoot the RX3000s. When I returned I was inspecting the data loggers and they did not have any of the channels or instruments loaded. I elected to restart both loggers and both populated all the channels that I had installed earlier that day. I once again returned to main base to see if the data was transmitting. I was able to pick up a Wi-Fi signal in the parking lot of the bowling alley and was able to verify that the data was indeed transmitting from both data loggers and the weather station.

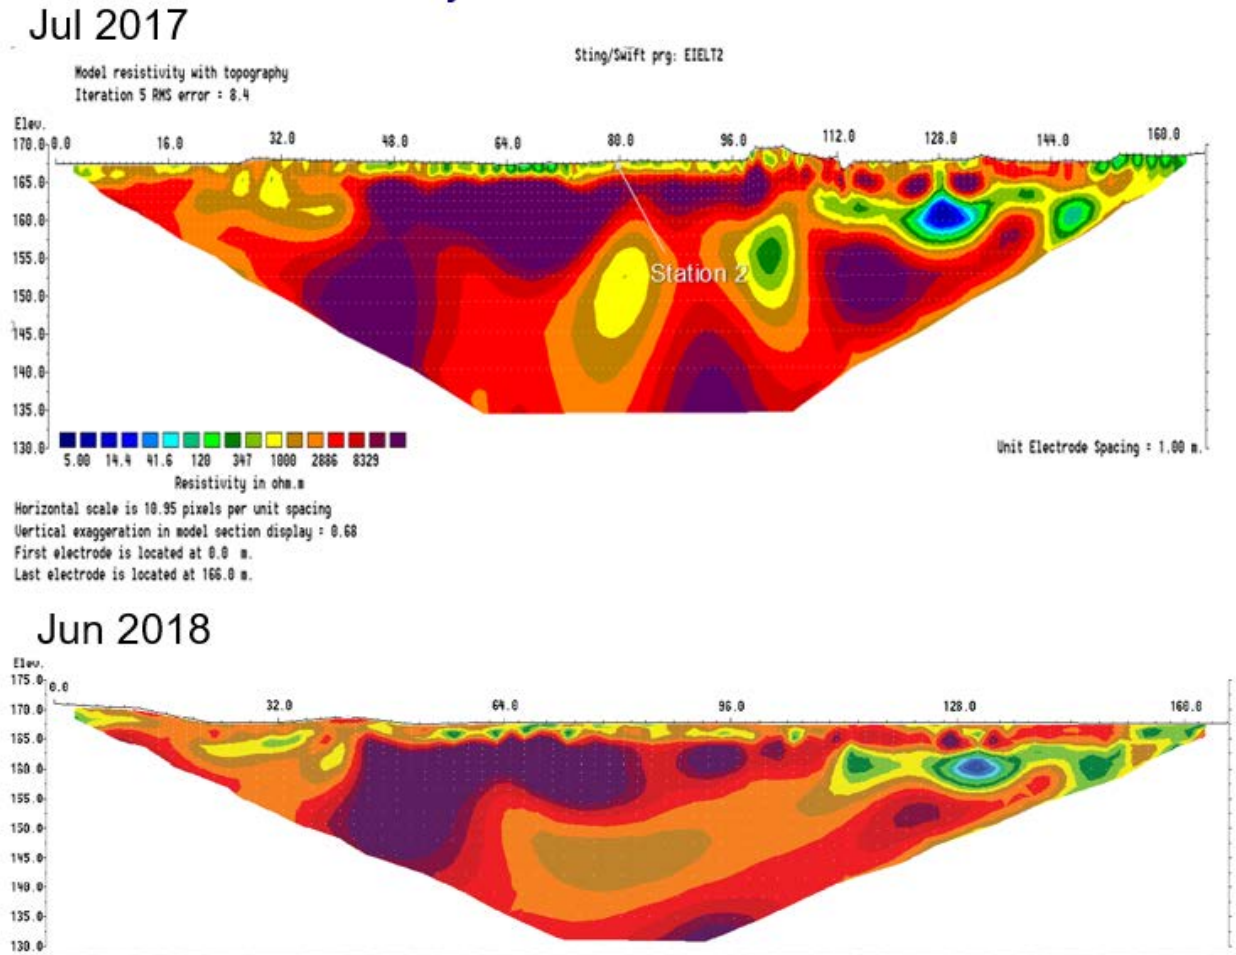
Figure 4.4: Transect Two Comparison. Note that despite the difference of one month in timing, the permafrost along Transect 2 appears to be largely unchanged from the previous year.

While the greatest changes to the permafrost are expected to be on Transect One, we conducted an additional ERT on Transect 2 during 2018 in order to see if any changes were readily apparent from the prior year. Similar to the Transect One, Figure 4.4 depicts that the soils on Transect 2 are in a more frozen state during June 2018 than July 2017. Once again, this is likely due to the fact that the ERT was conducted more than a month earlier than the previous year. Again, in order for there to be a fair comparison, the ERTs would need to have been conducted on as close to the same date as possible one year apart. Despite the earlier timing, the permafrost on Transect 2 appears to be largely unchanged albeit slightly more frozen. This lack of significant change (despite the change in timing) does provide some reassurance that these more undisturbed permafrost specimens further from the impacts of the construction activities, are serving as an adequate control point against which we can compare changes at Station One.
