**QUANTIFYING AND MONITORING PERMAFROST EXTENT, CONDITION,  
AND DEGRADATION AT EIELSON AIR FORCE BASE**

THESIS

Theodore J. Labedz, Captain, USAF

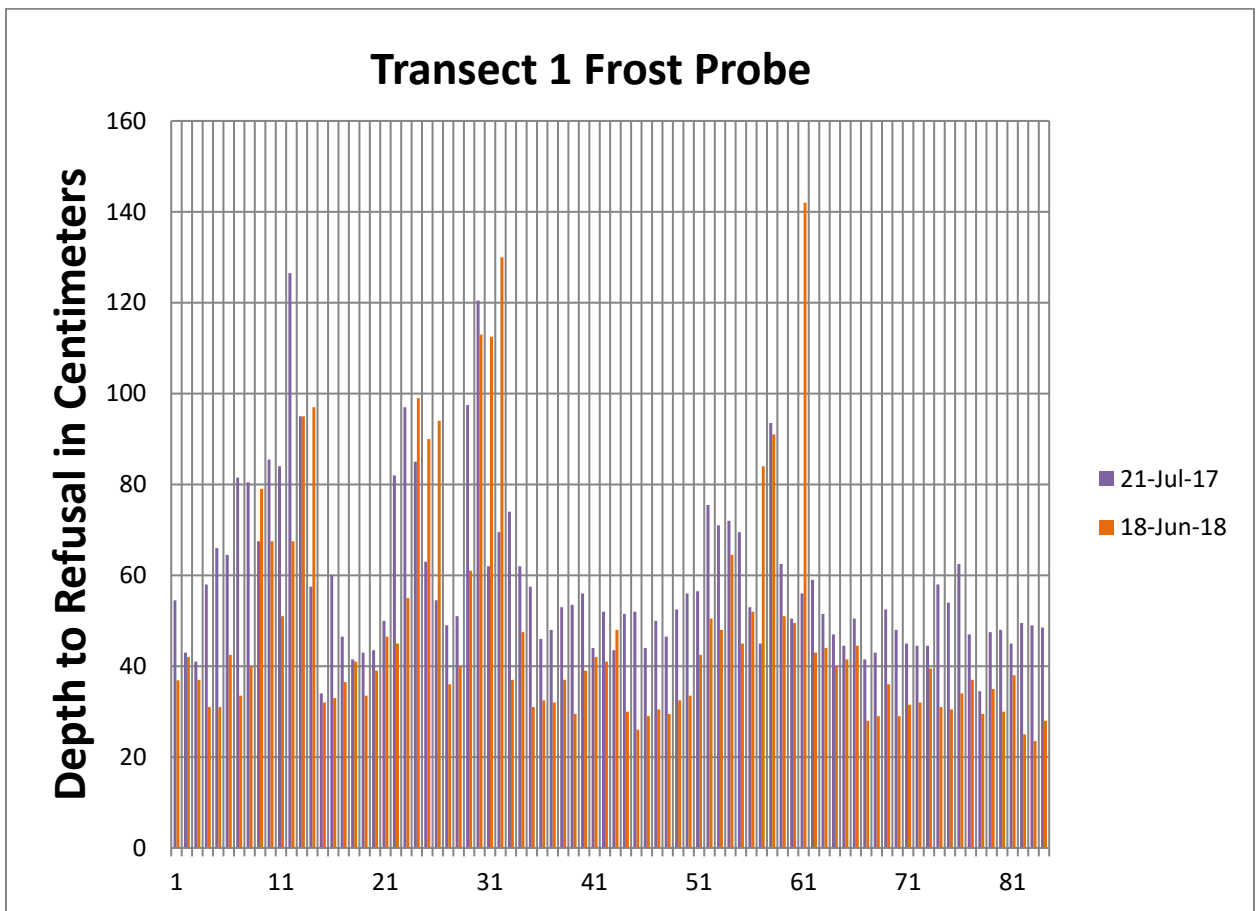
Figure 4.5: Transect One Frost Probe Depth Comparison

depth to the ERT. As I suspected from the ERT along Transect One, the frost depth in June 2018 was consistently shallower than the frost depth in July 2017. Figure 4.5 shows the depth of the frost probe between the two test dates and it clearly depicts a more frozen condition, likely due to the timing difference. This supports my hypothesis that conducting both the ERT and the frost probes at inconsistent dates does not provide accurate comparison from year to year. Once again, in order for there to be a fair comparison, the frost probes would need to be conducted on the same dates in order to provide conclusive evidence about the migration of the permafrost table.

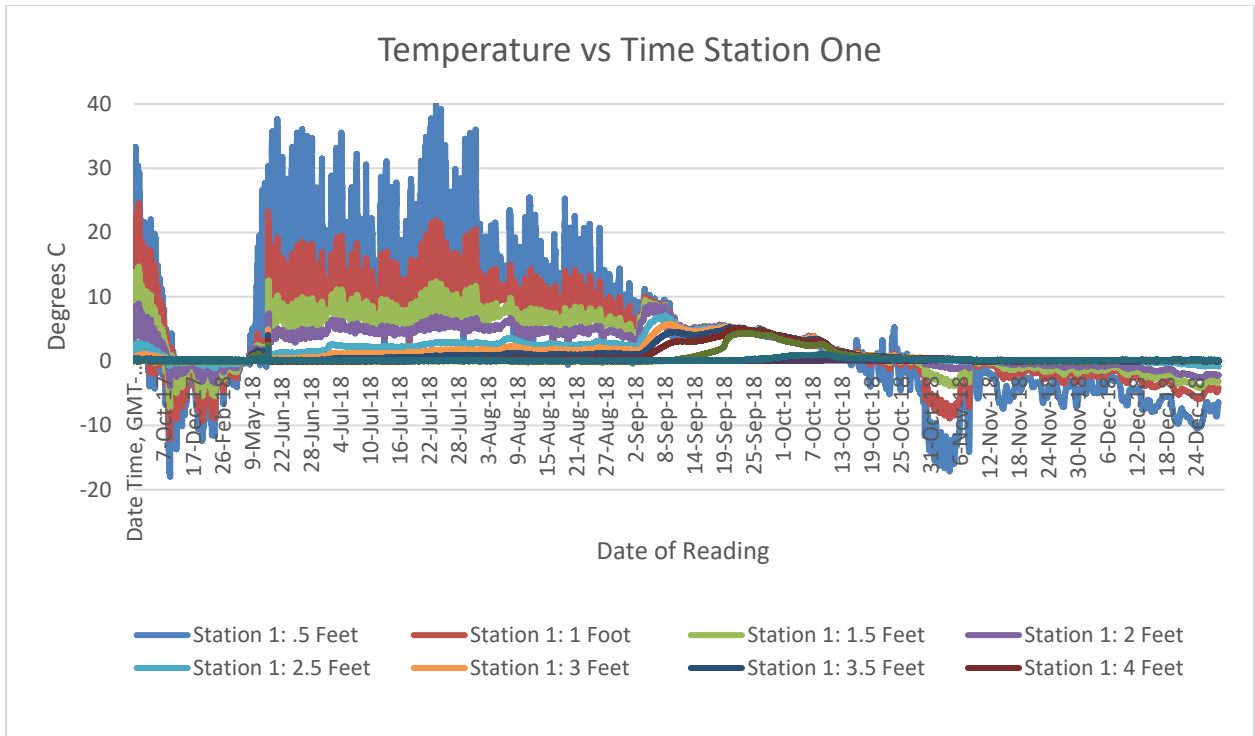
Figure 4.7: Temperature vs Time for Station One Depicting All Depths

In order to visualize the temperature variations over time for the thermistor readings, I began by plotting the temperature readings at each depth over time in Figure 4.7. This shows the temperature fluctuations as the soils go through their annual freeze thaw cycle. By plotting the data in this way, it is possible to see how the temperature changes with both time and depth. The shallowest thermistors read the greatest temperature fluctuations while the deeper thermistors are less influenced by the season extremes of climate. At first glance, the deepest sensors appear to show no thermal variation at all; a behavior that is expected during permafrost observation. The other fluctuations are indicative of the formation and degradation of the freeze/thaw process in the active layer of the permafrost. As further analysis is conducted on this data, it will be possible to determine the depth of zero amplitude as well as compare the behaviors of Borehole One to Borehole Two.

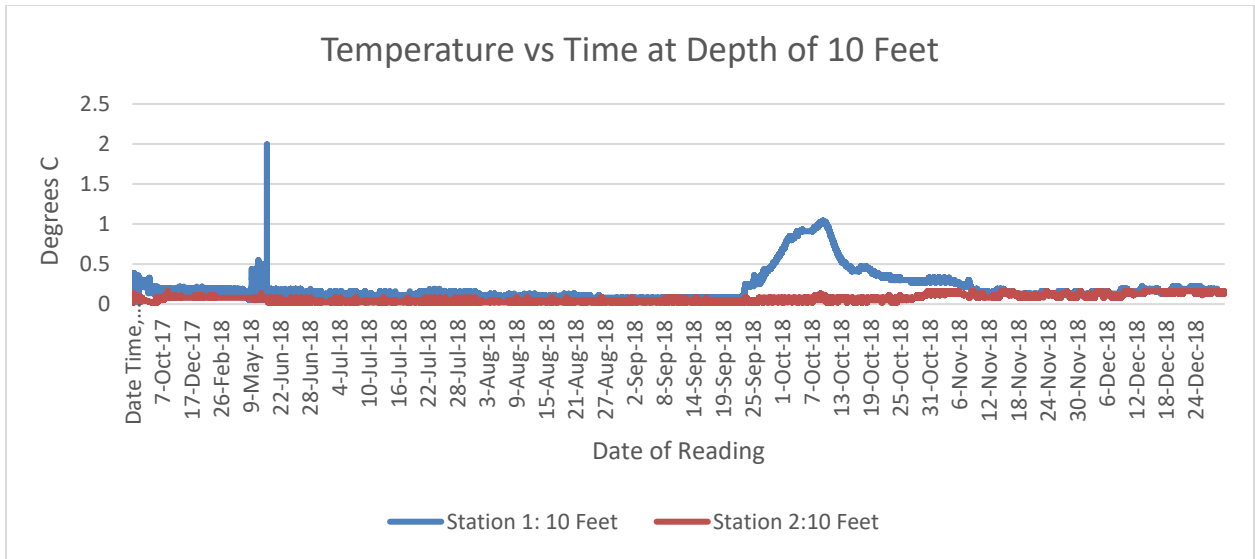
Figure 4.17: Small Scale Temperature vs Time at Depth of 3 Feet

Figure 4.18: Small Scale Temperature vs Time at Depth of 5 Feet

Figure 4.19: Small Scale Temperature vs Time at Depth of 10 Feet

The temperature delta at the depths of 3, 5, and 10 feet between Station One and Station Two represent an interesting anomaly. At the depth of the feet the temperatures very closely mirrored one another until the beginning of September and then there was a rapid warming at this depth until freeze up in late November when they once again shared similar characteristics, At three feet, the temperature difference achieved a maximum delta of 4 degrees Celsius, a significant divergence in permafrost behaviors in such a short period of time. This pattern presents itself again at the depth of 5 feet. In this instance, Station One was indicating permafrost behaviors until once again there was a massive temperature increase in late September of 2018. Station Two indicated that it broke zero degrees during the summer, which is an indicator that it is also part of the active layer at this location but Station One appeared to be in permafrost until September 2018 at the depth of 5 feet. This same trend also occurred at a depth of 10 feet where, during the same time period, the thermistors registered a temperature of 1 degree prior to the winter freeze at Station One while Station Two is clearly within a healthy layer of permafrost.
