Ceramic Matrix Composite Characterization under a Combustion and Loading Environment

**CERAMIC MATRIX COMPOSITE CHARACTERIZATION UNDER A
COMBUSTION AND LOADING ENVIRONMENT**

THESIS

AFIT/GMS/ENY/09-M01

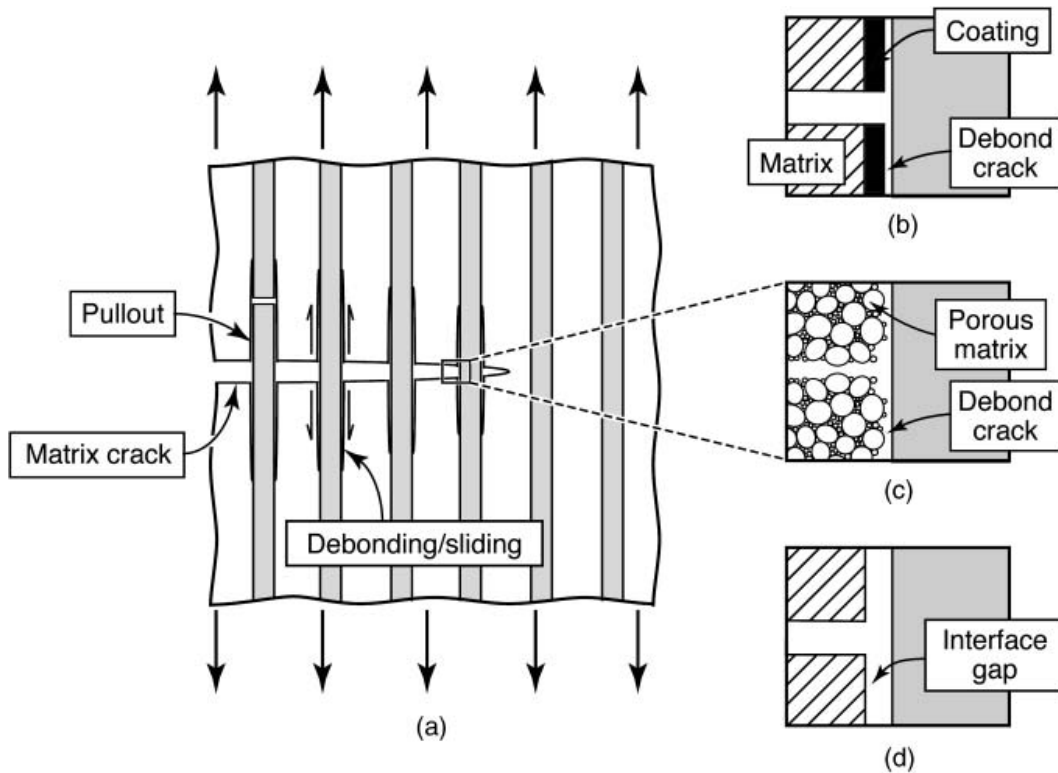
Figure 2. Damage Tolerance Mechanism of CMC's [24]

coating that will oxidize after the CMC manufacturing process, leaving a small interface gap between the fibers and matrix [24]. Figure 2 shows CMC energy dissipation behavior and the methods used.

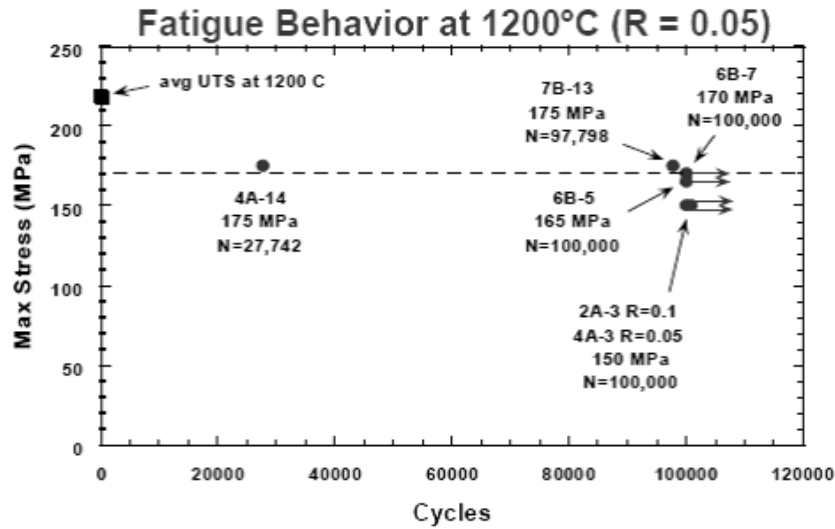
Figure 3. N720/A Fatigue Behavior at 1200°C [17]

Several fatigue tests have previously been performed on N720/A in a lab furnace environment. Fatigue testing has been accomplished at room temperature, 1200°C, and 1330°C [5; 19]. At 1200 and 1330°C, fatigue testing has also been performed in a 100% steam environment [5]. In addition, Fatigue testing at 1200°C was accomplished by the manufacturer of the CMC, with the results shown in Figure 3.

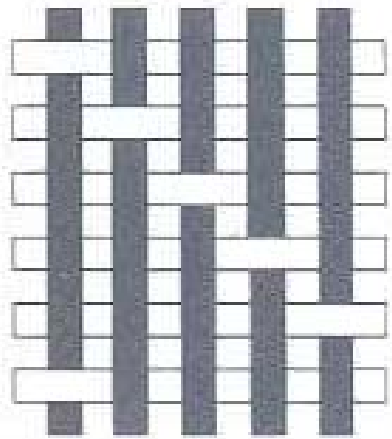
Figure 4. Satin Weave [3:51]

The N720/A CMC is manufactured by Composite Optics, Incorporated, now a division of ATK Space Systems. The manufacturing is accomplished using a sol-gel process. The Nextel™ 720 fibers are first woven into a fabric, in this case a satin weave. Figure 4 shows an example of a satin weave.

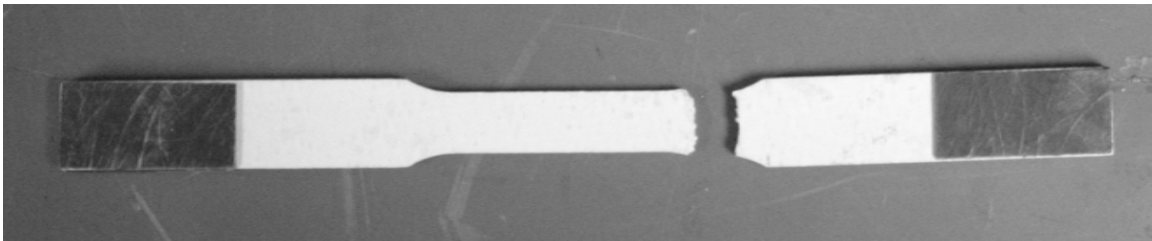
Figure 8. Premature Failure of Earlier Specimen Geometry

A large radius dog bone instead of a straight edge dog bone section was used because previous experience showed premature failure at the upper edge of the straight edge dog bone radius. Figure 8 shows an example of a straight edge dog bone specimen failure.

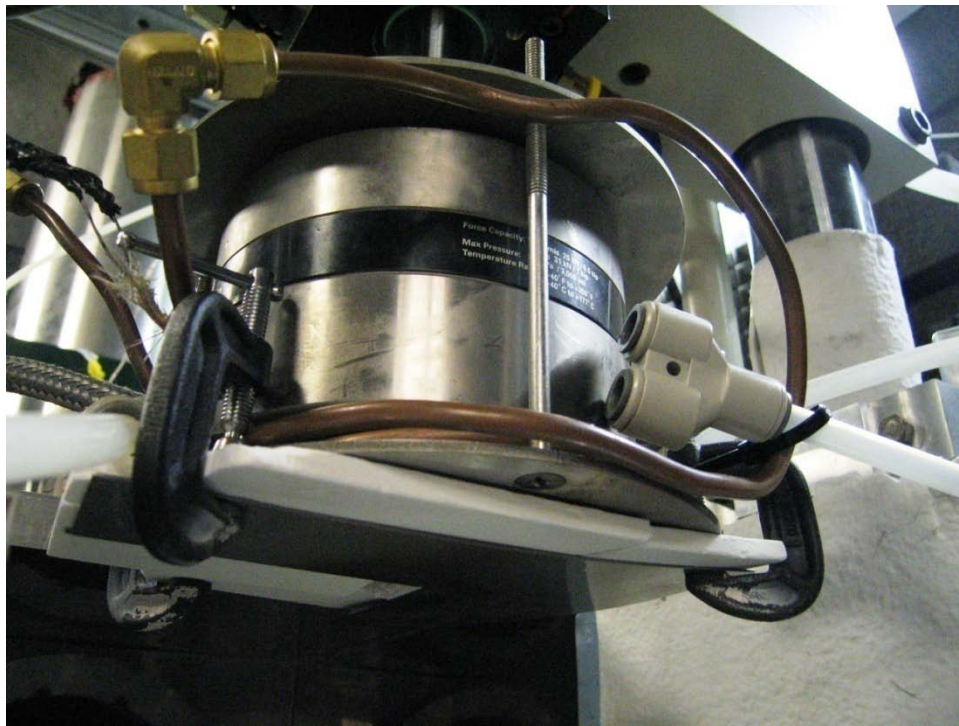
Figure 11. MTS Grip Cooling Scheme

plates, BUSTER M-35 ceramic plates were sandwiched between steel sheets which were clamped onto the steel plate. In addition, the wedge grips were cooled by lab air which was fed into them at 50 psi. The outer surfaces of the grips were also cooled with 15 psi lab air. The maximum temperature seen at the wedge grips with this scheme was 130°C, which is well below the 177°C temperature limit of the grips. Figure 11 shows the cooling scheme used on the grips.

The specimens were gripped with a pair of MTS 647 hydraulic wedge grips. The grip pressure used was 12 MPa. Using a flame to heat the specimen created a unique problem in keeping the grips cool, since there was no enclosure to help contain the heat of the flame solely on the specimen. In order to keep the grips cool, a multiple-layer insulating/cooling approach was needed. This first layer was copper coils held onto the grip surface by a steel plate bolted onto the grips. These copper coils flow 16°C deionized cooling water which is supplied by a NESLAB RTE 7 chiller. On the steel

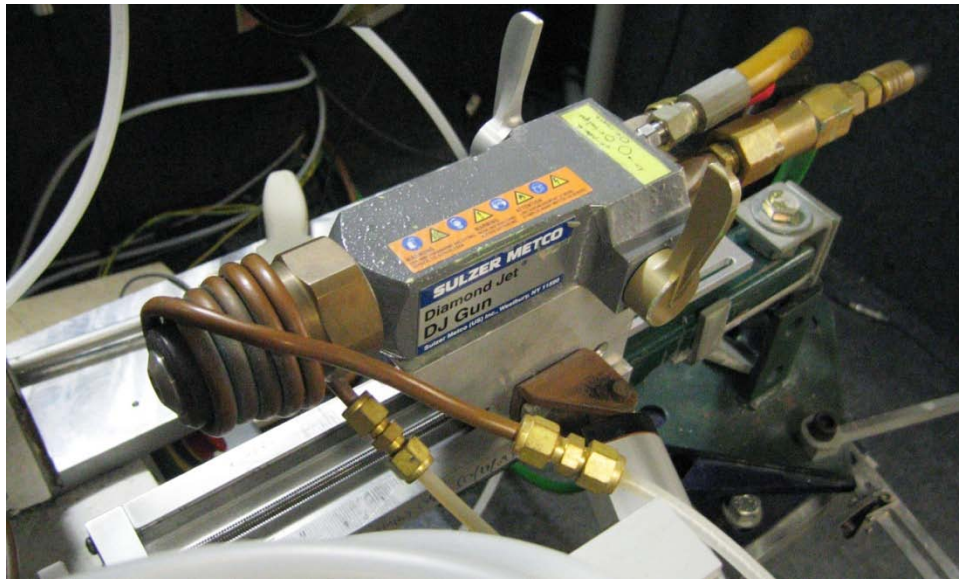
Figure 13. DJ9A HVOF Spray Gun

The spray gun is mounted onto the MTS machine and is affixed to a rail system to allow it to be adjusted in the left-right and front-back directions. Figure 13 shows the DJ gun mounted in the rig.

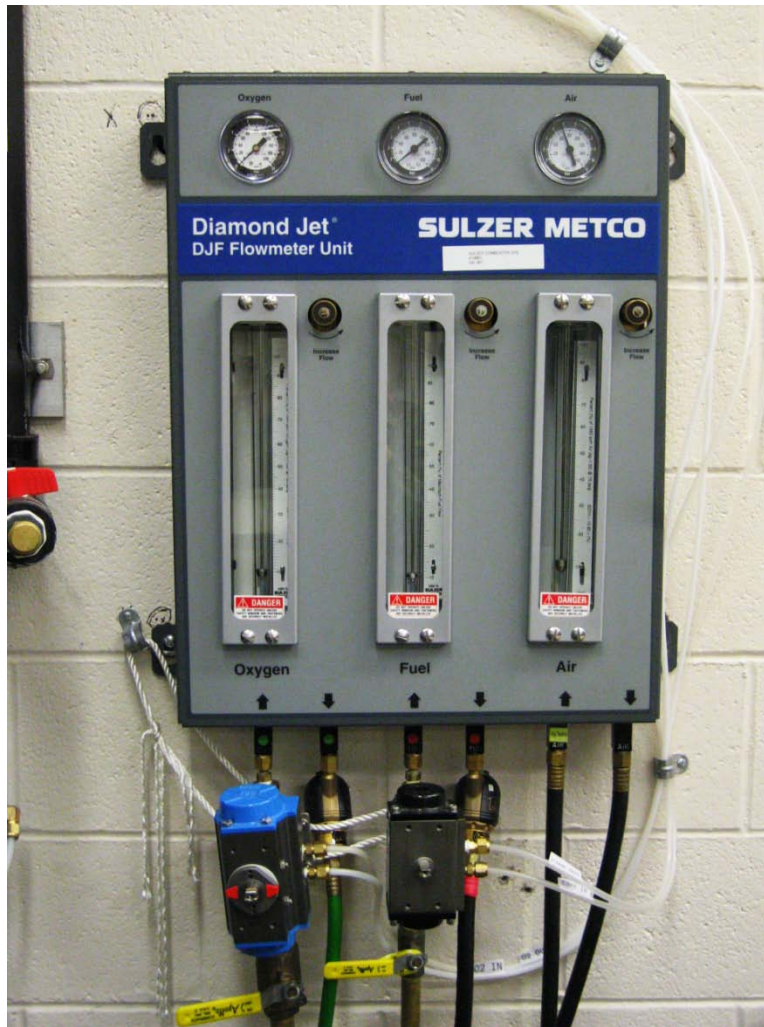
Figure 14. DJF Gas Flowmeter Unit

To control the flame, a DJF Diamond Jet Gas Flowmeter unit was used. The flowmeter unit consists of three rotameters: one for oxygen flow; one for propane gas flow; and one for air flow. These three rotameters allow the user to accurately control the amount of each gas being fed to the spray gun to control its flame. Figure 14 shows the DJF gas flowmeter unit.

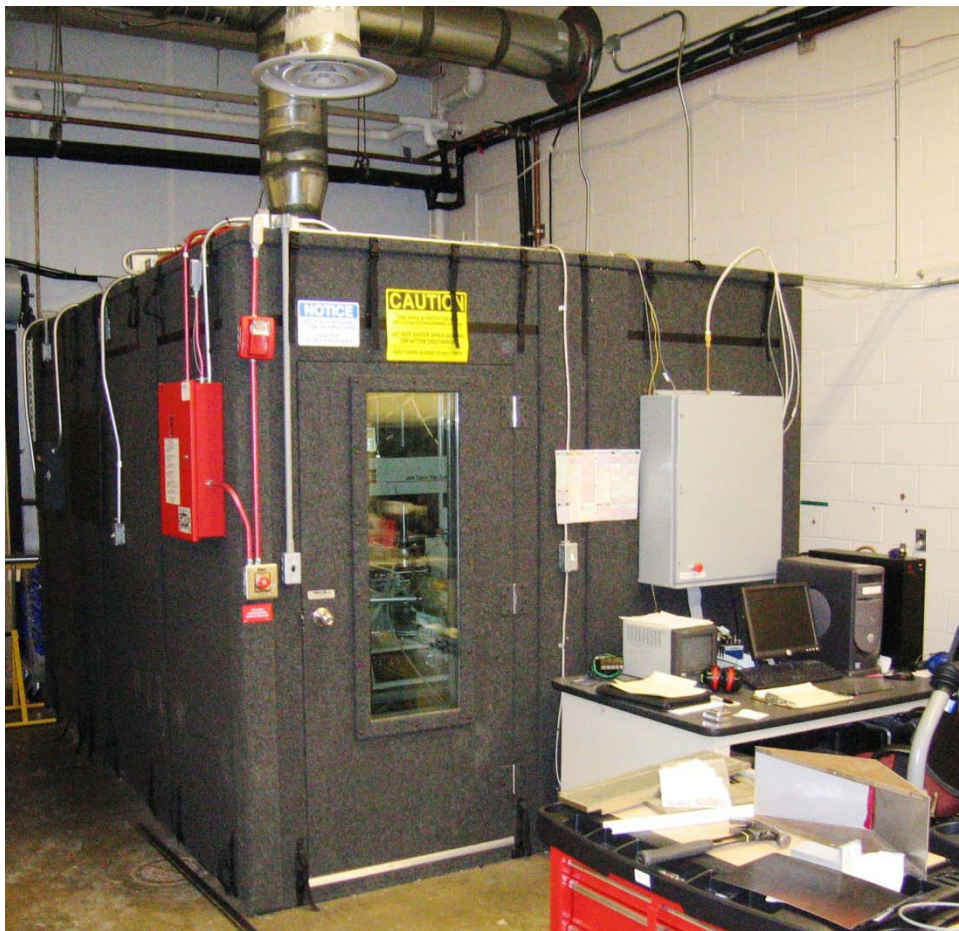
Figure 15. Whisper Room

Having a spray gun that creates a Mach 1 flame creates a noise hazard. For the HVOF gun, the max noise level it can produce is 140 dB [4:13]. Because this gun needs to be run for extended periods of time for fatigue testing, it was necessary to contain the sound. To do this, a WhisperRoom SE2000 series sound room was used to contain the MTS machine and DJ spray gun. The room was modified to include an exhaust duct to remove the flames gas byproducts and heat from the room. An HFC-227ea fire suppression system was also added to the room in the event of a fire in the room. Figure 15 shows the Whisper Room.

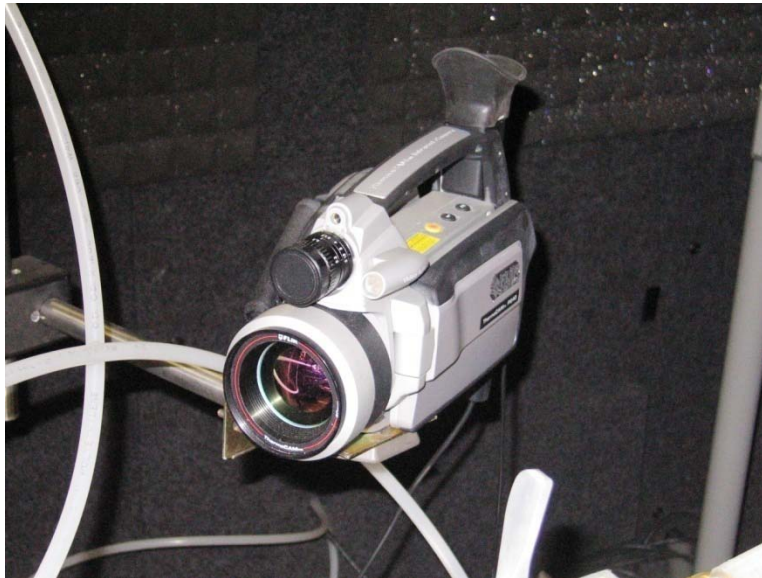
Figure 17. FLIR ThermaCAM P640 Camera

The ThermaCAM P640 has a 640x480 pixel infrared detector, with a $\pm 2\%$ accuracy and the ability to measure temperatures from -40 to 2000°C . The detector also has a spectral range of 7.5 to $13\ \mu\text{m}$, with a minimum focus distance of 0.3m . The thermal sensitivity of the camera is 55mK at 30°C [6]. Figure 17 shows the camera mounted on the test stand.

The temperature of the specimen was recorded using a FLIR system. For the front of the specimen, which is where the flame impinged the specimen, a FLIR ThermaCAM P640 camera was used. A FLIR ThermaCAM PM695 camera was used to record the temperature at the backside of the specimen.

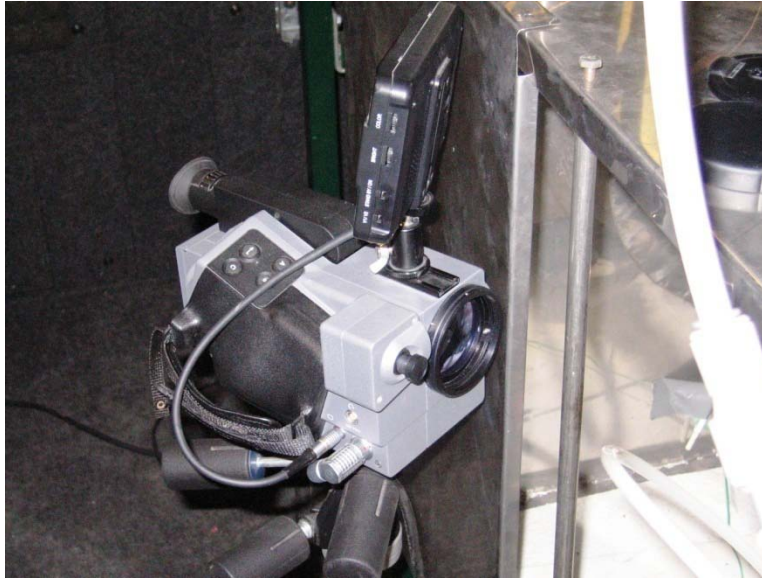
Figure 18. FLIR ThermaCAM PM695 Camera

The ThermaCAM PM695 camera is an older model with the same accuracy, temperature measurement range, and spectral range as the P640. However, it has a 320×240 pixel detector with a minimum focus distance of 0.5m . The thermal sensitivity is $< 0.08^{\circ}\text{C}$ @ 30°C , which is less than the P640 [21:56]. It is for these reasons that this camera was used to measure the temperatures at the back side of the specimen. Figure 18 shows this cameras placement in the room.

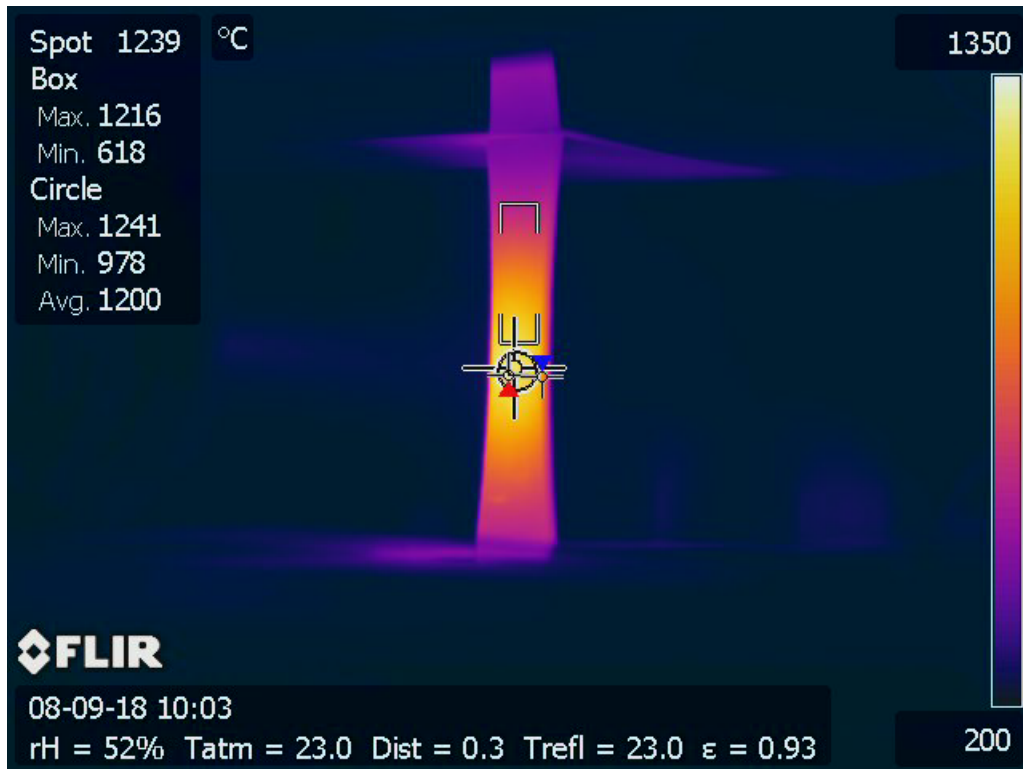
Figure 19. FLIR Measurement during Testing

specimen where the flame was impinging the specimen, with its diameter being the width of the specimen. The box measurement was placed at the upper end of the specimen, starting just above the circular measurement and ending where the specimen was no longer exposed. Figure 19 shows the measurement areas during a test.

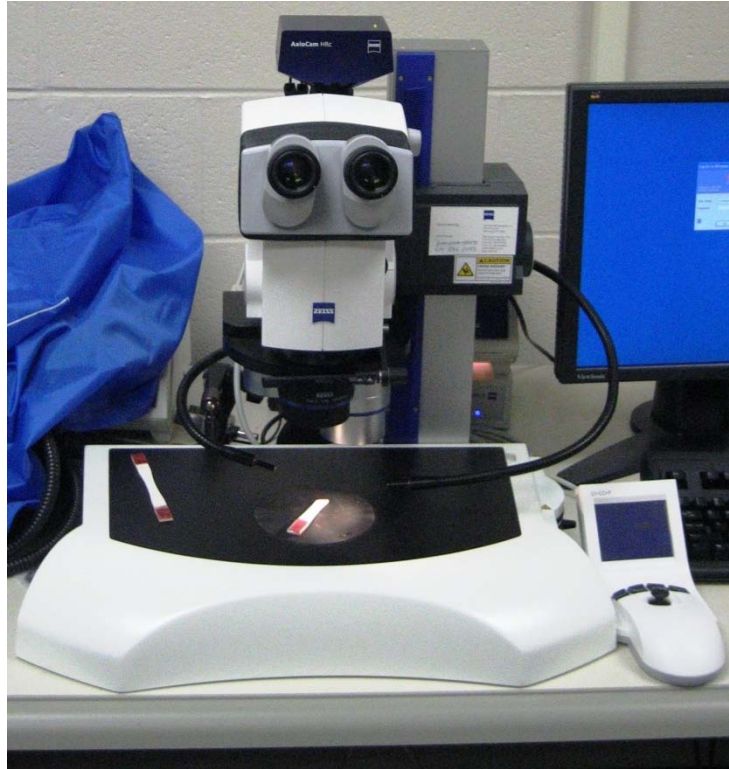
Figure 20. Zeiss Discovery V12 Optical Microscope

This was performed using a Zeiss Discovery V12 microscope with an attached Zeiss Axiocam HRC. Figure 20 shows the optical microscope

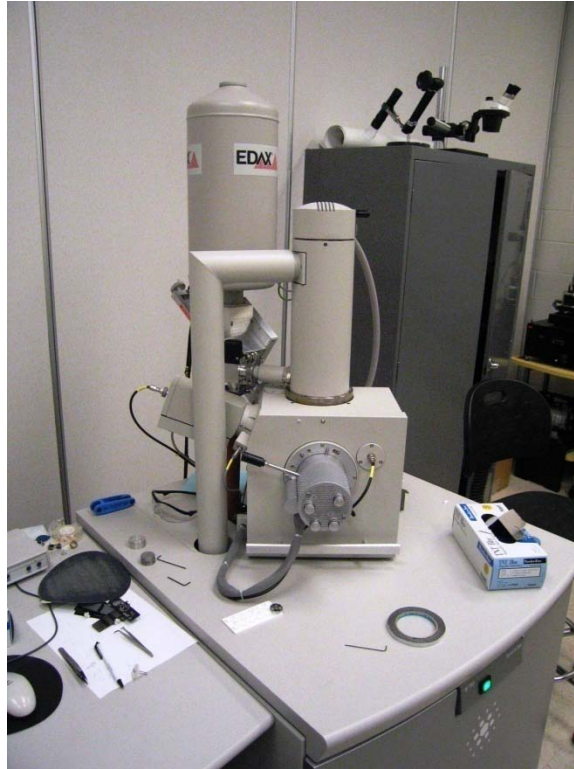
Figure 21. Quanta 200 SEM

were coated with gold for SEM imaging. This gold coating was applied using a SPI-Module 11428 coater. Figure 21 shows the SEM setup.

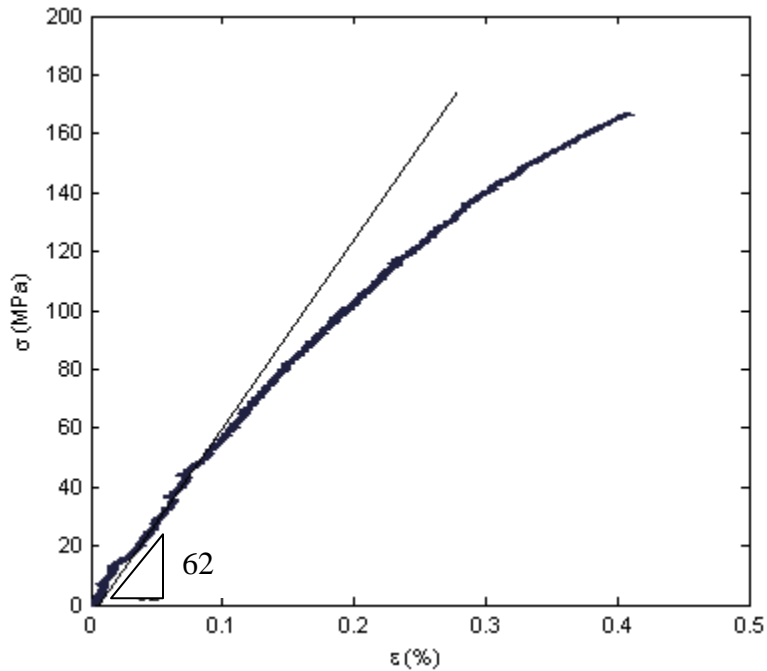
Figure 28. Combustion Environment Tensile Strength

To provide a baseline stress to accomplish fatigue testing, the tensile strength of the material needed to be determined in the combustion environment. The stress at failure was compared to tensile strength data from Sullivan, Eber/Harlan, and COI. Figure 28 shows the stress-strain curve. Table 12 shows the previous tensile strength data in 1200°C air and the tensile strength in the combustion environment.

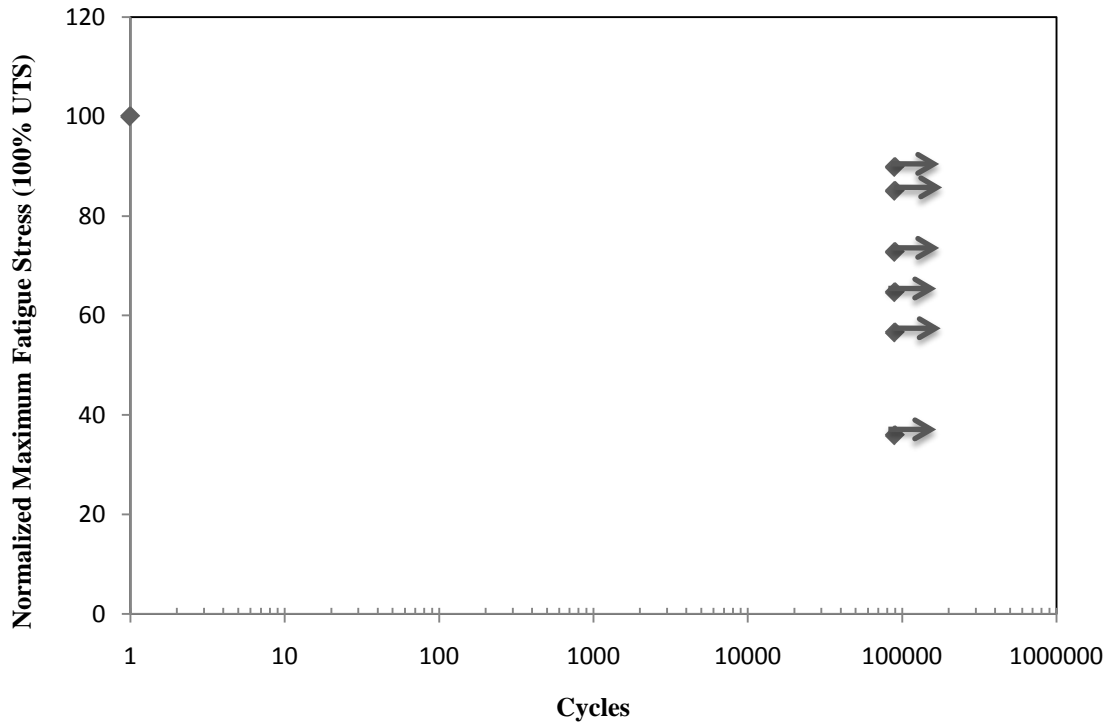
Figure 29. Fatigue Stress versus Cycles

Specimen Number	Fatigue Stress (MPa)	Fatigue Stress (% UTS)	Cycles to Failure	Failure Location
3	60	36	>90,000	Run-out
5	94.5	57	>90,000	Run-out
6	108	65	>90,000	Run-out
7	121.5	73	>90,000	Run-out
8	142	85	>90,000	Run-out
10	150	90	>90,000	Run-out

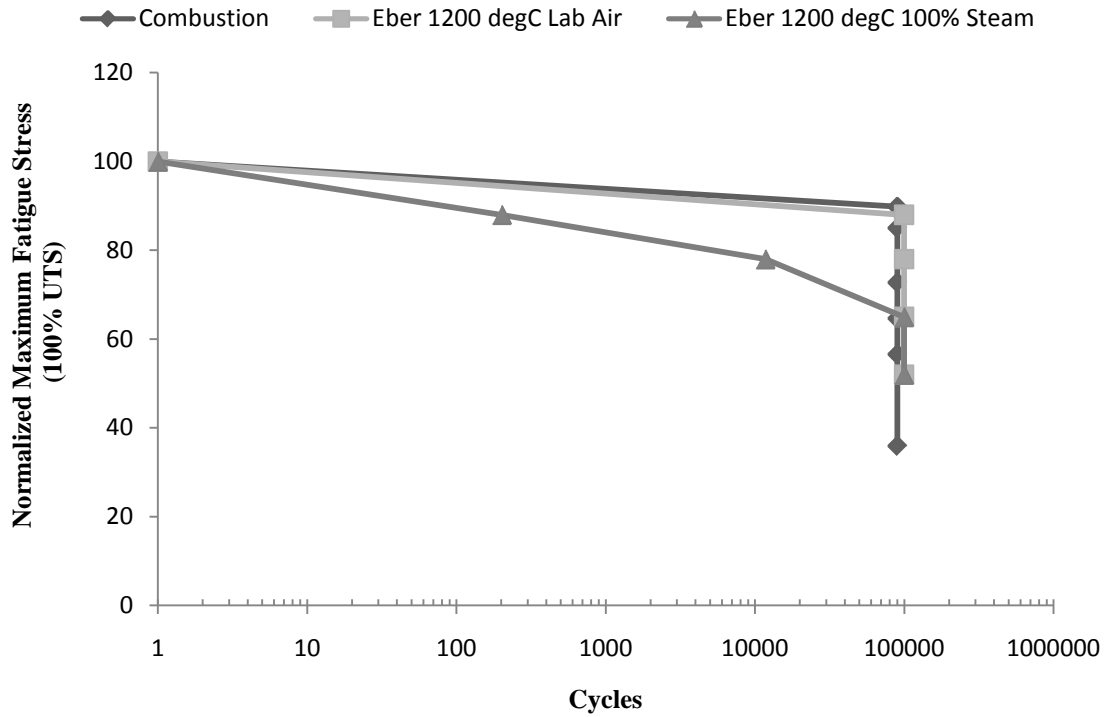
Figure 30. Normalized Fatigue Stress versus Cycles Comparison with Eber Data

Figure 30 shows that the combustion environment fatigue behavior is similar to the laboratory air fatigue behavior at 1200°C.

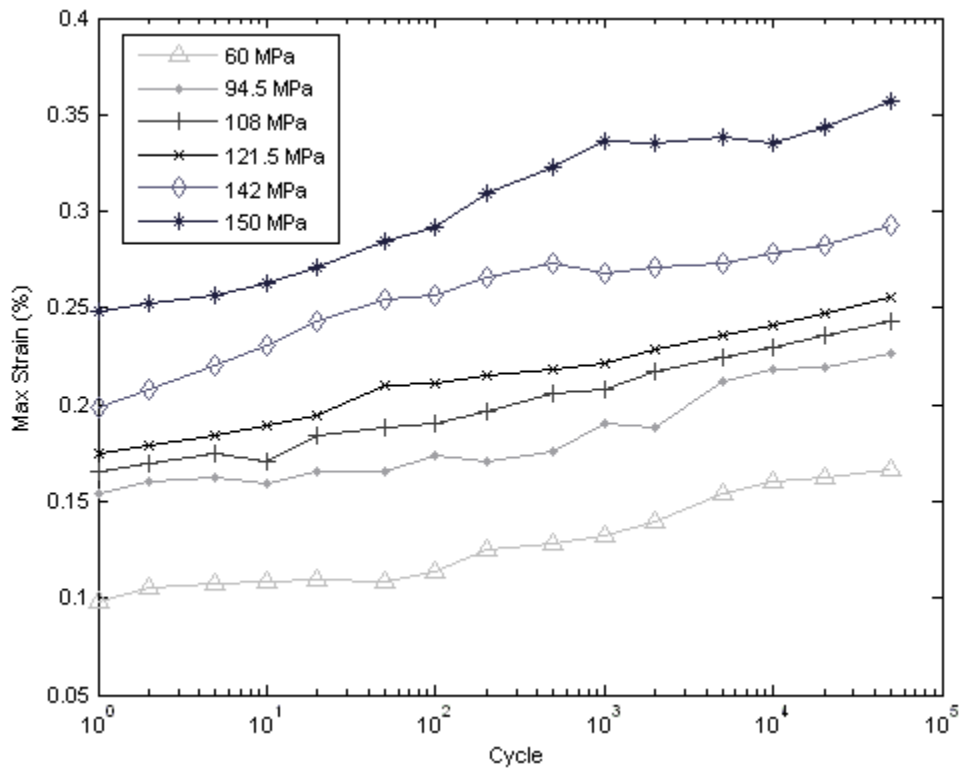
Figure 37. Maximum Strain Increase vs. Cycles

Another way to view the increasing strain over time during fatigue testing is to look at the maximum strain for each recorded cycle.

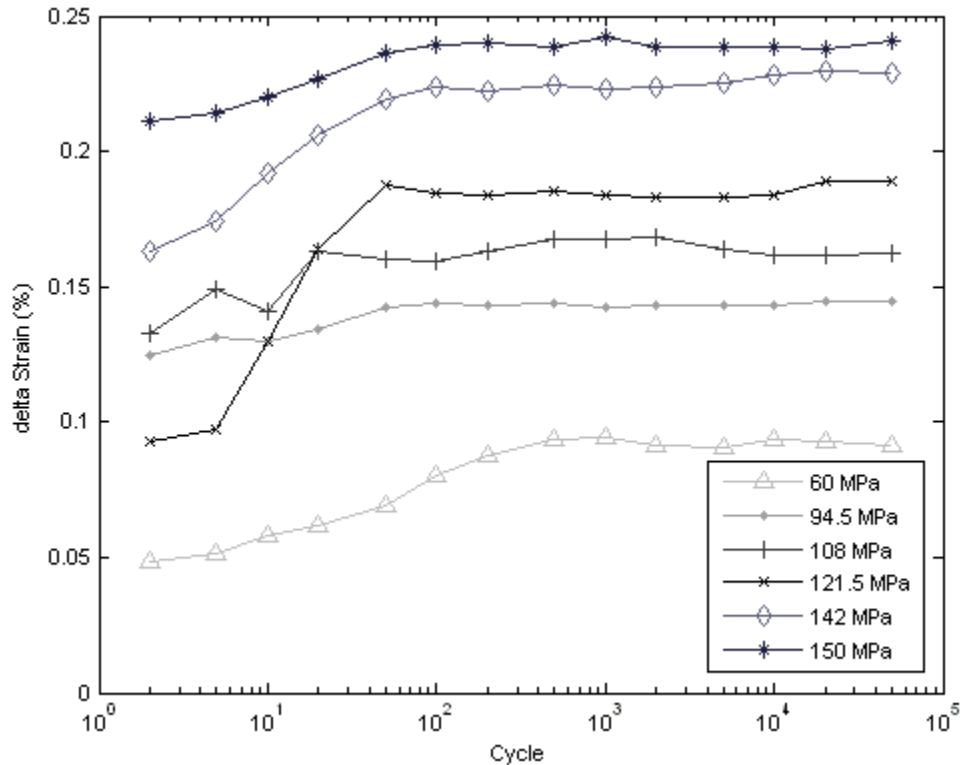
Figure 38. Delta Strain vs. Cycles

The difference in the maximum and minimum strains, or strain range is then calculated over time. The slope of this strain range is an indicator of the fatigue damage accumulated by a specimen. Figure 38 shows the strain range for each fatigue specimen versus the logarithmic cycles.

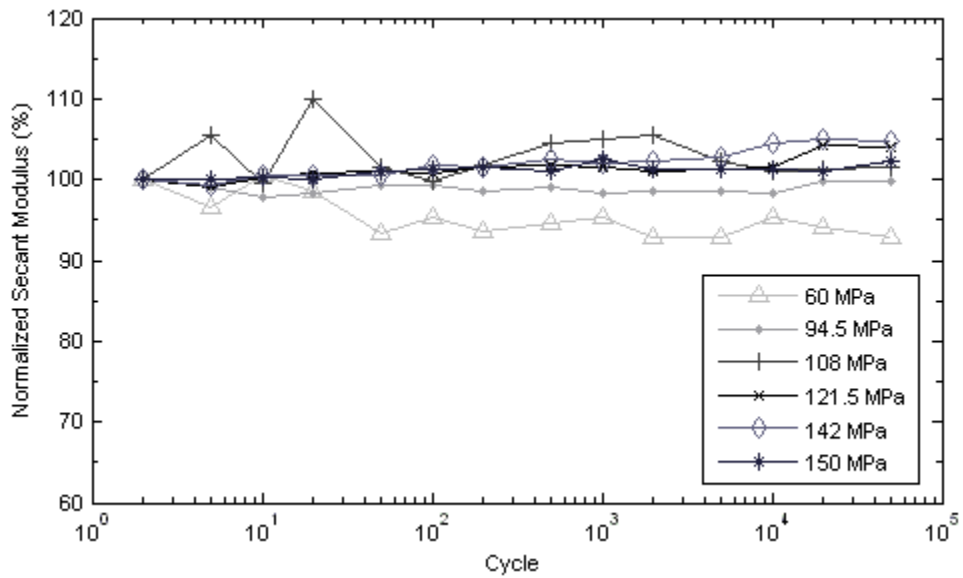
Figure 40. Normalized Secant Modulus vs. Cycle

The secant modulus can be normalized by dividing the modulus values by the modulus of the first cycle (S_0). This illustrates the change in modulus over time. Figure 40 shows the normalized modulus for all of the fatigue tests versus the logarithmic of the cycles.

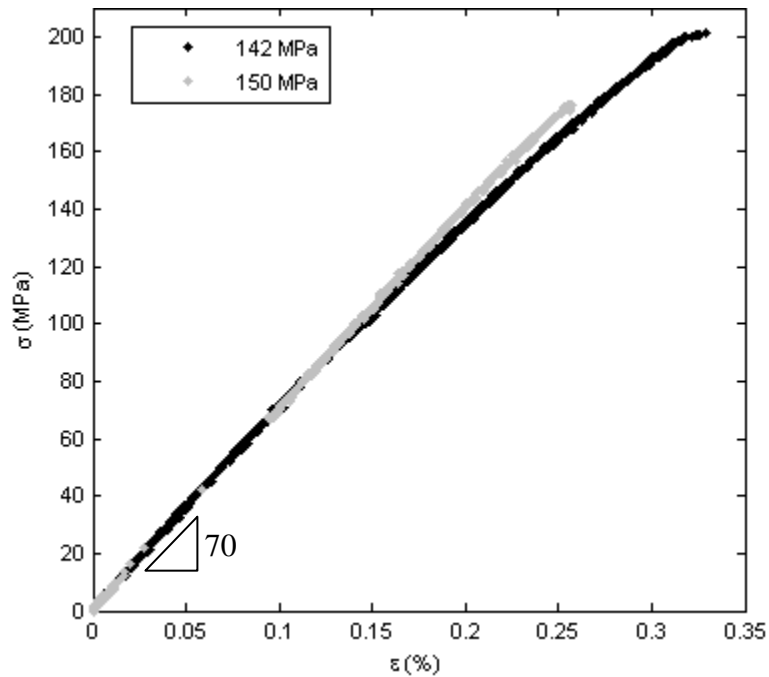
Figure 41. Residual Strength Stress-Strain Curves

To see what retained strength is present in the material after fatigue testing, the 142 MPa and 150 MPa specimens were monotonically tensile tested. Figure 41 shows the stress-strain curves of the residual strength testing.

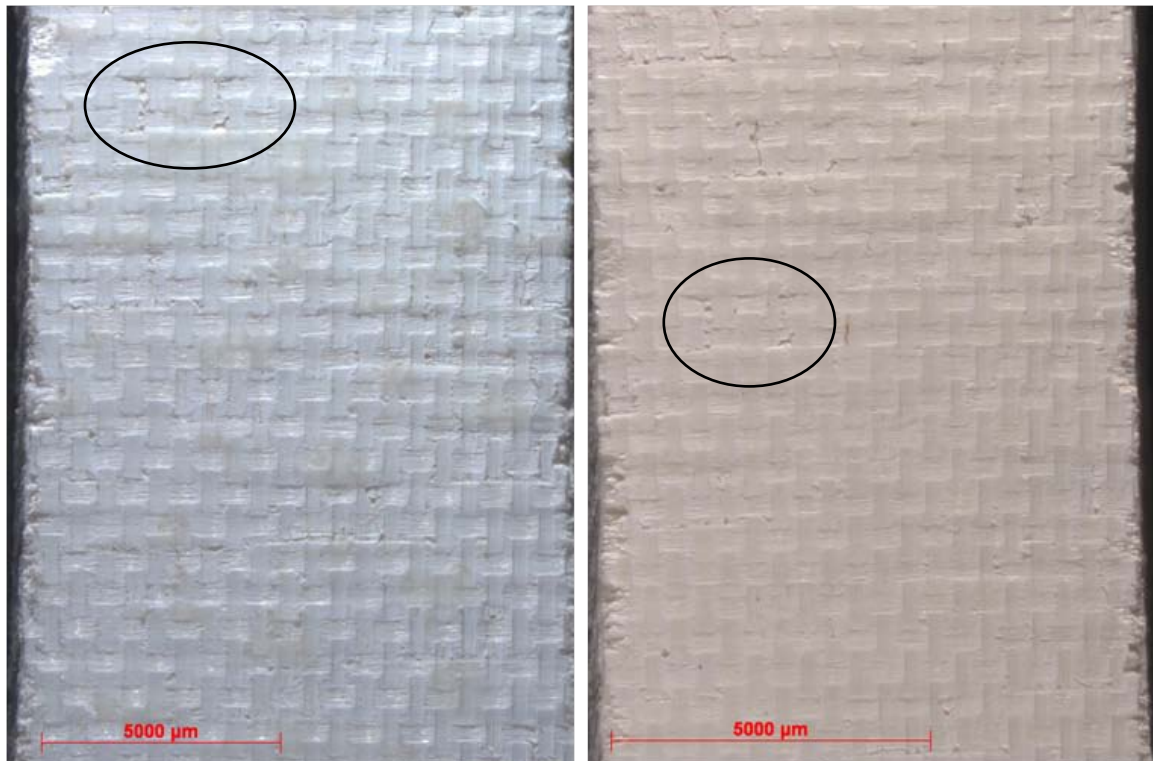
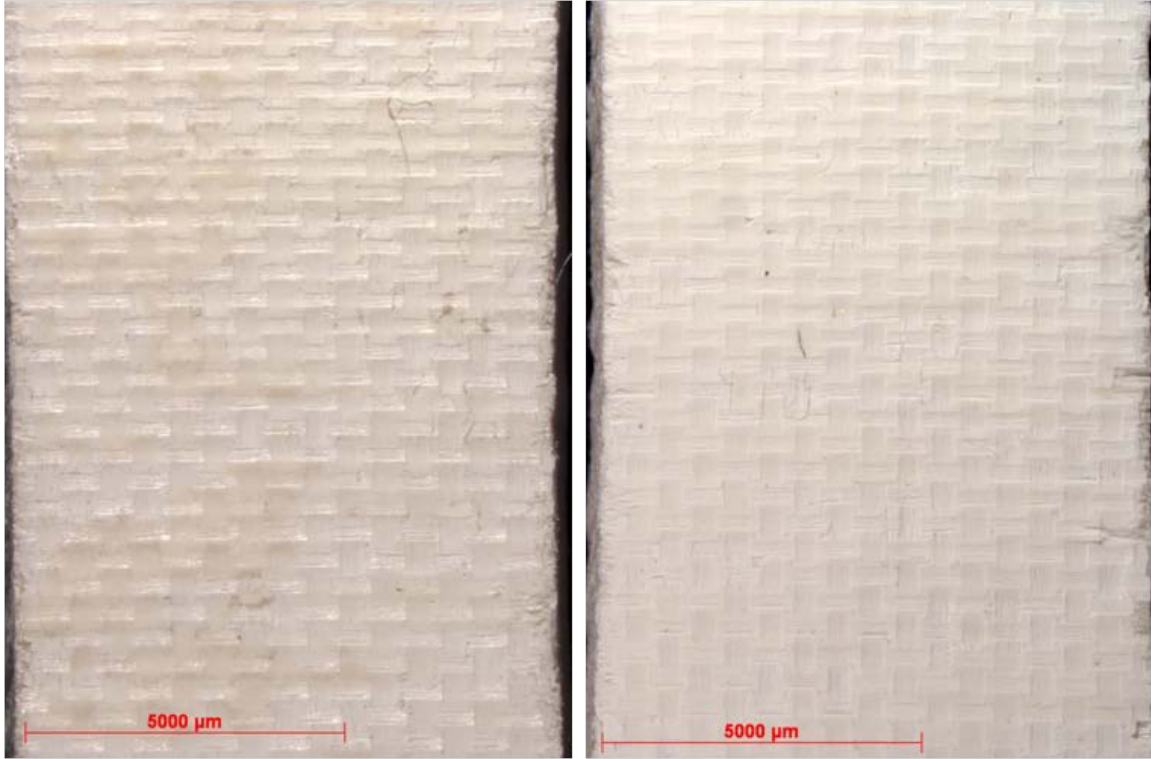
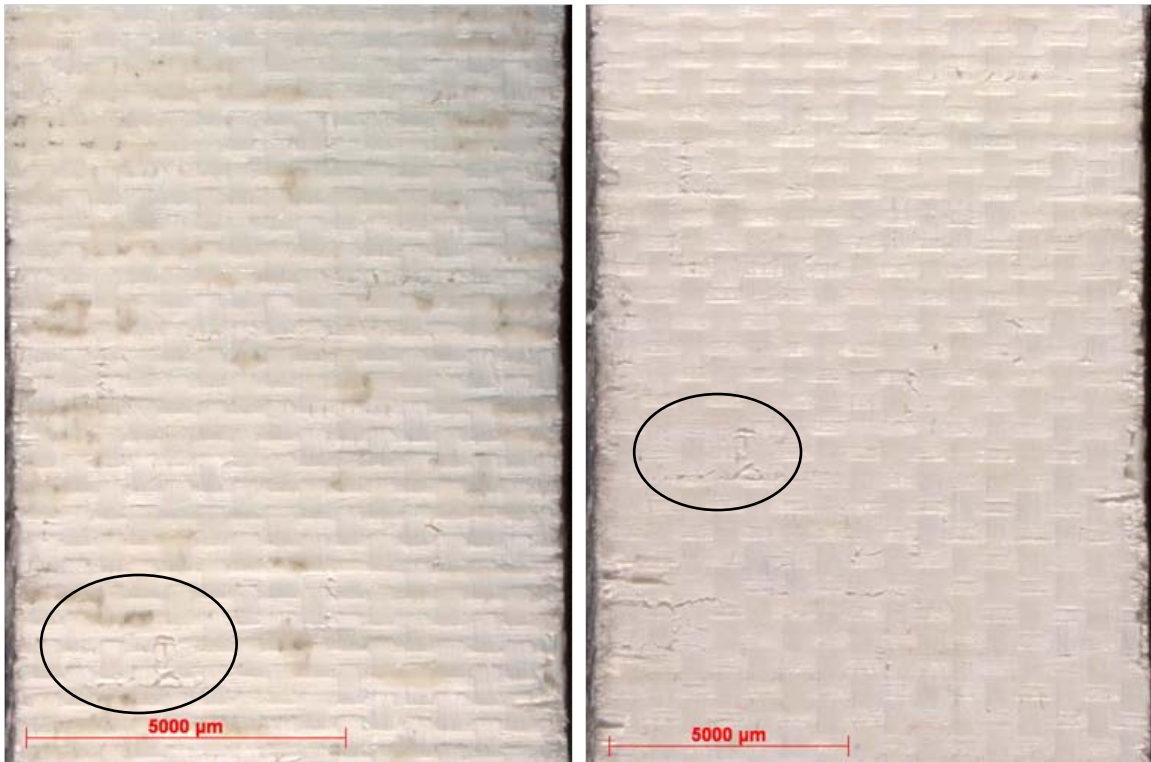
Figure 42 to Figure 44 show the dogbone surface before and after the fatigue testing for specimens 6 – 8; with the pretest photos on the left and, the posttest photos on the right. The blurred spots on the pretest specimens are from un-removed adhesive that held the protective Plexiglas plate on the panel. Matrix cracks on some of the specimens have been circled for reference and comparison.

Figure 42. 108 MPa Specimen Pre and Post Test (Flame Side)

Figure 43. 121.5 MPa Specimen Pre and Post Test (Flame Side)

Figure 44. 142 MPa Specimen Pre and Post Test (Flame Side)

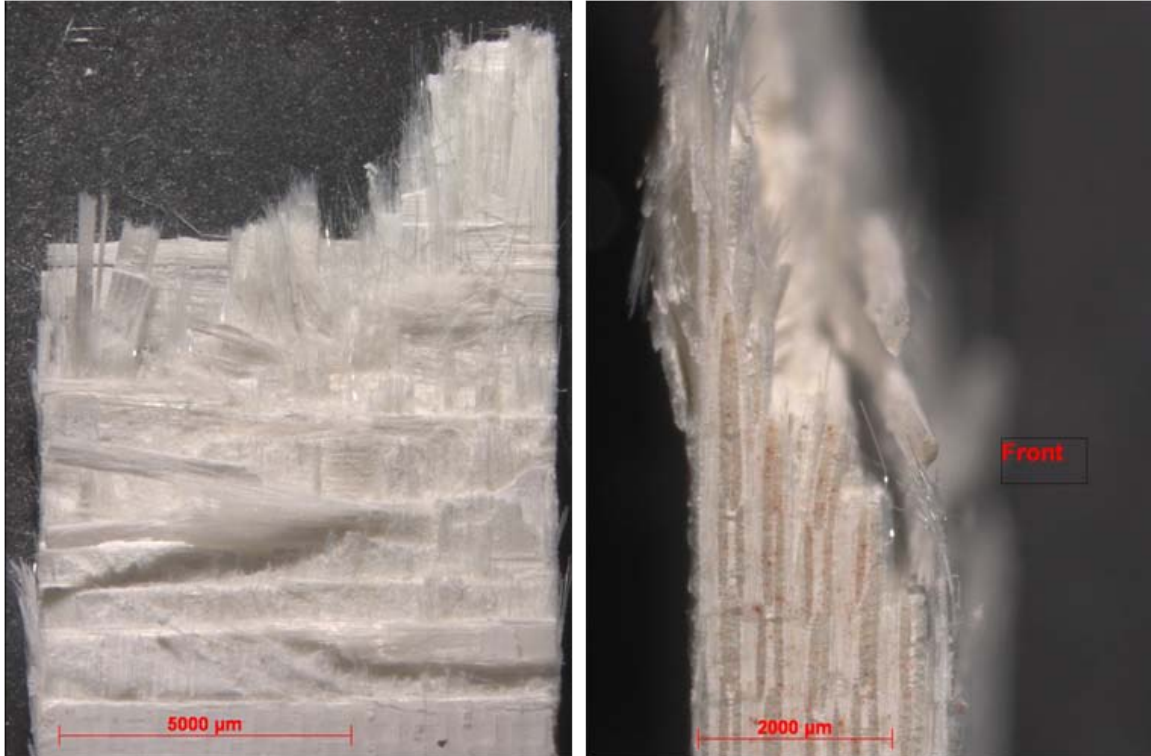
Figure 45. Tensile Strength Specimen Fracture Surface (Flame side labeled as “Front”)

Figure 45 shows the front view of the tensile strength test specimen fracture surface. The specimen was only inspected with the optical microscope. Before the specimen could be removed after the test, the power to the MTS computer was cut off. This caused the crosshead to come back down onto the other half of the specimen, damaging the fracture surface. Fortunately, the general profile of the fracture surface was maintained.

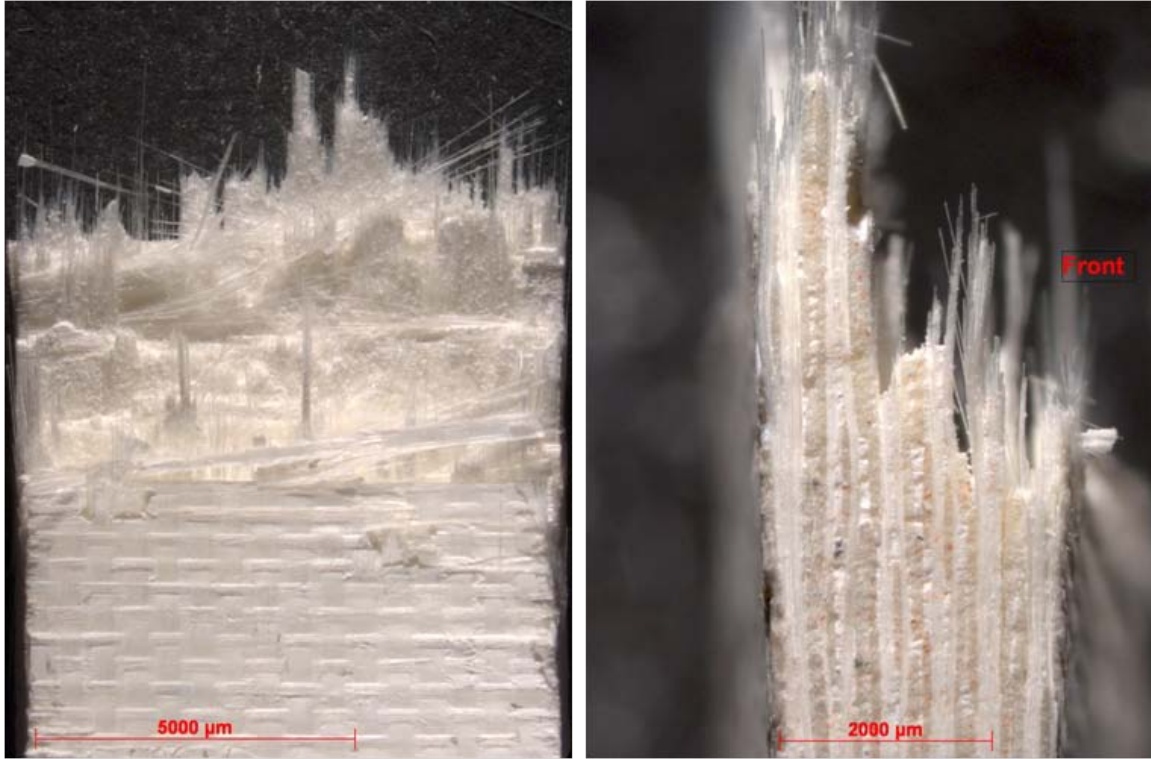
Figure 46. 142 MPa Specimen Residual Strength Fracture (Flame Side Labeled as “Front”)

Figure 46 shows the front and side view of the residual strength test fracture surface on the 142 MPa specimen. The fracture surface follows a similar pattern to the tensile specimen fracture.

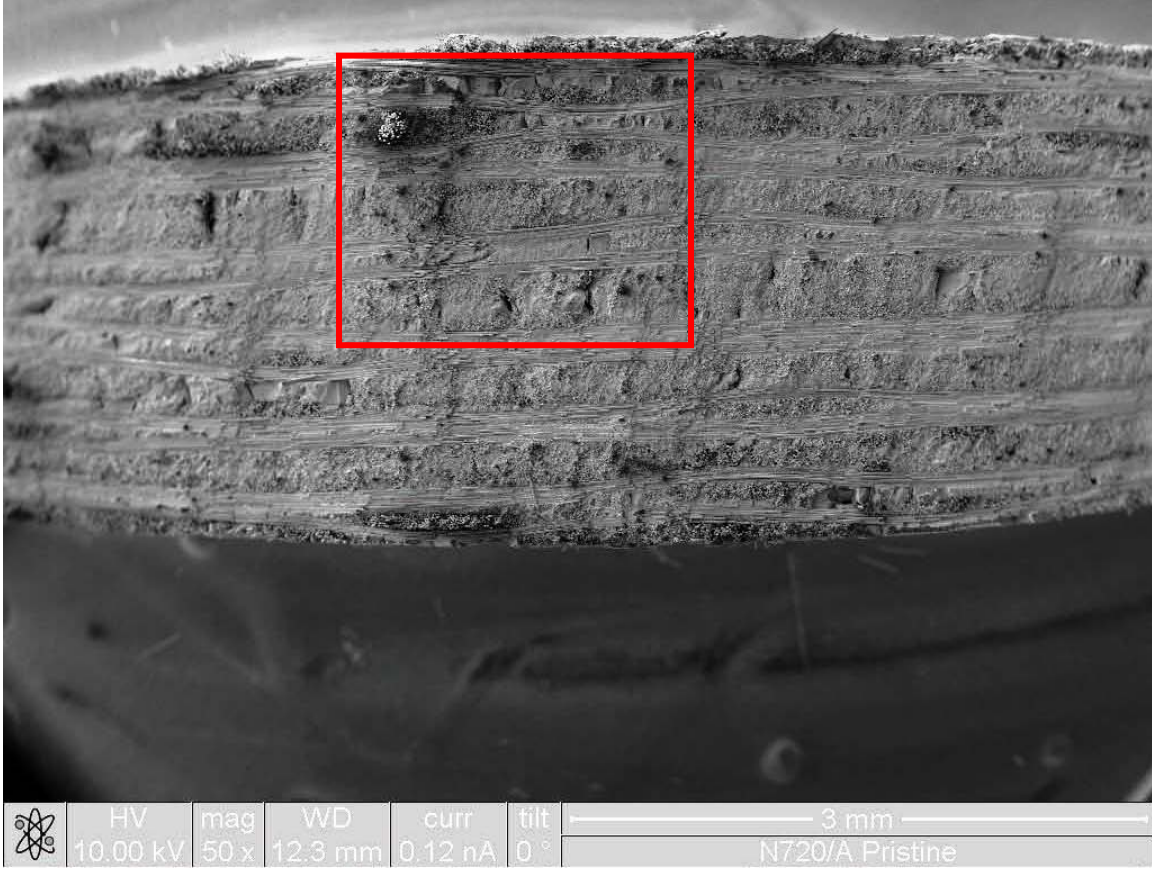
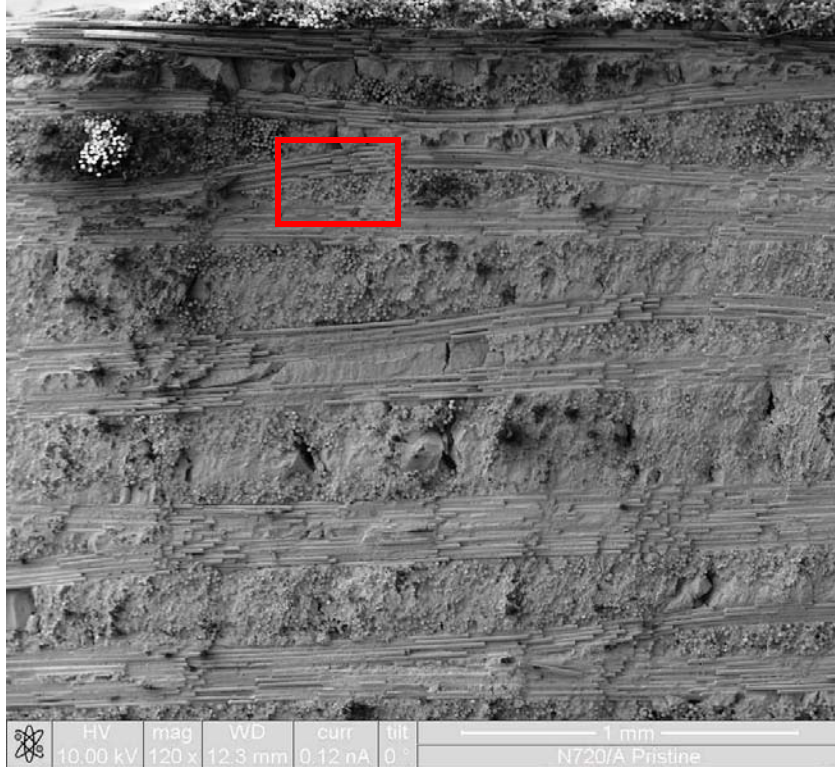
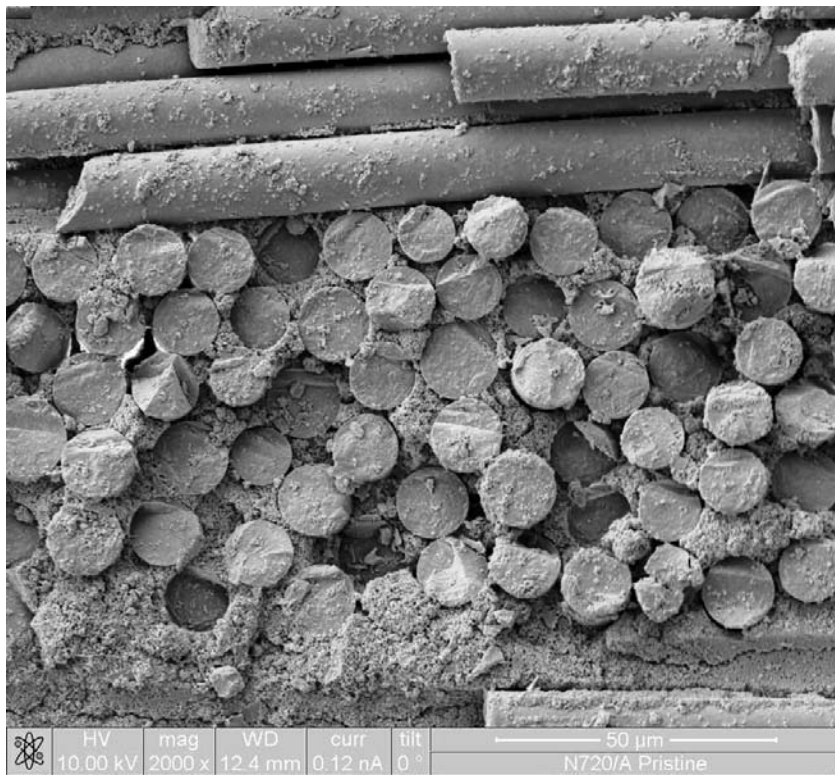
Figure 47 to Figure 49 show the internal structure of the pristine sample. The surface was slightly polished with fine-grit sandpaper after cutting. Boxes outline areas of interest that were subsequently focused on.

Figure 47. Pristine Specimen Overall Interior Structure

Figure 48. Pristine Specimen Matrix Crack

Figure 49. Pristine Specimen Fiber-Matrix Interface

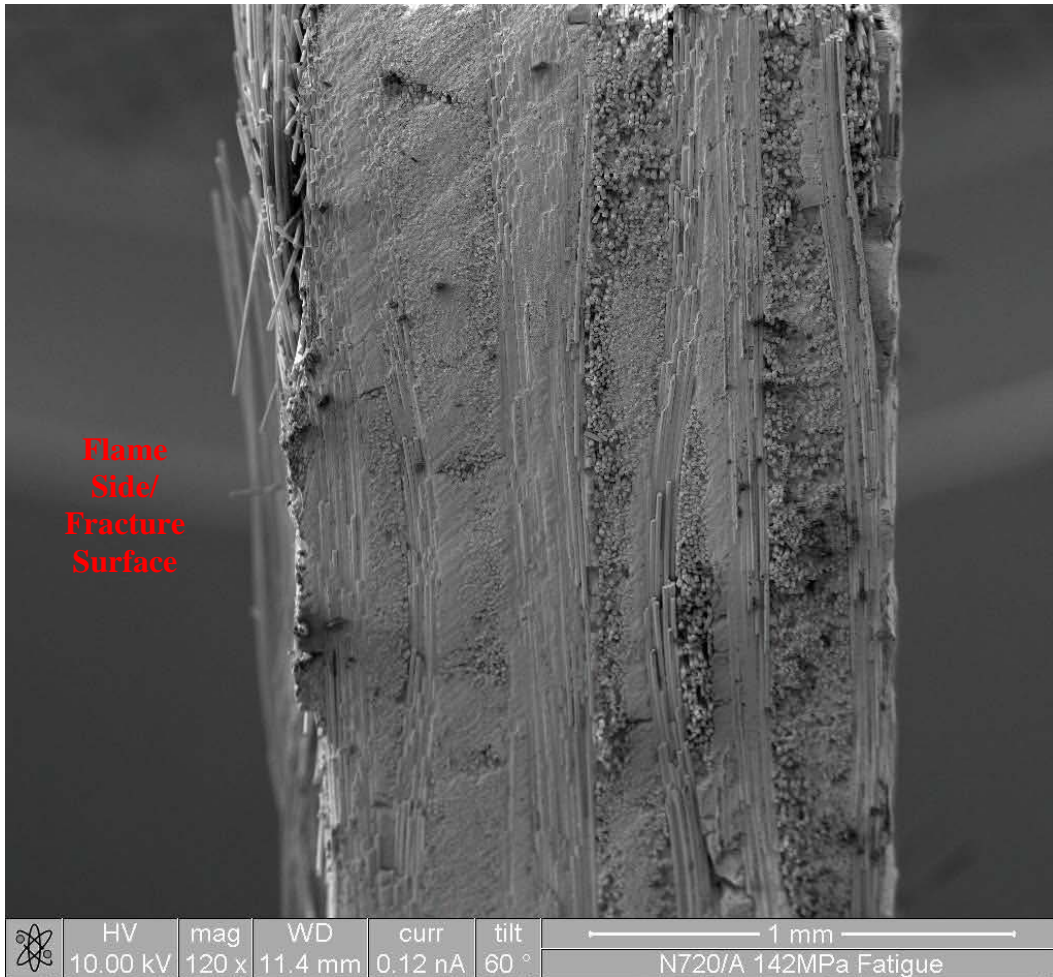
**Figure 50. Internal Structure of Fracture Specimen
(Flame Side at Left)**

The upper segment of the 142 MPa specimen was used to study the internal structure of the fiber-matrix interface after the combustion testing. The specimen was cut as close as possible to the end of the fracture surface, and the cut area was lightly sanded. Figure 50 shows the overall view of the internal area of the specimen.

At first glance, it appears that the fiber-matrix interface is smoother at the front of the specimen, and gets rougher as you go aft (left to right in figure). Higher magnification photos were taken approximately 1 mm down from the side edge of the specimen (top of Figure 50). The regions of interest were in the flame side, middle, and rear areas (going from left to right in Figure 50) of the specimen. Figure 51 to Figure 53 show the fiber-matrix interface in these regions. The flame side is towards the left side of the micrographs.
