Ceramic Matrix Composite Characterization under a Combustion and Loading Environment

**CERAMIC MATRIX COMPOSITE CHARACTERIZATION UNDER A
COMBUSTION AND LOADING ENVIRONMENT**

THESIS

AFIT/GMS/ENY/09-M01

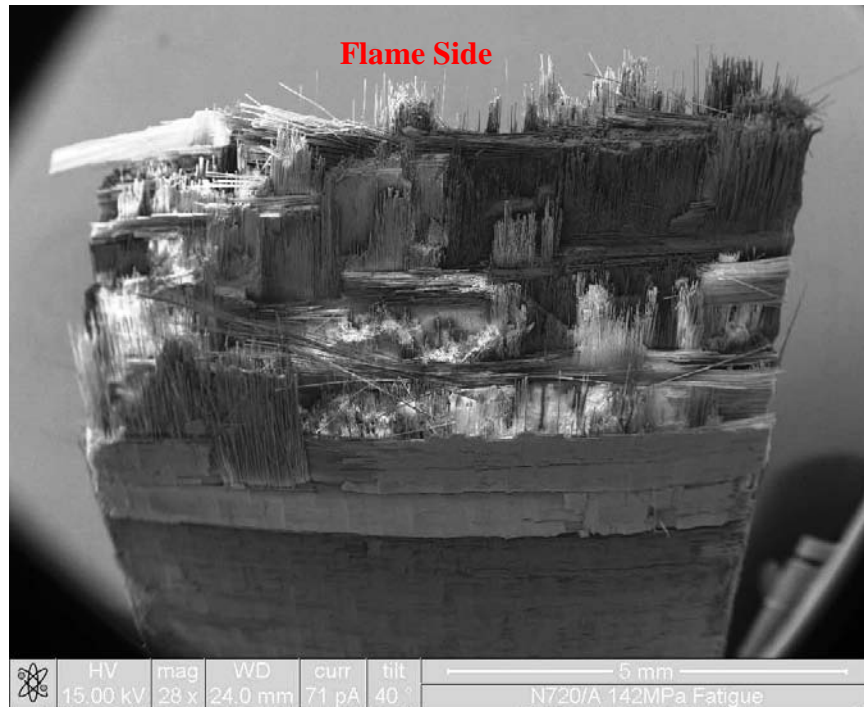
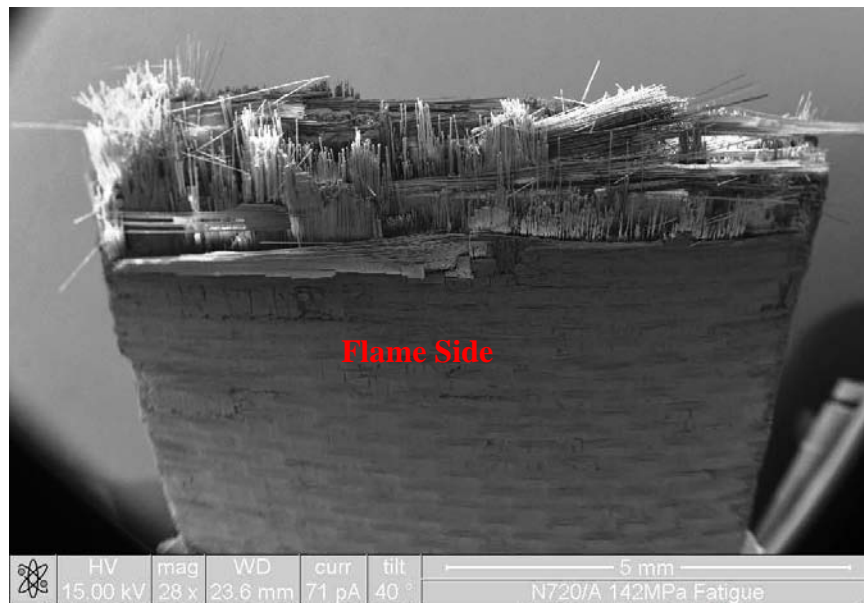
The bottom portion of the 142 MPa specimen was used to study the fracture surface. Figure 54 and Figure 55 show the SEM images of the total fracture surface.

Figure 54. 142 MPa Fracture Surface (Rear Looking Towards Flame Side)

Figure 55. 142 MPa Fracture Surface (Flame Side Looking Towards Rear)

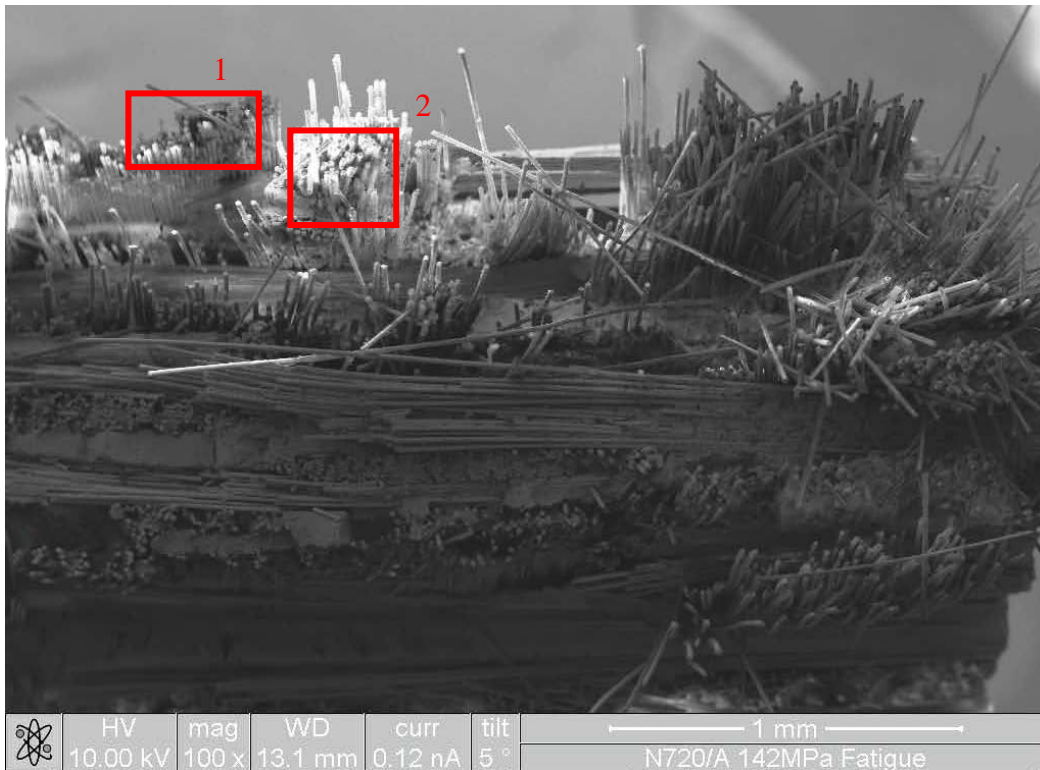
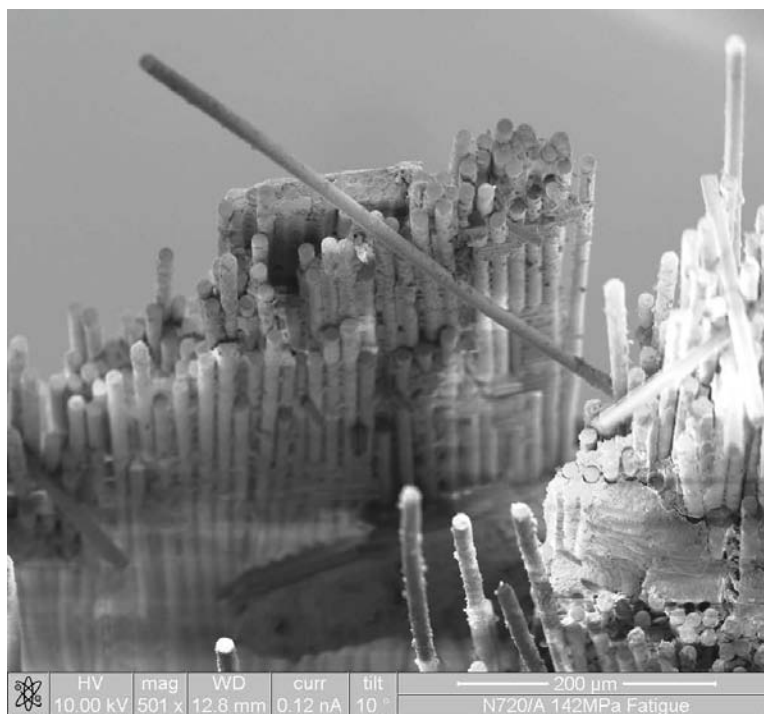
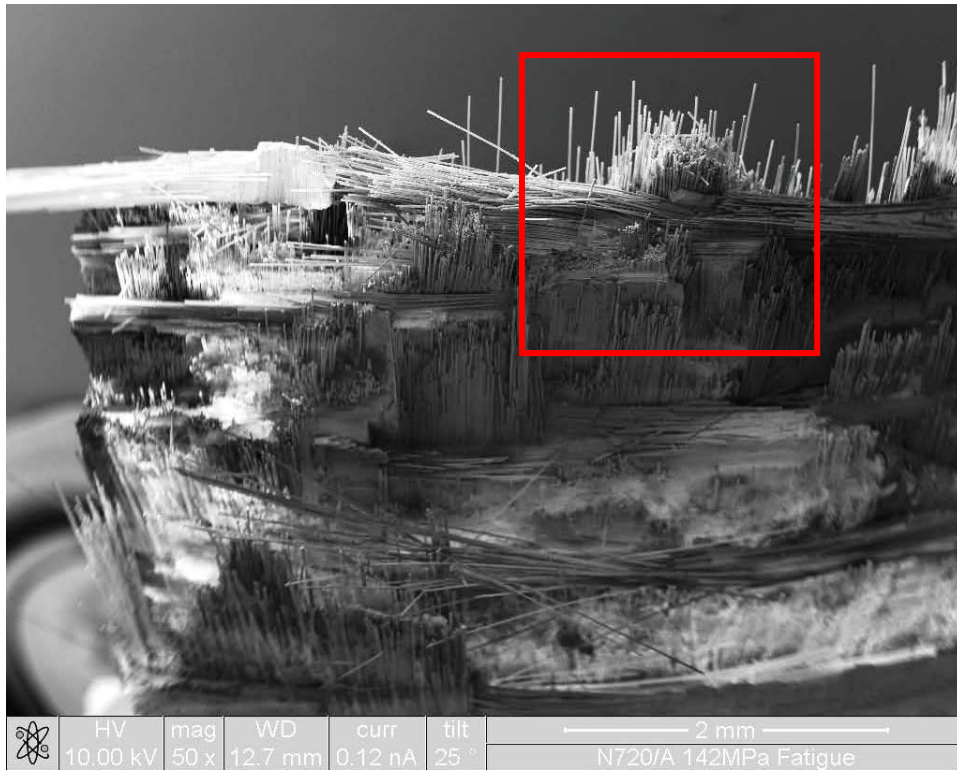
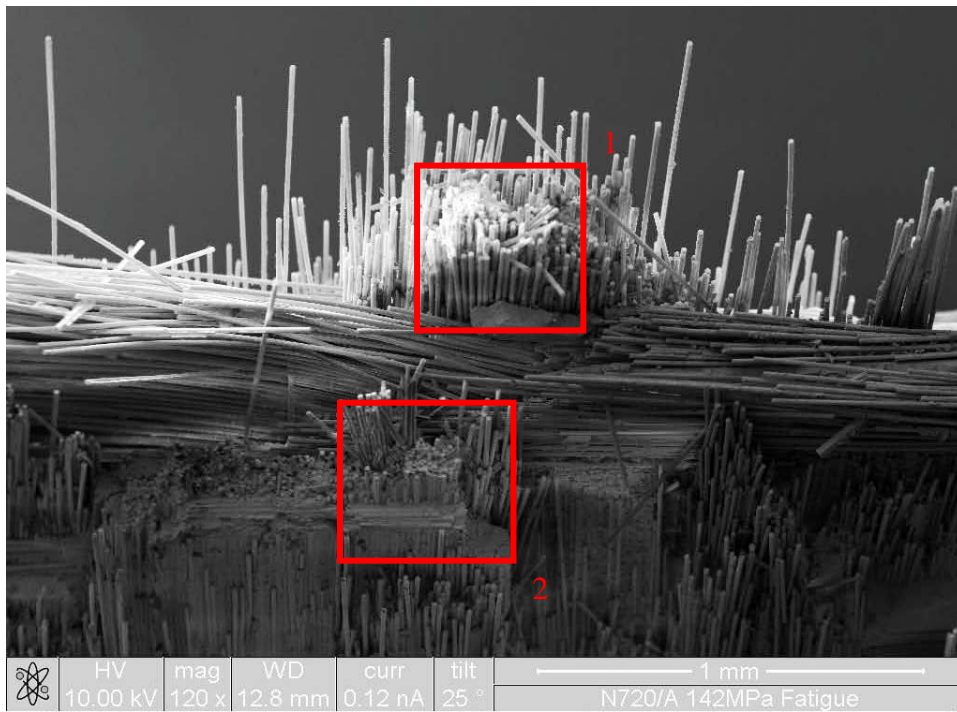
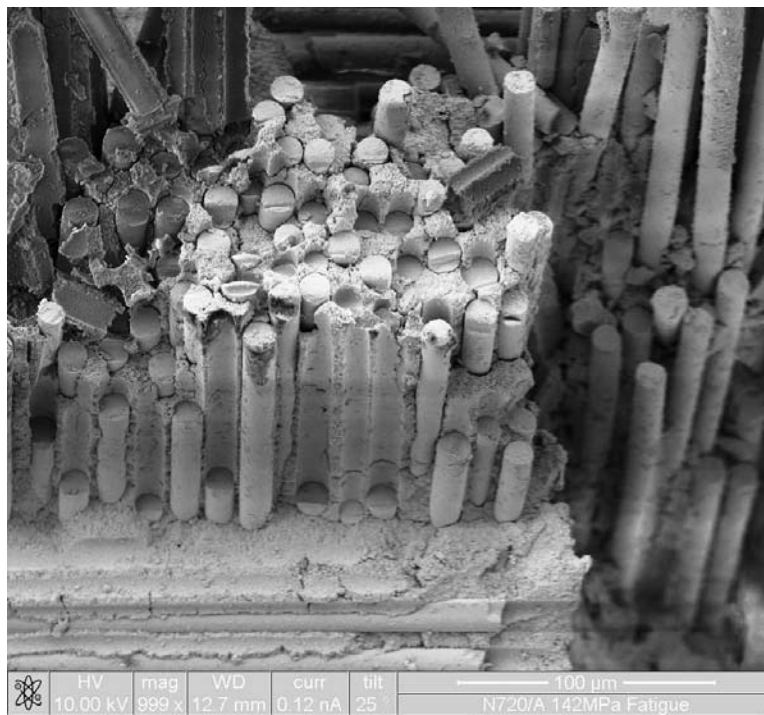
The matrix porosity and interface between the fibers looks similar on both the flame side and rear fracture surfaces of the specimen. This shows that the specimen fracture on the edges in the 0° fiber direction was similar, and the combustion environment did not affect the interface. Figure 58 to Figure 65 show the front fracture surface details.

With the exception of the fiber bundle shown in Figure 59, there is a great deal of fiber pullout along the front edge of the fracture surface. There is also little matrix present between these pullout fiber bundles. Towards the center of the fracture surface, the fiber pullout seems to lessen and the fracture of the fiber bundles is more abrupt. Figure 66 to Figure 69 show the rear fracture surface details.

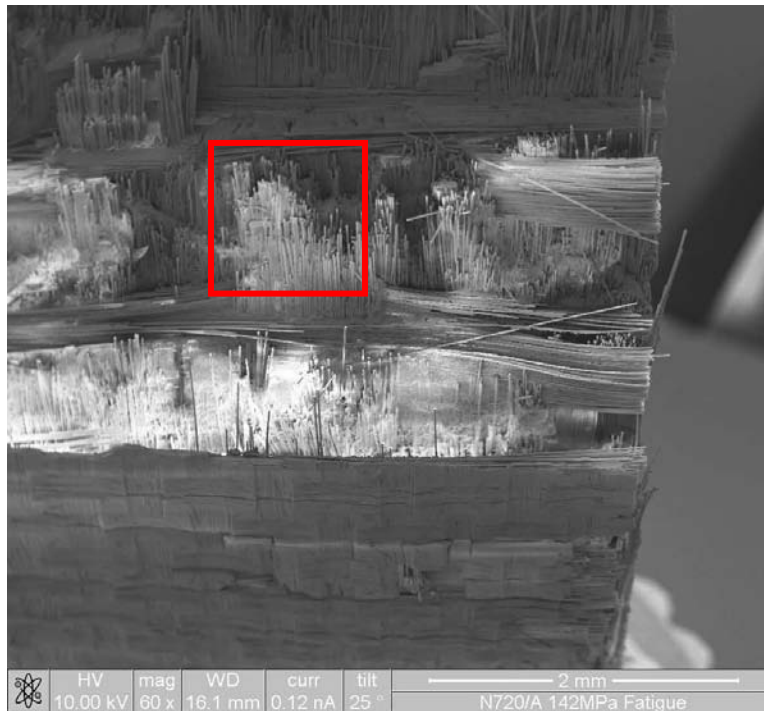
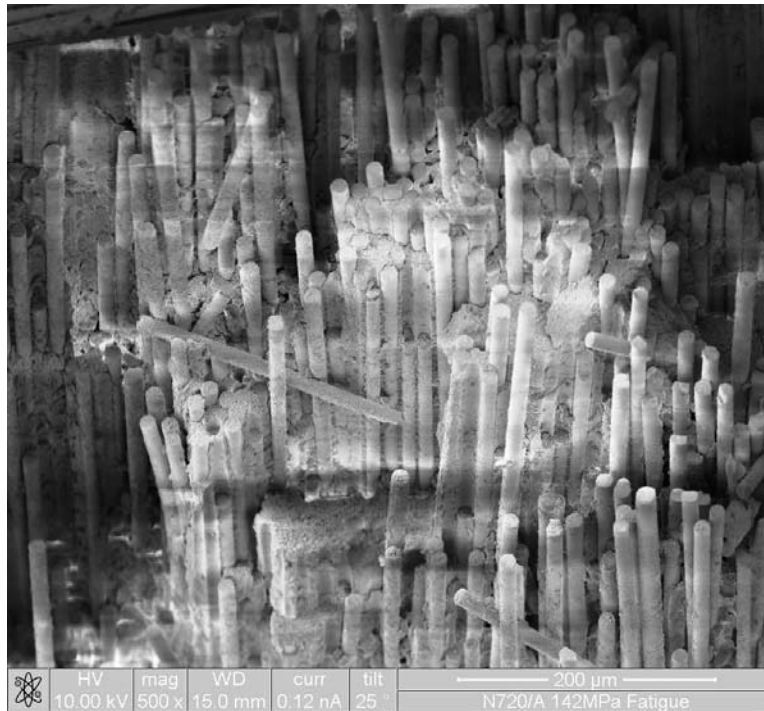
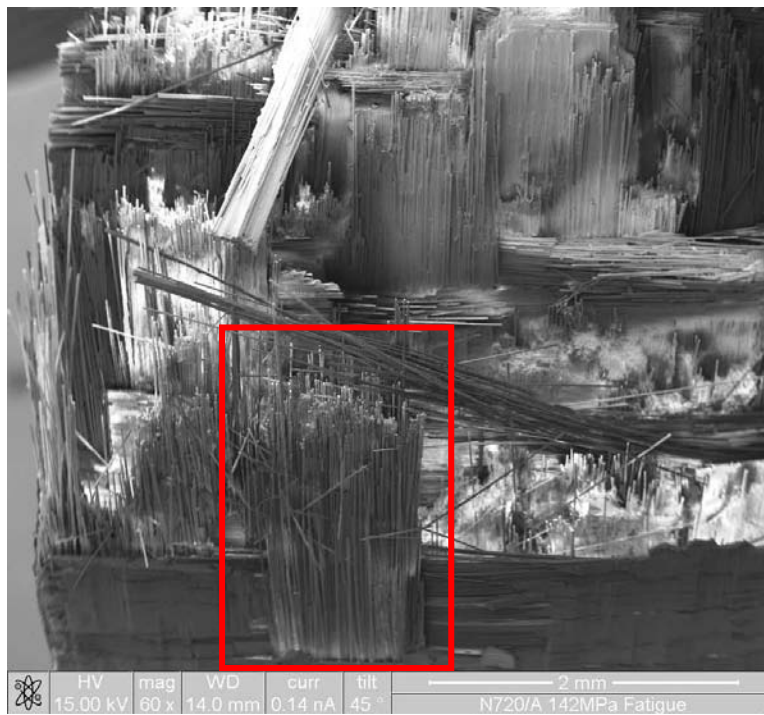
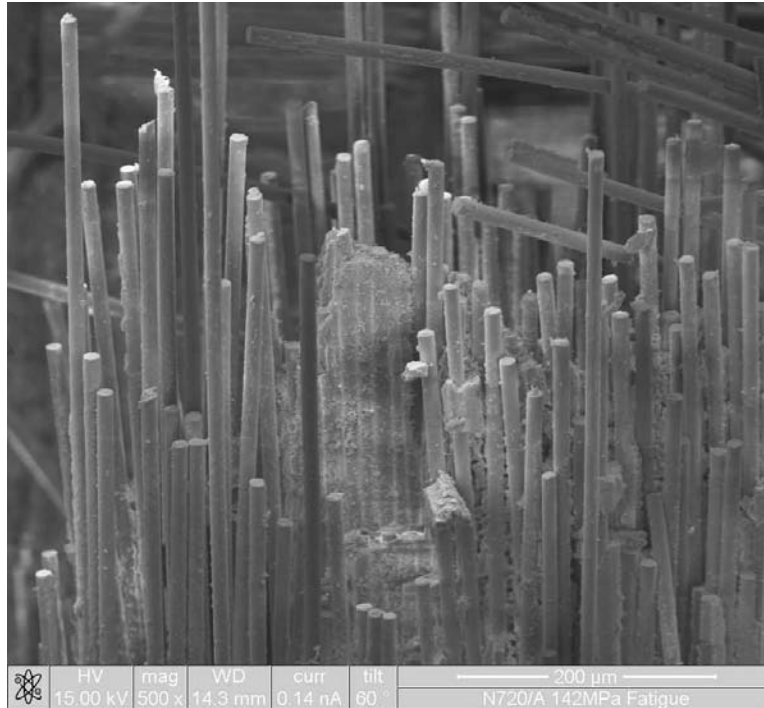
Figure 66. Rear Right Edge Fracture Surface (Flame Side Towards Top)

Figure 67. Rear Right Edge 90° Fiber Bundle

Figure 68. Rear Left Edge Fracture Surface (Flame Side Towards Top)

Figure 69. Rear Left Edge 90° Fiber Bundle

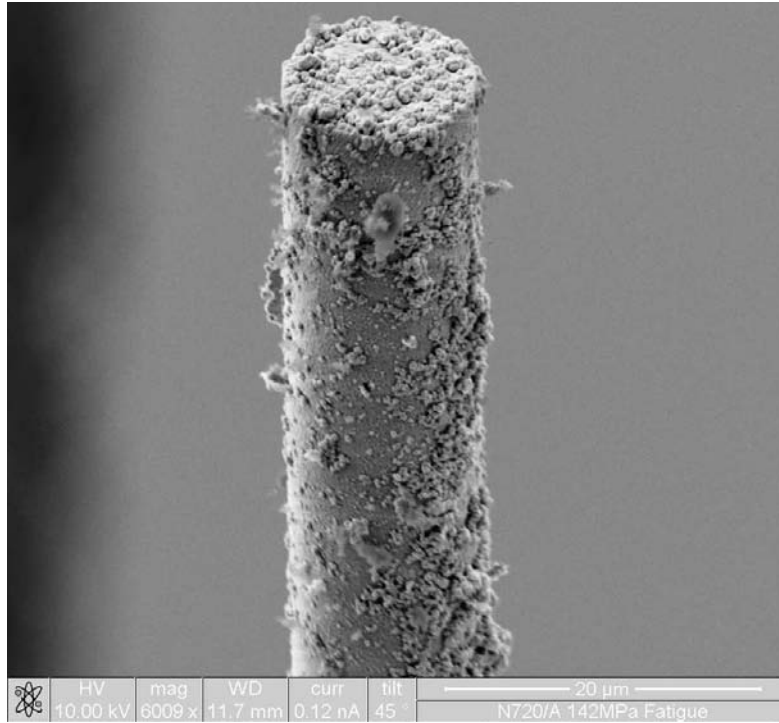
Figure 70. Flame Side Surface 90° Individual Fiber

Single 90° fibers from both the front and rear of the fracture surface were also looked at. This allowed for a comparison of matrix density on the individual fibers. Figure 70 and Figure 71 show the selected fibers.

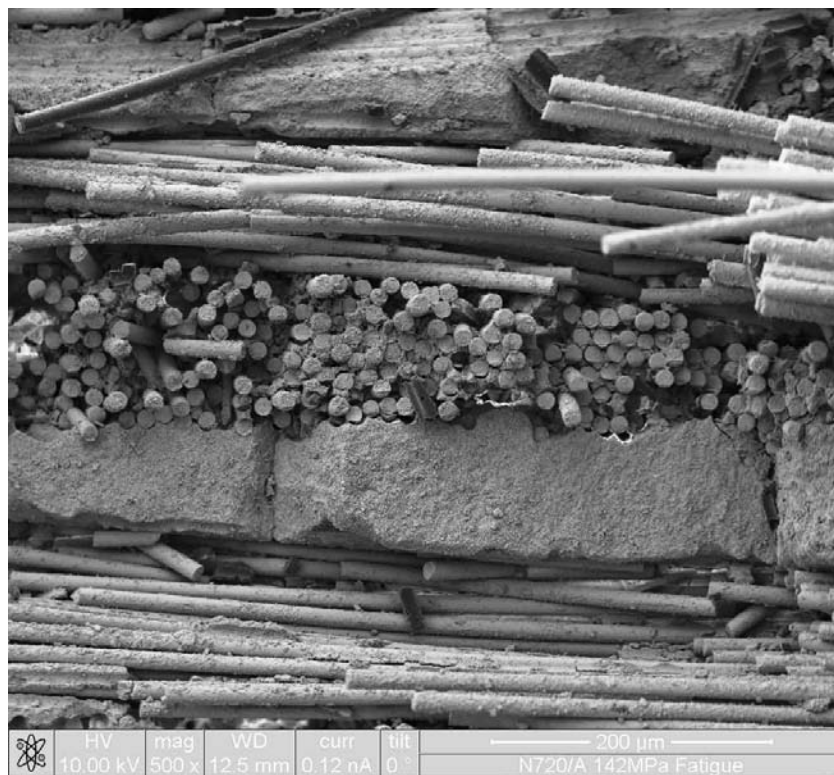
Figure 85. 142 MPa Fracture Surface, Front Right Fiber-Matrix, 500x

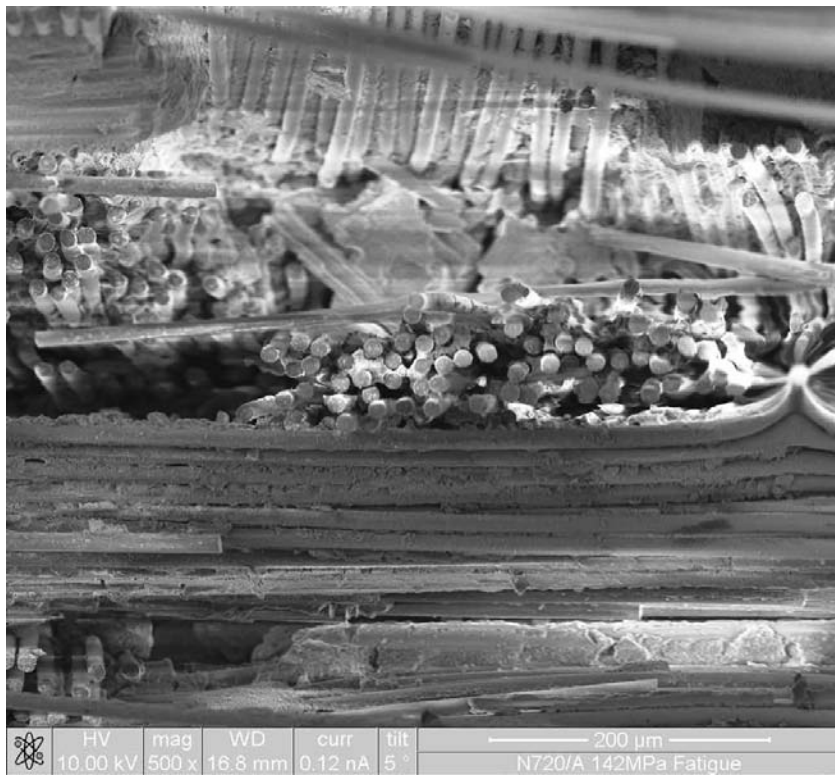
Figure 93. 142 MPa Fracture Surface, Rear Left Fiber Pullout, 500x

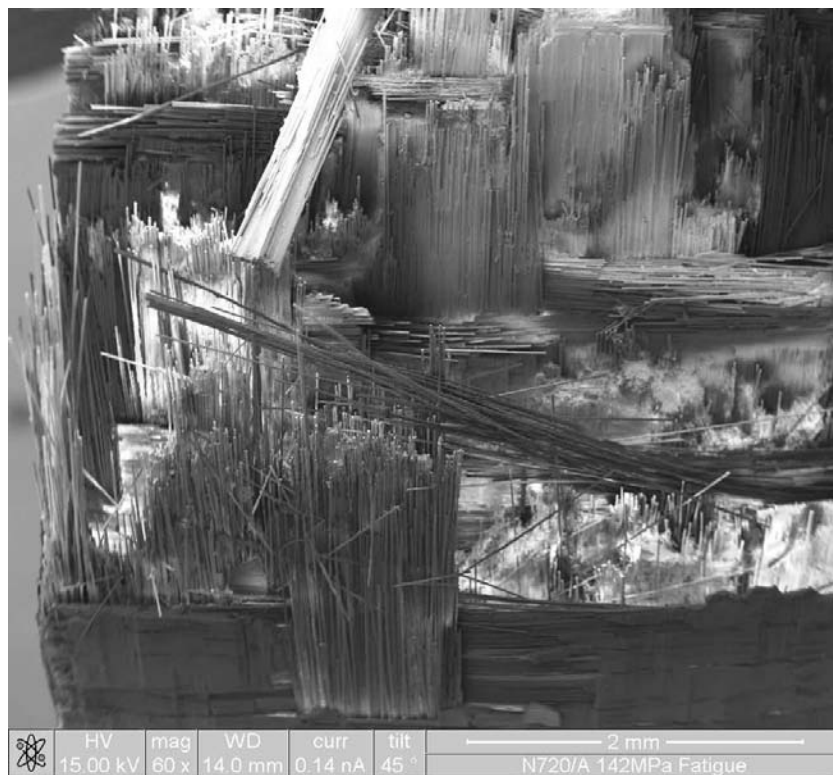
Figure 97. 142 MPa Fracture Surface, Rear Left Aft Looking Forward, 60x

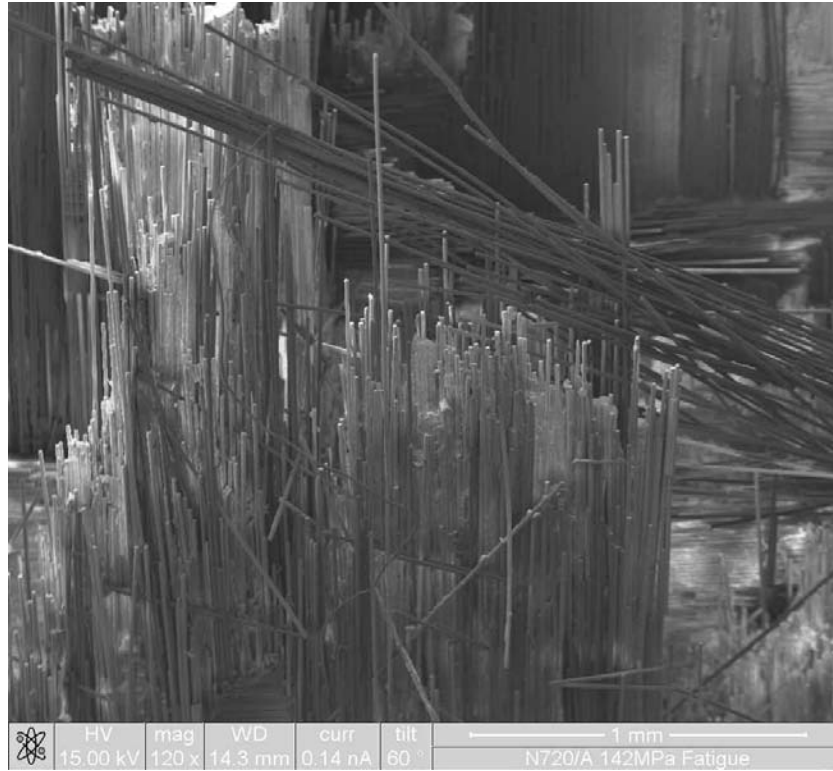
Figure 98. 142 MPa Fracture Surface, Rear Left Fiber Pullout, 120x
