## Non-Destructive Evaluation of Aerospace Composites

**NON-DESTRUCTIVE EVALUATION OF AEROSPACE COMPOSITES**

THESIS

Jeremy D. Johnson, Captain, USAF

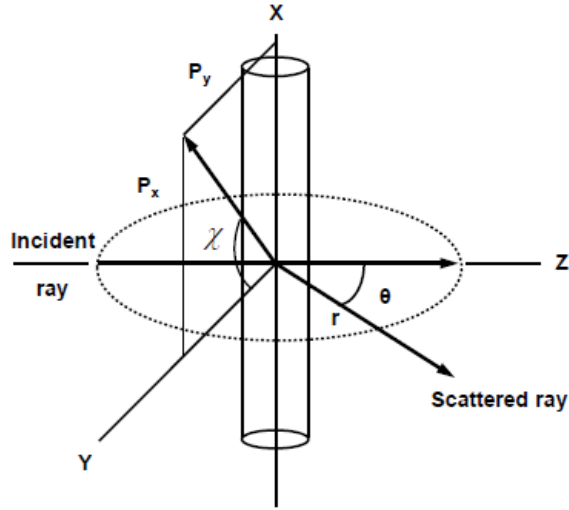
Figure 4. Scattering of radiation off an infinite cylinder [16].

Where  $\chi$  is the angle of the reflected beam's now cylindrical polarization with respect to the positive horizontal axis and  $\theta$  is the radial reflection angle away from initial propagation direction as depicted in Figure 4 [7].

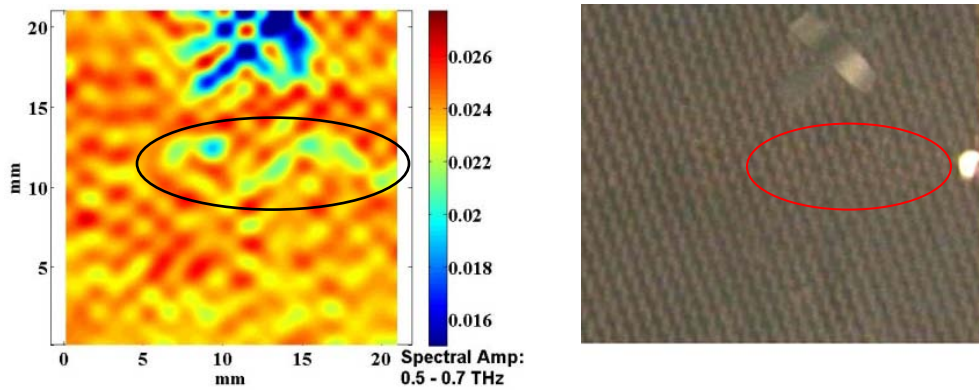
Figure 21. Pulsed THz imagery of a fiberglass composite sample showing a narrow frequency range of reflected pulse amplitudes of mechanical bending damage beneath electrical tape X.

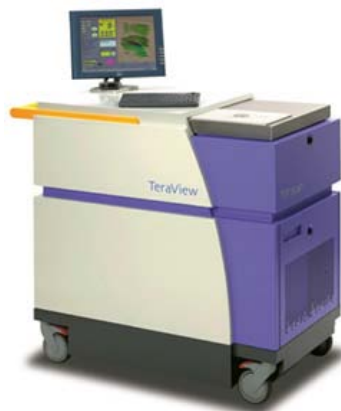
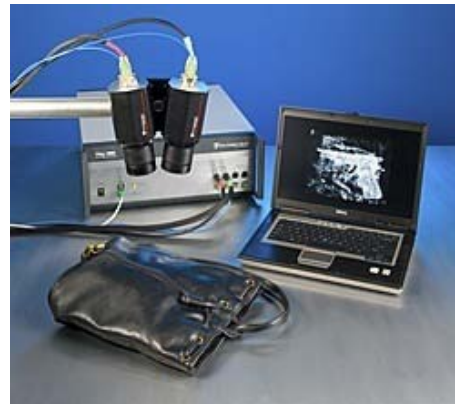
**Figure 25. Commercial systems for materials characterization: (a) TeraView TPI imaga 1000, (b) Picometrix T-Ray 4000 [34, 35].**
