Effects of Piers on Water Recession on the Southern Shores of Winam Gulf, Homa- Bay County, Kenya

Piers are important man-made water vessel landing facilities in lakes and seas. A study on the effects of piers on water recession was conducted on the Southern shores of Winam Gulf of lake Victoria, Homa Bay County in Kenya. It was conducted in three pier points namely Kendu Bay, Kowour/Homa Lime and Homa Bay. The study aimed at explaining a phenomenon whereby the Western side of the piers on the Southern shores of the gulf, having more water recession than on their Eastern side. This unique phenomenon has not been sufficiently researched on hence, instigated the research. It collected data on the length of recession at the sides of the piers, directions of water currents flow based on devised simple current simulator and empirical studies. Google map and Landsat map techniques were used for aerial data collection. Ground truthing was carried out to corroborate the findings of the aerial data based on physical ground measurement and observation. The result had it that the sides of the piers facing currents directly were more recessed than the opposite sides. Homa Bay pier had its Wes

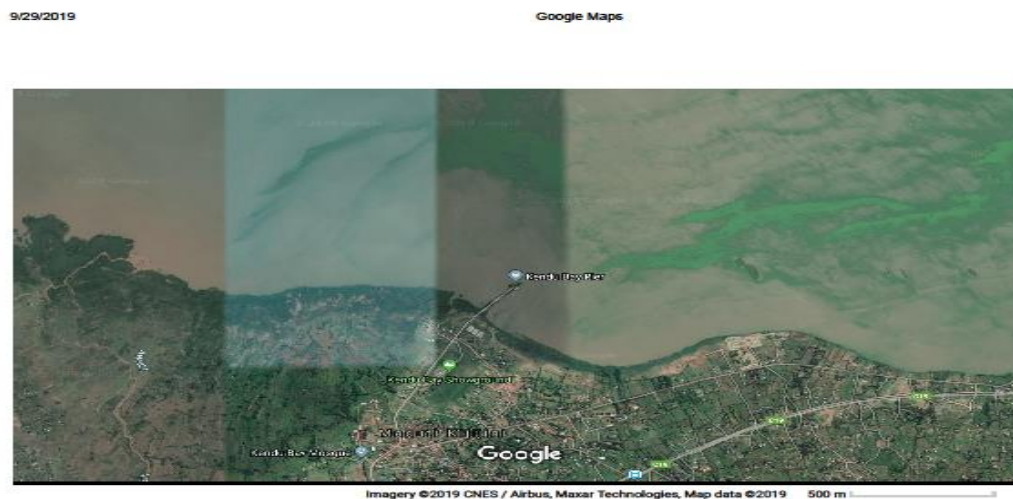
Figure 1. Landsat map data showing Kendu Bay pier and its environs as at 29th September, 2019

From the Landsat and Google maps (Figure 1, 2, 3 and 4), it is clear that the Western side of the piers are more protruded into the water than the Eastern side.

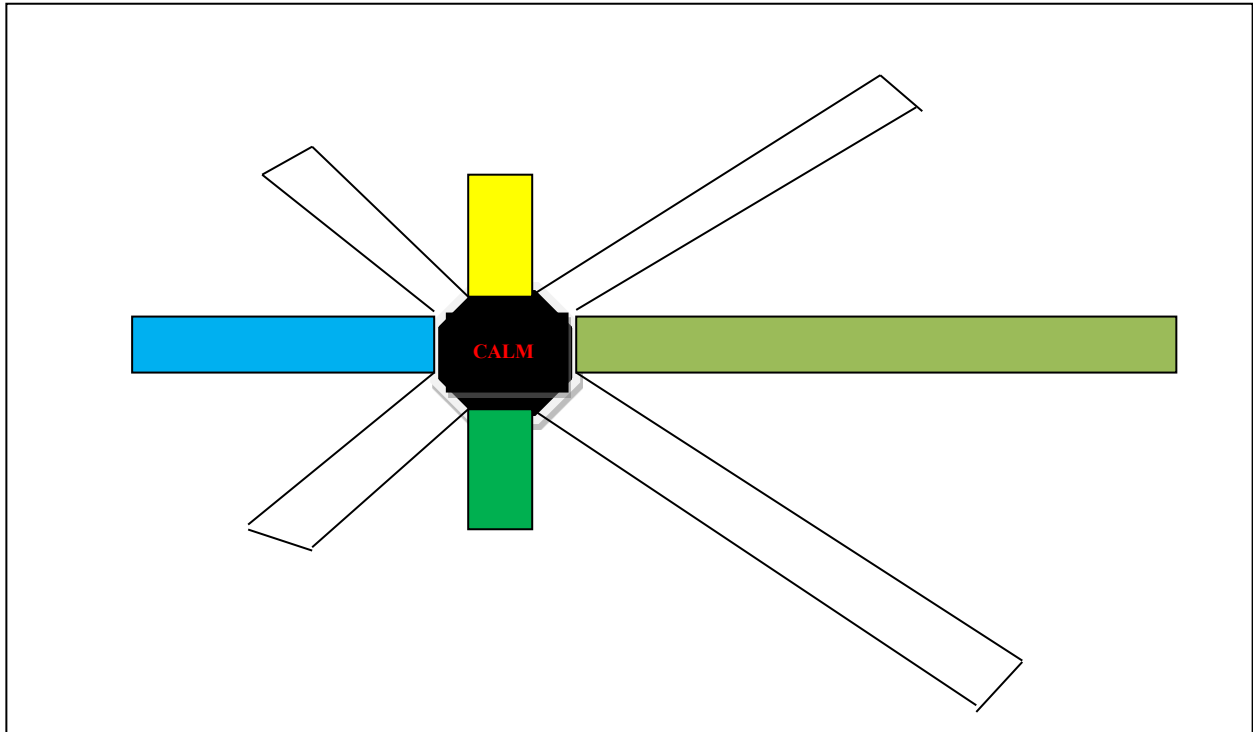
The result from the devised simple current flow simulator (Figure 5) is recorded in a ‘current rose’ in figure 6. From the figure, currents were mainly skewed Eastwards and Westwards attributed to the Easterlies and Westerly currents (Jason et al., 2005). These currents were responsible for deposition of sediments and retention of aquatic weeds on the sides of the pier. Since the flow was more skewed towards East (Figure 6), due to strong Westerly currents, the Western side of the shore was more recessed than the Eastern side (Figure 2 and 3). The East-West recession on the sides of the piers were only particular to Kendu Bay and Homa Bay (main) piers which lie North-South direction with the shore line.

Figure 6. Current rose showing the direction and average duration of current flow in hours for Kendu Bay and Homa bay piers

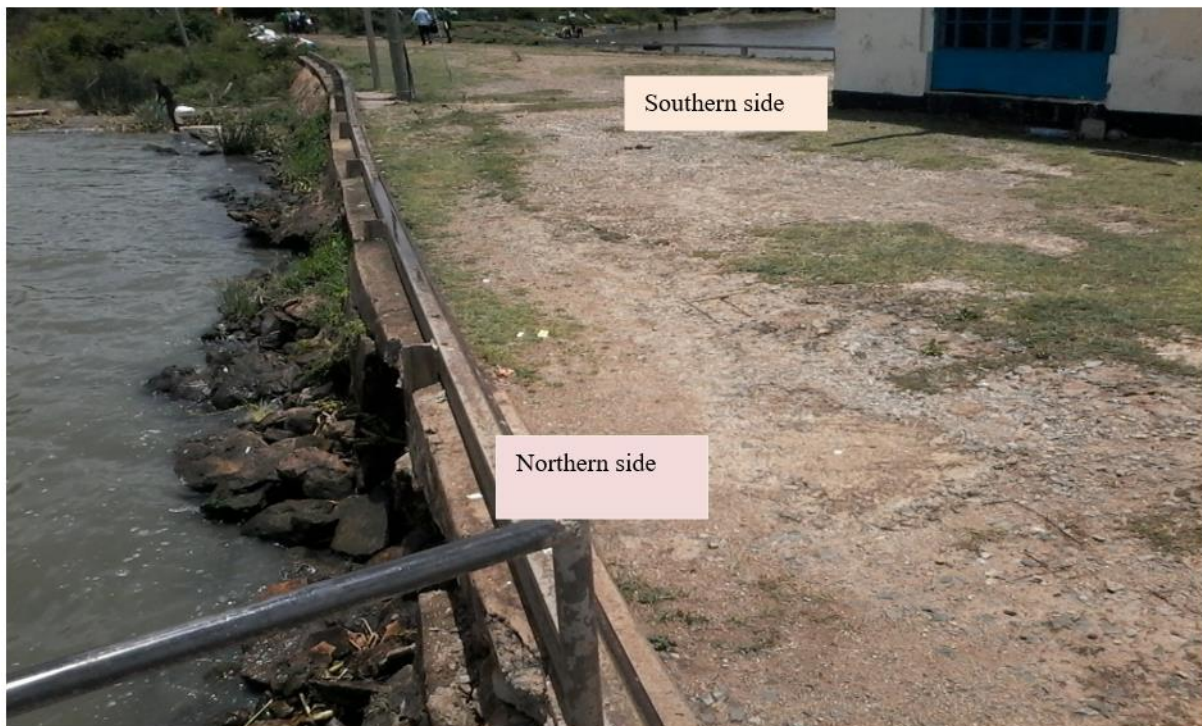
Plate 2. Water recession at Kowuor/Homa Lime pier

The Northern side of the pier was 32m more recessed than the southern side (Plate 2). This was attributed to the position of the pier in relation to other piers under the study and change of currents direction from West-East (W-E) to North-South (N-S) orientation. The N-S current orientation was attributed to more recession on the Northern side of the pier as compared to the Southern side. At Homa Bay pier (second longest), the difference in variation of water level at both sides of the pier was 40m. At Kendu Bay which was the longest pier, the study could not empirically establish the difference of the variations of water levels at the sides of the pier. This was because of the drenching activities carried out by the Kenya Ports Authority (KPA) at the time of the study, nevertheless, the Landsat data and Google map (Figure 1,2,3 and 4) explicitly showed that the Western side of the pier was more recessed than the Eastern side as per 29th September, 2019 when the data was taken.
