CHANGES IN SURFACE CONDITIONS WITH FIRST PLASMA  
IN THE PRINCETON LARGE TORUS (PLT)

H. F. DYLLA and S. A. COHEN  
Plasma Physics Laboratory, Princeton University,  
Princeton, New Jersey 08540

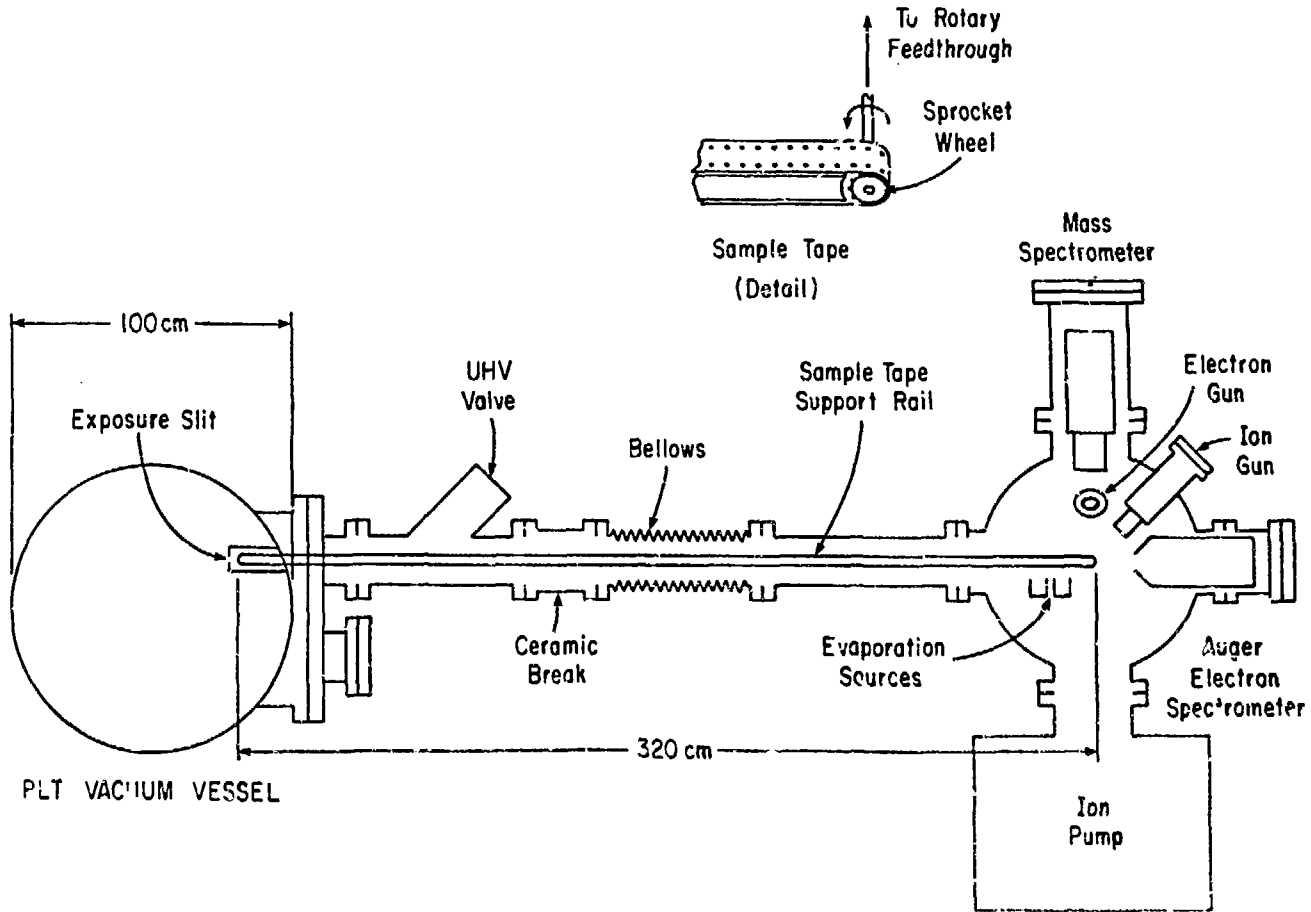
# SURFACE ANALYSIS STATION

A diagram of the SAS is shown in Figure 1, and the details of its construction and operation are described elsewhere [1]. Instrumentation for Auger electron spectroscopy (AES), secondary ion mass spectroscopy (SIMS), and electron stimulated desorption (ESD) are contained in an ion-pumped, ultrahigh vacuum chamber. Sample surfaces are provided by a movable, 1.2 cm wide, 0.008 cm thick 305 stainless steel tape loop. The tape loop rides on an insulated support rail, one end of which is centered in the analysis chamber. The other end protrudes into the PLT vacuum chamber through a long bellows section. After the initial surface conditions of a segment of tape have been determined, the sample surface is translated to a position inside the PLT vacuum chamber for exposure to plasma. After exposure the sample surface is translated back to the ultrahigh vacuum chamber for analysis.

- Figure 1. Schematic drawing of the surface analysis station (SAS) on the Princeton Large Torus (PLT).
- Figure 2. Characteristics of a typical high power  $H_2$  discharge: (2a) plasma current, 175 kA/div vertical, 10 msec/div horizontal; (2b) loop voltage, 20 V/div vertical, 10 msec/div horizontal; (2c) intensity of CIII (977 Å) VUV line, 5 msec/div horizontal; (2d) intensity of OIII (600 Å) VUV line, 5 msec/div horizontal; (2e) quadrupole mass spectrometer scan of residual gas with a total pressure =  $1.0 \times 10^{-7}$  torr.  $H_2$  fill pressure was typically  $5.0 \cdot 10^{-5}$  torr.

For the initial PLT experiments the sample surface was located 2.5 cm inside the PLT vacuum vessel wall and 4 cm behind the limiter radial position. The exposed region of the tape was further defined by a 0.25 cm Ta slit located 0.1 cm from the tape surface. There is no line-of-sight between the SAS and the limiter, the latter being positioned on the torus 180° relative to the former.

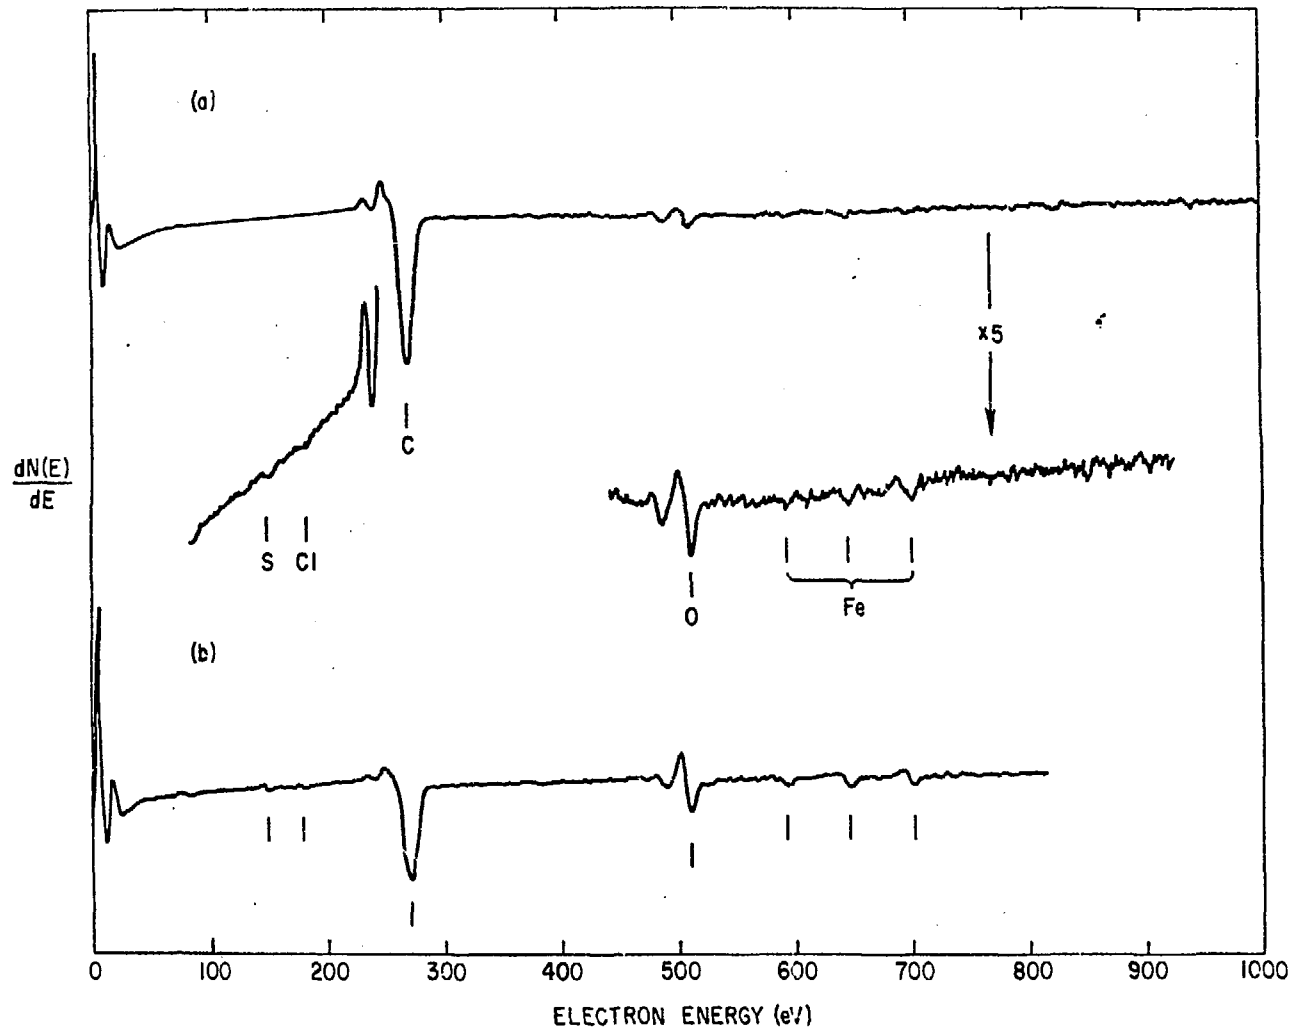
- Figure 3a. Typical Auger electron spectrum  $N'(E)$  of the sample tape before exposure to plasma showing C(272 eV) and O(510 eV) peaks. A scan at increased sensitivity (x 5) shows small substrate Fe peaks (598, 651, 703 eV) and S(152 eV) and Cl(181 eV) surface impurities.

- 3b. Auger spectrum of the sample tape after exposure to 670 low power  $H_2$  discharges (discharge cleaning). Note decrease in C peak and increase in O, Fe, Cl, and S peaks.

Figure 3a shows Auger spectra of a position of the sample tape before exposure to plasma. A strong multilayer carbon signal (272 eV) and a smaller oxygen signal (510 eV) are the only strong Auger transitions visible. With the sensitivity increased a factor of five small iron signals (598, 651, 703 eV) from the underlying stainless steel substrate are visible. In addition, there are trace amounts of chlorine (181 eV) and sulfur (152 eV). Figure 3b shows the same region of tape after exposure to the first discharge cleaning in PLT. The tape was exposed to 670 H<sub>2</sub> discharges in the low power mode (toroidal field = 10 kG, repetition rate = 14 sec/pulse, plasma current = 90-105 kA, and length of discharge = 10-15 msec). Here a decrease in the C Auger signal and increases in the O, Fe, S, and Cl signals are seen.

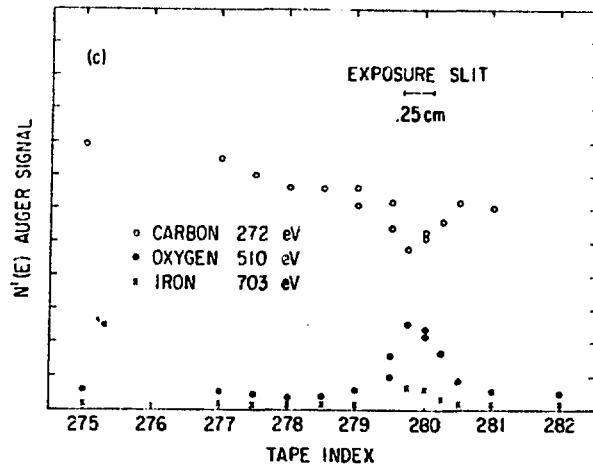
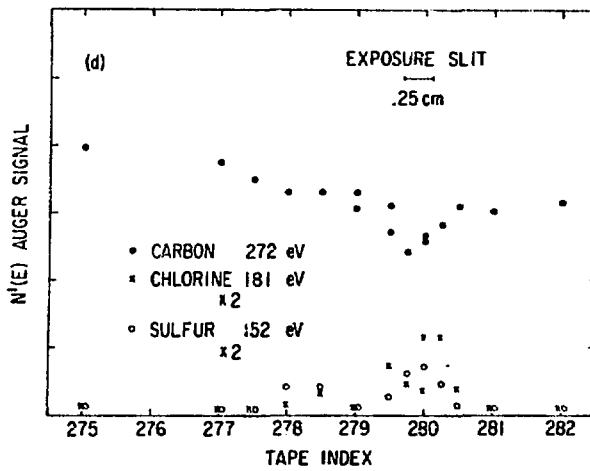
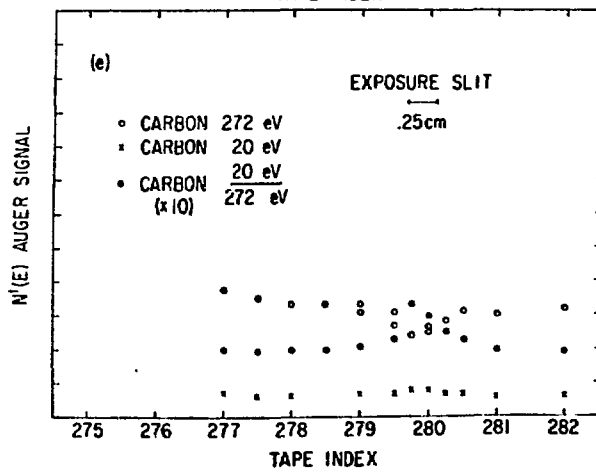
- 3c. Plot of peak-to-peak,  $N'(E)$  Auger signals versus tape position for C(272 eV), O(510 eV), and Fe(703 eV). Position of exposure slit is noted. One unit of tape index = 0.57 cm.

- 3d. Plot of peak-to-peak,  $N'(E)$  Auger signals versus tape position for C(272 eV), Cl(181 eV), and S(152 eV).
- 3e. Plot of peak-to-peak,  $N'(E)$  Auger signals versus tape position for C(272 eV), C(20 eV), and the ratio C(20 eV)/C(272 eV).

The surface changes due to plasma bombardment are more apparent when the peak-to-peak Auger signals are plotted as functions of tape position as shown in Figure 3c. This shows the decrease in C and corresponding increase in O and Fe signals on the exposed portion of the tape. It is

Figure 3d shows the change in C signal replotted along with the changes in Cl and S signals versus tape position. The Cl signal shows a curious asymmetry in position with respect to the exposure slit unlike the other Auger signals. This effect was reproduced in subsequent runs, always showing a higher Cl concentration on the higher index of the exposure slit. The effect was shown to be unrelated to the plasma exposure but due to enhanced surface diffusion of Cl by the Auger spectrometer electron beam. Subsequent to these surface measurements, Cl was identified in the discharge using the vacuum ultraviolet spectrometer. The original source of Cl in the wall could be a result of the pickling process of the steel (HCl or  $H_2SO_4$ -NaCl mixtures are often used), or a residue of an applied Cl-containing degreasing solvent. Possible damage to the wall could occur if Cl segregated at grain boundaries or weld fractures in the bellows section. The effectiveness of Cl in penetrating passivation films in stainless steel leading to intergranular or stress corrosion is well known [5].

Figure 3c shows the C(272 eV) signal plotted with the low energy C(20 eV) signal. The mean escape depth [6] of 272 eV electrons is approximately  $8 \text{ \AA}$  or the equivalent of several (3-4) atomic layers of C, whereas the escape depth of 20 eV electrons in carbon is essentially one atomic layer. Therefore, the constancy of the C(20 eV) signal relative to the

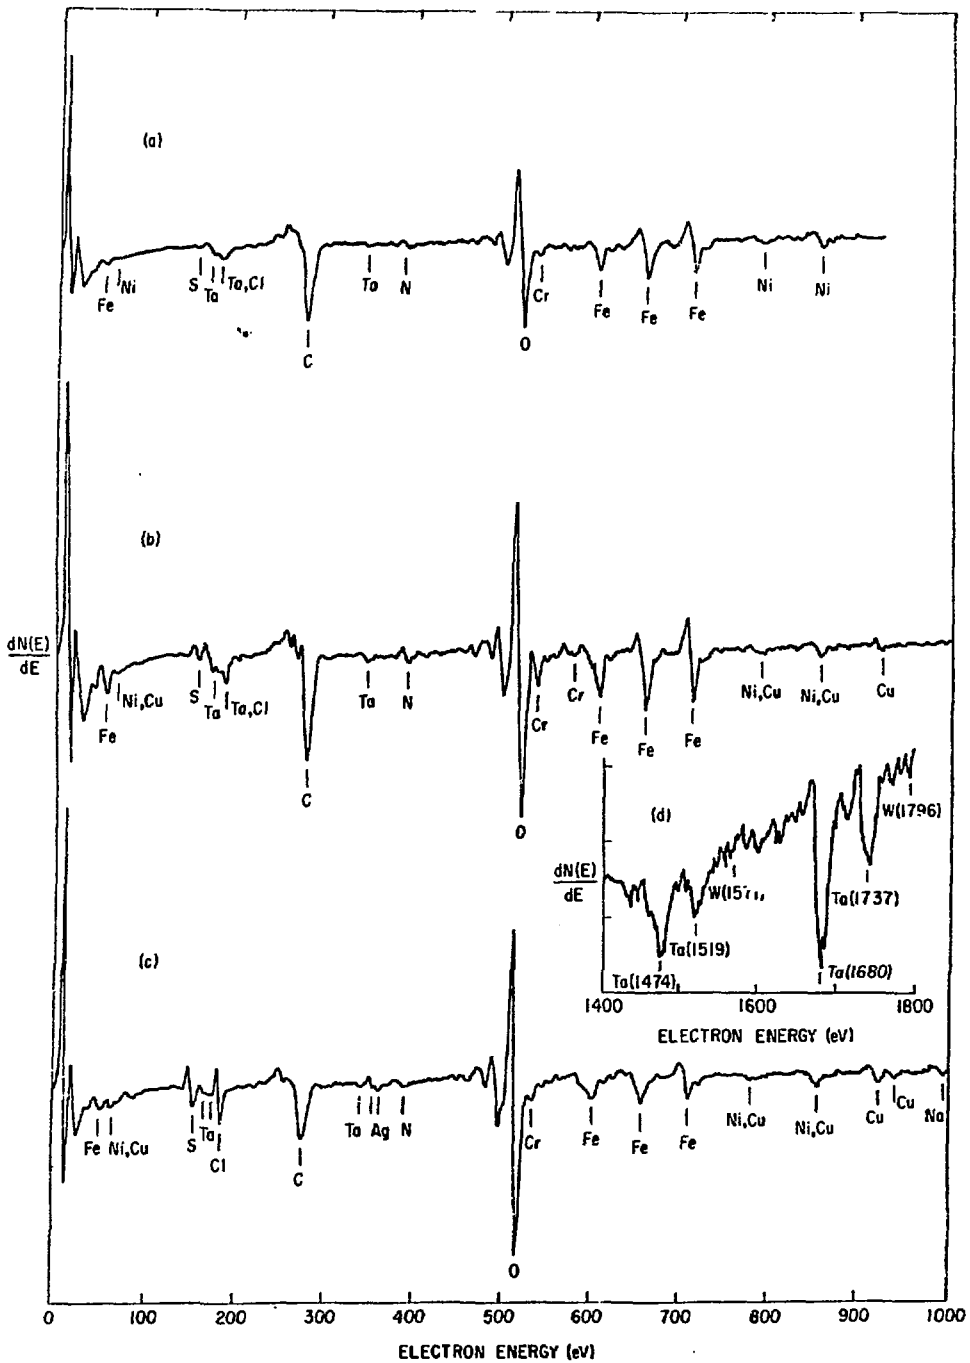
Figure 4a. Auger spectrum of a new sample tape position after exposure to 1000 low power  $H_2$  discharges. Note appearance of Cr(529 eV), Ni(848, 783 eV), and Ta(179, 171 eV) peaks.

4b. Auger spectrum of a third tape position exposed to 1000 low power discharges and 180 high power discharges ( $i_{max} \approx 350$  kA). Note trend of C(272 eV), O(510 eV), and Fe(703 eV) peaks in series of spectra shown in 3b, 4a, 4b.

4c. Auger spectrum of tape position shown in 4a after an additional exposure to five high power discharges. Note appearance of Cu(920, 940 eV) and Ag(351, 356 eV) peaks.

4d. High energy (1400-1800 eV) Auger spectrum showing Ta but no W(1571, 1796 eV) peaks above the noise level.

Figure 4 shows Auger spectra of exposed tape positions that have received increased plasma exposure relative to the data of Figure 3. Figure 4a shows a new area of the tape exposed to 1000 low power discharges. In this trace substantial removal of the carbon overlayer is noted. The stainless steel substrate is sufficiently cleaned that Cr (529 eV) and Ni (848, 783 eV) transitions are visible in addition to the enhanced Fe peaks. Consistent with the data of Figure 3, an enhancement of the O, Cl, and S signals is seen at the exposure region. Also visible for the first time is a significant amount of Ta (179, 171 eV) which obscures the Cl in the trace shown (4a). The high energy Auger spectrum, shown in Figure 4d, is necessary to distinguish Ta from W which has a similar low energy Auger spectrum. The Ta is no doubt ablated by the plasma from the Ta exposure slit onto the tape surface. W would be an expected impurity by plasma transport from the W limiters, but the absence of W (1571 eV) and W (1796 eV) signals above the noise level in Figure 4d, shows that no W has yet been detected above the sensitivity limit (= 1% W coverage).

Figure 4b shows a third tape position exposed to 1000 low power discharges followed by 180 high power discharges (with I, V parameters as shown in Fig. 2a,b). In this trace the base metal (F, Cr, Ni) and O peaks are further enhanced, and the appearance of Cu (920 eV) is noted. A stronger Cu signal along with appearance of Ag peaks (351, 356 eV) are evident in Figure 4c, which is a retrace of the tape position of 4a after an additional exposure to five high power discharges. A possible source
