## Bioforsk Rapport

Vol. 2 Nr. 94 2007

# The effect of piling on the preservation of cultural layers

## Physical-chemical assessment in a soil profile adjacent to a pile

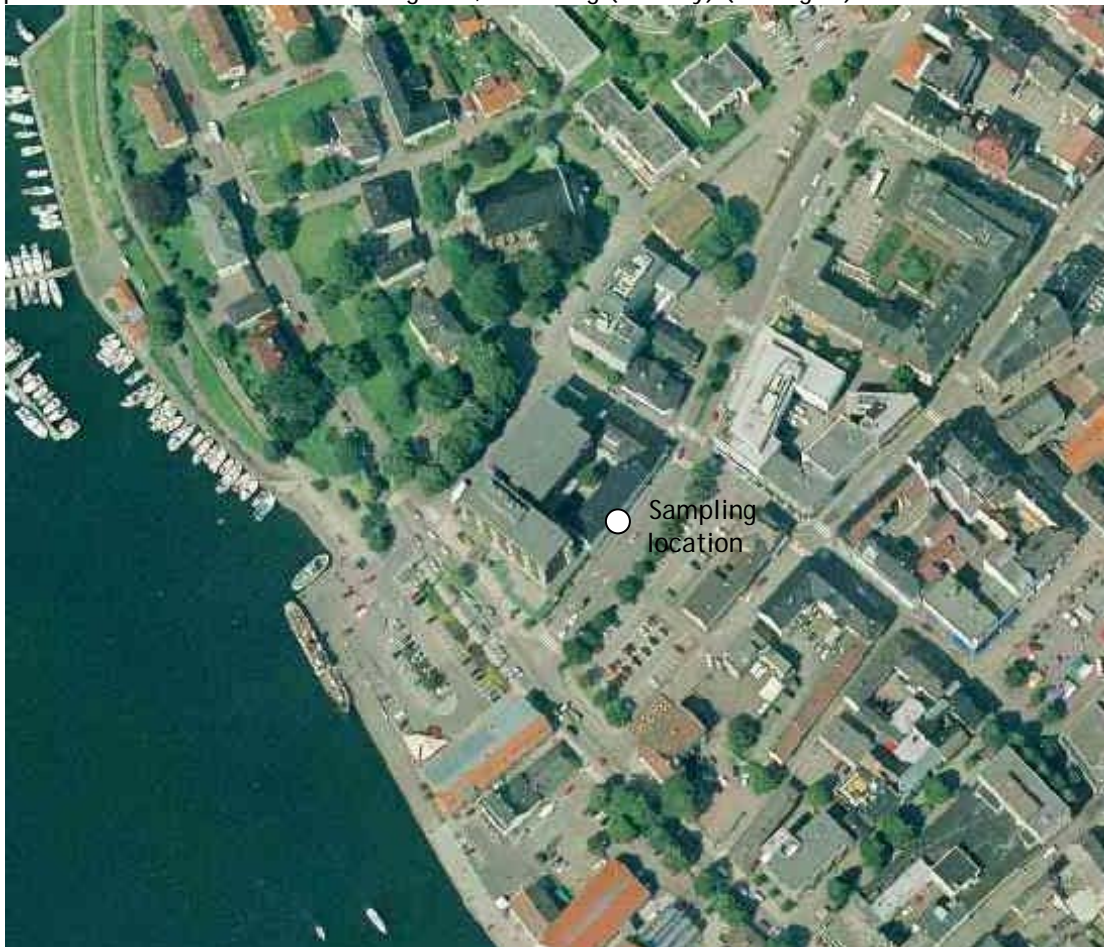
Figure 2: Field location at Hotel "Klubben" in Tønsberg

The characterisation of the environmental conditions was performed at an excavated soil profile near a pile at Hotel "Klubben" in Tolbodgaten, Tønsberg (Norway) (see fig. 2).

The pile was installed in 1991, and consisted of a steel tube of ?? cm in diameter that was filled with concrete and a steel rod. The pile was placed about 50 cm inside the outer wall of the building and was not dissected because of structural concerns. A girder of concrete was placed at a depth of 1.6 m below surface along the wall. The trench that was excavated when the girder was installed, was refilled with coarse gravel and stones. The cultural layers start at 110 cm below surface and continue below the excavated pit.

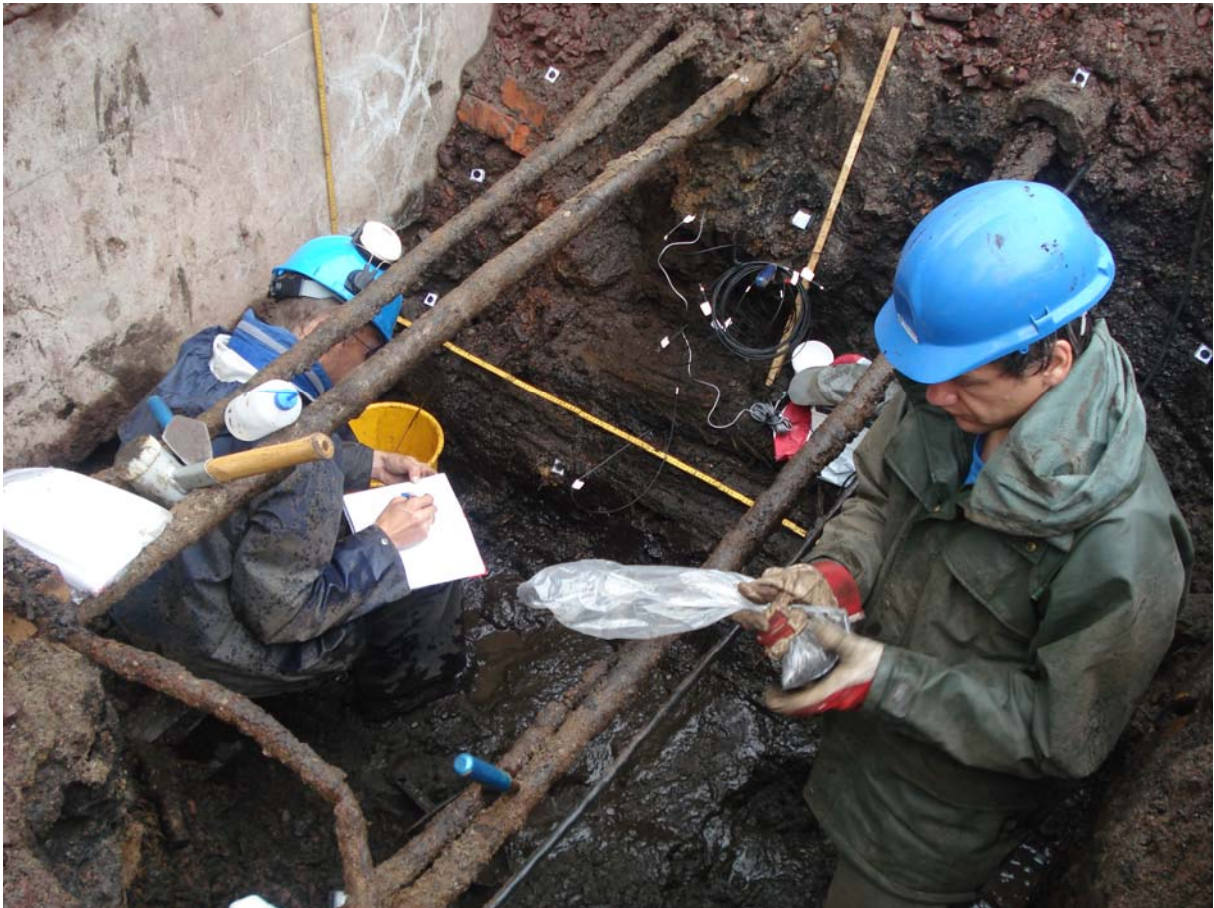
*Figure 3: Field work at the excavated north eastern profile. On the left the girder is shown. The tubes that reach over the pit are electric power cables.*

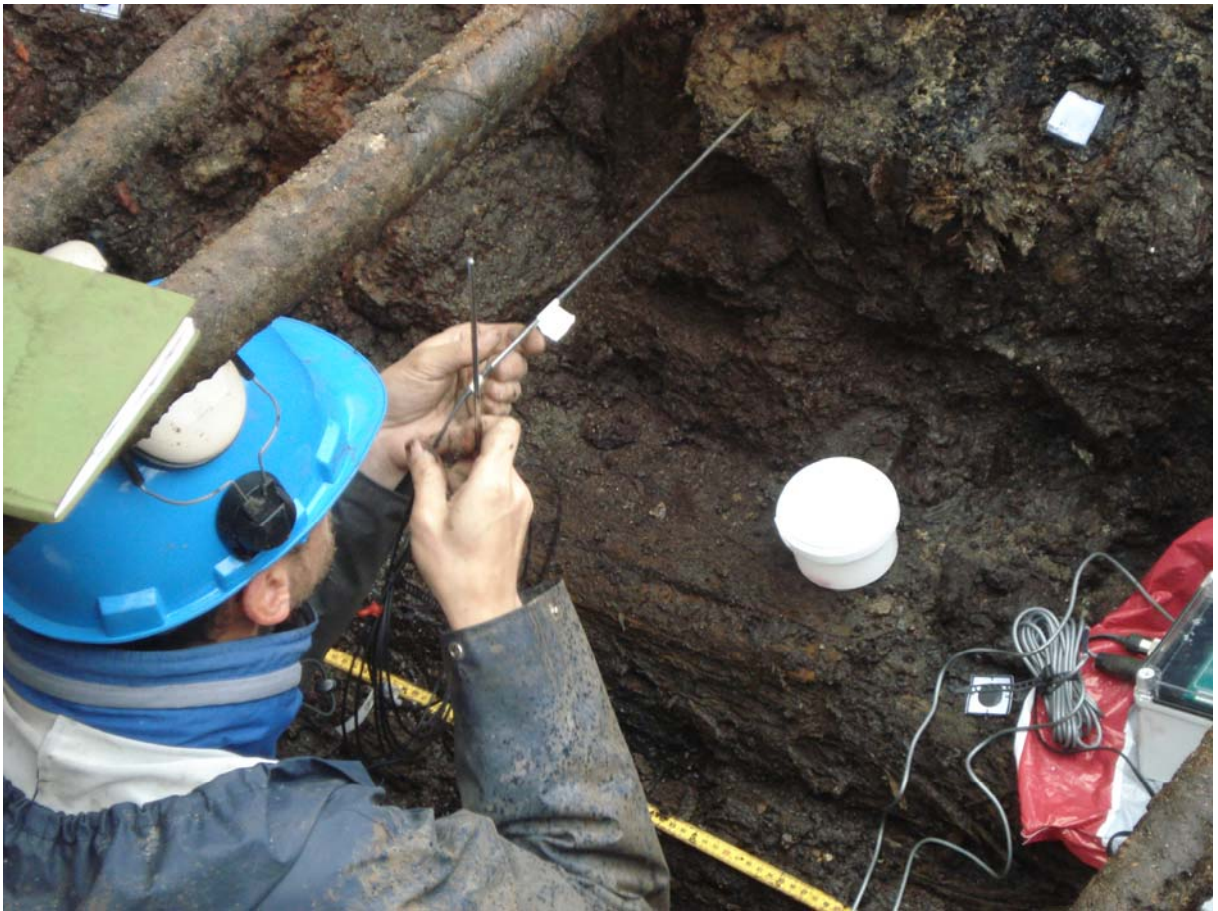
*Figure 4: Installation of the oxygen sensor in the profile.*

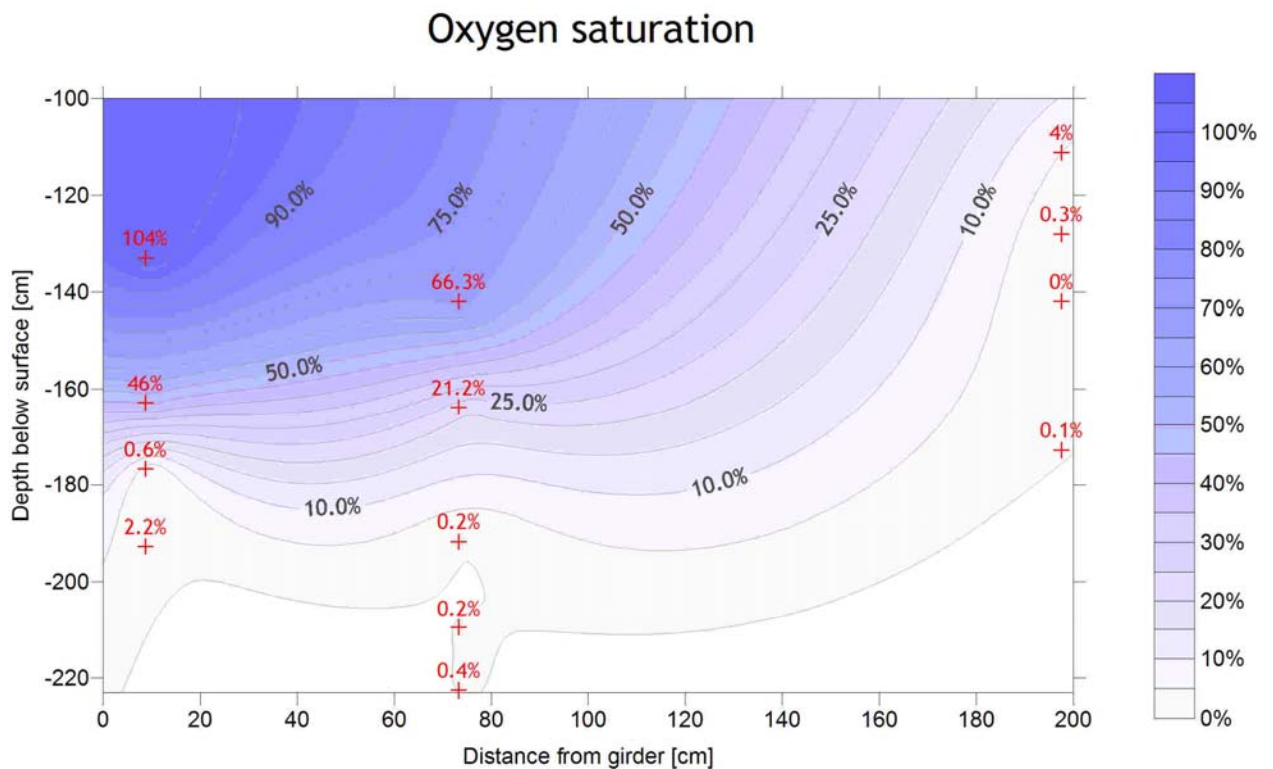
Oxygen concentrations in the soil profile varied between 0 and 104% oxygen saturation in the profile (fig. 6). Highest saturation was measured near the girder in a depth of 130 cm below surface where soil consisted of coarse gravel and bricks. With increasing depth and distance from the girder oxygen concentrations gradually declined. At depths below 180 cm oxygen concentrations dropped to 0% over the whole profile except for one measuring point where 2.2% oxygen saturation was measured. At a distance of 200 cm from the girder low oxygen concentrations were measured at soil depths of 100 cm below surface.

Figure 6: Oxygen saturation in the north-eastern profile

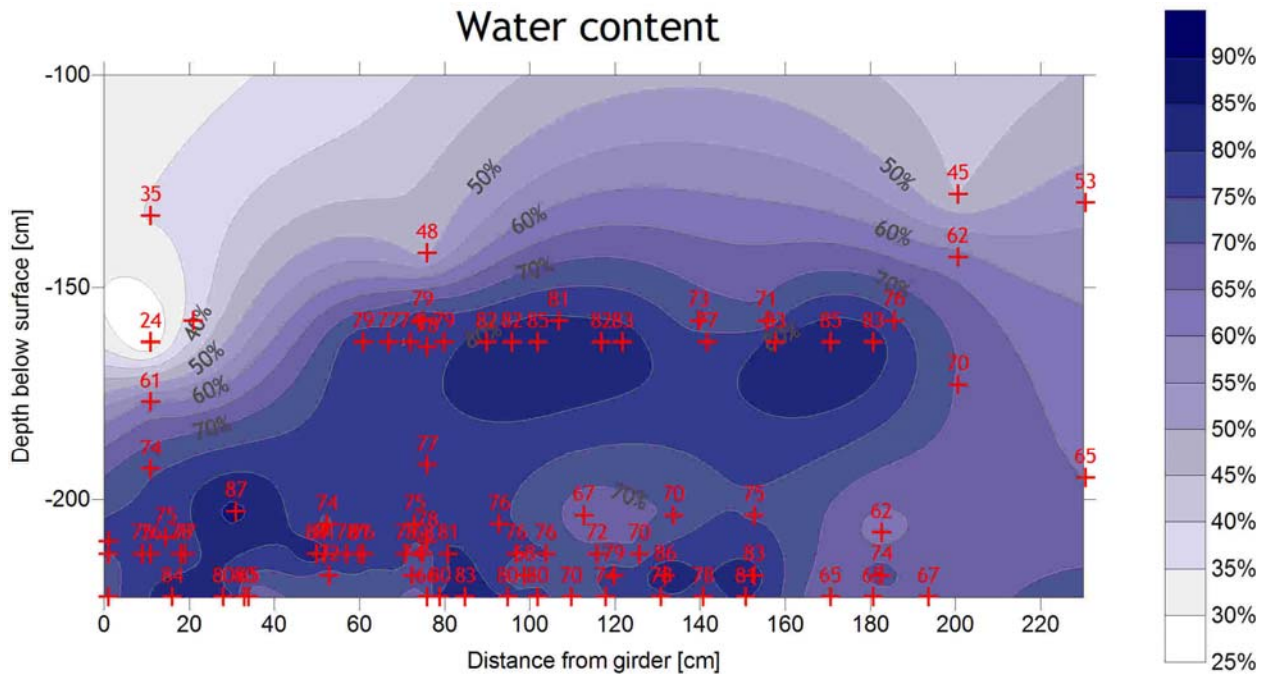
The volumetric water content in the soil profile was relatively high and varied between 15.3 and 85% (fig. 7). Highest water content was measured in a decayed timber at a depth of 160 and 180 cm and in the organic layer below 210 cm. The lowest water content was measured near girder in the coarse refilling masses at a depth of 160 cm. There was a gradient of the water content from the refilling masses along the girder to the cultural layers that are rich in organic material.

Figure 7: Volumetric water content in soil measured with TDR-sensors and by drying at 105° C for 24 hours

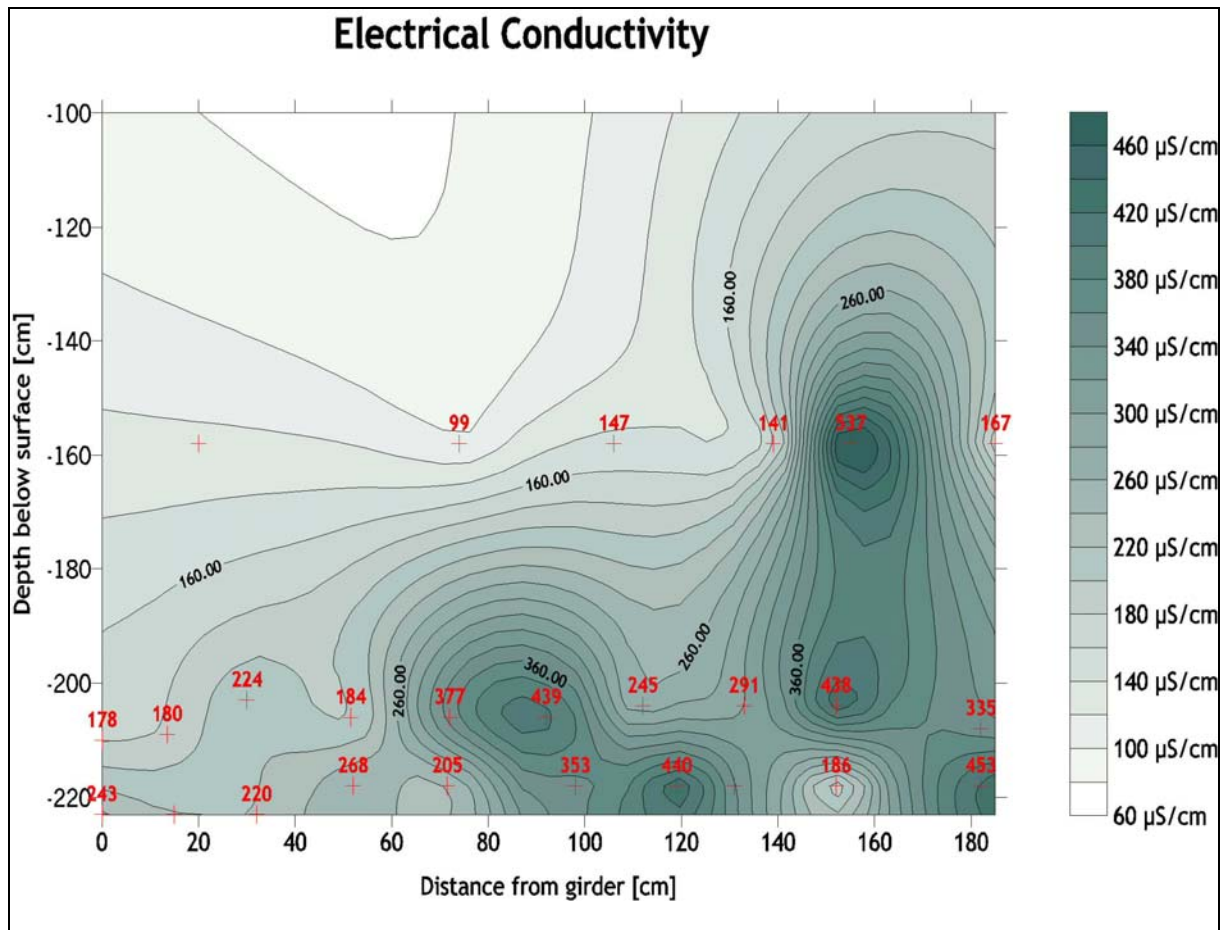
Electrical conductivity varied between 100 and 550  $\mu\text{S}/\text{cm}$ . Lowest conductivity was measured in the areas with highest oxygen saturation, i.e. the area with coarse refilling material along the girder. Relatively low conductivity was also measured at higher depth near the girder. With increasing distance from the pile/girder the conductivity gradually increased, most distinctly in major depth.

Figure 9: Electrical conductivity in the soil of the north eastern profile

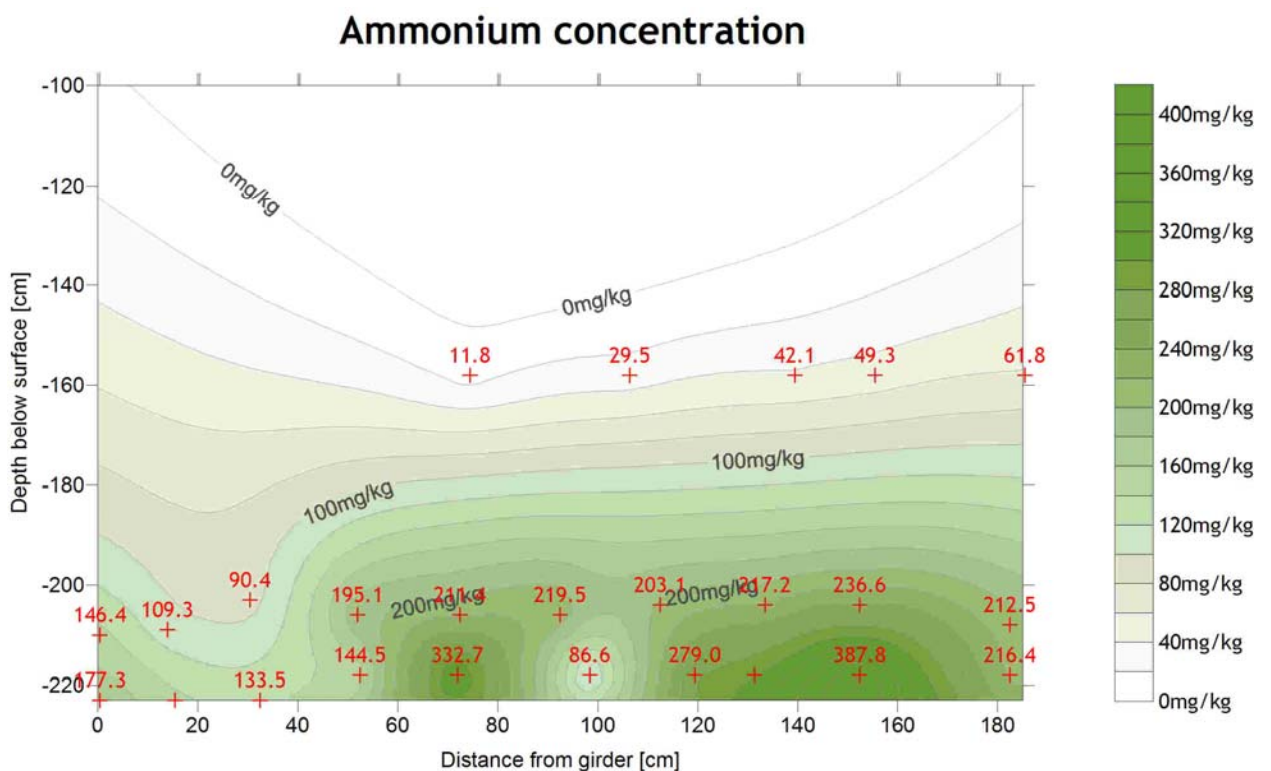
Nitrate concentrations in the soil profile are very low while ammonium concentration varied between 12 and 388 mg/kg dw. In all sampling points the ammonium concentration was considerably higher than the nitrate concentration. The concentration of the reduced ammonium from 11 to almost 400 mg/kg. What is more, there is a trend that the ammonium concentration gradually increased with increasing distance from the girder.

Figure 12: Ammonium concentrations in the north eastern soil profile (the ratio of ammonium and nitrate concentrations could not be shown because nitrate concentration in several sampling points were below detection limit).

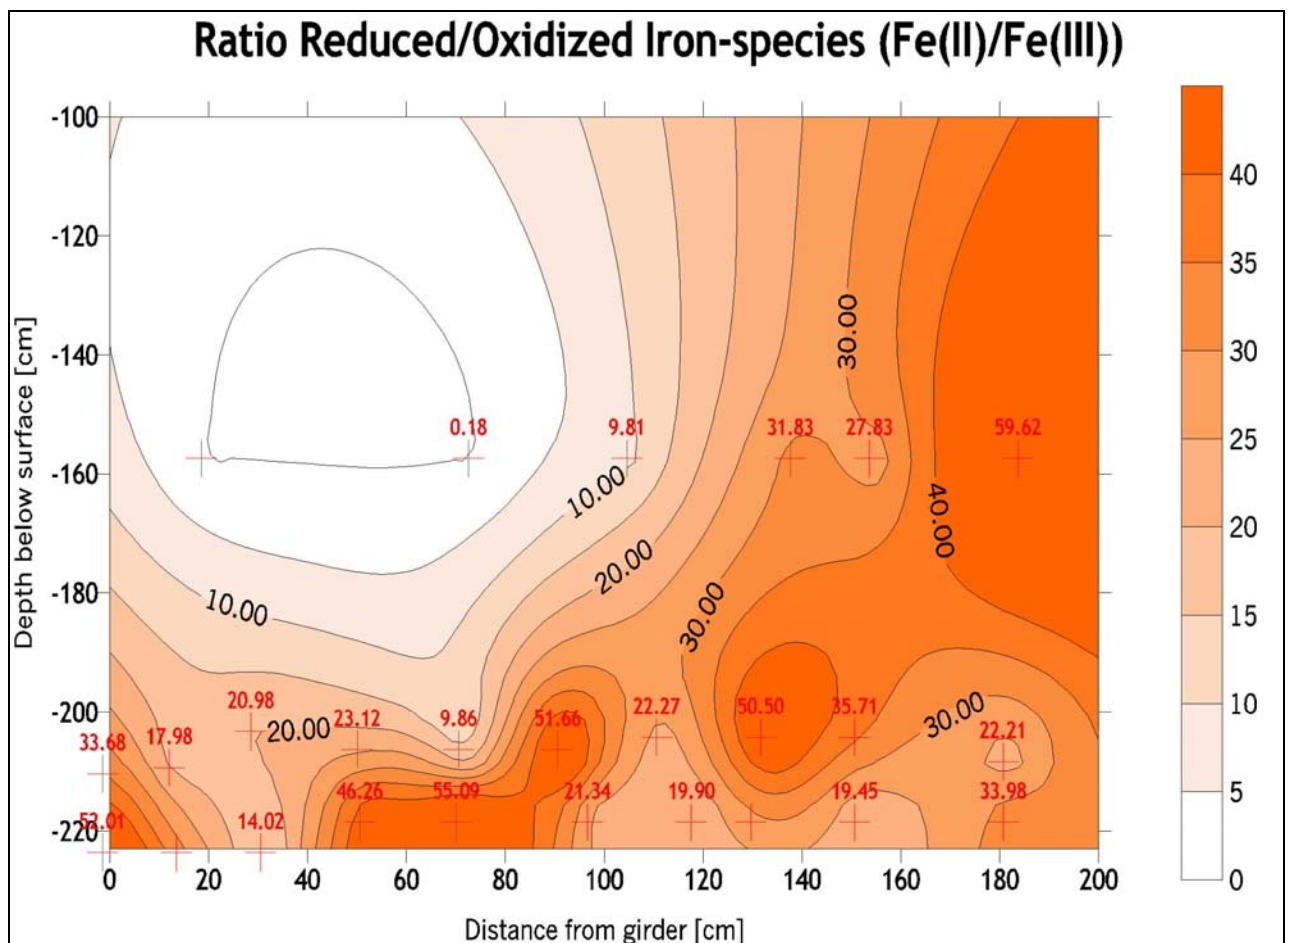
The ratio of molar concentrations of reduced and oxidized iron, namely two (Fe(II)) and three valent iron (Fe(III)) increased with increasing depth below surface and increasing distance from the girder/pile. The distribution of reduced and oxidized iron in the soil profile is similar to the distribution of oxygen. In areas with high oxygen saturation iron predominantly exists as oxidized iron (Fe III), whereas in areas with oxygen saturation near zero, iron exists for more than 90% as reduced iron (Fe II). This is the case for soil layers below 180 cm depth or with a minimum distance of 100 cm from the girder.

Figure 13: Ratio of reduced and oxidized iron species in the north eastern soil profile

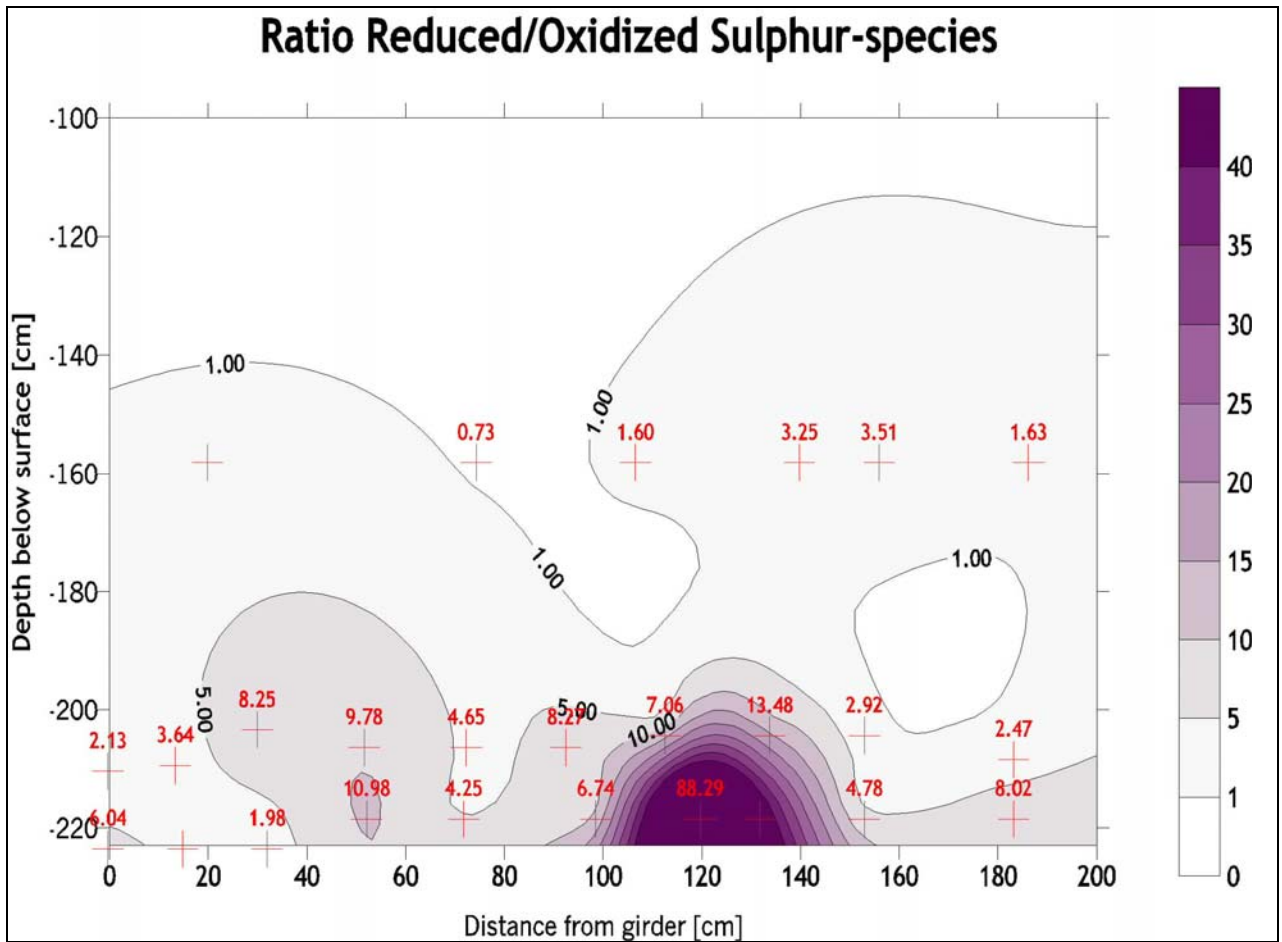
The ratio of reduced and oxidized sulphur species followed the same pattern as that of the other redox pairs with lowest values near the girder and close to the surface and high values at major depth and a distance of 120 cm from the girder.

Figure 14: Ratio of sulfide and sulphate concentrations in the north eastern soil profile.

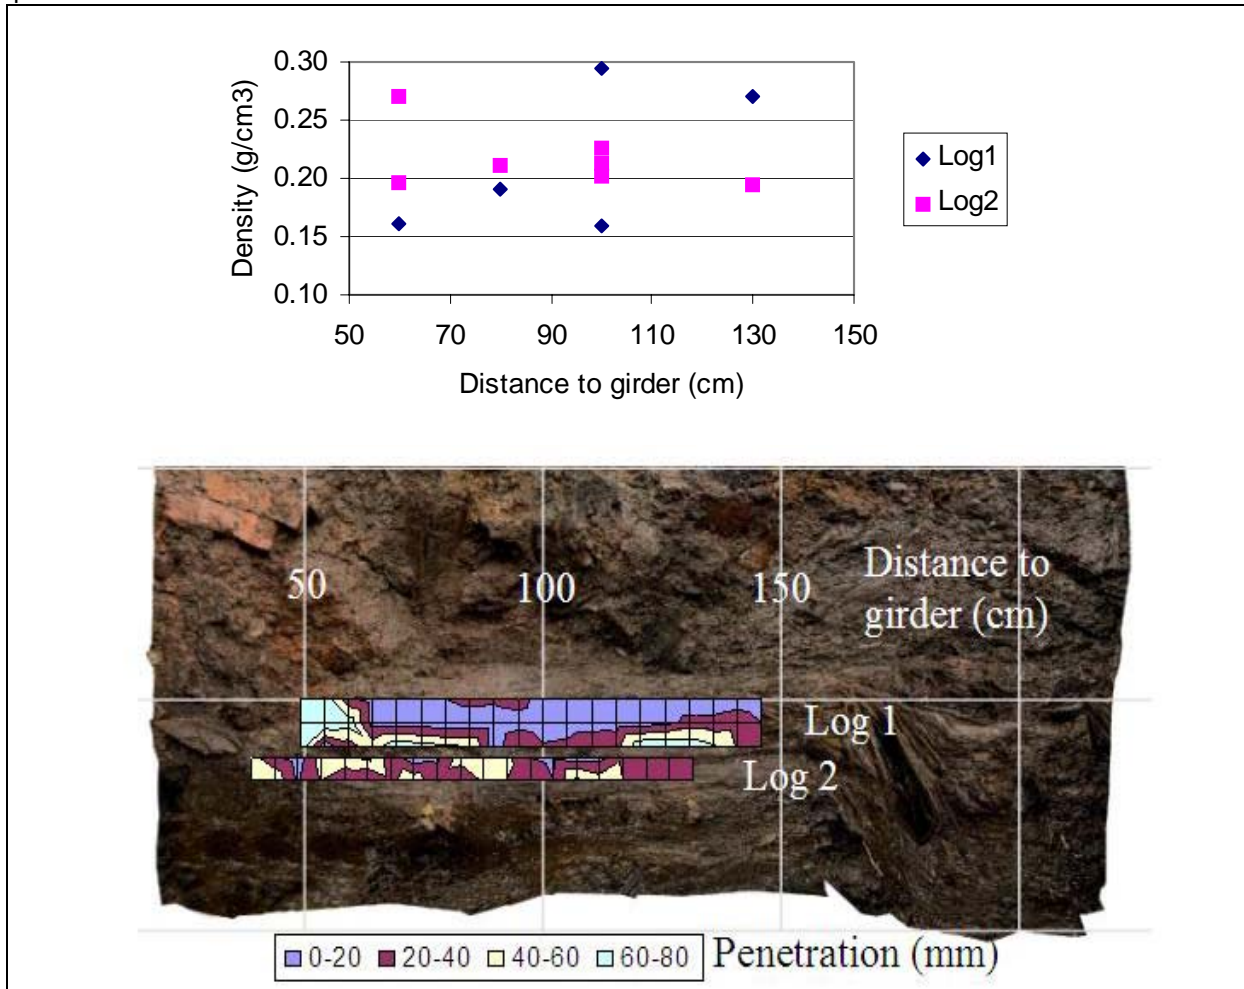
Two horizontal logs were encountered at 178-188 cm (log 1) and 188-193 cm (log 2) beneath the ground surface (figure 15). They were lying perpendicular to the girder, which made it possible to study if there was a gradient in their state of preservation with increasing distance to the girder and foundation pile.

Figure 15: Density and penetration strength of two logs. The density was measured in the laboratory on subsamples from the logs, while the penetration strength was measured in situ as the depth of penetration of a 4.5 mm thick screwdriver pressed firmly into the wood.

12 samples were taken for measuring the density of the wood logs (figure 15 upper), giving results between 0.16 and 0.29 g/cm<sup>3</sup>. These densities all indicate quite deteriorated wood (for comparison fresh pine tree has a density of 0.35-0.50 g/cm<sup>3</sup>) and there is no clear density gradient from the girder and outwards. The penetration strength was measured in triplicate for each 5 cm, and indicated soft and decayed wood. There is a slight tendency that log 1 is more decayed in left hand side near the girder (penetration > 60mm) but this is not necessarily due to the girder or foundation pile: It is the left hand end of the log and fungal decay often takes place from the ends. The right hand end of log 1 was destroyed by the caterpillar and couldn't be used as a reference.
