Eelgrass Habitat Creation in Nantucket Harbor, Massachusetts

**EELGRASS HABITAT CREATION
IN NANTUCKET HARBOR, MASSACHUSETTS**

Submitted to:

April 12th, 2012

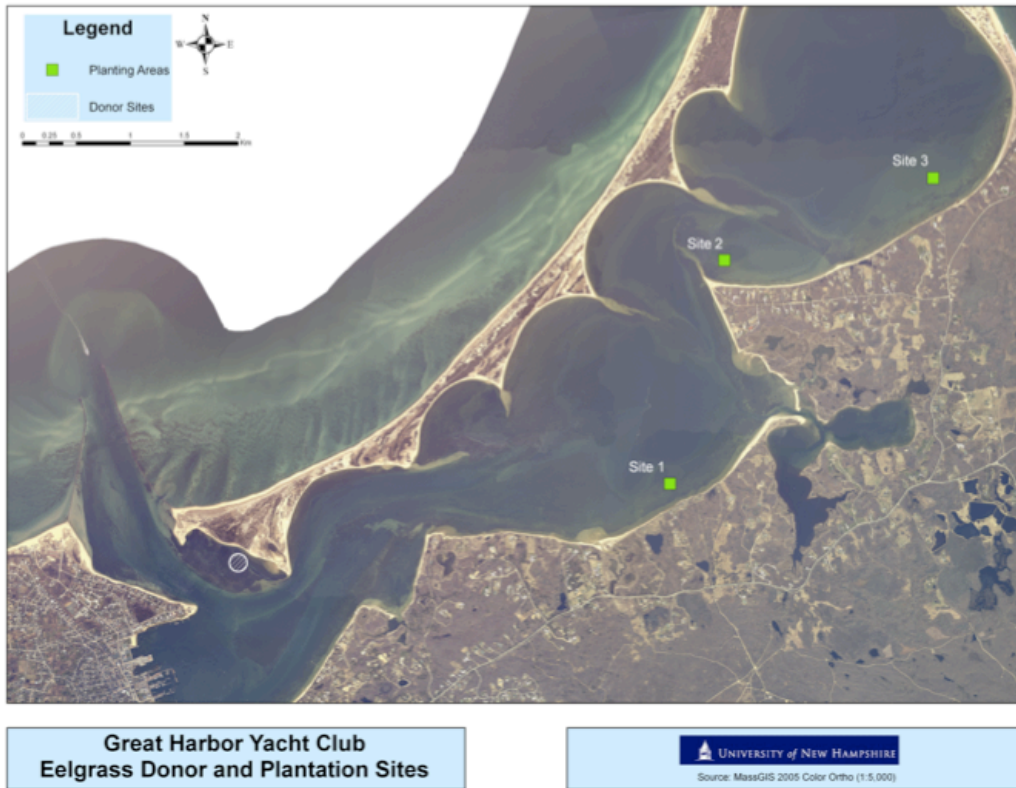
Figure 1. Potential areas for eelgrass creation sites (green) and donor bed (open circle). One reference site was established adjacent to the donor site, while another was established adjacent to the planting site.

To increase the likelihood of success, we carefully reviewed general site information and light data collected from the three potential planting sites. Our field survey on March 25, 2010 found abundant eelgrass plants throughout the majority of the potential planting sites we visited (some sites appeared to be re-colonizing from seedlings), leaving only three potentially suitable sites for transplanting as shown in Figure 1.

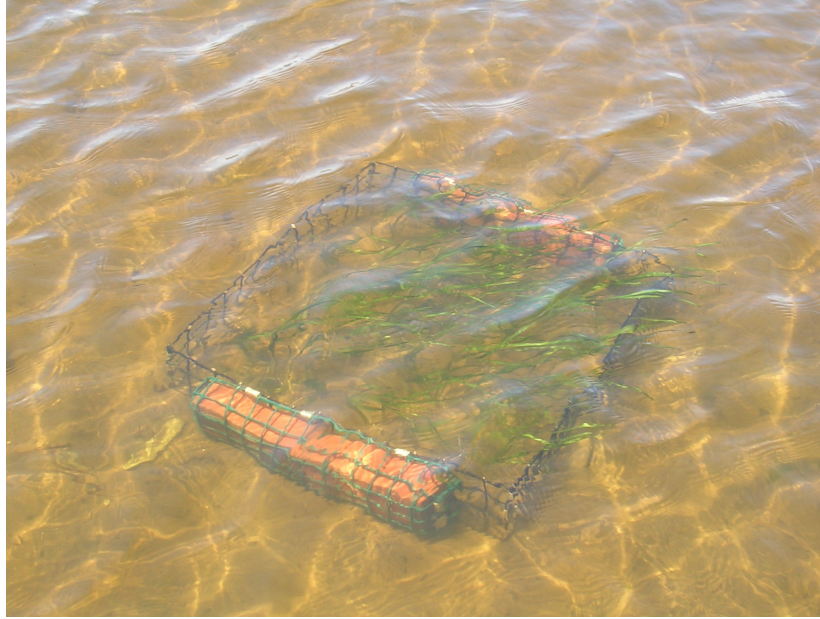
Figure 2. Original TERF™ unit deployed with attached eelgrass in Bellamy River, NH.

Review of various transplanting methodologies shows that shoots are often planted too deep in the sediment or too shallow so they are loosened and lost through typical wave action. When planted in clumps, the sediment often becomes anoxic after re-planting and impacts survival. An alternative method involves tying pairs of rhizomes to coated wire frames, known as TERFS™ (Short et al. 2006). This approach allows very shallow planting depths to minimize exposure to anoxic sediment conditions, yet protects the plants from becoming dislodged by waves or bioturbation (Short et al. 2006). In this method, crepe paper is twisted tightly to form rapidly biodegradable ‘string’ that holds rhizomes to the frame, while the frame itself is brought into close contact with the sediment using retrievable metal wire staples (Figure 2).

TERFS™ were originally constructed from plastic-coated wire mesh (typically used for lobster and crab traps; Short et al. 2006) with bricks along two edges to hold the structure to the marine bottom. Depending upon site conditions, a modified frame can be employed which lack the sides shown in Figure 2. These modified TERFS™ are simply coated wire frames held in place with bent wire staples. In either case, transplanted eelgrass plants will establish within six to eight weeks. Rooted plants have rooted in the sediment and the crepe is dissolved, so the frames and staples can be carefully removed and used again, leaving no permanent materials behind at the site.

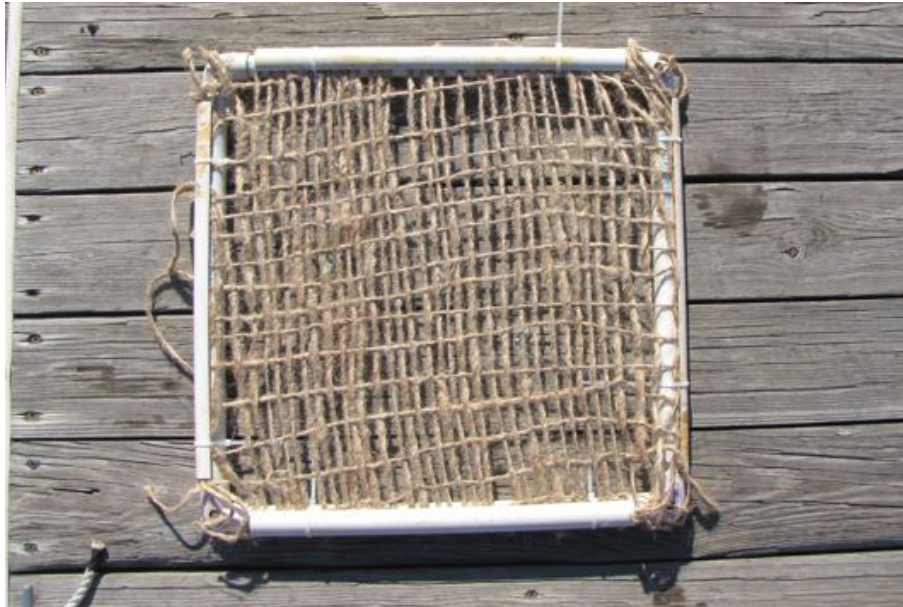
Figure 3. Planting frame developed by Leschen and colleagues (2007).

In Boston Harbor, TERFS™ were modified using biodegradable jute mat fastened to a frame of PVC pipe (Figure 3) and stapled to the sediment (Leschen et al. 2007). In this new adaptation, the jute is released from the frame and only the frame and staples are removed once plants become established after several weeks. This allows the jute to remain and continue protecting the plants until it slowly degrades. We used two types of frames that held 50 shoots each: the flat, coated wire frames and the newly developed PVC with jute frames.

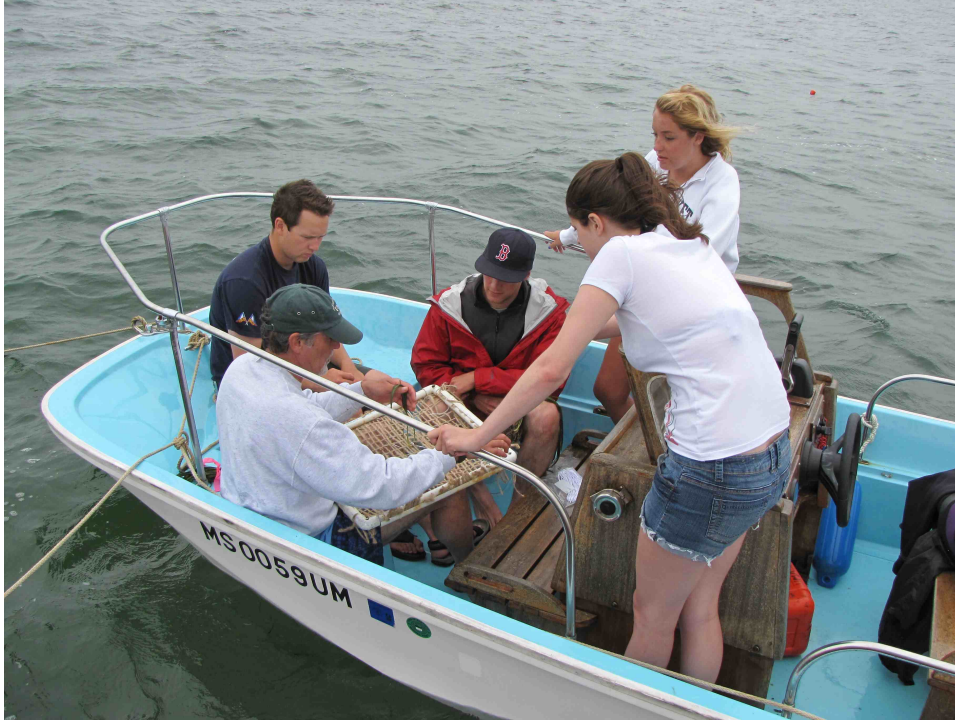
Figure 4. Volunteers learning how to tie eelgrass shoots to frames.

We received invaluable volunteer assistance from the NLC as well as volunteers organized and provided by the UMASS field station in harvesting, planting and monitoring the donor and planting sites (Figure 4). In total, 6,050 plants were collected and 120 frames were set with plants and installed at the planting site using two types of frames (Table 3). The majority of frames were removed on August 12th (seven weeks or more after installation) with the help of Chris Fuller, a local diver. However, several frames were left for later retrieval in early fall 2010 to allow more time for transplants to better root and establish. By mid-October, all frames deployed had been removed from the Harbor.

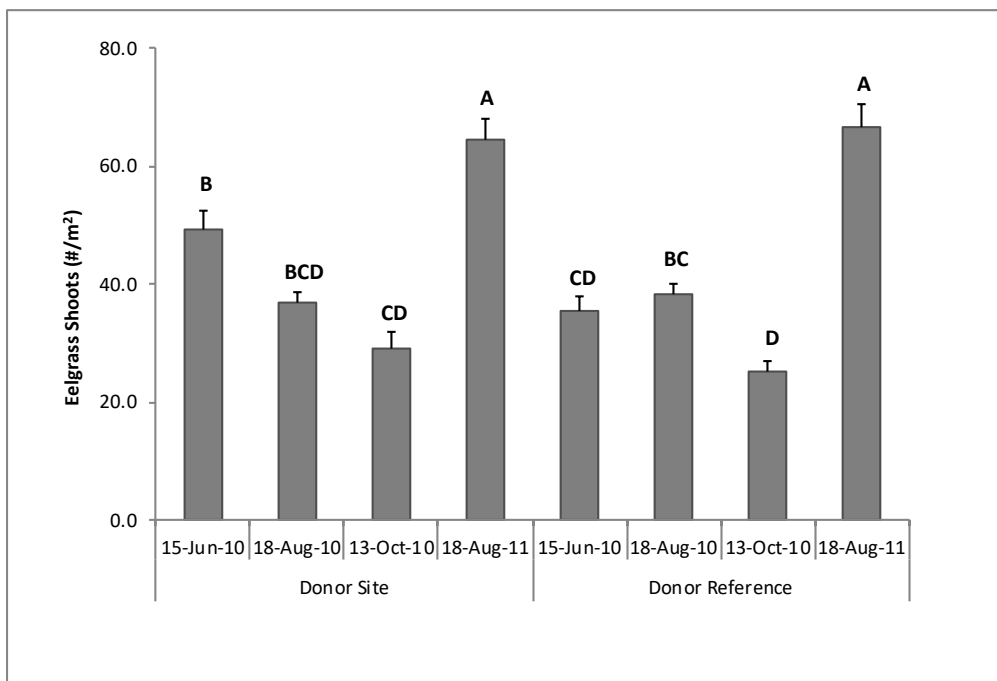
Figure 7. Number of eelgrass shoots in 0.1 m² quadrats collected at donor and adjacent reference areas before (June 15) and after (August 18 2010, October 13 2010, and August 18 2011) eelgrass collections. Mean values +/- SE; different letters over bars denote shoot density was significantly different, based on Tukey's post hoc means test.

As one might expect, a short-term decrease in eelgrass shoot density was observed in sample plots immediately following donor plant harvest (Figure 7, Table 4). Average shoot number in the reference area was similar on the first two dates, while shoot number in the donor area declined following collection of approximately 6,050 shoots. The donor area encompassed 140 m² and we estimate it originally had 68,600 shoots; after collection the second assessment was used to estimate 51,800 shoots (24% decline). While variability in data collection may be responsible for some of the decline in shoot number (we extrapolated from 0.1m² quadrats using twelve plots), many lateral shoots were discarded or not counted with the 6,050 shoots used for planting. This is because only terminal shoots are counted for planting whereas terminals and laterals cannot be distinguished and are both counted in when counting stem density in underwater plots. We were able to measure an immediate effect of the collection in a two-way Analysis of Variance (i.e., probability of no interaction effect was low: $P= 0.0065$). However after three months of re-growth and recovery, no differences were found between donor and reference sites (13 October; Figure 7). Monitoring continued in mid-August 2011 and documented a strong rebound in shoot density at both areas, illustrating no long-term impacts to the donor bed following harvest.

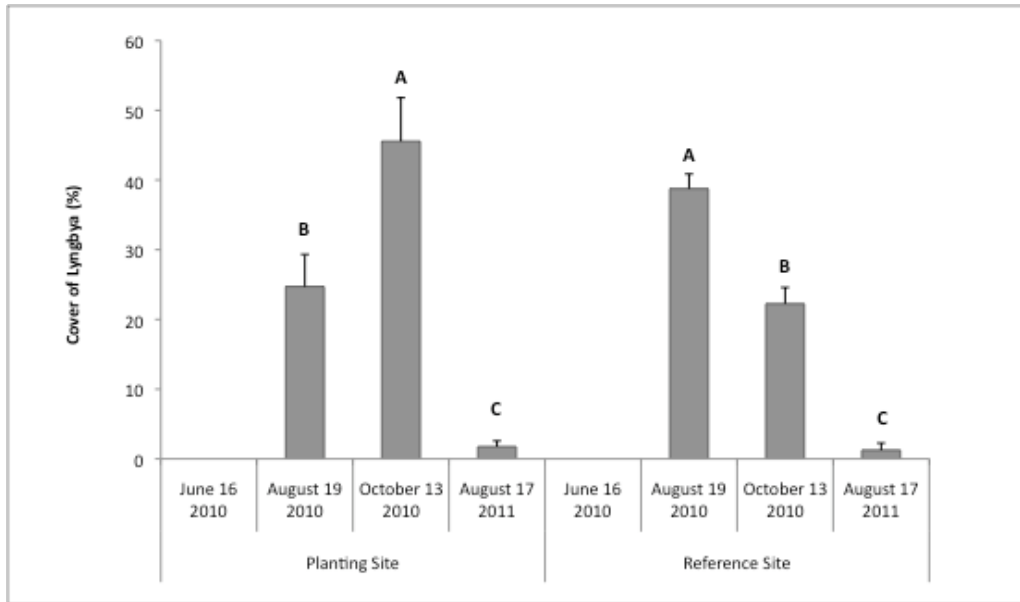
Figure 10. Cover of different alga genera in planted and reference areas before (June 2010) and two months (August 2010), four months (October, 2010) and thirteen months after planting (August 2011). In June, we noted ‘other algae’ besides *Codium* and these were primarily *Gracilaria*. Bars with different letters indicate significantly different means following a two-way ANOVA and Tukey’s post hoc test.
