STUDIUM PRZYPADKU / CLINICAL VIGNETTE

Lead-dependent infective endocarditis with a giant vegetation in the heart around an externalised VDD pacing lead. VDD lead externalisation in the course of tribological lead wear

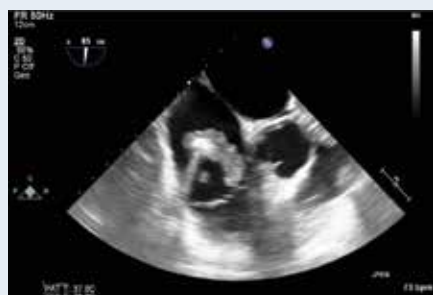
Figure 1. Transoesophageal echocardiography examination — vegetation on the lead in the right atrium and the right ventricle with length approximately 71 mm
