Self-healing of Concrete Under Diverse Environmental Exposure

Ahmed Ramadan Suleiman, *The University of Western Ontario*

A thesis submitted in partial fulfillment of the requirements for the Doctor of Philosophy degree
in Civil and Environmental Engineering

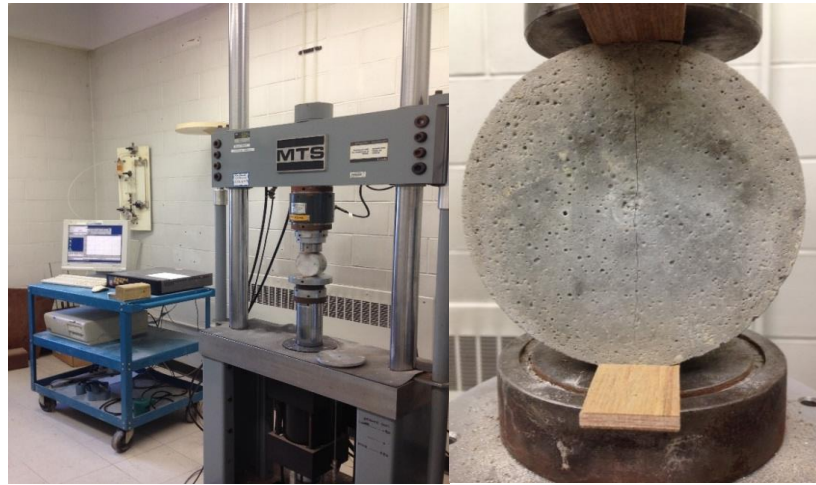
Figure 2.1: Cracking of specimens using MTS machine.

All 100 x 50 mm cylindrical specimens were pre-cracked (longitudinal crack) at the age of 28 days by means of a splitting test at a constant loading rate of 0.01 mm/s. The crack width was controlled during the splitting test via a calibration ruler as per the method described by Roig-Flores *et al.* (2015). For each environmental condition, three groups of specimens with three different values of crack width were tested. The first group consisted of three specimens with an average crack width in the range of 50 – 150 μm . For the second and third groups, the average crack widths were 150 – 300 μm and 300 – 500 μm , respectively.

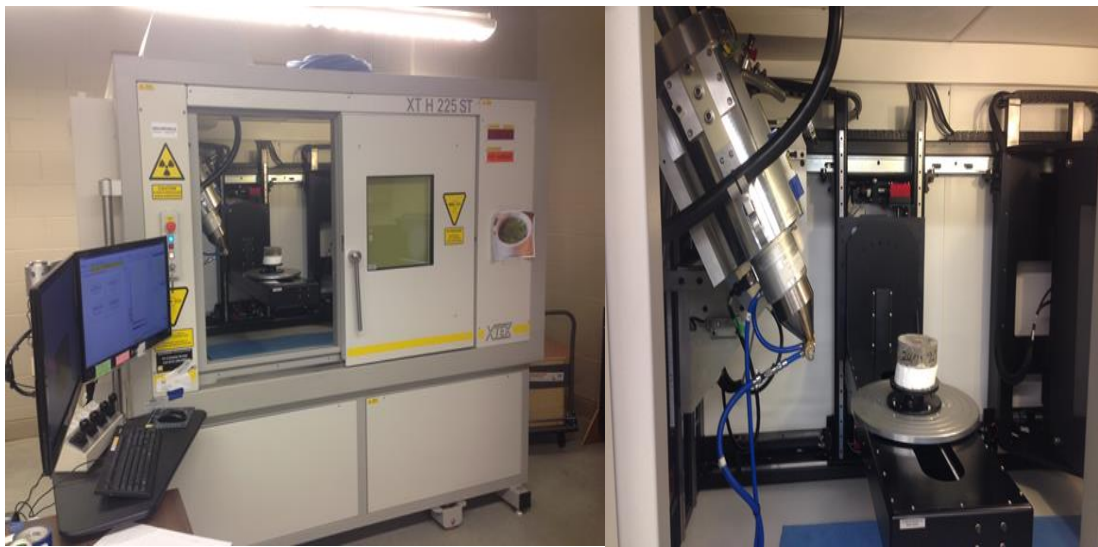
Figure 2.8: X-ray μ CT scanning.

Figure 2.8. The X-ray computed tomography scanner generates micrometer scale high resolution 3D and 2D images of both the sample's interior and exterior. The X-ray images are subsequently deployed to reconstruct the exterior and interior of the sample via computed tomography. X-ray μ CT provides non-destructively detailed 3D images of the internal structure of material by combining a series of cross-sectional images. In the 3-D image, resolution was 62.26 μ voxel size. Parameters of the scan were defined as follows: - 225 kVp -100 μ A-22.5 watts; panel gain = 24; 3141 images; 150 frames/projection on shading correction; panel at -116.517; 2.5mm Cu filter - fast CT - 53 min scan.

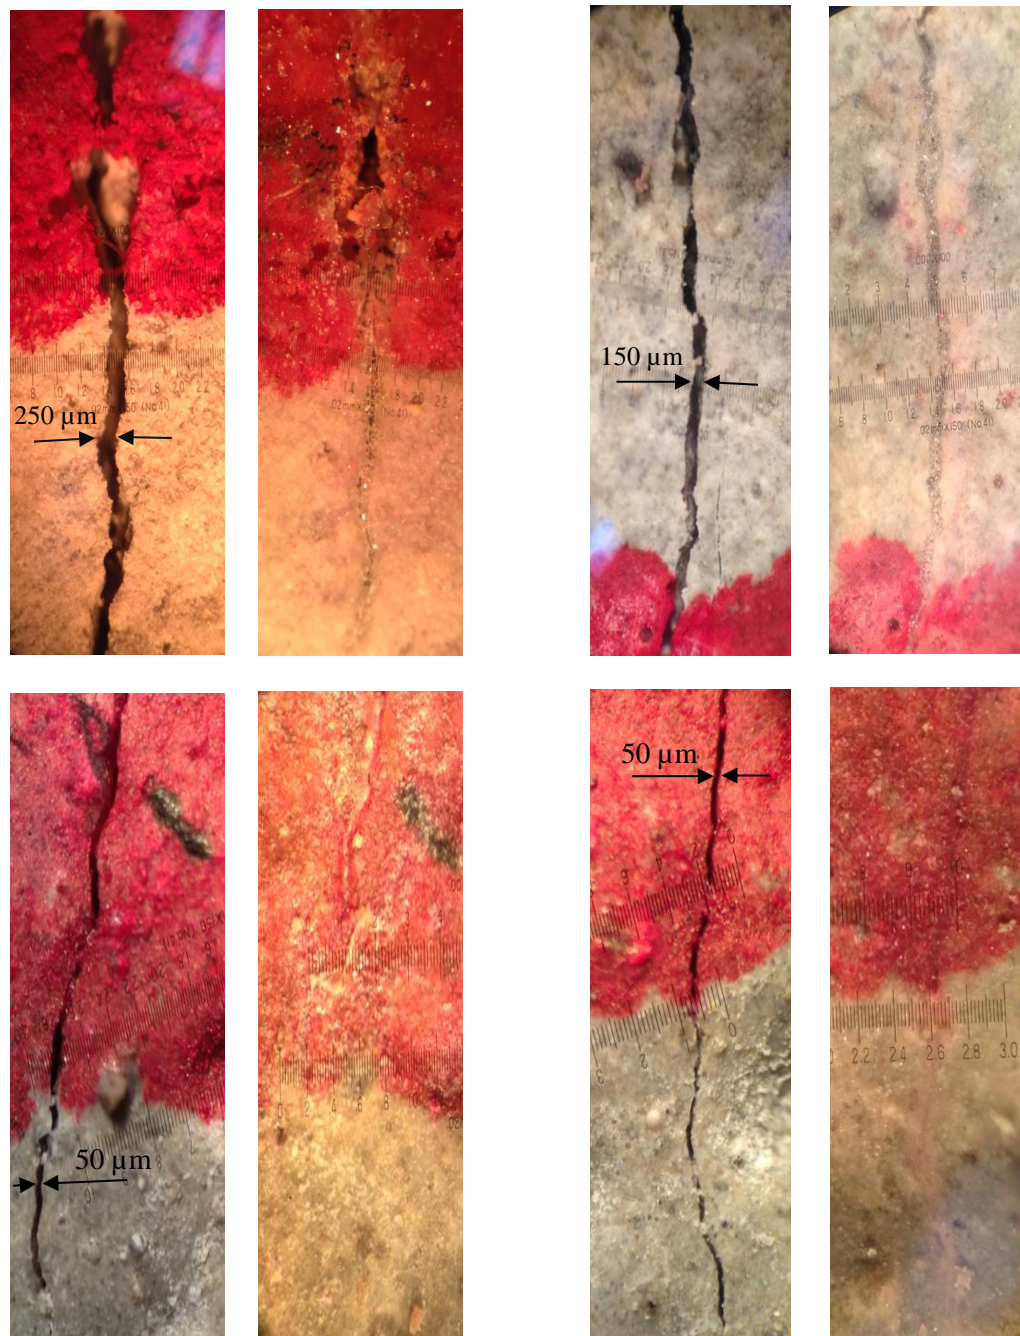
Figure 2.9: Surface cracks before and after water submersion showing self-healing.

cracking. However, cracks with width larger than $300\text{ }\mu\text{m}$ did not exhibit crack closing up to a one year.

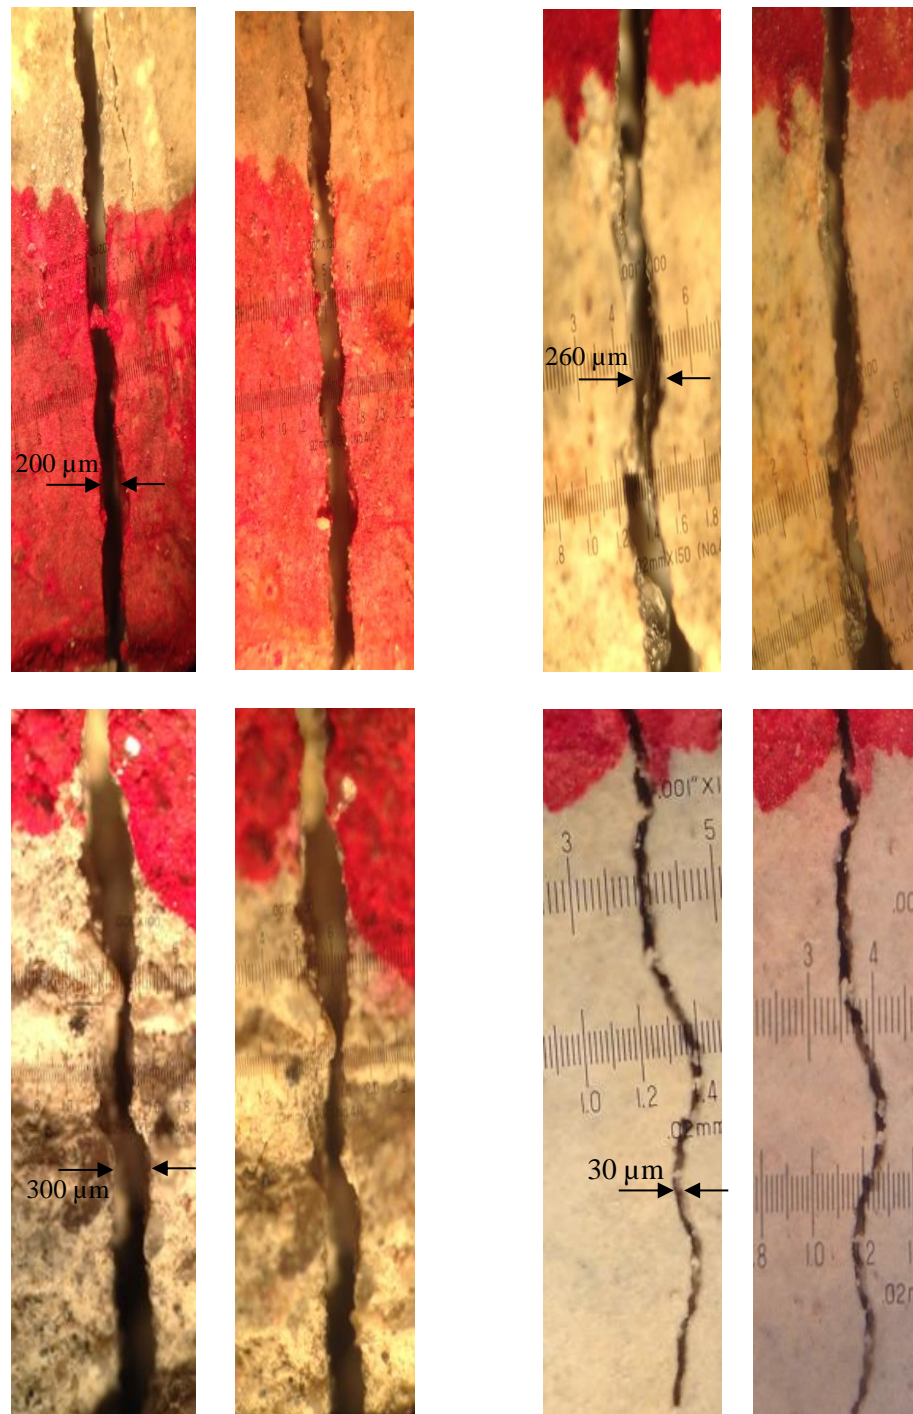
Figure 2.10: Surface cracks before and after exposure to cyclic T and RH showing no significant healing.

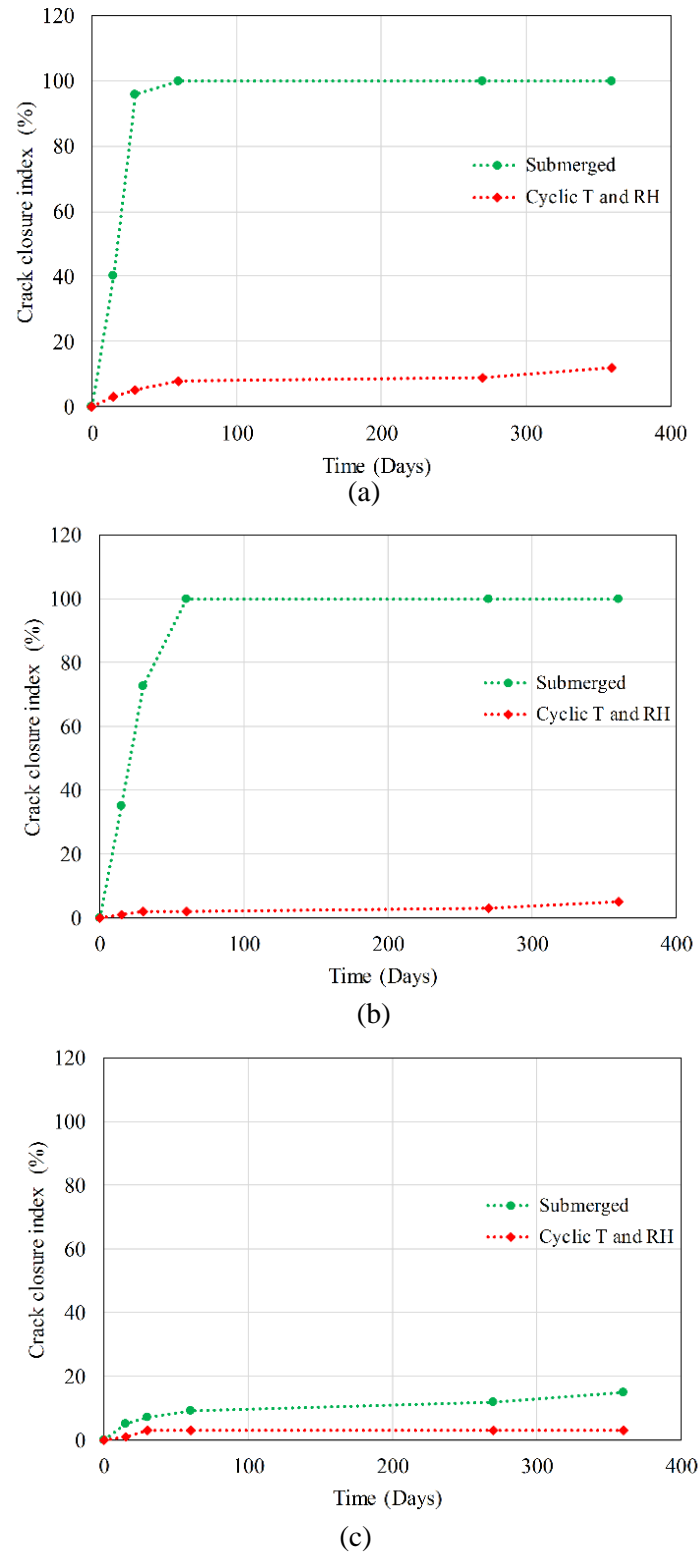
Figure 2.11: Change in surface crack width of specimens exposed to different environments with initial crack width (a) 50-150 μm ; (b) 150-300 μm ; and (c) 300-500 μm .

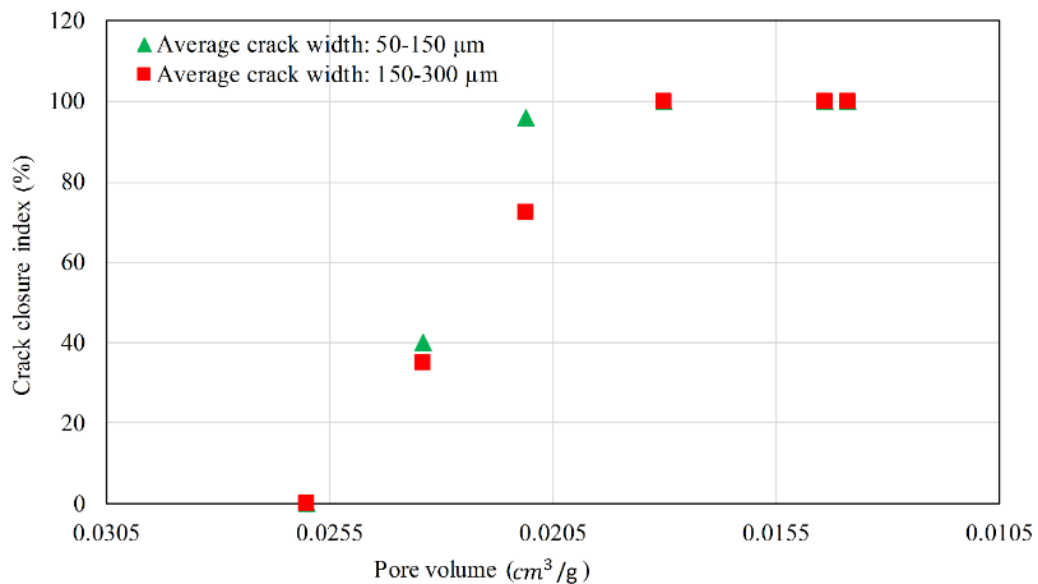
Figure 2.12: Crack closure index vs. pore volume.

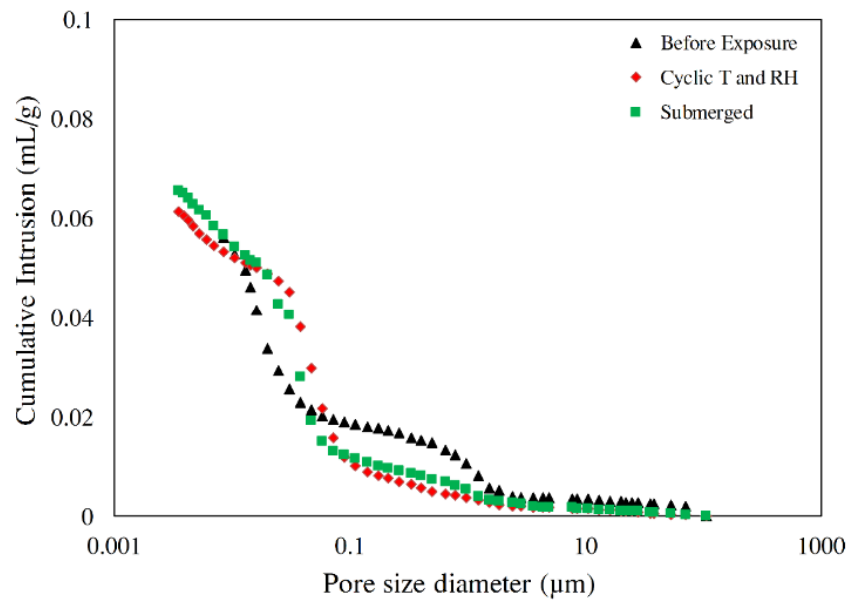
Figure 2.13: Cumulative intruded pore volume vs. pore diameter for cracked specimens exposed to different environments for a period of 2 months.

The evolution of pore structure with time was assessed using MIP. Specimens from each environmental exposure were tested at ages of 28, 45, 60, 270, and 360 days. The results were then cross-checked with the crack sealing index, as shown in the **Figure 2.12**. **Figure 2.13** shows the cumulative mercury intrusion curves as a function of the pore diameter for cracked mortar specimens before and after each environmental exposure. It can be observed that in both exposures, cracked specimens exhibited reduction in and refinement of pore size after 2 months. For example, the volume of pores with diameters from $2\text{ }\mu\text{m}$ to $0.05\text{ }\mu\text{m}$ was noticeably decreased compared to that of specimens before exposure. In addition, the percentage of pores with diameter smaller than $0.05\text{ }\mu\text{m}$ increased, indicating a refinement of pore structure. For those specimens submerged in water, the percentage of pores with diameter smaller than $0.015\text{ }\mu\text{m}$ increased in comparison to that of identical specimens exposed to cyclic T and RH. **Figure 2.14** illustrates the cumulative intruded pore volume vs. pore diameter for submerged specimens at different ages. It can be observed that specimens fully submerged in water continued to exhibit reduction in porosity, leading to microstructural densification, likely owing to ongoing cement hydration and pozzolanic reactions of fly ash.

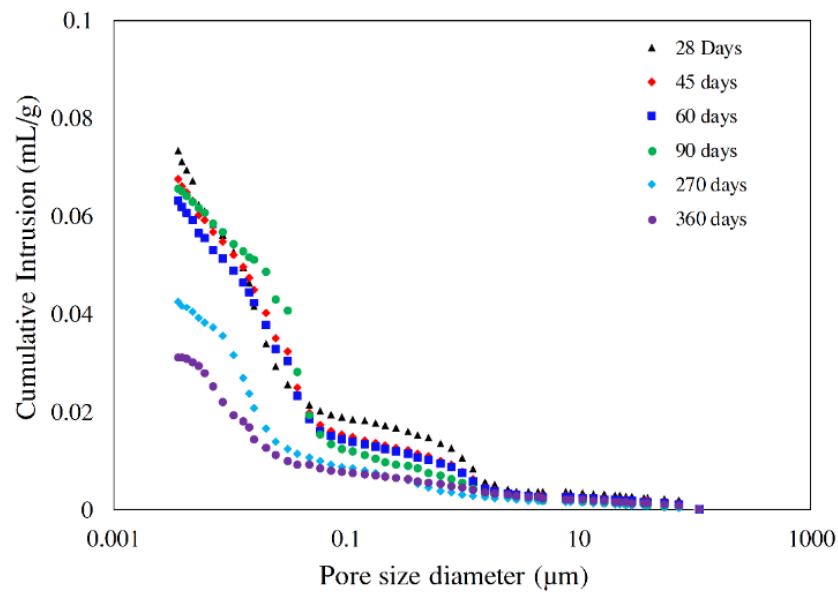
Figure 2.14: Cumulative intruded pore volume vs. pore diameter for submerged specimens at different ages.

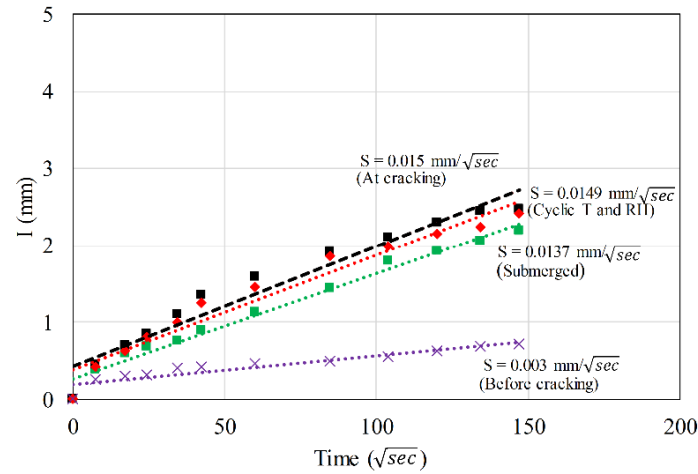
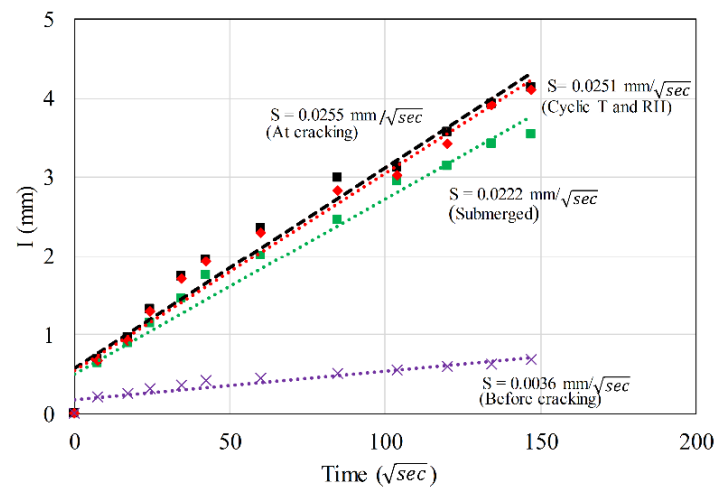
Figure 2.15: Change in water absorption of cracked specimens exposed to different environments for a period of 15 days with average crack width (a) 50-150 μm ; (b) 150-300 μm ; and (c) 300-500 μm .

Figures 2.15 to 2.18 show capillary water absorption results of cracked mortar specimens before and after each environmental exposure.

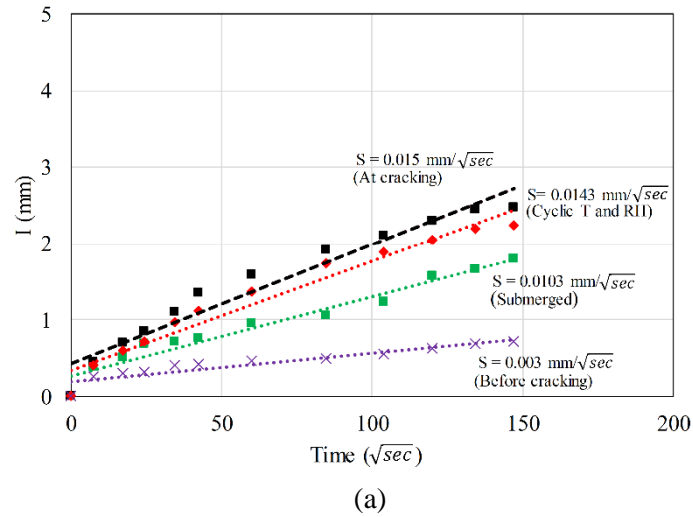
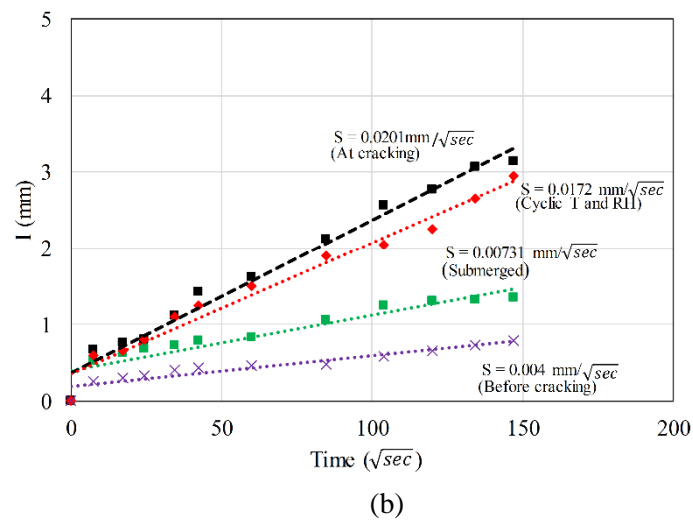
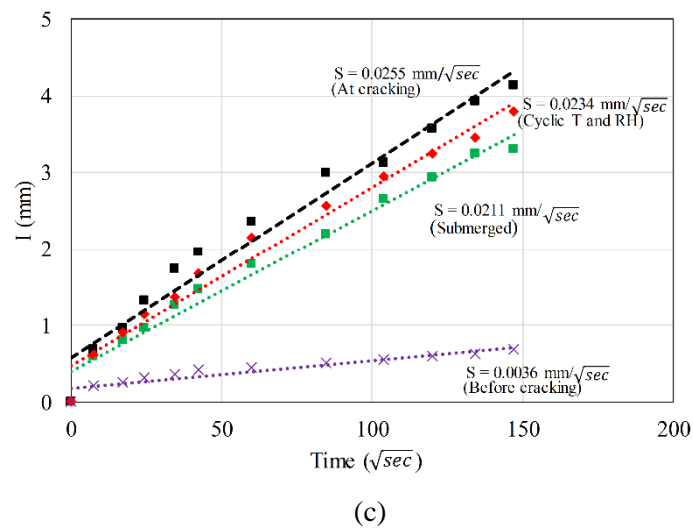
Figure 2.16: Change in water absorption of cracked specimens exposed to different environments for a period of 1 month with average crack width (a) 50-150 μm ; (b) 150-300 μm ; and (c) 300-500 μm .

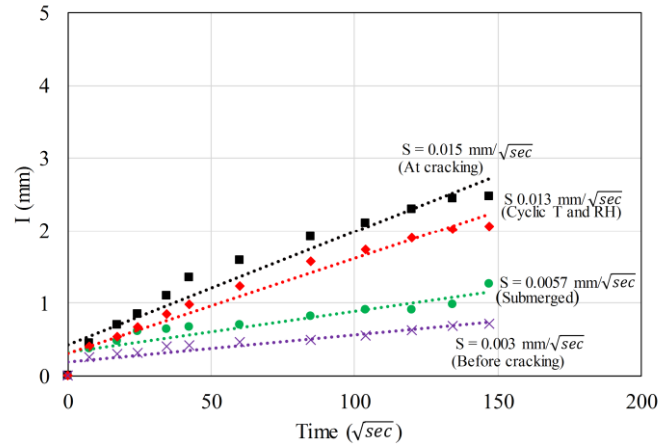
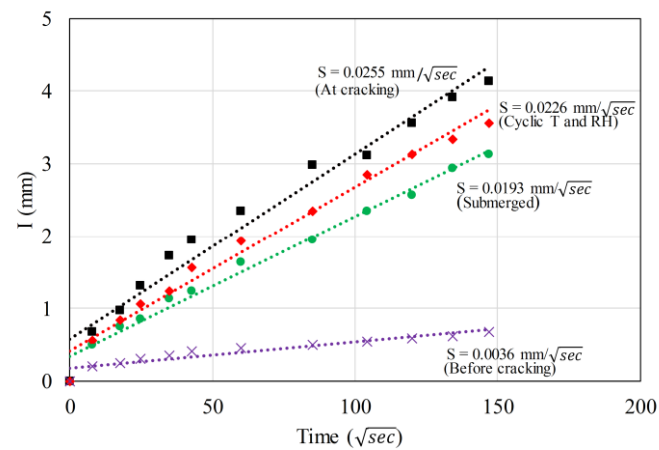
Figure 2.17: Change in water absorption of cracked specimens exposed to different environments for a period of 2 months with average crack width (a) 50-150 μm ; (b) 150-300 μm ; and (c) 300-500 μm .

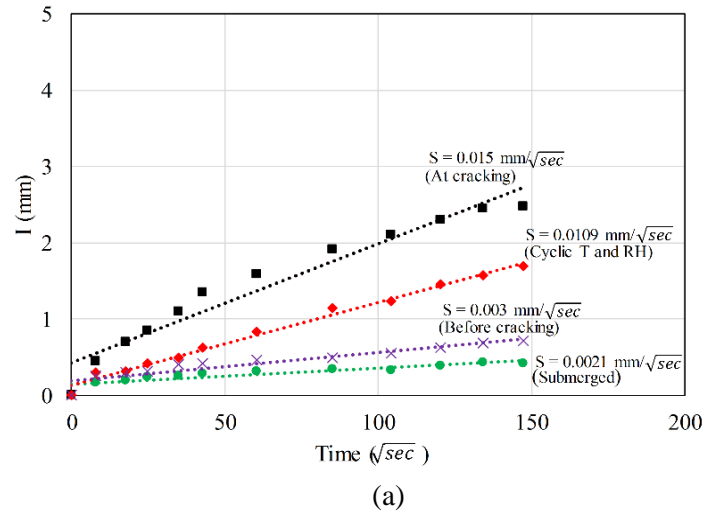
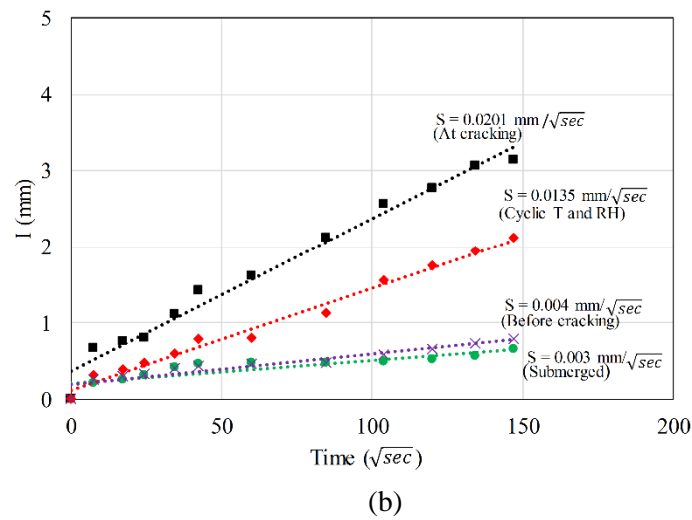
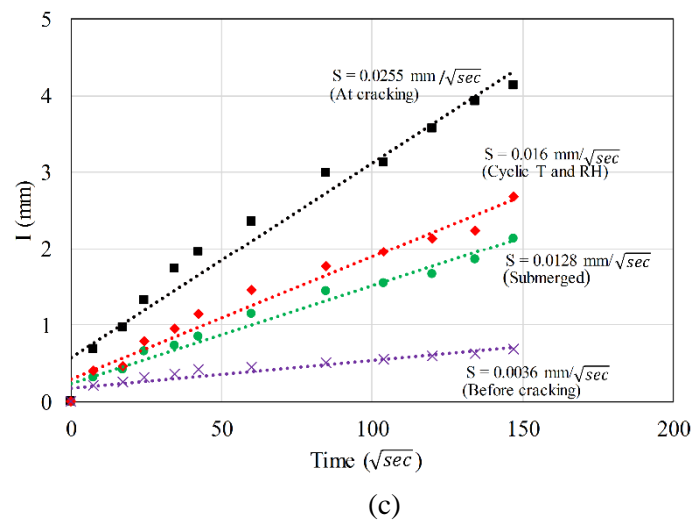
Figure 2.18: Change in water absorption of cracked specimens exposed to different environments for a period of 1 year with average crack width (a) 50-150 μm ; (b) 150-300 μm ; and (c) 300-500 μm .

Results also indicated that cracked specimens that were fully submerged in water exhibited higher reduction in absorption compared to that of identical specimens placed inside a walk-in environmental chamber and exposed to cyclic T and RH. For instance, after one year, the sorptivity index of the submerged specimens was $0.0021 \text{ mm}/\sqrt{\text{sec}}$, whereas that of specimens with similar initial crack width and exposed to cyclic T and RH was $0.0109 \text{ mm}/\sqrt{\text{sec}}$. It is believed that the reduction in absorption for submerged specimens reflects the observed microstructure densification owing to the development of hydration products and possibly self-healing of cracks. Interestingly, in both environments, specimens with initial crack width larger than $300 \mu\text{m}$ did not exhibit significant reduction in absorption in comparison to specimens with crack widths smaller than $300 \mu\text{m}$.

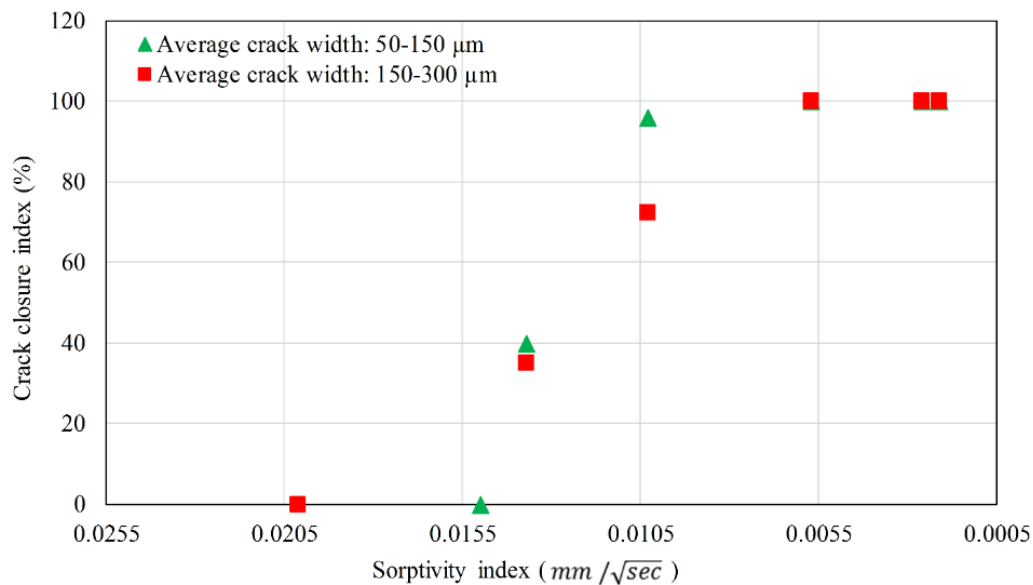
Figure 2.19 Crack closure index vs. sorptivity index.

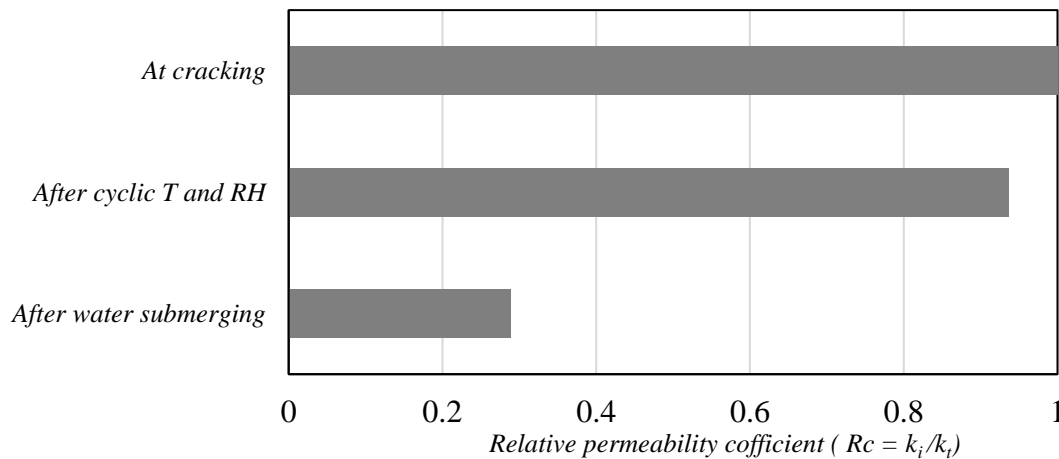
Figure 2.20 Change in relative permeability coefficient of cracked specimens with average crack width (150 to 300 μm) exposed to different environments for a period of 2 months.

Figure 2.20 exhibits the change in relative permeability of the pre-cracked mortar specimens submerged in water. It can be observed that the permeability coefficient of the cracked specimens dropped by up to 71% when they were fully submerged in water for 60 days. However, only 6% reduction in permeability was observed for the pre-cracked specimens exposed to cyclic T and RH. Again, this can be attributed to coupled microstructure densification through portland cement hydration and pozzolanic reactions of fly ash and formation of self-healing products that sealed cracks in the case of complete water submerging. Previous study by Jiang *et al.* (2015) reported that pre-cracked mortar specimens exposed to cyclic drying and wetting did not exhibit decrease in permeability, which could be related to the formation of microcracks upon exposing pre-cracked specimens to cyclic drying and wetting.

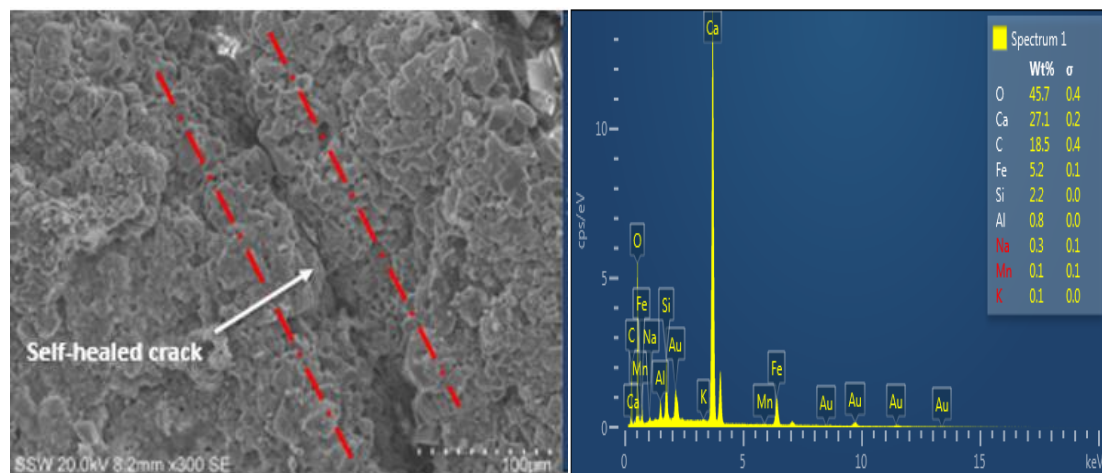
Figure 2.21 SEM micrograph with EDX pattern of products in self-healed cracks.

Figure 2.21 shows typical SEM image and EDX analysis for the healing product formed in surface cracks. SEM and EDX analyses were used to explore the microstructure and analyze the composition of self-healing products. The initial crack opening of the healed crack shown was $50 \pm 10 \mu\text{m}$. It can be observed that the self-healing product had multiple-shaped and irregular crystals including trigonal, cubical, and rectangular shapes. Energy-dispersive X-ray spectroscopy revealed that the healing products at the crack surface were mainly composed of calcium with some carbon and oxygen, indicating that it consists mainly of CaCO_3 . Formation of CaCO_3 as a healing product is mainly due to the leaching and re-deposition of calcium ions Ca^{2+} from the cementitious matrix and diffusion of carbonates into cracks (e.g. Jiang *et al.*, 2015; Sisomphon *et al.*, 2012).

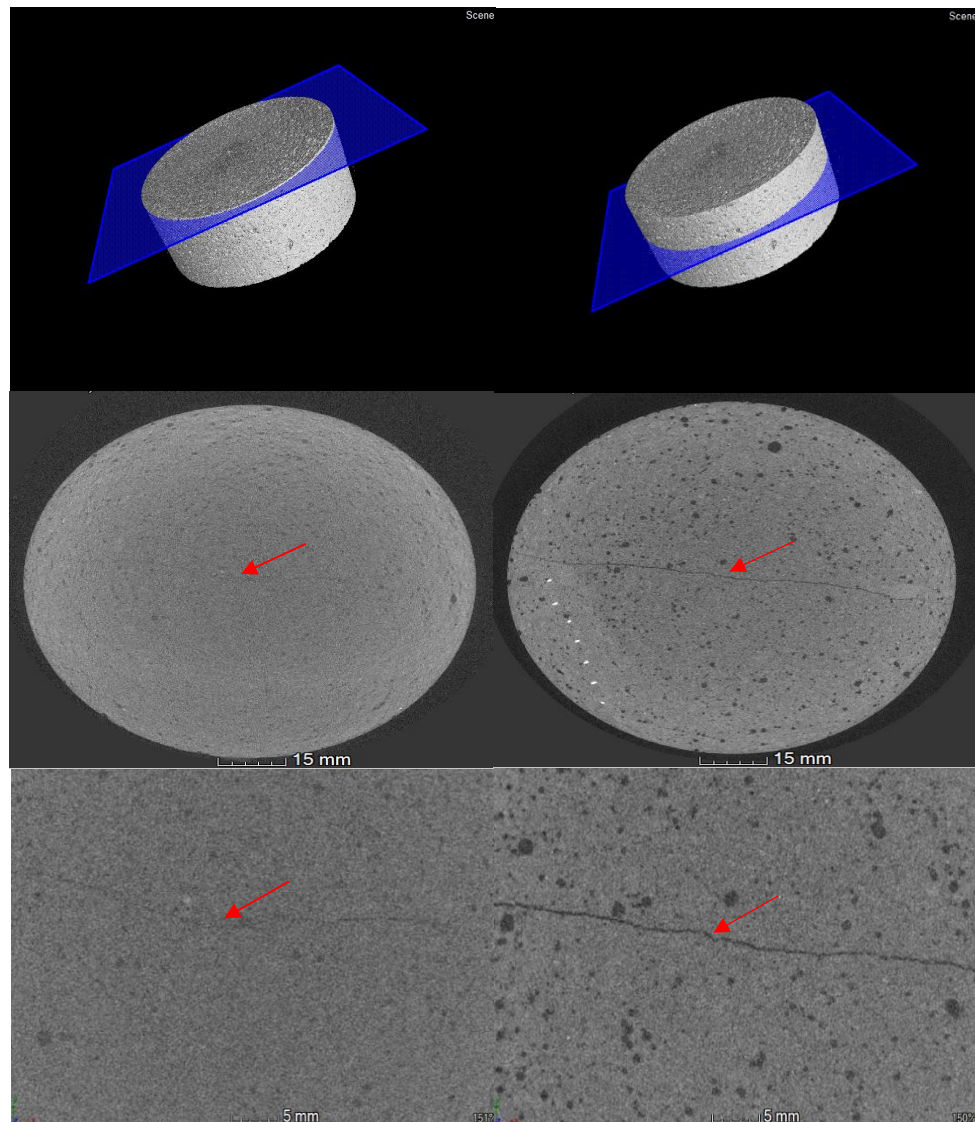
Figure 2.22 X-ray μ CT scan images show cracks at (a) surface, and (b) inside at the middle of the healed specimen.

Figure 2.22 shows X-ray tomography images of specimens after 3 months of healing. Only specimens submerged in water with crack width in the range (150 – 300 μm) were selected for X-ray μCt analysis since they exhibited visible crack healing in optical microscopy analysis.

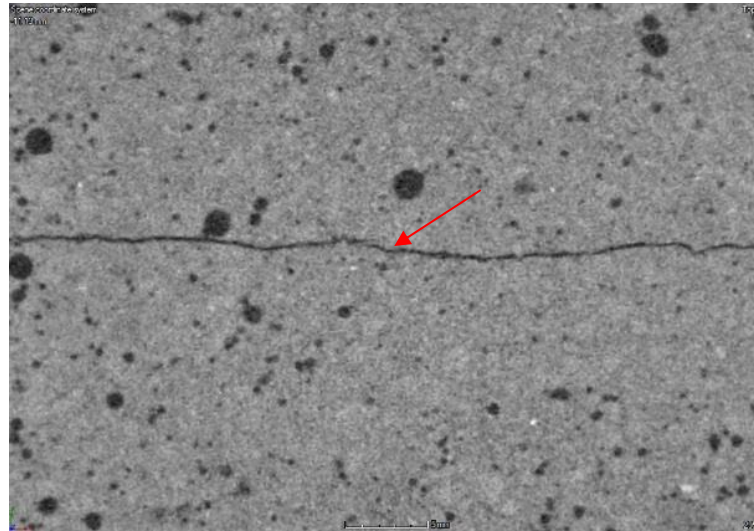
Figure 2.23 X-ray μ CT scanning images show internal cracks at 400 μ m depth below the surface of the self-healed specimen after 9 months of water submersion.

using X-ray μ Ct. Images from X-ray μ Ct scans indicate that the crack width at the interior of specimens remained unchanged, as shown in **Figure 2.23**.

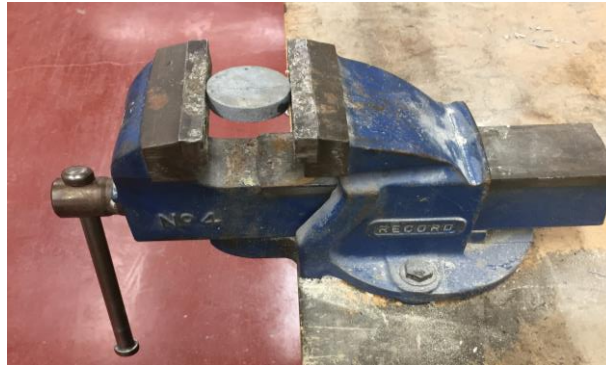
Figure 3.1 Cracking of specimens using screw jack.

Crack was created at the age of 28 days using a screw jack as shown in the (Fig. 3.1). The crack width was controlled during the screwing process via a calibration ruler. For each environmental exposure, three groups of specimens with three different values of crack width were tested. The first group consisted of three specimens with an average crack width in the range of 50 – 150 μm . For the second and third groups, the average crack widths were 150 – 300 μm and 300 – 500 μm , respectively.

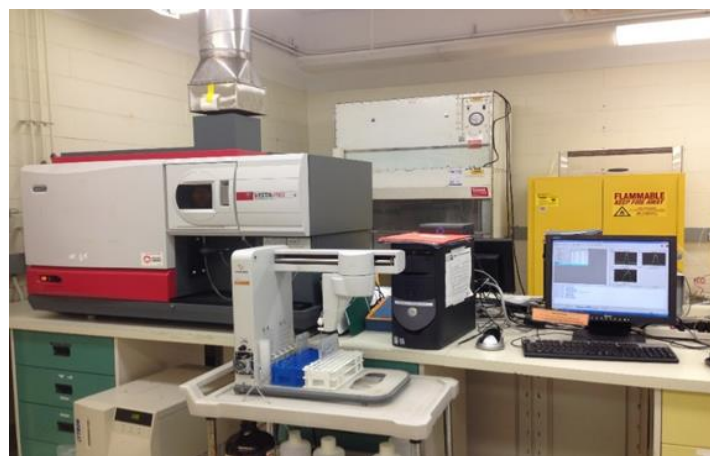
Figure 3.2 ICP-AES system.

Ions leached out from the pre-cracked mortar specimens were analysed using a Varian Vista Pro apparatus, as shown in (3.2). The wavelength range was 167-785 nanometer with Peltier cooled CCD detection. Before the test, pre-cracked mortar specimens were immersed into de-ionized water to allow the ions to leach out of the specimens.

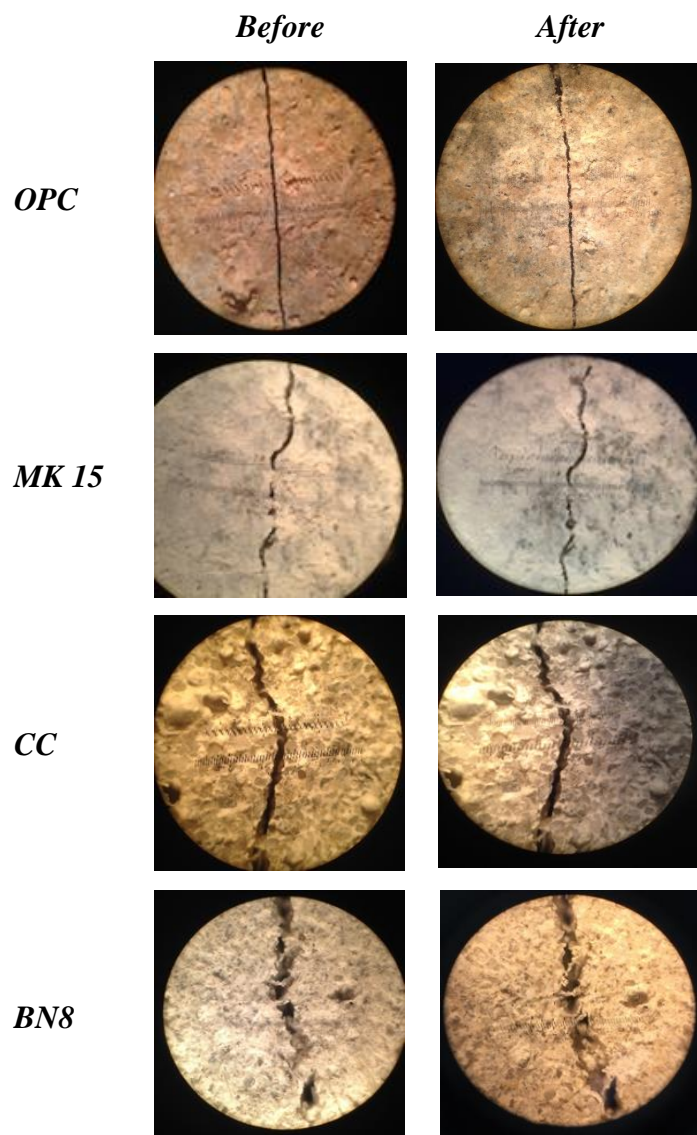
Figure 3.3 Surface cracks before and after exposure to cyclic T and RH showing no self-healing.

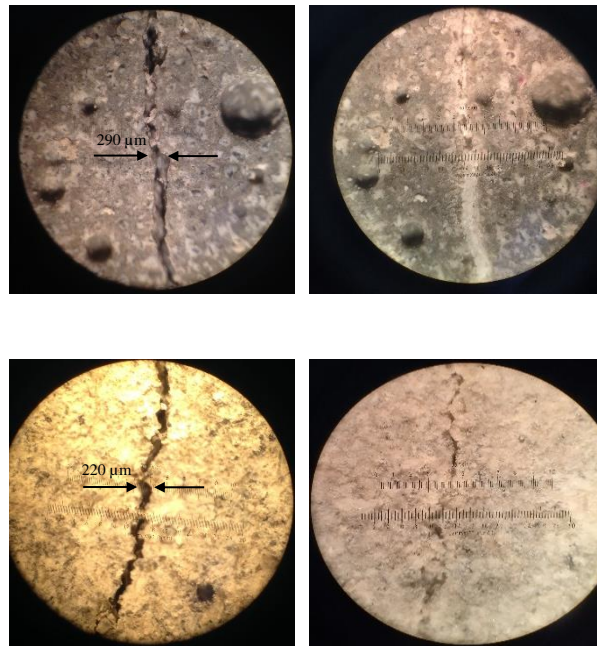
Figure 3.4 Surface cracks in OPC specimens before and after water submersion showing self-healing.

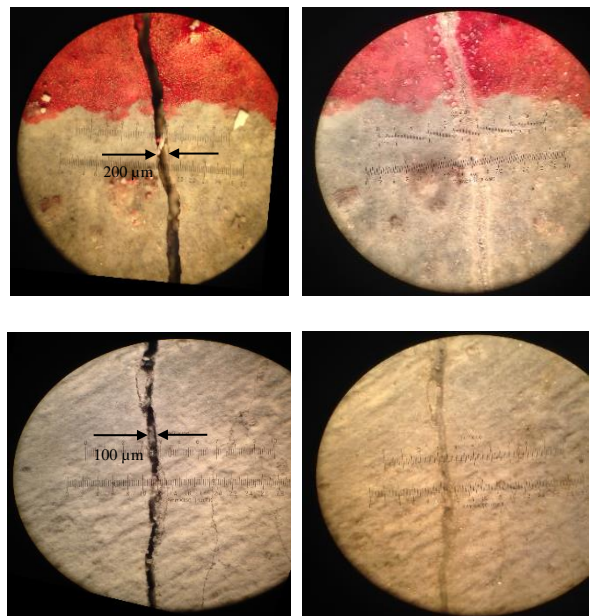
Figure 3.5 Surface cracks in MK15 specimens before and after water submersion showing self-healing.

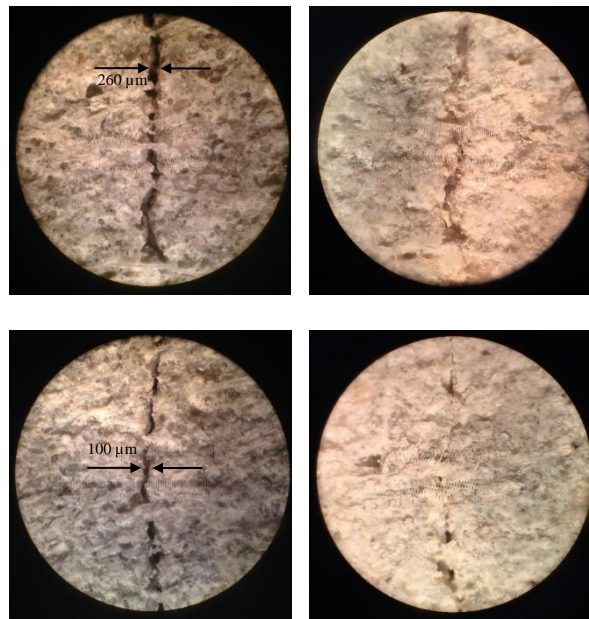
Figure 3.6 Surface cracks in BN8 specimens before and after water submersion showing self-healing.

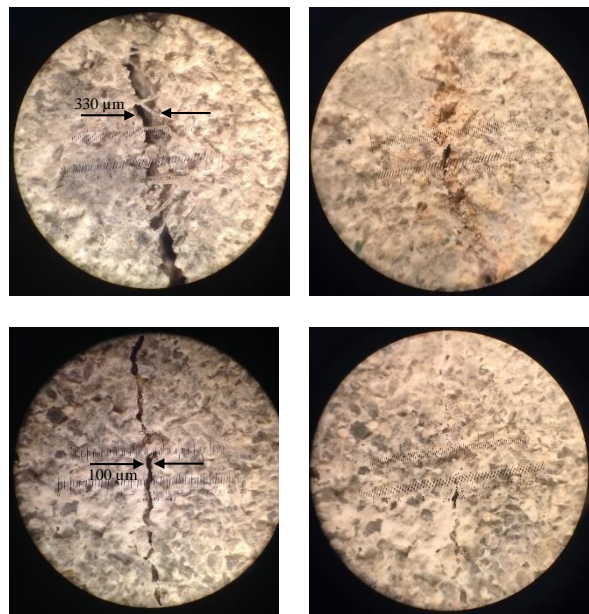
Figure 3.7 Surface cracks in CC8 specimens before and after water submersion showing self-healing.

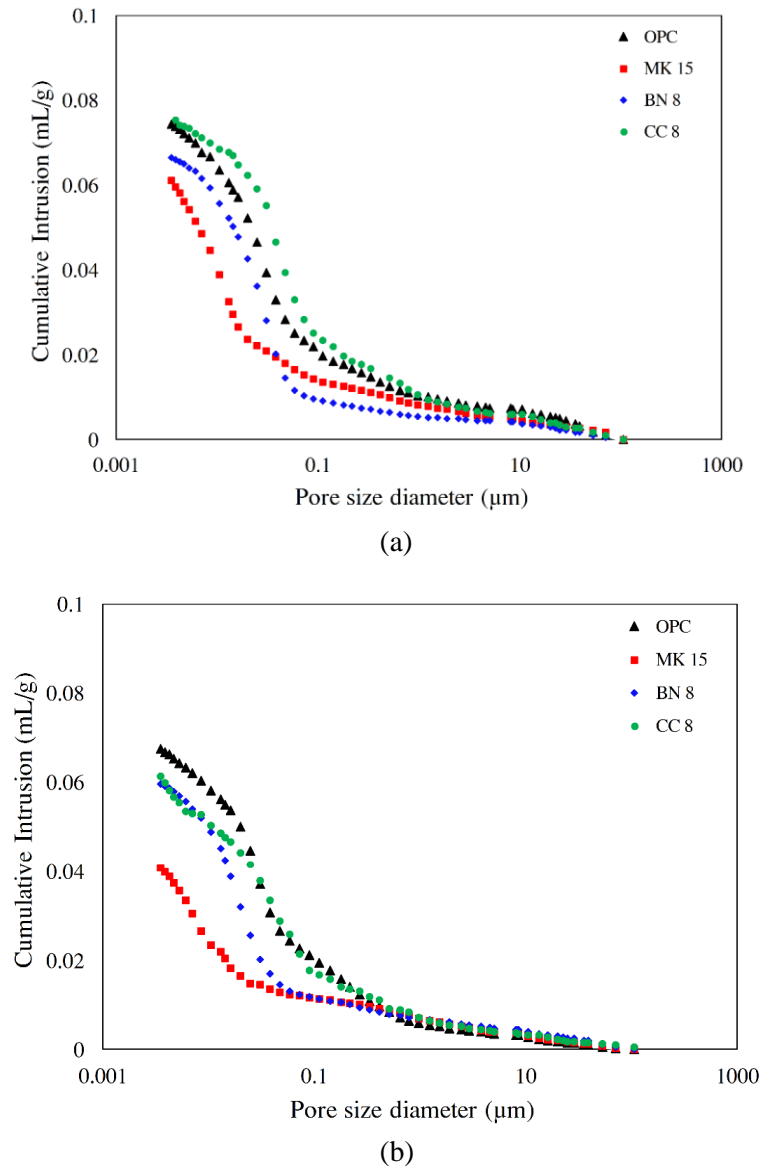
Figure 3.9 Cumulative intruded pore volume vs. pore diameter for cracked specimens (a) at 28 days, and (b) one year after water submersion.

The evolution of pore structure with time was investigated using MIP. Only specimens that exhibited self-healing were tested. **Figure 3.9** displays the cumulative mercury intrusion curves as a function of the pore diameter for cracked mortar specimens before and after water submersion.

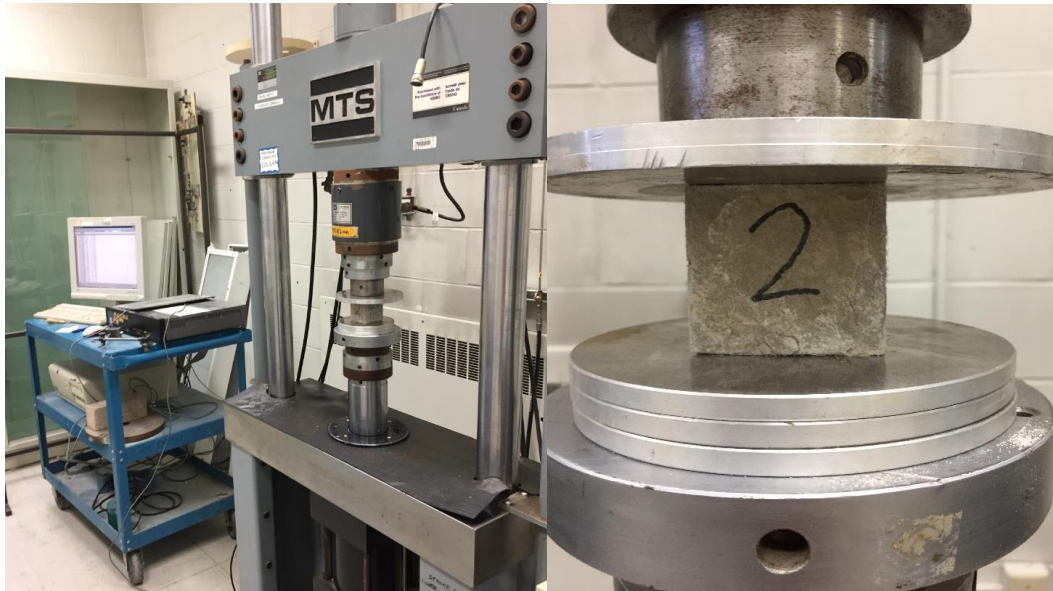
Figure 4.1 Cracking of specimens using MTS machine.

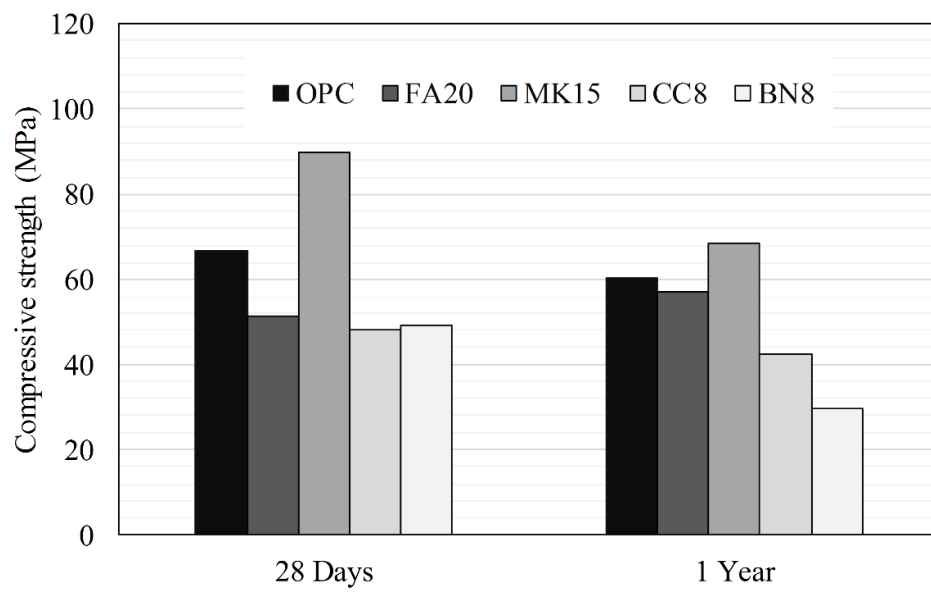
Figure 4.4 Compressive strength of pre-cracked specimens submerged in water.

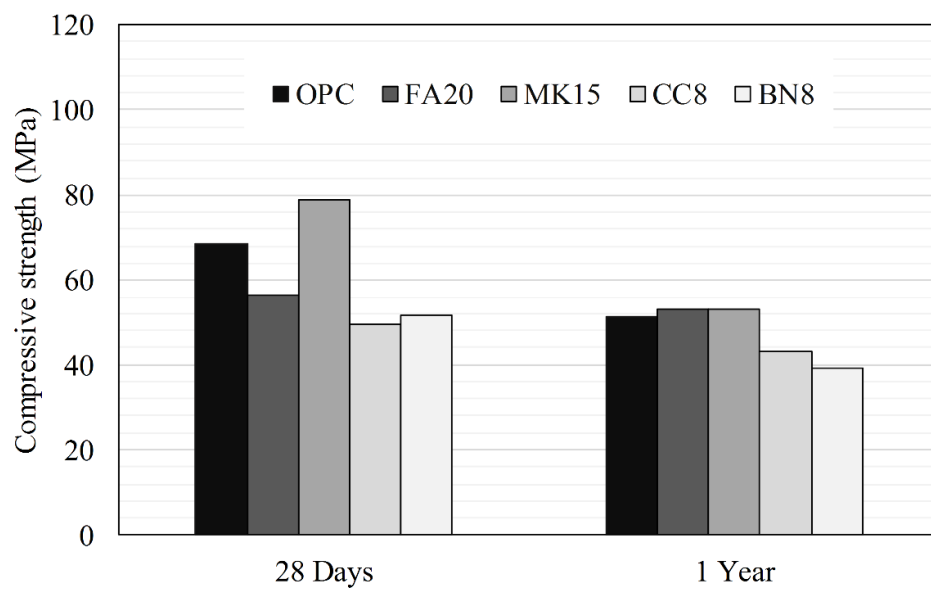
Figure 4.5 Compressive strength of pre-cracked specimens exposed to cyclic T and RH.

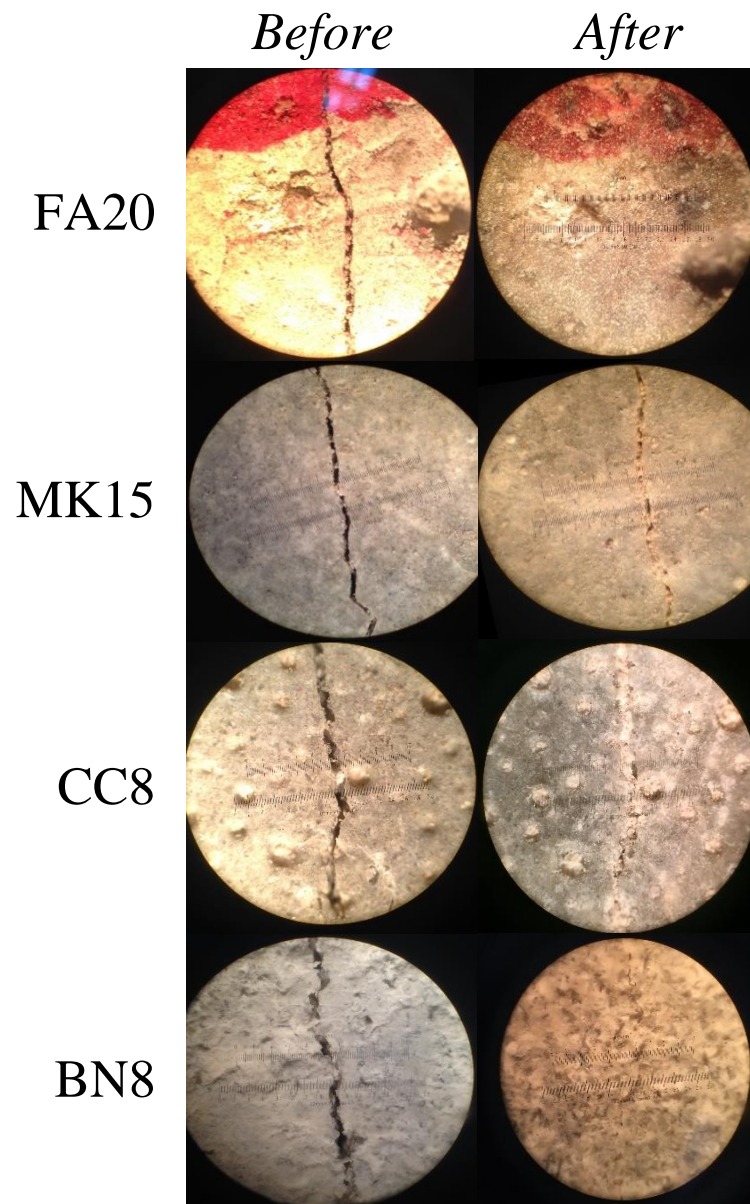
Figure 4.7 Surface cracks before and after water submersion showing self-healing.

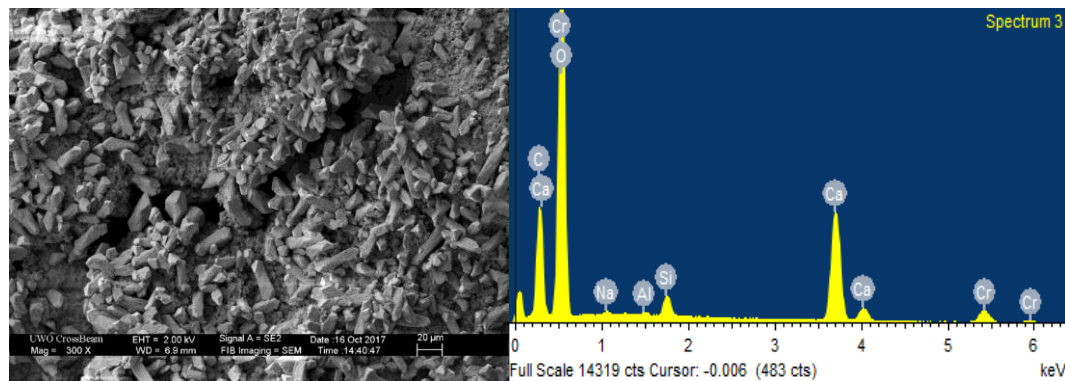
Figure 4.8 SEM micrograph with EDX pattern of products in self-healed cracks of CC8 specimens.

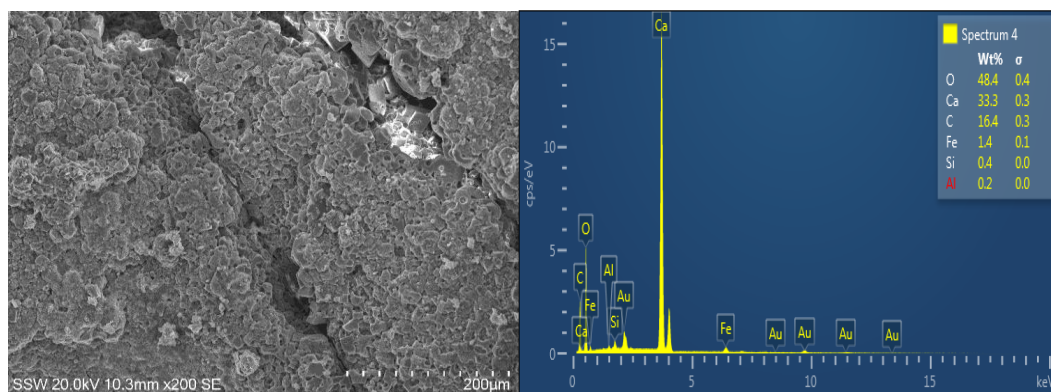
Figure 4.9 SEM micrograph with EDX pattern of products in self-healed cracks of FA20 specimens.
