Self-healing of Concrete Under Diverse Environmental Exposure

Ahmed Ramadan Suleiman, *The University of Western Ontario*

A thesis submitted in partial fulfillment of the requirements for the Doctor of Philosophy degree
in Civil and Environmental Engineering

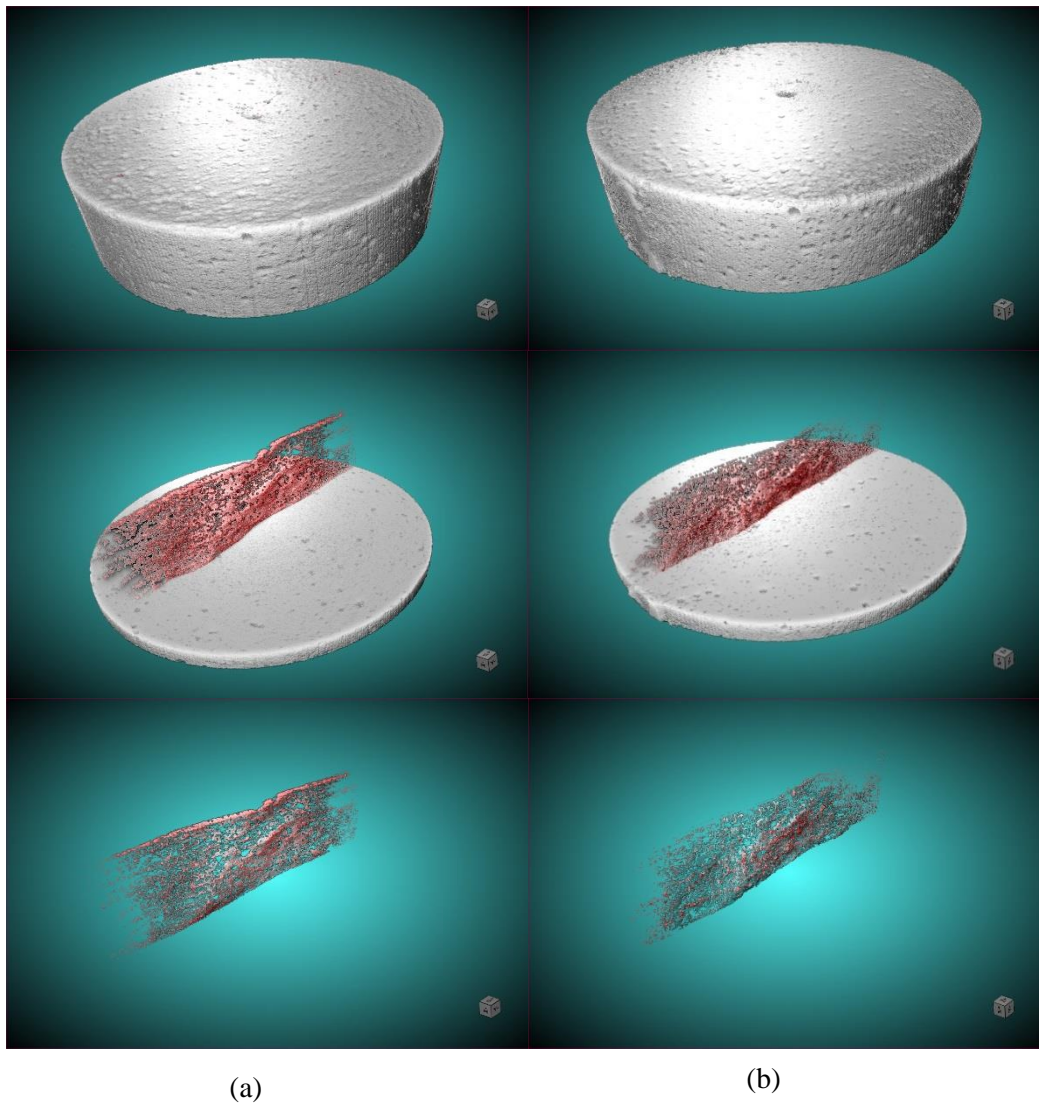
Figure 4.10 X-ray μ CT scan images for FA20 specimen submerged in water showing (a) before self-healing, and (b) after self-healing.

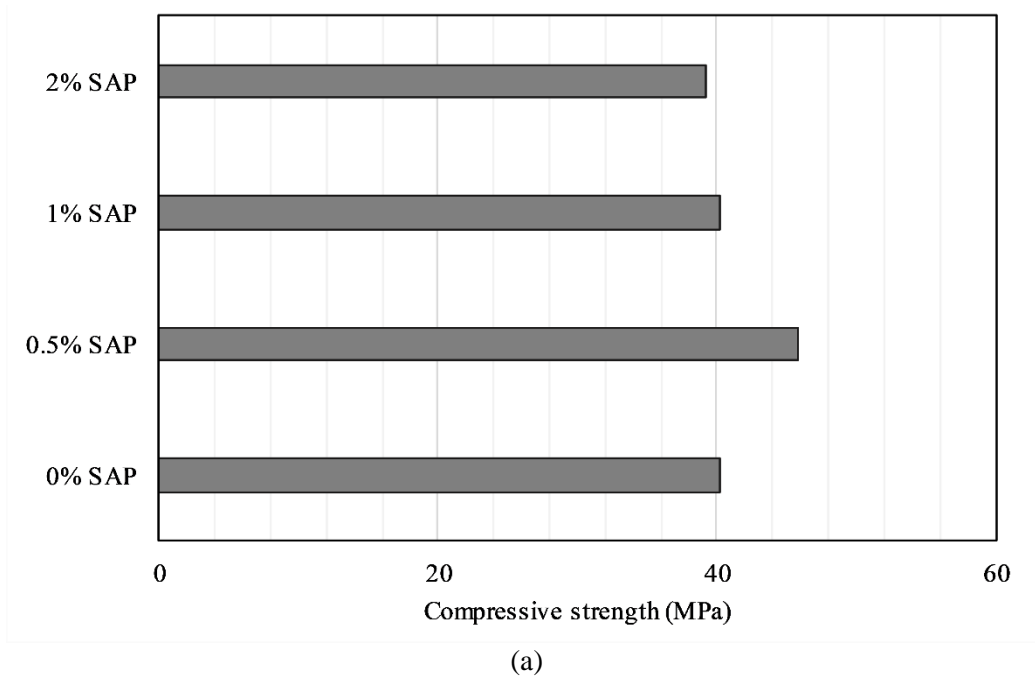
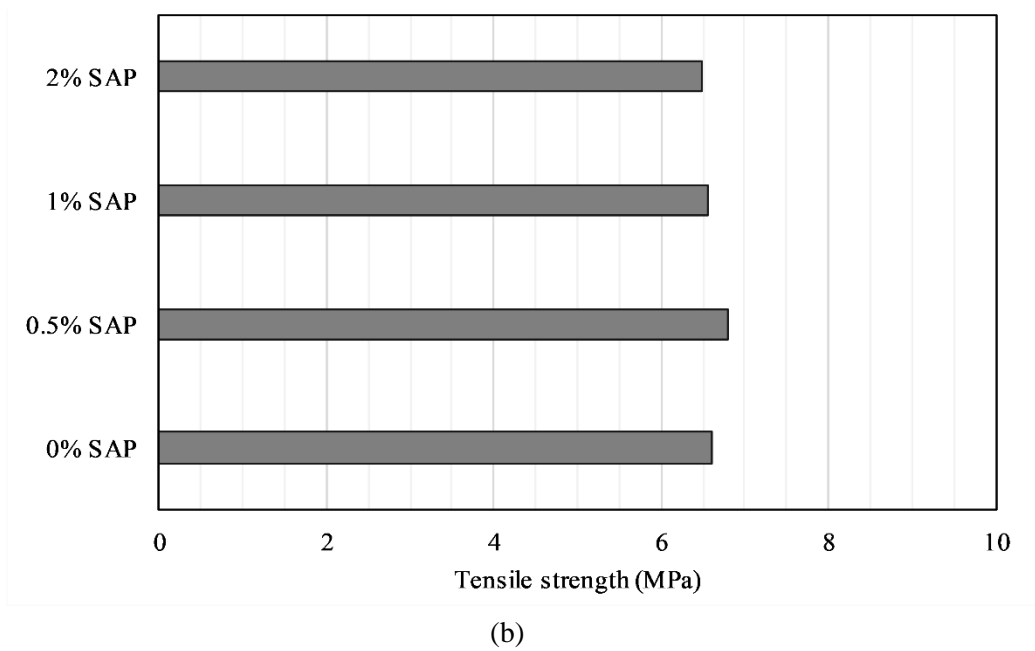
Figure 5.1 (a) Compressive, and (b) tensile strength of specimens (with and without SAPs) after 28 days.

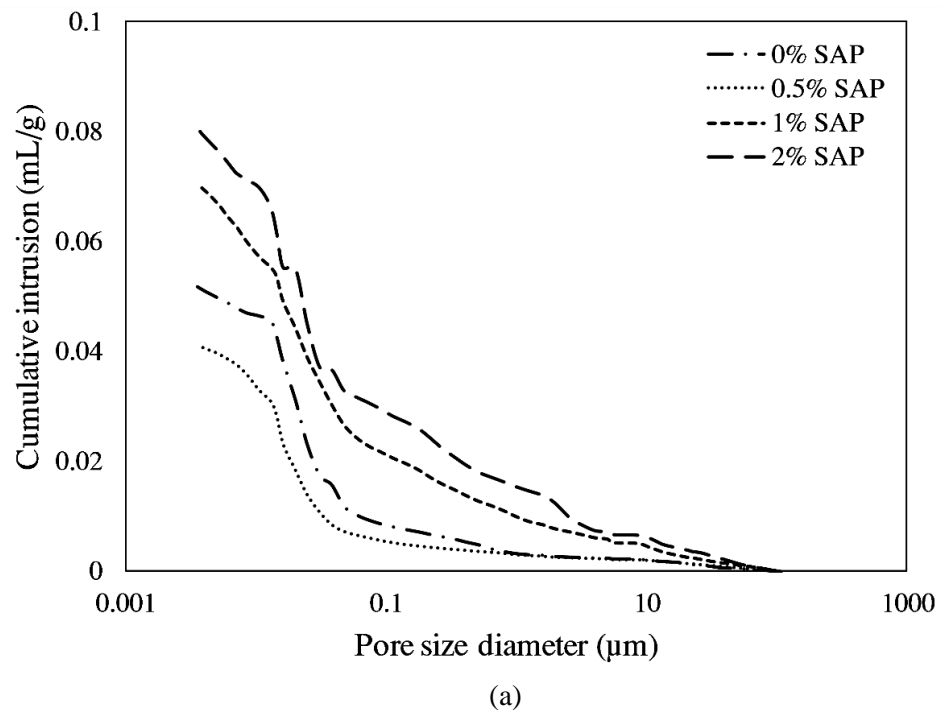
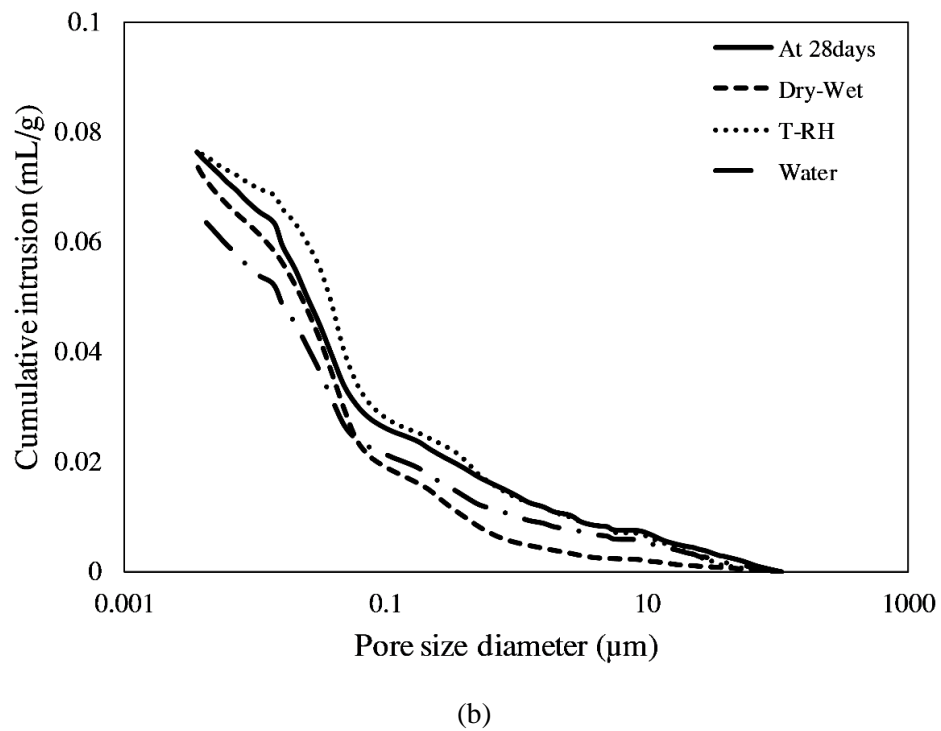
Figure 5.2 Cumulative intruded pore volume vs. pore diameter for cracked specimens (a) at 28 days, and (b) specimens with 1% SAP after five months of exposure to different environments.

On the other hand, MIP results showed that the total porosity of cement mortars with SAPs increased as the SAPs content increased beyond 0.5%. During hardening, SAP particles release the absorbed water and shrink, leaving behind in the cementitious matrix voids having hundreds of microns in size (Snoeck *et al.*, 2015-b); Lee *et al.*, 2016). For example, previous study by Snoeck *et al.* (2014) investigated the effect of high amounts of SAPs on the properties of cementitious materials. Their results showed that increasing the amount of SAP particles in cement mortars resulted in increasing the total amount of pores. This effect was more pronounced with smaller SAP particles, due to their higher surface area available to combine mixing water (Snoeck *et al.*, 2014).

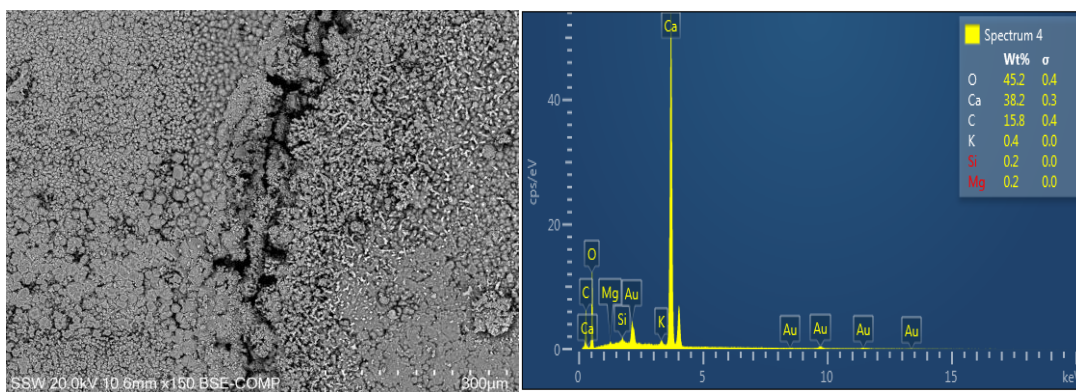
Figure 5.5 SEM micrograph with EDX pattern of products in self-healed cracks of specimens with 1% SAP after water submersion.

For the third group of specimens having initial crack widths of 300 – 500 μm , surface cracks showed no or very minor self-healing. Similar results were reported by others who found that the maximum surface crack width healed due to autogenous or improved autogenous self-healing (using crystalline, expansive, or other supplementary cementitious materials) was less than 400 μm for specimens submerged in water (Van Tittelboom *et al.*, 2012; Roig-Flores *et al.*, 2015; Sahmaran *et al.*, 2013; Sisomphon *et al.*, 2012; Jiang *et al.*, 2015). According to Van Tittelboom *et al.* (2012), as the crack width increased, crack self-healing became more difficult. This indicates that crack self-healing is inversely proportional to the crack width. In the current study, at the beginning of the experiment, although only the specimens incorporating SAPs exhibited rapid self-sealing, after five months of water submersion, the permeant surface crack healing for specimens (with and without SAPs) submerged in water was comparable. **Figure 5.5** shows typical SEM images and EDX analyses for healing products formed within surface cracks for specimens submerged in water. SEM was used to observe the surface morphologies of the healing products, and EDX was used for elemental analysis. It can be observed that the self-healing products had multiple-shaped and irregular crystals. EDX analysis at different locations showed that the healing products at crack surfaces in all specimens were mainly composed of three elements, namely calcium, carbon and oxygen, indicating that it primarily consists of CaCO_3 .

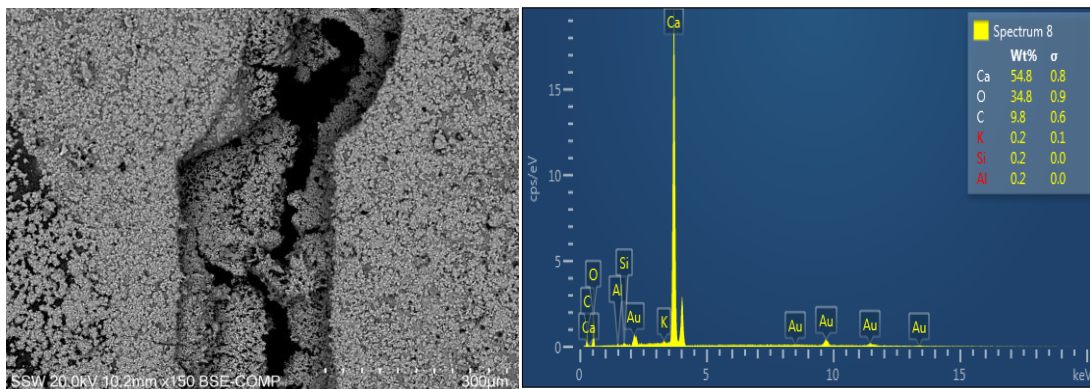
Figure 5.7 SEM micrograph with EDX pattern of products in self-healed cracks of specimens with 1% SAP after cyclic wetting and drying.

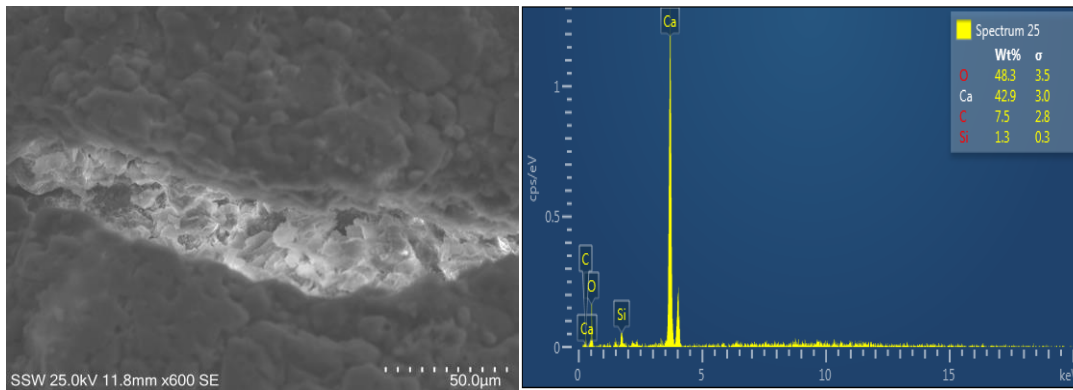
Figure 5.9 SEM micrograph with EDX pattern of products in self-healed cracks of specimens with 1% SAP after exposure to cyclic T and RH.

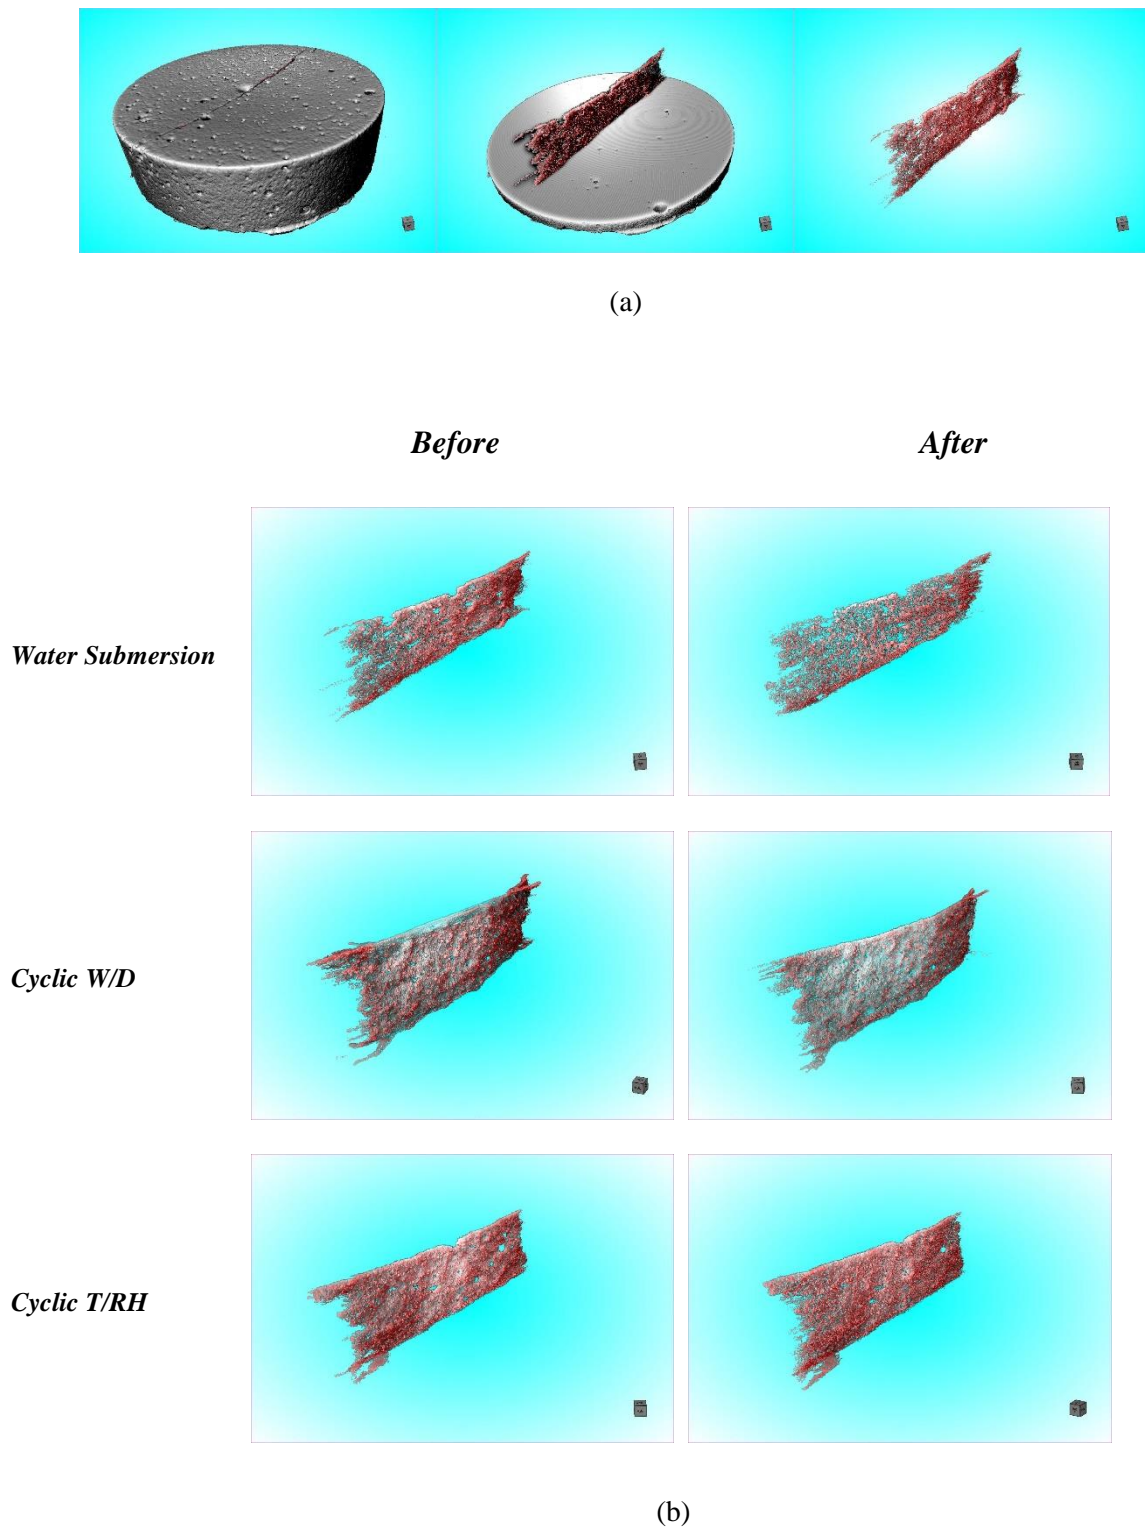
Figure 5.10 3D-images of the (a) crack segmentation, and (b) crack profile before and after self-healing.

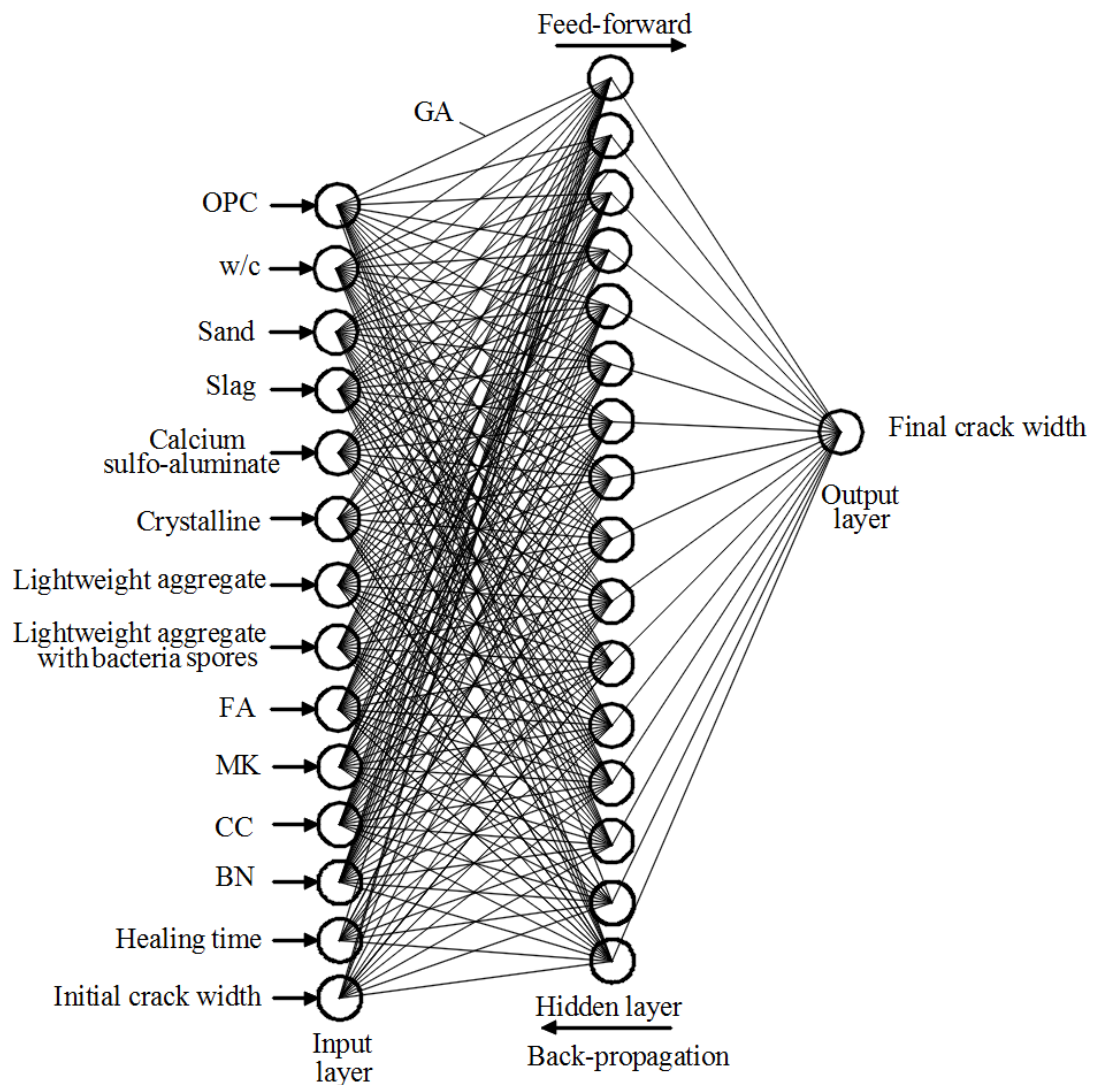
Figure 6.2 Architecture of genetic algorithm–artificial neural network (GA-ANN) model.

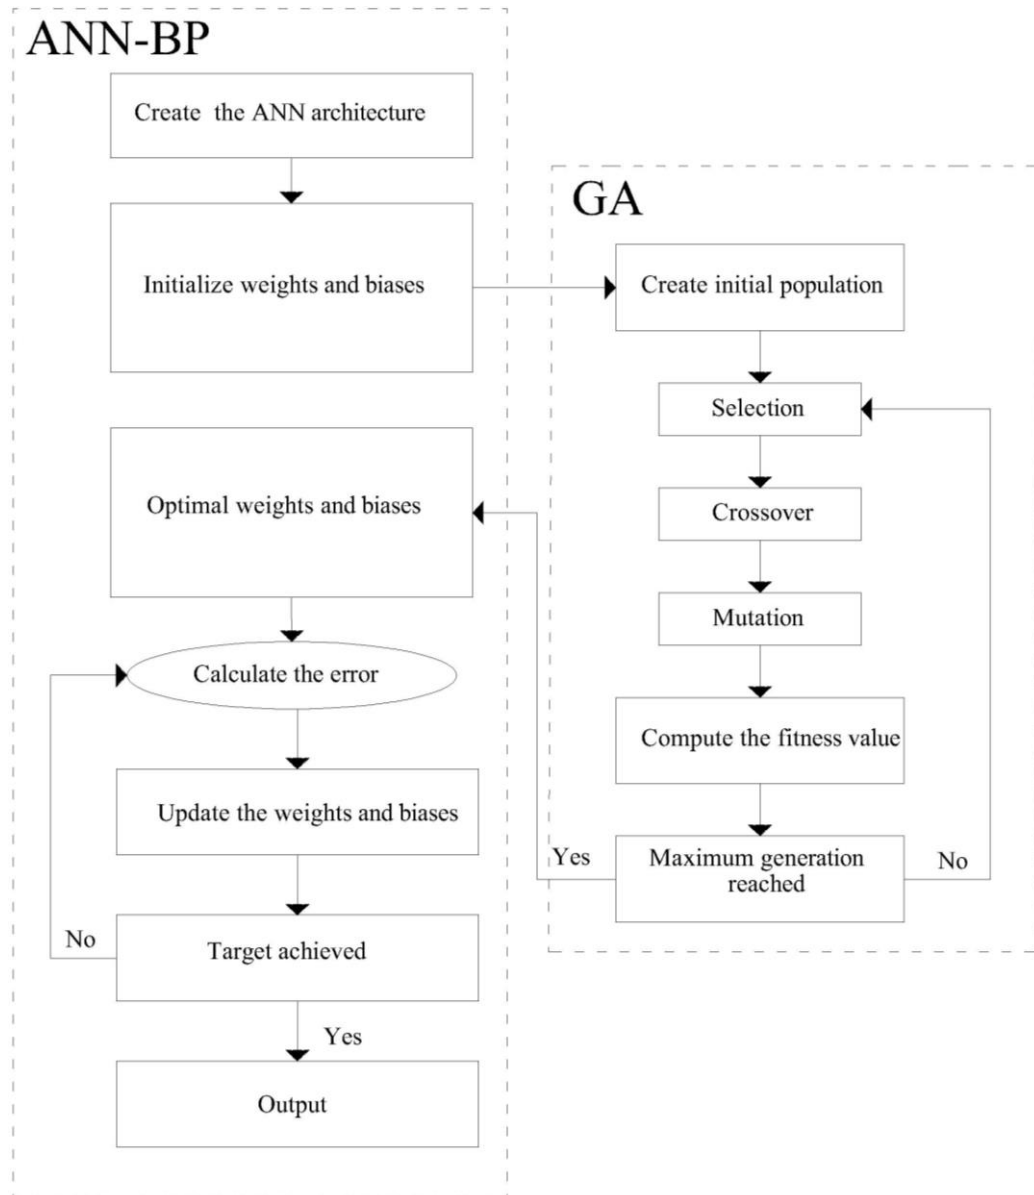
Figure 6.3 Flowchart of artificial neural network–back-propagation (ANN–BP) optimized by GA.

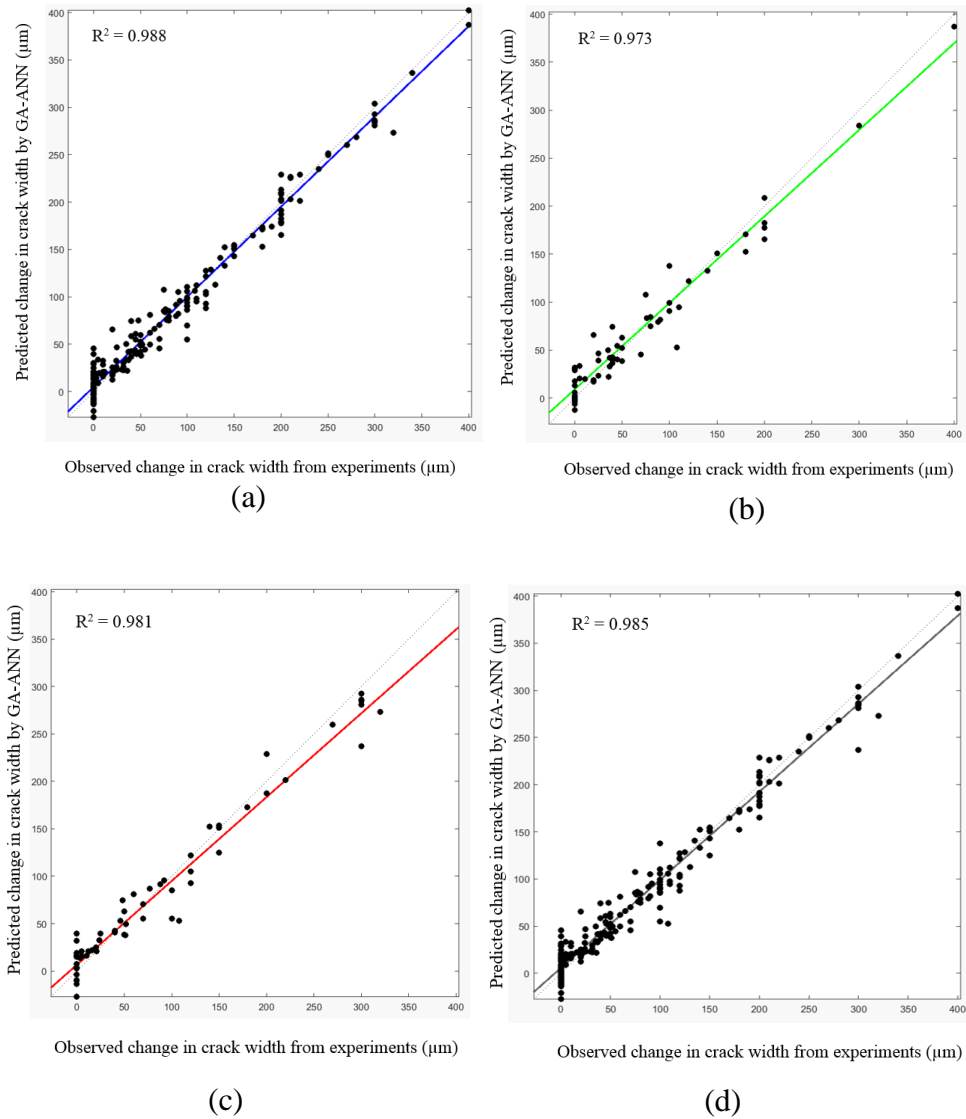
Figure 6.4 Regression plot of GA–ANN predicted change in crack width due to self-healing versus the corresponding experimentally observed change in crack width: (a) training; (b) validation; (c) test; and (d) complete data set.

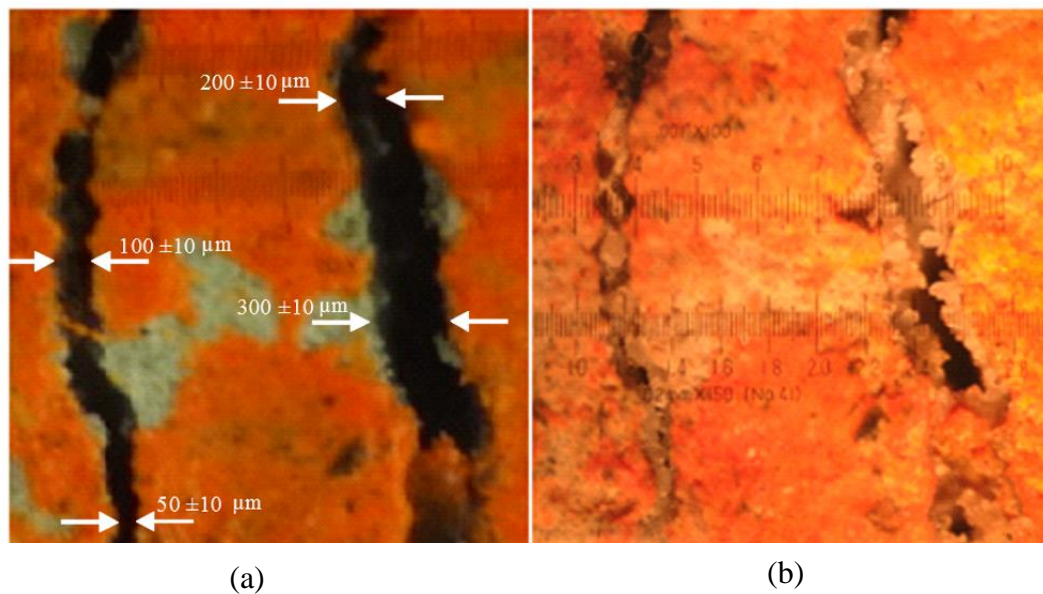
Figure 6.5 Crack healing process: (a) cracks before healing; (b) cracks after 42 days of healing.

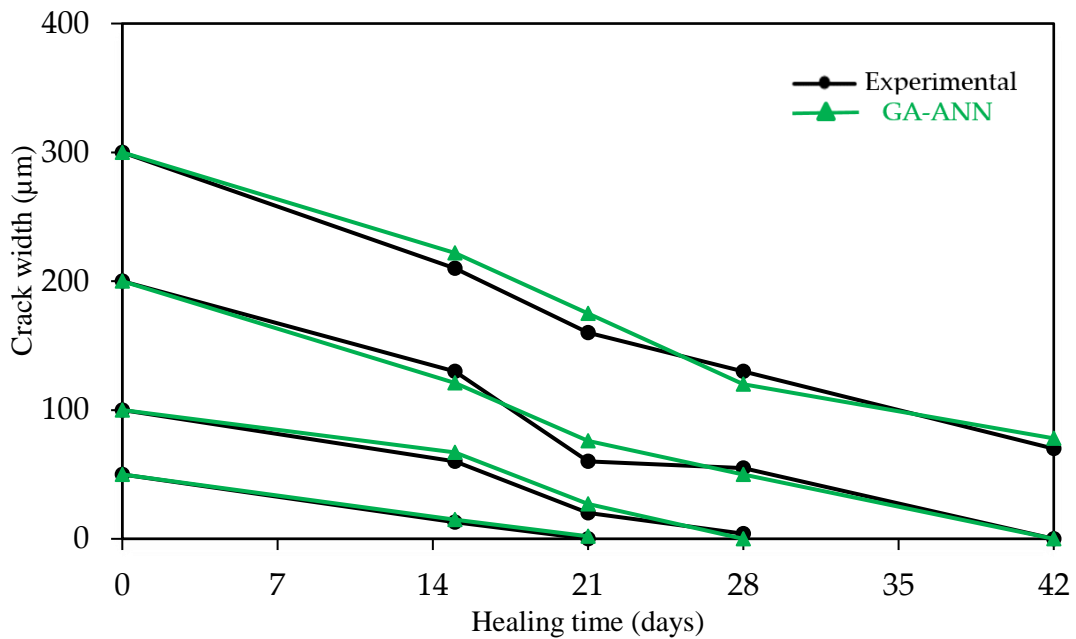
Figure 6.6. GA–ANN model predictions of crack self-healing (reduction in crack width) of cementitious materials versus corresponding experimentally measured results.

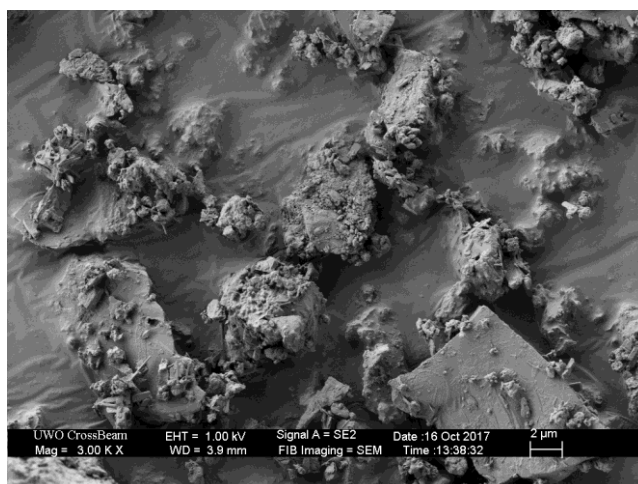
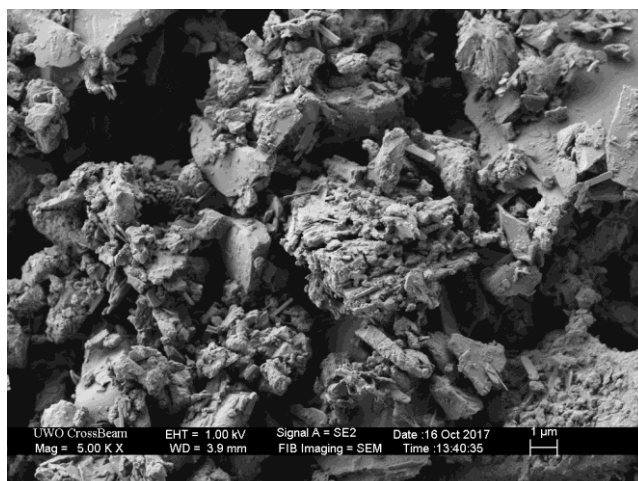
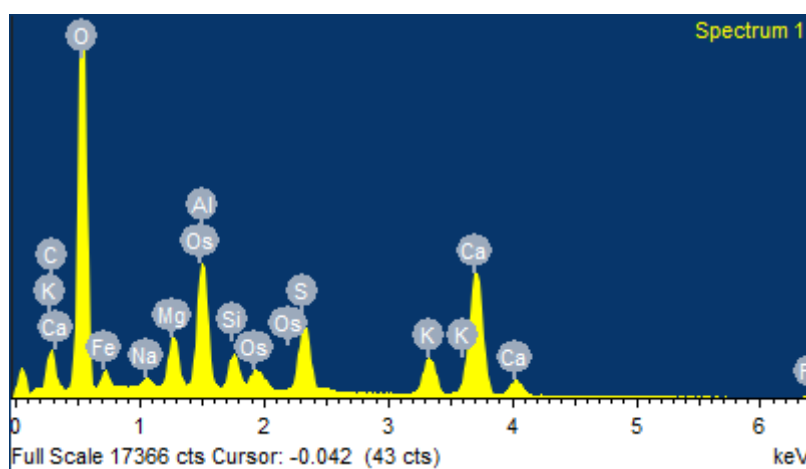
Figure A. 1 SEM micrograph with EDX pattern of the used cement.
