## Three-dimensional subsurface defect shape reconstruction and visualisation by pulsed thermography

Adisorn Sirikham<sup>a</sup>, Yifan Zhao<sup>a,\*</sup>, Haochen Liu<sup>a</sup>, Yigeng Xu<sup>a</sup>, Stewart Williams<sup>a</sup>, Jörn Mehnert<sup>b</sup>

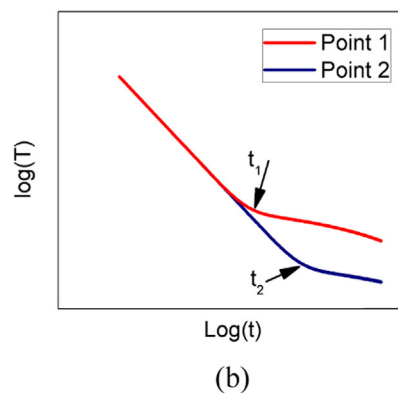
**Fig. 1.** (a) Experimental configuration of the pulsed thermographic inspection under the reflection mode, where point 1 denotes a surface location with a defect underneath and point 2 denotes a location on the sample surface with no defect underneath; (b) Typical observed time-temperature decay curves in the logarithmic domain for the point 1 and 2, respectively, where the time of  $t_1$  and  $t_2$  is the key to measure the thickness of local materials [7].

In a pulsed thermographic inspection in reflection mode, a short and high energy light pulse is projected onto the sample surface through one or two flash lamps (see Fig. 1(a) for typical experimental setup) [33].

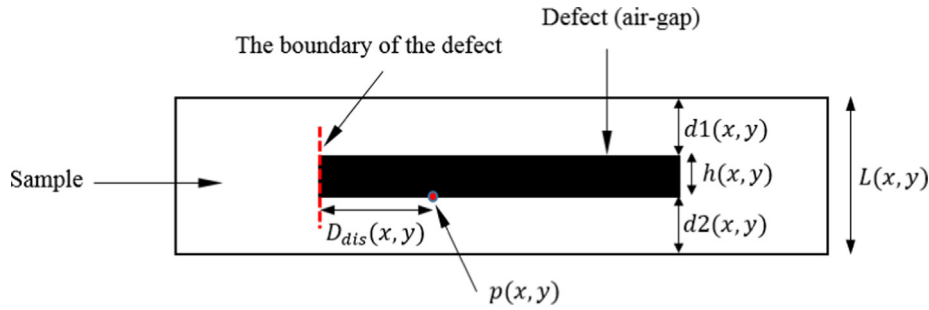
Fig. 2. The side view of subsurface defects.

The method of double-side inspection reconstructs the 3D structure of defects by evaluating the defect depth from both sides of the sample. As seen in Fig. 2, the defect thickness ( $h$ ), at the position of  $x$  and  $y$ , can be calculated by

$$h(x, y) = L(x, y) - (d1(x, y) + d2(x, y)) \quad (8)$$

where  $h(x, y)$  is the defect thickness,  $L(x, y)$  is the thickness of the sample,  $d1(x, y)$  is the defect depth from the top surface, and  $d2(x, y)$  is defect depth from the bottom surface. The thickness of the sample can be measured by general measurement tools such as ruler or Vernier calipers, or by the thermographic inspection directly through the method introduced in Section 2.1 if an automatic approach is required. Defect depth can be estimated by methods such as PST [4,12], LSD [14], APST [13], NSI [7], LSF [15,16], or NLSF [8] method. In this paper, the NLSF method is employed to estimate the defect depth due to its fine performance.

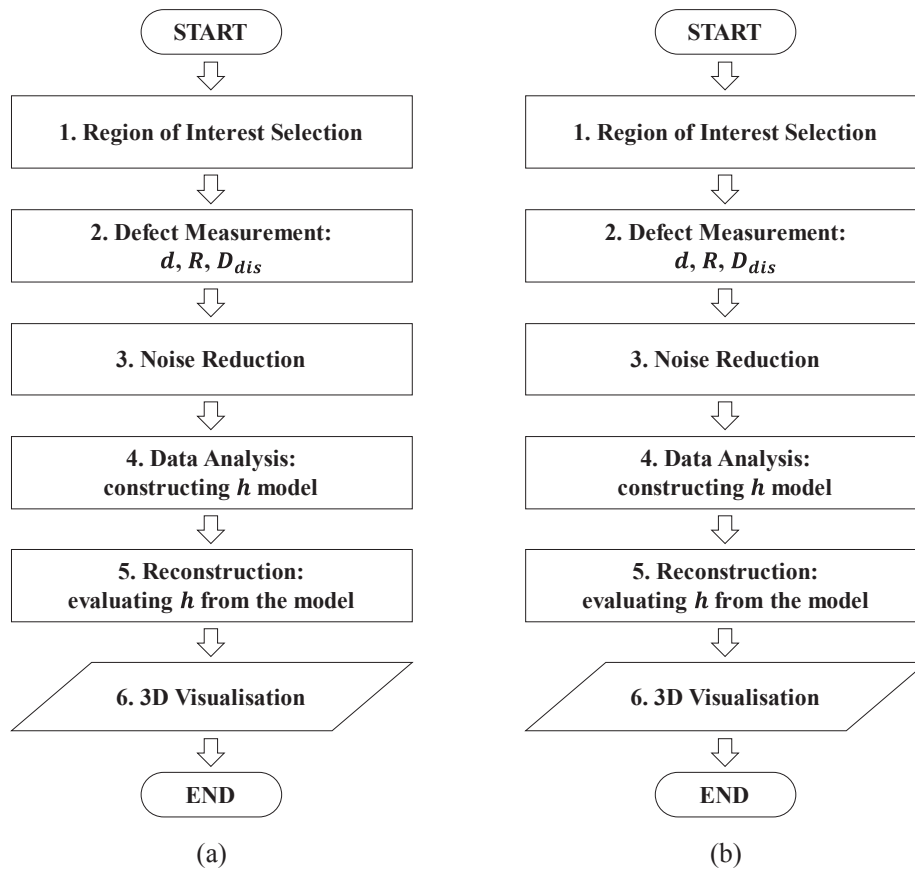
Fig. 3. Inspection process for (a) the single-side inspection and (b) the double-side inspection.

The single-side inspection and the double-side inspection can be described in the flowcharts as shown in Fig. 3. For the single-side inspection, the first step is to select the region of interest (ROI), which aims to select a region for defect estimation and visualisation to reduce overall processing time. The ROI was selected manually in this paper. The second step is defect measurement to obtain subsurface

information of ROI including defect depth ( $d$ ), the shortest distance from the boundary of the defect to the inspecting point ( $D_{dis}$ ), and thermal wave reflection coefficient of the defect ( $R$ ), which are achieved by the NLSF method. The third step is noise reduction to enhance image quality ( $R$  image and  $d$  image), which is achieved by the application of a Median Filter [35] in this paper. The fourth step is to establish the relationship model between  $h$ ,  $R$ , and  $D_{dis}$ , shown in Eq. (3), based on the estimated parameters in the second step. The fifth step is to estimate the defect thickness based on the established model. The last step is to visualise the defect in the form of a 3D image, where the reconstructed defect (size, depth, thickness, and location of the defect) is fused with the dimension (width, length and thickness) of the sample to produce a volume image. This volume image is then rendered and displayed in the form of a 3D image. For the double-side inspection, most steps are similar to the single-side inspection except the second, the fourth, and the fifth step. In the second step, the sample's thickness and defect depth of the both side of the sample are required, whilst the defect depth from the single-side inspection requires one side only. The fourth step is to align the position of the defect region between the front side and the back side and the fifth step is to estimate the defect thickness from Eq. (8).

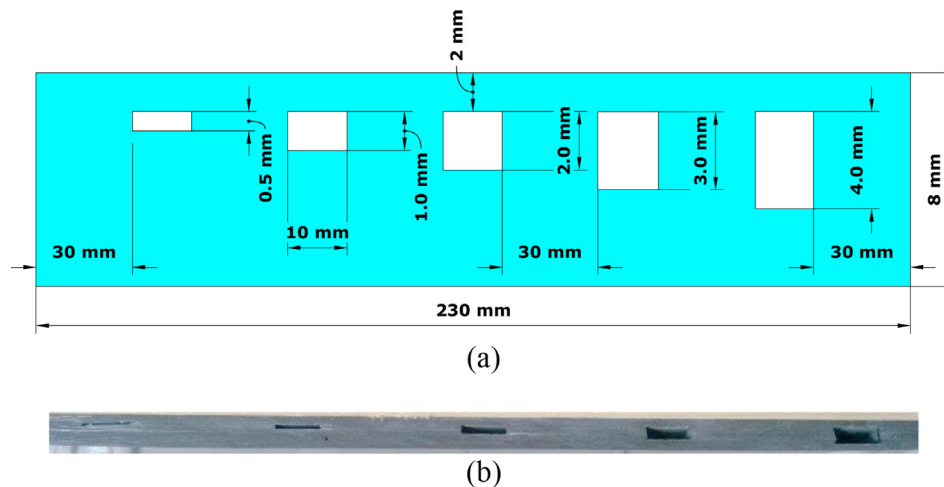
Fig. 4. Illustration of Sample 1 (a) Sample design (b) Side view.

A flat plate of carbon fibre reinforced polymer (CFRP) material was used in this study. The plate was made of unidirectional Toray 800 carbon fibres pre-impregnated with Hexcel M21 epoxy resin and manufactured in a traditional autoclaving process. The dimension of Sample 1 is 75 mm × 230 mm × 8 mm. As illustrated by Fig. 4(a), it includes five block defects with a thickness ( $h$ ) of 0.5 mm, 1.0 mm, 2.0 mm, 3.0 mm, and 4.0 mm, respectively, named Defect1 to Defect5. The width ( $r$ ), length, and depth ( $d$ ) for all defects are 10 mm, 75 mm, and 2 mm respectively. The distance between two adjacent defects is 30 mm, which aims to reduce the influence from the adjacent defects on the thermal behaviour. A side view of the produced sample is shown in Fig. 4(b). It should be noted that these defects are not fully closed because two sides of the defects are open. This sample is aimed at studying the relationship between  $R$ ,  $h$ , and  $D_{dis}$  when  $d$  is fixed.

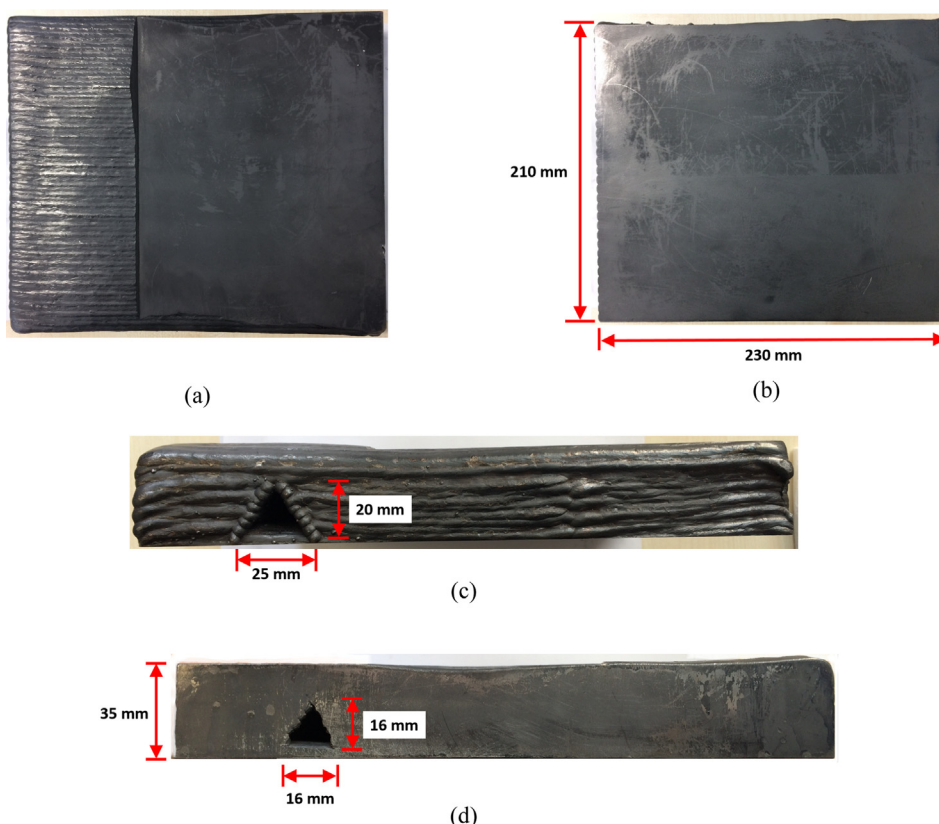
Fig. 5. Snapshots of Sample 2: a steel plate with triangle air-gap defects (a) the back side of the sample (b) the front side of the sample and inspected side (c) the top side of the sample (d) the bottom side of the sample.

As a use case, Sample 2 was made from steel with a dimension of 210 mm × 240 mm × 35 mm, as shown in Fig. 5. There is an 'S' shape triangular air-gap through the sample. By measurement, at the top side of the sample, the defect is estimated to be triangular in shape, which has the base about 25 mm and the maximal thickness about 20 mm, illustrated in Fig. 5(c). At the bottom side of the sample, the defect is also estimated to be triangular in shape, which has the base about 16 mm and the maximal thickness about 16 mm, illustrated in Fig. 5(d). The sample was inspected at the flat side using the proposed single-side thermographic inspection, illustrated as Fig. 5(b).

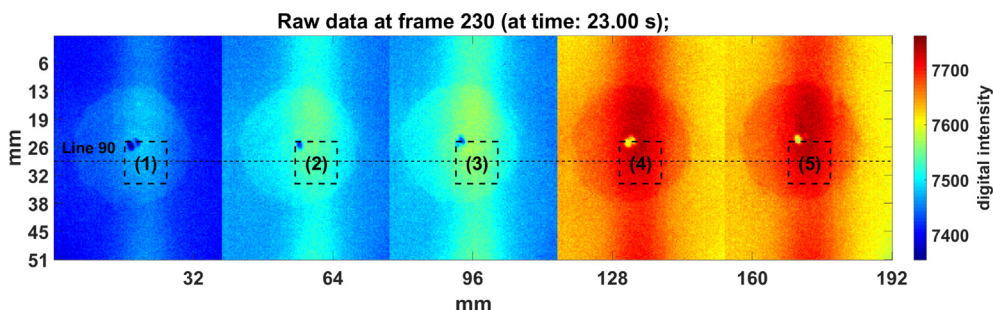
Fig. 6. The raw thermal image at the frame 230 for Sample 1 after combining 5 inspections, where the regions of interest are highlighted.

Due to the large width of Sample 1 (230 mm), the defects of this sample suffer non-uniform heating for a single inspection, which could lead to unreliable results [36]. To reduce this effect, in this study the sample has been inspected five times, where each defect was placed on the centre of the camera’s view once. An area of the centralised defect with the size of 160 × 120 pixels for five data files was then cropped and merged into one file with a size of 160 × 600 pixels for easier analysis. Fig. 6 shows a snapshot of the raw thermal image at time 23 s. The defects are labelled as “(1)”, “(2)”, “(3)”, “(4)”, and “(5)” to represent the defect thickness of 0.5 mm, 1.0 mm, 2.0 mm, 3.0 mm, and 4.0 mm, respectively. The ROI of each defect is about 10 mm × 10 mm (around 30 × 30 pixels), as highlighted in Fig. 6, which are used for evaluating the performance of the proposed technique.

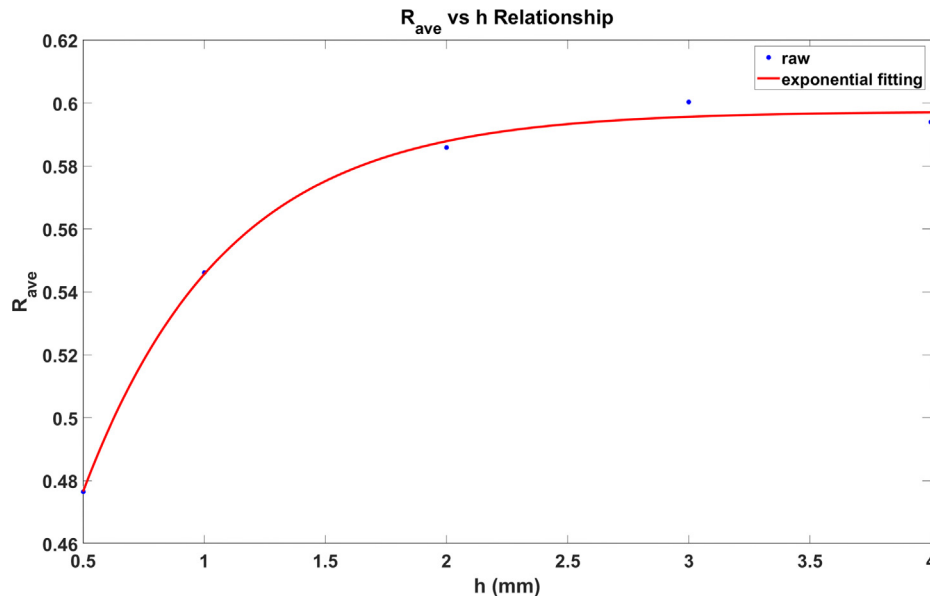
Fig. 7. The plot of  $R_{ave}$ - $h$  curve of Sample 1.

reflection coefficient ( $R$ ) requires to be established before prediction of  $h$ . To reduce the influence of the heat leaked to each opened side on the results, only a region of 6 × 30 pixels on the middle area of each defect were sampled to establish the model. Estimated  $R$  values were averaged and are shown in Table 1. The averaged  $R$  values, denoted by  $R_{ave}$ , in the middle area were used as the representative of  $R$  to establish the  $R_{ave}$  vs  $h$  relationship. It is observed that the averaged value of  $R$  increases following the increase of defect thickness. This observation is expected because the heat is more difficult to be leaked through the 3D conduction around air-gap if the defect is thicker. As can be seen from the plot between  $R_{ave}$  and  $h$  in Fig. 7, the associate is not linear but approximately exponential. An exponential fitting was applied on them, and the relationship between  $R_{ave}$  and  $h$  can be written as

$$R_{ave} = -0.2820e^{-\frac{h}{0.5898}} + 0.5974 \tag{9}$$

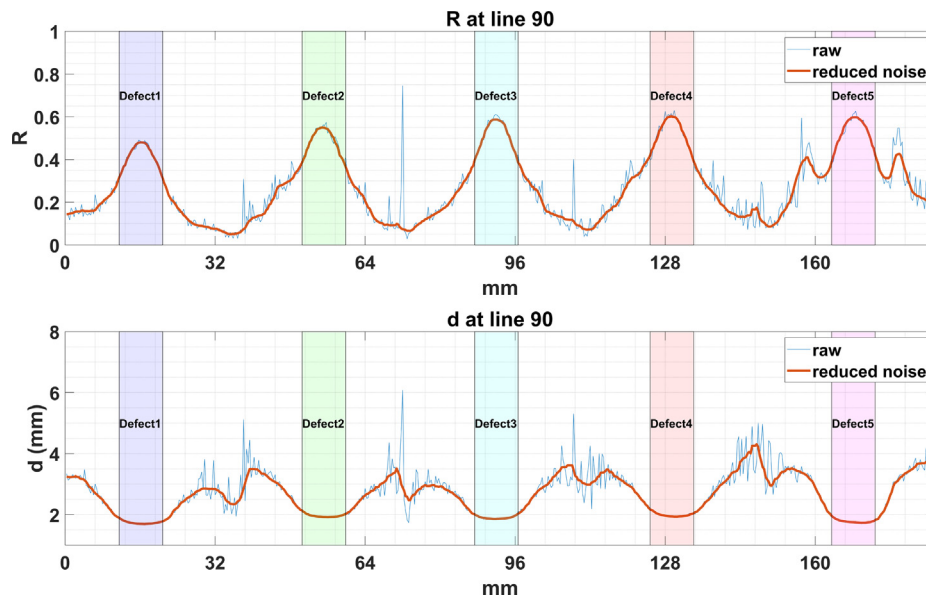
Fig. 8. Plots of estimated  $R$  and  $d$  of the cross-section at line 90.

Fig. 8 shows plots of estimated  $R$  and  $d$  of the cross-section at line 90, where it can be clearly seen that the  $R$  values are not consistent for one defect even though the five defects have a consistent thickness. It indicates that there are some other factors affected the  $R$  value. It is suggested in Fig. 8 that  $R$  value at both sides of defect's boundary is less than the middle region. This observation could be caused by the fact that the heat around the middle of the defect is more difficult to leak than that around the boundary of the defect. This issue must be addressed if the identified model from the regions of  $6 \times 30$  pixels is applied to the ROI of  $30 \times 30$  pixels. To improve the accuracy of  $R$  estimation, the shortest distance from the boundary of the defect to the inspected point ( $D_{dis}$ ), shown in Fig. 2, is taken into account to correct the  $R$  value. The re-calculated  $R$  ( $R_{new}$ ) is a function of  $R$  and  $D_{dis}$

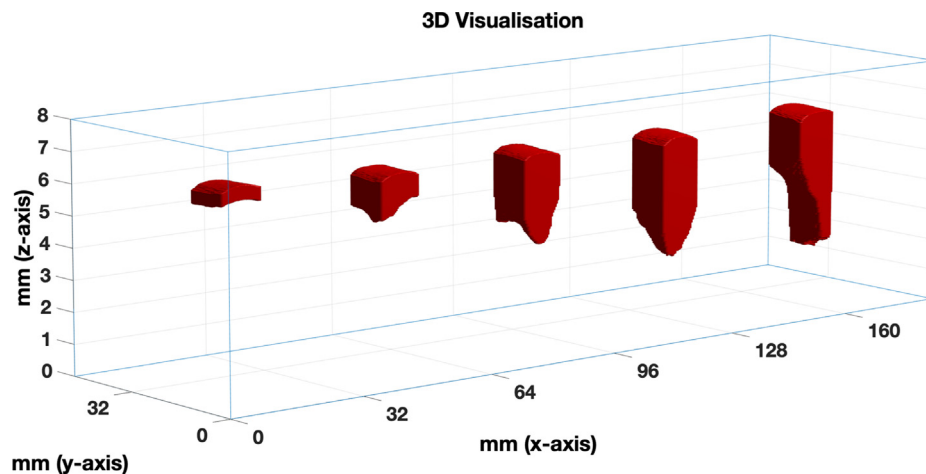
Fig. 9. The 3D visualisation of the five defects of Sample 1 using the proposed single-side inspection.

The reconstructed defects for the regions of  $30 \times 30$  pixels are visualised in Fig. 9, which suggests that the proposed technique can effectively reconstruct the 3D structure of simple defects. The estimation of the bottom surface has an increasing error following the increment of defect thickness.

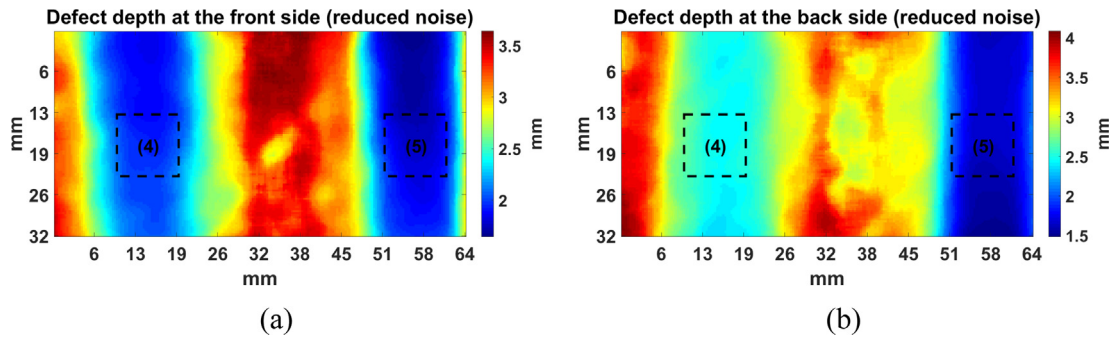
Fig. 10. The estimated defect depth image of Sample 1 after reducing noise (a) at the front side (b) at the back side, where the left defect is Defect 4 and the right one is Defect 5.

In this experiment Defect 4 and Defect 5, with the thickness of 3 mm and 4 mm, respectively, were in the focus because they can be detected from both sides of the sample. Defect 1, Defect 2 and Defect 3 were not selected because the defect depth of the back of these defects are too deep (5.5 mm, 5.0 mm, and 4.0 mm, respectively) to measure considering the depth to width ratio of a defect. The NLSF method was applied on the selected regions to estimate the defect depth where the thermal diffusivity ( $\alpha$ ) was chosen as  $0.5 \times 10^{-6} \text{ m}^2/\text{s}$ . The estimated defect depth after reducing noise from inspection of two sides are shown in Fig. 10. Observation from the front of the part shows that the measured depths for Defect 4 and Defect 5 are similar. This is expected as both defects have a 2 mm depth, as illustrated in Fig. 4. The depth map from the back shows that Defect 4 (light blue) is much deeper than Defect 5 (deep blue). In the data analysis process, the defect position at the front and the back of the part was aligned and registered. After that, the defect thickness was calculated by Eq. (8). The estimated parameters including defect depths and thickness are shown in Table 3. It is observed that, on the front, the average of the estimated defect depth of Defect 4 is approximately identical to the design (2 mm) with an error of 1%, while Defect 5 has about 10% error. For the back of the part, the average error of the estimated defect depth for Defect 4 and Defect 5 are around 18% and 16%, respectively. The computed defect thickness of Defect 4 and Defect 5 are 3.55 mm and 4.50 mm, which have the percentage error of 18.33% and 12.50%, respectively. Finally, the surface information (dimension of the sample) and subsurface information (defect depth and defect thickness) were used to build the 3D

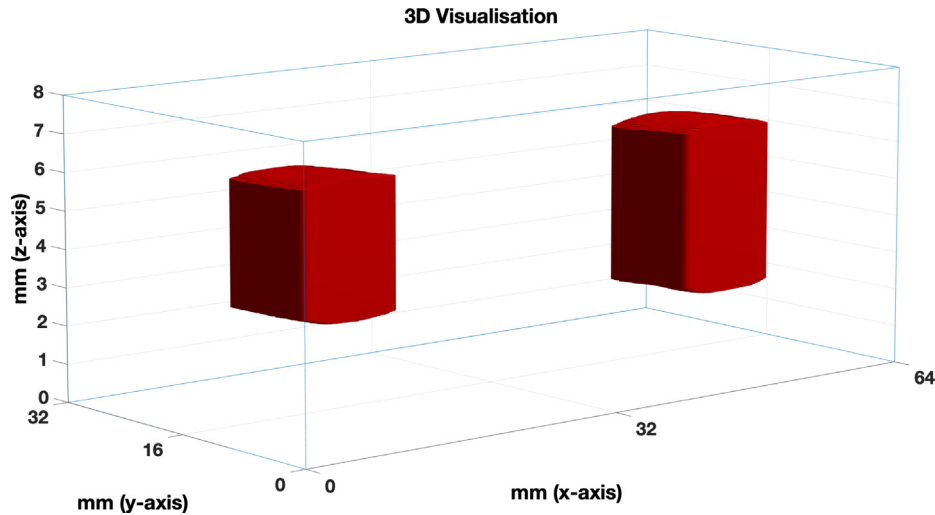
Fig. 11. The 3D visualisation of Sample 1 from the double-side inspection.

volume image and visualised in the form of 3D image, as shown in Fig. 11. It is clearly visible that Defect 5 is thicker than Defect 4, and the estimated 3D volume for both defects is close to the design shown in Fig. 4. It should be noted that the z-axis is scaled up to better visualise the detail of the defect surface.

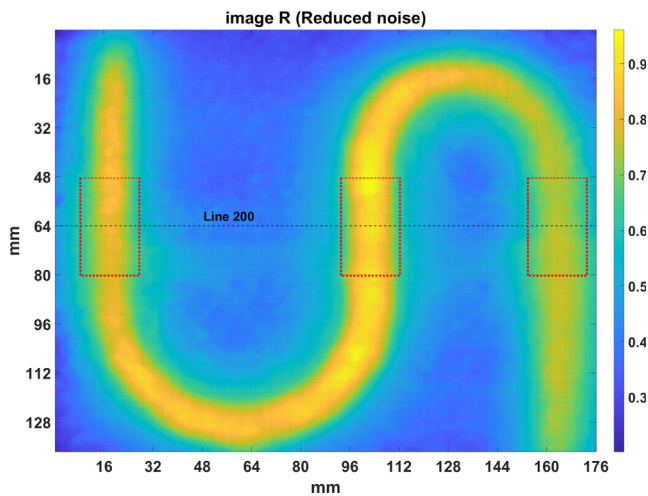
Fig. 12. The averaged  $R$  region over the top side triangle defect area for Sample 2.

Sample 2 was inspected by the single-side inspection because the defect was too deep to measure from the other side. To find the relationship between  $R$  and  $h$ ,  $R$  values in three areas with a size of

$100 \times 60$  pixels were sampled as highlighted in Fig. 12. It should be pointed out that the  $R$  values of 100 vertical pixels were averaged. Fig. 13 plots the cross-section at line 200 of the estimated  $R$  and  $d$ , where the three selected areas are highlighted. It can be observed that the middle area has the highest value of  $R$ , then the left one and the right now. Proven in the experiments of Sample 1, a higher value of  $R$  suggests a thicker defect. As illustrated in Fig. 5, the maximal thickness of the left defect is about 20 mm, and the right one is about 16 mm. Based on the observation of the  $R$  values, the maximum thickness of the middle area is assumed to be 24 mm. A numerical model was then established to represent the relationship between  $R$  and  $h$ , written as

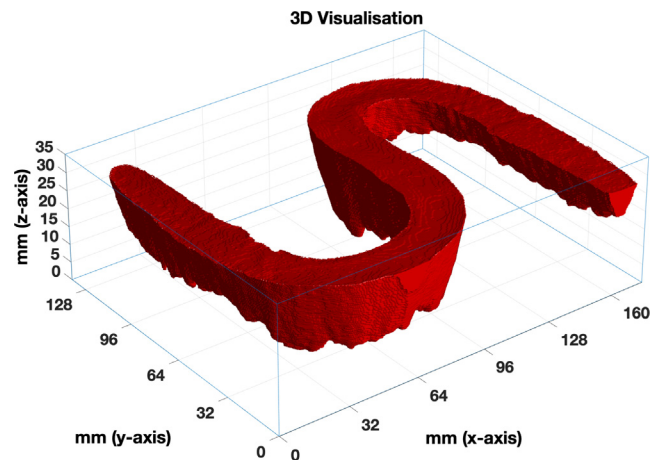
Fig. 14. 3D defect visualisation of Sample 2 defects using the proposed single-side inspection.

As the last step, the 3D volume image was reconstructed by combing the surface dimension (size and thickness of the sample) and subsurface information (defect depth and defect thickness) and result is shown in Fig. 14. The triangular ‘S’ shape defect can be clearly observed which matches the appearance of the defect shown in in Fig. 5(c) and Fig. 5(d). To validate the result using other NDT methods, Fig. 15 shows the comparison of the 2D image of the defect from pulsed thermography and X-ray. It can be seen that the defect shape of both images is similar. A quantitative comparison between these two imaging modalities in terms of 3D defect reconstruction was not conducted in this paper due to the distortion of thermal images caused by the lens. A further study is required to correct this distortion before conducting a comprehensive comparison.

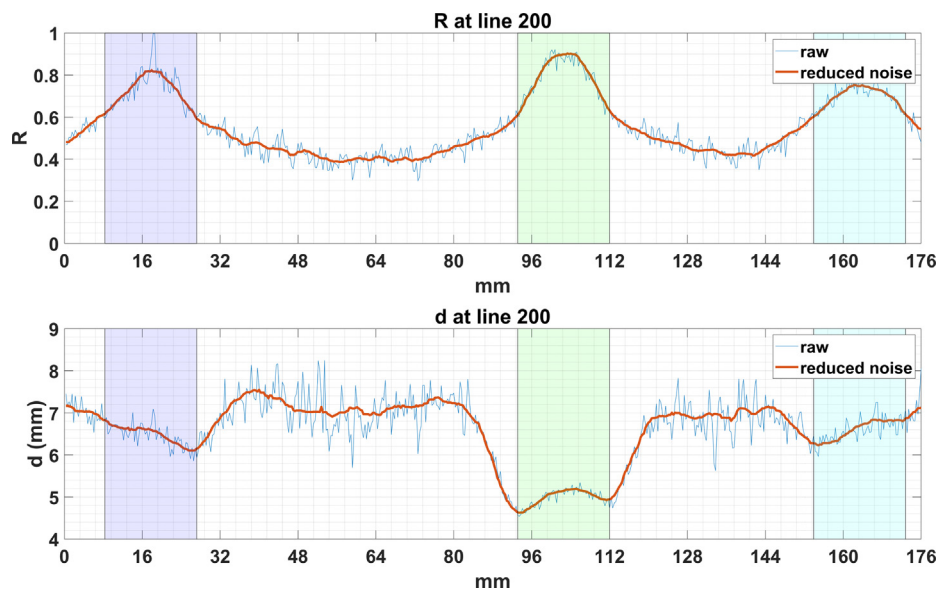
Fig. 13. Plots of estimated  $R$  and  $d$  of the cross-section at line 200 of Sample 2.
