Research and conservation of historic decorative schemes in the built environment

Project Name: Paint Analysis HMS Caroline

Client: National Museum of the Royal Navy

1.0: Outline brief & Method

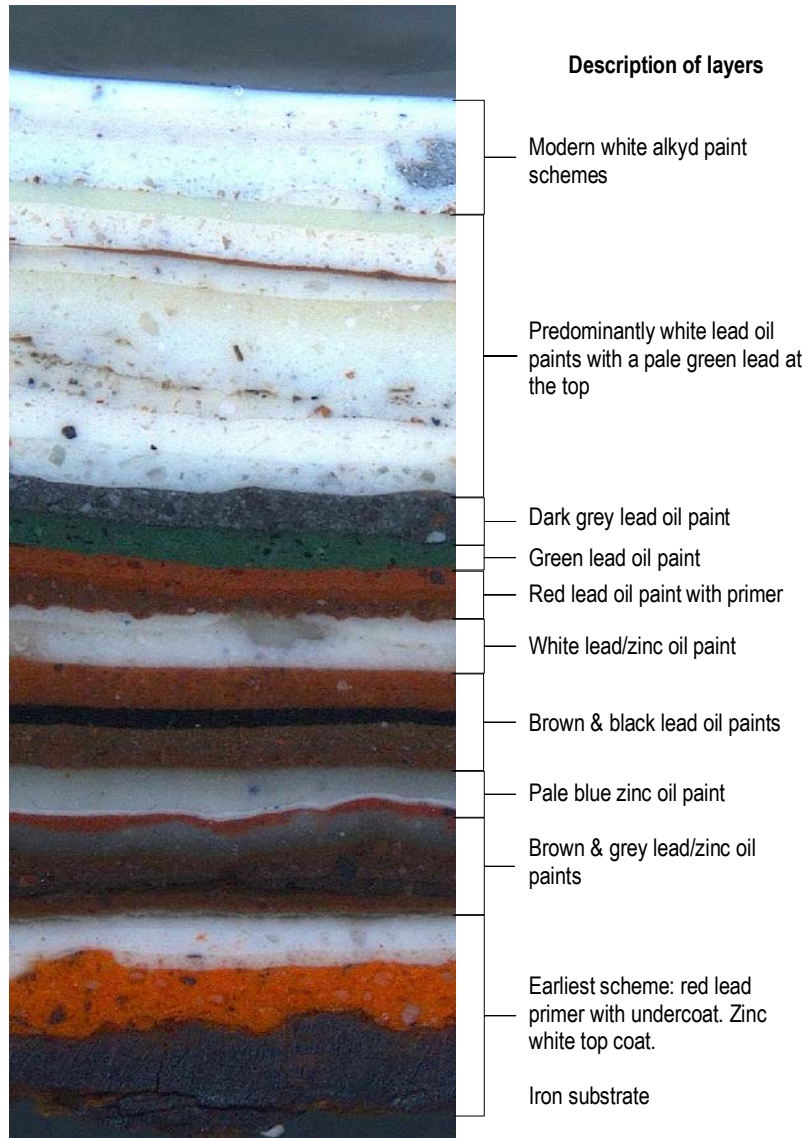
Fig.2: Sample 1.1, photomicrograph sick bay bulkhead (1)

The earliest scheme detected is a zinc white oil paint at the base of the image left (fig.2), followed by several schemes in greys, black, browns and green. The last lead oil paint scheme is a pale green, probably dating to the late 1950's / early 1960's. It is feasible the initial zinc enamel white scheme could be coeval with the WW1 period. Enamels were introduced in the late nineteenth century⁴ and became very popular as a hard wearing and colour fast alternative to varnished oil paints by the 1920's.

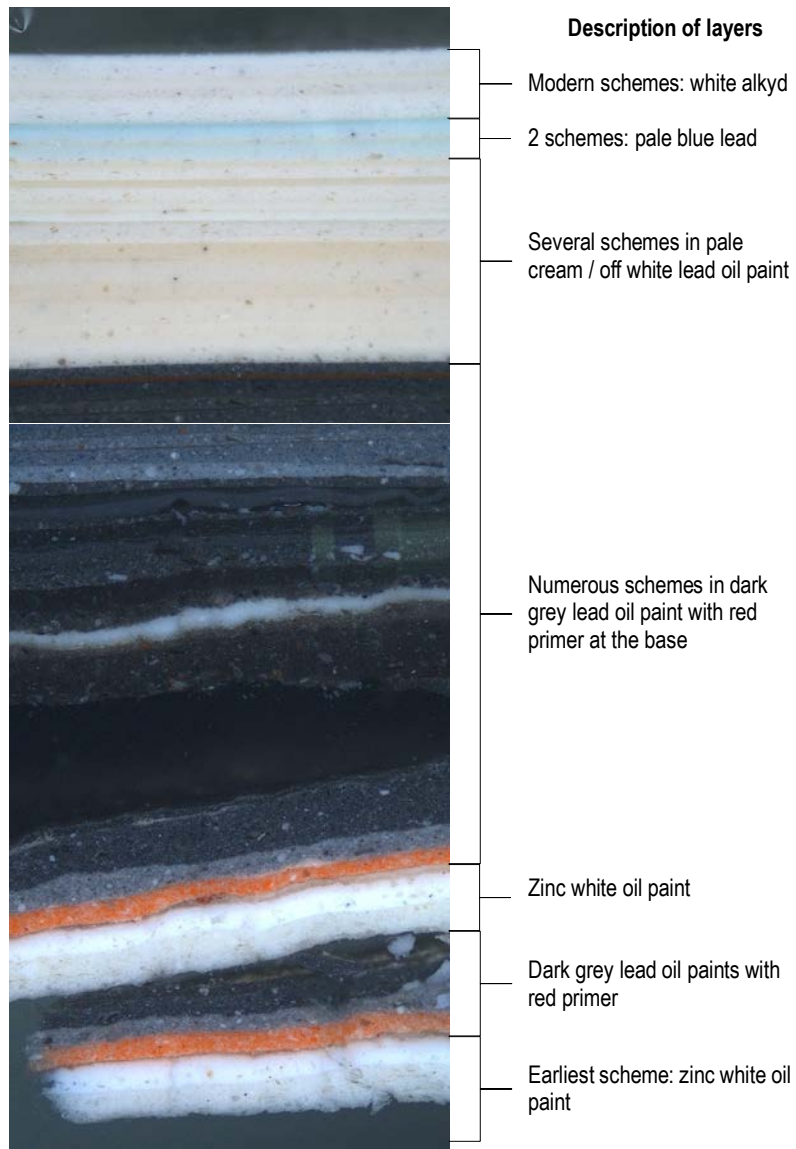
Fig.4: Sample 1.2 photomicrograph, sick bay doors, external face (1b)

The earliest scheme is a zinc white enamel oil paint with the red primer missing from the base of the sample. This is consistent with the earliest scheme detected on the bulkhead in the sick bay, with the earliest evidence for the entire area presented in a white enamel oil paint. There are numerous intermediate schemes in dark grey, probably dating to 1924 onward, with the final later schemes in pale cream / off white, later pale blue, prior to the application of the modern whites we see today.

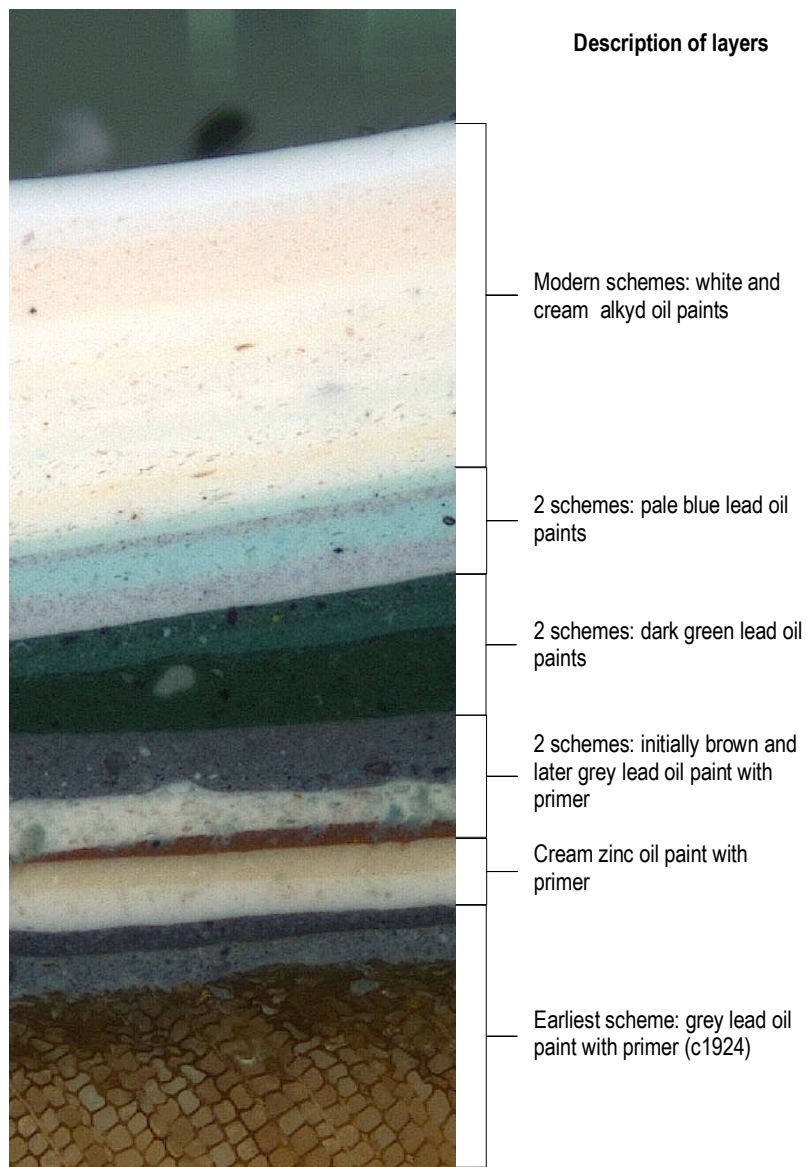
Fig.6: Sample 1.3 photomicrograph sick bay timber screen (1c)

The timber screen appears to be a later insertion, probably dating from 1924. Initially painted in a grey lead oil paint, followed by a cream zinc enamel. The two blue schemes date to the same period as the blues on the external face of the doors (fig.4) providing a useful datum to tie the two together (approx 1960's). The later whites and creams are all modern alkyd oil paints.

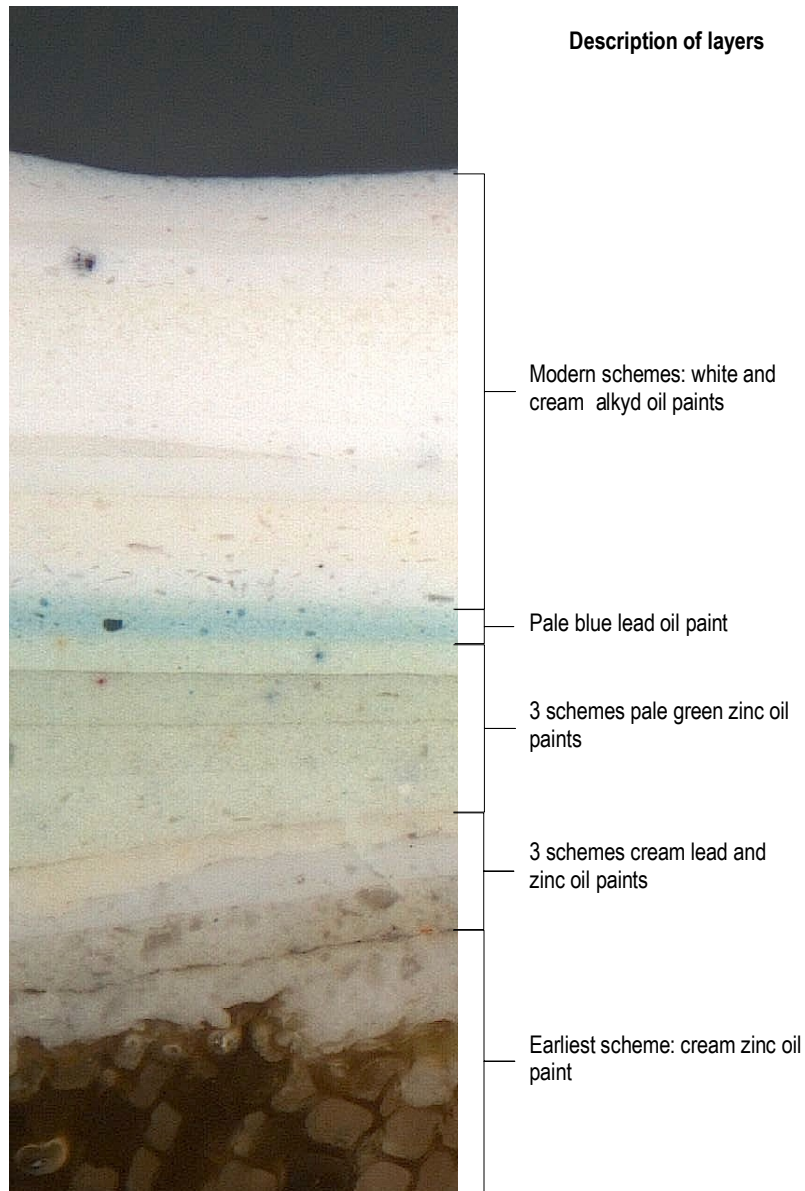
Fig.8: Sample 1.4 photomicrograph sick bay door, internal face (1d)

The earliest evidence for the paint schemes on the internal face of the sick bay doors is a pale cream coloured zinc enamel oil paint with a dirt layer on the surface indicating this was in place for some time. This is followed by three further creams and later pale greens, all in zinc enamels. The greens appear to date to approx the WW2 period with the pale blue coeval with the identical schemes on the timber screen and bulkhead within the sick bay.

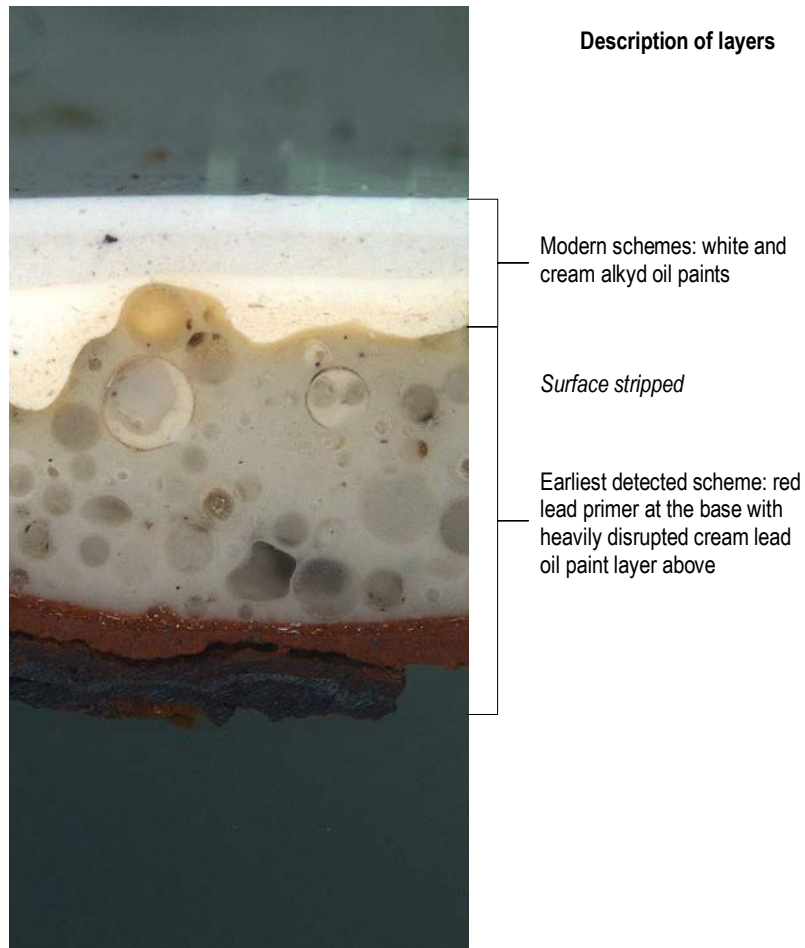
Fig.9: Sample 1.5 photomicrograph starboard superstructure (2)

A careful inspection of the starboard superstructure indicated very few paint schemes surviving and the sample indicated left was removed from an indicative area. Clearly stripped and repainted several times in the past, the earliest evidence is for a highly disrupted cream lead oil paint above a red lead primer. The schemes at the top of the image are all modern alkyd oil paints.

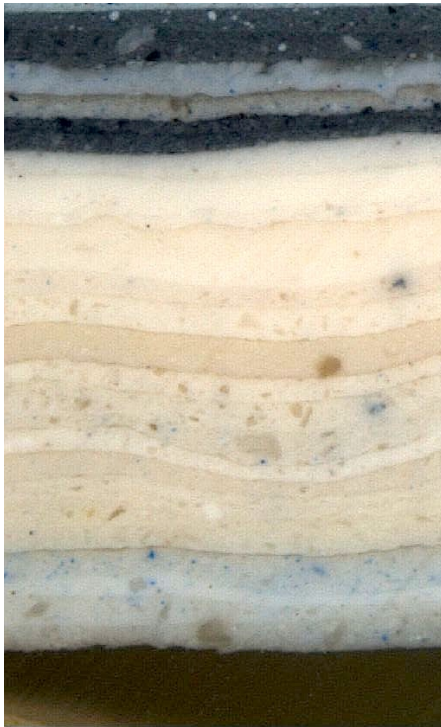
Fig.13: Comparison between internal paint chronology and the watertight door

Sample 2.7 (watertight door)

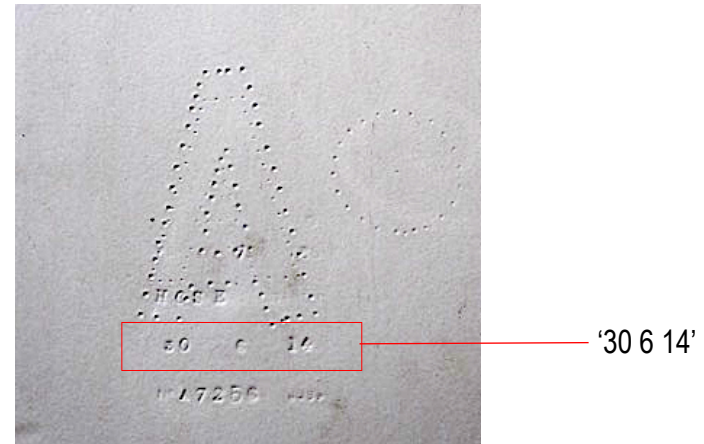
Fig.14: Stamped inscription watertight door

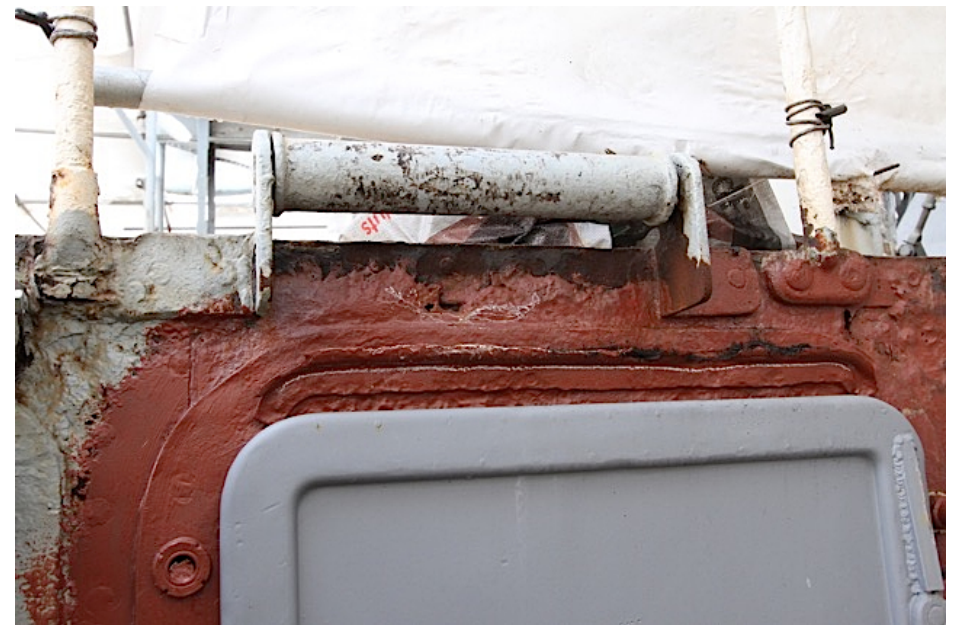
The port waist has been extensively stripped in the past, but the watertight door indicated above does retain a heavy build up of paint. At first glance this appears to display a complete chronology representing an early phase of blue/greys and later whites. However, there is a distinct lack of weathering on the surface of the early paint schemes and on close inspection the nature of the early paints used is remarkably similar to the schemes detected inside the vessel (see fig.13). Also, following the sampling exercise the door has been stripped in preparation for repair and repainting revealing a stamped inscription suggesting it dates from 30th June 1914 (see fig.14). It has also been noted this door is wider than the drip moulding above and does not match the curvature of the door opening (see fig.15) which is inconsistent with a

Fig.15: Poorly fitted watertight door

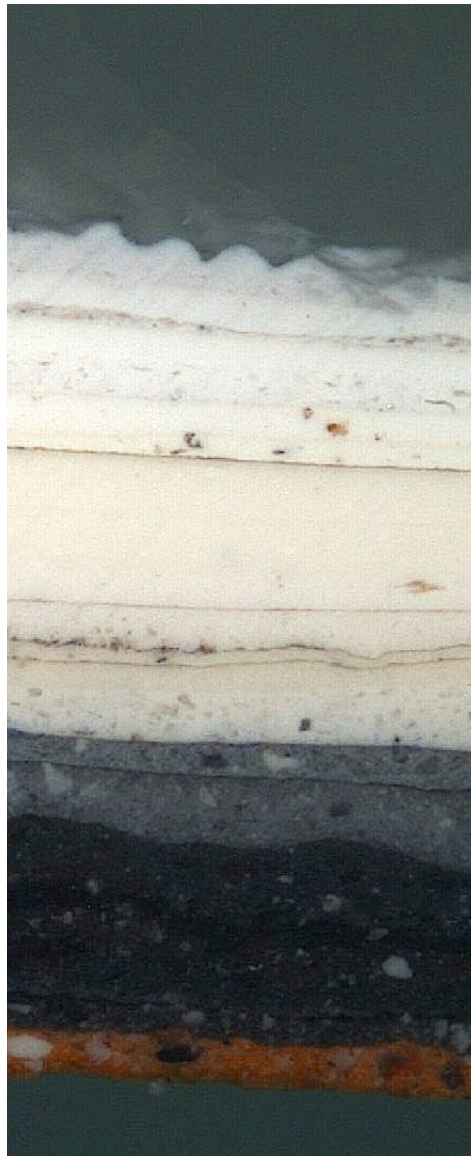
Fig.16: Sample 2.8 Drill Hall inner surface (4)

Numerous later schemes in white lead and alkyd oil paints

The earliest schemes detected in dark and mid grey lead oil paints with red lead primer at the base (1924)

The Drill Hall was installed in 1924 when Caroline first arrived in Belfast (the guns and boilers were removed at the same time). The earliest detected schemes in dark and mid grey oil paints date from this period and provide a useful datum point when compared to identical paint layers uncovered in other areas of the vessel. The grey theme continued until the introduction of the first white lead schemes – probably at the outbreak of WW2 when the vessel used used as a Depot Ship for patrol craft.

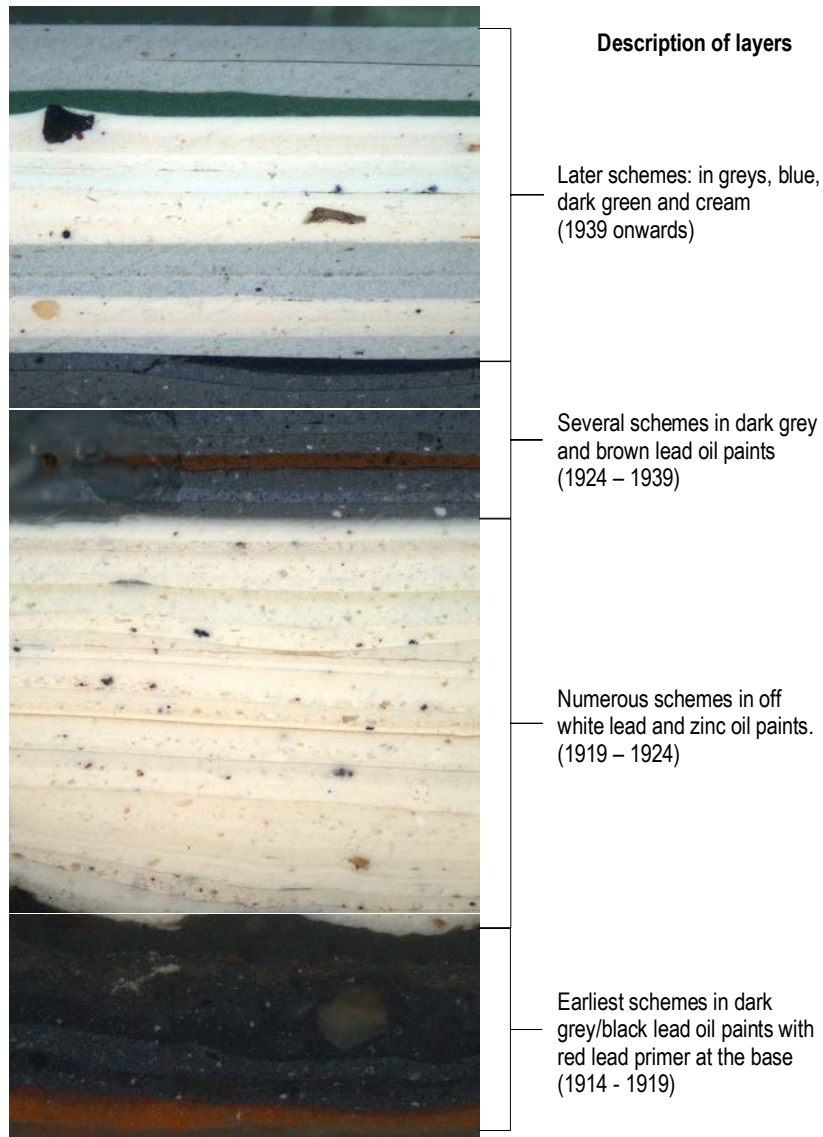
Fig.18: Sample 2.9/2.10 Low level near watertight door (5)

This sample was removed from low level on the grey band just above the deck. Furthermore, a small area was cleaned back to reveal the height of this band coeval with the earlier schemes (approx 12 inches above deck level).

The earliest evidence for this band is in a grey/black lead oil paint dating to the 1914 – 1919 phase. The schemes above this, in cream oil paints date to the 1919 – 1924 “tropical phase”, a time when

no distinction was made between upper and lower areas and the entire surface was painted in a uniform off white oil paint. Following this the lower level was again picked out (after arrival in Belfast in 1924) in dark grey. The final schemes date to 1939 onwards with the lower level periodically picked out in greys and finally displaying the grey we see today. The upper area of the bulkhead was also sampled (see overleaf) to determine the colours used in contrast to the lower level in this area.

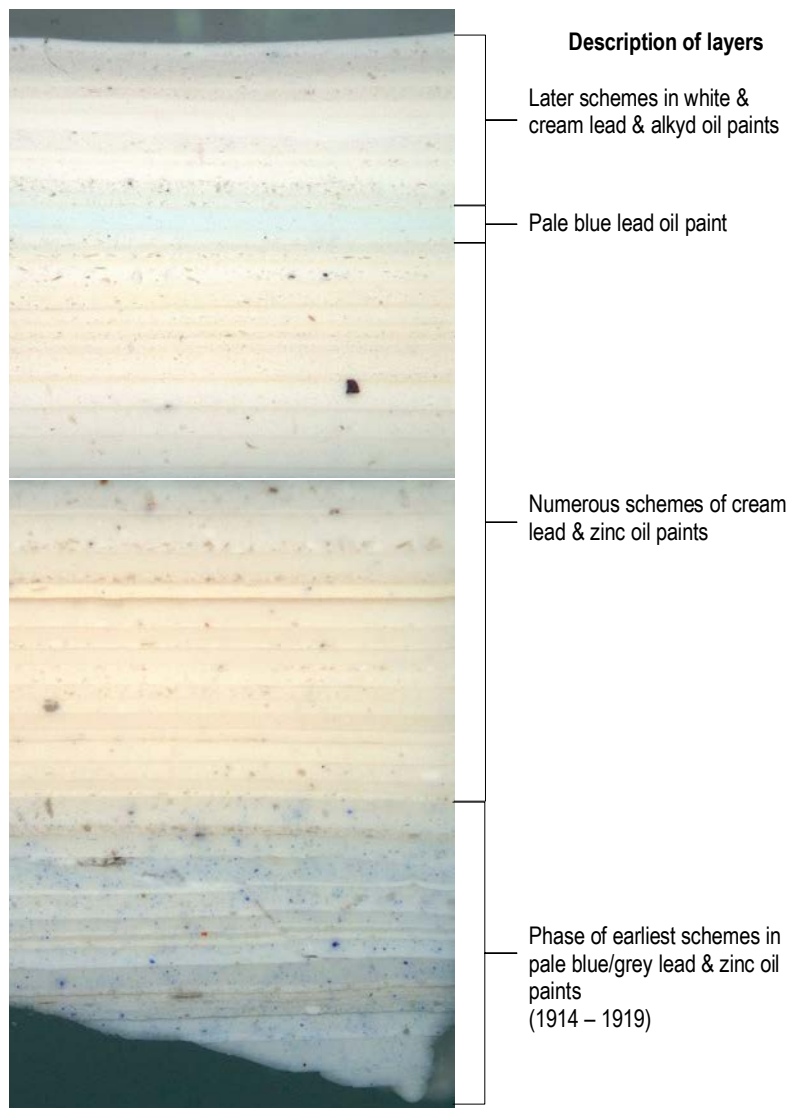
Fig.20: Sample 3.13/3.14 Vestibule higher level (6)

The earliest (phase I) schemes in pale blue/grey lead & zinc oil paints indicate the appearance of this area in pale blue with a grey/black band at the base extending approximately 12 inches above deck level. All the later cream schemes (interrupted by a single pale blue) indicate a uniformity of colour at times in contrast to the border painted at low level just above the deck.

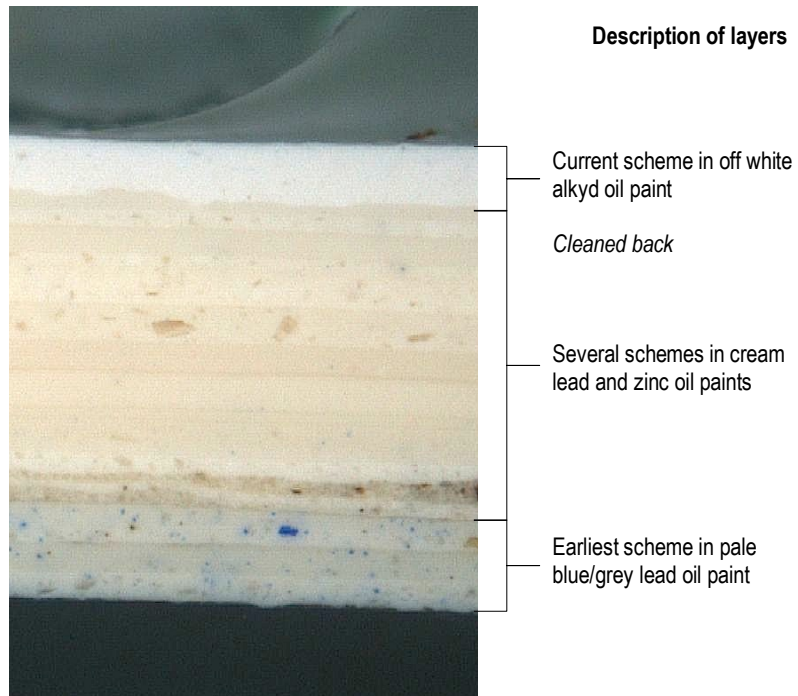
Fig.22: Sample 3.16, 6 inch gun support (7)

There are 3 early schemes at the base of this feature in pale blue/grey oil paints – the same pale blue/greys as detected in the vestibule (previous page), followed by several creams. The surface appears to have been cleaned back prior to the application of the off white scheme we see today.

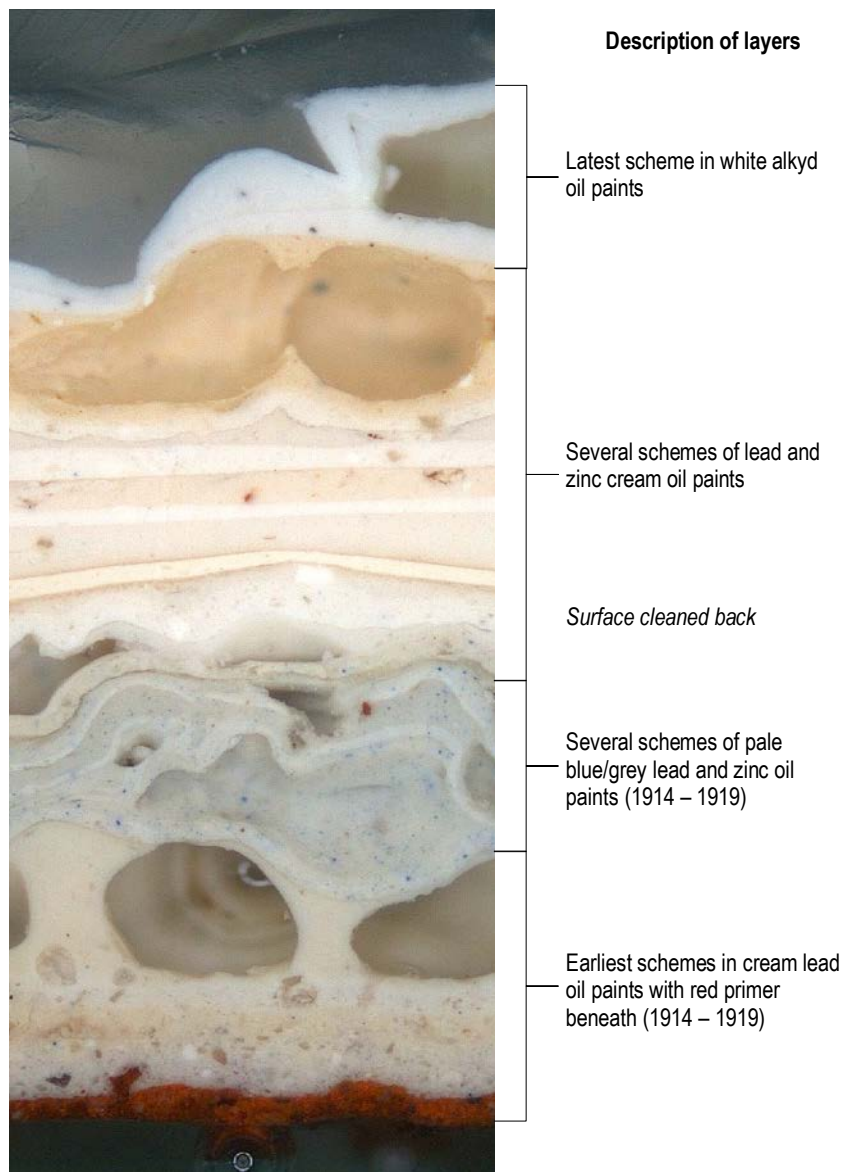
Fig.26: Sample 4.18, Historic Cabin bulkhead (9)

The exposed area of pale blue/grey oil paint shown in the image above corresponds to the later blue/grey schemes shown left (fig.26) dating to the 1914 – 1919 period. However, the earliest schemes are cream lead oil paints, suggesting the appearance of the cabin was changed from initial creams and brought more in line with the blue/greys used elsewhere during the 1914 – 1919 phase. The surfaces were then cleaned back prior to the application of the later creams, which appear to start from the WW2 period onwards. Also note the brown border at the base of this revealed area, just above the deck.

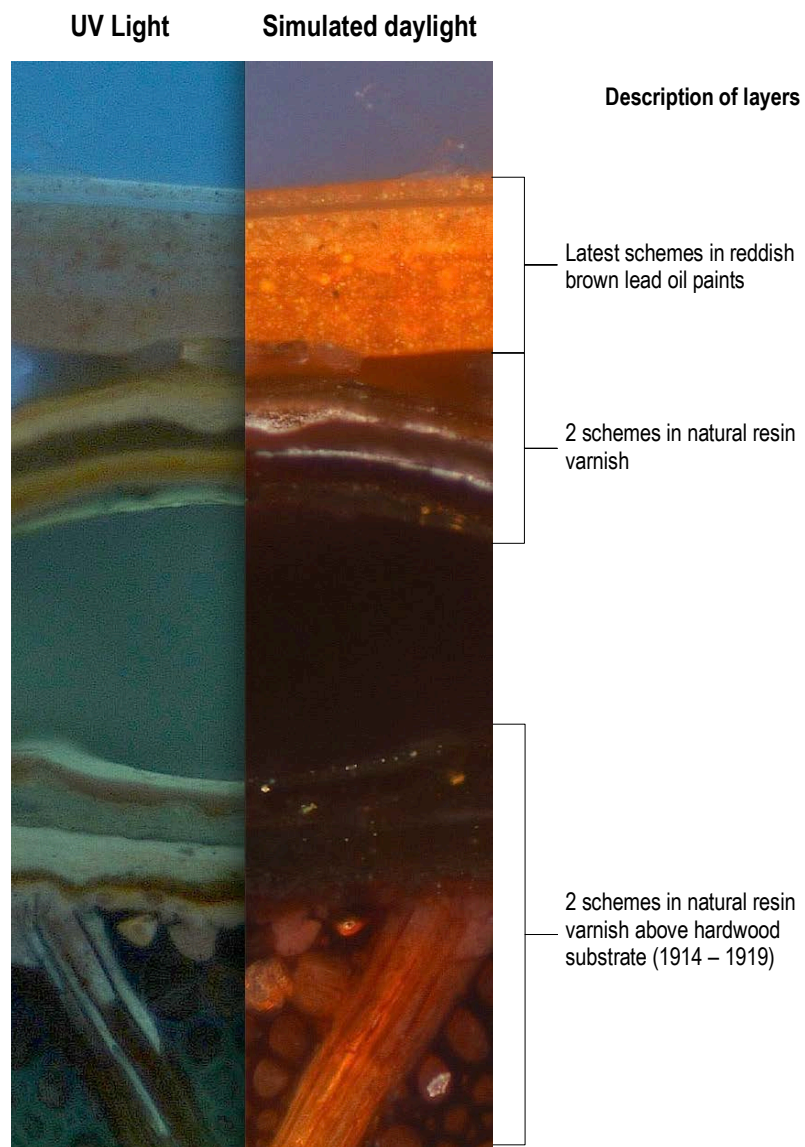
Fig.28: Sample 4.19 Historic Cabin joinery (9a)

The joinery in this historic cabin currently has an aged reddish brown lead oil paint with a crackled surface and has clearly been in place for some considerable time. The first schemes (1914 onwards) are a natural resin varnish (possibly Copal or Shellac) that has been reapplied subsequently three times (as displayed in the UV image in fig.28).

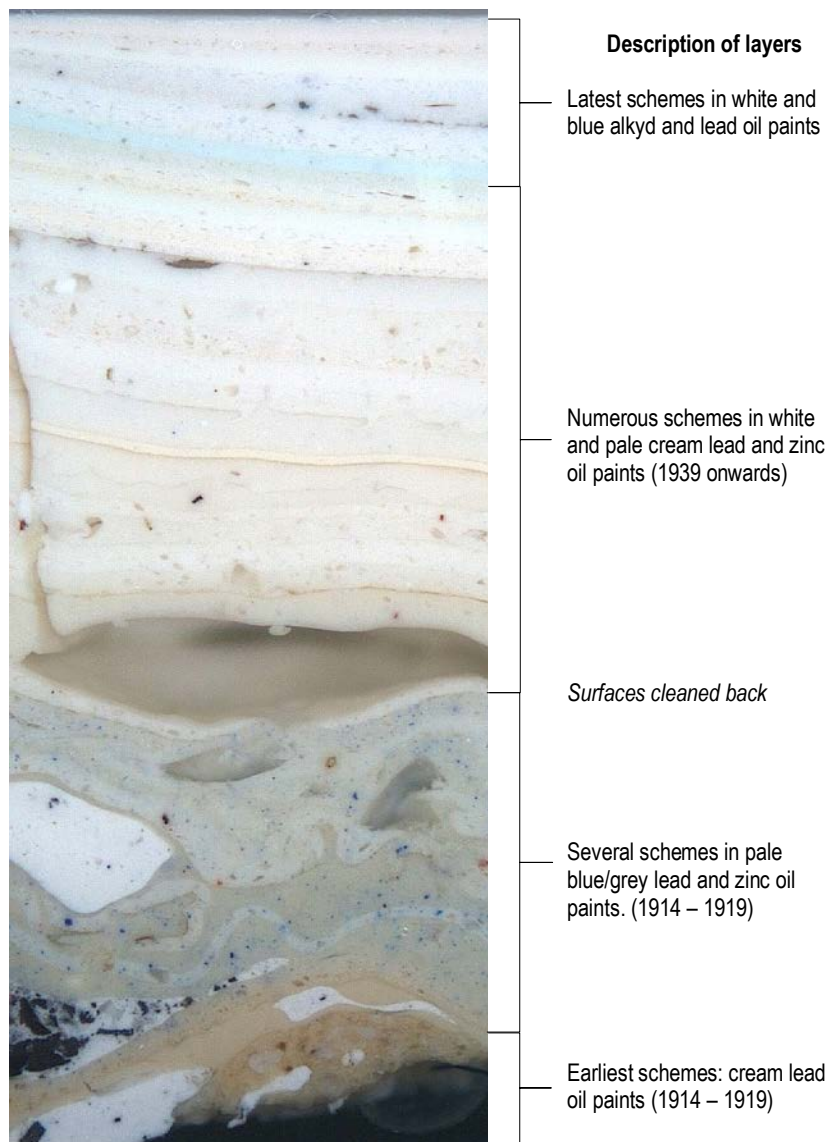
Fig.30: Sample 4.20 passage above tiller flat (10)

The paint schemes applied in this area display a very similar chronology to other areas inside the vessel. The same cream oil paints are evident as the earliest scheme (c.f. the historic cabin bulkhead – fig.26), followed by pale blue/greys, all of which date to the 1914 – 1919 phase. There is evidence the surfaces were cleaned and prepared ready to receive the numerous white and pale cream schemes that appear to date from 1939 onwards, interrupted by a single relatively modern blue scheme.

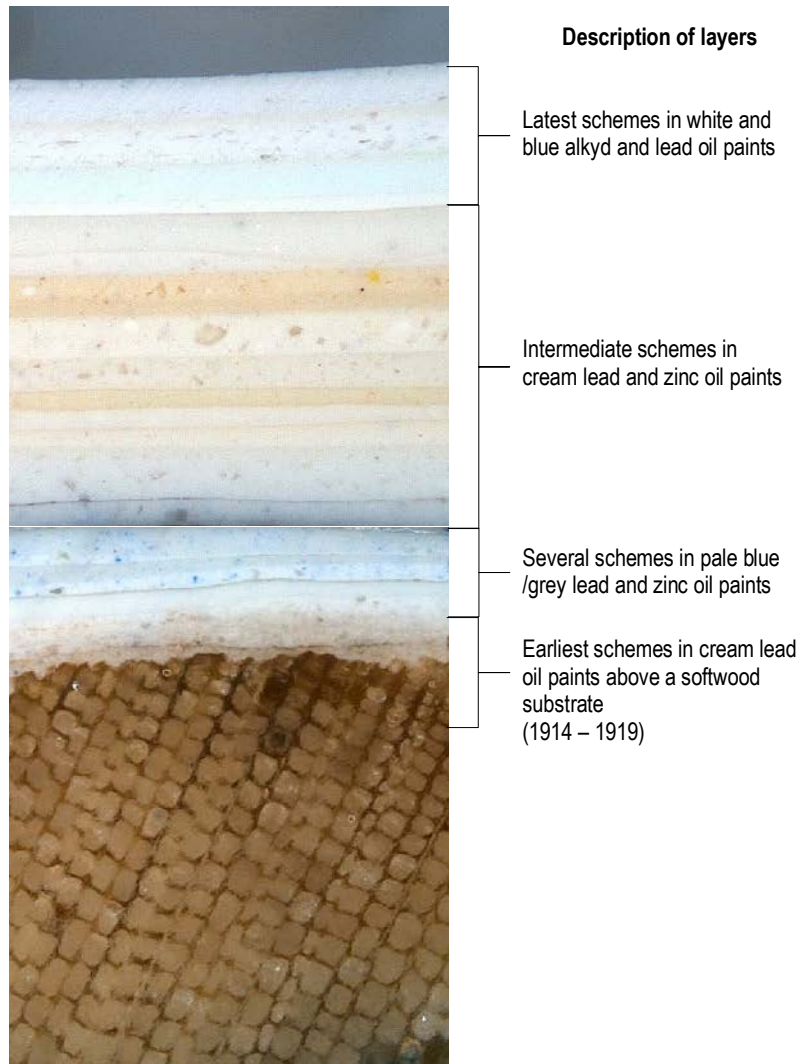
Fig.32: Sample 5.21 Historic Cabin bulkhead (11)

The sample left (fig.32) was removed from the softwood fillet fixed to the cabin bulkhead – an area that appeared to show the heaviest build up of paint. This is clearly an early fitting and appears to be coeval with the 1914 – 1919 phase, displaying the same cream lead oil paint detected beneath a group of pale blue/greys already noted in other areas of the ship.

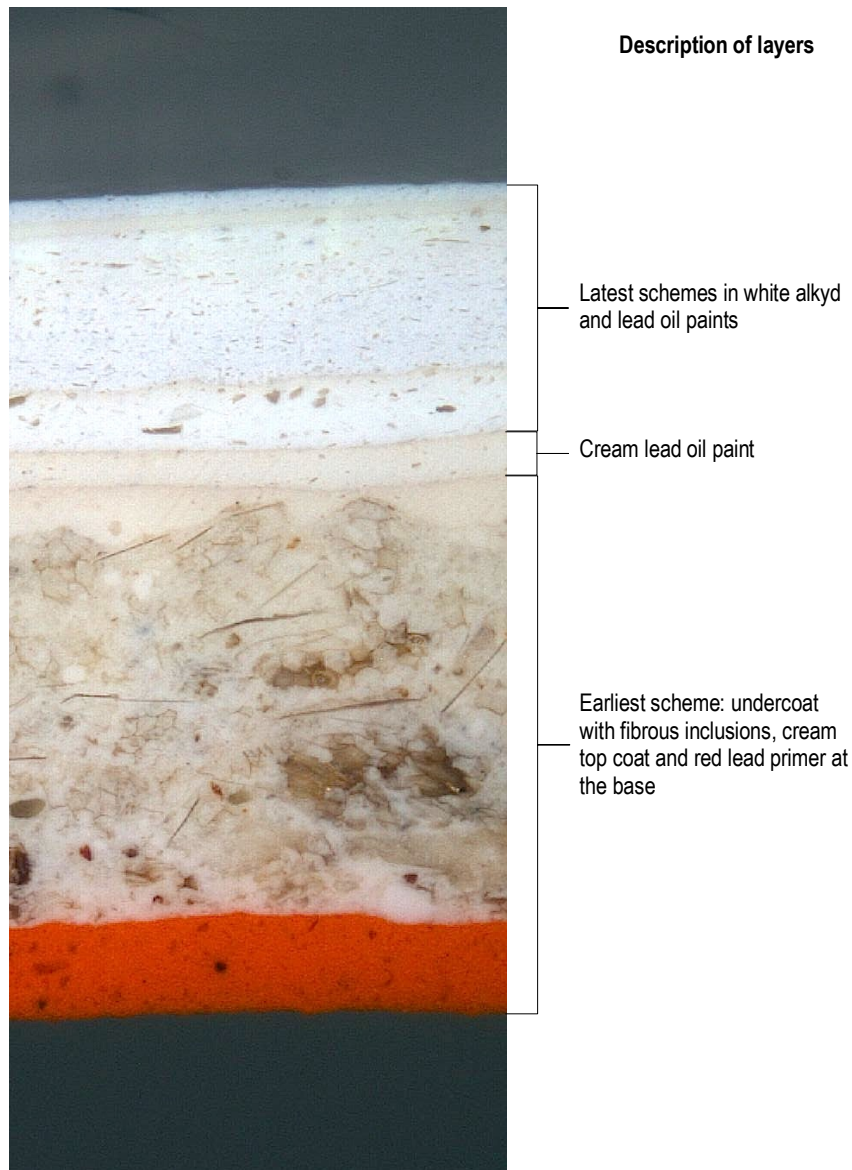
Fig.34: Sample 5.23 Wardroom deckhead (12)

At the base of this sample is a red lead primer with a fibrous undercoat and cream top coat. This is a relatively modern scheme and the nature of the fibrous material has not been analysed and remains unknown. However, it is feasible this may be an intumescent (fire resistant) layer and could contain asbestos, consequently further analysis is advised.

There is no evidence for early paint schemes on this deckhead and appears to have been cleaned back prior to the application of the modern schemes.

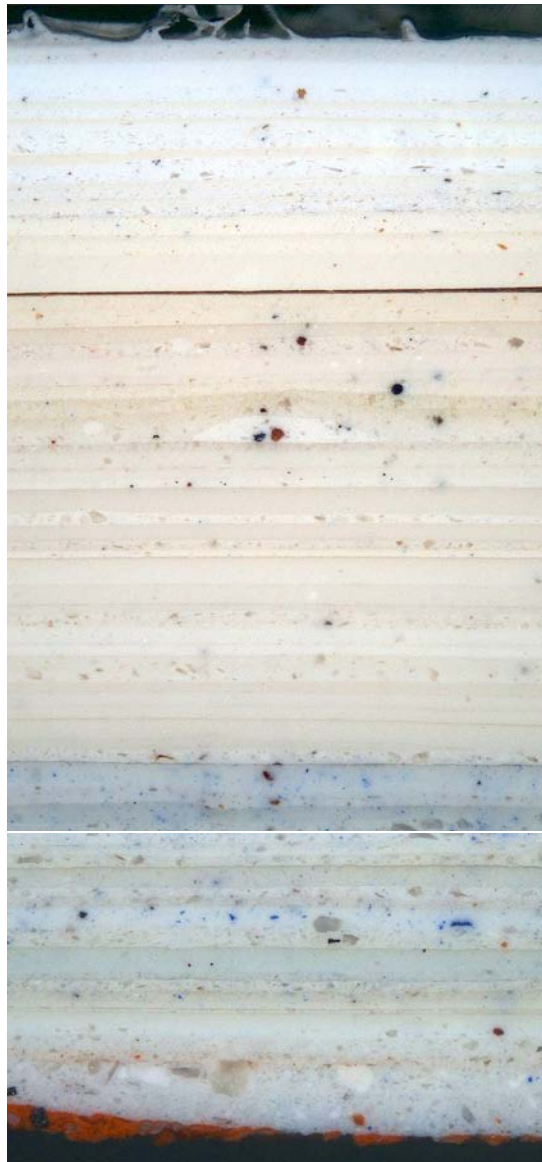
Fig.36: Sample 5.24, Wardroom inner hull (13)

Latest schemes in white & cream alkyd and lead oil paints

Numerous schemes in cream lead & zinc oil paints (1919 – 1924 onwards)

Earliest schemes: several schemes of pale blue/grey lead & zinc oil paints with red lead primer, white undercoat and a single scheme at the base in cream oil paint (1914 – 1919)

The wardroom inner hull displays an identical sequence of applied paint schemes to other areas sampled inside the ship. Traces of an early cream at the base, followed by a sequence of pale blue/greys, then creams and finally predominantly whites applied relatively recently.

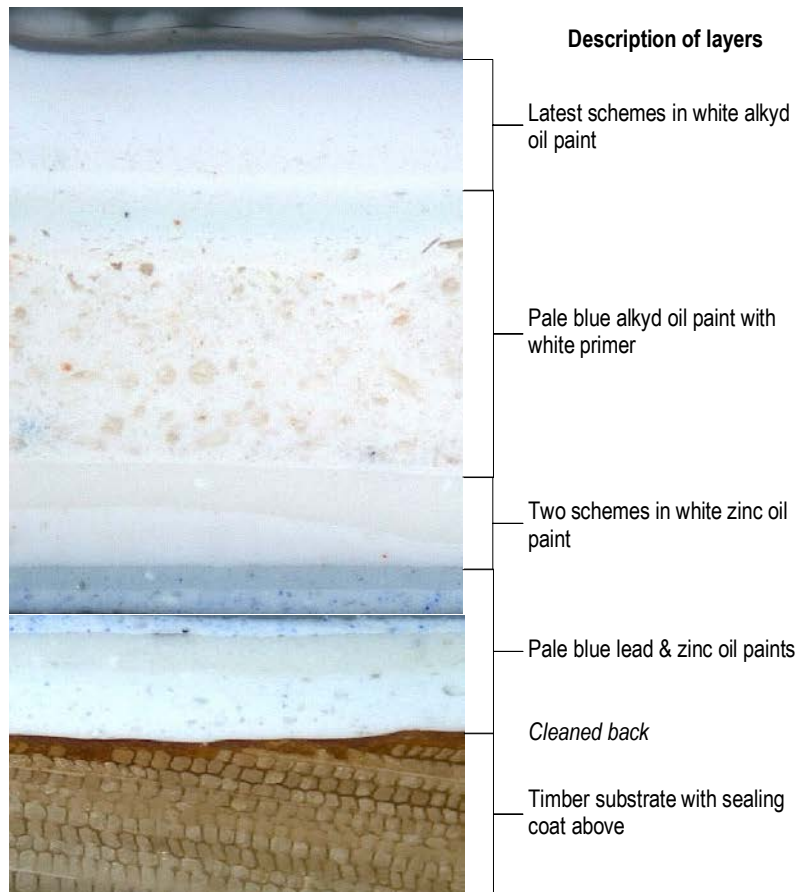
Fig.38: Sample 6.25/26 Aft Lobby (14)

This sample was removed from the panelling in the Aft Lobby and displays the softwood substrate at the base with a sealing coat above with an appearance that suggests the surfaces were cleaned back prior to the application of the first pale blue lead & zinc oil paints. Although difficult to date precisely, this earliest scheme is typical of the 1920's and suggests the panelling may have been installed at this time.

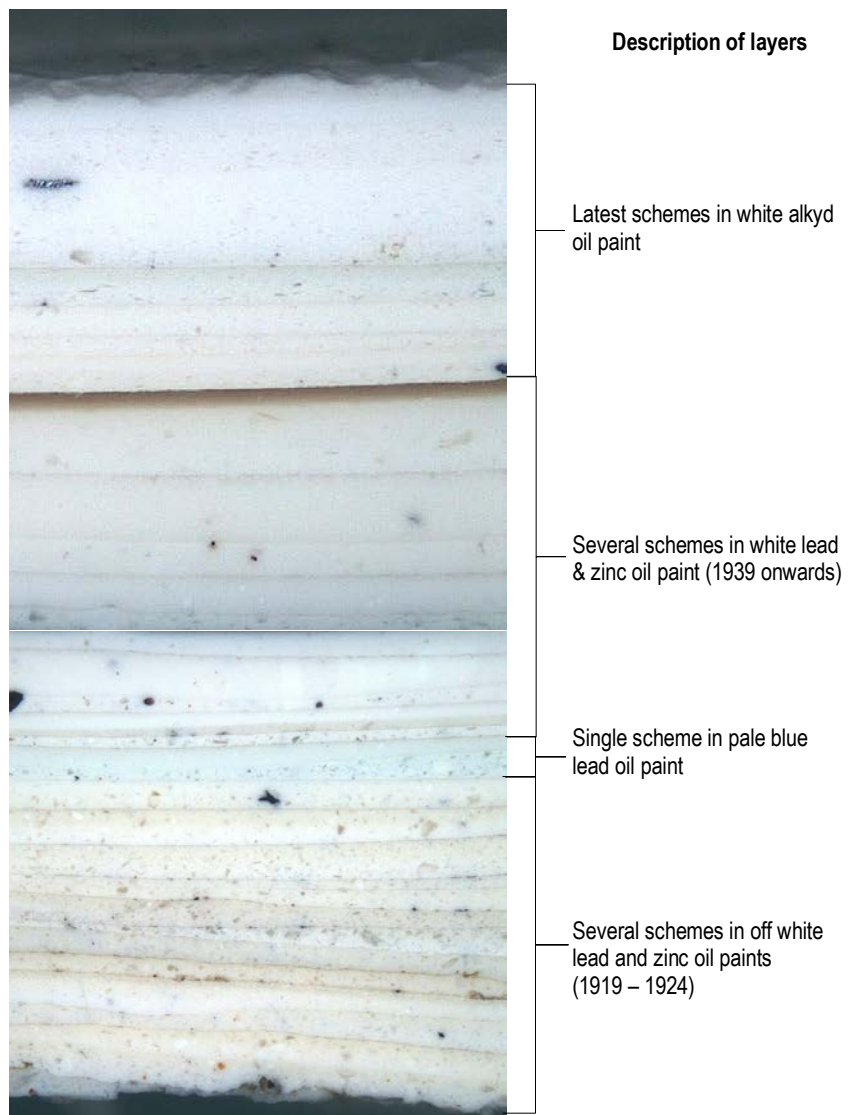
Fig.39: Sample 6.27/28 former mess deck inner hull (15)

The earliest evidence here is a group of off white lead and zinc oil paints at the base of the image left (fig.39). and probably dates to the second or “tropical” phase. The earliest schemes are missing from the base of the sample. This is followed by a single scheme in pale blue then further lead and zinc whites.

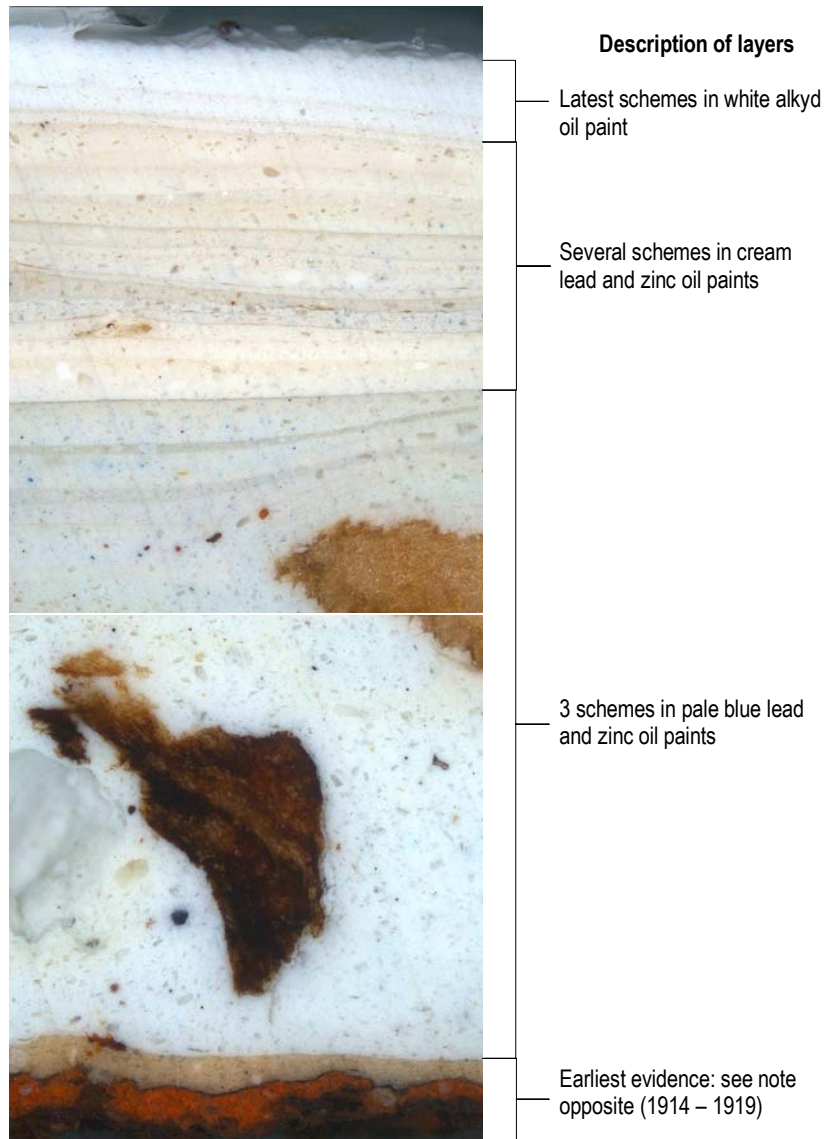
Fig.41: Sample 6.29 former mess deckhead (15a)

This a key sample displaying what is undoubtedly the original 1914 primer at the base. Interestingly there is a distinct dirt layer on top of the primer with a mid cream lead oil paint directly above. This suggests the red lead primer was left in place for some time prior to the application of the cream scheme directly above. This is clear evidence the vessel was launched for active service with at least some areas still requiring painting. If this area was used as a mess it is likely the dirt build up will have occurred relatively quickly and may be tobacco smoke residues (although this is speculative).

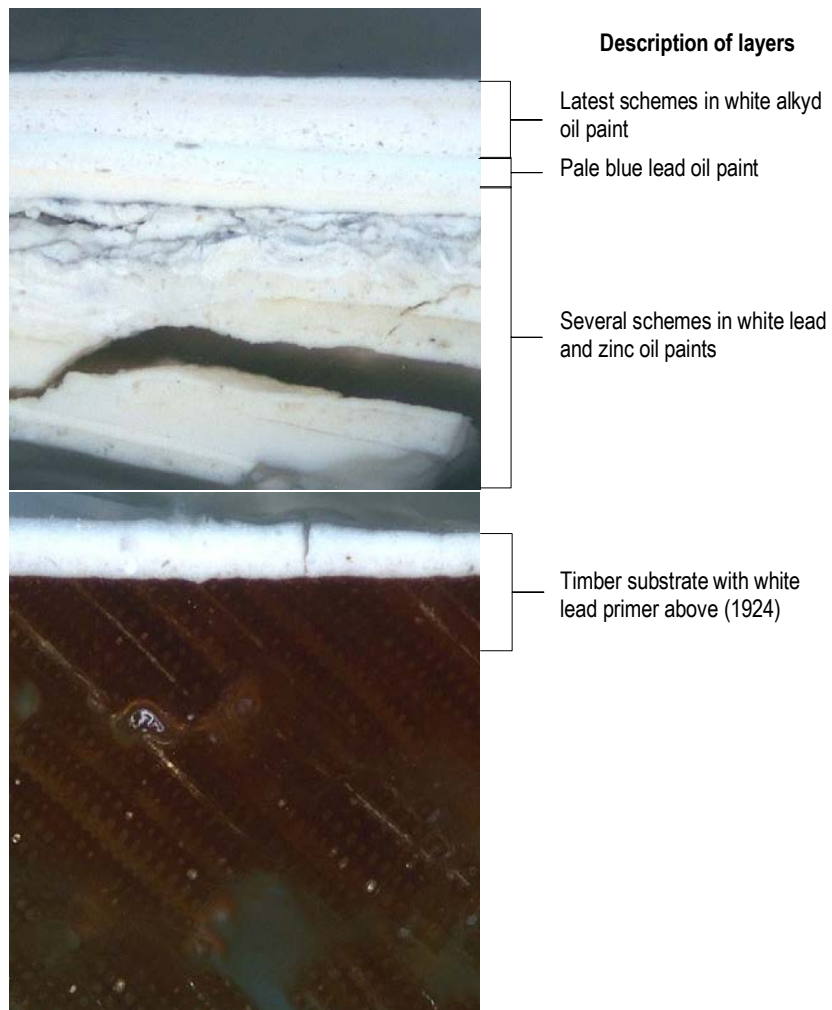
Fig.45: Sample 7.31/32 Office Passage tongue & groove panelling (16)

The earliest schemes on this panelling are zinc white enamel oil paints above a white lead primer. Enamels of this nature are typical of the 1920's suggesting this feature was inserted in 1924 or soon after. Later schemes remain predominantly white, with one pale blue scheme executed at a time when the when other areas inside the ship were painted pale blue.

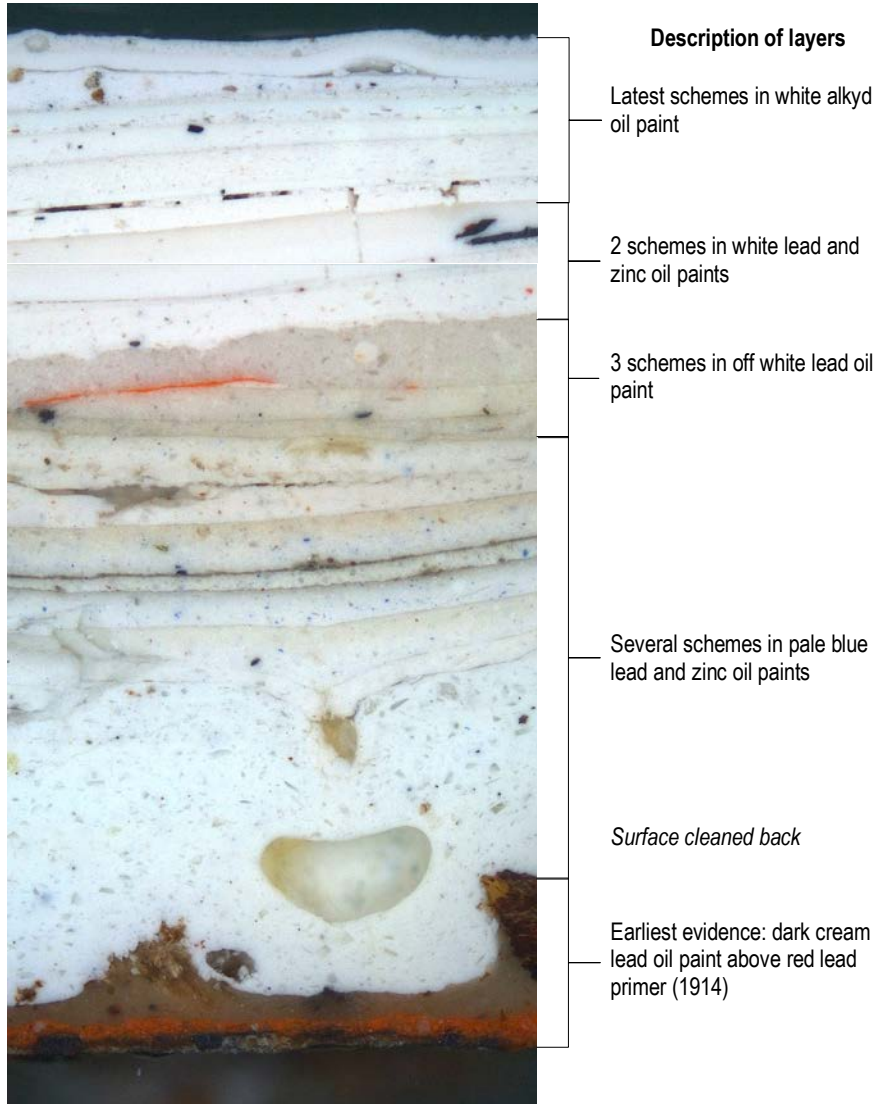
Fig.47: Sample 7.33 Former Engineer's Store (17)

This is another key sample, displaying traces of a dark cream lead oil paint at the base of the sample coeval with 1914 and the mid creams detected in the former mess and other areas of the ship. There is evidence this surface was cleaned back prior to the application of the pale blue oil paints applied subsequently.

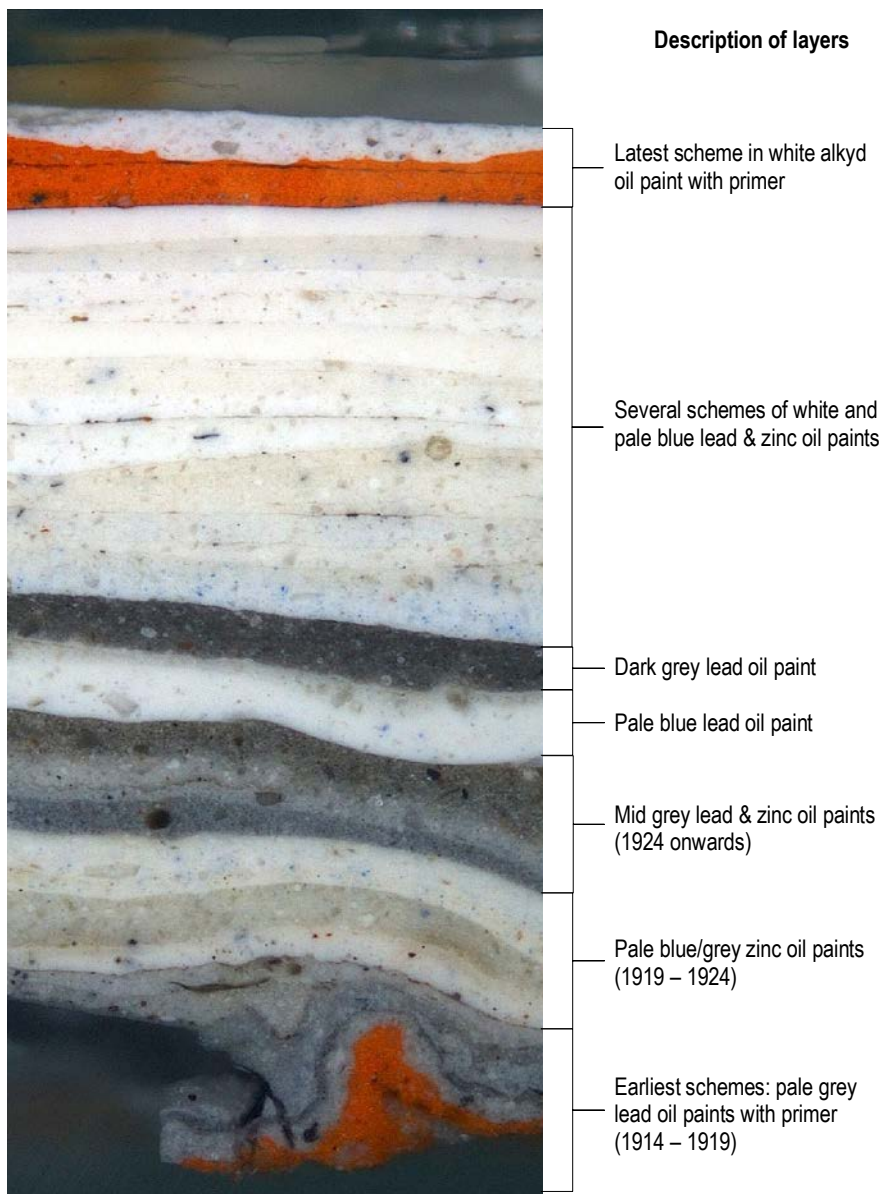
Fig.49: Sample 8.34 Wash Place Lobby (18)

The earliest pale grey lead oil paints at the base of the image left (fig.49) appear to be coeval with the 1914 – 1919 period, with the pale blue/greys applied directly above consistent with the 1919 – 1924 phase. However, the earliest pale greys here are inconsistent with the earliest creams detected in the wardroom, mess, historic cabin and Engineer’s Store, suggesting a different colour scheme in this area. The introduction of the mid greys later on date the post 1924 period.
