Research and conservation of historic decorative schemes in the built environment

Project Name: Paint Analysis HMS Caroline

Client: National Museum of the Royal Navy

1.0: Outline brief & Method

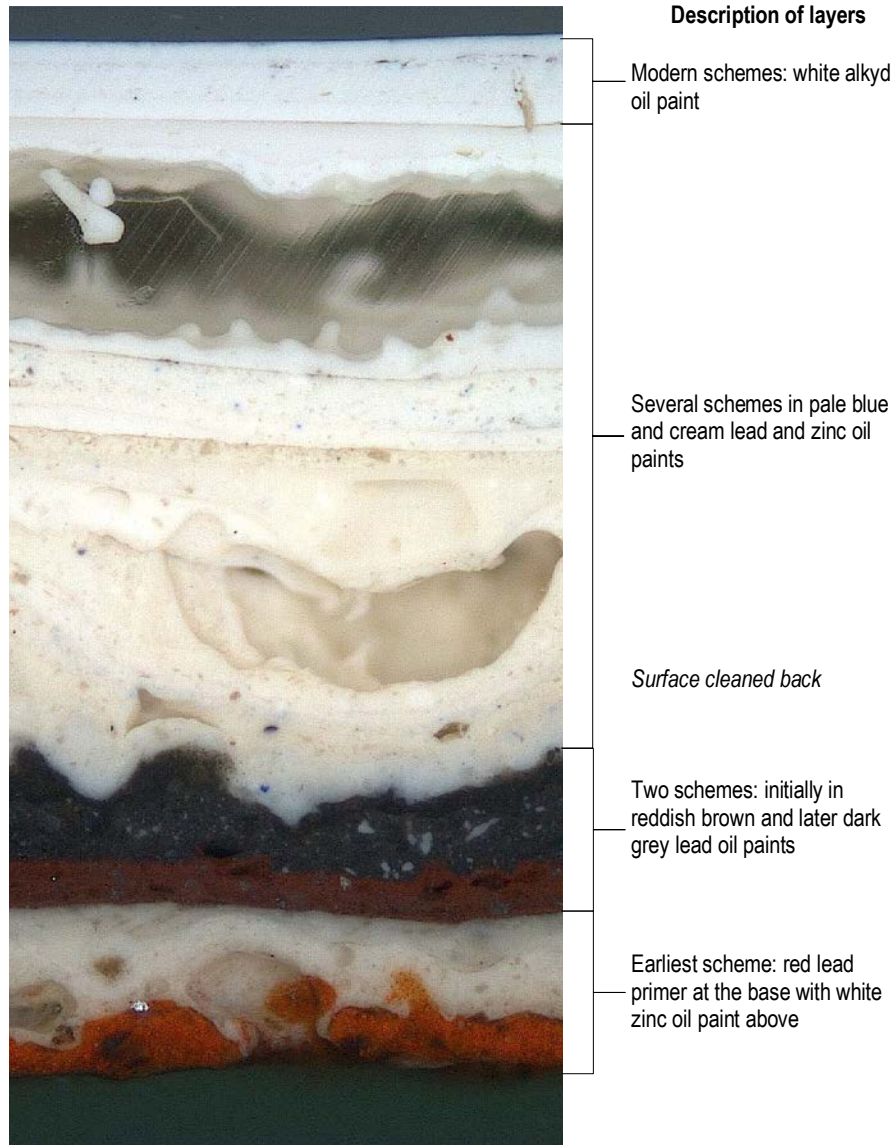
Fig.51: Sample 8.35 Boiler Room Passage (19)

The surfaces in this area are heavily disrupted and appear to show evidence of heat and possibly burning. This has resulted in a confusing paint chronology making it difficult to date the paint layers and relate to other areas inside the ship. There is also evidence for the surfaces being cleaned back after the application of the dark reddish brown and dark grey directly above the earliest scheme. The physical make-up of the dark grey is similar to the 1924 schemes seen elsewhere and may date to this period.

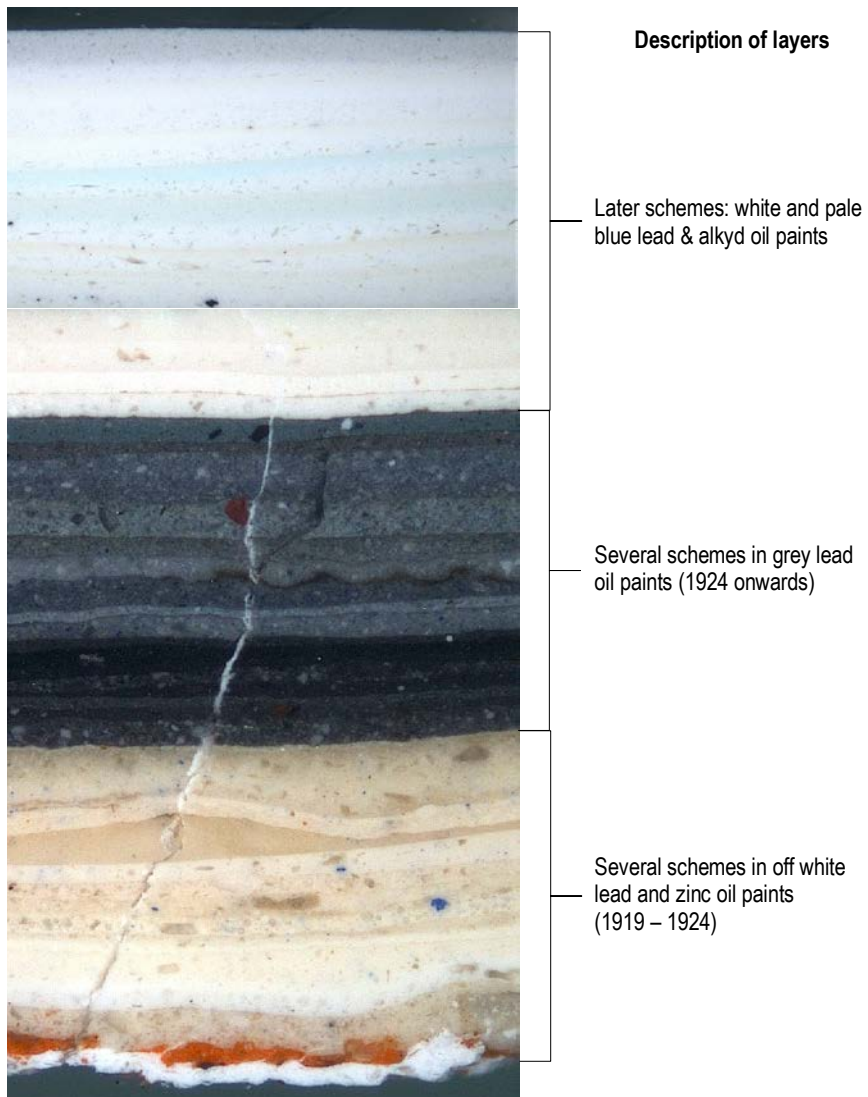
Fig.53: Sample 8.36/37 Steel bulkhead forward lobby (20)

The earliest schemes in off white at the base of the image left are consistent with the 1919 – 1924 phase and there appears to be no evidence for the WW1 schemes surviving in this area. The darker grey schemes above date to the post 1924 period and the first white schemes directly above to 1939 onwards.

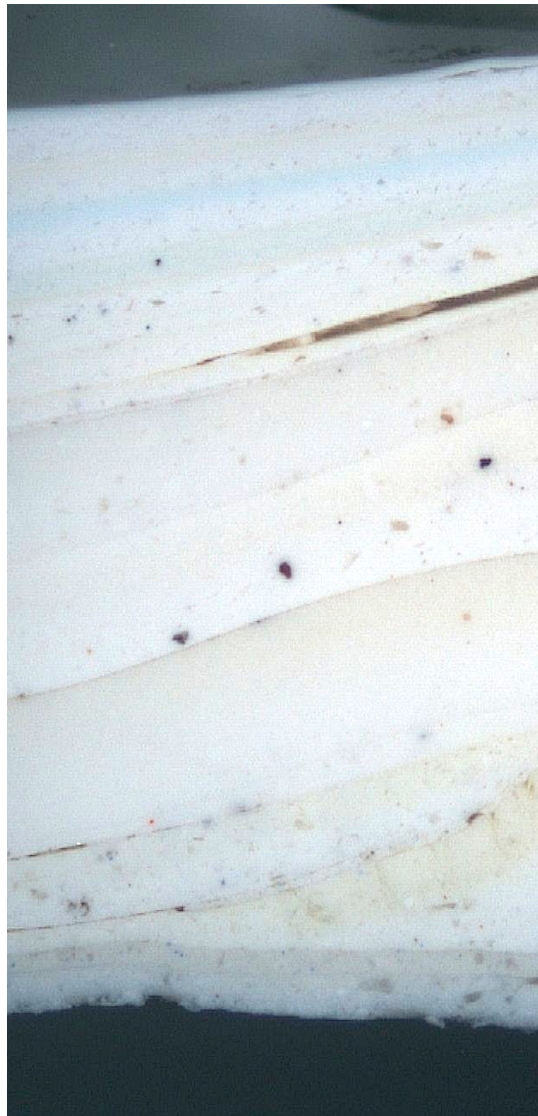
Fig.55: Sample 9.38/39 timber panelling forward lobby (20a)

Modern schemes in pale blue and later white oil paints

Several schemes in white lead and zinc oil paints

The chronology of paint schemes in this area are identical to the tongue and groove panelling in the Office Passage (c.f. fig.45) and appears to have been installed in the 1920's when the vessel first arrived in Belfast.

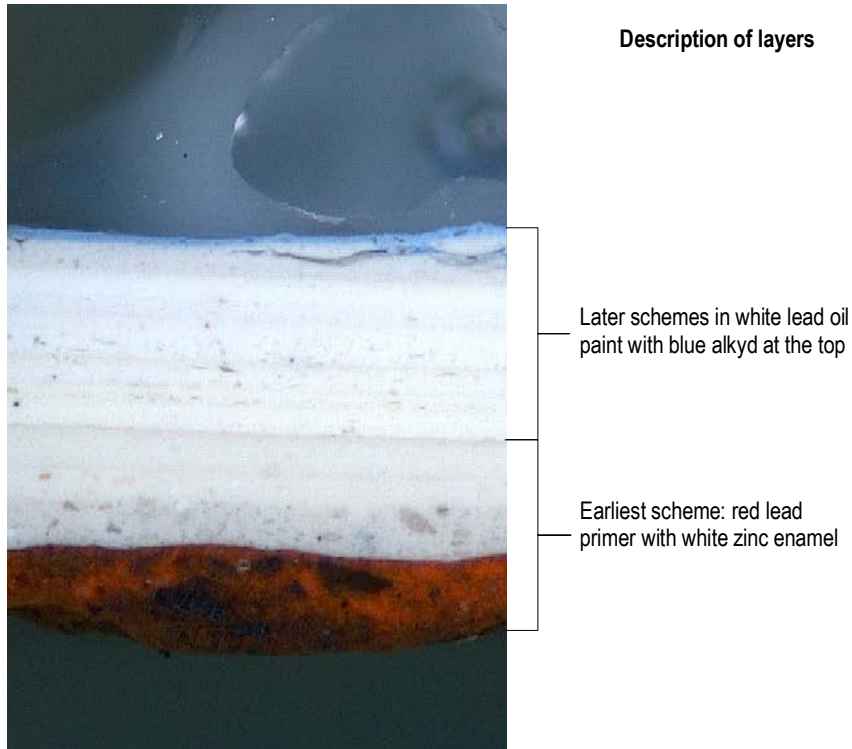
Fig.57: Sample 9.40 Lecture Room inner hull surface (21)

There is very little paint in this area. The earliest scheme above a red lead primer is a white zinc enamel with undercoat. This is followed by three lead white schemes and finally the blue we see today. All are relatively modern.

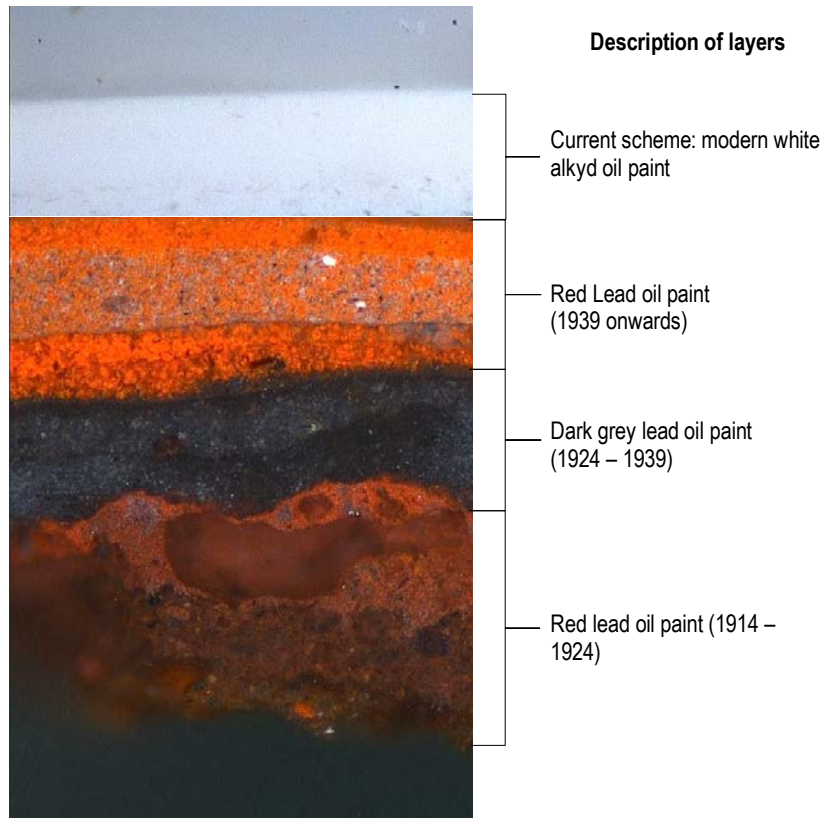
Fig.59: Sample 9.41/42 Engine Room 1 inner hull (22)

The Engine Room was originally simply painted with a red lead oil paint, primarily as a corrosion inhibitor. Dark grey leads applied from 1924 up until the post WW2 period when again it was painted in red lead. There is no precedent for the white scheme we see today, which is a modern interpretation.

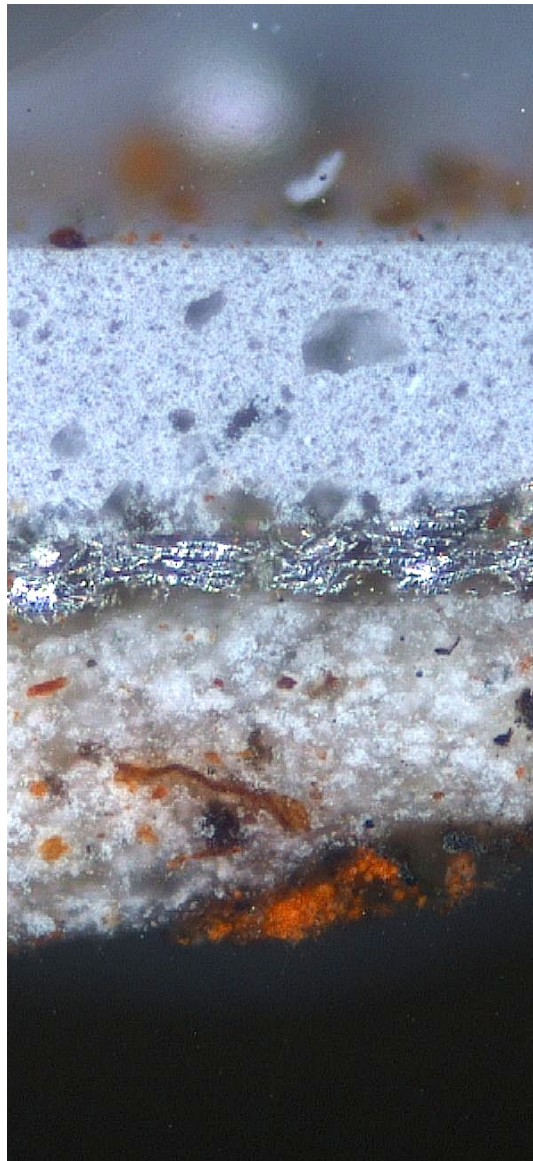
Fig.61: Sample 9.43 Engine Room front of turbine (23)

Current scheme: modern grey alkyd oil paint with aluminium primer beneath

Earliest scheme: red lead primer beneath heavily extended and oil rich white lead oil paint.

There are only two schemes on the turbines. The first scheme is an oil rich poor quality white lead oil paint above a primer. This may have been applied at the Foundry as a corrosion inhibitor or possibly in the shipyard during construction.

The modern grey above aluminium primer is clearly out of context without any historic precedent.

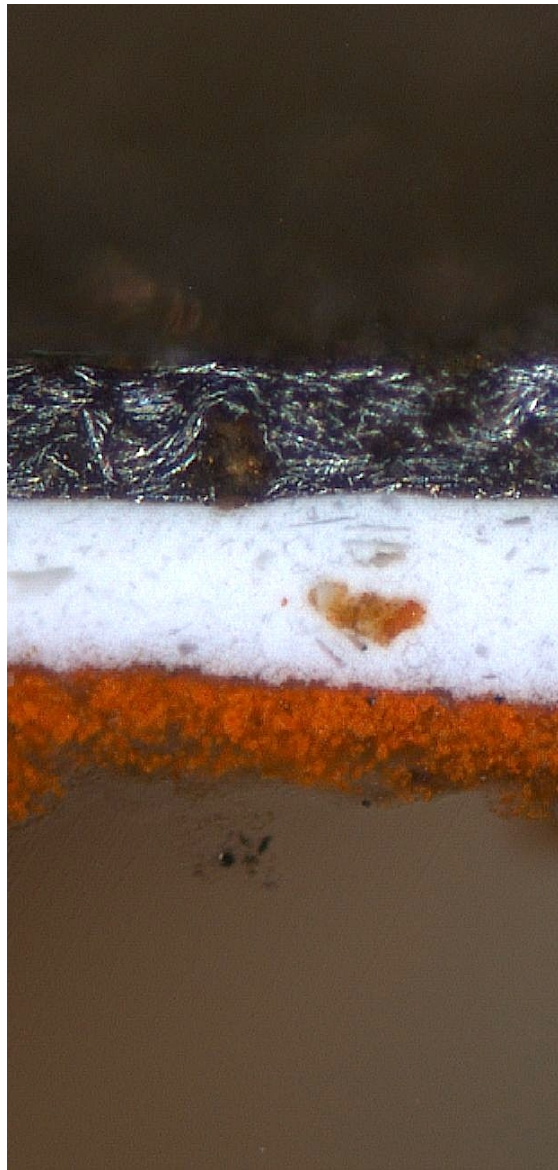
Fig.63: Sample 9.44 Engine Room gold painted pipes (24)

A single scheme of red lead primer with white lead undercoat and modern gold oil paint

The gold paint and primers on these pipes is modern. They were almost certainly originally unpainted.

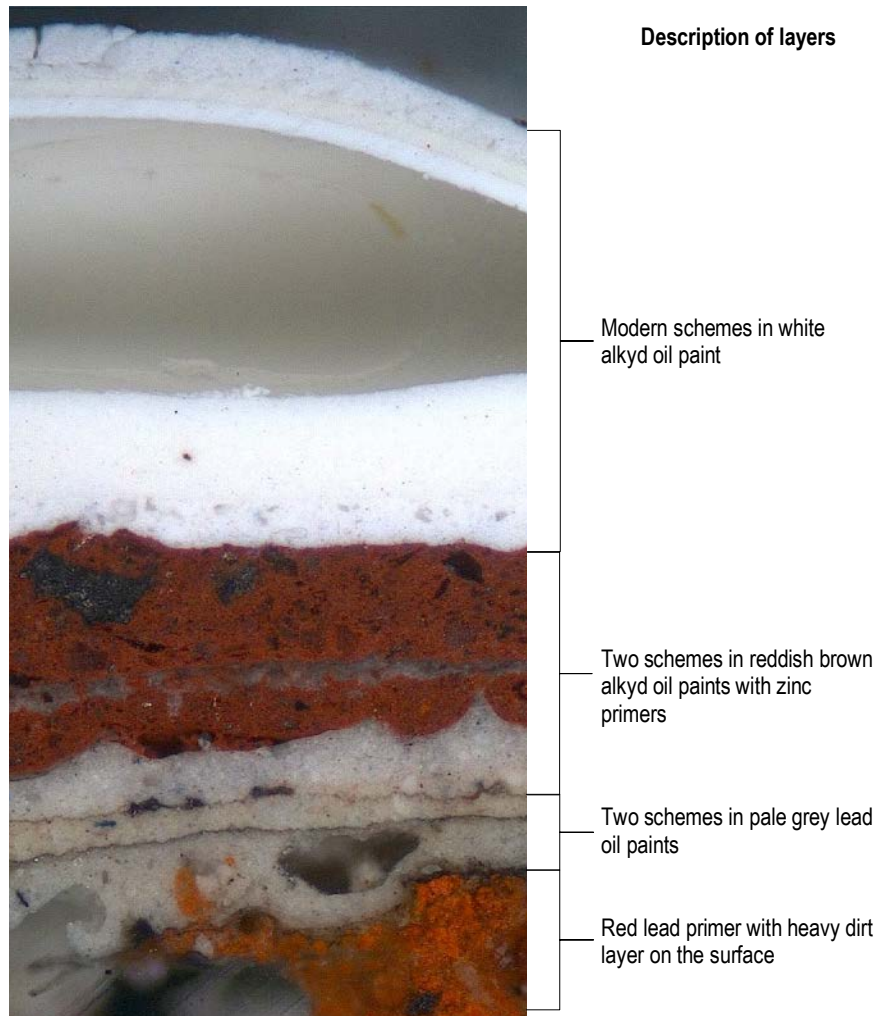
Fig.65: Sample 10.45 Former Boiler Room (25)

The earliest scheme in a red lead primer appears to be coeval with 1914 and was certainly in place for a long period, hence the heavy build up of dirt on the surface and it is worth noting this is consistent with the red lead in the Engine Room during the same period. The later schemes in pale grey probably date to the 1919 – 1924 period and again have heavy dirt layers, a testimony to the dirty conditions in the Boiler Room of a working sea going vessel. The two schemes in reddish brown date to the post 1924 period when the boilers were removed and this space repainted for a new purpose.

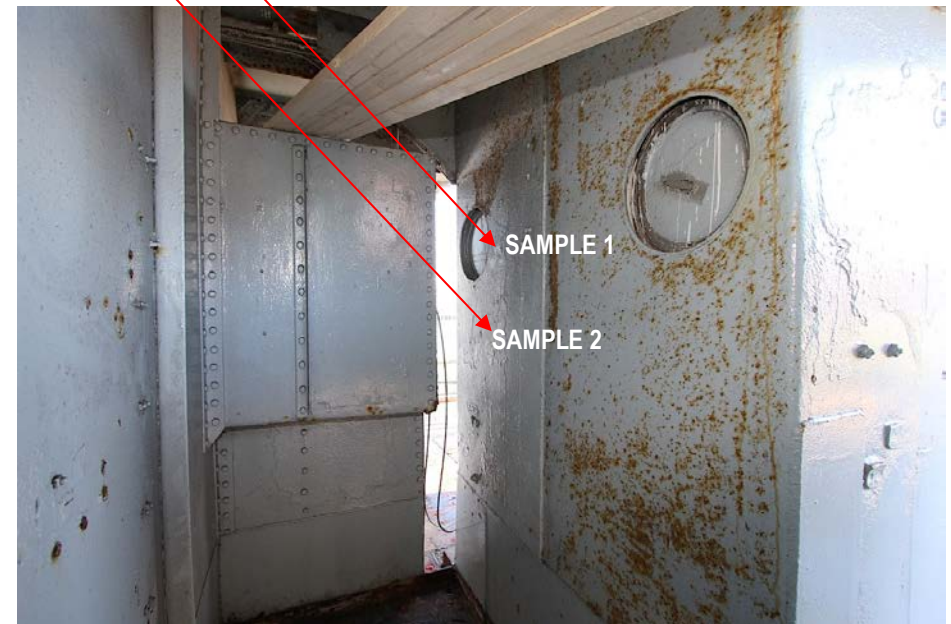
Fig.69: Sample locations

Following the removal of later interventions, further investigations uncovered an area on the Officer's Heads bulkhead, situated on the Forecastle, tucked into the frame of the Navigating Bridge, with a promising heavy build up of paint.

Two samples were removed from an area that appears to have escaped the vigorous blast cleaning carried out on the main superstructure in the past.

Sample 1 was removed from an area adjacent to the starboard side porthole with the second sample removed from an area just beneath. In both cases, these sample sites were selected because both appeared to have retained a heavy build up of paint and likely to yield a full chronology of results.

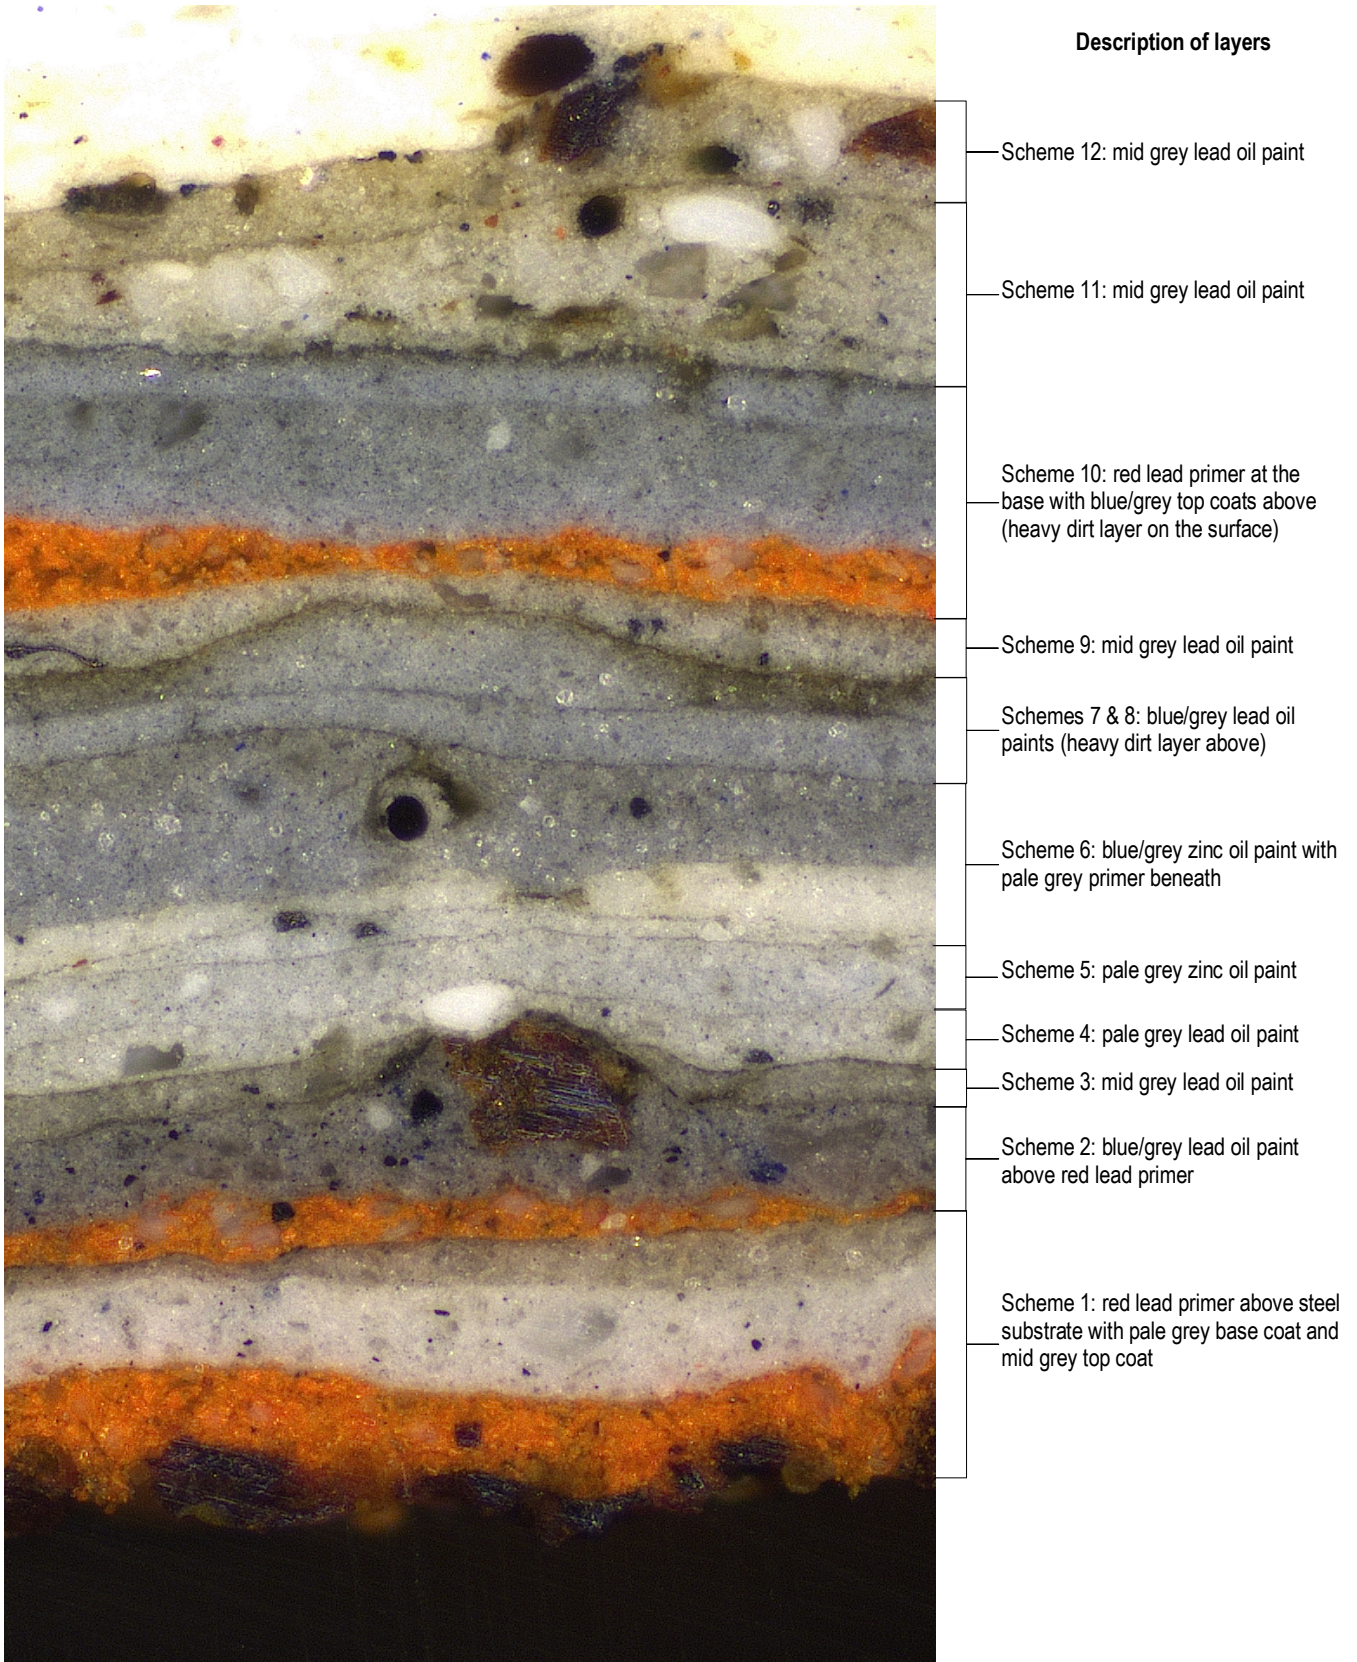
Large scale annotated photomicrographs at X100 magnification are provided in the following pages (figs.70 & 71) that clearly show the early grey oil paint schemes that were applied to Caroline prior to the first white schemes introduced in 1919 when she was posted to the East Indies Station.

The new evidence uncovered in January 2015 does undoubtedly display a full chronology of the paint schemes applied to Caroline during the 1914 – 1918 period and are clearly defined in the large-scale microscope images in figs. 70 & 71. As anticipated, bearing in mind the samples were removed from the same area, both do reveal an identical stratigraphy of paint layers applied over time.

Scheme 1 (earliest) at the base of the image displays the original 1914 red lead primer with pale grey lead base coat and mid grey top coat, both containing finely ground black pigment and chalk extenders in what is presumably a lead white base.

The second scheme was applied in a blue/grey lead oil paint, containing both blue and black pigment. However, the second sample clearly displays a red lead primer beneath, which does not appear on the sample 1 cross section and the reason for this remains unclear.

Pale Grey: 3000-N

Mid Grey: 5502-Y

Blue/Grey: 5502-B
