Experimental and Analytical Evaluation of the Strength of Selected Truss Members from the Approach Spans of the Winona Bridge

*Jason B. Lloyd, Leslie E. Campbell,
Francisco J. Bonachera Martín, Robert J. Connor*

The following report details a research project comprised of two phases. Phase I included the full-scale experimental testing of two built-up truss chord members removed from service. The members were installed into a reaction frame and loaded to failure to determine remaining capacity in the presence of pack rust, as well as after-failure load redistribution behavior mimicking the member in a state following complete fracture of half the cross section. Phase I also included a finite element-based parametric study calibrated by the experimental work. The study was focused on two-channel axially loaded members for the purpose of developing closed-form solutions intended for evaluation of internal member redundancy. During Phase II of the project, a small round-robin-style inspection and load rating study was performed with certified bridge inspectors and practicing load rating engineers. The purpose was to investigate the variability in the inspection and evaluation of sev

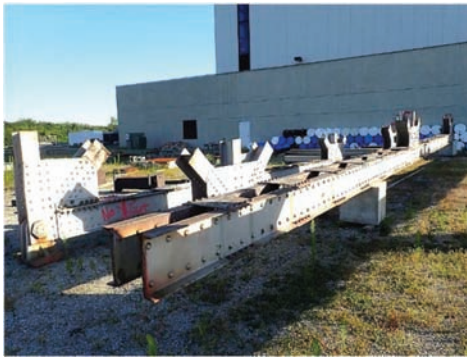
Figure 1.1 Winona Bridge Specimens as they arrived.

The Research Team (RT) received several individual truss members from the bridge in late summer of 2017. Figure 1.1 and Figure 1.2 show the general condition of the specimens in the as-delivered condition. The condition of the rolled channels included some minor section loss along the top interior edges resulting from corrosion. Areas of significant pack rust were evident between the channels and the cover plates along much of the length of the chords to a depth equal to the first row of stitching rivets. The gusset connections for the L2-L6 tension chord sections had some very light corrosion damage, as well. No fatigue or fracture damage

was visually detected by the RT. However, severe section loss at localized areas of the channel cover plates that resulted in crack-like defects were noted by the RT. These are briefly discussed later in the report.

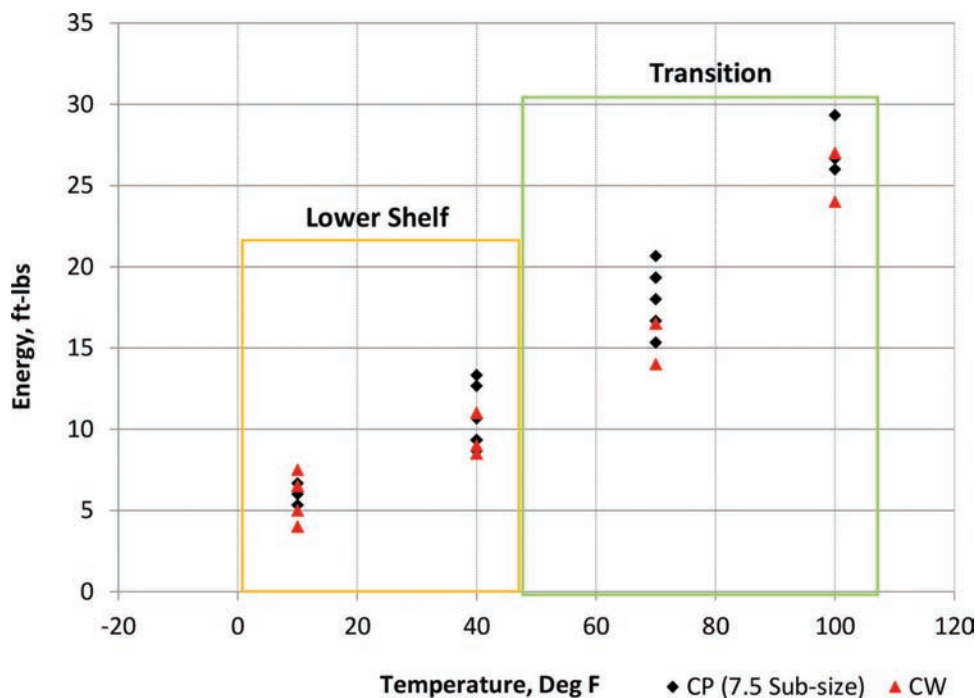
Figure 2.1 Plot of CVN impact energy vs. temperature: cover plate (CP) and channel web (CW).

(see Figure 2.1). However, the more data for each test temperature, the more reliable the estimate of toughness becomes. Therefore, more specimens were tested at selected temperature, such as 40°F and 70°F. Due to the single-digit energy measurements observed at 10°F, it was determined unnecessary to test at any cooler temperatures. The warmest temperature tested was 100°F at which the CVN data appear to remain in the transition region, but may also be approaching the upper shelf portion of the curve.

As noted in the figure, the specimens from the cover plate were “sub-size.” A standard CVN specimen is 10 mm × 10 mm × 40 mm long. However, because the cover plate is only 3/8 inch thick (9.5 mm), a full-size CVN could not be machined and thinner, or sub-size specimens, measuring 7.5 mm × 10 mm × 40 mm long were required. Standardized testing of sub-size CVN specimens can be performed. The smaller thickness dimension of a sub-size specimen can influence the results in two ways. First, the thinner material has a reduced cross sectional area, which reduces its ability to absorb energy. This means the absorbed energy of a sub-size specimen will be less than that of a standard size specimen. Second, the reduced thickness of a sub-size specimen reduces the tri-axial constraint against plastic flow. This means that the sub-size specimen will be more ductile making cleavage fracture less likely to occur. This effect results in fracture mode transition temperatures that are lower for sub-size specimens than for standard size specimens. As a result, the American Petroleum Institute (API) Fitness-For-Service manual (API 579-1/ASME FFS-1, 2007) provides guidance for the adjustment of the measured CVN energy absorbed and the test temperature at which the sub-size specimens

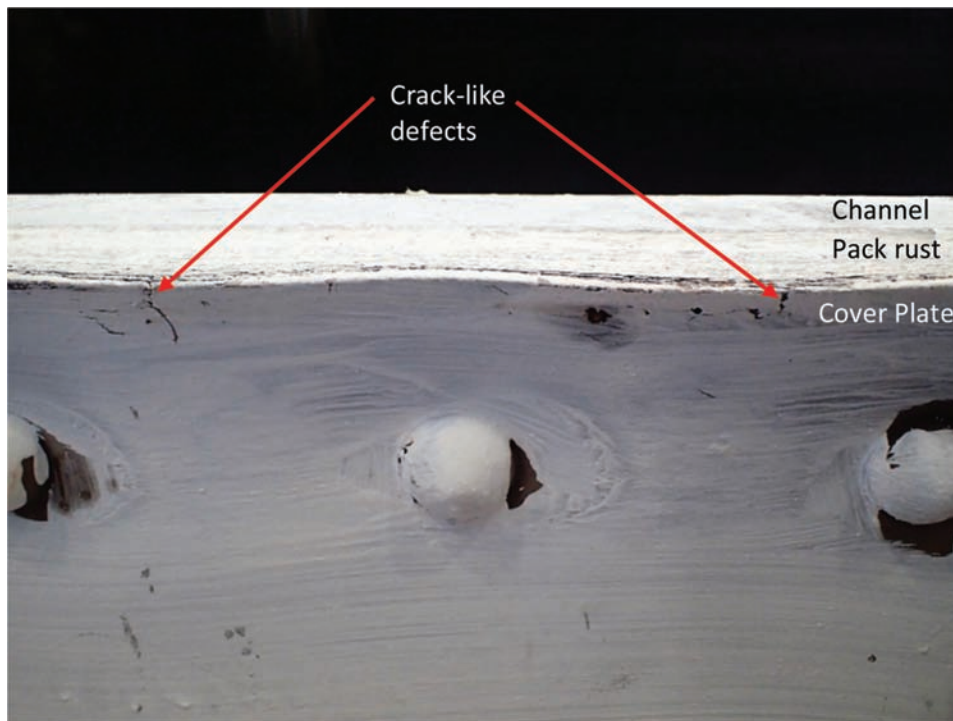
Figure 4.4 Section of Specimen 2 that was cooled for strength testing.

testing. Also, the opposite side (not pictured) has a small area of complete section loss of the cover plate near the top rivets.) These crack-like defects were identified prior to any testing; hence, it is clear that they did not result from testing. The research team believes these

crack-like defects were the result of the cover plate section loss combined with the outward bending from the pack rust that caused a local failure. In other words, the thickness was reduced by corrosion and due to the pressure from the pack out between the plies,

simply cracked the plate. Upon closer inspection, no other cracks, such as due to fatigue, were detected in either member.

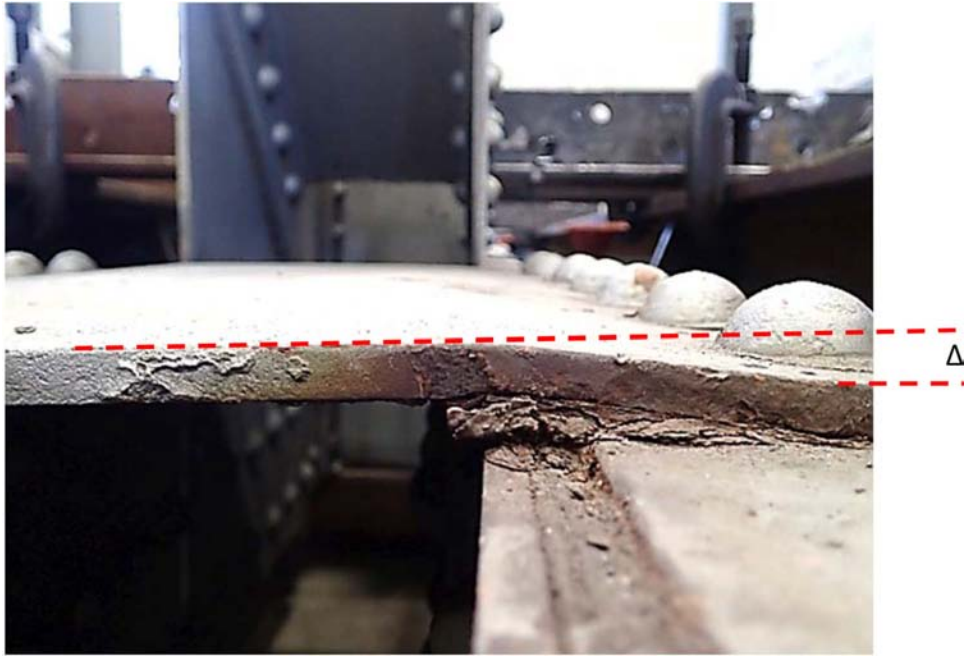
Figure 5.6 Specimen 1 end stay plate prior to testing showing pack rust-induced bending.

has yielded locally at the rivet hole, or both. The in-plane rotation of the stay plate shown in the figure was indicated at the corner of the end stay plate where a small, unpainted section of the channel was exposed. The stay plates resisted opening of the severed channel through horizontal in-plane shear action. This put part of the stay plate in tension and part of the plate in compression, the capacity of which would theoretically be controlled by the buckling capacity of the plate. However, in both experimental cases, and as was later confirmed in the parametric study, the faulted member capacity was not limited by the stay plate thickness (and thus buckling capacity), which was found to have no effect on the internal redundancy analysis. The plates for Specimen 1 and 2 were 3/8 inch thick—a common thickness for riveted built-up members and which can be considered a typical minimum thickness for stay plates.

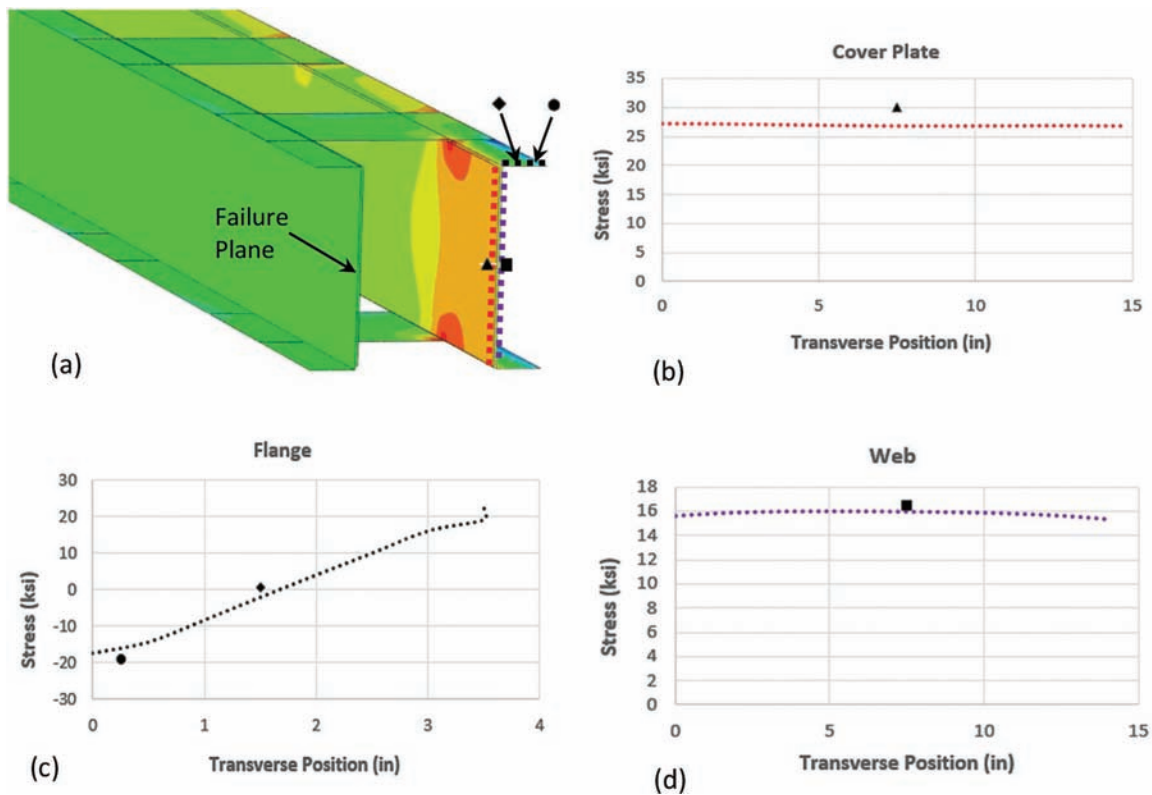
Figure 6.4 Benchmark data comparing FEA results to measured data at the location of failure.

Strain gages were placed at several cross sections along the full length of the specimens, as shown in the gage plans in Appendix C. The benchmark FEM generated longitudinal stress results within 10% or less of laboratory results at all critical areas, such as near the points of severed members, and within 15% or less of all other measured data. Figure 6.4(a) shows a cross-sectional view of the benchmark FEM at the site of the “failure” of Specimen 2. Symbols are sketched at approximate locations where the strain gages were installed, corresponding to the stress plots in Figure 6.4(b)–(d). Figure 6.4(b)–(d) plot stress on the vertical axes and transverse position on the horizontal axes. Dashed lines are also sketched on Figure 6.4(a),

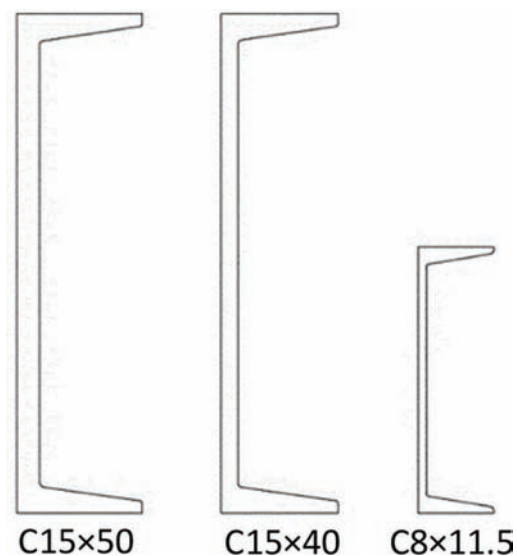
Figure 6.6 Channel sections included in the parametric study.

End boundary conditions were applied to the non-continuous, as well as continuous members, evaluating effects of fixed and pinned end boundary conditions. Furthermore, a pinned boundary condition was applied to interior panel points on continuous members allowing rotation at the joints, but constraining against translation out-of-plate to the truss line. This is consistent with expected behavior in an actual bridge where floorbeams, diagonals, and bracing elements would provide resistance to out-of-plane translation. Boundary conditions were found to have a significant effect on results, which is discussed in greater detail in Section 6.3. Three sizes of rolled channels were considered, however not all sections were considered for all combinations of parameters. They were the C15 × 50, C15 × 40, and C8 × 11.5, which are sketched to scale in Figure 6.6 to give a sense of relative sizes. C15 × 50 is the largest rolled channel section currently available, so it was selected to investigate the effects of varying other parameters between it and the next size smaller. C15 × 40 was chosen because it appeared to be the most commonly used channel section for main tension chords in legacy bridges. This was the channel size used to construct the Winona Bridge from which two test specimens, Specimen 1 and 2, were obtained for the present research. It was necessary to consider channel section size effects, if any. The C8 × 11.5 was selected as a channel that is most likely

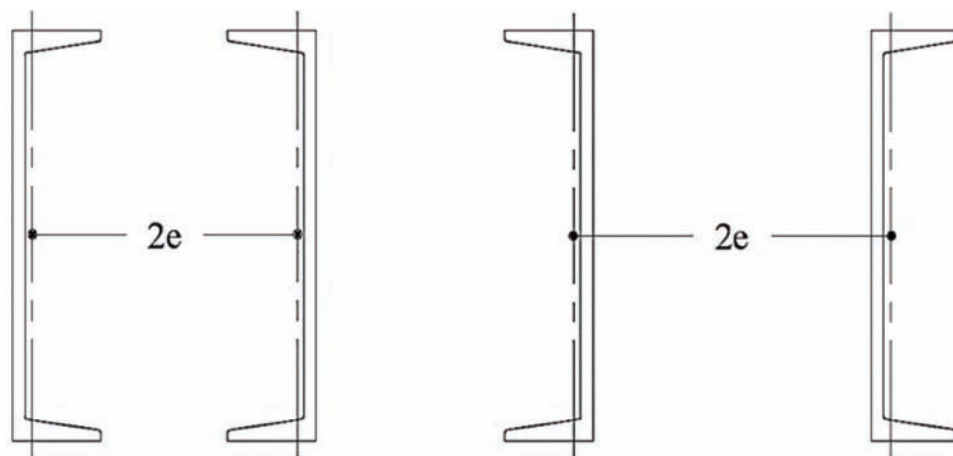
Figure 6.7 Illustrations showing eccentricity e used in development of the simplified evaluation method for two-channel members.

Figure 6.7 illustrates the dimension “ e ” used in the post processing of data from the parametric study. $2e$ represents the distance between the centroids of individual channels that make up a two-channel member, or in other words, the channel spacing. Hence, e would simply be half of $2e$, or the distance from the unfaulted *member centroid* to the centroid of an individual channel. The figure demonstrates how the eccentricity for two members that are comprised of the same size of channels with the same web-to-web spacing, but in reversed orientation, would be calculated and may differ from each other. The parametric study included

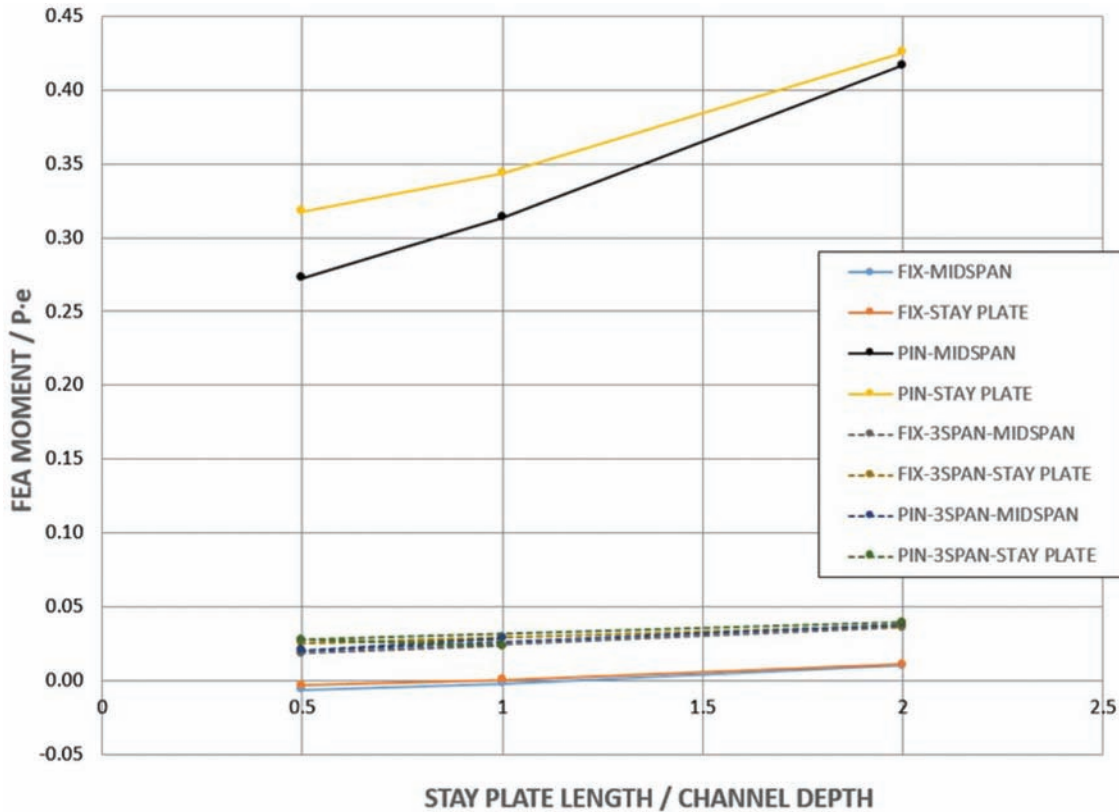
Figure 6.8 FEM results demonstrating effect of boundary conditions and member continuity.

Applied end boundary conditions proved to be the most influential parameter affecting the resulting second order moments in non-continuous two-channel members in the faulted condition. The applied end boundary conditions were effectively inconsequential to continuous members due to rotational stiffness provided by the continuity of the channels. Figure 6.8 plots selected data for several models where the length of stay plates parameter was being evaluated, which is used here only to illustrate the effect of end boundary conditions. A single channel was failed at the mid-panel location (centered between panel points). The vertical axis plots the resulting moment normalized by $P e$, or the percent of $P e$. The horizontal axis plots the length of a stay plate over the depth of a channel. Varying end boundary conditions were applied to each geometry, including a non-continuous member with pinned ends, a non-continuous member with fixed ends, a three-span continuous member with pinned ends, and a three-span continuous member with fixed ends. The dashed lines represent the continuous members. The percent $P e$ for the non-continuous member with pinned boundary conditions differed as much as $10 \times$ more than the same geometry with fixed boundaries. Figure 6.8 also shows that results for continuous members were very similar to non-continuous fixed members and that end boundary conditions on the continuous member had negligible effect on outcomes. This plot demonstrates that the rotational stiffness of the member at panel points

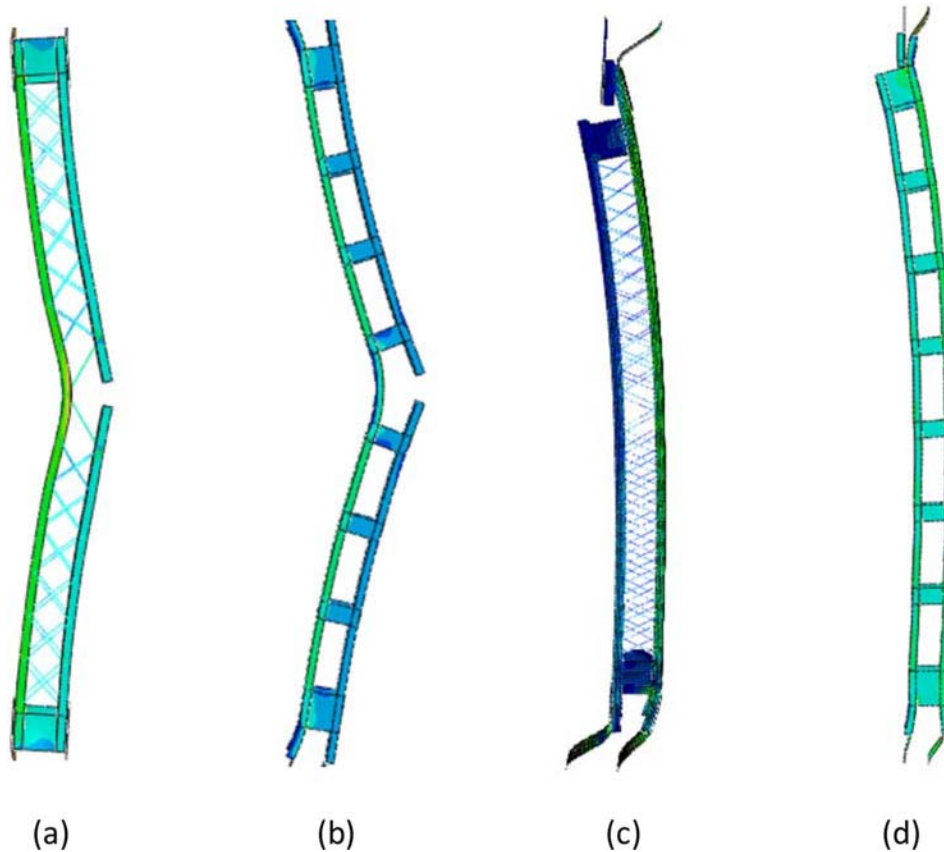
Figure 6.12 Non-continuous FEM results with deformations amplified $50\times$ for clarity. (a) Laced with mid-panel failure; (b) Stay-plated with mid-panel failure; (c) Laced with end failure near gusset; (d) Stay-plated with end failure near gusset.

The size of the channel was found to have negligible effect on the outcomes. This makes sense when considering that loads were proportioned to the area of the

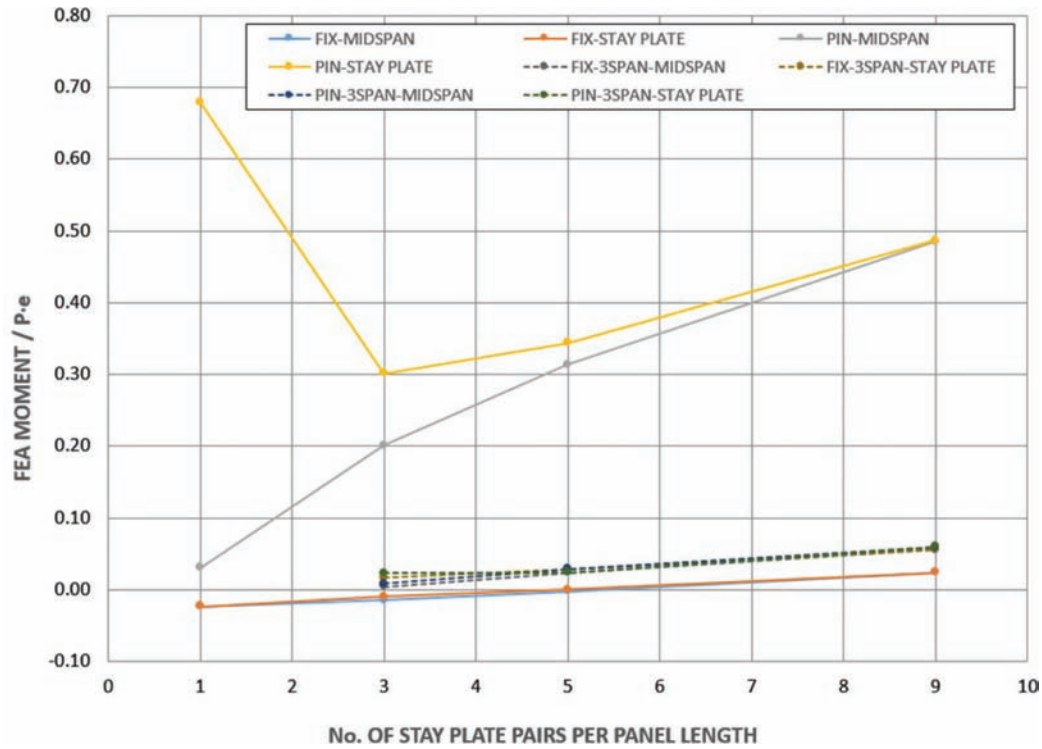
Figure 6.14 Plot showing the increase in moment resulting from more stay plates.

Lacing bar thickness, length, and spacing were examined for their effect on laced two-channel members. Lattice bars sizes ranged from 1/8- to 3/4-inch thick. Lattice fastener spacing ranged from half of the channel spacing to two times the channel spacing. Early design provisions limited the lattice spacing to about 45 degrees, which would be equal to the channel spacing. The same provisions also called for a lattice thickness-to-length ratio of about γ_{60} . The parametric study varied this ratio from γ_{169} to γ_{28} . It was found that these parameters all had negligible effects. One model was also analyzed in which the lattice bars were completely removed so that it only had the end stay plates. When the failure was at the mid-panel location of the member, the resulting moment at the location of the failure was reduced by about half compared to the same geometry with lattice bars, but the moment at the end stay plate was unaltered. When the failure was located between the end stay plate and the gusset connection of the member without lattice bars, the resulting moment at the mid-panel location was unchanged and the moment at the location of failure was nearly doubled, going from 5% to about 9% of $P e$. This behavior suggests that while the lattice may support some limited load redistribution, they are not critical to performance of the member in the faulted condition. This also suggests that even though the parametric study focused on double lattice with fastened intersections, less robust systems of lattice, such as single lattice, would not be expected to affect results significantly. This comparison suggests that the simplified method of analysis resulting

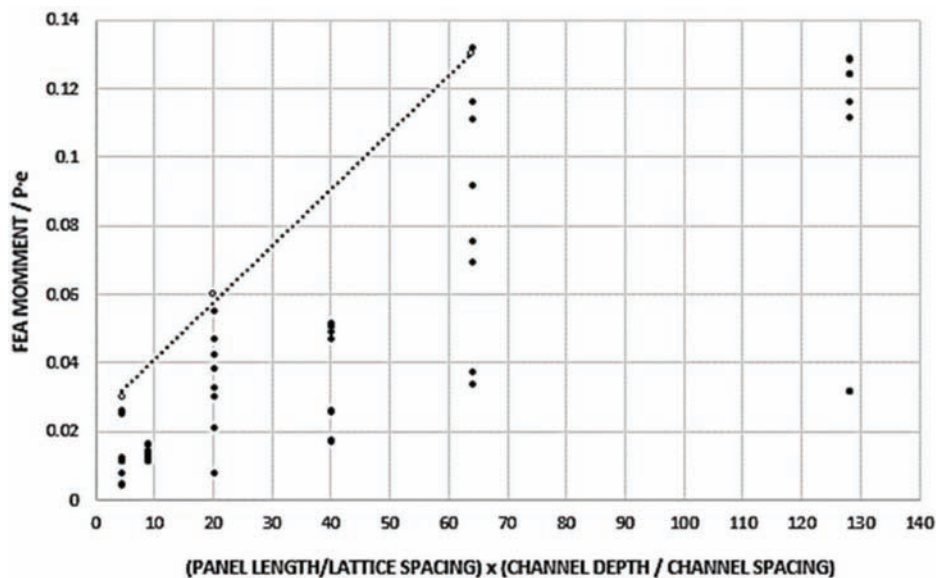
Figure 6.17 Plot of results for continuous laced two-channel members.

Regression analysis was used to conservatively fit a line to the maximum values. Less than 5% of the data exceeded the limit defined by the line, which was considered acceptable. The line is defined by Equation 6.3, which can be used to calculate the second order moment

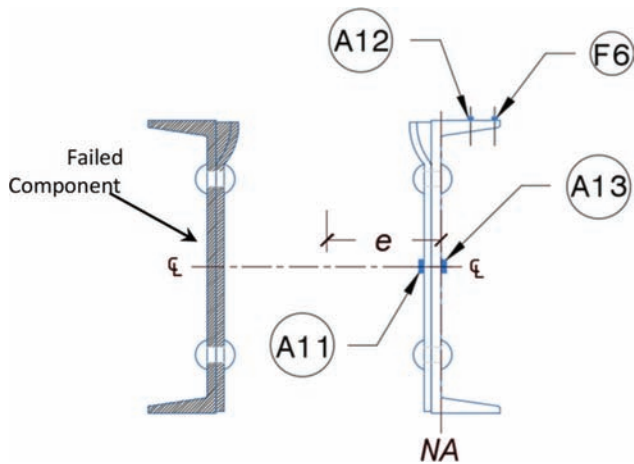
Figure 6.20 Cross sectional view of Winona Bridge Specimen 1, cut location “A.”

The flexural stress calculation requires the input of the variable, c , which is the distance from the channel weak orientation neutral axis to the spot on the channel for which the stress calculation is being made. Failure of a channel will result in the intact channel bending inward toward the failed channel, or toward the center of the member. This means that the highest combination of tensile axial and flexural stress will result at the interior surface of the intact channel. The stress should be estimated for the location of fasteners that are closest to the center of the member because they would likely be the most fatigue prone detail subjected to the greatest tensile stress range. For the case of the Winona Bridge Specimen 1, shown in Figure 6.20 where the channels were oriented with the flanges pointing away from the center of the member, this would be the inward surface of the cover plate where fasteners holes were located. Generally speaking though, two-channel members will only have fasteners in the flanges used for connection to lattice bars or stay plates. Therefore, the

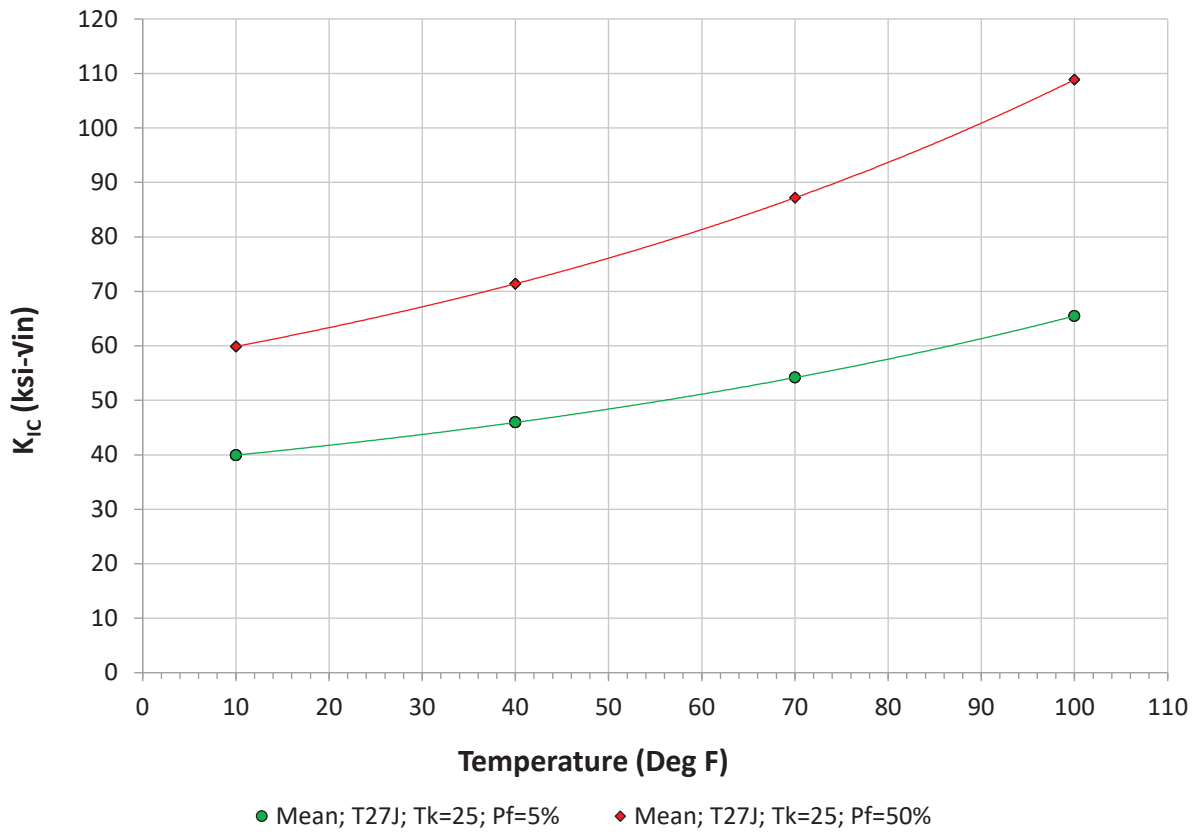
Figure A.1. Master Curve results for the channel web

- Mean $T_{27J} = 28^{\circ}\text{C}$
- $T_0 = 10^{\circ}\text{C}$
- $T_k = 25^{\circ}\text{C}$

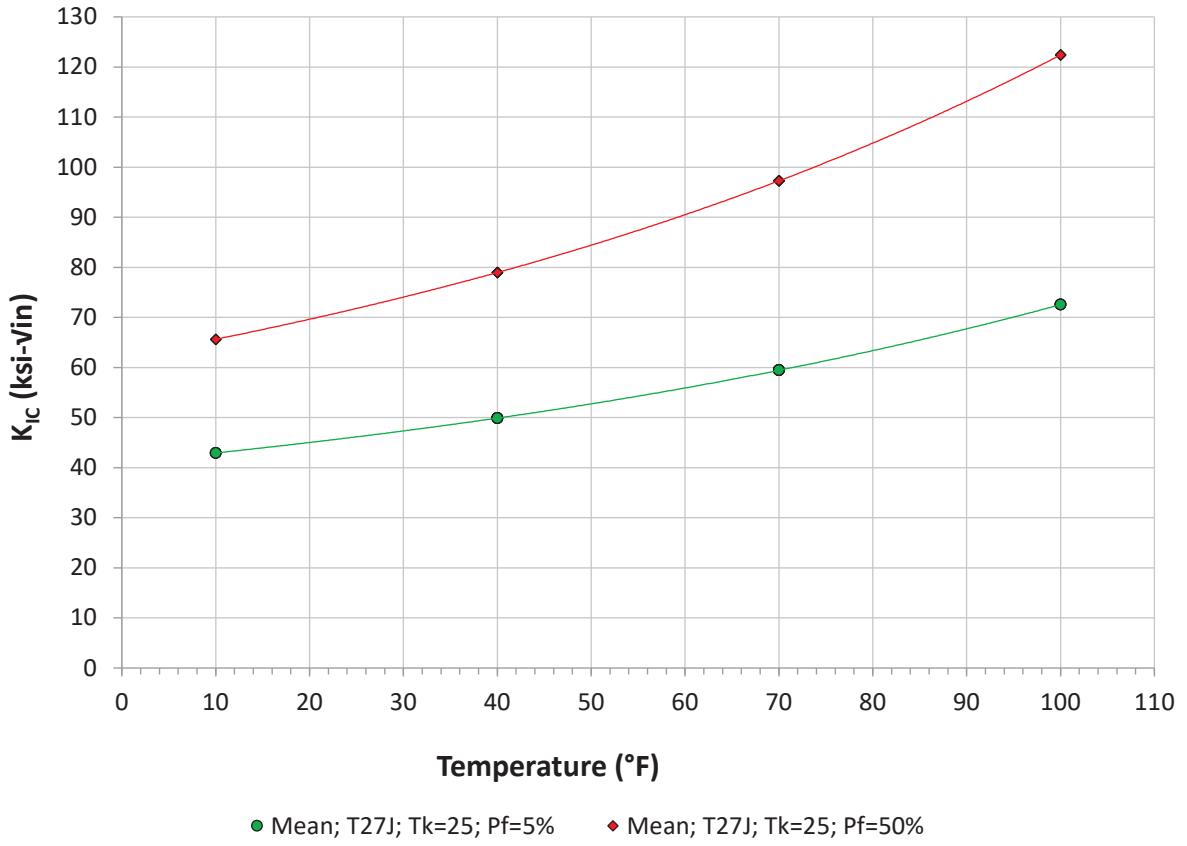
Figure A.2. Master Curve results for the cover plate

- Mean $T_{27J} = 24^{\circ}\text{C}$
- $T_0 = 6^{\circ}\text{C}$
- $T_k = 25^{\circ}\text{C}$

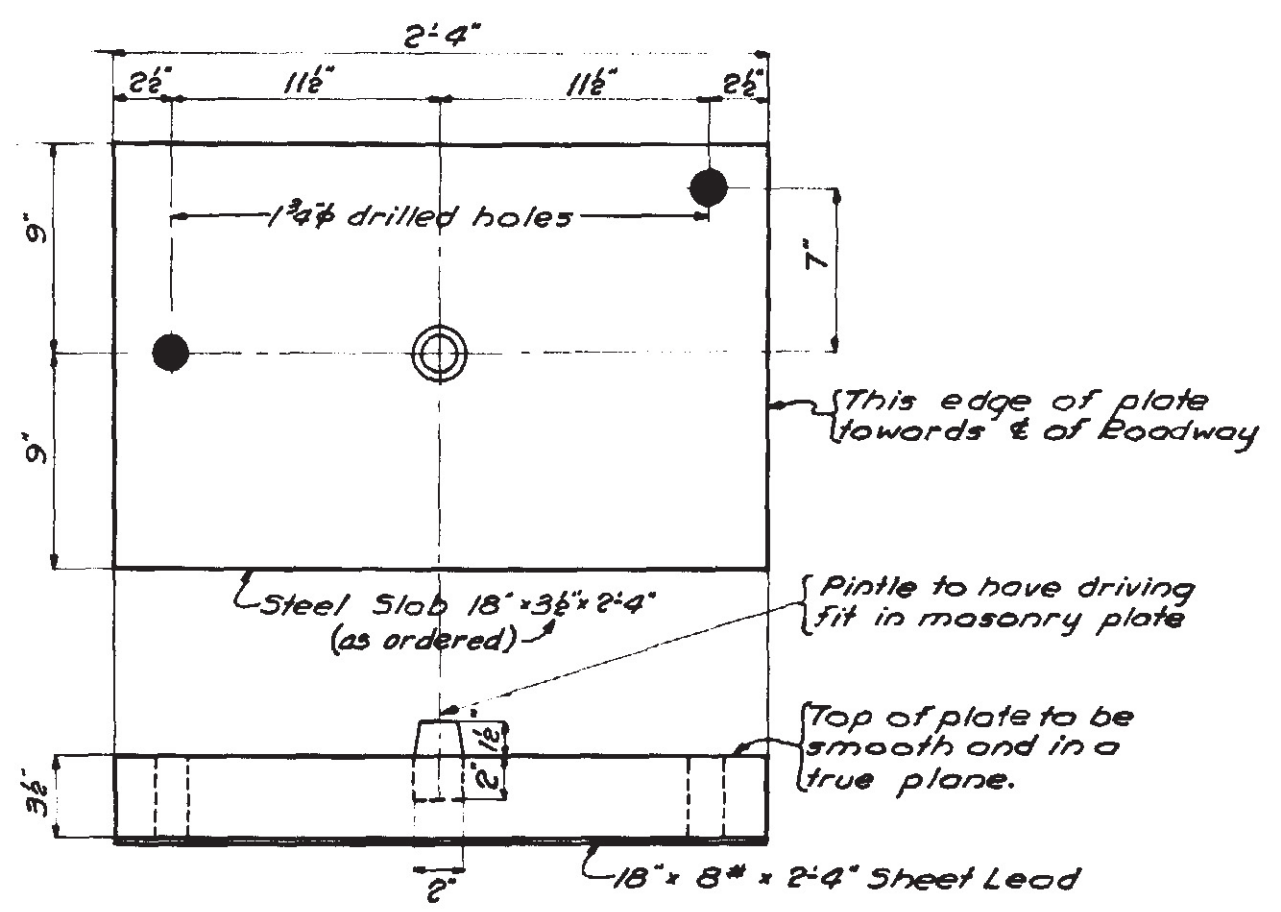
MASONRY PLATE
 Make 6 thus mark MPE
 Make 6 Rev. mark MPL
 Furnish one pair each for Piers 16, 17, 20, 21, 22 & 23

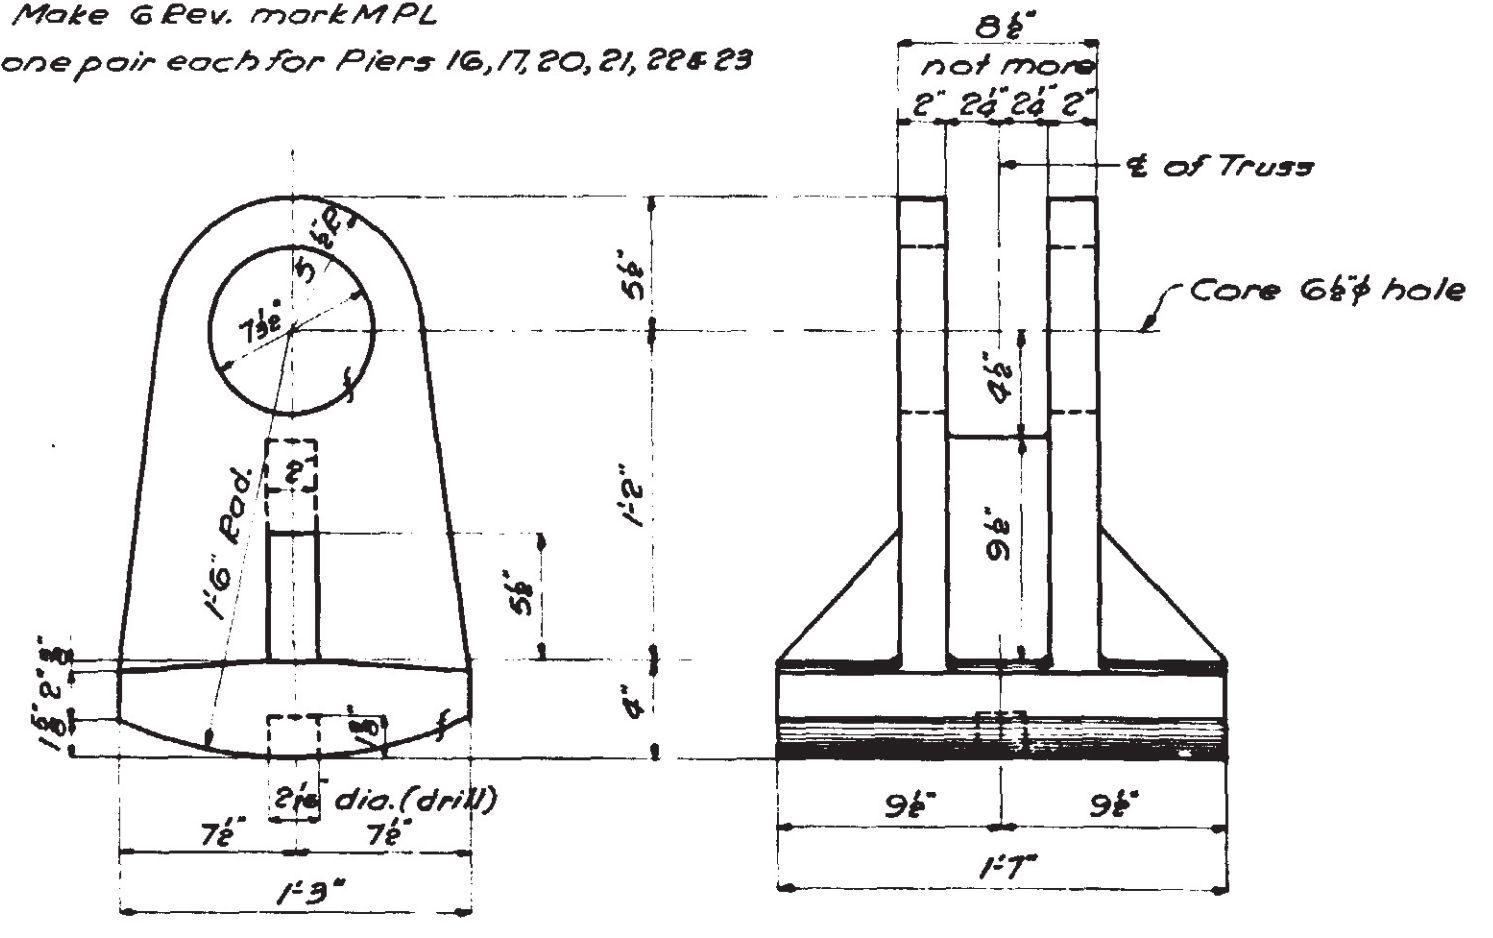
EXPANSION SHOE
 Cast Steel as per M.H.D. 3323
 Test bars as per M.H.D. 2407.3F3
 Make 12 as shown

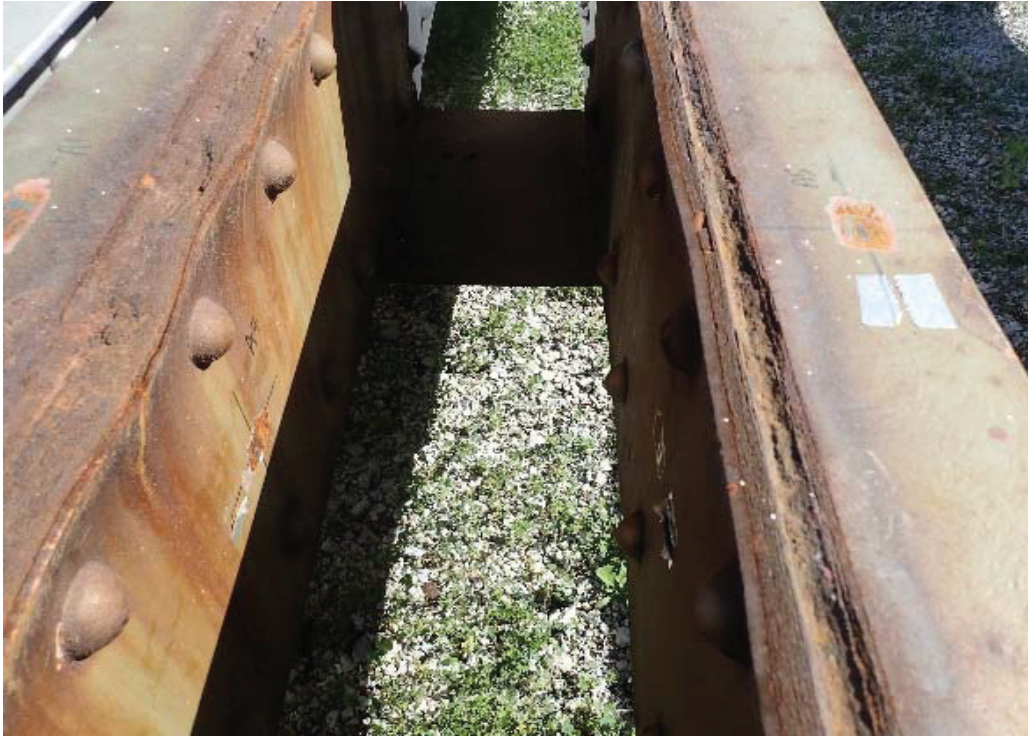
Photo 3: General condition of web plate and channels (looking from L2 to L4)

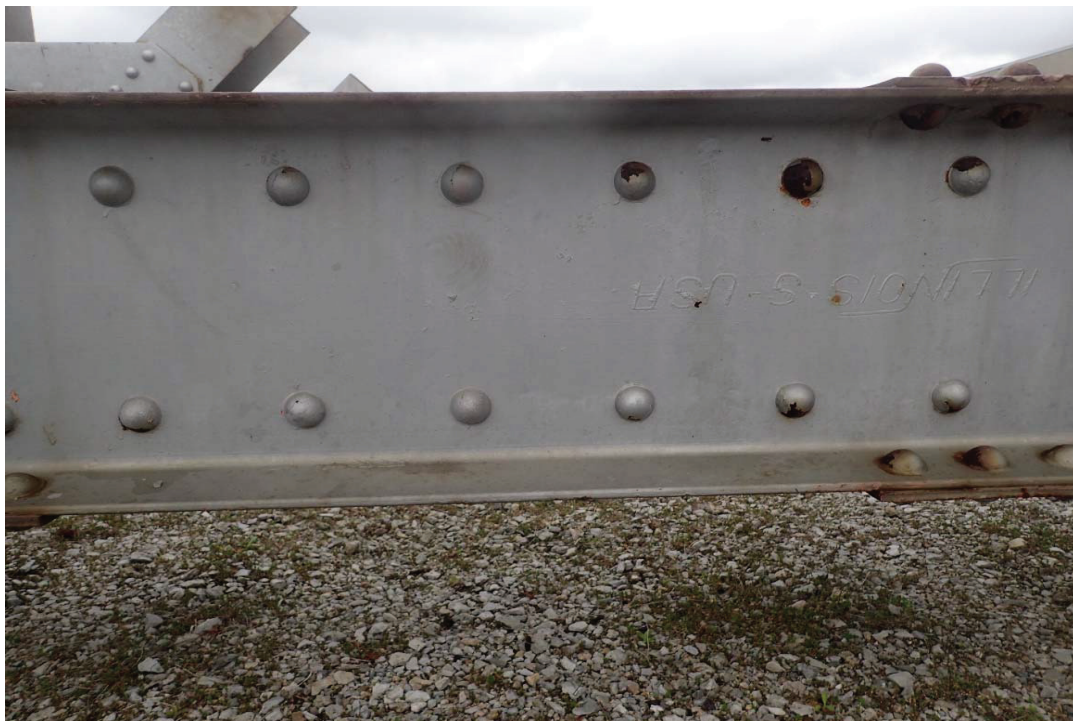
Photo 4: General condition of exterior face of channels (Channel A)

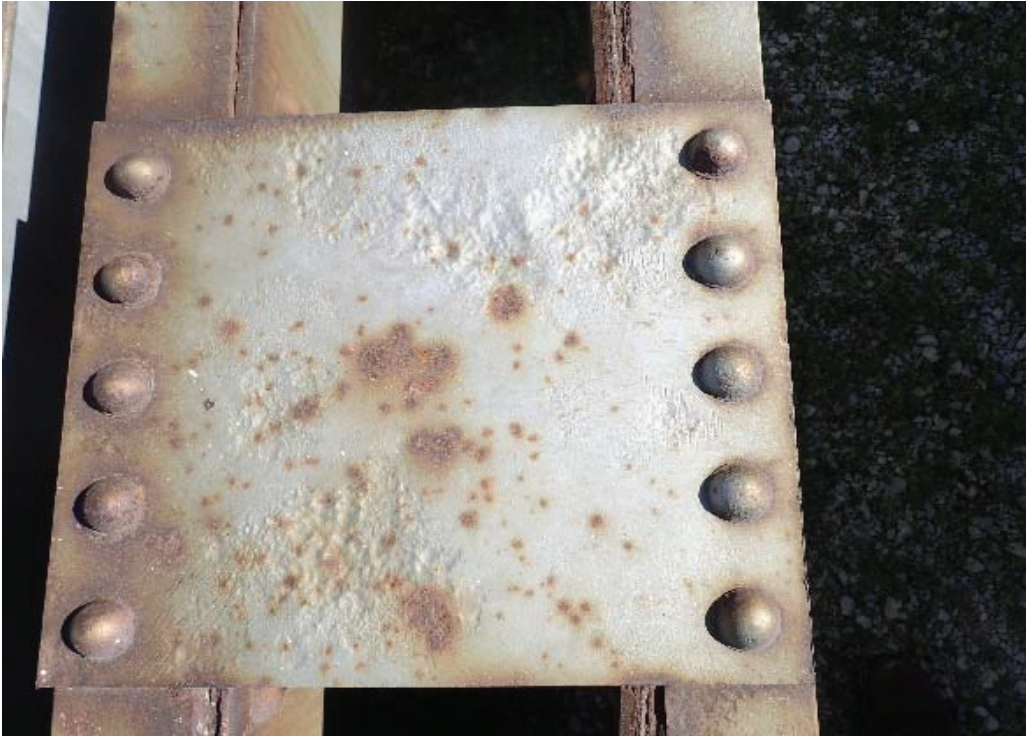
Photo 5: General condition of batten plates

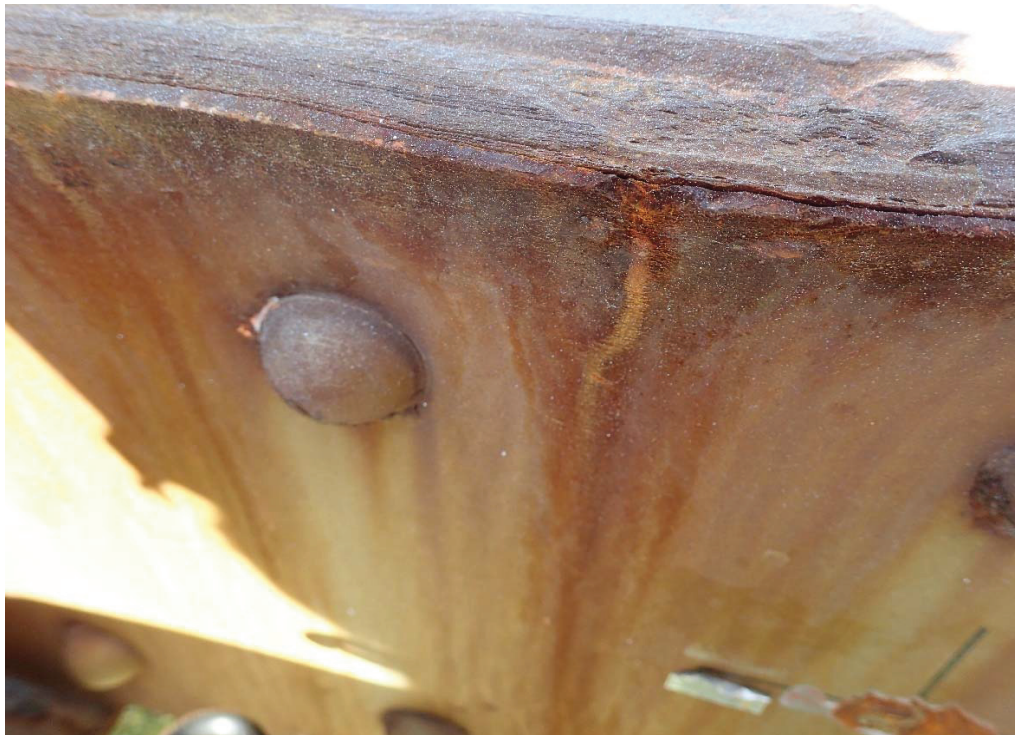
Photo 6: Crack in web plate near top (similar in a few locations)

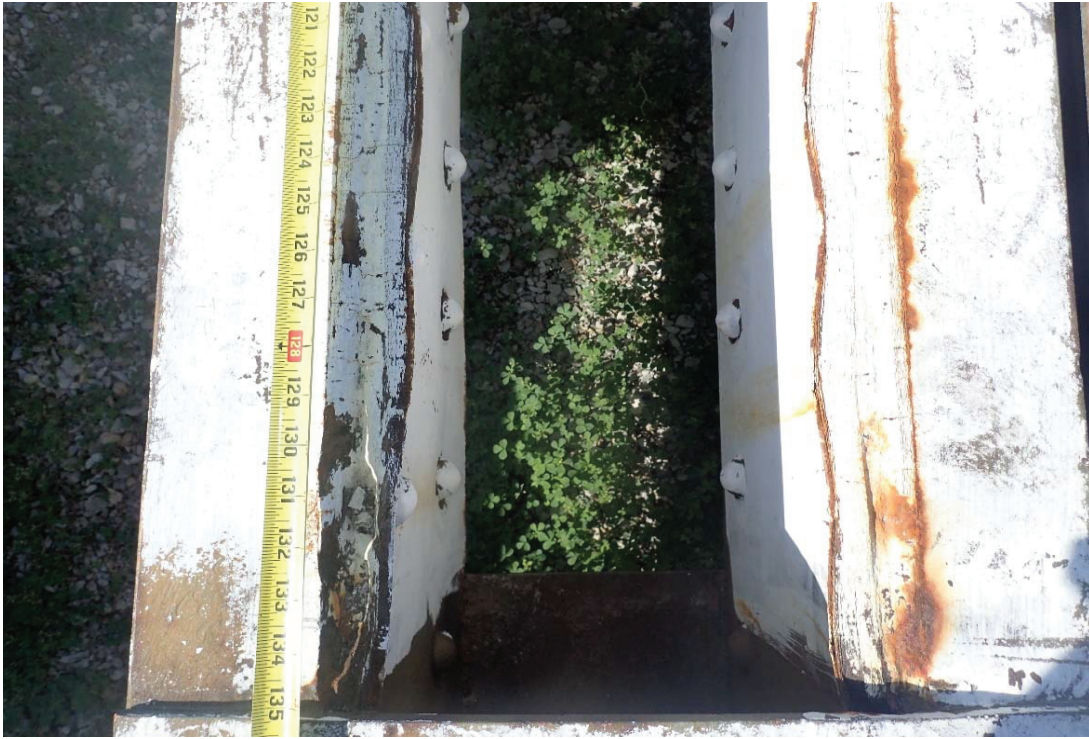
Photo 7: Cross Section 1 (129" from L2)

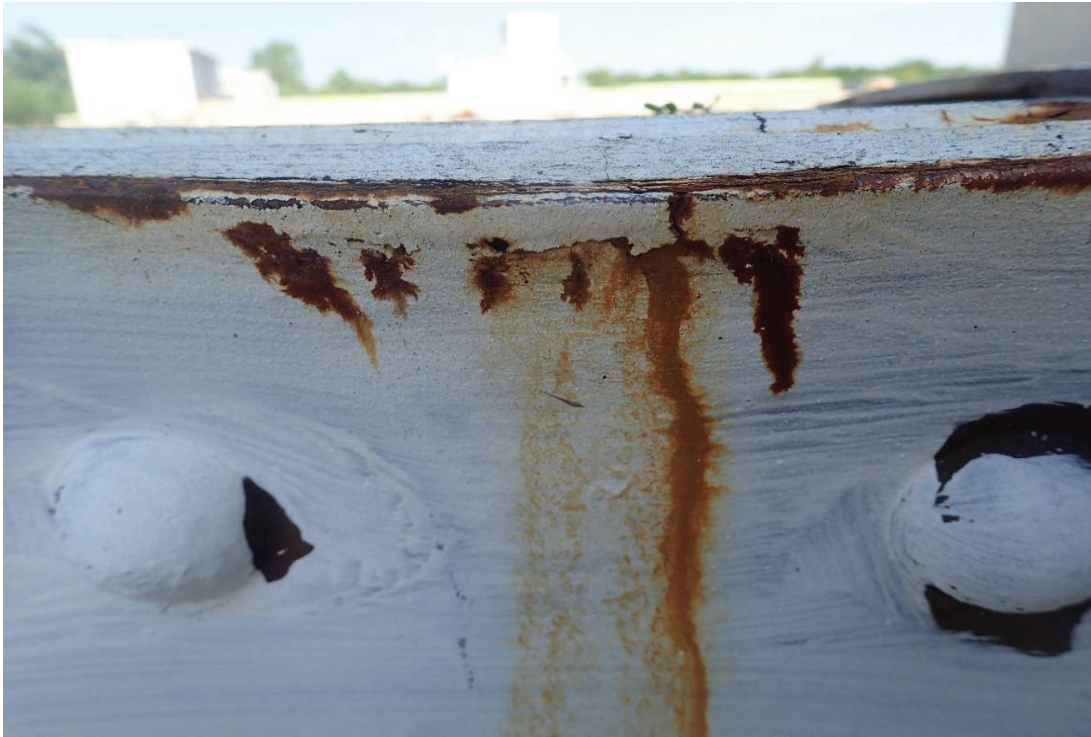
Photo 11: Small crack in web plate of Channel B at Cross Section 1

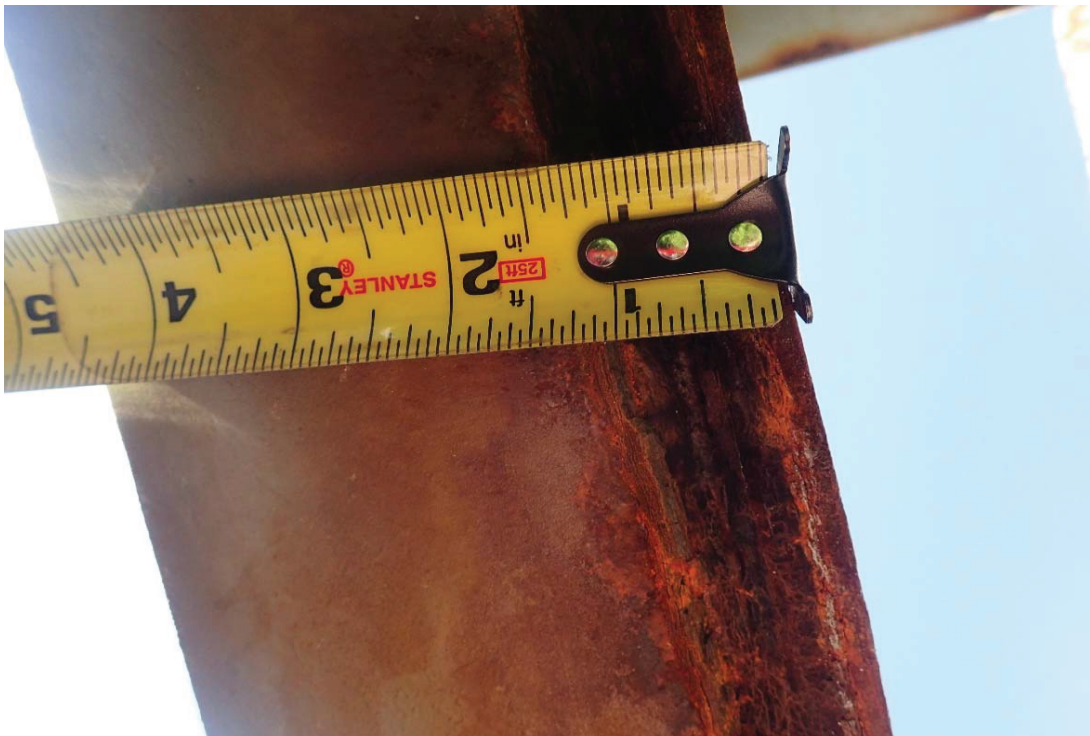
Photo 12: Channel A at Cross Section 1 (bottom)

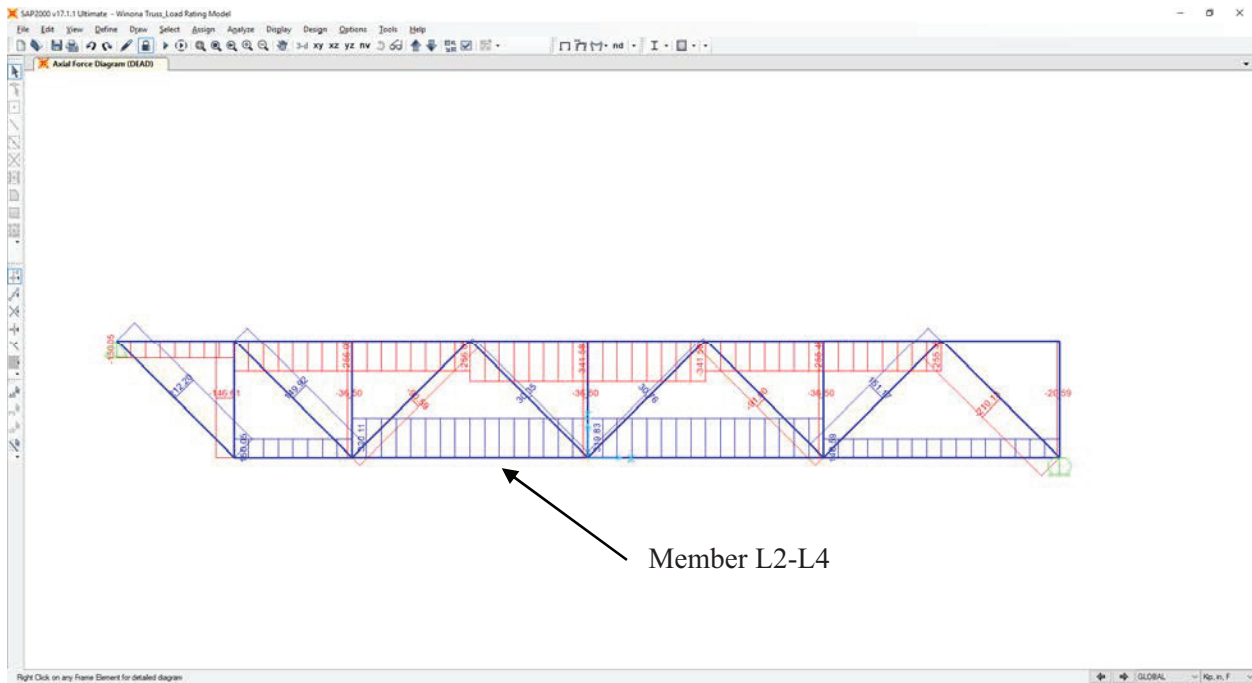
Summary of Member Forces (+ Tension, - Compression)		
Member	SAP2000 (kips)	Original Plans (kips)
U0U1	-150.05	-156.45
U1U3	-256.05	-268.2
U3U5	-341.58	-357.6
U5U7	-255.45	-268.2
U7U8	0	0
L1L2	150.05	156.45
L2L4	320.11	335.25
L4L6	319.85	335.25
L6L8	148.59	156.45
U0L1	212.5	221.25
U1L1	-146.61	-156.45
U1L2	149.92	158.03
U2L2	-36.5	-44.7
U3L2	-90.59	-94.82
U3L4	30.35	31.61
U4L4	-36.5	-44.7
L4U5	30.76	31.61
U5L6	-91	-94.82
U6L6	-36.5	-44.7
L6U7	151.17	158.03
U7L8	-210.13	-221.25
U8L8	-20.59	-22.55
