## Catastrophic tibial baseplate failure of a modern cementless total knee arthroplasty implant

## Case report

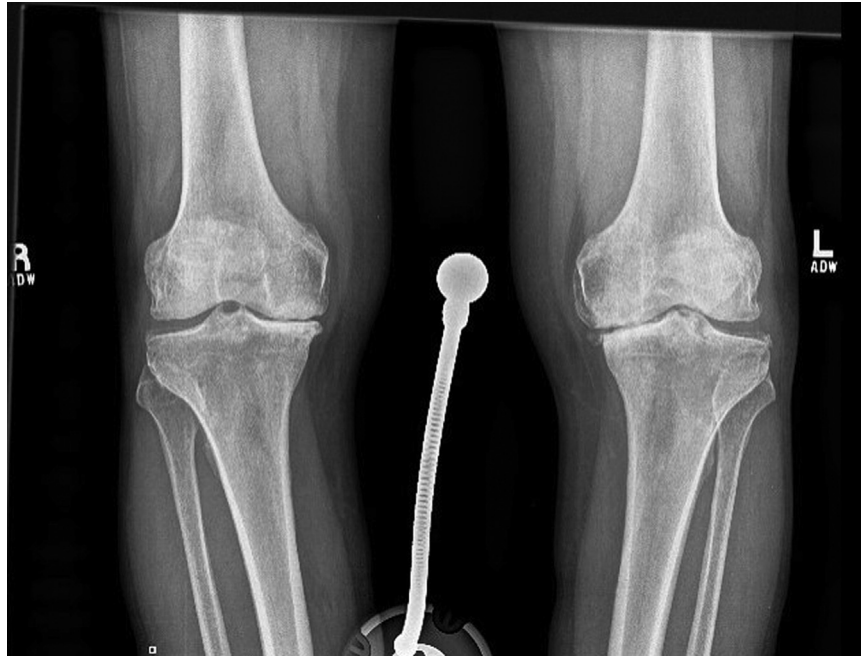
**Figure 1.** Preoperative bilateral anteroposterior knee radiographs.

At age 56, this Caucasian male patient underwent simultaneous bilateral TKA procedures for advanced varus osteoarthritis at an outside hospital (Fig. 1). The patient's past medical history was significant for obesity ( $35.5 \text{ kg/m}^2$ ) and hypertension. The left knee was reconstructed with a Zimmer NexGen cemented, cruciate-retaining size F femur, cementless modular trabecular metal size 6 tibial tray, 12-mm polyethylene insert, and 26-mm cemented patellar component

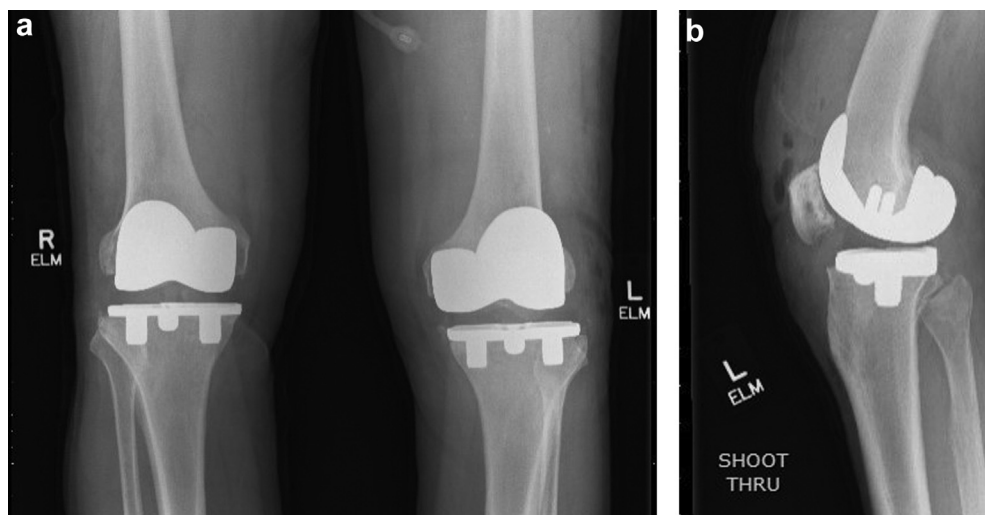
**Figure 2.** Initial postoperative knee radiographs. (a) Anteroposterior bilateral knees. (b) Lateral left knee.

(Fig. 2a and b). There were no perioperative or early postoperative complications. The patient subsequently anecdotally noted that both knees functioned well for approximately 4 years while he continued work as a FedEx truck driver. However, in the preceding months before revision surgery, he began to experience increasing medial-sided left knee discomfort. He denied injury, illness, or known cause for his deteriorating left knee function. Radiographs were obtained by the original surgeon around the time of symptom onset but no intervention was performed (Fig. 3a-c).

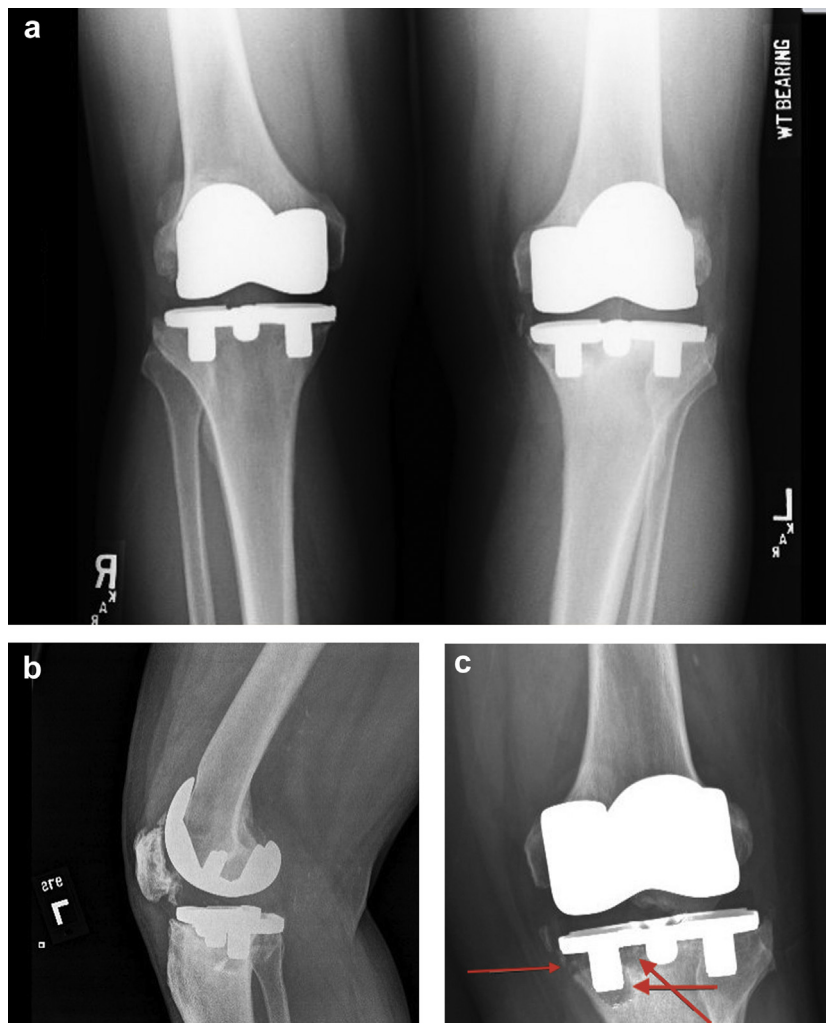
**Figure 3.** (a-c) Follow-up knee radiographs approximately 4 years following the index surgeries, depicting unilateral proximal medial tibial bone loss beneath the left tibial baseplate. Heterotopic ossification is present about the patella.

Careful inspection of the patient's radiographs at the time of symptom onset and prior to baseplate fracture (Fig. 3a-c) reveals this characteristic bone loss about the proximal medial tibia which likely led to the subsequent baseplate failure. The cause of this bone loss remains unclear in this case. With the superior wear properties of highly cross-linked UHMWPE [14] and minimal macroscopic wear noted on the polyethylene insert at the time of revision surgery, it is unlikely that substantial wear-induced osteolysis developed in this case at just 4 years postop. Periprosthetic joint infection, another potential cause for implant loosening and perimplant bone loss, was also definitively ruled out as detailed previously.

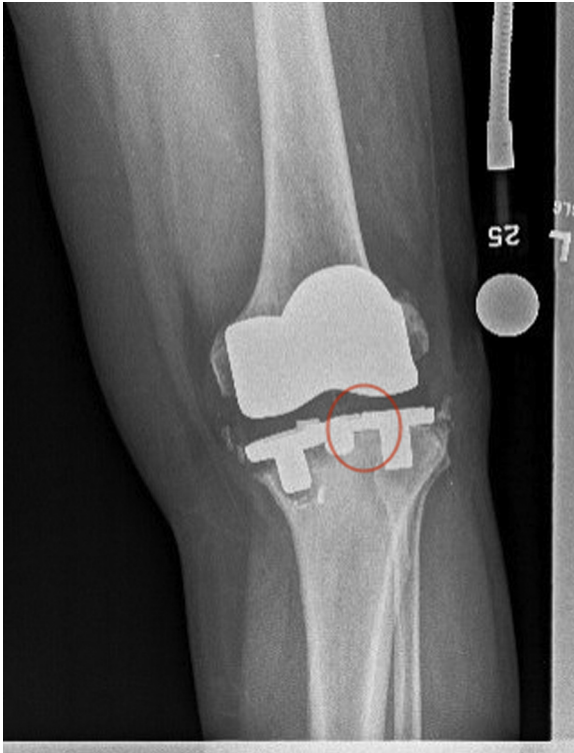
Radiographs of the left knee (Fig. 4a and b) depicted catastrophic failure of his tibial baseplate in conjunction with severe medial-sided tibial bone loss. Given these findings, his weight bearing was immediately protected and he was indicated for an expedited surgical revision. As part of a standard workup, infection was ruled out via standard laboratory tests to include a white blood cell count of 7.3 (normal range 3.7–11.0 × 10<sup>9</sup>/L), C-reactive protein of 0.3 (normal <0.9 mg/L), and erythrocyte sedimentation rate of 2 (normal range 0–15 mm/h), all of which were within normal limits. The patient also had a preoperative knee aspiration, which yielded a cell count of 647 cells/mL with 8% neutrophils and negative gram stain and aerobic/anaerobic cultures.

**Figure 4.** Subsequent left knee radiographs depicting fracture and displacement of the tibial baseplate.

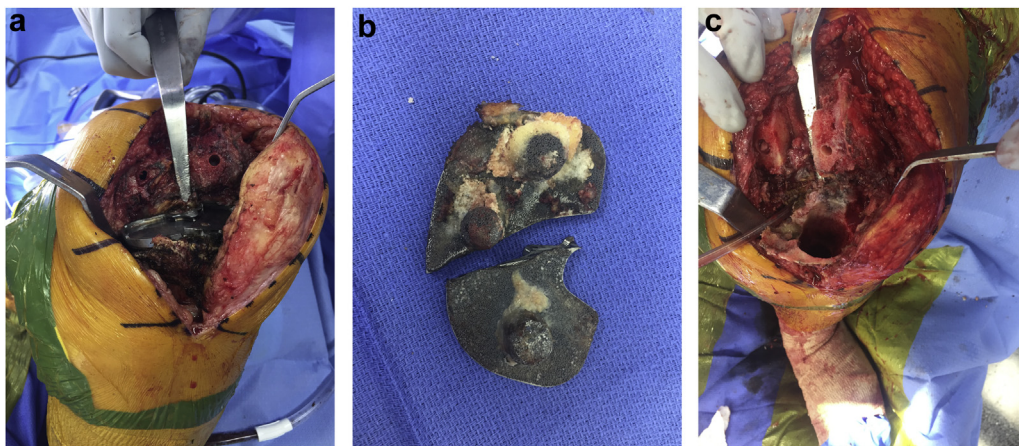
On subsequent surgical exploration, the tibial baseplate was found to have a complete and displaced, sagittally oriented fracture

with the medial half collapsed into a large, uncontained proximal medial tibial defect (Anderson Orthopedic Research Institute classification IIA) (Fig. 5a). The locking mechanism for the polyethylene insert was also damaged. The femoral component had no macroscopic damage. The broken tibial baseplate fragments were completely removed (Fig. 5b) along with the femoral component in the process of performing a full revision TKA procedure. Given the substantial, uncontained medial-sided tibial bone loss, an asymmetric tibial cone (Stryker, Mahwah, NJ) was utilized to provide medial-sided structural support for the revision tibial baseplate (Fig. 6), and stemmed, cemented femoral and tibial components were selected with a varus/valgus constrained polyethylene liner (Fig. 7a and b). Constraint was utilized to account for medial collateral ligament laxity. Three intraoperative tissue samples were sent for aerobic and anaerobic cultures, all of which came back negative.

**Figure 5.** (a-c) Clinical photographs depicting the fractured tibial baseplate and underlying severe proximal medial tibial bone loss. Note the extensive metallosis within the tissue appearing black. Underside of explanted tibial baseplate shows limited bony ingrowth medially. Final photograph shows the medial tibial bone loss just before final preparation of the tibial asymmetric metaphyseal cone.

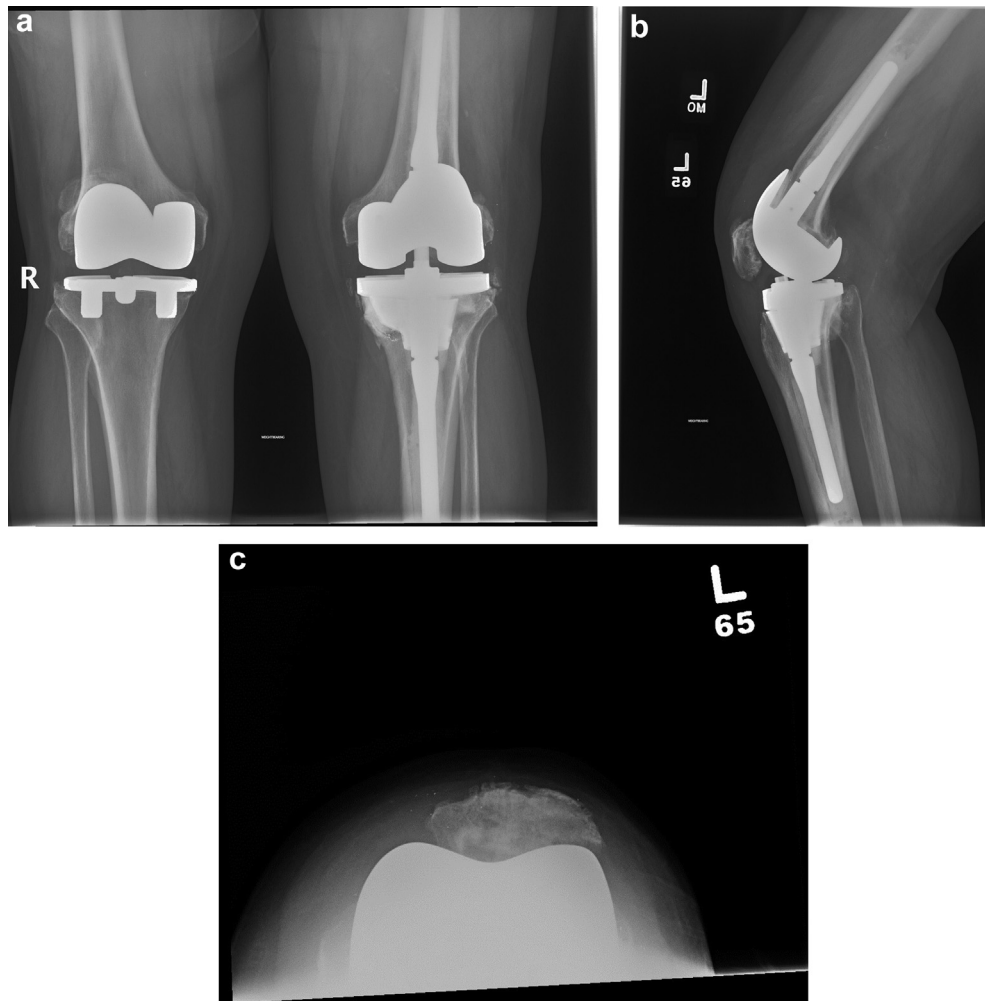
**Figure 8.** Anteroposterior bilateral (a), lateral left (b), and Merchant left (c) knee radiographs 1 year postop following the revision left total knee arthroplasty procedure.

The patient had no perioperative complications. Following a standard course of physical therapy, he returned to work at full capacity 2 months following the revision surgery. At 1 year follow-up, the patient is doing well with substantial improvement in his functional scores, no regular reported discomfort, normal gait without any assistive device, and range of motion of 0°–120° (Fig. 8a-c).
