Proceedings of the XVII ECSMGE-2019

A coarse sand barrier as an alternative preventive measure against backward erosion piping

U. Förster

Deltares, Delft, The Netherlands

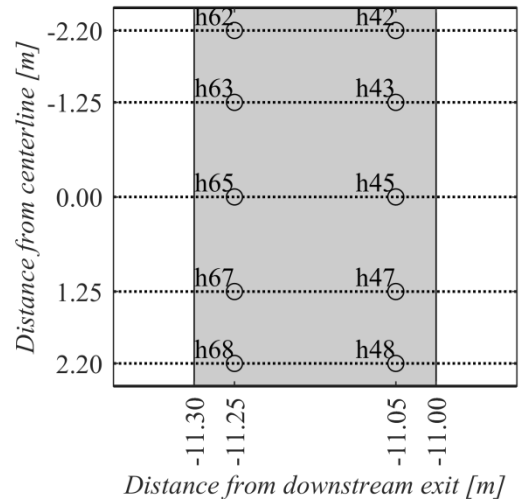
Beside the gauges (level meters), belonging to the standard equipment of the Delta Flume, 28 pore pressure transducers (PPTs) were installed (2 at a depth of 2.0 m with respect to the sand-clay-interface and the others directly at the sand-clay interface, which also concerns the PPTs in the coarse sand barrier), as illustrated in Figure 2 and Figure 3.

Figure 3 Detailed view of the positions of the PPTs in the CSB in Test 2

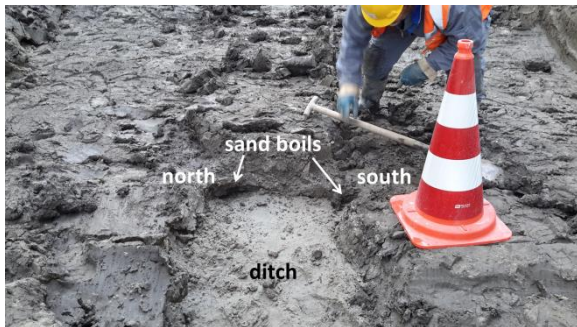
the levee in order to examine how the pipes had formed underneath the clay layer. Two sand boils were formed beginning from the upstream end of the ditch: one at the southern edge, one at the northern edge (Figure 5). Starting from the sand boil at the southern side a meandering path of deposited sand (partially coarse sand from the barrier) has formed, which has been conserved as positive relief in the blanket layer (Figure 6). This pipe is approximately 5 cm high and 5 cm wide and continues in an angle of approximately 45° in the direction of the flume wall. Nearby the exit point in the ditch the sand path in the blanket layer is cut into the blanket layer.

Figure 5 View on the upstream edge of the ditch with sand originating from two sand boils

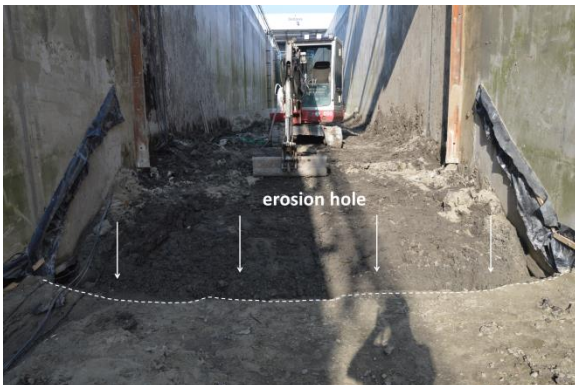
Figure 9 shows the erosion on the upstream side of the dike after the drawdown.

Figure 9 Erosion along the whole width of the Delta Flume on the upstream side after draw-down

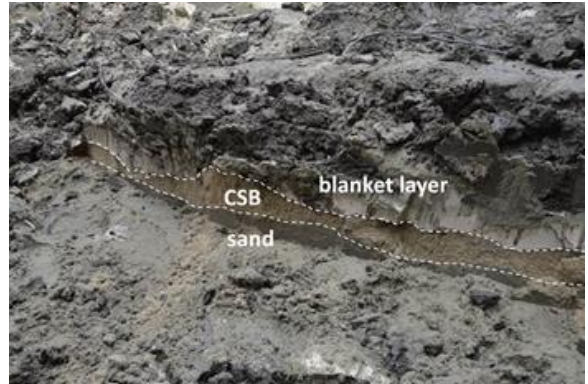
Subsequently, some parts of the CSB were excavated for examination of the failure mode. The CSB was largely eroded, but at some locations parts of the CSB were still intact (Figure 10).

At the location where the upstream eddy stopped (nearly the northern flume wall) the CSB was completely eroded. Pipes could not be found in the downstream background sand after excavation, since all evidence was destroyed after failure.

Figure 10 Irregularly eroded CSB with subsided blanket layer after failing in Test 2 (view in upstream direction). Length of the excavated CSB is approximately 2.5 m.
