1 Behaviour of H-section purlin connections in resisting progressive collapse of roofs

10 **Abstract:**

11 When a truss roof is subjected to sudden local damage, purlins are capable of bridging the damaged planar  
12 truss unit, thereby increasing the robustness of the integrated roof system. To investigate the bridging  
13 capacity that purlins can provide, experiments were carried out on the bolted fin plate connections that join  
14 thin-walled H-section purlins to the main truss, investigating their behaviour under a main truss-removal  
15 scenario. Eight specimens with varied connection details were tested. Results of all experiments are  
16 provided in detail, including the full-range vertical resistance-displacement curves, the collapse-resisting  
17 mechanisms, and the failure modes, being either bolt shear failure or combined bolt bearing and net-section  
18 tensile failure. Meanwhile, a theoretical model is proposed to predict the vertical resistance-displacement  
19 response of the purlin-to-connection assembly. This model is capable of capturing the slip of bolts, and the

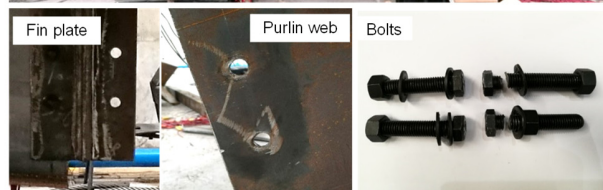
(b)

B(R): Bottom bolt at RHS fractured

Front view of the entire specimen

T(R) - Top bolt at RHS fractured

153 failure mode marked by the fracture of bolts in shear. Photos showing the key components at the two peak  
154 loads can be found in **Fig. 6(b)**. It is observed that the bolt holes on the purlin web experienced noticeable

155 plastic elongation approximately in the lengthwise direction of the purlin, while the bolt holes on the fin  
156 plate underwent smaller plastic deformation.

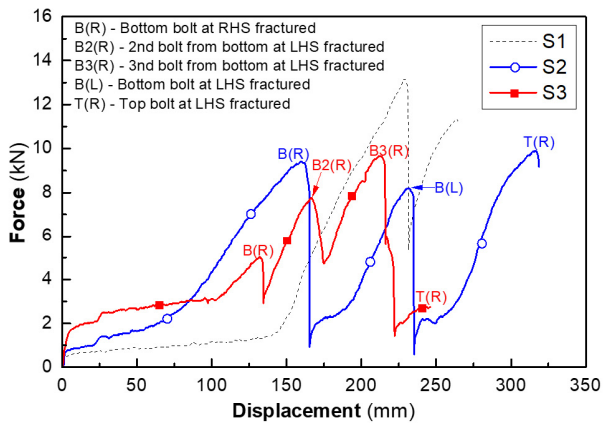
Fig. 7. Behaviour of Specimens S2 and S3. (a) Vertical load-connection displacement curves; (b) experimental phenomena.

157 In Specimens S2 and S3, the height of bolt group was increased to 150 mm. In addition, in Specimen  
158 S3, on each side of the connection, four grade 4.8 bolts were adopted to replace the two grade 8.8 bolts.  
159 Seeing the total shear strength of the four grade 4.8 bolts is the same as that of the two grade 8.8 bolts,  
160 Specimens S2 and S3 are collectively compared with Specimen S1 in Fig. 7(a). At the initial stage of loading,  
161 both specimens showed a linear flexural response similar to Specimen S1. However, different limits were  
162 observed for the initial linear ranges, with Specimens S3 and S1 having the largest and the smallest limits,  
163 respectively. This is readily understandable considering the force couple of the static friction forces at the  
164 bolts was affected by both the height of bolt group and the number of bolts. From the initial linear range  
165 onwards, each of Specimens S2 and S3 had a near plateau that was less apparent and also much shorter than

166 that of Specimen S1. The reason for the different plateau lengths can be found in Section 4.1, in which a  
167 theoretical model is developed to characterise the bolt-slip behaviour. For both specimens, the near plateau  
168 stage was followed by a rapid increase in the vertical load as a result of catenary action. Specimen S2  
169 reached the first peak load of 9.75 kN at a displacement of 155 mm when the RHS bottom bolt fractured in  
170 shear. Afterwards, the specimen regained its vertical resistance to 8.0 kN at a displacement of 234 mm,  
171 which was interrupted by the fracture of the left-hand-side (LHS) bottom bolt. The latter fracture was  
172 unexpected because normally the first failure in a connection propagates on the same side of the connection  
173 instead of on the opposite side. Specimen S2 reached its final and the largest peak load of 9.75 kN at a  
174 displacement of 314 mm. At this time, the RHS top bolt fractured in shear. Specimen S3 failed as a result

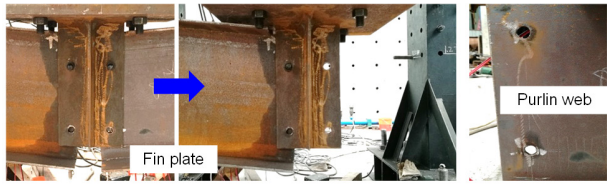
(b)

Specimen S2: fracture of bolts on both sides

Specimen S3: progressive fracture of the bolts on the RHS

175 of the progressive failure of the four bolts on the RHS side, leading to four peak loads on the vertical load-  
176 displacement curve. The premature first peak load was only 4.9 kN, while the ultimate resistance of the  
177 specimen was reached at the third peak load of 9.5 kN, which was close to that of Specimen S2. The above  
178 description of the experimental phenomena is depicted in Fig. 7(b).

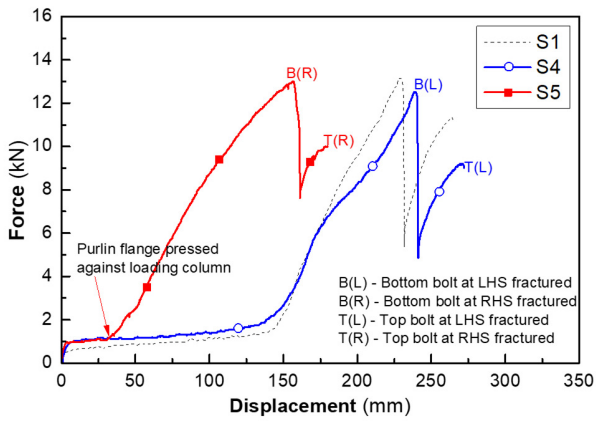
Fig. 8. Behaviour of Specimens S4 and S5. (a) Vertical load-connection displacement curves; (b) experimental phenomena.

181 decreased by 25 mm, to only 5 mm. Specimen S4 performed very similarly to Specimen S1 in terms of both  
182 the vertical load-displacement response and the failure mode, as shown in Fig. 8, except that in Specimen  
183 S4 the fractured bolts were on the LHS rather than on the RHS as in Specimen S1, which is unsurprising  
184 seeing a symmetric specimen can fail on either side under symmetric loading. In addition, at the later stage  
185 of loading, Specimen S4 had slightly lower stiffness and larger deformation. The ultimate resistance was  
186 about 12.5 kN, which was reached at a displacement of 240 mm. In Specimen S5, the expected contact  
187 between the purlin flange and the loading column occurred at a displacement of 31 mm, curtailing the slip  
188 of bolts and the plateau on the load-displacement curve, as shown in Fig. 8. From then onwards, the vertical  
189 load increased rapidly and reached an ultimate value of 13.0 kN at a displacement of only 157 mm.

190 Compared to Specimens S1 and S4, the purlin-to-loading column contact in Specimen S5 did not affect the  
191 ultimate resistance, but effectively shifted the vertical load-displacement curve leftwards.

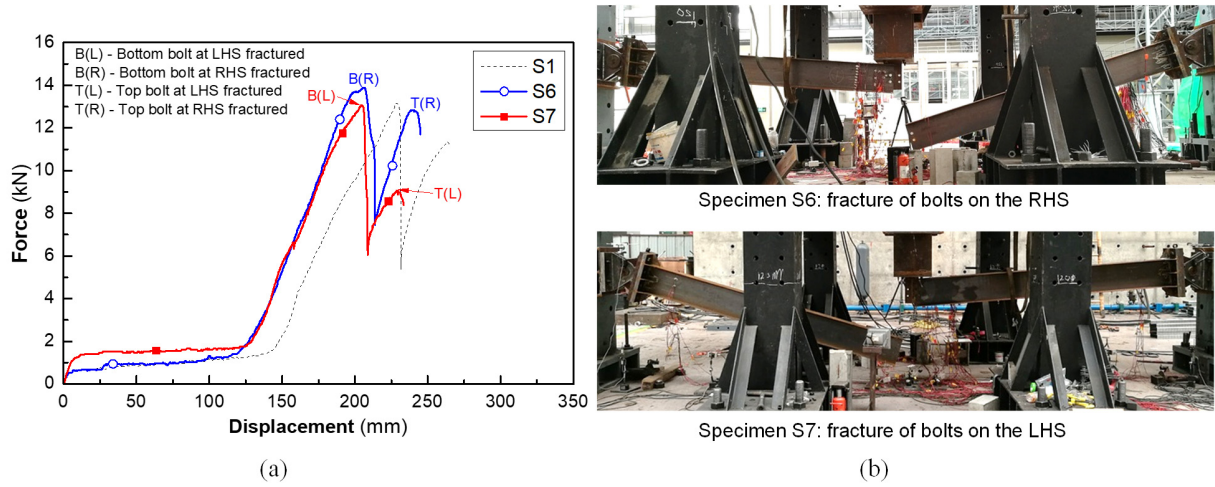
Fig. 9. Behaviour of Specimens S6 and S7. (a) Vertical load-connection displacement curves; (b) experimental phenomena.

192 Specimens S6, S7 and S8 featured different properties of the bolts. In Specimen S6, both bolt grade  
193 and bolt size were changed, from grade 8.8 M12 bolts in Specimen S1 to grade 4.8 M18 bolts, but the shear  
194 strength of a single bolt remained approximately unchanged, with the latter being slightly larger by 13%.  
195 As a whole, Specimen S6 performed similarly to Specimen S1, but the plateau on the load-displacement  
196 curve was shorter by a small margin of about 20 mm, thereby shifting the later part of the curve leftwards  
197 by this margin, as shown in Fig. 9 (a). The ultimate resistance was slightly larger than that of Specimen S1,  
198 i.e., 13.9 kN vs. 13.2 kN, which was most likely due to the larger bolt shear strength in Specimen S6. In  
199 Specimen S7, all bolts were installed with the larger preloading force of 30 kN, 10 kN larger than the bolt  
200 preloading force used for other specimens including Specimen S1. This resulted in a greater initial flexural

201 resistance for the specimen, as demonstrated by the higher plateau on the force-displacement curve, as  
202 shown in Fig. 9(a). The length of the plateau was shortened by about 20 mm, but the ultimate resistance of  
203 the specimen was not altered, which was 13.1 kN reached at a displacement of 202 mm.

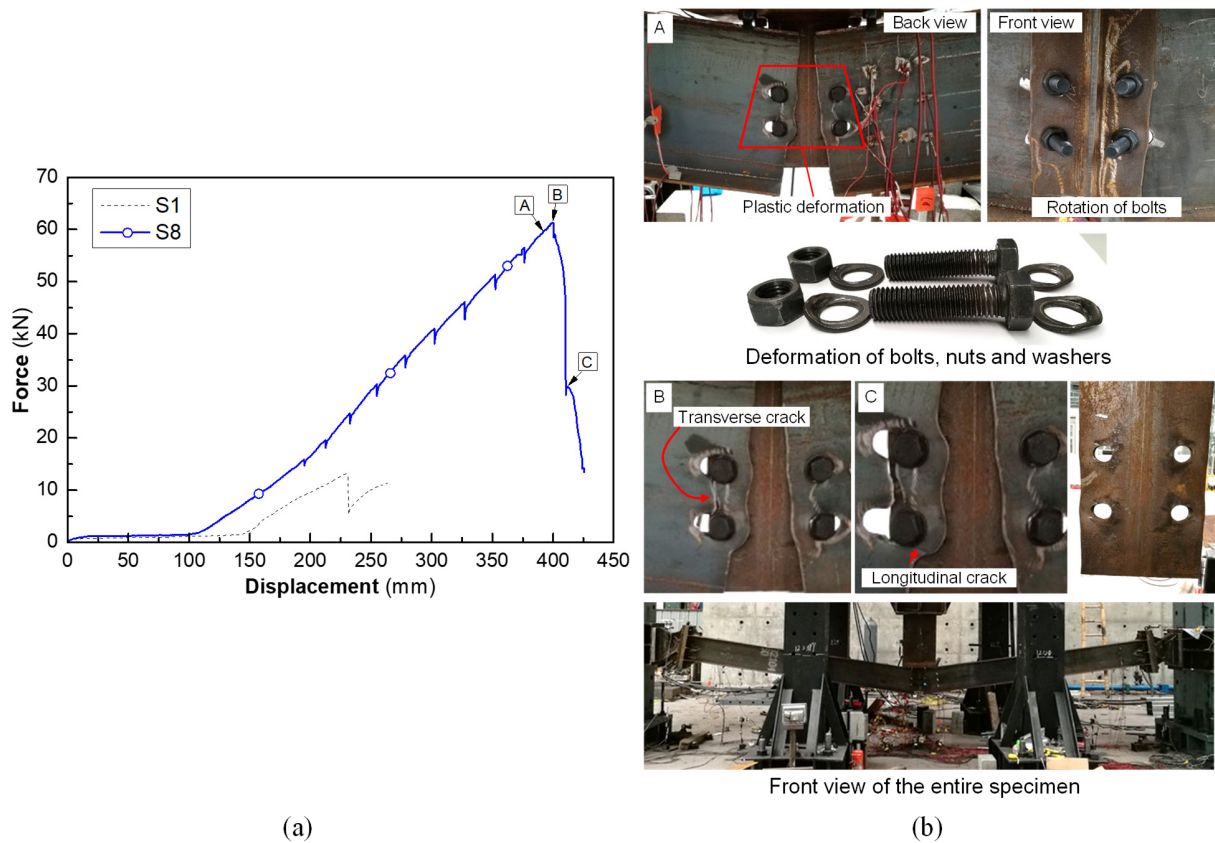
Fig. 10. Behaviour of Specimen S8. (a) Vertical load-connection displacement curves; (b) experimental phenomena.

204 Specimen S8 replaced the grade 8.8 M12 bolts used for Specimen S1 with larger bolts, i.e., grade 8.8  
205 M18 bolts. The larger bolts did not alter the initial linear response of the specimen, but shortened the bolt  
206 slip-induced plateau on the vertical load-displacement curve, as shown in Fig. 10 (a). The enlarged bolt size

207 increased the bolt shear strength to a value that was more than twice the bolt shear strength in Specimen  
208 S1, and is also greater than both the purlin-to-bolt bearing strength and the fin plate-to-bolt bearing strength.  
209 Therefore, under the growing axial force developed in each purlin, remarkable bearing plastic deformation  
210 was observed between the bolt holes and the end of the purlin web, as depicted by Stage “A” in Fig. 10. On  
211 the vertical load-displacement curve, there are several points where the applied load transiently unloaded  
212 by a very small amount and instantaneously recovered, forming a series of fluctuations on the curve. This  
213 was generated by the deformation of the washers and their interaction with the bolt heads and the nuts  
214 during the rotation of bolts, as shown in Fig. 10. The significant plasticity around the bolt holes subsequently

215 led to a transverse crack in the web of the purlin at a displacement of 400 mm, at which the ultimate  
216 resistance of 61.1 kN was reached. The crack initiated at the upper edge of the RHS bottom bolt hole and  
217 immediately propagated through the net-section to the top bolt hole, forming a through crack between the  
218 two bolt holes, as depicted by Stage “B” in Fig. 10. The formation of the transverse crack halved the  
219 resistance to 28.2 kN, which then recovered slightly to 29.8 kN when a longitudinal crack formed between  
220 the RHS bottom bolt hole and the end section of the purlin web, marking the final failure of the connection,  
221 as depicted by Stage “C” in Fig. 10. The failure mode of Specimen S8 was characterised by bolt bearing  
222 failure combined with net-section tensile failure, and was completely different from that of the previous  
223 seven specimens.

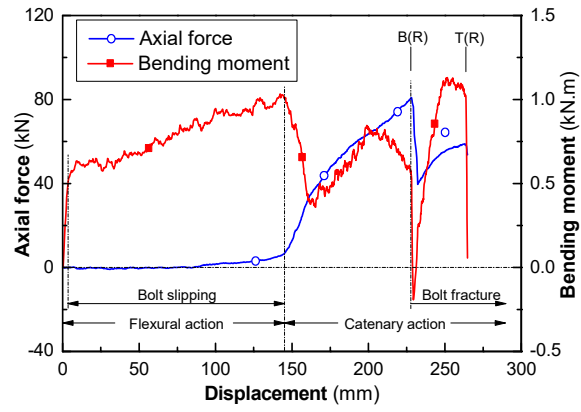
Fig. 11. Axial tension force and bending moment in Specimen S1.

268 **Figure 11** shows the axial force and bending moment developed in Section L2 of Specimen S1. As  
 269 soon as the test started, the bending moment increased linearly with the deflection of the specimen. After  
 270 the bolt began to slip at a vertical displacement of 3 mm, the bending moment went through a stage of very  
 271 slow increase, denoted as the “bolt slip” stage in **Fig. 11**. During this stage, until 86 mm, the axial force  
 272 remained almost zero. Between 86 mm and 145 mm, the axial tension increased slowly to 6.57 kN,  
 273 indicating that certain degree of catenary action was developing. However, this stage is also regarded as the  
 274 bolt-slip stage because, as will be explained later in Section 4.1, during the dynamic process of bolt slip  
 275 there was always factual contact between the bolt shaft and the bolt holes, resulting in the slow increase in  
 276 axial tension force in the purlin.

277 The slip of bolts would stop only when the bottom bolt shafts and bolt holes had built effective contact  
 278 along the longitudinal direction of the purlin, which occurred at about 145 mm in the case of Specimen S1,  
 279 leading to the rapid increase of axial tension. Therefore, the specimen behaviour after 145 mm is regarded  
 280 as the “catenary action” range, as illustrated in **Fig. 11**. The bending moment during this range generally

281 remained at around the same level as the flexural action range, experiencing two temporary decreases as a  
282 result of the suddenly growing contribution of the catenary action in carrying the vertical load. The fracture  
283 of a bottom bolt at the displacement of 229 mm terminated the fast increase in axial tension, causing a  
284 drastic decrease of both the axial force and the bending moment. There was even a transient period when  
285 the bending moment reversed direction. As the displacement kept increasing, the axial force started to  
286 recover until the final failure of the connection (after the RHS bottom bolt fractured, the bending moment  
287 in the LHS purlin was able to recover somewhat).

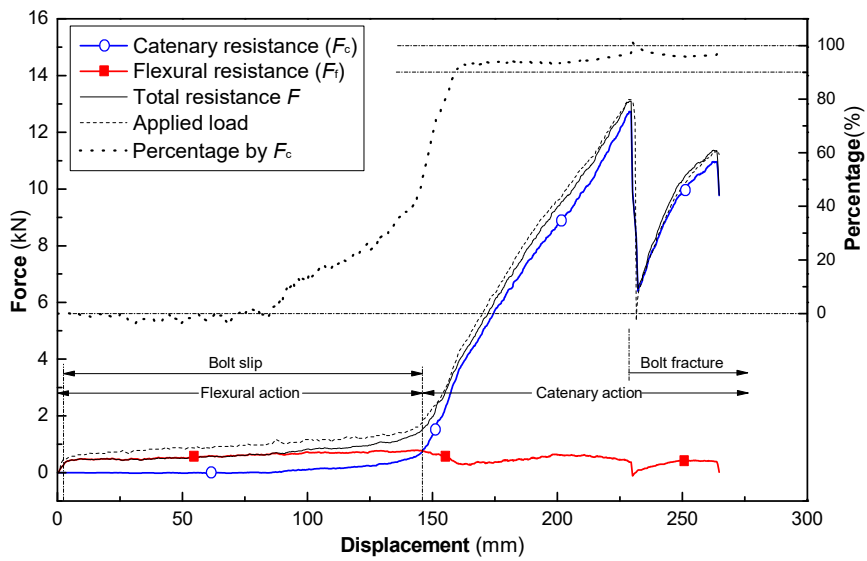
Fig. 12. Vertical resistance of Specimen S1.

295 Having obtained the internal forces in the purlin, the contribution of the flexural action and the catenary  
296 action in providing the vertical resistance can be assessed, as shown in Fig. 12. The flexural action  
297 accounted for almost all the resistance in the early flexural-action range up until the displacement of 86  
298 mm, when the catenary action started to have a role, corresponding to the gradually growing axial tension  
299 as shown in Fig. 11. At the displacement of 145 mm, the catenary action equalled the flexural action with  
300 respect to providing vertical resistance. Henceforth, the resistance contributed by the catenary action  
301 increased rapidly and accounted for over 90% of the total resistance, as shown in Fig. 12. Therefore, for the  
302 purlin connection investigated in this study, under a main truss-removal scenario, the vertical load  
303 resistance depends primarily on the development of an effective catenary action. In addition, the total

304 resistance calculated by Eq. (6) was in close agreement with the applied load over the entire loading process,  
305 demonstrating that the test was well organised and performed, and the experimental results were accurately  
306 recorded.

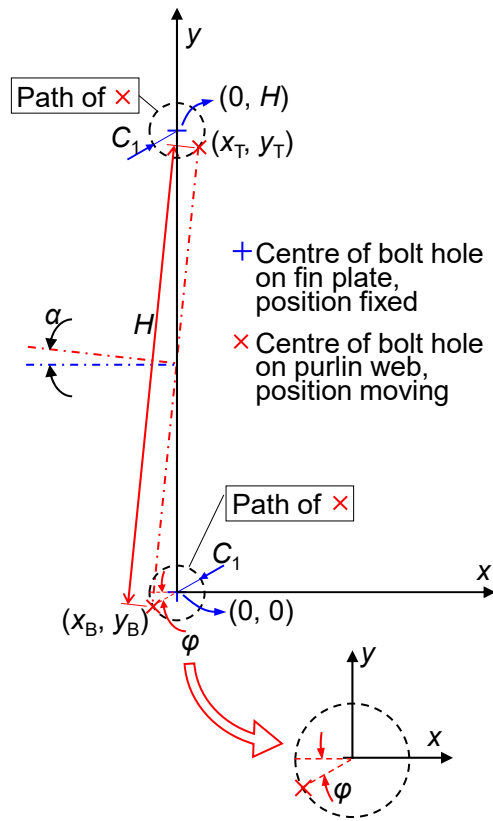
Fig. 15. Calculation model of bolt-slip behaviour.

391 To analytically characterise the above bolt-slip behaviour, a reference two-dimensional Cartesian  
 392 coordinate system is established with its origin at the centre of the bottom bolt hole on the fin plate, its  $x$ -  
 393 axis directed rightwards, and its  $y$ -axis directed upwards, as shown in Fig. 15. Then, the coordinates of the  
 394 centres of the bolt holes on the fin plate are  $(0, 0)$  and  $(0, H)$ , respectively, in which  $H$  is the height of the  
 395 bolt group. From the previous discussion related to Fig. 14, it is known that the top (or bottom) bolt hole  
 396 centre on the purlin web is always located on a circle centred at the top (or bottom) bolt hole centre on the  
 397 fin plate, with the radius of this circle being equal to the actual clearance between the bolt and the bolt  
 398 holes,  $C_1$ , as shown in Fig. 15. Due to random installation error,  $C_1$  is always smaller than the design

399 clearance,  $C$ , and is estimated to be 75% of  $C$  in this study, i.e.,  $C_1=0.75C$ . Moreover, the assumed rigid-  
 400 body movement of the purlin during the slip of bolts allows the assumption to be made that the distance  
 401 between the centres of the two bolt holes on the purlin web remains unchanged, equal to  $H$ .

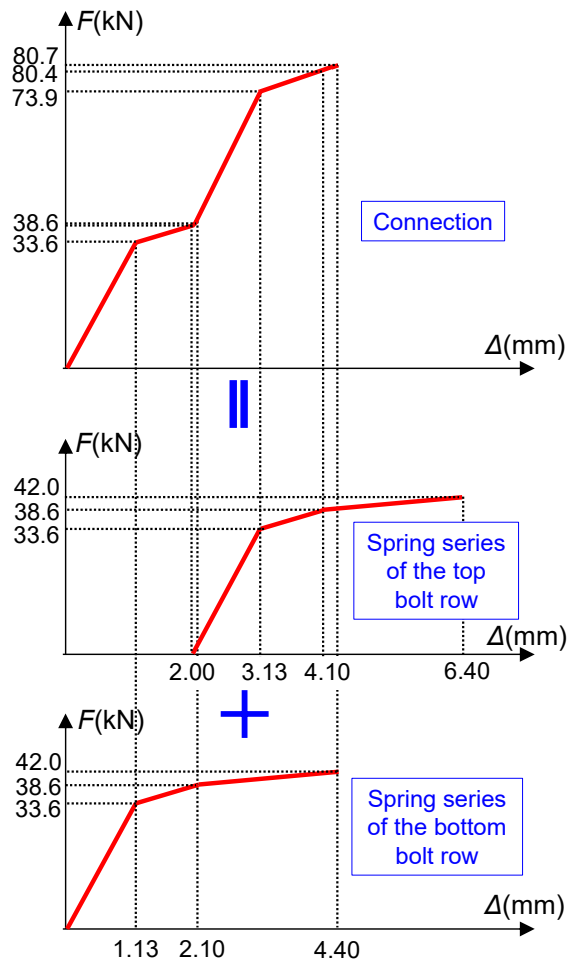
Fig. 18. Force-displacement relationship for Specimen S1 connection.

492 Using the above component properties, the axial force-displacement relationship of the connection can  
493 be determined, as shown in Figure 18 in which Specimen S1 is taken as an example. Note that the forces  
494 that cause the yielding of the purlin-to-bolt in bearing component and the yielding of the fin plate-to-bolt  
495 in bearing component are very close, and therefore, for simplicity, these two components are approximated  
496 to yield under the same force of 38.1 kN.

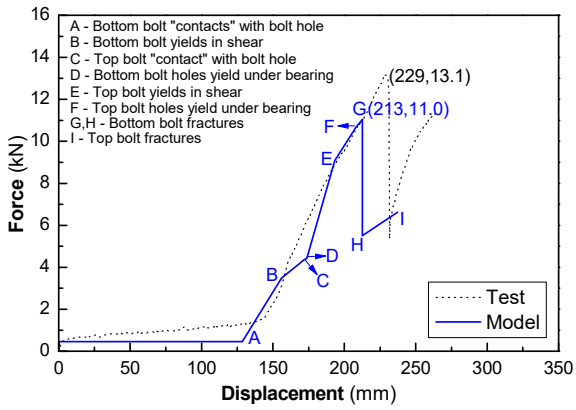
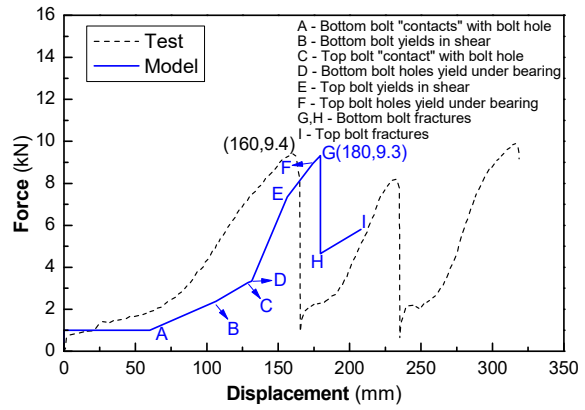
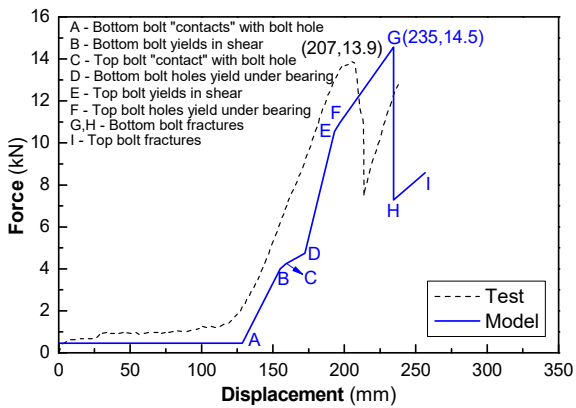
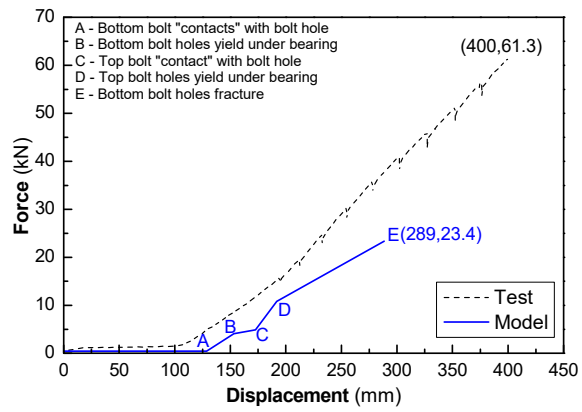
Fig. 19. Vertical force-displacement response predicted by the proposed model. (a) Specimen S1; (b) Specimen S2; (c) Specimen S3; (d) Specimen S4; (e) Specimen S6; (f) Specimen S7; (g) Specimen S8.

497 Figure 19 shows the model predictions as well as the comparisons against the experimental results. It  
498 is observed the proposed model is capable of capturing the experimental phenomena, including the slip of  
499 bolts, the yielding and failure of components, and thus gives reasonably good predictions on the force-  
500 displacement curves, the failure modes and the failure loads. Some discrepancy is observed for Specimens  
501 S3 and S8. However, the response of Specimen S3 prior to the first failure is well captured, and the  
502 discrepancy for Specimen S8 most likely results from a less accurate force-displacement assumption for
