# Stabilization of Erodible Slopes with Geofibers and Nontraditional Liquid Additives

May 2013

INE/AUTC 13.15

FHWA-AK-RD-13-09

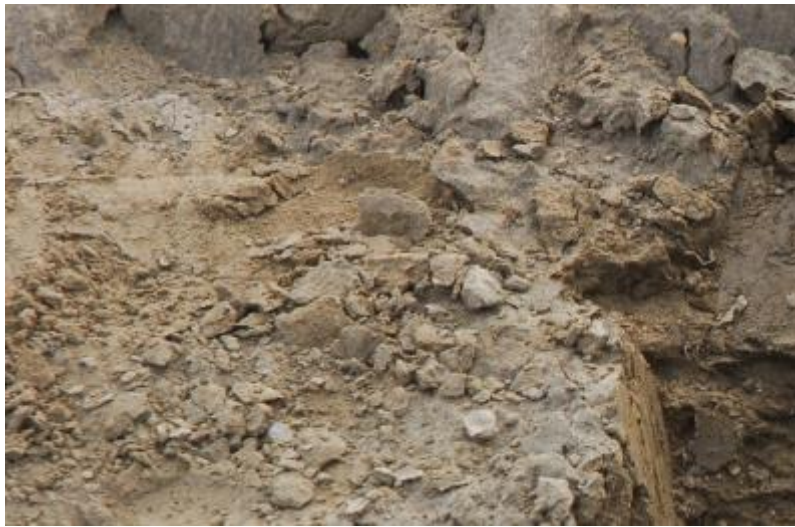
**Fig. 3-1: Sandy silt shown in the field**

The soil used in this research is sandy silt that was collected at Great Northwest, Inc. in Fairbanks, Alaska (64.8378° N, 147.7164° W). The embankment was constructed using sandy silt (ML), which is shown in Figure 3-1. The soil was extracted from the pond shown in Figure 3-2. After being extracted from the pond, the soil was stockpiled to drain the free water.

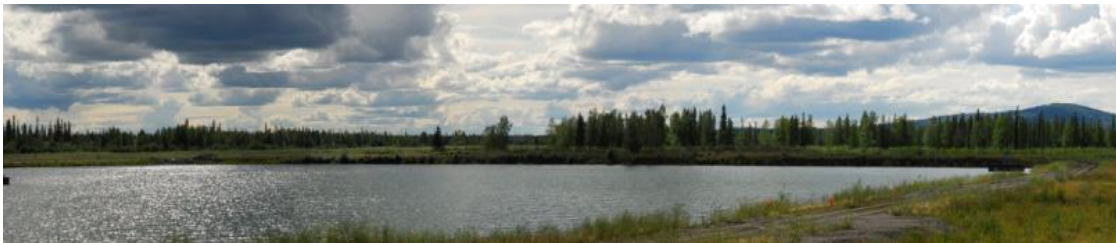
**Fig. 3-2: Source of soil used for embankment construction**

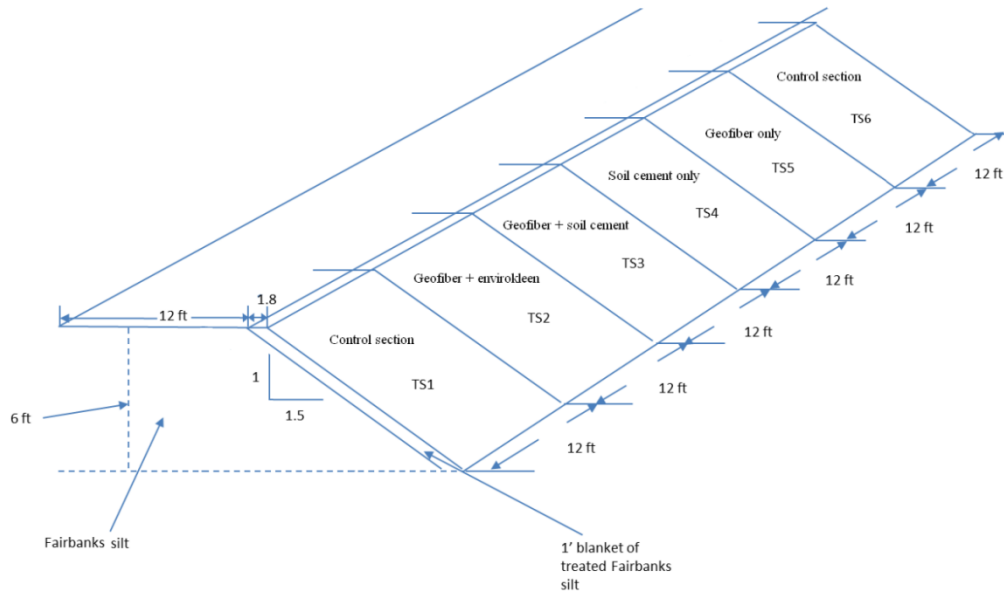
**Fig. 3-5: Idealize image of field site (TS1=0.5% Geofibers + 4% EnviroKleen, TS2=0.5% Geofibers + 1.5% Soil-Sement, TS3=2% Soil-Sement, TS4= 0.5% Geofibers, and TS5=Control.)**

An idealized picture of the field site with treatment sections is presented as Figure 3-5. To be consistent with real-world road embankment, the slope used for the trapezoid-shaped cross section was 1:1.5. This picture shows the width of each test section, which was 12 feet. The width of the test sections was chosen to match the width of the bulldozer blade used in construction. The embankment measured 6 feet in height. The top of the embankment measured 15.6 feet across; the base measured 33.6 feet across. A picture of the embankment prior to installation of the treated sections is presented as Figure 3-6. Six test strips were prepared. The test strips consisted of control sections and treatments, as follows:

- Two control sections on each end of the embankment
- 0.5% (by dry soil weight) geofibers
- 2% Soil-Sement
- 2% Soil-Sement and 0.5% geofibers
- 4% EnviroKleen and 0.5% geofibers

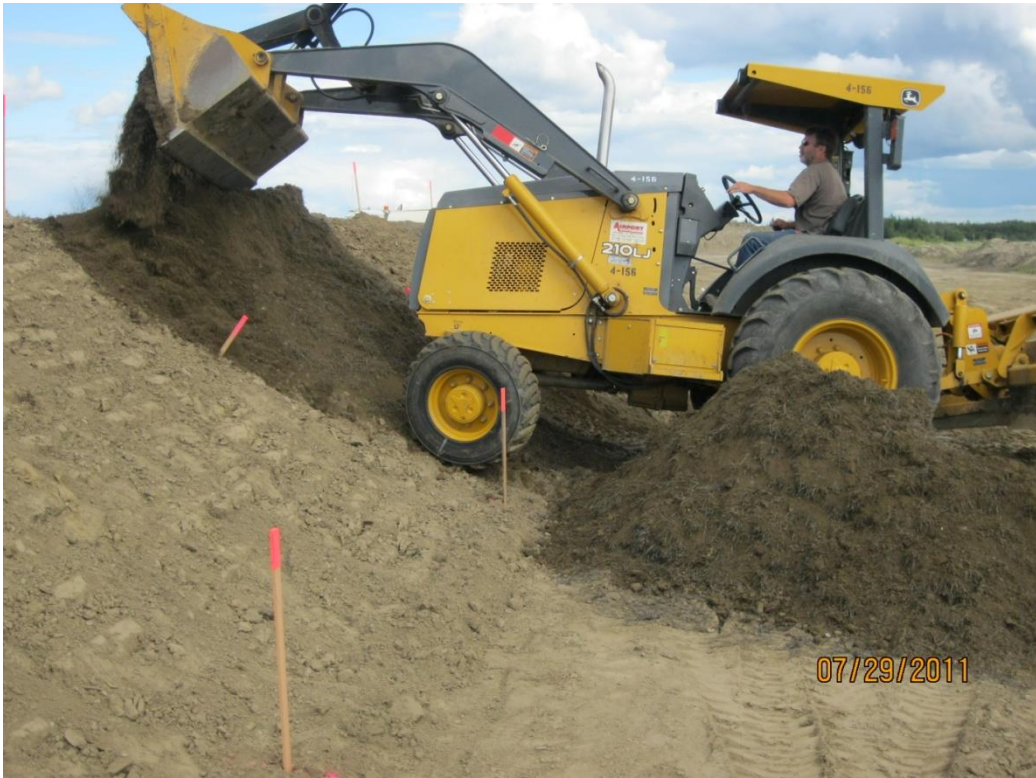
**Fig. 3-12: Treated soil pushed onto side of slope**

- The treated soil was pushed onto the side of the embankment using a loader (pictured in Figure 3-12.)
- A bulldozer was driven over the side of the embankment to provide compaction (pictured in Figure 3-13).

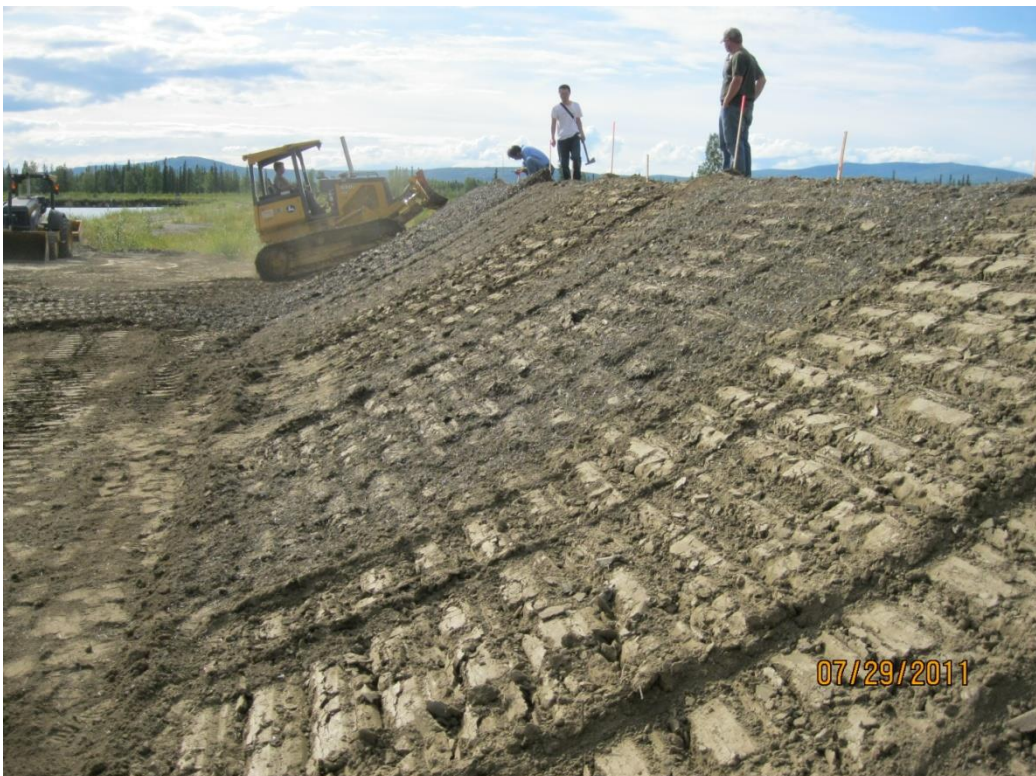
**Fig. 3-13: Bulldozer running over side of slope to provide compaction**

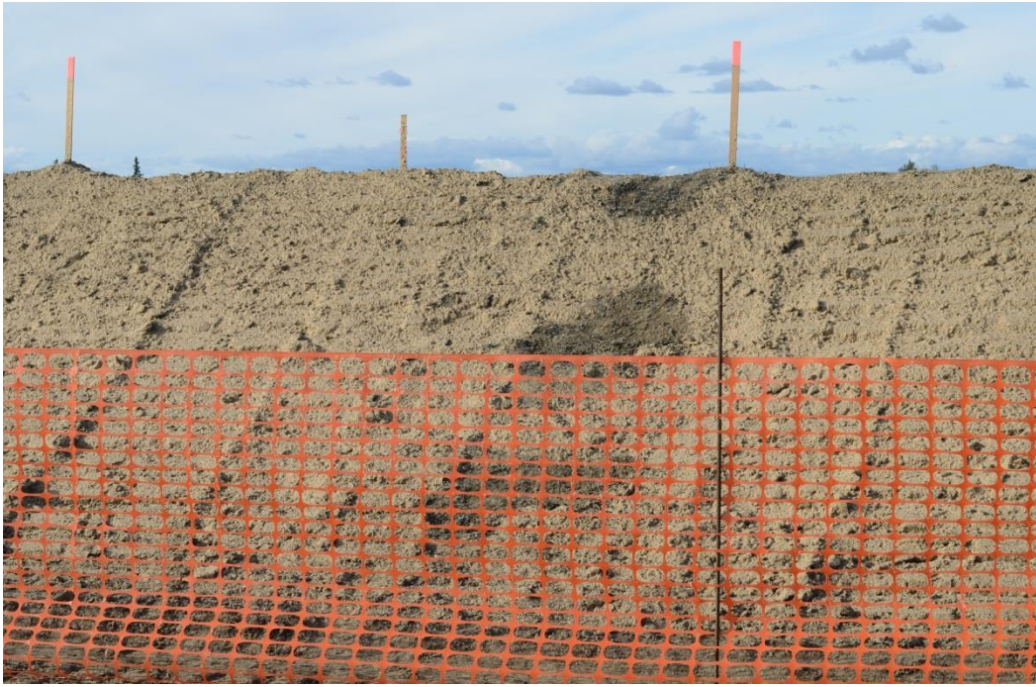
**Fig. 3-14: Slope after hydroseeding**

- The site was then hydroseeded using a blend typical for Fairbanks (the hydroseeded slope is shown in Figure 3-14. The hydroseed blend used was Actared red creeping fescue (*Festuca rubra L.*) (45%), Park Kentucky blue grass (*Poa praensis L.*) (45%), and annual ryegrass (*Lolium multiforum L.*) (10%). The hydroseeding mixture contained chemical fertilizer (8(N)-32(P<sub>2</sub>O<sub>5</sub>)-16(K<sub>2</sub>O)) at 488 kg/ha (10 lb/1000 ft<sup>2</sup>) and EcoFiber Plus at 4878 kg/ha (100 lb/1000 ft<sup>2</sup>).

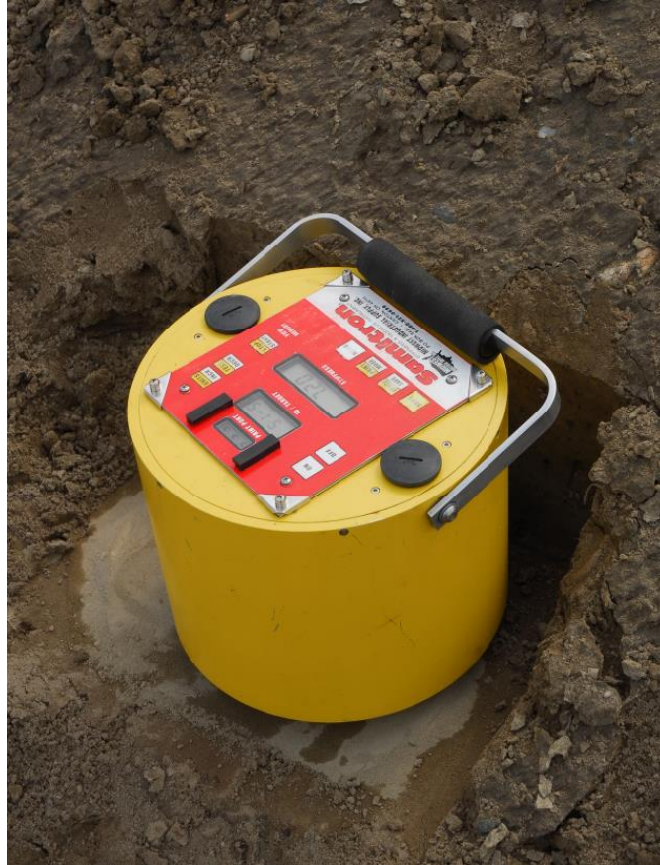
**Fig. 3-15: GeoGauge testing at the field site**

In a similar manner to the GeoGauge, DCP measurements can be used to determine CBR following ASTM 6951. Therefore, all DCP measurements were converted and reported as CBR values. The DCP measurements were taken on the same carved-out section of slope used to take the GeoGauge measurements.

Measurements of stiffness and DCP were taken at the top, middle, and bottom of each test section.

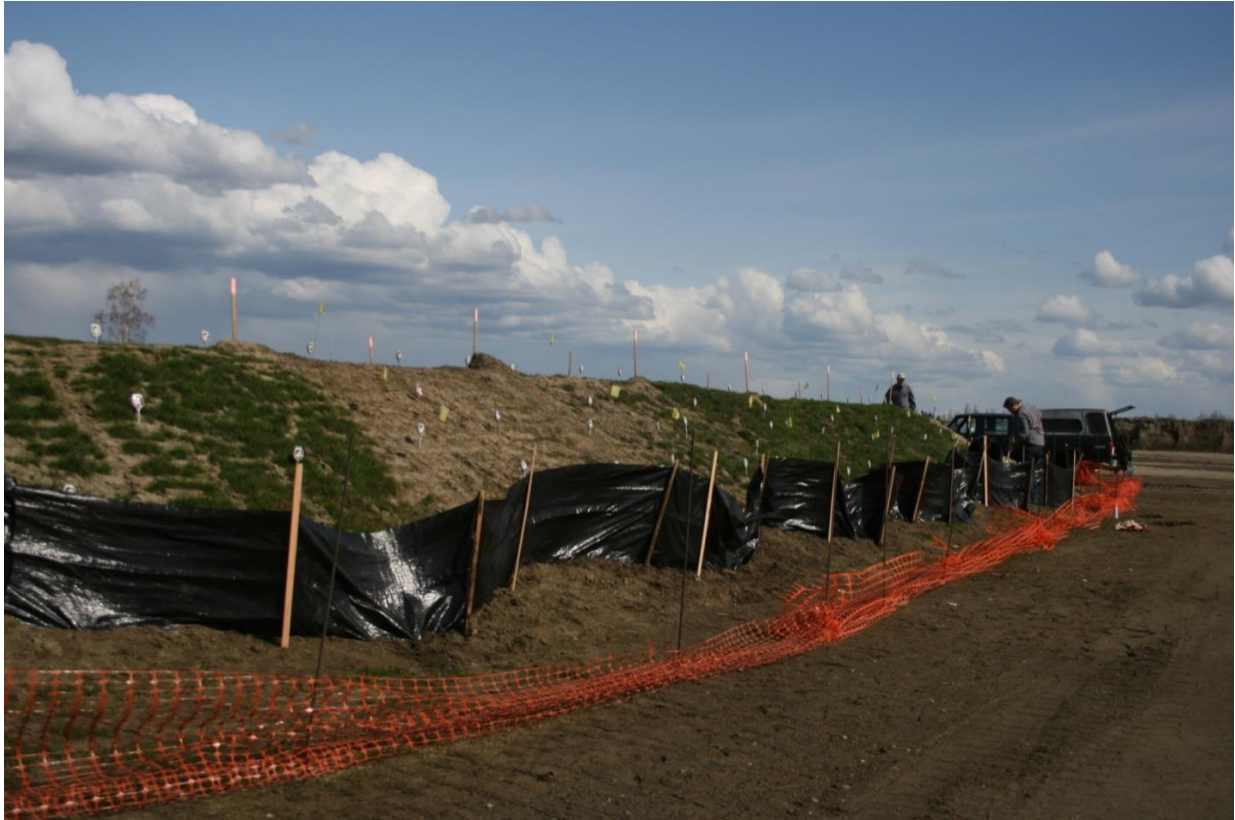
**Fig. 3-17: Installed silt fence**

One year after the construction of the embankment, a silt fence was installed at the field site to collect runoff material. A continuous fence with stakes pre-attached was installed at the bottom of the slope. The silt fence was placed in a “V” shape. For each slope, the ends were placed 36 inches above the base of the slope, with the middle placed at the base of the slope. To install the fence, a trench was dug using a flat-headed shovel and the claw end of a masonry hammer. The trench dug was 6 inches deep and approximately 6 inches wide to ensure adequate placement of the silt fence. Each side of the silt fence was backfilled and compacted to hold it firmly in place. An image of the silt fence is presented as Figure 3-17; the image shows the clearly visible “V” shape. Fluorescent orange dots were painted at the base of the silt fence on the upslope side. Runoff material will cover the dots, making it easy to identify and remove. The dots are shown in Figure 3-18.

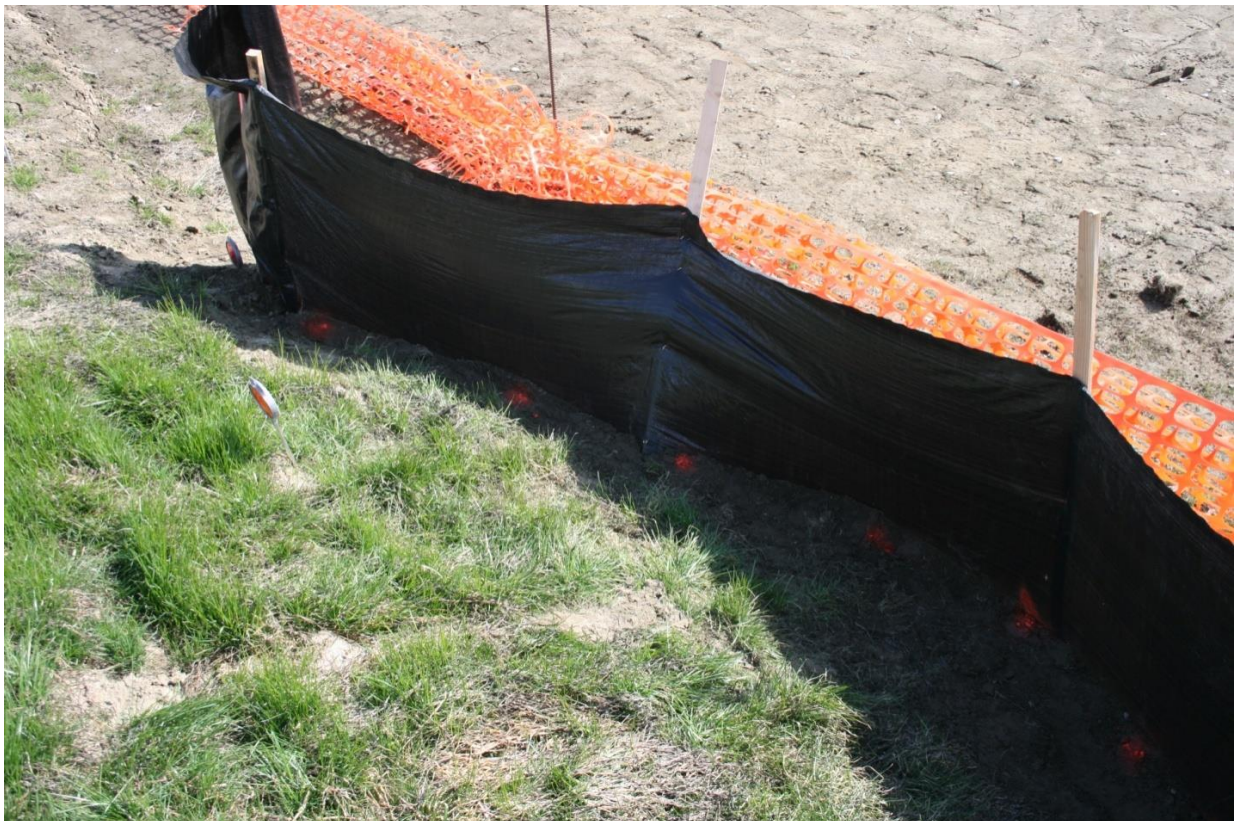
**Fig. 3-18: Dots painted below base of silt fence allow for identification of runoff material from the slope**

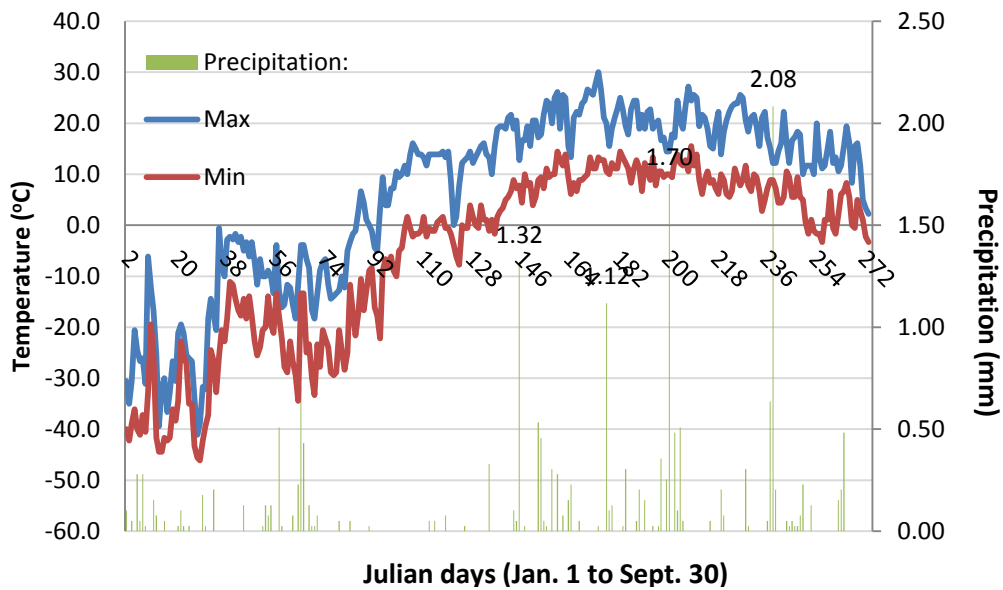
**Fig. 4-2: Minimum and maximum temperature and daily precipitation from Jan. 1 to Sept. 30, 2012**

The average cumulative monthly precipitation for 2012 was slightly below the average for the past 12 years (2000 to 2011) (Fig. 4-1). For daily precipitation, the frequency of above >2 mm/day precipitation in the past 12 years is a high of 92%, most of which was in the month of July in contrast to August (26<sup>th</sup>) of 2012 (Fig. 4-2). Samples were taken on September 1, after the big rain event in August, yet no sediments were found at the bottom of the hill from each treatment, indicating that with normal rain frequency, all treatments prevent a major erosion event, in particular the EnviroKleen® treatment where little grass was established (Fig. 4-3).

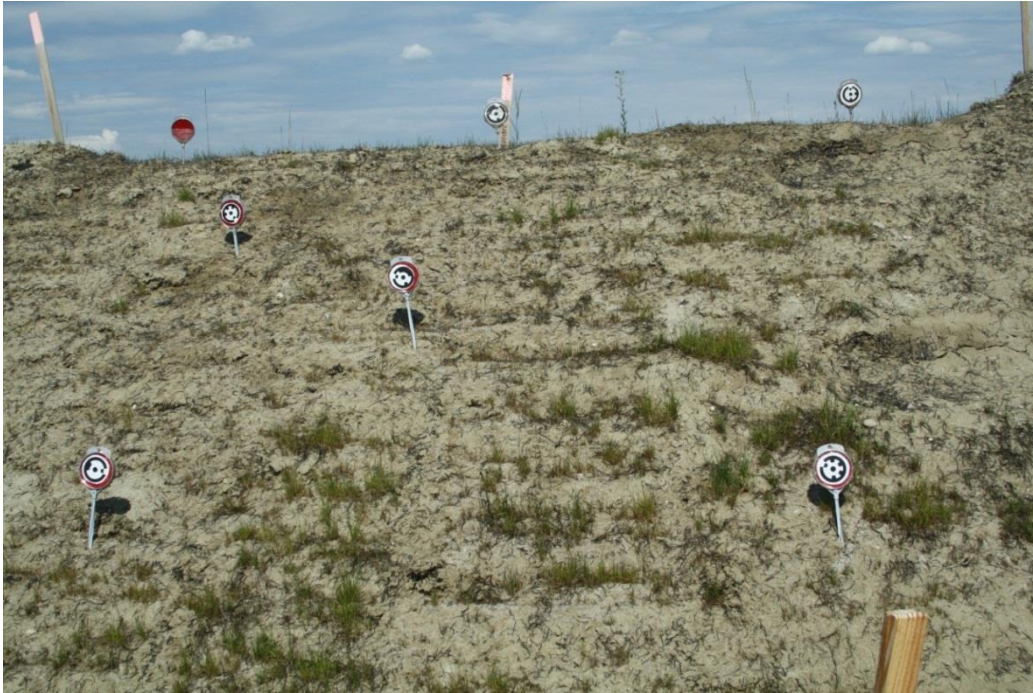
**Fig. 4-3: Geofibers + EnviroKleen treatment for erosion control (photo taken June 22, 2012)**

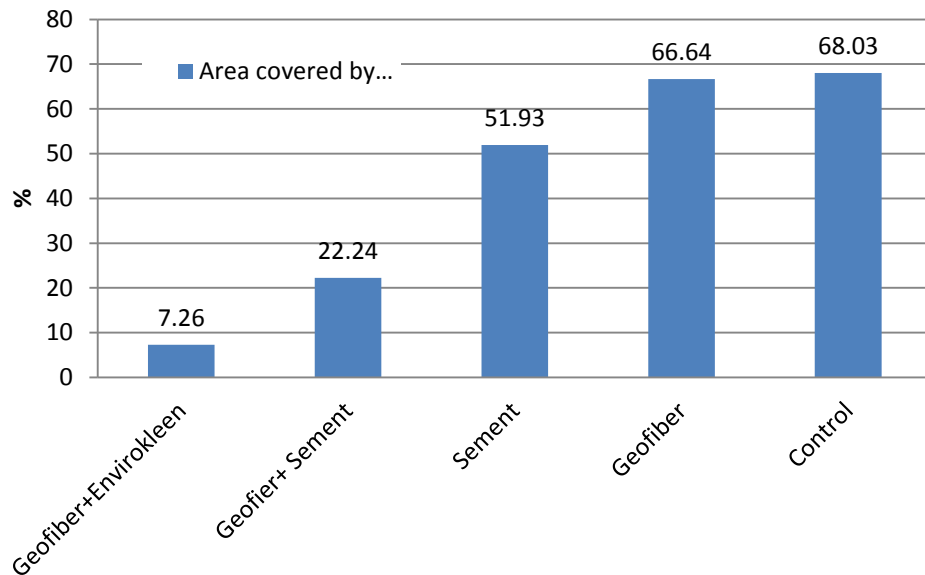
Fig. 4-5: Percentage of area covered by plants from each treatment based on color analysis of Fig. 4-4

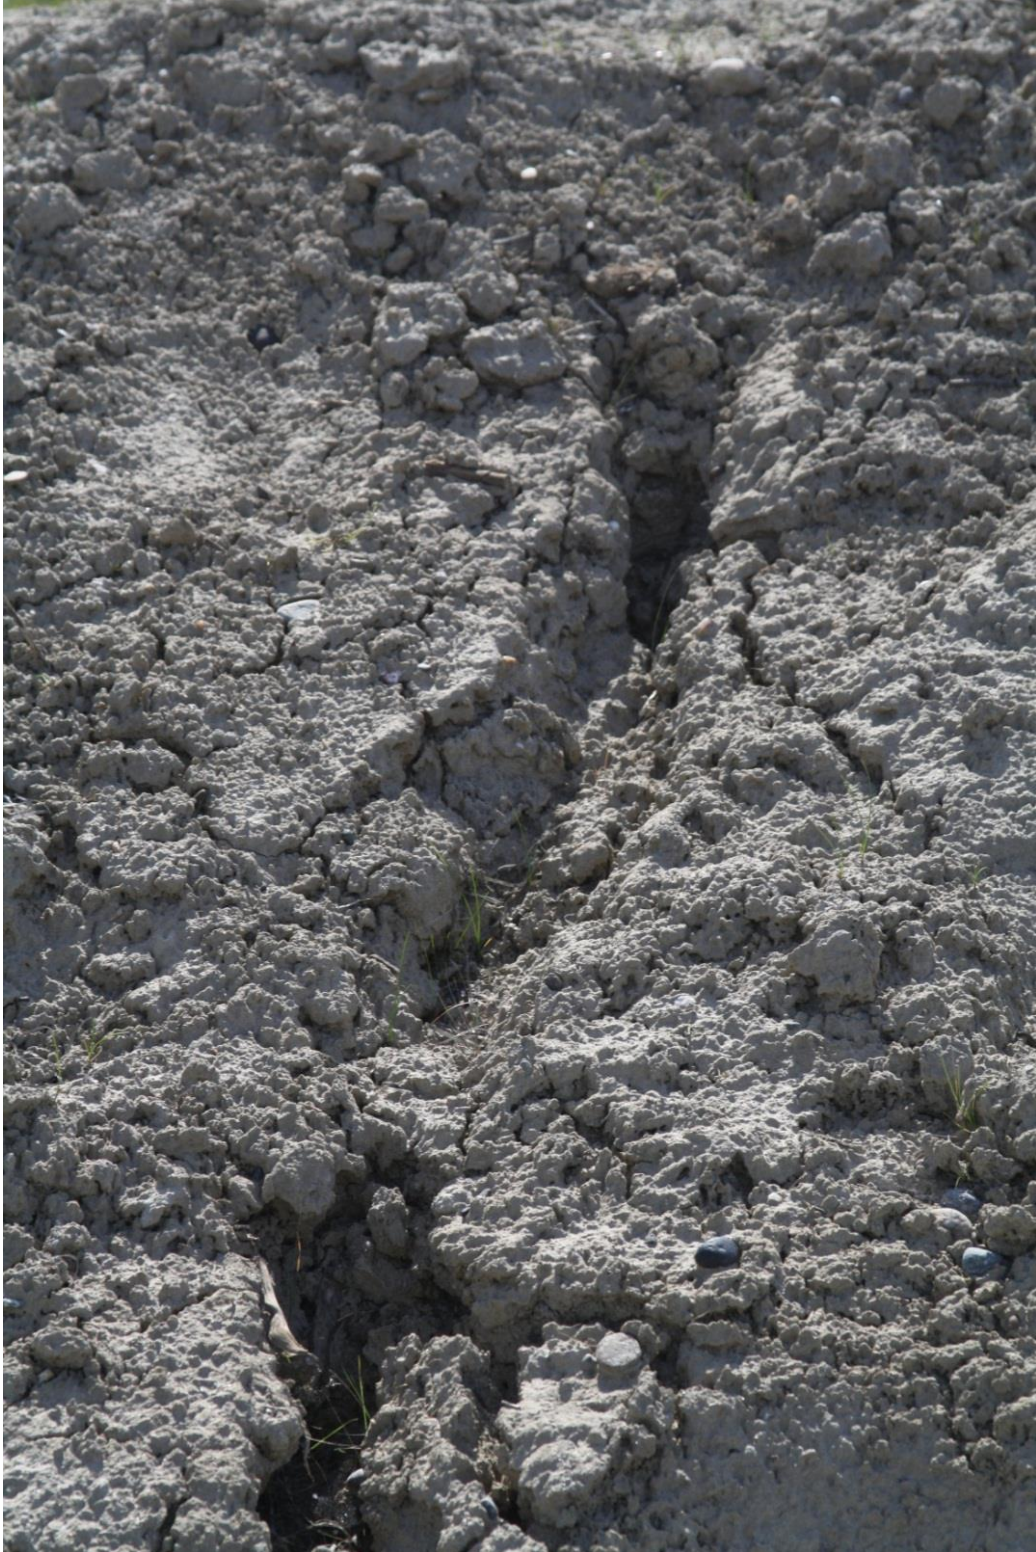
**Fig. 4-7: Erosion on the backside of the constructed test site. An illustration of erosion when soil was not covered by plants or addition of dust-depressing materials (photo taken June 28, 2012)**

0.04 for May and Sept. samples, respectively) (Table 4-5). The amount of mineral N in Geofibers + EnviroKleen was at least 20 times lower for the 0–15 cm sampling depth and 10 times lower for the 15–30 cm sampling depth than the rest of the treatments. Nitrate nitrogen possesses negative charges and is very mobile in soil. Comparing the May soil samples with the September ones, apparently some losses of mineral N occurred in the 2012 growing season, but most of these losses were not significant (Tables 4-4 and 4-5, Figs. 4-6a and 4-6b). Likely, the mineral N losses occurred in fall 2011 and in early spring 2012, when the ground started to thaw. Soil mineral N includes  $\text{NH}_4\text{-N}$  and  $\text{NO}_3\text{-N}$ . In an aerobic soil environment,  $\text{NH}_4\text{-N}$  has a short life in soil; it is quickly oxidized to  $\text{NO}_3\text{-N}$ . Because of this, in upland soils, the majority of mineral N extracted from soil is  $\text{NO}_3\text{-N}$ . In waterlogged conditions,  $\text{NO}_3\text{-N}$  can be easily lost through the denitrification process. For the treatment site,  $\text{NO}_3\text{-N}$  loss in spring runoff or the spring perched water table could be a cause for mineral N loss from the Geofibers + EnviroKleen treatment. A deep rill that formed in the back slope of the test site demonstrated the runoff problem at the site when the surface was not covered by grasses (Fig. 4-7).

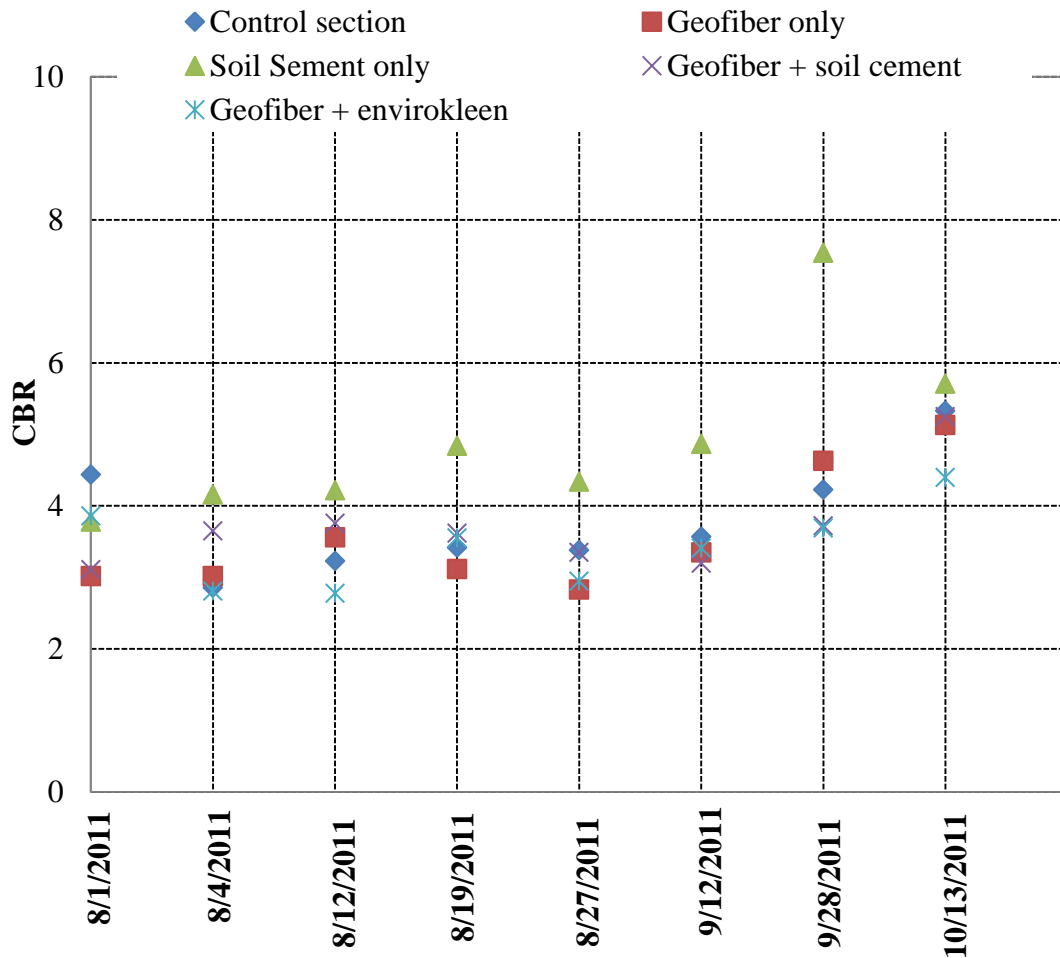
Fig. 5-1: CBR values determined from GeoGauge measurements taken at the middle of the field slope

The results of the GeoGauge stiffness measurements converted to the CBR are presented in Figure 5-1. These results show very little change in the CBR value over the total duration of the recorded measurements. Measurements show that the behavior has an upward trend, though the amount of increase is small. Treated sections had CBR values similar to the control section. It is worth noting that all the CBR values shown fall in the poor-to-fair general rating range (from Bowles 1978).

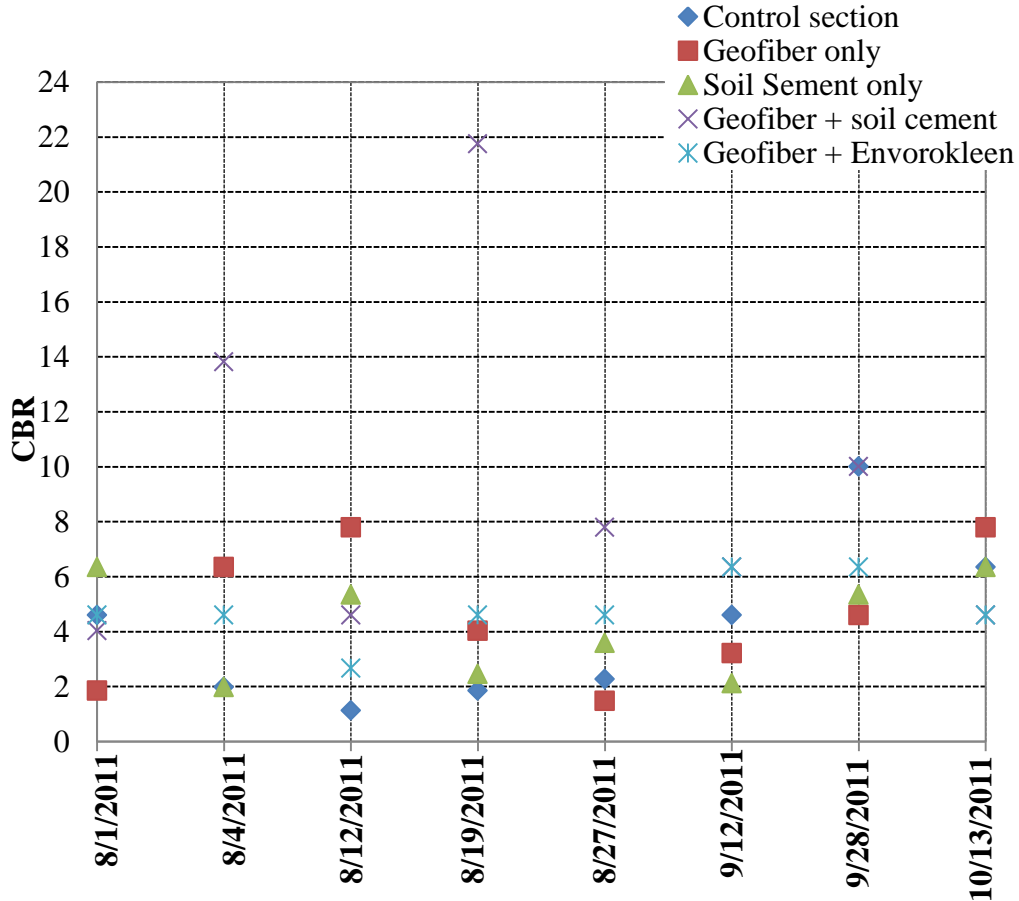
Fig. 5-2: CBR values determined from DCP measurements taken at the middle of the field slope

The DCP tests were converted to the CBR. The results of the DCP tests performed on the middle test section are presented in Figure 5-2. The results show that there is not much variation in the CBR value through the dates measured. Values fall in the poor-to-fair rating range for all measurements. The lone exception is the measurement recorded on August 19, 2011, with samples treated with geofibers and Soil-Sement®. This is likely an aberration, because in the following weeks, the data are closer to the other measurements.

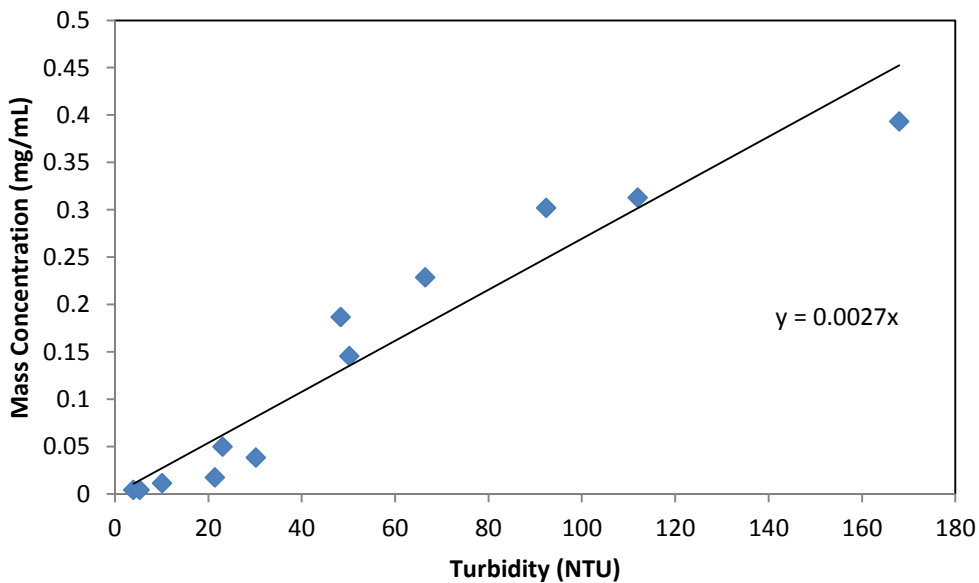
Fig. A-1: Calibration of Turbidity to Mass Concentration

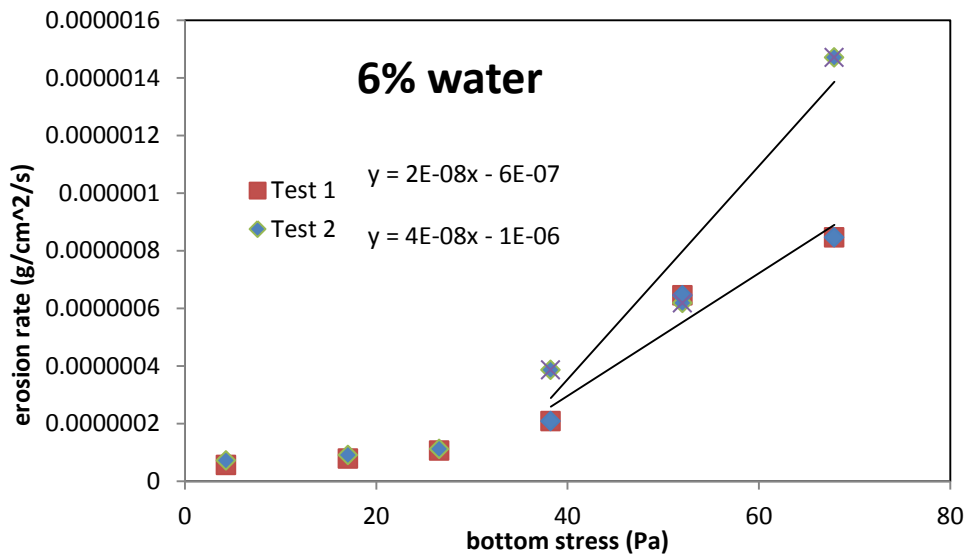
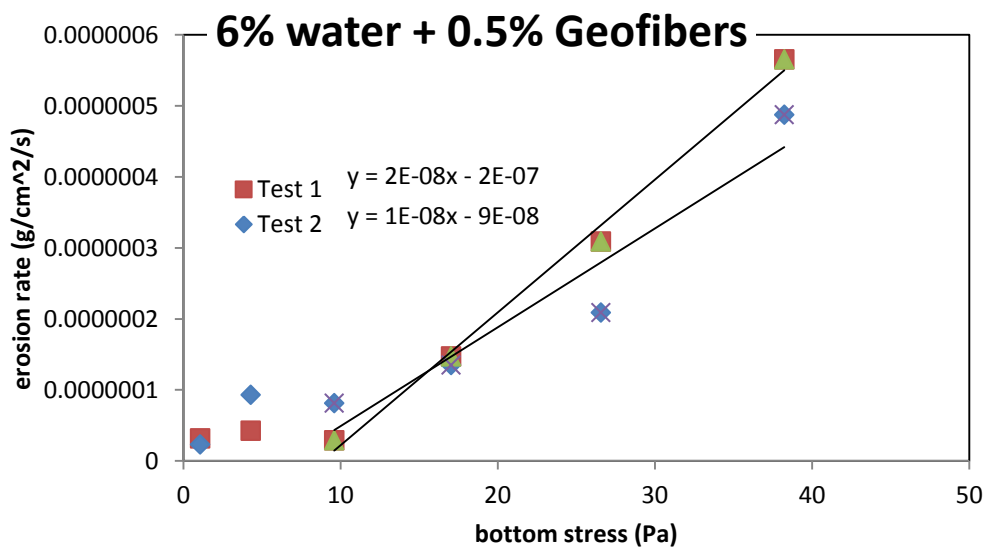
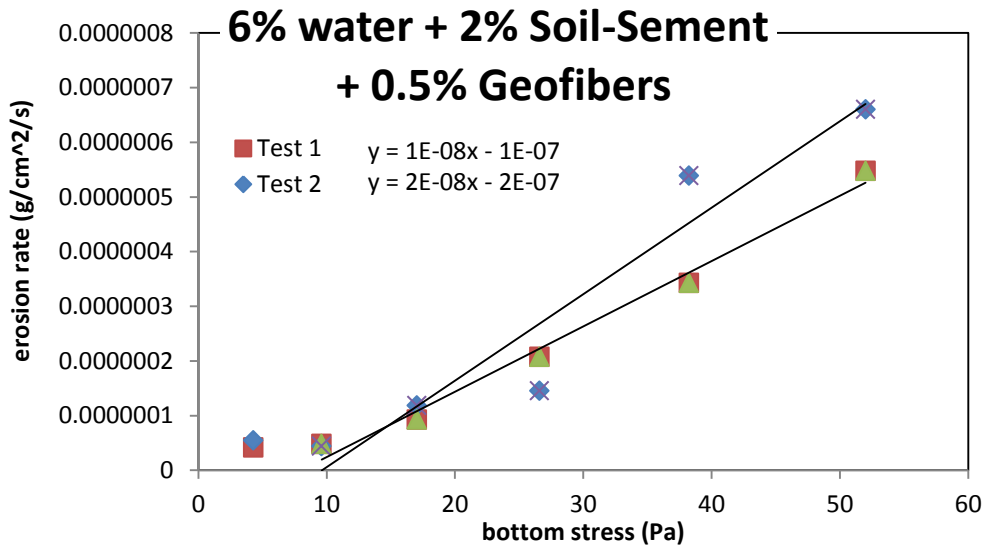
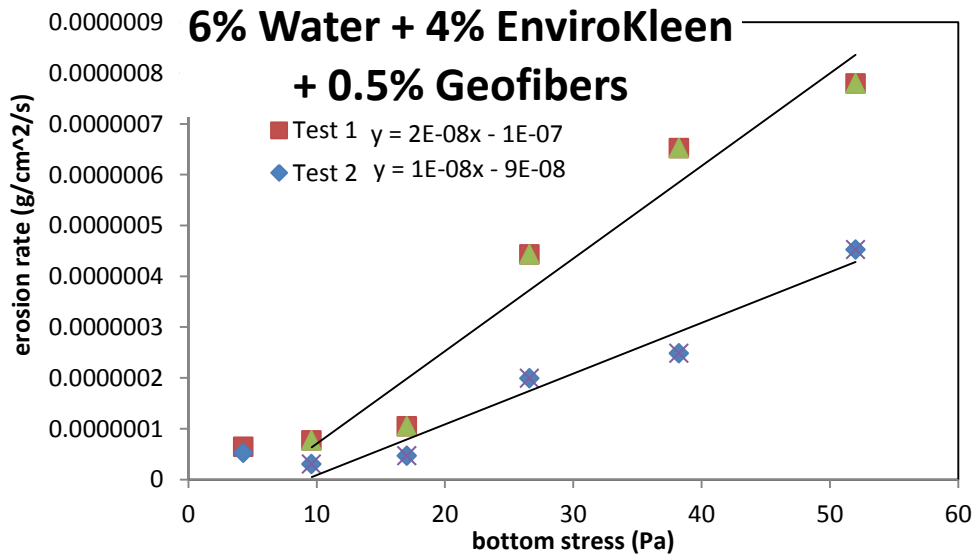
Fig. A-12: Erosion rate versus bottom stress for 6% water tests

Fig. A-13: Erosion rate versus bottom stress for 6% water + 2% Soil-Sement

Fig. A-14: Erosion rate versus bottom stress for 6% water + 0.5% Geofibers

Fig. A-15: Erosion rate versus bottom stress for 6% water + 2% Soil-Sement + 0.5% Geofibers

Fig. A-16: Erosion rate versus bottom stress for 6% water + 4% EnviroKleen + 0.5% Geofibers

Critical shear stress was determined for each of the treatment configurations. Results were found by plotting the erosion rate ( $\text{g/m}^2\text{s}$ ) versus the bottom stress measured at the surface of the soil sample, then plotting a linear “best fit” line through the area in the curve

The graphs showing bottom stress versus erosion rate are shown in Figs. A-12–A-16. Linear lines are drawn through the points where the erosion rate starts to significantly increase. The equations found for the lines were set equal to zero in order to solve for the critical shear stress.

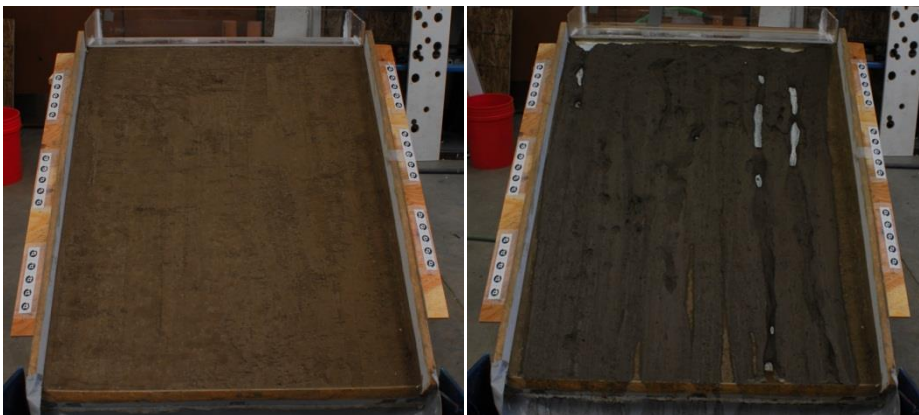
Fig. A-17: Before and After Pictures of 6% w – Test 1

Table 5-2 provides the results of the laboratory slope testing. Note that the 6% water-Test 1 (shown in Fig. A-17) was abandoned after only 45 seconds due to the severe erosion that was taking place. If the test had been allowed to run for another 20 seconds, it would have shown similar erosion to that indicated in Figure A-18. All other tests were run for a total time of 1 minute and 5 seconds, which was found based on experimentation. The 6% water-Test 2 is comparable to the other results. The results show that, in general, treatment causes a reduction in percentage of material loss. The greatest overall reduction in percentage

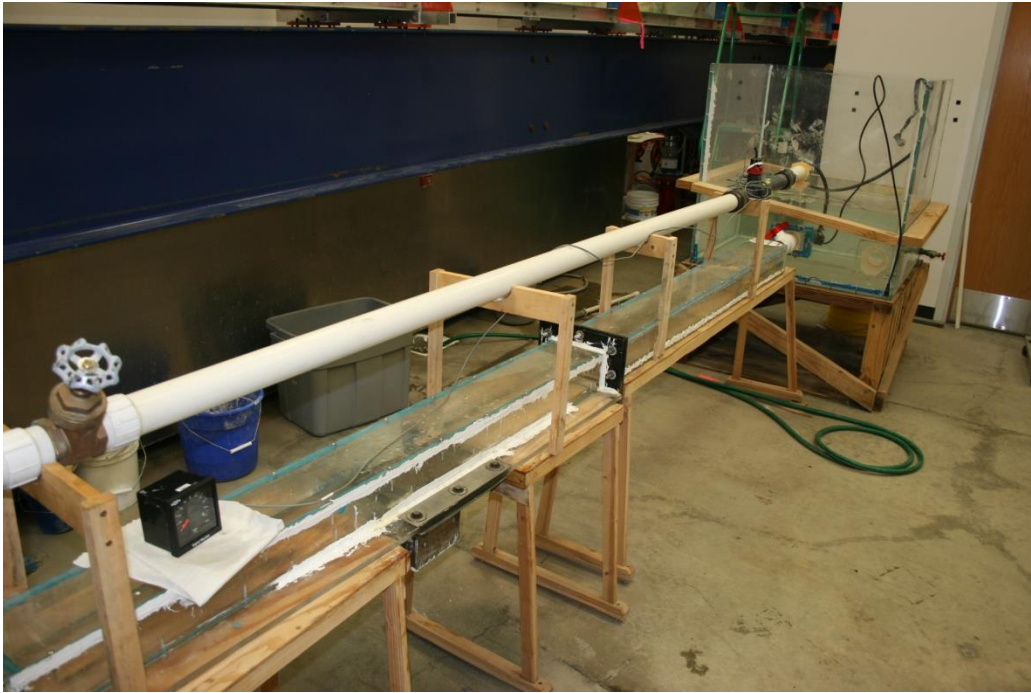
**Fig. A-27: The flume used to determine critical shear stress**
