## Evaluating the Need to Seal Thermal Cracks in Alaska's Asphalt Concrete Pavements

INE/AUTC 12.27

FHWA-AK-RD-12-20

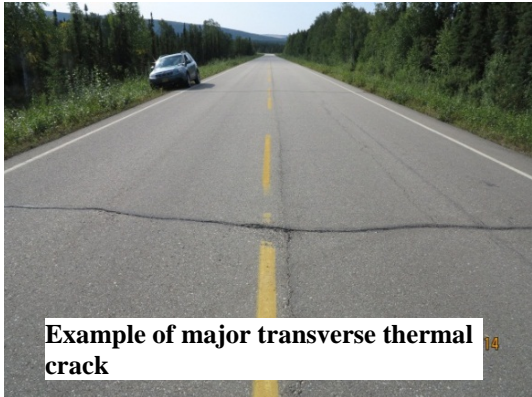
Example of major transverse thermal crack <sup>14</sup>

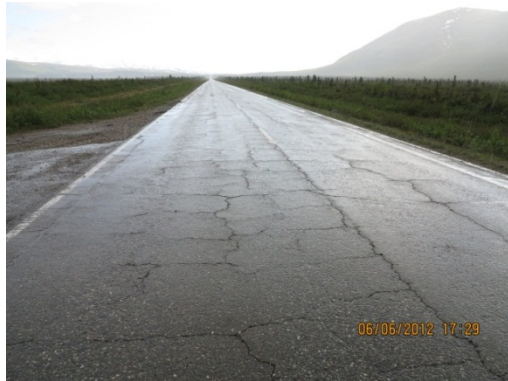
**Figure I.1 Example of lesser thermal cracking**

Only certain crack types are the subject of speculation here regarding required sealing. These include the two most common types of thermal cracks found on nearly every paved road in colder areas of Alaska. Figure I.1 shows an example of the grid-like pattern of thermal cracking categorized in this study as *lessor thermal cracking*, a term we have used to differentiate this form of thermal cracking from cracking identified in other literature, such as block, map, or grid types of cracking. These terms are used in other systems of pavement damage identification without the implicit (and essential) requirement that the cracks be the consequence of thermally induced stresses. By definition, lessor thermal cracking is thermally induced. Figure I.2 shows an example of a sealed *major transverse thermal crack*. This type of thermal crack, commonly known as a “thumper,” usually extends across the entire width of the

pavement surface, or nearly so, and tends to be oriented perpendicular to the roadway centerline. The driver can feel a definite thump caused by major transverse cracks when driving over them. By definition, major thermal cracks are thermally induced.

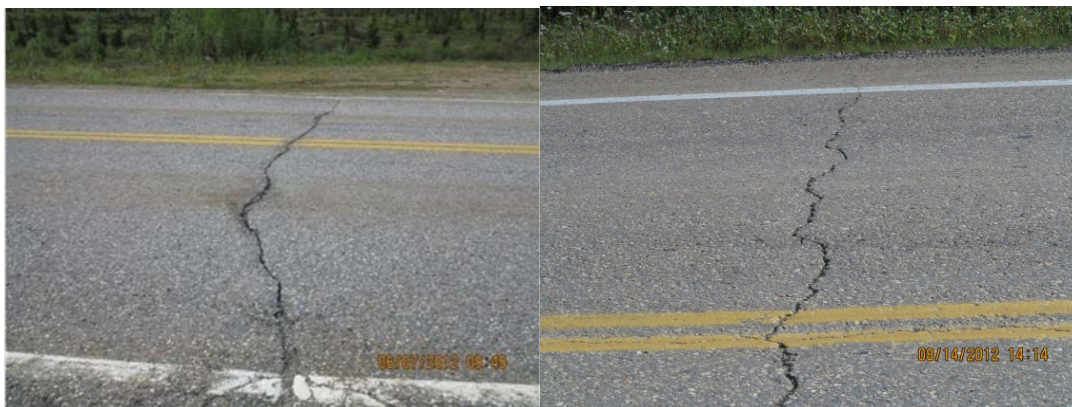
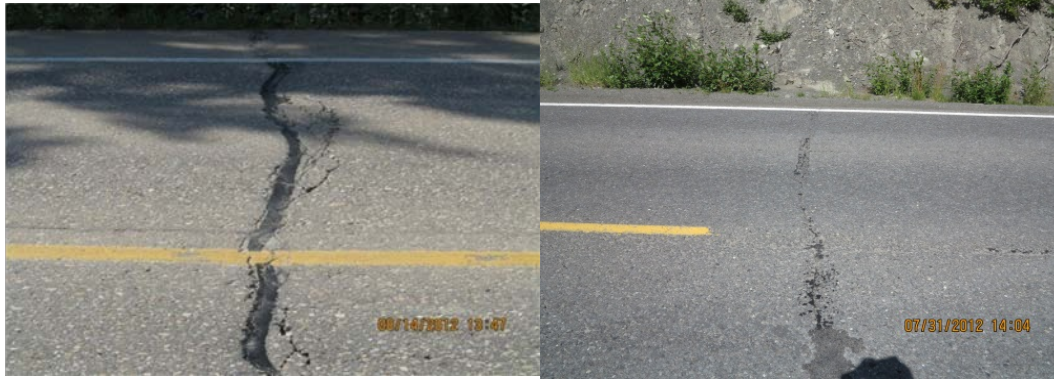
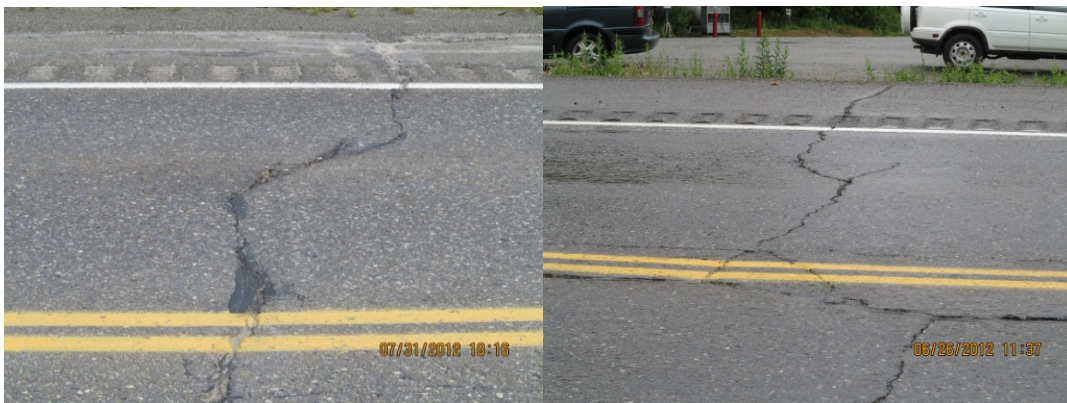
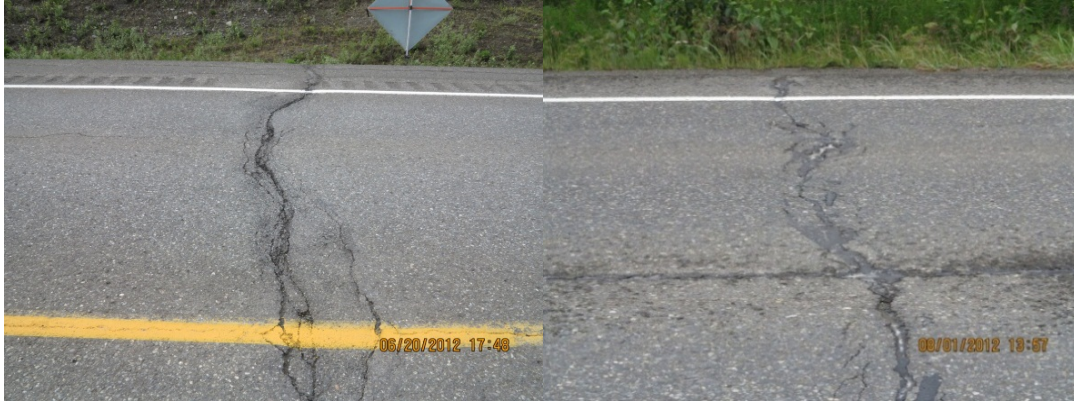
Major transverse thermal cracks (Figures III.1 to III.5) are very simple to identify; they run from one side of the road to the other and are more or less perpendicular to the roadway centerline. These thermal cracks are described in terms of general shape as well as the type and width of pavement deterioration along the crack. Other interesting features found in or near these cracks have been noted as well, such as the presence or absence of sealant and sealant condition.

**Figure III.1 Regular appearance of major transverse thermal cracks**

**Figure III.2 Major transverse thermal cracks with new sealant (left) and old sealant (right)**

**Figure III.3 Examples of crooked major transverse thermal cracks**

**Figure III.4 Examples of bifurcated major transverse thermal cracks**

Figure III.5 Examples of spalled zones along major transverse thermal cracks

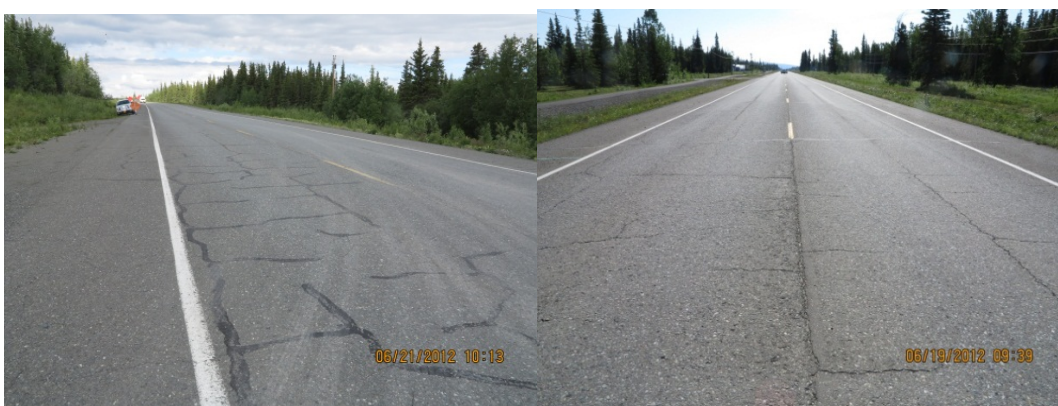
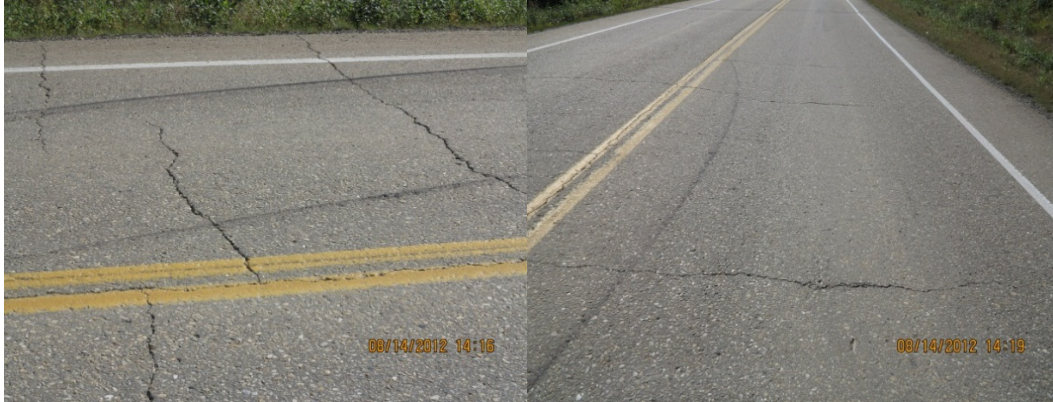
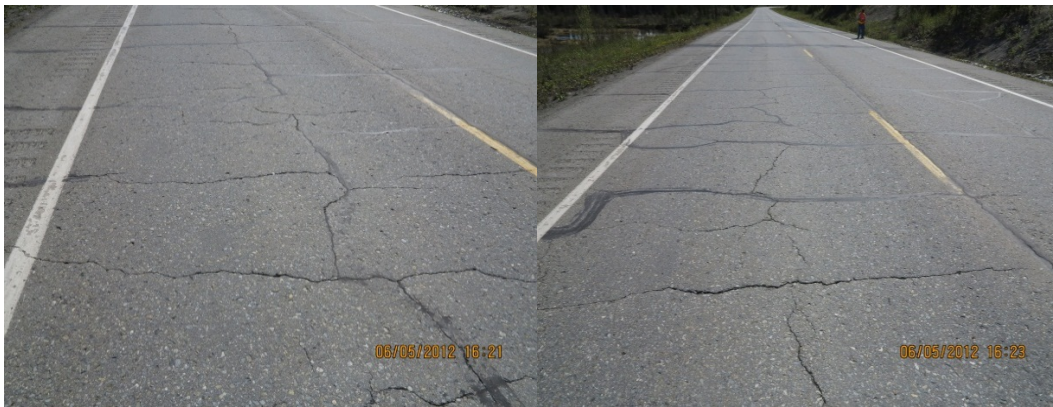
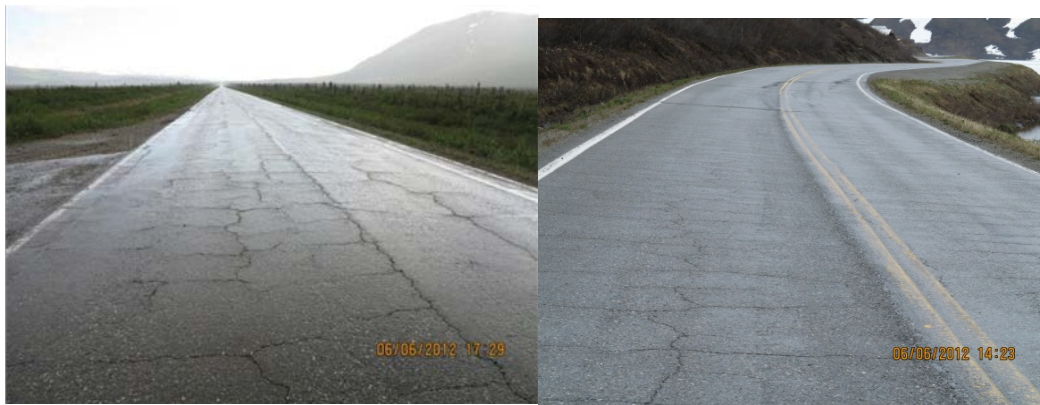
- **Slight** (Figures III.6 and III.7): Individual cracks are far apart, with little or no connectivity.
- **Moderate** (Figure III.8): An interconnected grid-type pattern has developed.
- **Severe** (Figure III.9): An interconnected grid-type pattern has developed with parallel grid elements usually closer than 10 feet. Cracks are also described as having an opening width of 1/8 inch or less, or more than 1/8 inch.

Figure III.6 Lessor thermal cracking—slight (note sealing in left photo)

**Figure III.7 Lessor thermal cracking—slight w/ cracks wider than 1/8 inch**

**Figure III.8 Lessor thermal cracks—moderate (note some very old sealant in left photo)**

**Figure III.9 Lessor thermal cracks—severe (no sealant)**

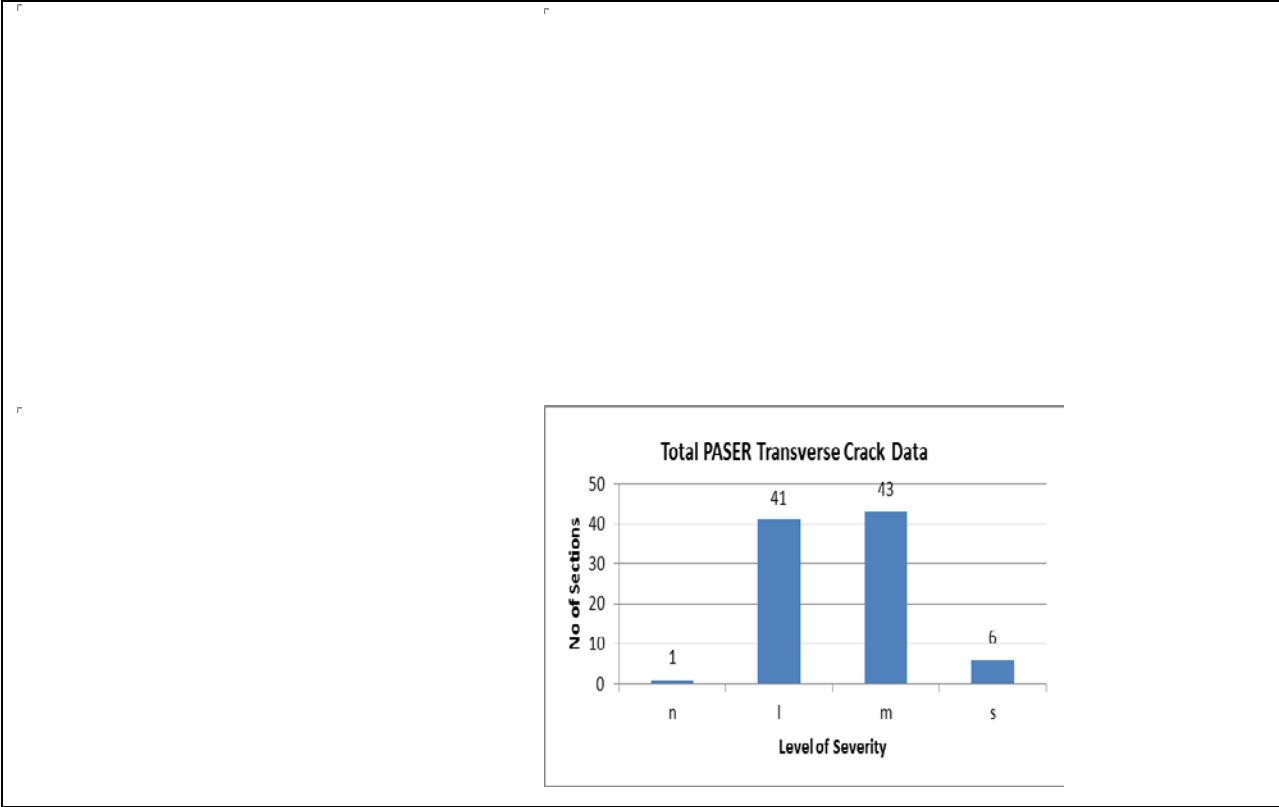
Figure V.4 PASER method for the number of sections on the different highways at each level of severity

- Only 1 out of 91 sites exhibited no transverse cracking. This site was on the Richardson Highway.
- Only 6 out of 91 sites exhibited severe transverse cracking (crack width more than 1/2 inch to 3/4 inch depending on the amount of spalling along the crack edge)
- All other sites have either low or moderate transverse cracking—about evenly split (all crack widths less than about 3/4 inch).

These data simply indicate that almost all old AC pavement sections studied in ADOT&PF's Central and Northern Regions contain major transverse thermal cracks that are no more than moderately severe.

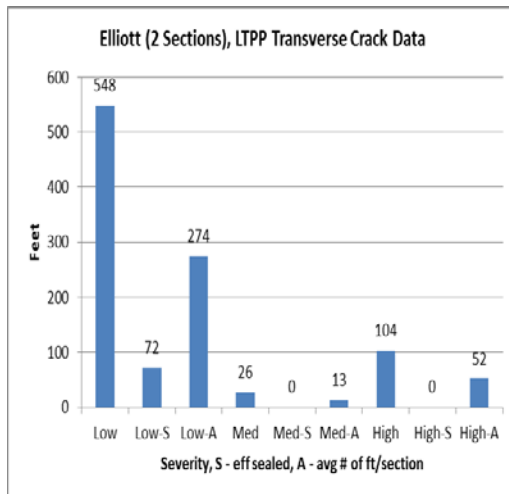
**Figure V.5 Length of transverse cracks at the different severity levels per LTPP method**

An interesting observation based on Figure V.5 is that transverse cracking (according to the LTPP category) is *not* obviously more severe on the more northern sites.

The effectiveness of transverse crack sealants has apparently played no major role in determining the present condition of old pavements. On this basis alone, one might question any presumed need for sealing transverse cracks within the large area of Alaska examined during this research.

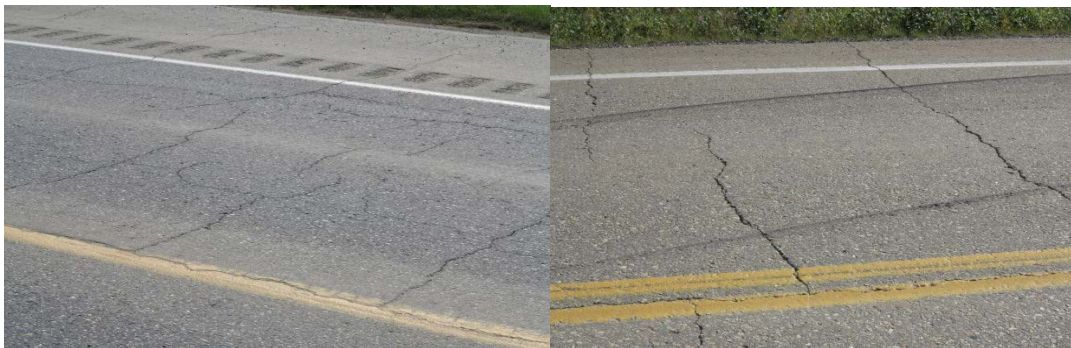
**Figure V.14 Lesser thermal cracks showing same performance in wheel path and non-wheel path locations (extremely common appearance)**

For lesser thermal cracking, visual observations identified *very few* instances where the condition of lesser thermal cracking was worse in wheel path areas than non-wheel path areas. The few examples where lesser thermal cracking showed more damage in the wheel paths were in areas where pavement delamination was occurring. These observations are well supported by substantial photographic evidence as in the following examples. Figure V.14 shows the typical appearance of nearly all lesser thermal cracks seen during fieldwork for this research. Note that there is essentially no difference in performance between wheel path and non-wheel path locations. Neither does pavement condition vary as a function of distance perpendicular to the edge of any individual crack.

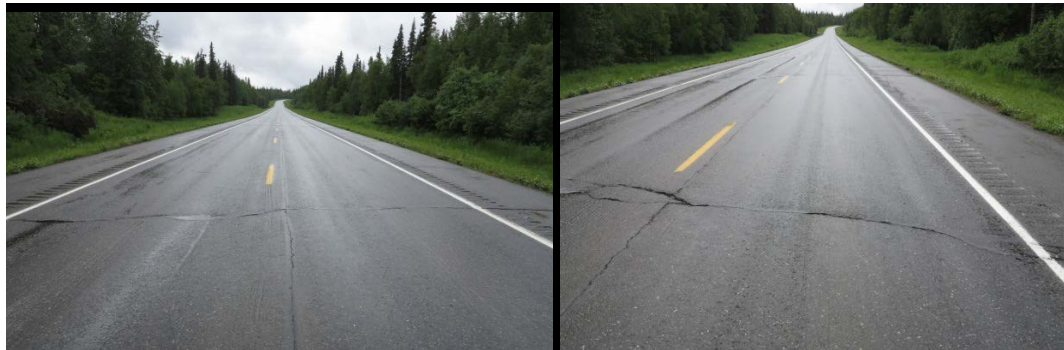
**Figure V.15 Severe major transverse cracks with little influence on pavement performance beyond crack edges (very common)**

Relatively few observations support the theory that open pavement cracks always allow enough surface water infiltration to facilitate load-related pavement damage. The negative influence of water would have been evident if the most heavily trafficked areas of the pavement exhibited significantly more damage than the least trafficked areas.

Here again, it must be emphasized that most observations certainly did not support the assumption that thermal cracks allow enough water past the AC pavement layer to soften the pavement structure.

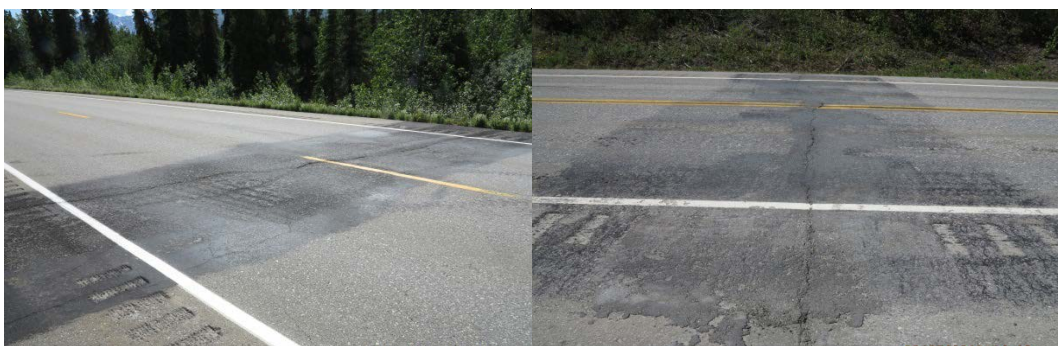
**Figure V.16 Examples of patch/seal band maintenance of major transverse thermal cracks**

Except for the newest of these treatments, nearly every band had re-cracked to reveal the old thermal crack. Failure of the sealing function appeared to cause no problem however. These bands appeared to be performing a valuable function. Most of the banded transverse cracks, even those with old bands, still provided a permanent re-leveling of the area adjacent to the crack, and certainly less of a bump for the driving public than if there were no band. Figure V.16 shows two examples of maintenance banding in ADOT&PF’s Northern Region.

Observations concerning the effectiveness of the bands provide more evidence that thermal cracks can be allowed to remain open without necessarily causing further pavement damage.

In areas where severe bumps are produced because the transverse crack zones are deeply depressed, apply a banded patch/seal of the type commonly used in ADOT&PF's Northern Region. Further discussion concerning application methods and materials regarding this technique is beyond the scope of this report. Contact ADOT&PF Northern Region Maintenance and Operations for further information.
6. **Major Transverse Cracks, Trying New Sealing Methods:**

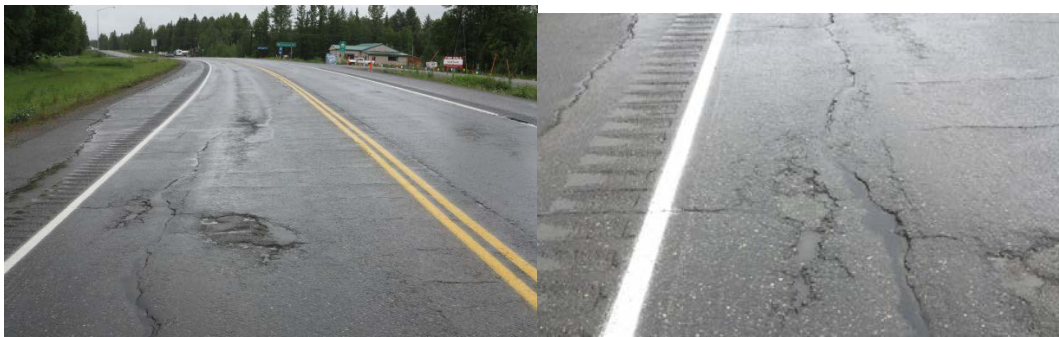
**Figure V.17 Examples of pavement delamination damage accentuated at crack locations**

The problem of pavement delamination was observed at some of the research field sites. This problem was easy to identify where (1) much potholing and raveling were present, and (2) where another pavement layer could be found at the bottom of the potholes and heavily raveled areas. Figure V.17 shows typical negative results of a combination of pavement cracks and delaminating pavement.

It was obvious that the delamination process greatly amplified the importance of all cracks in terms of other forms of surface damage. In fact, the delamination process seemed to be aggravated by *any* openings in the pavement surface that facilitated water getting to the interface between delaminating layers. Only in areas of delaminating pavement was pothole formation seen to be obviously associated with both types of thermal cracking. Delamination tended to increase the severity of spalling along major transverse cracks as well. It is fortunate that relatively few miles of Alaska’s paved roads exhibit delamination.

In areas where the pavement is delaminating, apply sealant as necessary to all cracks to limit potholing and raveling of the general pavement surface, and severe spalling along major transverse cracks. Pavement delamination results from a poor bond between AC

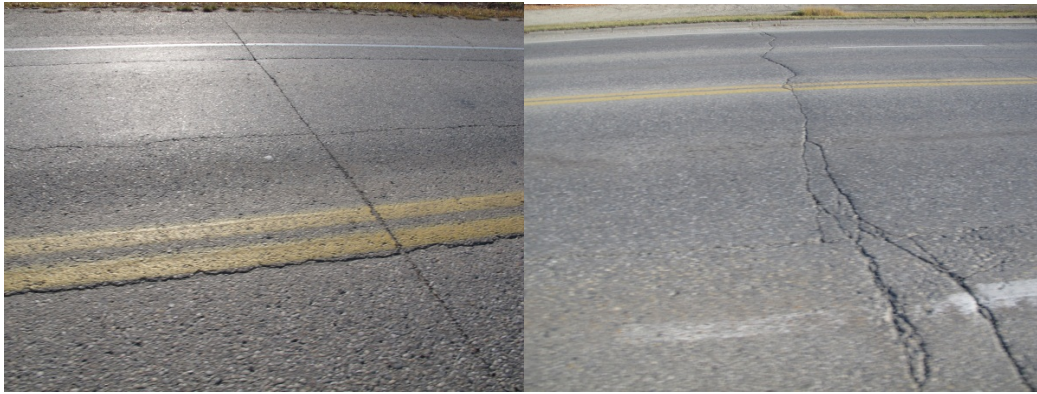
**Figure VI.1 25+ year old major transverse thermal cracks, precut (left) natural (right)**

Figure VI.1 compares a precut Phillips Field Road crack with a natural major transverse thermal crack on another local Fairbanks road. Both pavements are more than 25 years old. Neither crack has ever been sealed. The precut crack provides a much better appearance. The natural crack looks much worse, exhibiting both spalling and bifurcation. However, one must admit that pavement performance near the natural crack is—as was commonly found during this research—acceptable. Lessor thermal cracks abound between the transverse cracks on both of these old roads, but they have caused no maintenance problems to date.

It can be strongly argued that the better appearance of precut transverse cracks, especially in urban areas, provides the impression that the pavement has been more “professionally finished.” Regardless of other benefits, the driving public would obviously perceive a successfully precut pavement as being less in need of maintenance than its naturally cracked counterpart is.
