HIGH-MAST LIGHT POLES ANCHOR NUT LOOSENING IN ALASKA

AN INVESTIGATION USING FIELD MONITORING AND FINITE-ELEMENT ANALYSIS

FINAL PROJECT REPORT

Scott Hamel, P.E., Ph.D.
David Hoisington, M.S.
University of Alaska Anchorage

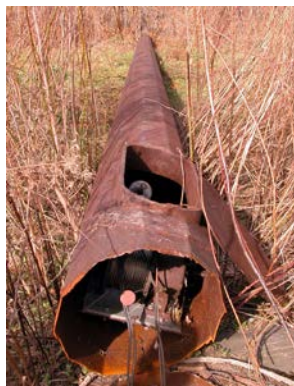
Catastrophic failure of the poles has occurred in several states, including Ohio, Iowa and South Dakota. An investigation including testing and analysis was initiated in Iowa after a failure in 2003 and it was determined that these failures were caused by wind-induced fatigue cracking (see fig 2.1). The remaining high-mast structures were retrofitted and recommendations were made relating to the weld details around the base and base plate thicknesses (1). AKDOT has monitored the research in the other states and has already implemented improved weld details and better weld inspections on the high-mast poles (3).

Figure 2.1: High-mast failure in Iowa

The testing in Iowa included analysis of the effects of some loosened nut configurations *on* the pole strength because it was speculated that this was the cause of the failure. However, it was determined that the insufficient welds had a much larger effect. No mention or speculation as to the cause or prevention of bolt loosening was made because it was assumed by the Iowa investigators that all loosening was the result of improper tightening during construction. Improper tightening has been ruled out as a cause by the Alaska DOT (3). An experimental study conducted in Texas determined the fatigue resistance of the bases of the high-mast poles. It was determined that fatigue life increases with thicker base plates, a larger number of bolts, and by using a full penetration weld (4). These practices have already been adopted in the installation of poles in Alaska.

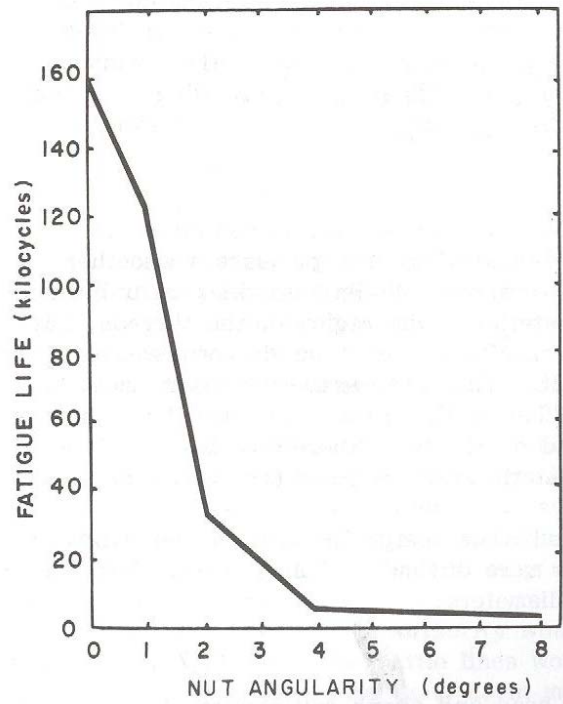
Figure 2.3: Relationship of nut angularity to fatigue life

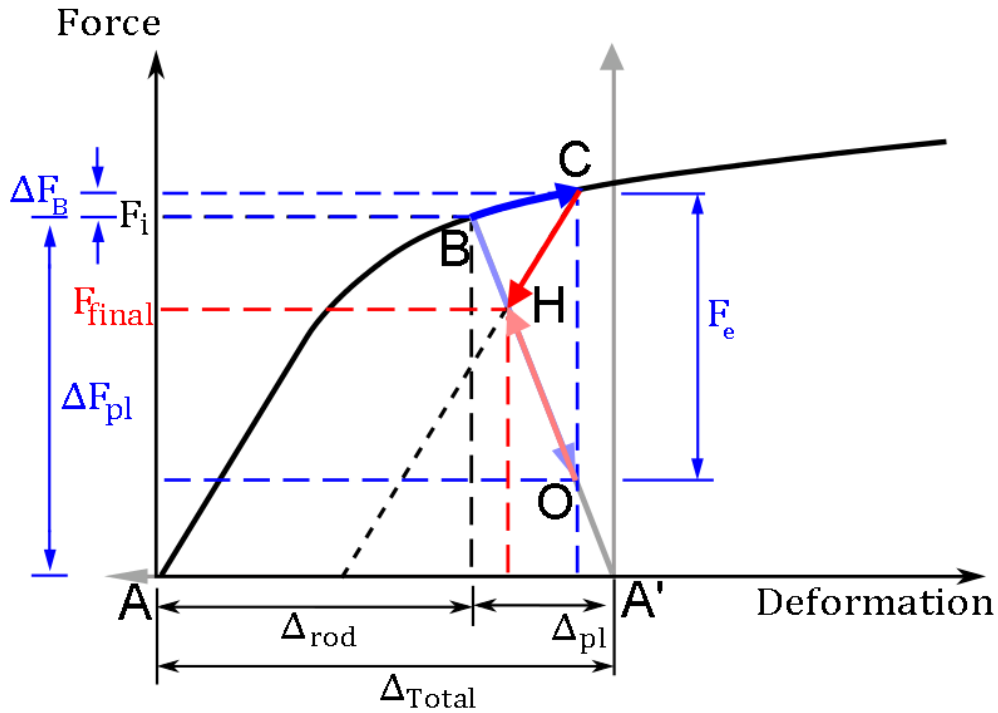
will result in a loss of clamp load. Figure 2.4, modified from Nassar & Matin shows how a high strength bolt loses clamp load when it is loaded beyond yield.

Figure 2.4: Clamp-load loss in High Strength Bolts

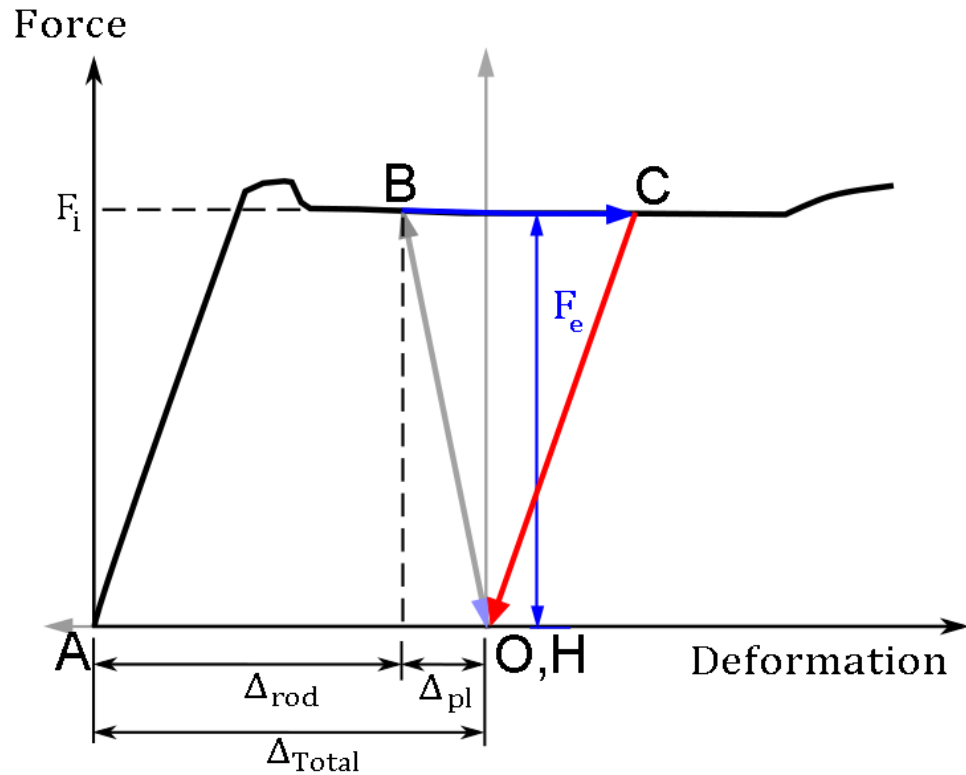
Figure 2.5: Clamp Loss in Mild Steel Bolts

The pretension develops in the rod during tightening through its stress-strain curve from point A to point B. The plate absorbs an equal and opposite compressive force, travelling from point O to point B. When an external tensile load is applied to the pre-tensioned interface, the plate absorbs all of it because the rod's stiffness is zero. If F_e is greater than or equal to F_i , the plate is completely unloaded to point O. During this external load, the rod will stretch depending on the stiffness of the plate and condition of adjacent bolts. When the load is removed, the rod relaxes down a slope equal to its elastic modulus until it meets the plate at point H. In this case, because F_e exceeded F_{ybolt} , the rod was forced to undergo permanent strain large enough to remove

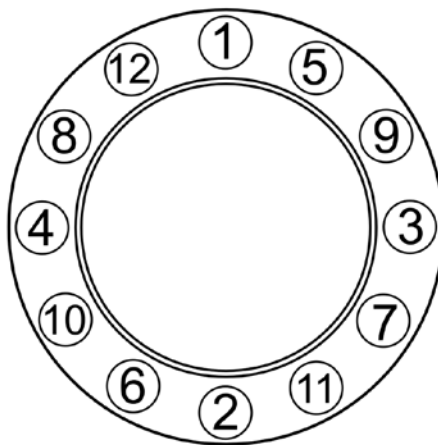
The Turn-of-the-nut method, in conjunction with a tightening procedure, outlines how many steps should be taken, how much the fastener should rotate, and the order in which they are tightened. While there are variations on the number of tightening steps taken, the tightening order remains static. Figure 2.6 shows the tightening order the Alaska DOT utilizes to reduce relaxation during the tightening process. For a 1.5 inch diameter, $F_y = 55$ ksi bolt, 60 degrees of tightening is expected to produce a pretension equal to 85% of yield. 60-90% of yield is generally accepted as appropriate to prevent the vast majority of loosening (7). With a bolted joint carrying this much pretension, how does a fastener receive enough torque to overcome frictional forces and loosen? The system can lose pretension simply due to natural relaxation of the joint, which has been shown to be as high as 5% of yield, depending on the pretension. (4) External loading can cause fatigue, large strains, or vibration, which can all promote pretension loss.

Figure 2.6: 12 Bolt Group Tightening Sequence

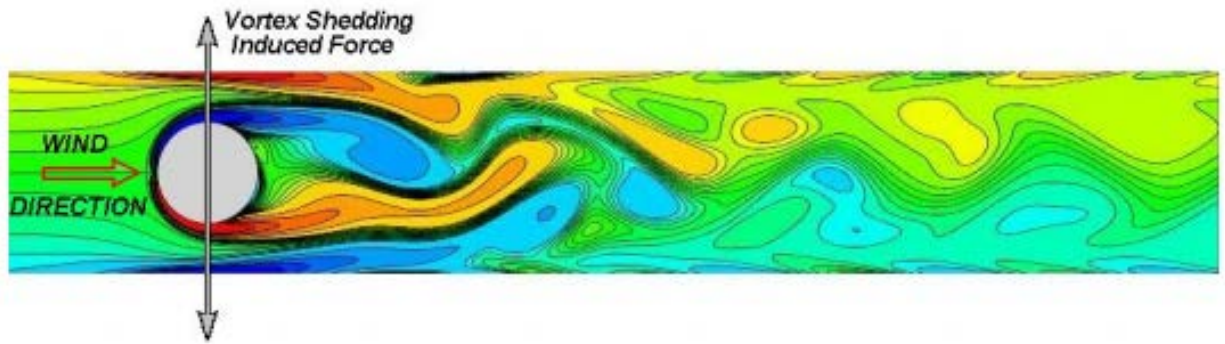
Figure 2.7: Oscillation induced by vortex shedding

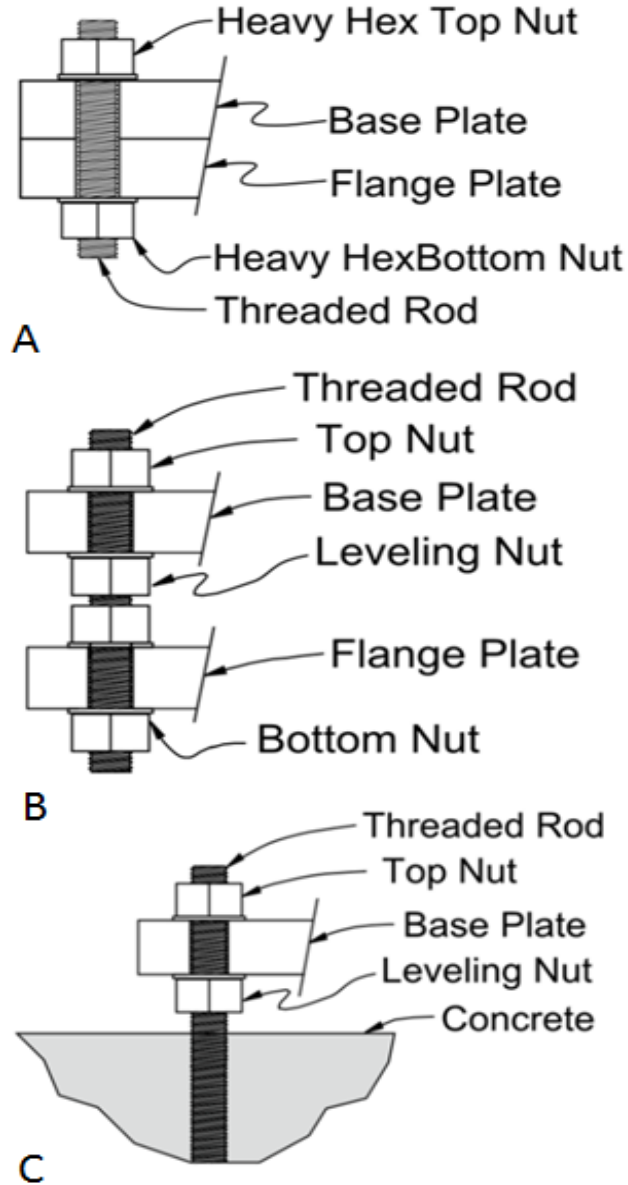
There are several HMLP foundation designs in service in Alaska. For all types, thick base plates that are welded to the pole are attached to the foundation using F1554 Grade 55 anchor rods. These rods have a diameter of are either 1½ inch (38 mm) or 2 inch (50 mm), and are arranged in groups of 12, 16, or 24. The base plates are attached to a foundation pile in two different ways. In the flange-flange type, a flange plate is welded to the top of steel pile, and then clamped to the HMLP's base plate with a short threaded rod and two nuts, as shown in Figure 3.1a. In the other type, a concrete cap is cast at the top of the pile with long, approximately 90 inch (2.3m), anchor rods cast in that protrude from the top, as illustrated in Figure 3.1c. The base plate of the HMLP is then positioned above the cap with leveling nuts and secured with top nuts on these anchor rods. An additional type of foundation, which is not common in Alaska, but prevalent in other states, utilizes two plates. In this foundation, the pile flange plate is secured with top and bottom nuts, then there is a short section of anchor rod, above which

the base plate sits on leveling nuts and is secured with top nuts. The double-plate type foundation is illustrated in Figure 3.1b.

Figure 3.1: HMLP Foundation Types; A: Flange-Flange B: Double Nut C:Cast in Place Concrete

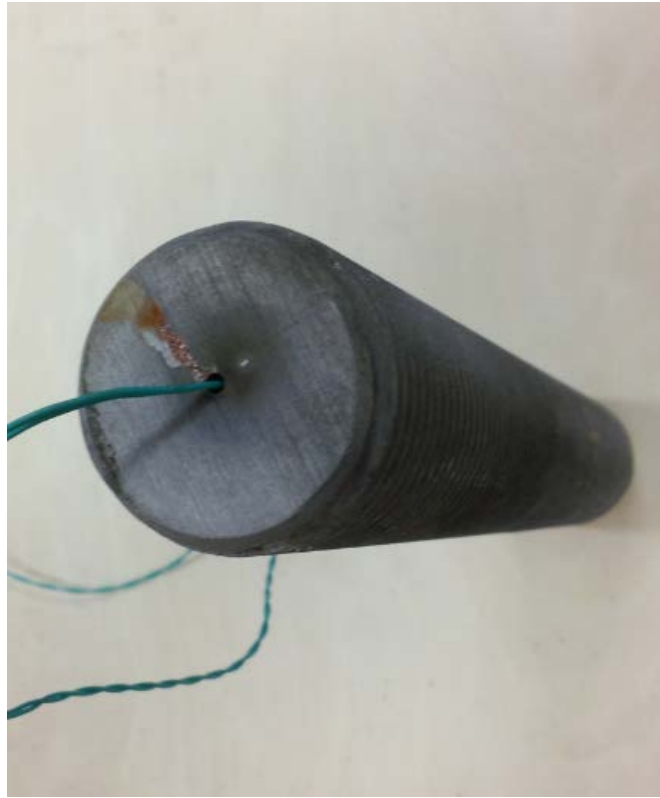
The best method to meet these requirements was to employ strain gages positioned along the central axis of the anchor rods. A 6 inch (150mm) deep, 0.079 inch (2mm) diameter hole was drilled via Electrical Discharge Machining (EDM) into the middle of each bolt. A strain gauge (Texas Measurements BTM-6C-1LDA Bolt Gages) and strain gauge epoxy (Micro-Measurements M-Bond AE15) with an acceptable minimum temperature of -20°F (-29°C) were inserted in the hole. A finished anchor rod is shown in Figure 4.1. The strain gauge was inserted 5.5 inches (140 mm) into the hole while the epoxy was extruded through a syringe & spinal needle into the hole. The epoxy extrusion continued while slowly pulling the needle out, until the entire volume of the hole was filled with the epoxy. The strain gauge is designed to float in the epoxy, while the epoxy bonds to walls of the hole.

Figure 4.1: Anchor Rod with embedded strain gage

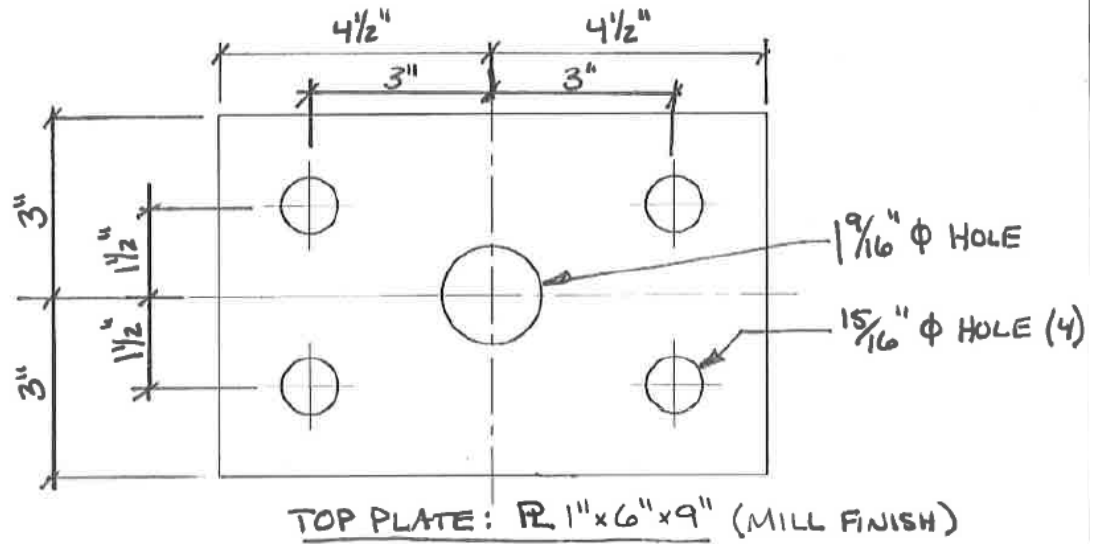
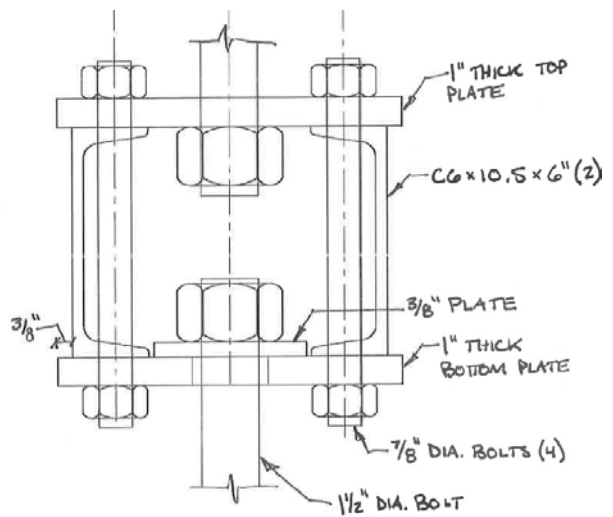
An hydraulic universal testing machine by MTS Systems, Inc. with a 110 kip (500 kN) capacity was used to calibrate the voltage output of the embedded strain gages to a applied axial load on the anchor rods. Custom-built steel adapters, shown in Figure 4.2, were used to mount the anchor rods in the test machine. These adapters were necessary because the anchor rods were too large for the normal grips. In addition, traditional grips do not allow space for the internal strain gage wire that was protruding from one end of the anchor rods.

Figure 4.2: Universal Test Machine Adapters for 1.5 inch Anchor Rods

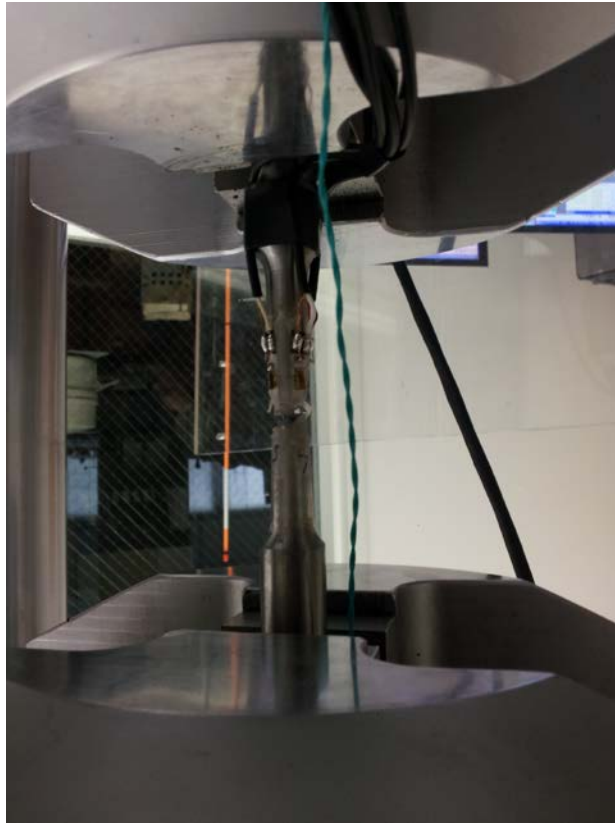
The displacement-controlled test was started at 0.03 inches/minute. At 6.5 minutes (15,000 lbs, approximately 4% strain), partway through strain-hardening, the displacement rate was increased to 0.100 inches/minute. It remained at this rate until fracture. The strain gauges were connected to a Wheatstone bridge using a ¼ bridge configuration and excited with 5 volts DC. The output voltage was monitored using an NI-9205 cDAQ module

Figure 4.4: Anchor Rod Strength Test

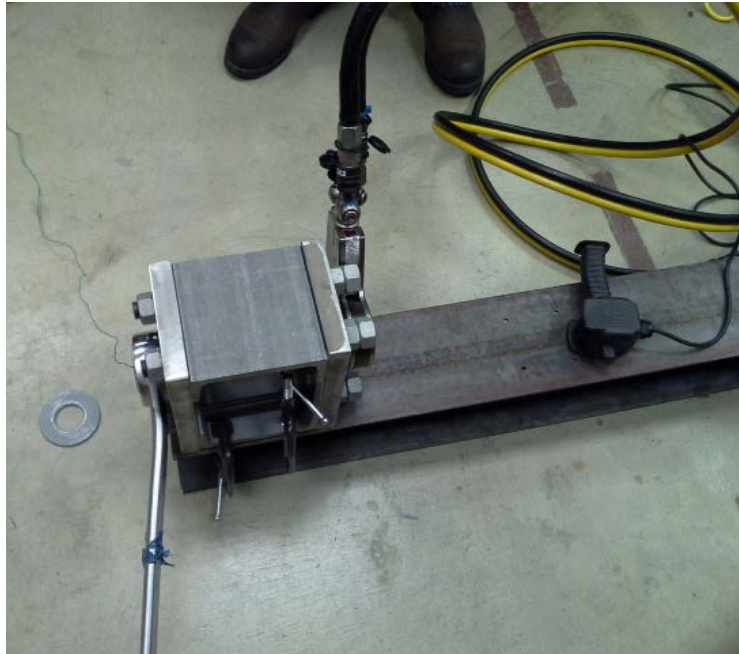
Figure 4.6: Full test assembly ready for torque to be applied

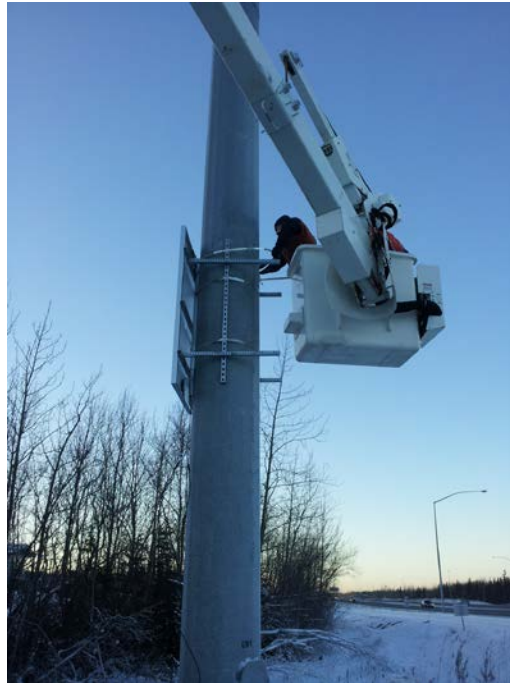
Because the pole is located across the parking lot from the weighstation building, and maintenance personnel wanted to avoid cables crossing on or over the parking lot, the system required its own source of power. To accommodate this, a 250 Watt solar panel from Lime Solar was mounted to the side of the pole using a 1 5/8" uni-strut frame, as shown in Figure 4.7. A 350 cold-crank amp car battery and solar charge controller (Instapark MPPT30) were placed in a weather-tight NEMA box on the ground near the pole foundation. The data acquisition system was placed in a 2nd NEMA enclosure attached to the pole.

Figure 4.7: Solar Panel Installation at Weighstation

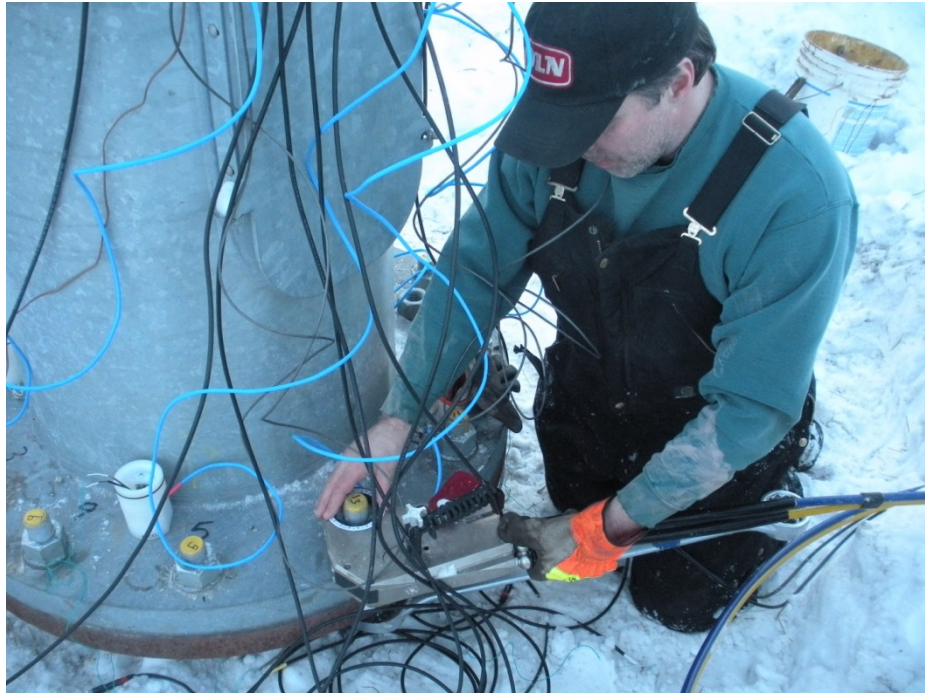
The anchor rods were tightened according to the “turn-of-the-nut-method” in a four stage process using the “star pattern” for a 12 bolt group specified by FHWA. Each existing anchor rod was loosened, replaced with a strain gauged rod, and the new rod was then tightened to the “snug tight” condition. After all the rods were replaced, each nut was turned 20 degrees with a hydraulic wrench. Figure 4.9 shows Rod Blohm (AKDOT bridge crew) rotating one of the anchor nuts 20 degrees.

Figure 4.9: Rod Blohm (AKDOT&PF Bridge Crew) turning an Anchor Nut 20 Degrees

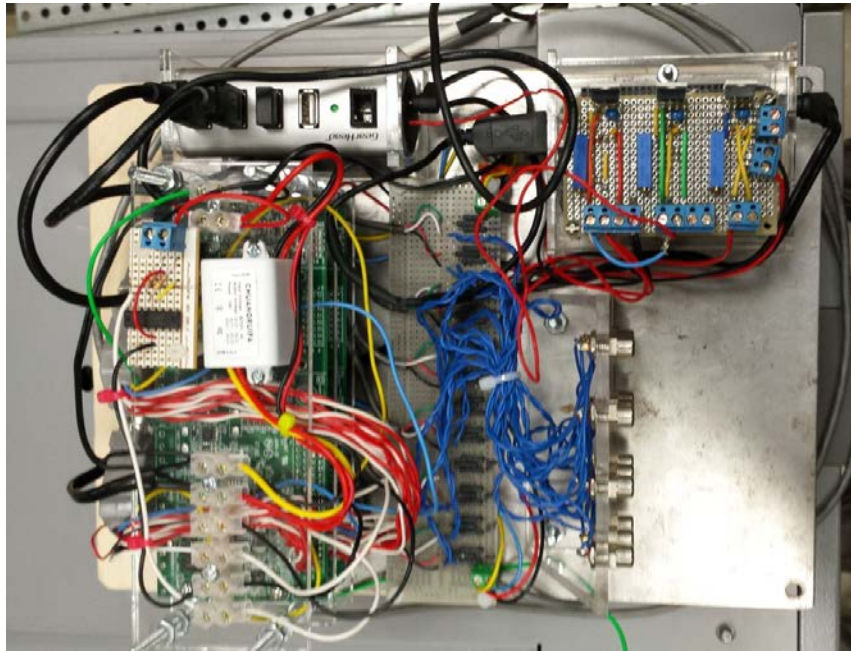
which recorded the strain gage output voltages, as well as the air temperature using an EI-1022 thermometer from Labjack Inc.

Figure 4.10: Peter’s Creek HMLP Custom-Built Data-Acquisition System

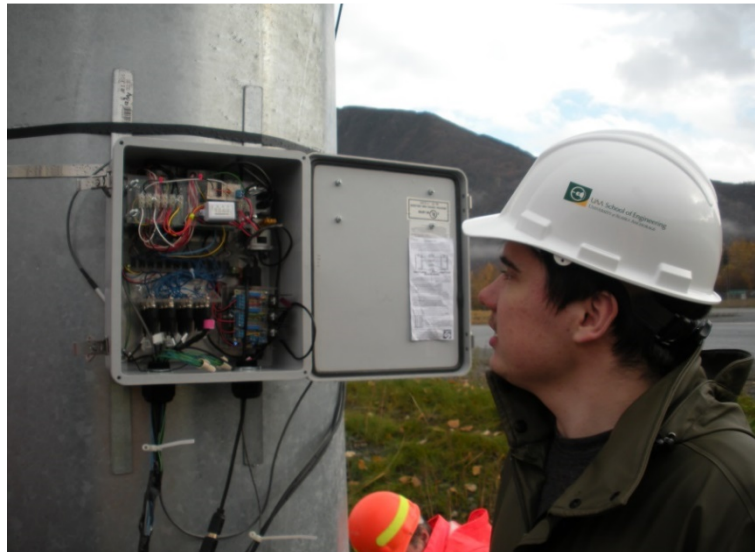
batteries. This was solved by creating a digital relay to shut down the USB hub, which also deactivated the Labjack DAQ units. This function significantly reduced power consumption and was successfully used in the laboratory in cold temperatures for several days before the DAQ was returned to the Peter's Creek HMLP. The completed and installed system can be seen in Figure 4.11.

Figure 4.11: Completed Data-acquisition System at Peter's Creek HMLP

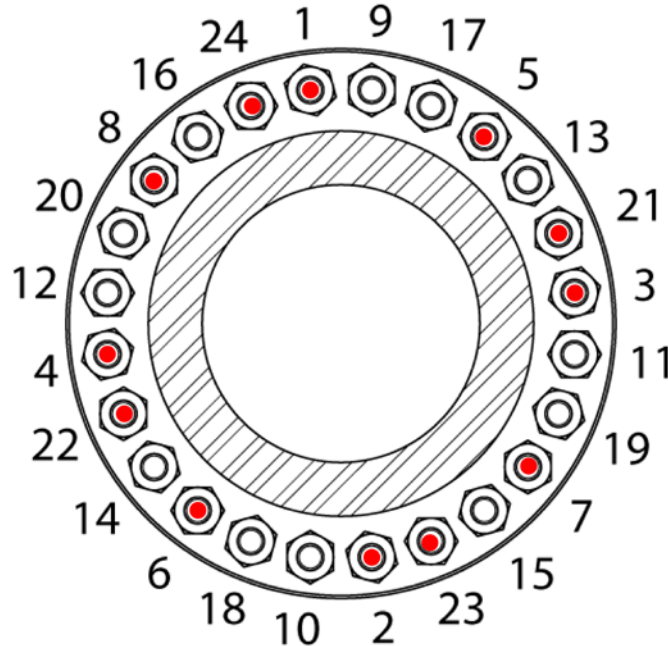
The anchor rods at Peter's Creek were tightened in a similar manner to those at the Weighstation. Turn-of-the-nut method was again utilized, along with a 24-bolt star pattern, shown in Figure 4.12. Existing anchor rods were loosened, replaced and tightened to the "snug tight" condition. After all the rods were replaced, each nut was turned 20 degrees with a hydraulic wrench. Due to the increased grip length of the anchor rods, additional 20-degree passes were required for all the rods. The anchor rods were turned a total of 100 degrees in six passes. Figure 4.13 shows Rod Blohm (AKDOT bridge crew) rotating one of the anchor nuts 20 degrees.

Figure 4.12: Peter's Creek HMLP Tightening Pattern. Red fill indicates rods with strain gages.

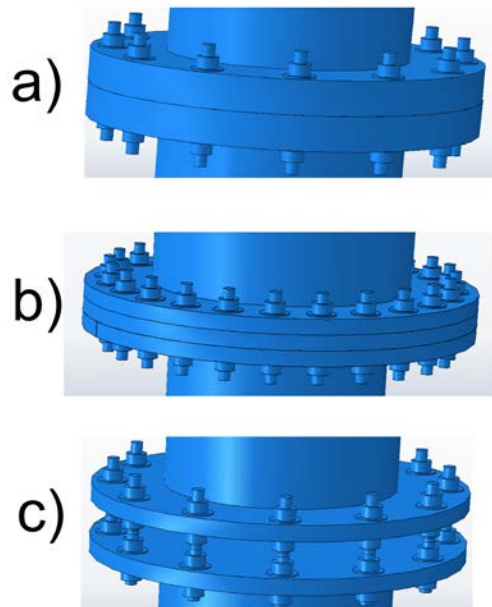
- A. Flange-Flange, 12 rods, 46 m (150 feet) height (Weigh-station HMLP)
- B. Flange-Spacer-Flange, 24 rods, 47 m (155 feet) height (Peter's Creek HMLP)
- C. Double Nut Moment, 12 rods, 46 m (150 feet) height

Figure 4.15: modeled HMLP foundation scenarios (a) twelve-rod flange-flange, (b) twenty-four-rod flange-spacer-flange, and (c) twelve-rod double-nut flanges

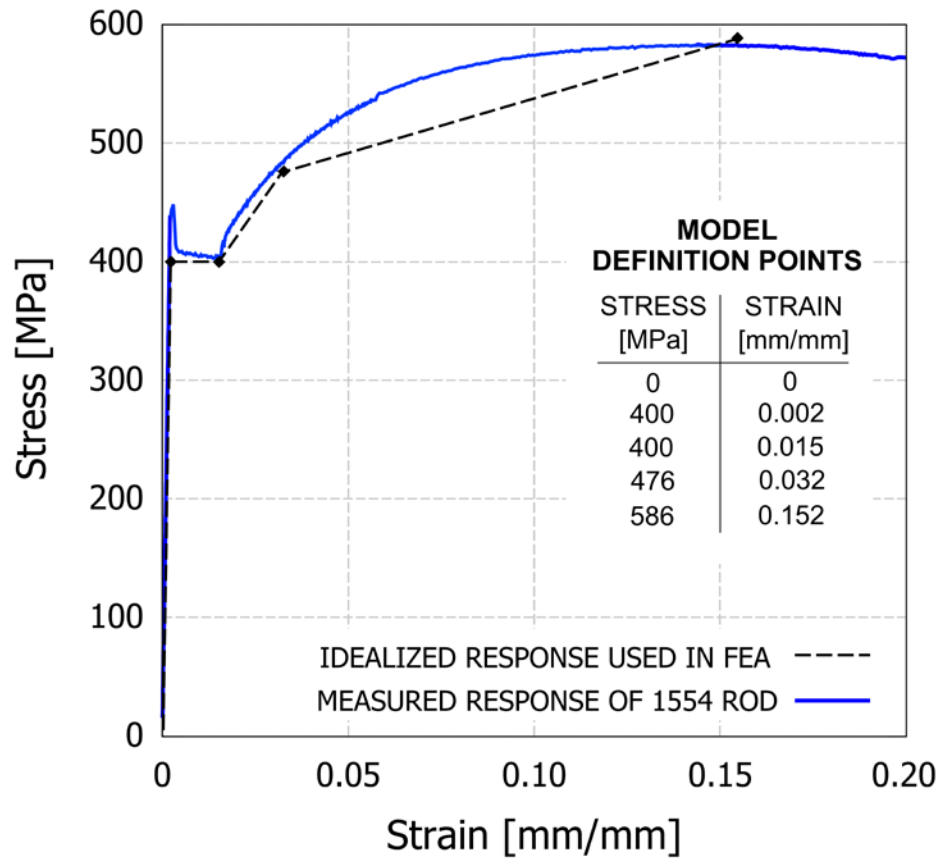
The approximate element size of all plates was set to 13 mm (0.5 inch), the pole was set to 75 mm (3 inch) and the pile was set to 150 mm (6 inch).

Figure 4.16: Stress-strain relationship used for anchor rods in FE models

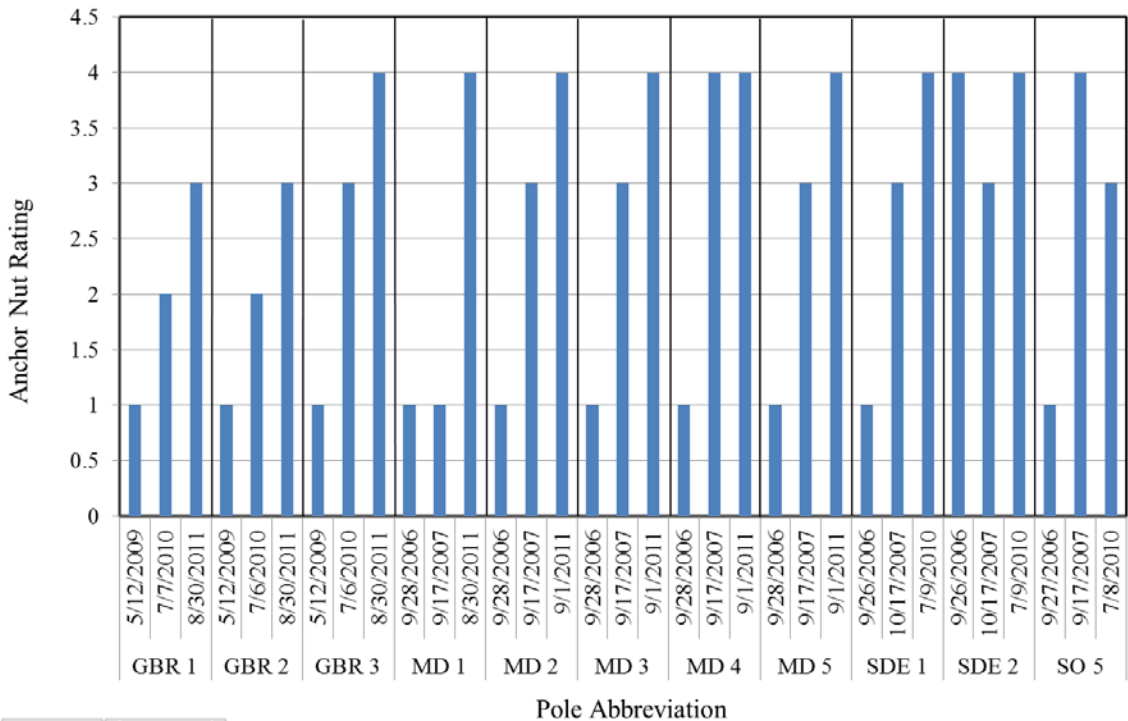
In addition to influence factor observations, it was noticed that for those poles with multiple inspections generally improved over time. That is, those poles who had their anchor rods retightened improved their rating over time, presumably because the anchor rods did not re-loosen. Figure 5.1 shows all of the HMLPs that have had three inspections to date, which as it happens, all have CIP concrete pile cap foundations. Almost all of the poles have had their ratings increase over the three inspections.

Figure 5.1: Anchor Nut Ratings on CIP Foundations with multiple inspections

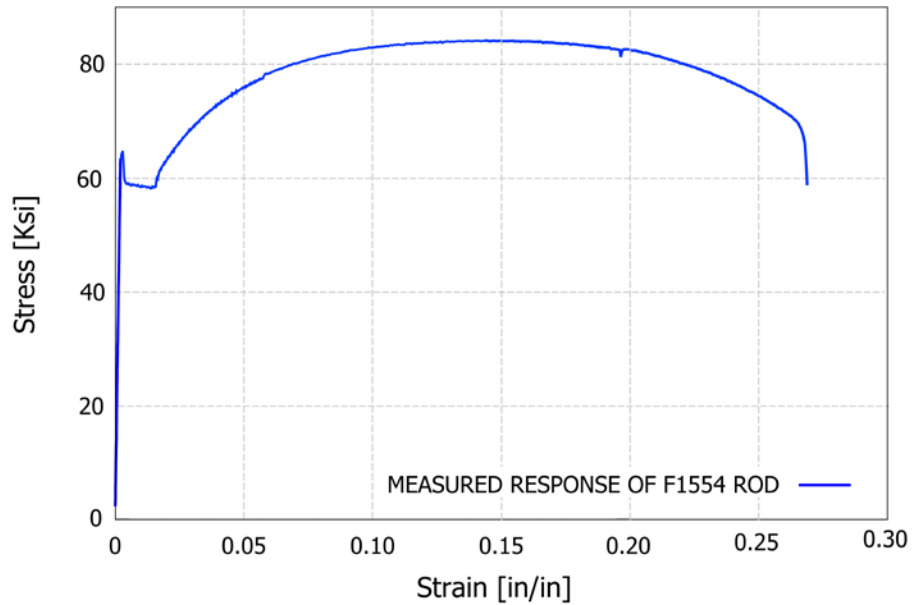
Figure 5.3: Plastic Stress-Strain Response of F1554 Threaded Rod

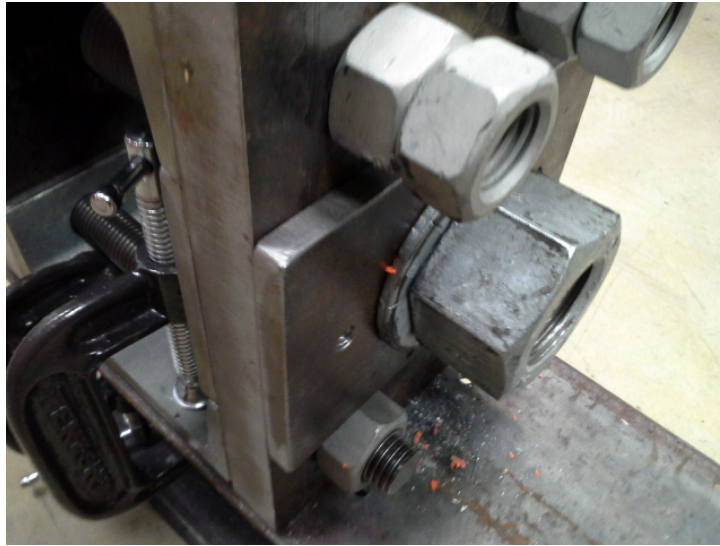
A total of six DTI's were loaded until an indication squirt took place, as observed by the orange beads of silicone on the perimeter of the washer as shown in Figure 5.4. Loads at the time of the indicator squirt ranged from 50 to 55 kips. Results from the strain gages are shown in Figure 5.5, which shows the increasingly slower application of hydraulic pressure to pinpoint the force at which the DTI washers “squirt”.

Figure 5.4: View of DTI after indication squirt as noted by the orange bead on the perimeter of the washer

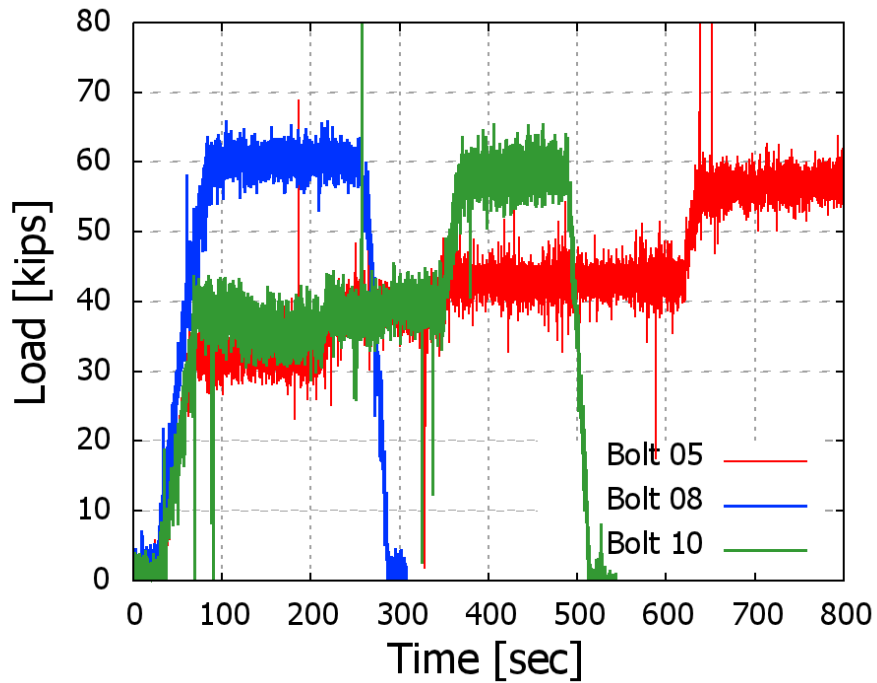
Figure 5.5: Results of DTI Washer Calibration

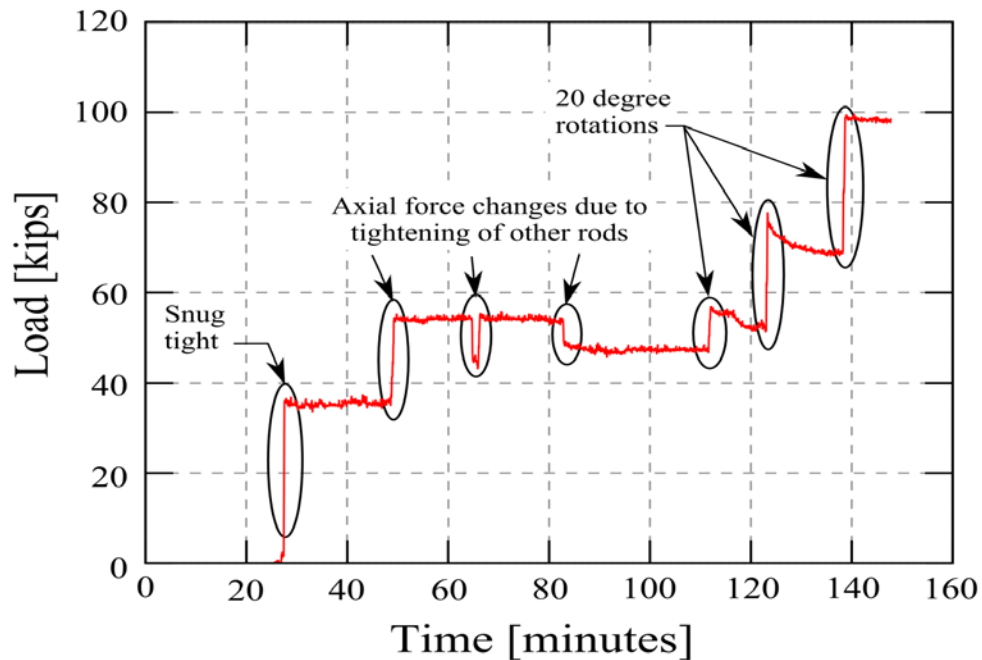
Figure 5.7: Tightening of Anchor Rod #3

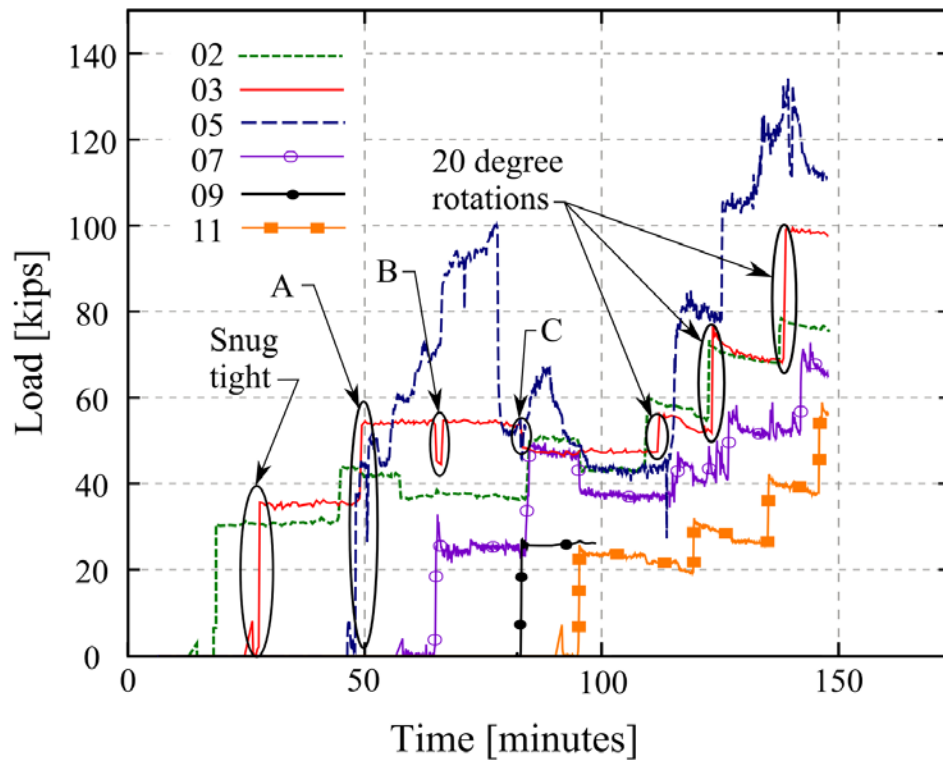
Figure 5.8 shows anchor rods that affected the axial tension in rod #3.

Figure 5.8: Effect of Adjacent Rods in Rod #3 During Tightening

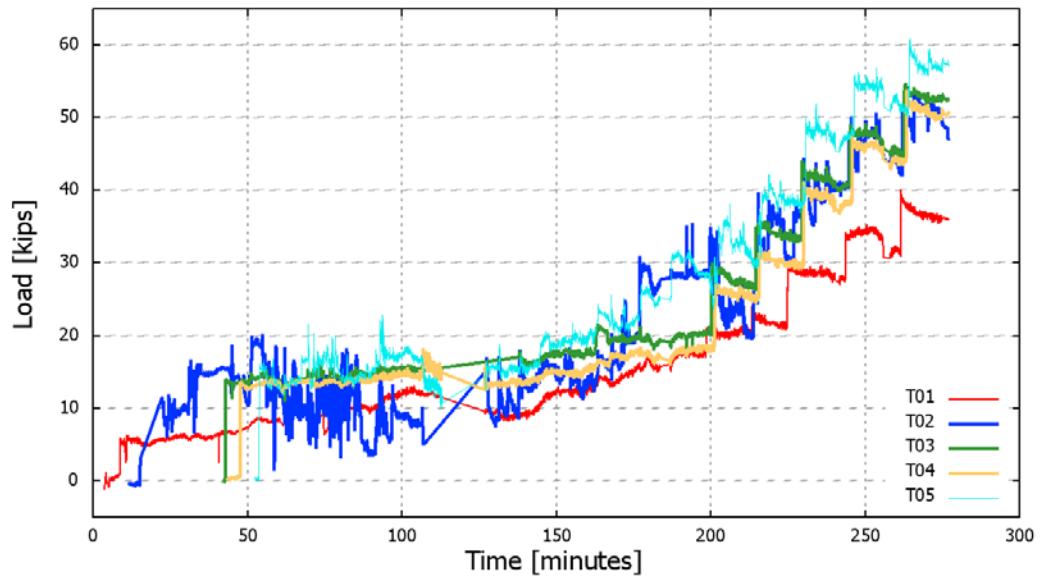
Figure 5.9: Peters Creek Tightening of Strain Gauges (1)

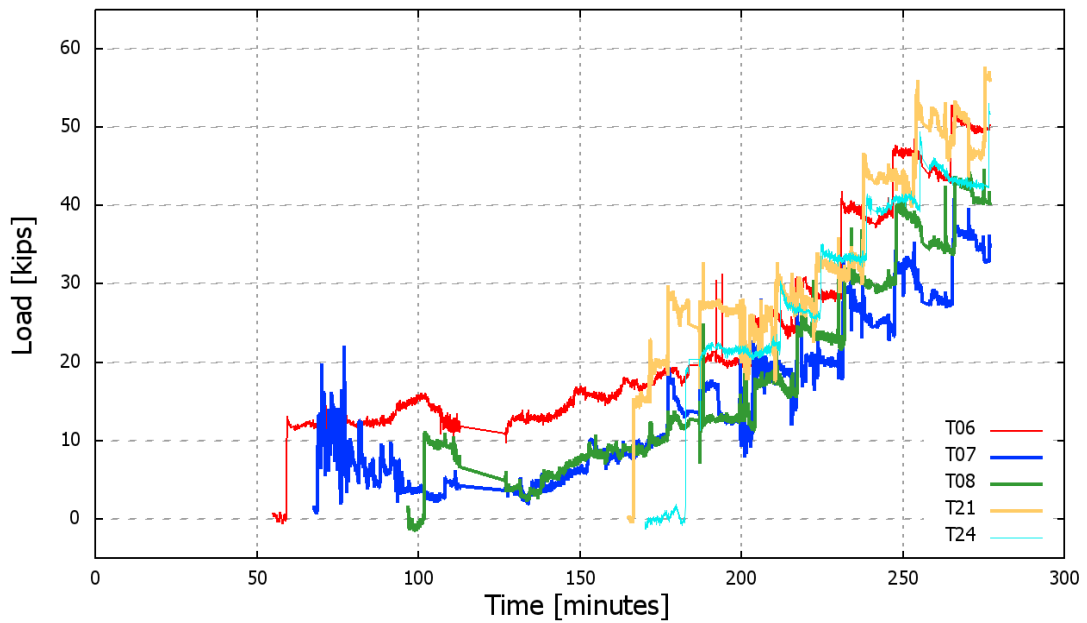
Figure 5.10: Peters Creek Tightening of Strain Gauges(2)

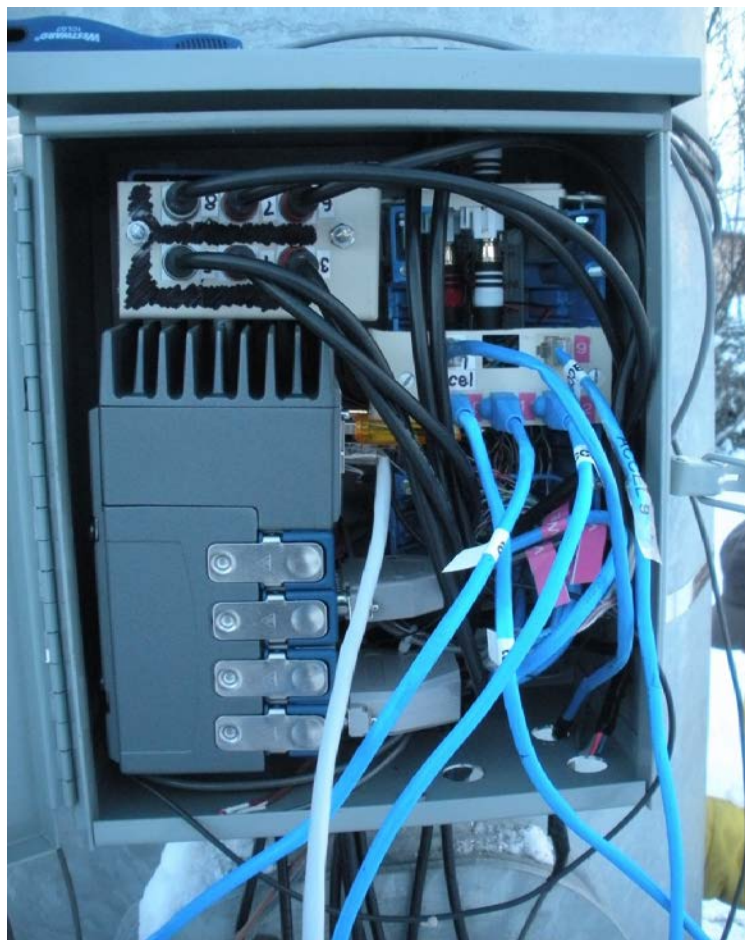
Figure 5.11: Weigh Station HMLP cRIO DAQ

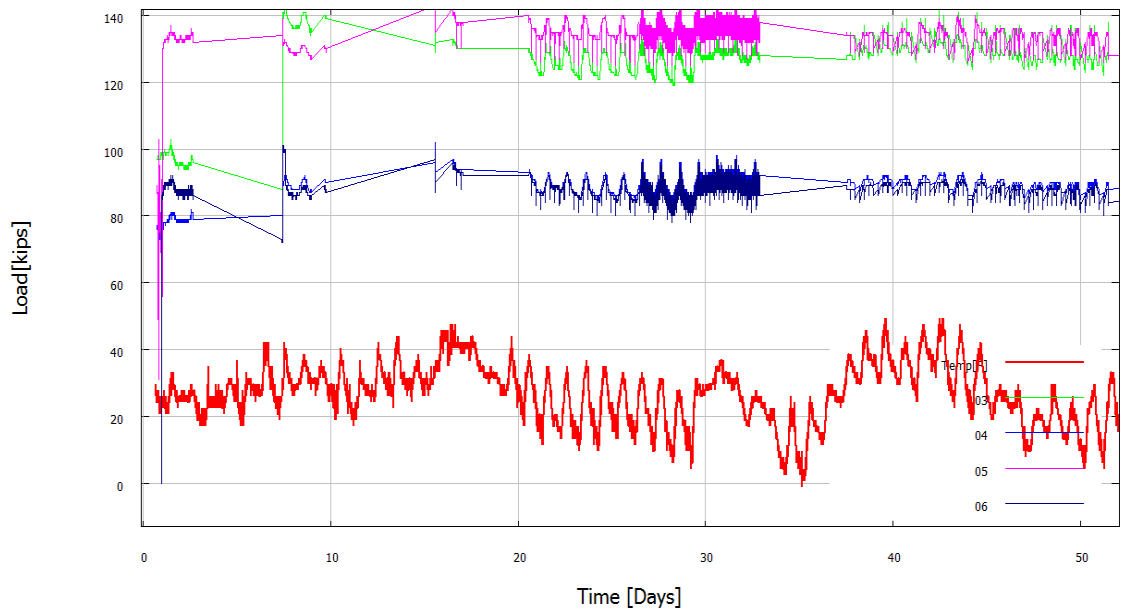
Figure 5.12: Weigh Station cRIO Long Term Data(1)

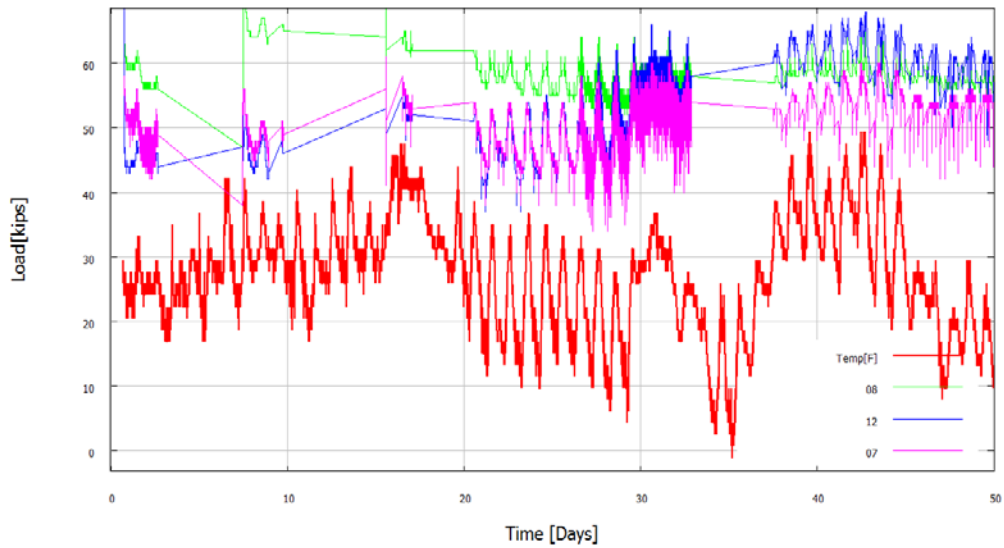
Figure 5.13: Weigh Station cRIO Long Term Data(2)

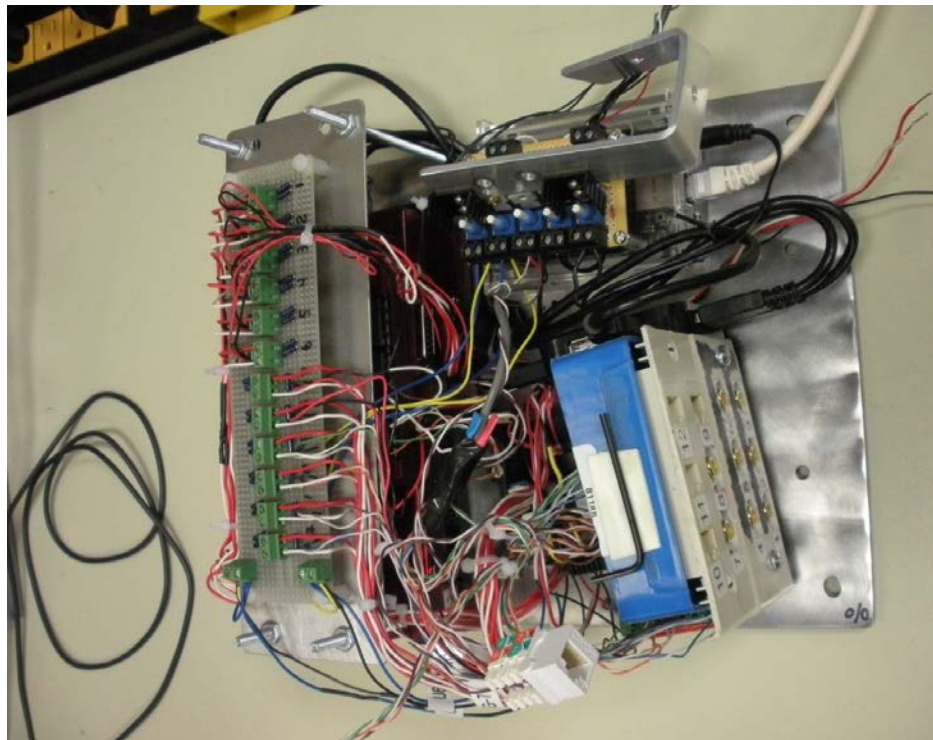
Figure 5.14: Weigh Station Custom Built Data-Acquisition System

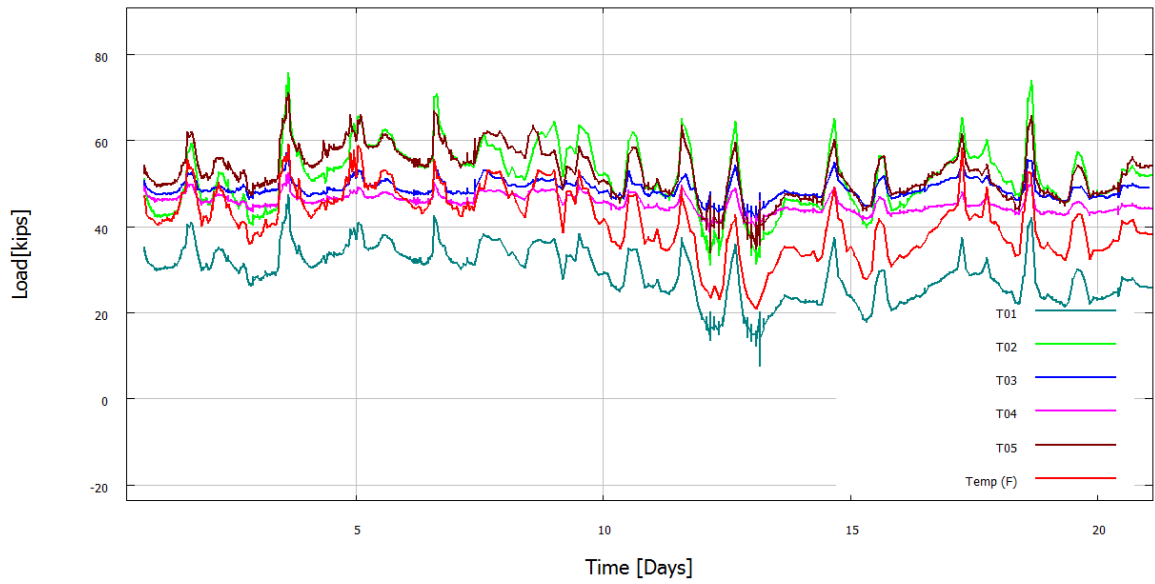
Figure 5.15: Peter's Creek Time Data (1)

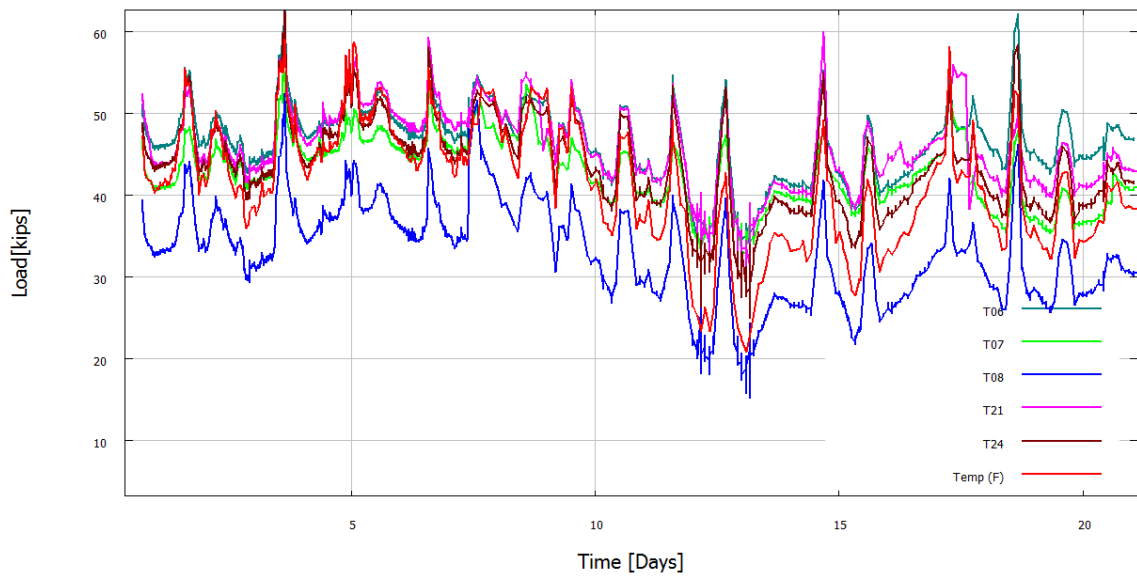
Figure 5.16: Peter's Creek Time Data (2)

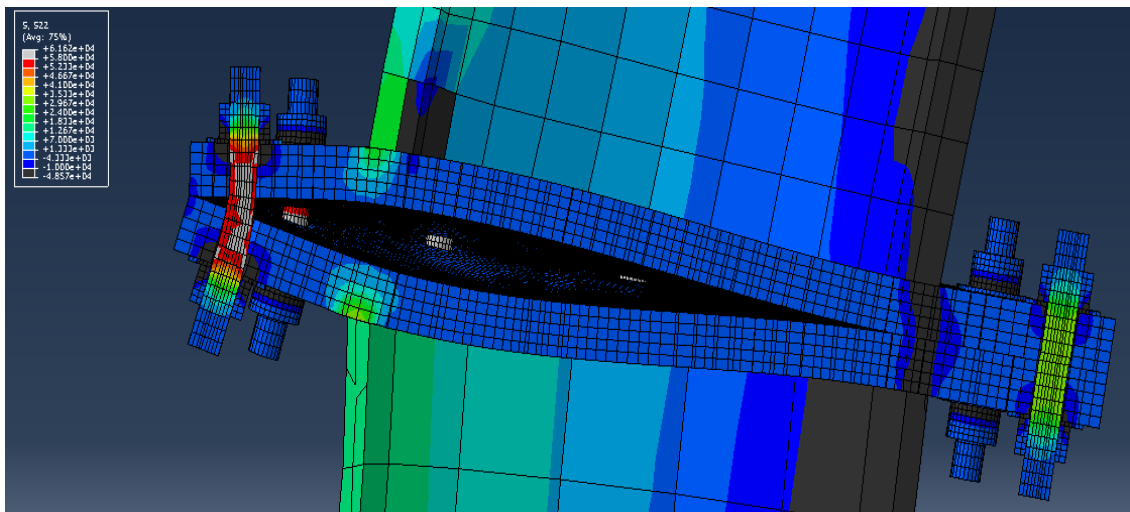
Figure 5.17: Z-axis (vertical) stress results of scenario A: twelve-rod flange-flange subjected to a 6800 k-in (768 kN-m) moment

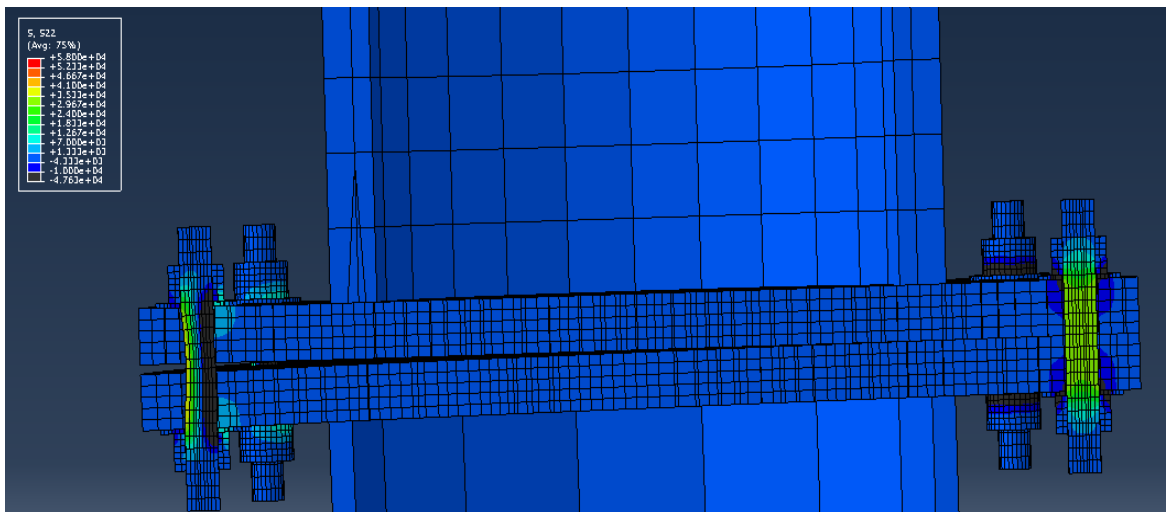
Figure 5.18: Scenario A unload (6800 k-in Moment)
