HIGH-MAST LIGHT POLES ANCHOR NUT LOOSENING IN ALASKA

AN INVESTIGATION USING FIELD MONITORING AND FINITE-ELEMENT ANALYSIS

FINAL PROJECT REPORT

Scott Hamel, P.E., Ph.D.
David Hoisington, M.S.
University of Alaska Anchorage

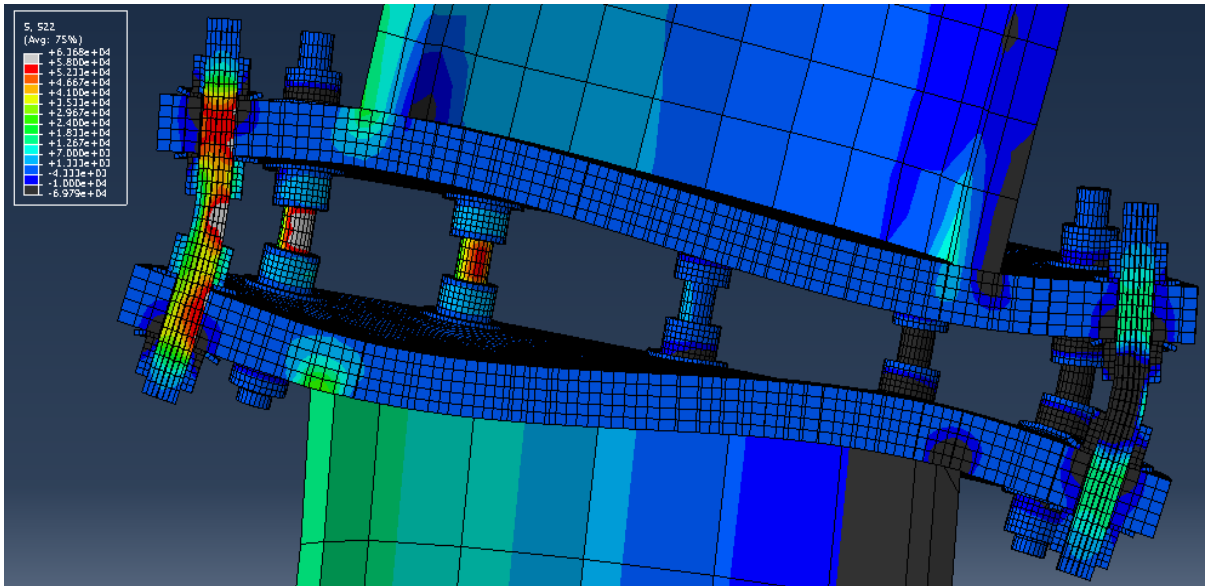
Figure 5.19: Scenario C Load (6800 k-in Moment)

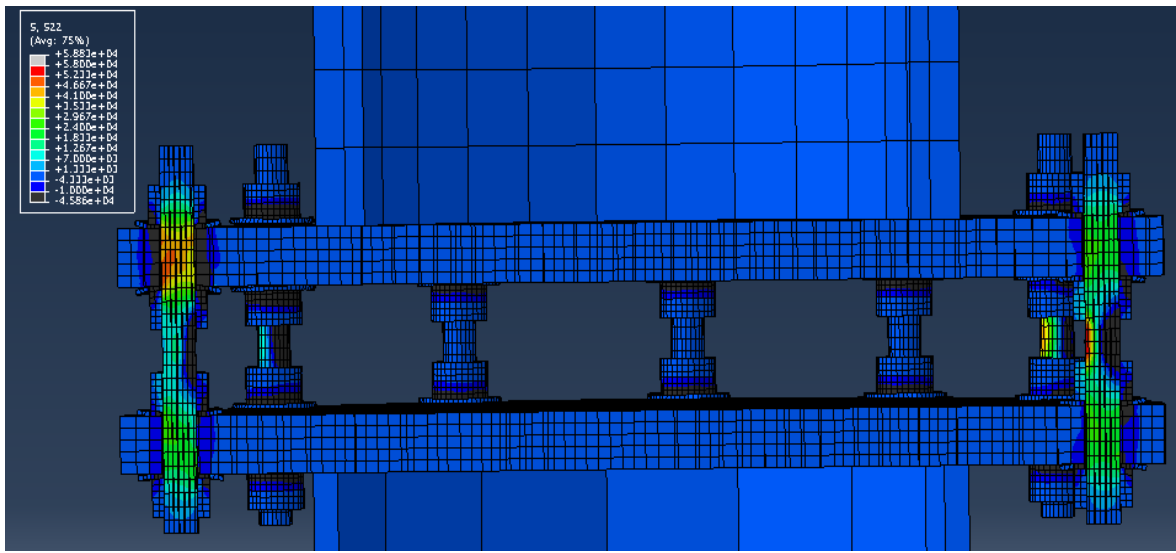
Figure 5.20: Scenario C Unload (6800 k-in Moment)

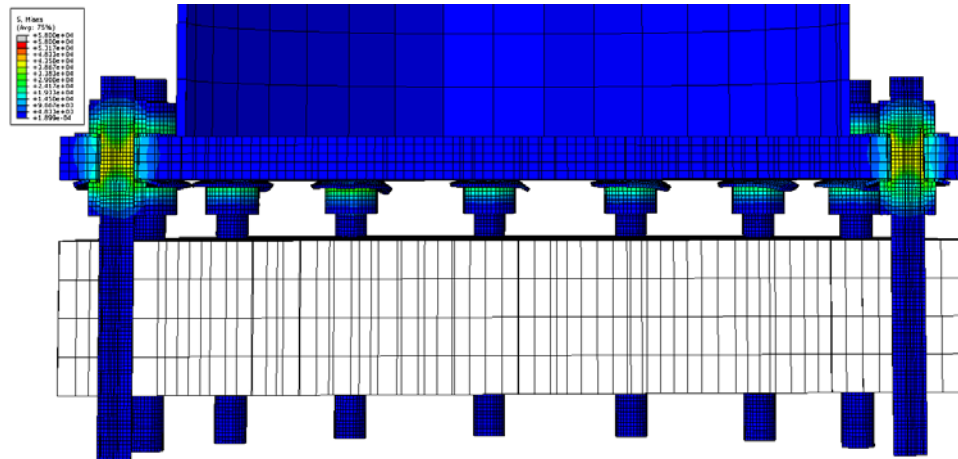
Figure 5.21: CIP Concrete Pretension ($\Delta_B = 0.008''$)

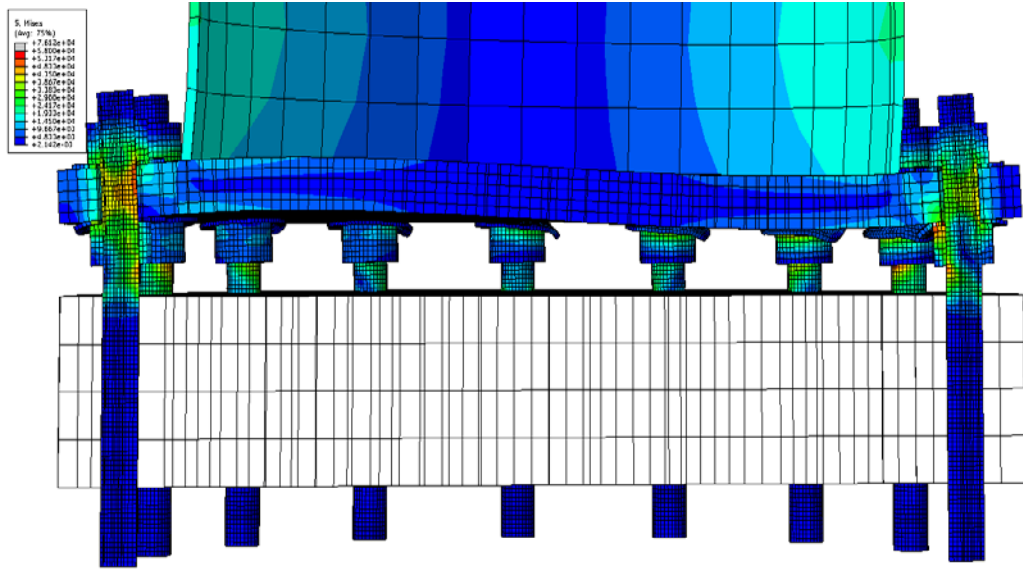
Figure 5.22: CIP Concrete Load (9500 k-in Moment)

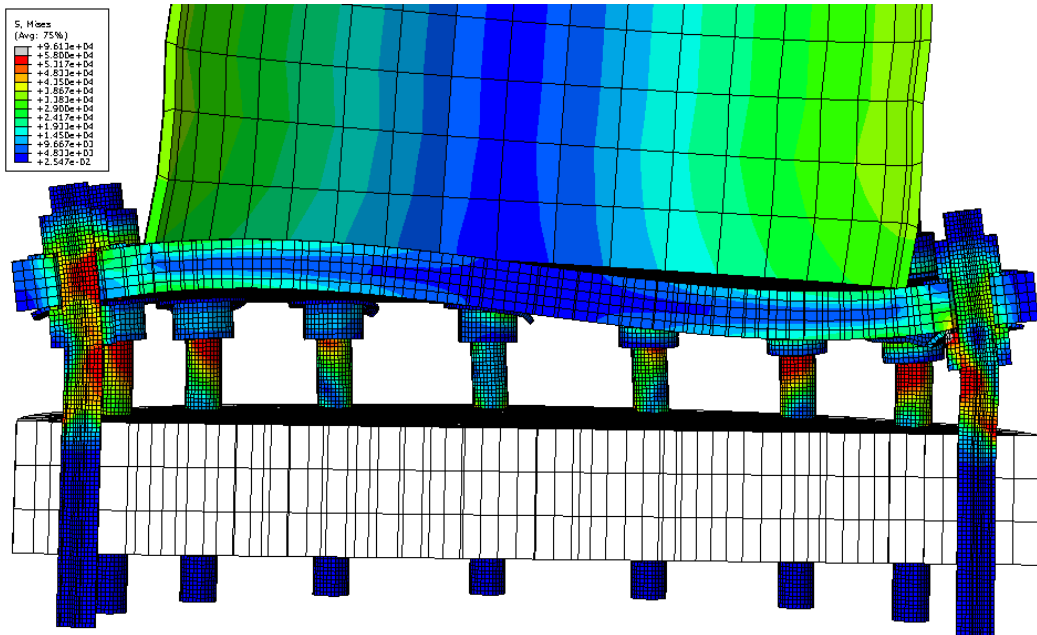
Figure 5.23: CIP Concrete Load (18000 k-in Moment)

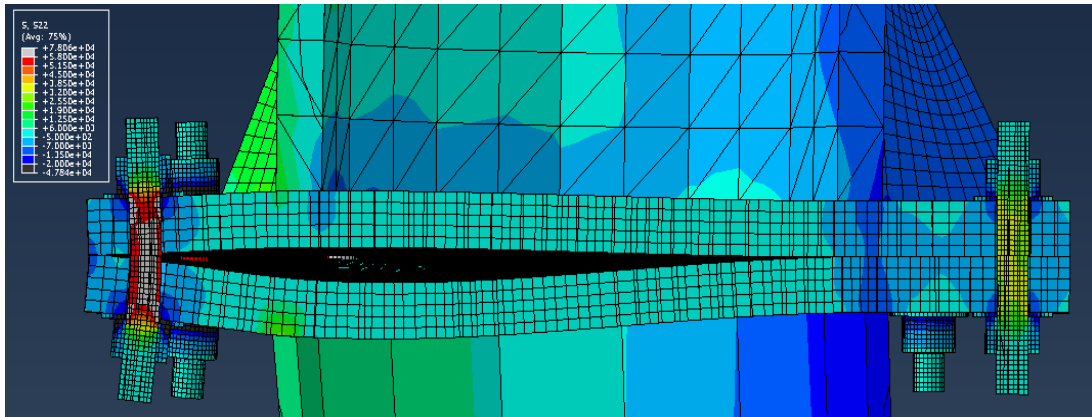
Figure 5.24:Scenario A with Stiffeners Load (6800 k-in)

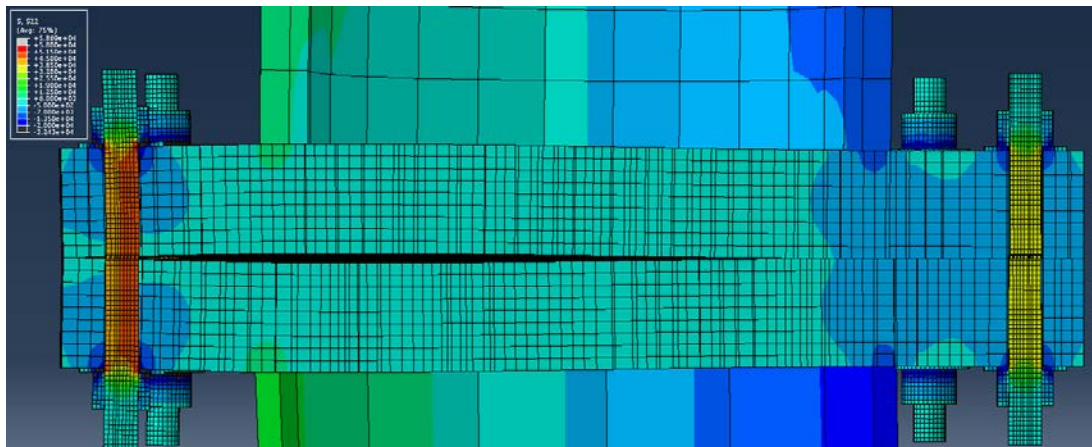
Figure 5.25: Scenario A with 4.5 Inch Thick Plates Load (6800 k-in)

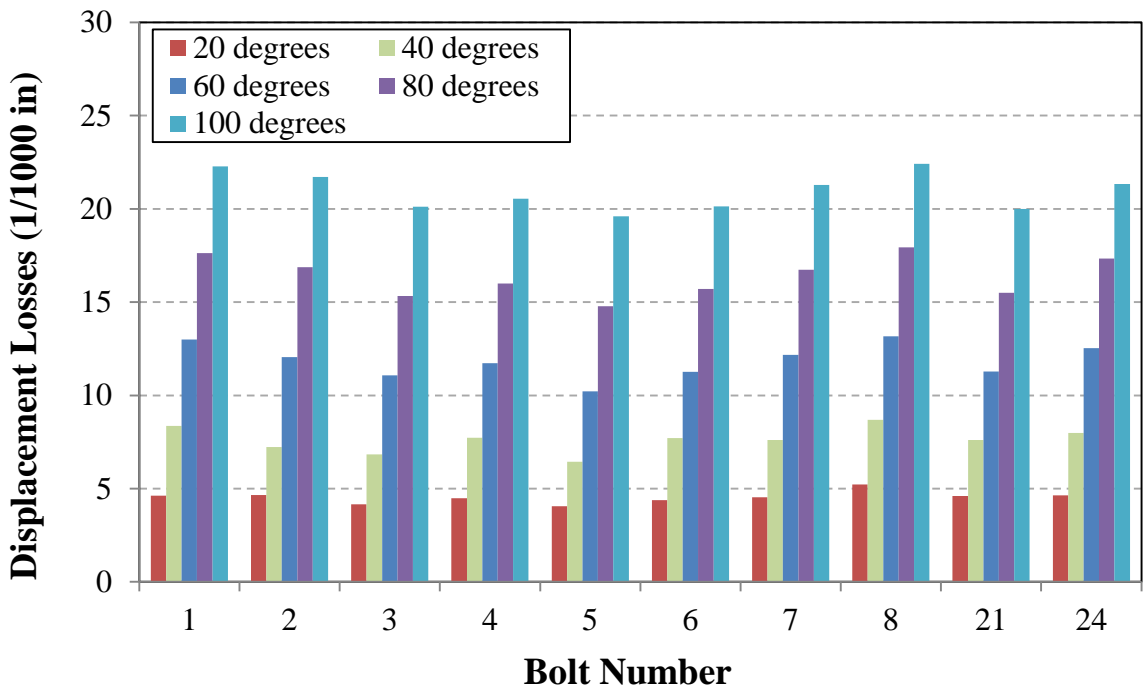
Figure 6.4: Displacement Losses at Peter's Creek during Tightening

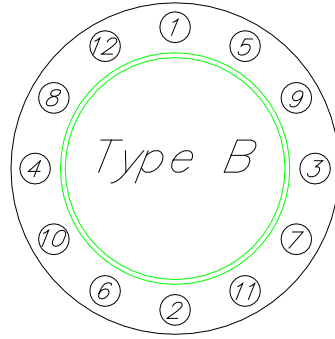
Figure A.1: Type 'B' Tightening Sequence

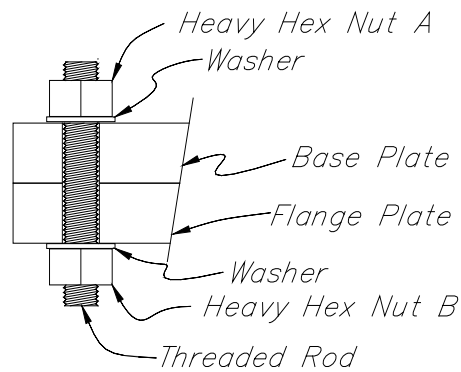
Figure A.2: Type 'B' Rod Assembly

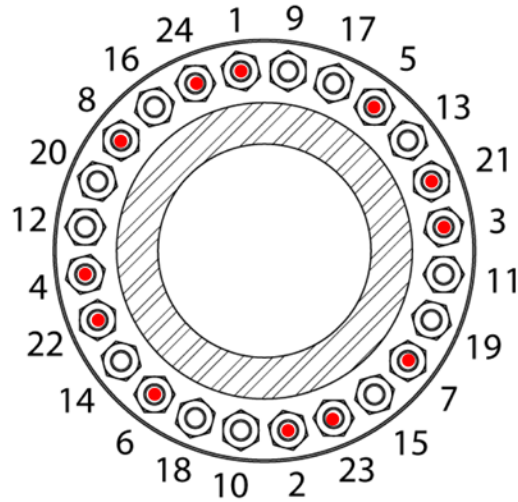
Figure B.1: Tightening Sequence

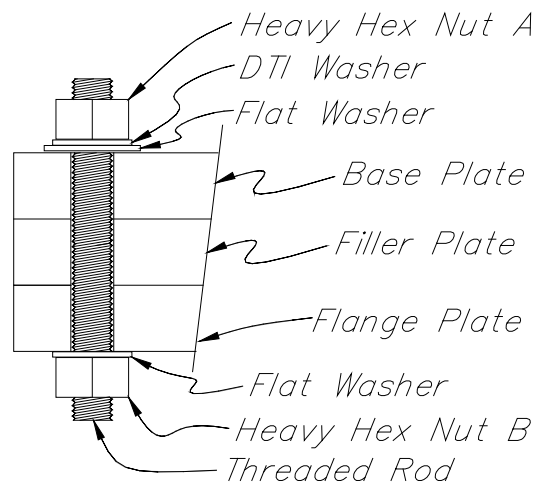
Figure B.2: Rod Assembly

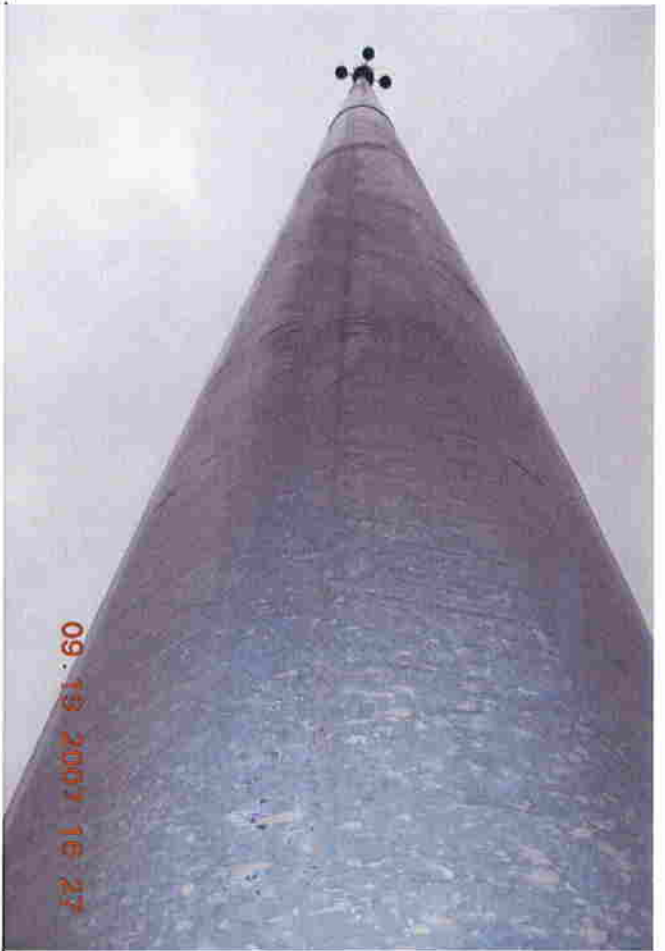
Number **5** Structure **Glenn Hwy-Weigh Sta** Date **09/19/07**
Roll No. **5** Inspectors **Higgs / Stelbach** Frame **173**
Coating above Rod **5**

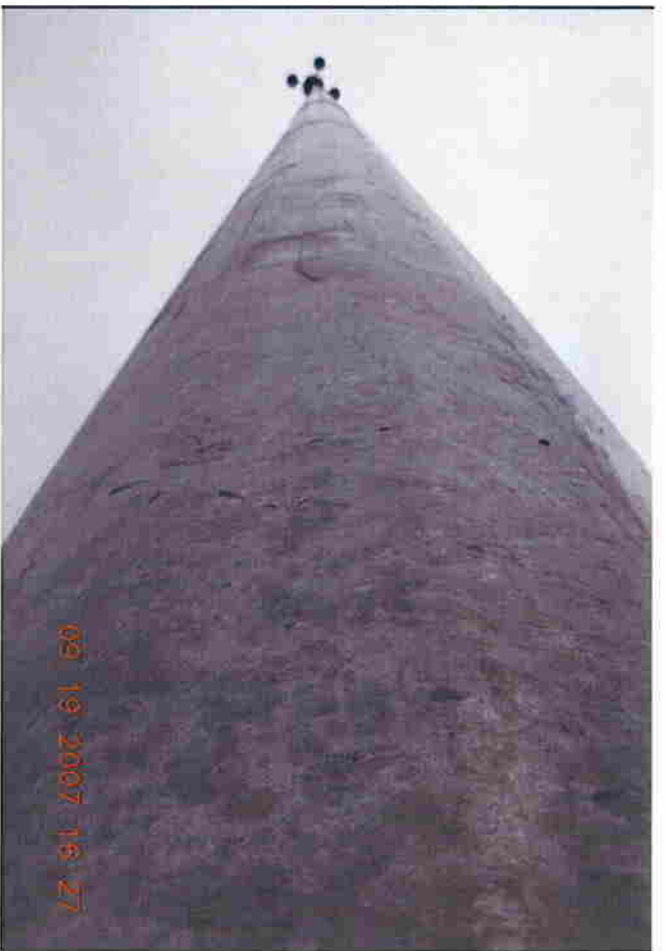
Number **5** Structure **Glenn Hwy-Weigh Sta** Date **09/19/07**
Roll No. **5** Inspectors **Higgs / Stelbach** Frame **174**
Coating above Rod **9**

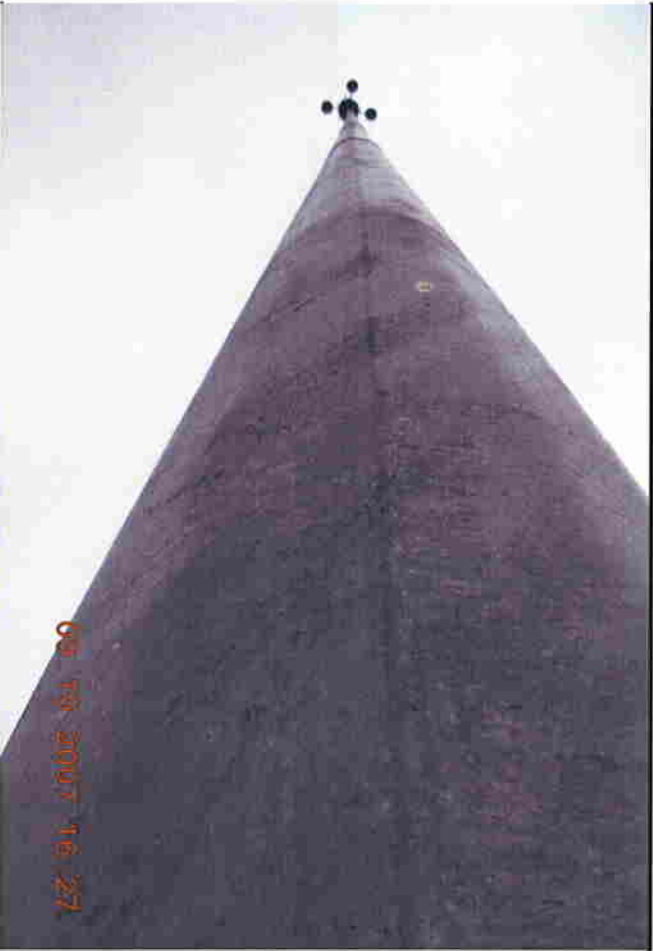
Number **5** Structure **Glenn Hwy-Weigh Sta** Date **09/19/07**
Roll No. **5** Inspectors **Higgs / Stelbach** Frame **175**
Coating above Rod **13**

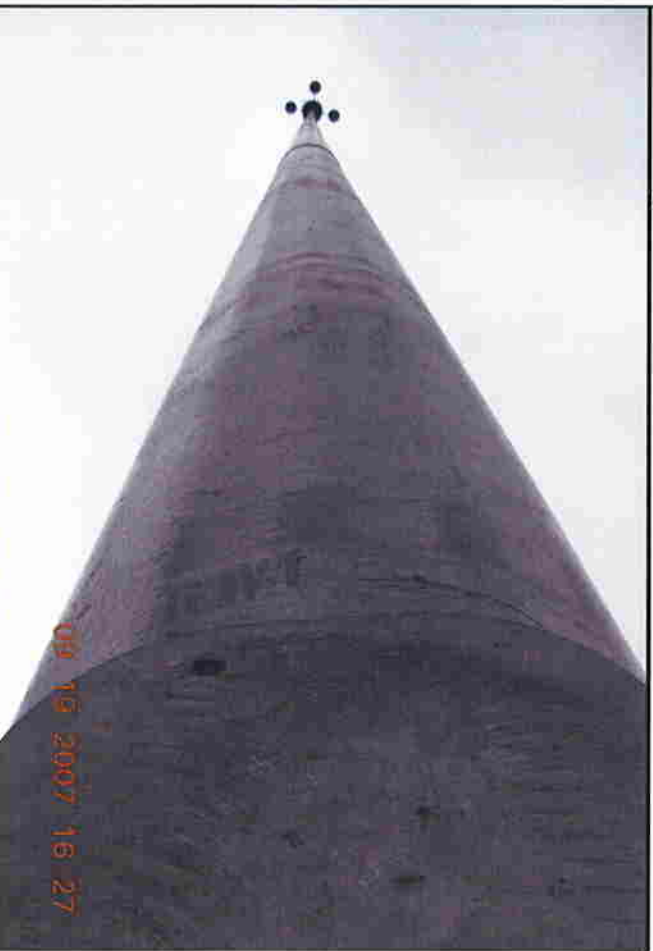
Number **5** Structure **Glenn Hwy-Weigh Sta** Date **09/19/07**
Roll No. **5** Inspectors **Higgs / Stelbach** Frame **176**
Coating above Rod **1**
