Performance of TenCate Paving Interlayers in Asphalt Concrete Pavements

August 2017

INE/AUTC 17.18

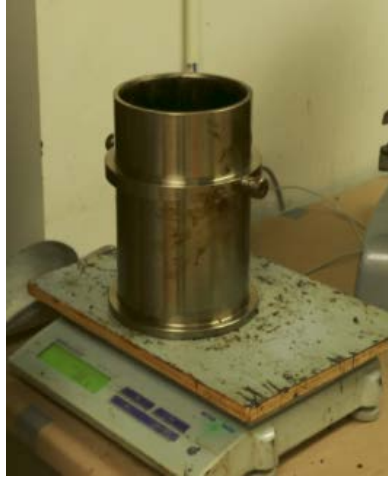
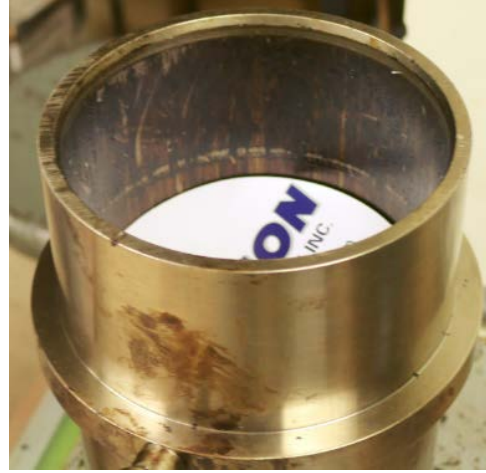
- Step 1: Load the loose mixture to the compaction mold and compact the first half of the specimen as shown in Figures 2.3a and 2.3b.
- Step 2: For the control group, do nothing. For the patching group, place the paving interlayer on top of the first half of the specimen (Figure 2.3c).
- Step 3: Load the remaining loose mixture and complete final compaction (Figures 2.3d and 2.3e).

(a) Load loose mixture

(b) Bottom layer of the specimen (inside the mold)

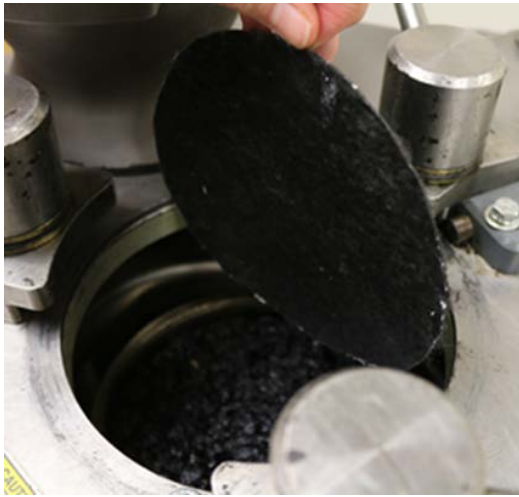
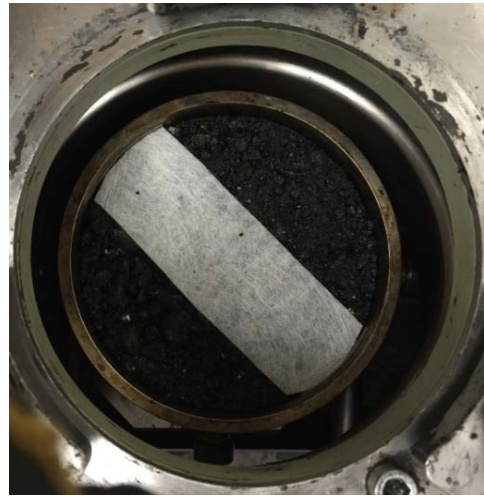
(c) Bottom layer of the specimen (entire interlayer or interlayer strip)

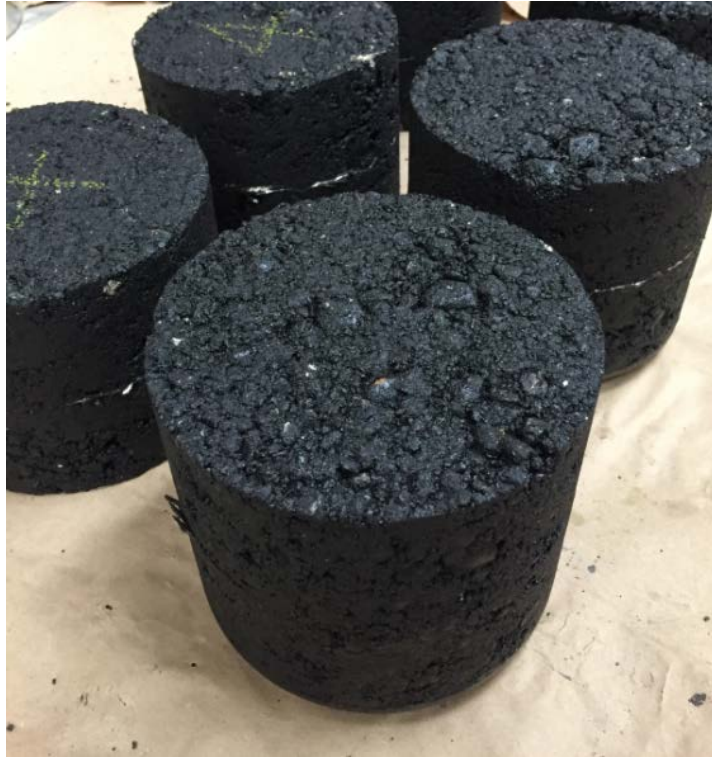
(d) Specimens compacted for the overlay, IDT tests, and dynamic modulus test in IDT mode

Figures 2.3d and 2.3e show typical images of the compacted specimens for different tests. Three groups of samples were fabricated including the control group, patching group with Mirapave, and patching group with TruPave. When cooled to room temperature, the specimens were cut into different shapes and sizes as required for the overlay, IDT, and dynamic modulus tests.

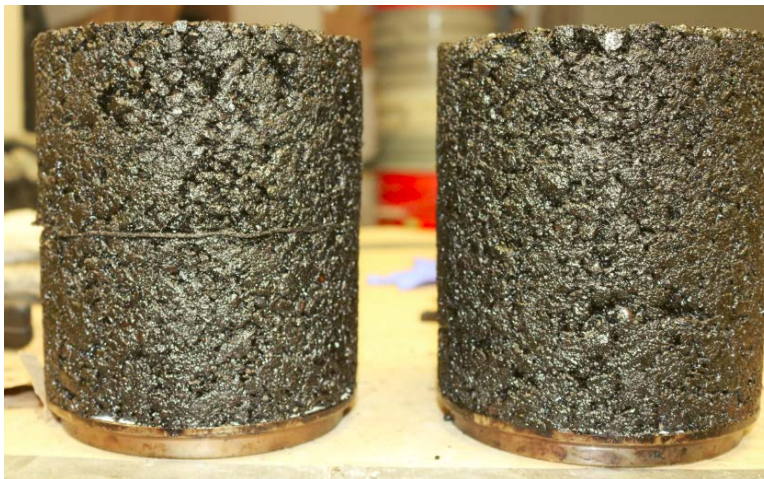
Figure 2.3 Specimen compaction

(e) Specimens compacted for the dynamic modulus test by the AMPT (patching group at left, control group at right)

After compaction and cooling to room temperature, the cylindrical specimens (Figure 2.3e) were cut into $150 \pm 2 \text{ mm} \times 75 \pm 0.5 \text{ mm} \times 38 \pm 0.5 \text{ mm}$ core specimens. The coring procedure was as follows:

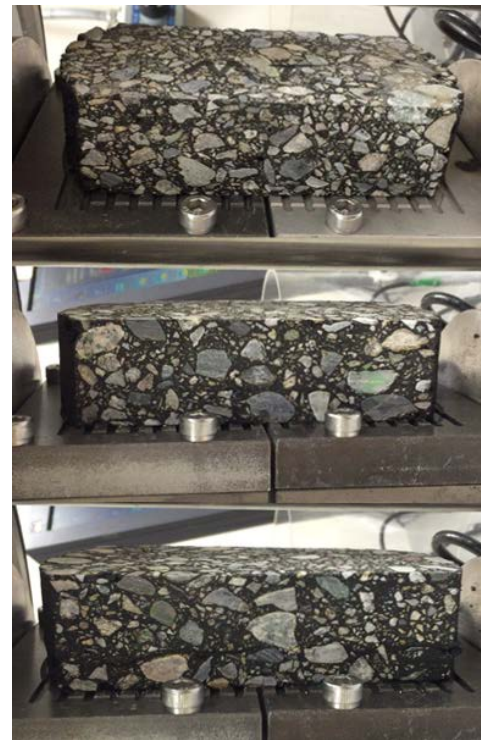
The overlay test was conducted following the procedures according to the Texas overlay test (Zhou and Scullion 2005). Two sizes of TruPave or Mirapave, as shown in Figure 2.1, were used. The overlay test configuration is schematically shown in Figure 2.4a for the specimens with/without patching material. When the test begins, cracks form from the center of the bottom of the sample and propagate to the area where the paving interlayer is placed. In order to reveal how these paving interlayers mitigate and control the growth of cracks, the crack failure modes of specimens with and without TruPave and Mirapave were recorded under monotonic tension loading.

(a) Schematic of design

(b) Specimen installation

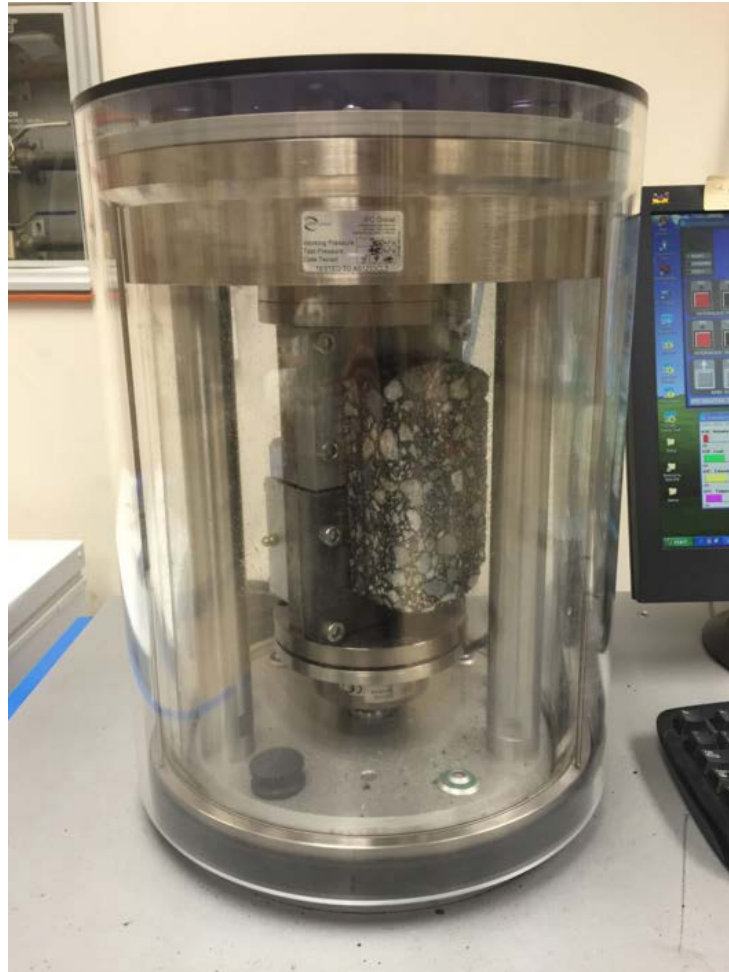
After coring, the trimmed specimens were oven-dried at 40°C to constant weights. Then, using a two-part epoxy (approximately 12 g/specimen), the specimens were glued to the base plates. Note that each specimen was required to be centered and aligned parallel to the edges of the base plate. In addition, to ensure full contact with the base plates, weight was used to apply pressure to the contact surface between the specimens and the base plates. The epoxy was allowed to cure for 8 hours. Then the specimen with the base plates was installed as shown in Figure 2.4b. Figure 2.6

shows an installed specimen in the testing chamber. The temperature of the chamber was set to 25°C. The specimen was conditioned at 25°C for at least 1 hour before the overlay test.

Figure 2.6 Overlay test setup

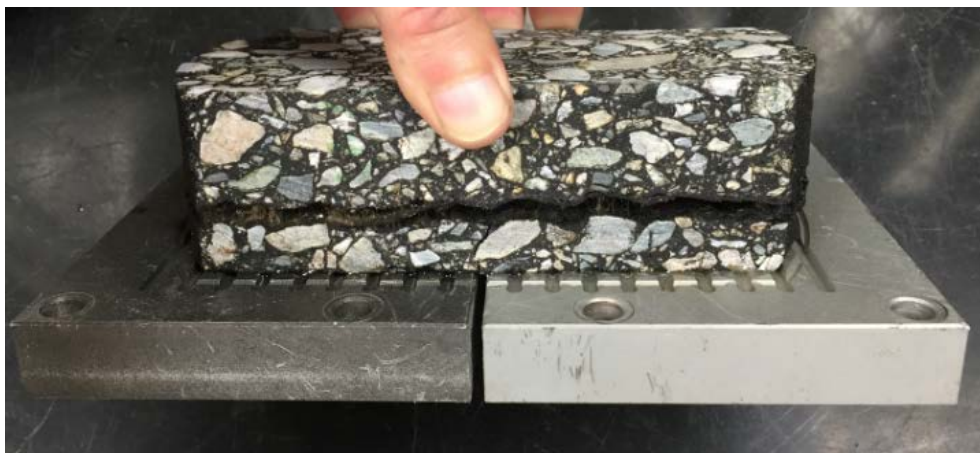
Figure 2.8 Specimen debonding during overlay testing

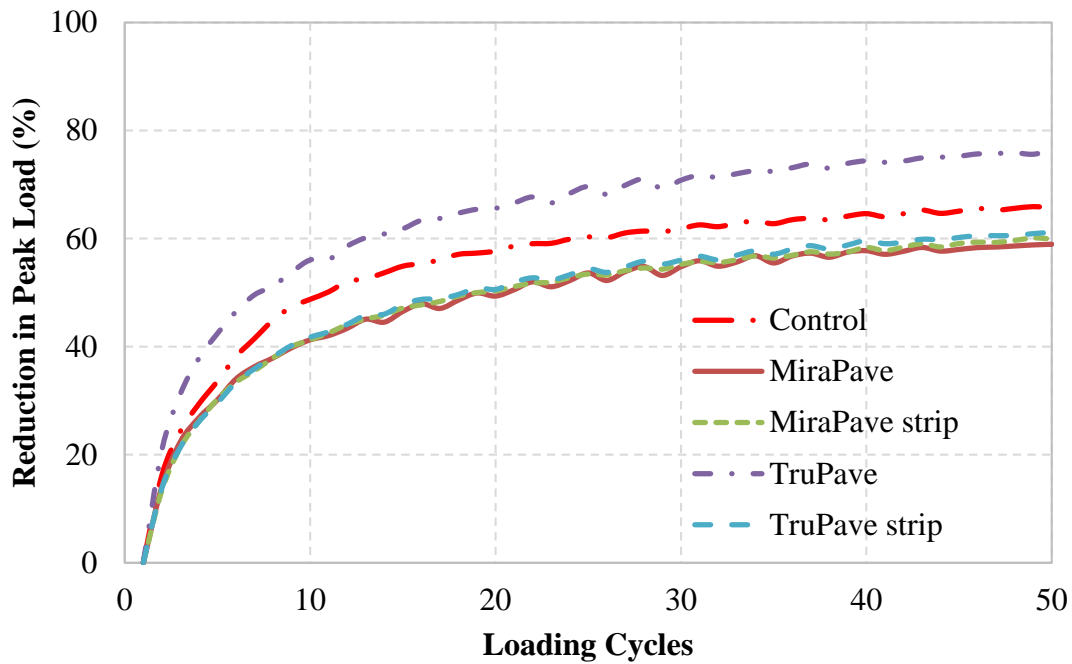
Figure 2.10 Overlay test results for first 100 loading cycles

According to the mechanism of the overlay test, a lower reduction percentage of the peak load is more desirable in terms of reflective cracking resistance. That being said, the results displayed in Figures 2.9 and 2.10 seem supportive of using paving interlayers. As previously discussed and displayed in Figure 2.8, the early failure of samples with an entire layer of TruPave might be subject to debonding between the asphalt mixture and the TruPave interlayer. Note that TruPave is adhesive on one-side only. In this study, the adhesive side faced down when placed to simulate patching an assumable crack on top of the bottom layer. A layer of HMA was then placed on top of the non-adhesive side of the TruPave material. The two layers of samples with an entire layer of TruPave cracked first and then debonded, as shown in Figure 2.8, when subject to tensile stress. This failure of AC with an entire layer of TruPave does not necessarily mean that the

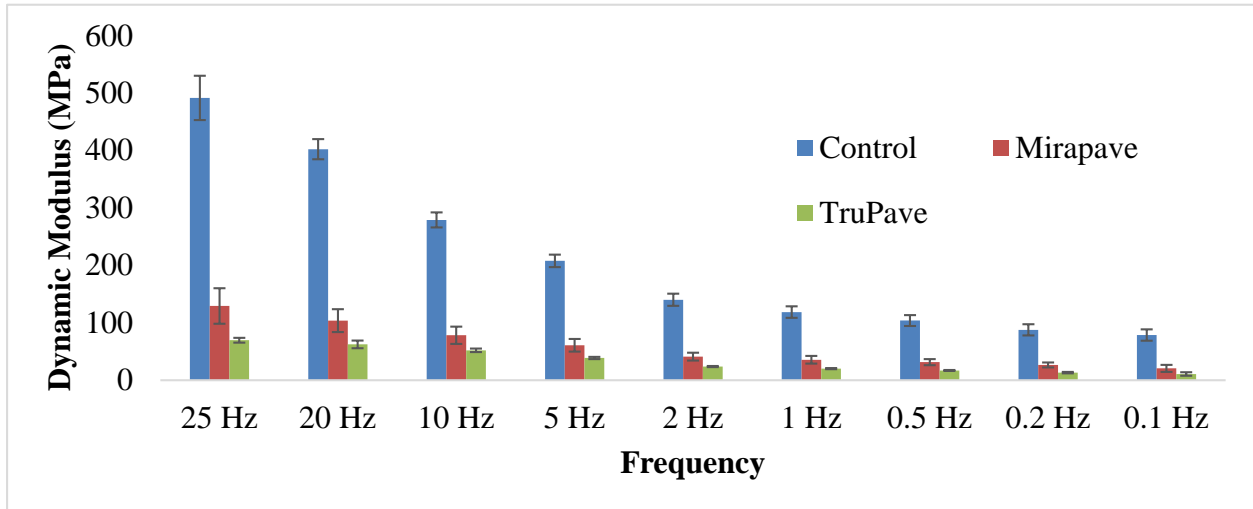
Figure 2.16 Dynamic modulus results tested at 54°C

According to Figures 2.13 to 2.16, the measured $|E^*|$ of control specimens was remarkably higher than the mixes with paving interlayers. At low temperature levels, the measured $|E^*|$ of the Mirapave-treated specimen was nearly the same as that of the TruPave-treated specimen. However, with increasing temperature, it was found that the $|E^*|$ of the Mirapave-treated specimen rose higher than that of the TruPave-treated specimen. Using the principle of time-temperature superposition, a master curve was constructed by shifting the data at various temperatures to the reference temperature (21°C) with respect to the time until the curves merge into a single smooth function. The master curves of three groups are organized in Figure 2.17, where it can be seen that the master curves of all paving interlayer-treated specimens were substantially lower than the master curve of the control mix, indicating that interlayer-treated specimens had lower $|E^*|$. The measured $|E^*|$, which was extremely low, exceeded the lower limit of input for the Mechanistic

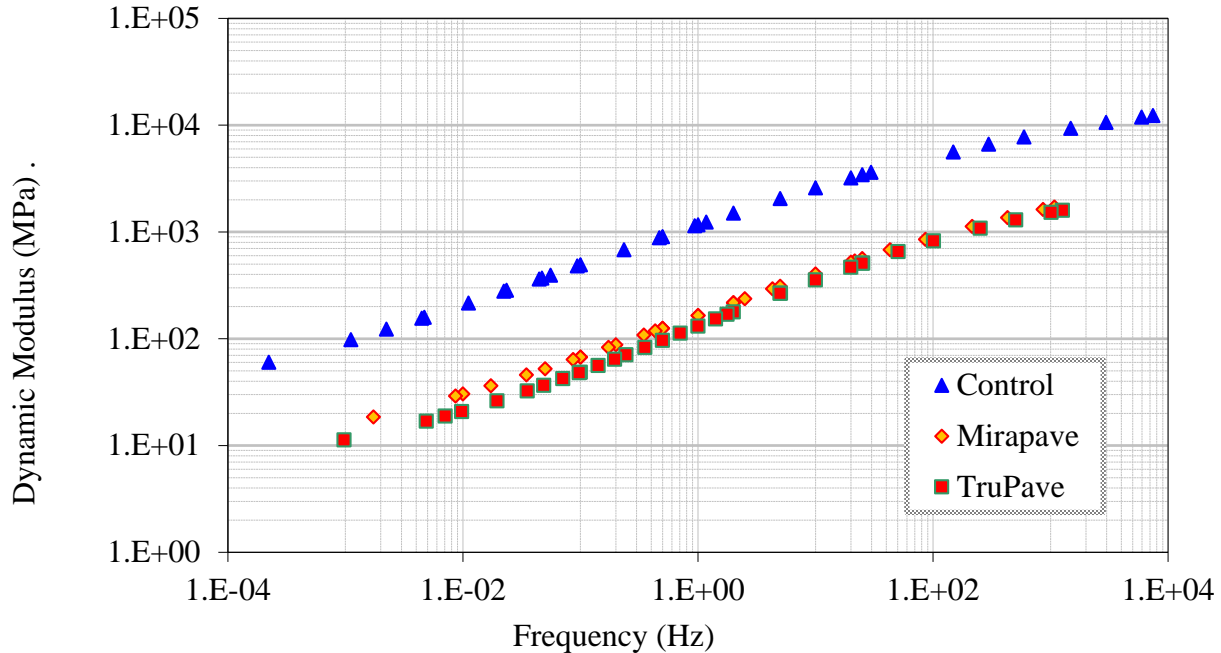
Figure 2.17 Master curves of dynamic modulus test results using the AMPT

Since the mix part used for the specimens was the same as the mix used for the control sample, the low $|E^*|$ of the specimens with paving interlayer was attributed to the inclusion of the paving interlayer and its low stiffness. In addition, the paving interlayer was under compression rather than tension, which is different from the stress state that the fabric would experience in the field. As a result, the reinforcement of the paving interlayer could not be reflected by this test. The paving interlayer is used to improve the cracking resistance of the AC layer structure by taking advantage of its high tensile strength; thus, the measured $|E^*|$ was not representative. In addition to using the AMPT, the $|E^*|$ can be measured in IDT mode as reported by Kim et al. (2004). In the

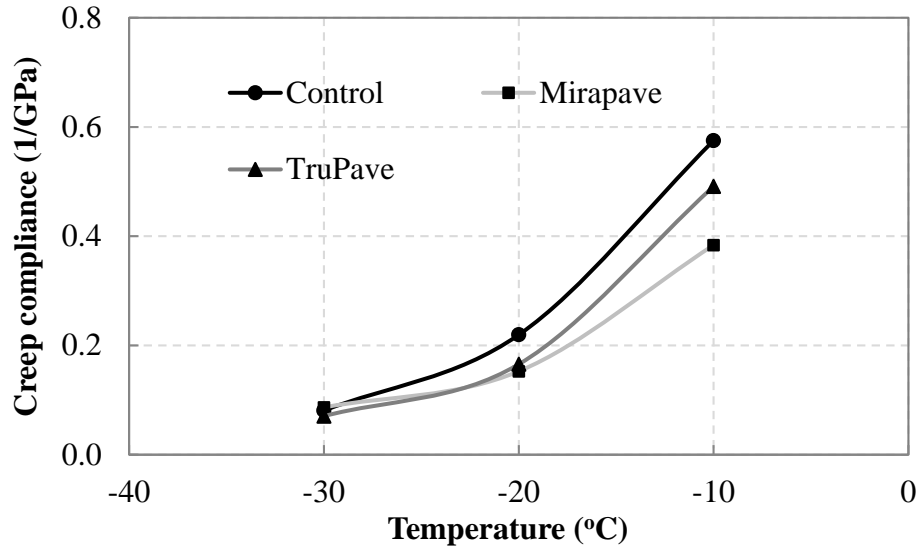
Usually, AC with lower creep compliance is considered more susceptible to low-temperature cracking. Since cracking due to thermal contraction only occurs at low temperatures, the creep compliance of AC with/without paving interlayers at subfreezing temperatures are plotted in Figure 2.22. At very low temperatures (i.e., -30°C), the creep compliances of mixtures with paving interlayers were close to those of the control mixtures. As a result, the inclusion of the paving interlayers in the pavement structure did not compromise pavement performance in low-temperature cracking resistance. Note that the variation of creep compliance in the control group was more dramatic than that of the mixtures with paving interlayers, as shown in Figure 2.22. In

Figure 2.22 Effect of temperature on creep compliance (500s)

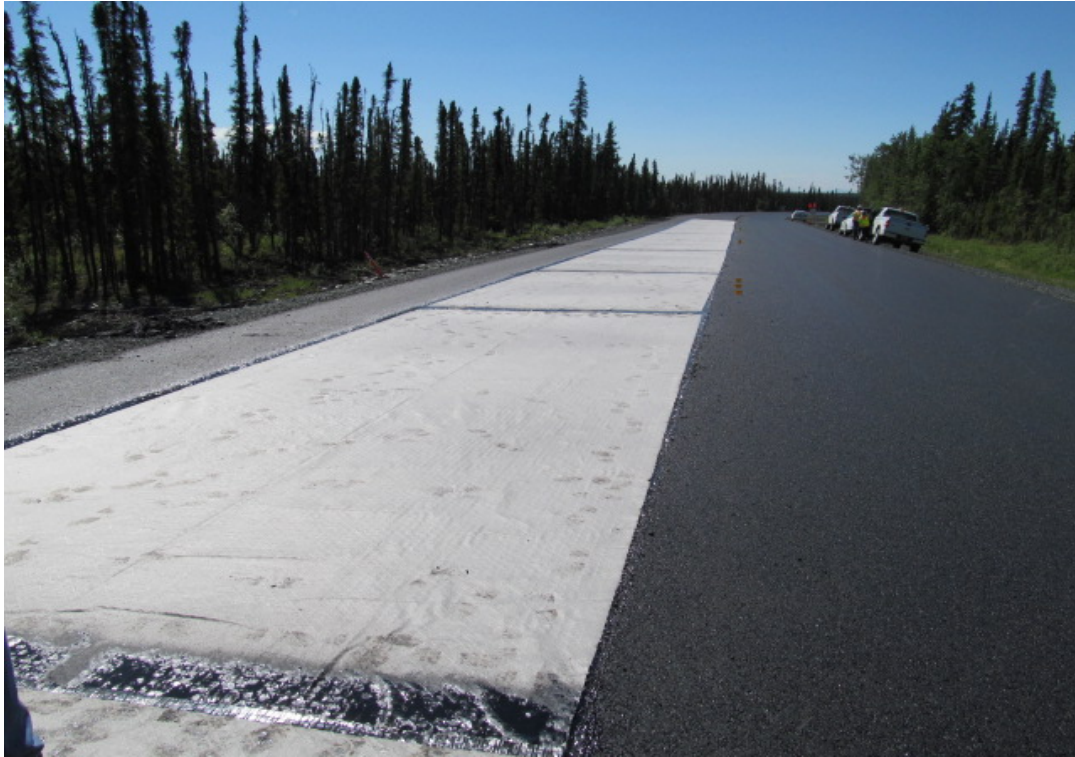
(a) Construction of the test section

Figure 3.14 G⁴ test section

Three test sections reinforced with paving interlayers were established in July 2013: one with G⁴ in areas 2 and 3 (Figure 3.14), one with G50/50 in area 9 (Figure 3.15), and one with G100/100 in area 10 (Figure 3.16). A tack coat of neat oil was applied at the shooting rates of 0.19 gal/yd², 0.27 gal/yd², and 0.27 gal/yd² for sections with G⁴, G50/50 and, G100/100, respectively. Area 4 was selected as the control section for further field survey. The pavement structures in four sections are presented in Figures 3.14 to 3.17.

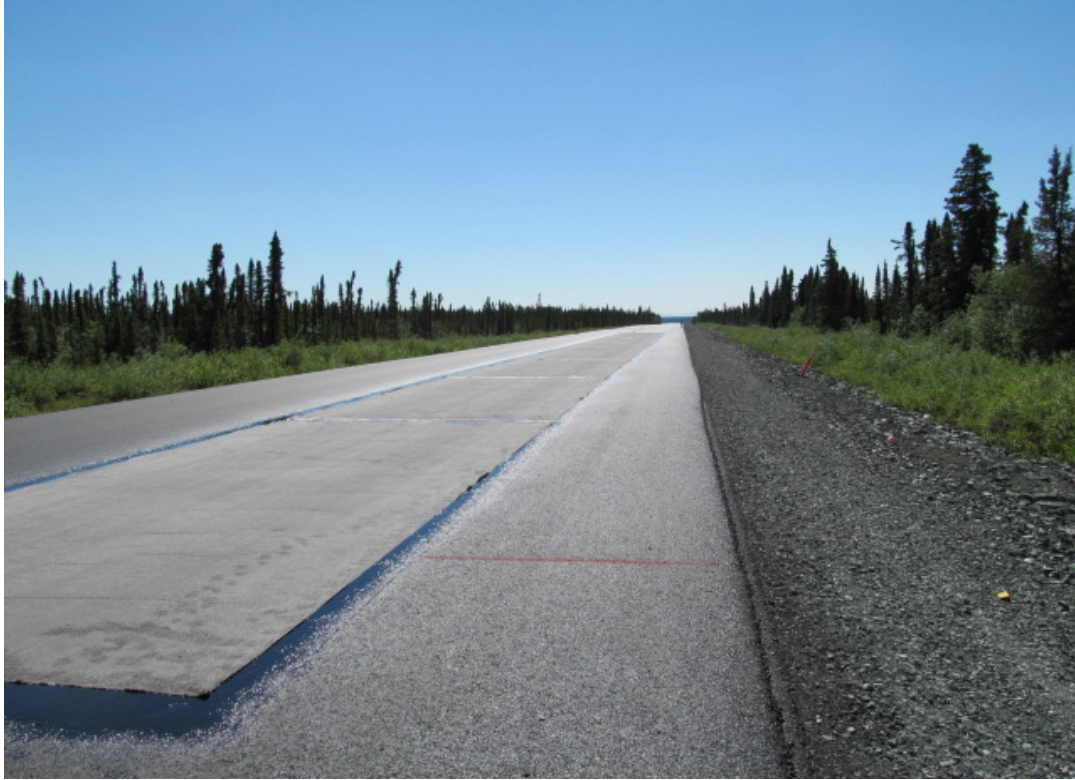
(a) Construction of the test section

Figure 3.15 G50/50 test section

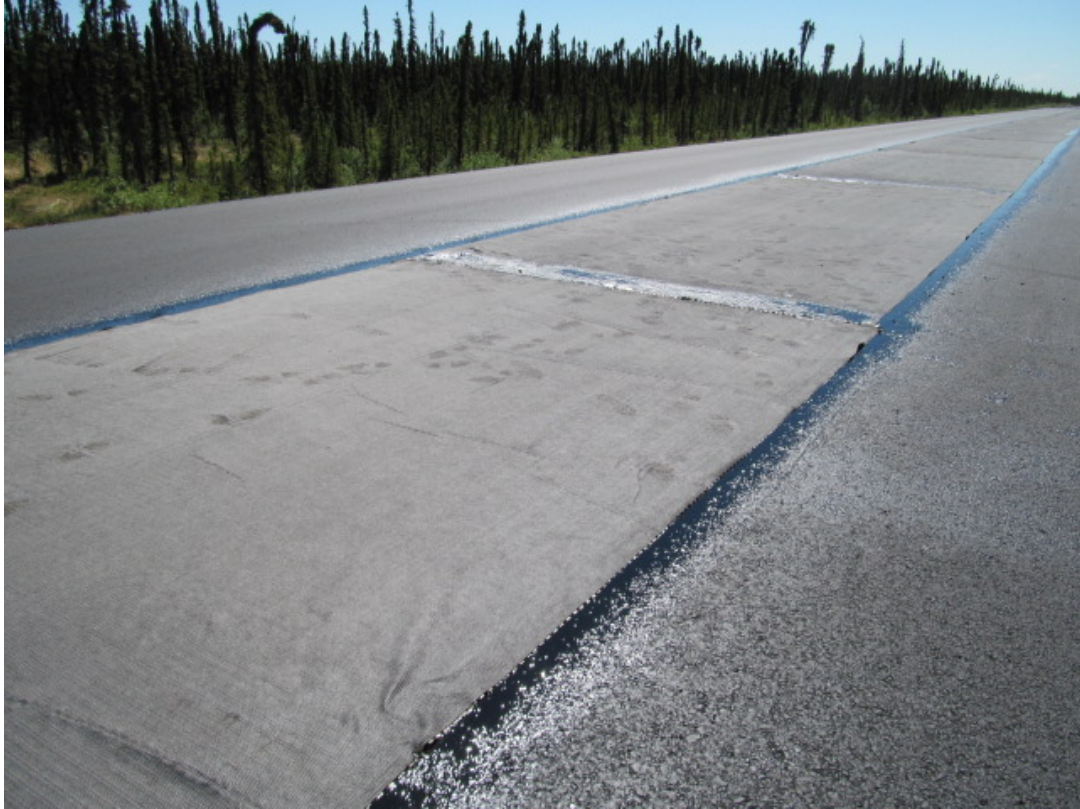
(a) Construction of the test section

Figure 3.16 G100/100 test section

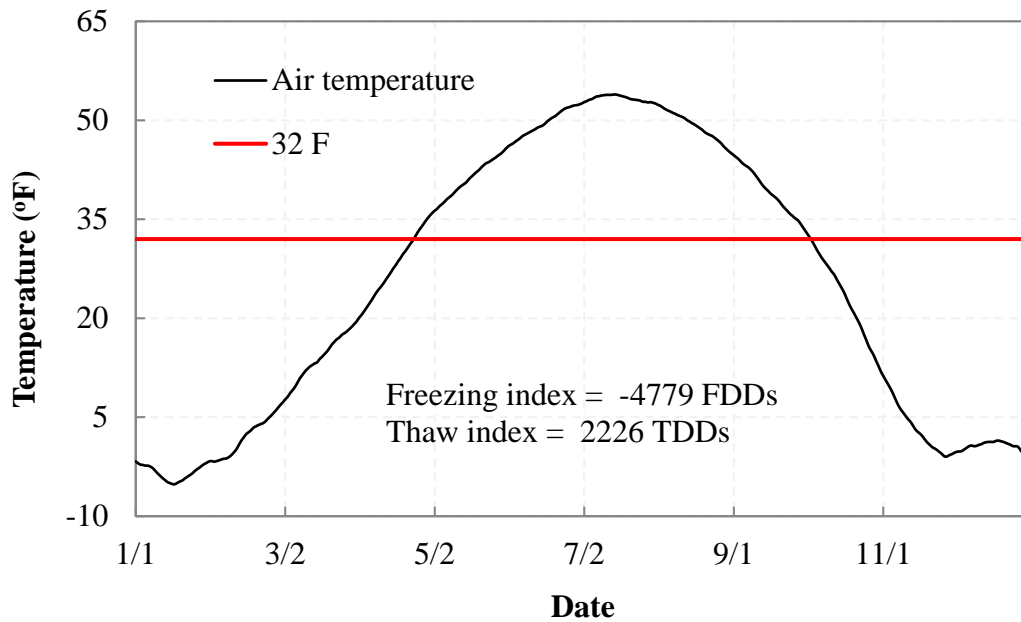
average of the data at two stations was used as the representative traffic volume at the test sections. The annual average daily traffic between the years 2010 and 2015 is presented in Figure 3.18b. The daily traffic did not vary much (from 361 per day to 382 per day) during this period. The annual traffic by month in 2015 is summarized in Figure 3.18c. The traffic volume in summer was approximately 4 times greater than in winter. The traffic by hour of day in 2015 is summarized in Figure 3.18d. The daily traffic peak was between 12:00 and 16:00 with average traffic volume of 30 per hour.

(a) Annual climatic condition

(b) Annual average daily traffic

(d) Annual traffic by hour of day

Figure 3.18 Climatic and traffic condition at the test section (1981–2010)

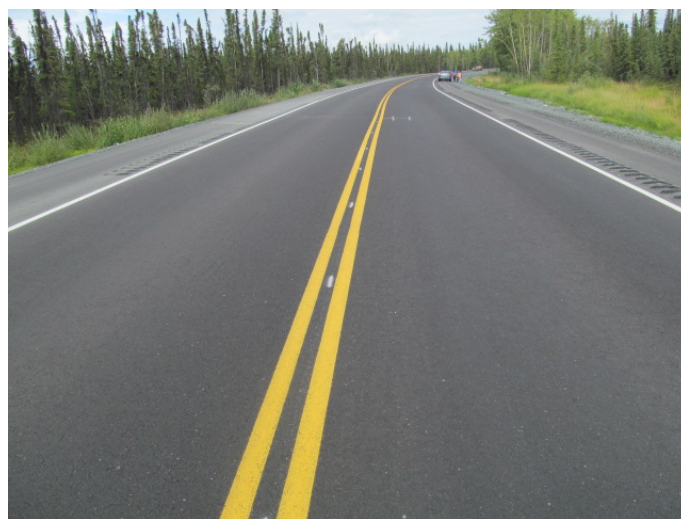
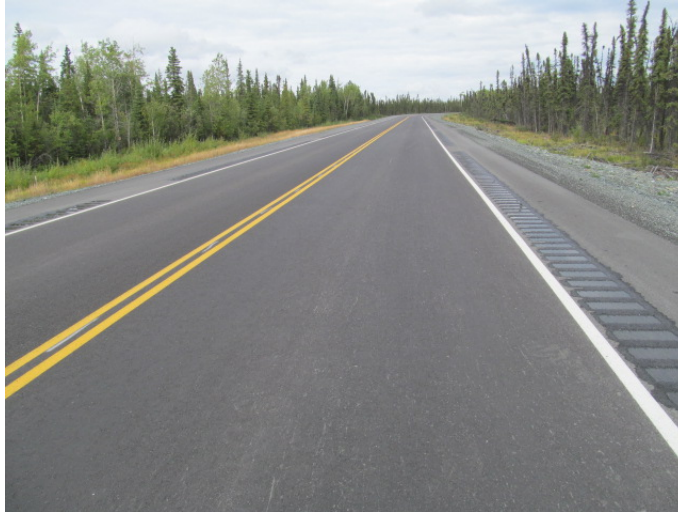
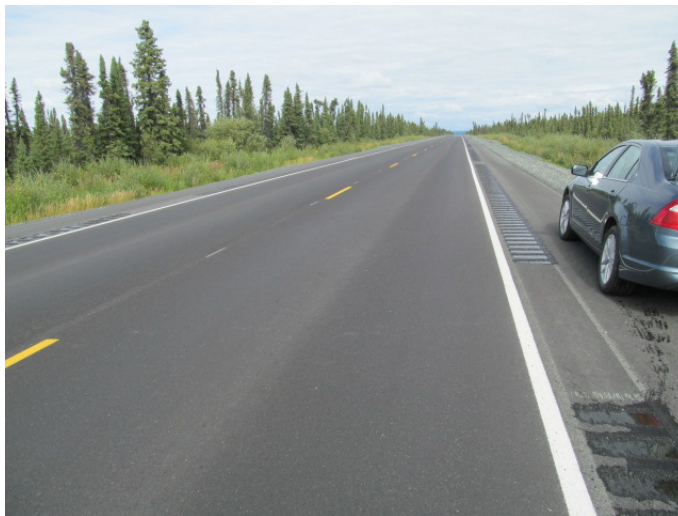
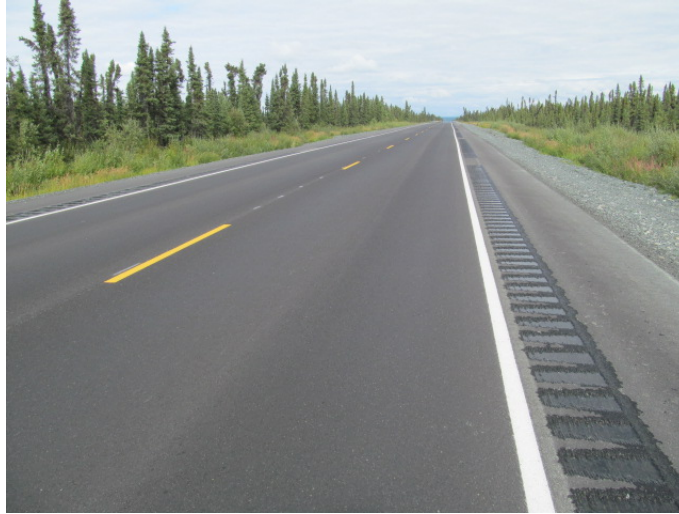
Two pavement condition surveys were conducted on August 19 and October 12, 2013. No cracks were found in any of the test sections during these two field trips (Figures 3.19–3.22).

Figure 3.19 Control section (300 feet in area 4)

Figure 3.20 G^4 test section (reinforced with 300 feet of G^4 paving interlayer in the right lane in area 2, no visible cracks)

Figure 3.21 $G50/50$ test section (reinforced with 300 feet of $G50/50$ in the left lane in area 9, no visible cracks)

Figure 3.22 G100/100 test section (reinforced with 300 feet G100/100 in the left lane in area 10, no visible cracks present)

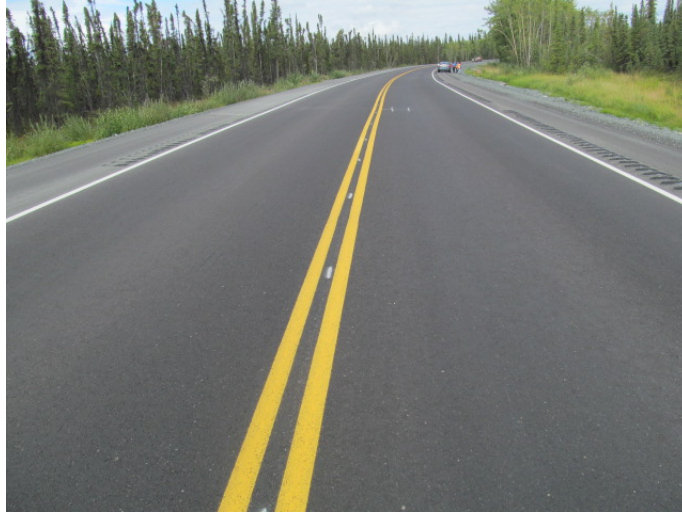
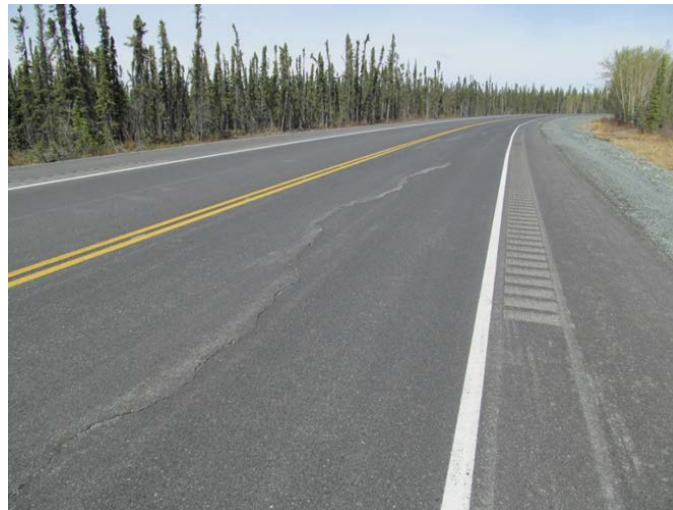
Figure 3.23 Control section: (a) no visible cracks (October 12, 2013); (b) 266 feet of longitudinal crack (May 15, 2014)

Field evaluations were performed on May 15 and in September 2014 to see how the paving interlayers had functioned over the course of the winter. Cracks were observed in every test section (Figures 3.23–3.26). Table 3.2 summarizes the crack data collected.

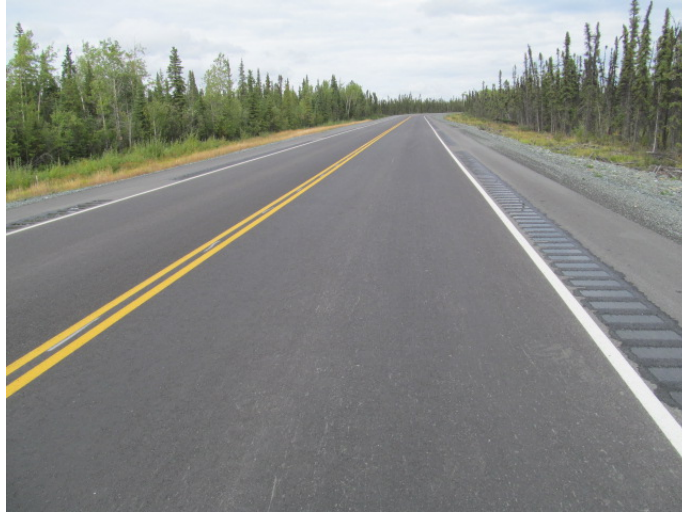
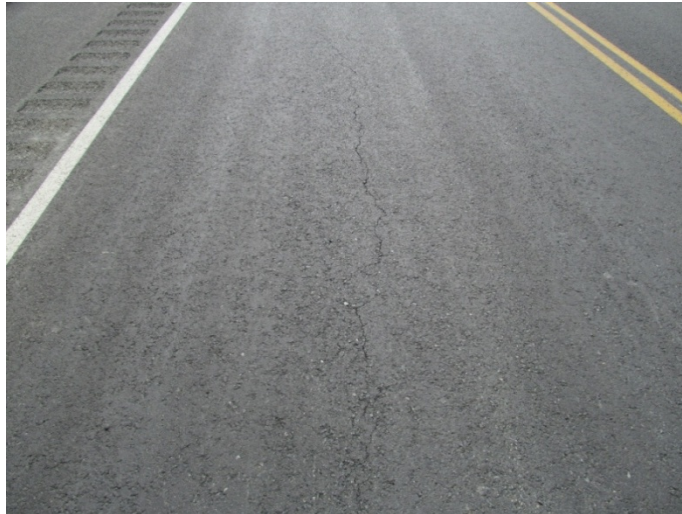
Figure 3.24 G^4 test section: (a) no visible cracks (October 12, 2013); (b) both longitudinal and transverse cracks present (May 15, 2014)

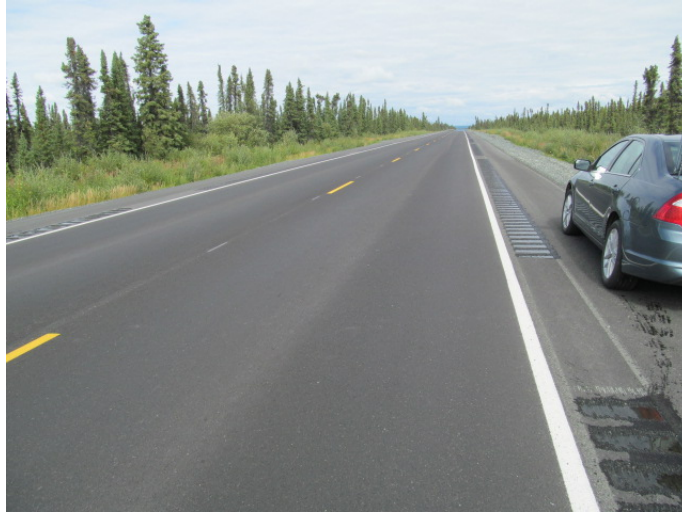
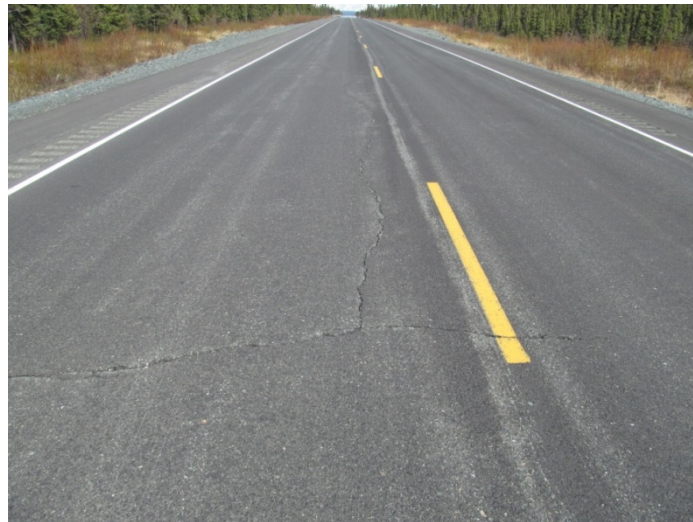
Figure 3.25 G50/50 test section: (a) no visible cracks (October 12, 2013); (b) both transverse and longitudinal cracks present (May 15, 2014)

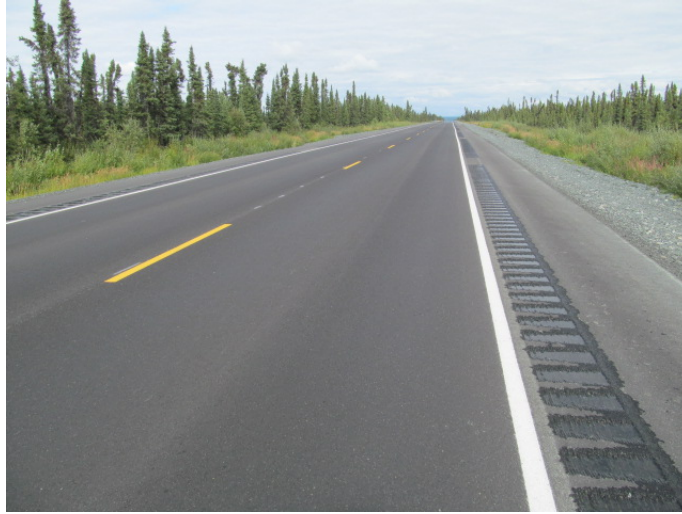
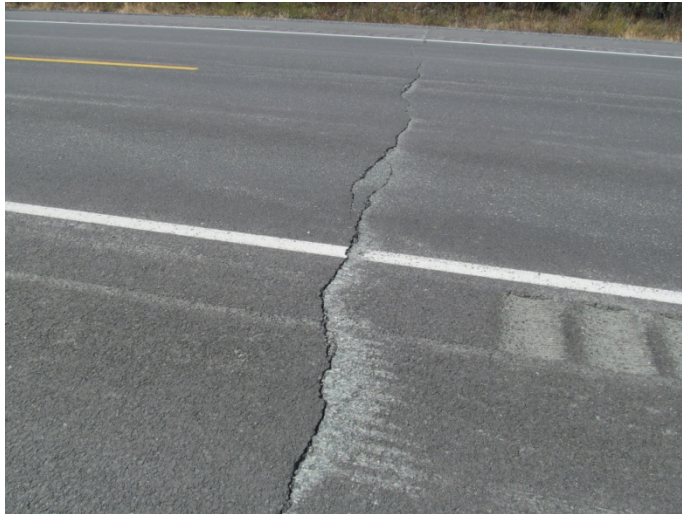
Figure 3.26 G100/100 test section: (a) no visible cracks (October 12, 2013); (b) transverse crack present (May 15, 2014)

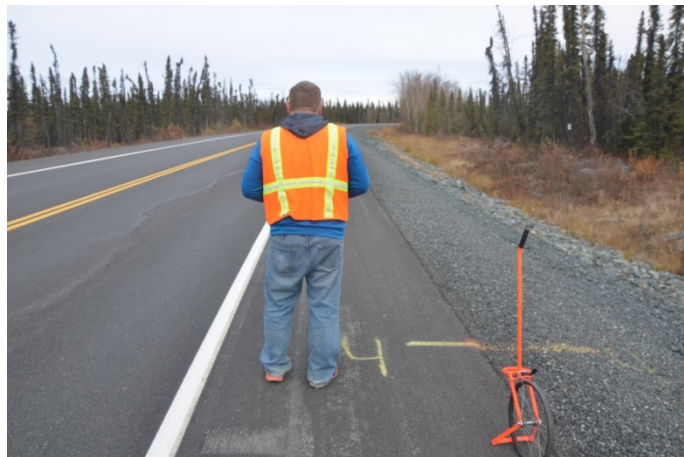
Figure 3.27 Control section (area 4) no new crack

In September 2014, the G⁴ reinforced section (area 2) had the only new crack found in all of the test sections, and it was minor (Figure 3.27–3.29). Many very small fissures were observed where likely, after the next winter, more cracks would become pronounced. Overall, the test sections including the control sections were in the same condition as the evaluation performed in May 2014.

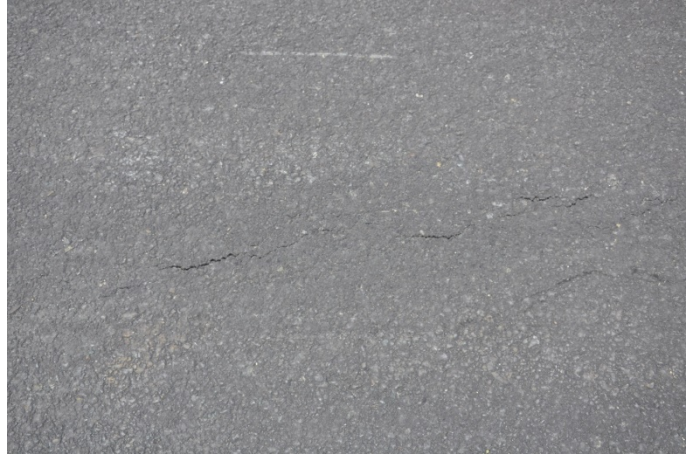
Figure 3.28 G⁴ section (area 2) new minor crack

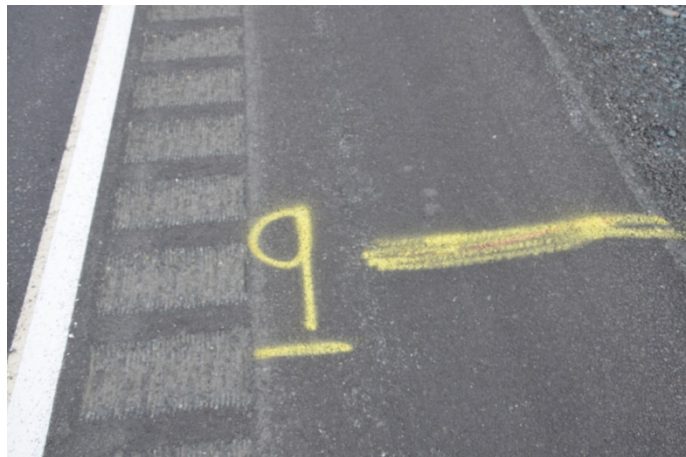
Figure 3.29 G50/50 and G100/100 (sections 9 and 10) no new crack

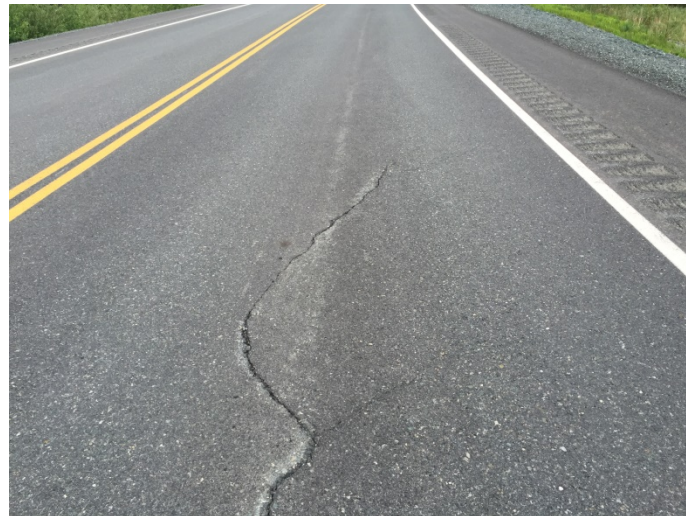
Figure 3.30 Control section: (a) new minor transverse crack; (b) new moderate-major longitudinal crack

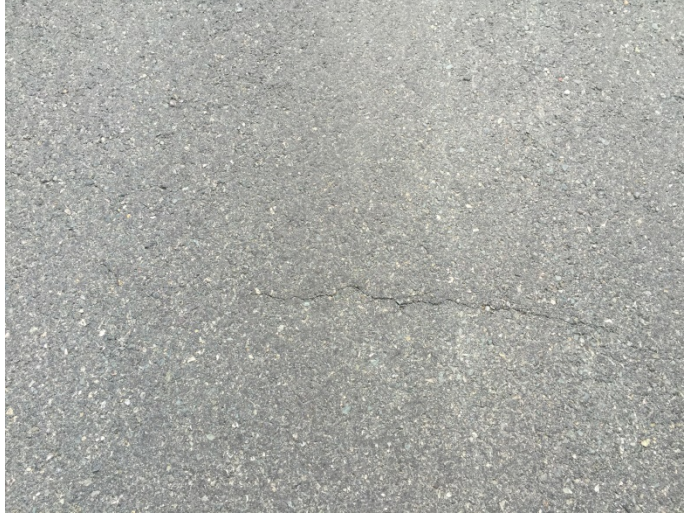
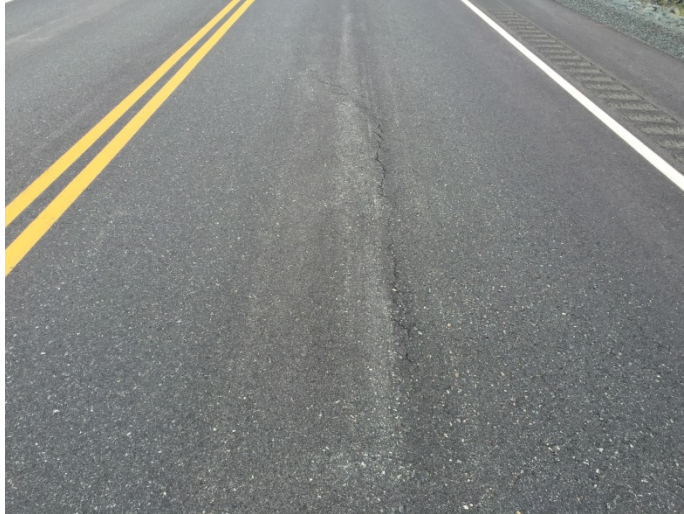
Figure 3.31 G^4 test section: (a) new minor transverse crack; (b) new minor longitudinal crack

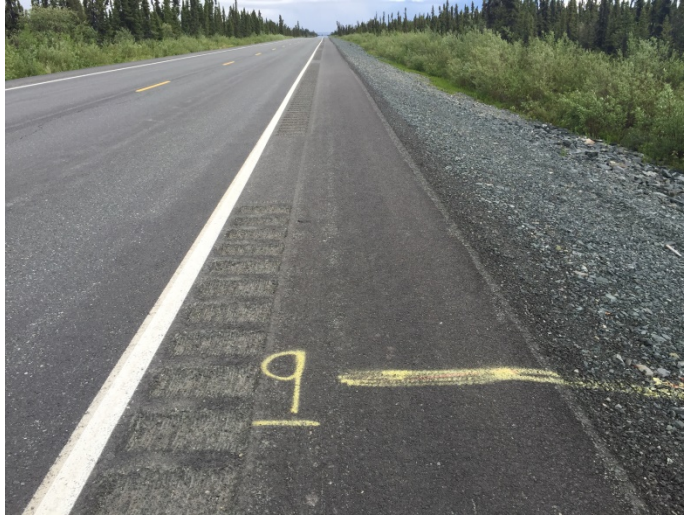
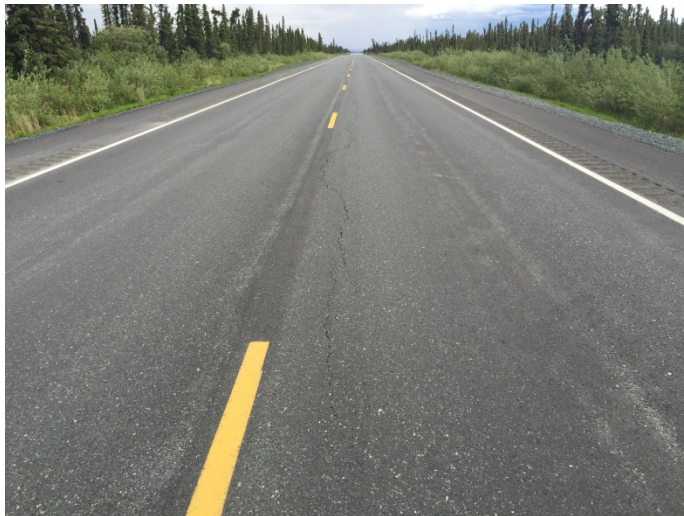
Figure 3.32 G50/50 test section: (a) no new transverse crack; (b) new minor longitudinal crack

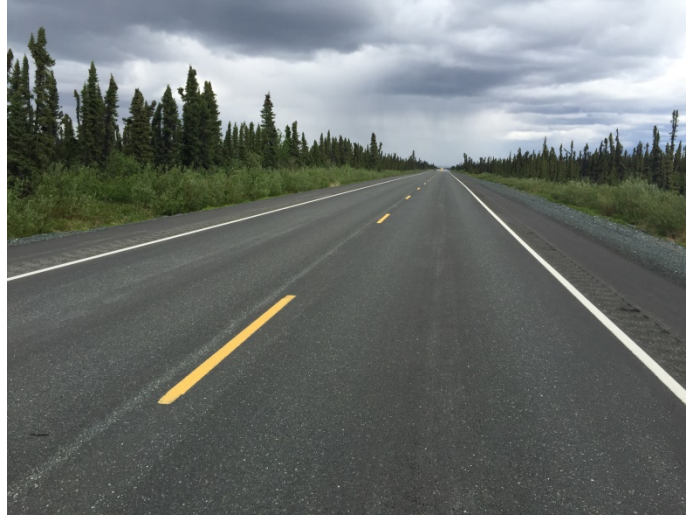
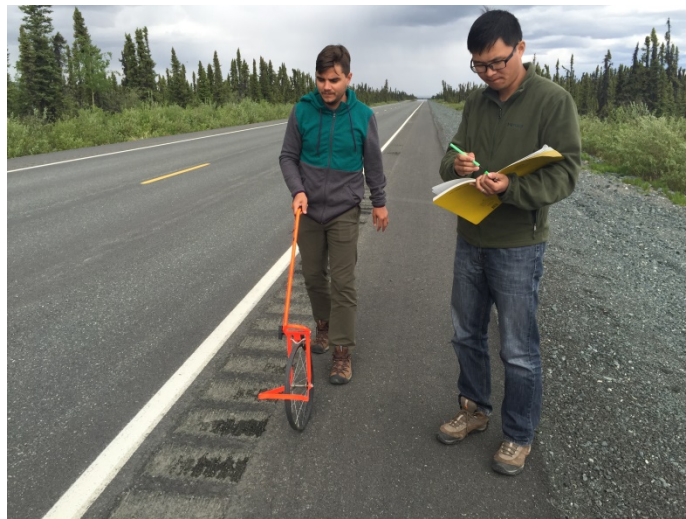
Figure 3.33 G100/100 test section: (a) no new transverse crack; (b) no new longitudinal crack

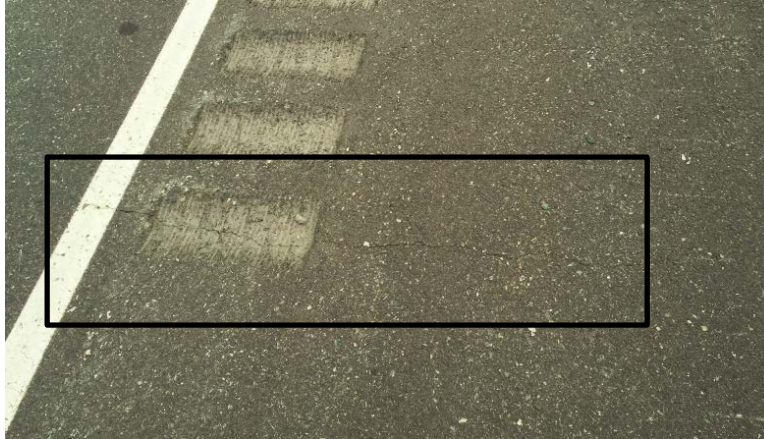
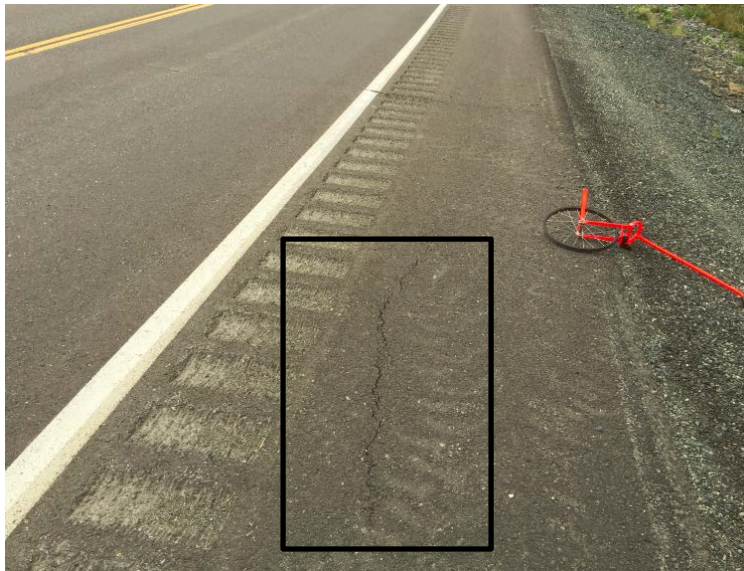
Figure 3.35 G^4 test section: (a) new minor transverse crack; (b) new minor longitudinal crack

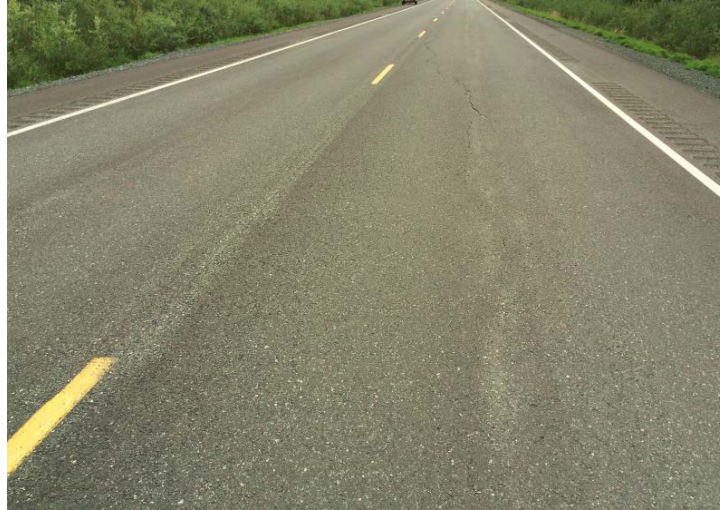
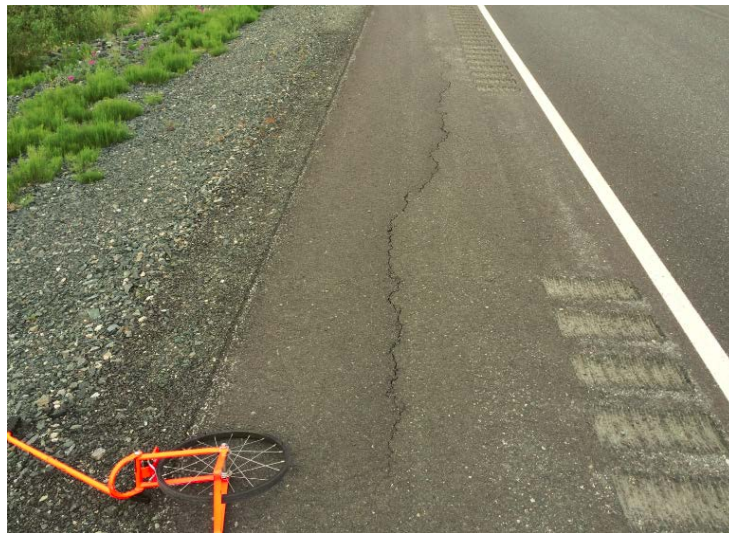
Figure 3.36 G50/50 test section: (a) no new transverse crack (but polishing is very obvious); (b) new minor longitudinal crack on the shoulder

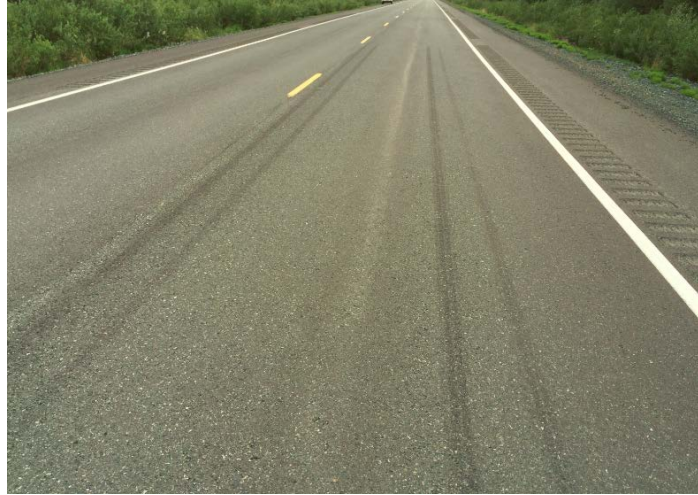
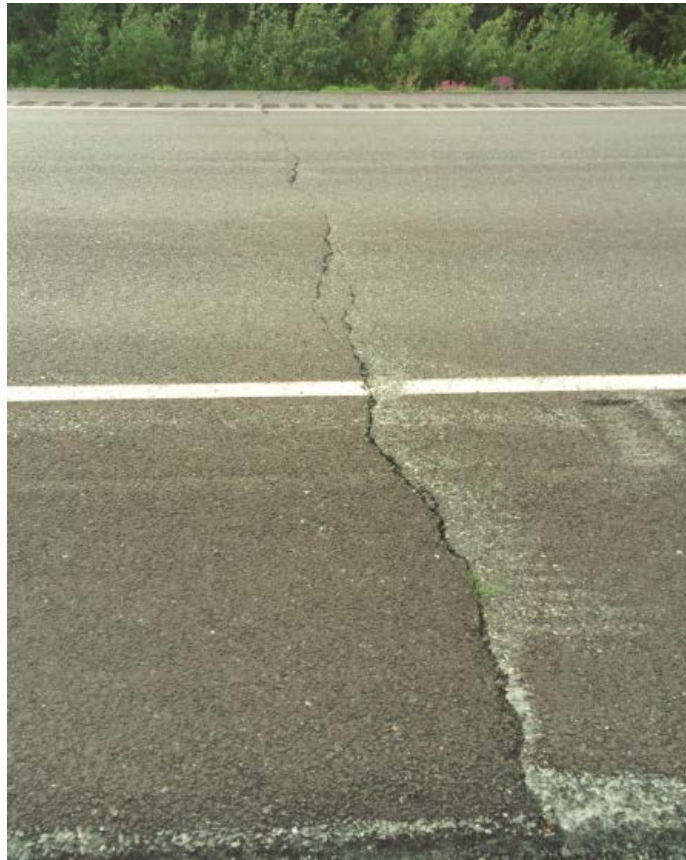
Figure 3.37 G100/100 test section: (a) no new transverse or longitudinal crack (but polishing is very obvious); (b) the major crack observed from May 2014, 1/8 to 1 in width

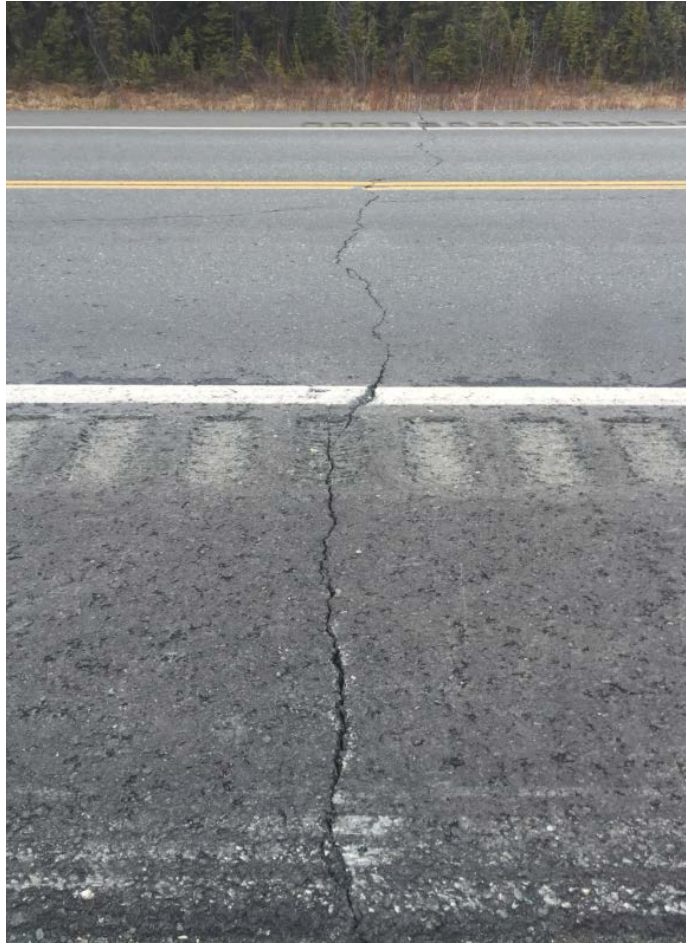
Figure 3.38 Evolution of a transverse crack from minor to major in G⁴ test section
