Performance of TenCate Paving Interlayers in Asphalt Concrete Pavements

August 2017

INE/AUTC 17.18

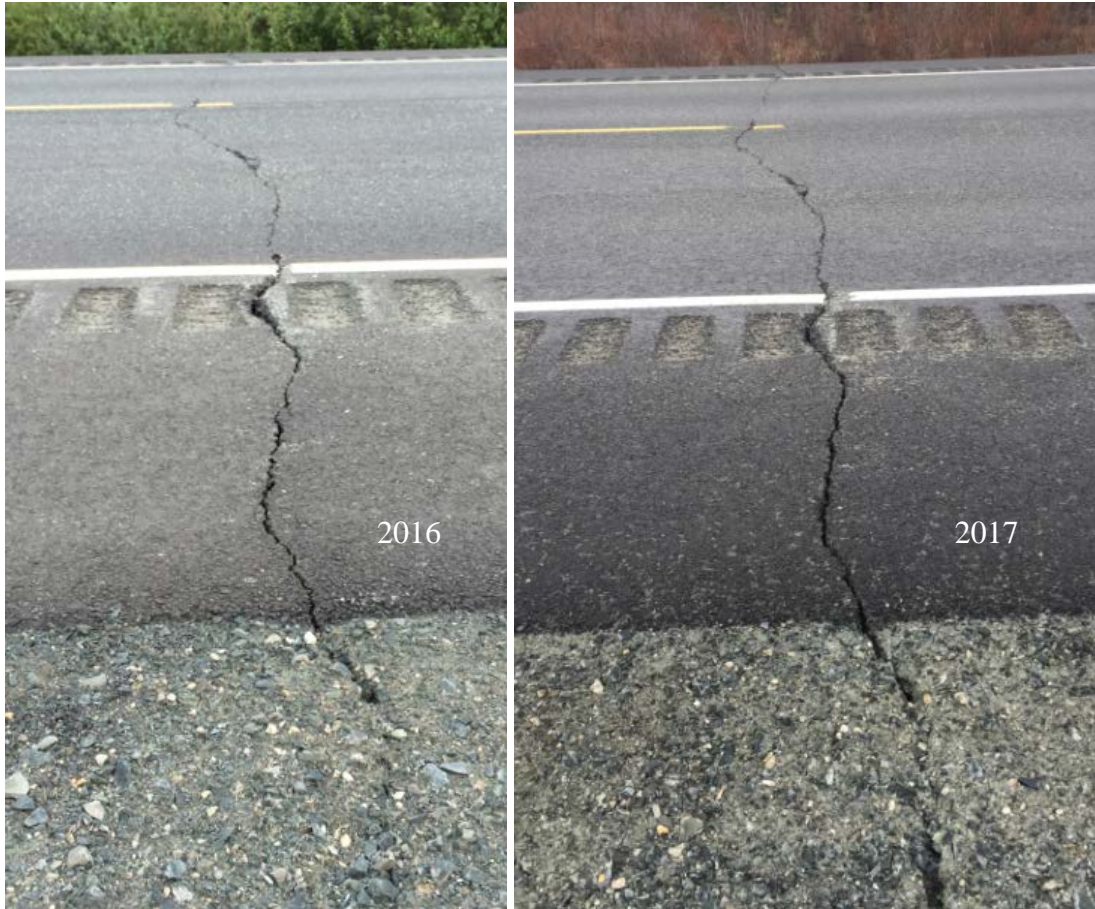
Figure 3.39 A transverse crack in G50/50 section
